DOT/FAA/CT-94/53

Joint Sealants for Airport Pavements

April 1995

Final Report

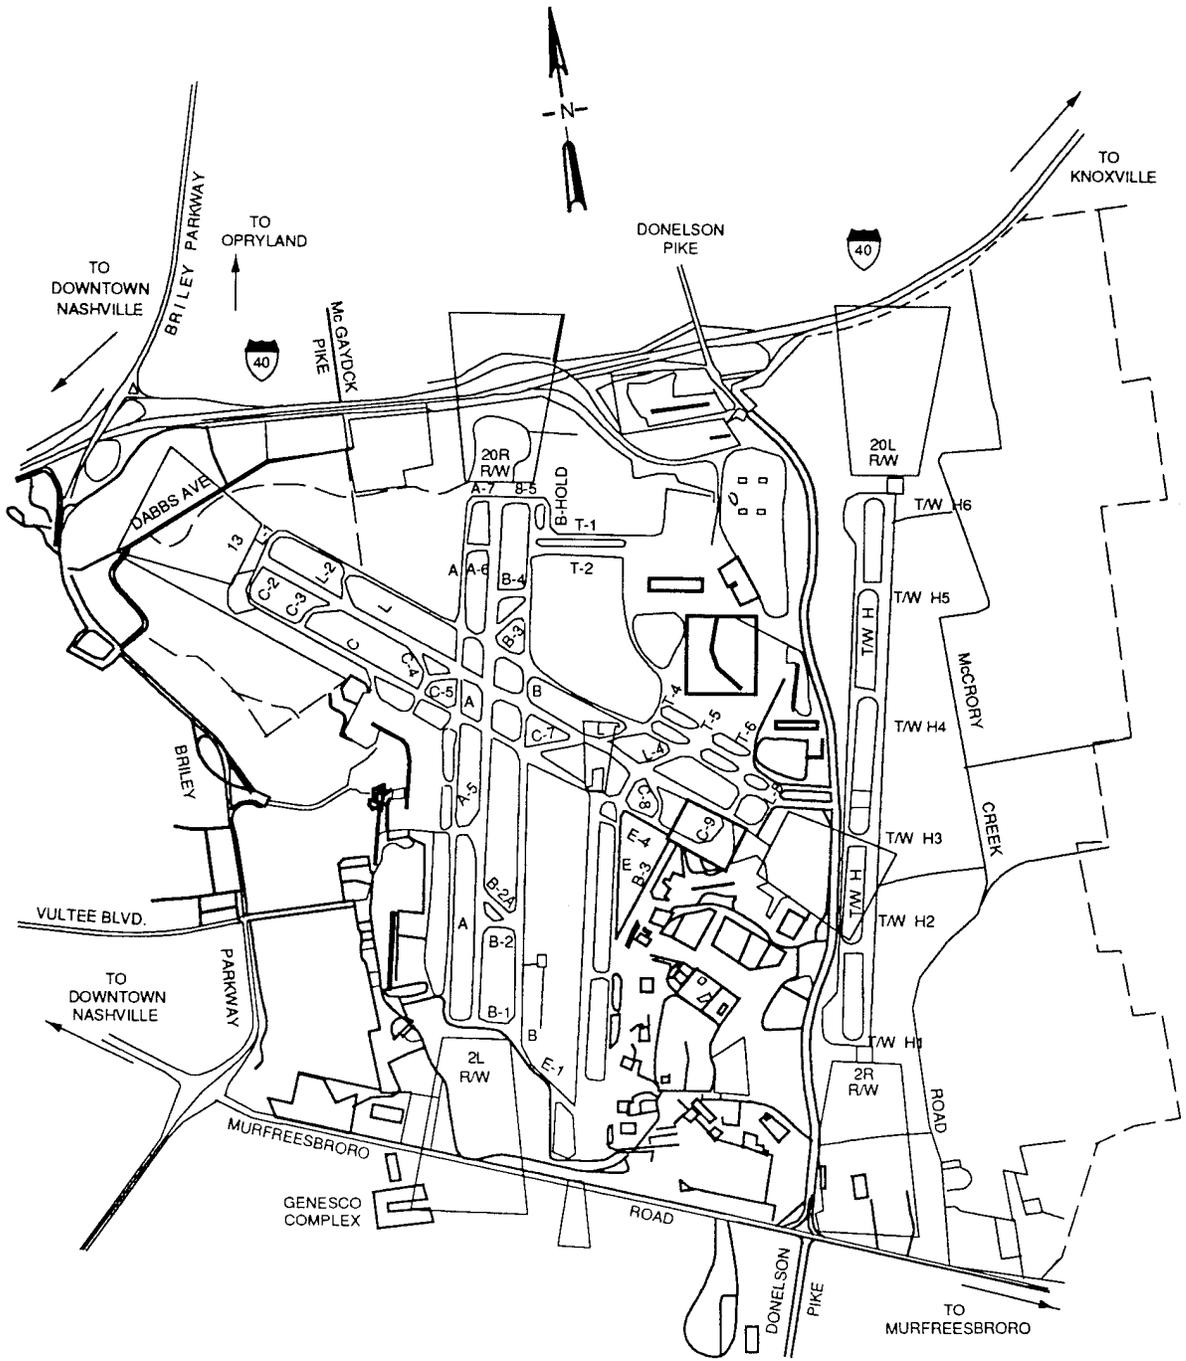
Figure 1. Site Map of Metro Nashville Airport.

To eliminate as many variables as possible, the purchased sealants were stored in a temperature controlled area at WES until they were required in the field, the same batch or lot number of each of the selected sealants was used at all five locations, and the joint configuration at all locations were as similar as possible. Each project site consisted of approximately 10,000 linear feet of sealed joints. Approximately 5,000 linear feet of those joints were located in a taxiway area and 5,000 linear feet were located in a parking apron or gate area. For example, the two small highlighted blocks in figure 1 illustrate the locations of the joint sealant sections at the Metro Nashville Airport, one of

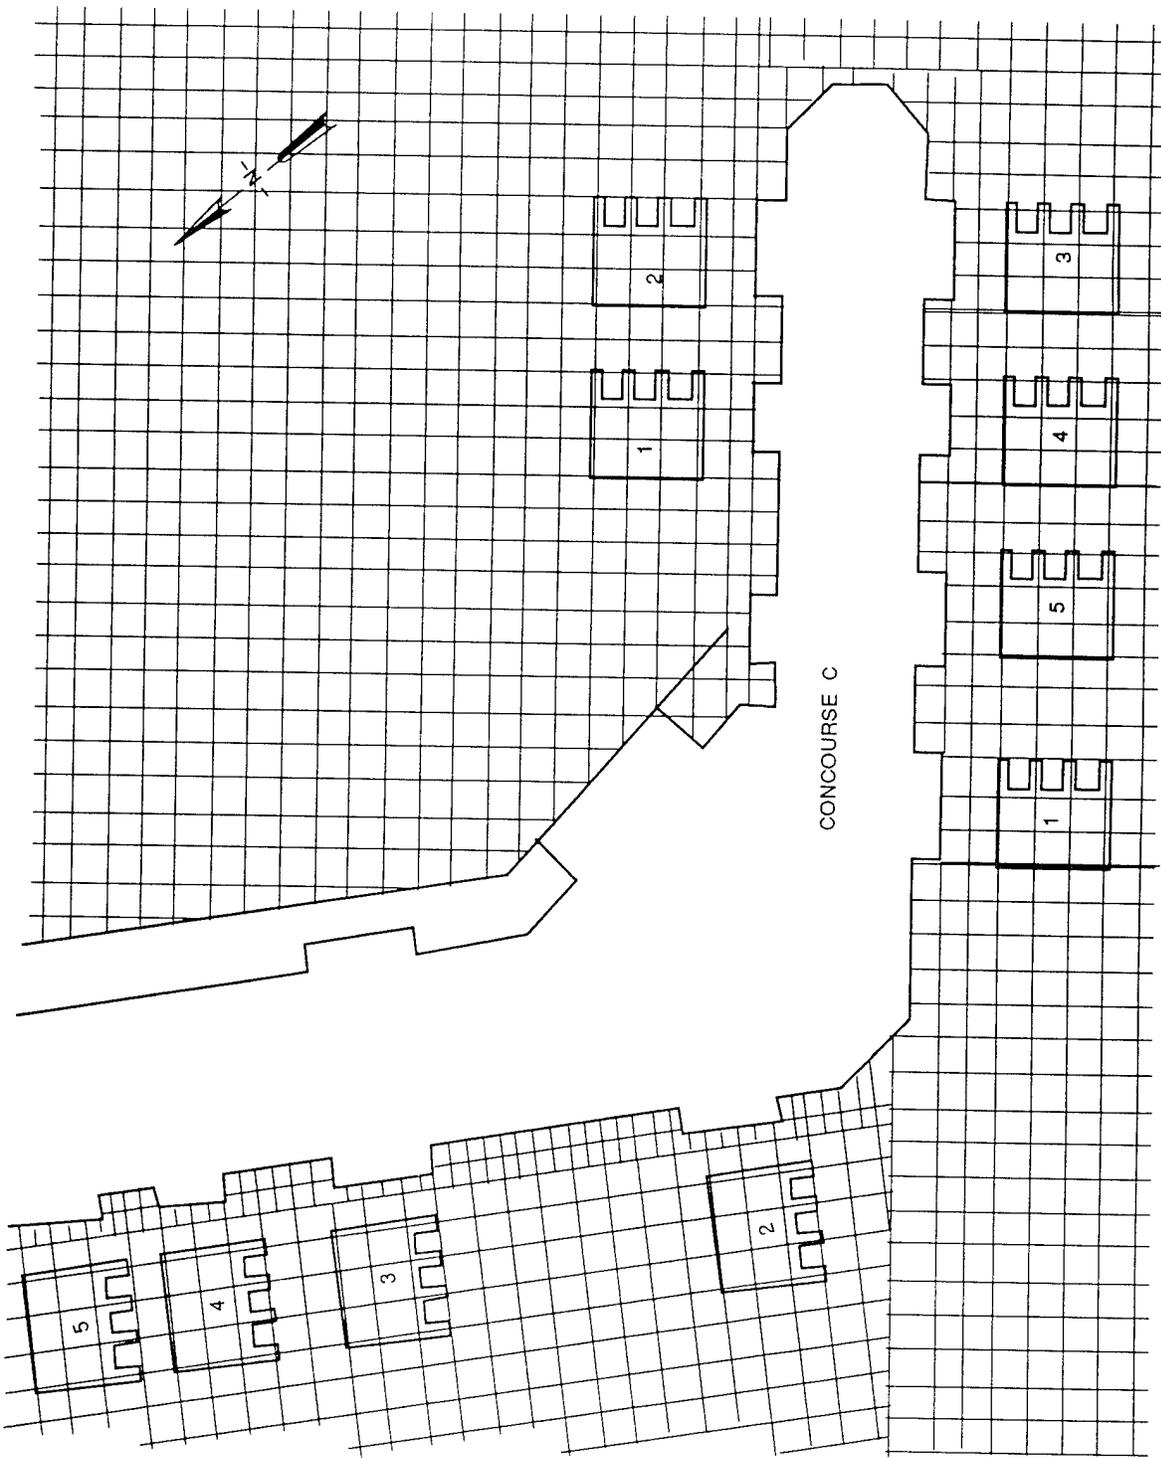
Figure 2. Concourse C at the Metro Nashville Airport
(numbered blocks indicate areas sealed)

the selected airports. Concourse C was selected as the area where the joints would likely receive fuel spillage and Taxiway C-9 at the end of Runway 31 R/W was selected for the non fuel spillage area. Figure 2 provides a close up view of the pavement around Concourse C that was sealed during the project. Figure 3 provides a close up view of Taxiway C-9. These figures illustrate the typical pattern used for each section and the numbers used in Figures 2 and 3 represent the sealant that was installed in that area. The sealant location at each of the five airports was selected so that the materials would be exposed to the same type of traffic and environmental conditions at the particular airport. The joint sealant locations at the other airports are provided in appendix A.

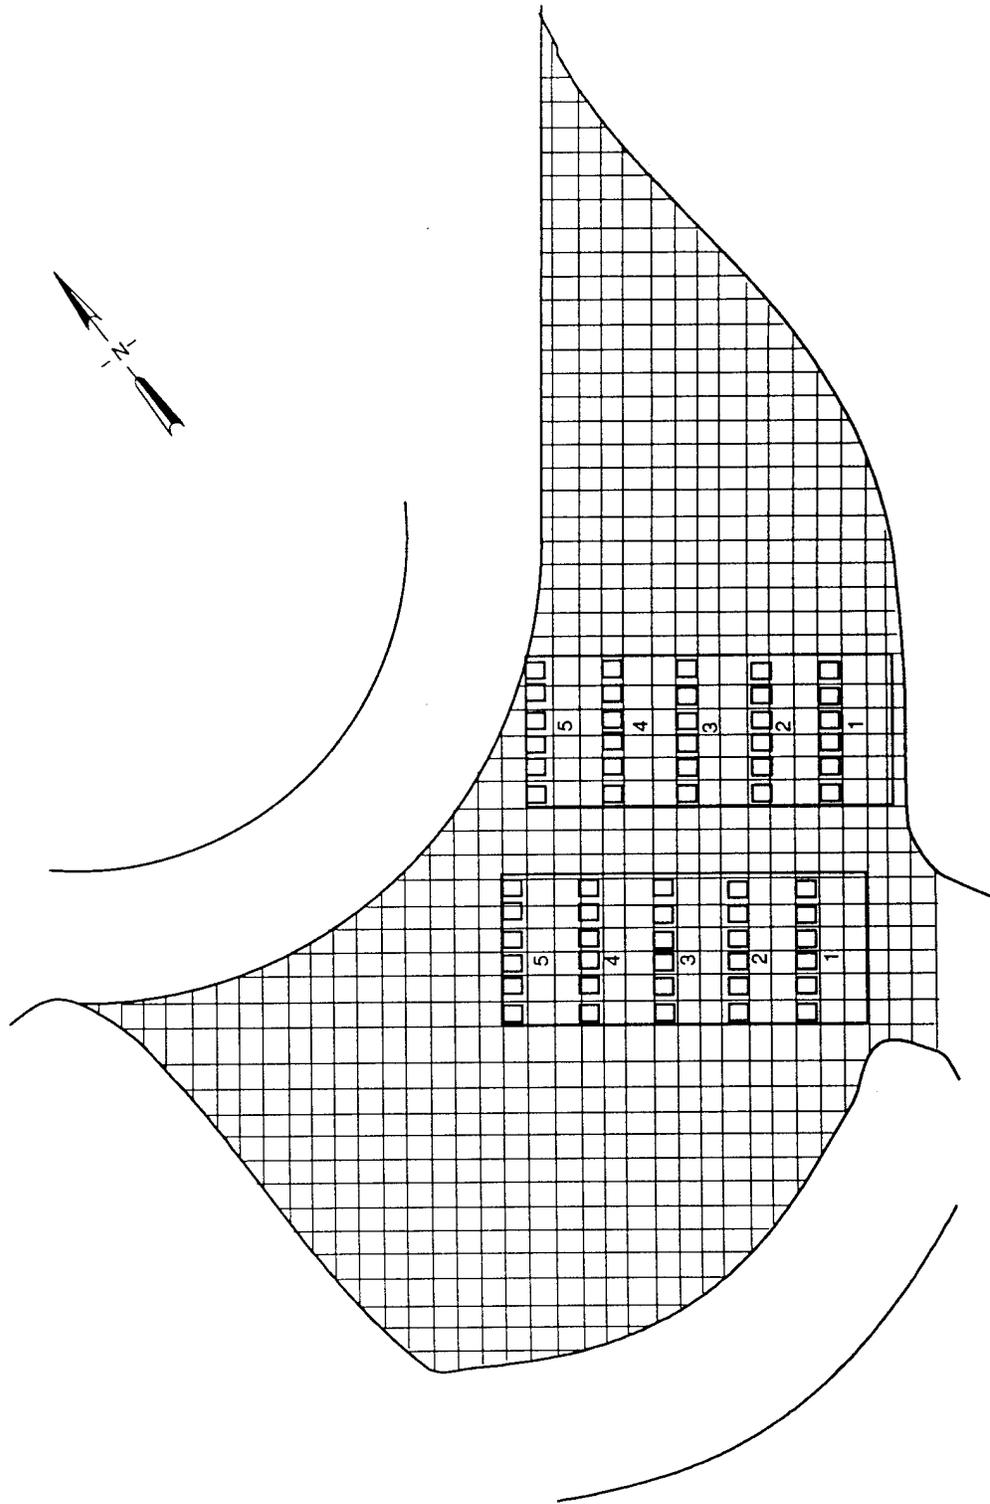
Figure 3. Area C-9 at the Metro Nashville Airport.

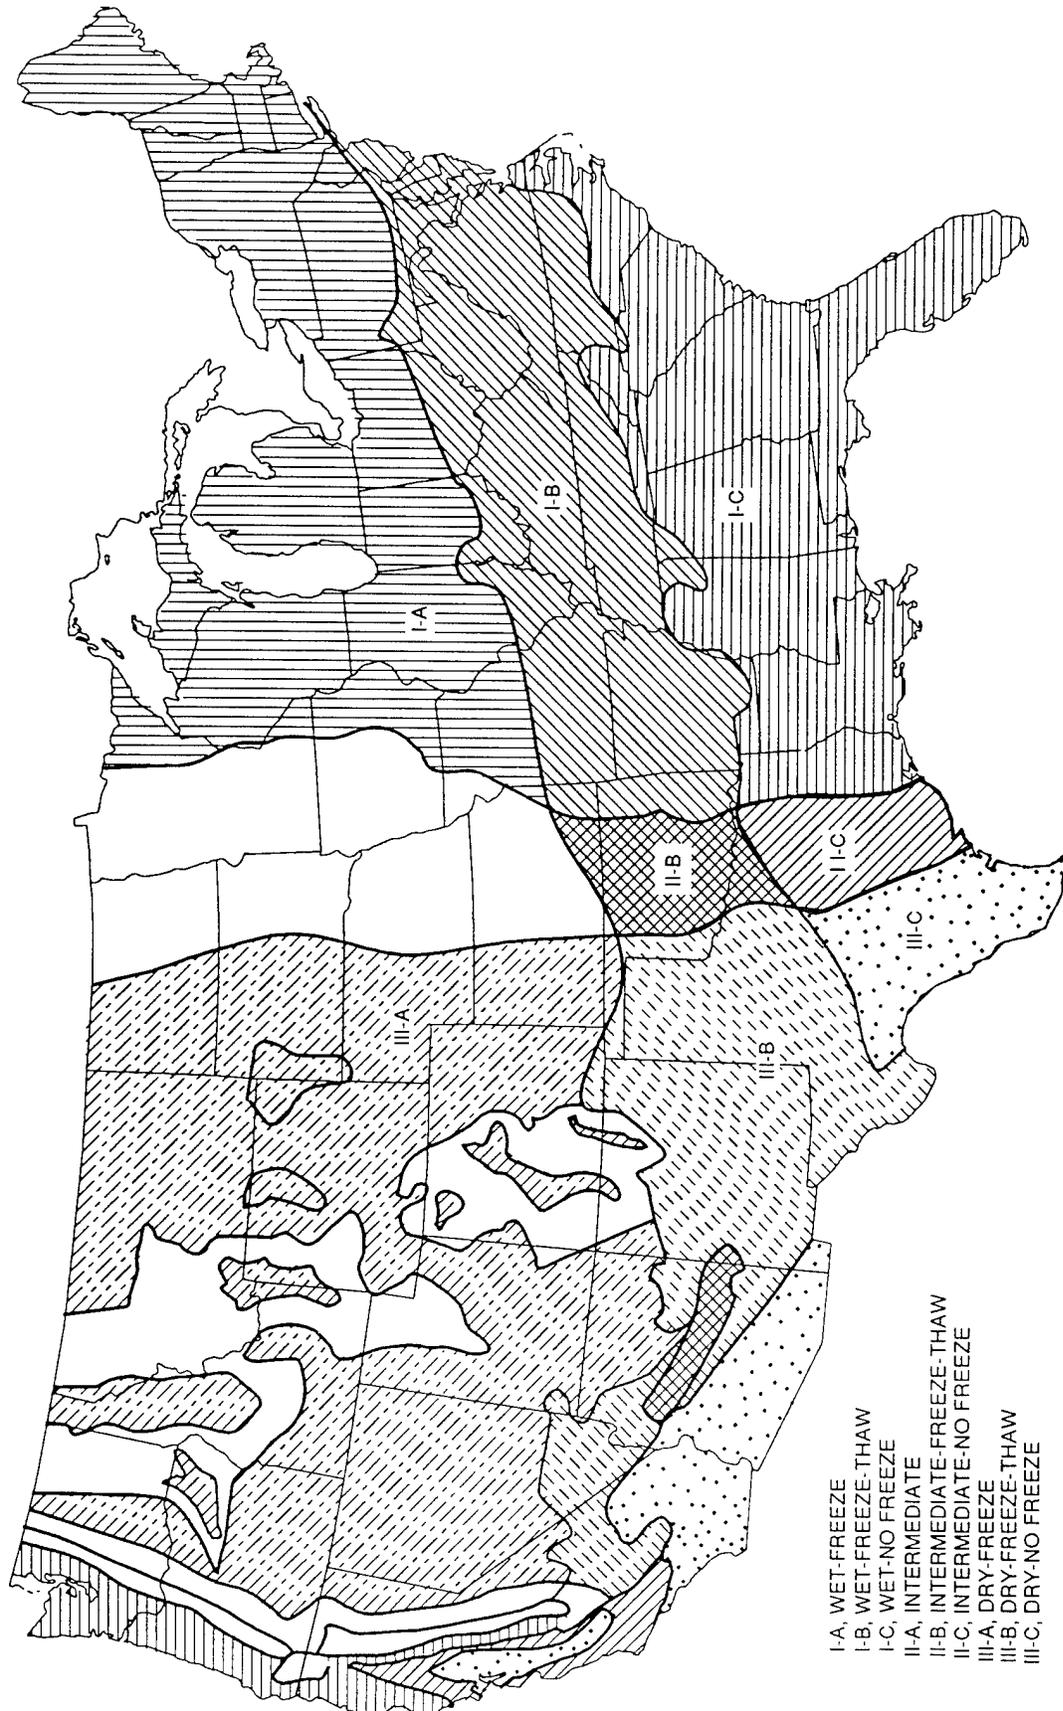
Figure 4. Climatic Regions of the United States
 Taken from page 23 of NCHRP-SHP 98 (Peterson, 1982).

Figure 4 taken from Peterson (Peterson 1982), was used to define the climatic regions and to ensure that the airports selected were in different climatic regions. The climatic regions which were selected are not necessarily the most severe, but they are the ones which cover 80 to 90 percent of the United States. Therefore, the sealant performance in these climatic regions may be more representative to other areas in the United States.

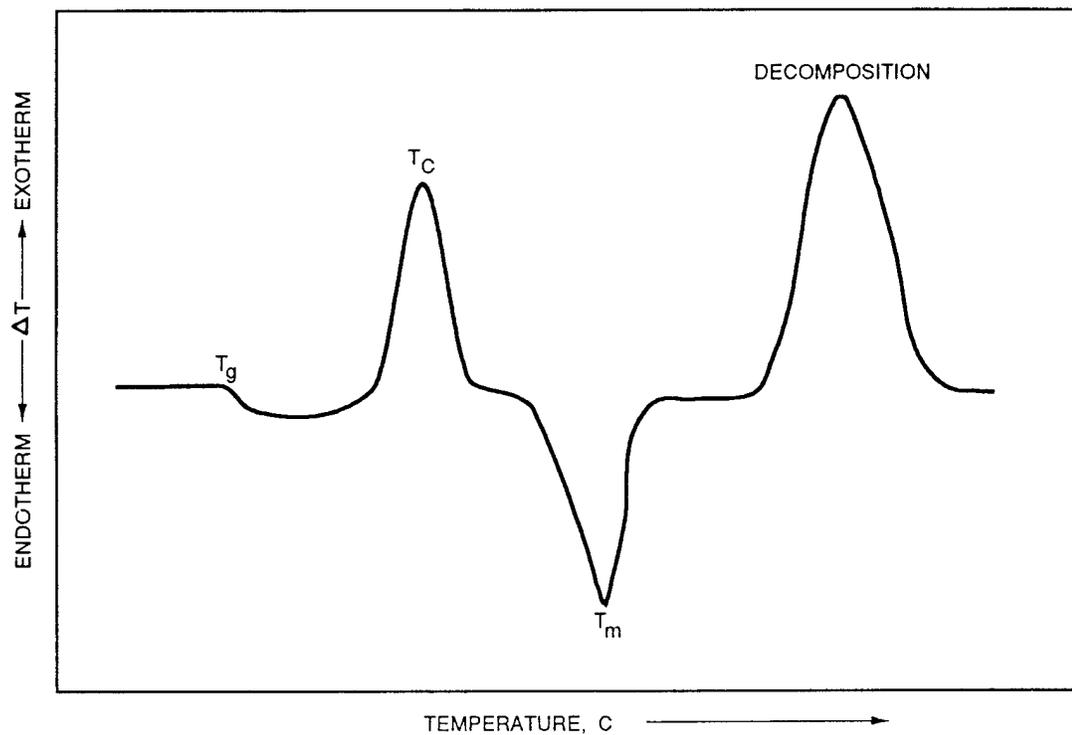
Figure 5. Typical DSC Analysis Results.

For example, figure 5 illustrates typical results that can be obtained from DSC analysis. Four regions are evident in this figure. The first region is the glass transition temperature (T_g) which is an endothermic process. Below T_g , the polymeric material undergoes a significant change in properties due to the virtual cessation of local molecular movement. In the case of a pavement joint sealant, the properties would change from being soft, flexible, and resilient above the T_g to hard, stiff, and brittle below T_g . Theoretically, this implies that when the joint begins to open during cooler temperatures, the sealant could fracture and fail. Based upon this discussion, it would appear that the user would simply select a sealant that has a T_g below the minimum expected temperature to which the sealant would be exposed. However, the T_g of various materials can be increased by the aging and weathering of the material. The T_g can also be increased if the material continues to cure or if additional cross-linking occurs. The increase in T_g could be significant enough to make the sealant become brittle at normal temperatures experienced during the winter months.

Often the T_g of polymeric materials is not as easily discernable as illustrated in figure 5, especially if the material is a mixture of constituents. Also some of the raw materials used to produce joint sealant materials, asphalt cement and coal tar for example, do not exhibit a true well-defined T_g .

The second region marked on the figure is the temperature at which crystallization (T_c) occurs in the material and it is an exothermic process. This peak will be present only in materials that exhibit some crystallinity (i.e., an ordering of the molecules or a preferred orientation of molecules that is repeated throughout the system). It was expected that most of the pavement joint sealant materials would be amorphous in nature (i.e., no

The last region on the thermogram in figure 5 is decomposition. This is the temperature at which the material begins to char and burn. The other regions that have been discussed are reversible, that is if the temperature is decreased below the T_m the material will revert back to a solid. If the temperature is decreased below the T_g the material becomes brittle, etc. However, if the material is exposed to temperatures above the decomposition temperature and then the temperature is reduced, the material does not regenerate.

One other region that may be exhibited by some materials is an exothermic peak indicating cross-linking in the material. On figure 5, this region would be present between the T_m and the decomposition temperature. Some of the coal tar-based materials used in this investigation undergo some cross-linking. It is expected that most of the cross-linking occurs during the heating and application of the material and therefore would not be evident

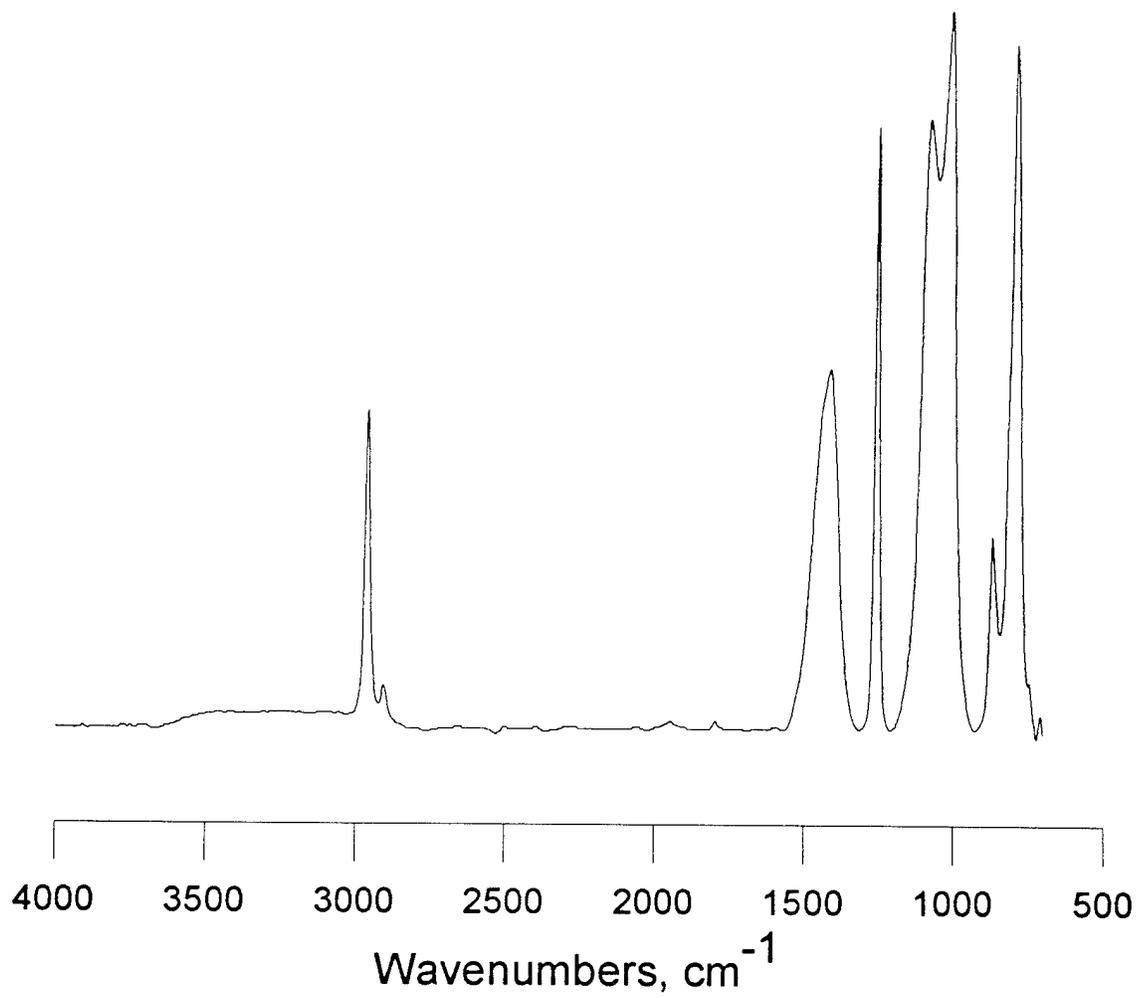
Figure 6. Example of a Fourier Transform Infrared Spectrum.

FTIR is based upon the principle that most organic compounds absorb energy in the infrared region. When an infrared beam of radiation is passed through a sample, the covalent bonds of the different functional groups absorb energy at specific characteristic frequencies. A plot of the amount of energy absorbed by a sample versus frequency is called a spectrum. An example of a spectrum is shown in figure 6. The peaks evident in the spectrum indicate specific chemical functional groups.

The sample and IRE were then placed into the FTIR sample compartment where an infrared beam of energy was passed through the IRE. The IRE causes the beam to undergo multiple internal reflections which creates an effect called the evanescent wave. The beam is then collected by the detector and is converted to the type of spectra shown in figure 6.

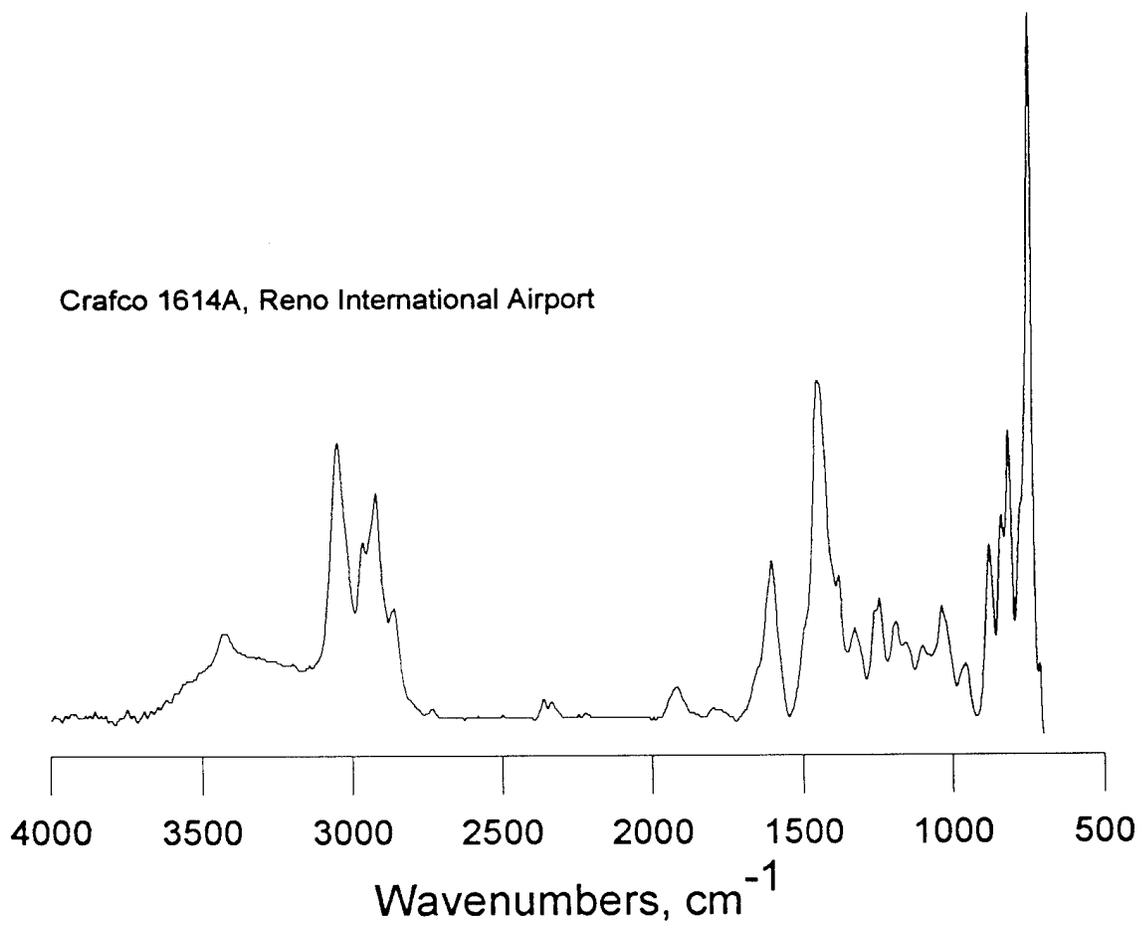
Figure 7. FTIR-ATR Spectra of Crafco Superseal 1614A.

Representative FTIR-ATR spectra for each of the sealants analyzed in this study are presented in figures 7 - 11. The spectra are those of actual samples collected from the field.

In figure 7, the FTIR-ATR spectrum of the Crafco Superseal 1614A material sampled from the North Ramp at Reno International Airport is shown. The MSDS available for the 1614A material lists coal tar and rubber as major components of this joint sealant. The aromatic nature of the coal tar material is evident by the peaks near 3000 cm^{-1} (aromatic C-H stretch) 1960 cm^{-1} (overtone or combination bands), and the bands from $1600\text{--}1400\text{ cm}^{-1}$ (aromatic C-C stretch). The peaks centered around 1025 cm^{-1} arise from the in-plane bending of aliphatic hydrogens and the peaks near 750 cm^{-1} from the out-of-plane bending. There is a broad band centered at 3400 cm^{-1} indicative of intermolecular hydrogen bonding of alcohols and phenols. Due to the heterogenous nature of coal tar materials, it is impossible to assign specific peaks to either the coal tar or the rubber. This spectrum is representative of the additional samples collected from the other test areas in which this sealant was applied. Although not shown, additional spectra were obtained at approximately 6-month intervals over the course of 1 to 1.5 years after the sealants were placed into service. Examination of these spectra yielded no evidence of observable chemical changes occurring in the 1614A material with 1.5 years of aging. As with other bituminous materials, reaction with atmospheric oxygen over time results in the formation of carbonyl-containing compounds, with the appearance of bands near 1750 cm^{-1} .

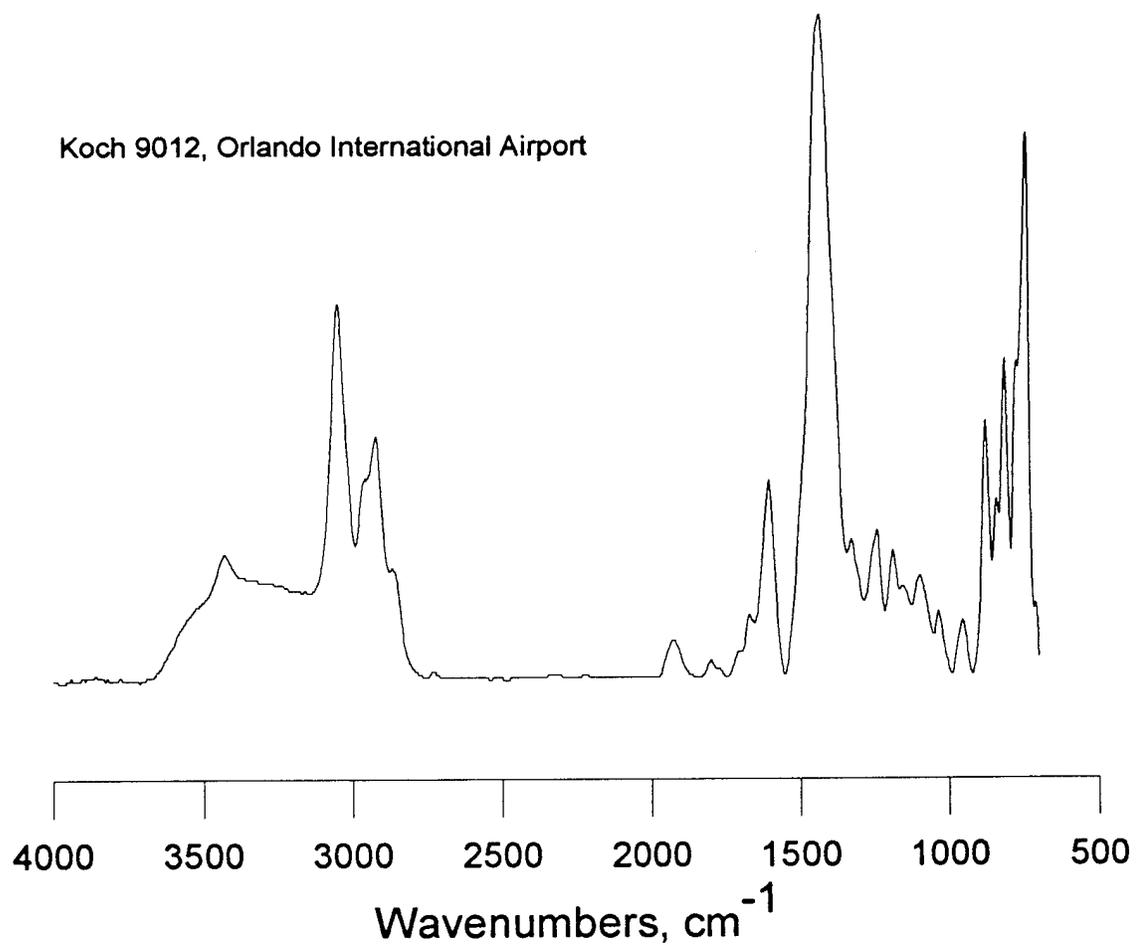
Figure 8. FTIR-ATR Spectra of Koch Materials Product 9012.

The FTIR-ATR spectrum of the Koch 9012 joint sealant material is displayed in figure 8. The MSDS of this material, as with the Crafco 1614A product, lists coal tar as a major ingredient. Again, this is supported by the FTIR data which shows strong aromatic peaks at 3000 , 1960 , and 1600 cm^{-1} with aliphatic peaks near 2900 cm^{-1} . The peaks near 1025 cm^{-1} arise from the in-plane bending of aliphatic hydrogens and the peaks near 750 cm^{-1} from the out-of-plane bending. This material is similar to 1614A in that no observable chemical changes are noted from the FTIR spectra collected over a period of months.

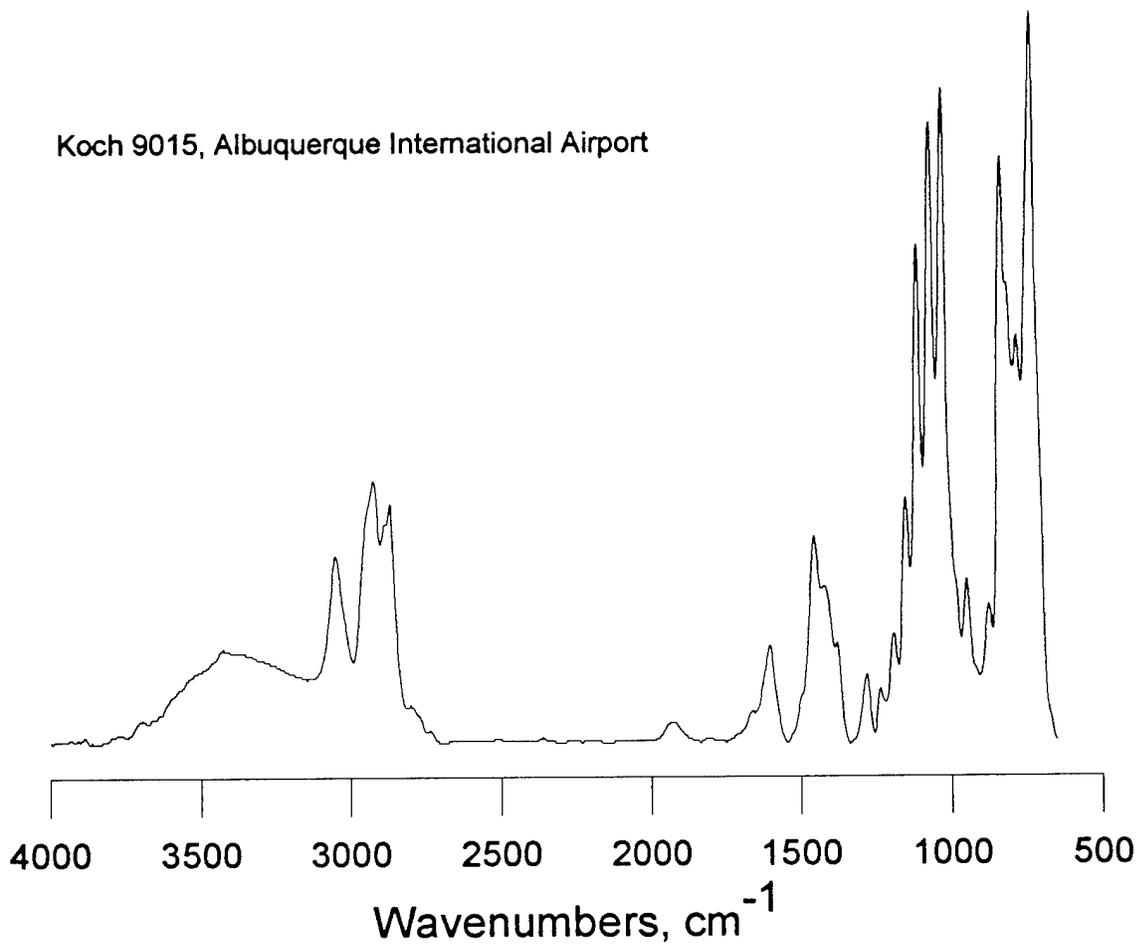
Koch 9015, Albuquerque International Airport

Figure 9. FTIR-ATR Spectra of Koch Materials Product 9015M.

In figure 9, the FTIR-ATR spectrum of the Koch 9015M product is shown. From the MSDS, and discussions with company representatives, this material reportedly contains a mixture of coal tars and oils and polysulfide polymer. Examination of the FTIR spectrum and comparison with the previous spectrum of the coal tar materials reveals aromatic peaks above 3000 cm^{-1} , near 1600 , and 1450 cm^{-1} with aliphatic peaks near 2900 , 1025 , and 750 cm^{-1} . However, there are several other peaks that probably arise from the presence of the polymer material in the region from $1250\text{--}1000\text{ cm}^{-1}$. These peaks are found in the range that sulfide (C-S-C) and related ether (C-O-C) linkages absorb. Analysis of the spectra collected over the course of this study indicate no readily observable chemical changes as viewed by FTIR-ATR.

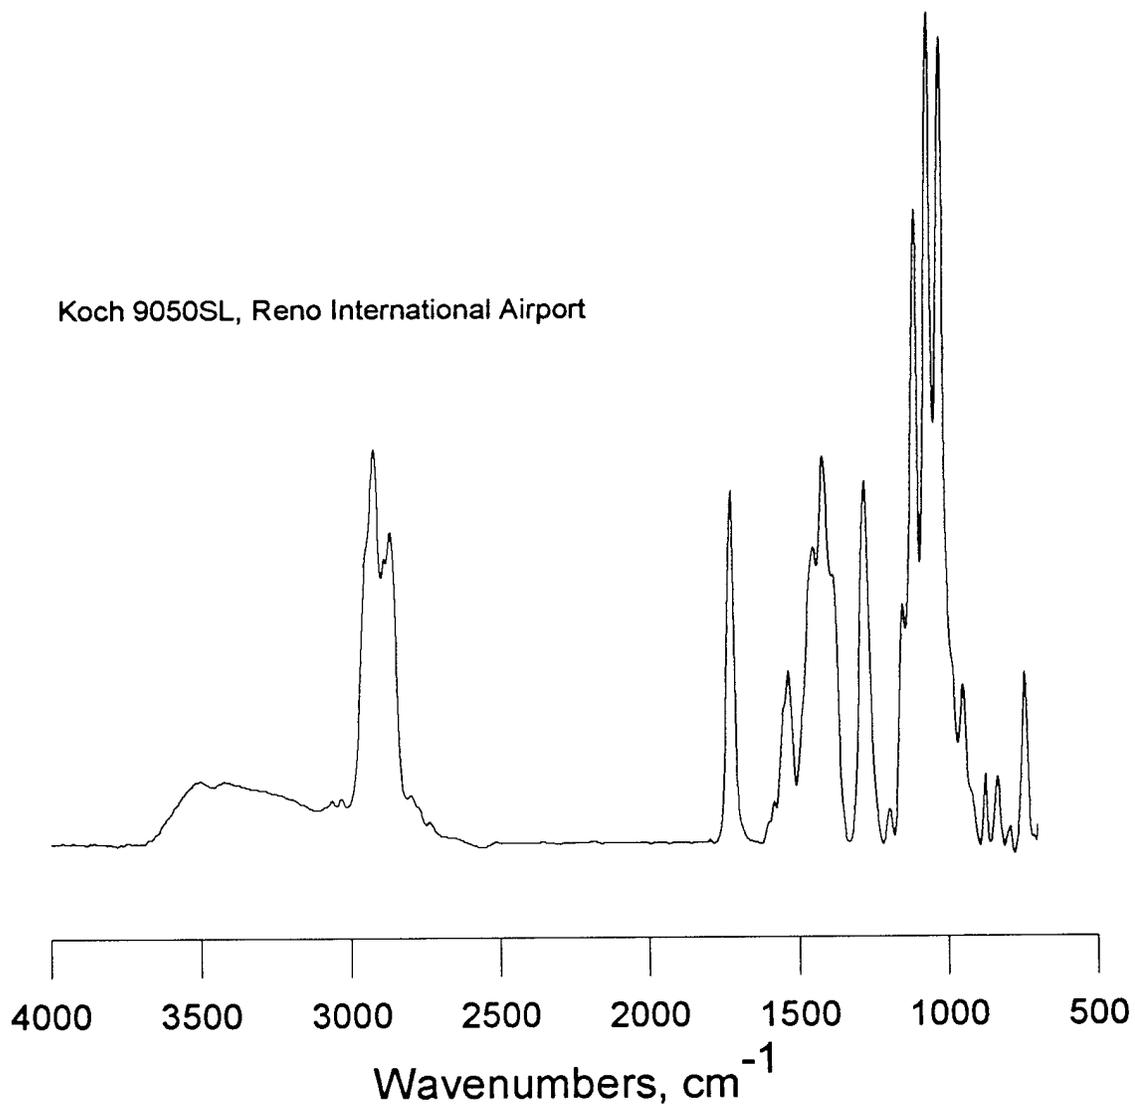
Koch 9050SL, Reno International Airport

Figure 10. FTIR-ATR Spectra of Koch Materials Product 9050SL.

In figure 10, The FTIR-ATR spectra of the Koch 9050 SL material is shown. This material is reported to contain polysulfide polymer as a major component. The FTIR-ATR spectra shows the presence of a broad absorption near 3400, typical of a alcohol or phenol-containing material. Aliphatic peaks are found centered near 2900, 1025, and 750 cm^{-1} . The peaks located between 1150-1000 cm^{-1} have previously been attributed to the polysulfide component. Additional peaks in this material are found at 1280, 1530, and 1725 cm^{-1} . The peak at 1725 cm^{-1} arises from a carbonyl-containing portion of the sealant but cannot be absolutely assigned to a particular known component. Again, no observable chemical changes occurred in this material during the 1 to 1.5 year test period.

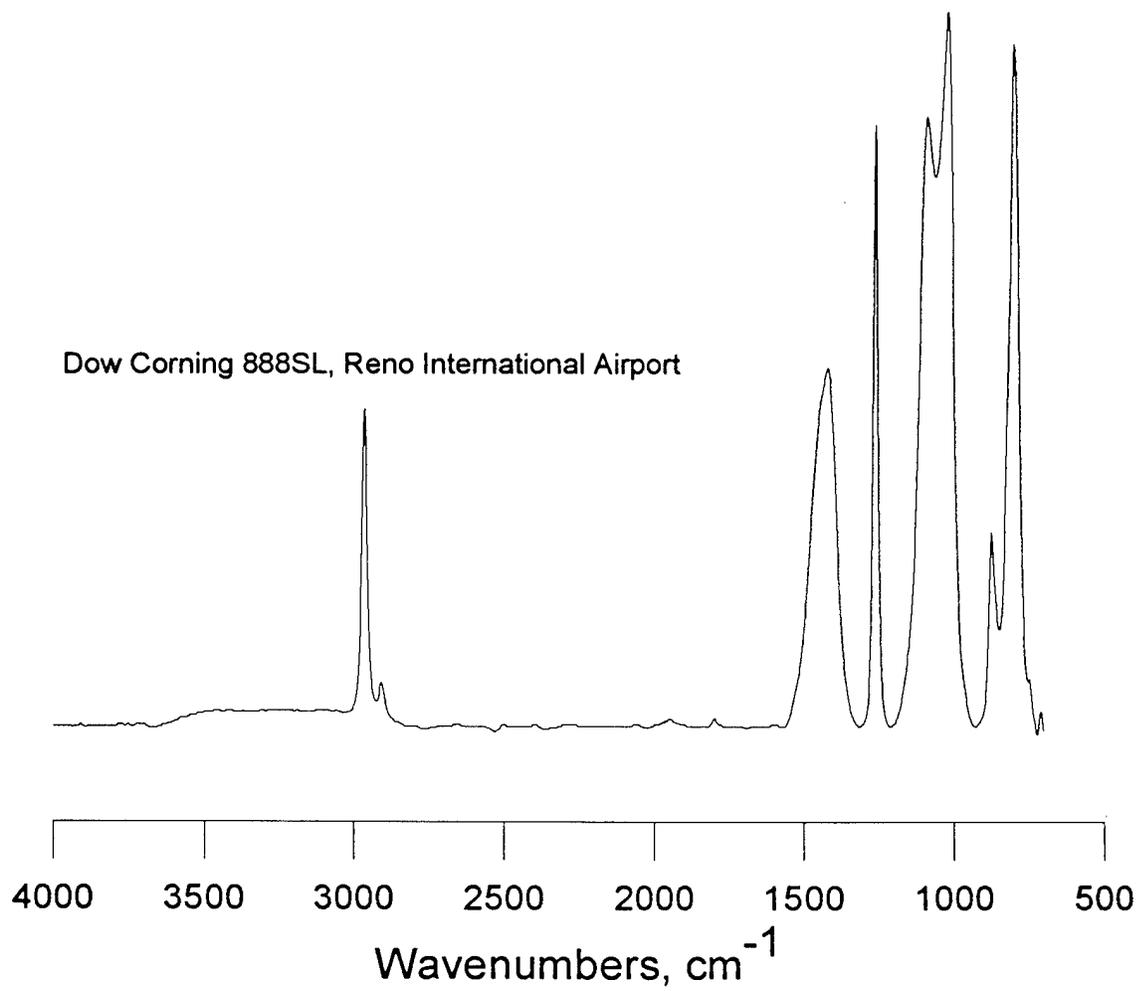
Figure 11. FTIR-ATR Spectra of Dow Corning® 888SL.

The FTIR-ATR spectrum shown in figure 11 is that of the Dow Corning® 888SL material. This sealant is reported to be a silicone-based sealant material. Analysis of the FTIR-ATR spectra indicated that this material is primarily composed of polydimethyl-siloxane (PDMS). PDMS shows a strong absorption at 2900 cm^{-1} attributed to the methyl C-H stretch. The peaks at 1420 and 1260 cm^{-1} are due to the C-H bending modes. The strong absorption near 1000 cm^{-1} is due to the Si-O-Si bending mode. The peak centered near 750 cm^{-1} arises from the C-H bending. No changes in the spectra were observed during the 1 to 1.5 year test period.

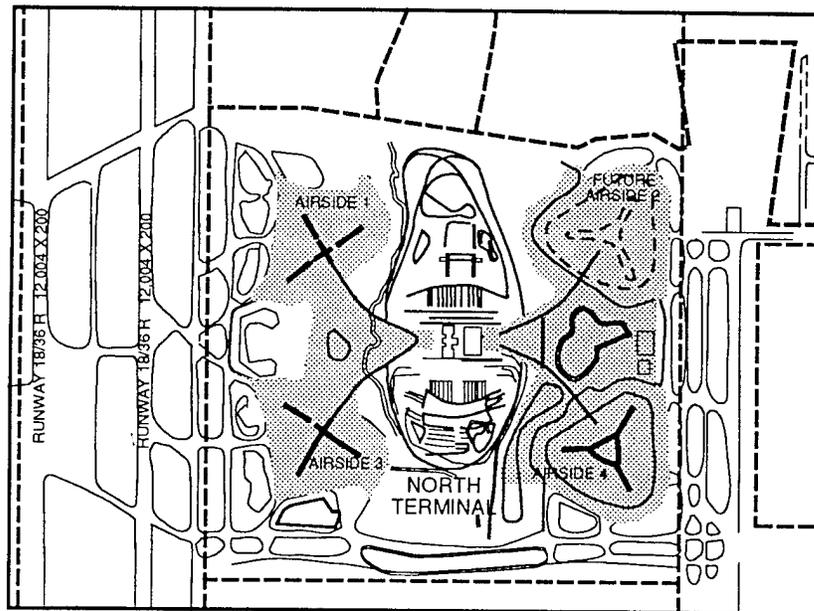
ORLANDO INTERNATIONAL AIRPORT

Figure A-1. Area Sealed at Orlando International Airport.

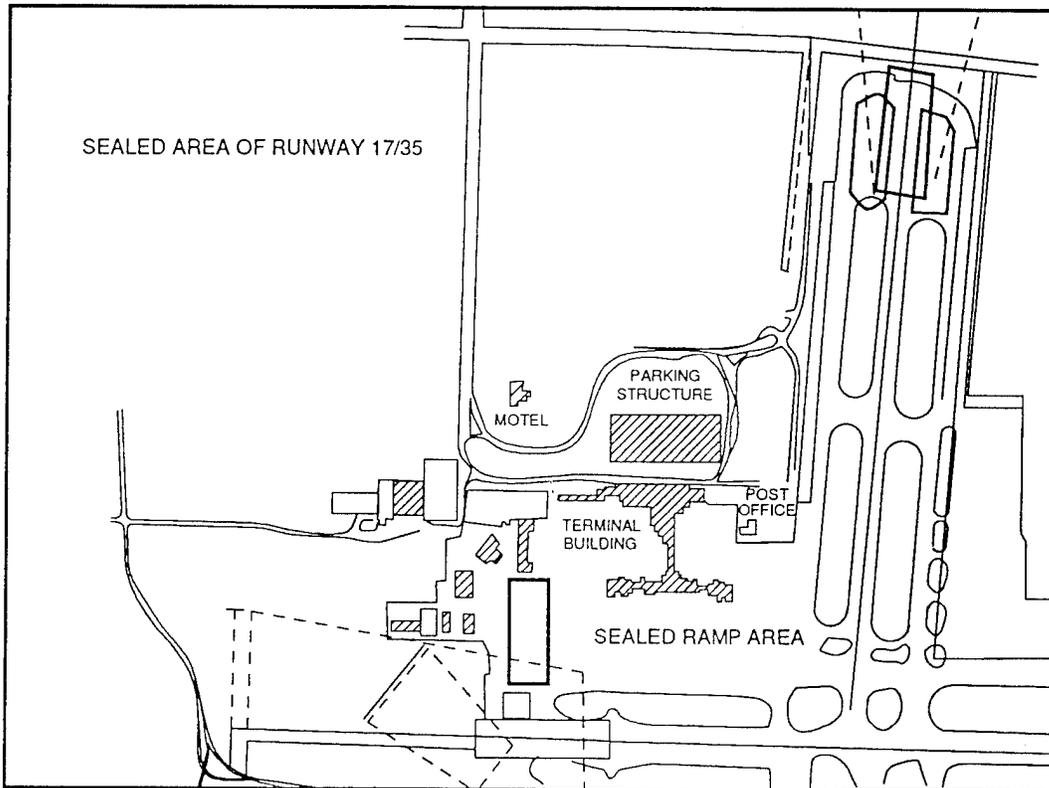
Figure A-2. Area Sealed at Albuquerque International Airport.

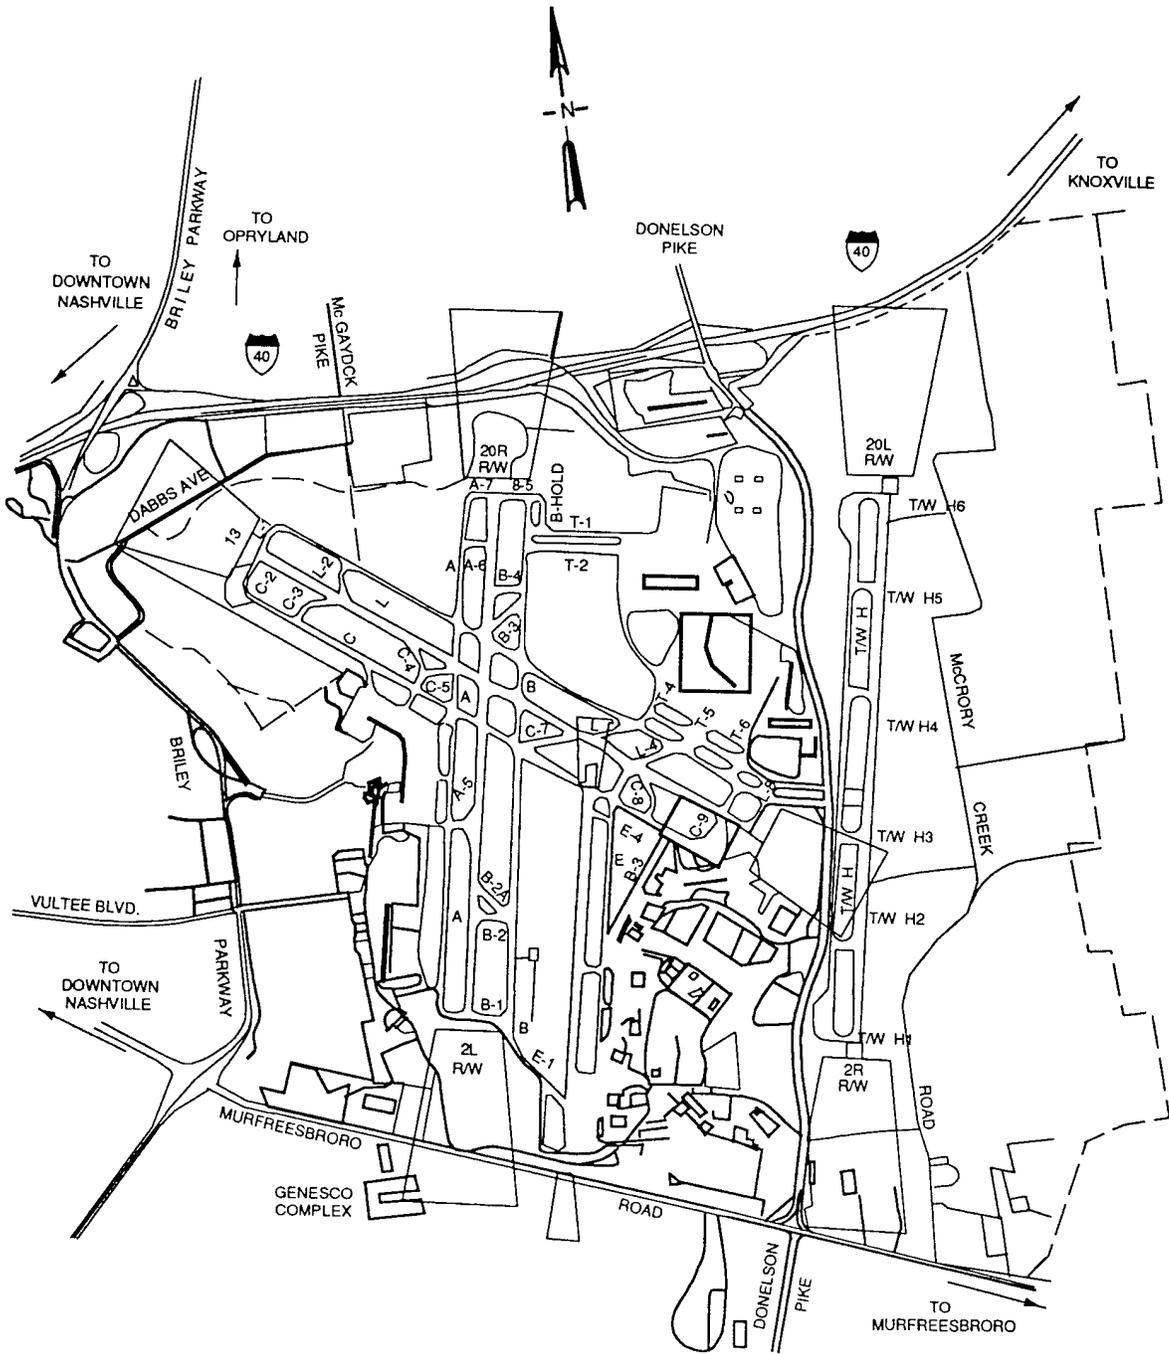
Figure A-3. Area Sealed at Metro Nashville Airport.

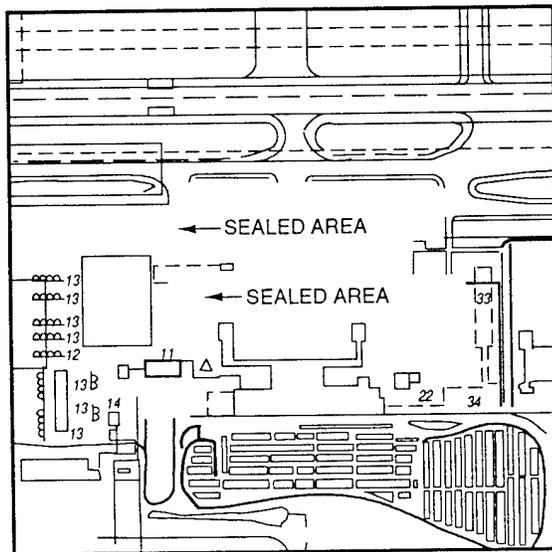
Figure A-4. Area Sealed at Reno-Cannon International Airport.

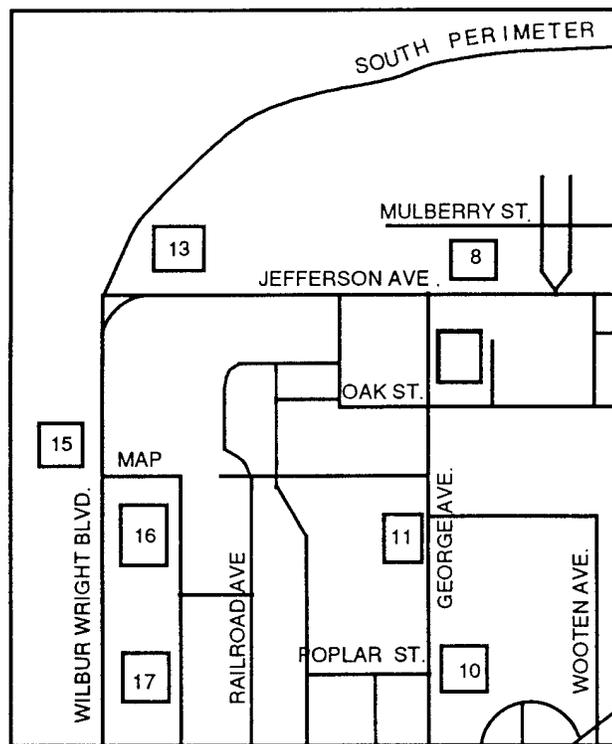
Figure A-5. Fuel Storage Area Sealed at Selfridge Air National Guard Base
