**Assessment of Instrumentation
at Camp Lejeune**

Dennis DeRiggi

March 2001

IDA Document D-2527

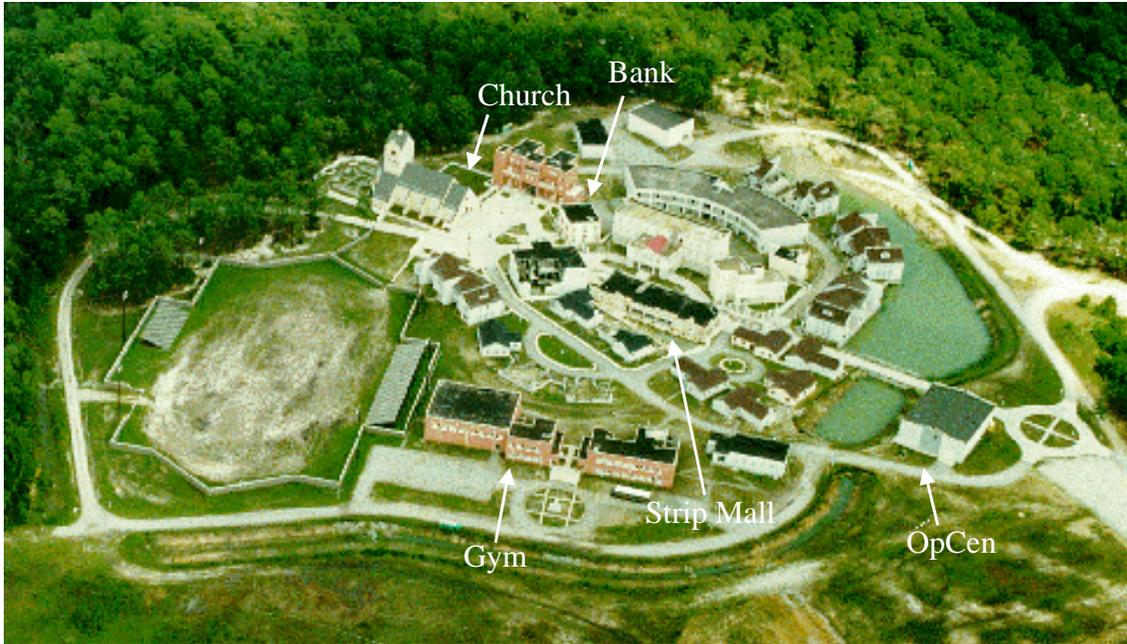
Figure 1. The Camp Lejeune MOUT Facility (with highlighted instrumented buildings)

Before embarking on a detailed description of the instrumentation at Camp Lejeune, it will be helpful to describe the layout of the site itself. The MOUT site consists of over 20 buildings. Four of these – the Church, Bank, Gym, and Strip Mall – are instrumented and will be the focus of this report. Figure 1 is an aerial view of the site, showing the building sites in relationship to the other buildings. The Operations Center (OPCEN) is not one of the MOUT buildings per se; it is the coordination and after-action-review facility (described in more detail below) from which exercises are controlled and directed.
