NASA/CR-2001-211223
ICASE Report No. 2001-27

Progressive Failure Studies of Composite Panels with and without Cutouts

*Navin Jaunky
ICASE, Hampton, Virginia*

PROGRESSIVE FAILURE STUDIES OF COMPOSITE PANELS WITH AND WITHOUT CUTOUTS

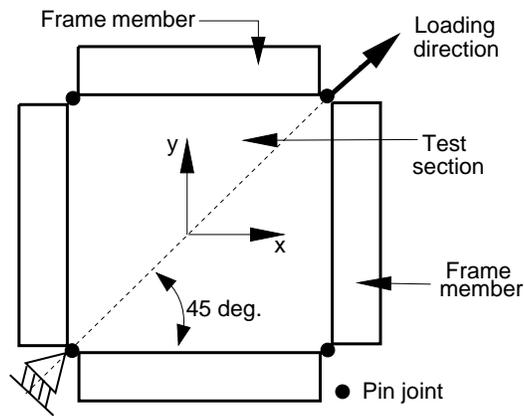
Figure 1: Schematic diagram of picture frame test fixture.

3.1. Flat Panel Loaded in In-plane Shear. The flat panels were loaded using a picture frame fixture to subject it to a pure in-plane shear loading. The test sections of the panel is 12.0-in. by 12.0-in. in size and the members of the picture frame were 2.75-in. wide and 6.75-in thick. The fixture is made of steel. Figure 1 shows a schematic diagram of the picture frame test fixture. In the finite element model, nodes on each member were constrained for the out-of-plane displacement. Pin joint consists of two co-incident nodes tied

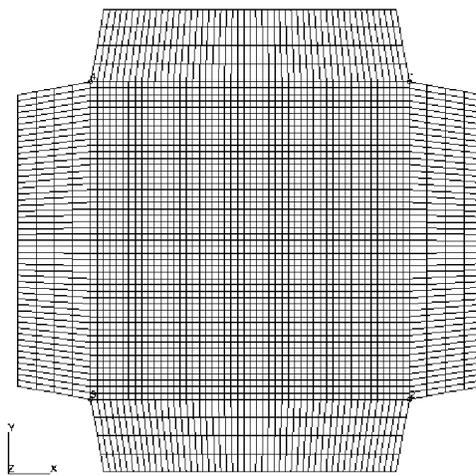
Figure 2: Finite element model of a flat composite panel in the picture frame test fixture.

A finite element model of that flat panel is shown in Figure 2. This model consists of 3425 nodes and 3300 elements. An imperfection based on static analysis results for a pressure load is added to the model to simulate an imperfect shape similar to that of a bubble (one half wave in each direction of the panel). Progressive failure analysis (PFA) is carried out for this case with a maximum imperfection magnitude equal to 5% of the laminate thickness. Three integration points through each ply thickness are used in the analysis for computation of section properties. A post-buckling analysis of the panel with the same level of imperfection is also performed.

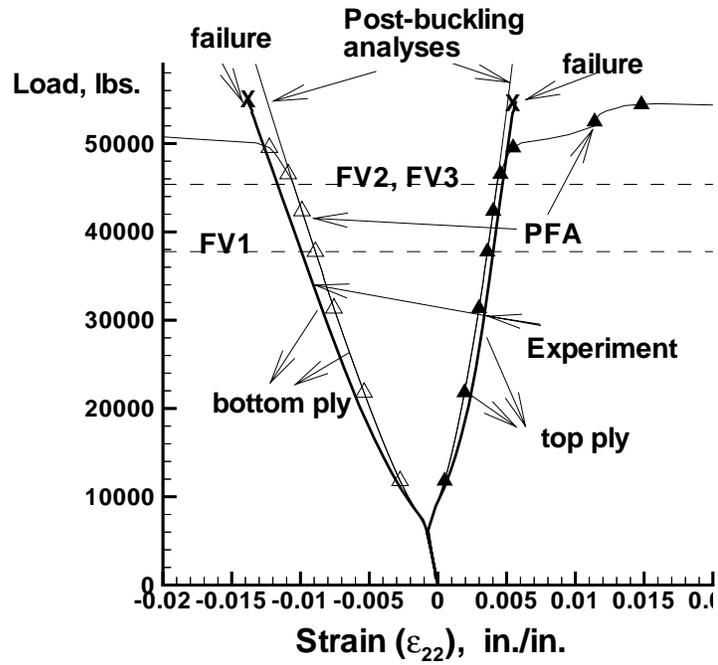
Figure 3: Load vs. strain component normal to fiber direction results in top and bottom plies of flat panel loaded in shear.

The results for the flat panel loaded in shear are shown in Figure 3, where the load is plotted versus the strain normal to the fiber direction (ϵ_{22}) in the top and bottom plies (45° ply) at the center of the test specimen. The dashed lines marked FV1, FV2 and FV3 indicate the load levels at which damage described by field variable *FV1* through *FV3* are initiated well into the post buckling regime. These failures are due to severe bending. The thick solid line represents the experimental results and the thin solid line represents the postbuckling analysis results. The solid and open triangles are analytical results for the panel response with progressive failure. The analysis results are in good agreement with the experimental results until the initiation of all failure modes, well into the postbuckling regime. The final failure load obtained from the experiment is 54.81 kips, which is 6 % more than the final failure load of approximately 51.5 kips obtained from progressive failure analysis.

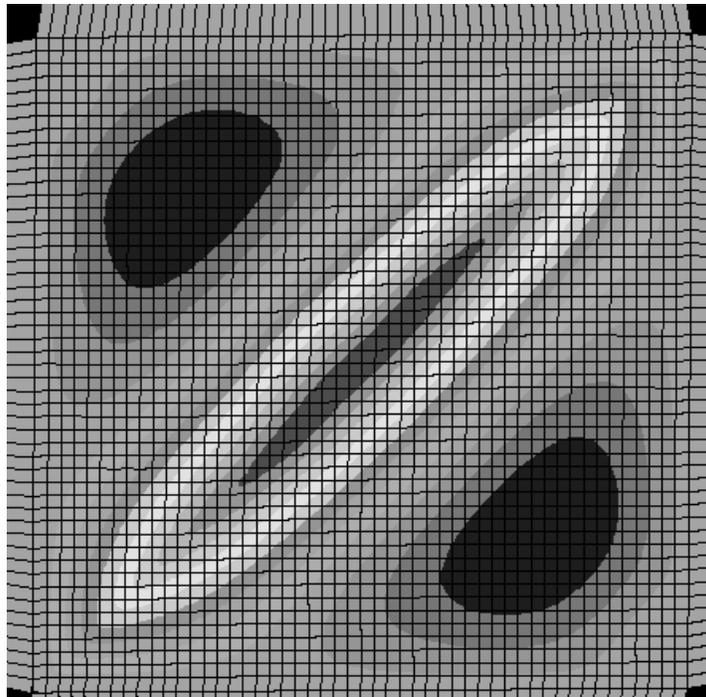
Figure 4: Out-of-plane deflection contour for flat panel in the post-buckling regime.

All the failure modes initiated near the steel supporting fixture along the diagonal in the panel loading direction and propagate in the region close to this diagonal. Figure 4 shows an out-of-plane deflection fringe plot for the panel well after buckling which is similar to the mode shape observed in the experiment. Fringe plots of damage after the final failure load are shown in Figure 5(a) through 5(d) for matrix cracking in the top 45 degree ply, matrix cracking in the bottom -45 degree ply, fiber-shear matrix in the bottom -45 degree ply, and fiber failure in the bottom -45 degree ply, respectively. The dark contours denote damaged regions

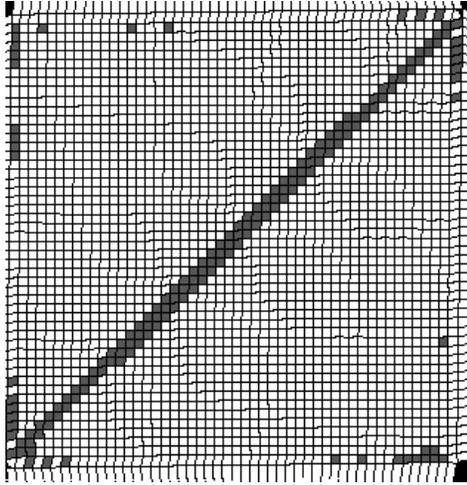
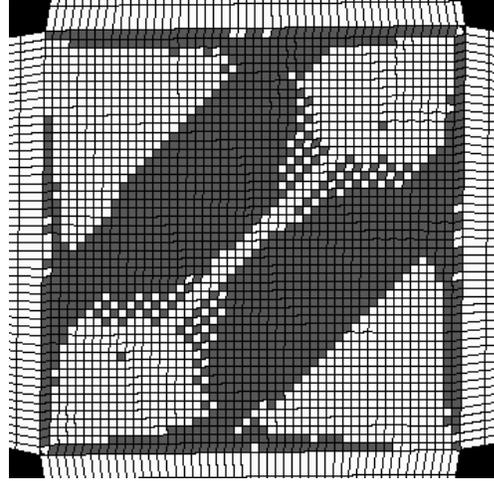
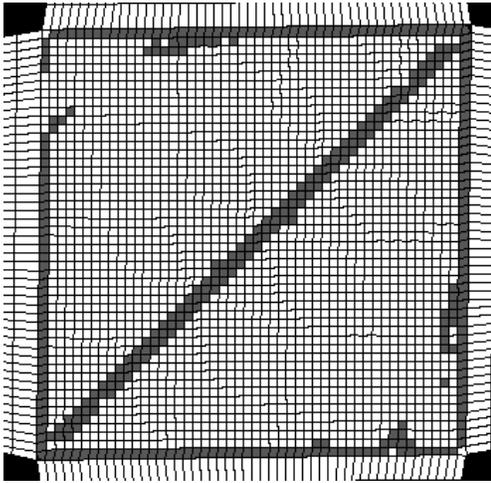
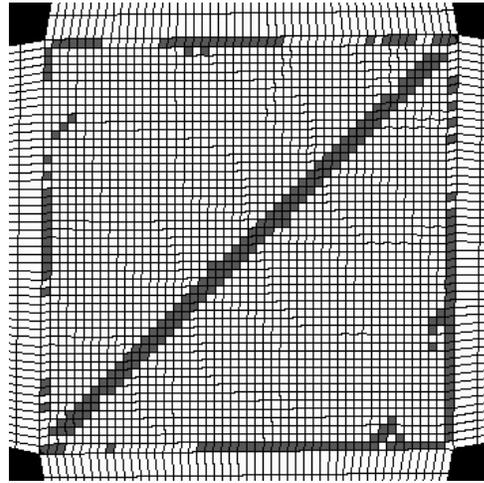
(a) Fringe plot of matrix cracking (FV1) in the top 45° ply

(b) Fringe plot of matrix cracking (FV1) in the bottom -45° ply

(c) Fringe plot of fiber-matrix shear (FV2) in the bottom -45° ply

(d) Fringe plot of fiber failure (FV3) in the bottom -45° ply

Figure 5: Fringe plot of damage in flat panel subjected to shear loading after final failure.

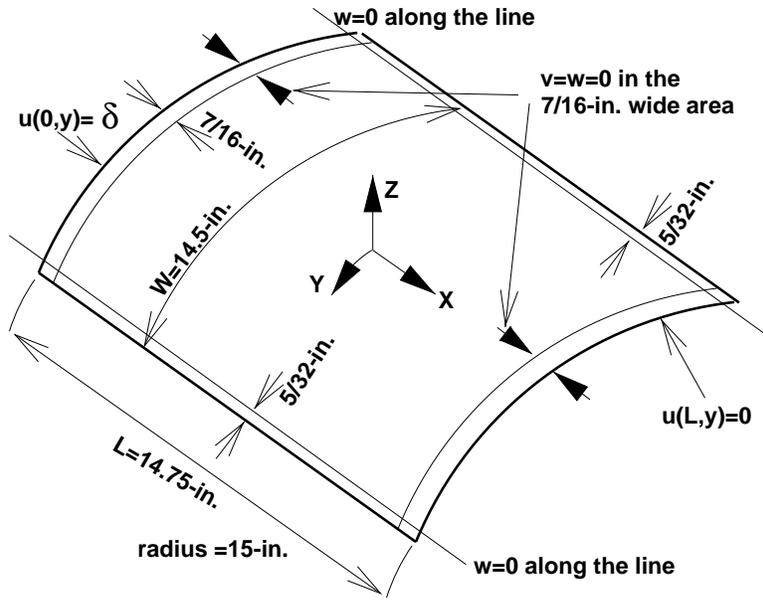
Figure 6: Geometry and boundary conditions for the curved composite panel.

The panel geometry, boundary conditions and loading are shown in Figure 6. The panel finite element model consists of 6561 nodes and 6400 shear deformable S4R elements ([23]). Measured geometric imperfection from a typical test specimen was included in the model. Three integration points through each ply thickness are used in the analysis for computation of section properties. Progressive failure analyses are performed using both geometrically perfect and imperfect panel models.

3.4. Curved Panel with a Cutout and Loaded in Compression. The curved panels investigated with cutouts have the same laminate stacking sequence and material properties as the curved panel without cutout described above. The dimensions and boundary conditions for the panel are described in Figure 6. These panels have a circular cutout that are centrally located. Three panels with different cutout sizes are considered such that the ratio of cutout diameter to the panel width, d/W , is 0.2, 0.4 and 0.6. Experimental results for this test are reported in Reference [25].

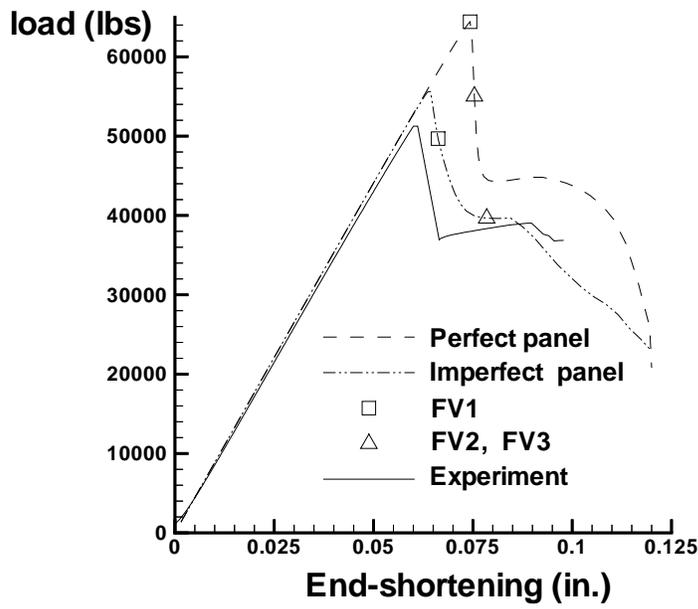
Figure 7: Load vs. end-shortening displacement results for the curved panel loaded in axial compression.

The results for the curved panel loaded in compression are shown in Figure 7, where the load is plotted against the end-shortening displacement. The open symbols representing FV1, FV2, and FV3 indicate the load levels at which damage described by field variable $FV1$ through $FV3$ are initiated. The analysis results with geometric imperfection and the experimental results are in good agreement. The final failure load from the experiment is 51.25 kips, which is about 8% less than the final failure load obtained from progressive failure analysis that included geometric imperfection of 55.3 kips. Analysis results suggest that all damage modes initiate after the panel buckling which corresponds to its maximum load bearing capability. Matrix cracking ($FV1$) initiated at a load level of 47.9 kips just after buckling. Fiber-matrix shear ($FV2$) and fiber failure ($FV3$) initiated at a load level of 40.2 kips. Progressive failure analyses indicates that the perfect panel buckles at 64.4 kips, matrix cracking is initiated at this load, and fiber-shear matrix and fiber failure are initiated at 55.02 kips.

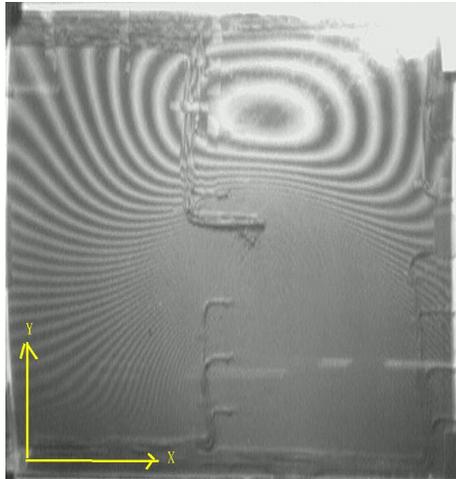
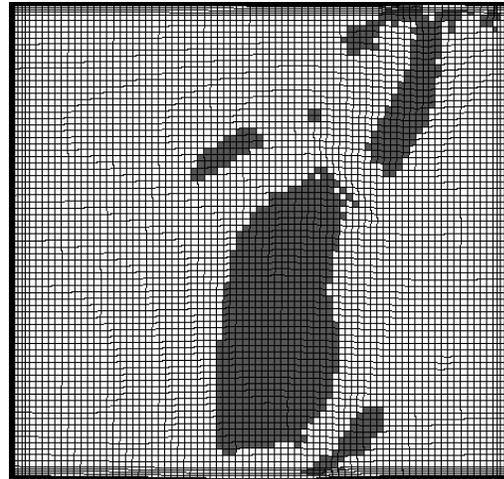
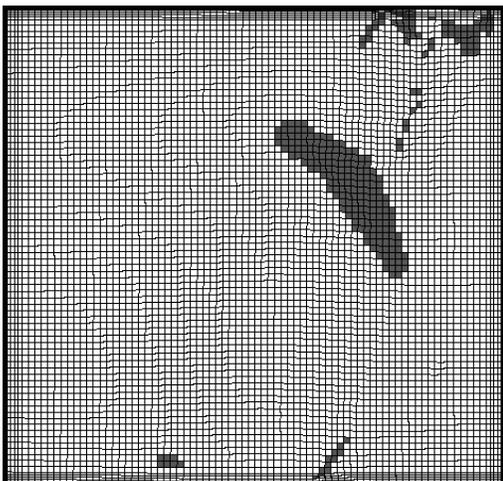
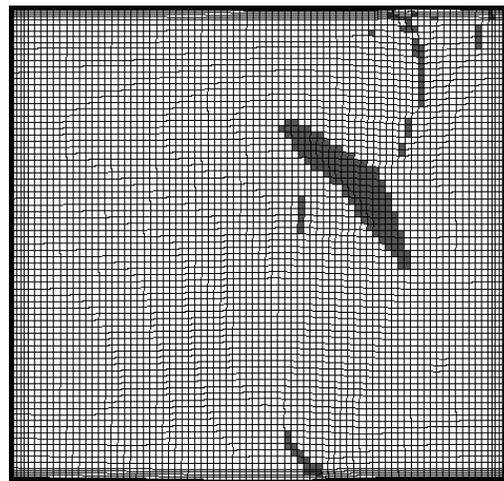
(a) Experimental out-of-plane displacement contour at failure

(b) Fringe plot of matrix cracking (FV1) in the bottom 45° ply

(c) Fringe plot of fiber-matrix shear failure (FV2) in the bottom 45° ply.

(d) Fringe plot of fiber failure (FV3) in the bottom 45° ply

Figure 8: Axial compression response and damage modes in curved panel after final failure.

Figure 8(a) through 8(d) show contour plots of out-of-plane displacement from moire interferometry, fringe plots of matrix cracking ($FV1$) in the bottom ply, fiber-matrix shear ($FV2$) in the bottom ply, and fiber failure ($FV3$) in the bottom ply after final failure respectively. The moire contour plot is consistent with the deformed shape obtained from the progressive failure analysis where the half wavelength at the lower region of the panel has a larger displacement gradient. Analysis results indicates that damage initiated within the lower region of the deformed panel and propagated to the area shown in Figure 8(b) through 8(d). Damage also accumulated in part of the region supported by the knife edges of the fixture. These results are consistent with observations from the experiments which did not indicate delamination failure.

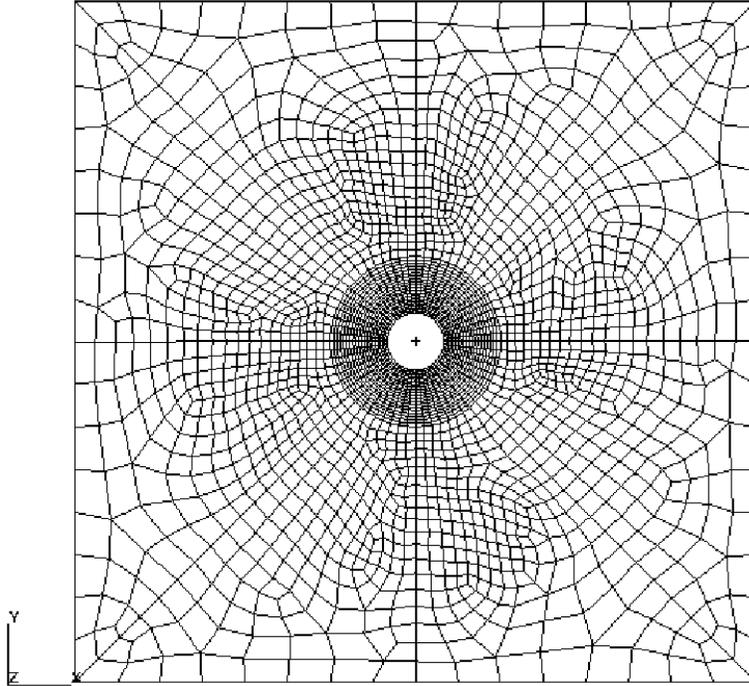
Figure 9: Finite element model of flat panel with a circular cutout.

in Figure 9. Geometric imperfection based on static analysis results for a pressure loaded panel was used to simulate an imperfect shape similar to one half wave in the axial and transverse directions of the panel. Since no measured geometric imperfection data was available, progressive failure analyses were carried out for this case with a maximum imperfection of magnitude equal to 5% and 1% of the laminate thickness. Three integration points through each ply thickness are used in the analysis for computation of section properties.

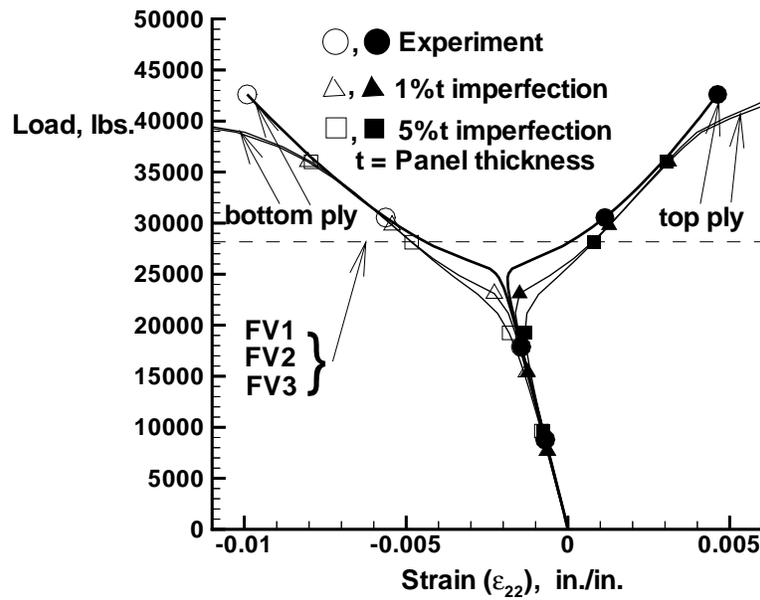
Figure 10: Load vs. strain component normal to fiber direction in the top and bottom plies of flat panel with a cutout loaded in shear.

The load versus strain normal to the fiber direction (ϵ_{22}) on the top and bottom plies (45° ply) at a location 0.5-in. below the edge of the hole along the diagonal that is in the panel loading direction are shown in Figure 10. The largest analytical buckling load was for the case where the imperfection magnitude was 1% of the laminate thickness. The experimental buckling load is approximately 25.1 kips, whereas numerical buckling load is approximately 23.2 kips and 19.5 kips for the case of imperfections equal to 1% and 5% of laminate thickness, respectively. A more accurate prediction of buckling load can be obtained by using measured geometric imperfection which was not available for this case. Damage modes *FV1*, *FV2* and *FV3* initiated very near the edge of the hole at a load level of 28.17 kips which is above the buckling load as indicated by the dashed curve Figure 10. The experimental failure load is 42.6 kips whereas the predicted failure load is 47.3 kips (data not shown in Figure 10) or 11% above the experimental final failure load. Based on the prediction of initial failure, it seems that the panel can carry an additional load of 14.4 kips (33% of the experimental final failure load) before final failure. At approximately 36 kips the computed strain data begins to diverge from the experimental strain data. This divergence may be due to not accounting for the delamination failure that occurred in the test. A fringe plot of out-of-plane deflection and damage plot in the region around the hole for the bottom 45° ply are shown in Figure 11(a) through 11(d) at a load level just after final failure. These damage locations are consistent with experimental observations and occurs in a region of high displacement gradient as shown in Figure 11(a).

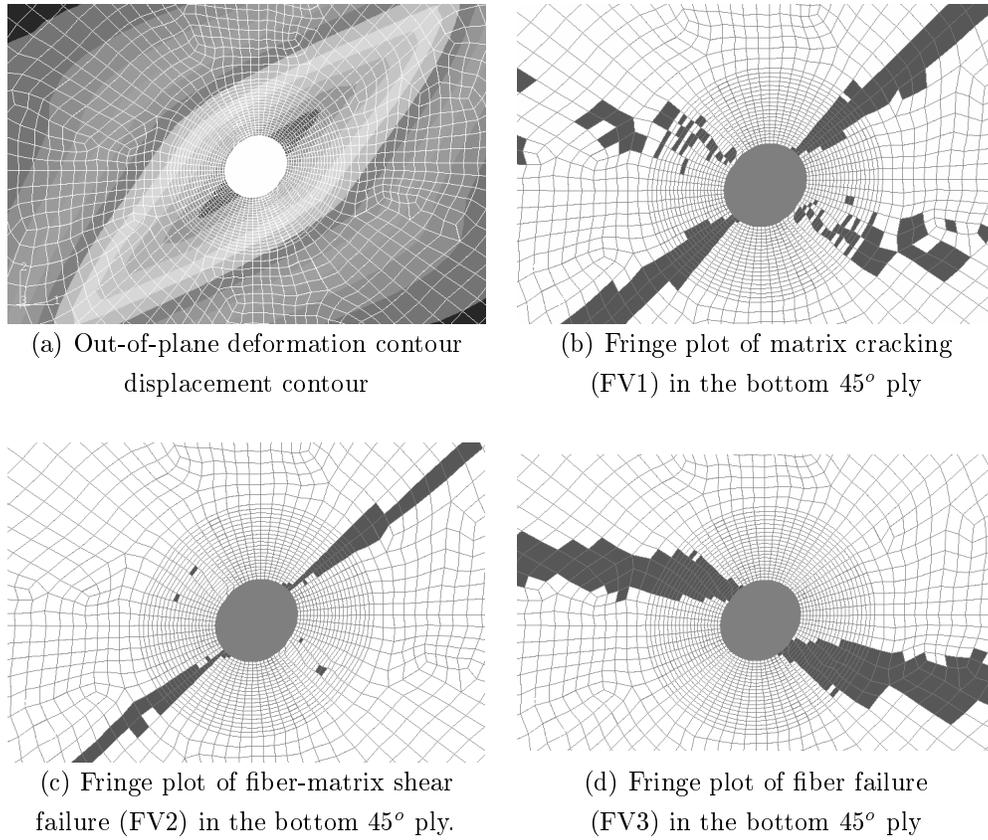
Figure 11: Analytical response and damage mode for a flat panel with a cutout and loaded in shear after final failure.

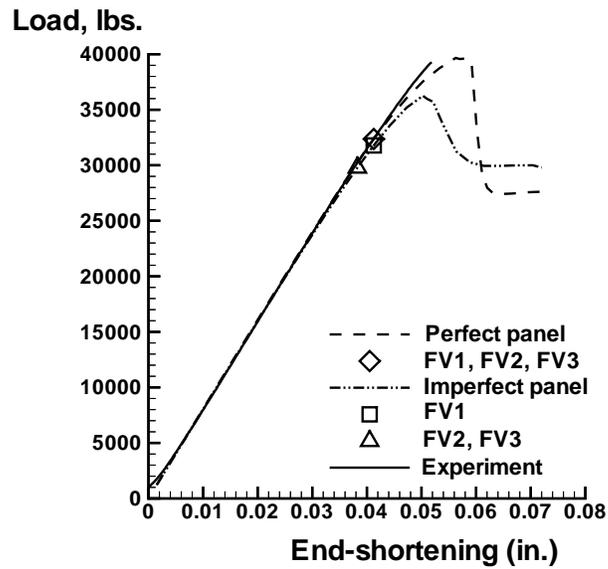
Figure 12: Load versus end-shortening displacement results for a curved panel with cutout ($d/W=0.2$) and subjected to axial compression loading.

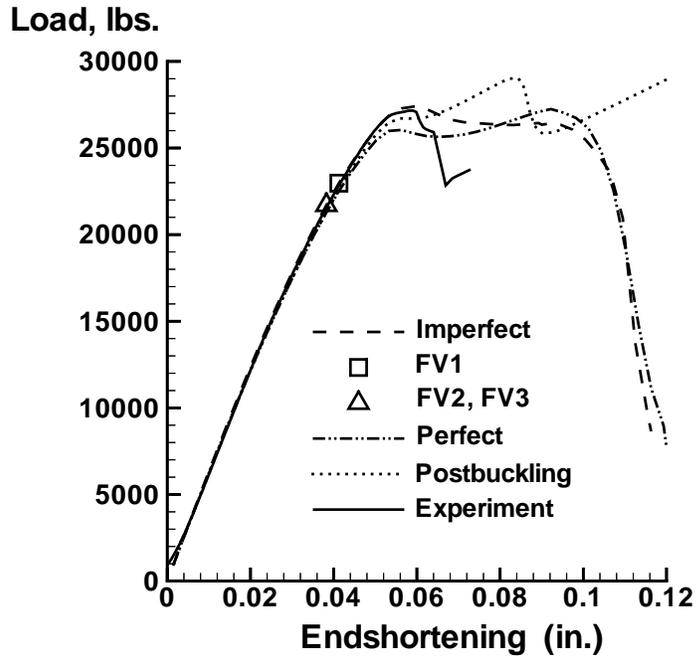
Figure 13: Load versus end-shortening displacement results for a curved panel with cutout ($d/W=0.4$) and subjected to axial compression loading.

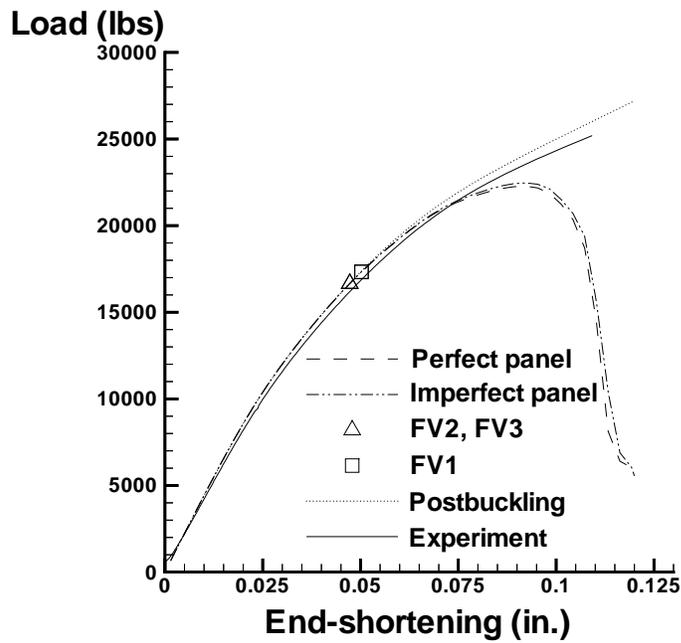
Figure 14: Load versus end-shortening displacement results for a curved panel with cutout ($d/W=0.6$) and subjected to axial compression loading.

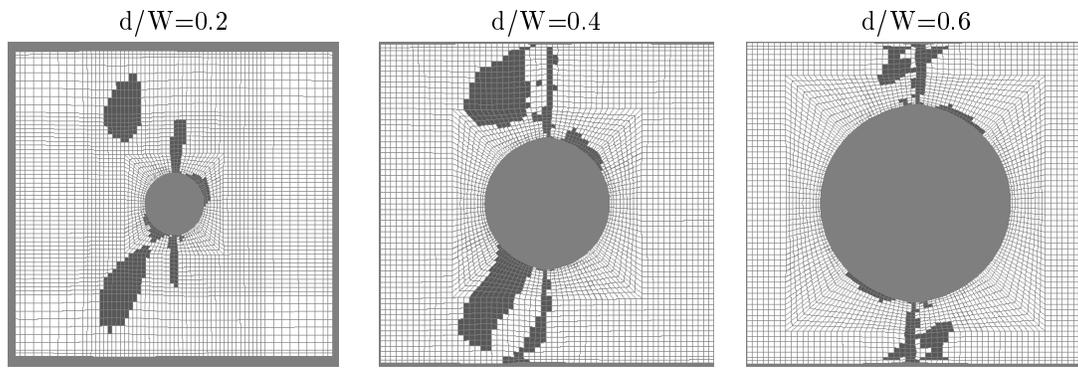
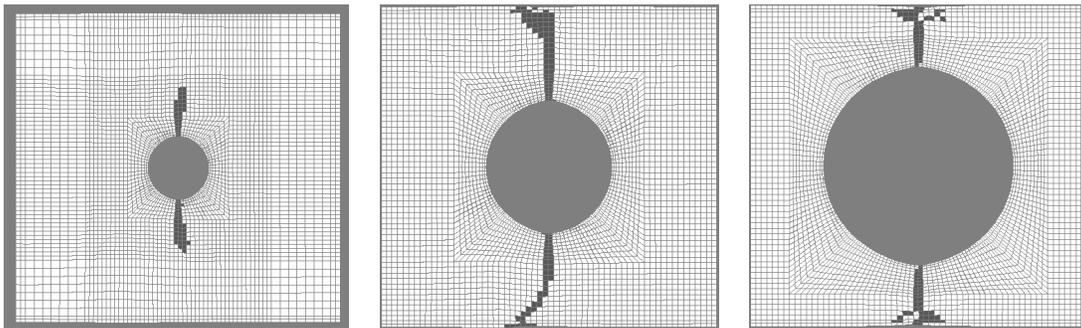
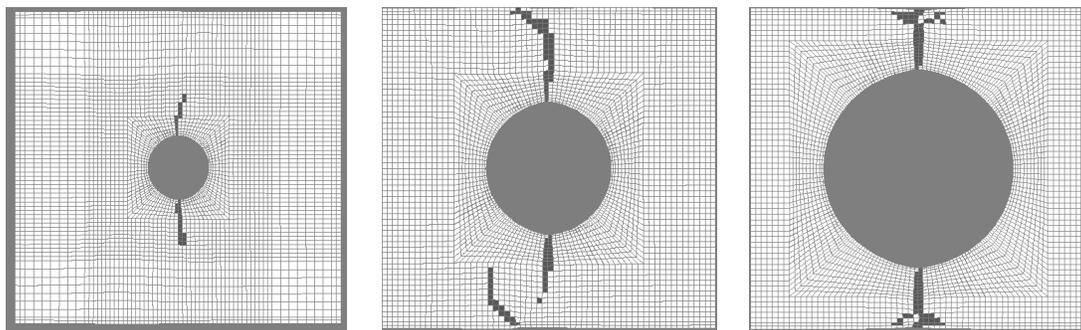
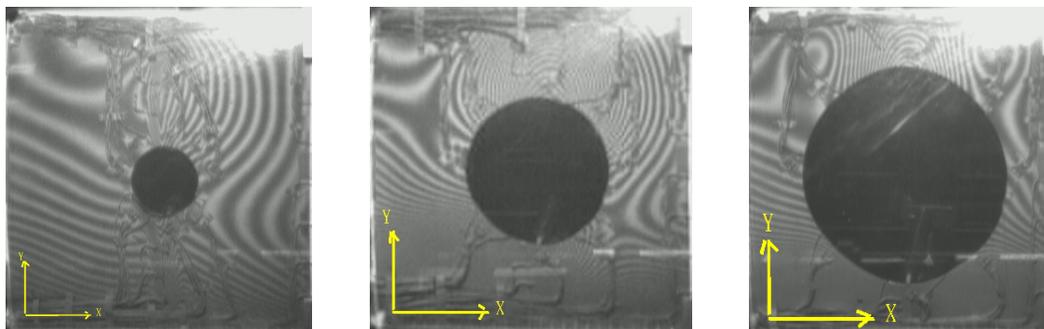
a. Fringe plot of matrix cracking in bottom ply (45°)

b. Fringe plot of fiber-matrix shear in bottom ply (45°)

c. Fringe plot of fiber failure shear in bottom ply (45°)

d. Out-of-plane displacement contour

Figure 15: Damage fringe plots and out-of-plane displacement contours for curved panels with cutouts and loaded in compression after final failure.

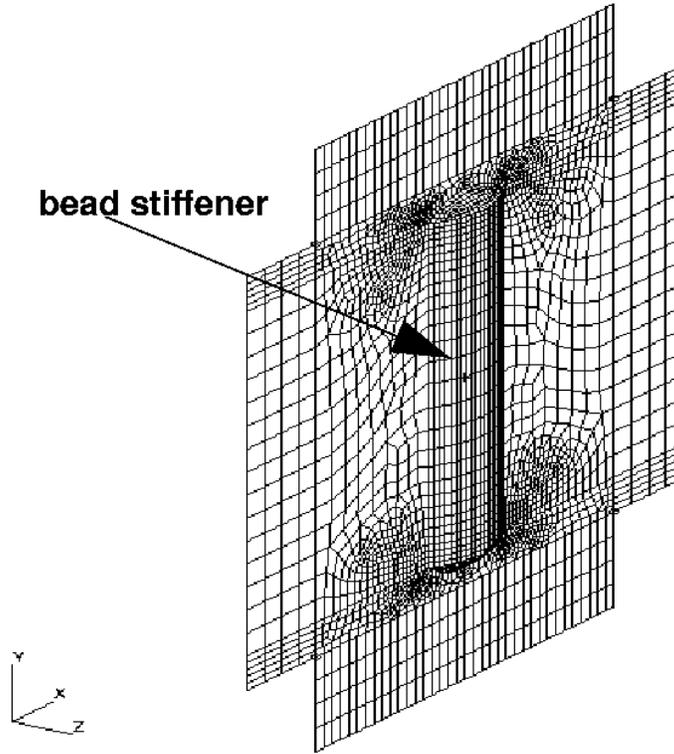
Figure 16: Finite element model of the bead-stiffened panel in picture frame test fixture.

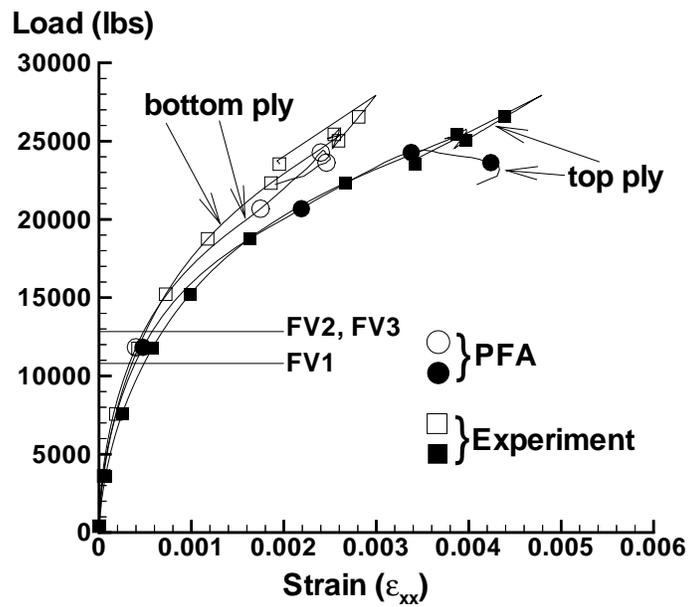
Figure 17: Load versus axial strain, (ϵ_{xx}) results at the center of bead-stiffened panel.

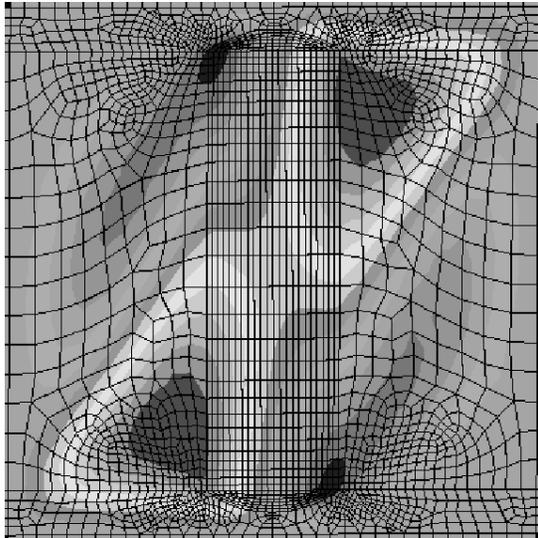
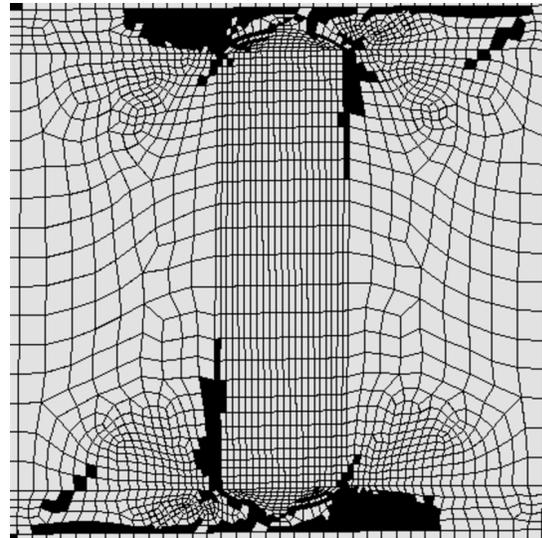
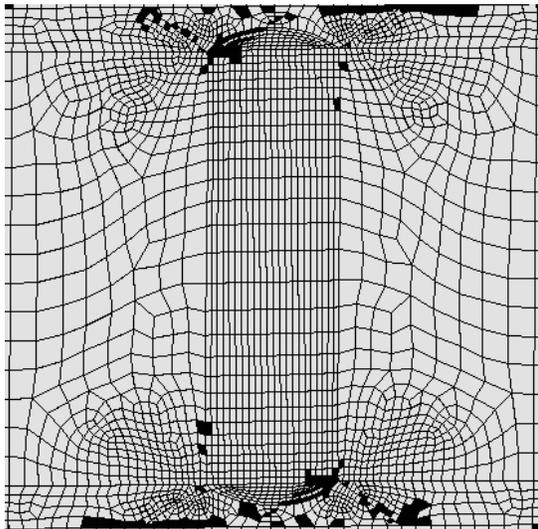
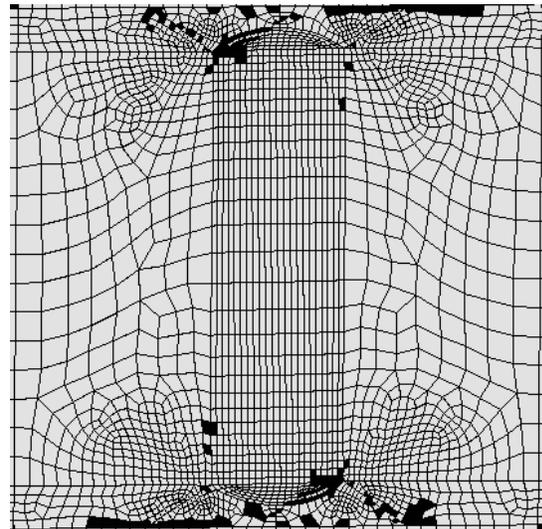
(a) Out-of-plane deformation contour displacement contour after failure

(b) Fringe plot of matrix cracking (FV1) in the top 45° ply

(c) Fringe plot of fiber-matrix shear failure (FV2) in the top 45° ply.

(d) Fringe plot of fiber failure (FV3) in the top 45° ply

Figure 18: Fringe plot of damage for the bead-stiffened panel after failure.
