MANPRINT ANALYSIS OF THE DIVAD SYSTEM:

VOLUME I. HUMAN FACTORS DATA FROM SGT
YORK FOLLOW-ON EVALUATION I

This report is the first of two volumes presenting a MANPRINT analysis of the Division Air Defense (DIVAD) Gun System, also known as Sgt York. The first volume is a consolidation and analysis of the human factors data obtained from the Sgt York Follow-On Evaluation I tests. The second volume is a discussion of the lessons learned from that experience.

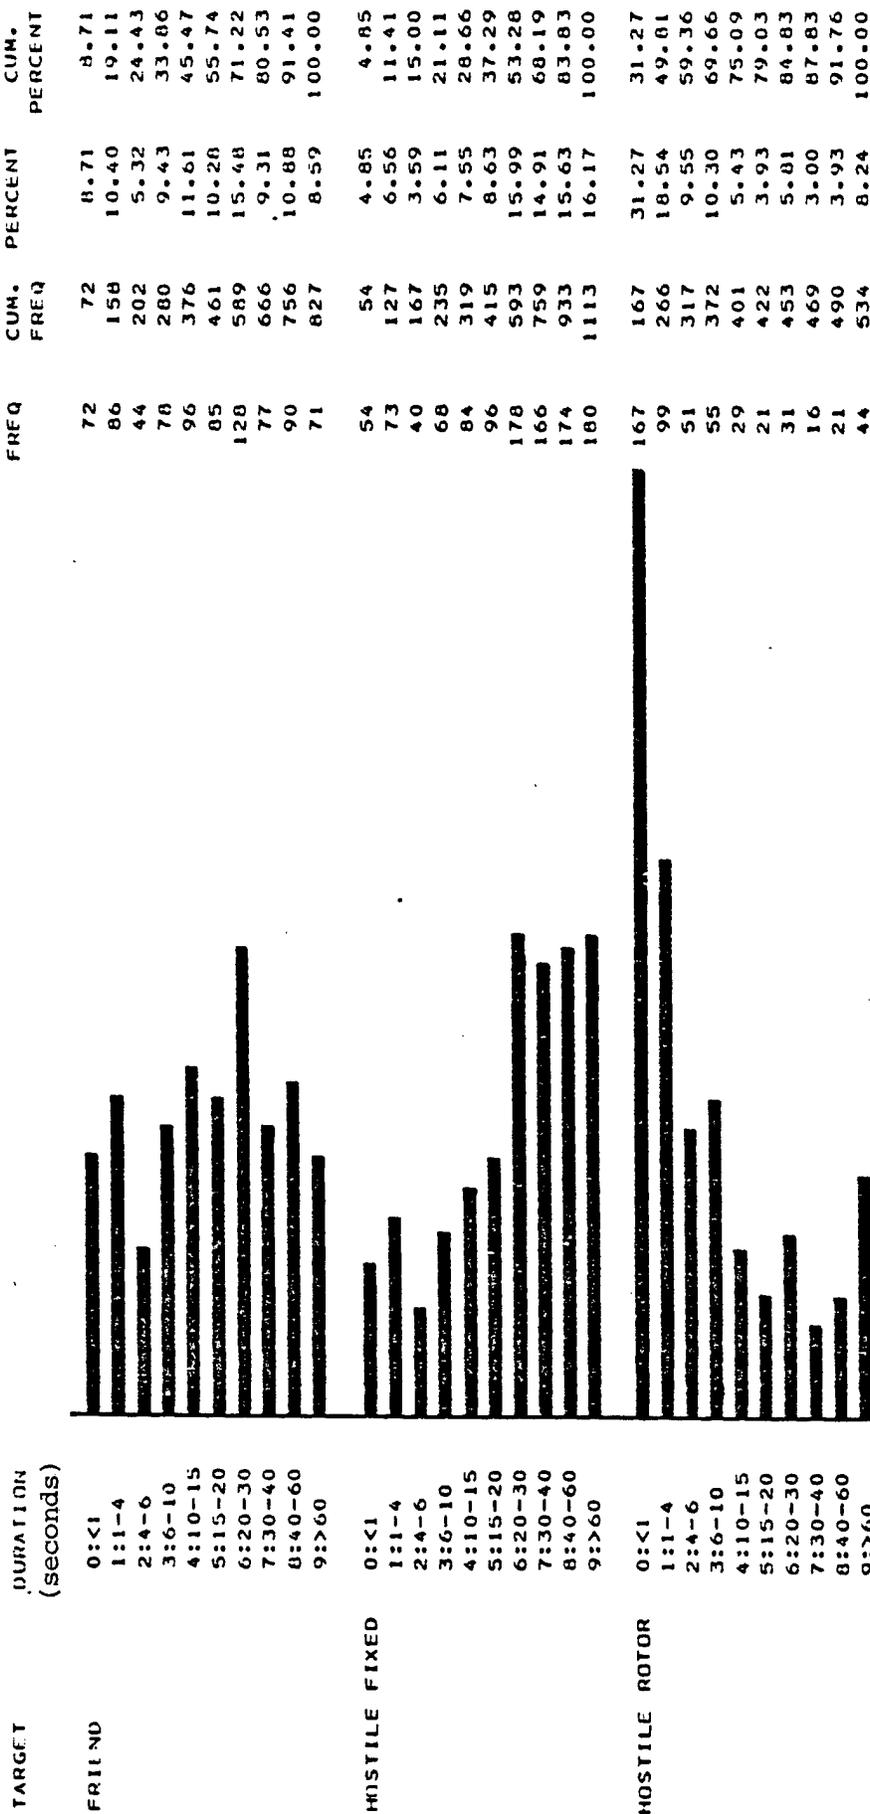
Figure 1. Distribution of Intervisibility Durations for Targets That Were Displayed. Summary Over All the Trials.

As Figure 1 indicates, in the case of hostile rotary-wing aircraft, almost 50% of the intervisibility segments lasted 4 seconds or less. Because of crew reaction and turret slew times, it is possible that if any of these targets were designated, the target would have masked before the slew was complete.

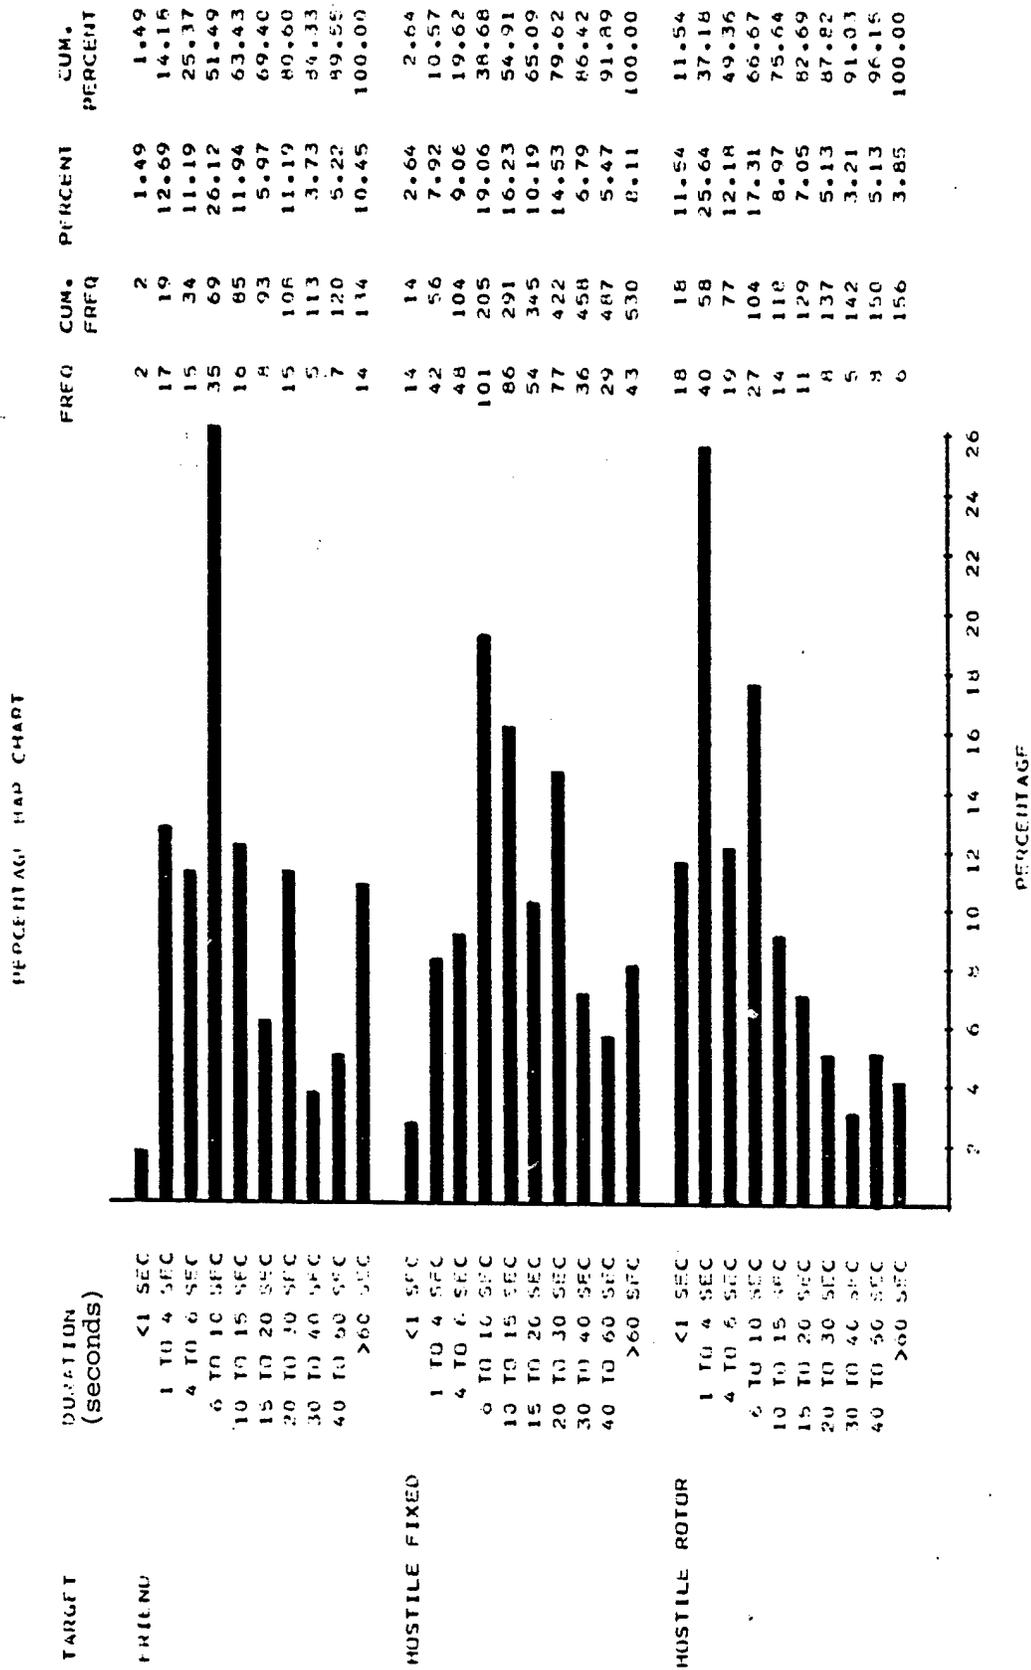
Figure 2. Distribution of Times from Start Intervisibility to Designate for All Engagements of Correlated Targets. Summary Over All Trials.

As shown in Figure 2, for the distribution of durations from the start of intervisibility to designate for correlated targets, only 11.54% of the cases were hostile rotary-wing aircraft. They were designated within 1 second of start intervisibility. It is unlikely that extremely short segments would have been designated at all.

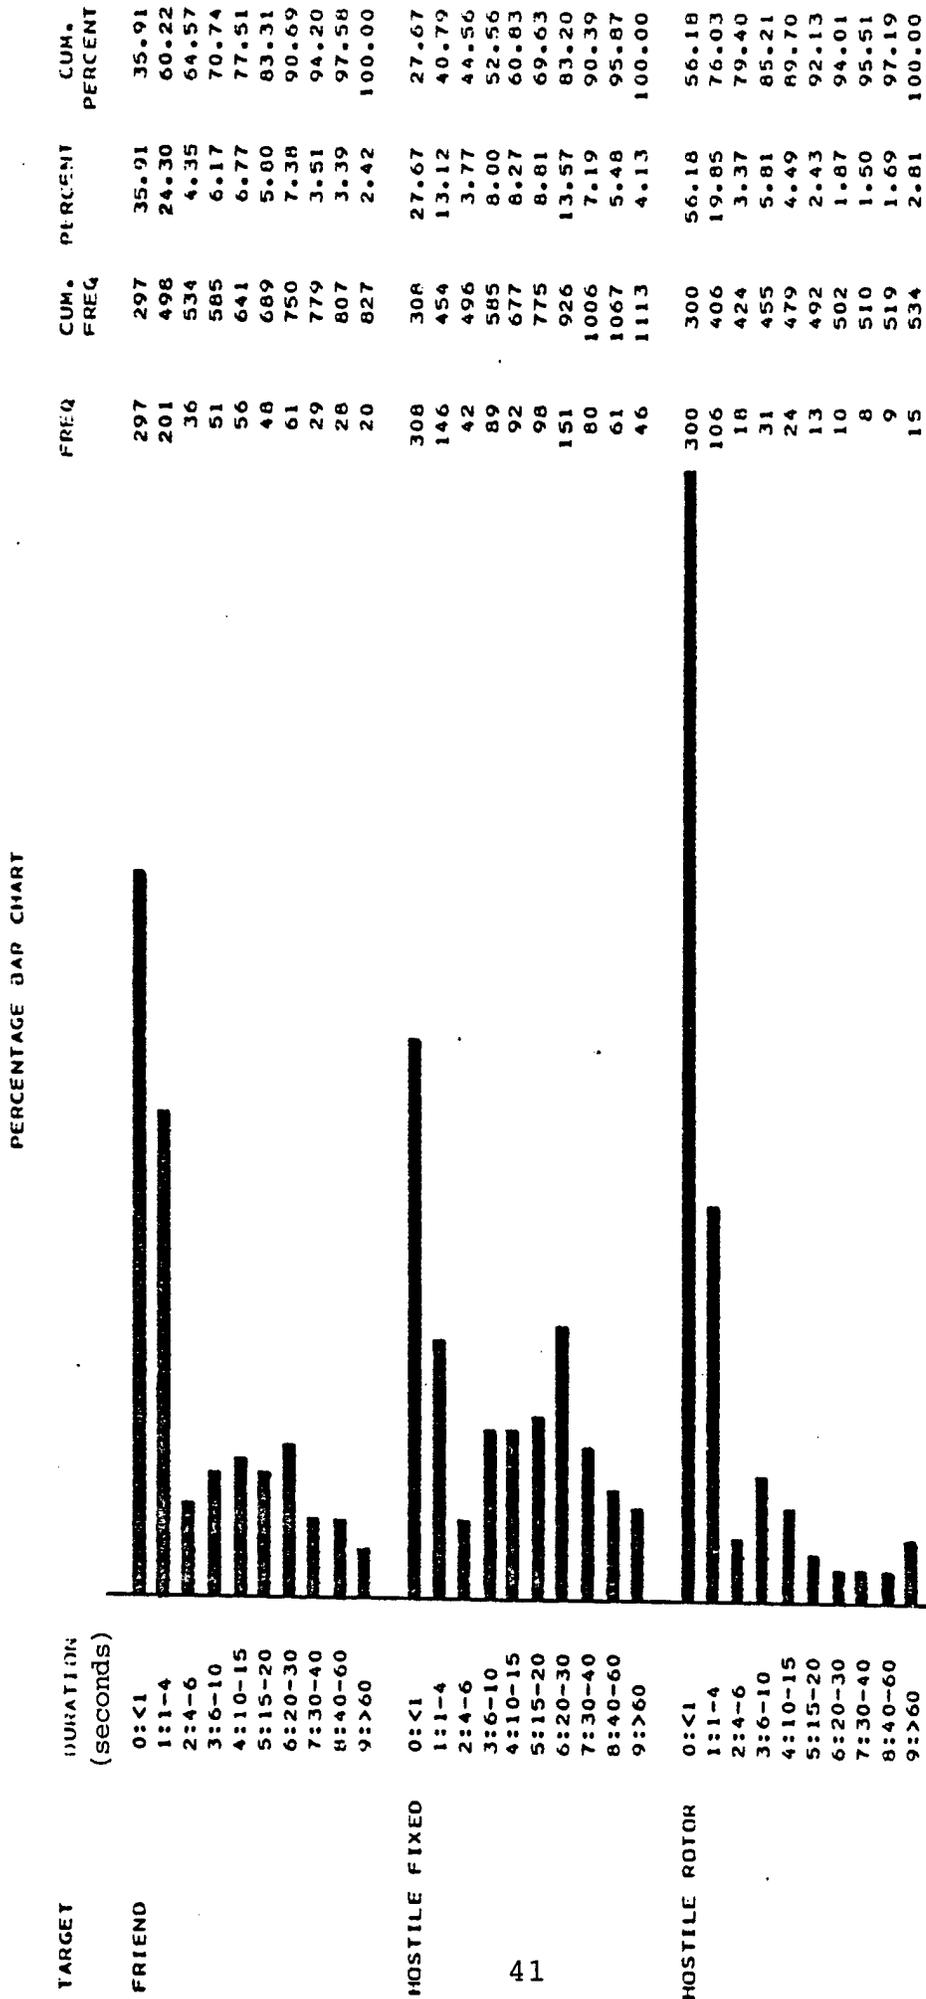
Figure 3. Distribution of Times from Start Intervisibility to First Display for All Displayed Targets. Summary Over All Trials.

As shown in Figure 3, after the start of intervisibility, 76% of the hostile rotary-wing aircraft were displayed within 4.0 seconds. Over 56% of the hostile rotary-wing aircraft were displayed in less than 1.0 second. There were a large number of short-duration hostile rotary aircraft intervisibility segments. A great proportion of intervisibility segments would have been on the verge of ending when the target was first displayed. This was substantiated by data which indicated that 48% of in-range targets were displayed for less than 5.0 seconds plus flight time.

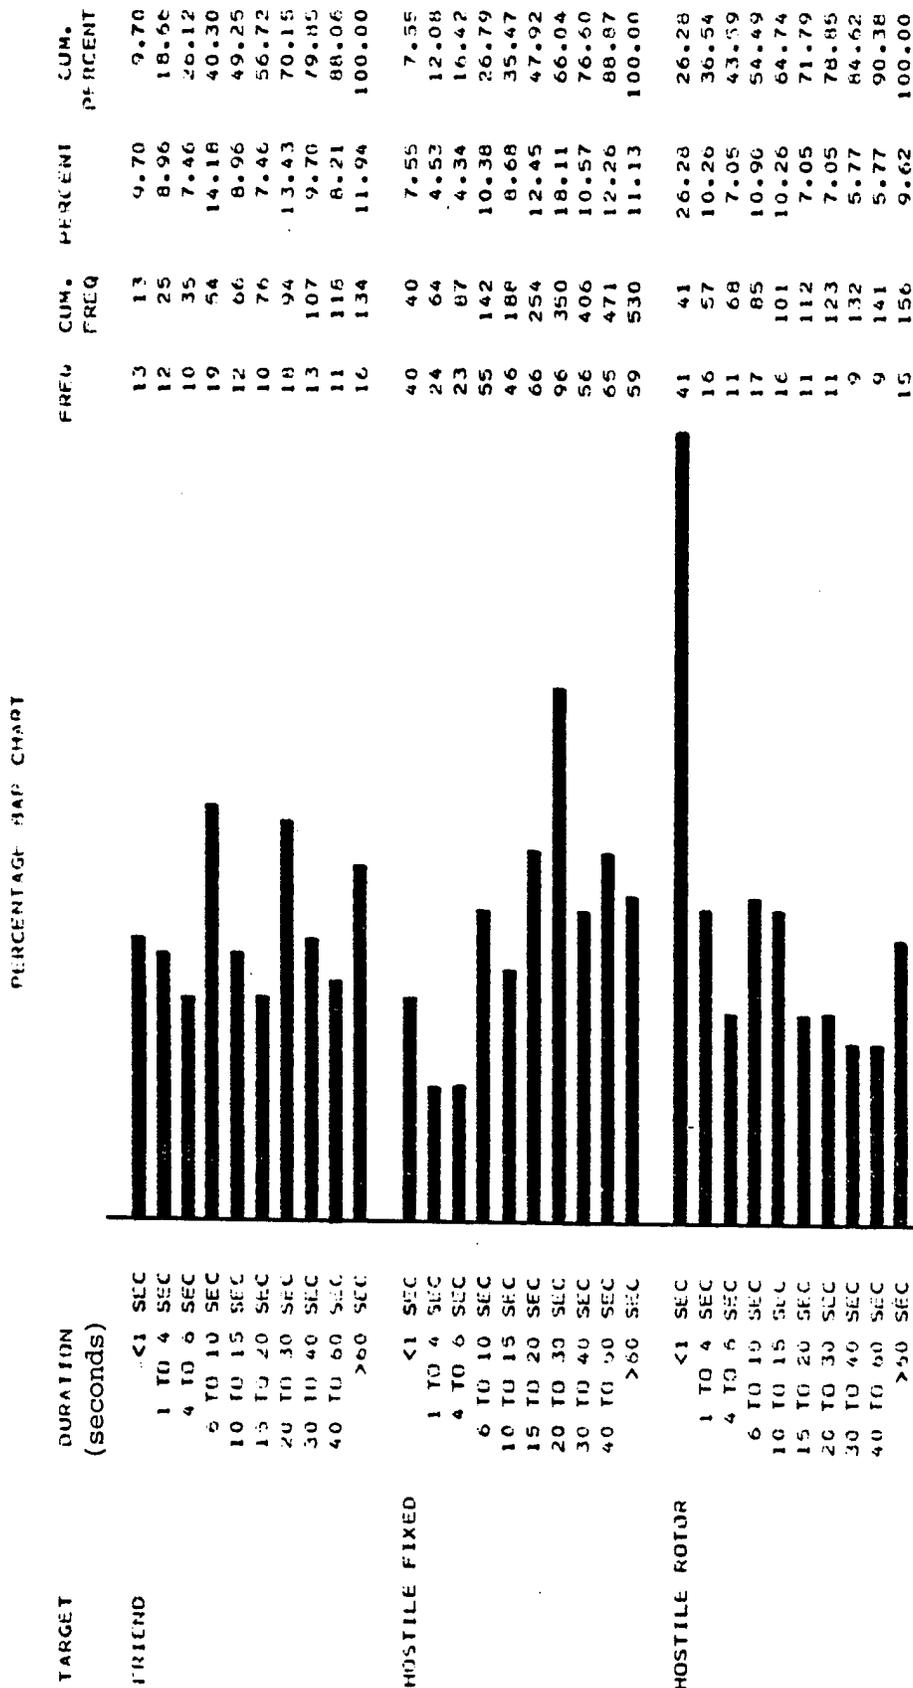
Figure 4. Distribution of Times from Designate to Intervisibility End for All Engagements of Correlated Targets. Summary Over All Trials.

As shown in Figure 4, over one-third of the durations between designate and end of intervisibility were 4.0 seconds or less for hostile rotary-wing aircraft targets. Thus, these

targets would have been in the process of masking at about the same time the slew was completed. The crew might never have seen the target unless the gunsight was initially pointed directly at the target.

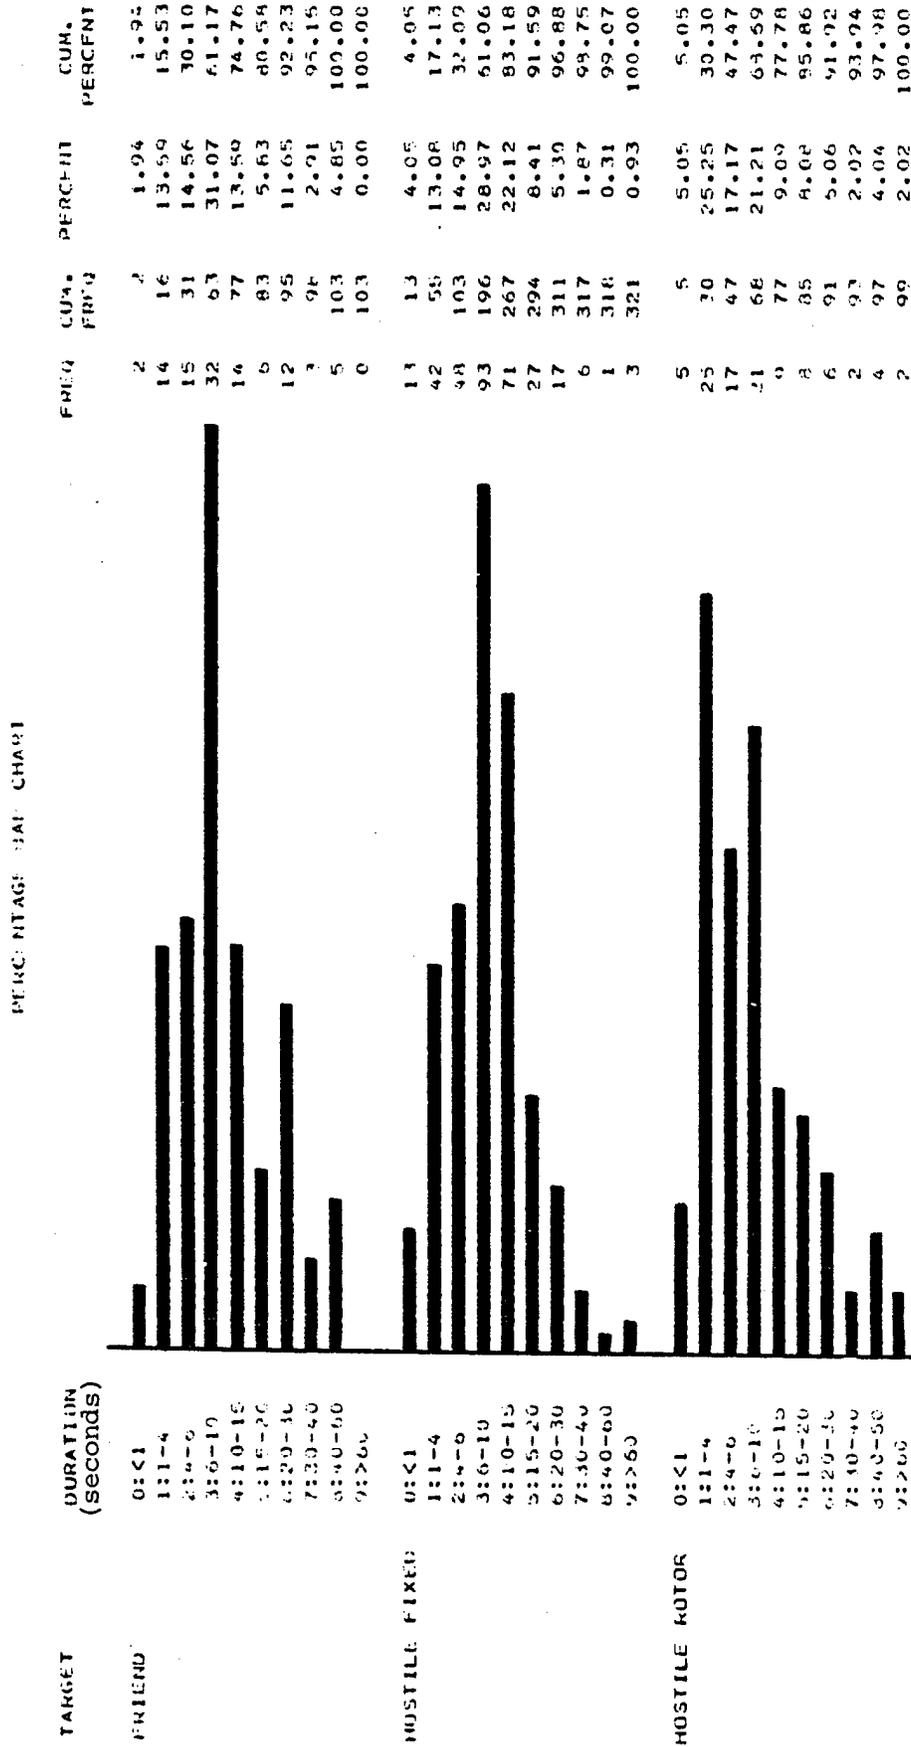
Figure 5. Distribution of Times from Intervisibility Start to Designate for Reaction Type (Single Threat) Engagements. Summary Over All Trials.

As shown in Figures 5 and 6, the amount of time spent processing other targets was a major factor in crew reaction time. Designations were categorized as either (1) designations for reaction-type engagements or (2) designations for servicing-type engagements. The first category, reaction designations, were the designations made in response to the appearance of a target when no other target was currently designated. The second category, servicing designations, were the designations made on targets that appeared while another target already was being designated. In this situation, the crew had to terminate the previous engagement before designating the new target.

When the two types of engagements are compared (Figures 5 and 6), the crew response times to start of intervisibility are distributed more toward short duration for reaction designations than for servicing designations. Such a finding is reasonable, since the servicing designation times must include the time it took to terminate the existing designation as well as the time to make the new designation. The exception to this would be the less than 1.0 second interval for rotary-wing targets. In this case, only 5.05% of the reaction designations were made in under 1 second, but 22.81% of the servicing designations were made that quickly. Perhaps the fact that a target was being tracked raised the level of attention and when a hostile rotary-wing target was sighted that was judged to constitute a more immediate threat, the crewmember was able to, and decided to, switch immediately to the new threat. Overall, however, the mean for the servicing designation of hostile rotary-wing targets is almost 1.5 seconds longer than the mean for reaction designations. The difference in distributions was statistically significant at the .05 level for responses to fixed-wing and rotary-wing aircraft.

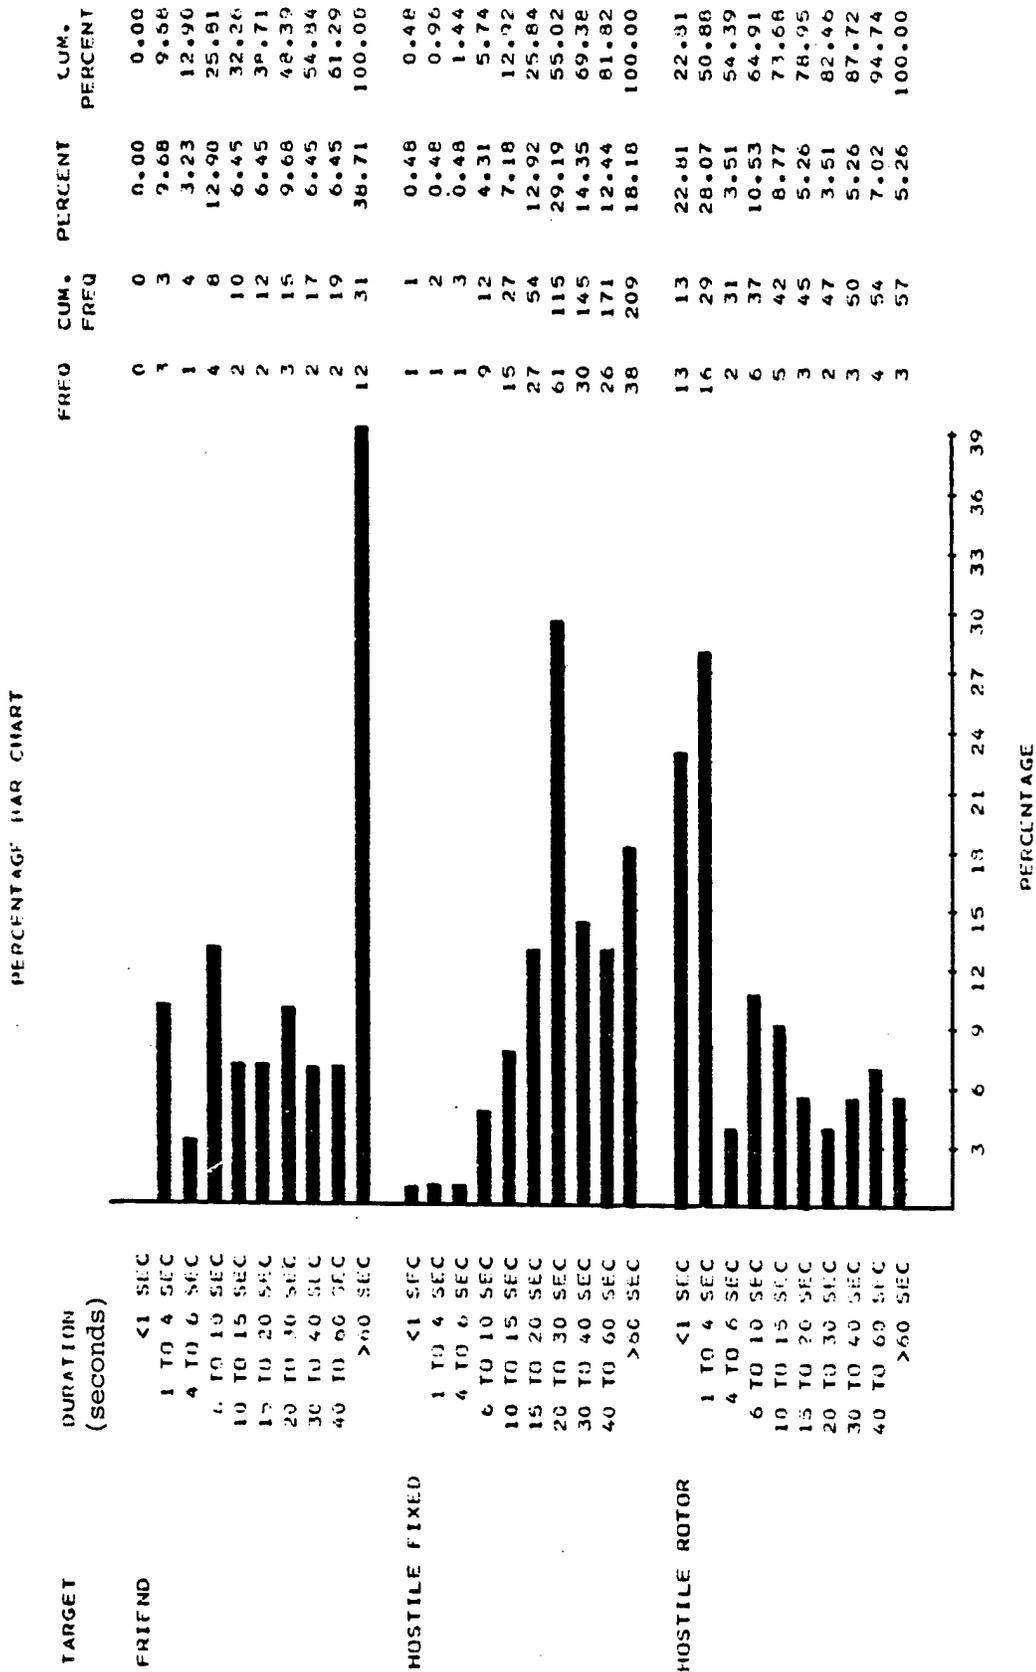
Figure 6. Distribution of Times from Start Intervisibility to Designate for Servicing Type (Multiple Threat) Engagements. Summary Over All Trials.

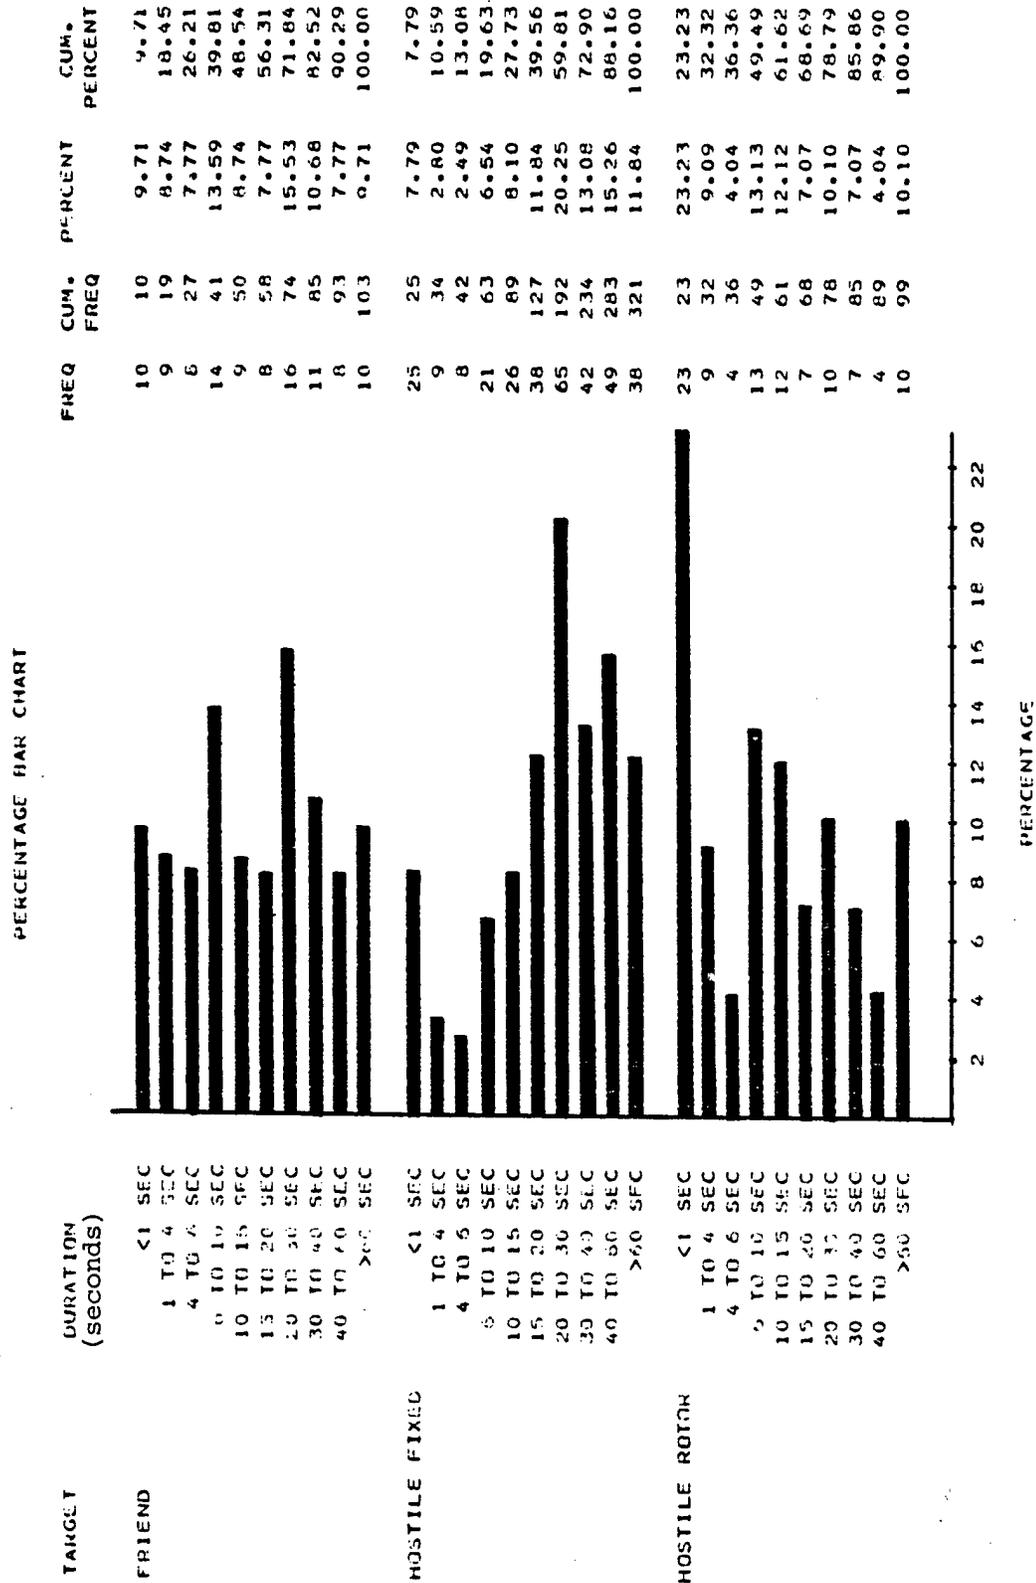
Figure 7. Distribution of Times from Designate to Intervisibility End for Reaction Type (Single Threat) Engagements. Summary Over All Trials.

As shown in Figures 7 and 8, the distribution times from designate to intervisibility end indicated that many hostile rotary-wing targets masked soon after they were designated. For reaction-type engagements (Figure 7), 32% of the durations were 4.0 seconds or less. Servicing-type engagements (Figure 8) had durations of 4.0 seconds or less for 44% of the trials. This difference was not statistically significant.

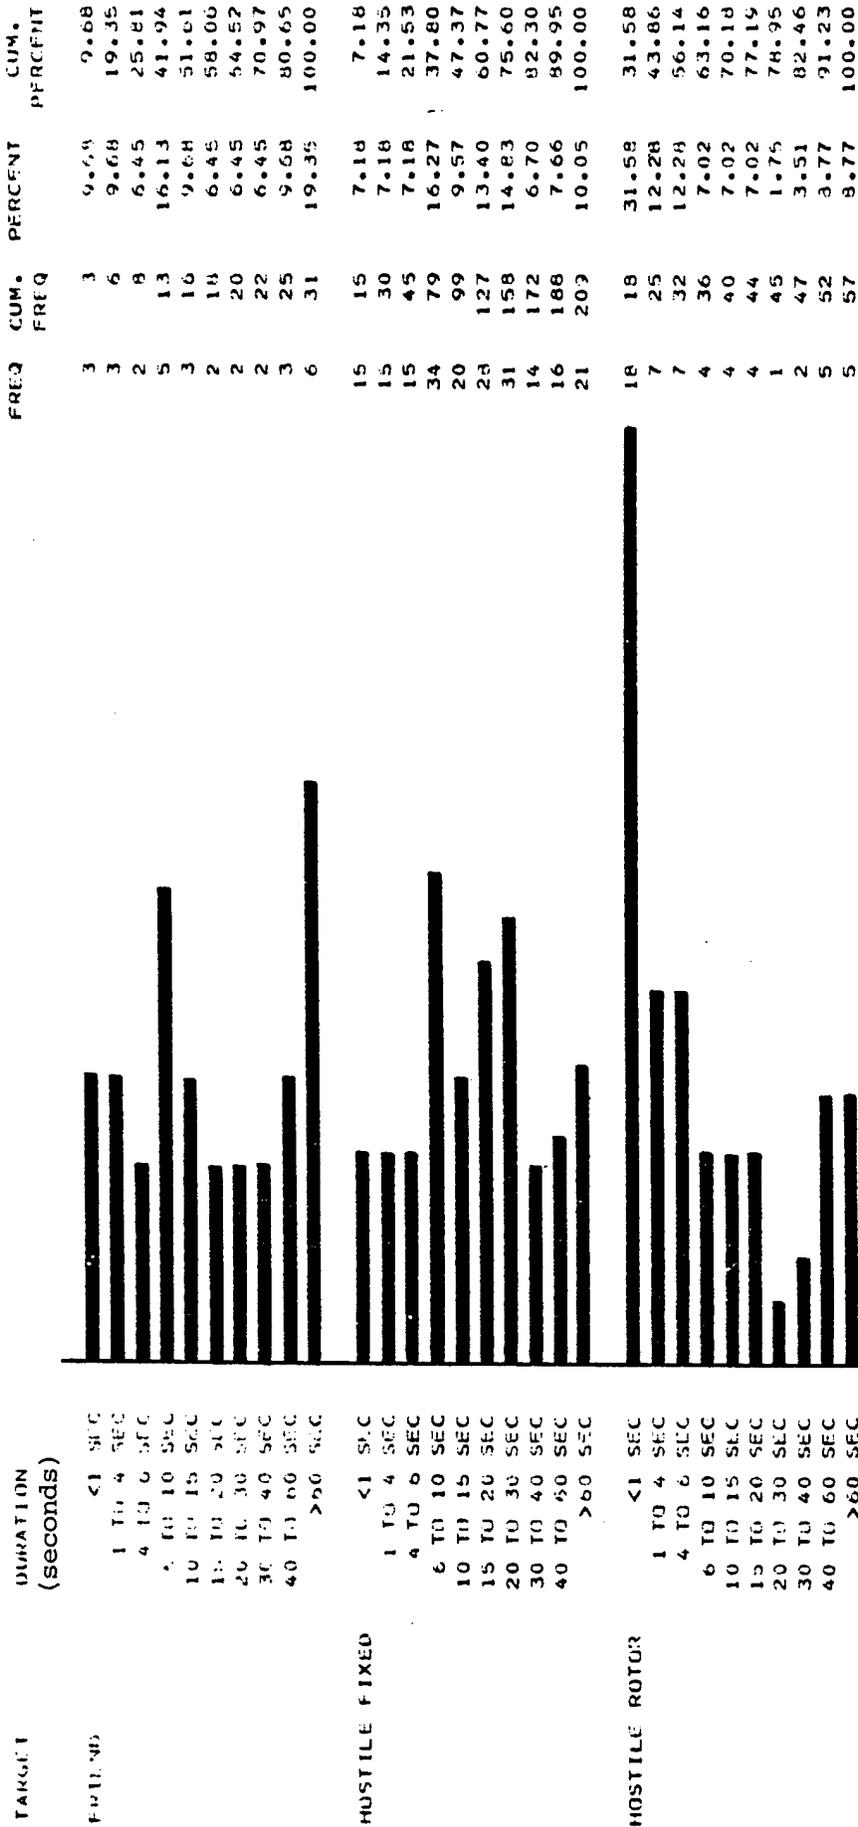
Figure 8. Distribution of Times from Designate to Intervisibility End for Servicing Type (Multiple Threat) Engagements. Summary Over All Trials.

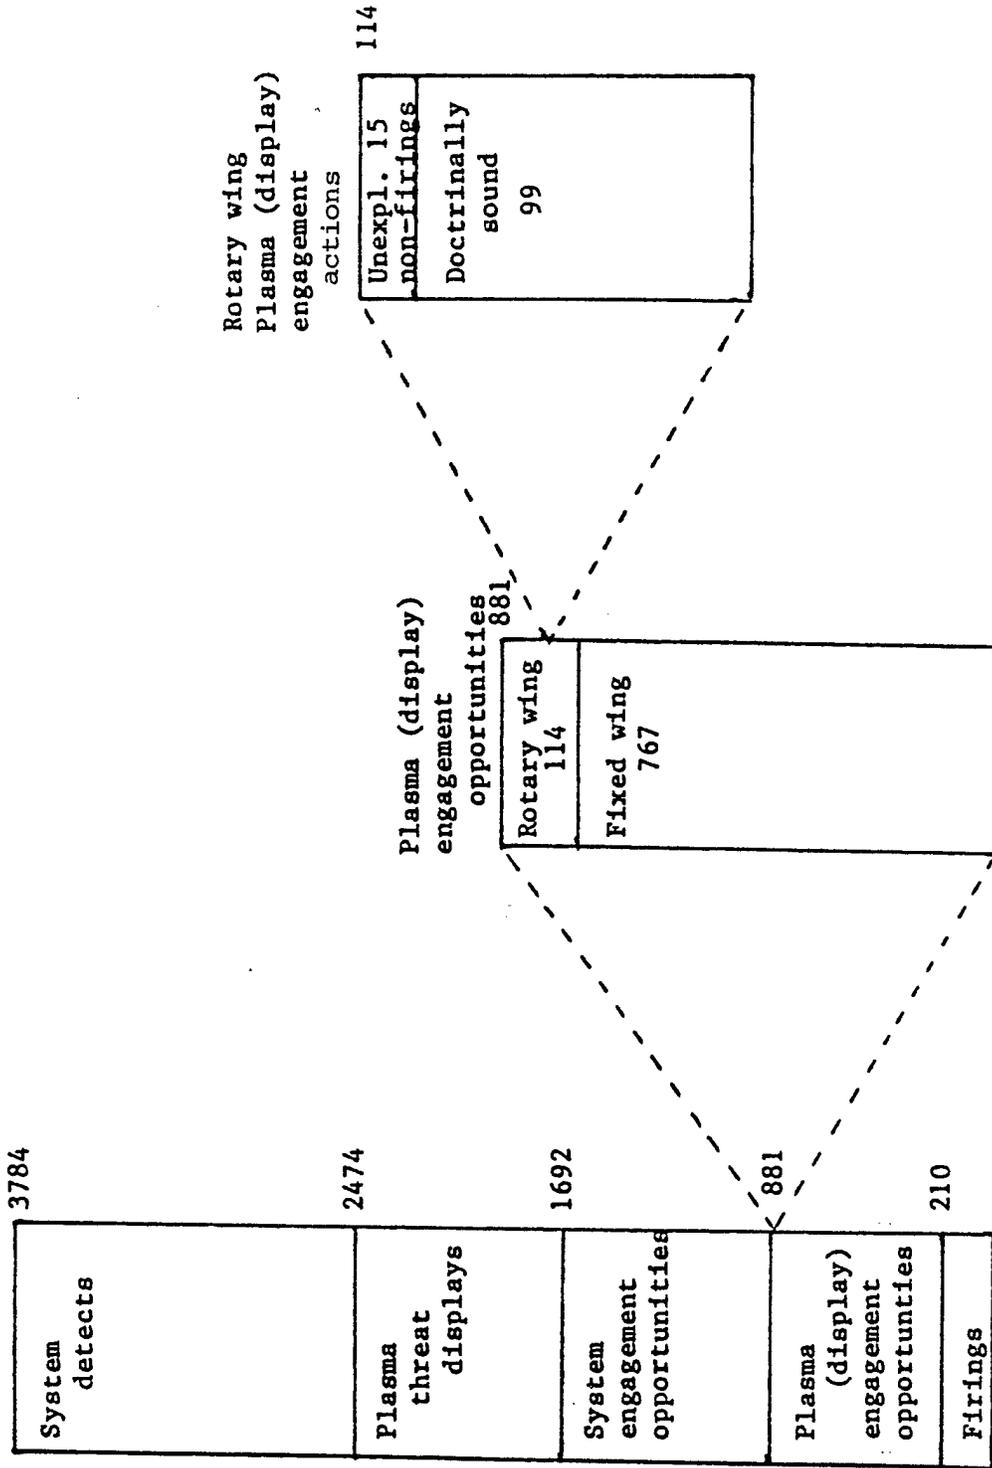
Unexplained non-firings (RW): Rotary wing targets that were not fired at, for reasons that could not be determined by examination of plasma display and thru-sight video, and information from the 1553 data bus recordings.

Figure 9. Breakout of Crew Response to Plasma Display.

The Plasma Display. The crewmember responses to the information on the plasma display during Force-on-Force trials was analyzed. The results are summarized in Table 20 and Figure 9.

In these 99 cases, the crews' actions were considered to be doctrinally sound. (It should be pointed out that the crews were aware of the general locations of the 29 targets that had masked, and in combat likely would have fired in order to suppress them.) This left 15 cases, labeled "unexplained non-firings," in which for unknown reasons the crews did not fire on the targets. Examination of thru-sight and plasma video and of 1553 Data Bus printouts did not reveal reasons for the crews not firing in these cases. Figure 9 presents a graphic display of the results of this analysis.
