SURVIVABILITY MODELING AND VALIDATION IN COMPLEX RIB-SKIN STRUCTURES

This paper presents a coordinated effort to model, test and validate the structural response of complex aerospace rib-skin structures in both undamaged and damaged configurations. Coordinated experimental and finite element model results are presented for cylindrical rib-skin structures each approximately nine foot long, and thirty inches in diameter. The test articles considered are of riveted aluminum construction and include internal structural components including bulkheads and complex stiffeners. Experimental reproduction of the highly idealized loading conditions used in the finite element models required the development of a custom loading rig that is described in detail. In summary, the finite element models were found to predict the structural stiffness of both the damaged and undamaged structures well for small deflections and strains. However, structural failure was not well predicted because large deflections and nonlinear material behavior were intentionally not modeled for simplicity.

13. SUPPLEMENTARY NOTES 44TH AIAA/ASME/ASCE/AHS STRUCTURES, STRUCTURAL DYNAMICS, AND MATERIALS CONFERENCE 7-10 APRI

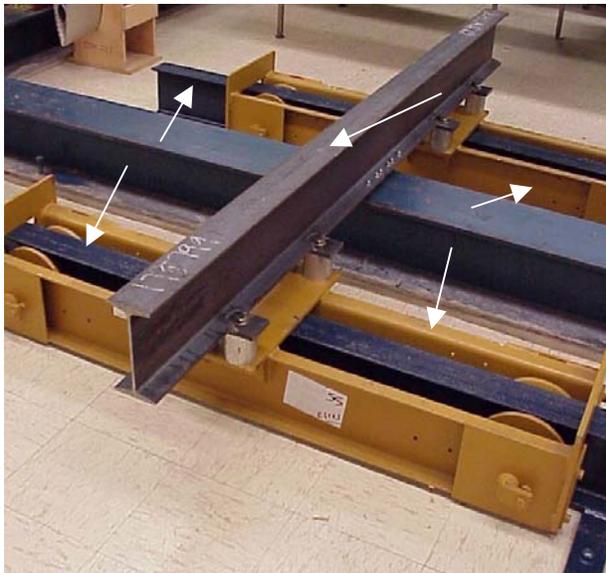
Figure 1. Runway beams, bridge beam and left and right end trucks.

specimen suddenly fails, the load is relieved but the displacement remains a constant until the operator makes a change. The complication, however, is to create a displacement controlled bending rig which also allows for tip deflections both lateral and longitudinal. The solution used in this study was to invert a bridge crane, which is normally mounted to the ceiling, and mount it to the floor. A typical bridge crane, Figure 1, is composed of two runway beams, two end trucks, a bridge beam and a trolley, Figure 2, which traverses the bridge beam.

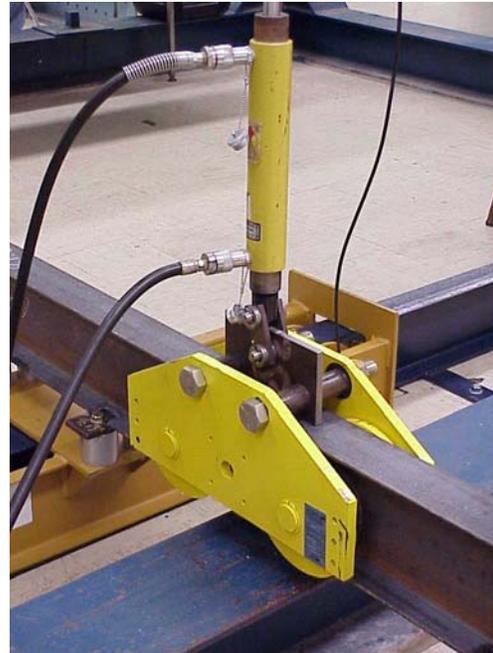
Figure 2. Bridge beam and trolley.

The structure being tested is positioned equidistant between the end trucks and fixed rigidly at one end. The end trucks can then be positioned along the runway beams so that the bridge beam lies directly below the load point on the structure. Consequently, the bend rig is capable of accommodating a wide range of structures. Most importantly, however, during loading if the load point on the structure moves perpendicular to the line of action of the applied load the hydraulic cylinder is capable of tracking the motion by the traversing along the bridge beam on the trolley with little resistive force.

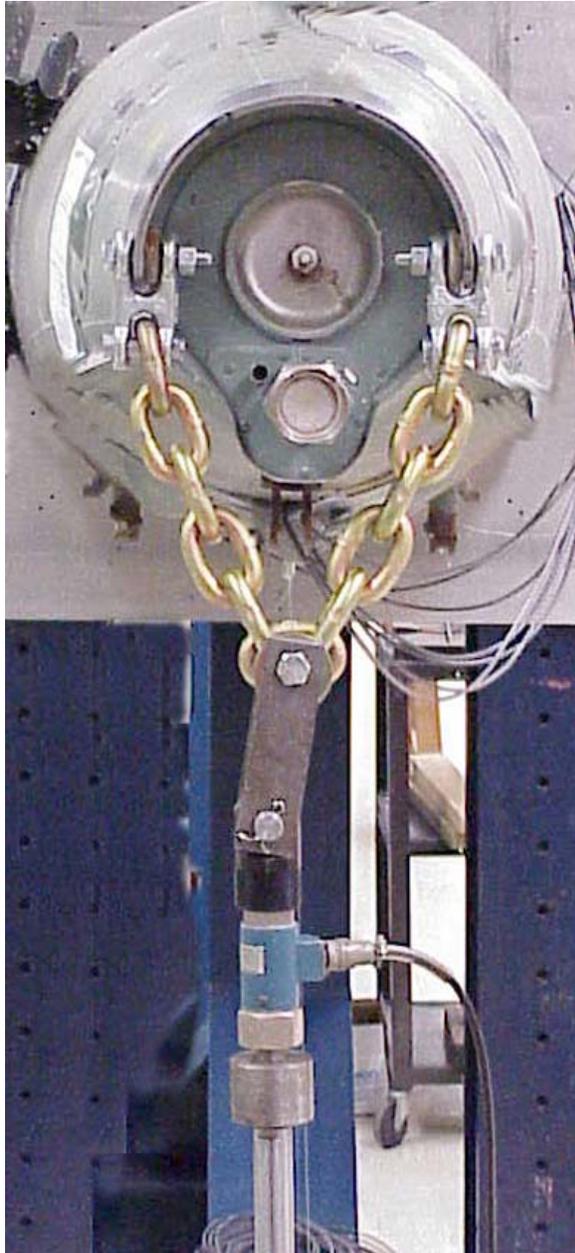
Figure 3. Loading harness and load cell.

Loads were applied to the structures using a sheet metal harness fixed to the free end of the test article with clevises on either side. The harness was attached to a link plate using a length of chain. A 20 kip load cell was pin connected to the link plate and then fixed to the hydraulic actuator as shown in Figure 3.

Loads were applied to the structure using a 10-ton, long stroke, double-acting Enerpac hydraulic cylinder driven by a hand actuated hydraulic pump.

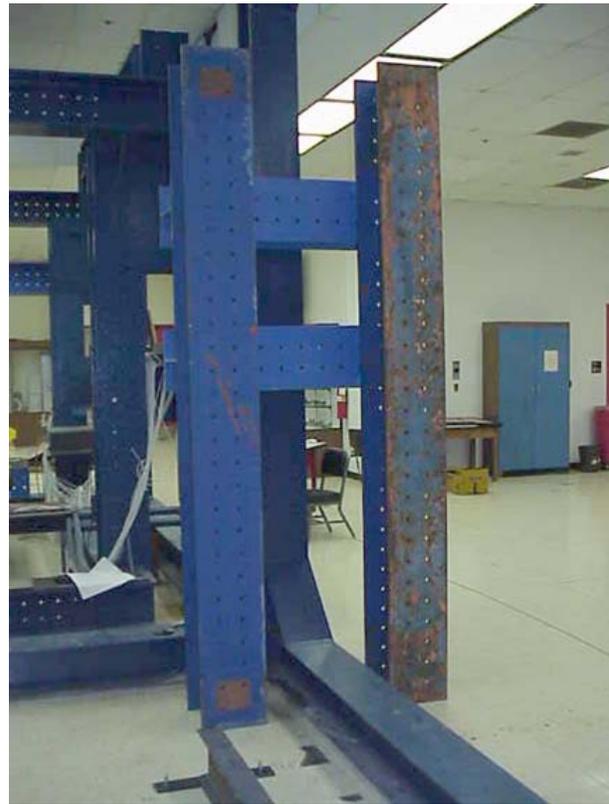
Figure 4. Load frame before mounting test article.

The test articles were mounted to the load frame, Figure 4, by a custom built test fixture. As designed the test fixture provides complete support for the fixed end of the test articles all the way around the circumference. To accomplish this an aluminum base plate was machined to attach to the load frame and then a ring of twenty four 3 in. x 3 in. x 6 in. long fixture blocks were attached to the base plate in an annular ring

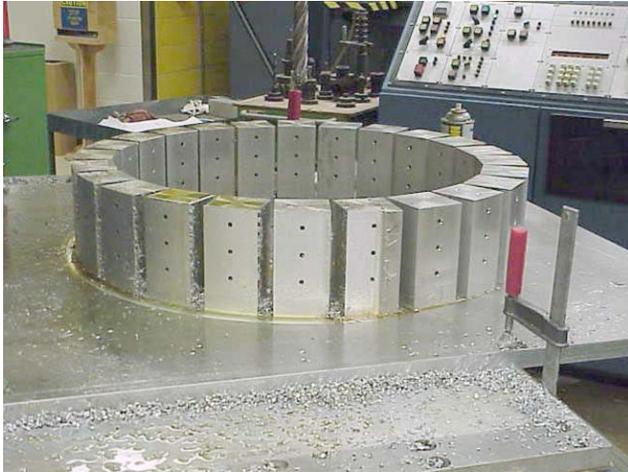
Figure 5. Fixture machining.

using two 1/4-20 cap screws. Once attached the fixture blocks were machined into a circular pattern using a CNC mill to fit the test article, Figure 5. The machining pattern was based on measurements of the interior circumference of the test articles at the fore end and was rehearsed prior to cutting metal by machining a plywood plug. This manufacturing technique was chosen to reduce material waste and minimize machining time necessary to fabricate the loading ring. The loading ring was then fitted to the test article and bolted tight at each location using 1/4-20 cap screws bolted through a carefully fitted steel collar designed to distribute the load around the circumference of the test article.

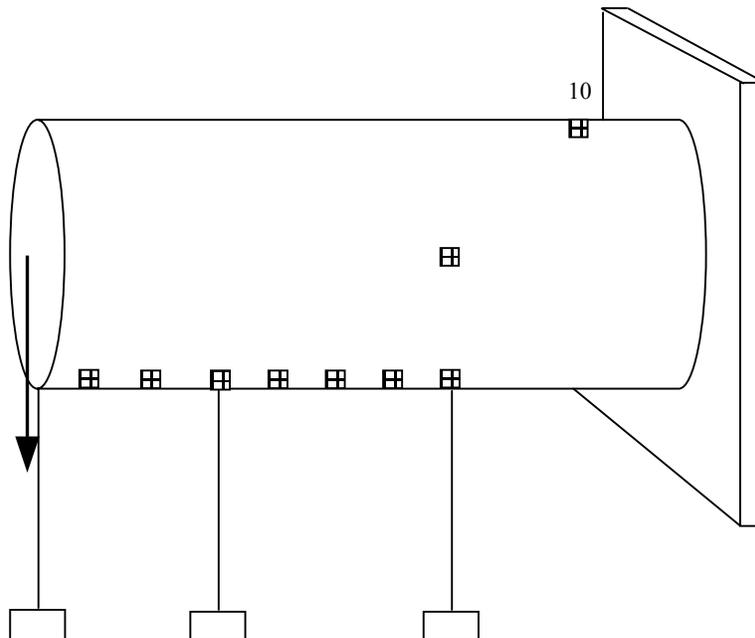
Figure 6. Strain gage and string potentiometer schematic.

In addition to the 20 kip load cell discussed above each structure was instrumented along the length for deflection and around the exterior for strain in the skin as shown below, Figure 6. Deflections were measured at locations along the length of the specimen (at the free end where the load was applied, at approximately $L/4$ and $L/2$) using Celesco Model PT101 string potentiometers with a 5 in. full range. Strain gages 1-7 to measure the flexural strains were installed along the ventral axis of the test article, evenly

space from the free end to approximately $L/2$. Strain gages 8 and 9 were installed along the midline of the test article at approximately $L/2$, to measure the axial strain and the hoop strain at the midline. Strain gage 10 was installed on the dorsal axis approximately $L/5$ from the fixed end of the test article to measure the flexural strain. All of the strain gages were single pattern 120 Ω CEA-13-250UW-120 type gages from MicroMeasurements.

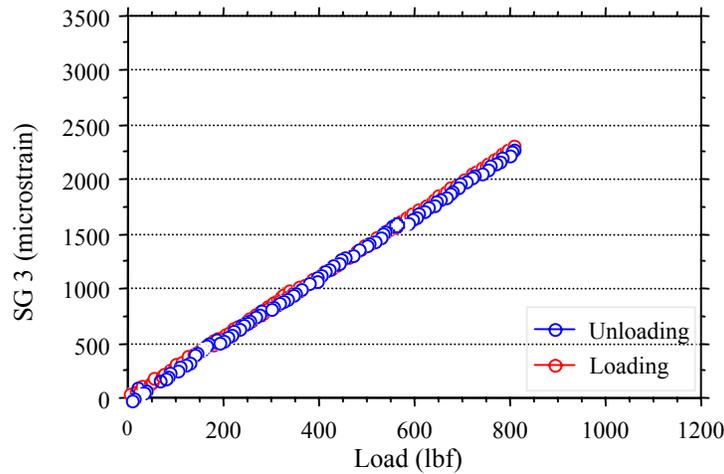
Figure 7. Strain versus load hysteresis plot.

Initial tests of the loading rig showed little hysteresis in either the strain/load data or the displacement/load data (see Figure 7 and 8.) The data in Figure 7 and 8 was collected during loading and unloading of one of the test articles in the elastic range.

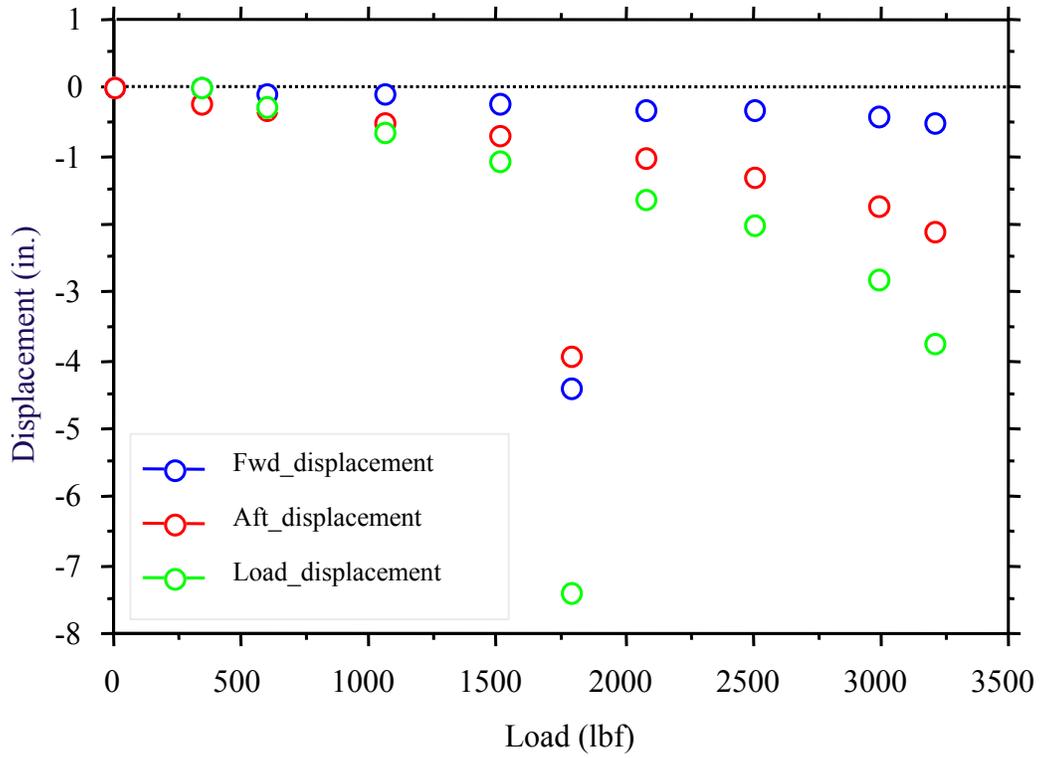
Figure 9. Displacement versus load.

Typical displacement/load data and strain/load to failure are included in Figures 9 and 10. Figure 9 shows the expected pattern of increasing deflection with increased load becoming non-linear in this instance at or before 2500 lbs, which proved to be the onset of buckling in the skin. Also as expected we observed and decreased vertical deflection at $L/4$ and $L/2$, both points closer to the fixed end of the test article. Figure 10 exhibits a similar pattern of increasing flexural strain along the ventral axis of the

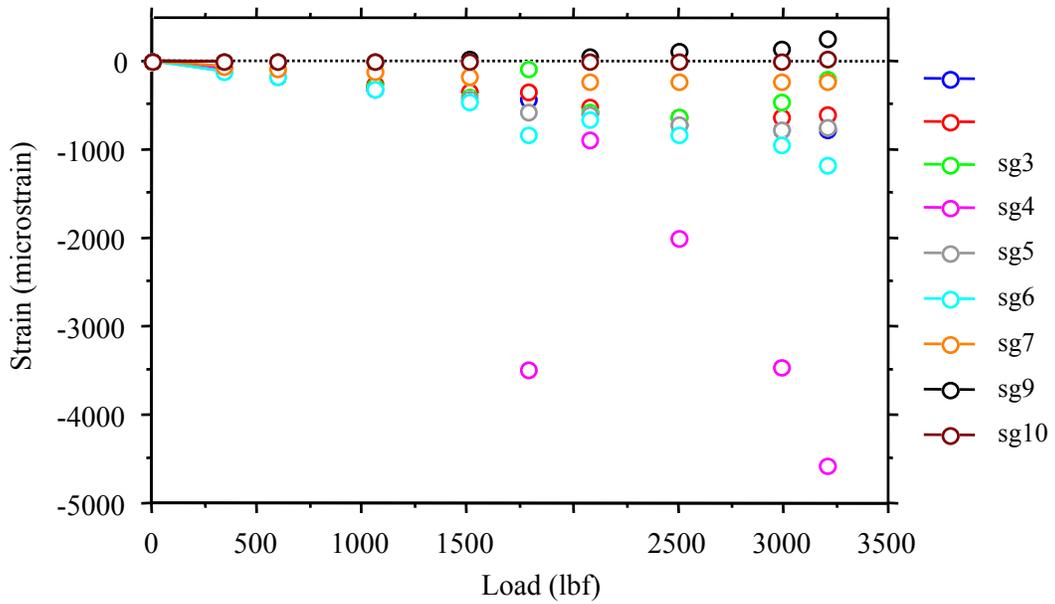
Figure 10. Strain versus load.

test article with increasing load finally resulting in a dramatic divergence of the strains at strain gage location 4 at approximately 2500 lbs load. Post mortem inspection of the test article showed skin buckling in the vicinity of strain gage 4.

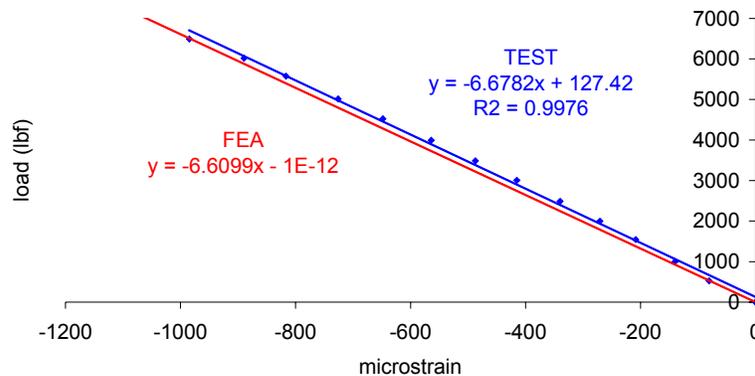
Figure 11. Experimental (—) vs. predicted FEA (—) response for undamaged structure.

Comparisons of test data with the finite element analysis results have shown very good agreement. As shown in Figure 11 the finite element analysis prediction for the undamaged target matches well with test data for a strain gage location close to the aft end (sg4) on the ventral surface. Additionally, the bending stiffness of the structure is well predicted by the finite element analysis whose prediction differs by only 1.02% from the experimentally determined value. The bending stiffness of the damaged structure was also accurately predicted by the finite element analysis up to the onset of buckling as shown in Figure 12. Moreover, in the damaged structure the bending stiffness has been reduced by 48% with respect to the undamaged

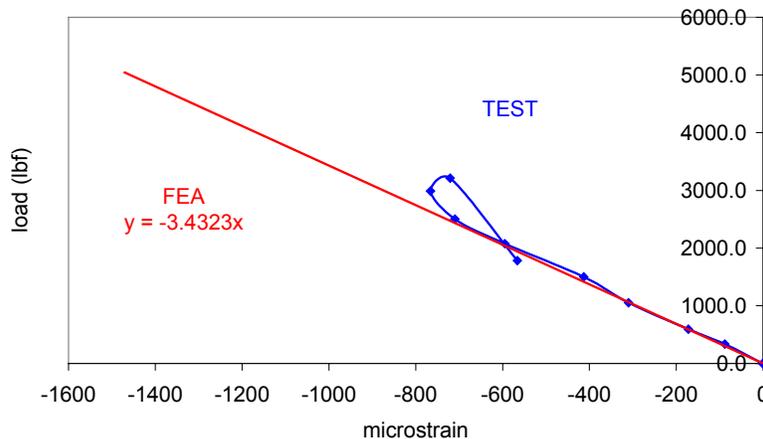
Figure 12. Experimental (—) vs. predicted FEA (—) response for damaged structure.

The accuracy of the finite element analyses is, as expected, suspect at larger strains and deflections as indicated in the data for a damaged structure as in Figure 12. The restriction of the finite element model to small deflections and strains renders it incapable of predicting the complex behavior observed during the testing of the damaged structure. The finite element analysis shows good correlation with measured loads up to approximately 2,500 lbs. At larger loads, however, the structure began to fail due to buckling of the skin. Because of the buckling, the load paths through the structure are redistributed resulting in a discrepancy between measured and predicted strains. This is an area where the analysis falls short, since the limitations of the finite element model fidelity, such as missing interior components, prevented a prediction of where and at what load the structure would fail.
