# **Use of Multidimensional Fiber Grating Strain Sensors for Damage Detection in Composite Pressure Vessels**

Marley Kunzler<sup>a</sup>, Eric Udd  
Blue Road Research, 376 NE 219th Avenue, Gresham, OR 97030

Mont Johnson and Kurt Mildenhall  
ATK Thiokol, PO Box 707, M/S 252, Brigham City, Utah 84302

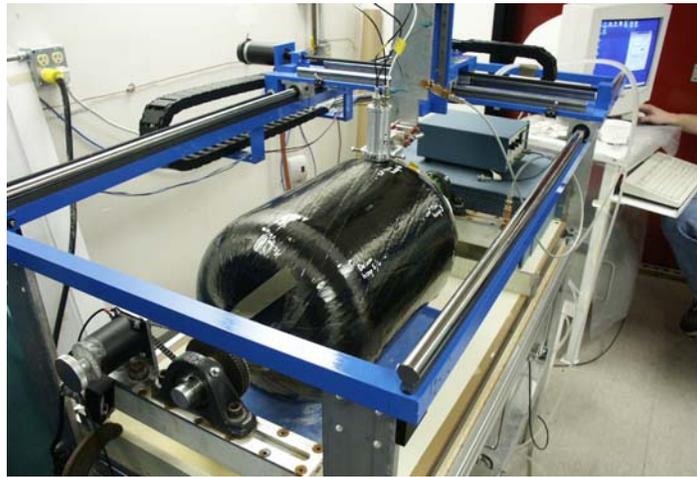
**Figure 6. Eddy current scanning machine used to assess damage.**

To provide a basis for comparison, eddy current and ultrasonic scans were performed after each pressure cycle and impact. Figure 6 shows the eddy current system used. Shown in Figure 7 are eddy current scans of the pressure bottle for Quadrant 1. There are three impact areas corresponding to a Teflon tape defect (upper right hand corner) and the two cut tows. Figure 8 shows a similar scan using ultrasonic techniques.
