THE IMPACT OF THE USS *FORRESTAL*'S 1967 FIRE ON UNITED STATES
NAVY SHIPBOARD DAMAGE CONTROL

A thesis presented to the Faculty of the U.S. Army
Command and General Staff College in partial
fulfillment of the requirements for the
degree

MASTER OF MILITARY ART AND SCIENCE
Military History

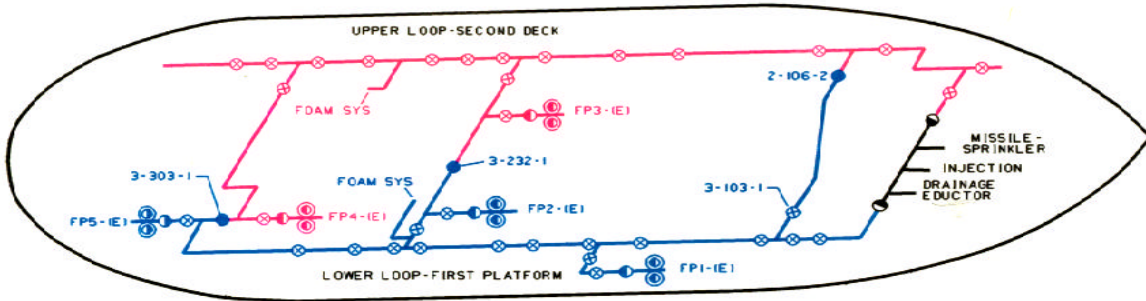
TYPICAL NAVY FIREMAIN "LOOP" DIAGRAM

ALL PUMPS AVAILABLE FOR OPERATION OF THE MK13 GUIDED MISSILE LAUNCHING SYSTEM, SPRINKLER SYSTEM, BOOSTER SUPPRESSION & DRAINAGE EDUCTORS

LOWER LOOP - FP1-(E), FP2-(E), & FP5-(E)

THE FIREMAIN LOOP IS SEGREGATED INTO TWO SECTIONS. IN CONDITION "ZEBRA" AS INDICATED ABOVE. TO ESTABLISH CONDITION "ZEBRA" FROM CONDITION "X-RAY" OR "YOKE", THE FOLLOWING THREE "ZEBRA" VALVES ARE CLOSED.

VALVE NO.	LOCATION	REMOTE CONTROL
2-106-2	2-100-4-L	2-292-01-C
3-232-1	5-212-0-E	2-292-01-C
3-303-1	5-292-0-E	2-292-01-C
3-103-1	3-100-1-L

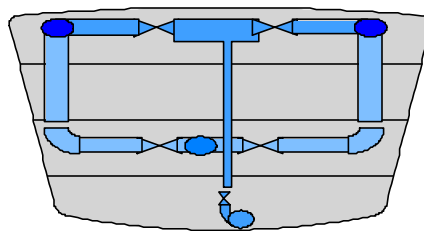
Cutaway View of Loop

Source: These diagrams originally appeared in a training presentation prepared by the US Navy's Surface Warfare Officer School at the Naval Education and Training Center, Newport, Rhode Island.
