**MECHANICAL BEHAVIOR OF CRACKED PANELS
REPAIRED WITH BONDED COMPOSITE PATCH**

THESIS

Michael A. Hansen, Captain, USAF

AFIT/GA/ENY/05-J01

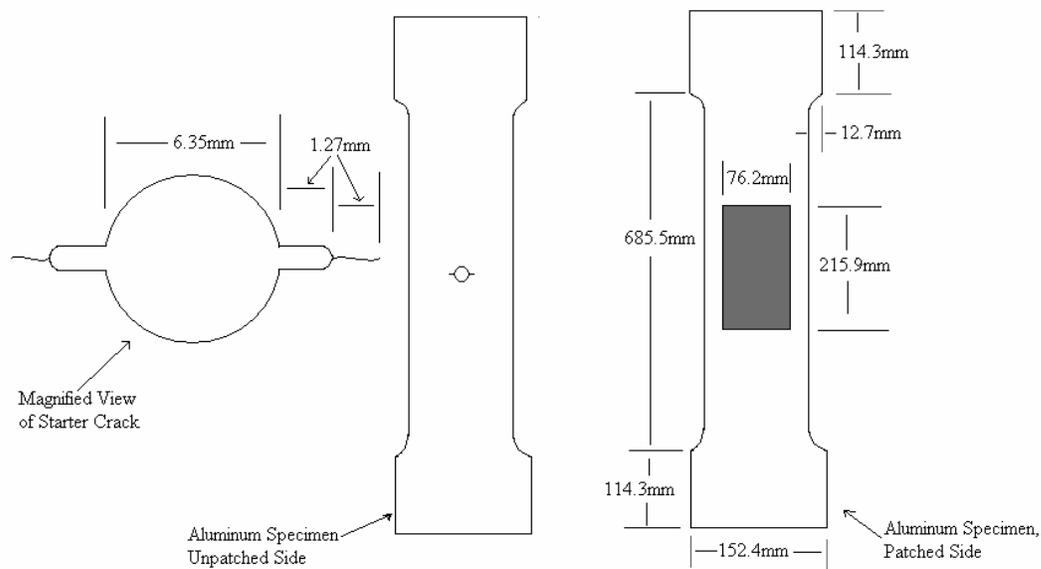
A series of fatigue and tensile tests will be performed with six specimens in this study. The specimens used are 914.4 mm long by 152.4 mm wide, by 0.4763 mm thick of unclad 7075-T6 aluminum, cut into a dogbone shape with a 127 mm gage section. Cracks were machined at the center of each specimen. A 6.35 mm diameter hole was cut on the center of each specimen with 1.27 mm EDM notches cut into each side of the hole. Starter Cracks of about 1.27 mm were then grown from the notches. (See figure 1) Each specimen had a 16 ply, 76.2 mm wide long boron/epoxy 5521 patch centered on the hole. The patches were tapered at the ends with a 20:1 ratio of overlap length to patch

thickness. The length of the longest patch ply is 215.9 mm. With a nominal 0.14224 mm ply thickness, the length of the tapered region at each end of the patch is 39.624 mm and the constant thickness patch length is 139.7 mm. The patches are all unidirectional plies, with the fibers oriented along the length of the specimen. The patches were bonded to the aluminum with a nominal 0.0381 mm layer of FM-73 knit carrier adhesive with a nominal weight of 0.085 Newtons per square meter. [9]

Figure 1. Specimen diagram

Cracks were machined into the center of each specimen. A 6.35 mm diameter hole was cut into the center of each specimen with 1.27 mm EDM notches cut into each side of the hole. Starter cracks of about 1.27 mm were then grown. Refer back to Figure 1 for the specimen diagram. [9]

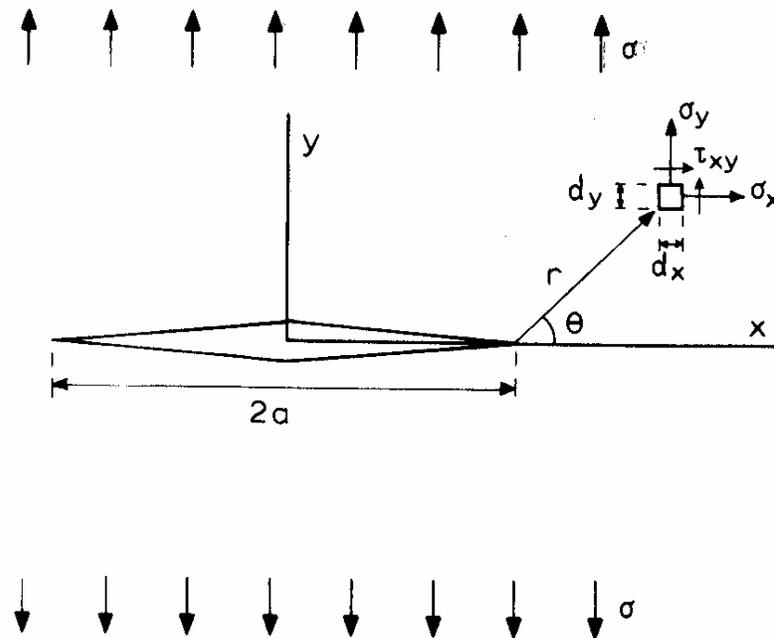
Consider first a crack in an infinite plate (Figure 2). From the inherent flaws in the material this crack may have grown due to structural loading, environmental conditions or both. Over time the crack will continue to grow due to combinations of further environmental effects, and additional loading.

Figure 2. Crack in an infinite plate.[10]

Again the cracked infinite plate in Figure 2 is considered. To understand the stresses at the crack, the stress intensity factor K must first be defined. For the given crack and loading in a mode I situation, the stress intensity factor is given by

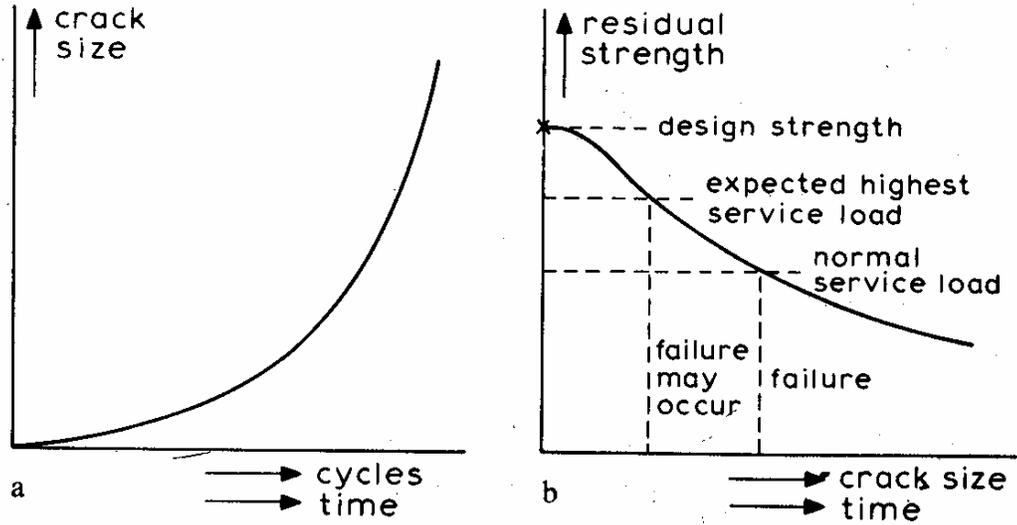
As the crack gets larger over time (Figure 3), the structures residual strength will decrease, decreasing its load capability, and ultimately decrease the time to failure for the given structure.

Figure 3 The Engineering Problem
 a. Crack Growth Curve; b. Residual Strength Curve.[10]

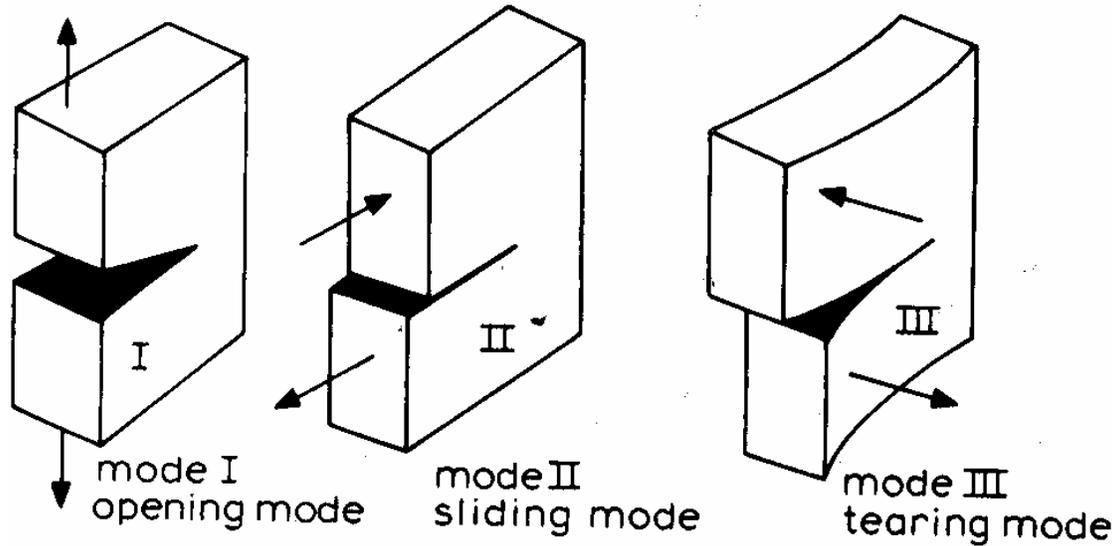
Stresses on a crack can occur in any of three different loading modes as shown in Figure 4. Mode I loading is often referred to as the opening mode. In mode I the loading is in-plane and perpendicular to the crack, where the loading is causing the crack to be pulled open. Mode II loading is called the sliding mode. In mode II the loading is in plane and parallel to the crack causing a sliding motion. Mode III is referred to as the tearing mode. Mode III occurs as the result of out-of-plane loading parallel to the crack which causes an associated tearing motion. In a cracked aircraft structure mode I is the primary loading situation. This loading will be focused upon for this discussion. The reader is referred to any fracture mechanics text for further information on mode II and mode III loading.

Figure 4 The three modes of loading.[10]

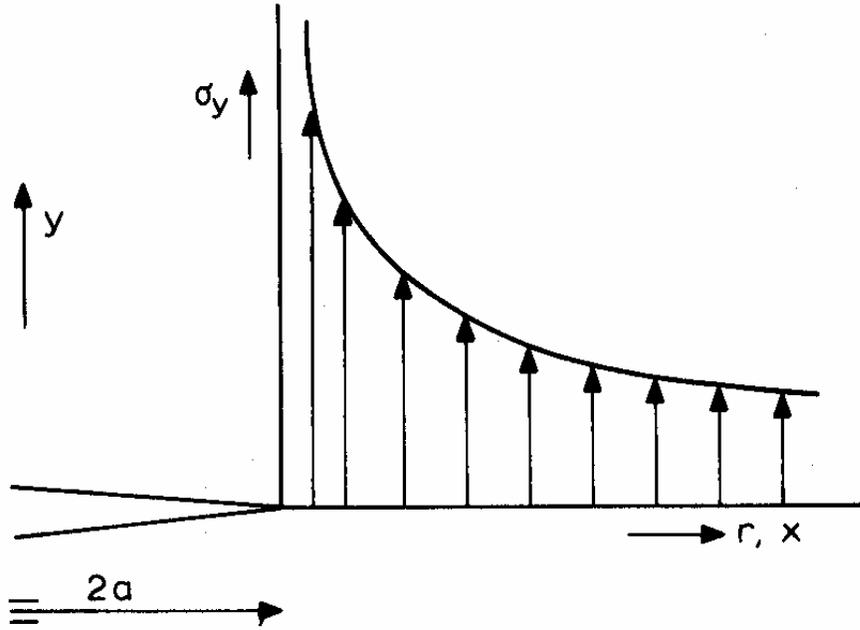
The stress intensity factor K_I at first can be difficult to comprehend in seeing that it has units of stress * $\sqrt{\text{length}}$. The stress intensity factor is the value that helps us quantify the stress field at and in front of the crack tip. The crack in the plate leads to larger stress values around the crack (see fig 5).

Figure 5. Elastic stress σ_y at the crack tip [10]

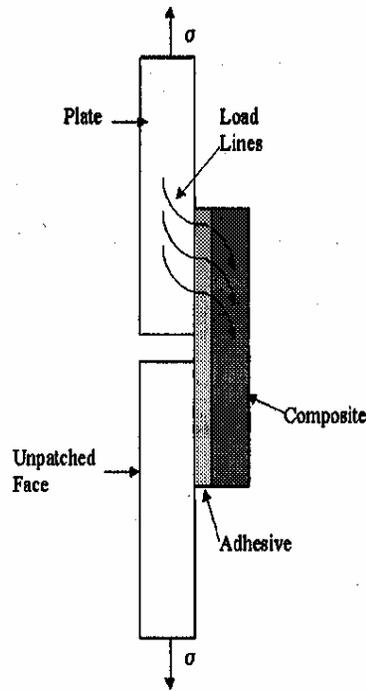
crack tip itself, where these stresses are the primary source of crack growth. This is the goal in crack patching. When a patch is put on the specimen, the stress field in the plate is partially rerouted through the patch, instead of into the crack tip (Figure 6). The stresses that would have gone into opening the crack are now rerouted through the patch. Fewer stresses at the crack tip in turn reduce the crack growth rate, if not stop the crack growth completely.

Figure 6. Load Flow into a Repair.[11]

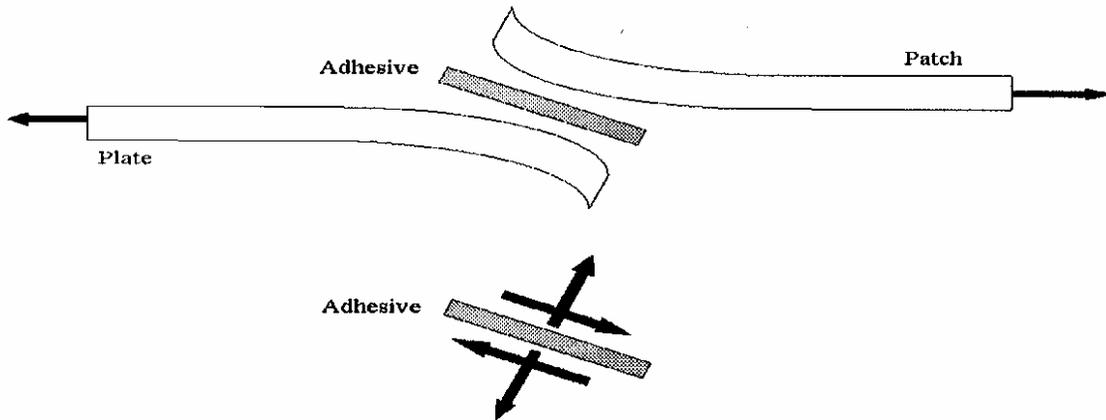
While the plate is loaded in tension, the patch, in picking up a portion of the loading, creates a neutral axis shift. This, in addition to any bending caused through a difference of coefficients of thermal expansion between the structure and the patch during the repair process, creates normal stresses in the form of out-of-plane bending that acts on the tips of the patch as shown in Figure 7.

Figure 7. Bending Caused by Neutral Axis Shift in Single Sided Repair [11].

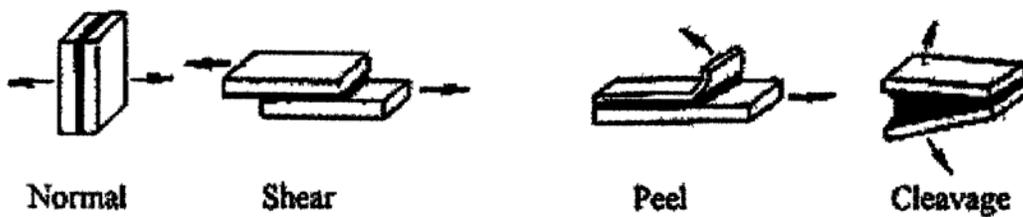
The combination of shear and normal stresses may potentially lead to two common bond line failures known as peel and cleavage as shown in Figure 8.

Figure 8 Loading on Adhesive Bonds[5].

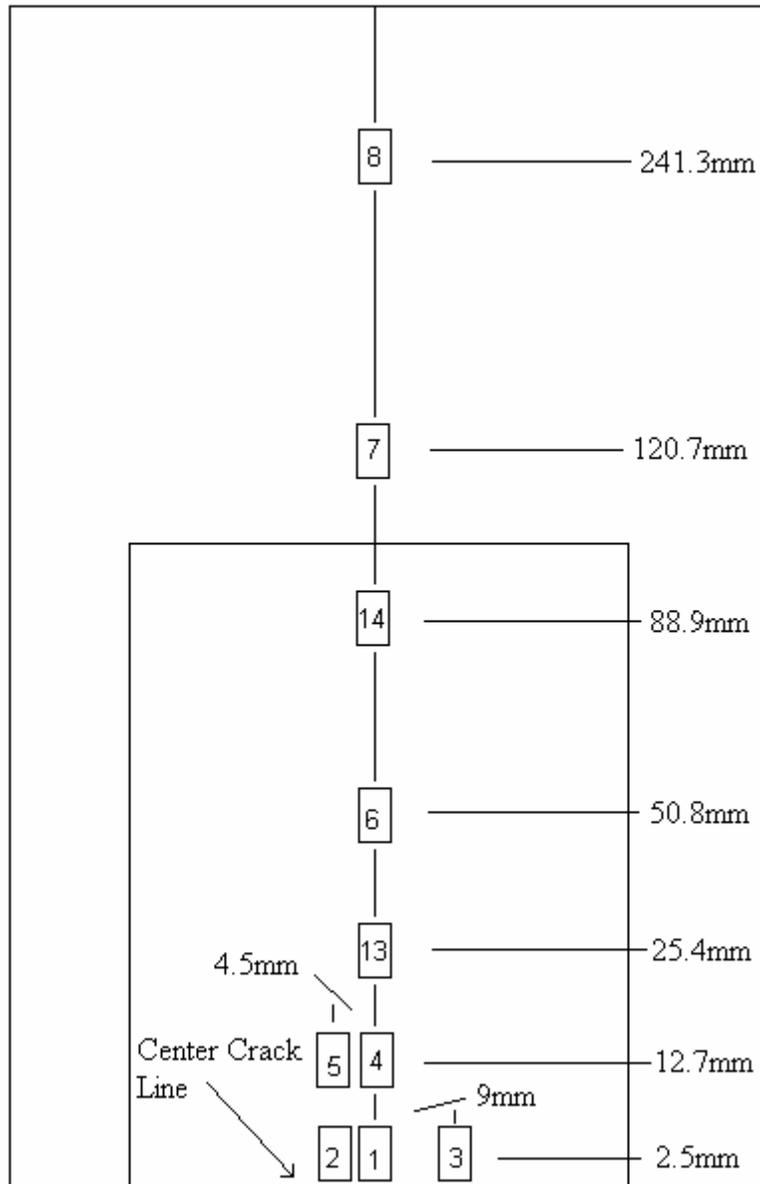
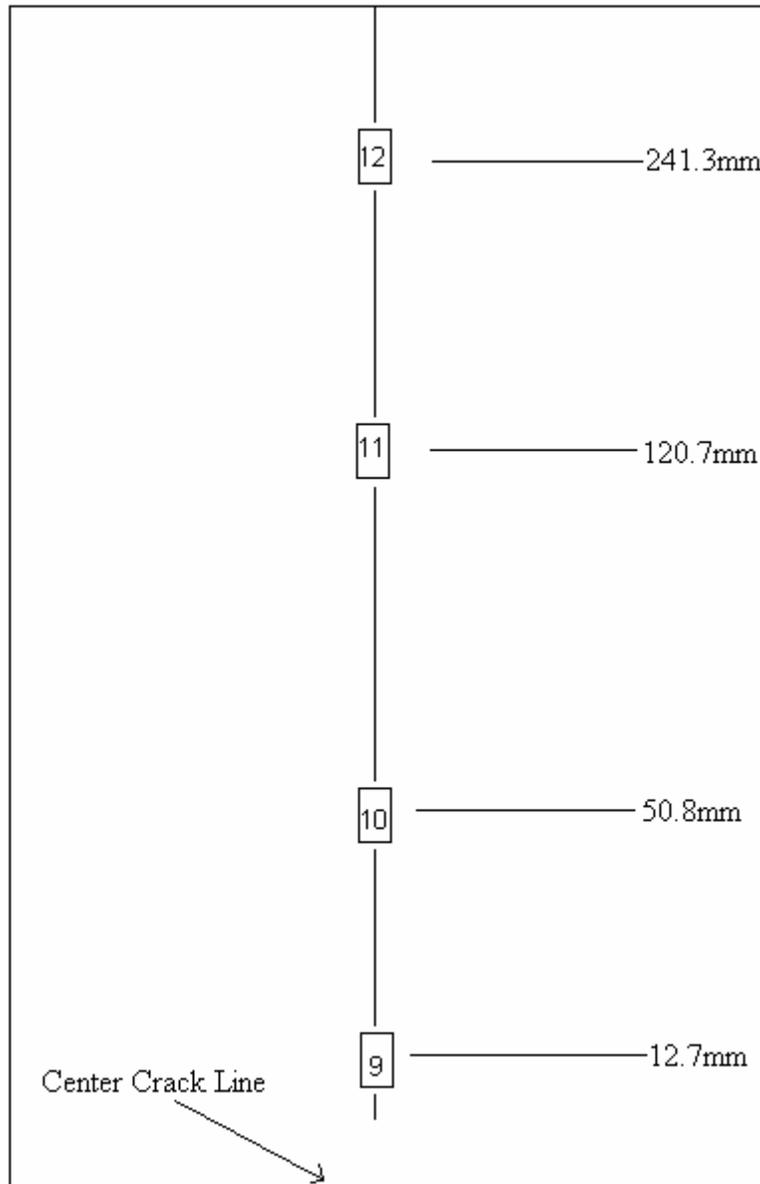
Each test specimen was laid out with twelve 350 ohm strain gages. The strain gages were either 3.175 mm gages, or 1.5875 mm gages depending on their location. Fourteen strain gage positions were used throughout testing. The locations of certain strain gages changed to try to acquire better data in later tests. Refer to table 7 for which strain gage positions were used on which tests, and Figures 9 and 10 for the positions of each of the gage positions on the front and back side of the specimen.

Figure 9. Strain Gage Diagram, Patched Side.

Figure 10. Strain Gage Diagram, Unpatched Side.

Each specimen was first laid out with 12 strain gages. The majority of the strain gages were put on the patched side of the specimen, and nearest to the center line crack (refer back to Figures 9 and 10 and table 7). Here is where the most interesting data will occur. To fit in the hydraulic machine specifically designed grips had to be attached (see Figure 15). Each specimen had to first have the five 12.7 mm diameter holes machined into the grip section, to accommodate the grips, so that it could be loaded into the machine.

Before each specimen was loaded into the hydraulic machine the strain gages were zeroed out. After the specimen was loaded into the machine strain readings were taken at 0 MPa, 7.35 MPa, 110 MPa, and 221 MPa. Those initial strains can be seen in Table 9 through 12. Refer back to Figures 9 and 10 for where the locations of these strain gages on the specimen. Figures 19 and 20 show the average stress strain curves for each individual strain gage.

How the strain values change over the life of the specimen will be examined in this section. In Figures 30 through 43 the maximum and minimum strain values versus the total crack length are examined. These appear to be the best graphs to examine how the strain changes over the life of the specimen. The crack growth rate is fairly different among the different tests, making max-min strain versus number of cycles graphs much more difficult to compare. The graphs showing the results for strain gages one and two have been split up to better show the maximum and minimum values, due to the overlapping nature of these graphs. For the exact locations of each strain gage, refer back to Figures 9 and 10.

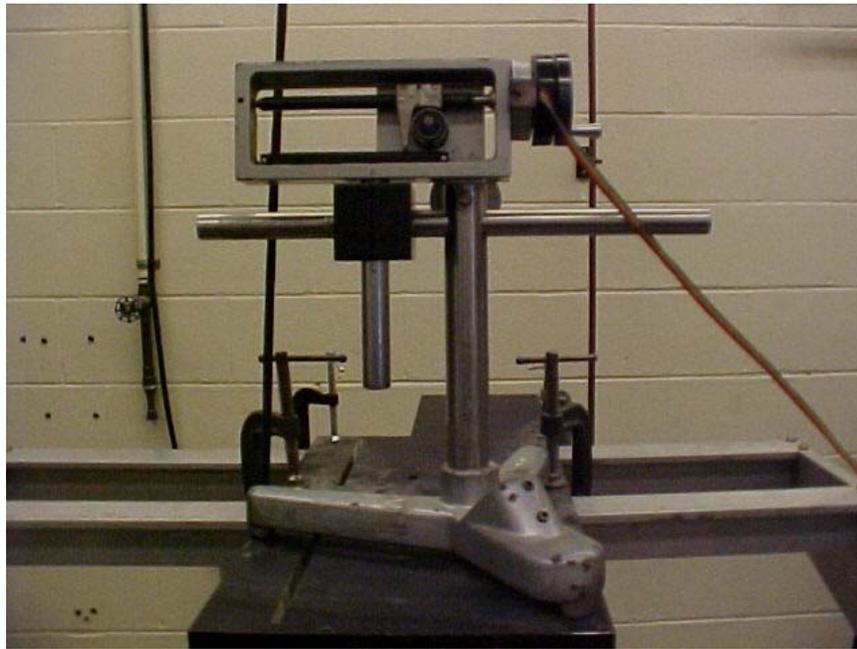
To measure the crack length a Gaertner travelling microscope with a digital readout system was used to optically measure the crack length periodically during the test (see Figures 11 and 12)

Figure 11. Gaertner Traveling Microscope

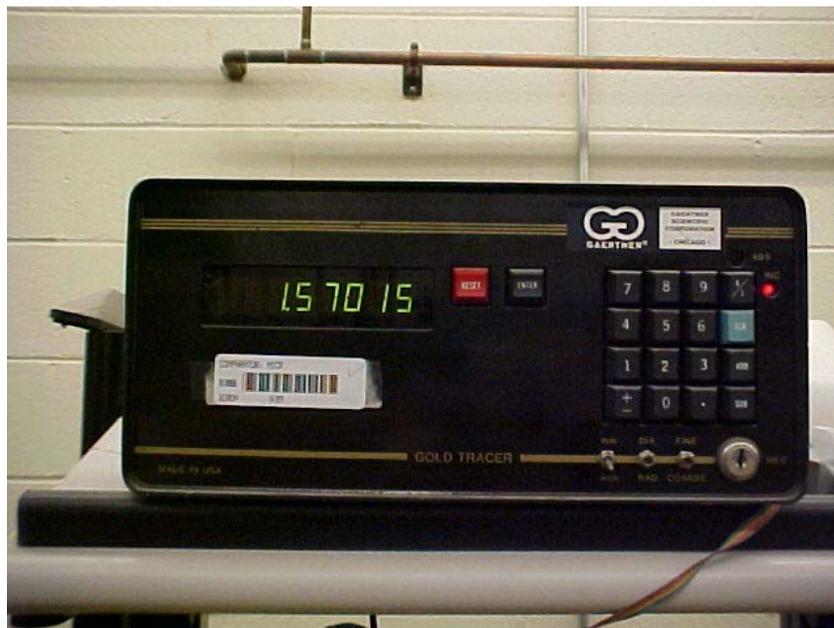
Figure 12. Gaertner Microscope Digital Readout

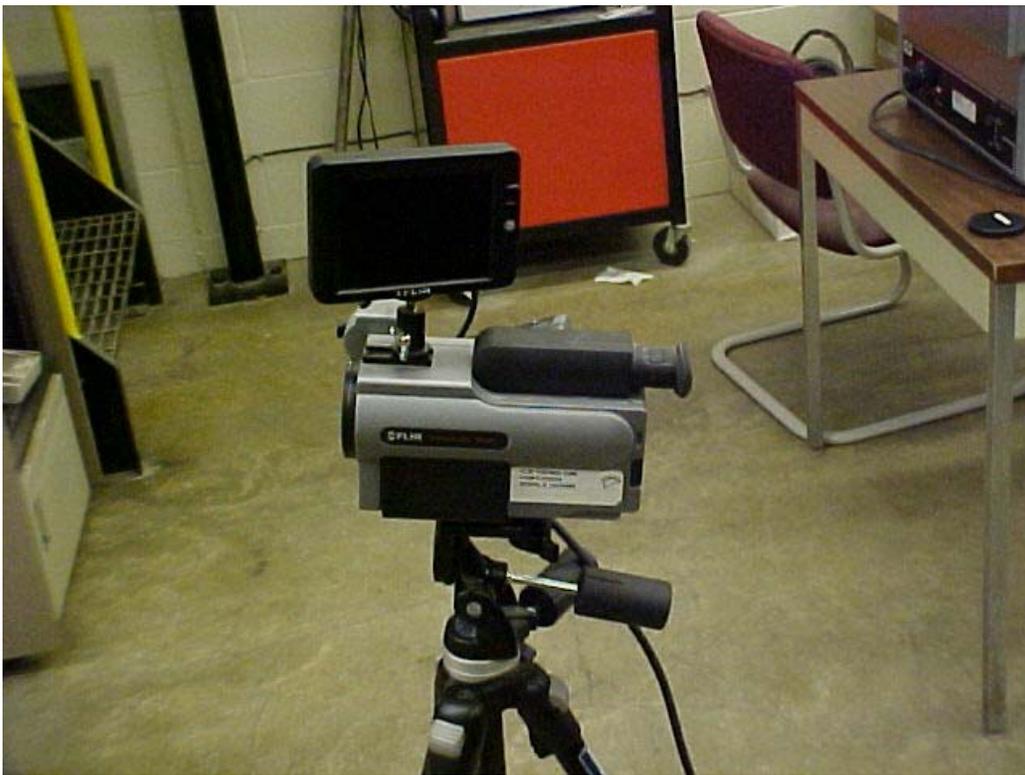
IR pictures were taken of the specimens using a FLIR IR camera, and analyzed with the associated software (see Figure13). A Master-Mite heat gun was used during the IR readings in order to quickly heat up the specimen, in order to best get the different IR readings as the areas of the disbond region would potentially heat up at a different rate than the rest of the sample (see Figure 14).

Figure 13. FLIR IR Camera

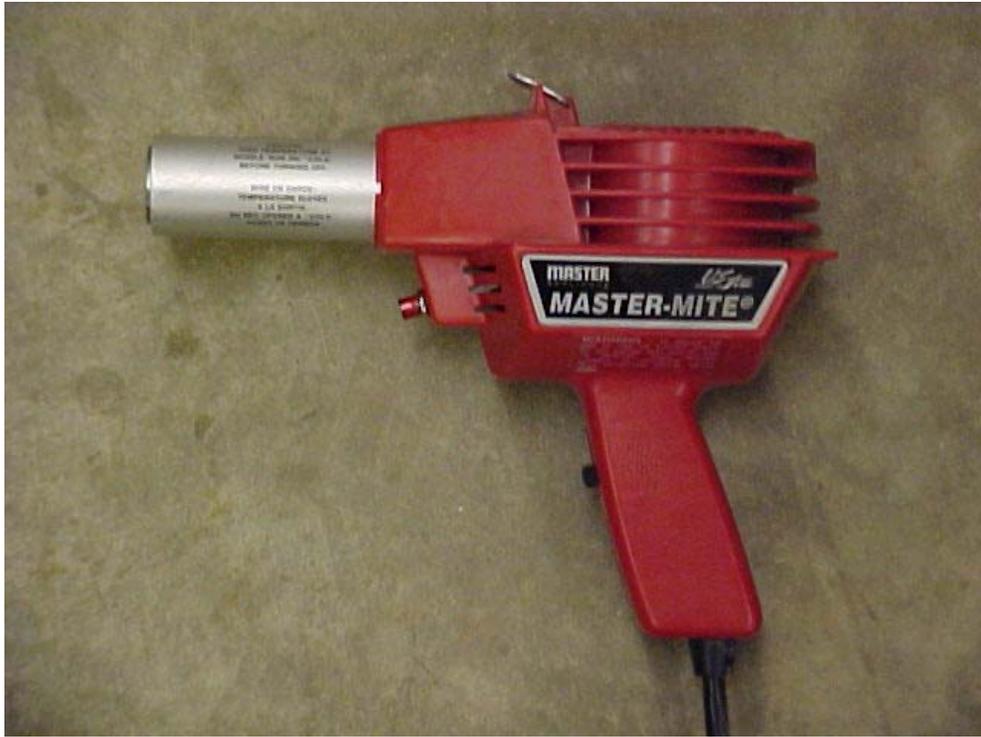
Figure 14. Master-Mite Heat Gun

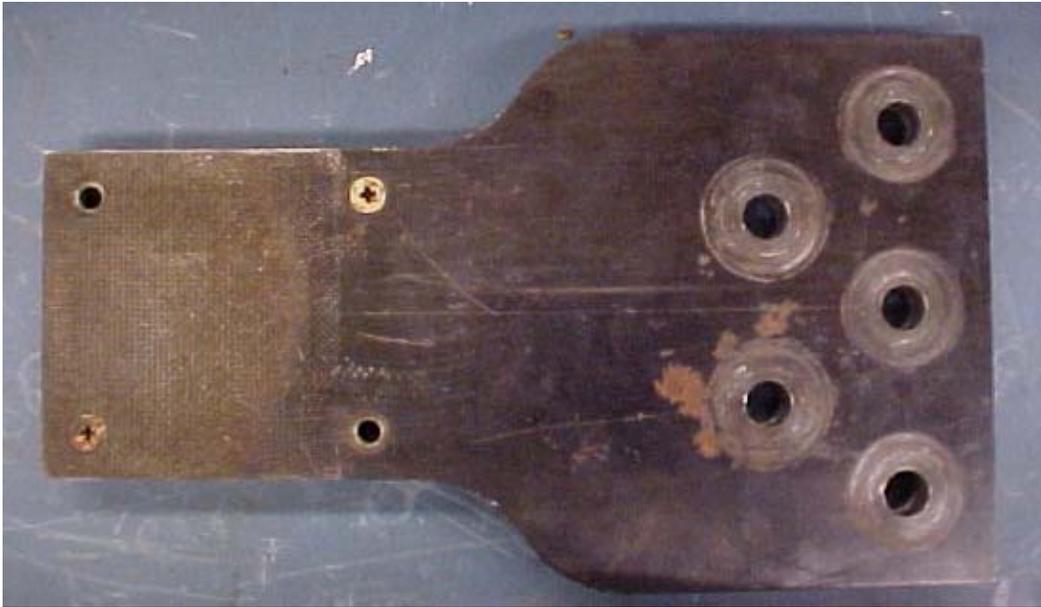
Figure 15. Specimen Grips

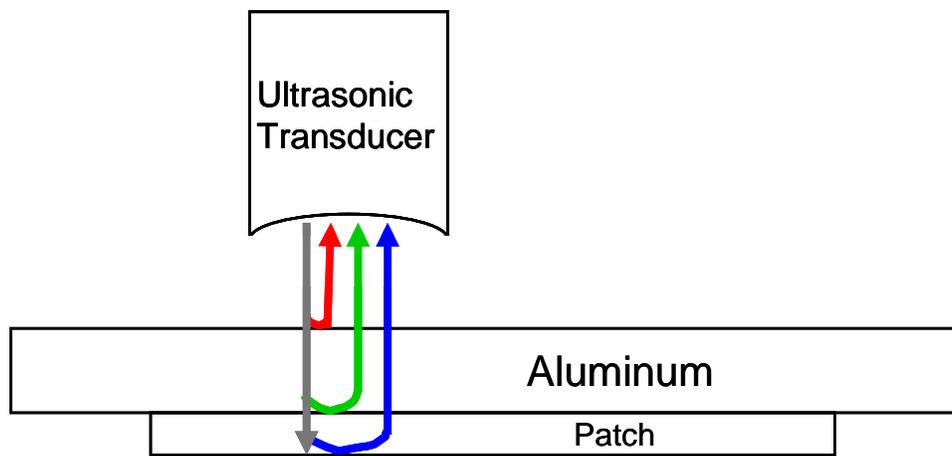
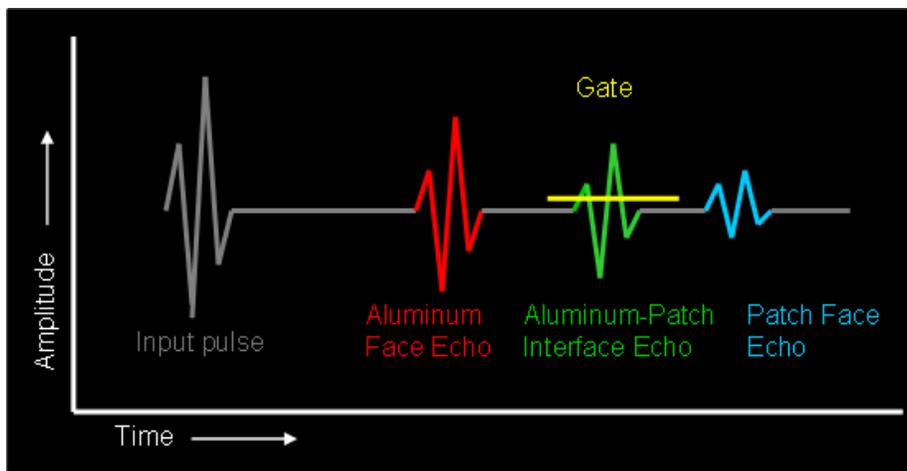
When each test was finished, if some of the patch was still adhered, it was sent over to AFRL to be scanned to get the best pictures of the debond area behind the patch. Images of these specimens were taken using scanning acoustic microscopy. The specimen is submersed in a water tank, patch side down, so a submersed ultrasonic transducer can be scanned over the aluminum surface. The transducer height above the part is optimized to give the best signal from the back side (the aluminum surface of the side with the patch). This way the transducer is also optimized for the aluminum-patch interface. The system is used in a pulse-echo configuration in that a pulse is sent in to the part and the echo received back is from any surfaces and interfaces. Gates are set up in software on the received waveform (echo) to measure the amplitude and time of flight at different points of interest in the waveform. The points of interest are chosen to be the

places in the received waveform that appear to change the most when the transducer is moved across the area of the part that is to be imaged. After all the optimization steps, the ultrasonic transducer is then scanned over the area of the part to be scanned for a quick low resolution initial scan to make sure all the parameters are correct. Any adjustments are then made and a final higher resolution scan is performed. The spot size is approximately $500\mu\text{m}$ for the frequency used, 5 MHz. Refer to Figures 16 and 17 for rough diagrams of the procedure. [25]

Figure: 16 Scanning Acoustic Microscopy System [25]

Figure: 17. Oscilloscope Screen [25]

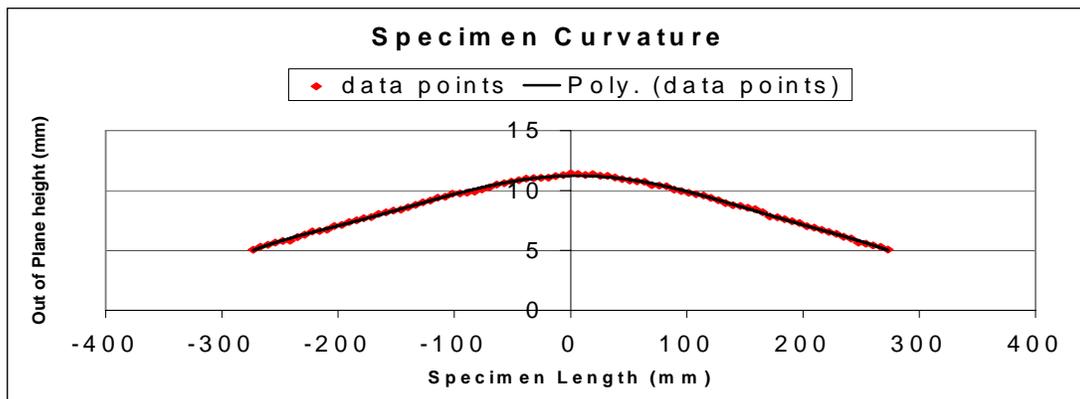
Each specimen had an initial curvature to it after the patch was bonded. This is due to the differences in the coefficients of thermal expansion between the aluminum specimen and the composite patch during the patches application process. This initial curvature will lead to additional internal stresses within the specimen. The specimen's curvature has been plotted out in Figure 18. Here the patch is in place on the top of the curve in the out of plane direction. The x-axis zero line is in the center of the specimen, along the crack line. The y-axis dimensions are the out of plane displacement. A best-fit sixth degree polynomial was determined to be:

$$y(x) = -1 \cdot 10^{-7} x^6 + 2 \cdot 10^{-7} x^5 + 3 \cdot 10^{-5} x^4 - 4 \cdot 10^{-5} x^3 - 0.0041x^2 + 0.0017x + 0.442 \quad (11)$$

Figure 18 Specimen Curvature Data Points and Polynomial Fit Line

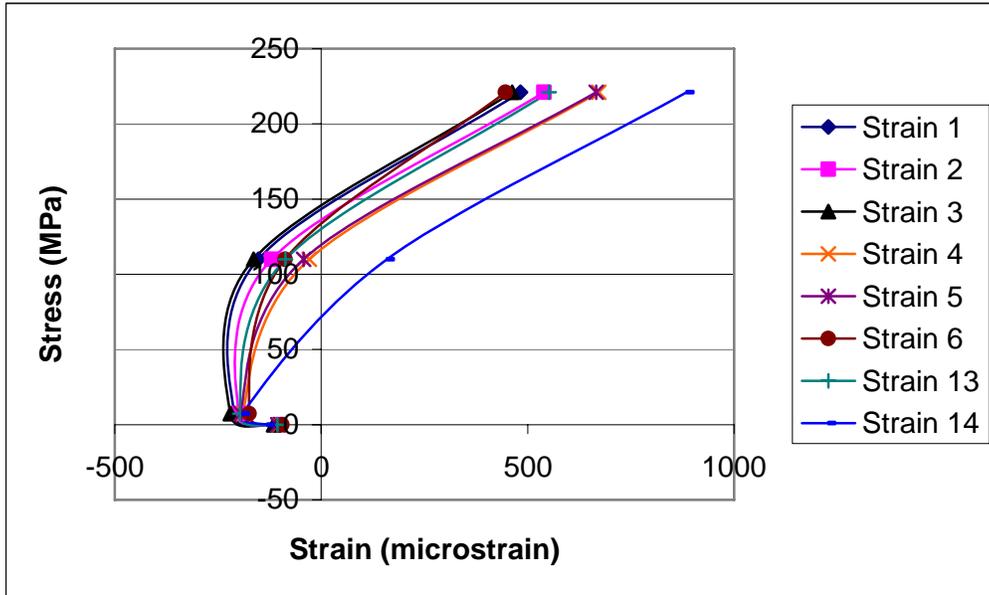
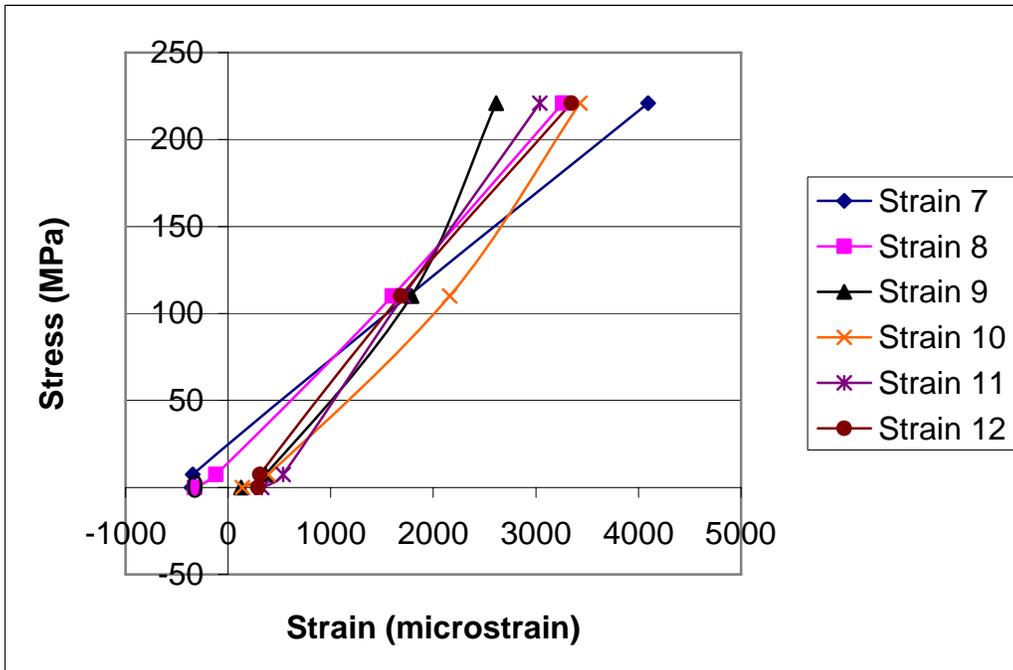
Figure 19. Average Initial Strain Values for Strain Gages 1-6, 13, 14

Figure 20. Average Initial Strain Values for Strain Gages 7-12

In Table 9 the initial strains are due to only the gripping action of the hydraulic machine. All of the strains on the patched side of the specimens begin with negative strains and those on the unpatched side with positive strains, as expected. The grips grabbing on to each end force a small amount of straightening on the specimen, even without any tensile load. With the initial curvature, this creates a bending moment on the specimen, resulting in compression on the patch side, and tension on the unpatched side, producing the appropriate strains seen.

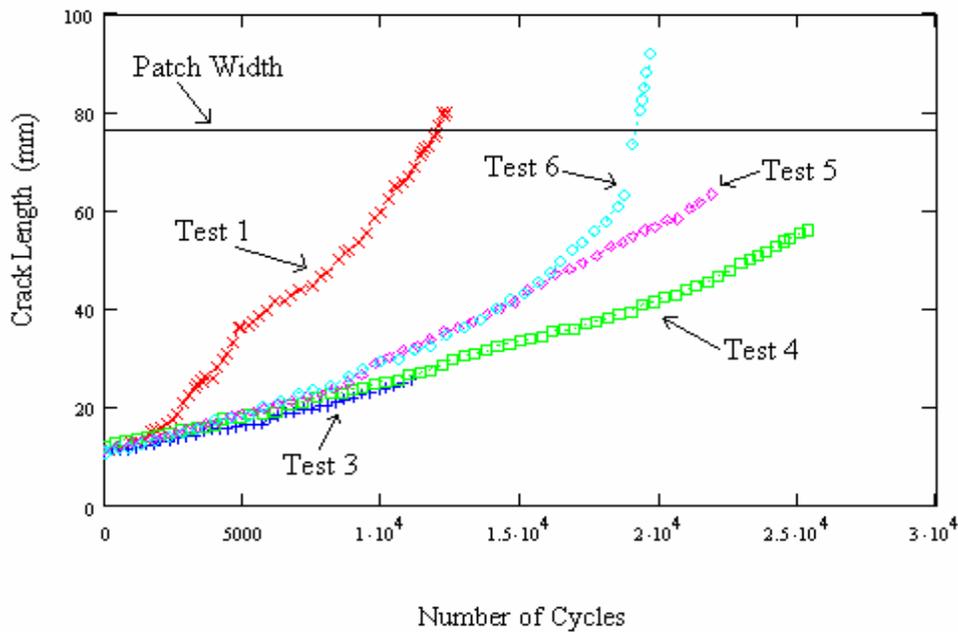
In Figure 21 the total crack length versus the number of cycles is plotted, followed by Figure 22 which plots the associated trend lines. Each graph has a line at 76.2 mm showing the length of the patch. In these graphs it is seen that the crack growth did actually change somewhat significantly in the different tests. Specifically test number one was the most different from the other tests, however it is the closest to the results of previous tests on similar samples [9]. This appears to be due to poor compensators in hydraulic machine and changes in lab conditions between tests. The building has been under heavy construction, and the laboratory and hydraulic system went under a series of repairs between the individual tests. This likely led to the differences in the tests. The stress vs. time curves for the different crack growth patterns that were seen need to be examined. (Figures 23-25)

Figure 21. Crack Growth Rate.

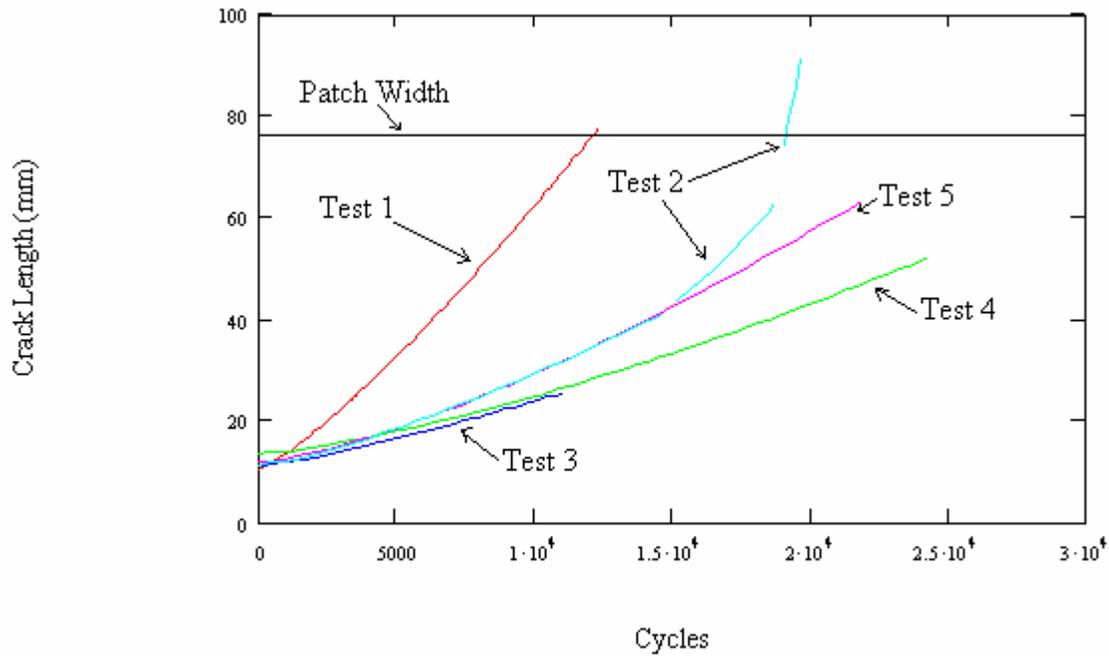
Figure 22. Fitted Crack Growth Curve Lines.

In Figures 26-27 the crack growth rate in mm per cycle is examined. These growth rates are based on our trend lines from Figure 22. Here several different patterns are seen. Test one lies all by itself. Tests three and four have very similar growth rates. Tests five and six match up with similar growth rates most of the way through. It is also seen that test number six begins to rise to approach similar growth rates to that of test after it switched over to the tapered growth pattern for the initial fatiguing.

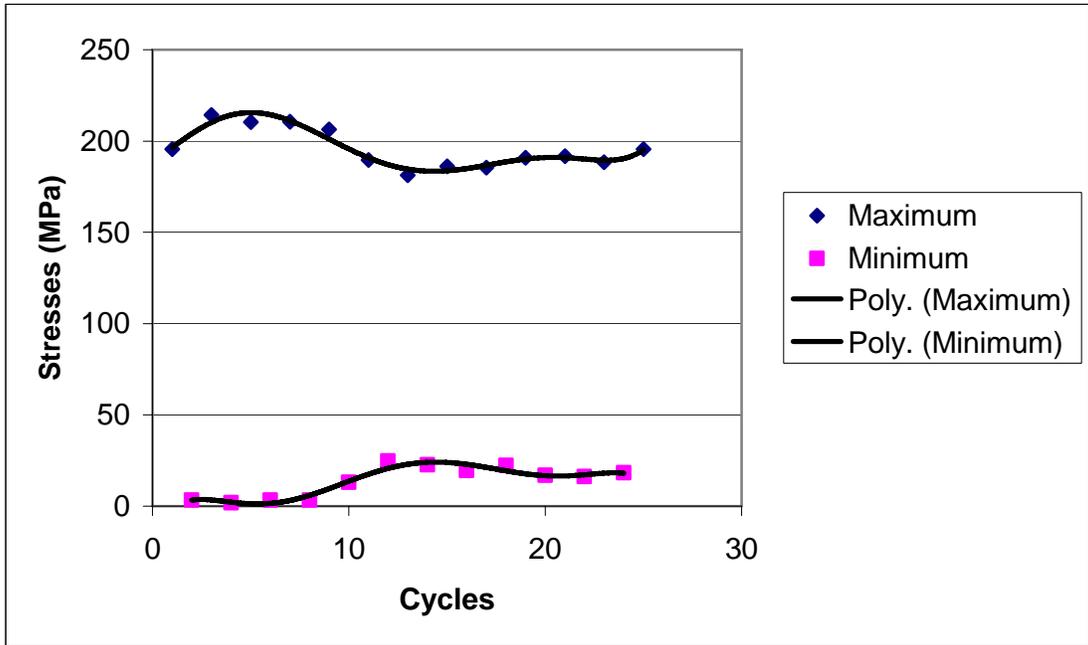
For the duration of the experiment the testing was stopped every few hundred cycles to take crack growth measurements. When the test was restarted, the machine took a second or two to have the compensators kick in fully. As a result, the loading would overshoot and undershoot the prescribed loading conditions for the first few cycles before it leveled off. This was seen throughout the length of each test. During the first test some overloading did occur (Figure 23), but not nearly to the degree that it did in the following tests, which all matched fairly closely (Figures 24).

Figure 23. Test 1 Initial Max-Min Fatigue Loading Showing Small Overloads.

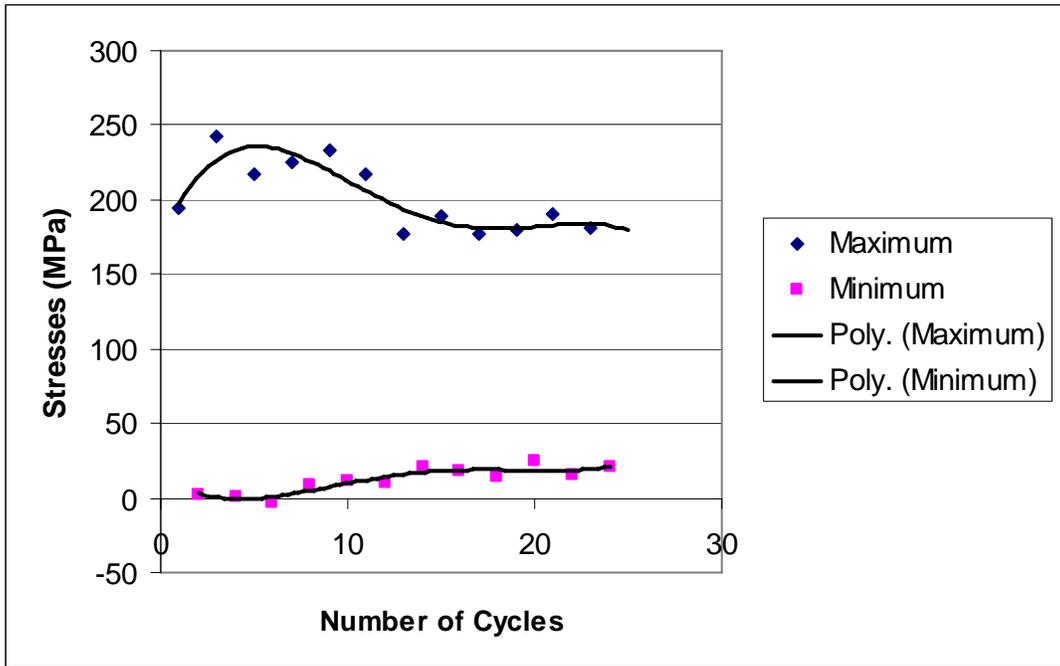
Figure 24. Tests 3-6 Representative Initial Max-Min Fatigue Loading Showing Larger Overloads.

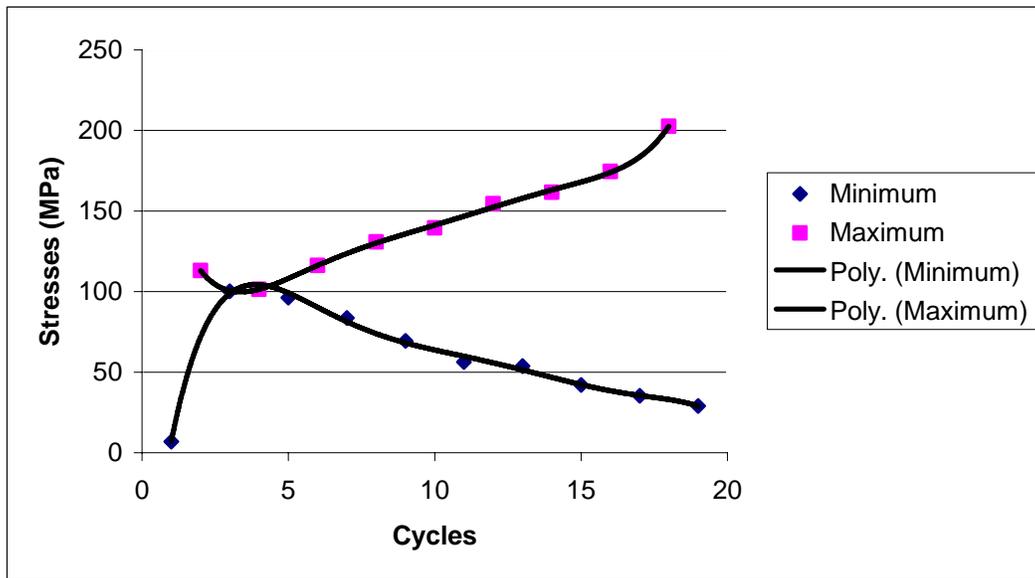
The overloading problem was difficult to rectify, however part way through test 6 it was found that a tapered sine wave pattern could be used to avoid this initial over and undershooting (Figure 25). At around 15000 cycles in test six this was implemented. The machine would gradually increase the maximum and minimum loads over the first 10 cycles. This way it didn't get the sudden shock overshoot at the beginning. This let the system build up to the required loading conditions, instead of being forced into it suddenly and having to compensate. Here it is seen that at this point when test number six is no longer subjected to those initial overload conditions it begins to start growing quickly, and its rate of growth at this point is similar to that of the rate of growth of the first test when it started to grow and take off.

Figure 25. Test 6 Tapered Initial Max-Min Fatigue Loading.

The data points at the end of test six that grow rapidly are believed to be unreliable. Those data points were taken shortly after an IR reading. In this reading the specimen had a crack of 63.5 mm. It was heated up with the heat gun, and cooled down

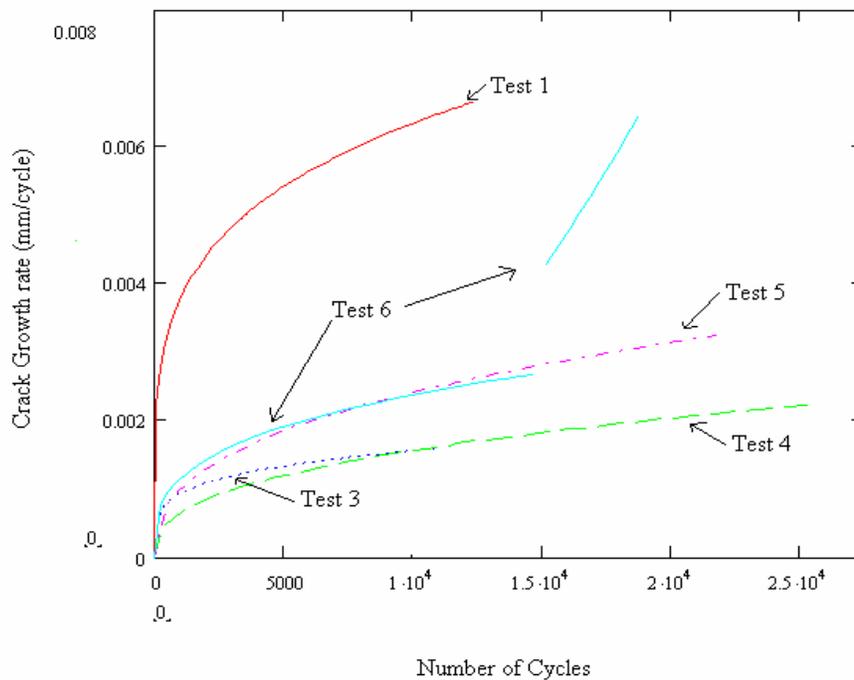
Figure 26. Crack Growth Rate vs. Number of Cycles

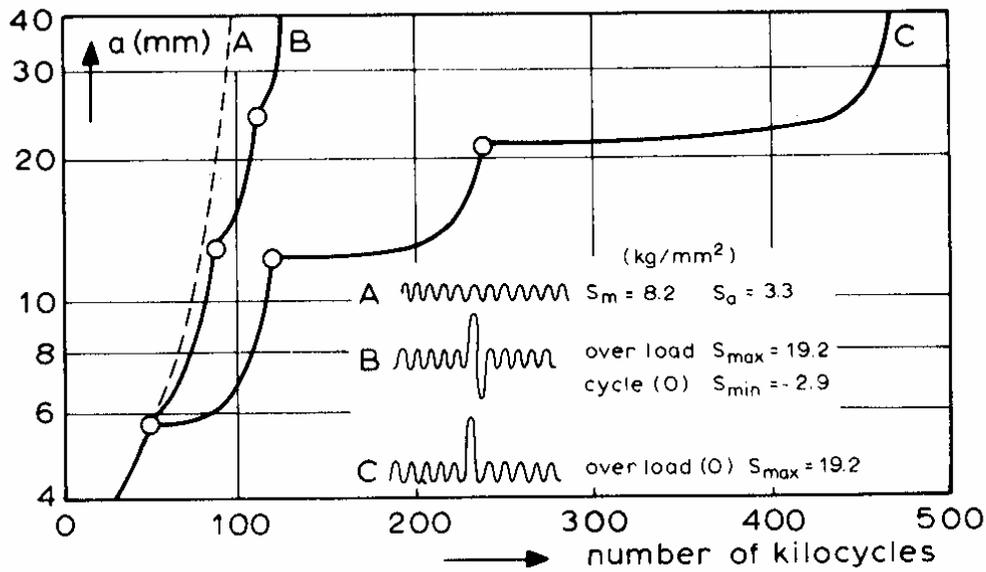
Figure 28. Retardation as a Result of Overloads (2024-T3 Al-alloy) [10]

Here the overload situation is discussed, and resulting retardation effects on the crack growth, and how it applies to each of the tests. An overload during a cyclical test is where there is a cycle, or very small number of cycles that go significantly over the standard cyclical loading. After the application of an overload in a cyclical test, crack growth will be slowed. Figure 28 illustrates this retardation effect of overloads on crack propagation. [10]

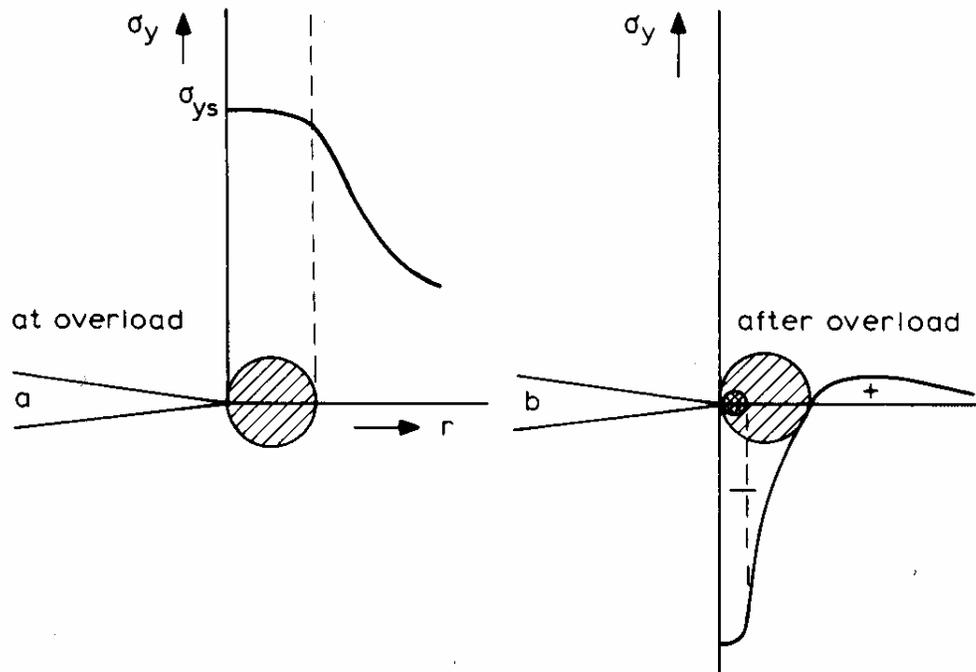
Figure 29. Residual Compressive Stresses at Crack Tip as a Result of Overload. [10]

The overload has introduced a large plastic zone in the material causing a permanent deformation region around the crack tip as shown in Figure 29. After unloading the sample, the deformed region still must fit in the surrounding elastic material. While the elastic material resumes its original size, the material in the plastic zone does not. If the surrounding elastic zone contracts upon release of the load, the plastic zone will be too large to fit in the resulting area. The elastic material will have to make it fit by exerting compressive stresses on the plastically deformed material at the crack tip. The residual stresses can also be seen in Figure 29. [10]

The residual compressive stresses tend to close the crack tip over some distance. Further cycling can cause crack growth only if the residual stresses are overcome to a degree that the crack tip is opened again. As soon as the crack has grown through the area of residual stresses, the original crack propagation curve will be resumed. This explains the low growth rate after the overload. [10]
