**MECHANICAL BEHAVIOR OF CRACKED PANELS
REPAIRED WITH BONDED COMPOSITE PATCH**

THESIS

Michael A. Hansen, Captain, USAF

AFIT/GA/ENY/05-J01

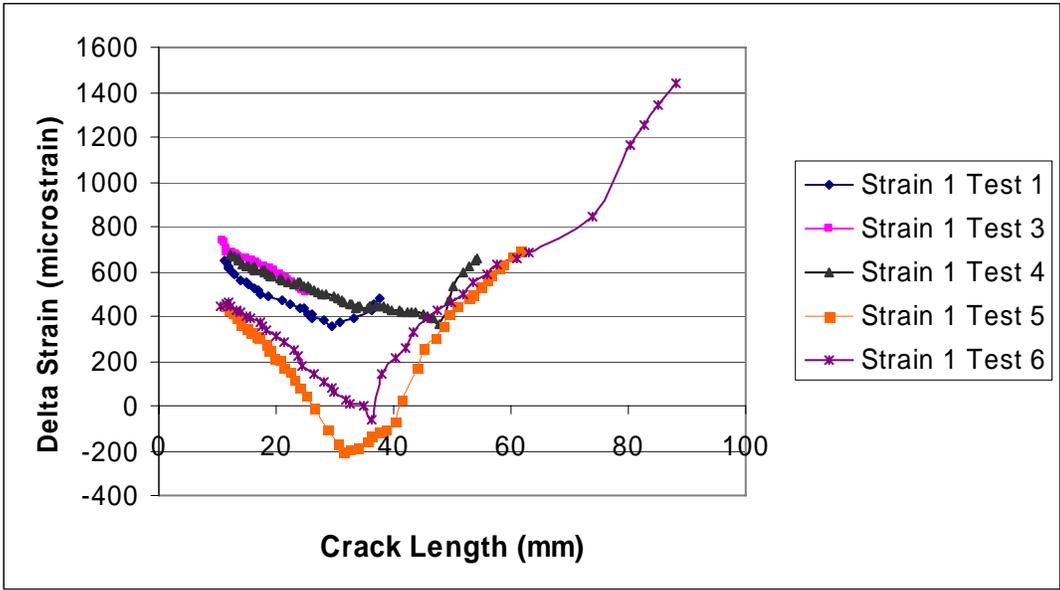
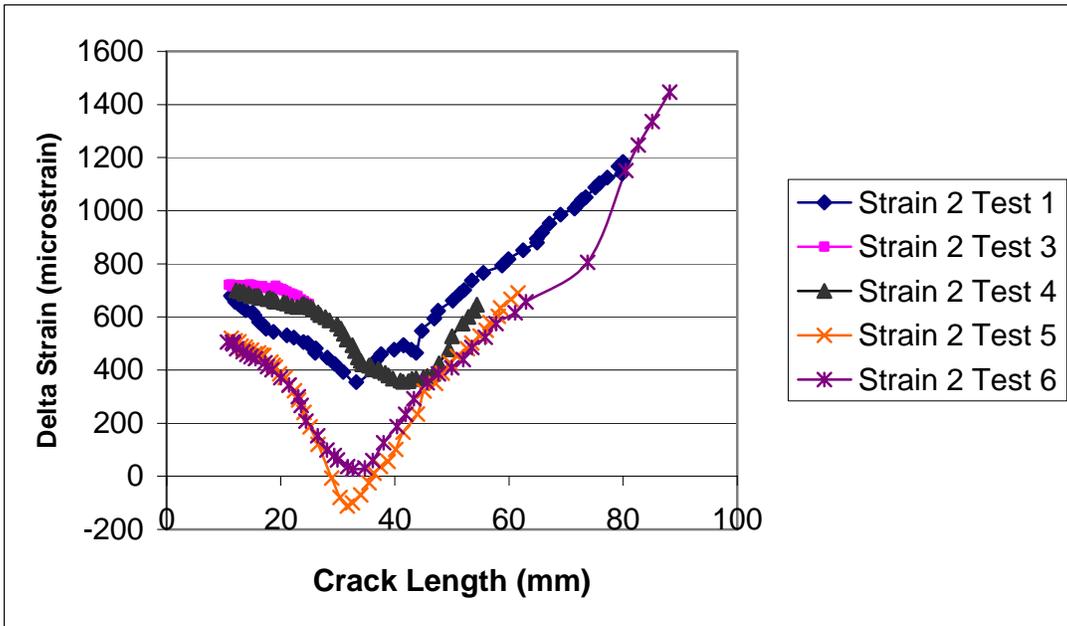
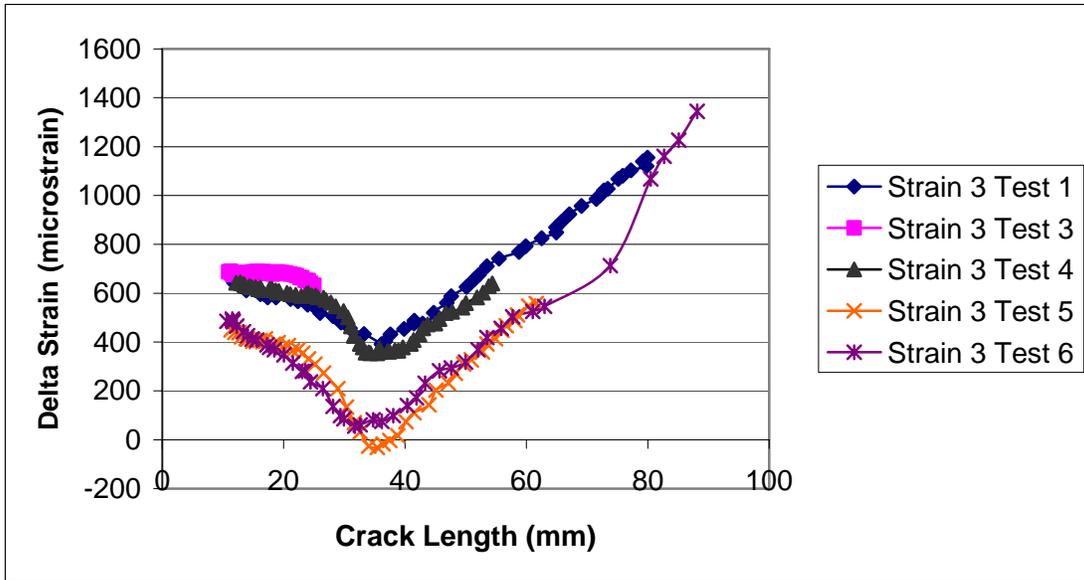
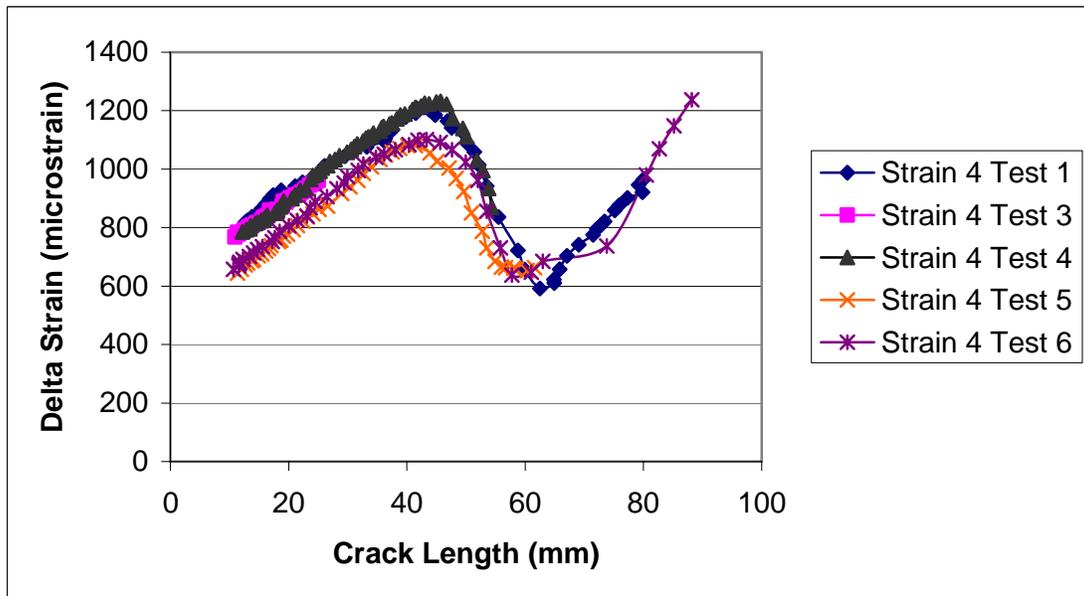
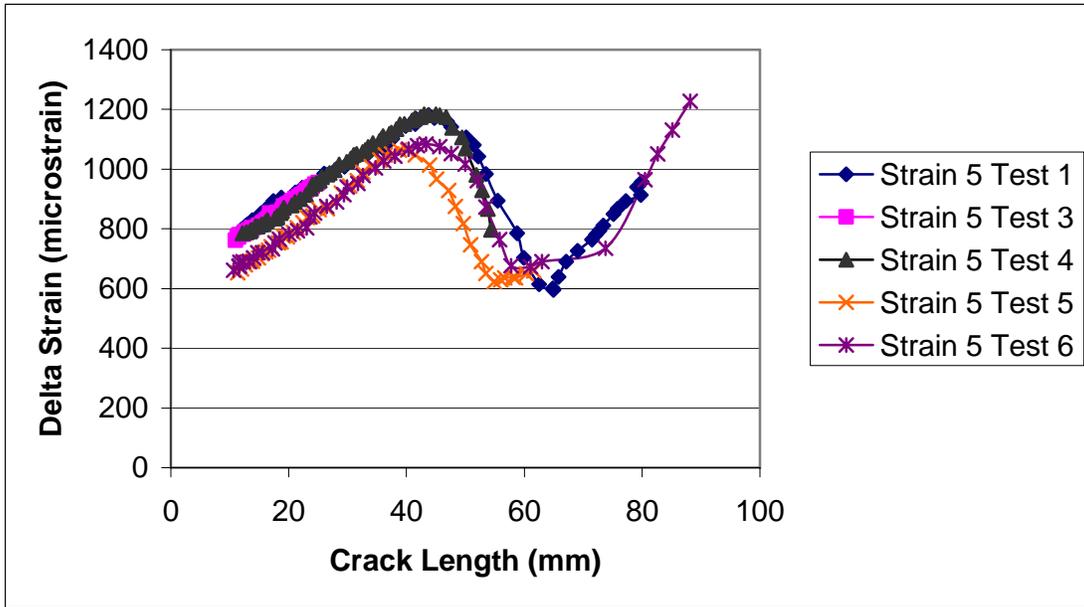
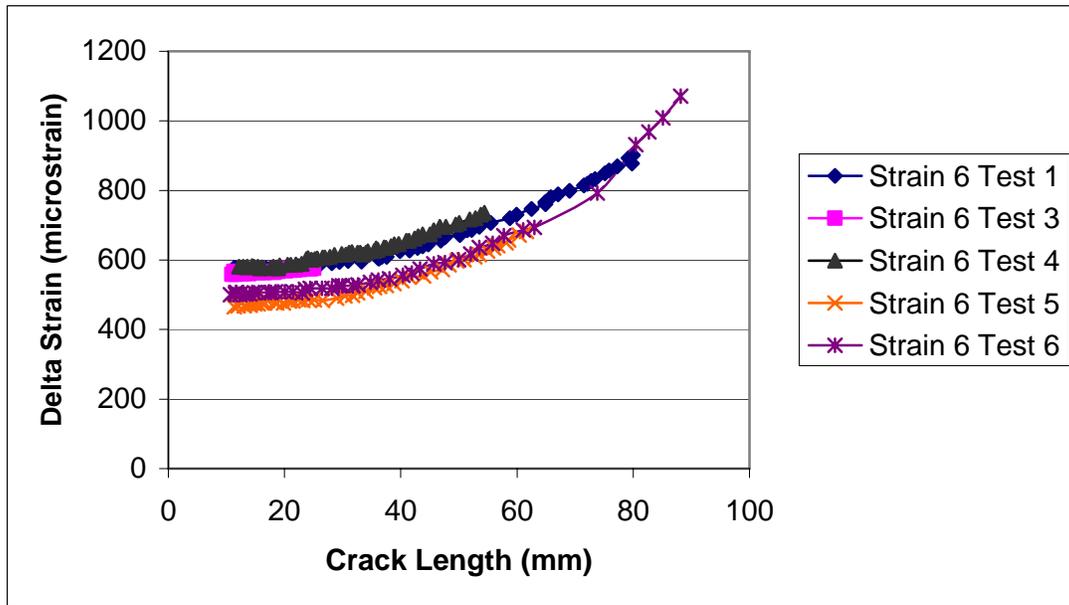
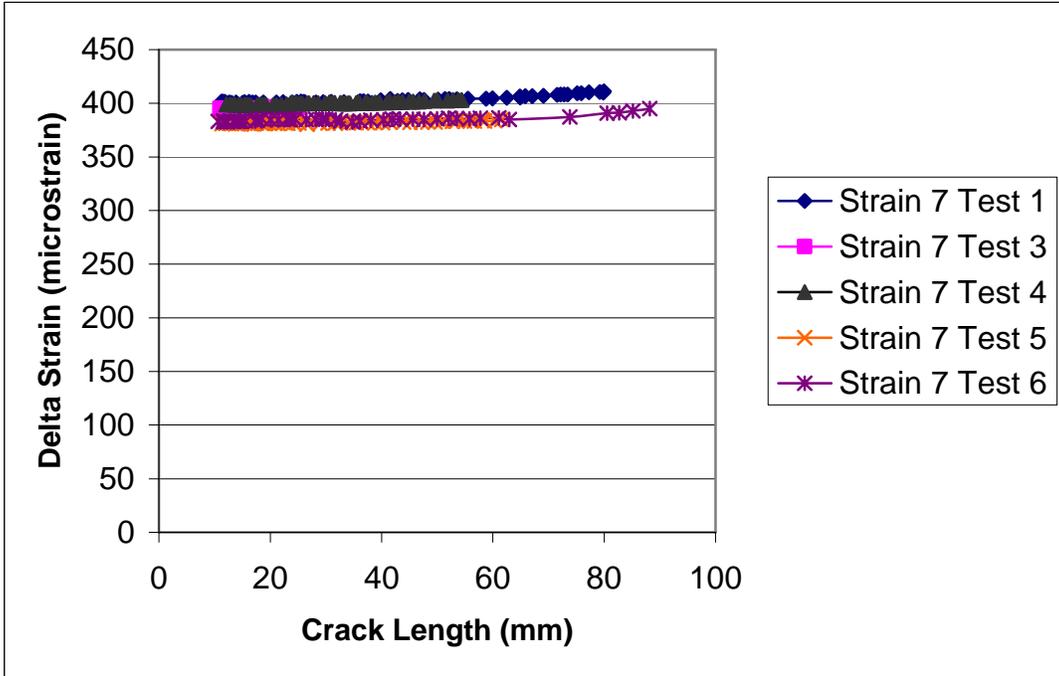
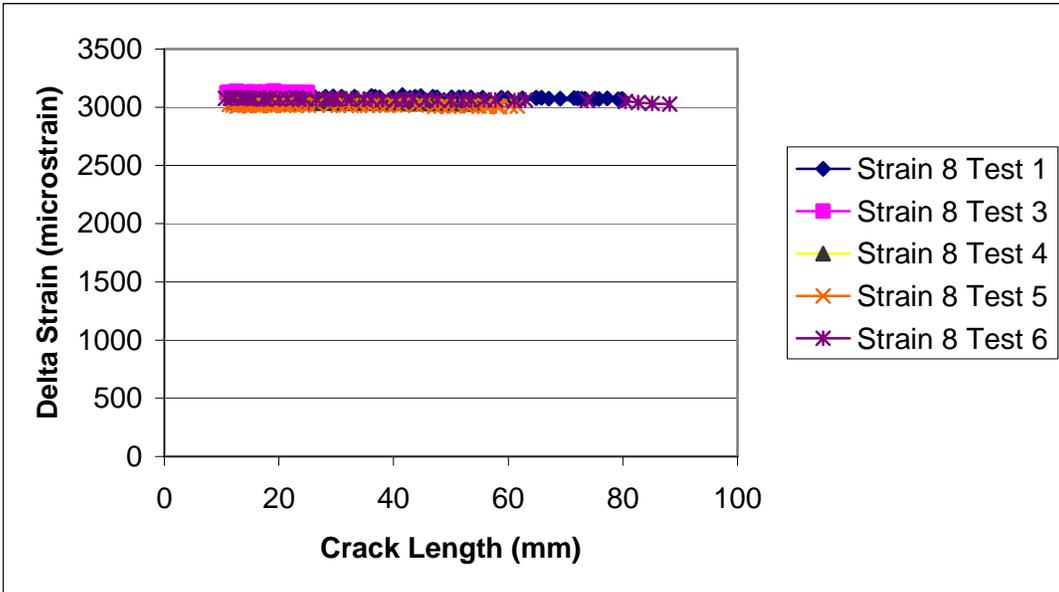
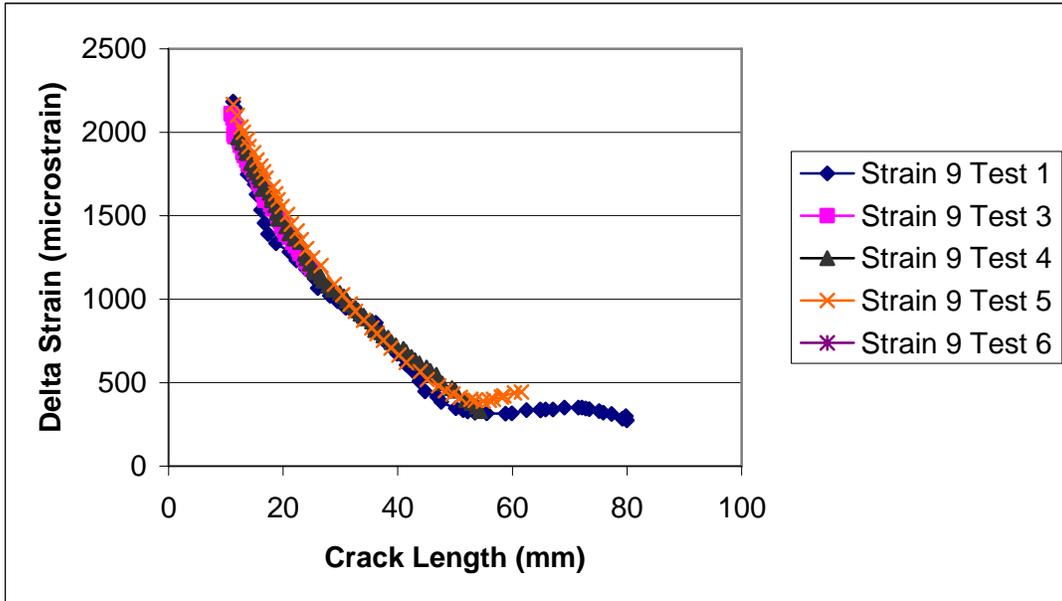
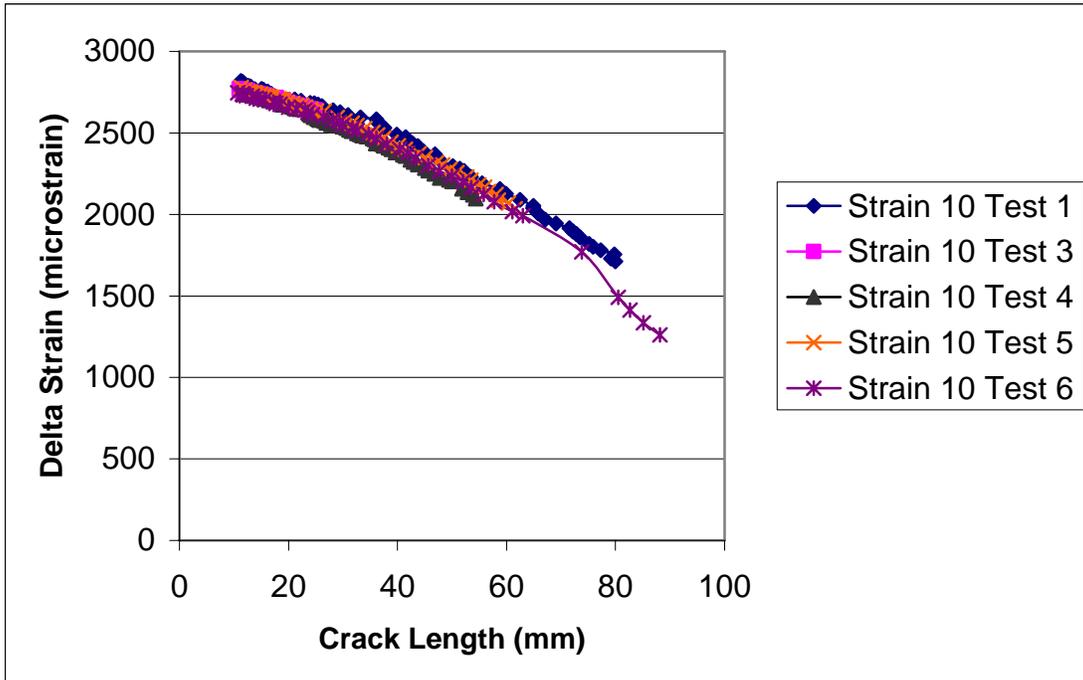
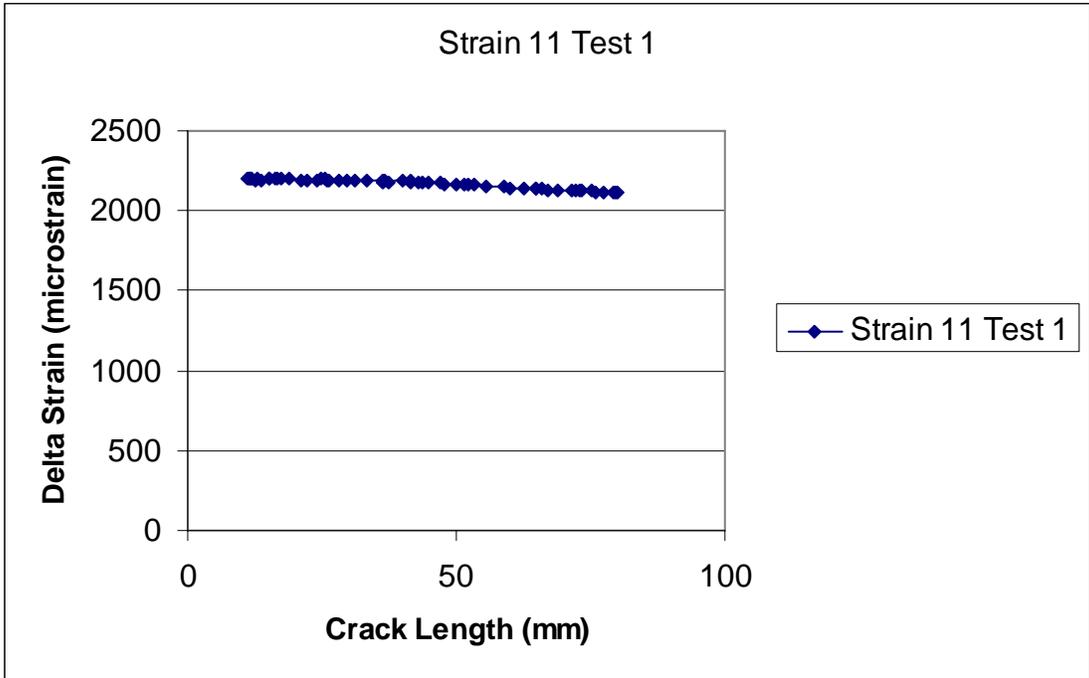
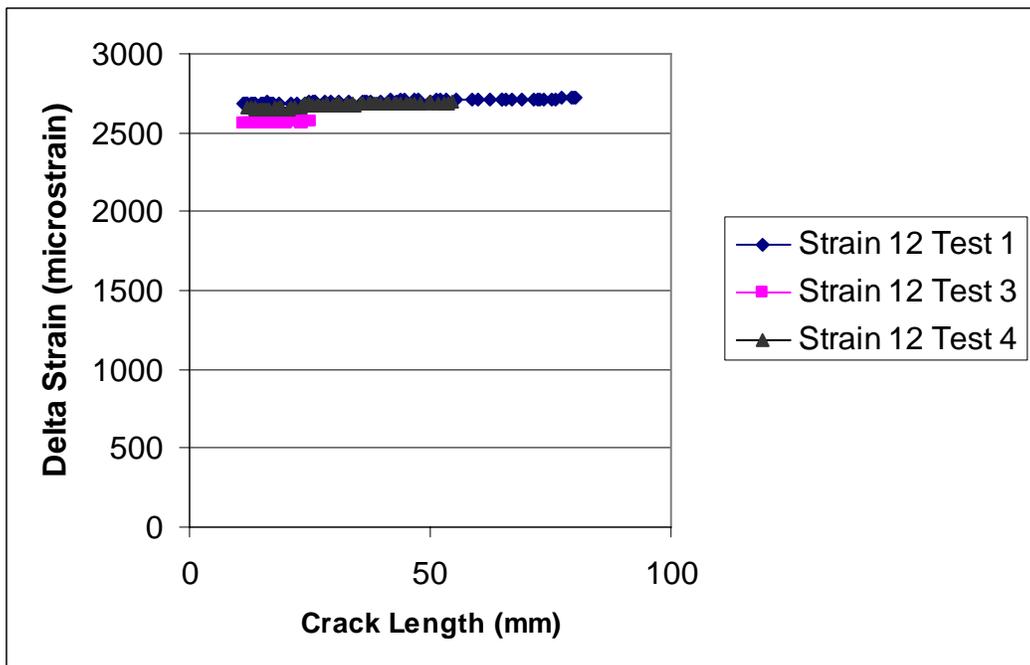
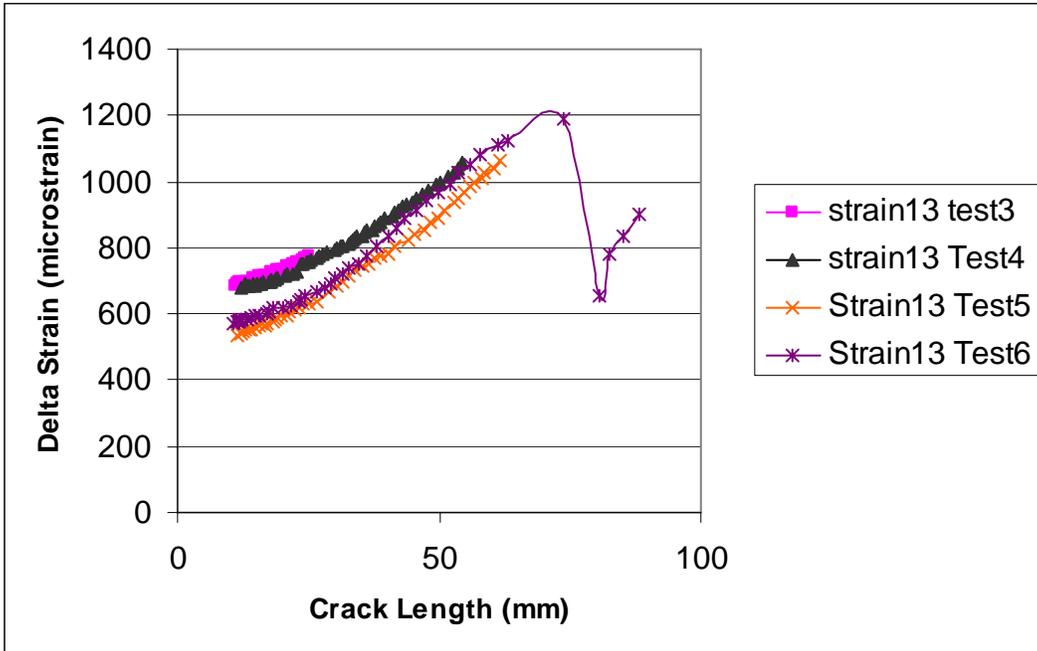
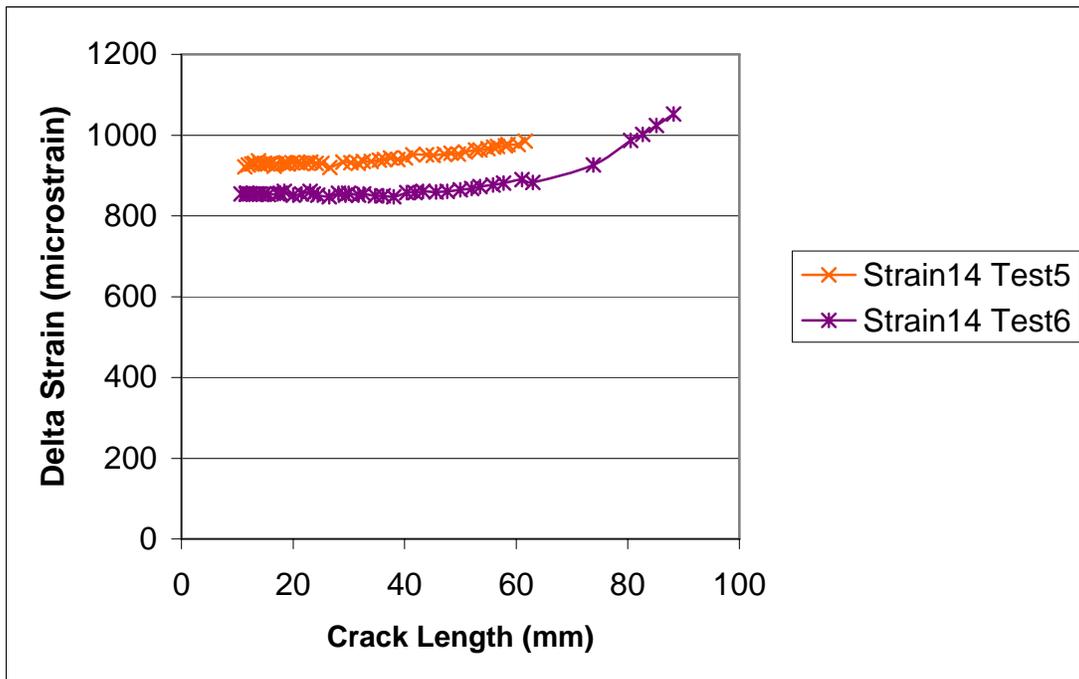
Figure 44 to 57 show the change in strain values over the length of the tests. These numbers are the maximum strain minus the minimum strain as plotted out in Figures 31-43. In looking at the change in strain values for strain gages 9 through 11 on the back of the panel, we see that it is continually decreasing as the crack gets larger, where the lowest change in strain values are closest to the crack. In this instance the loading is required to go around the crack more and more as the crack gets larger. The stresses are now decreasing in the aluminum nearest the crack, as it increasingly flows around the crack tips in the aluminum further away from the center line that the strain gages are on, in addition to more and more of the center loading flowing through the patch.

It is seen in the change in strains on the patched side, that it is increasingly growing as more loading is flowing through the patch. On strain gages 1 through 5 and 13, areas where the change in strain decreases is seen for a time before it begins to rise again. This appears to be where the debond is growing over the strain gage. This will be shown more definitively when the shape of the debond is looked at in a later section. With no debonds below the strain gage, the gage produces a strain value based on the stresses through the combined aluminum/composite material. When the debond appears below the strain gage, the strain values are no longer based on the combined aluminum/composite, but only on the composite patch, as they are now separated. With

the composite patch having the higher modulus of elasticity, the strains are lowered now that they are based on the patches modulus of elasticity and not a combined modulus of elasticity. However when the debond fully grows over the strain gage, the strains continue to rise again, as the stresses are continually flowing more through the patch, and less through the aluminum, as the crack length grows.

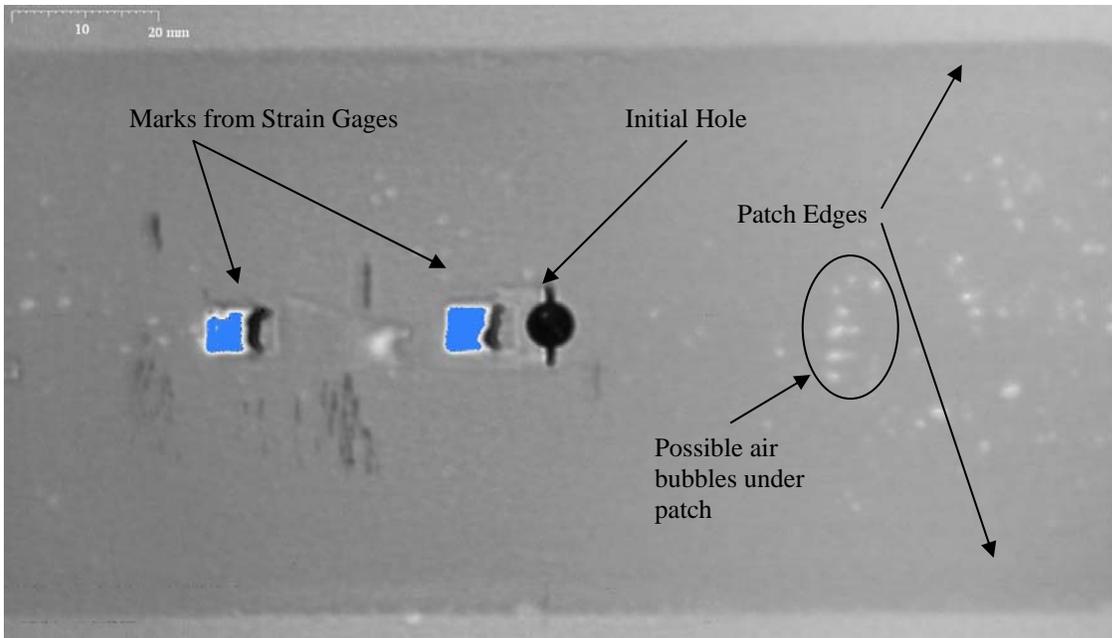
Figure 58. Test 2 Acoustic Microscopy Image.

Some of the debonds that occurred beneath the patch as the crack grew and the specimens broke will now be examined. They will be looked at in successive order of crack length at fractures. The first specimens to be looked at are the specimens from test two and test three (see Figures 58 and 59). Test two was a pure tensile test with no crack growth. In this image no debonding around the initial hole is seen. However some

lighter areas did show up, which may be possible air bubbles under the patch due to an imperfect bonding. These possible bubbles can be seen in most all of the scanned images.

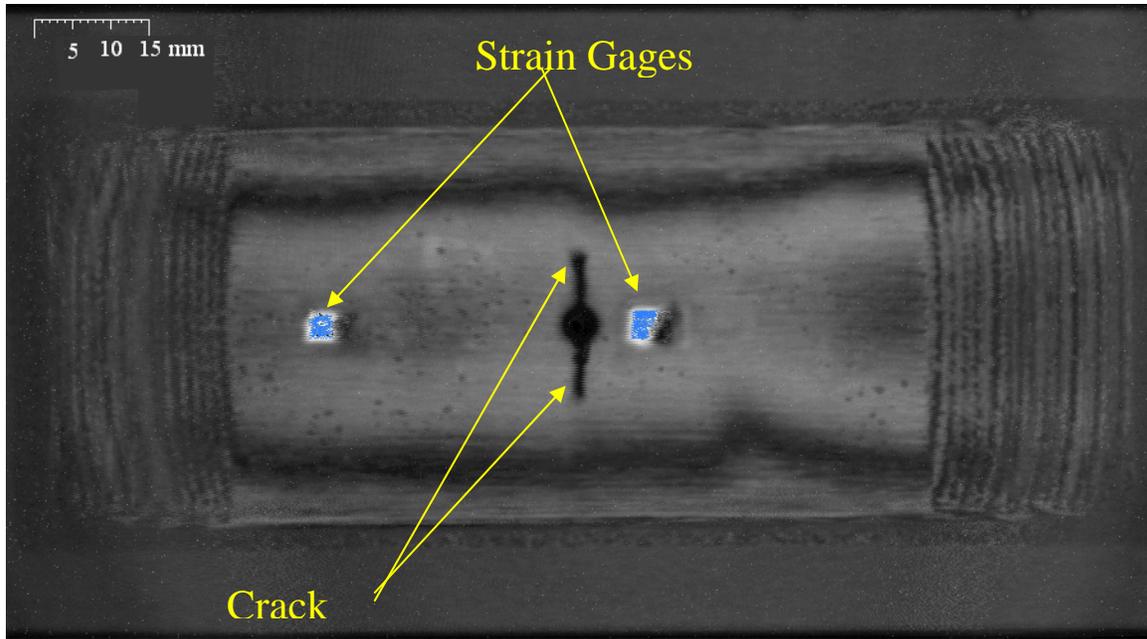
Figure 59. Test 3 Acoustic Microscopy Image.

For the test two scan, the crack was grown from 11.43 mm to 25.4 mm before it was put under tensile loading. In this image no definitive debonding is seen. There appears to be a possible oval shaped disbond around the crack with a little lighter coloring in that area, however those who did the scans do not believe this to be a debond.

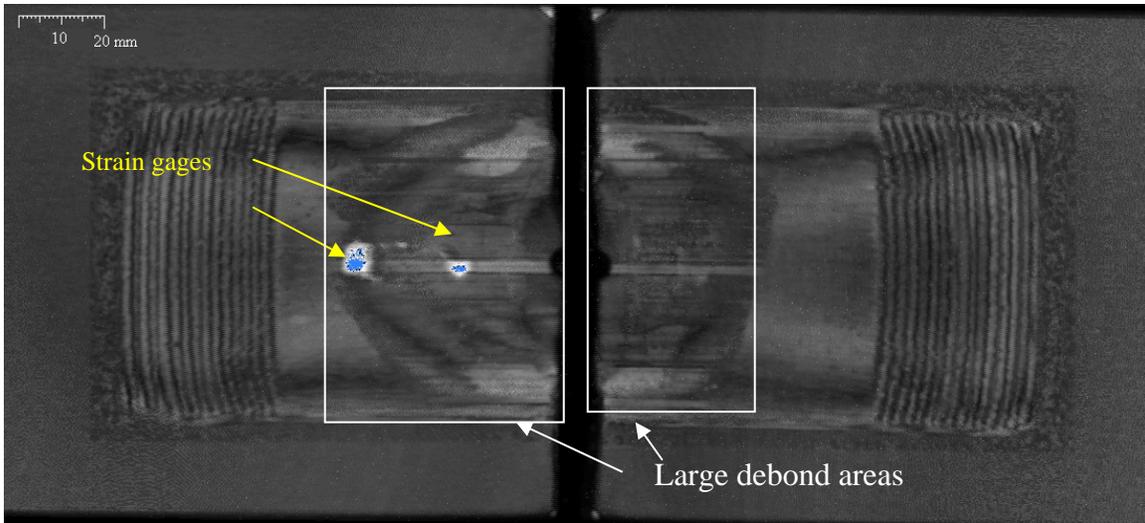
Figure 60. Acoustic Microscopy Image of Test 4 Specimen.

The rest of the samples show significant debonding. Test four and test five had their cracks grow to 55.88 mm and 63.5 mm respectively before they were put under tensile loading to failure (See Figures 60 through 63). Specimen four broke the patch in two, right down the crack line. In Figure 60 it is seen that the large disbond area going all the way to the edge of the patch at the full three inches. The height of the circular debonds are measured to be 57.15 mm on the left, and 43.18 mm on the right. It is not completely clear why this debond grew in the unsymetric manner that it did.

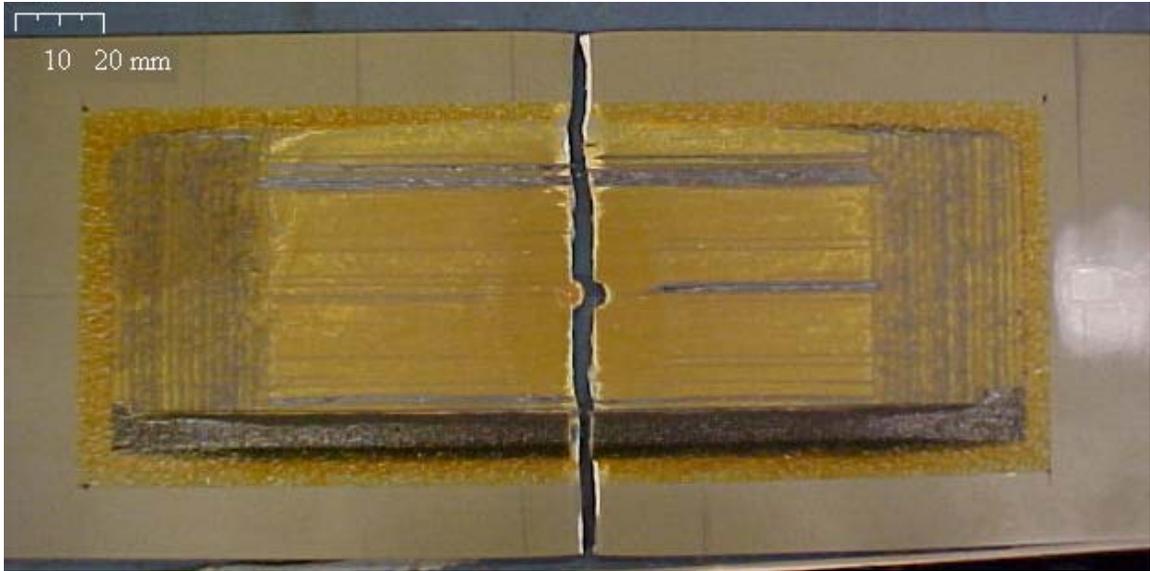
Figure 61. Photographic Image of Test 5 Specimen.

In test five, as seen in Figures 61 through 63 there was no patch left on the specimen to scan for debonds. However, the shape of the debond on the aluminum specimen and on the back of the patch can be seen fairly clearly. It is seen that in this test, most clearly in Figure 63 that this debond is unsymmetric in a different way, in that the debond is greater to the left side of the patch in this figure. This is almost certainly due to the fact that in this test the crack grew faster on that side than it did on the other. At a total crack length of 63.5 mm there was a difference in crack growth of 3.81 mm on the one side compared to the other. The unsymmetric crack growth would lead to the unsymmetric debond area.

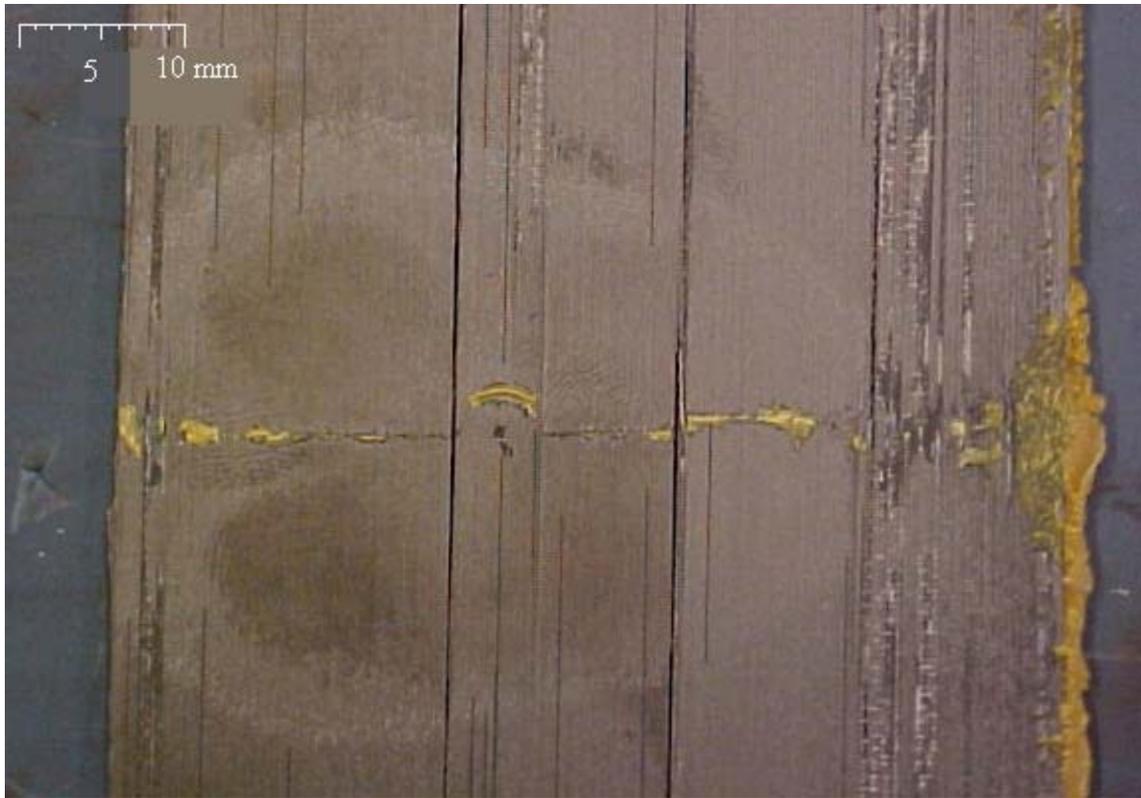
Figure 63. Photo of the Back Side of the Patch of Test 5 Specimen

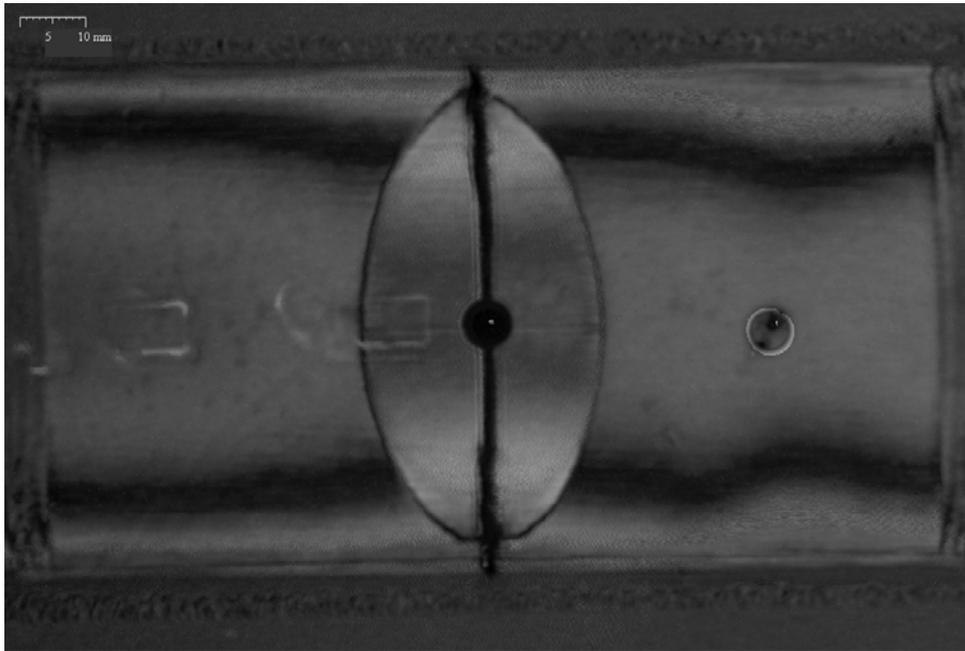
Figure 64. Acoustic Microscopy Image of Specimen from Test 1

Tests one and six grew the crack without any tensile loading. Test one grew the crack to the edge of the patch at 76.2 mm, whereas in test six the crack was grown until failure at 91.44 mm. These debonds are seen in Figures 64 to 66. In the scanning acoustic microscopy image of test one it is seen that while the crack grew to the full length of the patch, the debond oval stopped a little short. This specimen has the most symmetric of the debond areas. This could very well be due to the fact that this was also the only specimen to not be tested to failure. The irregular shapes of some of the other debonds could be partially from the failure loads that they were subjected to. This debond area appears to be a near perfect oval 76.2 mm in length and 43.18 mm total width.

Here some of the previous data will be put together. There are several images of the debonds behind the patch that can be compared to the strain versus crack length curves (Figures 30 through 43). It was seen in Figure 64 that the debond width, at a length of 76.2 mm, was 43.18 mm. When looking at the strain gages that were centered at 2.54 mm and 12.7 mm away from the crack, the valleys in the strain readings occurring at successively larger crack lengths are seen.

a half times as long as it is wide. In addition it is seen in Figure 64 that the length of the crack leads the debond somewhat. In this figure, the total crack length is about eight millimeters longer than the debond. It is expected that the tips of the crack would lead the debond as the tips of the crack are still very narrow, in addition to starting with an initial crack length of about 11.4 mm. If this information is extrapolated out an interesting relationship is seen with the shape of the debond versus the strain readings. For the shape of the debond as related to the crack length the following relationship will be used:

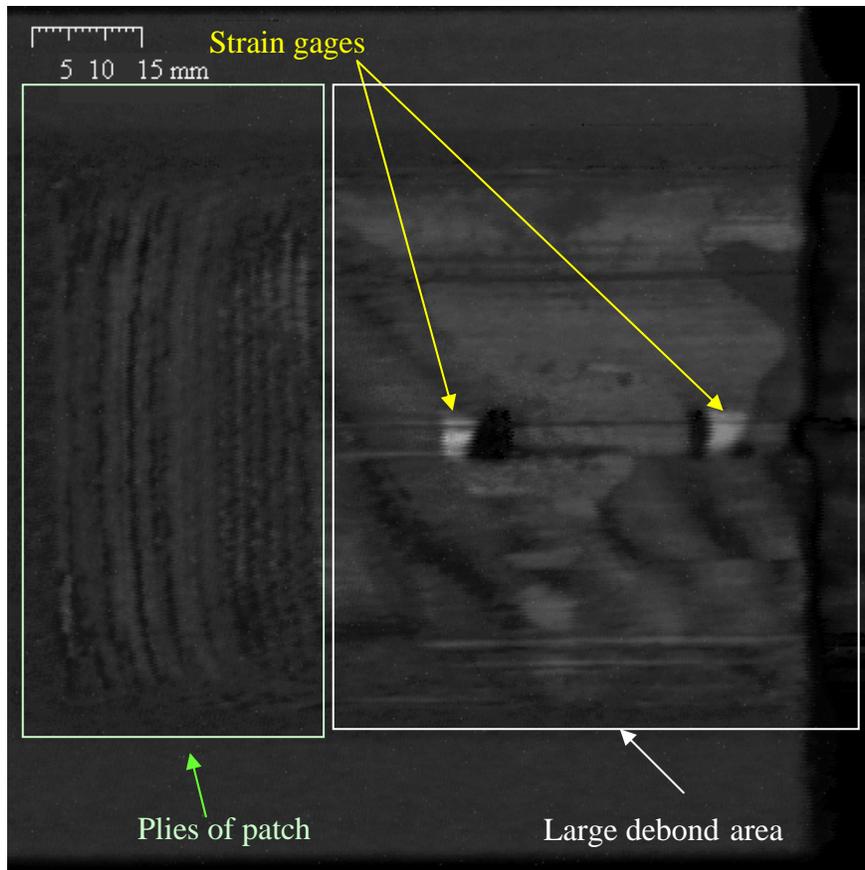
Figure 65. Acoustic Microscopy Image of Specimen from Test 6

Specimen six grew the crack to failure, and when the specimen failed the patch was smoothly stripped off of the bottom half of the specimen, leaving it attached to only the top half of the specimen. In its scanning acoustic microscopy image, a clearly defined oval debond can not be seen. When the specimen failed, it was enough to fully strip away the bonding from the lower half of the specimen. Some additional debonding certainly occurred in the top half at failure, leaving it nearly all debonded in the top half also. In Figure 66 the shape of how the debond grew before failure is seen. Here in this image the oval debond shape can be seen. A curve has been drawn to better identify this debond. Here the debond is seen to go to the edge of the 76.2 mm patch, and grew 33.02 mm from the center line.

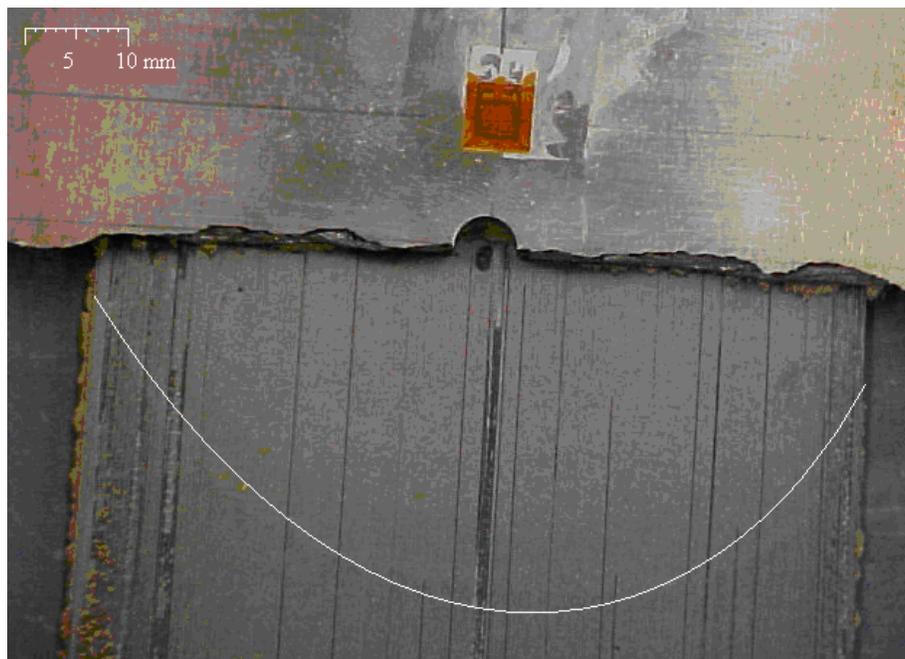
Figure 66. Photo Image of Specimen 6 Patch Debond Area.

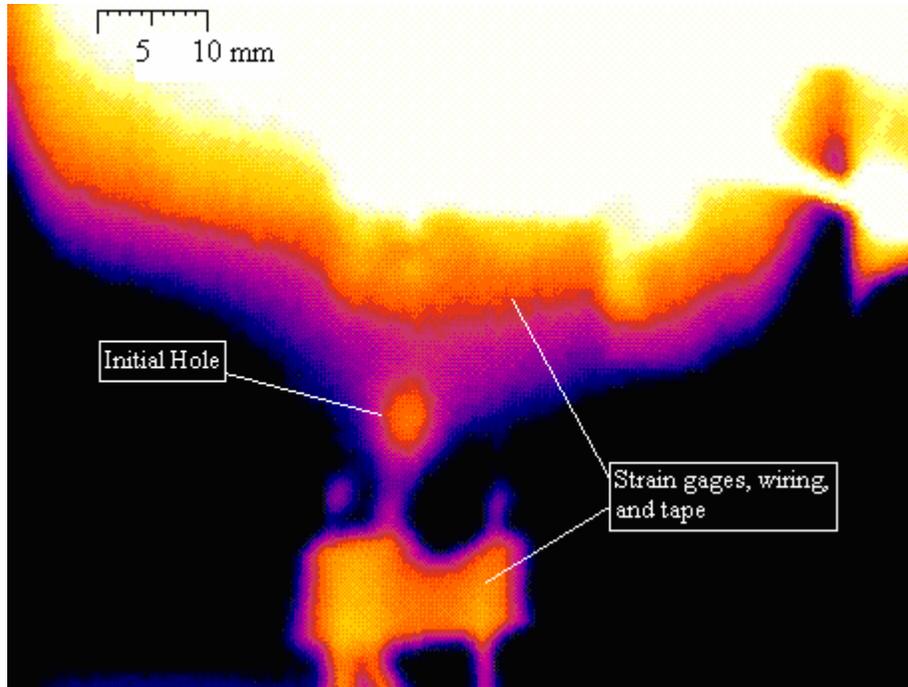
Figure 67. Thermal IR Scan of Test 6 Sample at 63 mm Crack Length

During each test, various Thermal IR pictures were taken. The test would be paused to try to get an IR picture of the debond area underneath the patch. The samples were then rapidly heated up using the heat gun. Due to the different rates of heating of the trapped air in the debond area, the debond should heat up at a different rate than the rest of the sample. In some tests the IR pictures were able to detect the debonds better than others. The thermal IR camera was unreliable in these tests to effectively detect debonds. In the early tests, debonds were unable to be detected. In test 6 only the initial machined hole was able to be detected even though there most certainly was a large debond at this measurement of 63 mm. (Figure 67) One thing that led to additional difficulties were the numerous strain gages that were applied to the system. The gages, wires, and tape that were all on the specimen, hinder the view of potential debonds, in that they have an all together different IR signature themselves. The best IR pictures occurred when the finished specimen was removed from the machine. In test four an IR image was taken of one of the broken halves of the specimen. (Figure 68) In this IR picture there was the advantage of the specimen no longer being gripped in the machine, which provided initial strains in the specimen even with no load, as seen previously in Table 9 In test 5 some noticeable debonds were seen in the final IR picture taken at a crack length of 63 mm. (Figure 69) While the debonds can be seen, it is difficult to get an accurate determination of the true debond size.

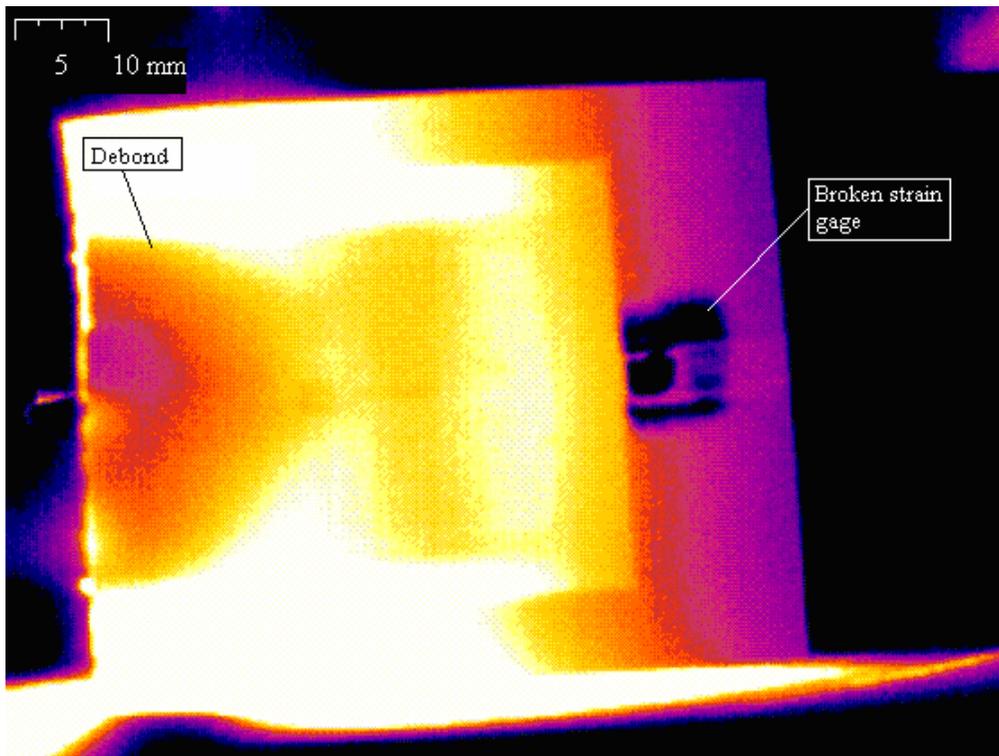
Figure 68. Thermal IR Scan of Test 4 Sample After Failure.

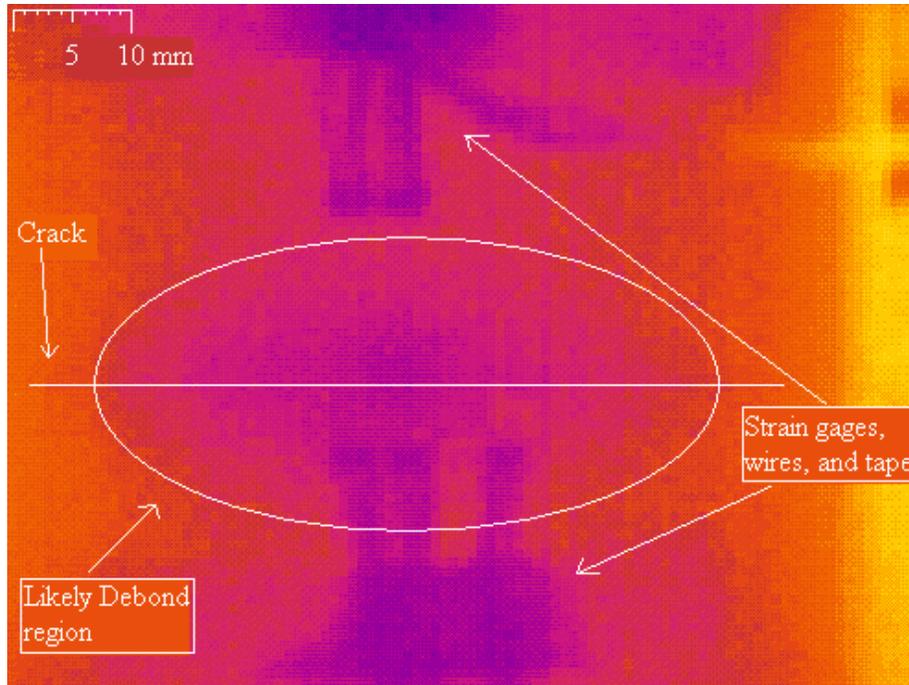
Figure 69. Thermal IR Scan of Test 5 Sample at 63 mm Crack Length
