US Army Corps
of Engineers®
Engineer Research and
Development Center

Investigation of Mechanical Processes for Removing Lead-Based Paint (LBP) from Wood Siding

September 2006

Final report

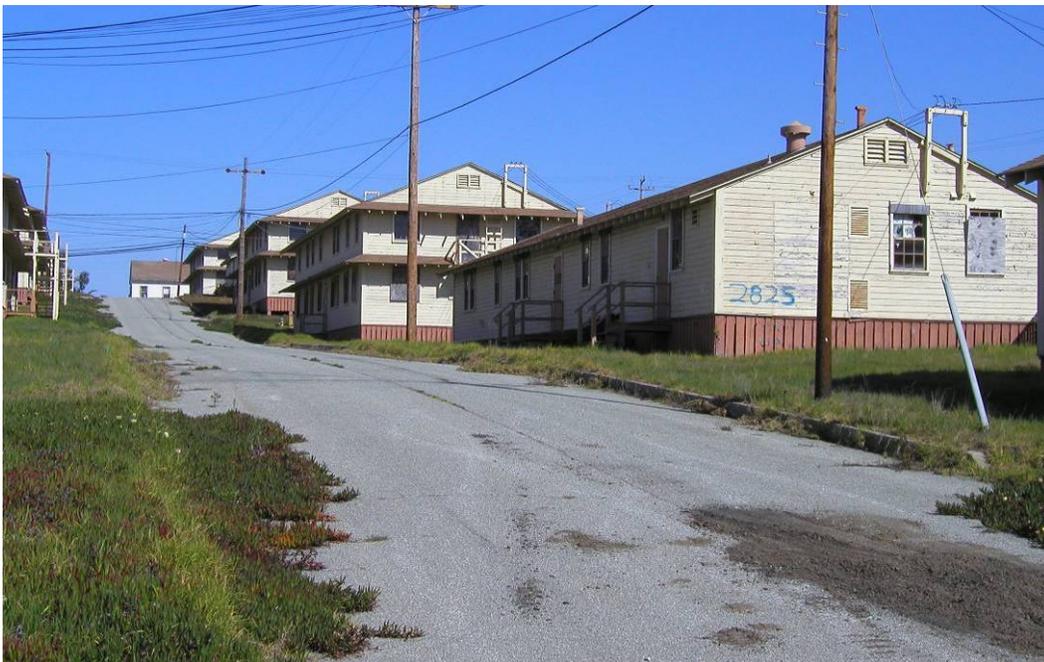
Figure 1. Typical World War II-era wooden barracks at Fort Ord, showing Building T2825 in right foreground.

Fort Ord provided the principal source of salvaged siding evaluated in this study. Using hand tools, the siding was manually removed from two single-story barracks buildings (24 x 82 ft), numbered T2824 and T2825. These buildings were scheduled for removal in the summer of 2002 as part of a local municipal road improvement construction project (commonly referred to as the 12th Street Project). These two buildings are representative of many other one- and two-story wood frame barracks still standing at Fort Ord. This project made use of two single-story barracks for ease of access and siding removal. The total siding recovered from two single-story barracks would approximately equal the amount recovered from one two-story barracks, not including the extra board-feet available from the gable area of the second single-story building. Typical World War II-era temporary wooden barracks are shown in Figure 1.

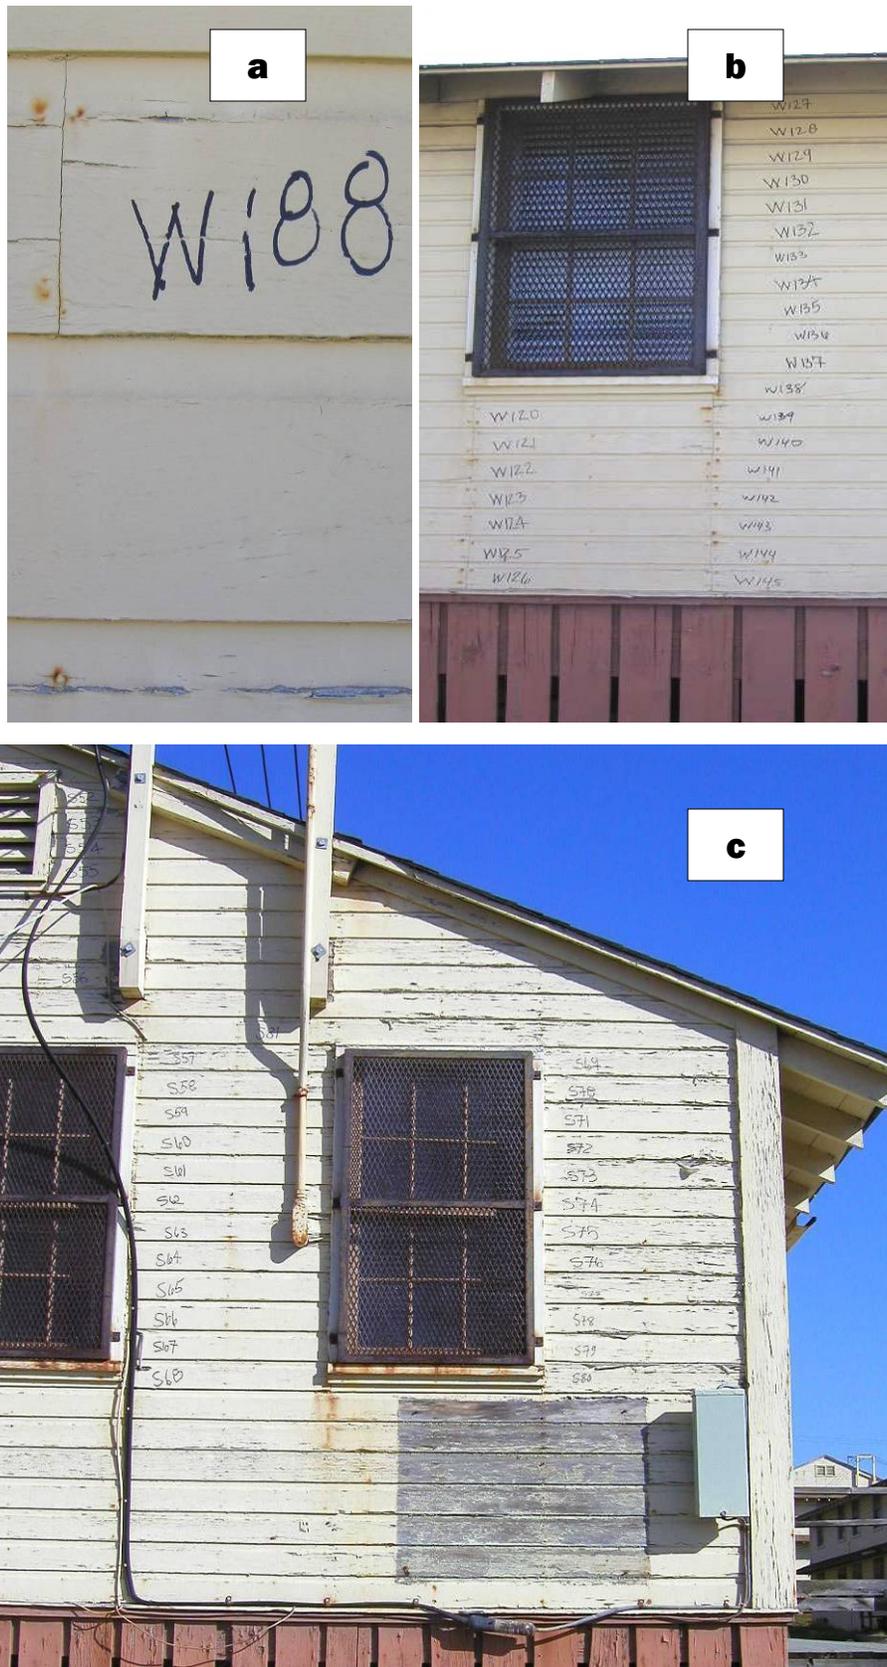
In Figure 2a, note double nail pattern at left, indicated by rust spots. Also, note the difference in siding condition in Figures 2b (west wall) and 2c (south wall), which is apparently a result of differences in weathering and exposure.

Figure 2. Typical ID numbering of individual siding pieces at Fort Ord.

An onsite appraisal of the barracks siding materials at Fort Ord was completed in April 2002. The siding was visually inspected and photographed to document building exterior conditions. During the visit, each piece of siding on each building was given an identification (ID) number. The ID number included a letter prefix indicating wall orientation – north (N), east (E), south (S) or west (W) – and a number giving vertical location Figure 2 (a, b, and c). Building T2824 was marked with a red permanent marker and Building T2825 was marked with black.

In spite of a difference in siding width, both the Fort Campbell and Fort Ord siding were nailed to the building framing using a double nail pattern spaced 24 in. on-center, as shown in Figure 2. Because the Fort Campbell buildings had wood siding overlaid with vinyl siding, additional nail holes were evident in every piece. Nail holes in salvaged siding are a significant factor that can reduce its value or limit its usefulness in certain ready-to-finish millwork products.

The siding salvaged from Fort Ord (Figure 6) was generally in much better condition than the Fort Campbell siding. In general, the same defects as described for Fort Campbell were found in the Fort Ord siding, but with much less frequency. The paint loss and wood weathering of the Fort Ord siding was more location-specific; the most severe degree of weathering and checking were found on pieces from the south sides of the building, where solar exposure was highest. Figure 2c shows a typical southern exposure and Figure 2b shows a typical western exposure.

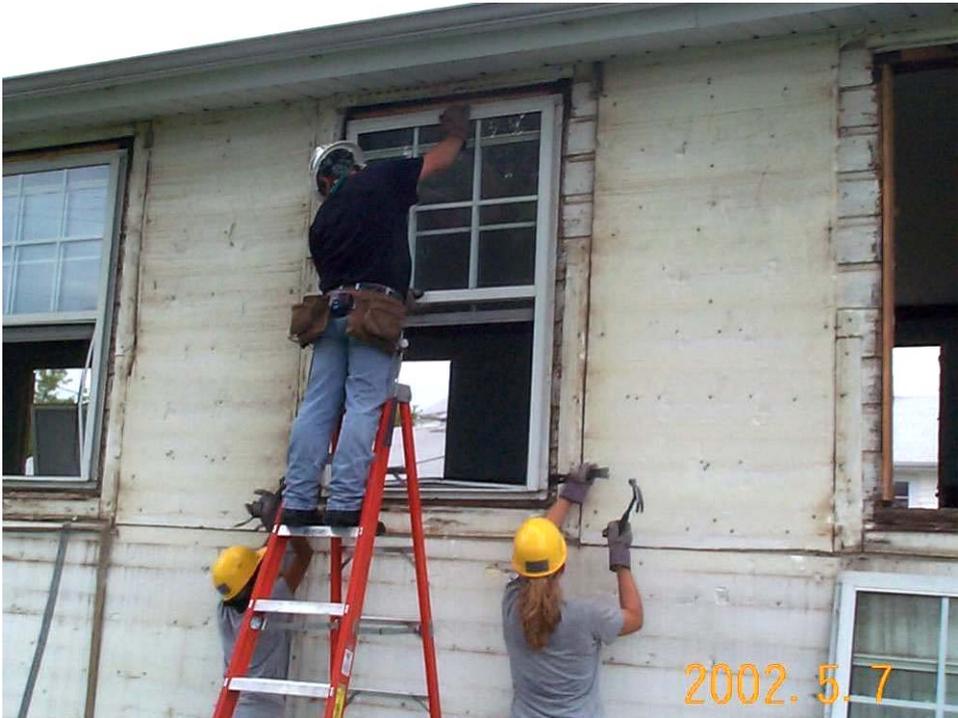
Figure 3. Deconstruction at Fort Campbell.

The scheduled deconstruction of five buildings at Fort Campbell (Figure 3) provided another source of wood siding for evaluation. The siding from those buildings was separated from the other salvaged materials because of its LBP content and the poor condition of the paint film. The siding was disposed of as debris except for boards from one two-story barracks building. Those boards were removed, bundled, banded, and shipped to FPL. In order to assess the condition of the siding boards relative to their position on the building, a coding scheme was adopted similar to that used at Fort Ord, with N, E, S, and W indicating compass orientation and a number indicating vertical and horizontal location of each piece. ERDC-CERL personnel coded each siding piece, and the boards were removed by Austin Habitat for Humanity, Austin, TX, the deconstruction contractors for this project.

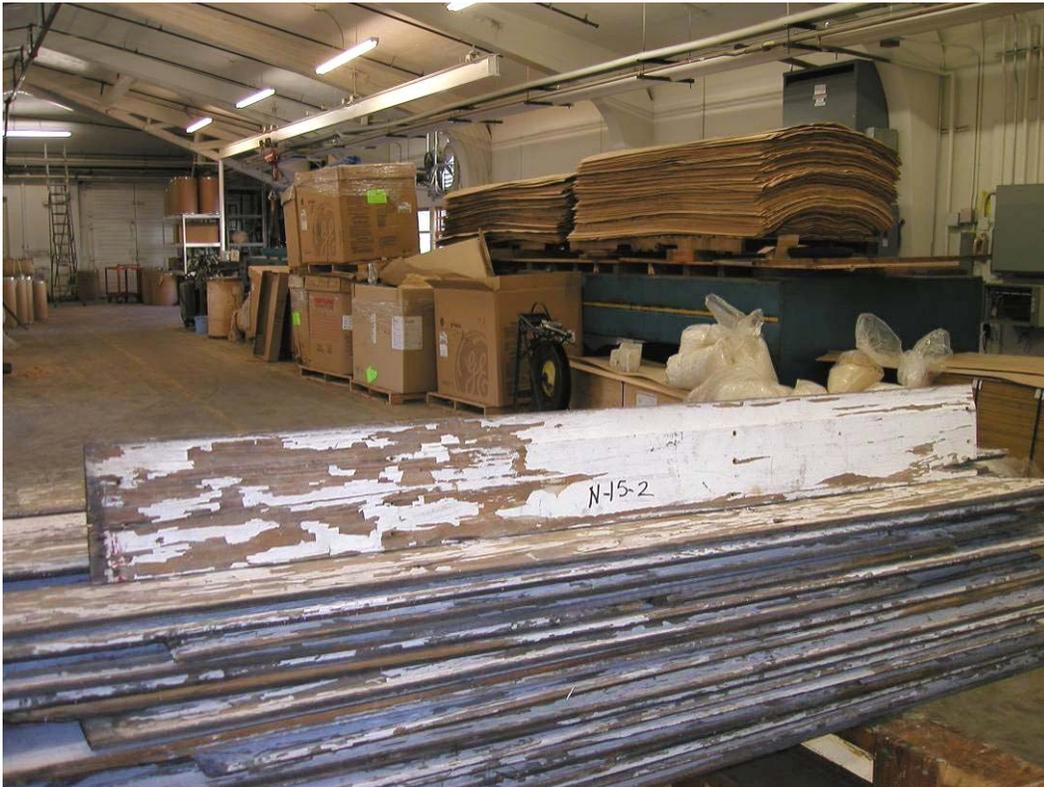
Figure 5. Salvaged siding from Fort Campbell.

A visual assessment of the siding specimens from Fort Campbell indicated that it had been painted several times, but the paint surface was in poor condition. Surface quality varied considerably, and paint film separation and flaking were evident in most pieces (Figure 5). This paint failure was problematic because many siding pieces lost the hand-marked ID numbers during handling and transportation. This problem limited the ability to accurately account for and track all the siding back to its original building position.

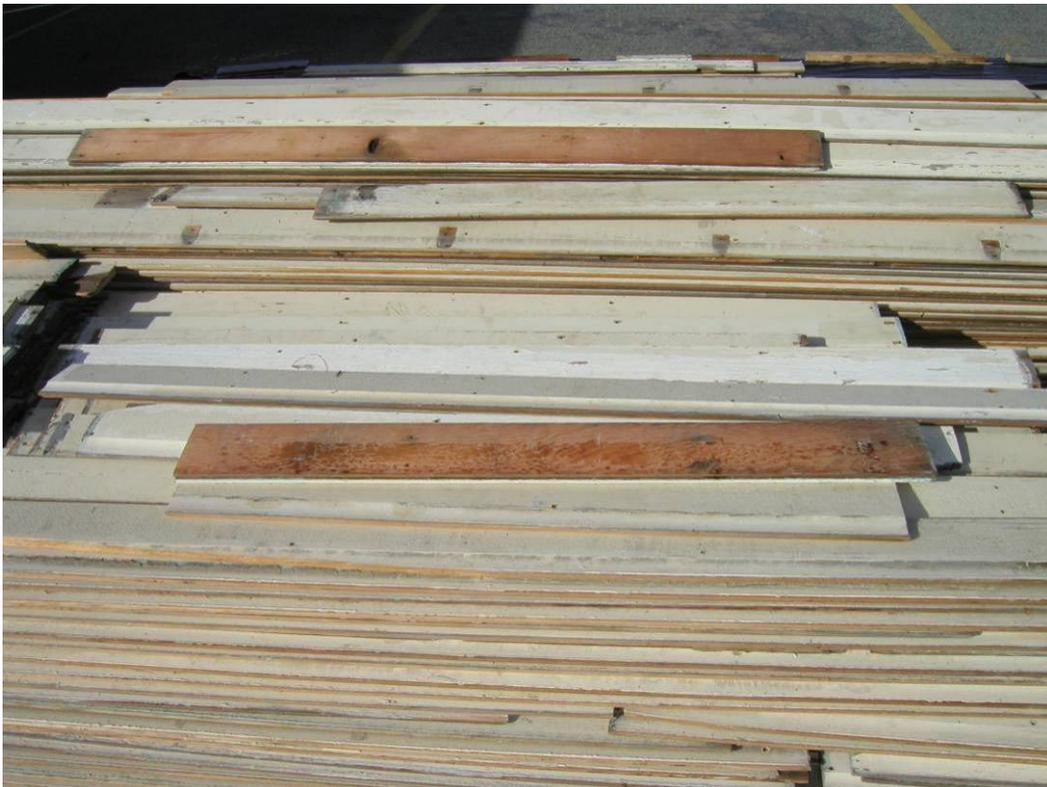
Figure 6. Douglas fir siding salvaged from Fort Ord.

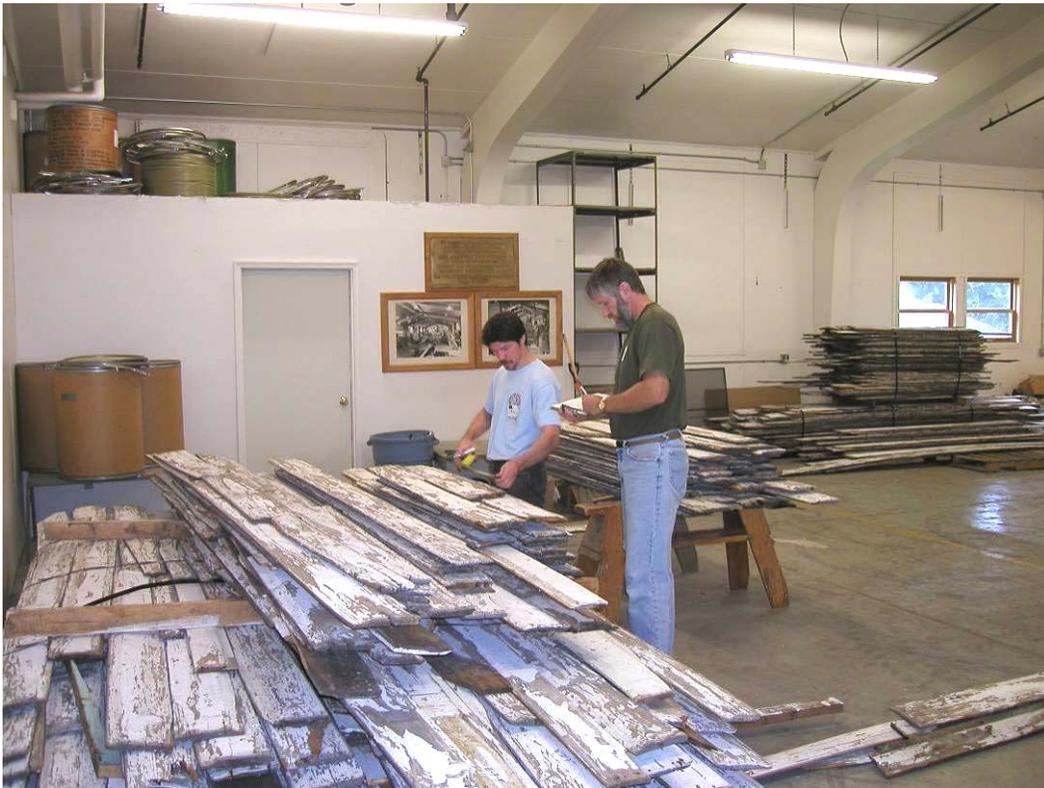
Figure 7. Quantitative inspection of Fort Campbell siding.

Separation by profile classification was based mainly on recoverable length. Because wood flooring grades allow pieces as short as 16 in., pieces up to 7 ft in length were classified as tongue and groove (T&G) flooring. Wood paneling is typically sold in lengths greater than 8 ft, often to 10 ft, to accommodate vertical placement on interior walls. Therefore, siding pieces from 8 – 10 ft were separated for remanufacture into V-groove paneling. Lengths more than 10 ft were segregated as bevel siding for remanufacture, because longer siding is preferred in the home building market and commands the highest price. Figure 7 shows the first inspection in progress.

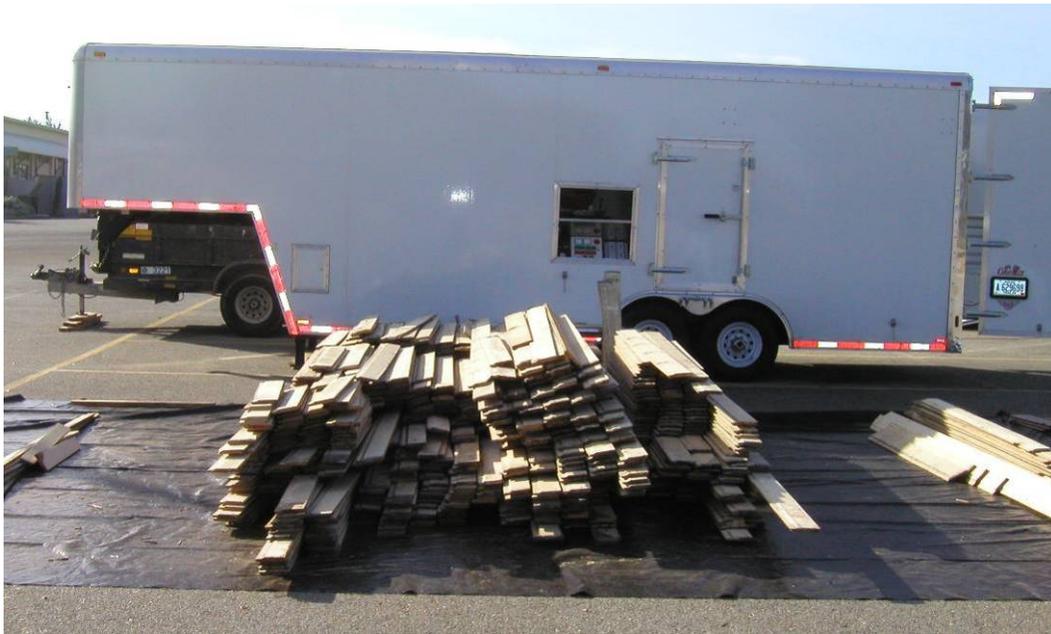
Figure 8. Fort Ord siding provided for remanufacture by Auburn.

FORA donated 1,226 pieces of siding (7,830 lf) from previous deconstruction projects for use in the demonstration by Auburn Machinery, Inc. (later renamed Auburn Enterprises, Inc., Auburn, ME). The siding had been stored for many years under cover and was left over from a previous deconstruction project. A visual inspection of the wood indicated no discernable difference between this siding and the siding shipped to FPL. For this reason, all conclusions on the quality of the siding evaluated at FPL can be assumed applicable for the siding remilled by Auburn. The siding made available to Auburn at Fort Ord is shown in Figure 8.

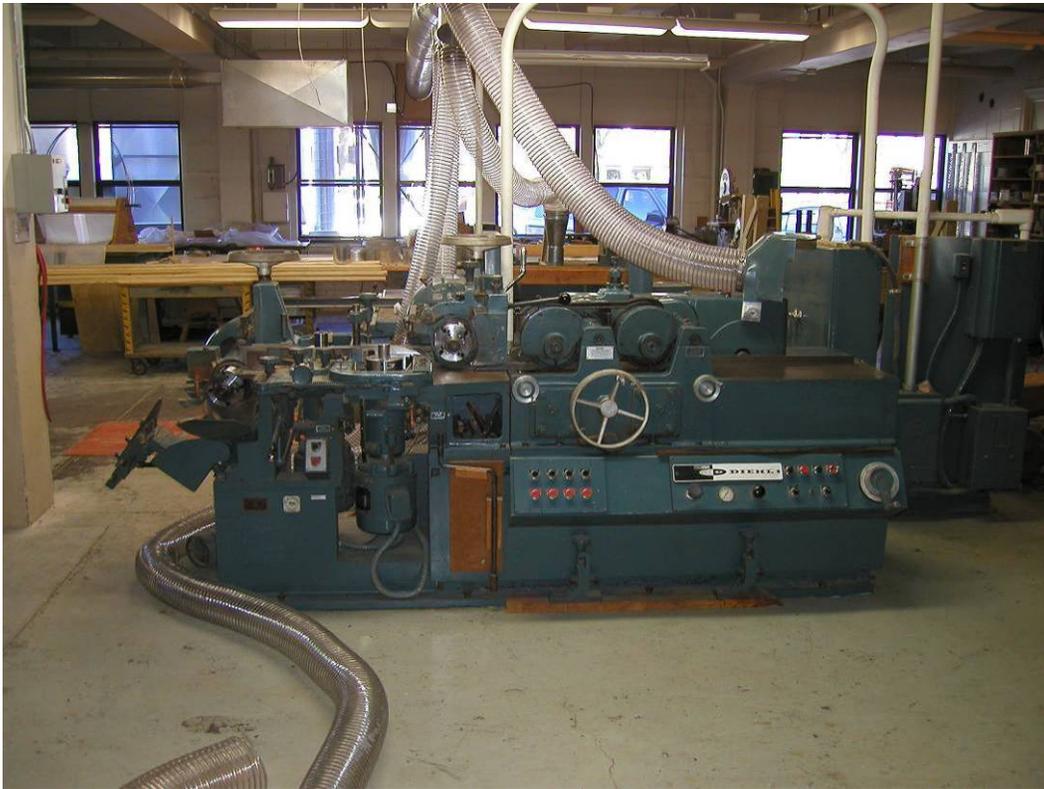
Figure 12. FPL's Diehl S4S molder.

A Diehl molder (Model D-6) located at FPL was used in the laboratory portion of this study (Figure 12). The machine, manufactured in 1966, is fully functional and typical of molder/planer equipment used widely by mill-work producers. It is versatile enough to convert feedstock into many different types of surfaced four side (S4S) wood products in a single pass. In addition, these machines are readily found on the used machine market. The unit is equipped with four cutting heads — two for side cutting, and two for surface cutting.

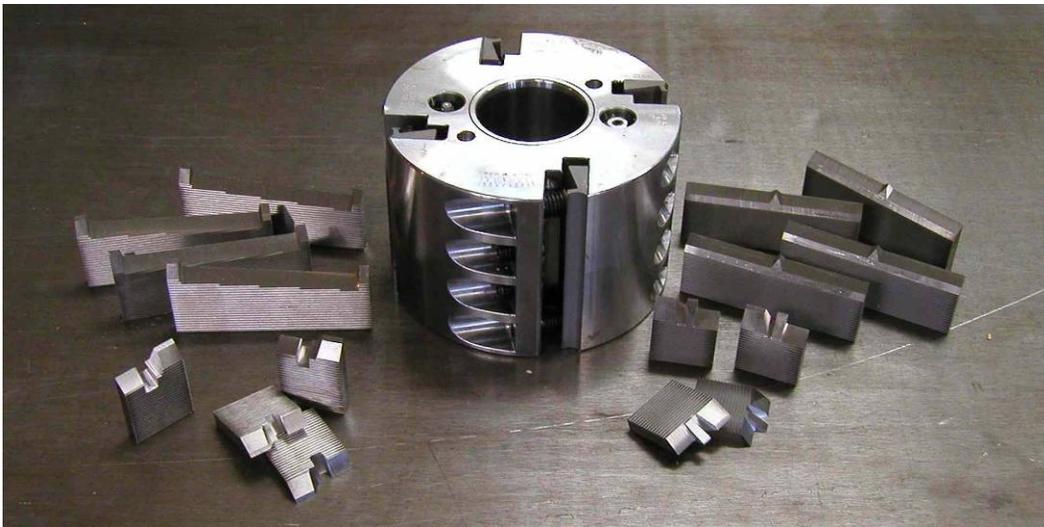
Figure 13. High-speed steel profile knives and Hydroloc™ cutter head.

Inspection of the molder indicated that the cutter heads and arbor assemblies needed to be replaced. The existing rotor-style cutter heads with hub lockdowns for constant axial setup were replaced with precision chamber pressure sleeve cylinder cutter heads. This substitution was made to as-

sure accuracy, uniformity, and concentricity for quality processing performance. These replacement parts are shown in Figure 13.

New Hydroloc™ cylinder 150 mm diameter, 150 mm height body (2-1/8 in. bore) surface cutter heads and 150 mm diameter, 60 mm body height (1-13/16 in. bore) side cutter heads were purchased from Hermance Machinery, Inc., in Williamsport, PA. All four cylinder heads were ordered with a 12-degree cutting angle. This cutting angle is optimal for Douglas fir, but less efficient for other pine species, which machine better at different cutting angles.

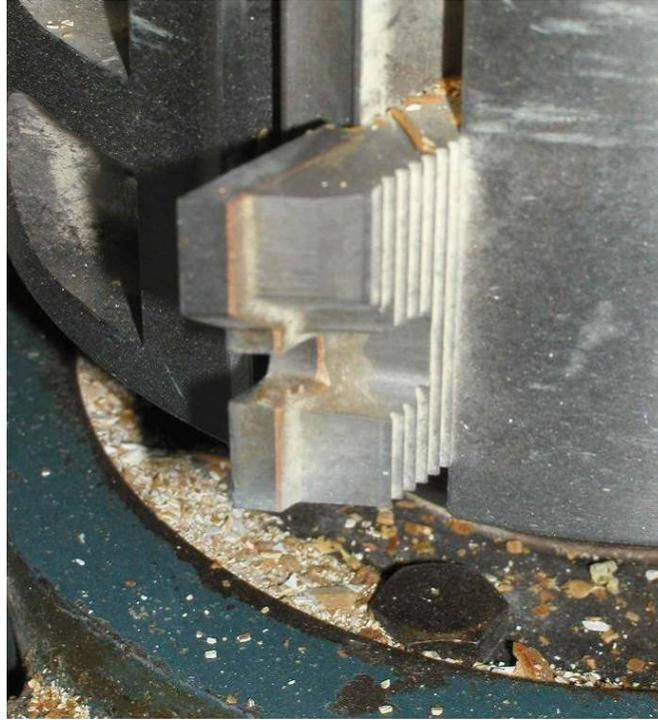
Figure 14. Carbide knife used to machine southern pine, showing corrugation on back.

Most of the Fort Ord siding was milled using the ordinary steel blades; the remainder of the Fort Ord siding and all of the Fort Campbell siding was milled using carbide steel blades. The Fort Ord Douglas fir siding was processed using flat and profile M-2 grade, high-speed steel (HSS) knives manufactured by Wisconsin Knife Works, Beloit, WI. Four knives were used in each cutter head. These 35-degree bevel knives with 16/60 corrugated back blades were matched to the replacement cutter heads. The corrugations on the backs of the knives simplified installation, removal, and mechanical locking of the knife in the cutter head; they are shown in Figure 14.

The excessive wear of HSS knives witnessed in early machining trials suggested that carbide knives could be a logical alternative. In addition to the abrasive nature of the paint, the Southern Pine siding from Fort Campbell

had a larger number of knots, which also tends to rapidly dull knives, also shown in Figure 14.

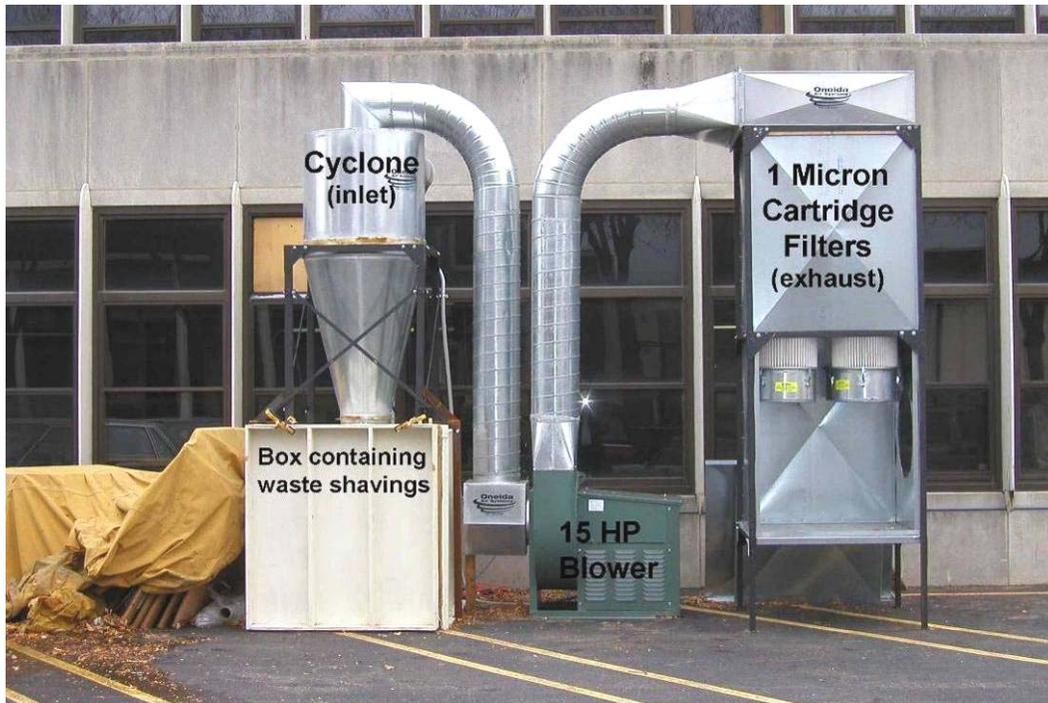
Figure 15. Oneida dust collection system as installed outdoors at FPL.

As shown in Figure 15, the new dust collection system was installed outside the FPL mill shop in order to help reduce potential LBP exposure hazards.

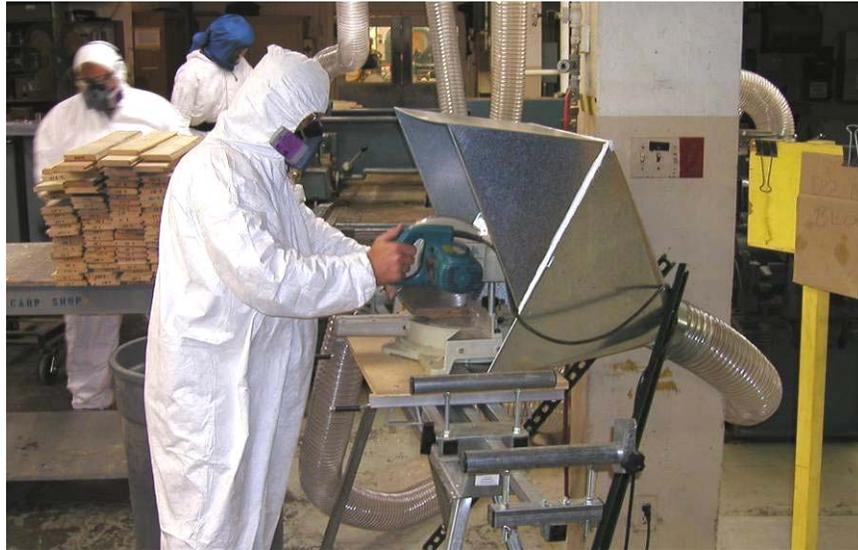
Figure 16. End-trimming with sliding compound miter saw.

Before processing, each piece of siding was square end-trimmed. This step minimized material feeding problems in the four-head molder, removed wood that was unusable because of end-grain splitting or residual fasteners remaining after deconstruction, and ensured that only usable wood would be machined into finished millwork. End-cuts and crosscutting were performed on the 10 in. Makita compound sliding power miter box shown in Figure 16.

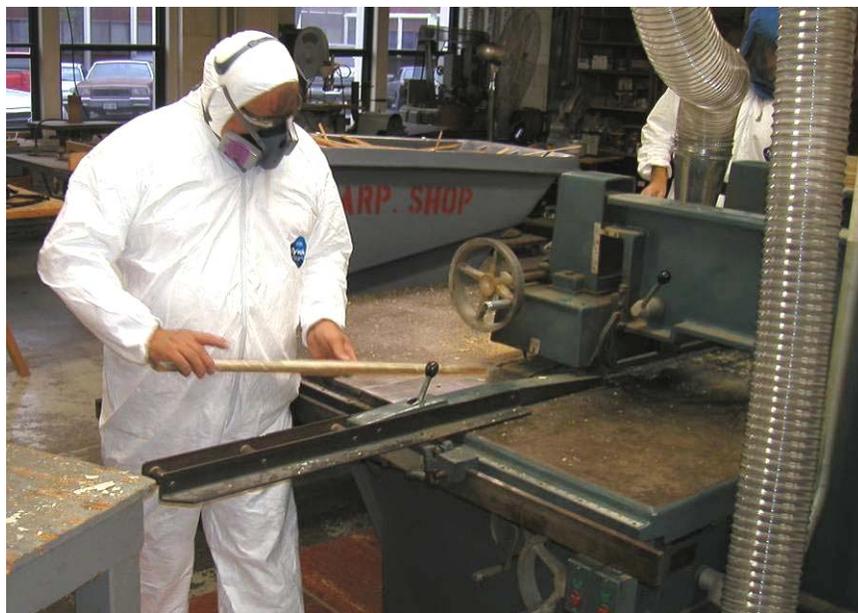
Figure 17. Ripping of siding to width.

Directly after end-trimming, all siding pieces were ripped to a consistent width that was appropriate for the profile to be manufactured. The inline rip saw used in this step is shown in Figure 17.

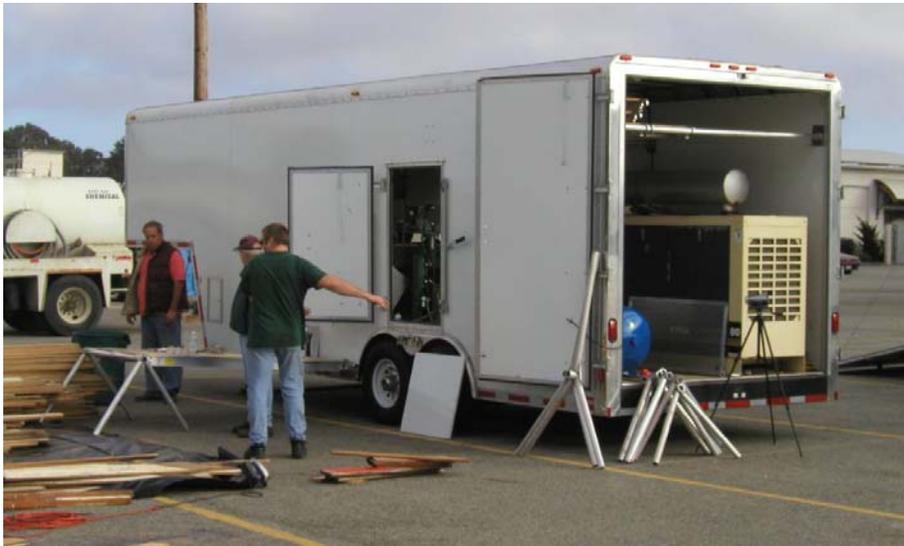
Figure 19. Auburn's Yield Pro mobile unit at Fort Ord.

The Yield Pro machine evaluated in this study consisted of two planing heads (one top and one side head) and a side-ripping blade. (The side-ripping blade can be replaced with a hogging blade to grind up the removed material rather than leaving it in the form of a strip.) The machine is enclosed in a self-contained trailer that includes an electrical generator, an air compressor, a dust collection and storage system, and a fire suppression system (Figure 19).

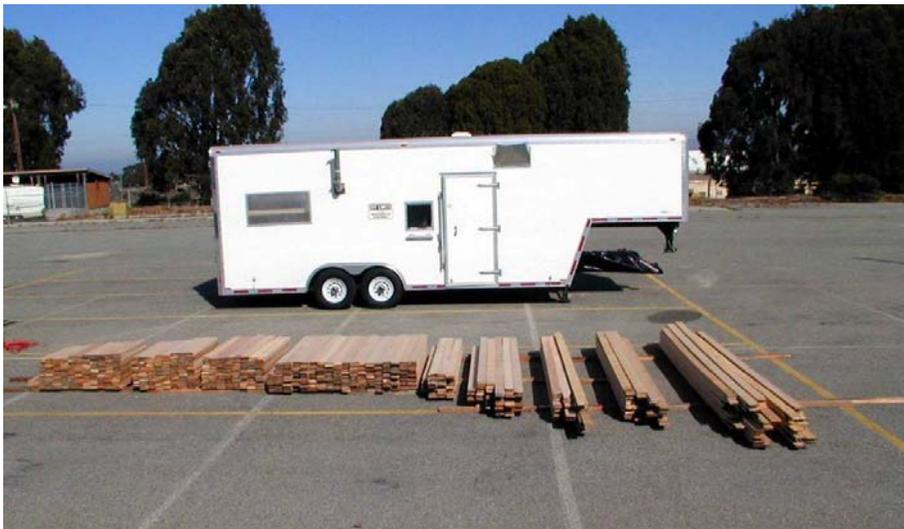
Figure 20. Salvaged Fort Ord wood siding remilled into 5/8 x 4 in. boards for molding into value-added wood products.

Using cutting tools designed to process wood with embedded nails and surface coatings, this system can resize and profile salvaged wood into uniformly-dimensioned stock. Figure 20 shows the 5/8 in. x 4 in. rectangular blanks produced from salvaged wood using the Auburn system.

As indicated in Figure 20 and Figure 25, Auburn mobile unit operations were conducted in a very large parking lot at Fort Ord. This location provided good conditions for isolating mobile unit operations from nearby activities and the general public.

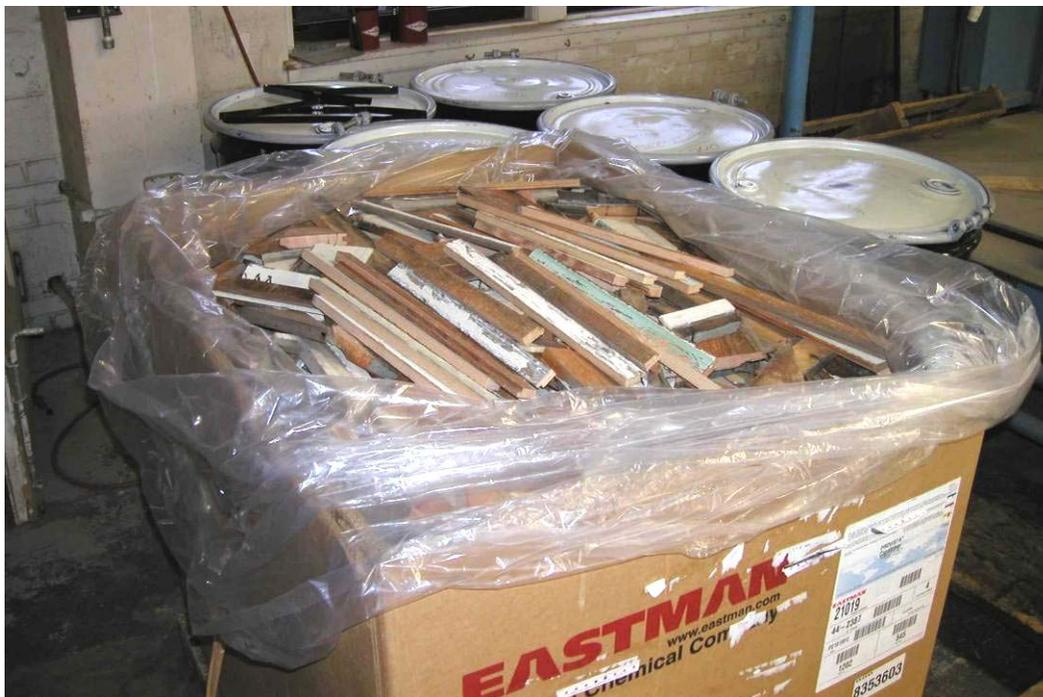
Figure 24. Containers used for storage and shipping of lead-contaminated wood waste.

ERDC-CERL requested that all wood waste materials generated by the re-milling work be placed in containers to be shipped to other locations for further waste treatability studies. All cutoff scraps, edge trim pieces, and shavings from the molding operations were placed in either 55 gal* steel drums or standard Gaylord-type corrugated shipping boxes with plastic liners, as shown in Figure 24.

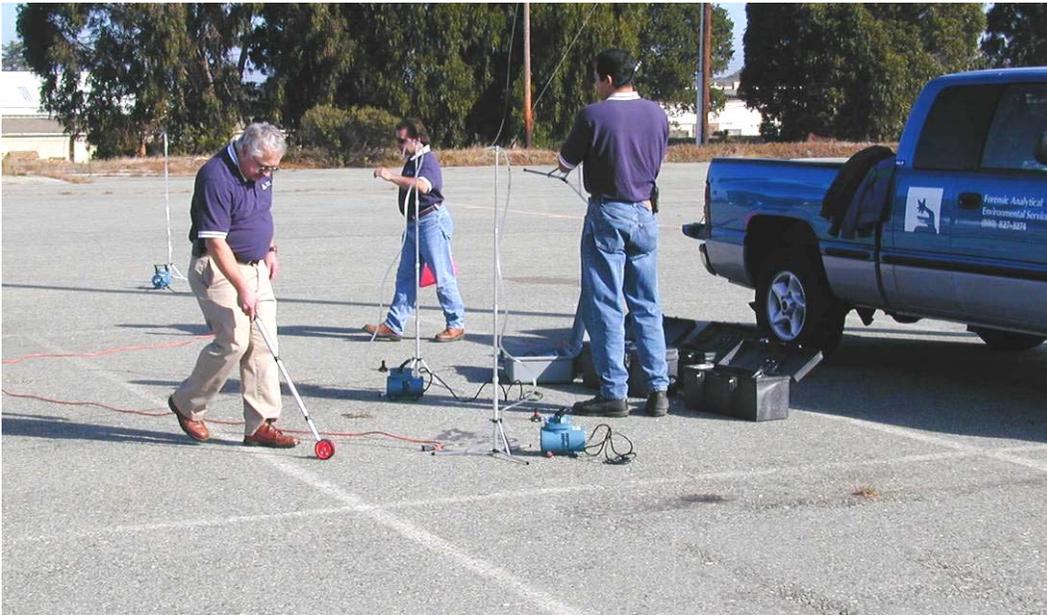
Figure 26. Setting up for air monitoring at Fort Ord demonstration.

During demonstration of the mobile unit on October 31, 2002, air quality was measured both inside and outside the unit. Forensic Analytical, a California-based environmental consulting firm, was contracted to perform the air sampling. As shown in Figure 26, measurement stations were established around the perimeter of the mobile unit at distances up to 65 ft.

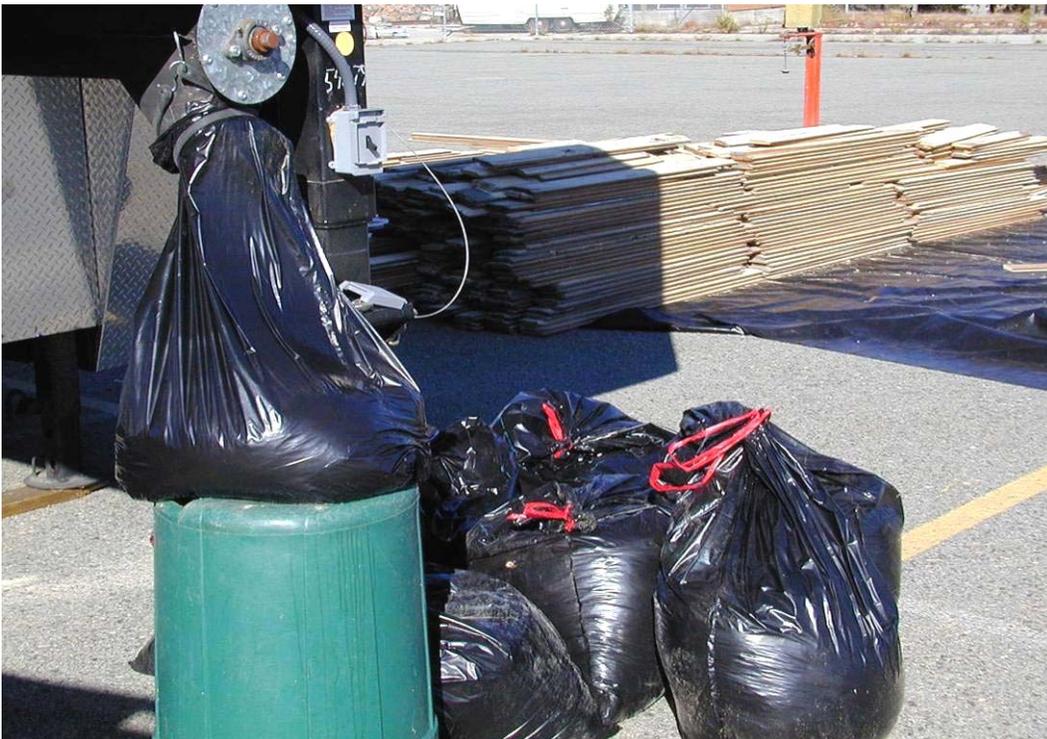
Figure 27. Waste collection from mobile processing unit.

The waste materials generated by mobile unit operations were sequestered from the dust collection area into plastic bags using an auguring system (Figure 27). These materials were disposed of by Wood Waste Diversion.

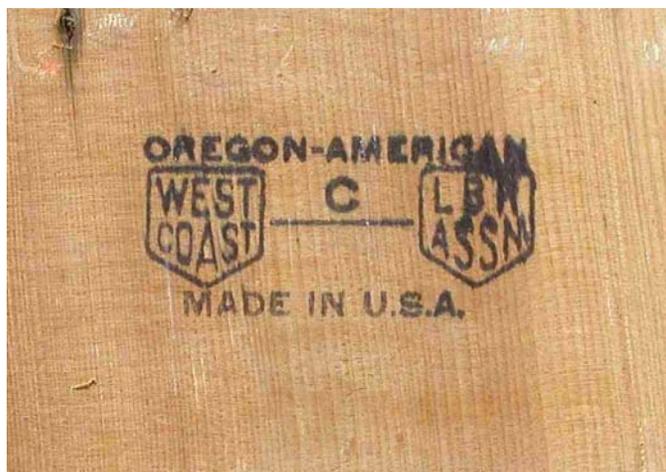
(C = visual grade, Oregon-American = Mill ID)

Figure 28. West Coast Lumber Association grade stamp on sample of salvaged Fort Ord siding.

A visual assessment of all pieces indicated that the siding recovered from Fort Ord was manufactured of very high quality Douglas fir. This determination was confirmed by the discovery of old grade stamps on the siding, as shown in Figure 28. This stamp shows that the siding as installed was grade C or better which, at the time, represented the highest grade of Douglas fir siding available. The condition of the siding as recovered was generally very good, with good paint adhesion and relatively little wood damage or degradation.

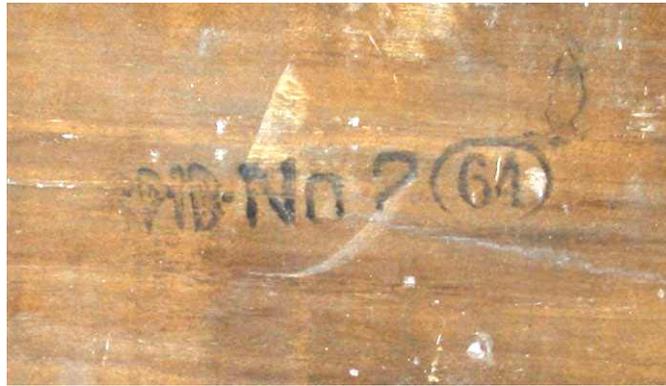
(SPIB = Southern Pine Inspection Bureau, No. 2 = visual grade, 64 = mill number.)

Figure 29. Southern Pine Inspection Bureau grade stamp on sample of salvaged Fort Campbell siding.

Visual inspection of all the pieces indicated that the Fort Campbell siding was manufactured from Southern Pine and contained many larger knots. The siding was generally in poor condition, with considerable flaking paint, warping and cracking, and a significant amount of deconstruction damage. More importantly, the grade stamps found on the siding indicated that the original wood was only of moderate quality —No. 2 lumber board stock , which allows much larger knots than siding grades. It is likely that, because these barracks were classified as temporary structures with an assumed service life of 3 years, No. 2 stock was considered adequate for the application. The stamp is shown in Figure 29.

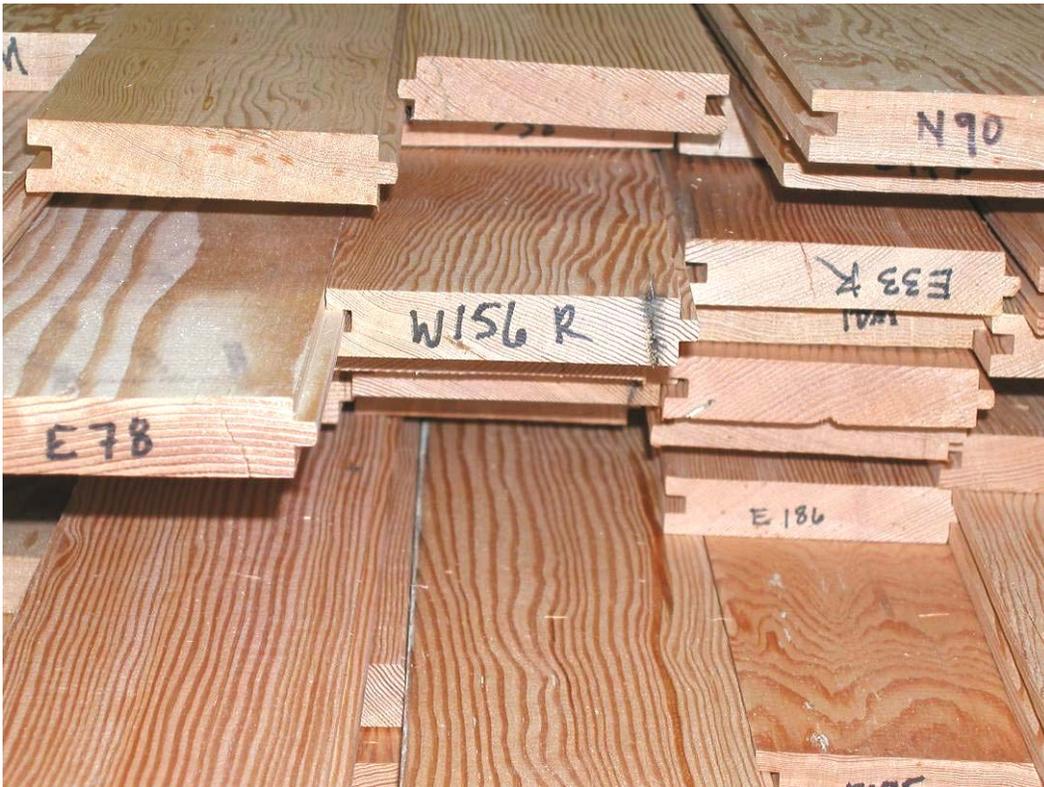
Figure 30. T&G flooring produced from Fort Ord siding.

Figure 30 – Figure 32 show examples of the T&G flooring, V-groove paneling, and bevel siding, respectively, remanufactured from the Fort Ord siding.

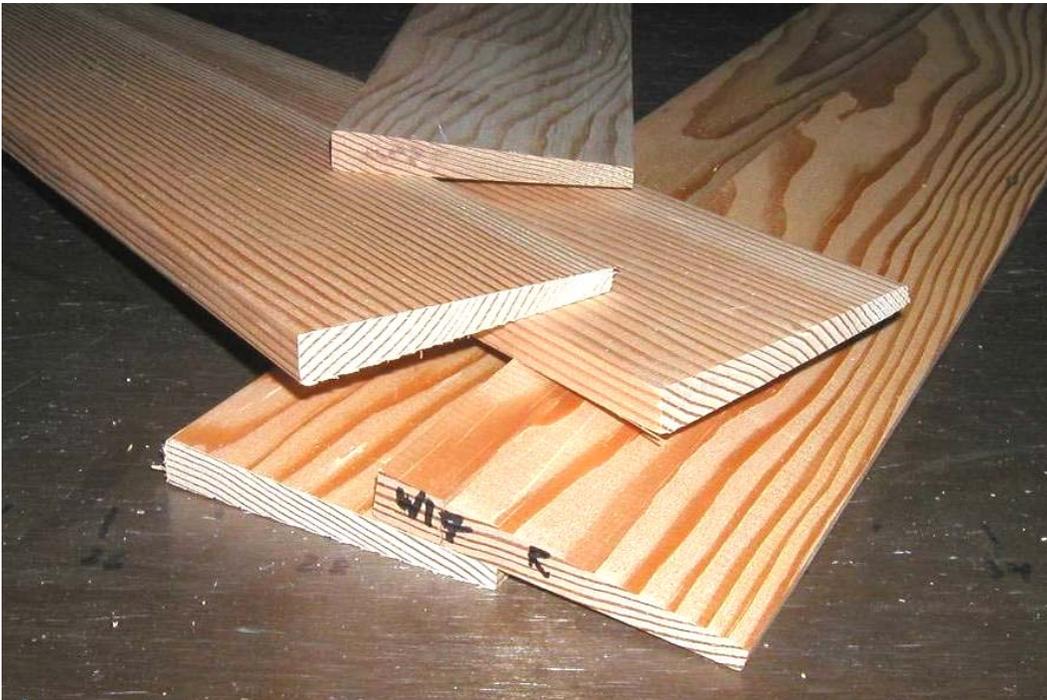
Figure 32. Bevel siding produced from Fort Ord siding.

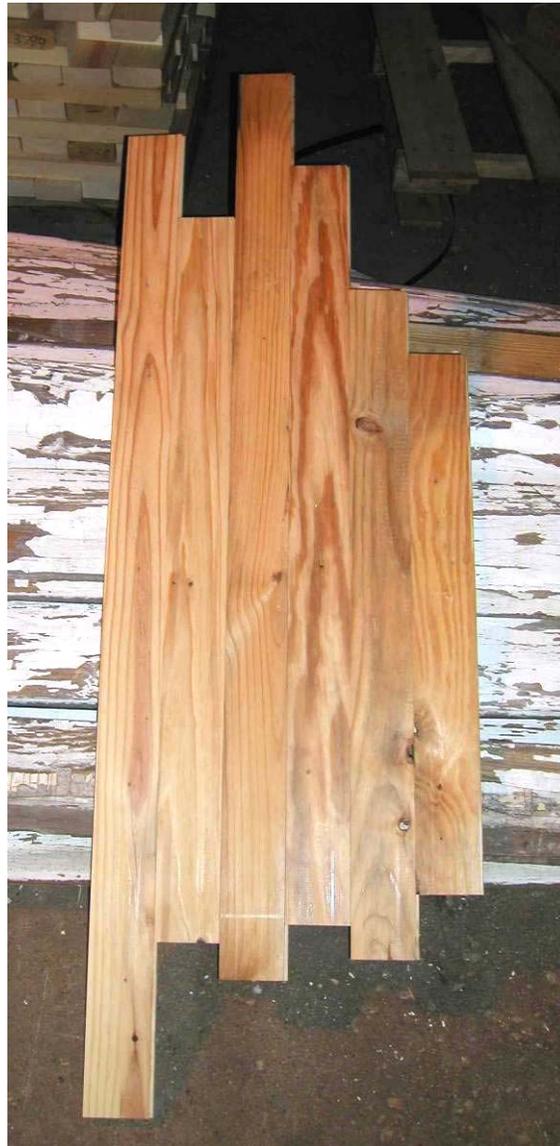
Figure 33. T&G flooring produced from Fort Campbell siding.

Figure 33 shows T&G flooring produced from the Fort Campbell siding. Although there were many knots in the product because of the original grade of wood used, it appeared to be attractive and marketable.

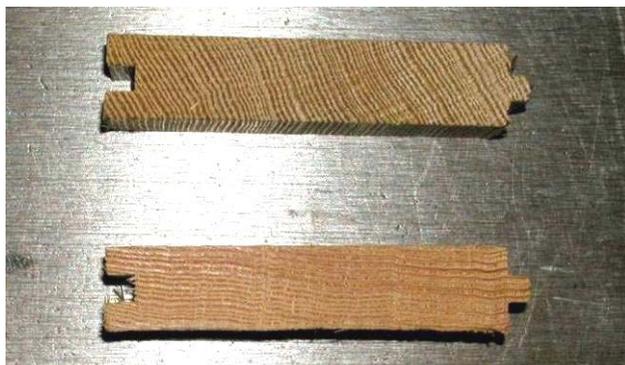
Figure 34. Samples of vertical grain (top) and flat grain (bottom).

As discussed in Chapter 2, the remanufactured products were visually inspected after processing to determine the losses due to defects not detected in the feedstock or otherwise not allowed by the applicable grading standard. For the Fort Ord materials this inspection also included examination of a large percentage of the milled pieces to determine grain orientation (i.e., either vertical or flat). Grain is an important characteristic for pricing wood because vertical grain commands a much higher price in some niche markets than flat grain due to its warp resistance, superior paint adhesion, and evenness of grain appearance. Figure 34 shows the difference between these two grain orientations. Table 7 indicates the distribution of vertical versus flat grain from the Fort Ord siding. Because the

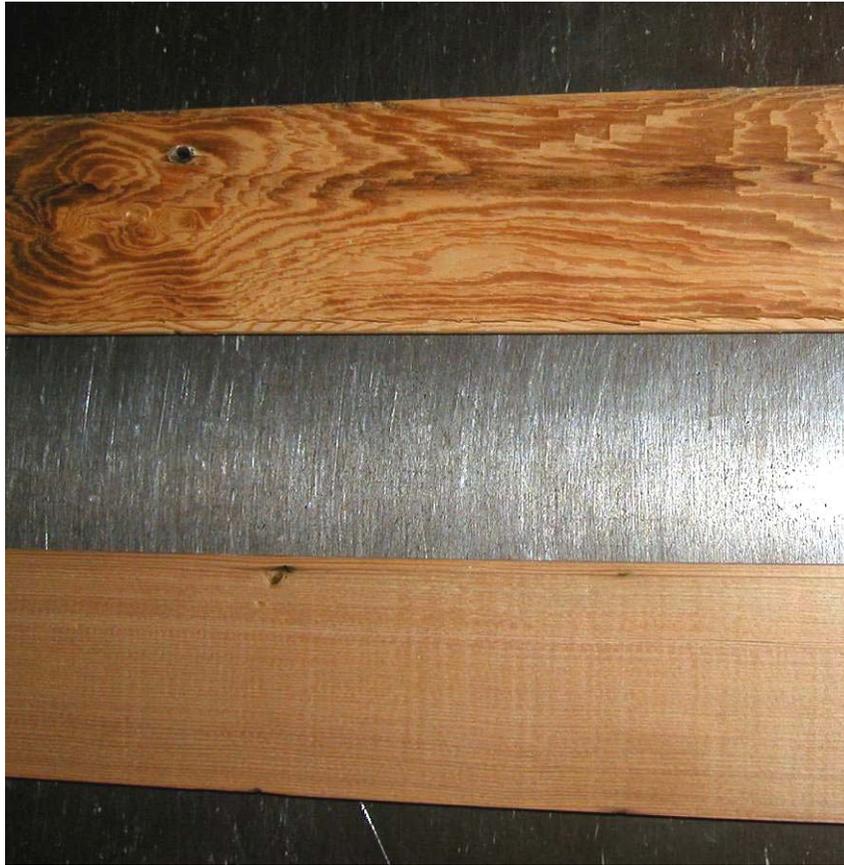
Figure 36. Degradation of wood surface quality (top) due to dulling of HSS knives.

As shown in Figure 35, the machining of the LBP siding was very abrasive to HSS knives; the knife was razor sharp when installed but dulled dramatically after machining less than 1,000 lf of siding. This dulling in turn degraded the surface quality of the machined wood, as shown in Figure 36.

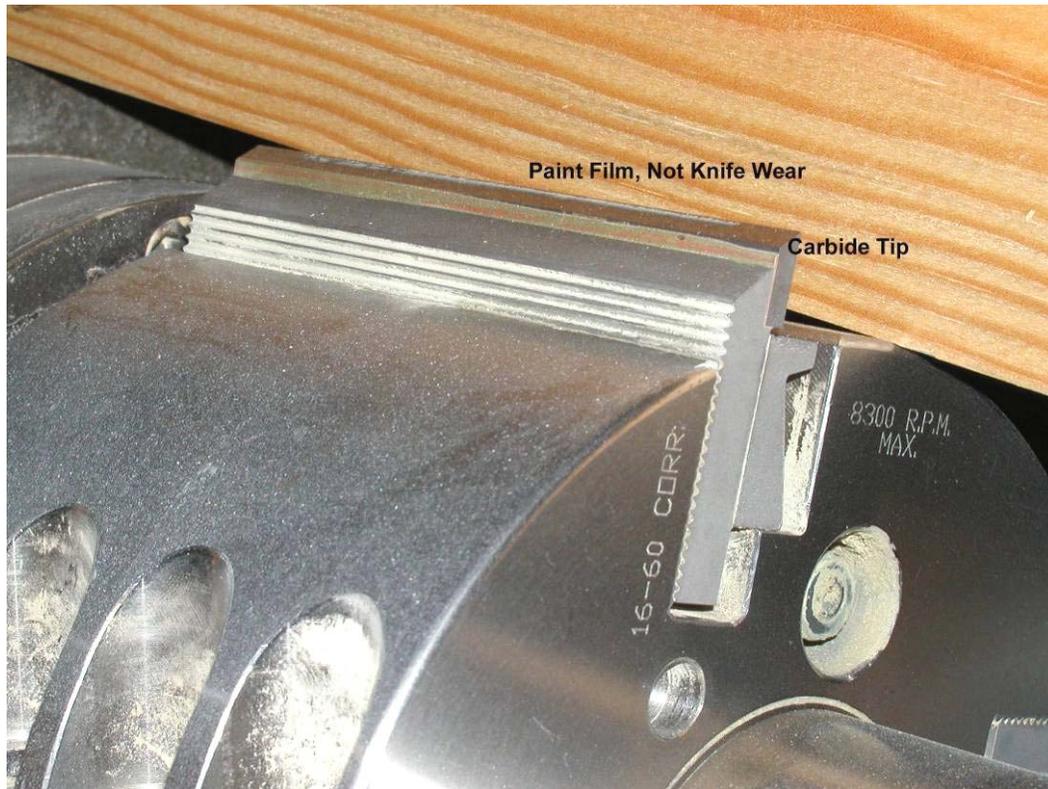
Figure 37. Carbide knife after machining, showing sharp edge with traces of paint residue.

Carbide knives were investigated in machining the Fort Campbell siding. As shown in Table 10, 882 lf of siding were machined with HSS knives before serious dulling of the knives occurred. Using carbide tipped knives, 3,277 lf of siding were machined with no noticeable knife wear or surface quality degradation, as illustrated in Figure 37. This is nearly four times the amount of siding produced with the HSS knives. The test had to be discontinued at 3,277 lf, since no more siding was available to be machined. It was felt that significantly more footage of siding could be produced with these carbide knives before re-sharpening.

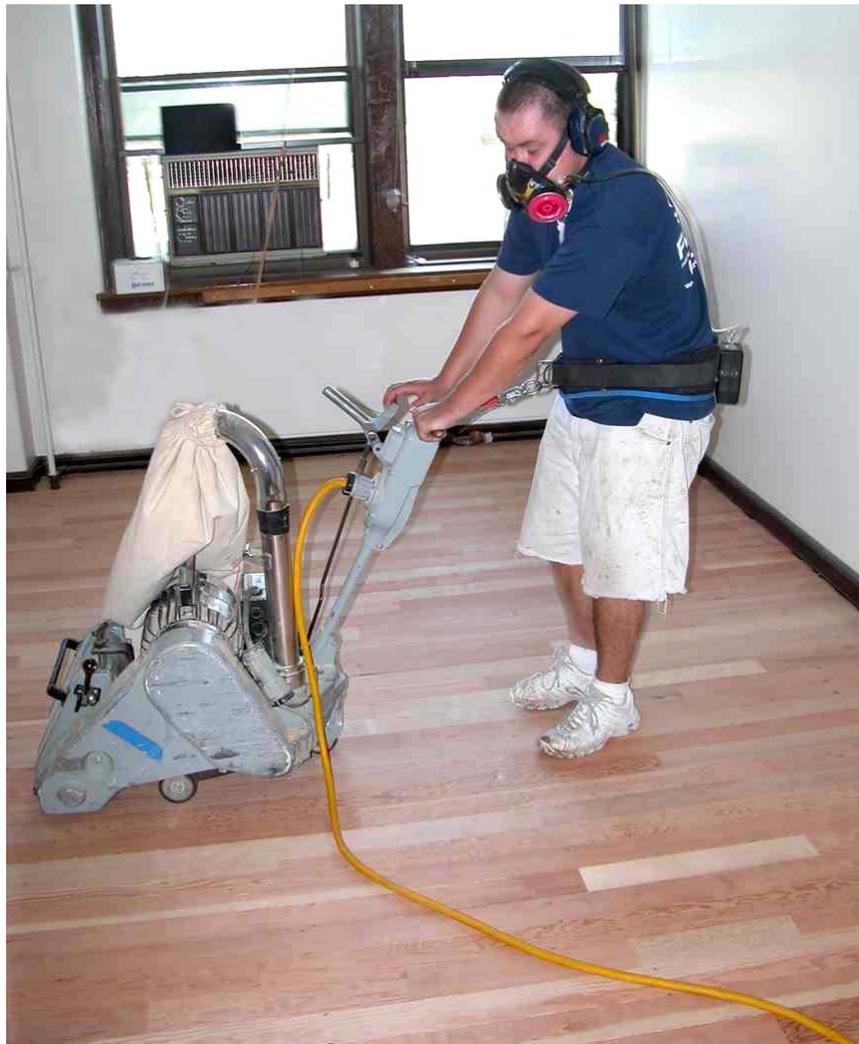
Figure 38. Sanding process for remanufactured flooring, showing air monitoring pump fitted at operator's waist.

A portion of the produced T&G flooring was installed in two rooms at the FPL for display purposes. Although the lead penetration tests indicated that only a trace amount of lead was likely to be present in the remanufactured flooring (because more than 0.06 in. was removed from the painted surface), the air was monitored during the floor sanding process to ensure that the workers were not exposed to an unsafe level of lead-containing dust. A personal air monitoring pump was fitted to the floor sander operator (Figure 38). No lead was detected in the air sample, indicating that the remanufactured flooring product was free of any significant lead content. A swab test for lead, after the floor was finished with polyurethane, produced negative results. Figure 39 shows the floor after finishing.
