US Army Corps
of Engineers®
Engineer Research and
Development Center

Investigation of Mechanical Processes for Removing Lead-Based Paint (LBP) from Wood Siding

September 2006

Final report

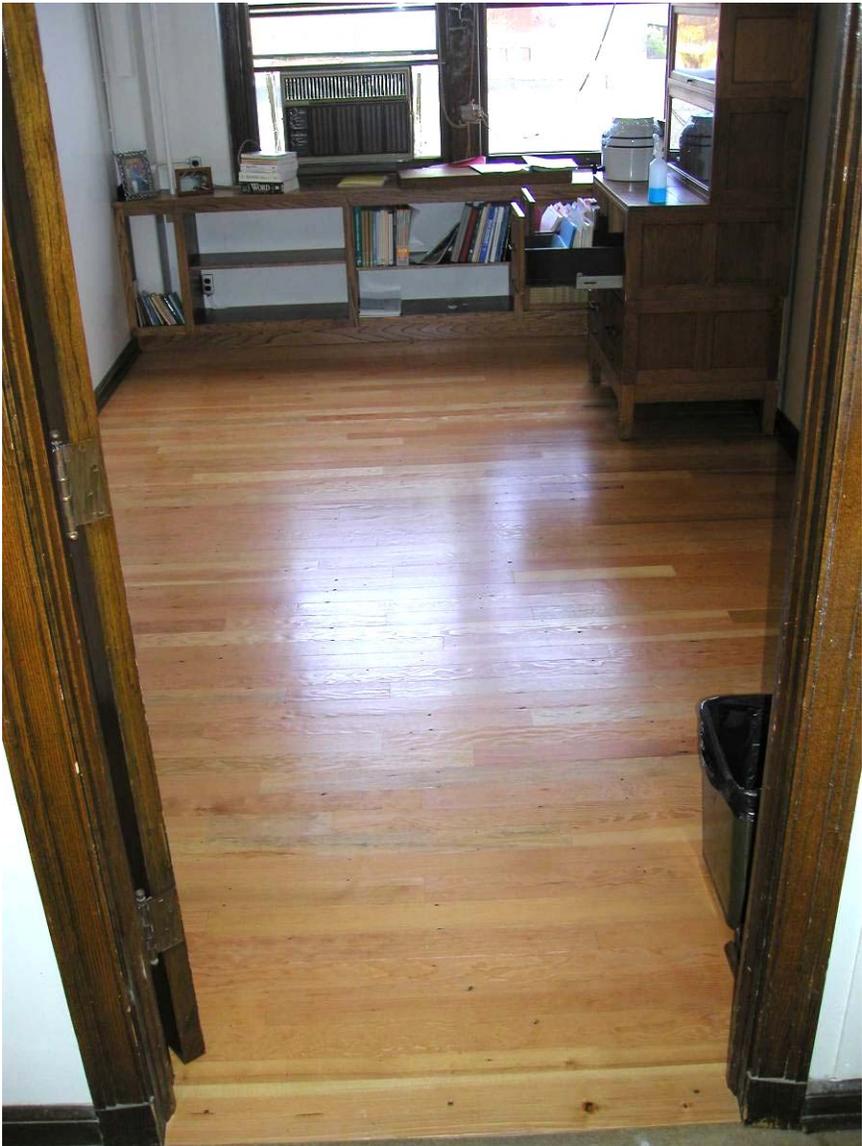
Figure 39. Installed floor after finishing.

A portion of the produced T&G flooring was installed in two rooms at the FPL for display purposes. Although the lead penetration tests indicated that only a trace amount of lead was likely to be present in the remanufactured flooring (because more than 0.06 in. was removed from the painted surface), the air was monitored during the floor sanding process to ensure that the workers were not exposed to an unsafe level of lead-containing dust. A personal air monitoring pump was fitted to the floor sander operator (Figure 38). No lead was detected in the air sample, indicating that the remanufactured flooring product was free of any significant lead content. A swab test for lead, after the floor was finished with polyurethane, produced negative results. Figure 39 shows the floor after finishing.
