# AEROPLANE AND ARMAMENT EXPERIMENTAL ESTABLISHMENT

CANBERRA P. R. MK. 3 VX. 181  
(2 AVON 1)

CARRIAGE AND RELEASE OF FLASHES, PHOTOGRAPHIC,  
AIRCRAFT, 4.5 INCH FUZED M111-A2

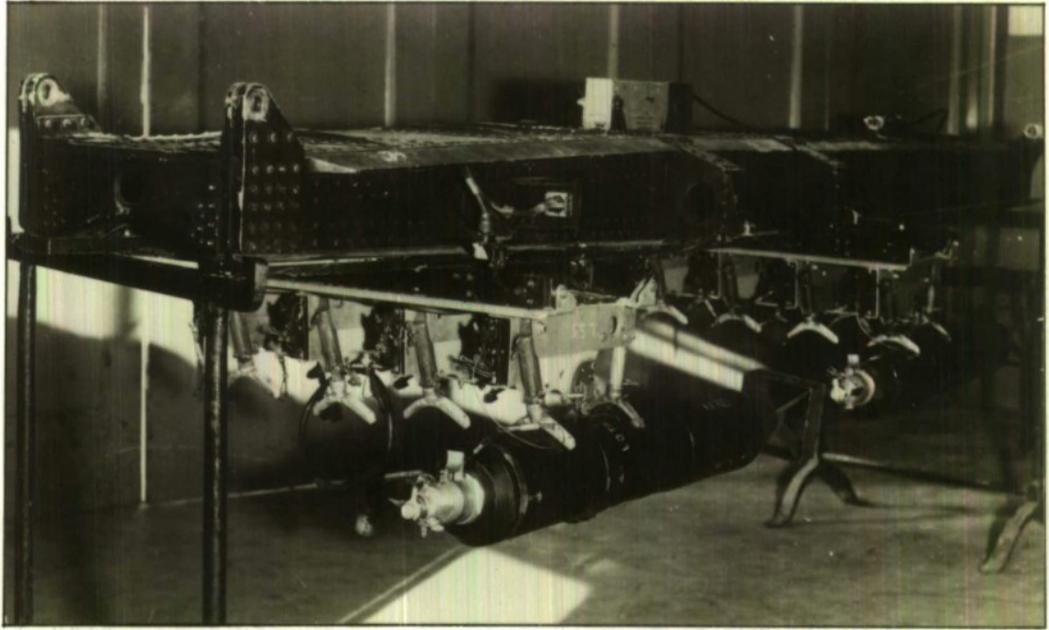
FIG. 1 LIGHT SERIES CARRIERS FITTED TO FLARE BEAM

5.1.2 A photograph of the installation is at Fig.1.

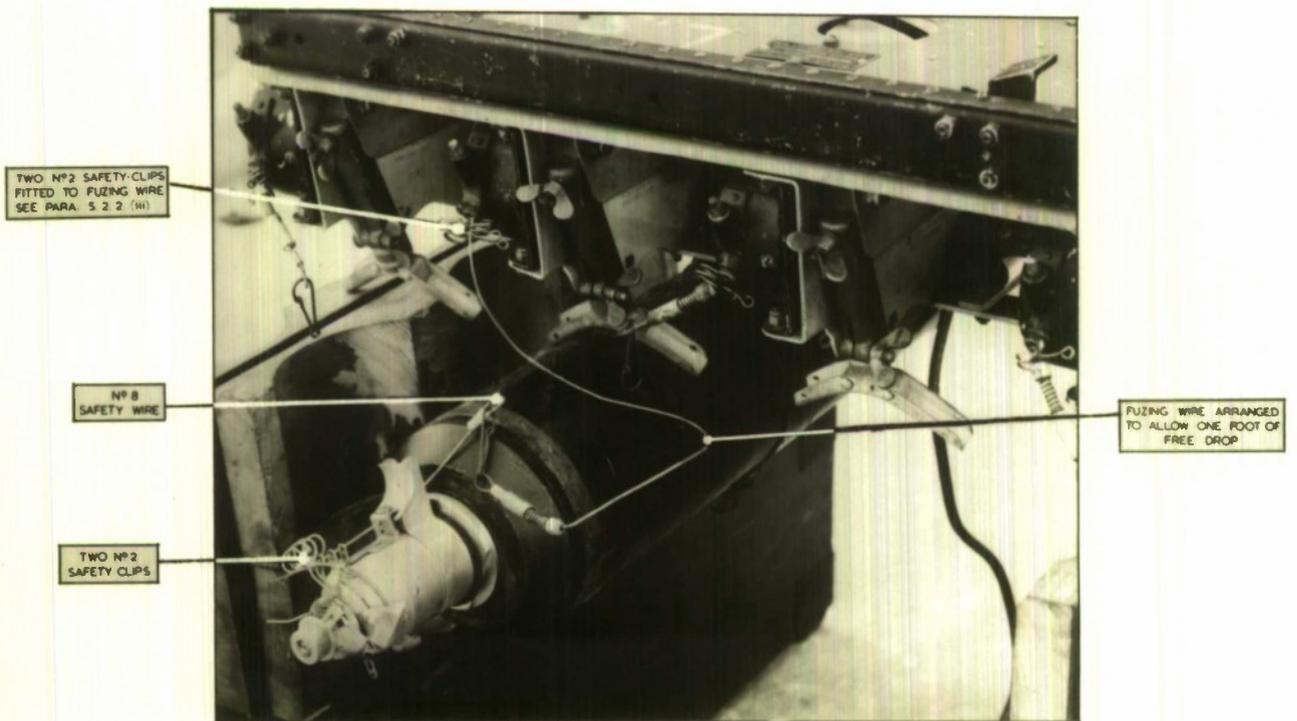
FIG. 2 FUZING ARRANGEMENTS- 4.5 INCH PHOTO FLASH

4.2.3 The fuizing wire of the No.2 Mark 1 fuizing unit was connected to the No.8 safety wire by a standard Buggins clip. Two No.2 Mark 1 Safety Clips (12G/1068) were fitted to the fuizing wire so that one foot of wire was extended permanently. This method of fuizing was found necessary and satisfactory when releasing 4.5 inch photoflashes from a Canberra B.2 aircraft.

(iii) Films of the releases also showed that if the photoflash left tail first from the flare bay the tail was blown back into the flare bay and the photoflash tended to topple. Allowing the photoflash to gain momentum, by giving it a foot of free fall before the safety wire was withdrawn, prevented this. In two instances where it did happen, it was considered that the fuzing wire had been retracted into the fuzing unit, and to prevent this, two No.2 Mark 1 Safety Clips were fitted on the fuzing wire. The details are shown in Figure 2.

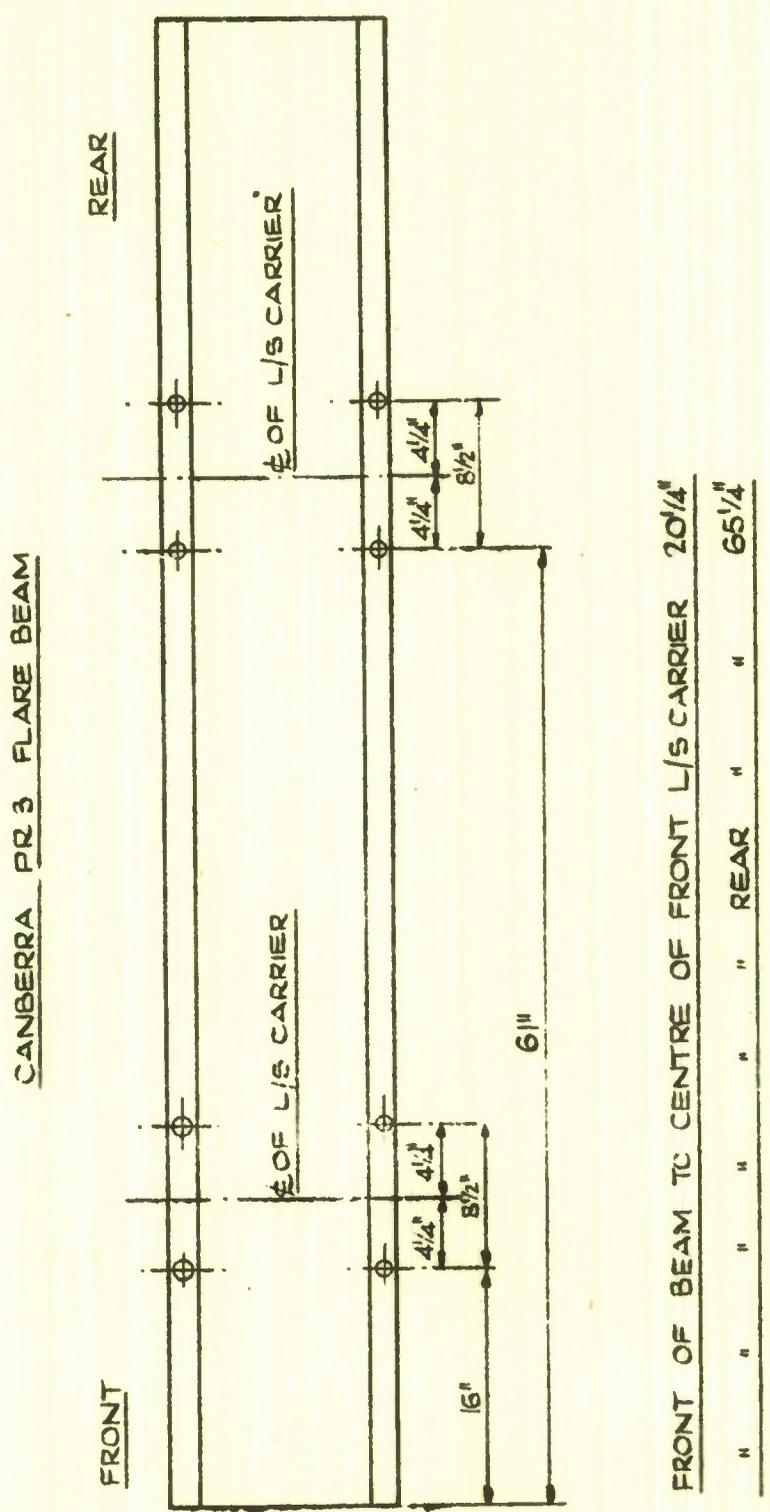
FIG. 3.

POSITION OF HOLES FOR BEAM ADAPTOR. SECURING BOLTS.

3.1. The flare beam to be drilled in the positions shown in Figure 3 to take the eight 1.25" x  $\frac{1}{4}$ " B.S.F. bolts. The bolts are used to fit the beam adaptors in position.

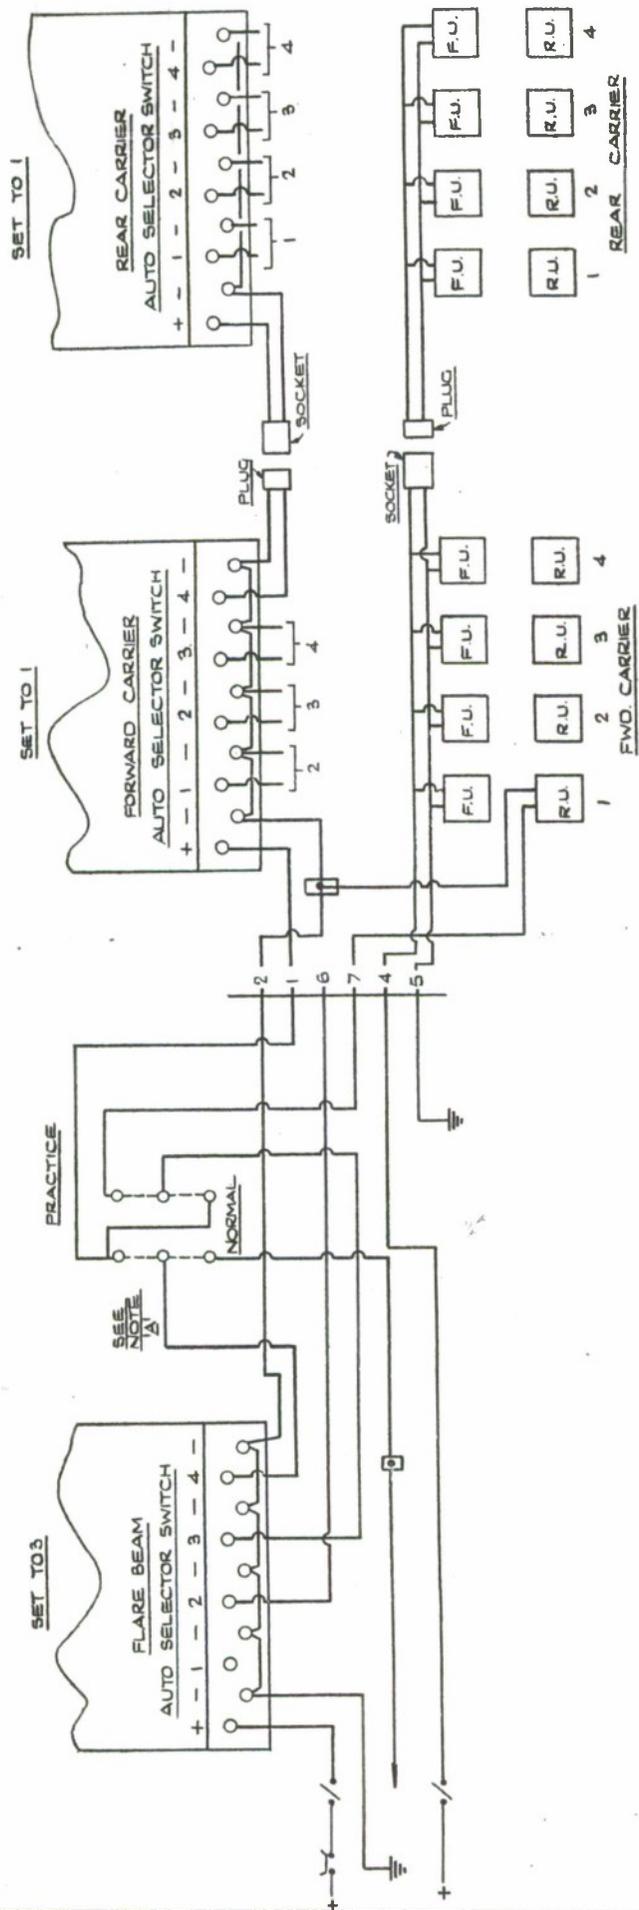
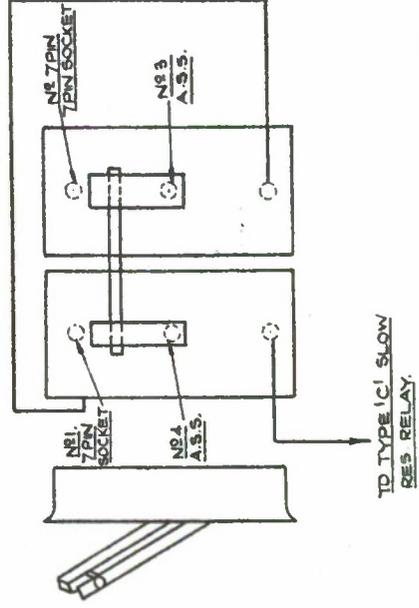
FIG. 4

NOTE 1A: THESE ARE TWO POSITION (WITH TOGGLES LINKED) SWITCHES.

FLARE BEAM & L.S. CARRIER WIRING AS MODIFIED TO CARRY EIGHT PHOTOFLASHES 4-5"

3.3. The electric wiring of the flare beam and Light Series carriers to be modified to conform to the wiring diagram in Fig. 4.
