A Study of Nail Impact at High Speed
on Light Alloy Plates

I. I. McNaughtan

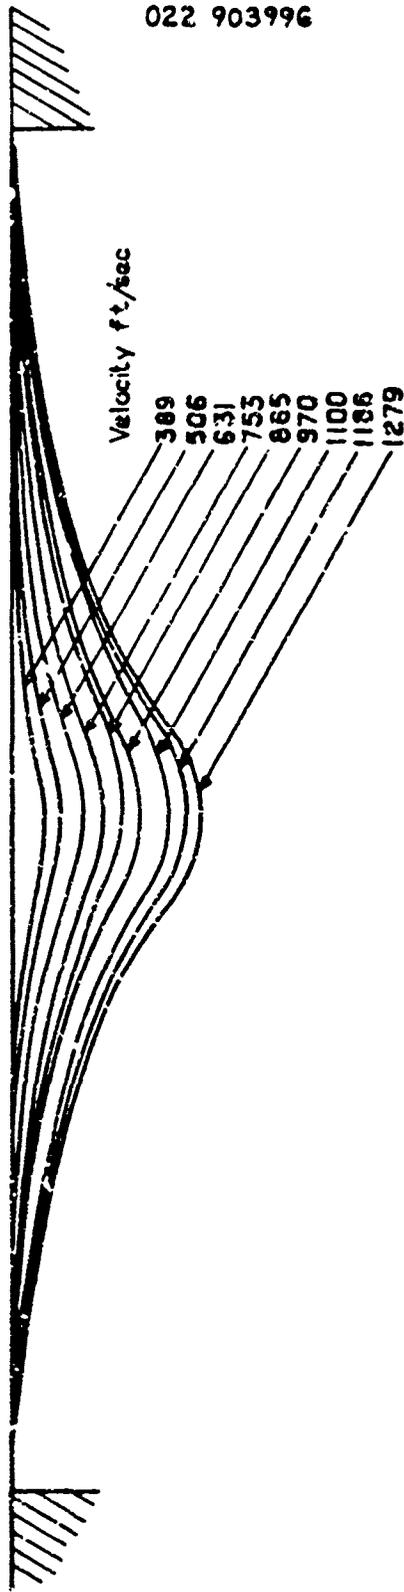
Fig. 2 Indentation profile at maximum depth. Full size
(1 in dia hail - mat: L 72/20 swg)

When hail impacts on the plate at zero impact angle it makes a symmetrical smooth contoured dent which increases in size with impact speed as shown in Fig.2. Visually it is not possible to estimate the dent diameter.

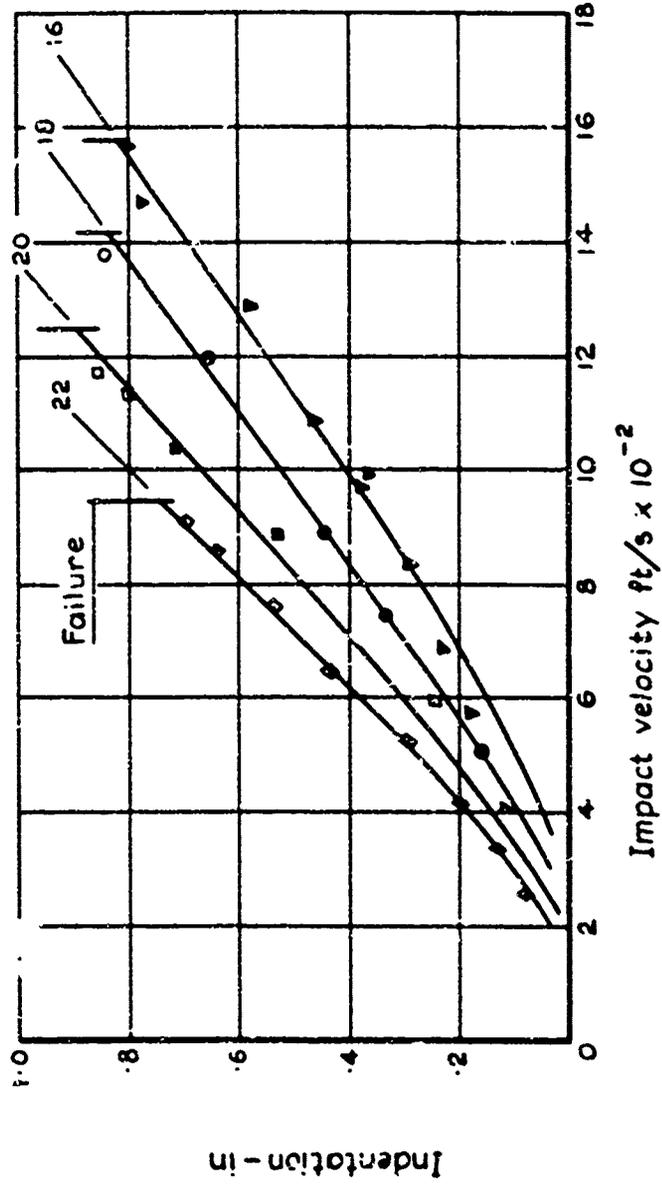
Fig. 3 Normal impact 1 in dia hail - aluminium alloy L73 flat plate

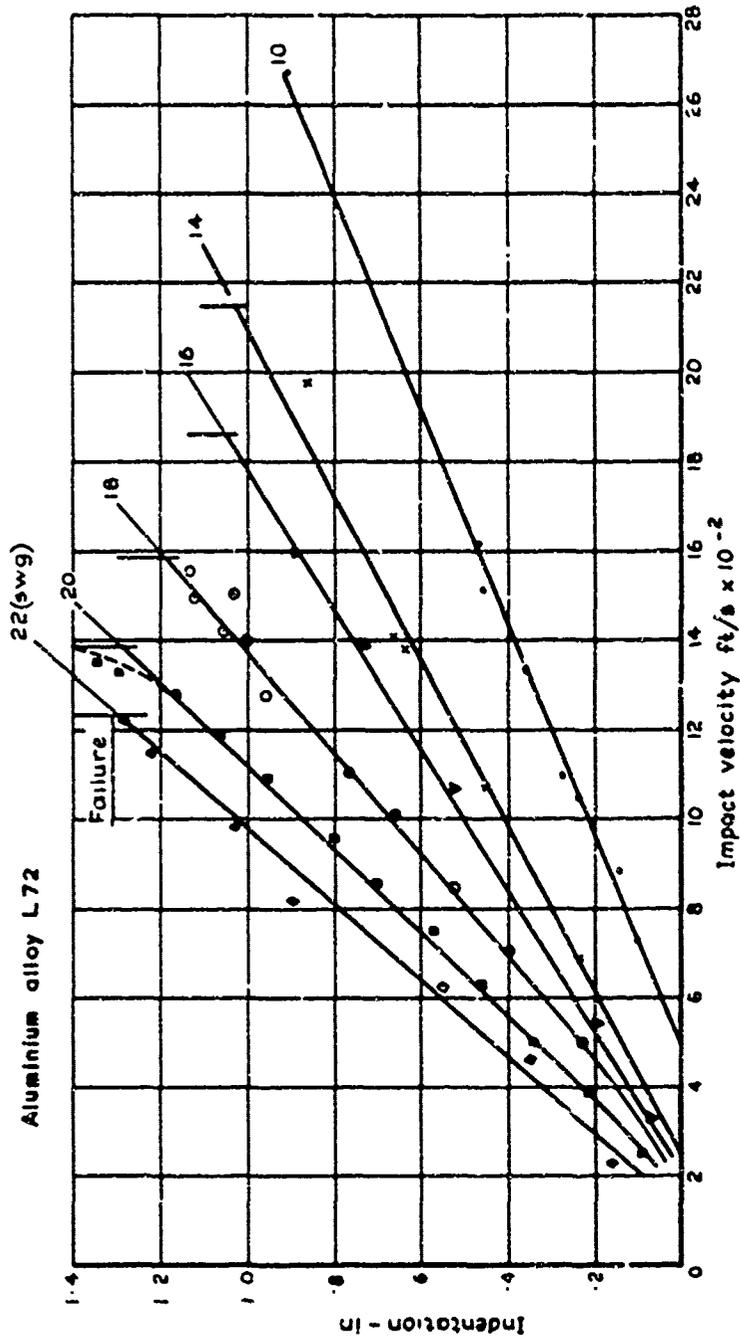
Fig.4 Normal impact 1in dia hail - aluminium alloy L72 - flat plate

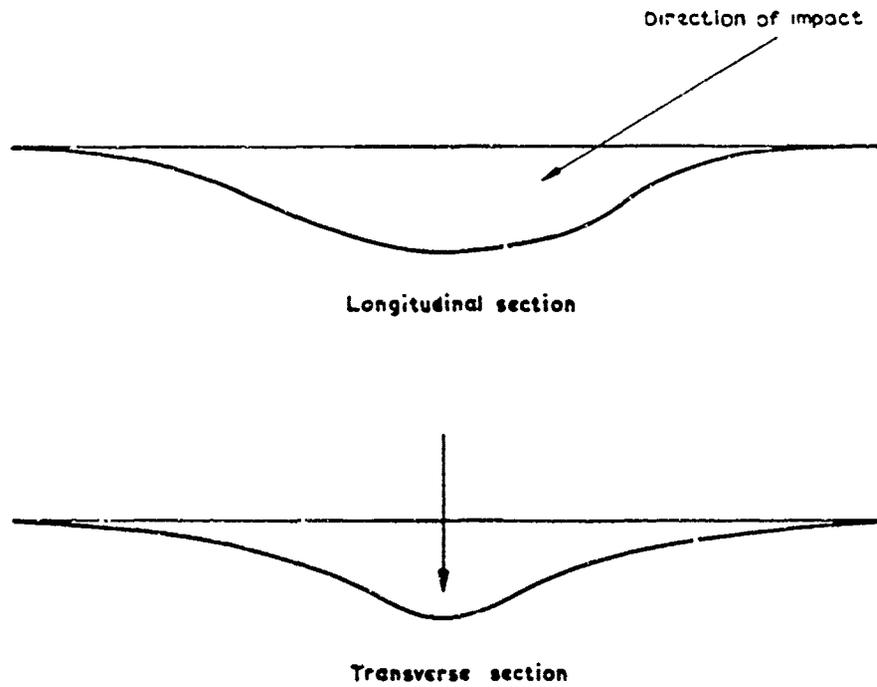
| Impact velocity | 1560 ft/s |
| Hail | 1 in. dia |

In the case of angled impact the dent is not symmetrical but it is again smooth contoured and it is impossible to estimate visually the dent diameter. Typical dent profiles are shown in Fig.5. Over the impact angle range 0° to 60° the depth of dent varies linearly with the component of impact velocity normal to the plate. Typical results are shown in Fig.6. A similar relationship was observed in tests of Concorde fuselage panel specimens (Ref. 1).

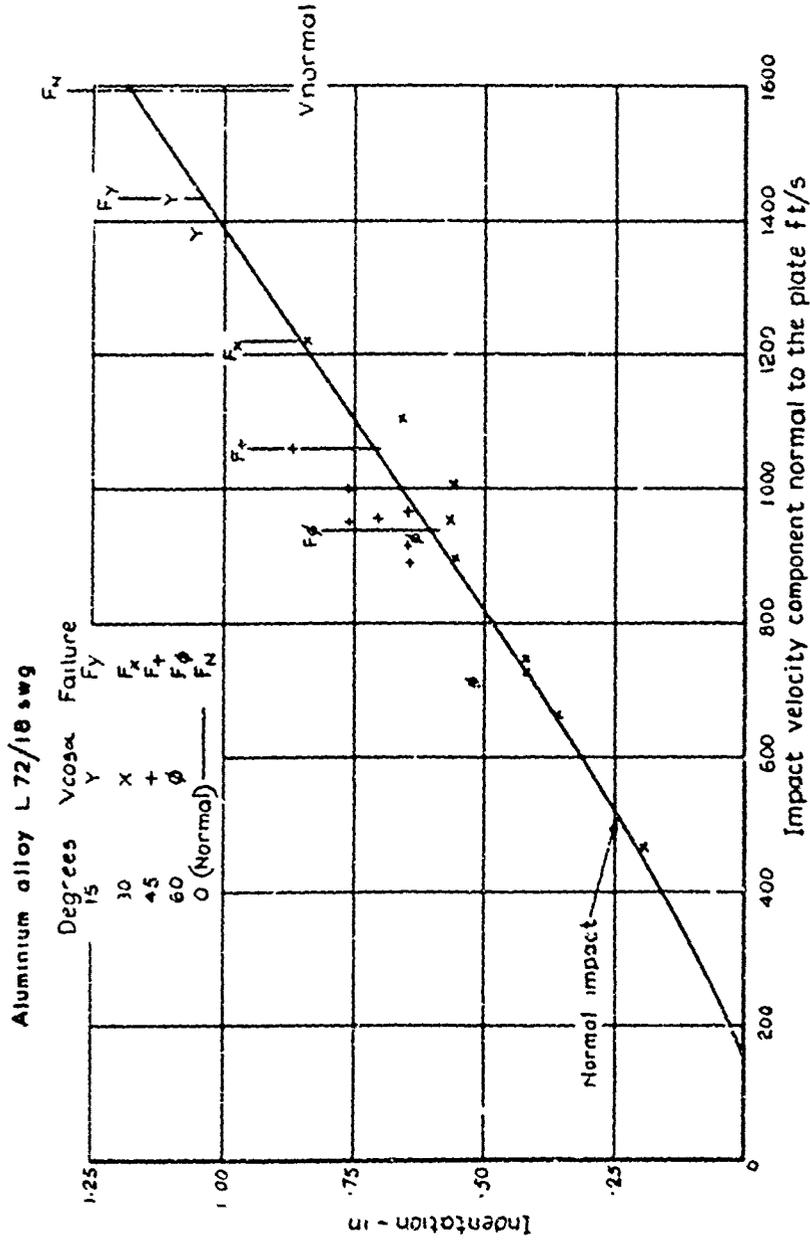
Fig.6 Comparison of normal & angular impact of 1/4 in dia hail on flat plates

On this evidence it was suggested that high speed impact at large impact angles (e.g. highly swept surfaces) could be simulated by tests at zero impact angle with the same normal velocity component. This would avoid the need to develop high speed hail test facilities for supersonic aircraft testing. This $V \cos \alpha = \text{constant}$ relationship has been found to apply in a number of impact cases - e.g. bird impact tests on windscreens. It can be seen in Fig.6, that, for penetration, $V \cos$ is not constant.

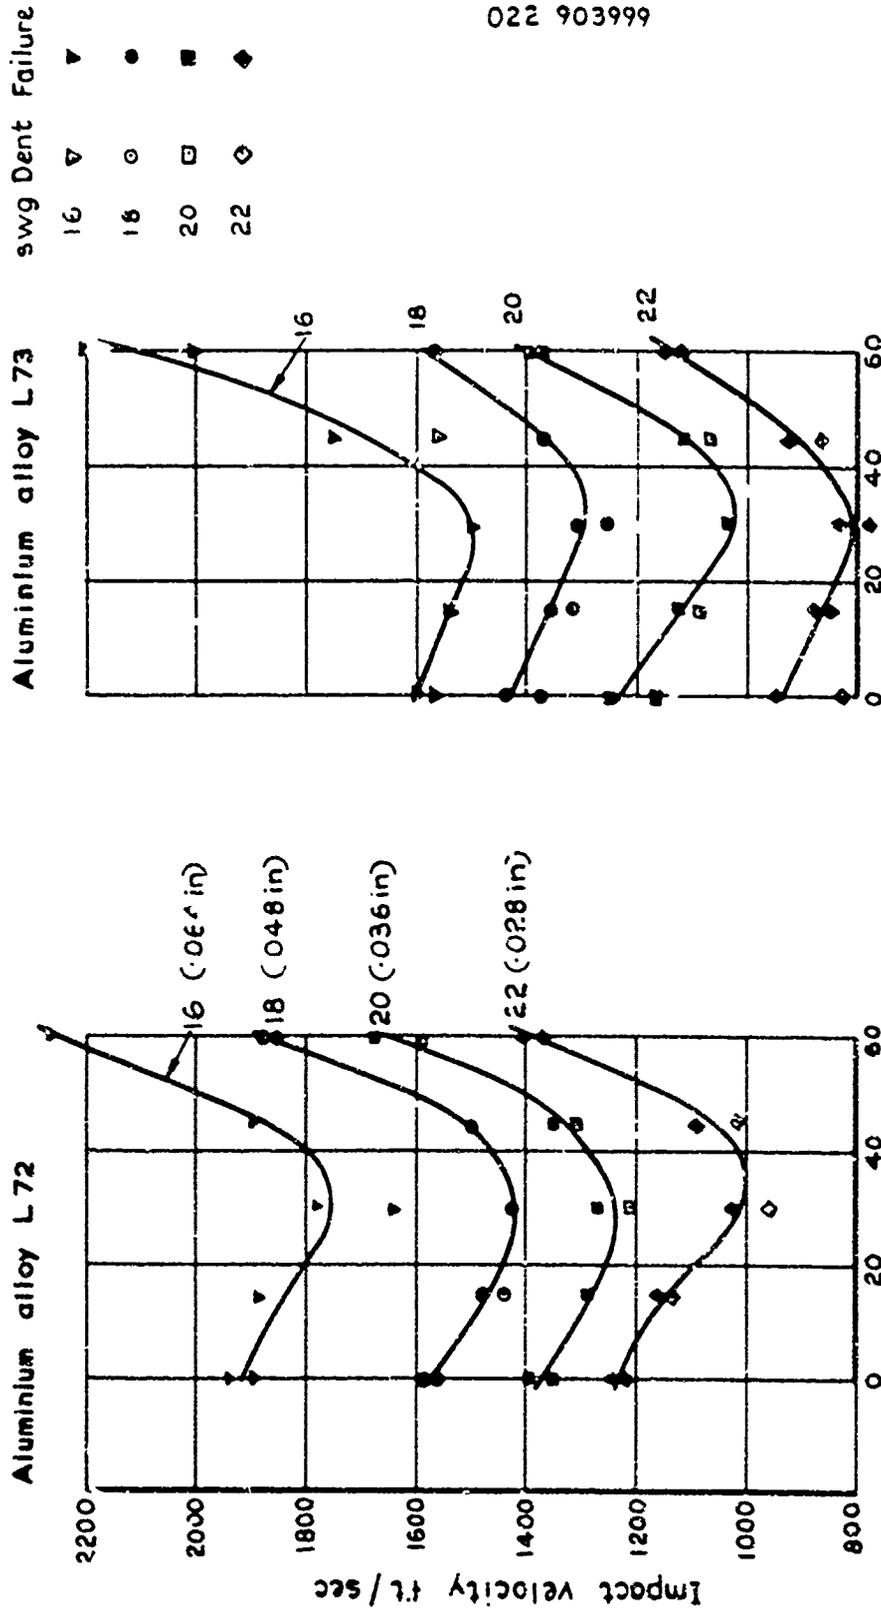
Impact angle - degrees

Fig.7 Effect of impact angle on panel failure by impact with lin dic hail

Fig.7 presents the true penetration speeds for both alloys over the range $\alpha = 0^\circ$ to 60° and thickness 0.028 inch to 0.064 inch. The curves are reasonably similar and show that resistance to penetration decreases with increase in impact angle to a minimum value at about 30° and then increases. (It was the discovery of this phenomenon with the thinnest plate specimens that resulted in our developing the gun performance to allow fuller investigation with the more representative thicker specimens.) It is interesting to

where f = ultimate tensile strength, t = shell thickness and r = shell radius. The pressure generated during impact will be some function of impact speed and of the projectile and specimen material properties under high rates of loading. For a given material, projectile and projectile size it is probable that the pressure will be related to the kinetic energy of the projectile and penetration speed would then be proportional to the square root of specimen thickness. The results in Fig.7 are in fair agreement with this relationship.

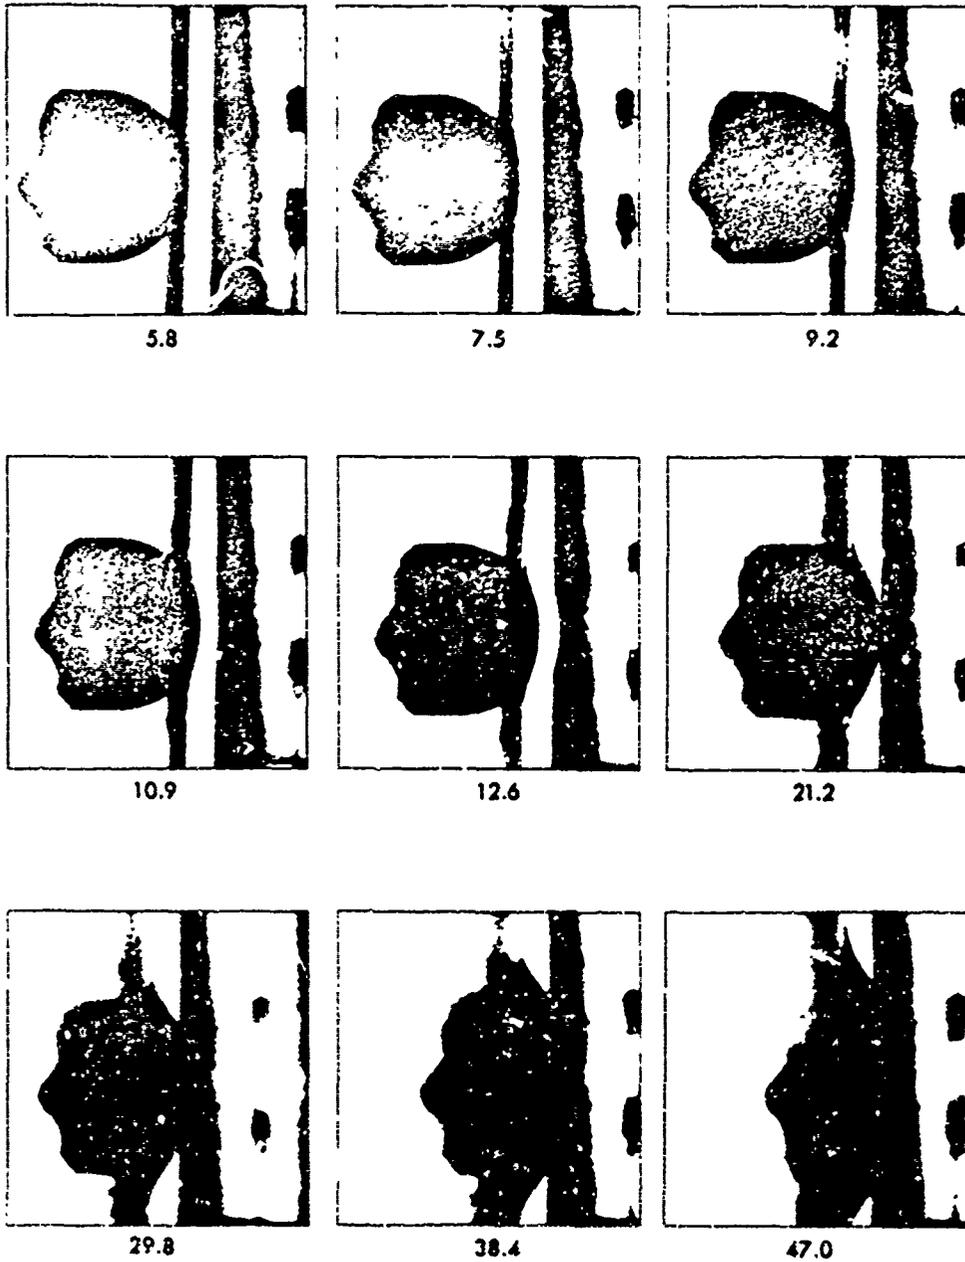
Fig.8 Impact of 1in. dia hail bullet at 1100ft/sec:

L73/20 swg: $\alpha = 0^\circ$

Time after impact in μ sec as indicated

A very high speed cine-camera was available and a number of impacts were photographed in silhouette at 500 000 to 600 000 frames per second. Fig.8 shows the impact of a 1 inch diameter hail bullet at a speed of $M = 1.0$ on a plate of L73 alloy 0.036 inch thick at zero impact angle. The following features can be seen.

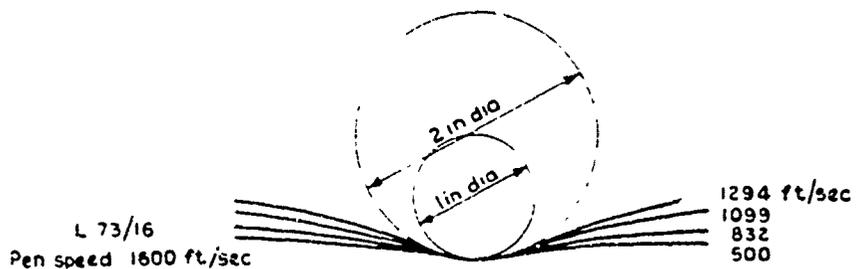
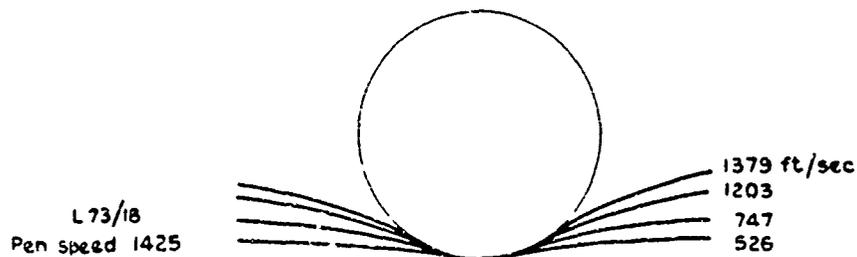
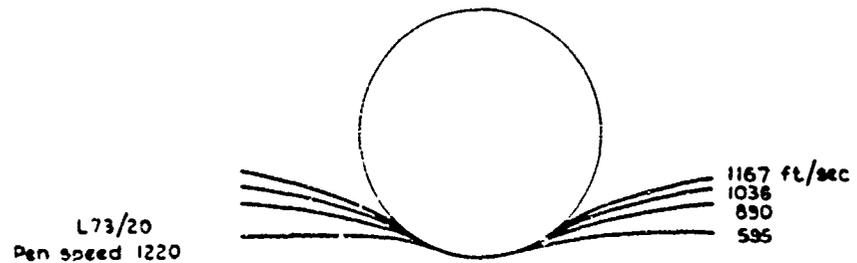
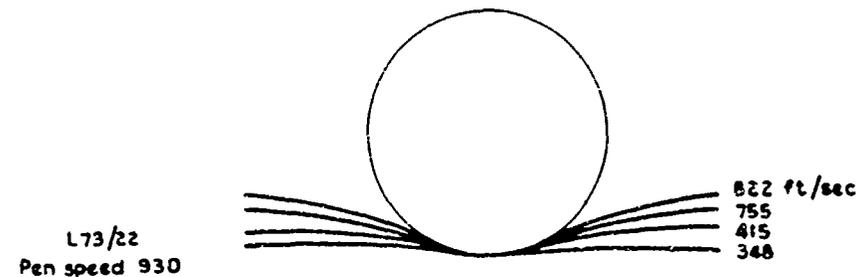
Fig.9 Dent profiles - normal impact

Figs.9 and 10 show indentation profiles constructed from a common base for various thicknesses of both materials and it can be seen that these base shape diameters apply over the full range tested. Additional tests of L73 alloy

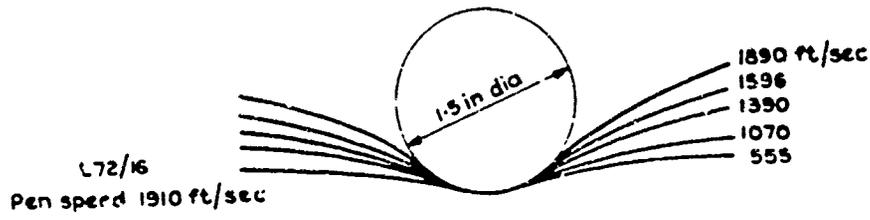
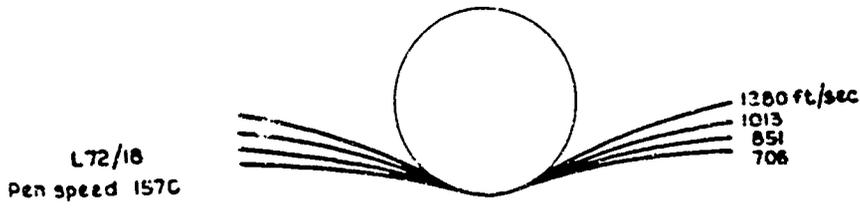
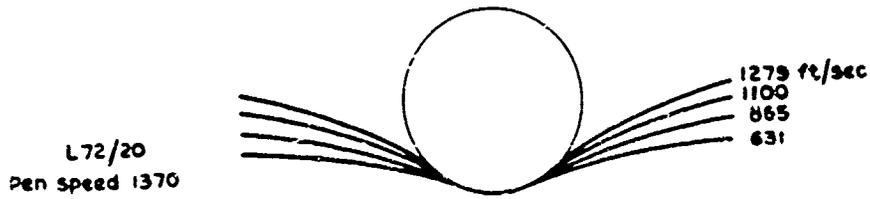
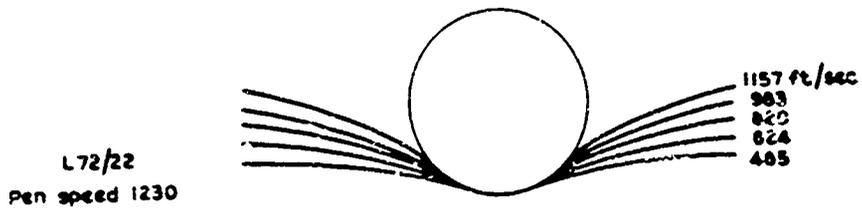
Fig.10 Dent profiles - normal impact

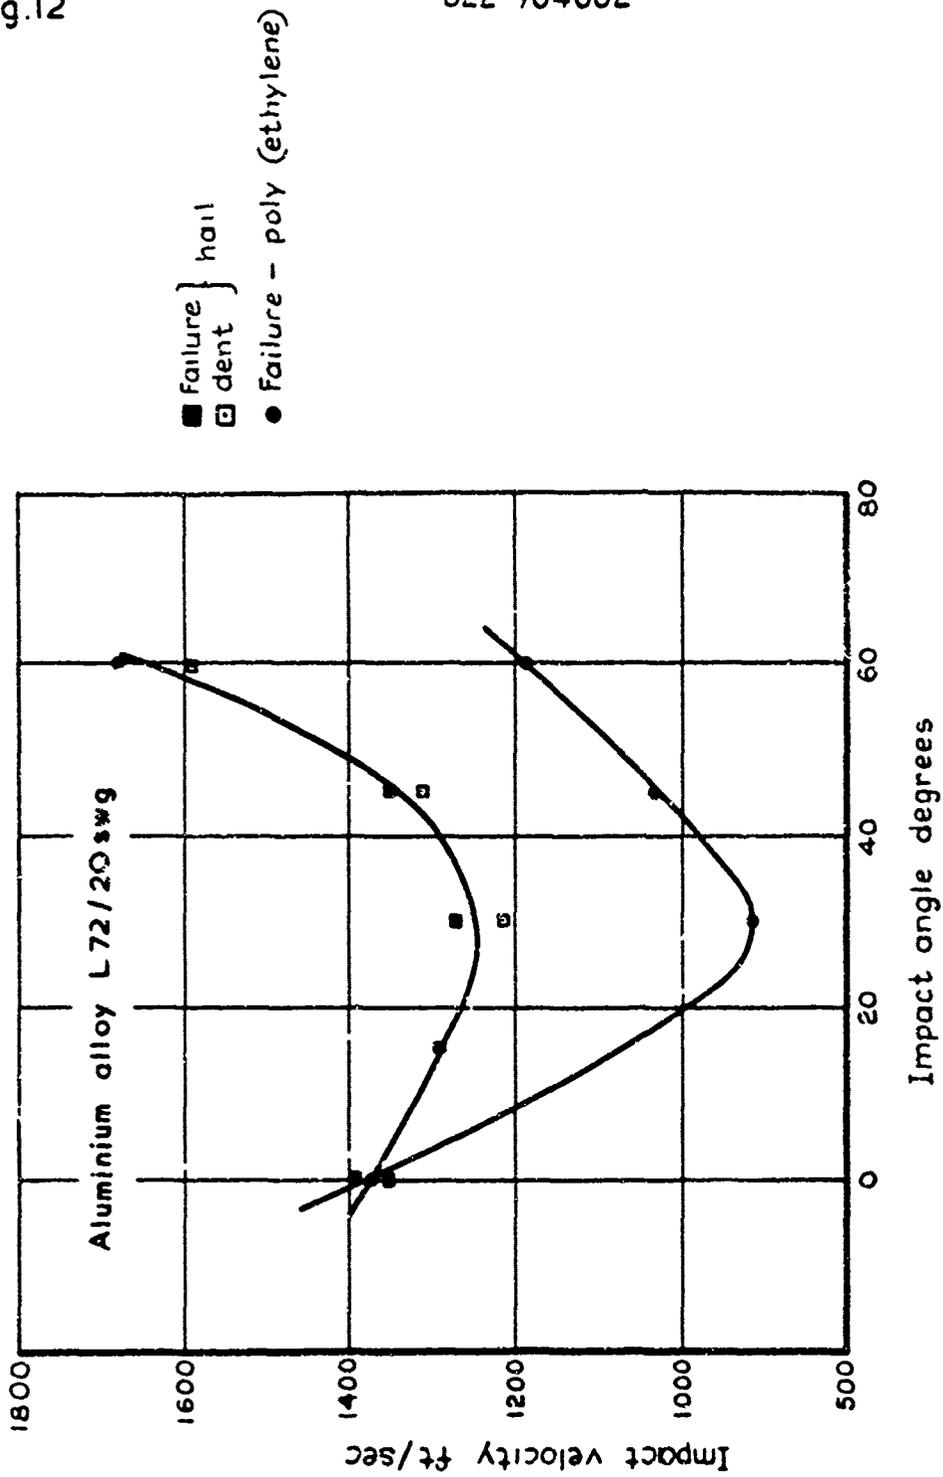
Fig.12 Comparison of panel failure by impact with 1 in dia hail and poly (ethylene)

Simulation of ice projectiles with alternative materials can also give erroneous results. Fig.11 gives penetration results for 1 inch ice spheres a 1 inch poly (ethylene) spheres and the differences are clearly shown; they are attributed to the different behaviour of ice and poly (ethylene) during the impact phase. Poly (ethylene) pancakes out on impact but recovers rapidly to almost its original shape (Ref. 4) and rebounds if penetration has not been achieved. Before an alternative material to ice could be accepted it would be necessary to make comparative tests at representative speeds. This itself would require a high speed hail impact facility so there would be little reason to develop an ice-equivalent material.
