TECHNICAL REPORT ARSCD-TR-83007

**CORROSION SUSCEPTIBILITIES OF MAGNESIUM ALLOYS
AZ91, EZ33 AND ZE41**

**ANTHONY GALLACCIO
WILLIAM T. EBHARA**

**US ARMY ARMAMENT RESEARCH AND DEVELOPMENT COMMAND
FIRE CONTROL AND SMALL CALIBER
WEAPON SYSTEMS LABORATORY
DOVER, NEW JERSEY**

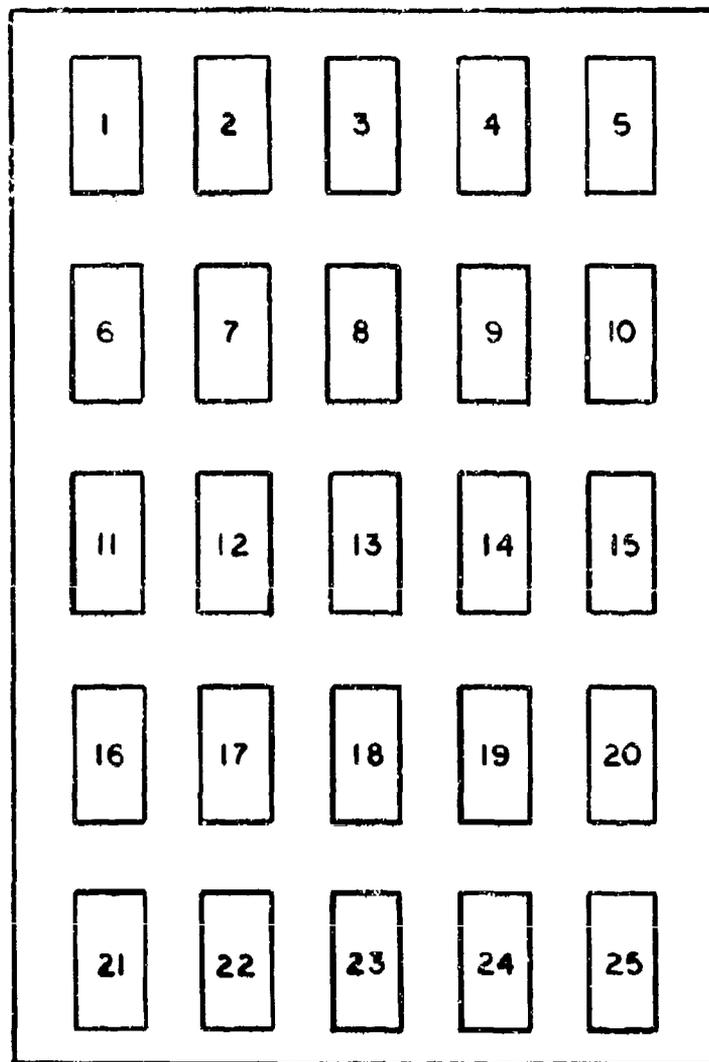
Figure 1. Pattern of specimens, 1 x 2 cm, taken from panels 9.5 x 10.2 x 15.2 cm for measurements of H₂ evolution

Specimens (1 x 2 cm) were cut from three panels of each alloy (each panel representing different heat) and from strips removed from the helicopter housing, as mapped in figures 1 through 4. Panel specimens with the original as-cast top and bottom surfaces, but with machined edges and sides, and specimens from the helicopter housing with one (external as-cast surface, are referred to herein as as-cast specimens. Other specimens from panels or housing strips, were machined and abraded to remove the as-cast surfaces. These are referred to as machined specimens. These were prepared to compare corrosion of as-cast and machined specimens from the same panel. The as-cast specimens were 0.95-cm thick. The machined specimens were 0.90-cm thick since approximately 0.025 cm was removed from each surface.

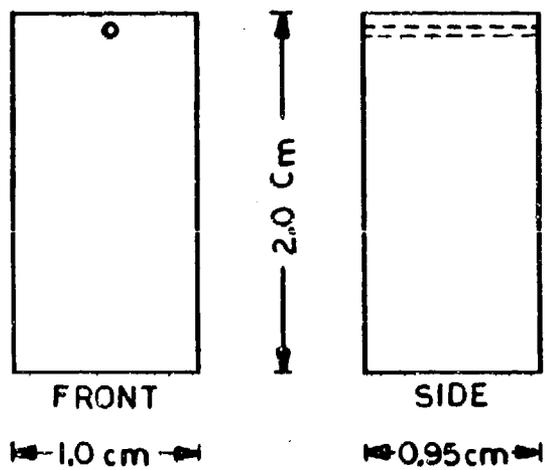
Figure 5. Detail of specimen for hydrogen evolution measurements

A 0.2 cm diameter hole was drilled in all specimens to accommodate a thin chromel (B&S 26) wire hook to suspend the coupon during the measurements (figure 5).

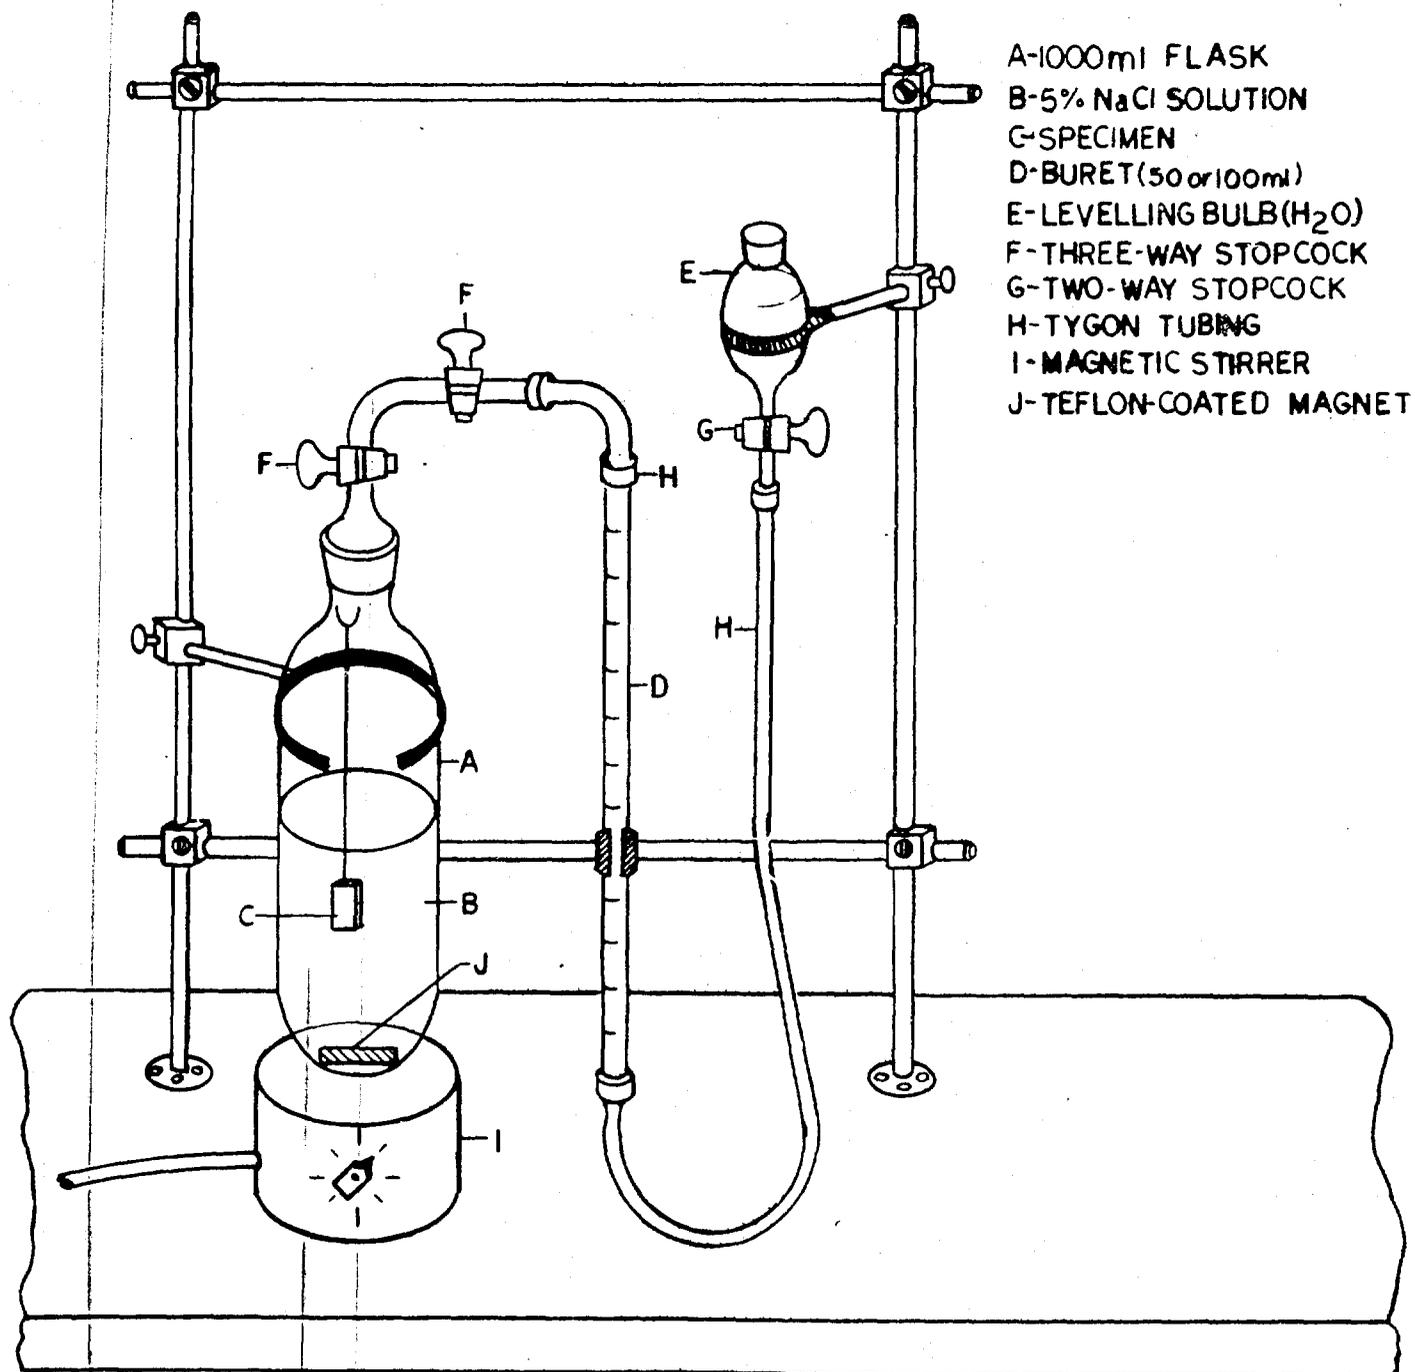
Figure 6. Apparatus for collecting and measuring hydrogen evolved by a magnesium specimen in sodium chloride solution

After the specimens had been abraded, they were cleaned in a liter solution of sodium orthosilicate (60g/l) with an addition of 3g Nacconal 4 at about 30°C (86°F). A reaction flask, eudiometer and auxiliary components were arranged, as shown in figure 6, to collect hydrogen evolved by the magnesium specimens. The corrosion medium was neutral 5 percent sodium chloride solution. A new 500-ml solution was used for each determination. A magnetic stirrer was added so that the solution could be agitated continuously during the determination to preclude buildup of magnesium ions at the specimen surface. Four apparatuses were operated simultaneously and tests were conducted within an eight hour shift.

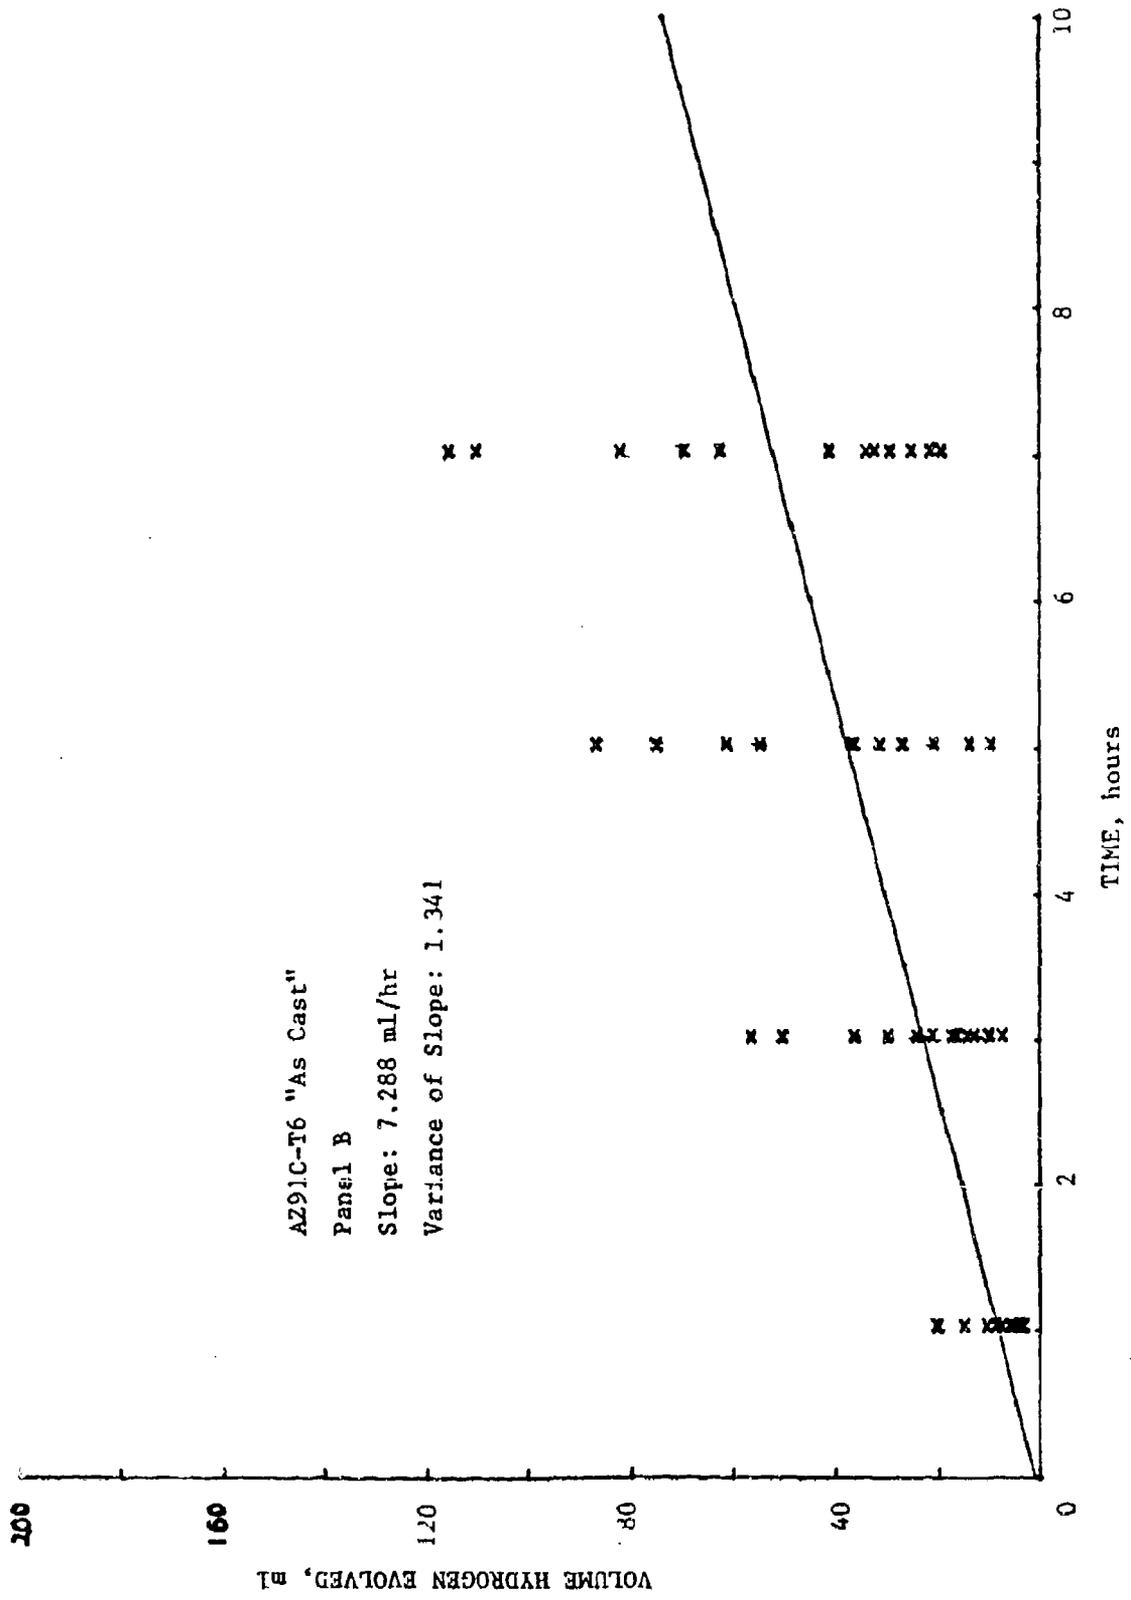
Figure 7. Hydrogen evolution, AZ91C-T6 as-cast, panel B

The results of the hydrogen evolution tests are given in table 2. The reduced data presented were obtained utilizing computerized plotting and linear-least squares analyses. The evolution rate is the average slope obtained from the linear least-squares analysis along with variance computed for each set of data. Representative graphical plots for each alloy, as-cast and machined are shown in figures 7 to 14.

As shown in table 2, as-cast specimens of panel A exhibited an extremely high average corrosion rate of 6138 mg/dm²/day compared with rates of 1318 to 2021 mg/dm²/day for as-cast specimens of B and C panels, respectively. Fairly high variances, especially for A and B panels (figures 7 and 8), are also noted.

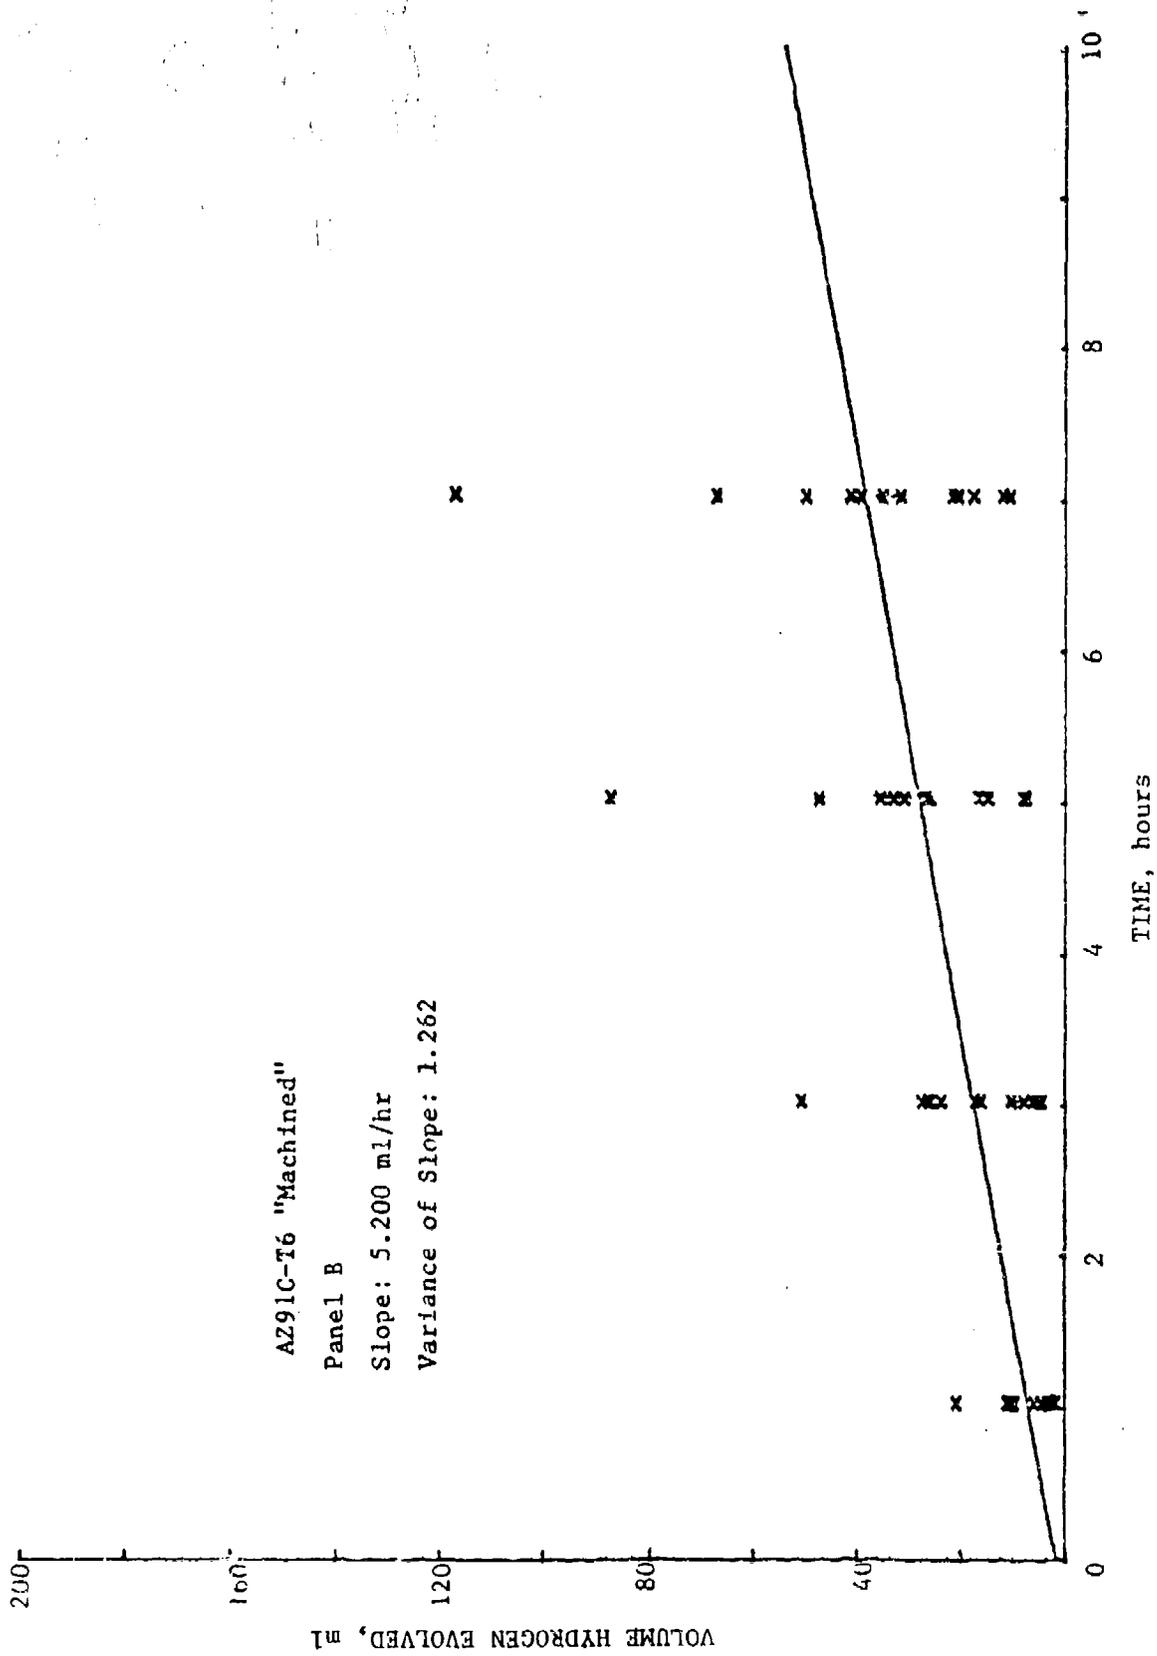
Figure 8. Hydrogen evolution, AZ91C-T6 machined, panel B

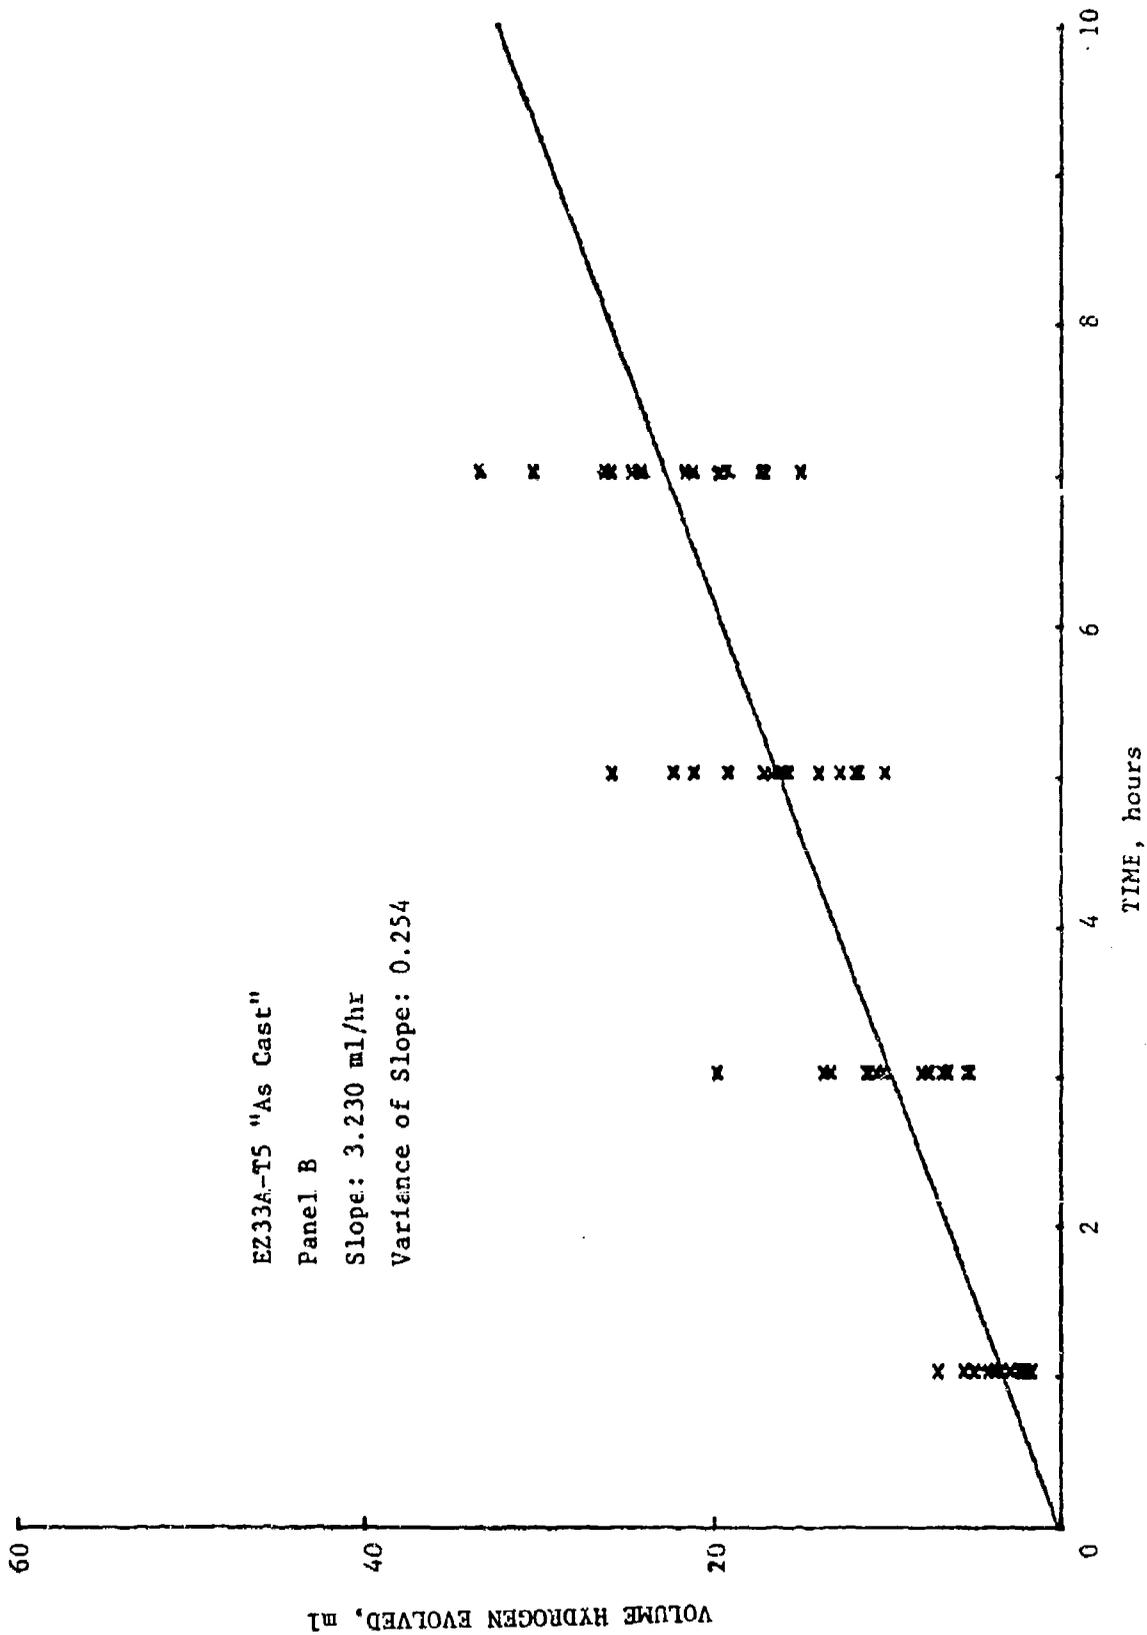
Figure 9. Hydrogen evolution, EZ33A-T5 as-cast, panel B

The plots of corrosion data obtained for as-cast and machined specimens of panel B (figures 9 and 10, respectively) are typical for all the panels regardless of surface condition. The average corrosion rate for the as-cast panels ranged from 895 to 1188 mg/dm²/day and for the machined panels, from 1033 to 1048 mg/dm²/day. Again, other than the greater consistency observed for the corrosion of machined specimens, marked differences in corrosion rate between the two surface conditions could not be found. The average corrosion rate for the EZ33 alloy specimens was lower than that observed for the AZ91 alloy specimens.

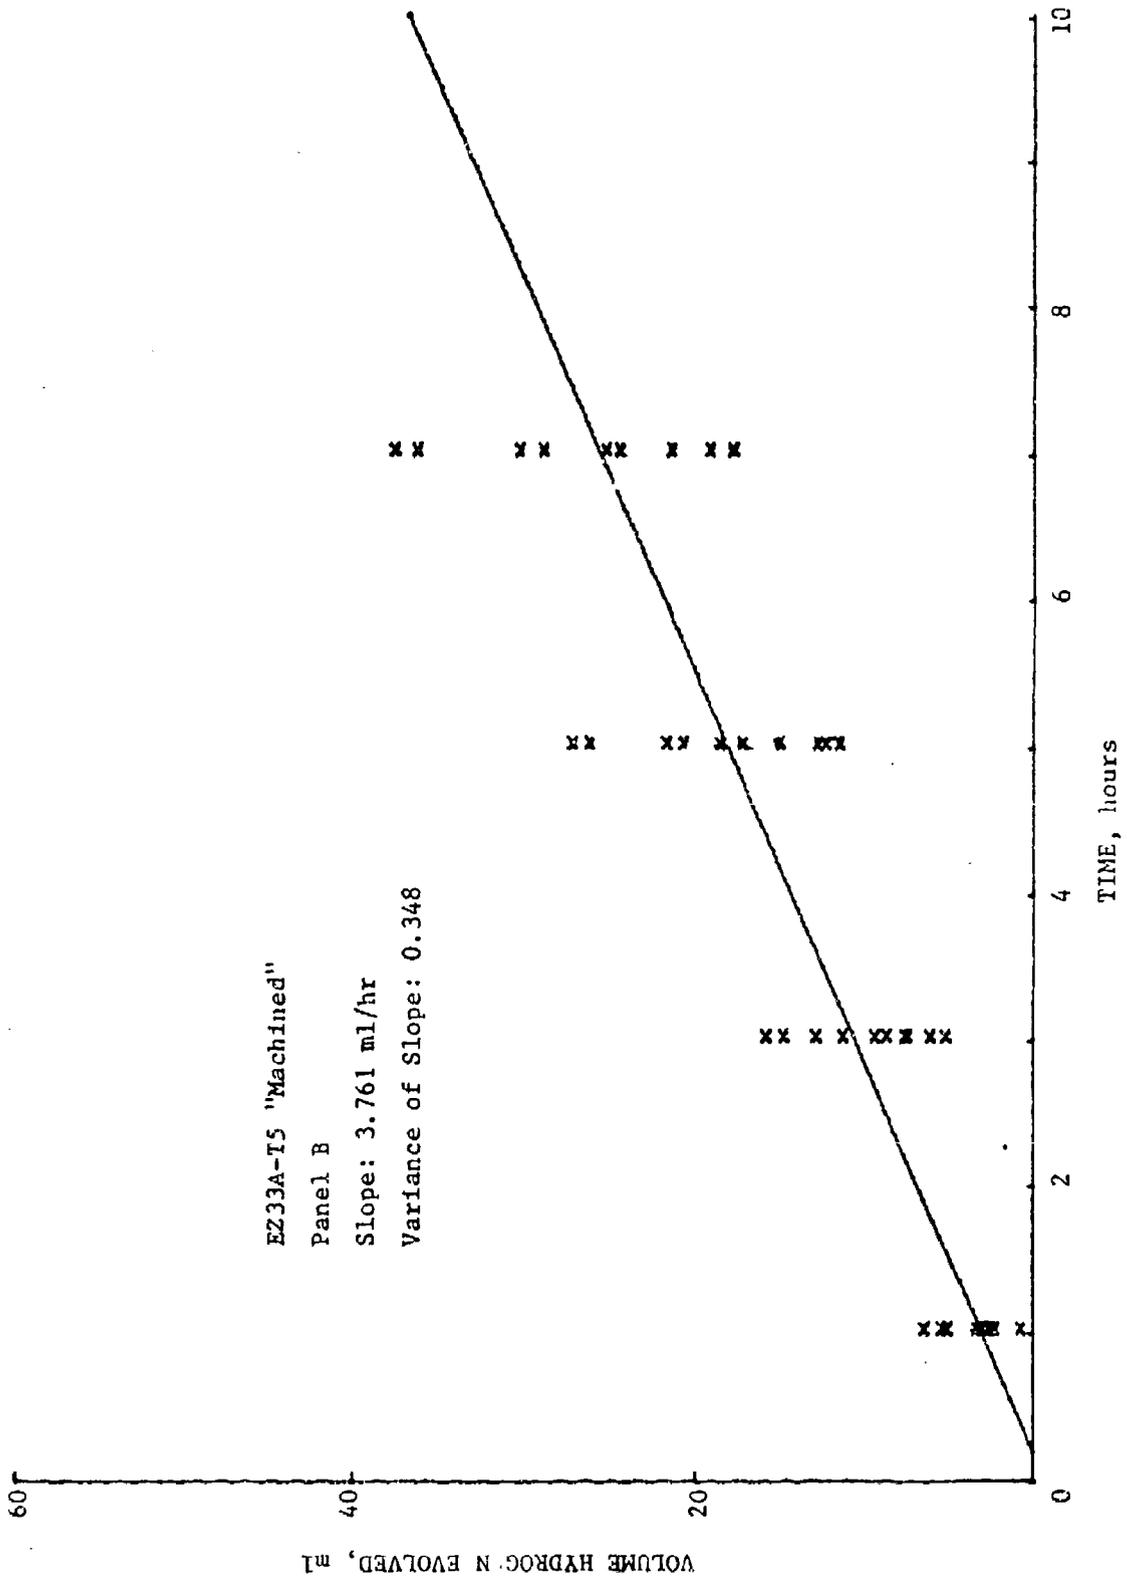
Figure 10. Hydrogen evolution, E233A-T5 machined, panel B

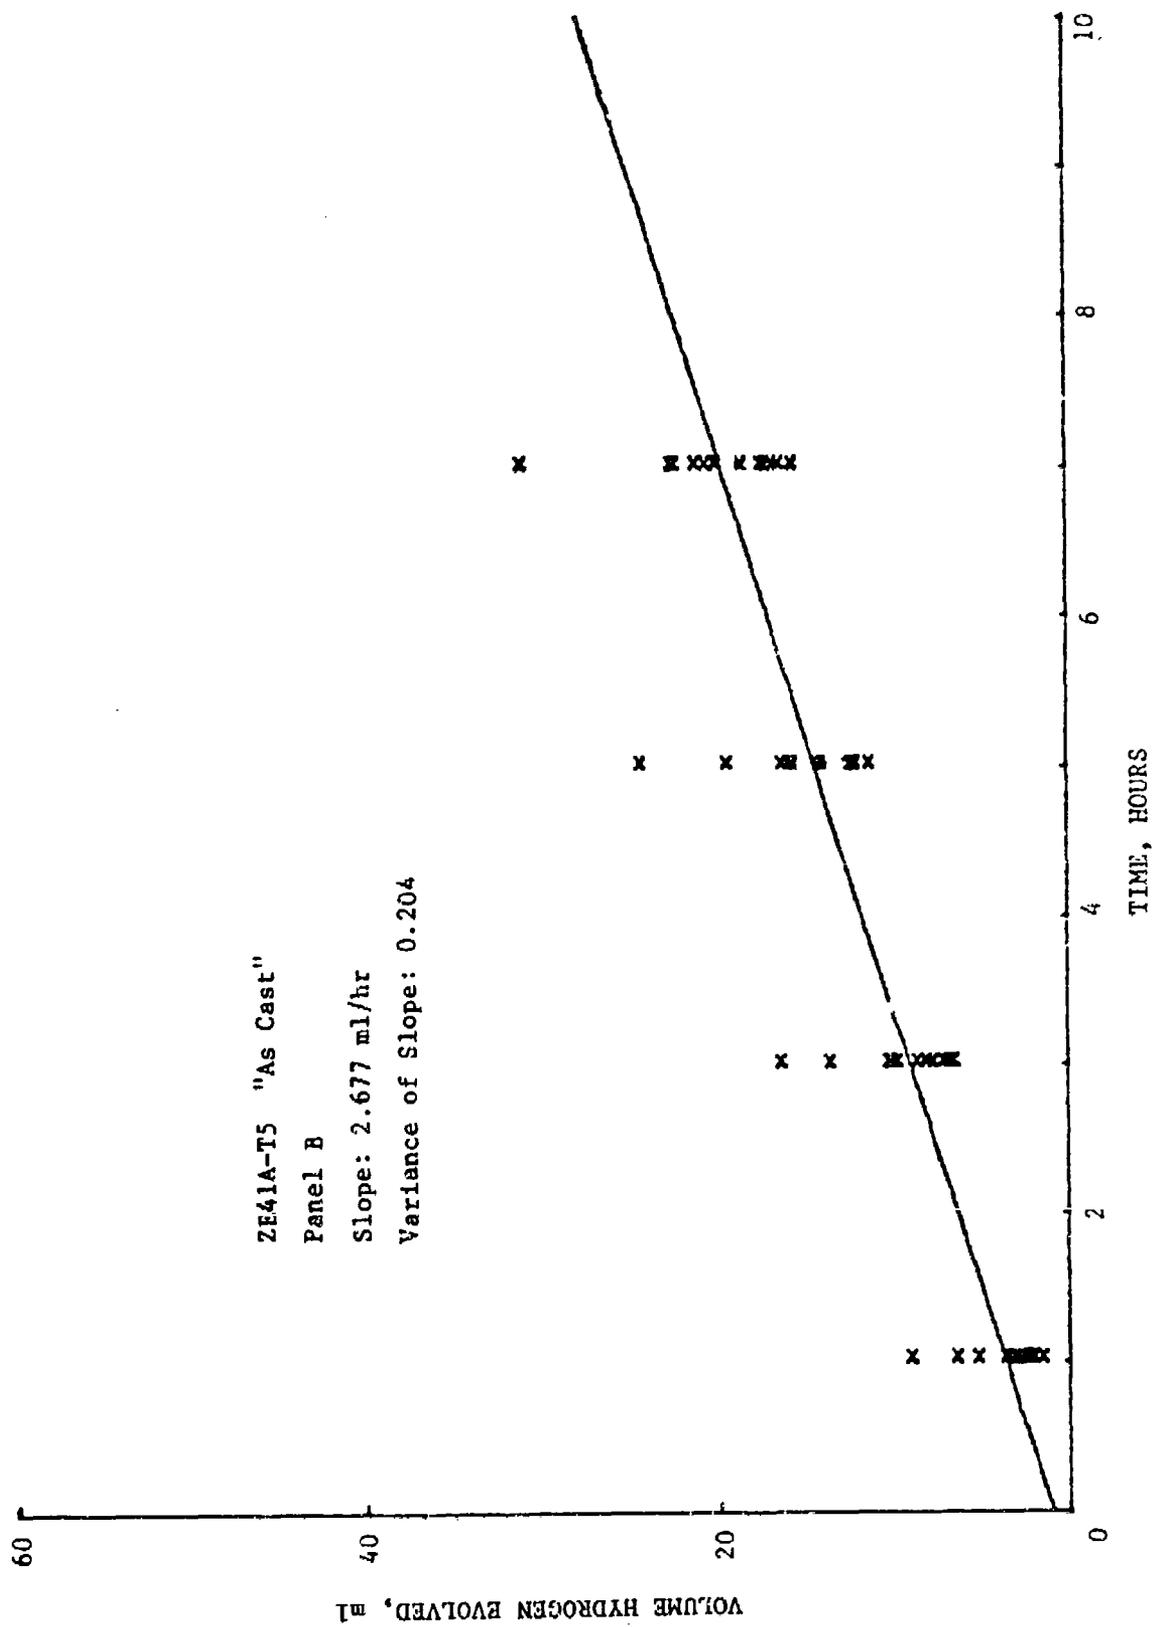
Figure 1'. Hydrogen evolution, ZE41A-T5 as-cast, panel B

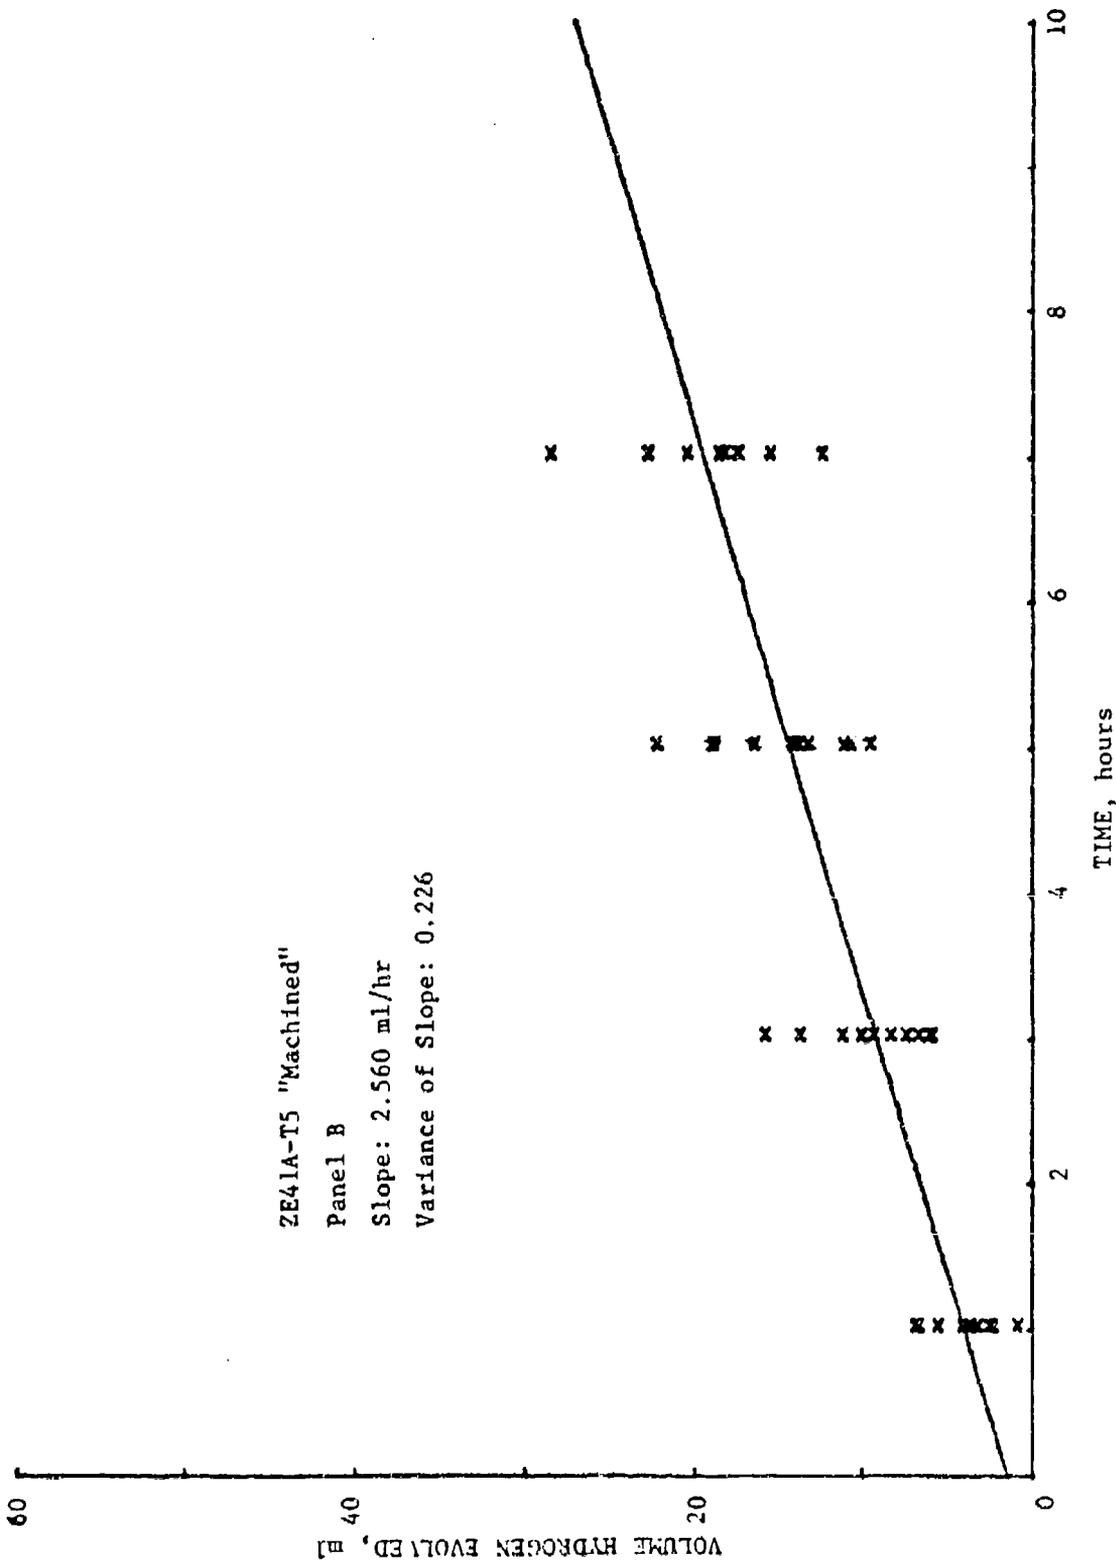
Figure 12. Hydrogen evolution, ZE41A-T5 machined, panel B

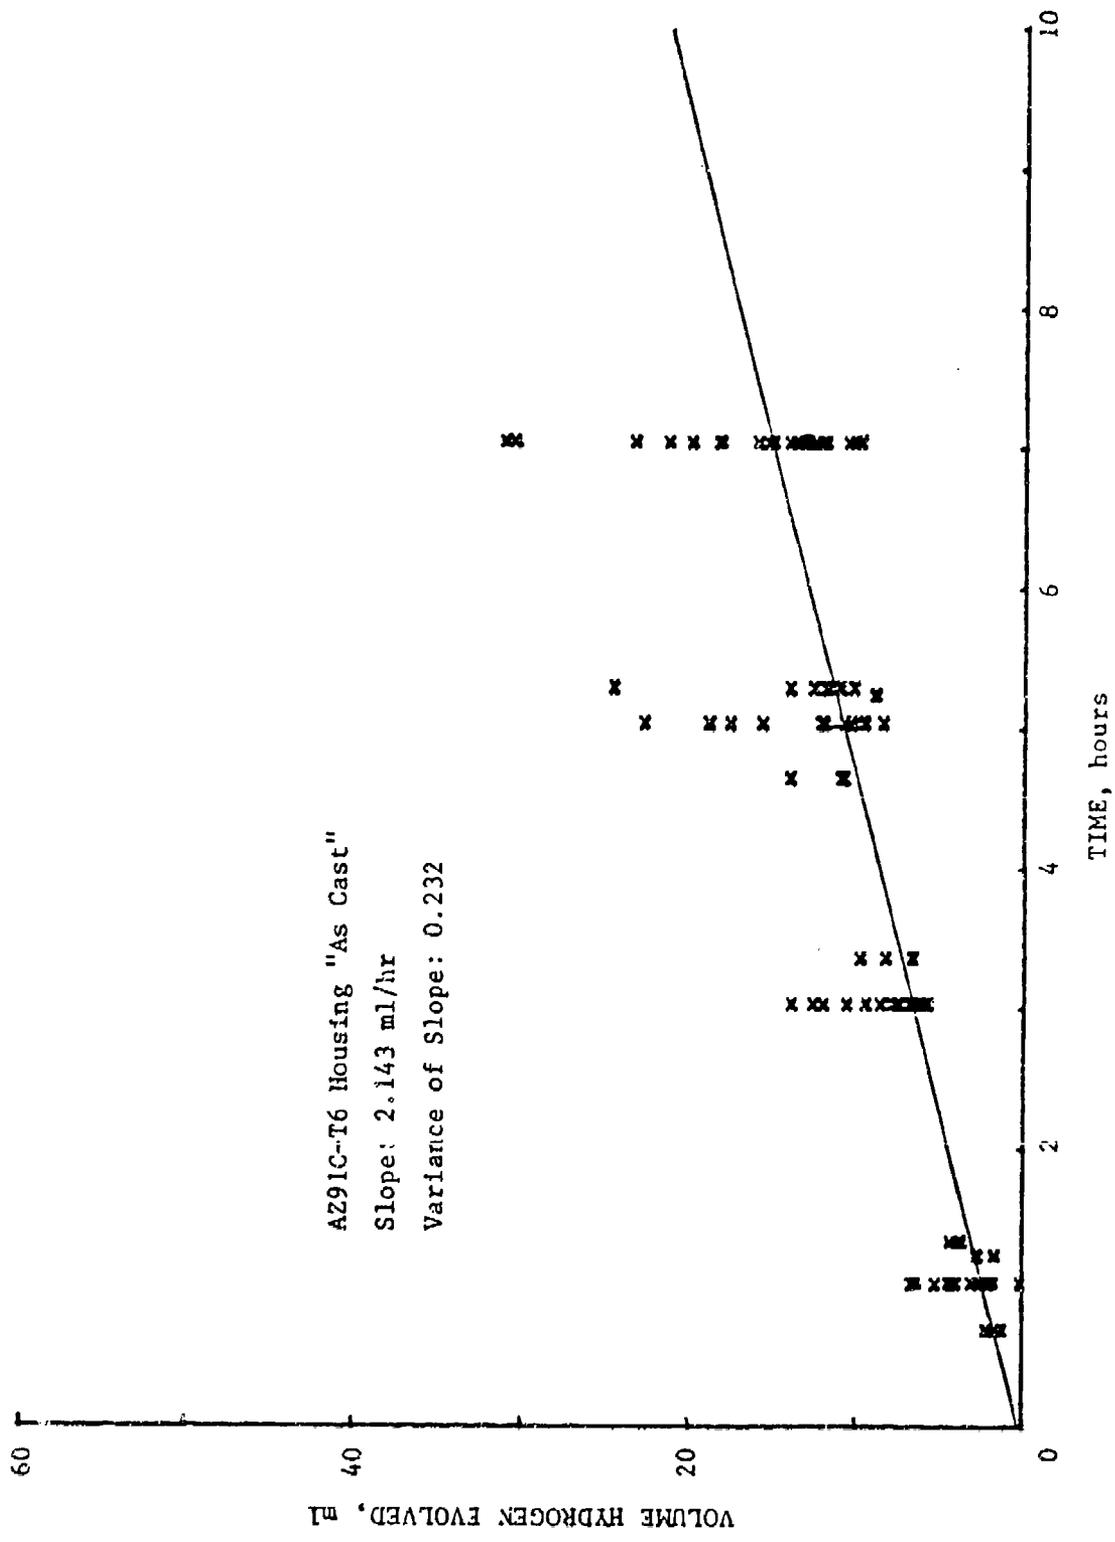
Figure 13. Hydrogen evolution, AZ91C-T6 housing as-cast

The corrosion behavior observed for the helicopter housing specimens is displayed in figures 13 and 14 for the as-cast and machined surface conditions, respectively. Compared with the AZ91 alloy panel results, markedly lower rates, as well as low scatter of data, were exhibited by the AZ91 housing specimens. Specifically, the rates observed for the machined housing specimens were approximately one-fourth that exhibited by machined AZ91 panels. Also, the machined housing specimens exhibited a significantly lower corrosion rate (361 mg/dm²/day), as well as extremely low data point scatter, compared with the as-cast housing specimens (594 mg/dm²/day). The other observation is that the corrosion rate exhibited by the housing specimens was also lower than that observed for the EZ33 and ZE41 alloy panels. The exception to this general observation is that the as-cast ZE41 panel A specimens exhibited slightly lower corrosion rate compared with rate for the as-cast AZ91 housing specimens.

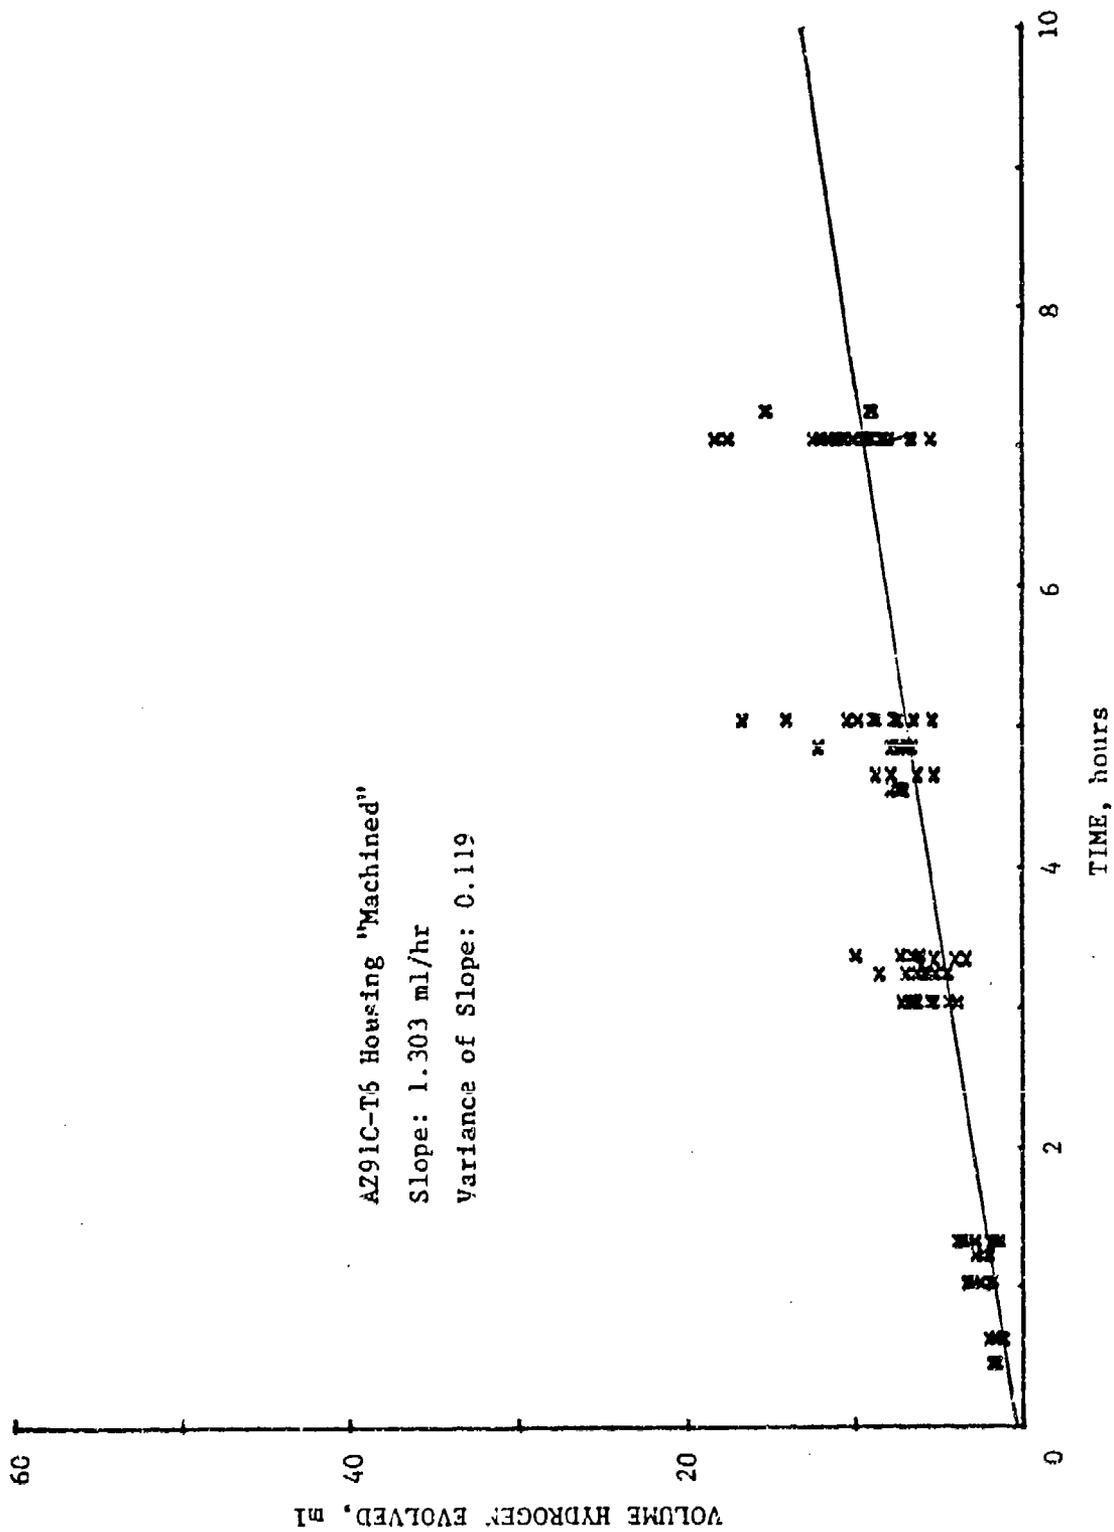
Figure 14. Hydrogen evolution, AZ91C-T6 housing machined
