**AFRL-ML-WP-TR-2003-4170**

**NONDESTRUCTIVE INSPECTION (NDI)  
THROUGH HIGH-VELOCITY OXYGEN  
FUEL (HVOF) THERMAL SPRAY  
COATINGS**

**Delivery Order 0001: Nondestructive Evaluation  
Exploratory Development for Air Force Systems**

**Interim Report for 01 August 2001 – 30 May 2002**

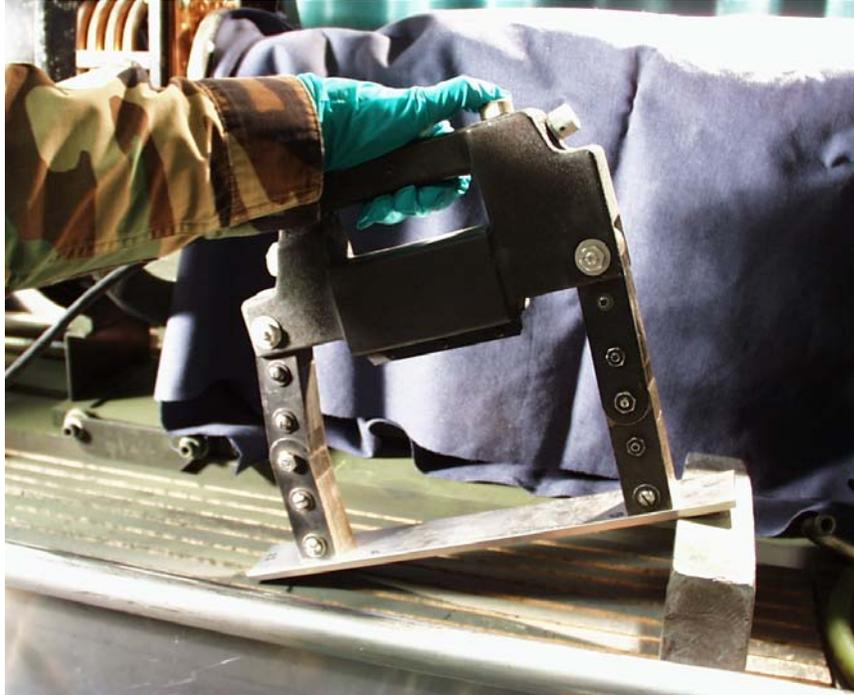
**Figure 2a. Magnetic particle inspection using Parker Probe.**

flat against the specimen approximately one inch from each end. The Parker Probe was set on AC and the highest level of magnetizing power. The probe was used to magnetize the specimen for approximately 6 seconds. Magnetic particle suspension was then immediately poured over the specimen. The specimen was then immediately magnetized for an additional 8 seconds (see Figures 2a and 2b). Next, the specimen was propped up nearly vertical allowing the magnetic particle suspension to continue to flow perpendicular to the cracks. This facilitated an optimum accumulation of fluorescent particles at crack sites. A specimen was allowed to drain for approximately 30 seconds. Then the specimen was inspected under an ultraviolet light (UV-A) (see Figure 3). After identifying the cracks, digital pictures of the fluorescent indications were obtained. The pictures were downloaded into an image processing software enabling the measurement of the indication lengths (see Figure 3).

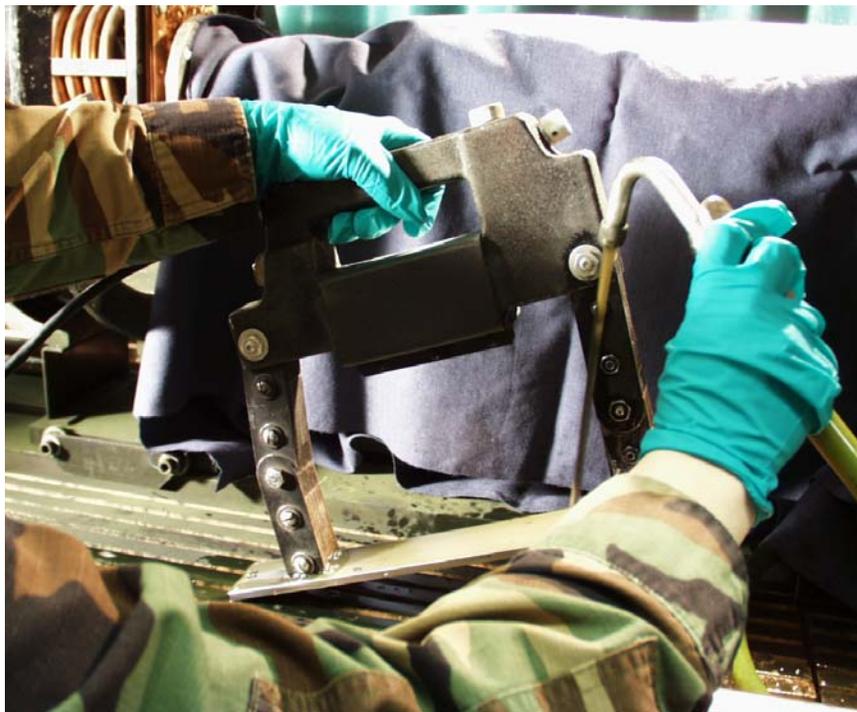
**Figure 2b. Magnetic particle bath being poured onto specimen.**

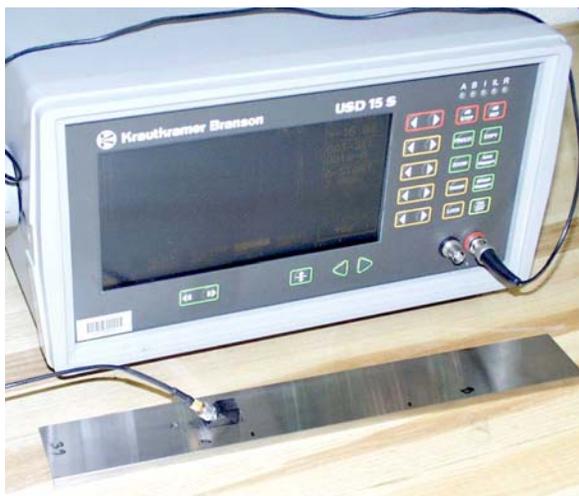
**Figure 4a. Ultrasonic inspection setup.**

Before the specimens were coated, a manual ultrasonic pulse-echo, shear-wave technique was developed with a Krautkramer Model 15S ultrasonic instrument and a Krautkramer KB-A (part number 90289) ¼ inch, 10 MHz transducer. The transducer was attached to a plastic wedge in order to produce a shear-wave ultrasonic beam in a specimen at a 60-degree angle (with respect to a line perpendicular to the surface of the specimen). The transducer was placed on the same surface as a crack so that the sound beam bounced off the opposite surface back towards the crack. The transducer was scanned and rotated by hand until the amplitude of the reflected signal from the crack was maximized. Figure 4a depicts the ultrasonic equipment and setup. Figure 4b shows a close-up of the ultrasonic probe. Figure 4c is a picture of an ultrasonic response.

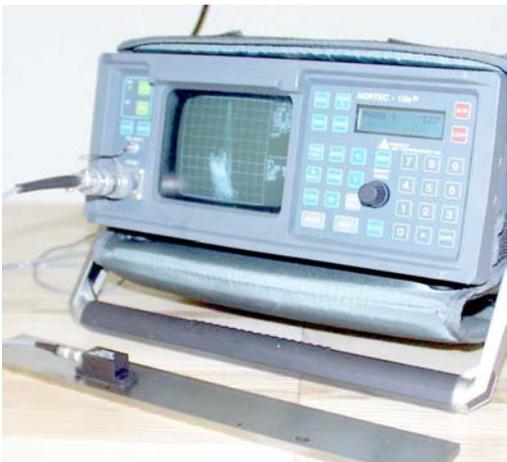
**Figure 5a. Eddy current inspection setup.**

A manual eddy current technique was developed with a Nortec 19e<sup>II</sup> instrument and a Nortec absolute probe (part number 972511) with a frequency range of 100 to 500 kHz. The instrument was set to operate at 200 kHz. The probe was inserted into a holder to maintain its orientation perpendicular to the inspection surface. The probe was scanned by hand until a crack signal was maximized. Figure 5a depicts the eddy current inspection setup. In order to reduce the effects of variable permeability on the eddy current signals, each specimen was first magnetized with the Parker Probe set to apply direct-current magnetization.

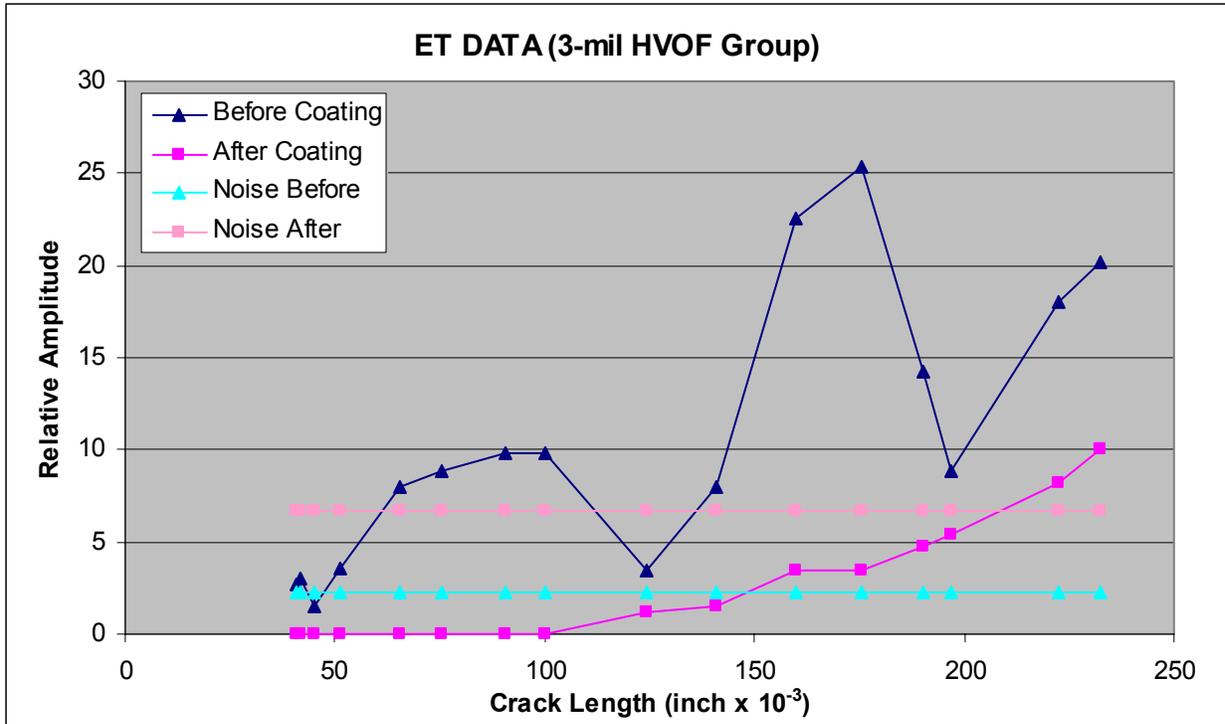
**Figure 11. Eddy Current data for specimens on which 0.003 inch of HVOF coating was applied.**
