TECHNICAL NOTE No. AERO. 2886

TESTS ON A HUNTER F.2 OF TWO
STRAIN GAUGE METHODS FOR
MEASURING TAILPLANE LOADS
IN FLIGHT, WITH SOME LOADS
MEASURED IN LEVEL FLIGHT,
PITCH-UPS AND TRANSONIC DIVES

APRIL, 1963

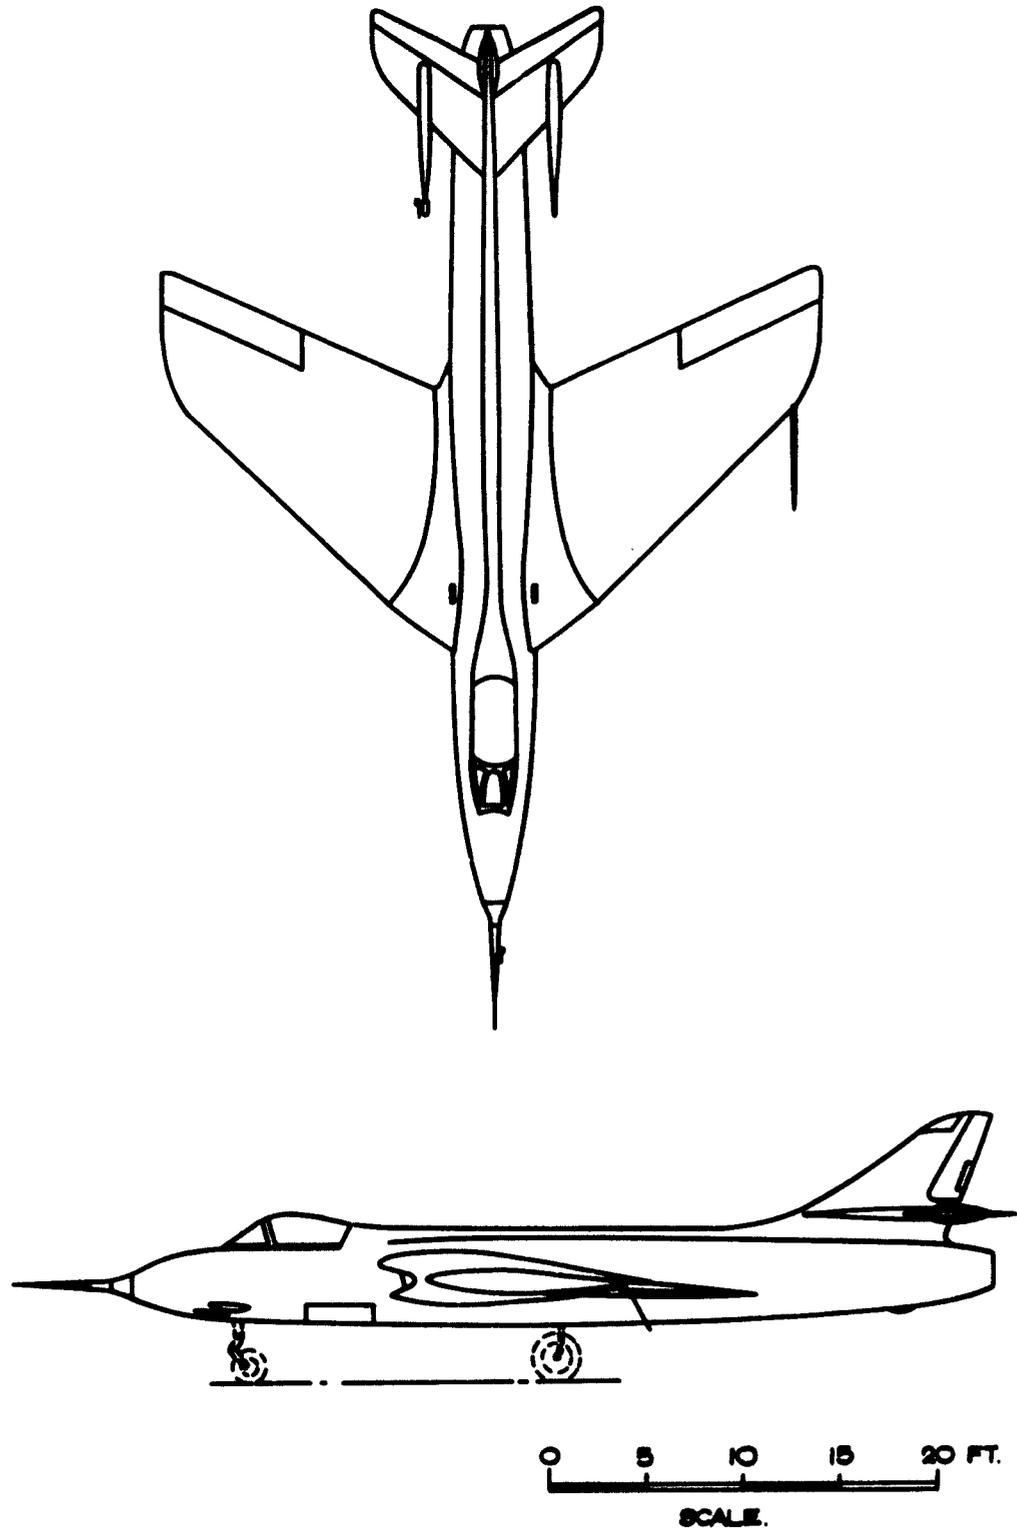
FIG. 2. HAWKER HUNTER F.2. (WN.893.)

The aircraft used in the tests, WN 893, is shown in the photograph Fig.1, and the two view drawing Fig.2. It had the following external differences from a standard Hunter F.2:

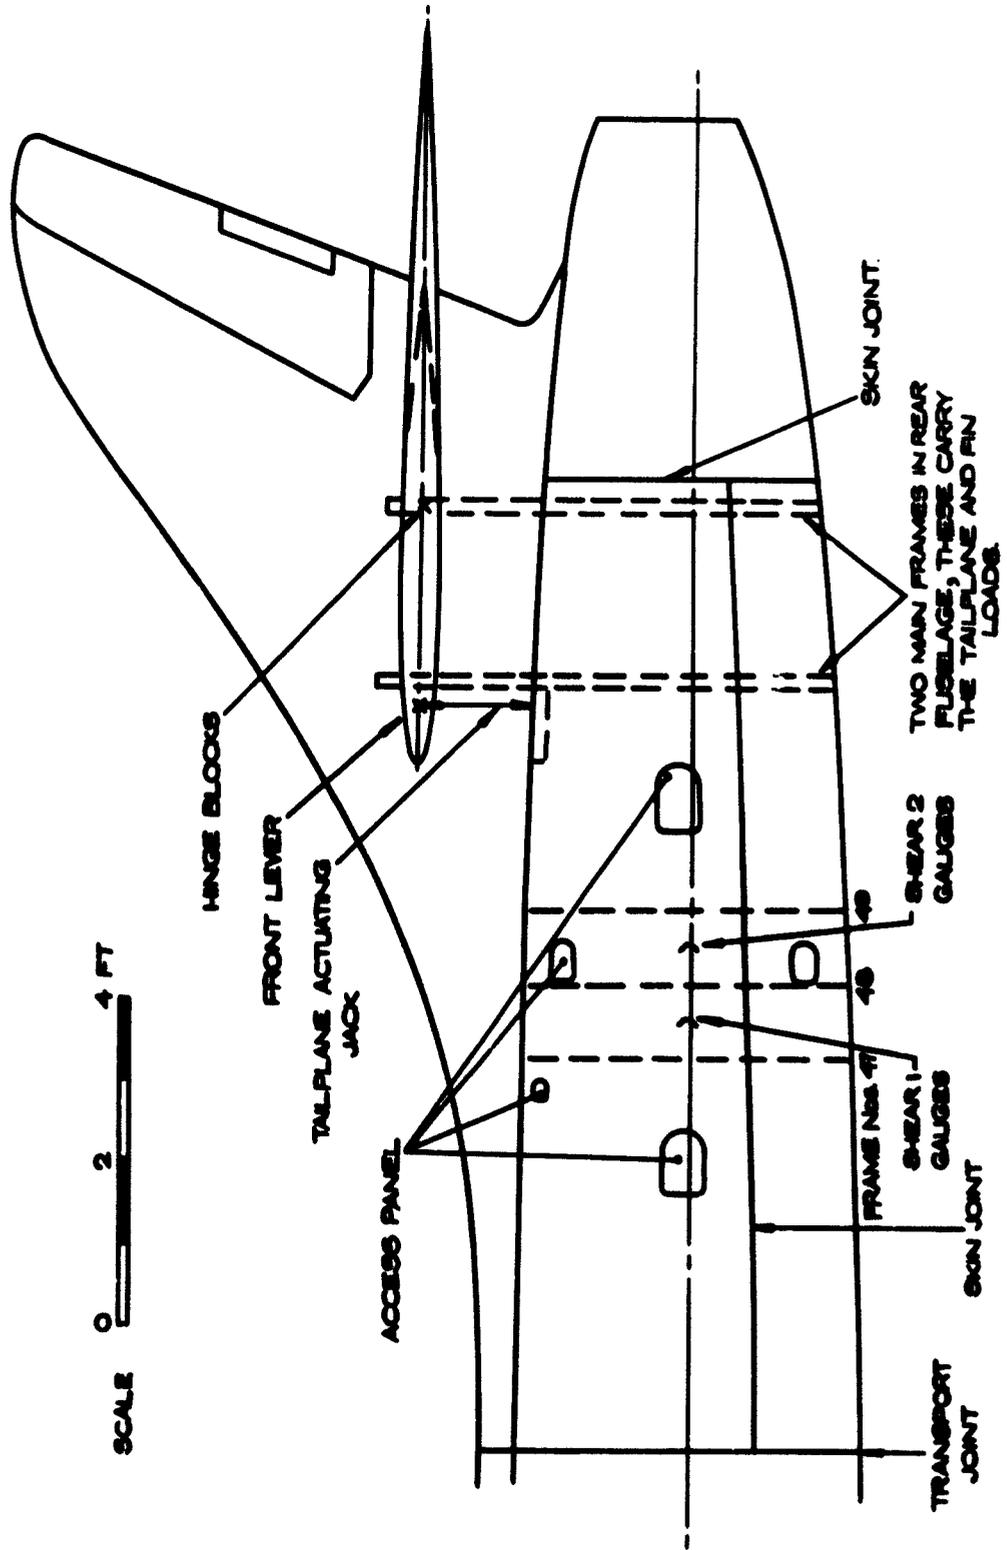
FIG. 3 DIAGRAM OF REAR FUSELAGE AND TAILPLANE OF HUNTER, SHOWING POSITION OF STRAIN GAUGES.

The variable incidence tailplane of the standard Hunter F.2 is carried on short fixed shafts which project from either side of the fin. Bearing blocks attached to the rear spar of the tailplane mate with these shafts to form a pivot, so that the tailplane incidence can be varied by a jack connected to a lever fixed at the front of the tailplane. The loads applied to the tailplane are transferred to the fuselage partly through the bearing blocks (hinge blocks) and the fixed shafts, and thence via the fin to a fuselage frame, and partly through the front lever and tailplane actuator. The positions of these mountings are shown in Fig.3

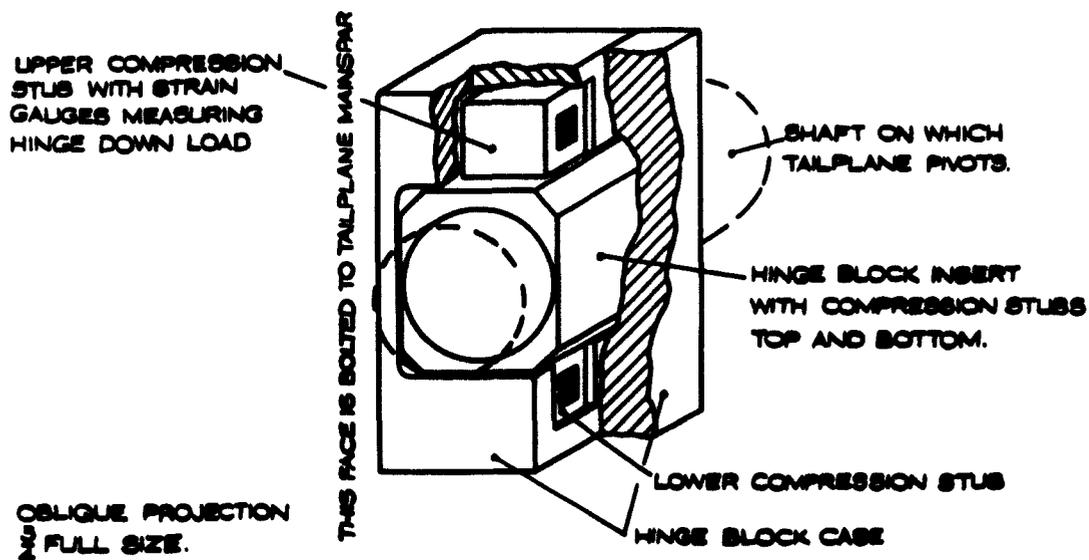
FIG 4(a) DIAGRAM OF HINGE BLOCK

The modified hinge blocks consisted essentially of two components, as shown in Figs.4a and 5a; one was a strain gauged member which pivoted on the fin shaft, and the other an outer case which contained this member and was bolted to the rear face of the tailplane rear spar. The case was itself made of two parts, the main body and a rear cover plate, to allow the hinge block to be assembled. The inner member (the insert) was a close sliding fit in the outer case, which restrained it horizontally but allowed it a certain amount of free vertical movement. This free movement was limited at the top by the insert's upper stub coming into contact with the inside of the top of the case, and similarly at the bottom by the insert's lower stub coming into contact with the inside of the bottom of the case. The tailplane was restrained in a spanwise sense by the inboard face of one or other of the hinge block cases bearing against a shoulder on the fixed pivot shafts on the fin, in the same way as when the standard hinge blocks were fitted. Chordwise movement of the tailplane was prevented because the hinge block cases fitted closely on their inserts. The vertical play of the inserts within their cases allowed a total of approximately 0.002 inches overall vertical movement of the tailplane at each hinge block (0.001 inch either side of the neutral position), before the case came into contact with either the upper or lower stub of its insert. Thus, if the overall load on the tailplane produced a resultant up load on a hinge block, the case would move upward to the limit of its travel and then put the lower stub of its insert into compression, leaving the upper stub unloaded, and vice versa. The stubs were slightly dome ended to reduce loading asymmetries. The compressive strain in each of them was measured by strain gauges, mounted as shown in Figs.4a and 5a. The stubs were only sufficiently large for two gauges to be attached to them, so it was necessary to

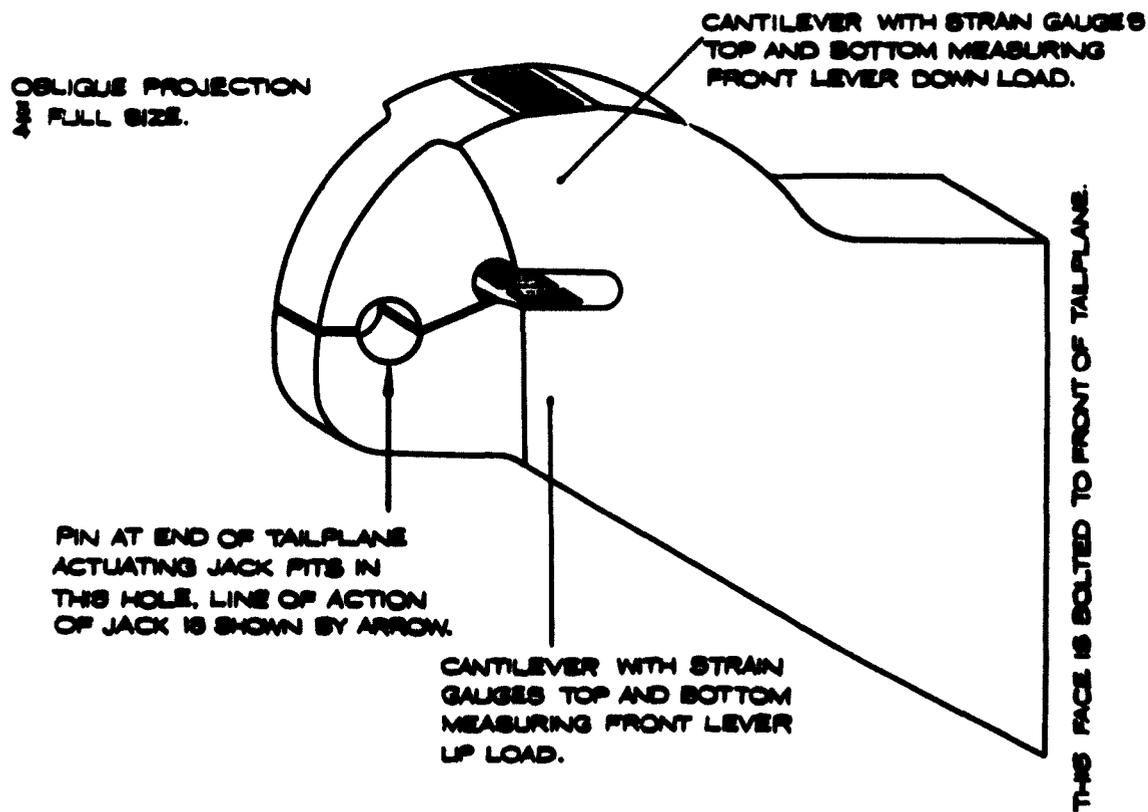
FIG. 4(b) DIAGRAM OF FRONT LEVER.

The modified front lever was designed on the same principle of measuring up and down loads separately. It was split at the jack attachment point, as shown in Figs.4b and 5b, to form two cantilevers. A load on the tailplane which produced a resultant up load on the front lever caused the lower cantilever to be stressed, and left the upper cantilever unloaded (since the jack attachment pin retained its normal working clearance), and vice versa. Bending strain in each cantilever was measured by strain gauge bridges, each consisting of two tension and two compression gauges connected to form four active arms.

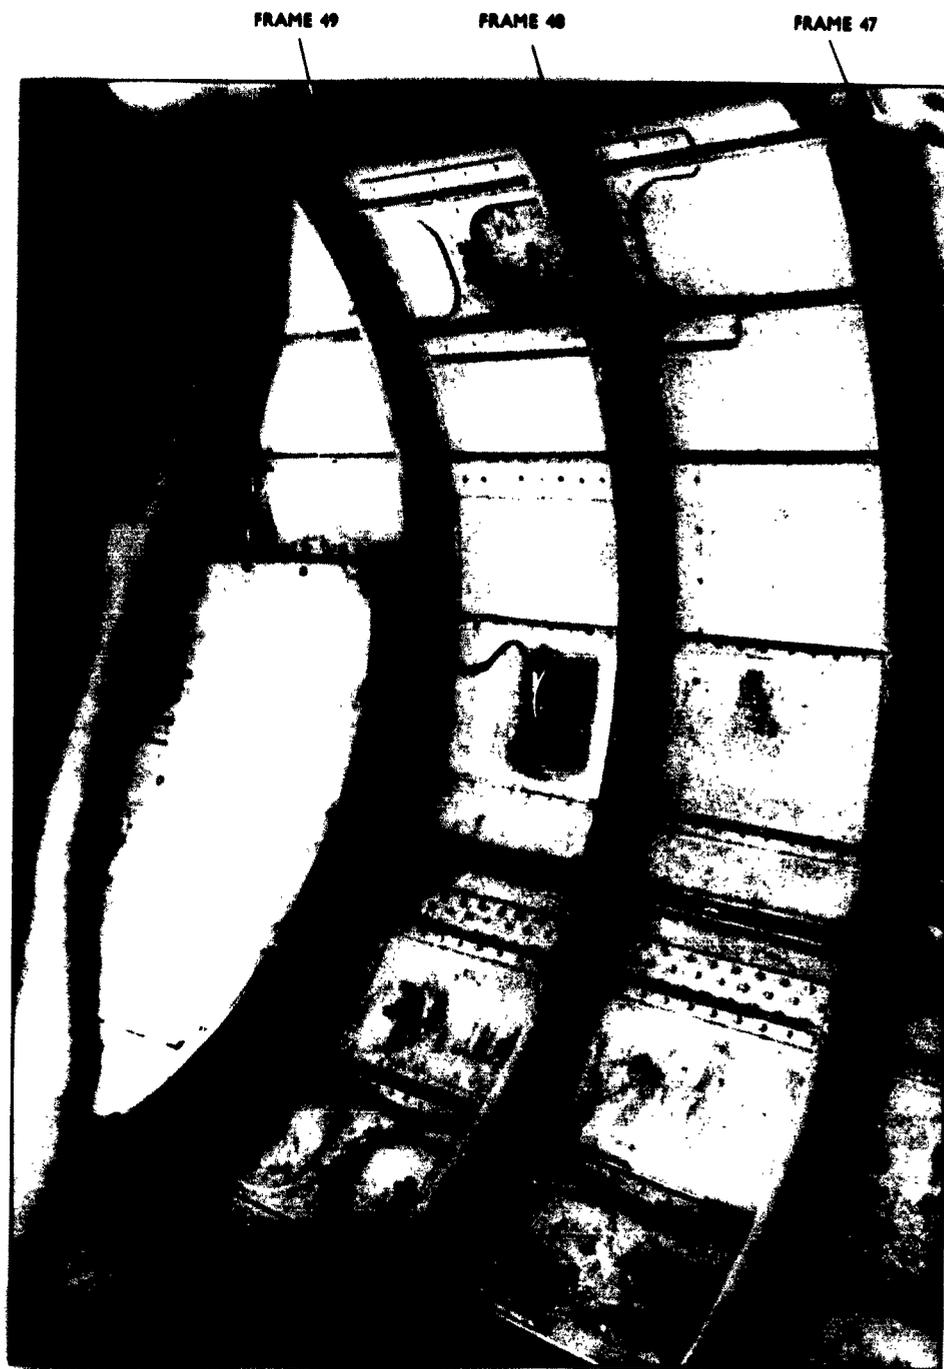
FIG.6. INSIDE OF REAR FUSELAGE, SHOWING THE
SHEAR 2 BRIDGE STRAIN GAUGES

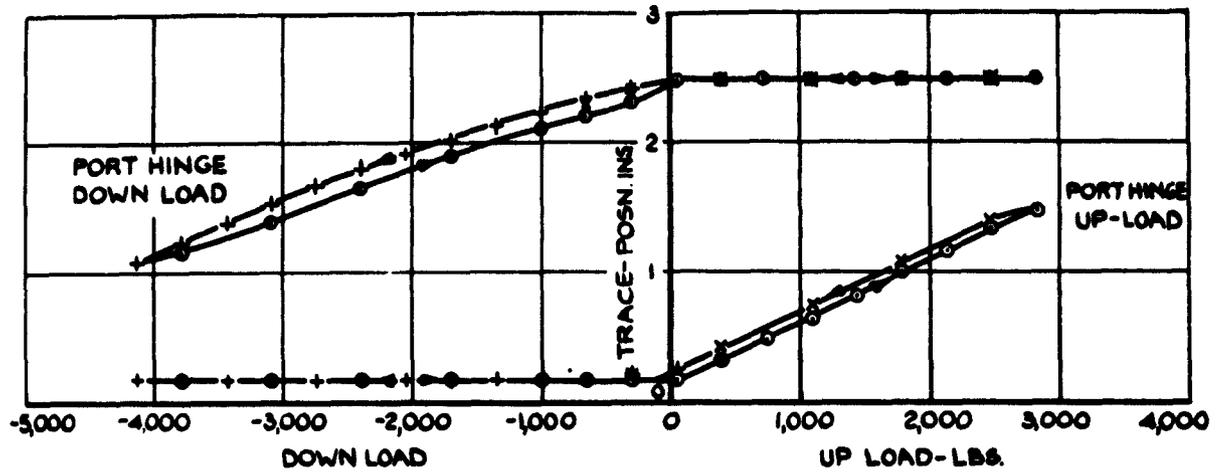
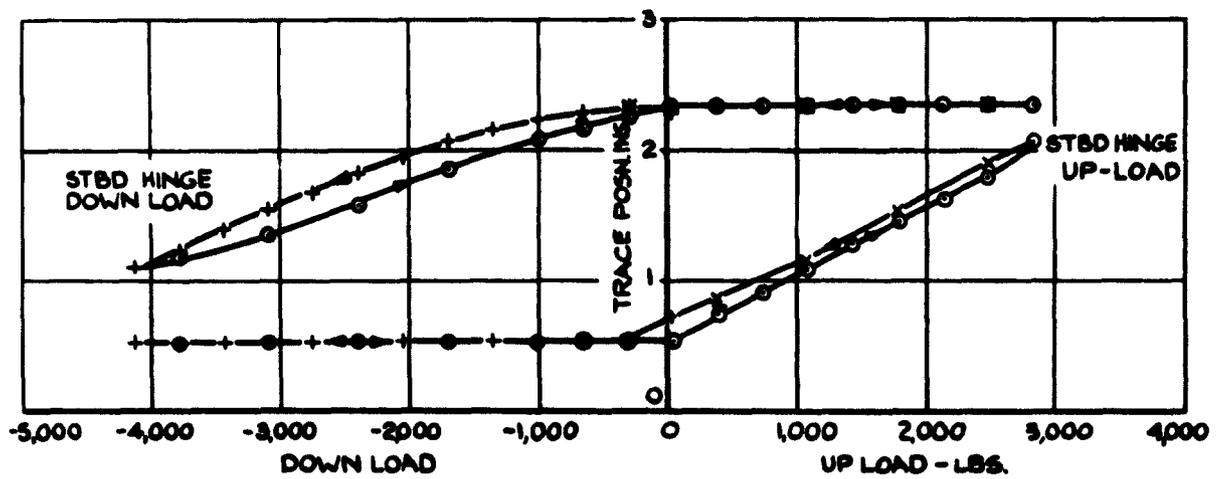
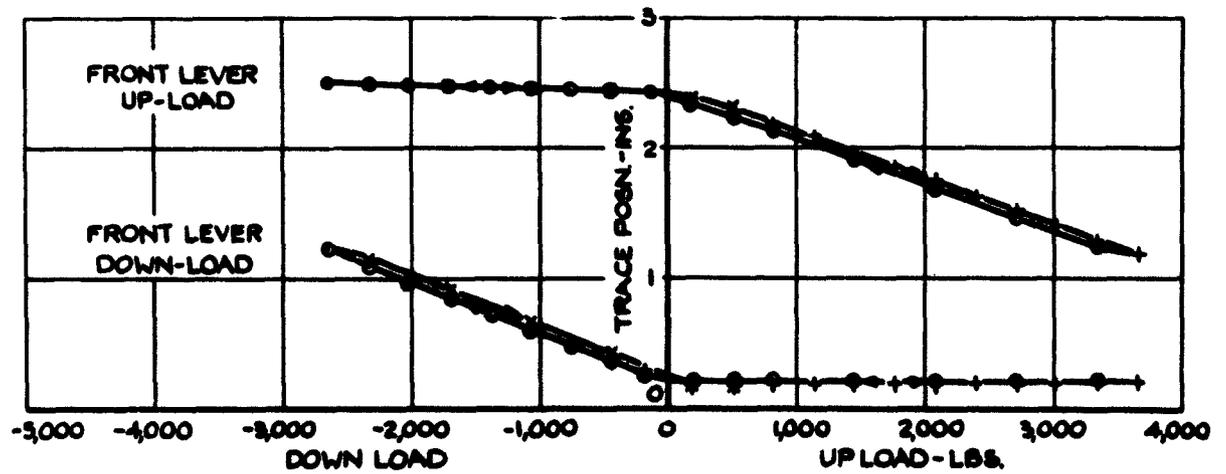
FIG. 8(a)

FIG. 8(q) CALIBRATIONS OF HINGE BLOCKS AND FRONT LEVER.

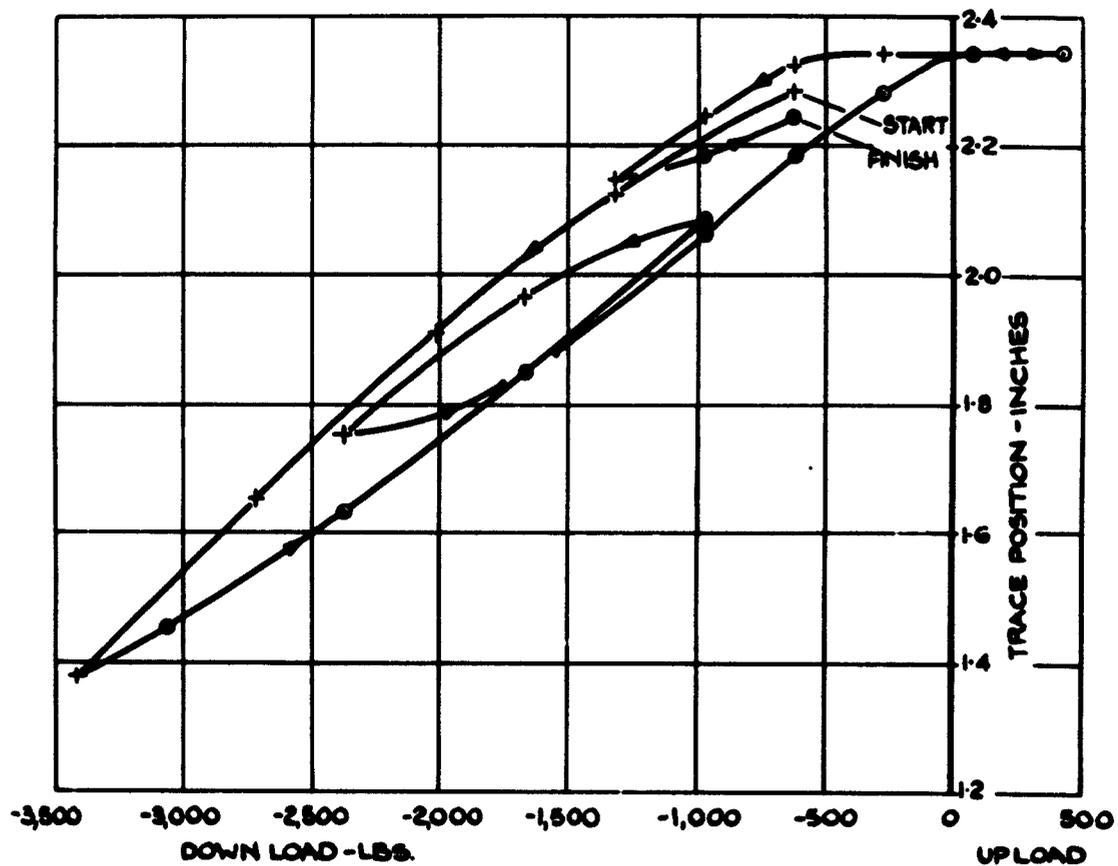
FIG. 8(b) STARBOARD HINGE DOWN-LOAD CALIBRATION TO SHOW HYSTERESIS EFFECTS.

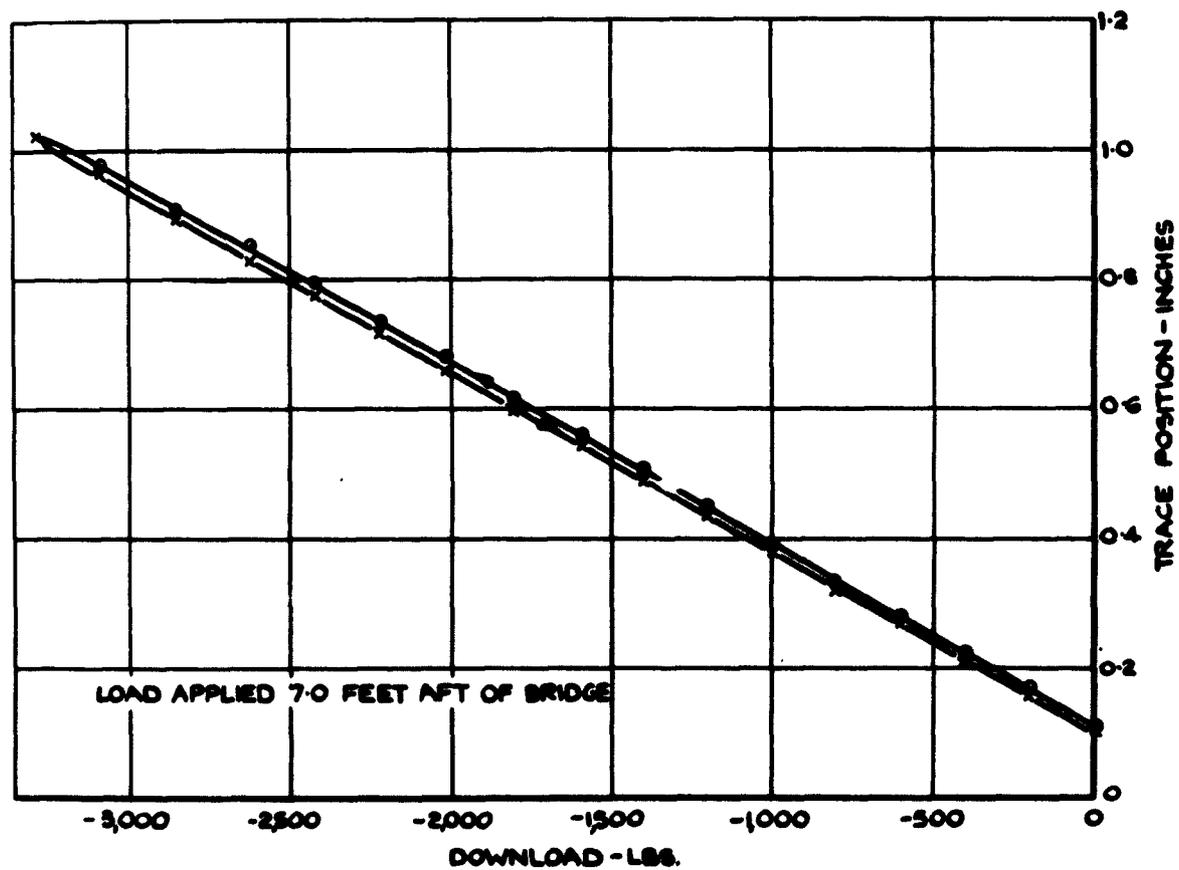
FIG. 9. CALIBRATION OF FUSELAGE SHEAR I BRIDGE.

As stated in section 3.2 it was necessary to determine the sensitivity of the fuselage shear strain gauge bridges, both to shear and to other types of loading. Both shear bridges were found to behave very similarly when being calibrated, so only the results obtained during the calibration of the Shear 1 bridge will be discussed.

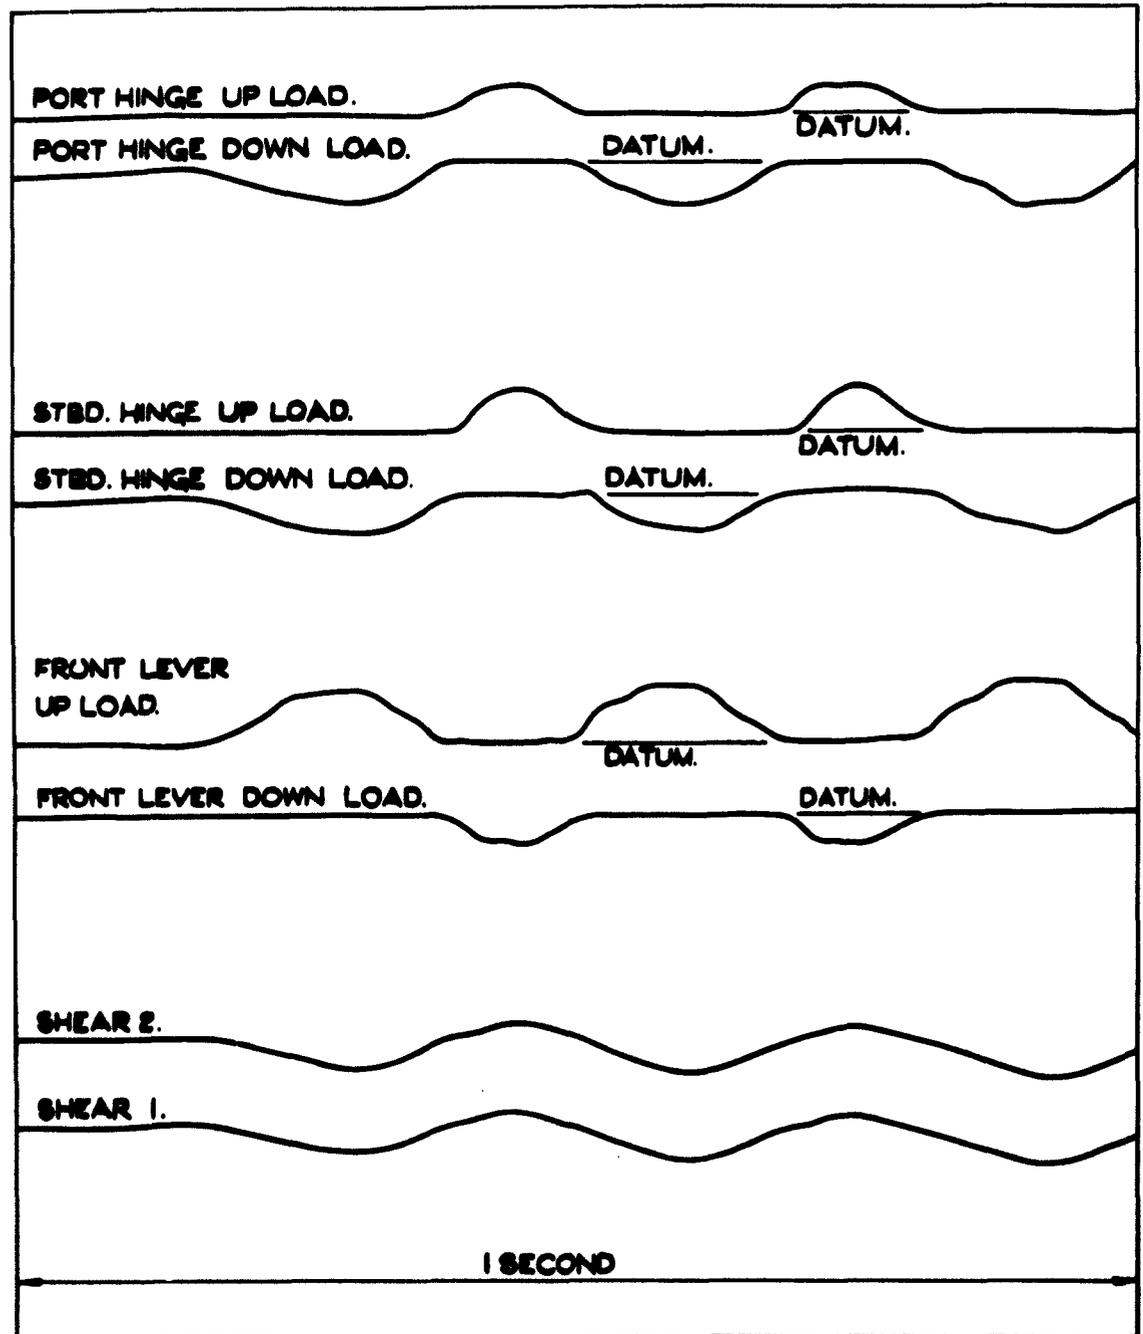
FIG. 10. TYPICAL LOAD RECORDS DURING IN-FLIGHT DATUM DETERMINATION.

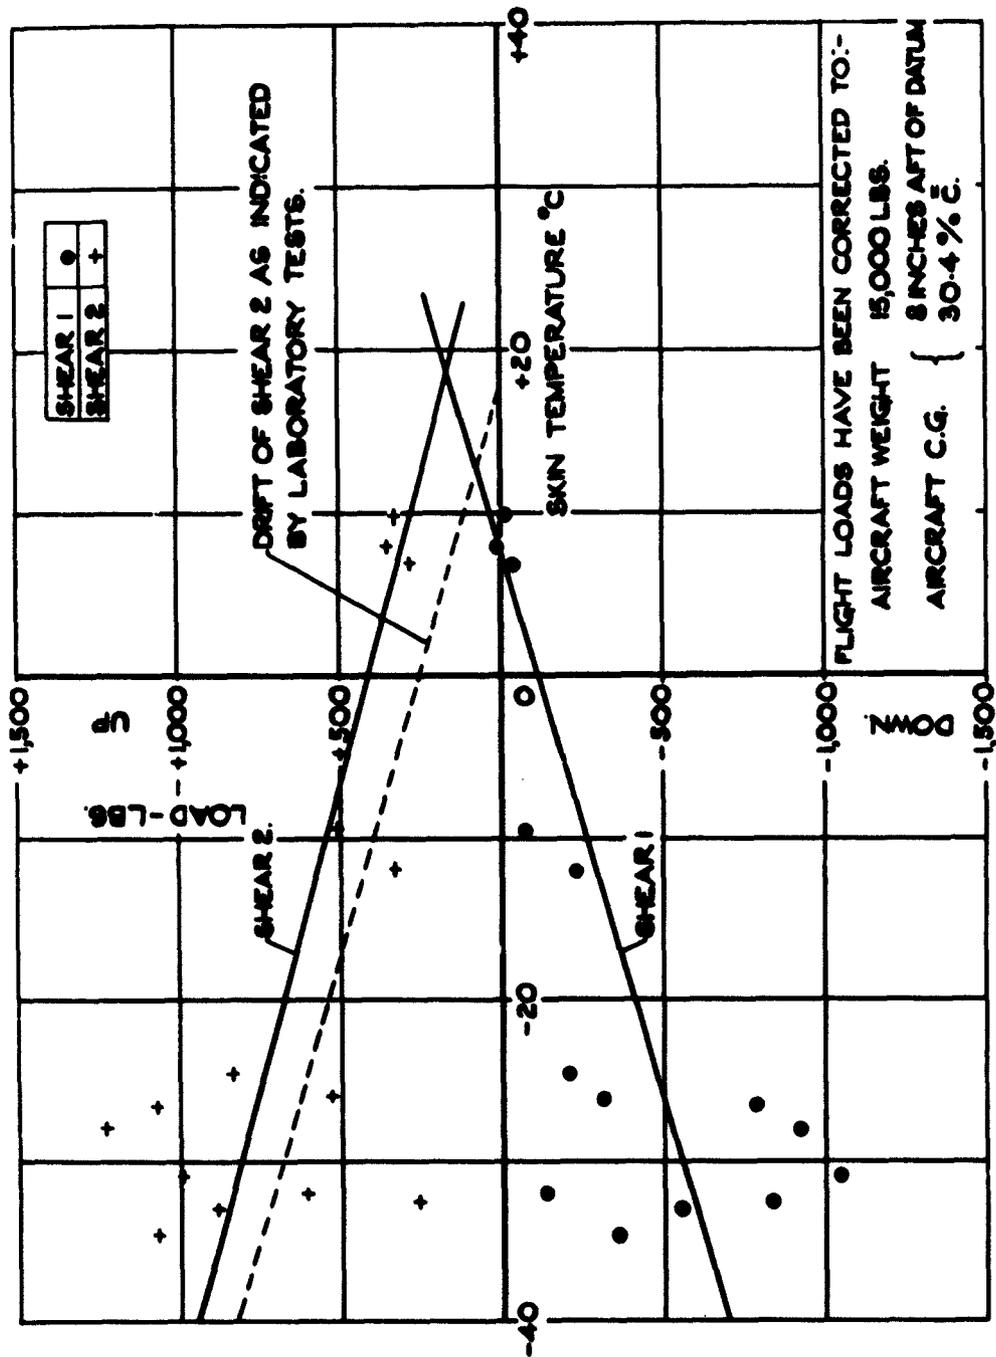
FIG. 11. LOADS INDICATED BY SHEAR BRIDGES IN LEVEL FLIGHT AT 200 KNOTS.

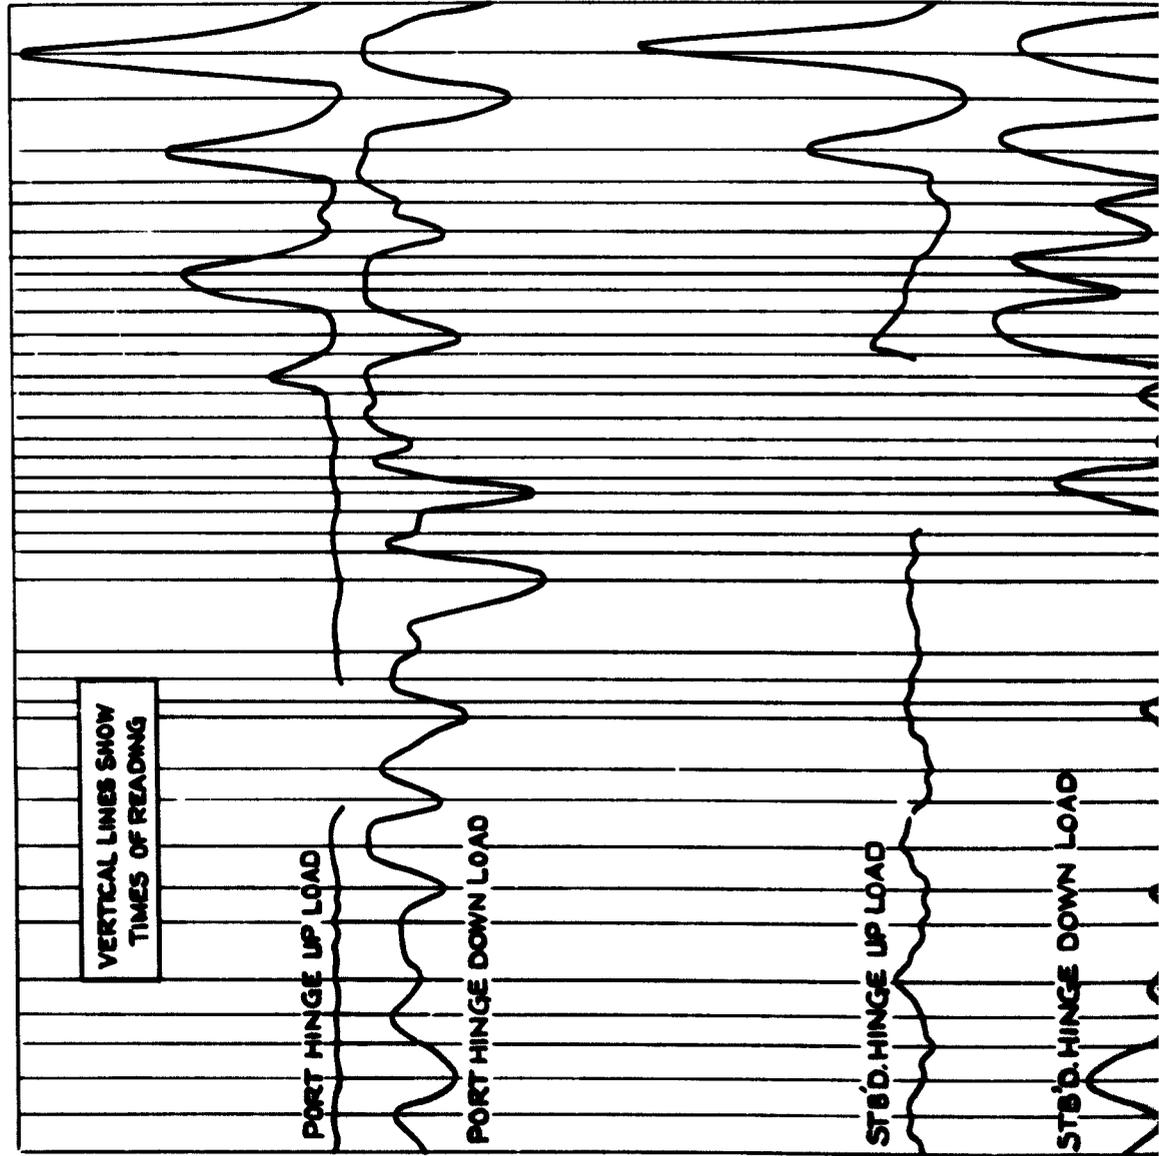
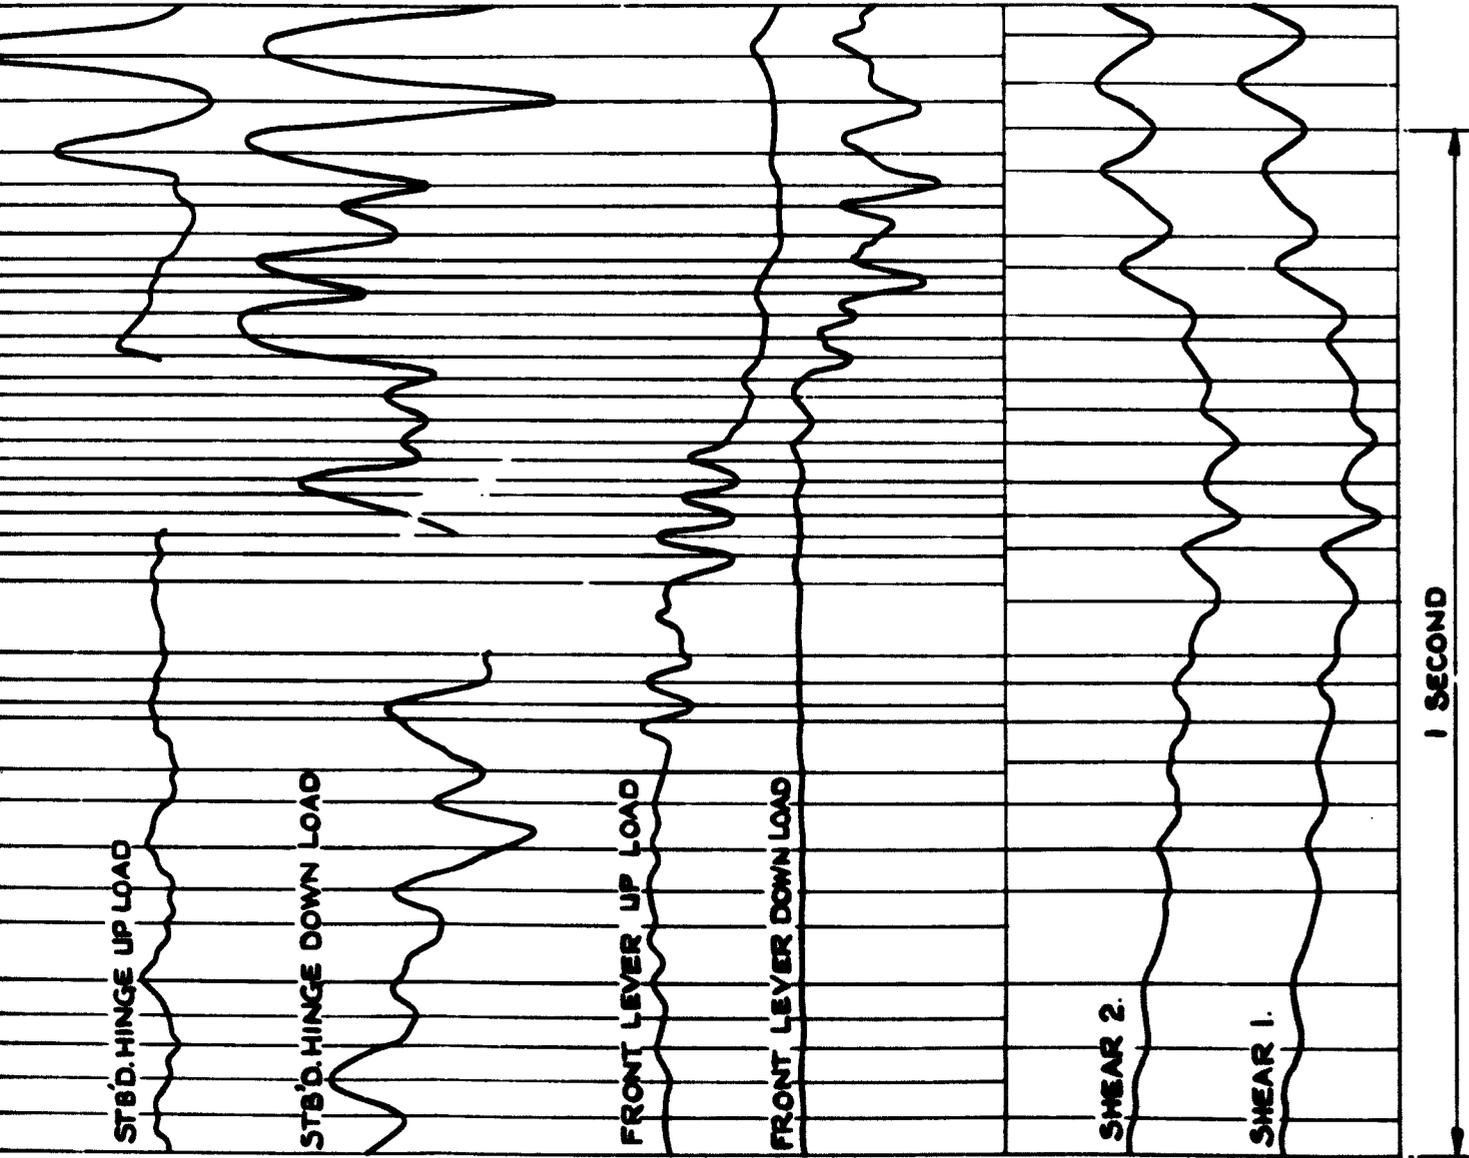
FIG.12. TYPICAL LOAD RECORDS DURING PITCH -UP BUFFET

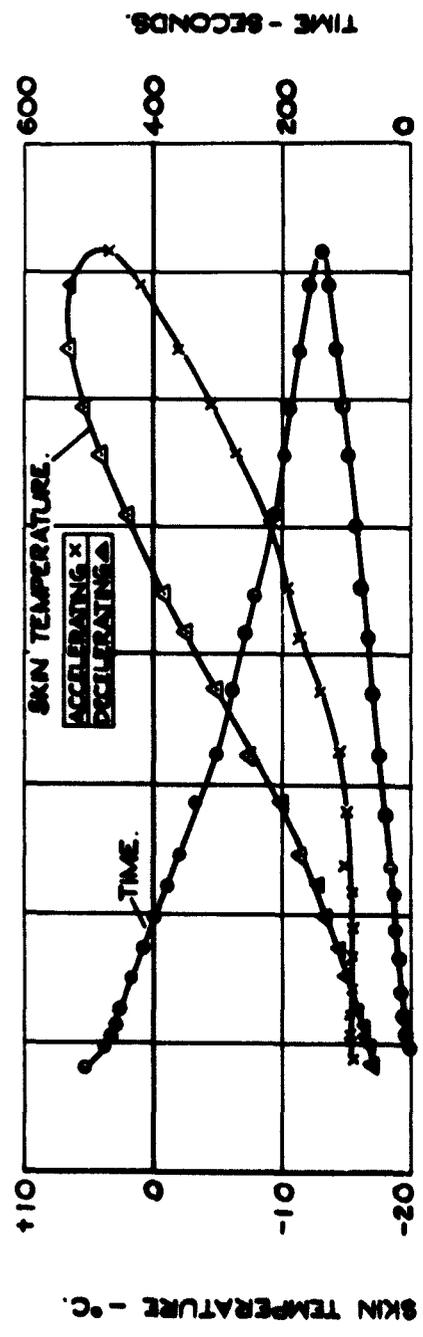
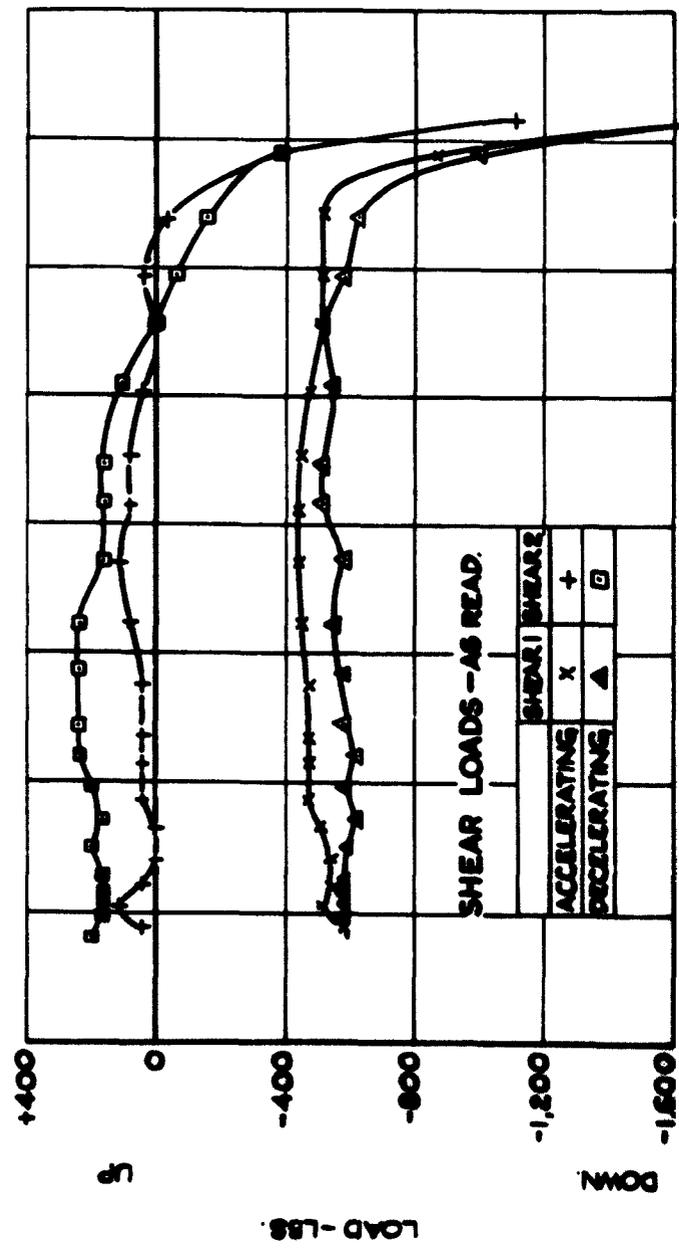
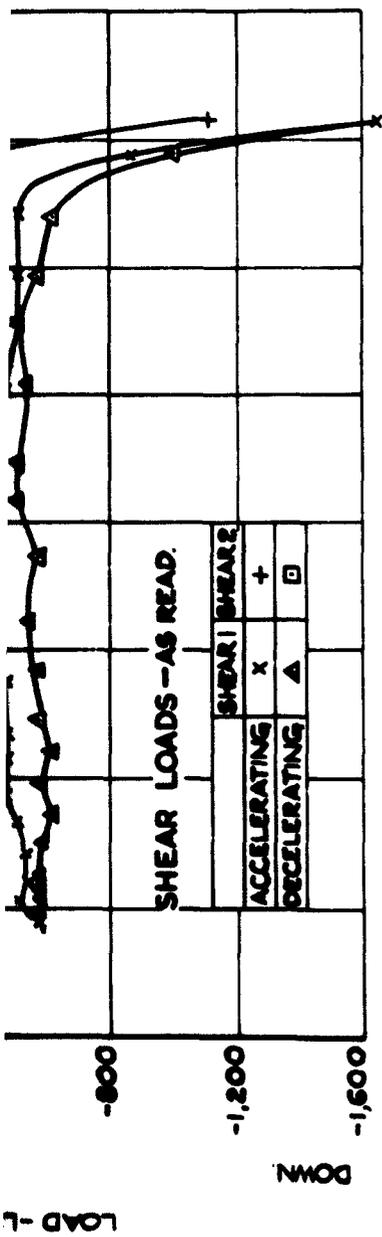
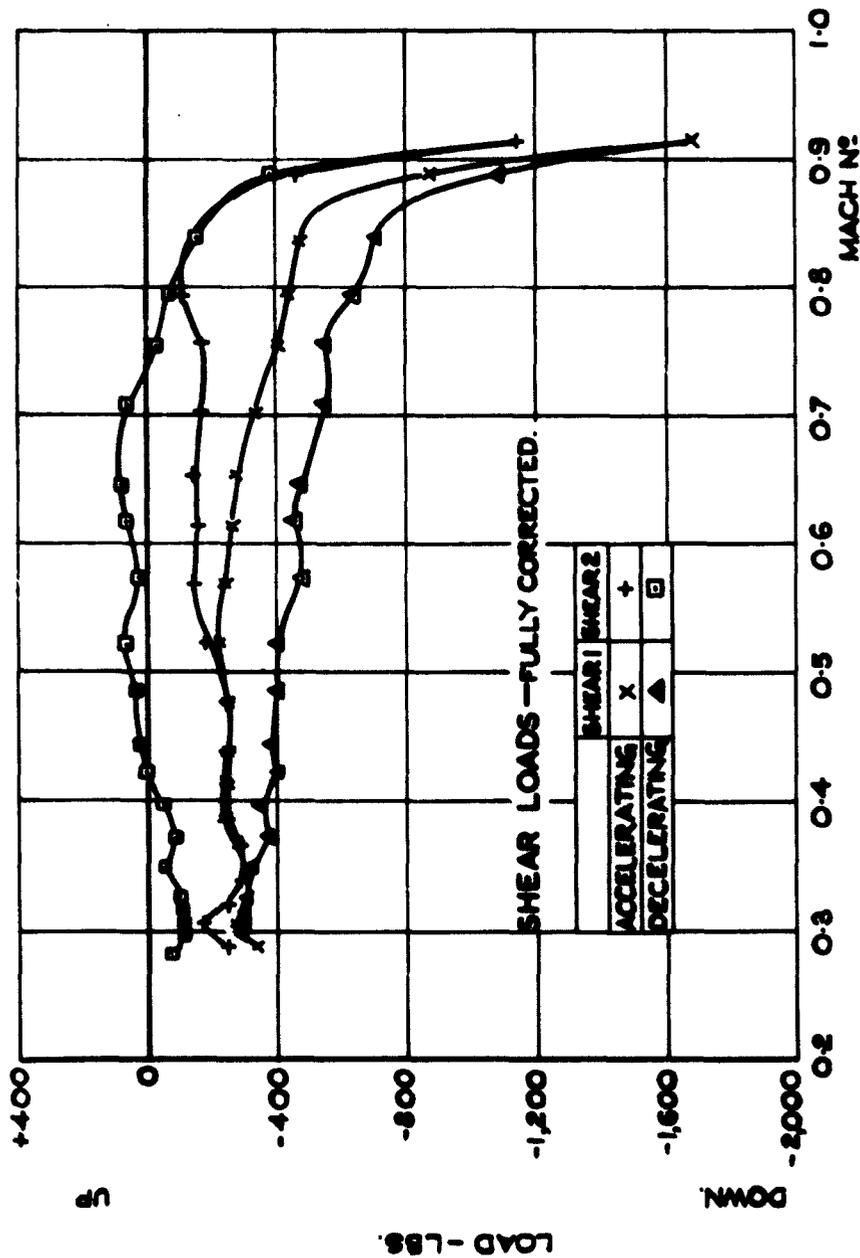
MEAN WEIGHT 15,500 LBS.
 MEAN C.G. 25.3% L.

FIG.13(a) LOADS MEASURED IN LEVEL FLIGHT AT 20,000 FEET - FORWARD C.G.

Tail loads were recorded in level flight over a range of subsonic speeds at 20,000 feet. Records were taken while the aircraft was accelerating at full throttle, from near its minimum speed to near its maximum, and then decelerating again with the throttle closed. This took approximately 8 minutes. The actual loads are of interest, and so also is the assessment of the stability of the shear bridges under the varying temperature conditions experienced in each run. This assessment can only be made for the shear bridges, since the loads over most of the speed range were too small to be determined by the tailplane mounting bridges, because of the hinge blocks' insensitivity to small loads. The shear loads were recorded in two flights with different aircraft weights and centre of gravity positions. In all records the aircraft normal acceleration was virtually 1 g "total", so no corrections for inertia load were required. Each reading

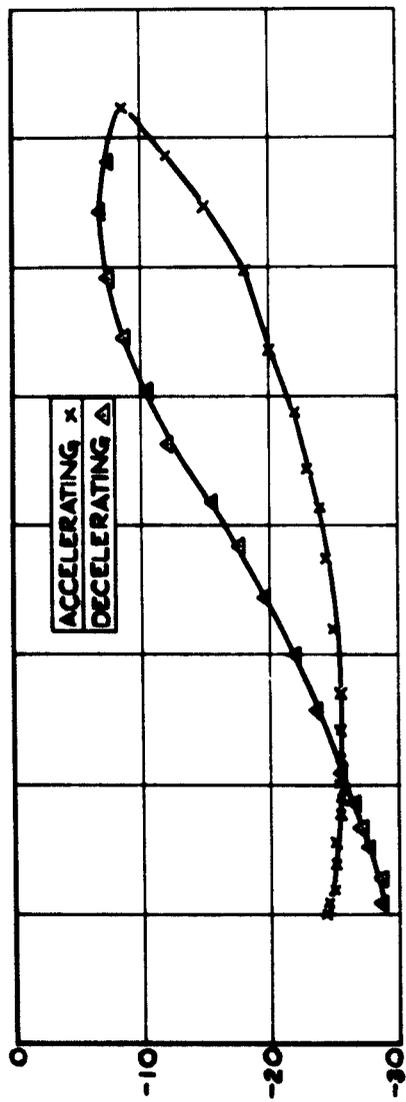
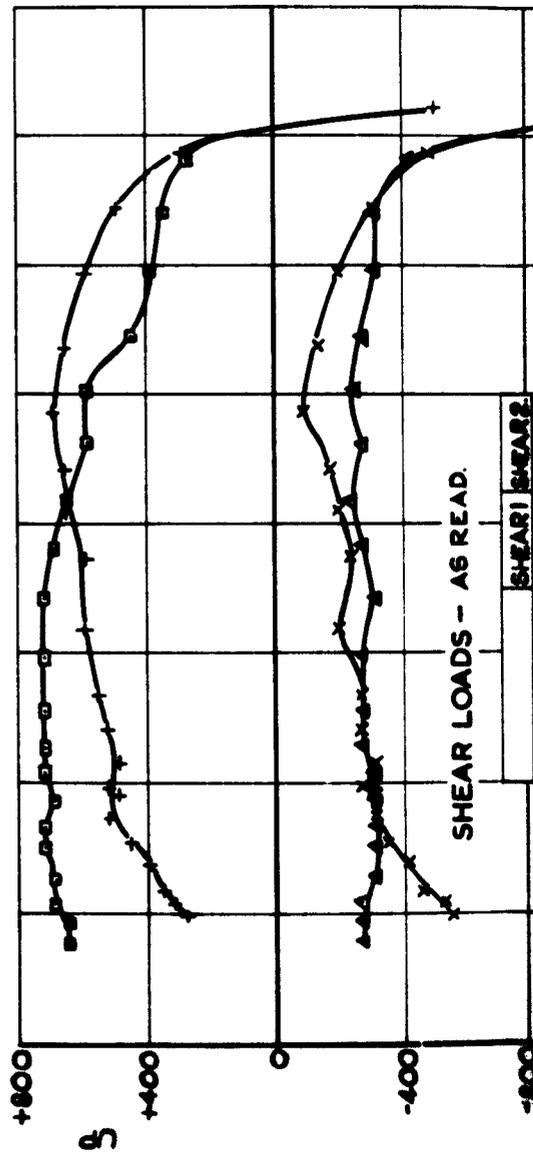
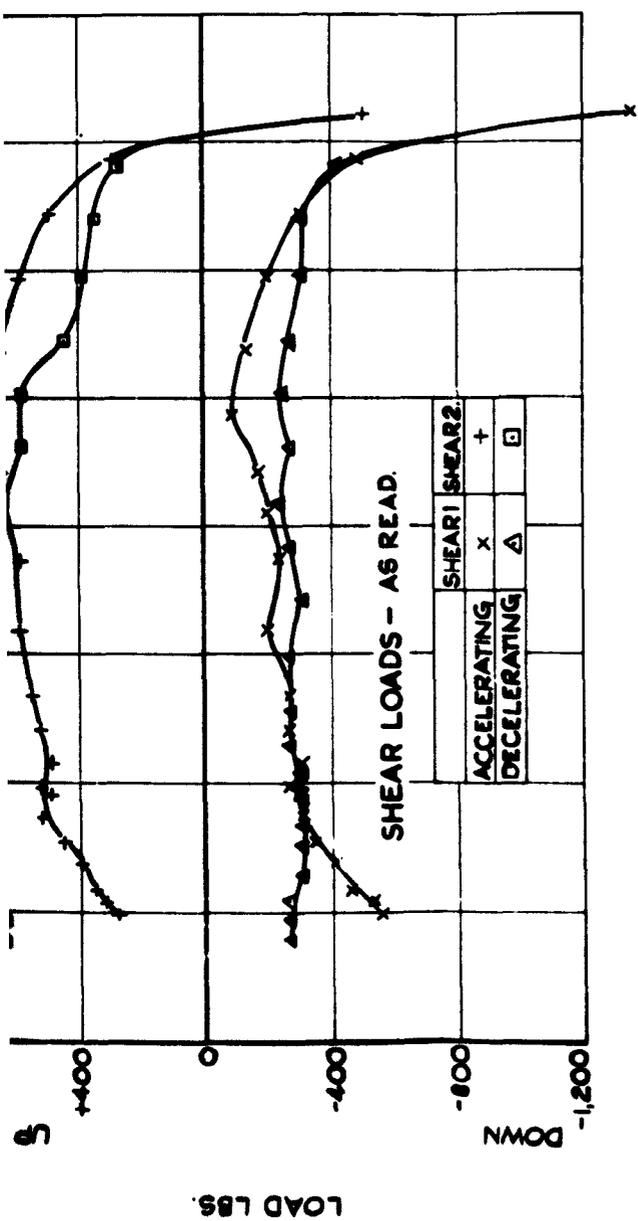
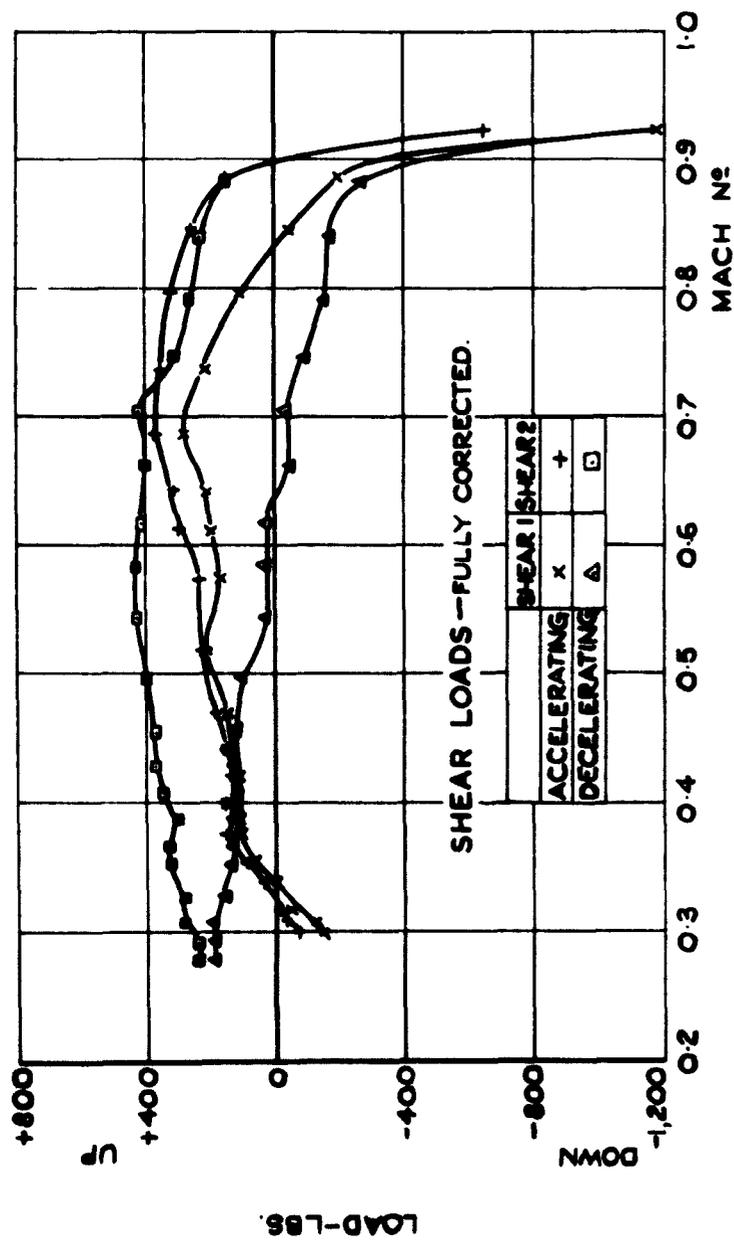
MEAN WEIGHT 14,900 LBS.
MEAN C.G. 30.2 % \bar{c} .

FIG. 13(b) LOADS MEASURED IN LEVEL FLIGHT AT 20,000 FEET - AFT C.G.
