TECHNICAL NOTE No. AERO. 2886

TESTS ON A HUNTER F.2 OF TWO
STRAIN GAUGE METHODS FOR
MEASURING TAILPLANE LOADS
IN FLIGHT, WITH SOME LOADS
MEASURED IN LEVEL FLIGHT,
PITCH-UPS AND TRANSONIC DIVES

APRIL, 1963

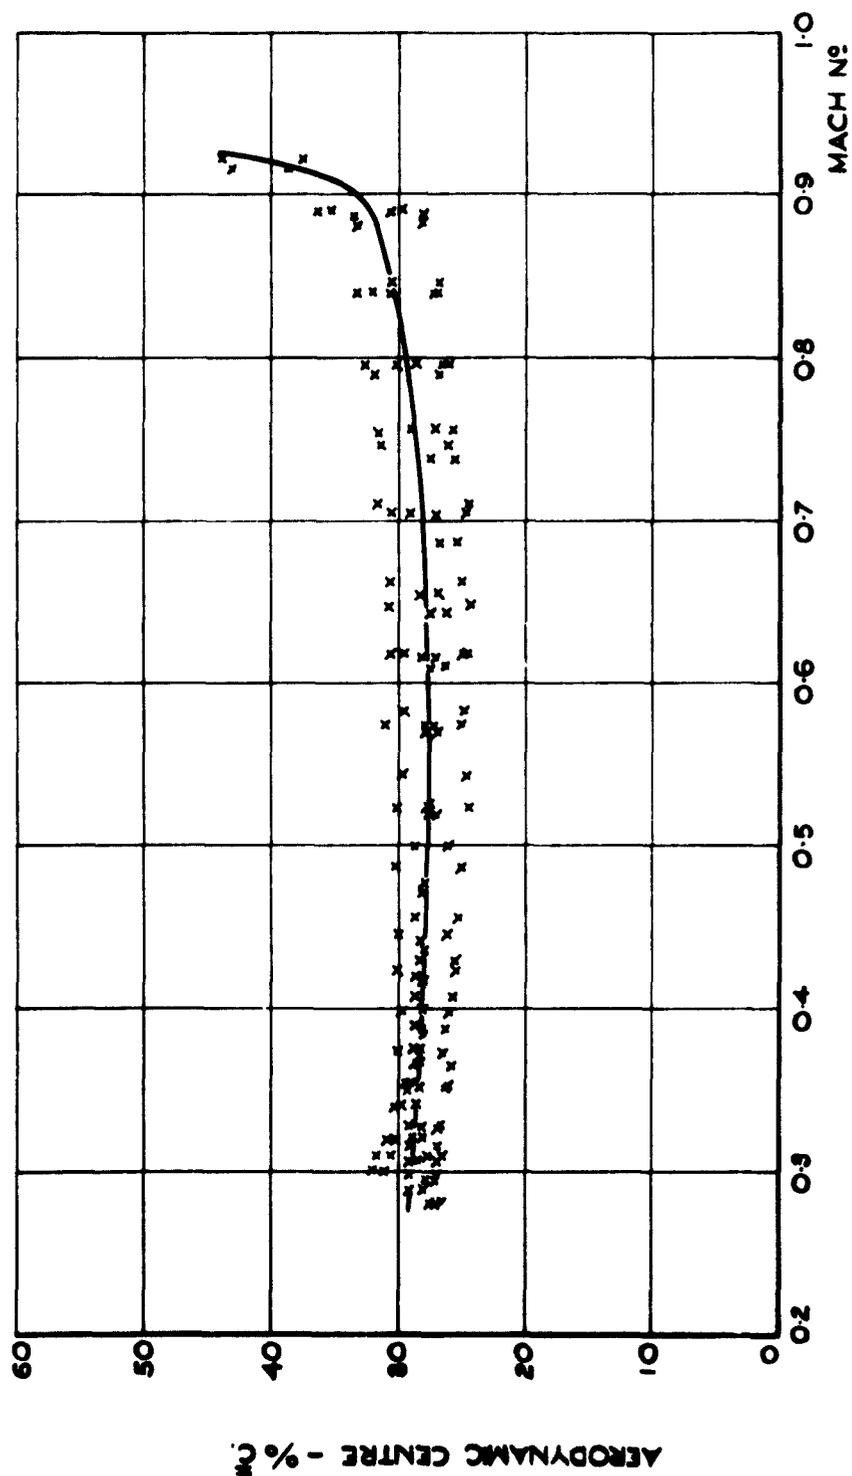
FIG. 14. AERODYNAMIC CENTRE OF WING PLUS FUSELAGE AHEAD OF SHEAR GAUGES.

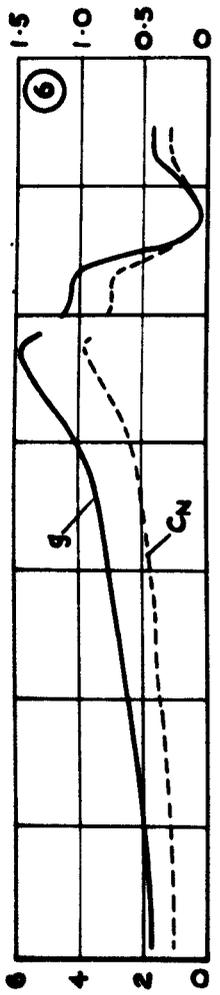
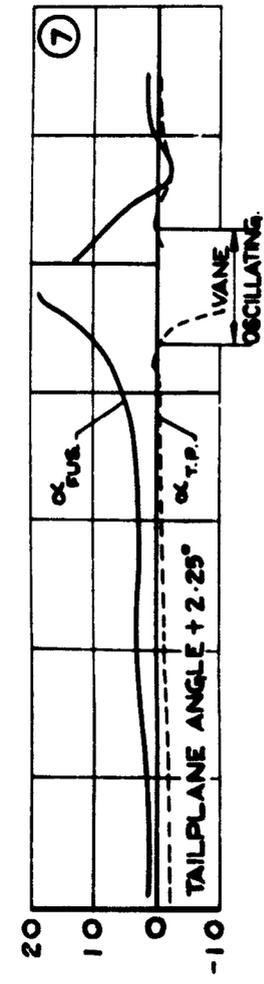
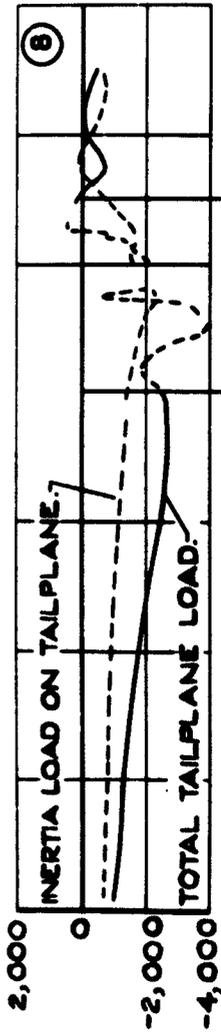
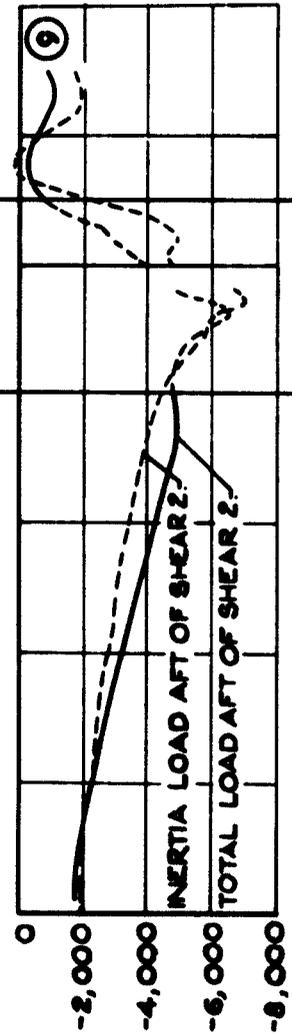
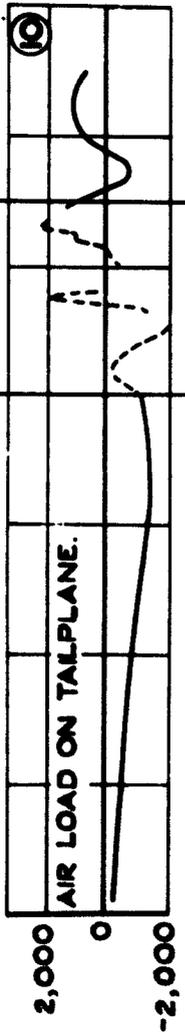
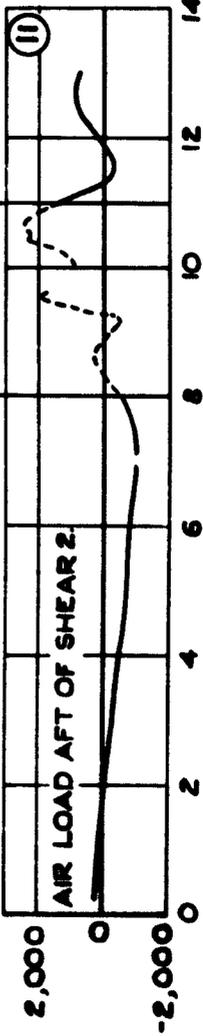
FIG.15(a) TIME HISTORY OF A PITCH-UP AT M=0.9, WITH IMMEDIATE RECOVERY.

The time history of a typical pitch-up at a Mach number of 0.9 is presented in Figs. 15a and 15b. In this pitch-up recovery action was taken as soon as the pitch-up started. The corrections which have been applied to the indicated loads in order to obtain aerodynamic loads are shown. The break in the records between the times 9.7 and 10 seconds is caused by an instrumentation fault. The other breaks in the load records are produced by the trace identifying interrupter.

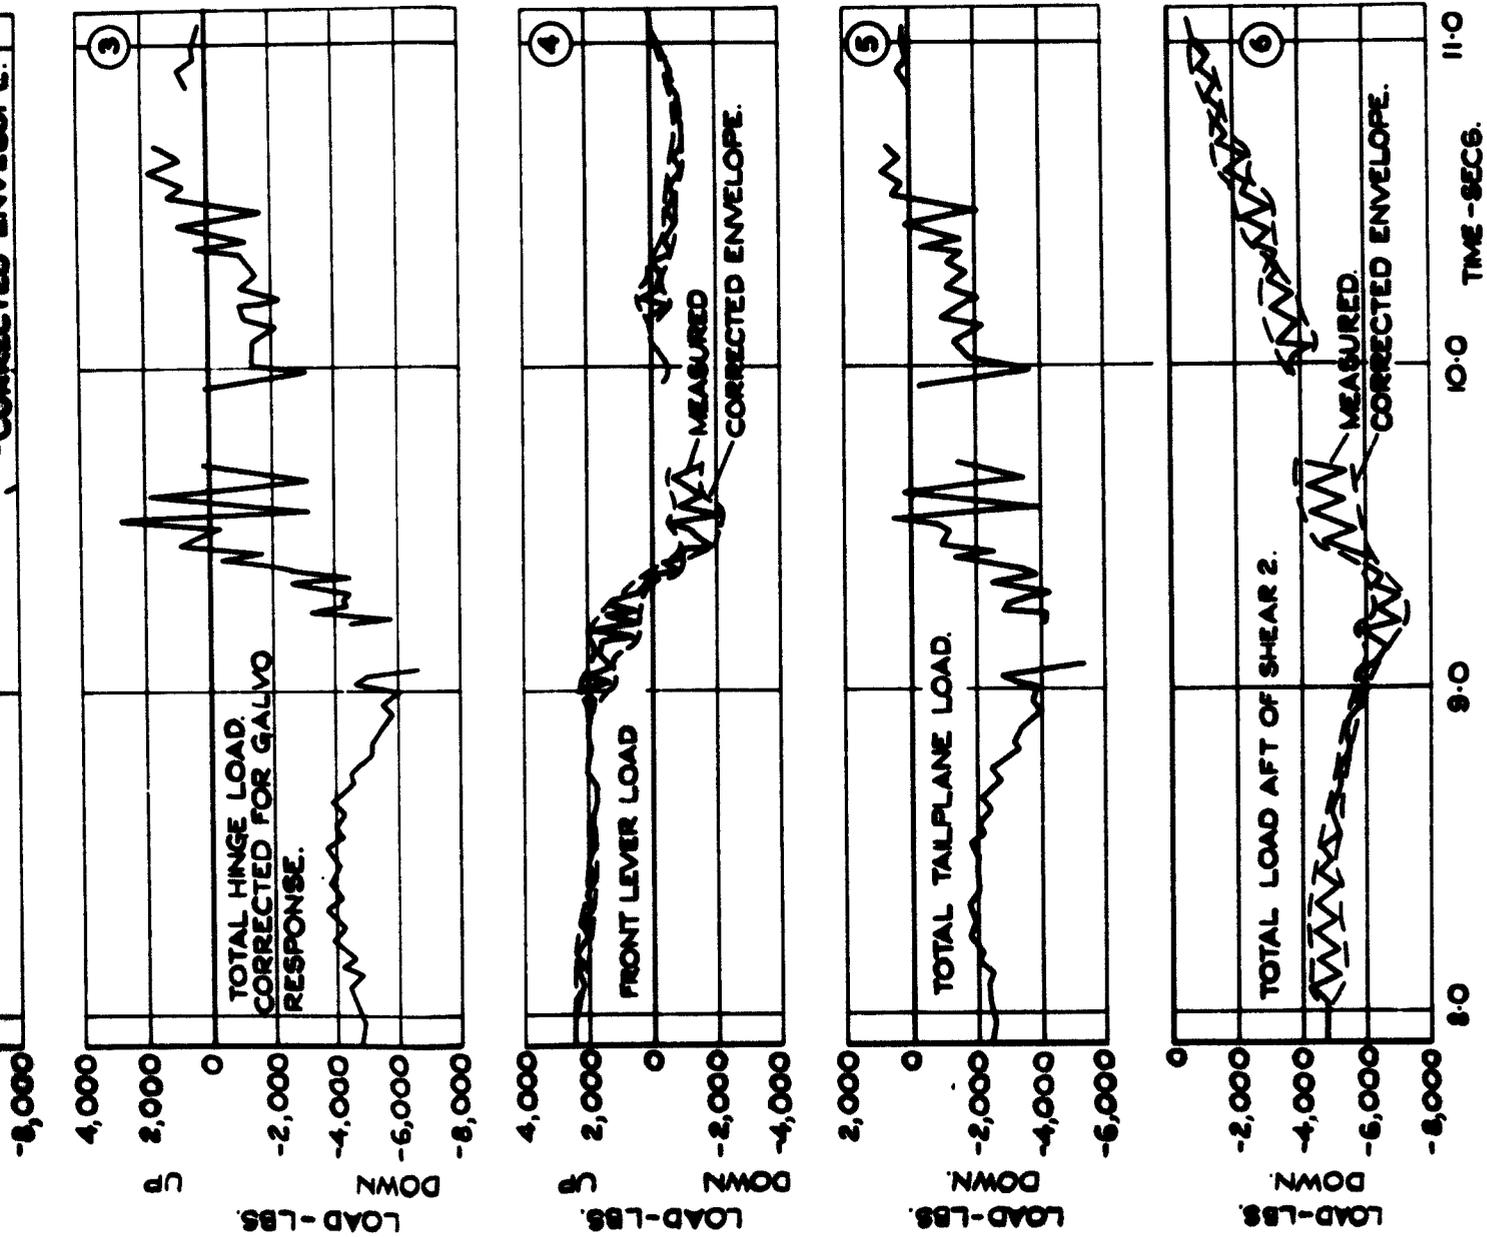
FIG.15(b) BUFFETING LOADS DURING THE PITCH-UP SHOWN IN FIG. 15(a)

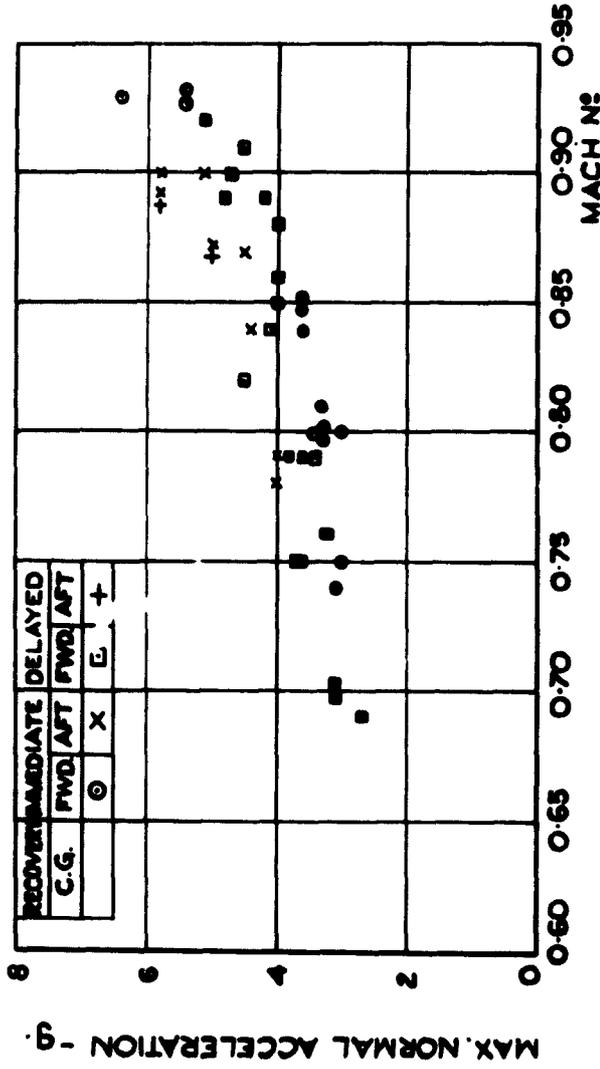
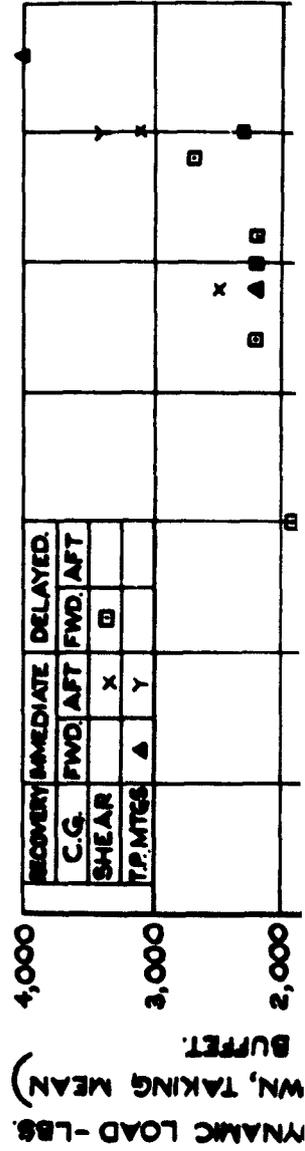
FIG.16. MAXIMUM NORMAL ACCELERATION IN PITCH -UPS.

The results obtained from pitch-ups at different Mach numbers at 35,000 feet are summarised in Figs.16-20. Pitch-ups were carried out at two centre of gravity positions, and with either immediate or delayed recovery action. The various test conditions are shown by different symbols in the figures, but, in general, any consistent differences due to centre of gravity position or type of recovery action are masked by the general scatter of the results. In Fig.16, which shows the maximum normal acceleration experienced in the different pitch-ups, it is perhaps possible to detect slightly higher levels of acceleration for the tests at an aft centre of gravity and with delayed recovery, but the effect is small.

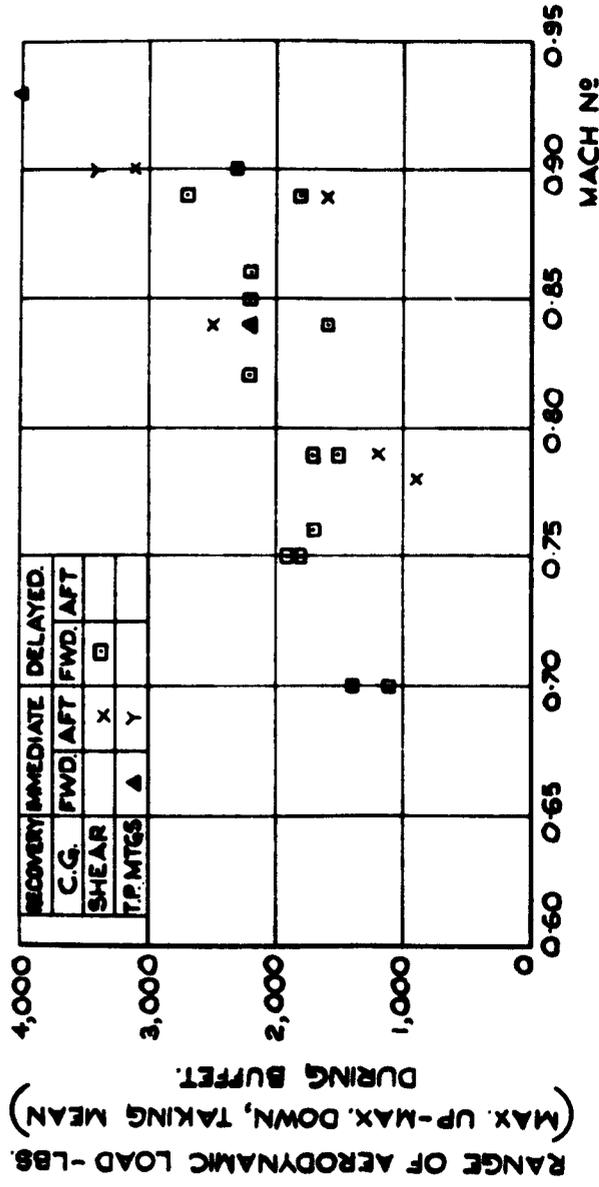
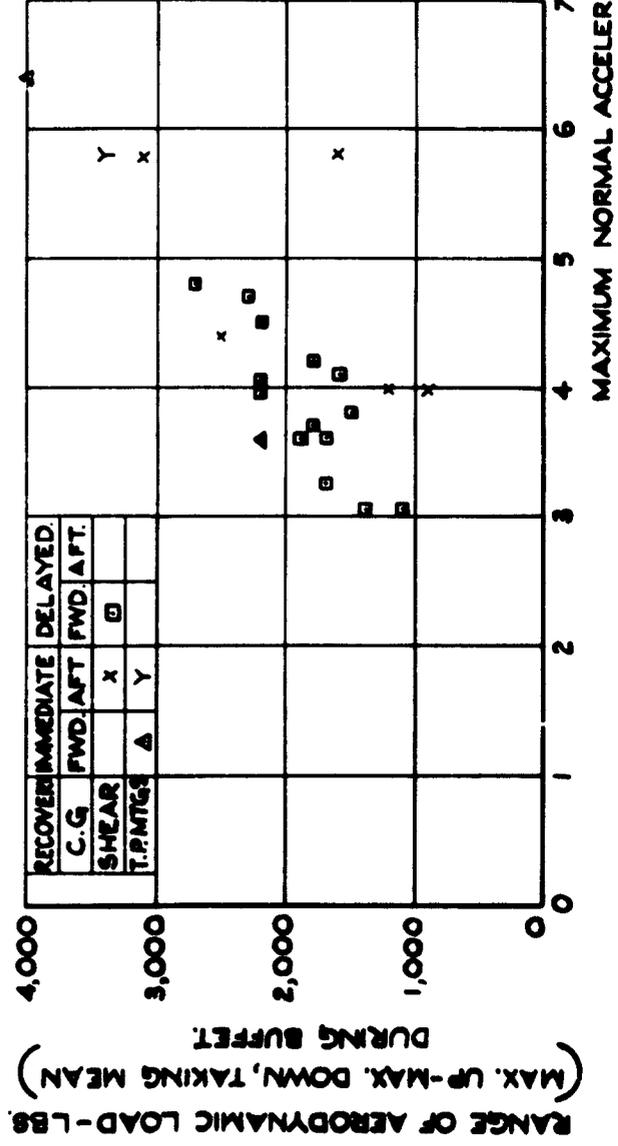
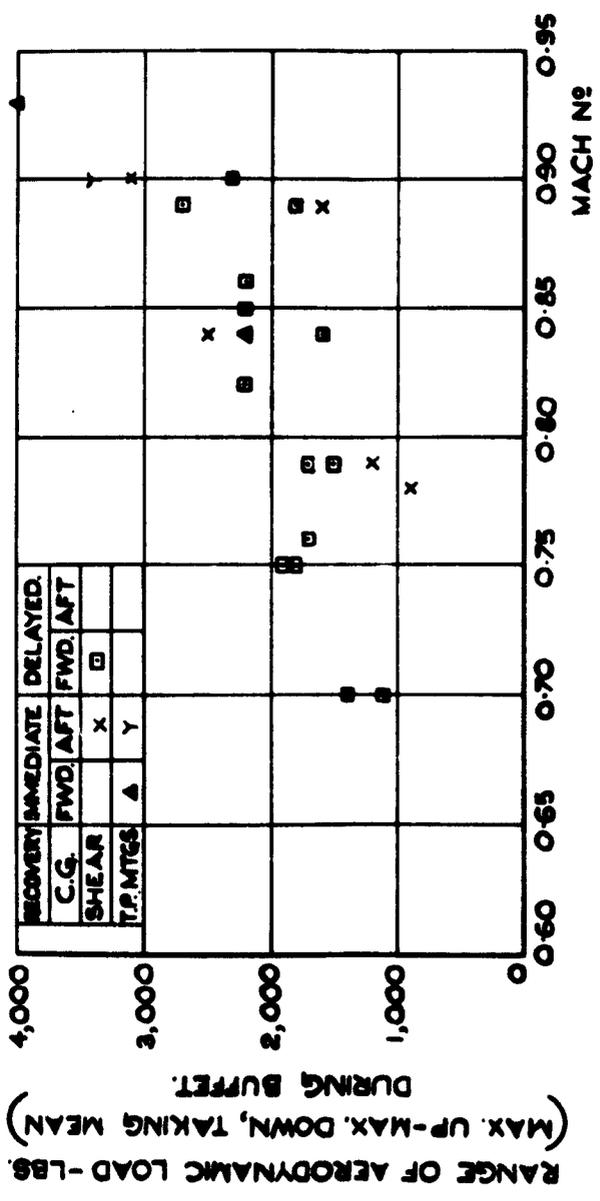
FIG.17. RANGE OF AERODYNAMIC LOAD IN PITCH—UPS, vs. MACH No.

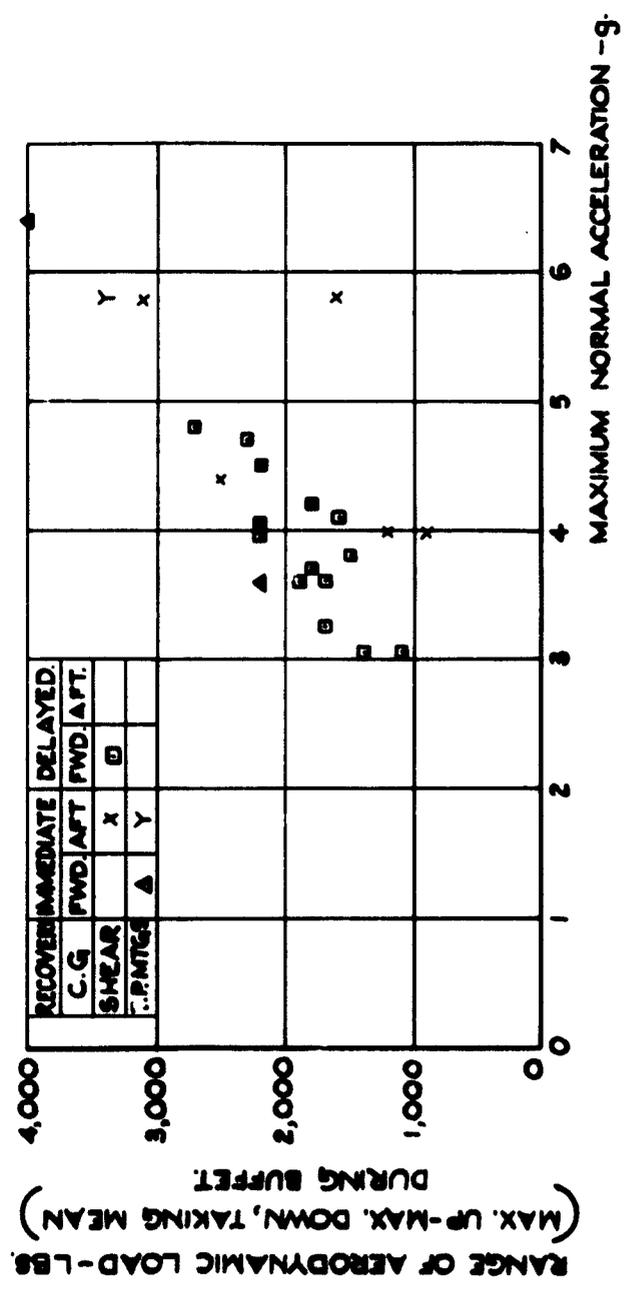
FIG.18. RANGE OF AERODYNAMIC LOAD IN PITCH-UPS, vs. MAX. NORMAL ACCELERATION

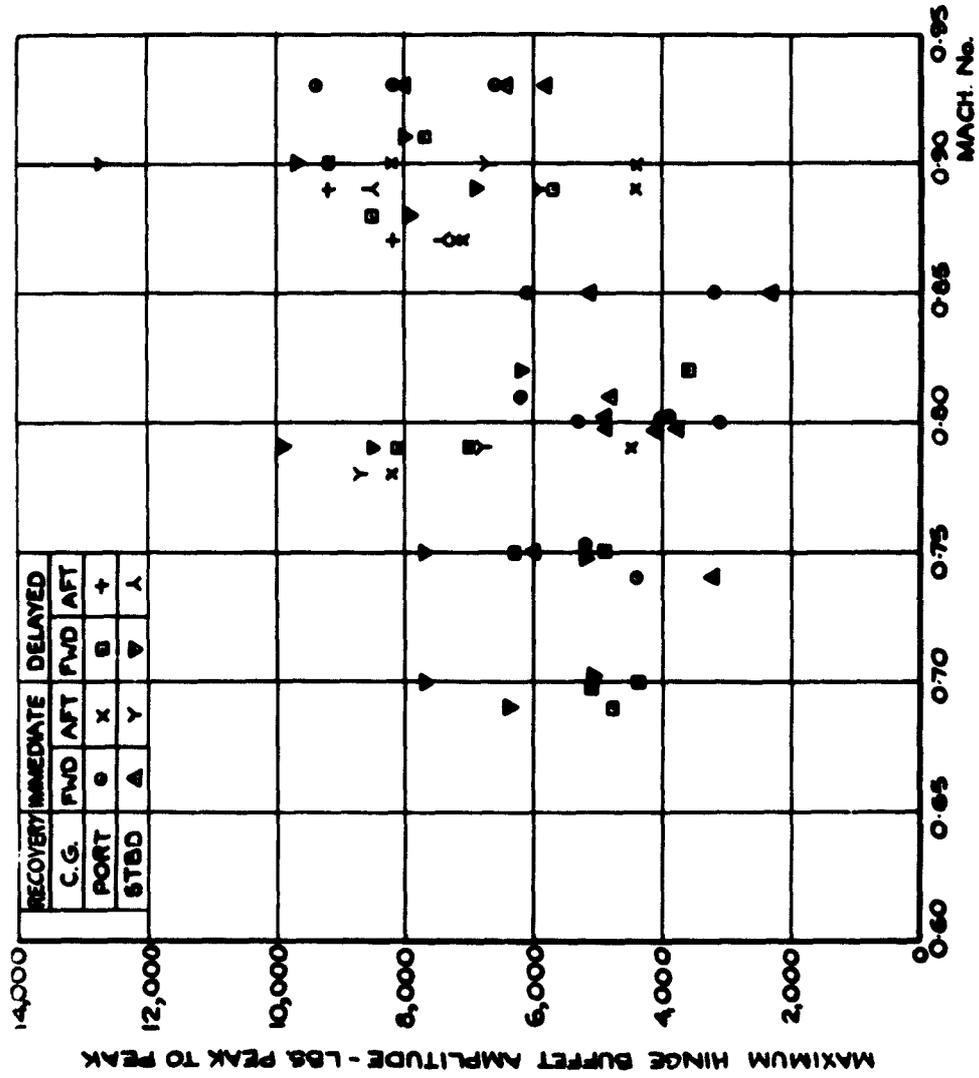
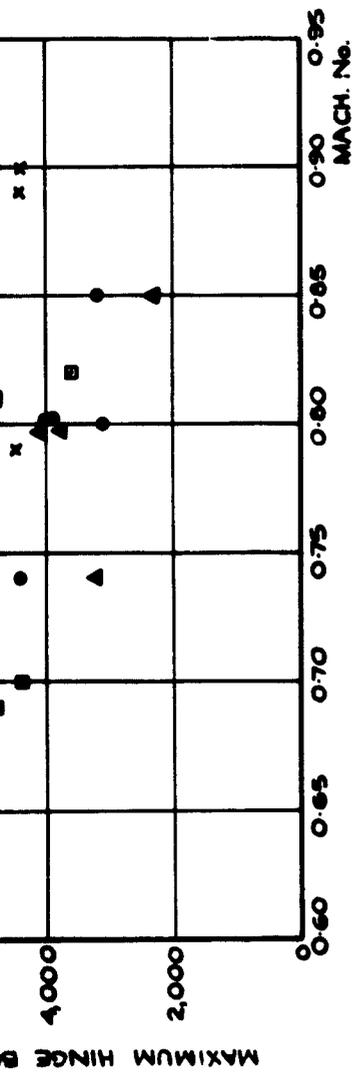
FIG. 19a. MAXIMUM HINGE BUFFET AMPLITUDE IN PITCH-UPS.

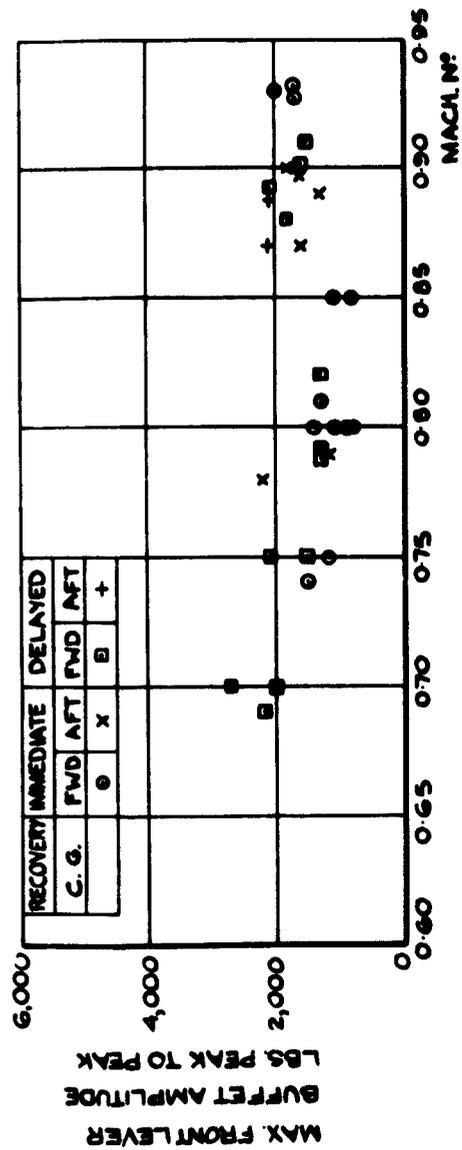
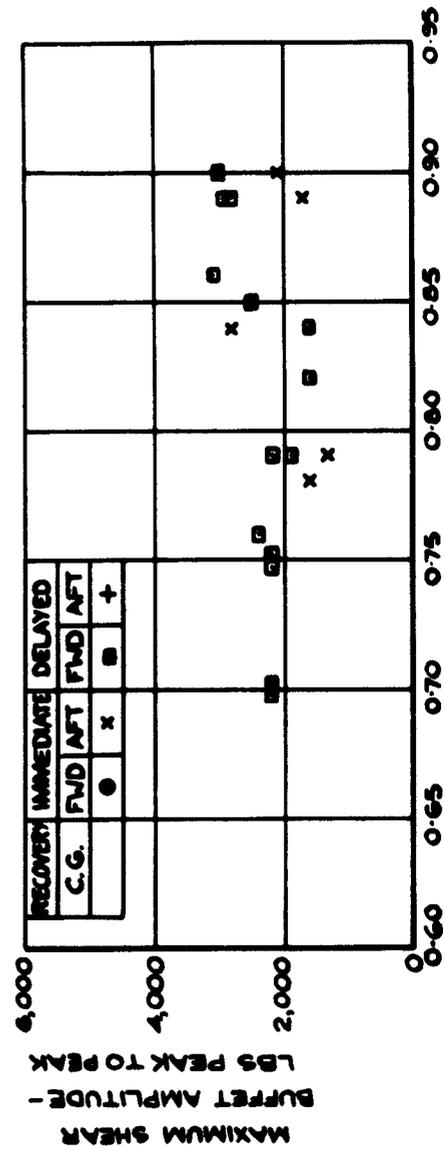
FIG. 19 b. MAXIMUM FRONT LEVER BUFFET AMPLITUDE PITCH-UPS.

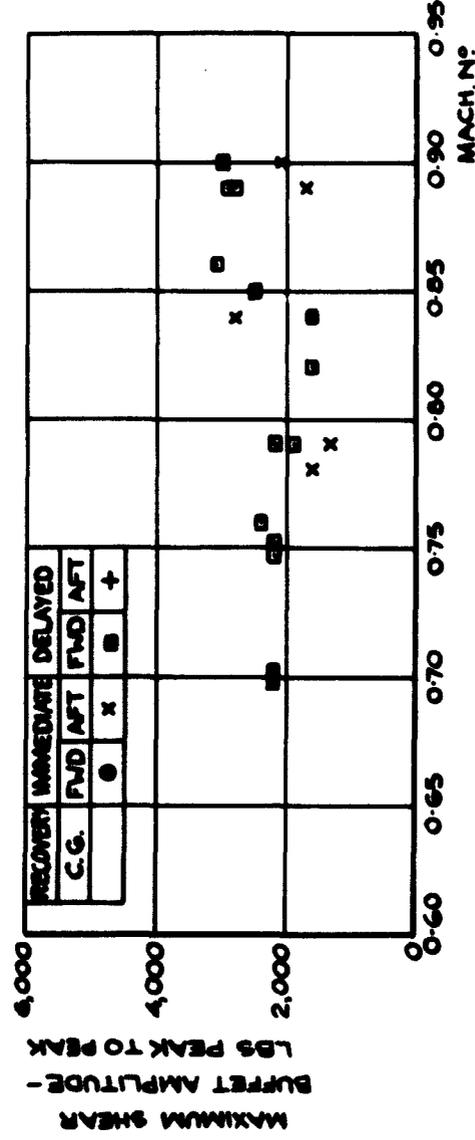
FIG. 19 c. MAXIMUM SHEAR BUFFET AMPLITUDE IN PITCH - UPS.

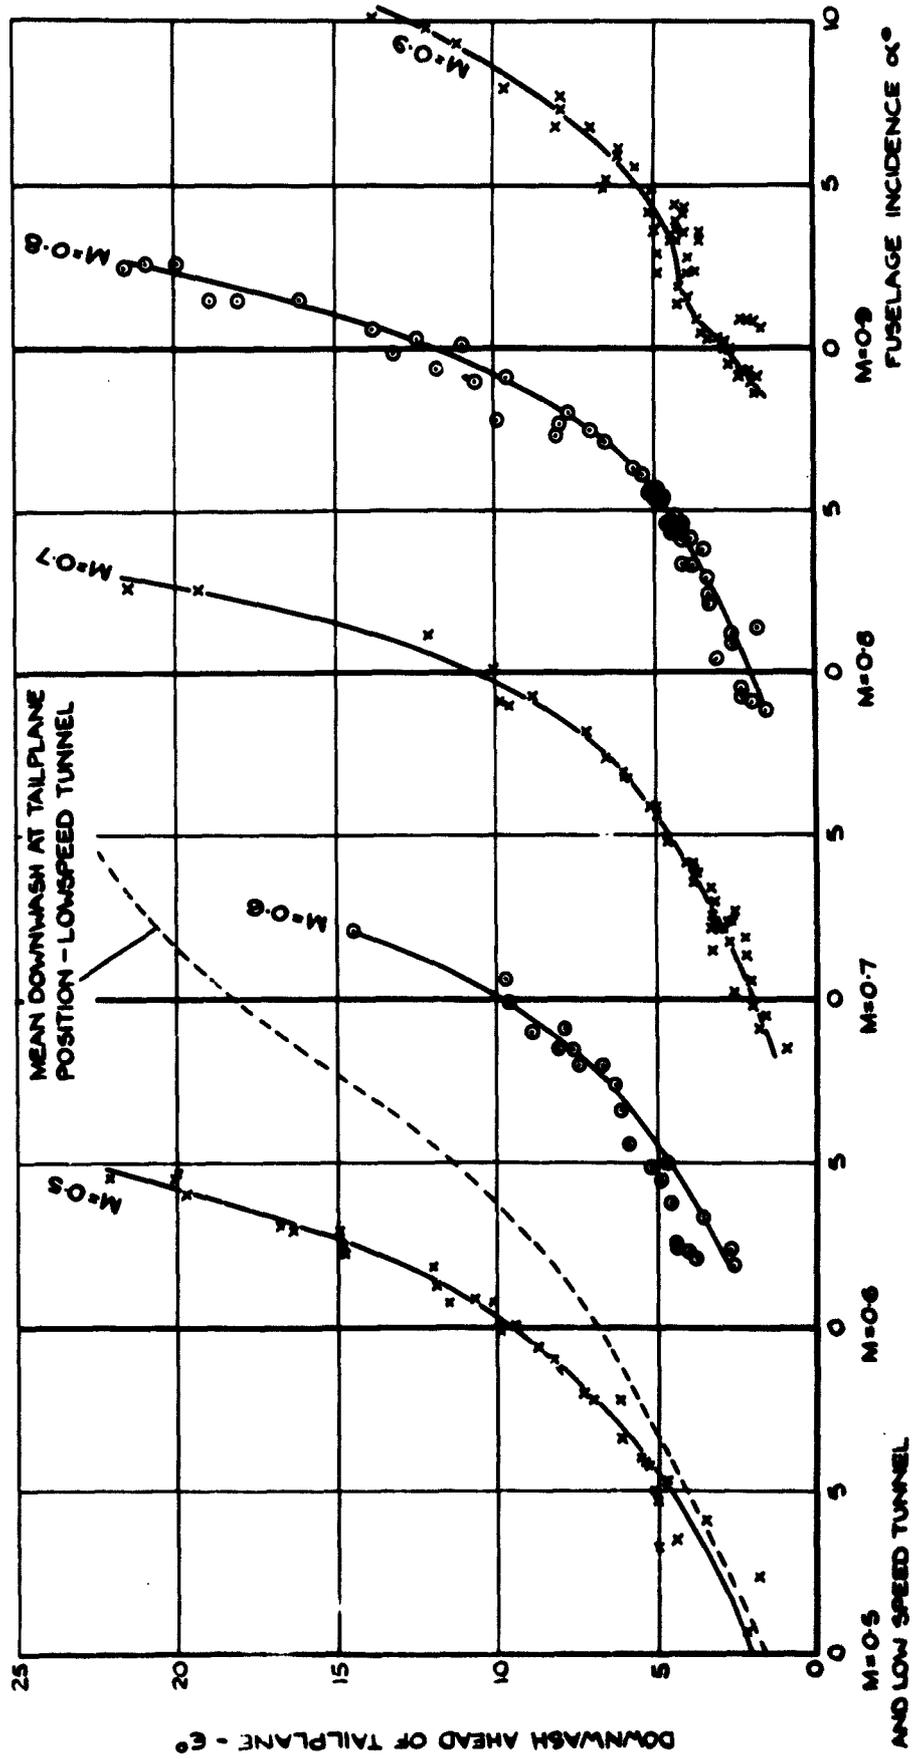
FIG. 20. DOWNWASH AHEAD OF TAILPLANE AT MID-SEMISPAN.

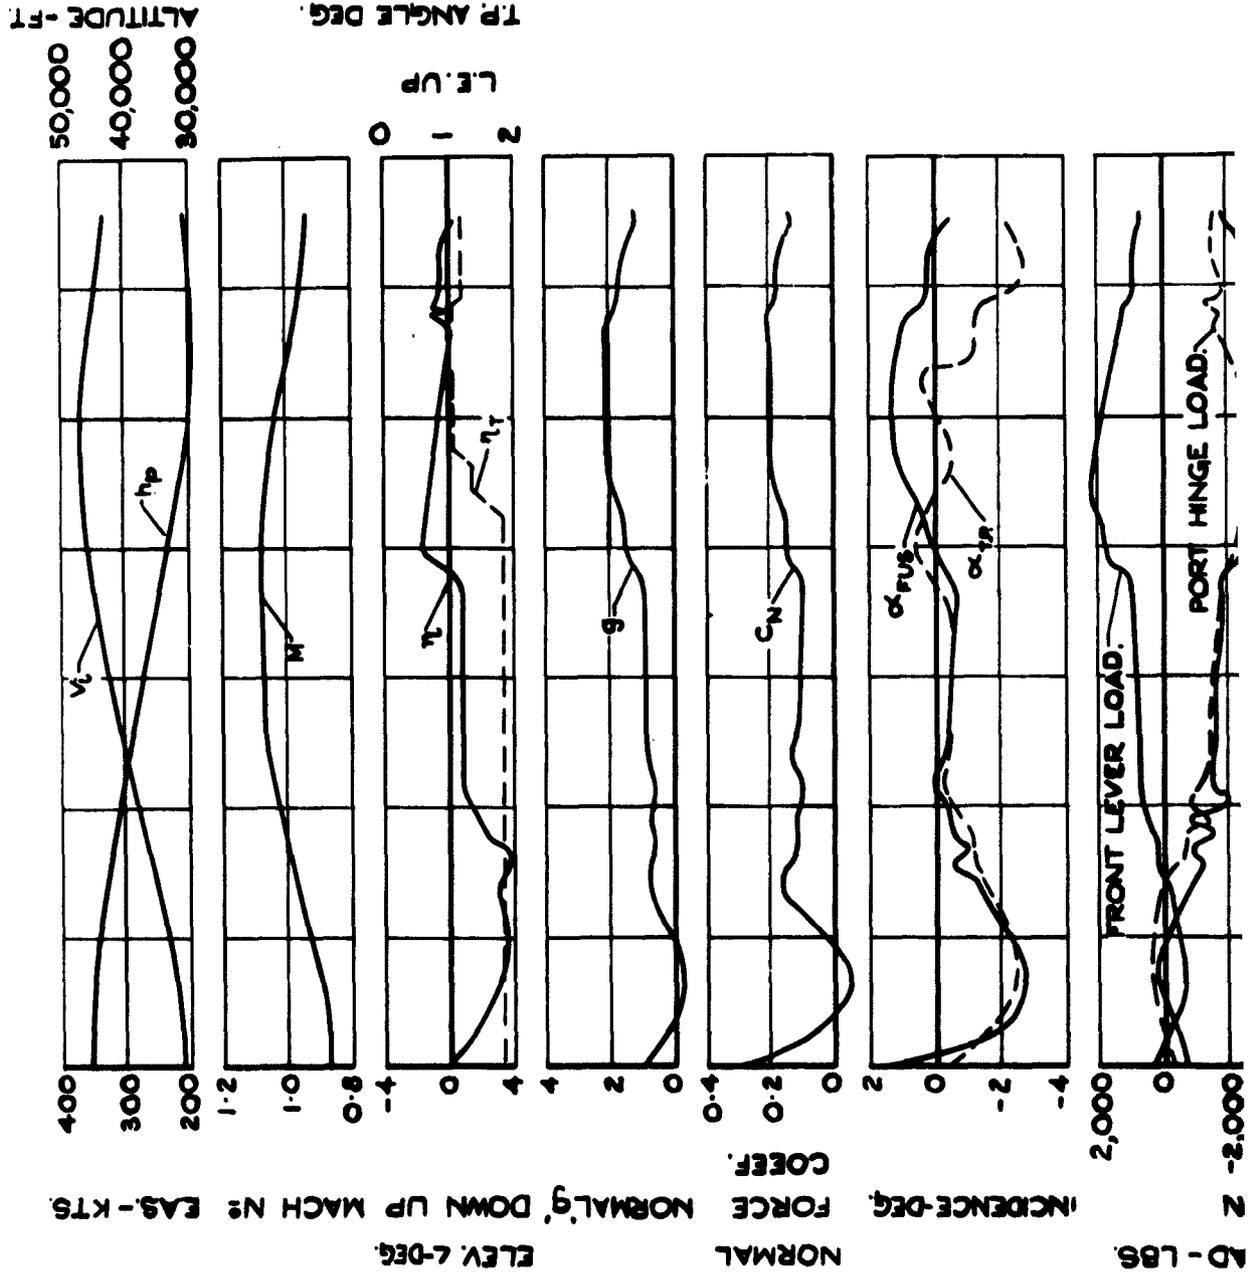
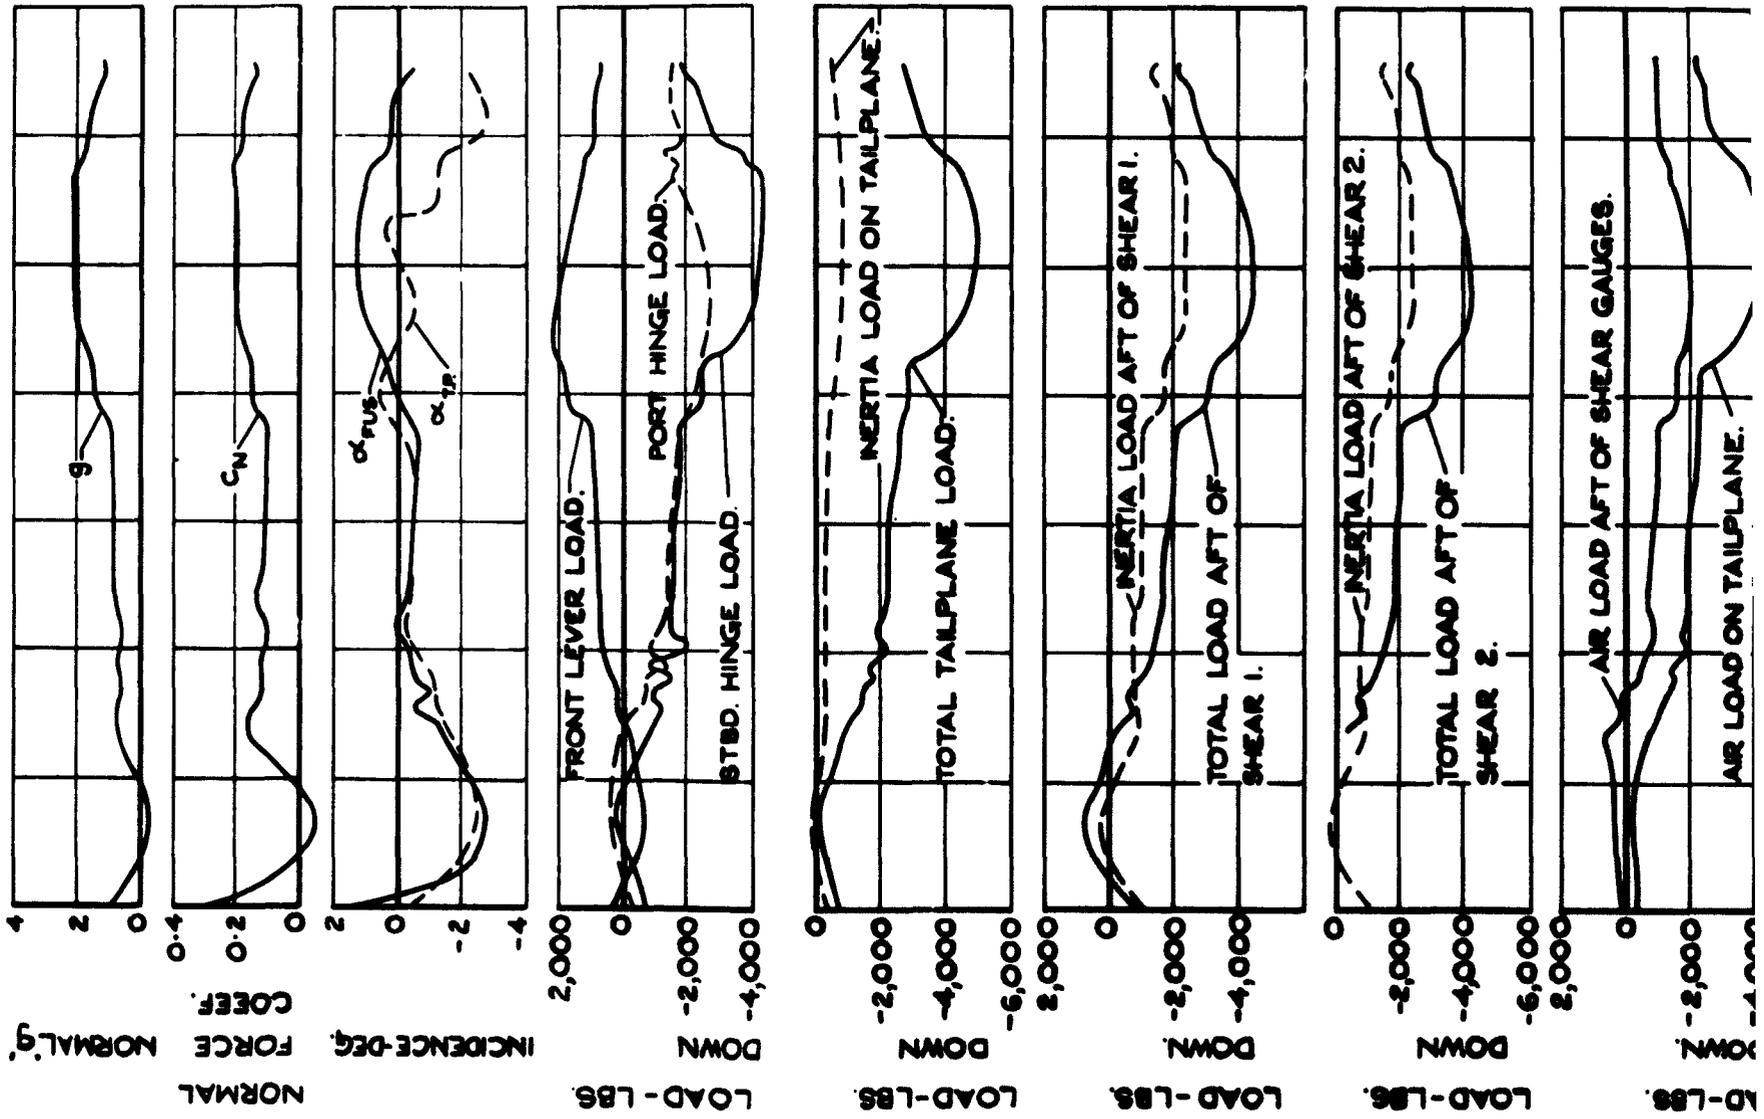
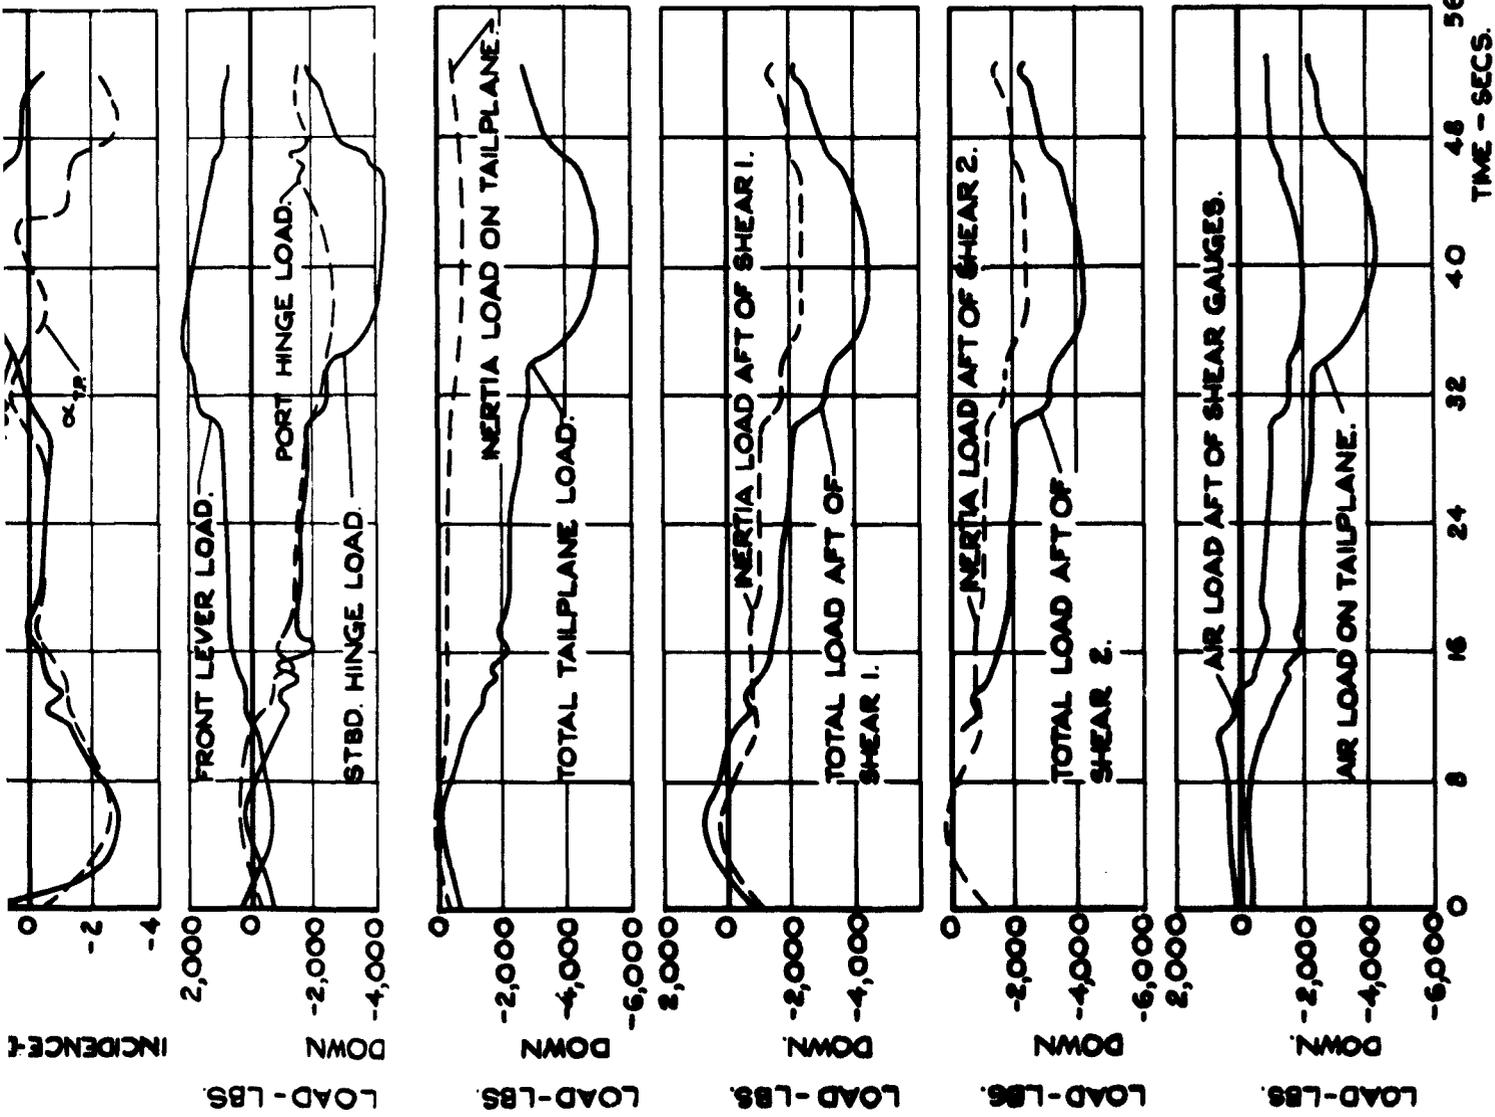
FIG. 21. TIME HISTORY OF A TRANSONIC DIVE.
