INVESTIGATION OF THE OCCURRENCE OF CONDENSATION IN FLIGHT INSTRUMENTS

BATTELLE MEMORIAL INSTITUTE

TECHNICAL REPORT SEG-TR-66-2

JANUARY 1966

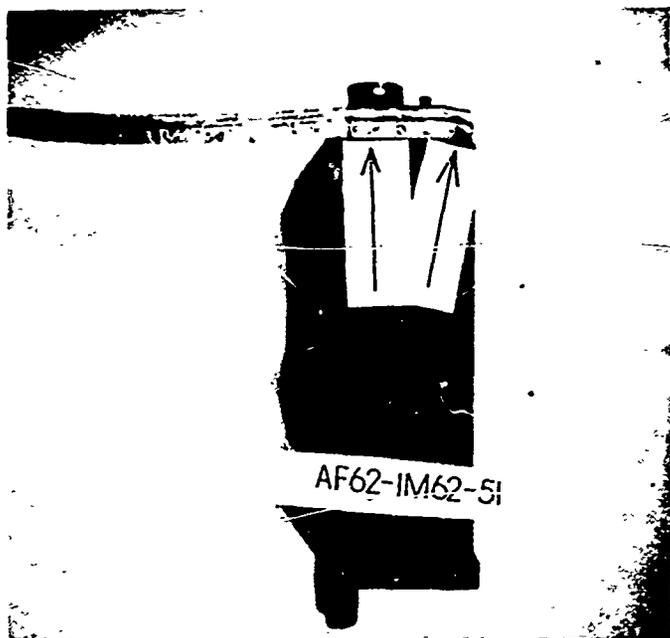
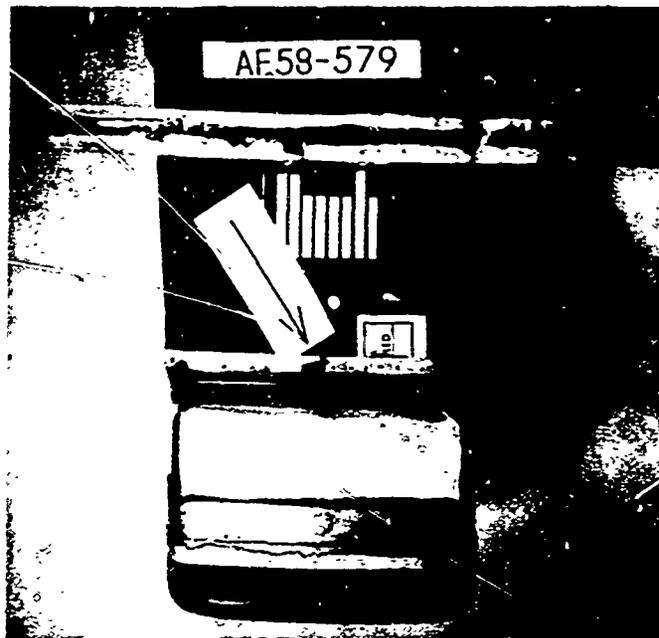
FIGURE 1. TYPICAL LEAKY HERMETIC SEALS

Instrument AF58-1322 was pressurized and placed under water. Bubbles could be seen escaping from two points (both on corners) around the tear strip. Removal of the tear strip showed that a proper seal had not been made at the points where leakage was occurring, due to imperfect contact of the strip with the solder on the case.

Examination of the tear strip on other instruments showed similarly poor contact of the strip with the underlying solder, giving a poor seal that could (and probably did) result in leaks in the hermetic seal.

Figure 1 shows some typical examples of defective tear-strip seals. The dark areas in the photographs are places where the solder did not contact the tear strip, thus leaving an opening where humid air could enter or leave the instrument with temperature and pressure changes.

It is strongly recommended that the seal of these instruments be investigated with the goal of redesigning either the seal or the method of making it, since it is apparent that at least a major portion of the moisture-fog problem can be attributed to humid air entering the imperfectly sealed case, carrying with it an appreciable quantity of moisture vapor.

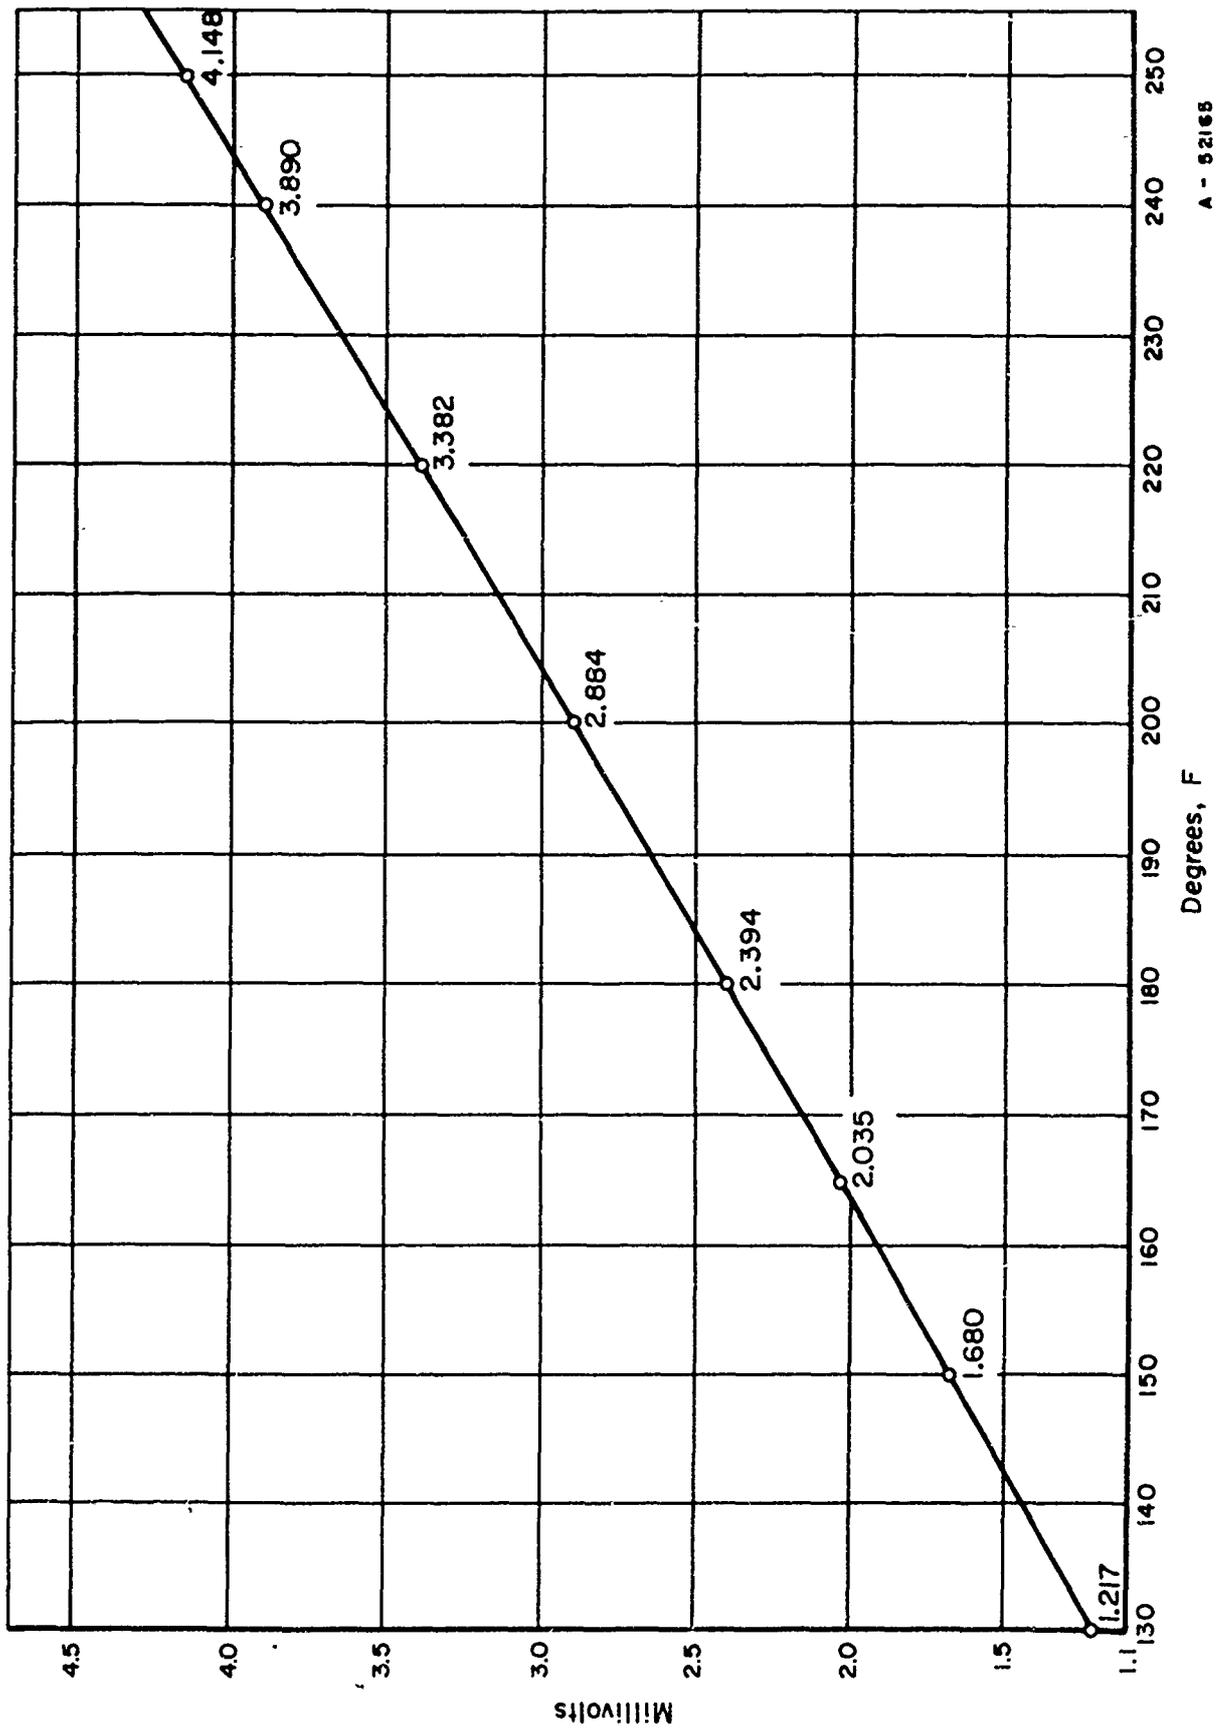
FIGURE 5. REVISED COPPER-CONSTANTAN CALIBRATION

Reference Junction - 75 F.
