Technical Report

WINDOWS FOR EXTERNAL OR INTERNAL
HYDROSTATIC PRESSURE VESSELS

PART II. Flat Acrylic Windows Under Short-Term
Pressure Application

NAVAL FACILITIES ENGINEERING COMMAND

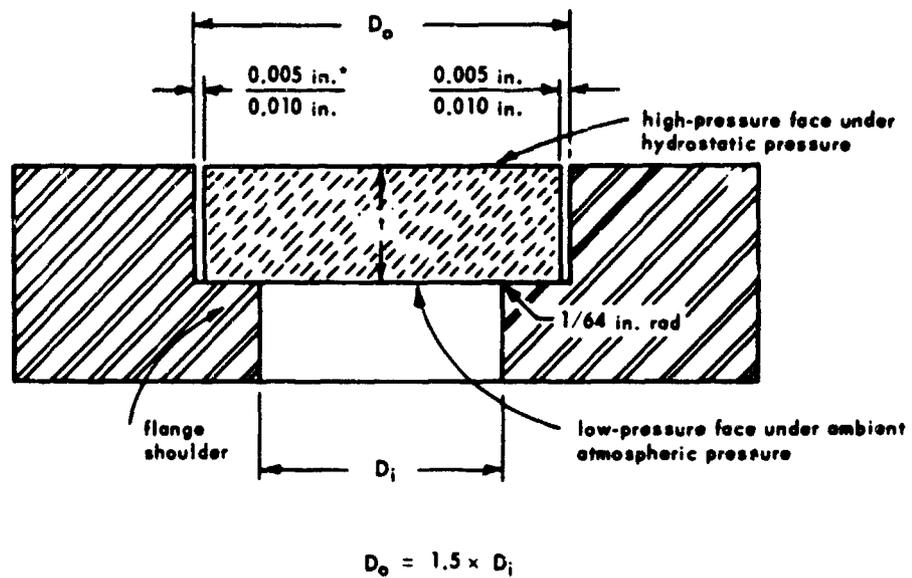
Figure 1. DOL type III flange configuration for short-term testing of flat acrylic windows.

The window test specimens for this study (Table 1) were fabricated by lathe turning Plexiglas grade G sheet stock. The circular disks (Figure 1) thus formed had an overall diameter (D_o) of 0.010 inch to 0.020 inch less than the flange's high-pressure opening diameter (D_o), permitting the window to seat in its flange cavity with 0.005 to 0.010 inch radial clearance. The manufacturer's tolerances for variation in the nominal thickness of commercial sheets were accepted for the thickness tolerance of the finished circular flat windows. The finish of the disk edges was held to 32 rms. Dimensions recorded were the average of micrometer measurements taken at three different locations for the window's diameter and for its thickness.

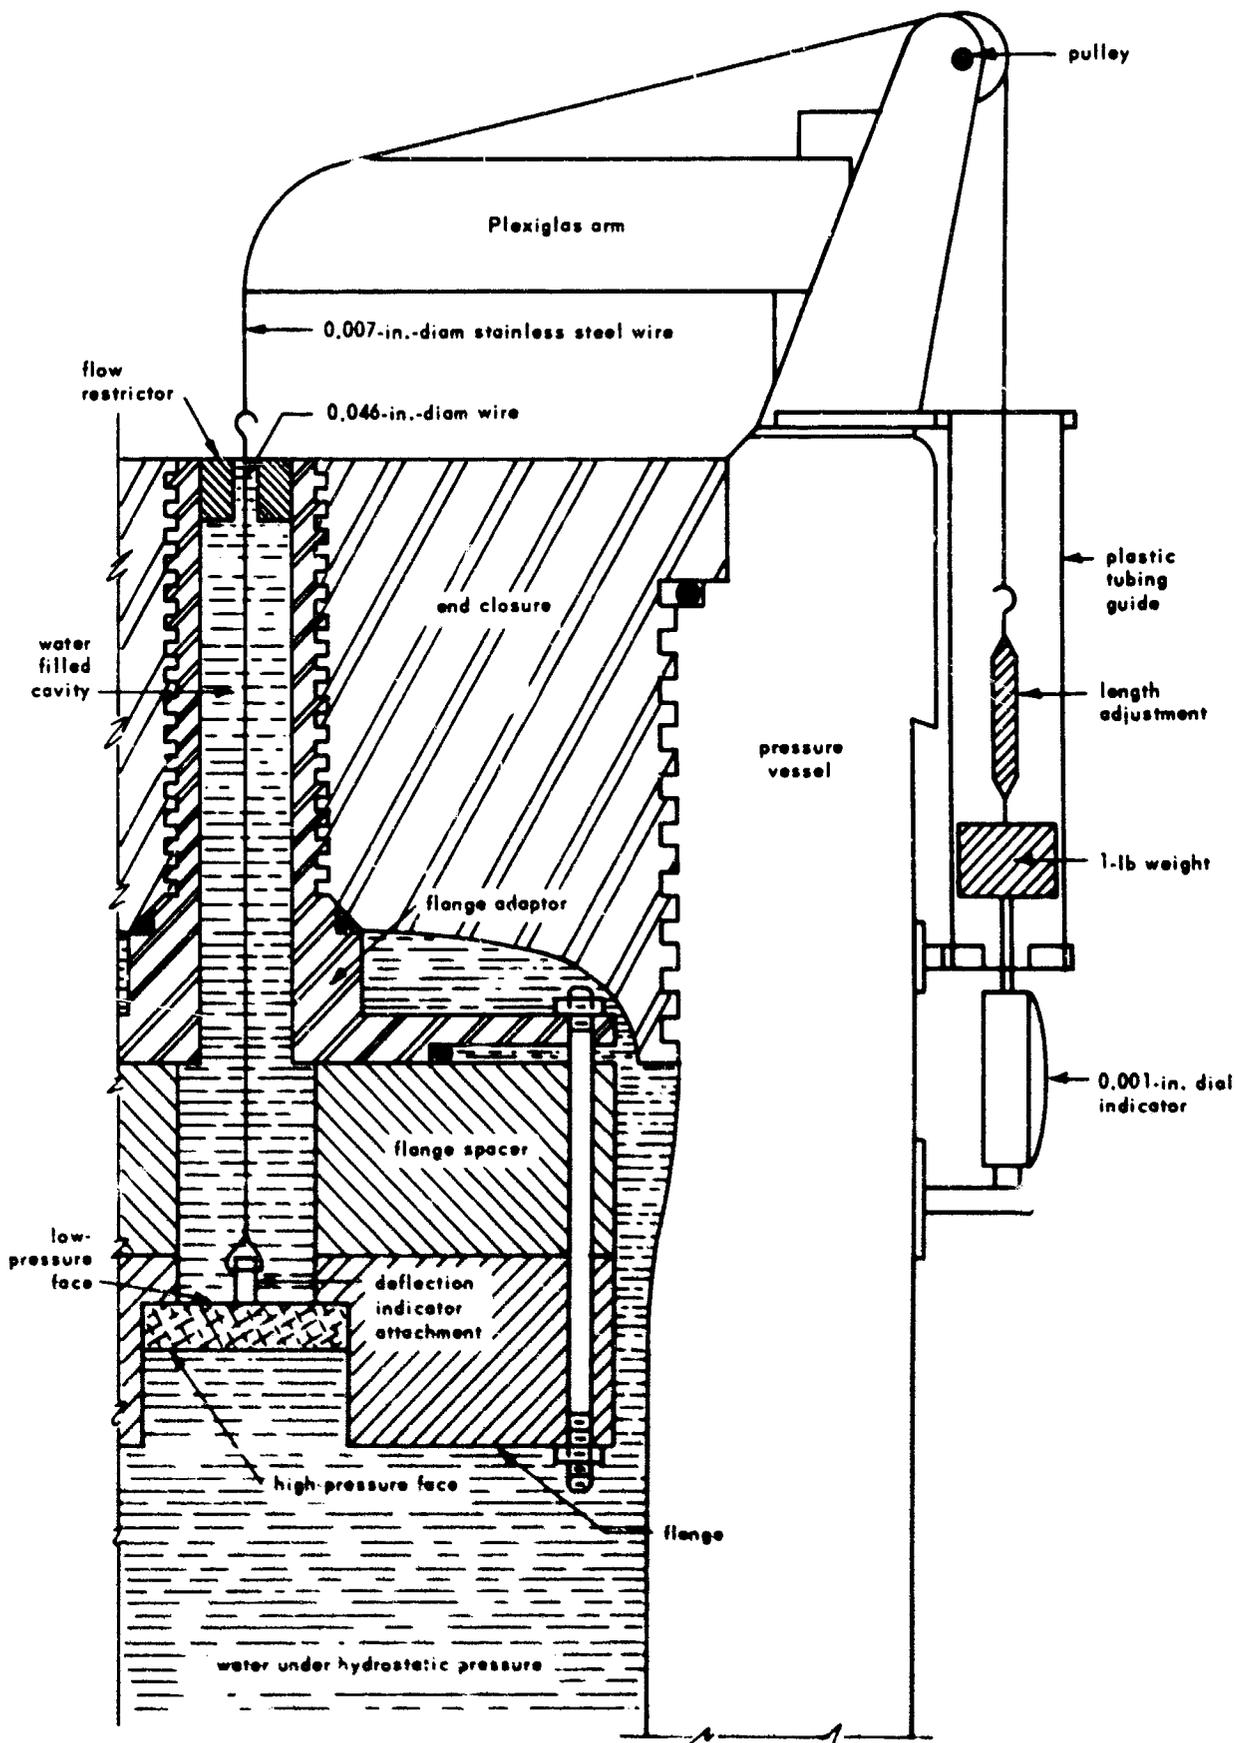
Figure 5. Schematic drawing of deflection measuring apparatus and flange mounting used in the testing of windows.

The hydrostatic testing consisted of pressurizing a flange-mounted window (Figure 5) until failure occurred. Since the window flange is open on one side to the atmosphere, window fragments were ejected upon its failure (Figure 6). The displacement of the window's low-pressure face during pressurization was measured to ± 0.001 inch by means of a wire that transmitted the displacement of the window to a mechanical dial indicator over a pulley system without any mechanical amplification (Figures 5 and 7). To permit the attachment of a displacement indicator wire to the center of the window's low-pressure face, a short acrylic rod with a small transverse hole in one end was bonded to the window's surface with solvent-type cement. The displacement of the window under hydrostatic pressure was read directly from the dial indicator with a closed-circuit television system that permitted the operators to be in a safe location during the ejection of the window from its retaining flange when critical pressure was reached (Figures 8 and 9).

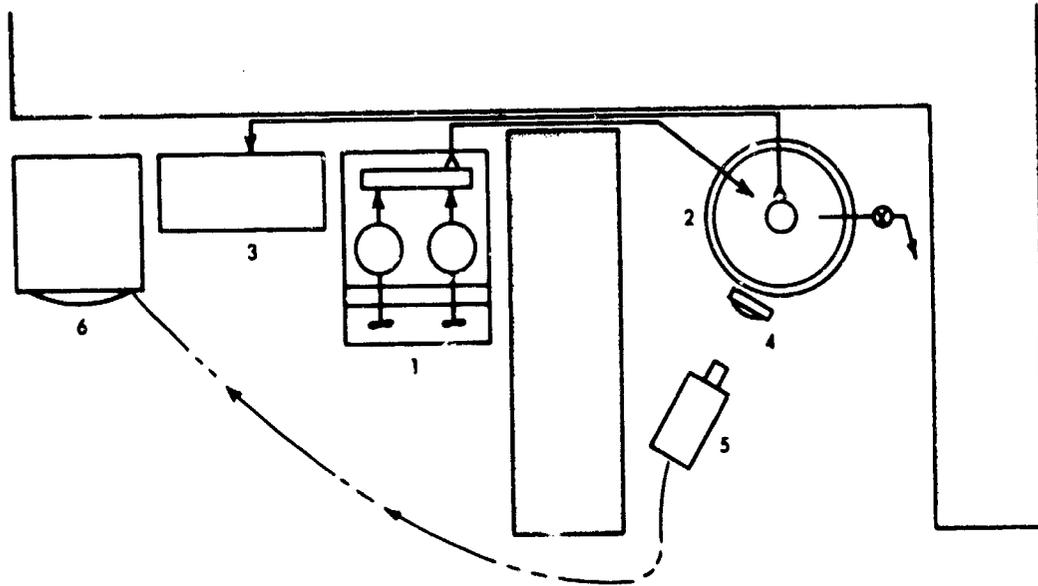
Air-driven positive displacement pumps (1) supply water under pressure to the Mk I 9-in. pressure vessel (2). Pressure is monitored by gage (3) and recorded. Dial indicator (4) is watched via closed-circuit television camera (5) and monitor (6). Operator is thus enabled to record data behind safety barricade.

Figure 8. Schematic plan of experimental setup.

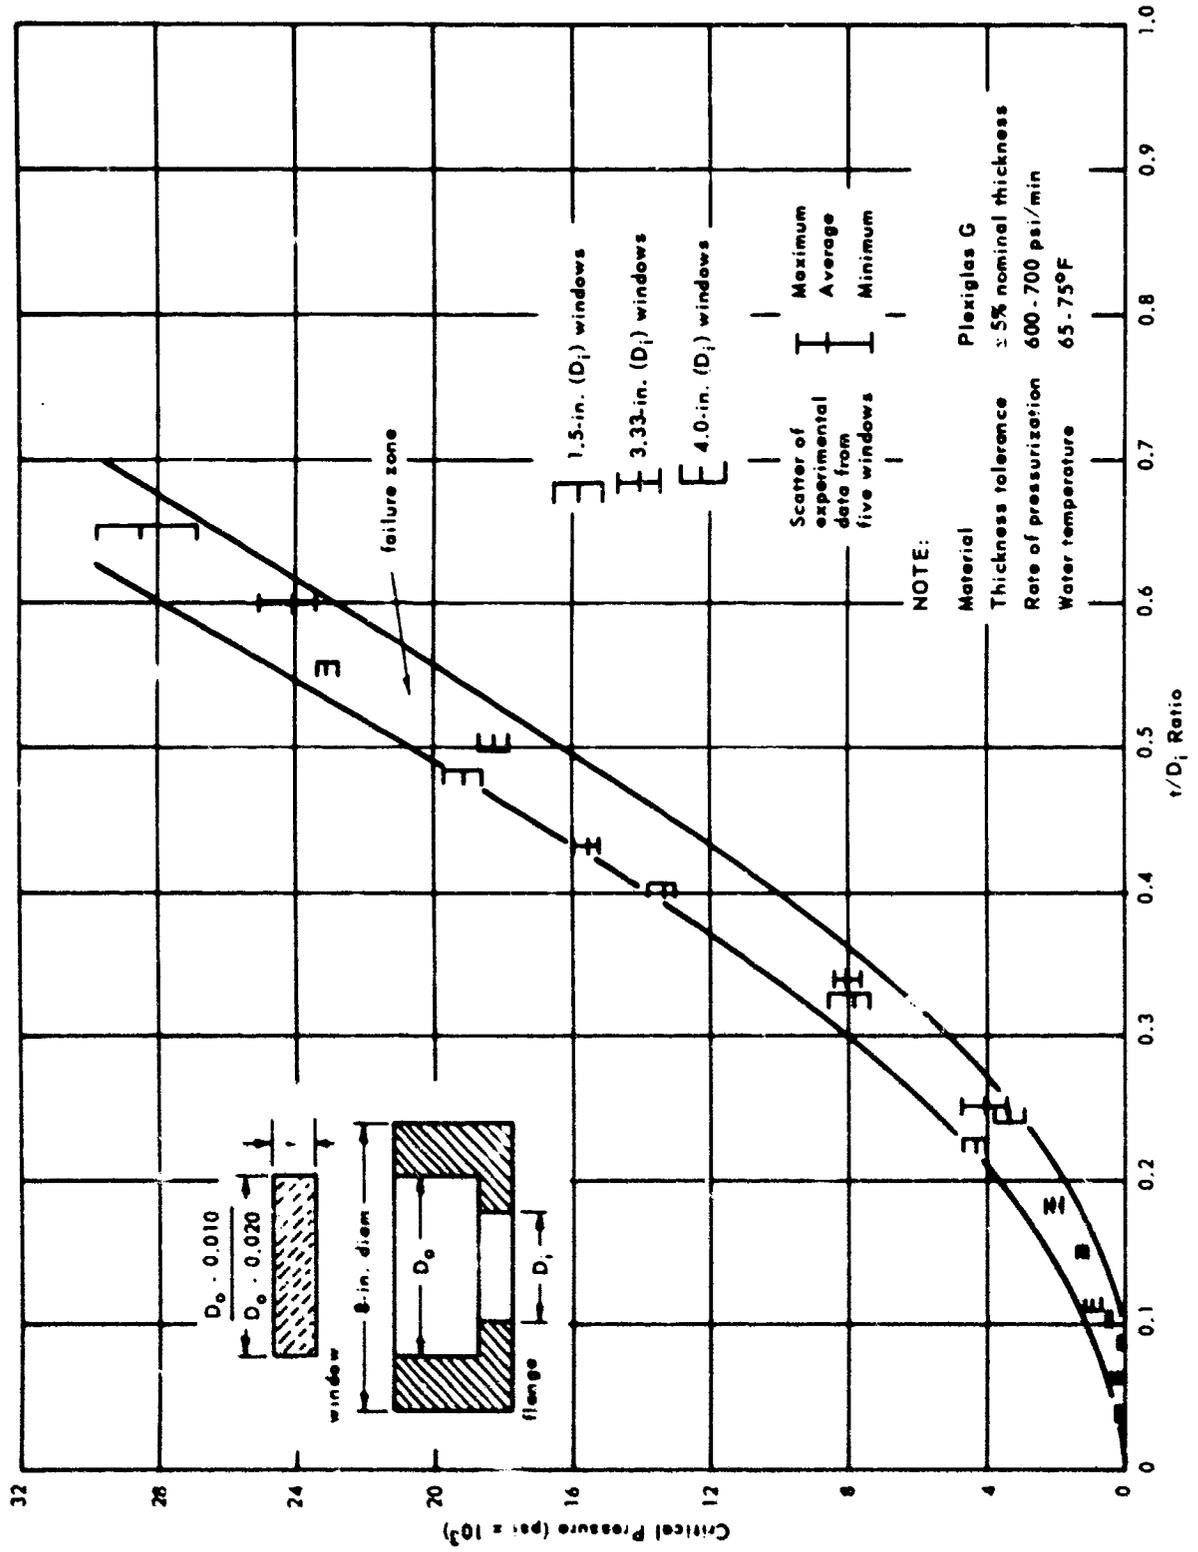
Figure 10. The experimental relationship between critical pressure and t/D_i ratio for flat acrylic windows with D_o/D_i ratio equal to 1.5.

The flat acrylic windows failed either in flexure or in shear, depending on their t/D_i ratio. The failure modes and mechanisms are discussed in detail in Appendix B, and deflection data are presented in Appendix C. In most cases, the center of the window was ejected in the form of small fragments, while in few cases in the low t/D_i ratio range the center was not ejected, as the formation of large cracks in the window at low pressure vented the pressurized water, and thus removed the energy required for ejection of the window. The critical pressures of windows were found to vary exponentially with their t/D_i ratio. When the critical pressures of windows with the same D_o/D_i and t/D_i ratios, and effective diameters of 1.50, 3.33, and 4.00 inches were plotted on the same graph (Figure 10) they were found to fall in the same failure region. This indicates that the critical pressure of a flat acrylic window is dependent only on the t/D_i ratio (and the mounting of the window in the flange).

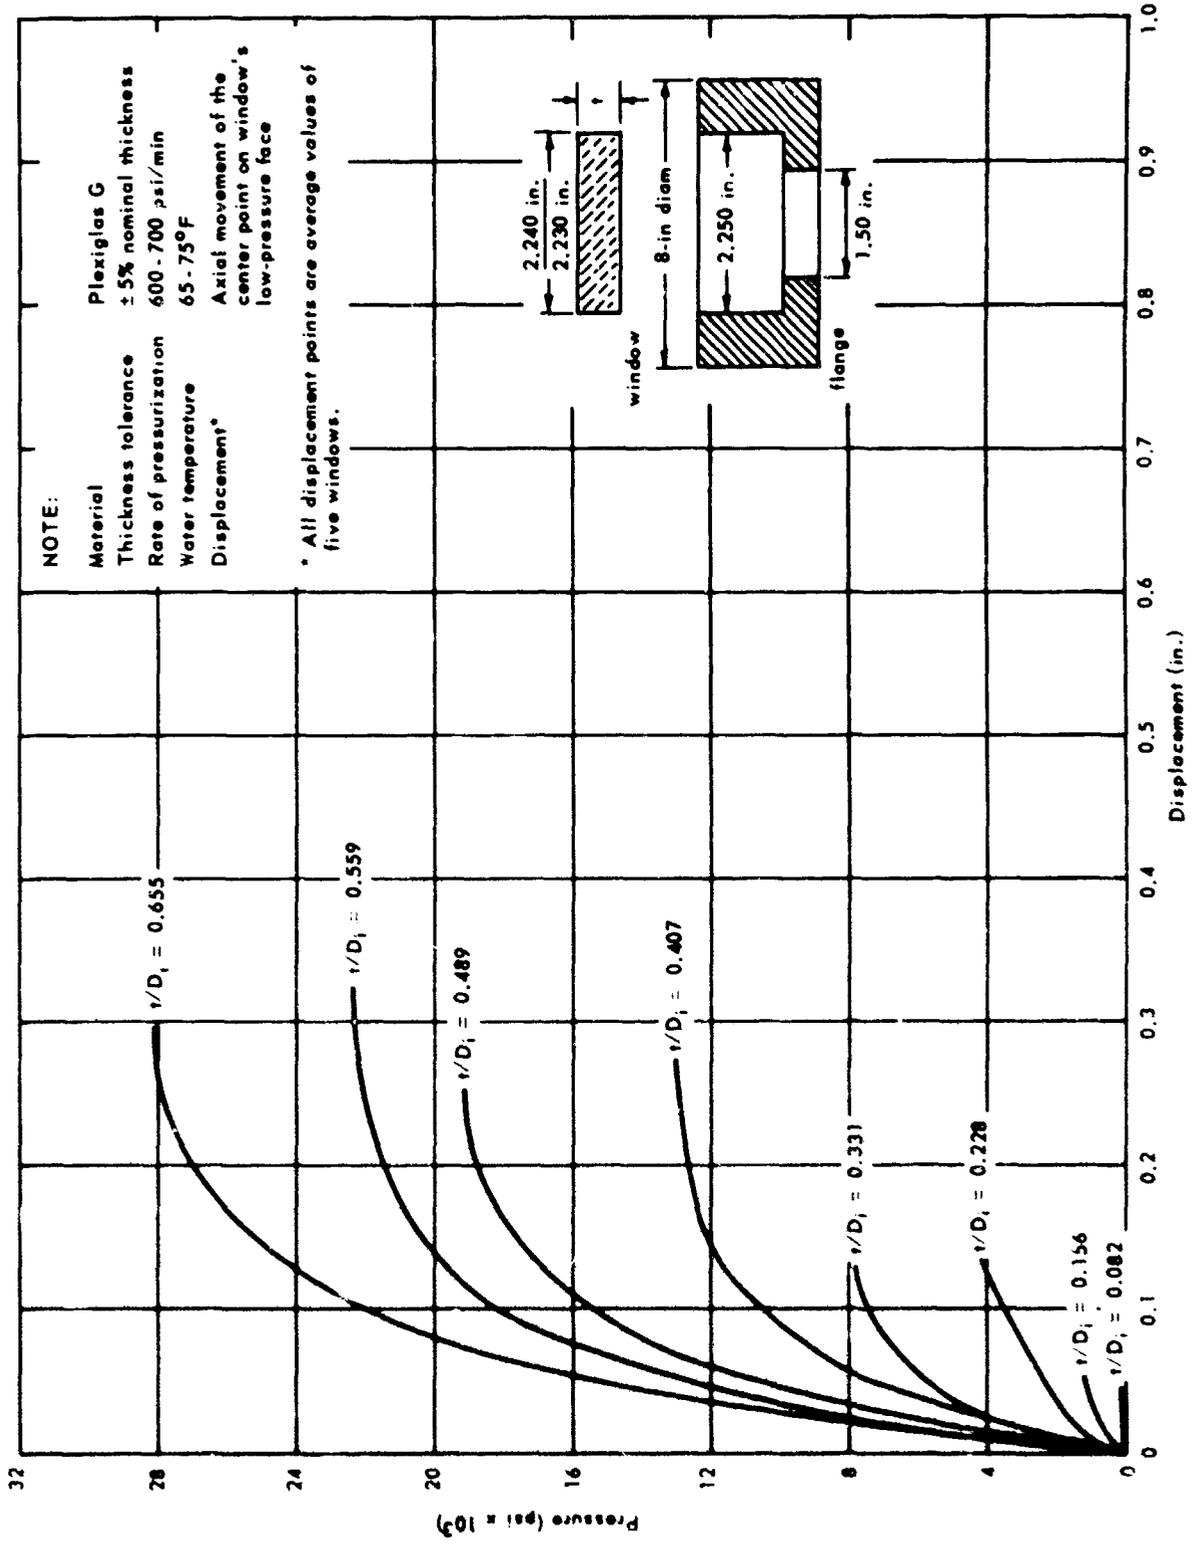
Figure 11. The experimental relationship between displacement and t/D_i ratio of flat acrylic windows with 1.5-inch D_i and with D_o/D_i ratio equal to 1.5.

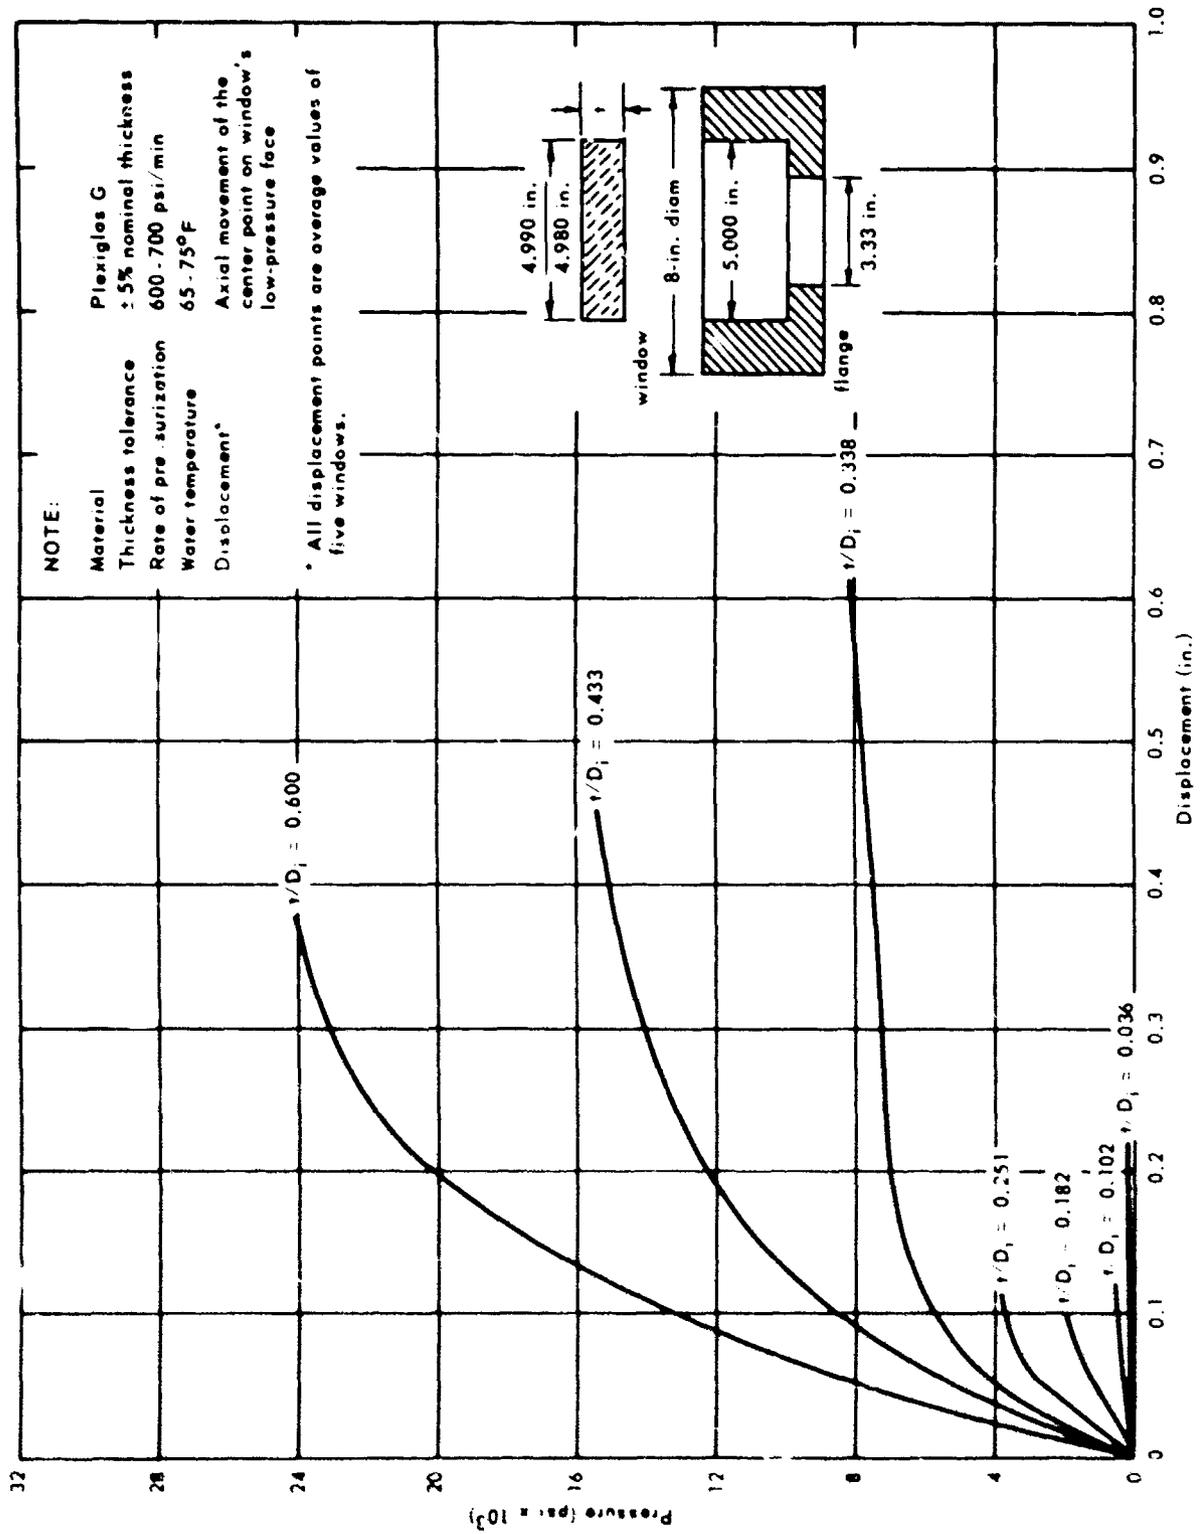
Figure 12. The experimental relationship between displacement and t/D_i ratio of flat acrylic windows with 3.33-inch D_i and with D_o/D_i ratio equal to 1.5.

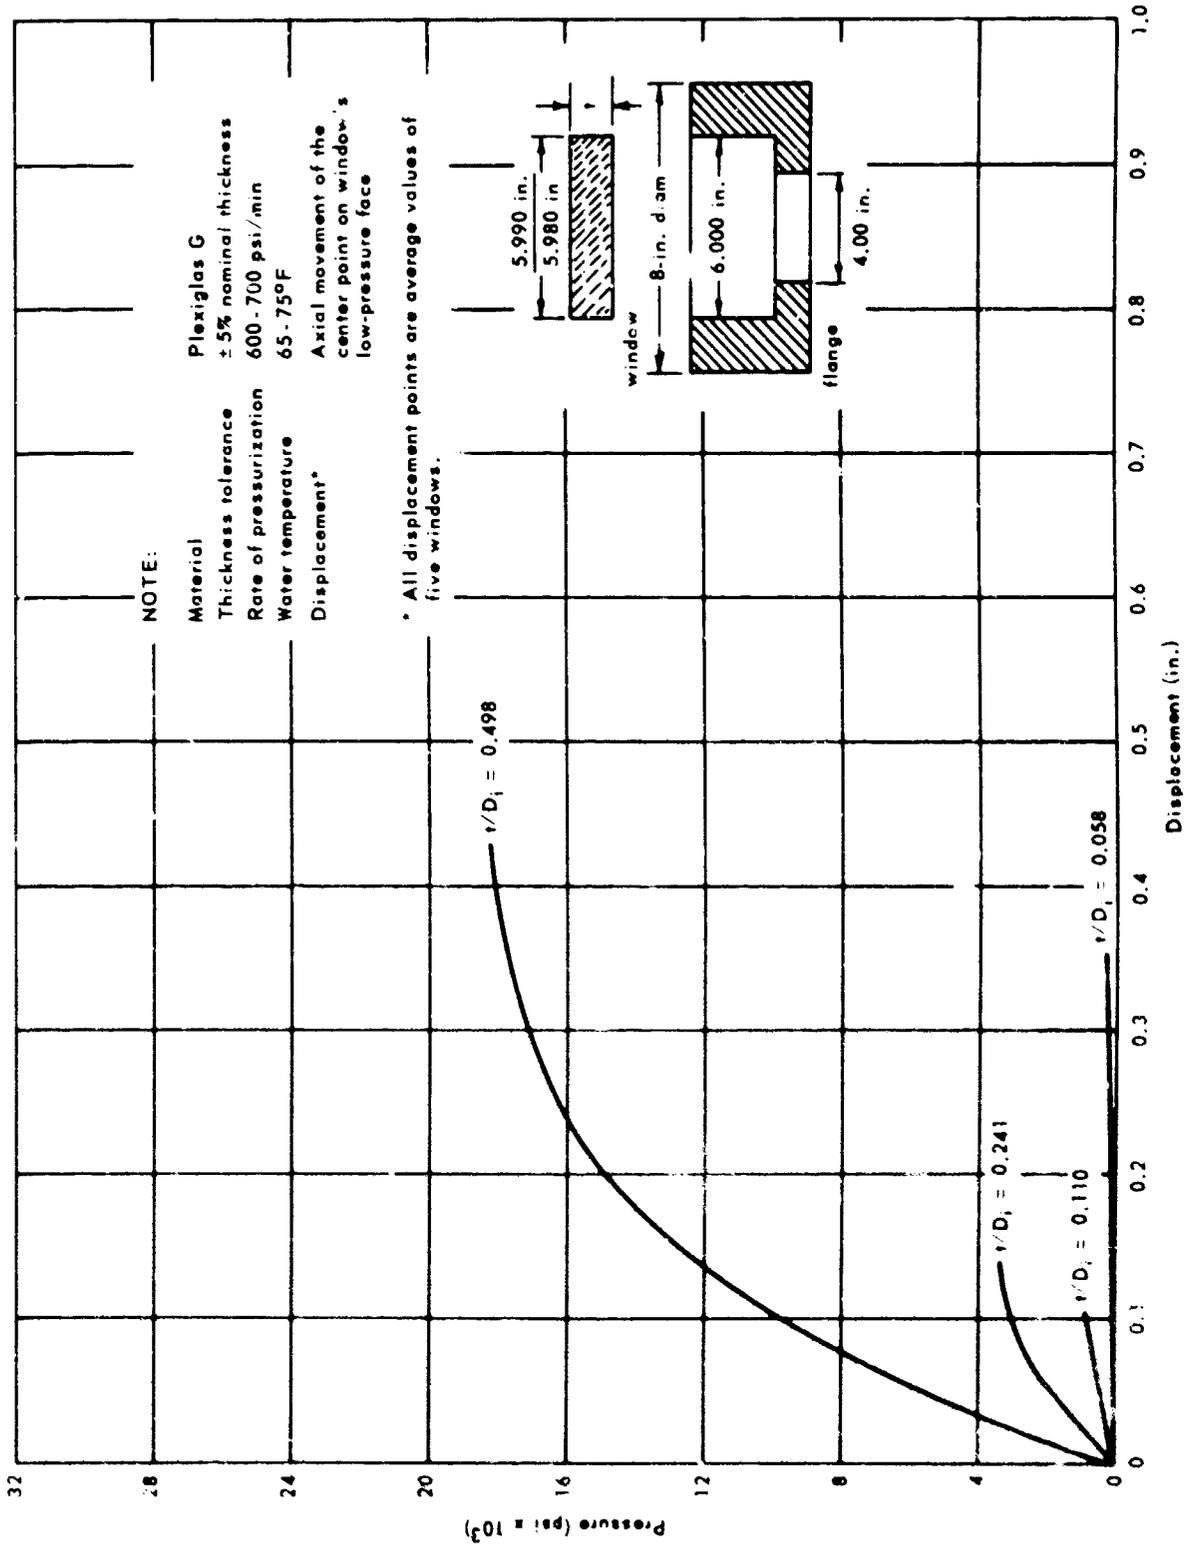
Figure 13. The experimental relationship between displacement and t/D_i ratio of flat acrylic windows with 4.00-inch D_i and with D_o/D_i ratio equal to 1.5.

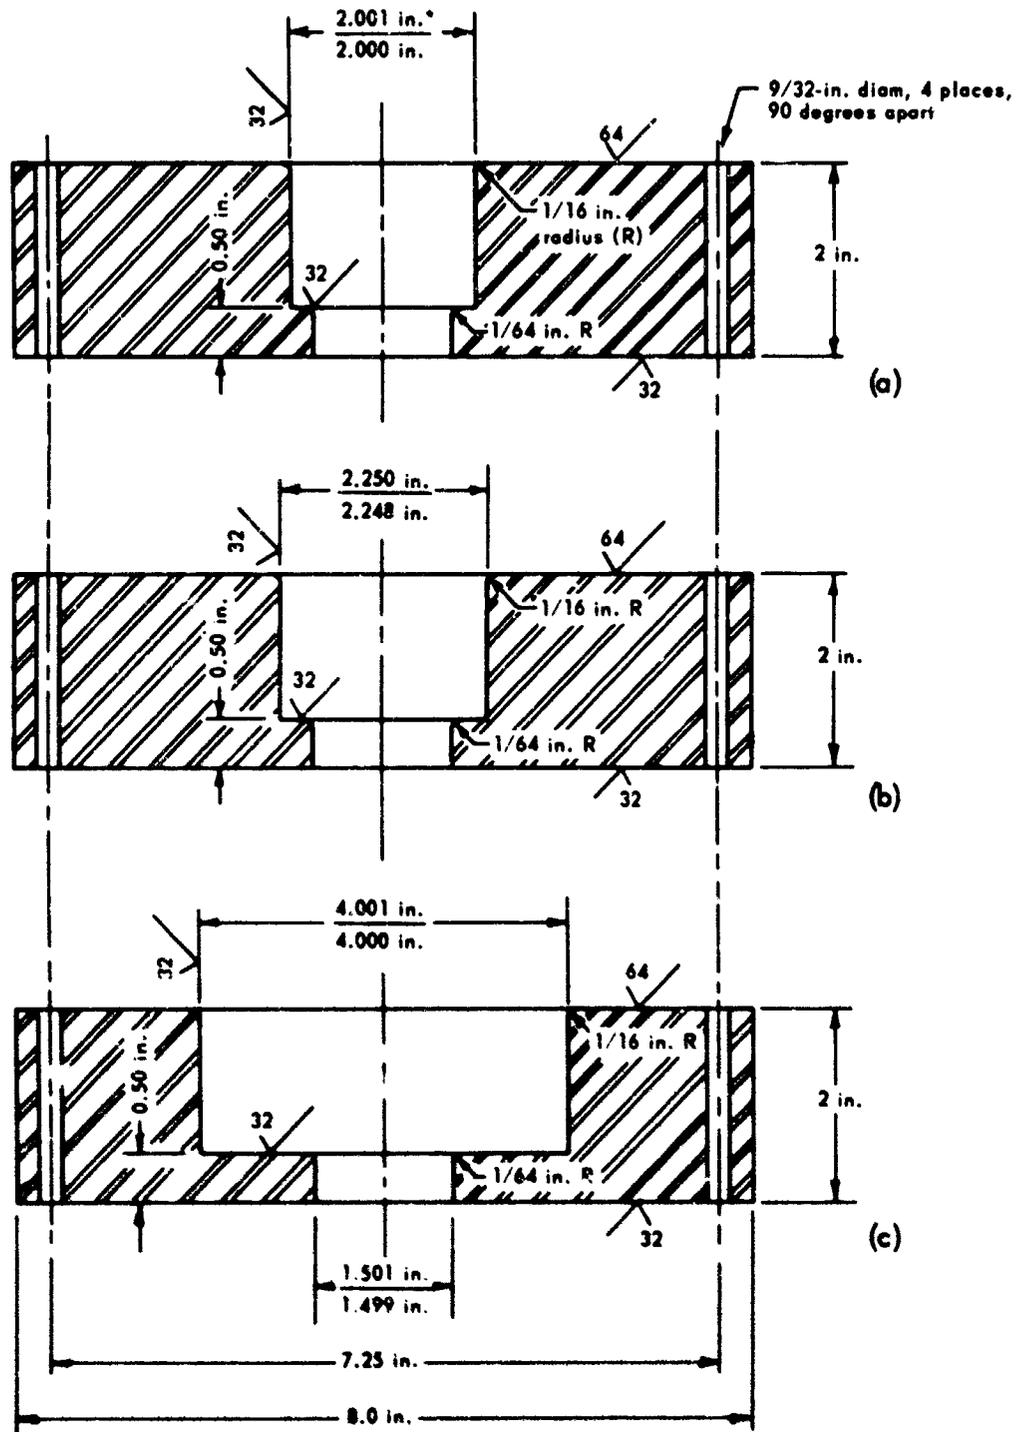
Figure A-1. Flanges employed in investigation of window mountings.

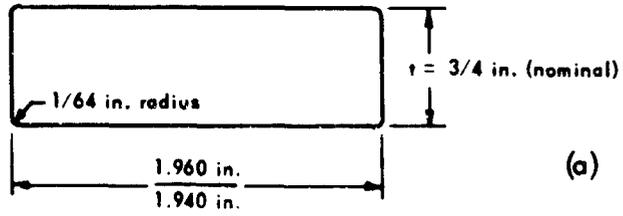
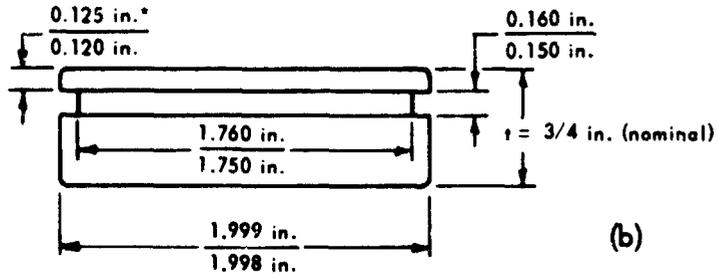
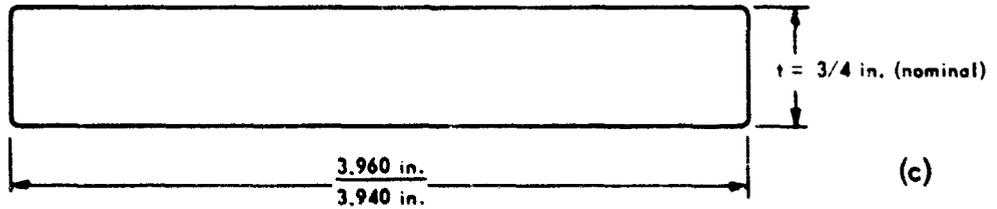
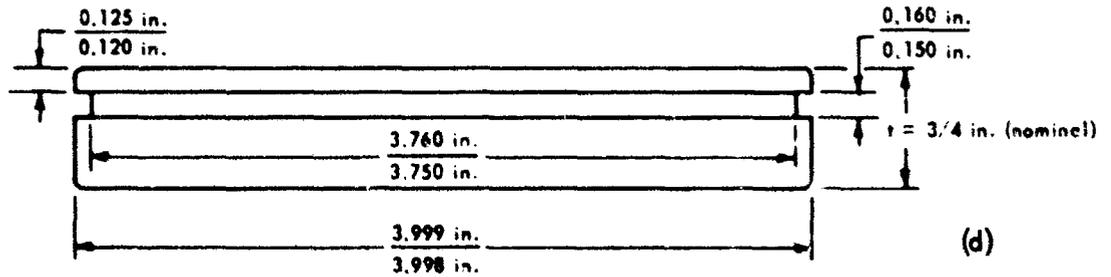
Figure A-3. Details of flat acrylic windows used in investigation of window mountings.

The influence of window fit on the critical pressure was investigated with windows having the same D_o/D_i ratio and thickness (Figures A-3a and A-3b) fitted into flanges with different major diameters (Figures A-1a and A-1b). In one of the flanges (Figure A-1a) the pretest radial clearance between the windows and the flange was either 0.001 inch (Figure A-3b) or 0.025 inch (Figure A-3a), while in the other flange (Figure A-1b) the clearance was 0.125 inch. A radial clearance of 0.001 or 0.025 inch when the window is subjected to hydrostatic pressures above 10,000 psi is calculated to result in an interference fit between the window and the flange, thus resulting in a lateral constraint of the window. The flange (Figure A-1b) and window (Figure A-3a) assembly with the initially larger radial clearance of 0.150 inch, even when subjected to hydrostatic pressures that destroyed the window, did not cause it to be wedged inside the flange opening. With such an arrangement it was possible to determine whether the wedging in of the window in the flange under hydrostatic pressure had any measurable influence on the critical pressure of flat windows.

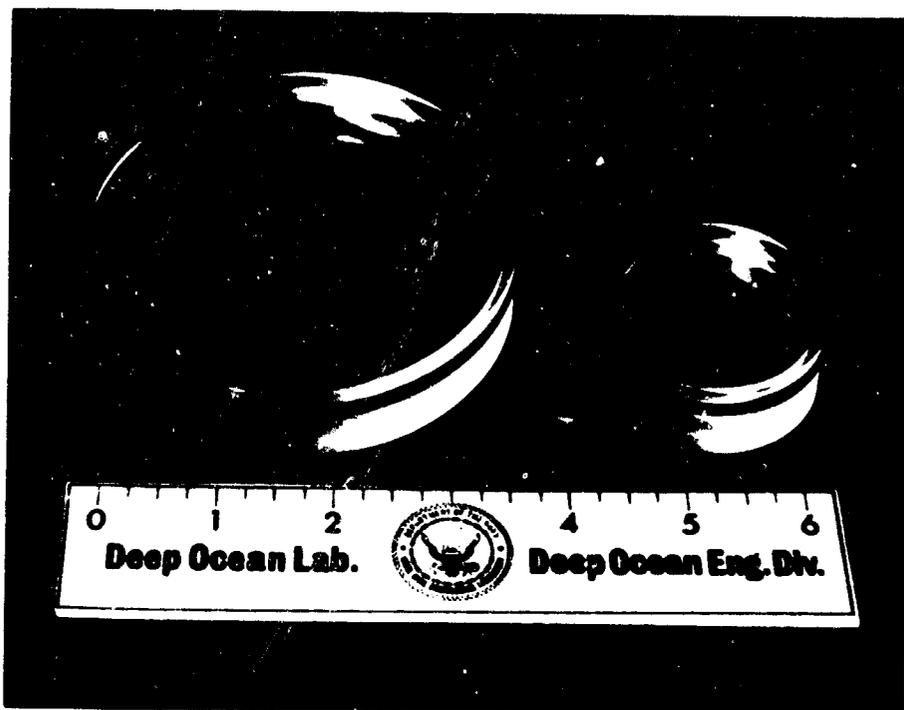
Figure A-4. Flat acrylic windows used with O-ring sealing technique in the investigation of window mountings.

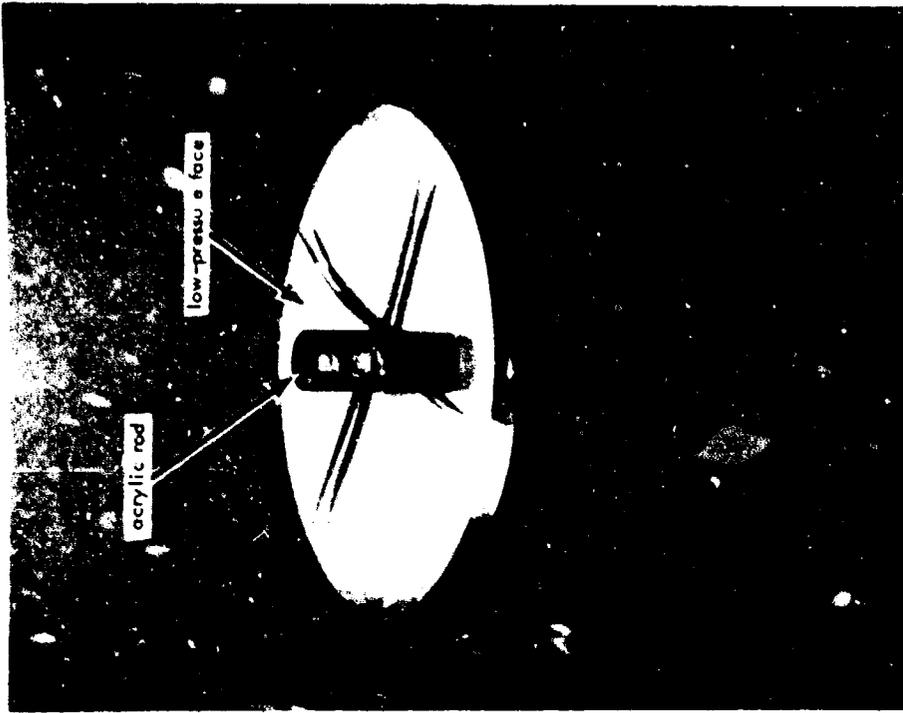
Figure B-2. Crack pattern in failed 0.122-inch-thick window with a t/D_i ratio of 0.081. Maximum pressurization 62 psi.

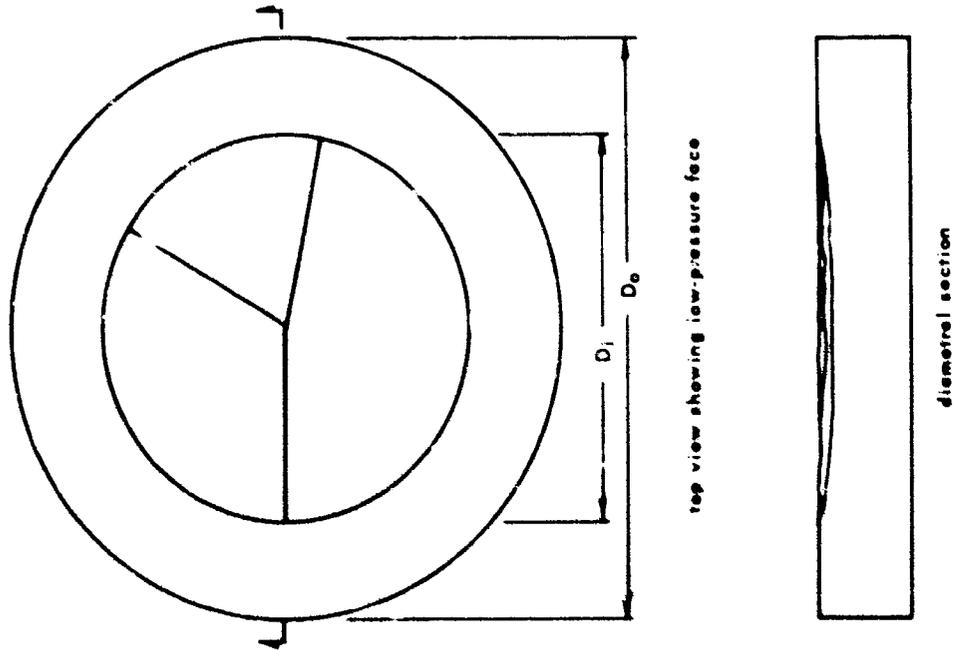
Figure B-1. Initial radial crack pattern in low-pressure face of windows.

In nearly all cases for all sizes of windows tested, failure began with radial cracking on the window's low-pressure face. Radiating outward from near the center, the cracks commonly formed a nonsymmetrical, three- or four-pointed figure. This form of cracking preceded failure in nearly all cases and is assumed to be the beginning of failure (Figures B-1 and B-2). Depth of cracking was found to be a function of the thickness, t/D_i ratio of the window, and the pressure of the fluid. Since audible cracking was noted during testing, it is postulated that these radial cracks were rapidly formed, terminating at the window's D_i . Depth of cracking in the low-pressure face in most cases was found to be a small fraction of the window's thickness.

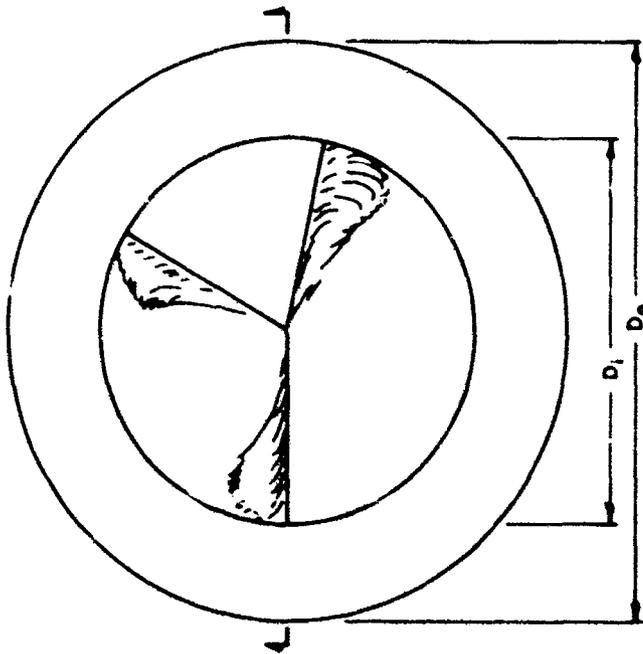
top view showing low-pressure face

diametral section

Figure B-3. Second stage conchoidal fracture pattern, early development.

With additional pressurization, a second stage of failure began to develop. A conchoidal or "cupped cone" fracture was established, emanating from the base of the radial cracks and proceeding radially inward and circumferentially (Figures B-3 and B-4). The formation of a conchoidal fracture surface preceded failure in all cases observed.

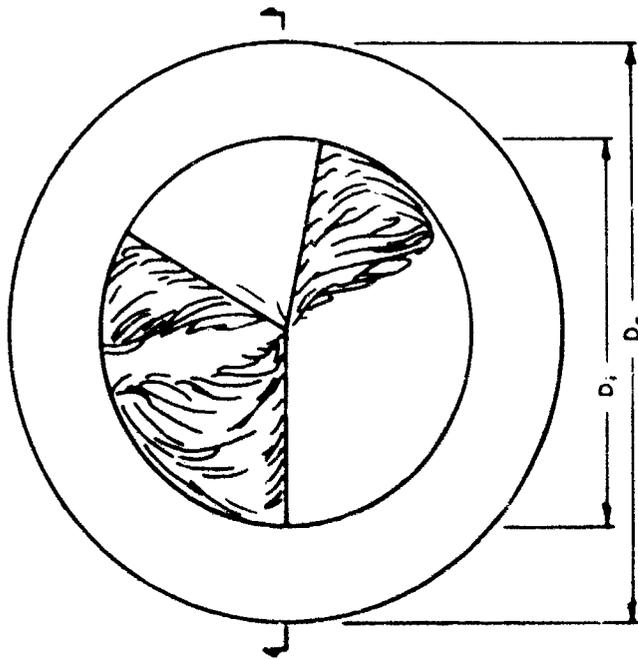
top view showing low-pressure face

diametral section

Figure B-5. Conchoidal fracture pattern, advanced stage of development.

Simultaneously, as the conchoidal fracture surface was formed, the radial cracks increased slightly in depth (Figures B-5 and B-6). Cracks did not deepen uniformly and new cracks developed with further pressurization. The additional cracking gave rise to formation of new and deeper conchoidal fracture surfaces. Additional pressurization caused the circumferential expansion and coalescence of the conchoidal fracture surfaces into one conical fracture surface as well as an increase in fracture depth (Figures B-7 and B-8). Cracking and formation of conchoidal fracture surfaces continued (Figures B-9 and B-10) deeper into the window's thickness until the critical pressure was finally reached resulting in the fragmentation and expulsion of the window's low-pressure face (Figures B-11 and B-12). The size of the central hole was a function of t/D_i ratio and D_i . The conical cavity resulting from the expulsion of the center portion of the window consistently assumed an approximate angle of 30 degrees with the high-pressure face.

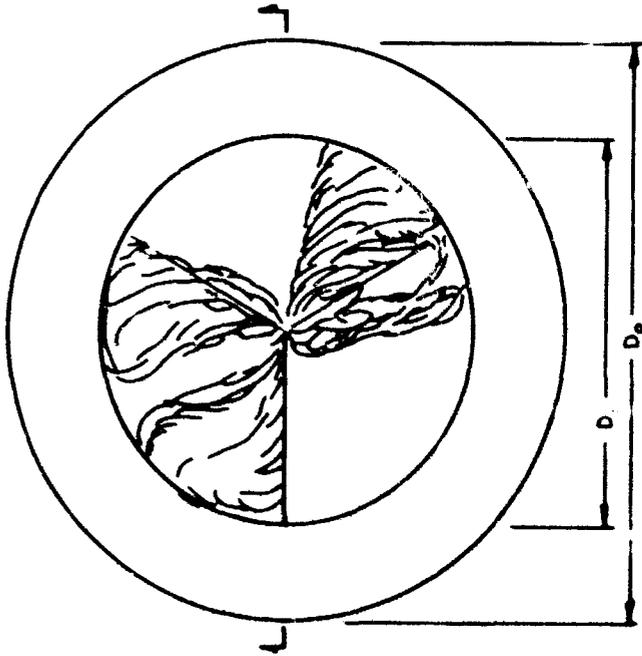
top view showing low-pressure face

diametral section

Figure B-7. Imminent coalescence of conchoidal fractures as critical pressure is approached.

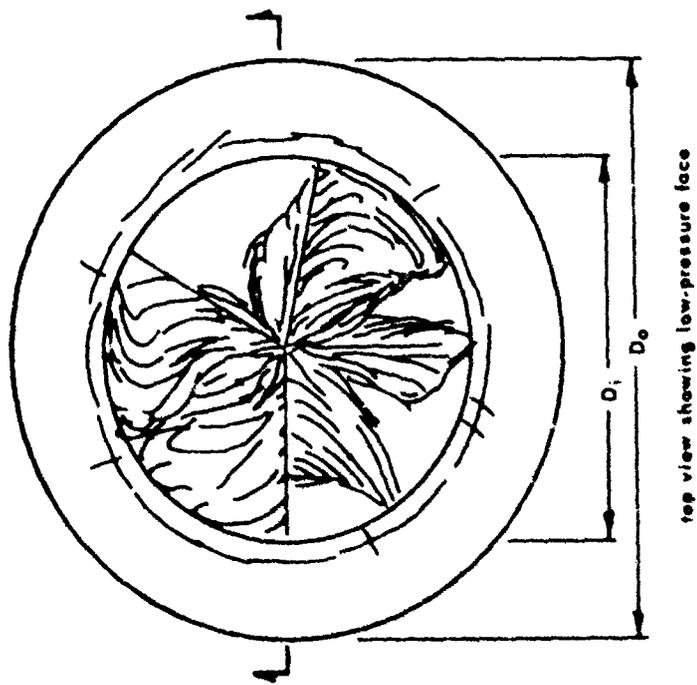
Figure B-9. An advanced stage of coalescence of conchoidal fractures as critical pressure is approached.

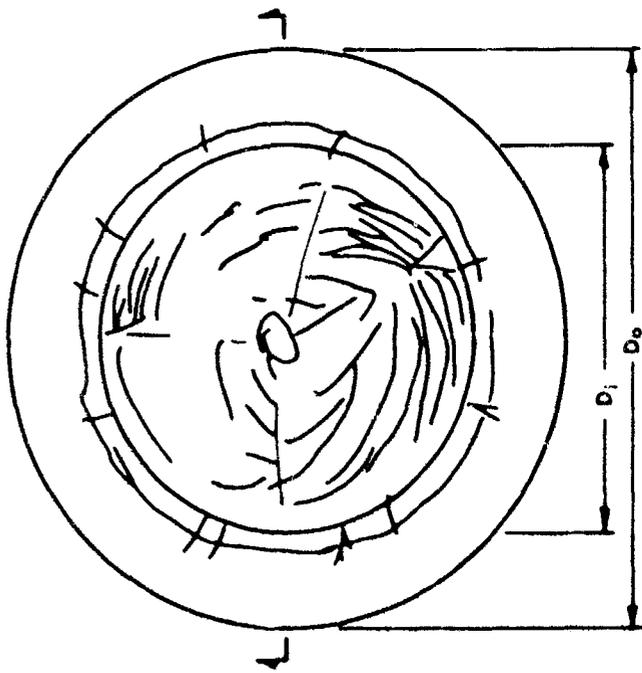
top view showing low-pressure face

dismetral section

Figure B-11. The type of failure which follows complete coalescence of conical fracture surfaces.

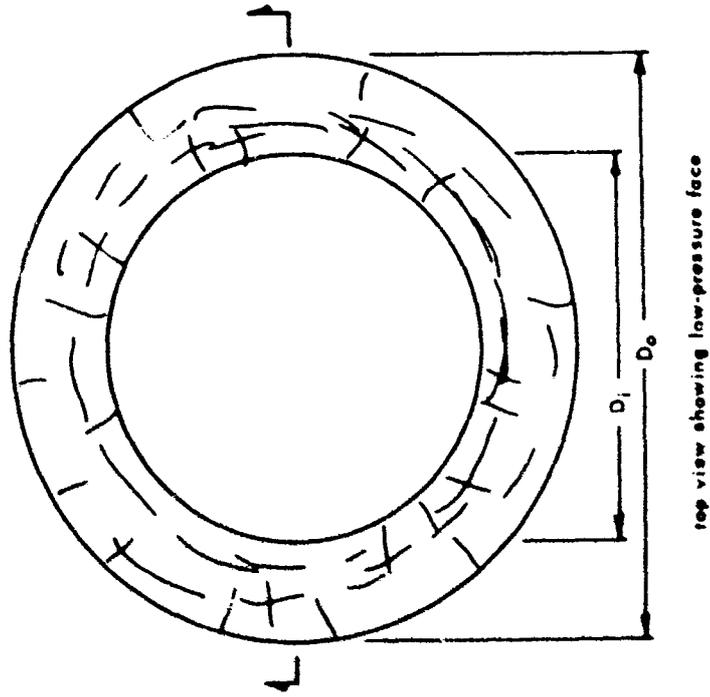
Figure 8-15. Shear-type failure common to windows with large t/D_i ratios.

Windows whose t/D_i ratios exceeded about 0.50 failed predominately by shear; the conical fracture surface was unable to penetrate the thickness of the material (Figures B-15 and B-16). At the critical pressure, the entire window was penetrated by discontinuous cracks and the central portion (bounded by D_i) was completely ejected.

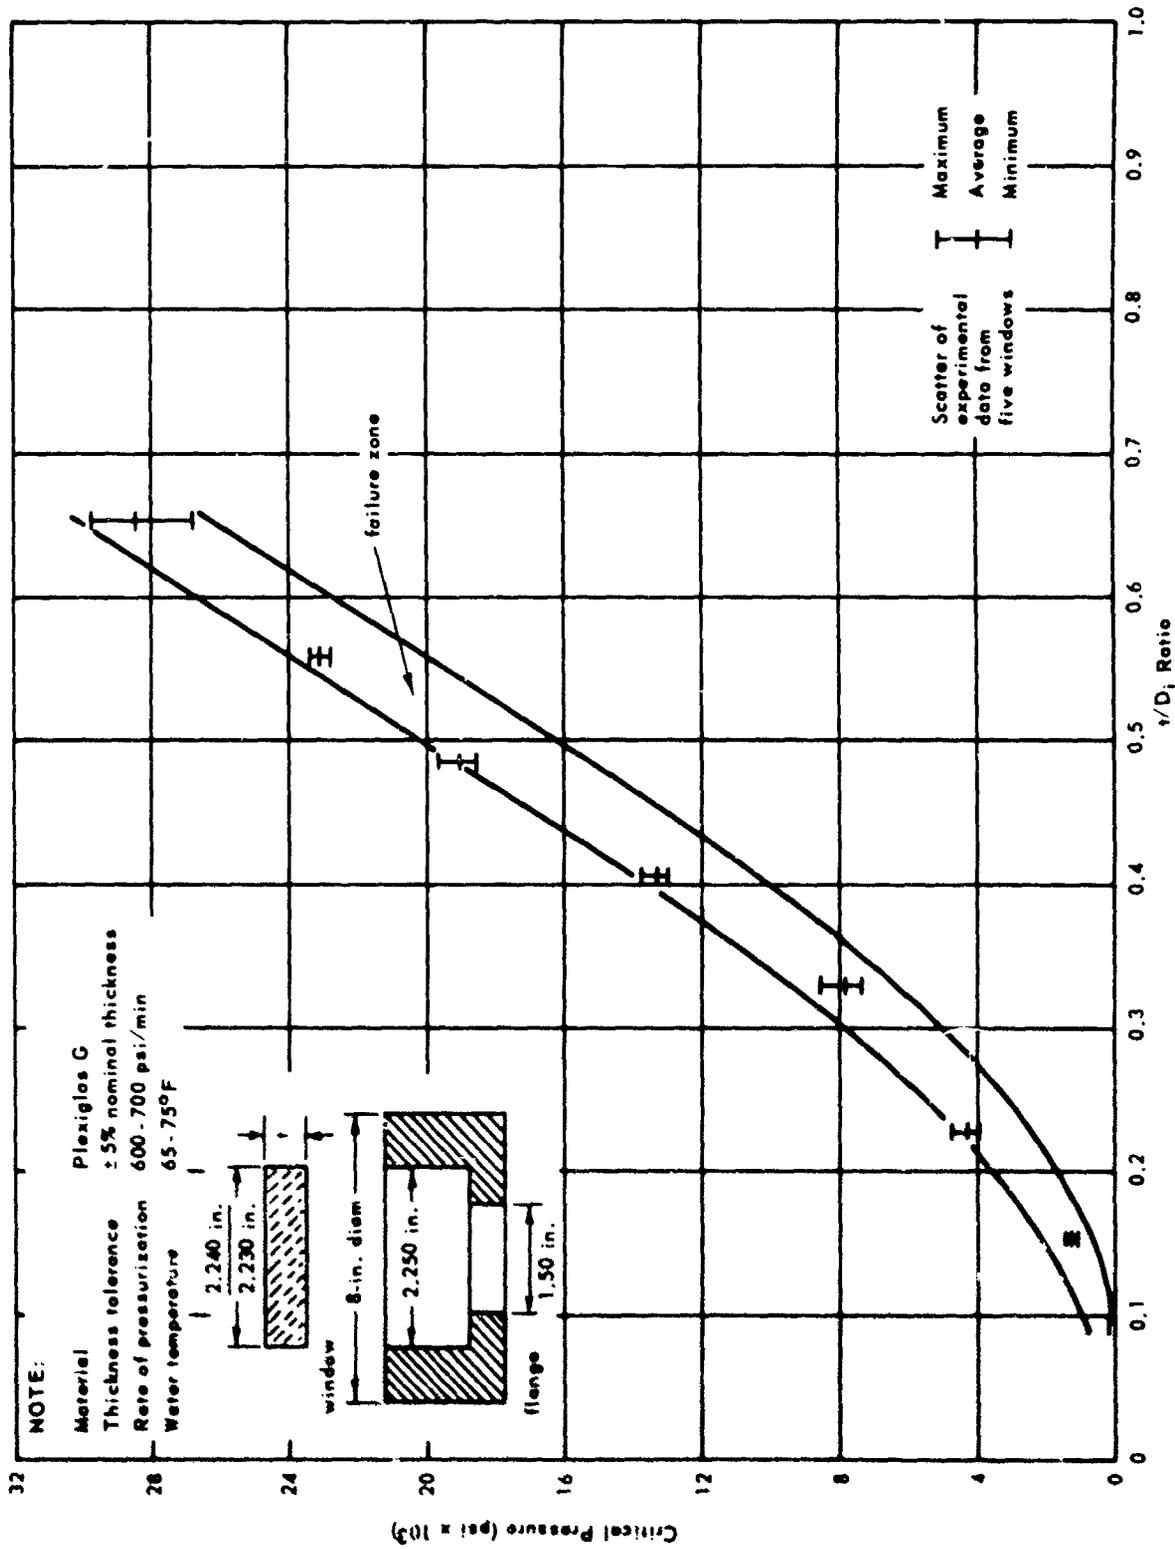
Figure 8-17. Relationship between critical pressure and t/D_i ratio of 1.50-inch (D_i) flat acrylic windows.
