Technical Report

WINDOWS FOR EXTERNAL OR INTERNAL
HYDROSTATIC PRESSURE VESSELS

PART II. Flat Acrylic Windows Under Short-Term
Pressure Application

NAVAL FACILITIES ENGINEERING COMMAND

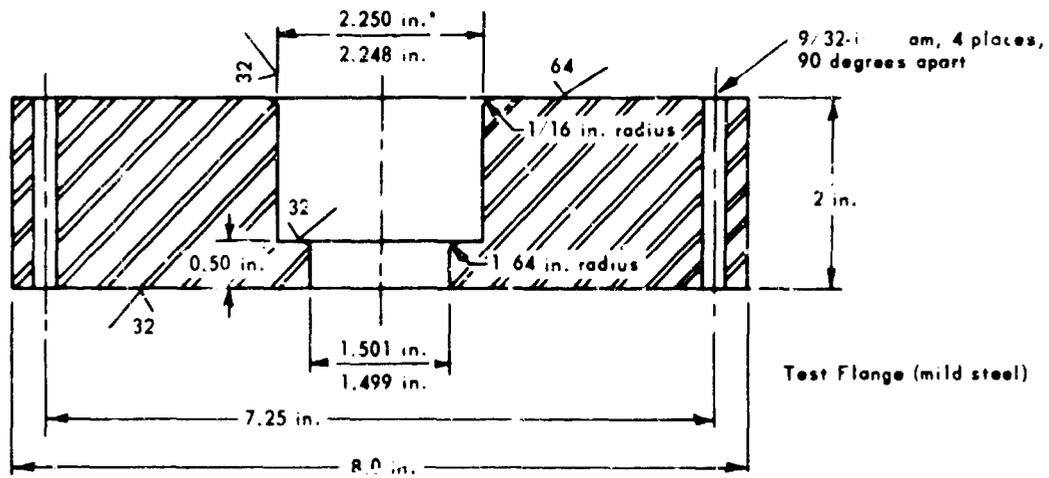
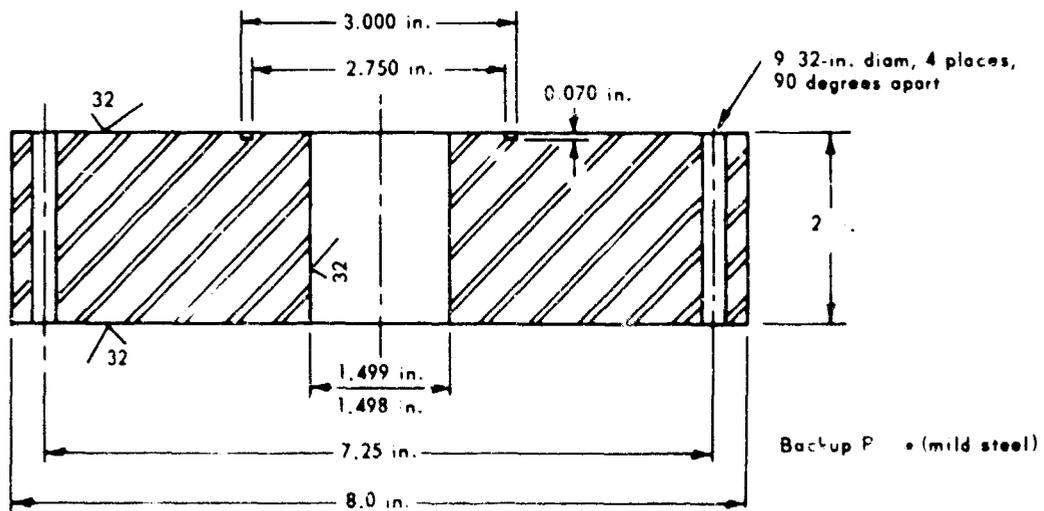
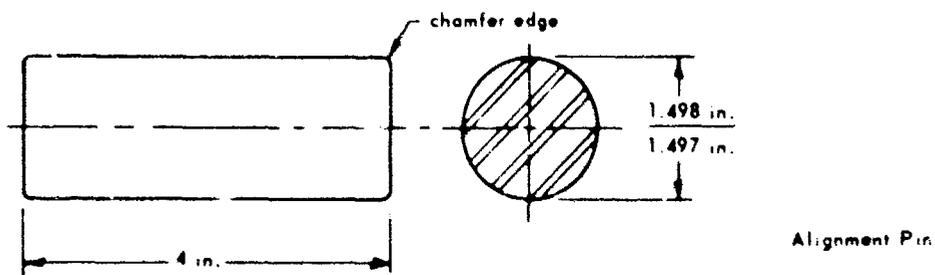
Figure B-18. Details of flange assembly used to determine the relationship between the window's critical pressure and t/D_i ratio for 1.50-inch (D_i) windows.

Details of flanges used in testing the 1.5-inch (D_i) windows are shown in Figure B-18 and an in-place schematic is shown in Figure B-19.

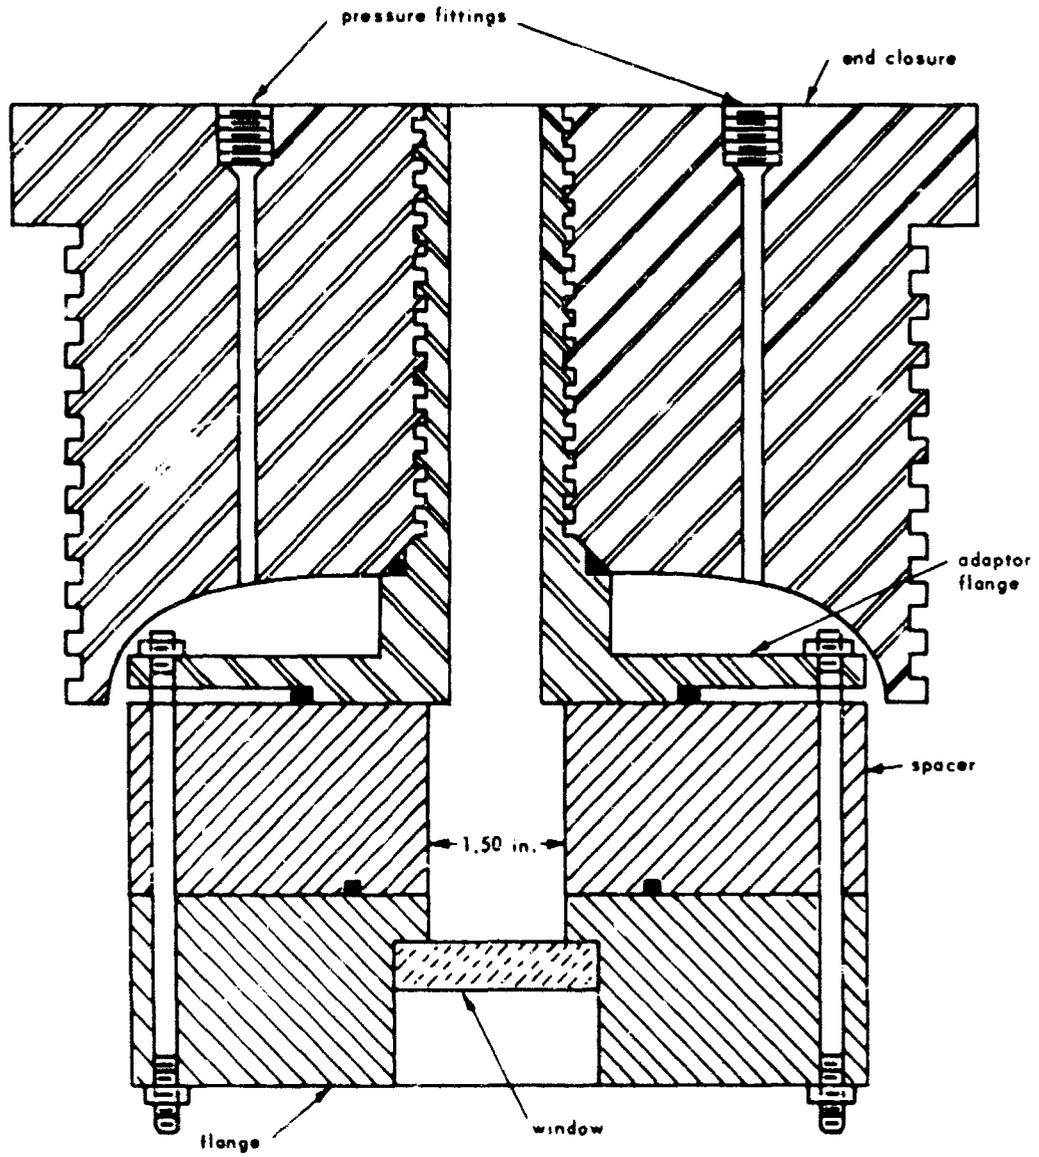
Figure B-19. Schematic of a typical window and flange test assembly secured to the end closure of a Mk I 9-inch pressure vessel.

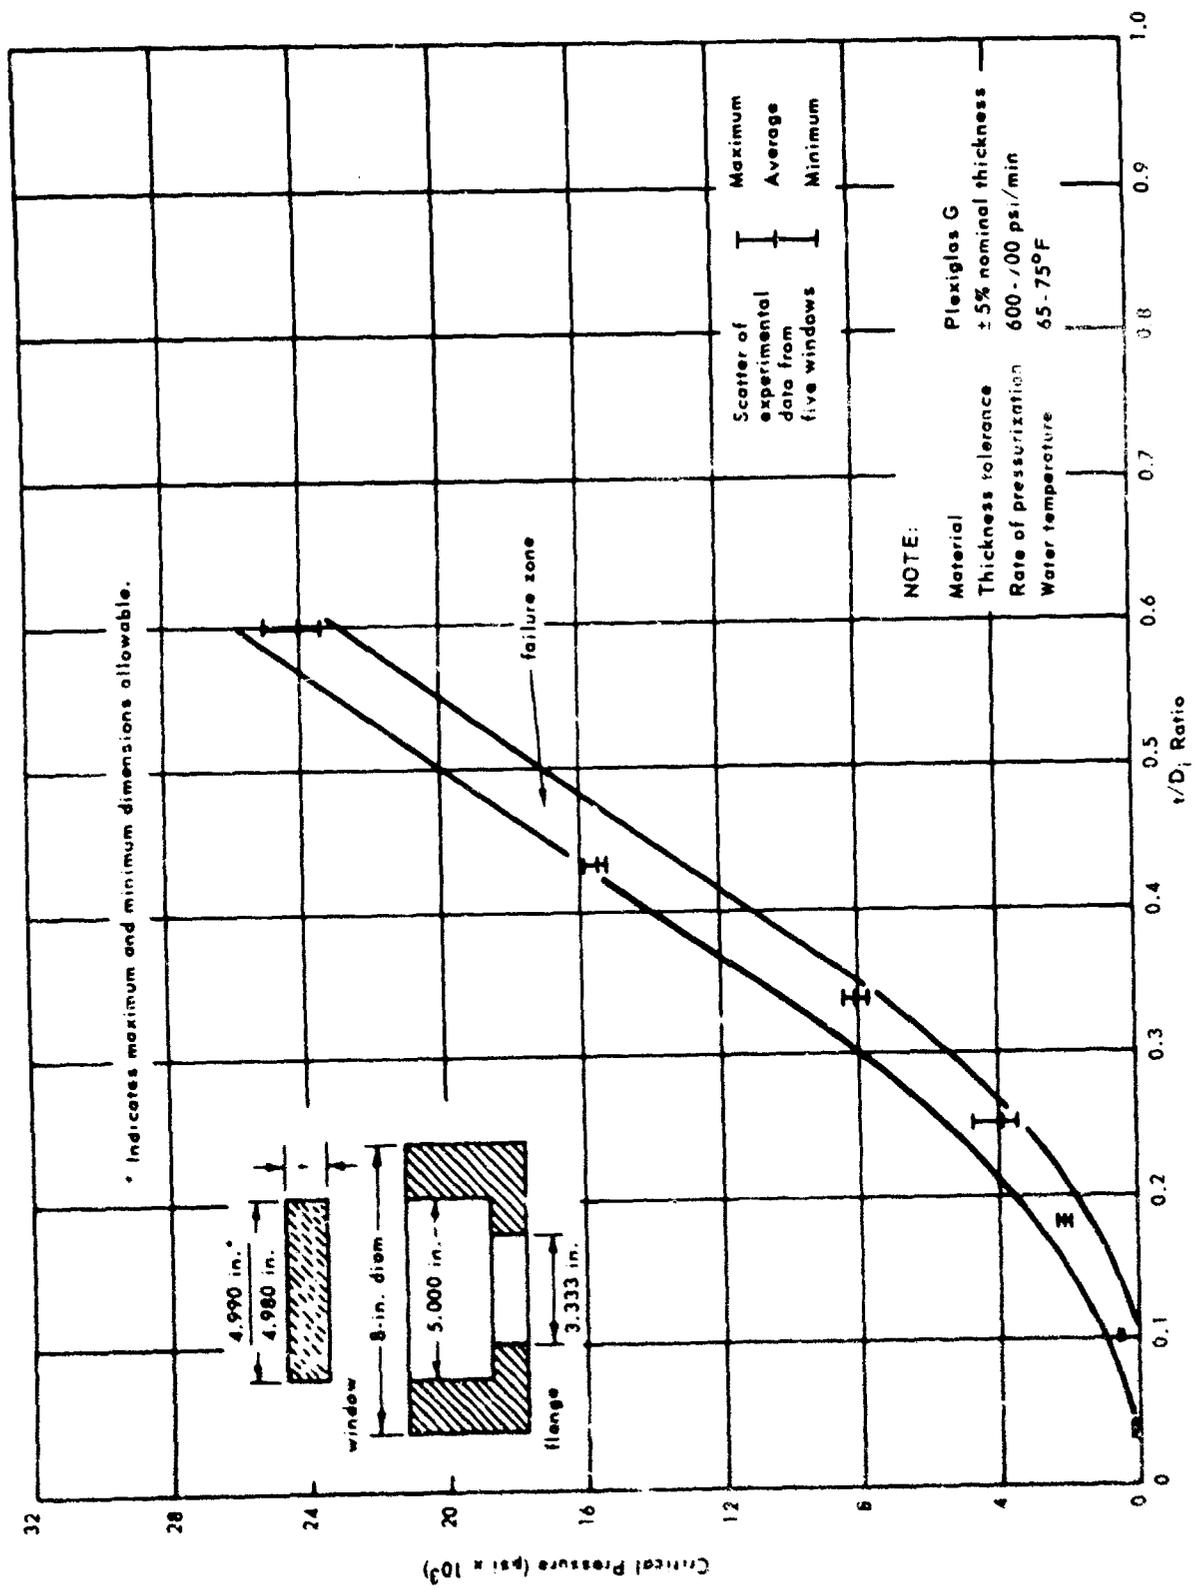
Figure B-20. Relationship between critical pressure and t/D_j ratio of 3.33-inch (D_j) flat acrylic windows.

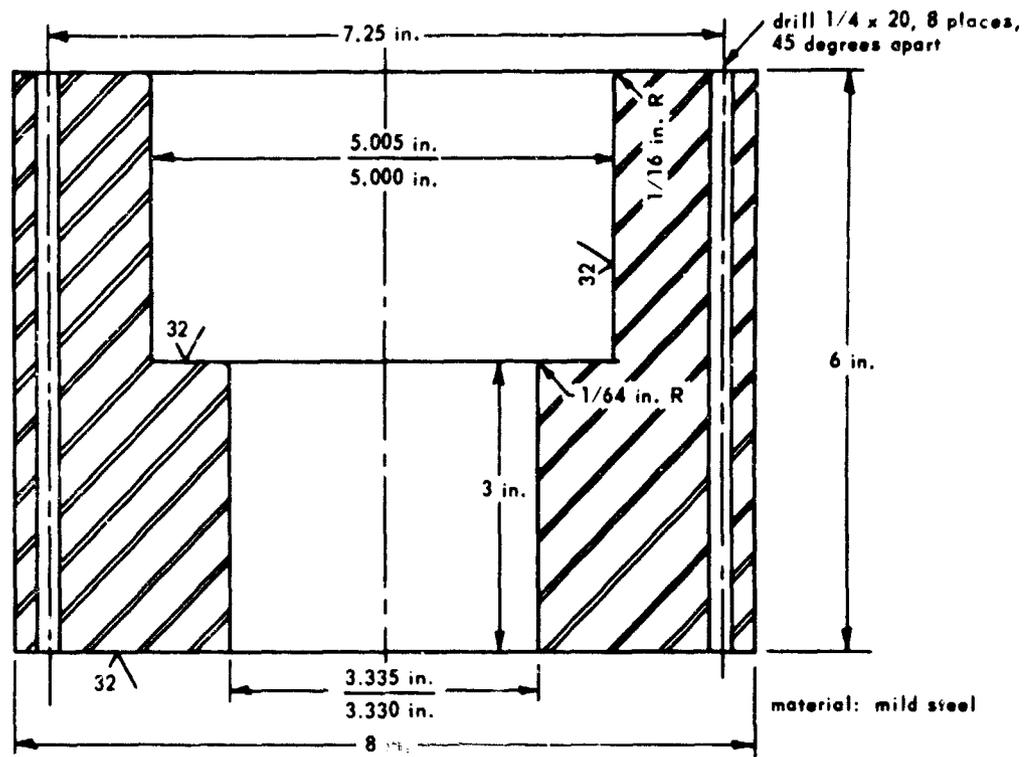
Figure B-21. Details of assembly used to determine the relationship between the window's critical pressure and t/D_i ratio for 3.33-inch (D_i) windows.

Shear failures were characteristic of windows whose t/D_i ratios were greater than about 0.4 (Figure B-16). Combined with the shear failure pattern were the various combinations of radial and circumferential cracks discontinuous throughout the window. Details of flanges used in testing the 3.33-inch (D_i) windows are shown in Figure B-21 and an in-place schematic is shown in Figure B-22.

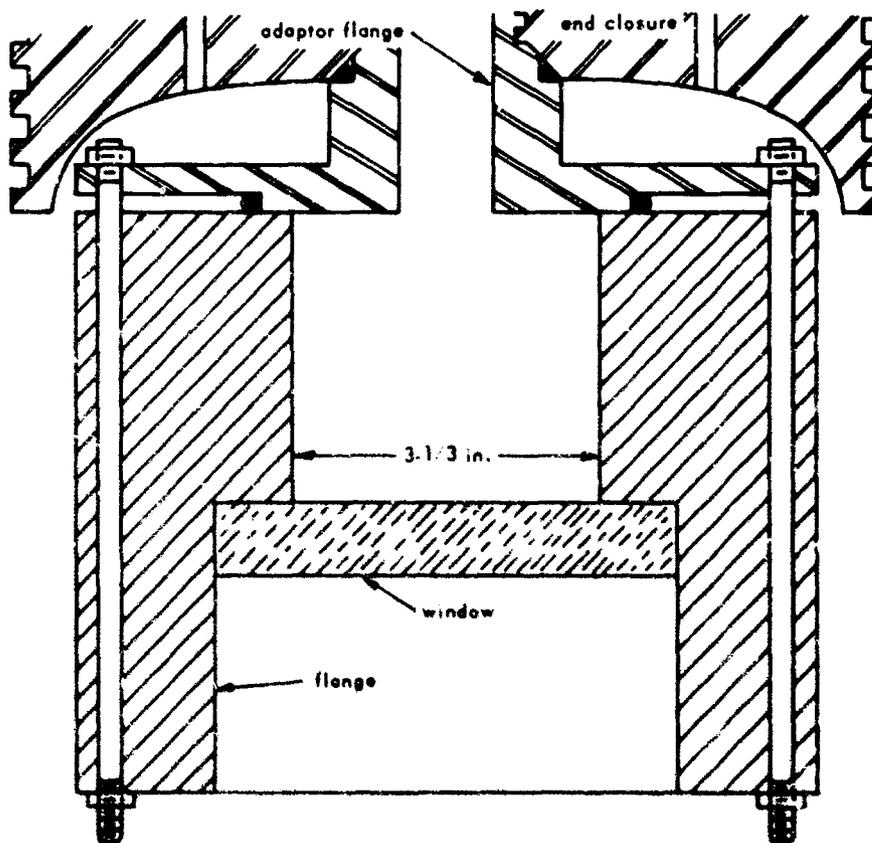
Figure B-22. Schematic of 3.33-inch (D_i) window and flange in end closure of Mk I 9-inch pressure vessel.

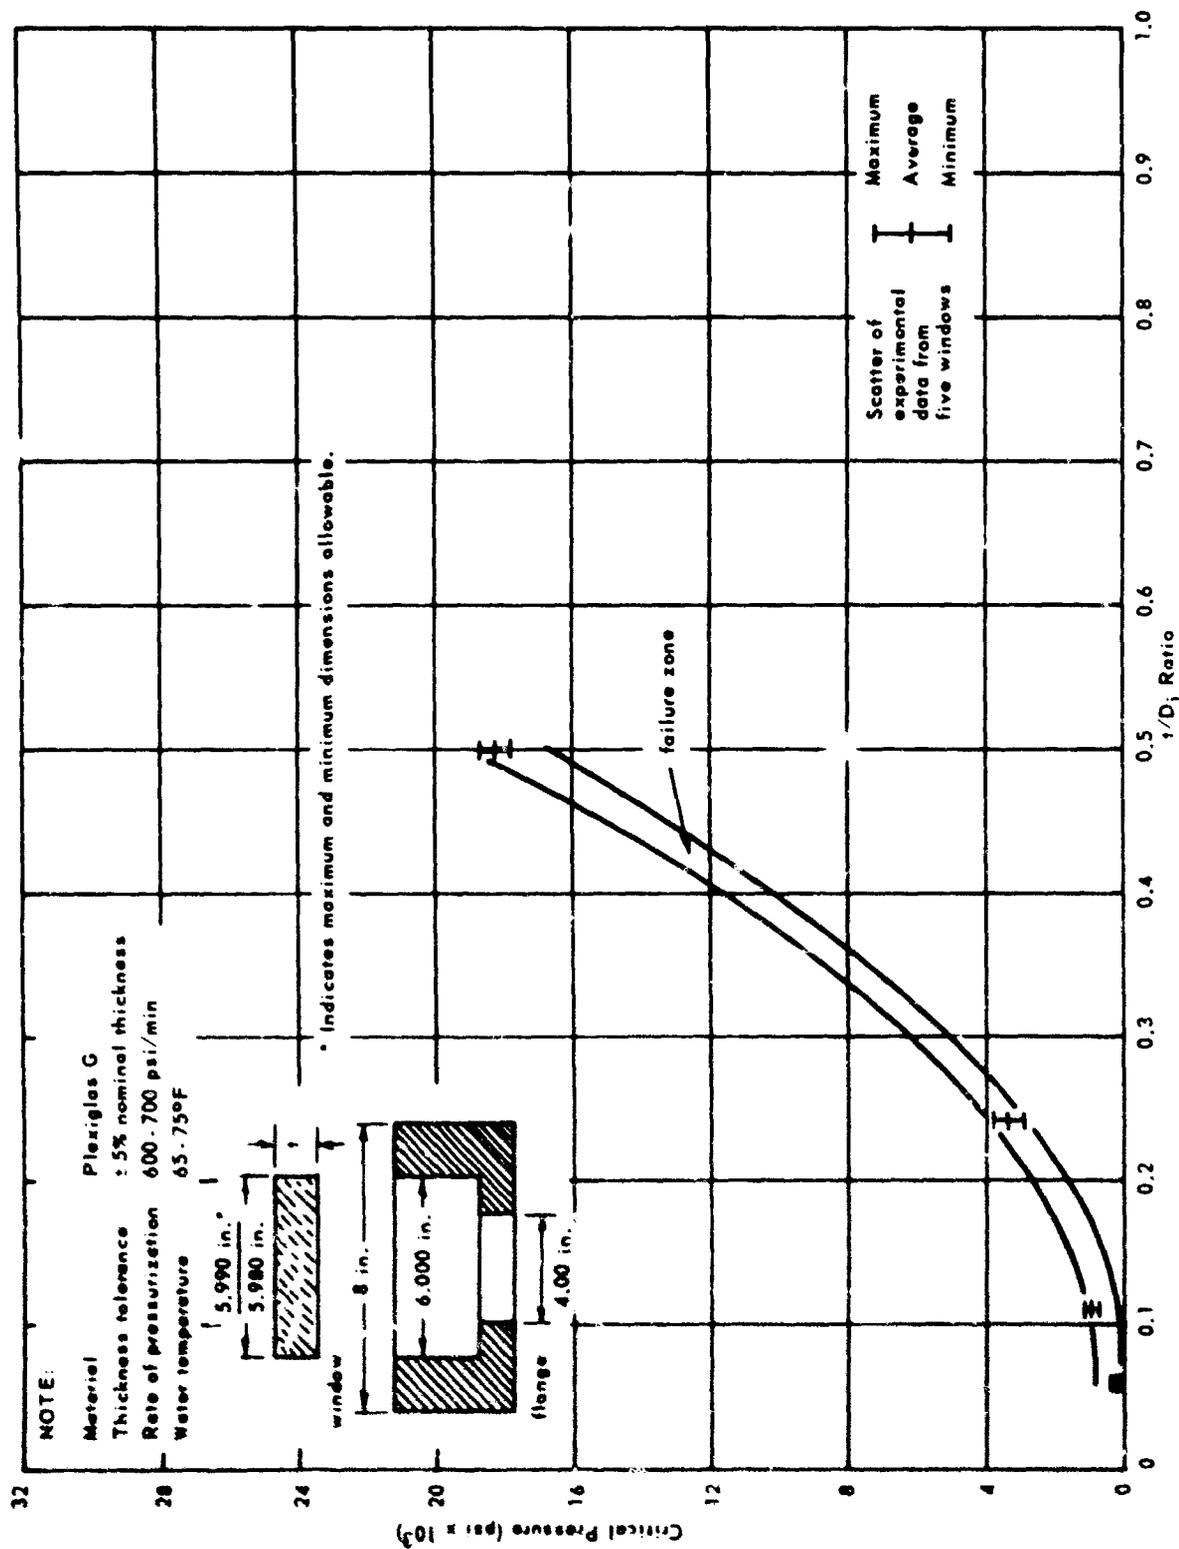
Figure B-23. Relationship between the critical pressure and t/D_i ratio of 4.00-inch (D_i) flat acrylic windows.

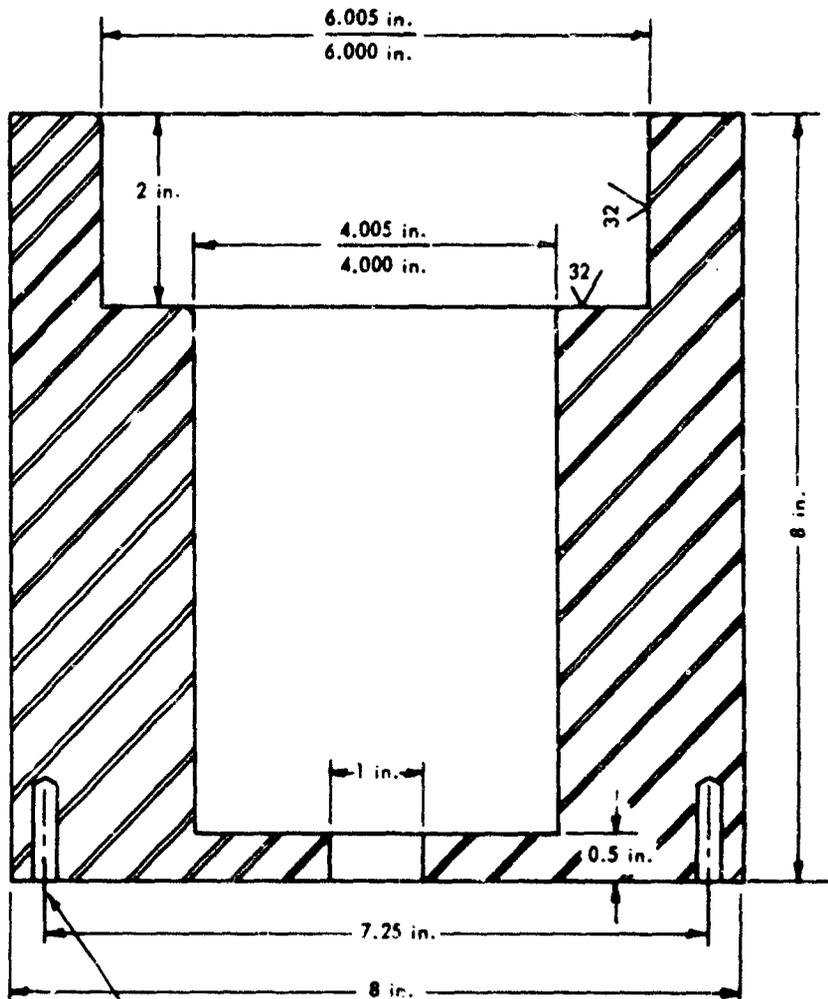
drill 1/4 x 20, 8 places,
45 degrees apart

material: mild steel

Figure B-24. Details of flange used to determine the relationships between the window's critical pressure and t/D_i ratio for 4.00-inch (D_i) windows.

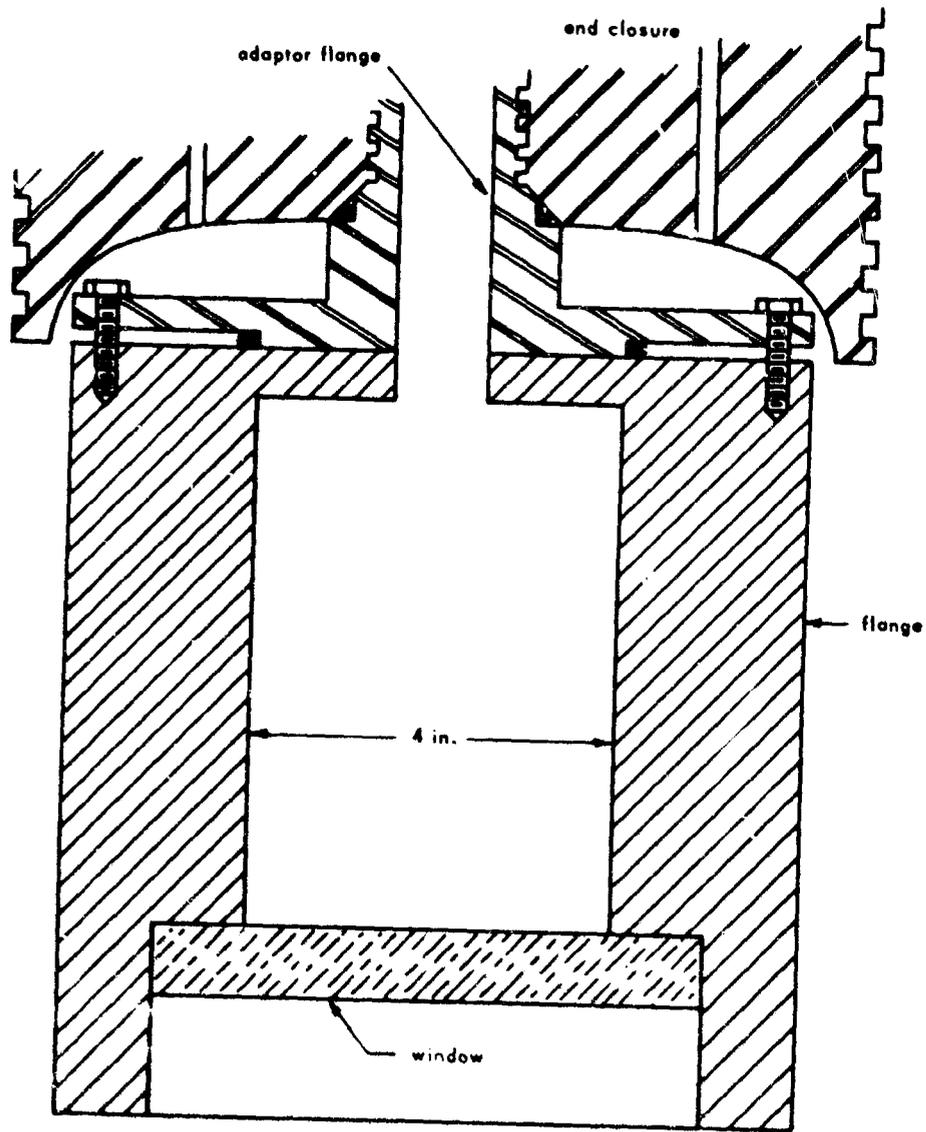
Figure B-25. Schematic of 4.00-inch (D_i) window and test flange assembled to the end closure of the Mk I 9-inch pressure vessel.
