NUMBER D8-1038

TITLE Fatigue Properties of 17-4 PH and 15-5 PH
Steel in the H-900 and H-1050 Condition

BOEING

VERTOL DIVISION

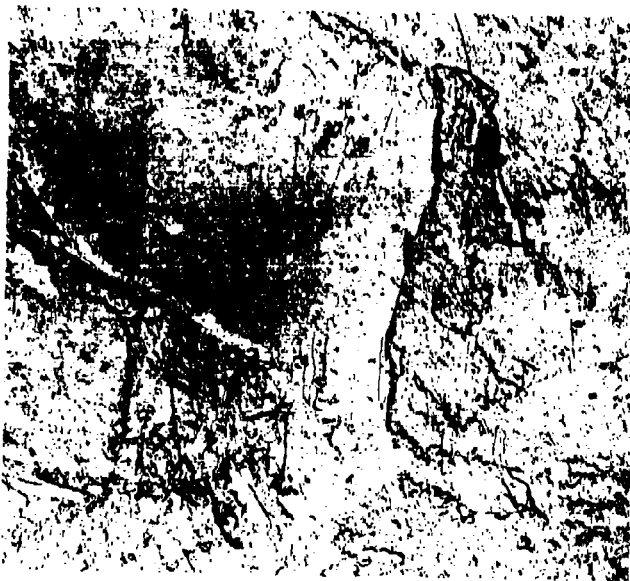
FIGURE 7

H-1050 CONDITION, NOTE
DEGREE OF PRECIPITATION

ELECTRON PHOTOMICROGRAPHS OF TYPICAL 15-5 PH MICROSTRUCTURES
3000X, HCl & Picric Acid Etch

The effect of overaging on the microstructure of 15-5 PH is shown in Figure 7, and is typical of both alloys. Coalescence and growth of the copper rich hardening phase is evident in the specimen aged at 1050°F.

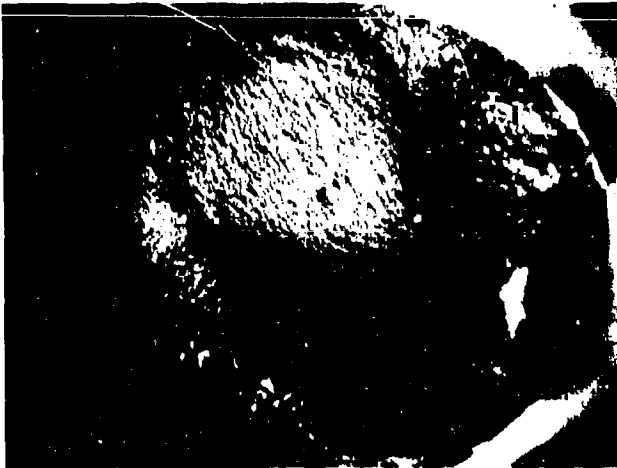
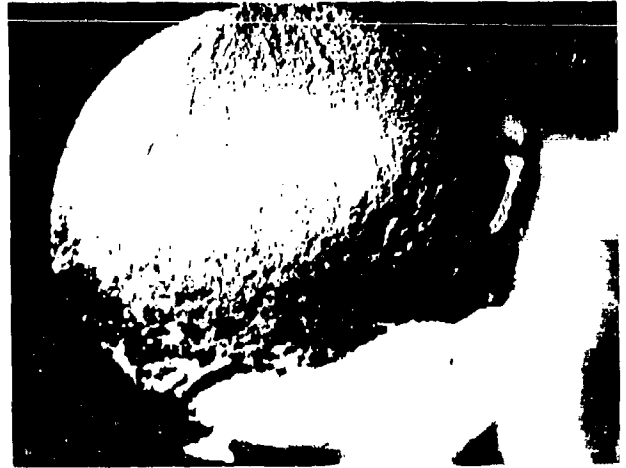
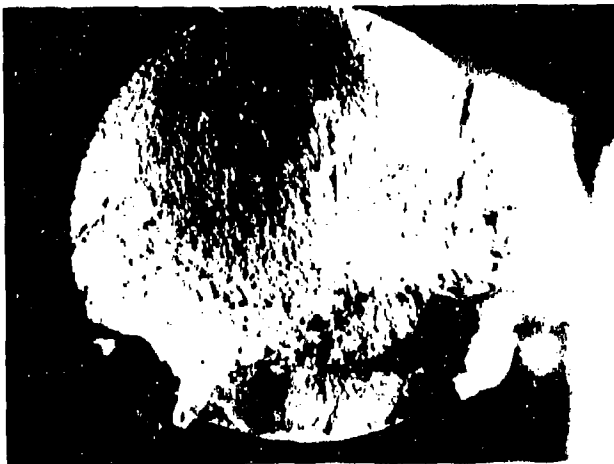
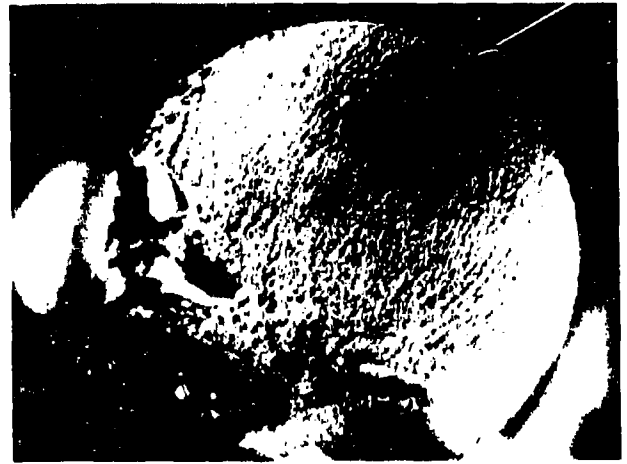
FIGURE 13X, TYPICAL FRACTURE FACES OF 17-4 PH and 15-5 PH.

ARROWS INDICATE ORIGINS.

Typical fracture faces of failed specimens are shown in Figure 8. Macroscopic examination revealed that all origins were at the surface and, in general, the macroscopic fatigue characteristics of both alloys was identical. Examination of the shot peened 15-5 PH specimen revealed that the primary fatigue origins were located .002" to .006" below the surface. Most specimens also contained one or more secondary origins. Typical examples are shown in Figure 9.

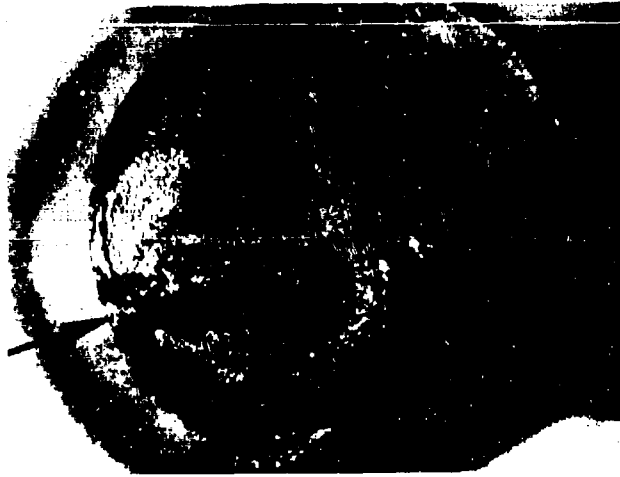
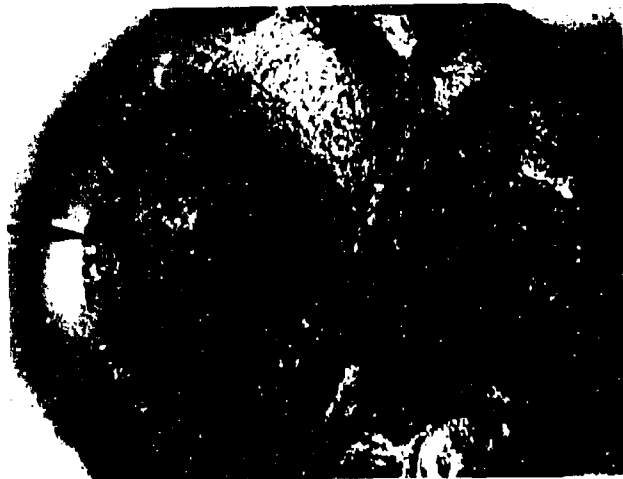
TYPICAL FRACTURE FACES OF SHOT PEENED 15-5 PH STEEL.
ARROWS INDICATE PRIMARY ORIGINS - NOTE SECONDARY ORIGINS.

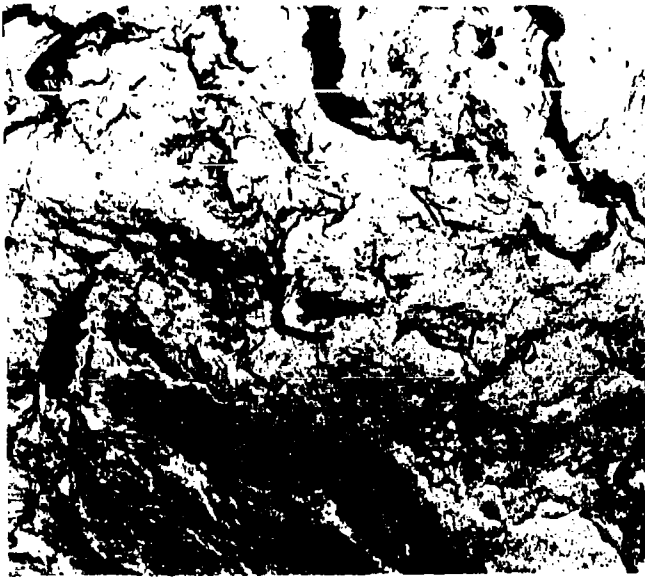
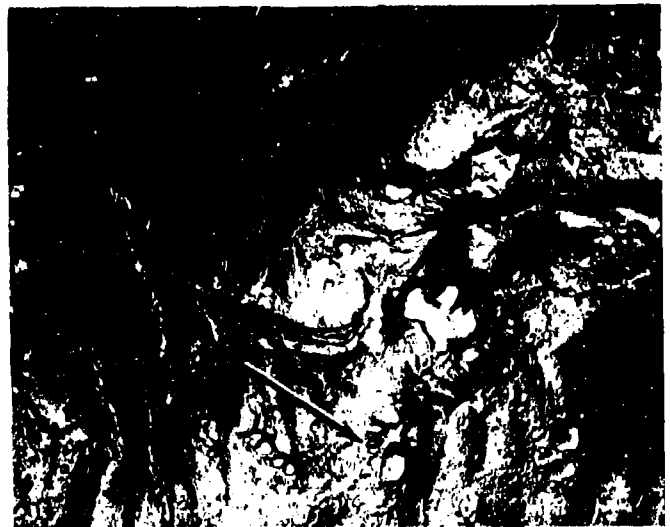
FIGURE 10

ELECTRON FRACTOGRAPHS OF TYPICAL FRACTURE FACES. ARROWS INDICATE COPPER RICH PRECIPITATE INDICATIVE OF THE H-1050 CONDITION.

Electron fractographic evaluation of selected samples did not reveal any differences in the two alloys. However, in the H-1050 condition, clusters of the copper rich precipitate were observed on the fracture face. This is shown in Figure 10.
