**HARDIMAN I ARM TEST**

**HARDIMAN I PROTOTYPE PROJECT**

This report is a description of the test and evaluation of the left arm assembly.

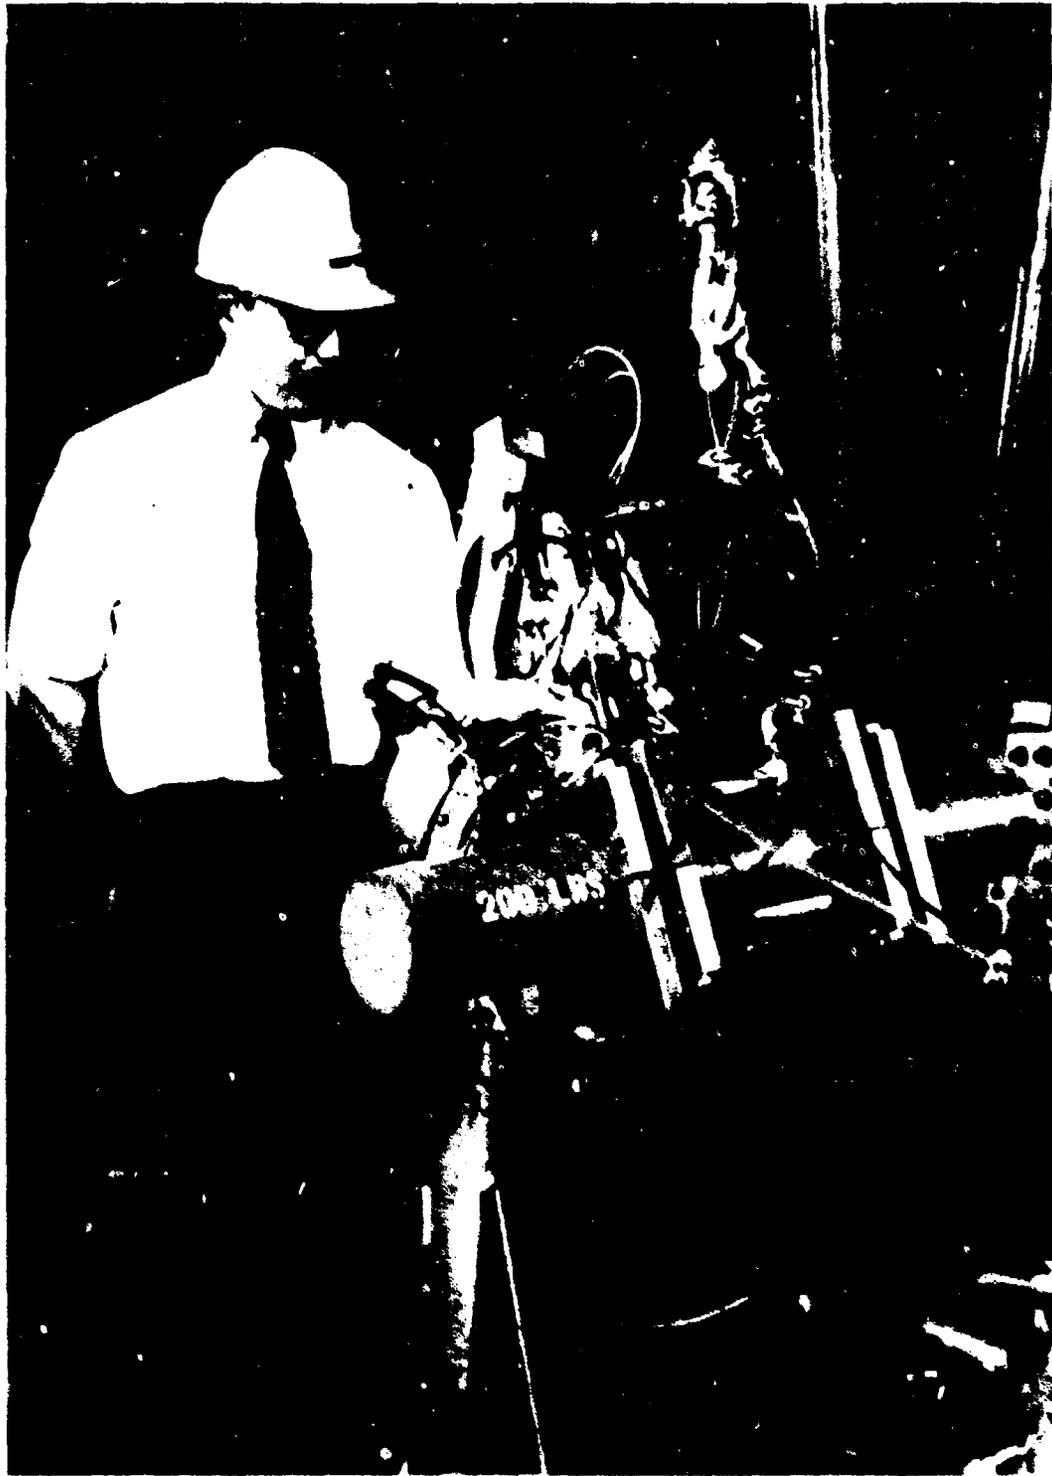
Figure 9. Arm System Lifting 250 Pounds

Figure 9 shows the arm system lifting the 200 pound weight plus 50 pounds of rigging. The frame work in the background is used to support a hoist which acts as a tether and also handles the weights. The operator is wearing the hard hat as normal operating procedure when overhead equipment is being used.

The weight was raised to a height of six feet and in general was handled easily. The operator was able to hold the weight for a period of about one and one half minutes. This was limited because the operator was bending over and reaching out when lifting the weight and therefore exerted a great deal of energy. When the leg system is added, much of this will be eliminated as the legs will do most of the lifting, and the operator will be able to keep the weight in closer to his body.

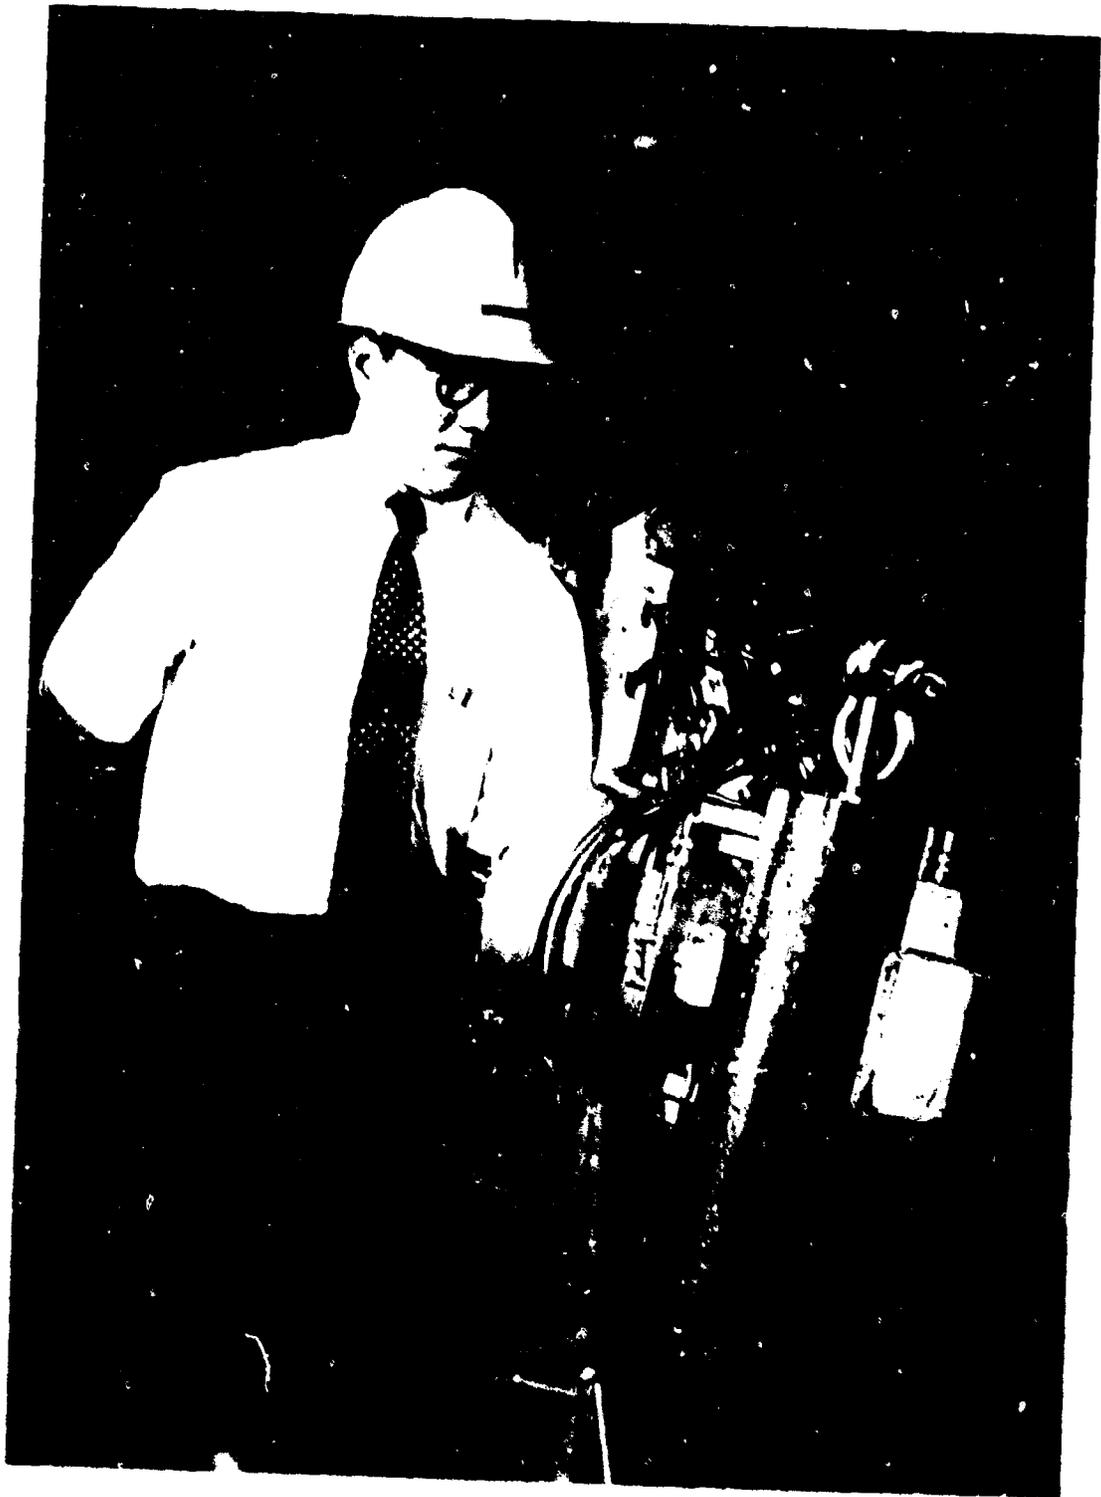
Figure 11. Lifting 100 Pounds Untethered

In Figure 11, the machine is shown lifting the 100 pound weight without the tether. In this position, the gripping force of the thumb is strong enough to support the load. During this test, the weight was removed from a hook, held in the vertical position, rotated 90° to a horizontal position, rotated again to the vertical position, and then placed in a circular tube.
