D6-25219

February 1970

**STRESS-CORROSION PROPERTIES
OF
HIGH-STRENGTH PRECIPITATION-HARDENING STAINLESS STEELS
IN
3.5% AQUEOUS SODIUM CHLORIDE SOLUTION**

BOEING COMMERCIAL AIRPLANE GROUP
SEATTLE, WASHINGTON

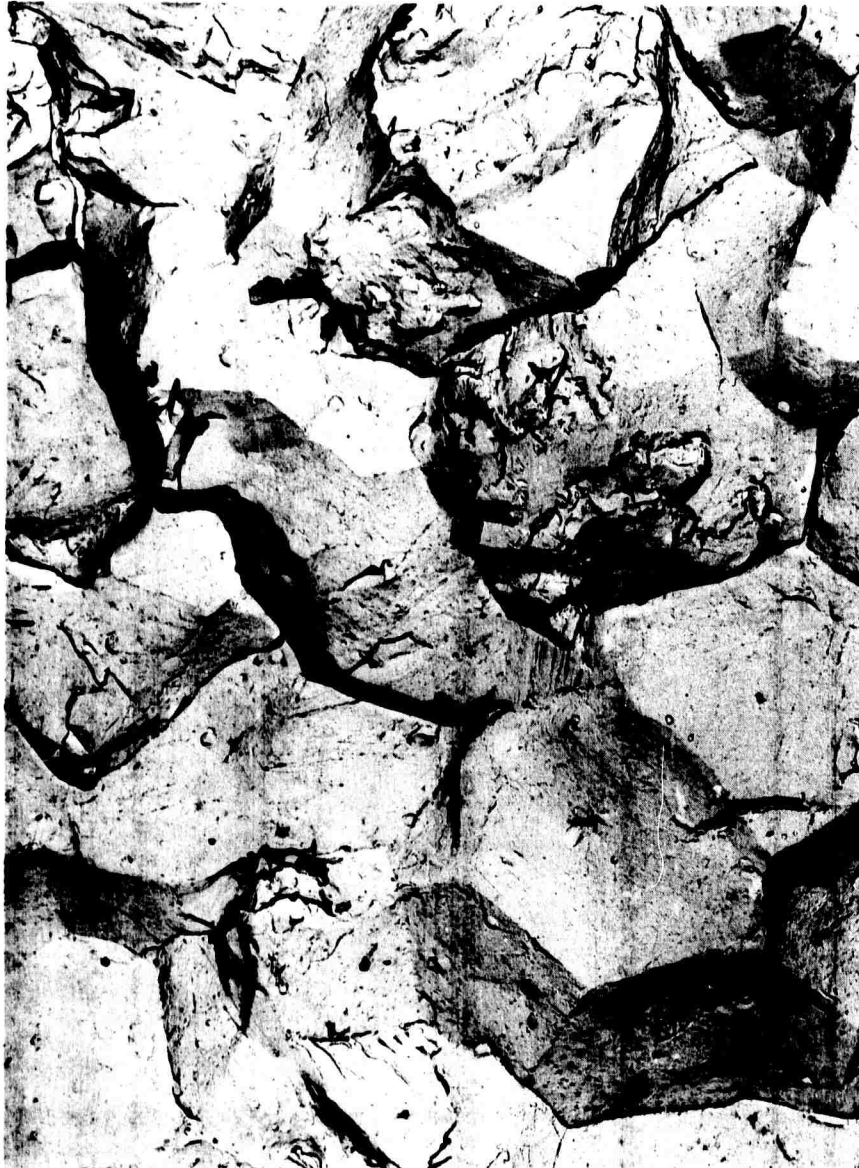
Figure 16 Intergranular stress-corrosion cracking in martensitic stainless steel AM 362 (H 900) (X4,000).

Fractographic examination revealed that the stress-corrosion cracks in both the semiaustenitic and martensitic steels invariably propagated in an intergranular manner. Typical fractographs are shown in Figs. 15 and 16.
