OWENS-ILLINOIS TECHNICAL CENTER

SEMI-ANNUAL TECHNICAL REPORT
BY: ROBERT W. BECK

DAMAGE THRESHOLD STUDIES OF GLASS LASER MATERIALS

31 JULY 1970
CONTRACT NO. DAHC15-69-C-0303

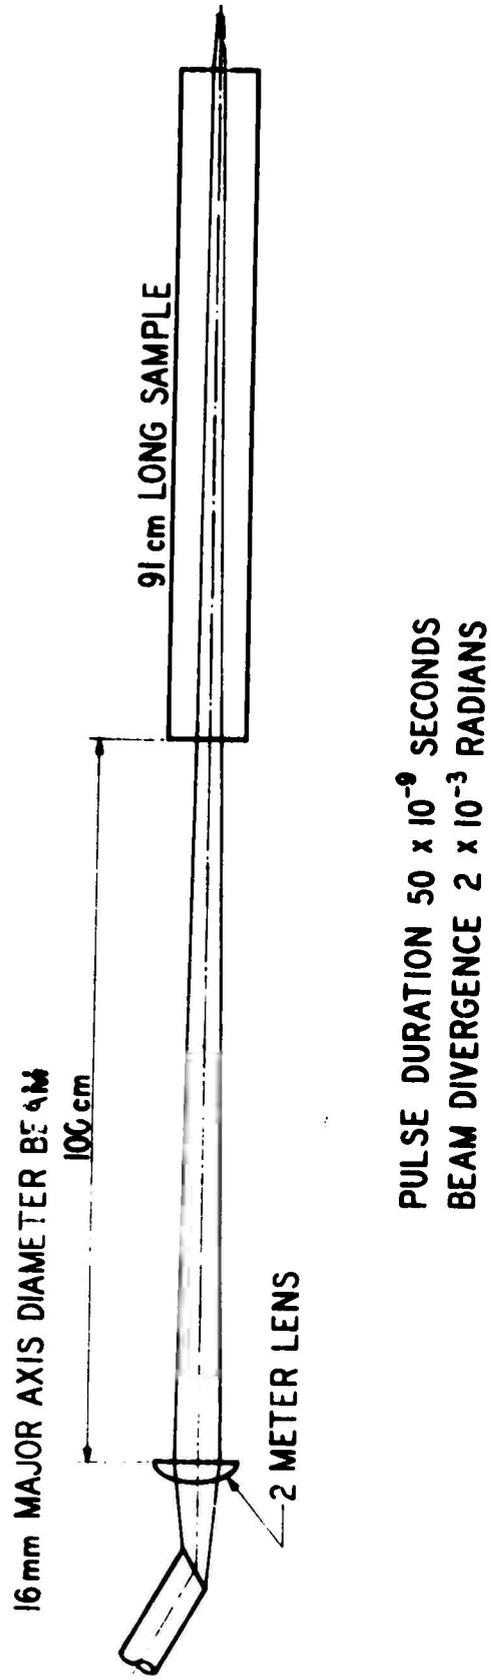
FIGURE 1

SELF-TRAPPING & SURFACE DAMAGE EXPERIMENTAL ARRANGEMENT

Having produced no damage with the unfocused beam, a 2 meter lens was placed in the system as shown in Figure 1. With this arrangement, as the output energy of the laser was increased the first appearance of damage was an orange peel effect on the output surface of the test sample. Examples of this type of damage may be found in Figures 2 and 3. In Figure 2 the surface is slightly out of focus to more effectively show the waviness, while in Figure 3 the surface is in focus and both the orange peel and pitting damage are apparent. Sampling the output surface at several locations showed that this type of damage occurs on the average at an energy density of 136 joules/cm².
