REPORT NO. FAA-FS-600-8

# EVALUATION OF Approach Procedures for ILS Back Course with Glide Slope

July 1972  
FINAL REPORT

**DEPARTMENT OF TRANSPORTATION  
FEDERAL AVIATION ADMINISTRATION**

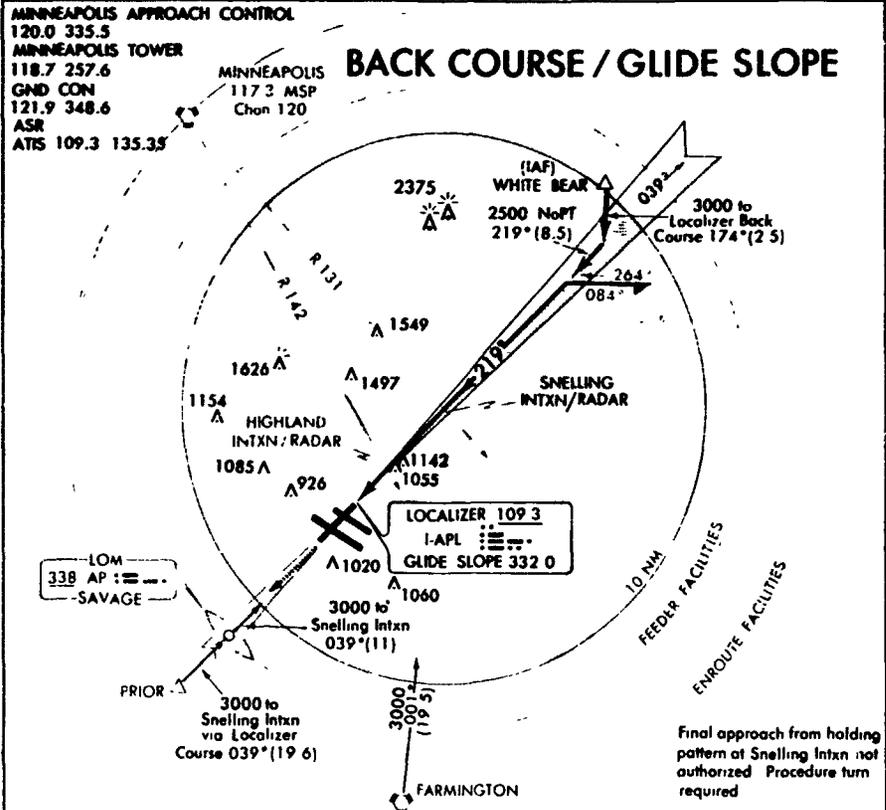
# ILS BC RWY 22

MINNEAPOLIS-ST PAUL INTL (WOLD-CHAMBERLAIN FIELD)  
AL-264 (FAA) MINNEAPOLIS, MINNESOTA

Dual VOR receivers or Radar required  
Inoperative table does not apply to REIL Rwy 22  
Sliding scale not authorized  
Air carriers will not reduce landing visibility due to local conditions Rwy 22

REIL Rwys 11R, 22 and 29R  
HIRL Rwys 4-22, 11L-29R and 11R-29L

Each of the two back course procedures uses the same localizer transmitters serving the front course approaches. Marker beacons had not been installed for the procedures at the time of this evaluation, but have since been provided. Both runways have REILs and HIRLs. See approach plates, Pages v & vi.

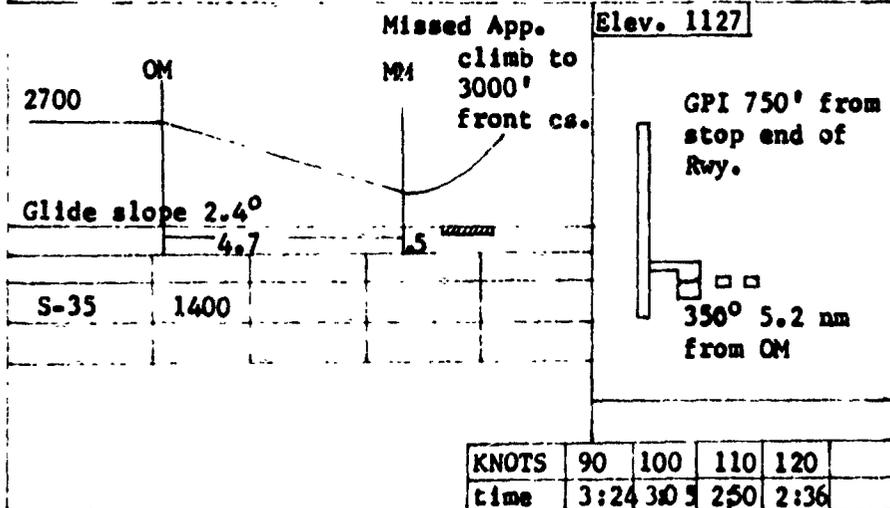
ILS BACK COURSE Rwy 35

BACK COURSE WITH  
GLIDE SLOPE  
(experimental)

Glide path  
ant.

Loc. ant.

An approach procedure was developed (CHK Back Course ILS Rwy 35, attached), to present a flyability situation approximating the one on Minn.-St. Paul Back Course ILS Rwy 22. See Figures 2, 3, and 4, Pages 4, 5, and 6.

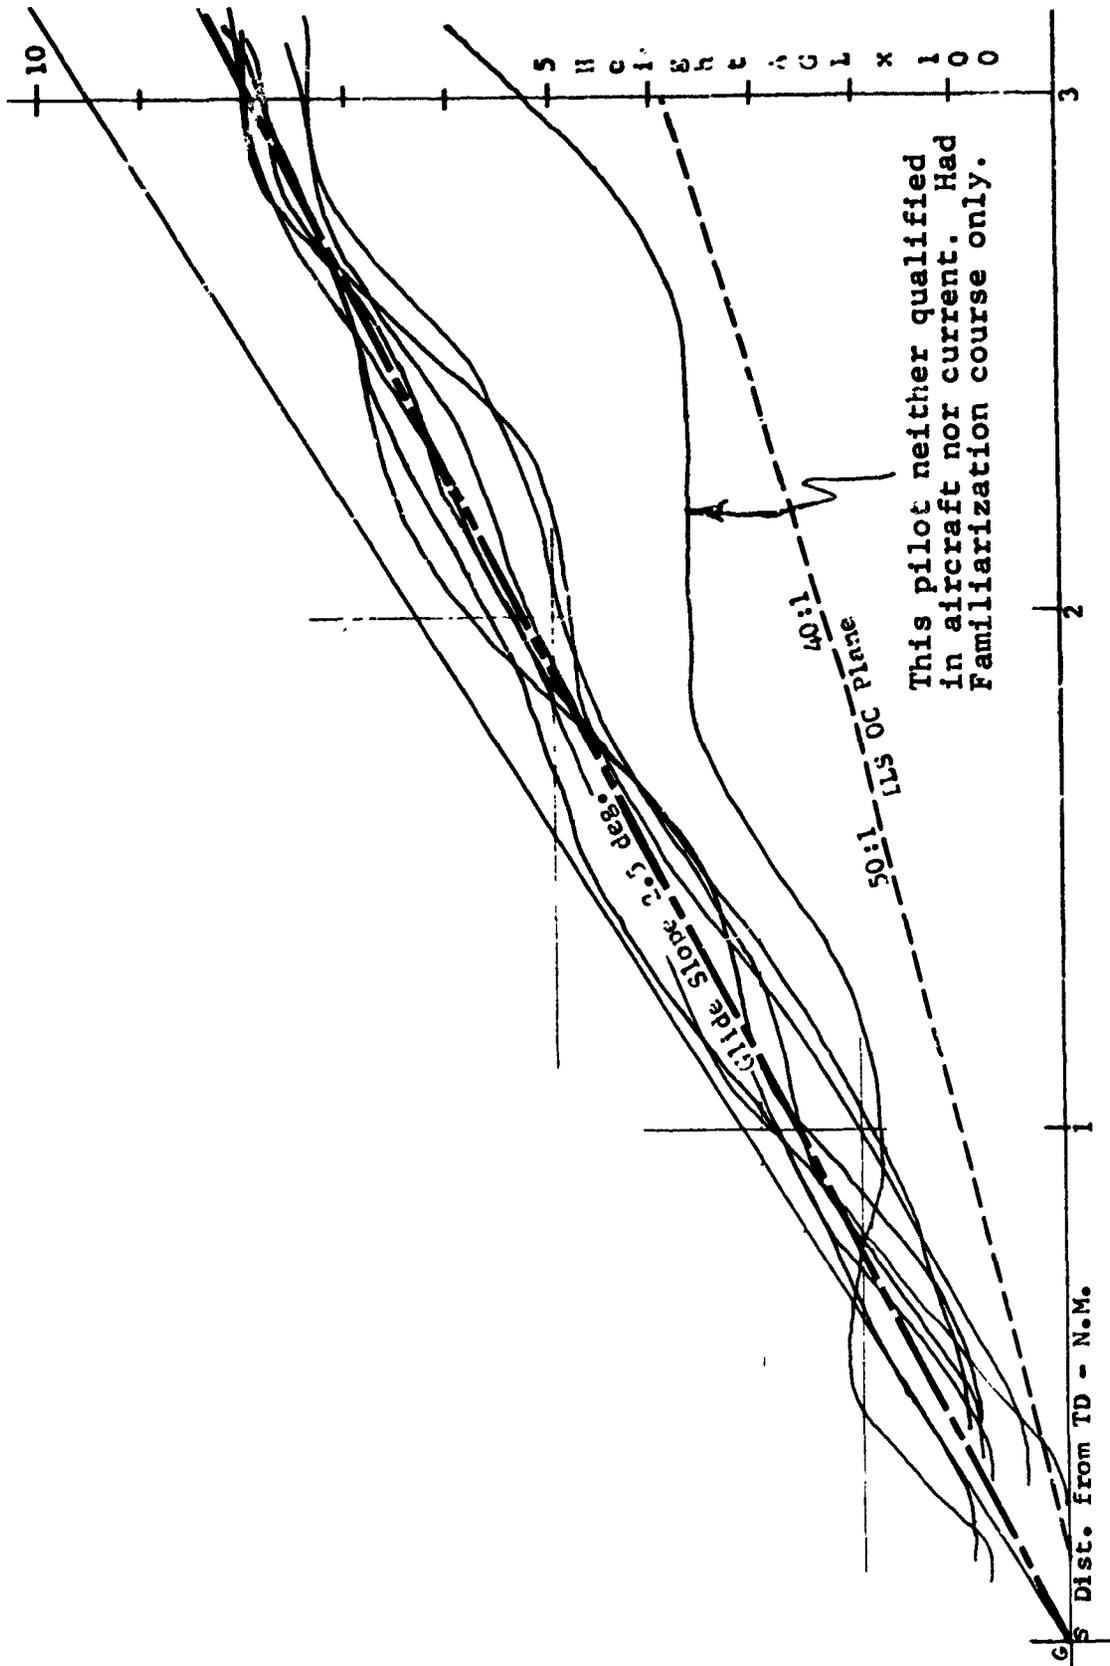
Figure 7. B720 Simulator Composite. LOC/GS. Raw Data. (Front Course) Glide Slope Plot.

This pilot neither qualified  
in aircraft nor current. Had  
Familiarization course only.

Composites of each type of back course approach and of one front course approach were produced from the simulator recordings to show azimuth and elevation comparisons under the following guidance conditions: (See Pages 12 through 19)

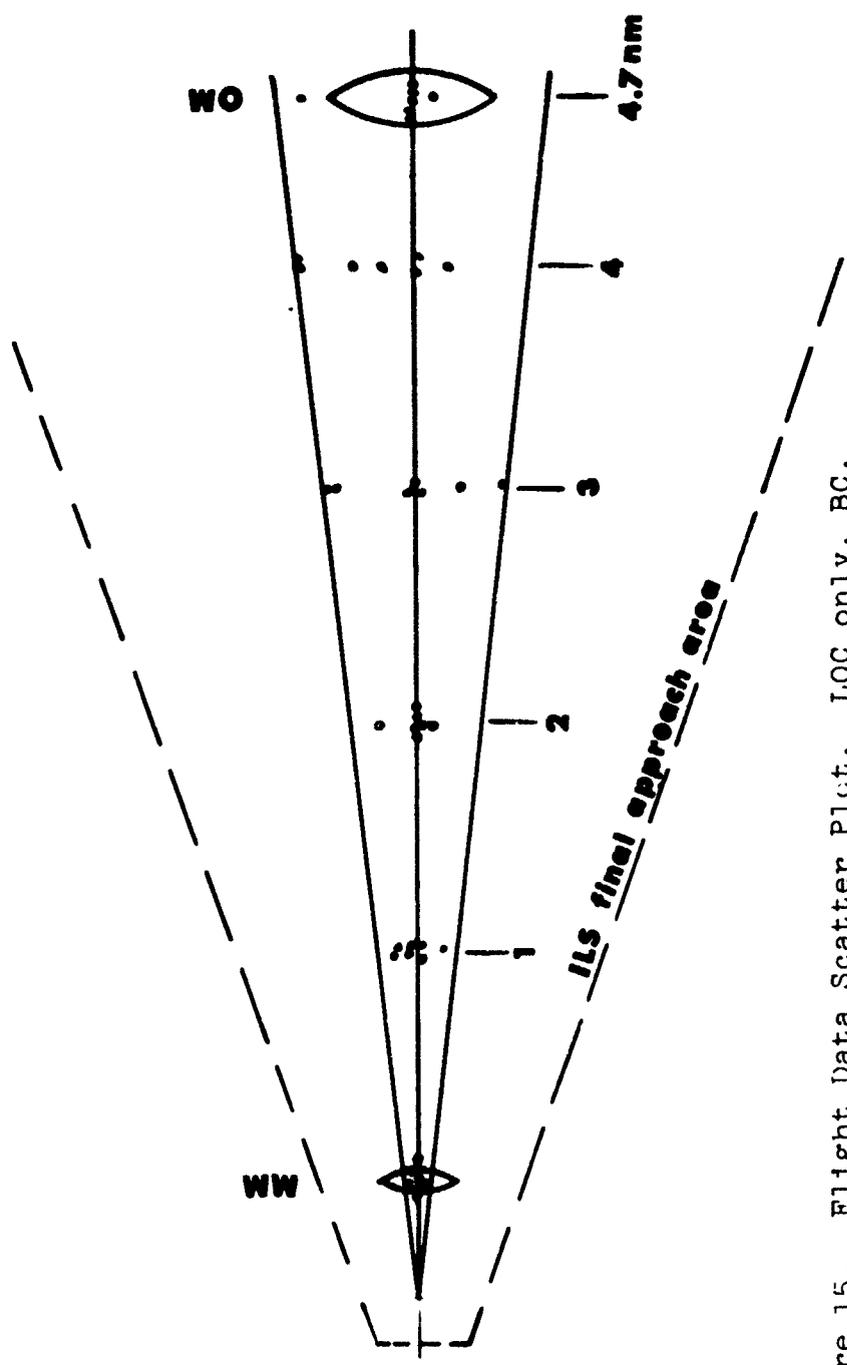
Figure 15. Flight Data Scatter Plct. LOC only. BC.  
Localizer Plot.

Back course approach, Chickasha ILS  
 Localizer only (3 light twin, 3 exec. Jet, 1 DC-3  
 aircraft) Aircraft position about the localizer  
 course, MM to OM at 1 mile intervals.

Two scatter plots were drawn showing aircraft position at six data points from MM to OM on the back course approach with glide slope and on the "localizer only" approach. Each composite represents one approach by each of the light twins, executive jets, and DC-3. See Figs. 15 and 16(Pages 24 and 25)

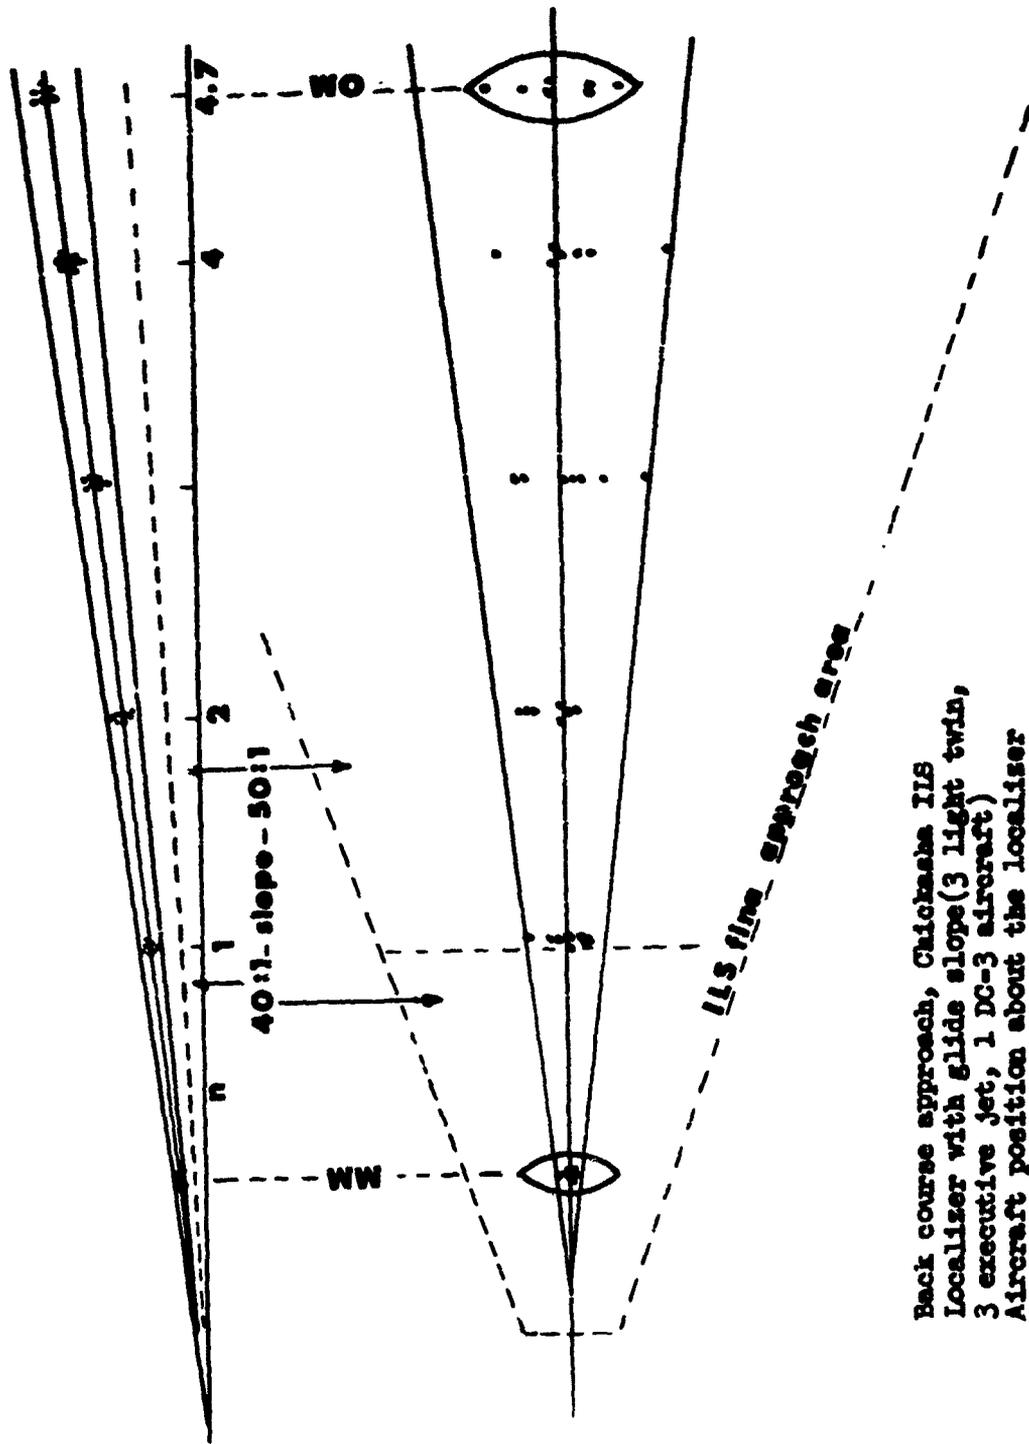
Figure 16. Flight Data Scatter Plot. LOC/GS. BC.  
Localizer and Glide Slope Plot.

Back course approach, Chickamauga ILS  
 Localizer with glide slope (3 light twin,  
 3 executive jet, 1 DC-3 aircraft)  
 Aircraft position about the localizer  
 course and glide path, MM to OM at  
 1 nmi. intervals.
