GLASS OR CERAMIC SPHERICAL-SHELL
WINDOW ASSEMBLY FOR 20,000-PSI
OPERATIONAL PRESSURE

Jerry D. Stachiw

Naval Undersea Center
San Diego, California

May 1974

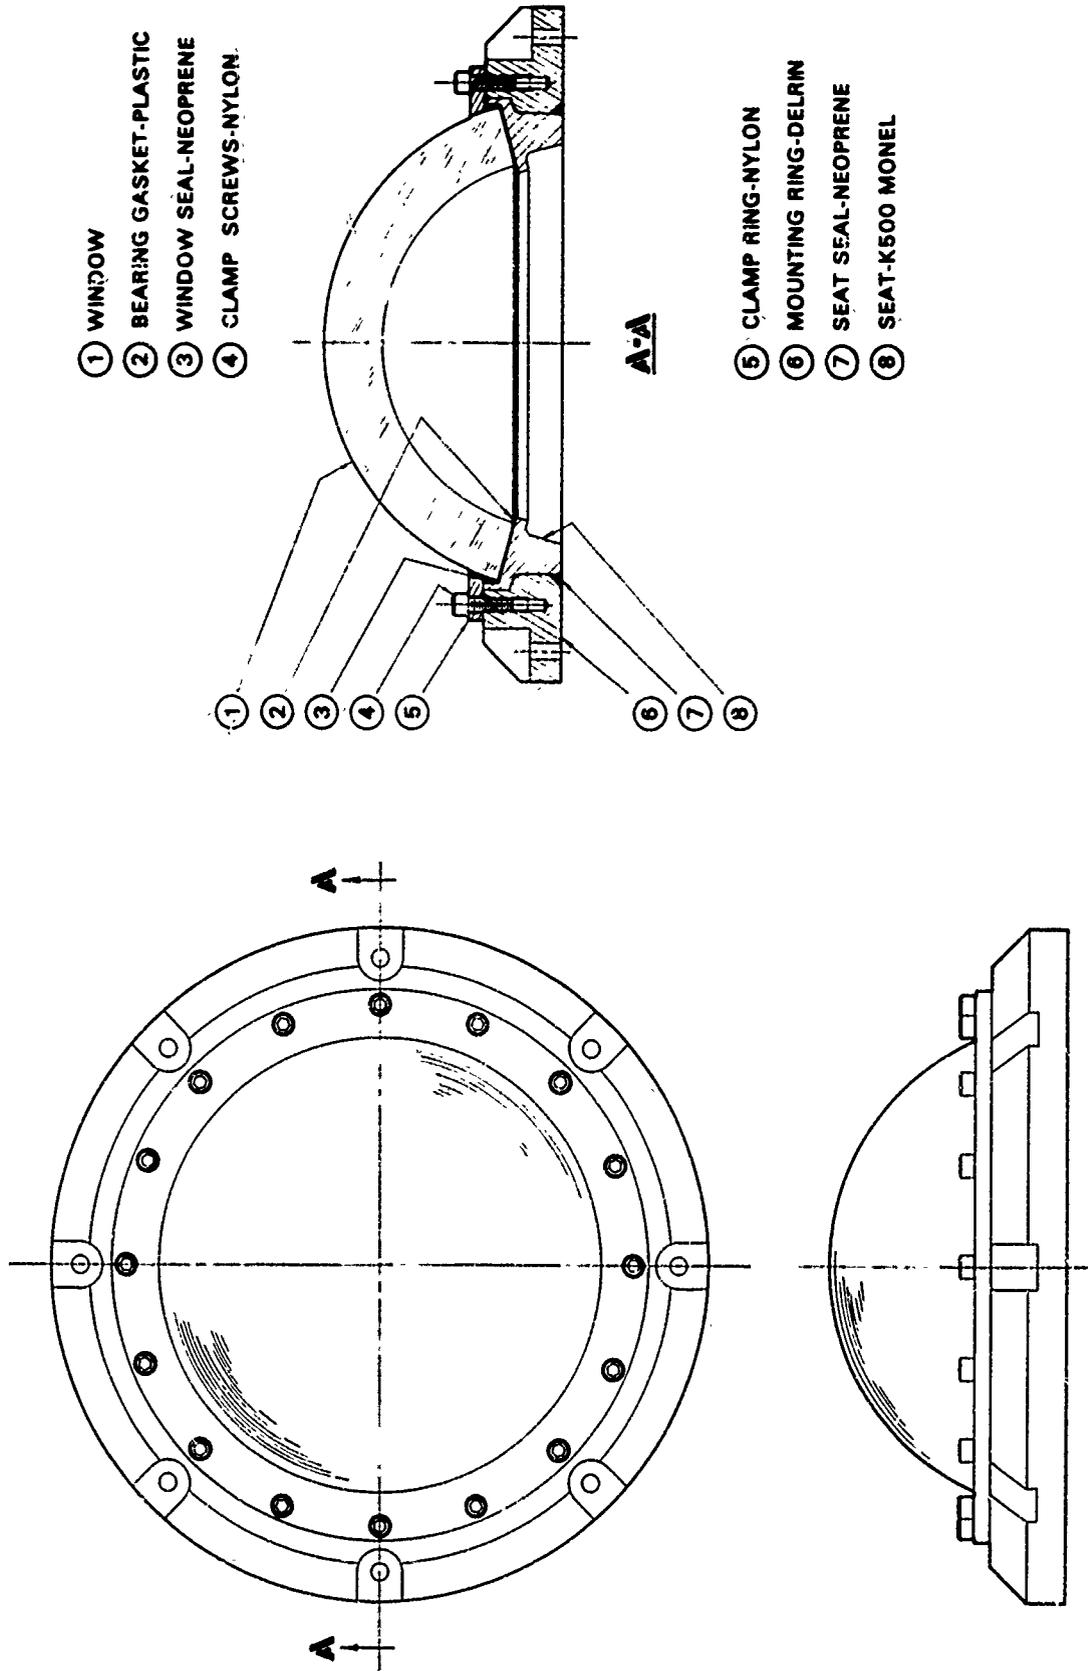
Figure 1. NUC spherical-shell window-flange assembly with 150-degree included spherical angle for service to 20,000-psi hydrostatic pressure.

To make the assembly a self-contained structural subsystem (Appendix A), the window was designed to rest on a flange and be retained by rings that do not form a part of the hull structure (figure 1). Since the flange mounting-ring that bolts to the hull is not rigidly attached to the flange, the latter is free to contract radially under the influence of hydrostatic pressure. The sliding friction between the flange and the hull imposes some restraint on the flange; but this is minor and, in addition, the frictional constraint between two flat surfaces does not readily transmit bending moments from the hull to the flange. The mounting ring also, although bolted to the hull, is not subjected to high stresses by the hull because it is made of DELRIN plastic with a significantly lower modulus of elasticity than that of a typical metallic hull.

The clamp ring for holding the window in the flange and the mounting ring for the attachment of the flange to the hull were made from Nylon and Delrin, respectively. Plastics were chosen for this application because of their compliance to hull deformation and superior corrosion resistance (figure 1).

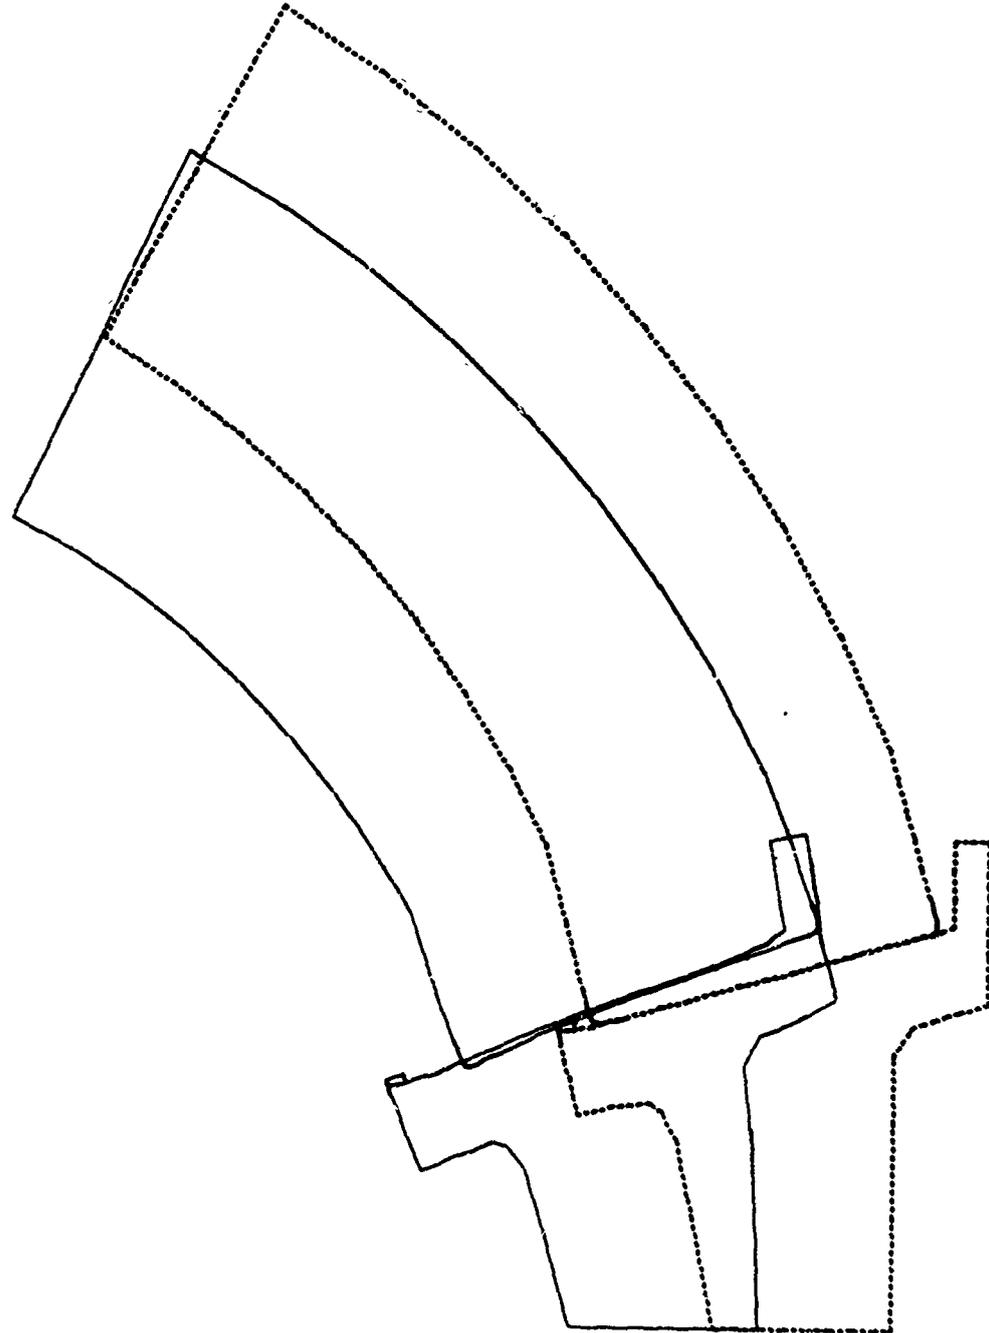
Figure 2. Finite element stress analysis of the NUC window-flange assembly subjected to external hydrostatic pressure; a glass window was supported by a Monel K-500 flange on an epoxy-coated PRD-49 cloth gasket. (sheet 1 of 10)

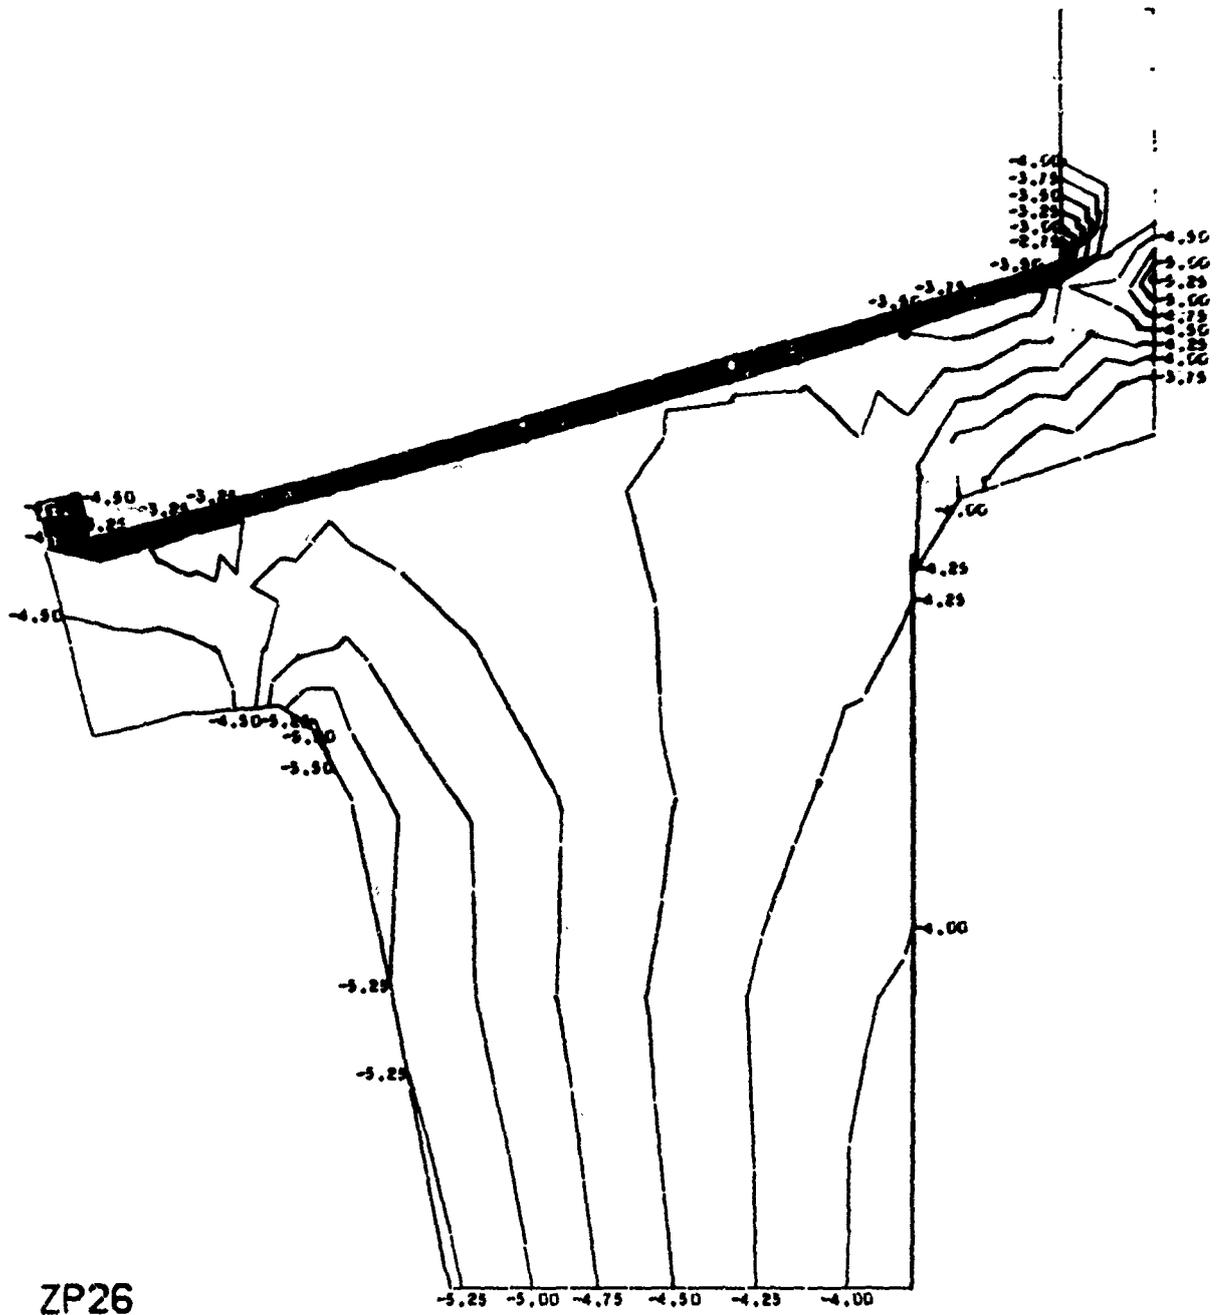
Figure 2. Finite element stress analysis of the NUC window-flange assembly subjected to external hydrostatic pressure; a glass window was supported by a Monel K-500 flange on an epoxy-coated PRD-49 cloth gasket. (sheet 2 of 10)

ZP26
 CONTOUR PLOT * CIRCUMFERENTIAL STRESS * INCREMENT NUMBER 1

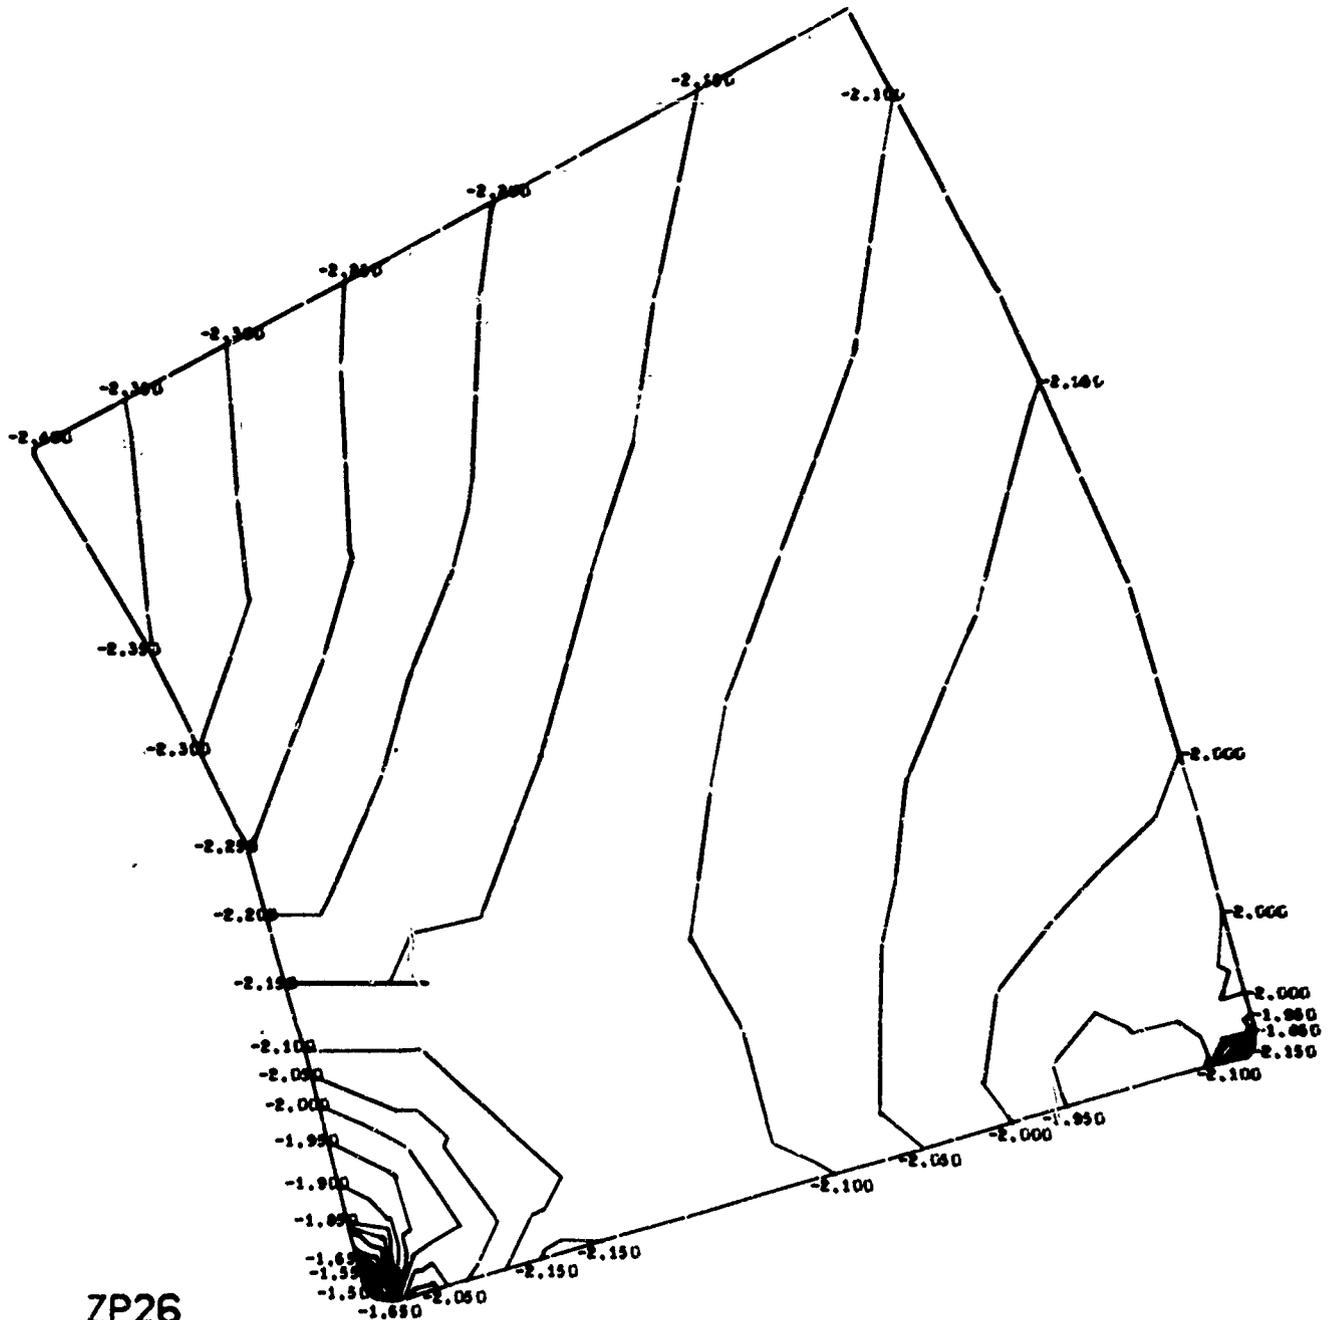
Figure 2. Finite element stress analysis of the NUC window-flange assembly subjected to external hydrostatic pressure; a glass window was supported by a Monel K-500 flange on an epoxy-coated PRD-49 cloth gasket. (sheet 3 of 10)

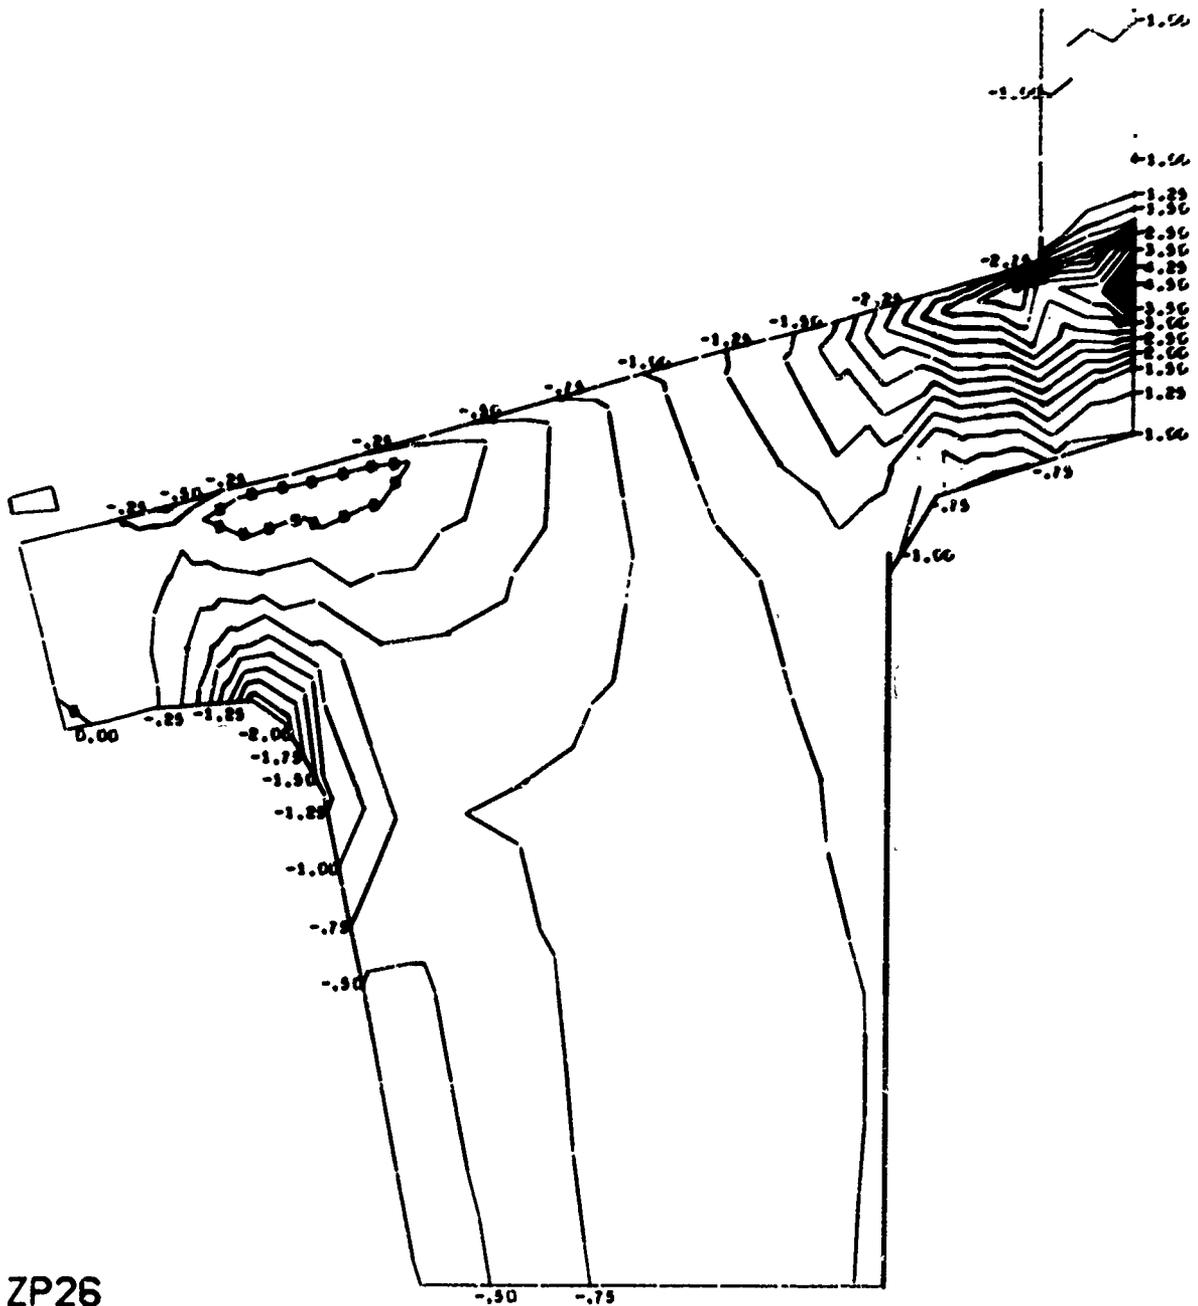
Figure 2. Finite element stress analysis of the NUC window-flange assembly subjected to external hydrostatic pressure; a glass window was supported by a Monel K-500 flange on an epoxy-coated PRD-49 cloth gasket. (sheet 4 of 10)

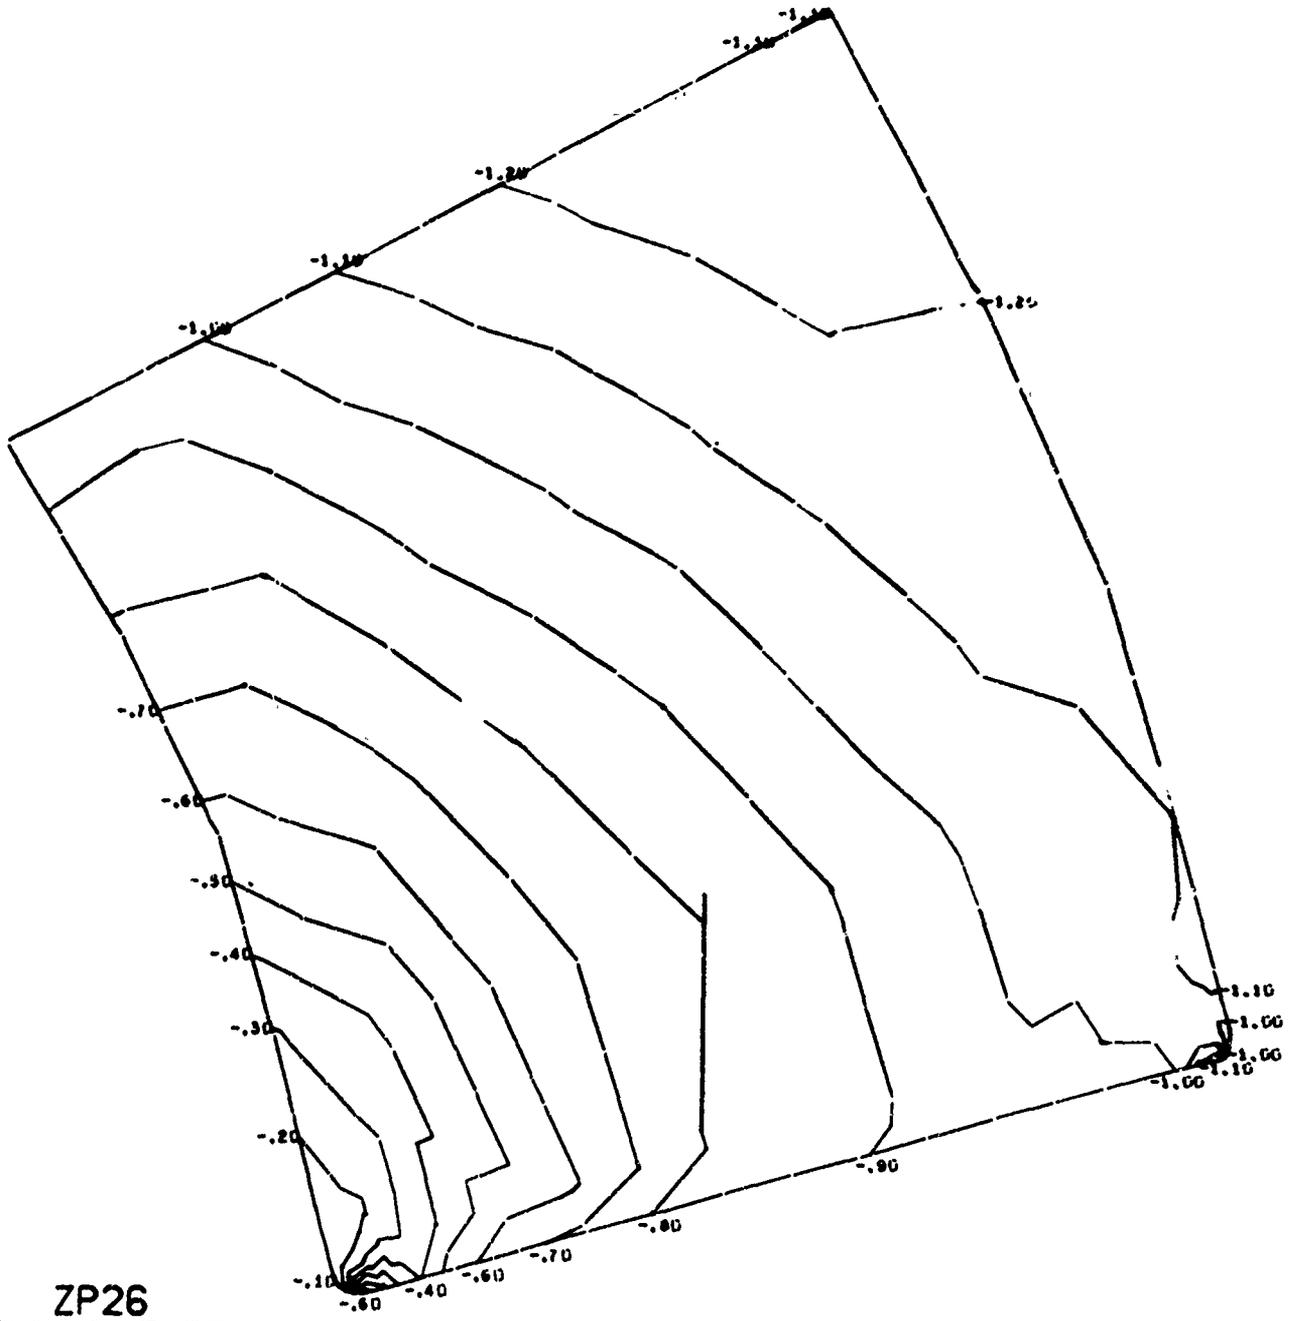
Figure 2. Finite element stress analysis of the NUC window-flange assembly subjected to external hydrostatic pressure; a glass window was supported by a Monel K-500 flange on an epoxy-coated PRD-49 cloth gasket. (sheet 5 of 10)

ZP26
 CONTOUR PLOT * RADIAL STRESS * INCREMENT NUMBER 1

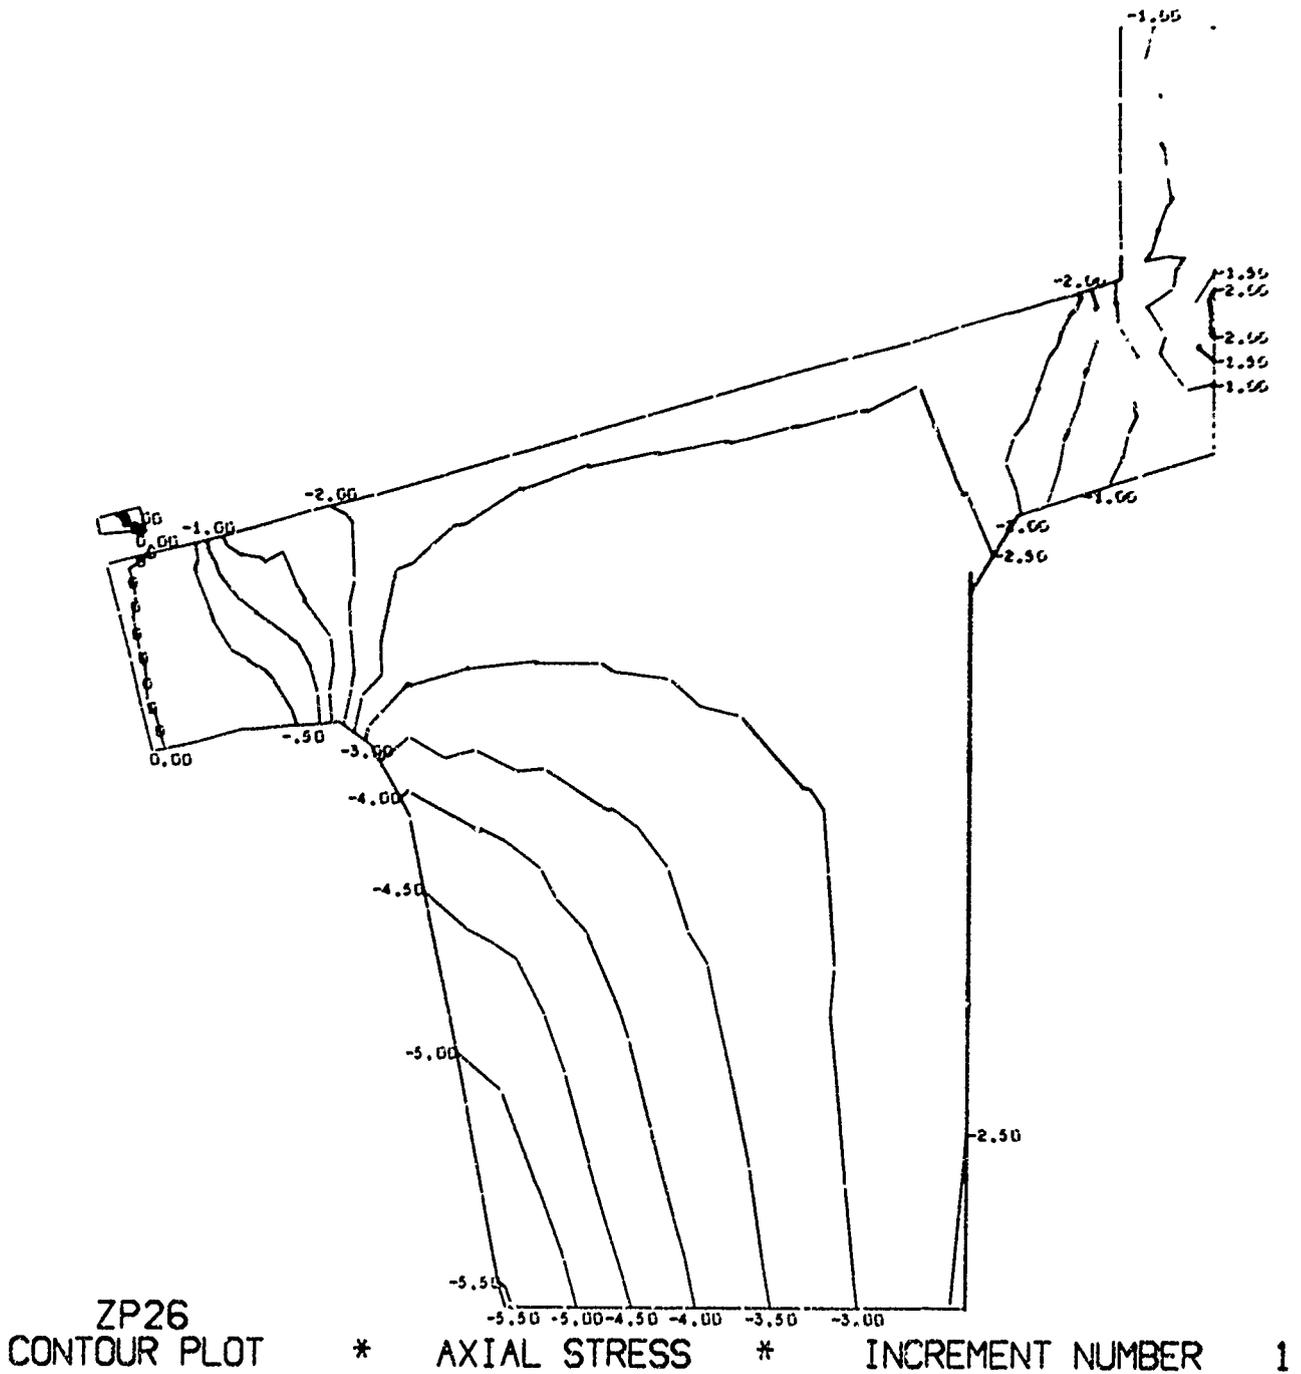
Figure 2. Finite element stress analysis of the NUC window-flange assembly subjected to external hydrostatic pressure; a glass window was supported by a Monel K-500 flange on an epoxy-coated PRD-49 cloth gasket. (sheet 6 of 10)

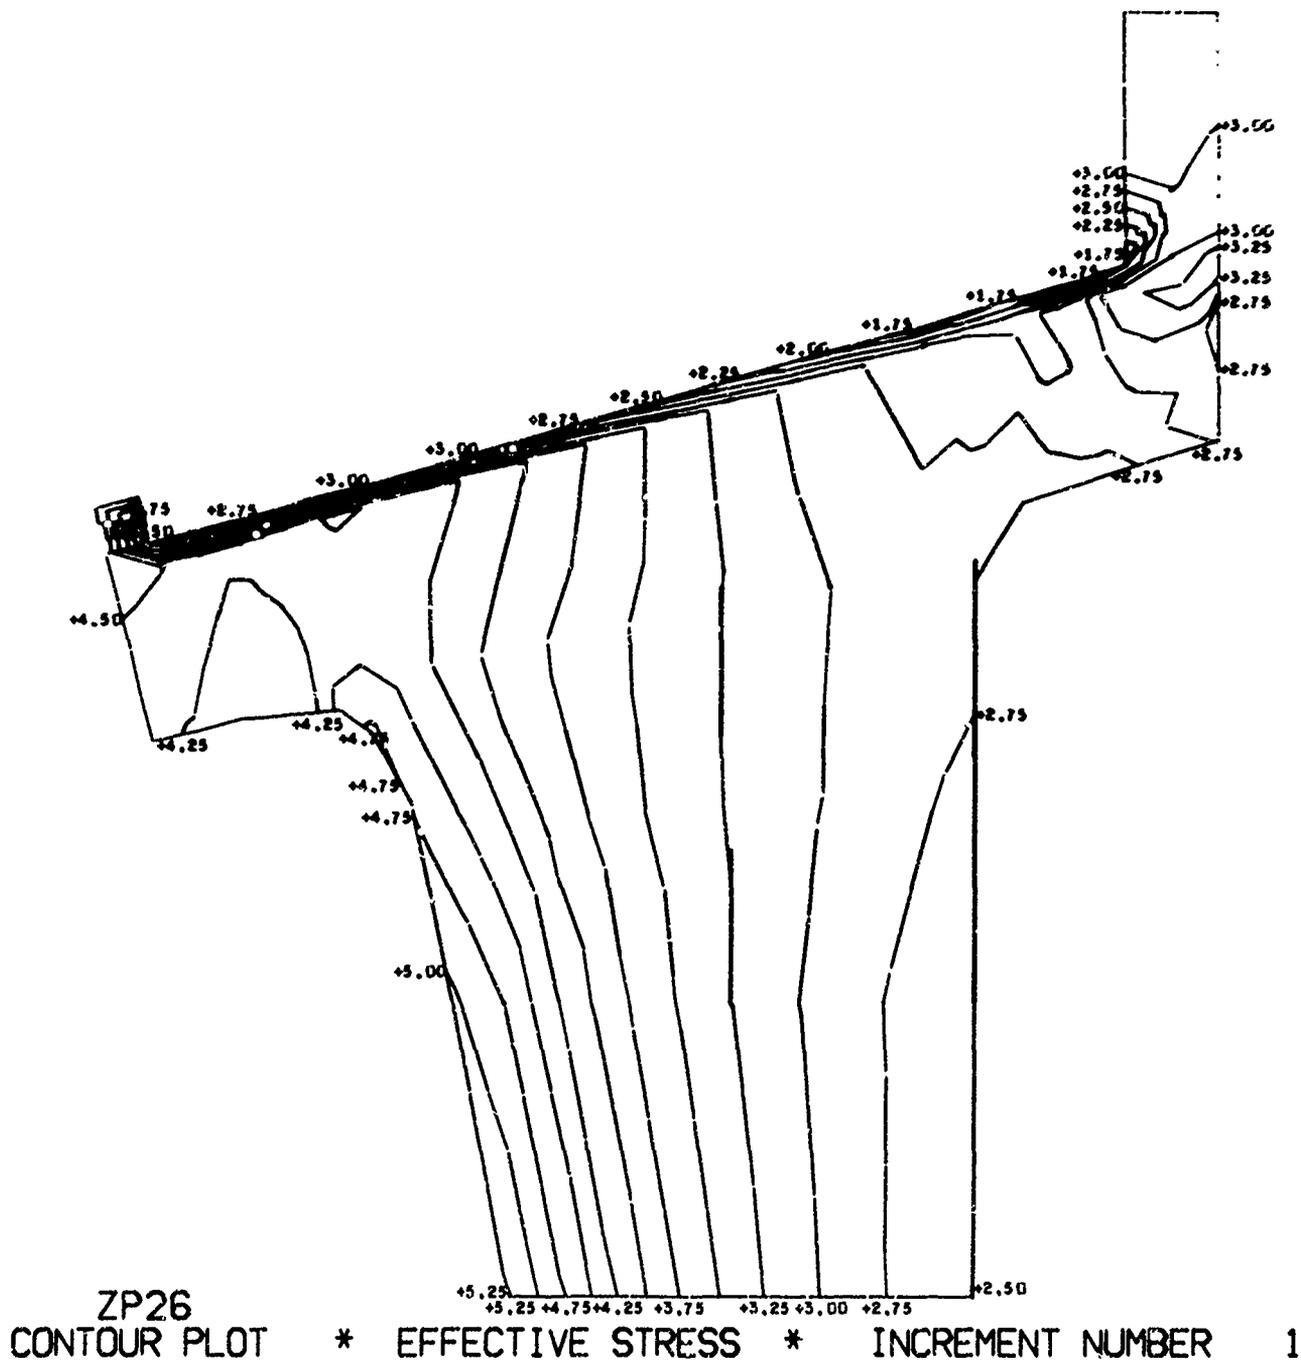
Figure 2. Finite element stress analysis of the NUC window-flange assembly subjected to external hydrostatic pressure; a glass window was supported by a Monel K-500 flange on an epoxy-coated PRD-49 cloth gasket. (sheet 7 of 10)

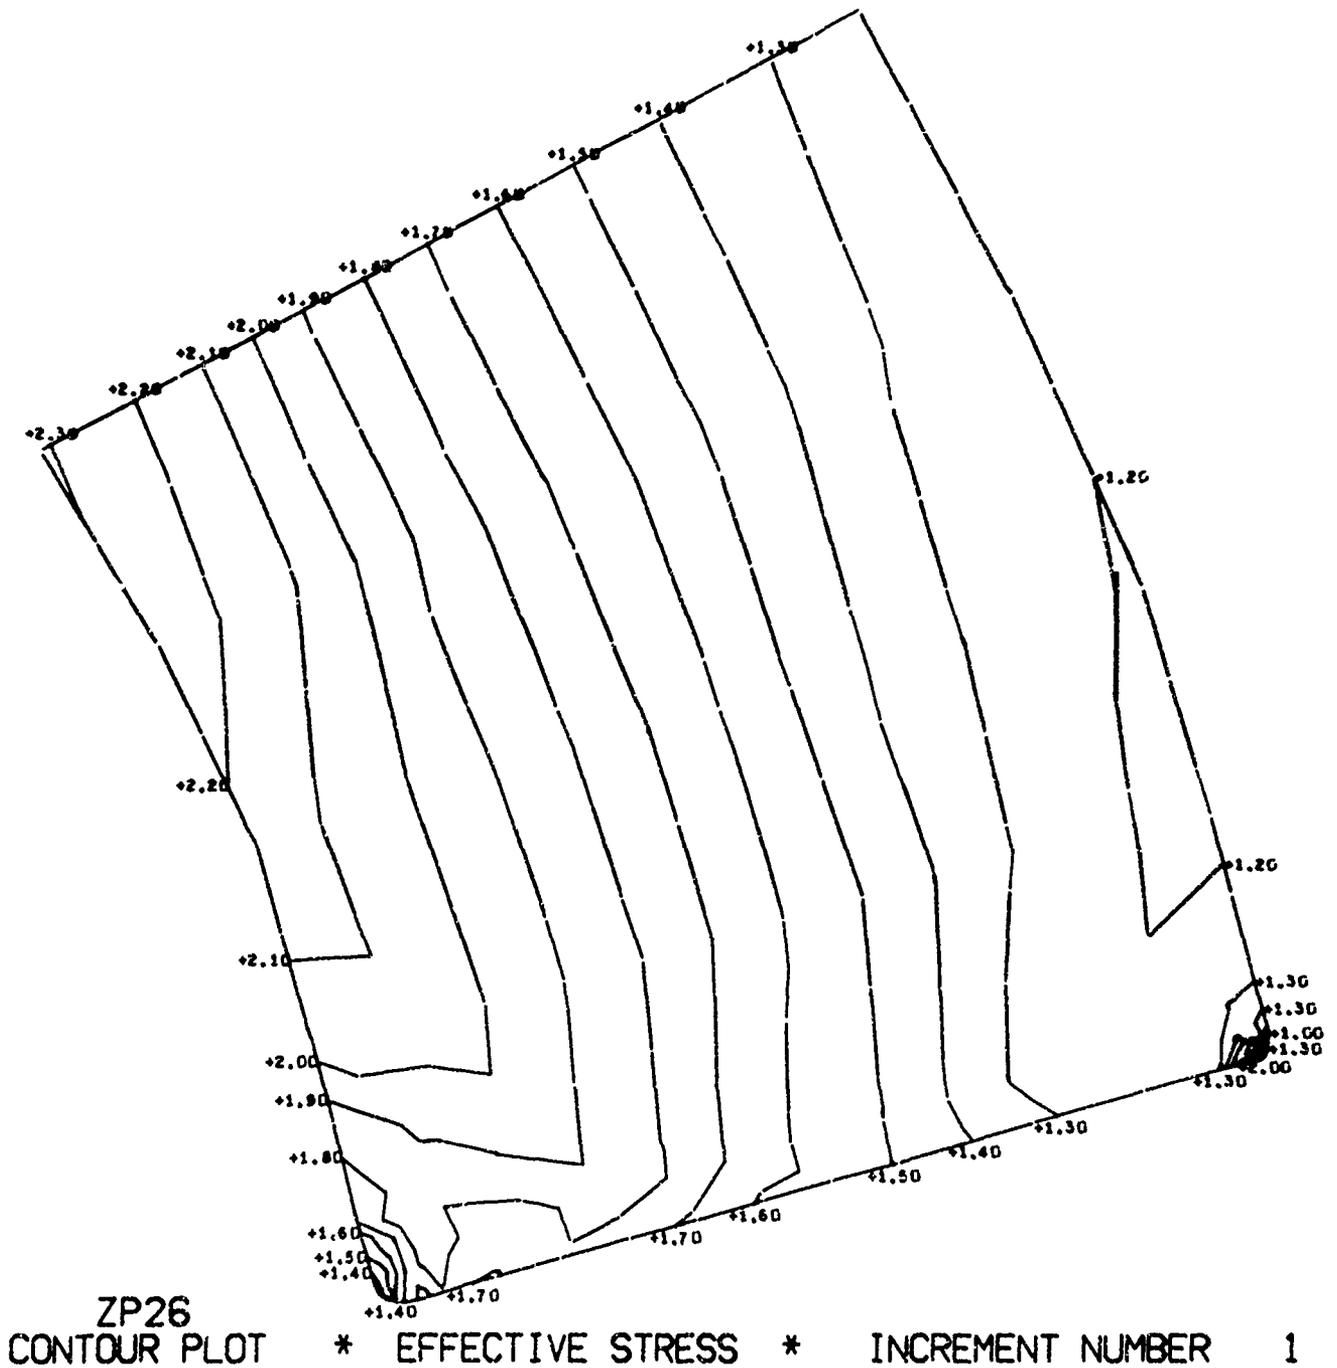
Figure 2. Finite element stress analysis of the NUC window-flange assembly subjected to external hydrostatic pressure; a glass window was supported by a Monel K-500 flange on an epoxy-coated PRD-49 cloth gasket. (sheet 9 of 10)

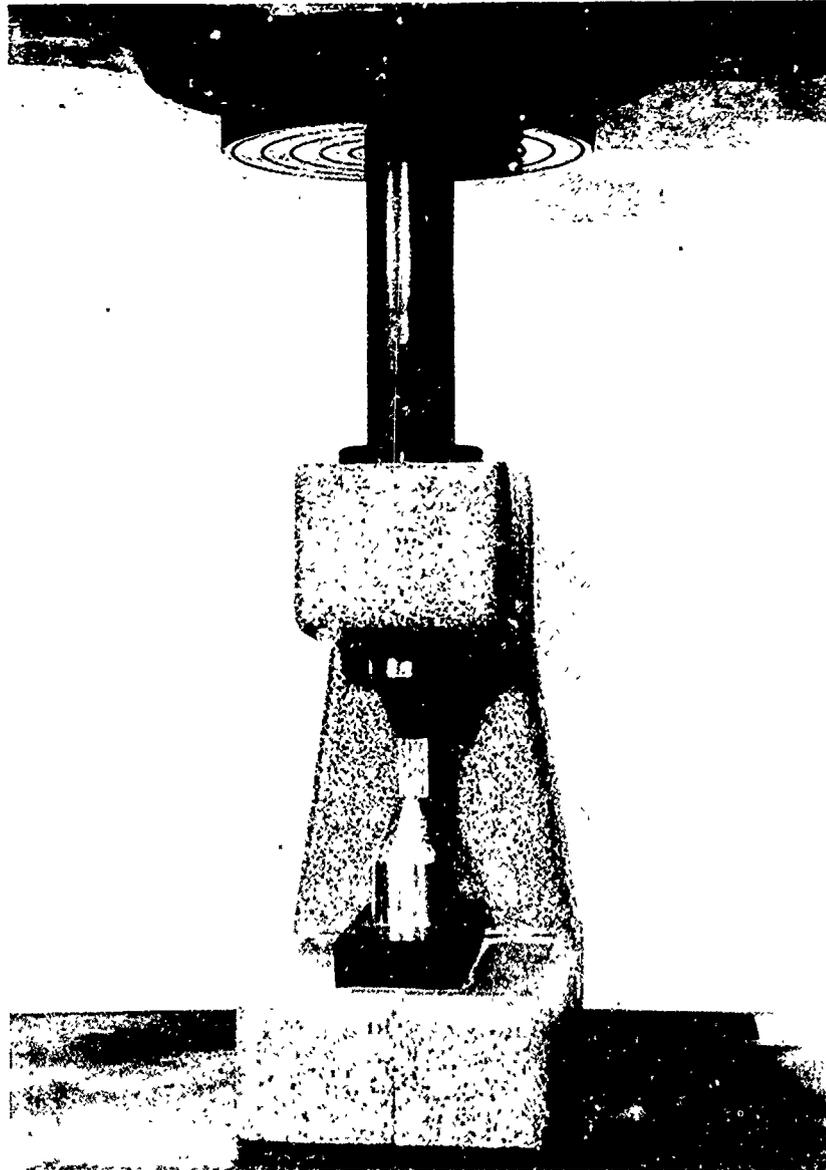
Figure 4. Test apparatus for determining the uniaxial compressive strength of glass and ceramic.

The effect of the test jig configuration on the ultimate compressive strength was also significant. During the tests on Cer-Vit C-101 specimens, in which the diameter of the anvil matched that of the test specimens (figure 4), the average ultimate compressive loading at failure was higher (203,666 psi; $\bar{x} = 21,400$ psi) than that measured during tests in which the diameter of the anvil was several times larger (174,000 psi; $\bar{x} = 3,740$ psi). At the termination of tests for which

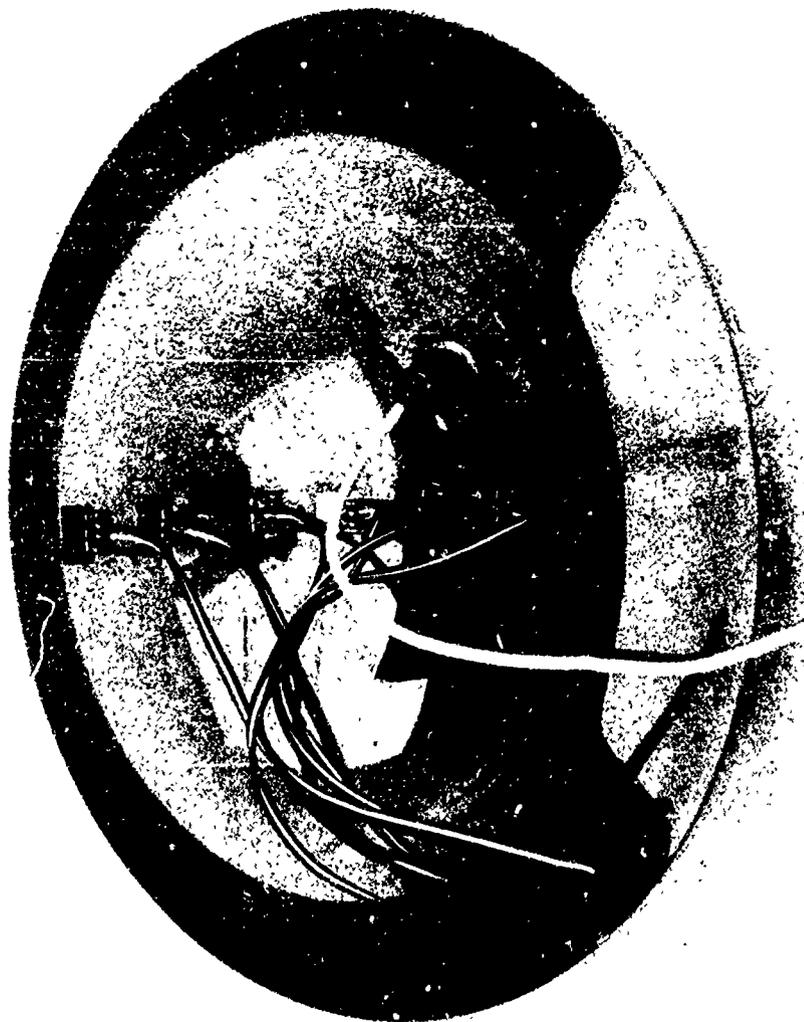
Figure 11. Instrumentation used to record strain and acoustic emissions of 150-degree spherical-shell window subjected to hydrostatic loading.

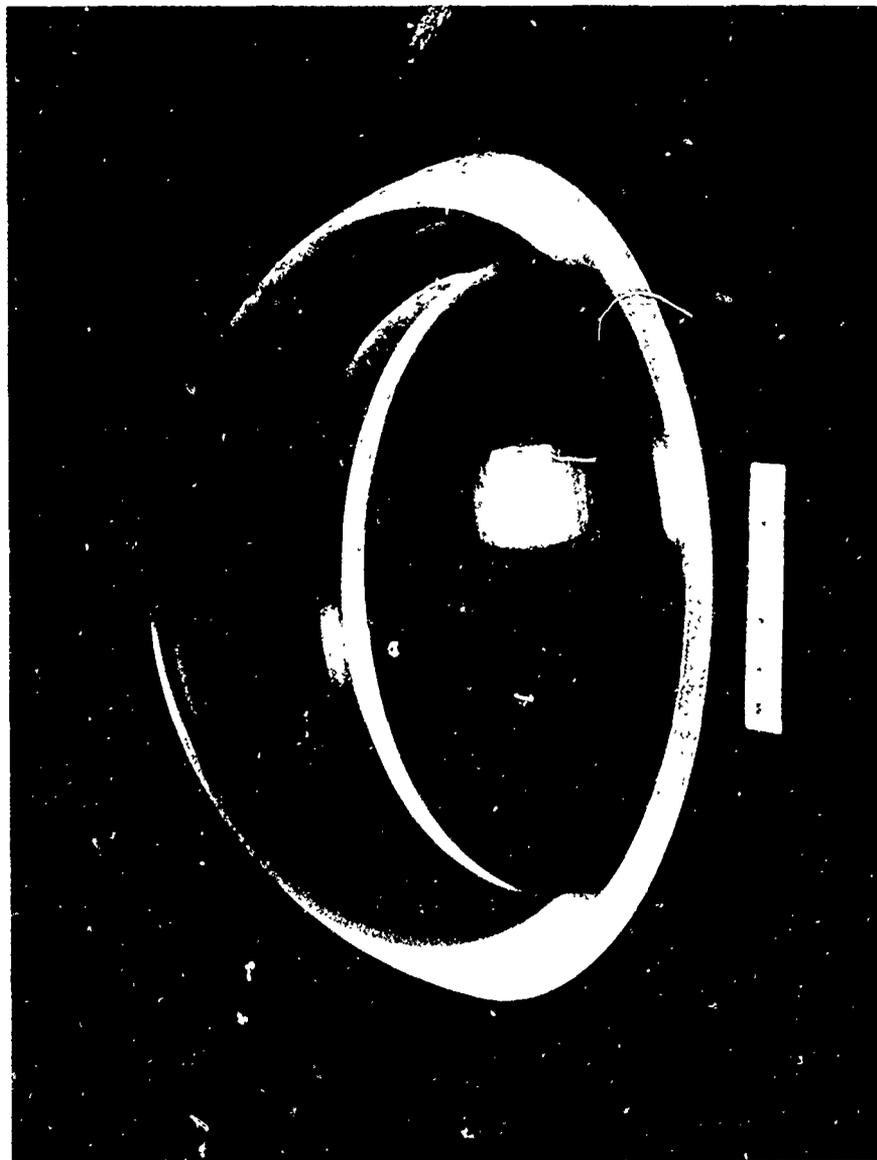
Figure 16. Plexiglas G acrylic plastic window did not fail even under the hydrodynamic impulse of an 8.2-gram explosive charge set off at a 12-inch standoff and a simulated 1,000-foot depth.

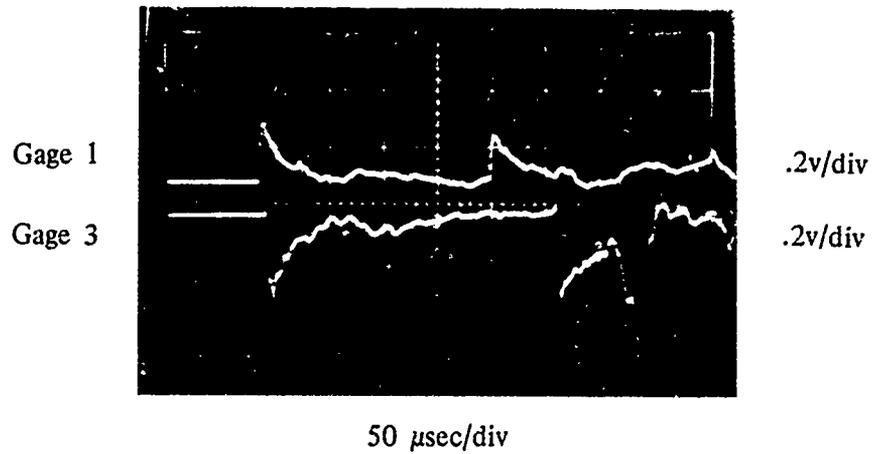
<u>Gage 1</u>	<u>Gage 2</u>	<u>Calculated</u>
Peak Shock Overpressure, psi:	5,020	3,250	4,950 psi
Unit Impulse, psi-sec:	.244	.138	0.140 psi sec
Duration, μ sec:	150	160	150

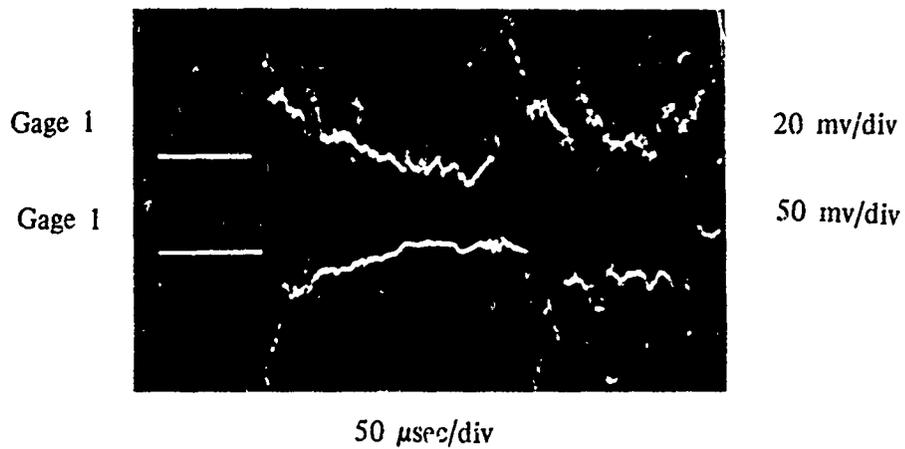
<u>Gage_1</u>	<u>Gage_2</u>	<u>Calculated</u>
Peak Shock Overpressure, psi:	NA	2,350	2,290
Unit Impulse, psi-sec:	NA	.0682	.0358
Duration, μsec:	120	120	NA

Notes: (1) Model failed.

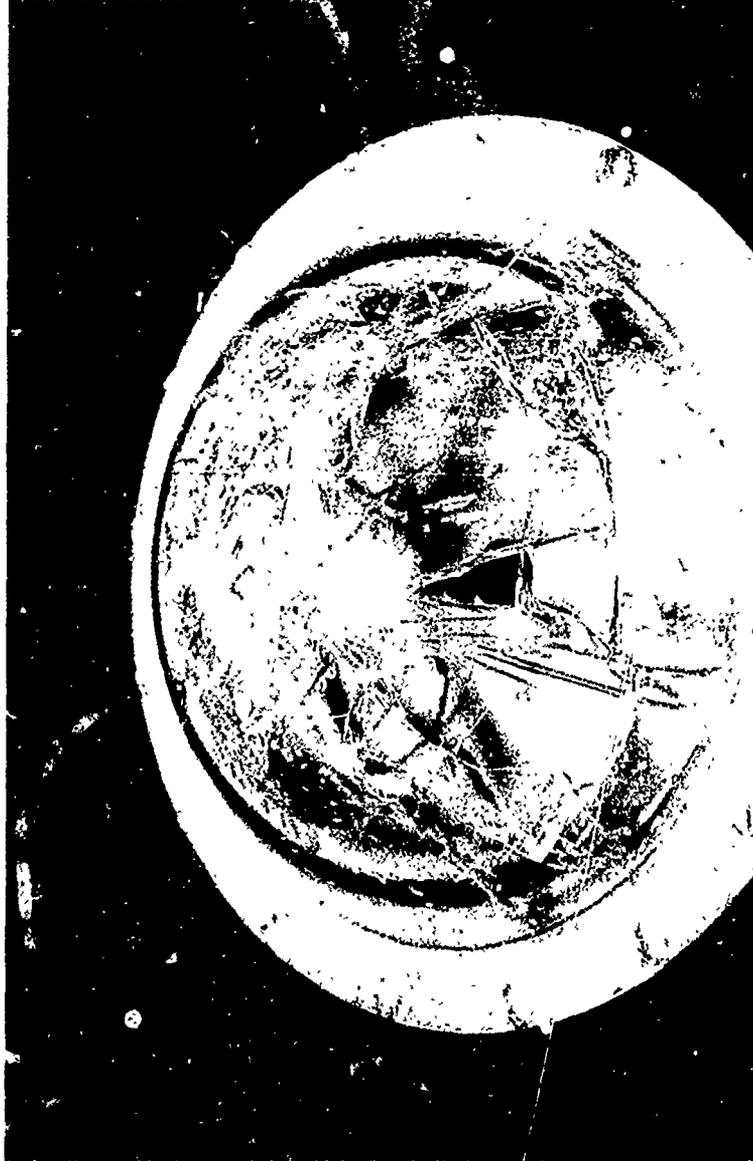
Figure 22. BK-7 glass window failed under the hydrodynamic impulse of a 1.1-gram explosive charge set off at a 12-inch standoff and a simulated 1,000-foot depth.

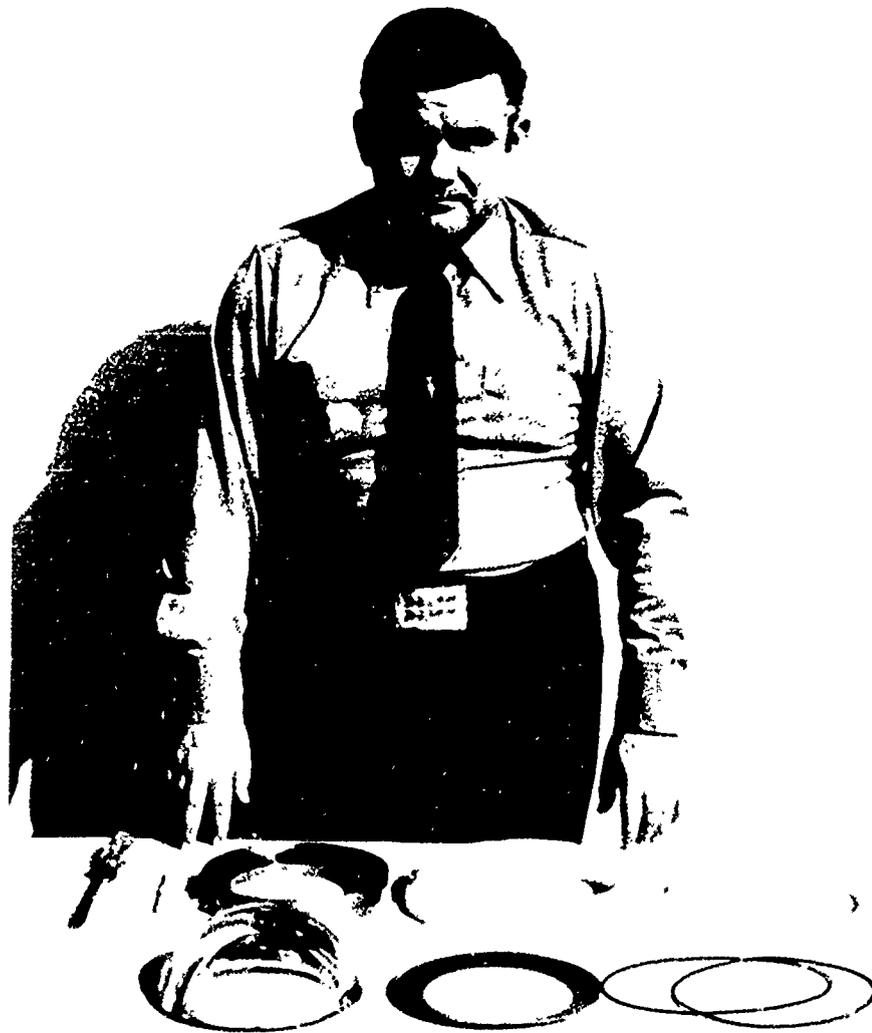
Figure A.1. Components of the window-flange subsystem.
