GLASS OR CERAMIC SPHERICAL-SHELL
WINDOW ASSEMBLY FOR 20,000-PSI
OPERATIONAL PRESSURE

Jerry D. Stachiw

Naval Undersea Center
San Diego, California

May 1974

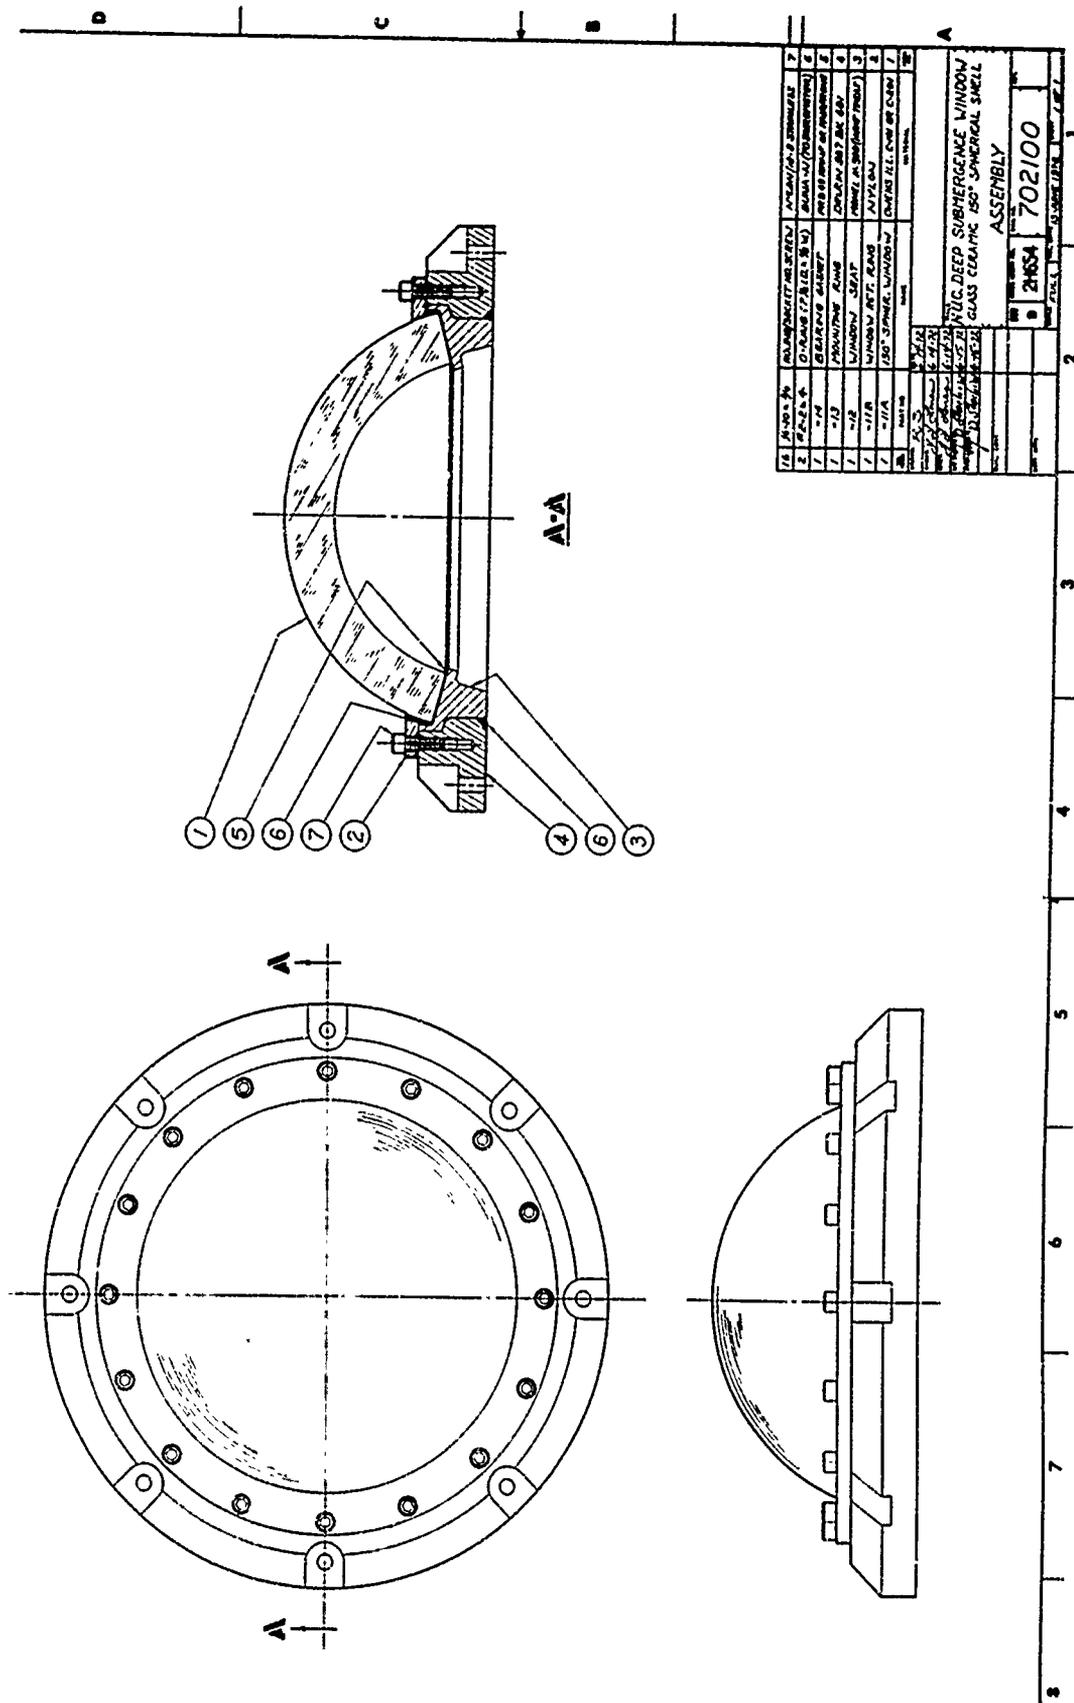
Figure A.11. Scale drawing of the window-flange subsystem.

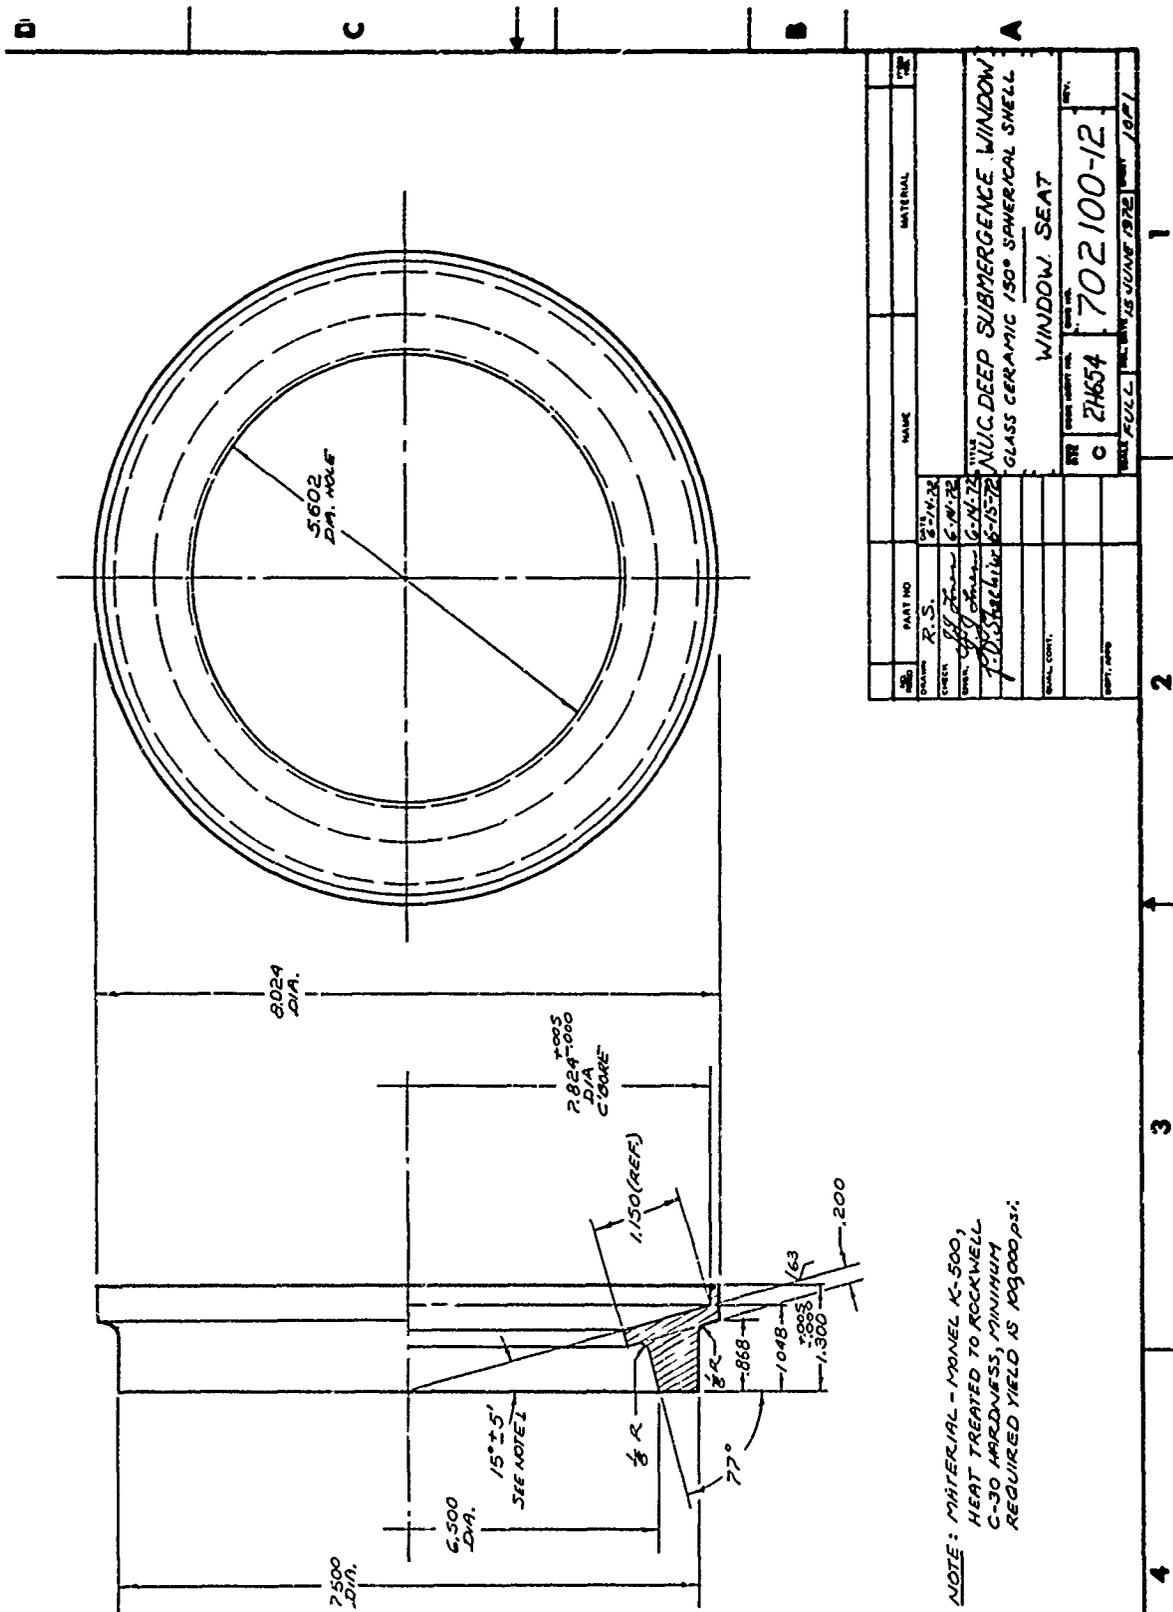
NOTE: MATERIAL - MONEL K-500,
HEAT TREATED TO ROCKWELL
C-30 HARDNESS, MINIMUM
REQUIRED YIELD IS 109,000 psi.

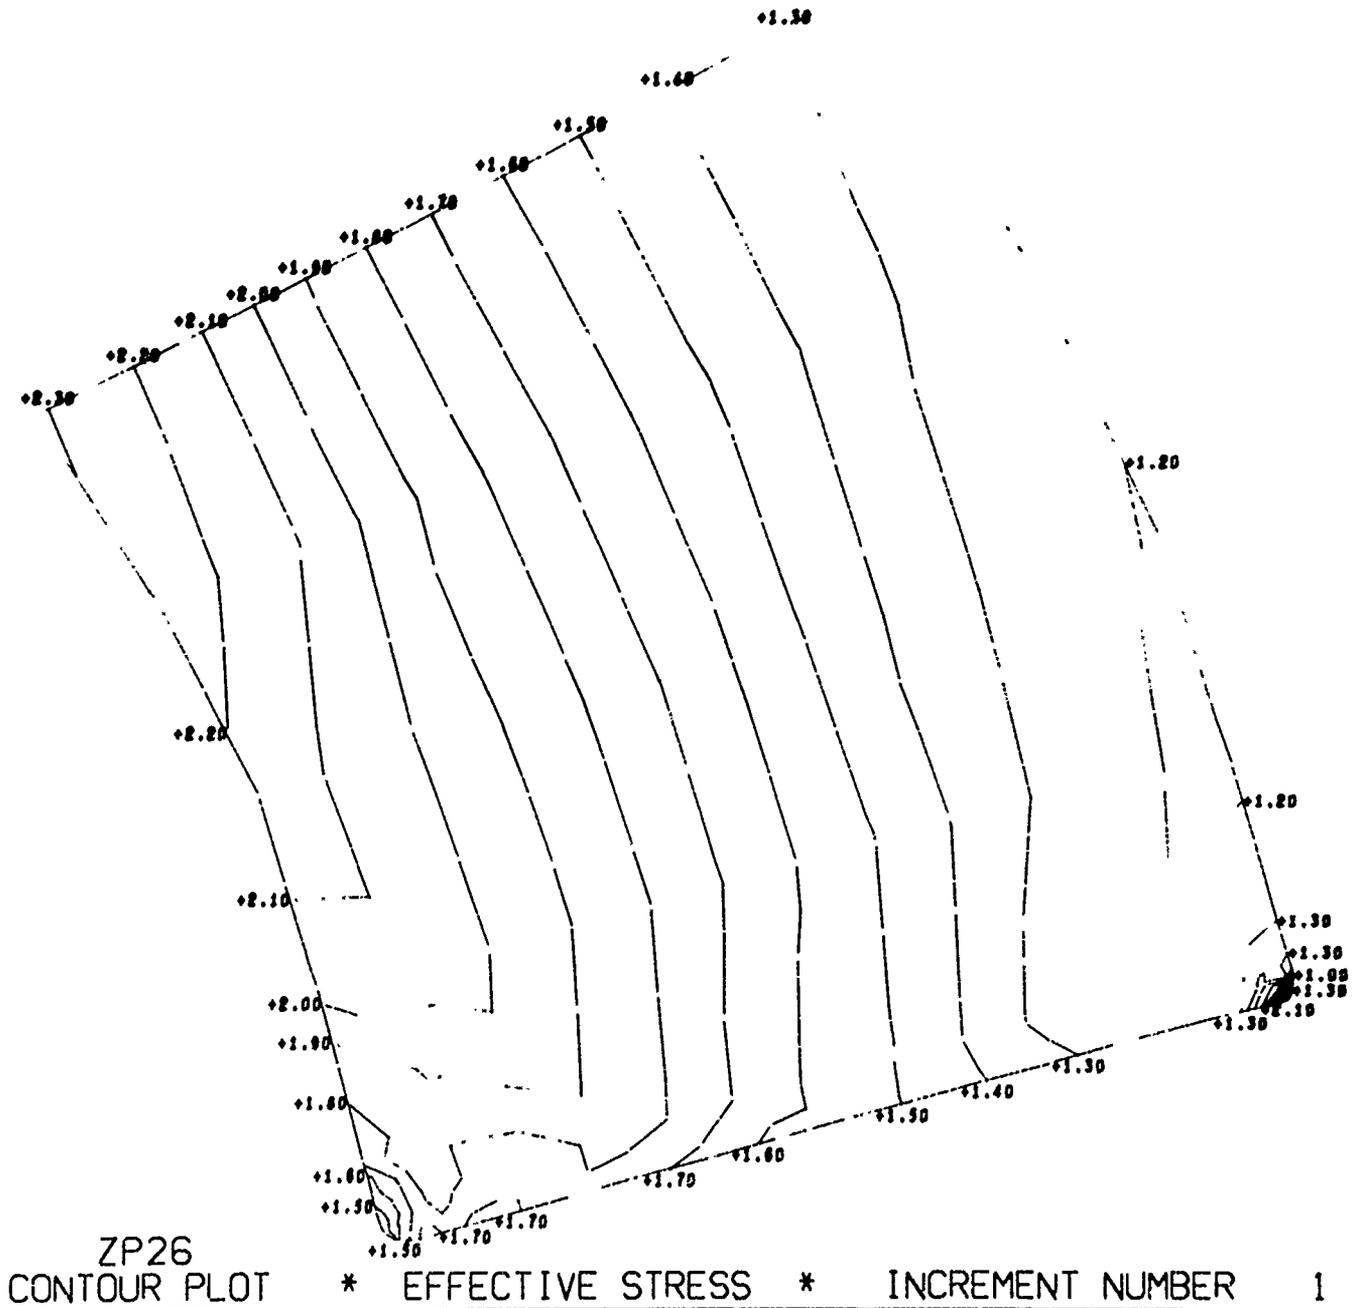
Figure B.5. Magnitude and distribution of stresses in window-flange assembly Configuration A utilizing a steel flange, fiber-reinforced-epoxy gasket, and glass ceramic window (problem 102). (sheet 2 of 7)

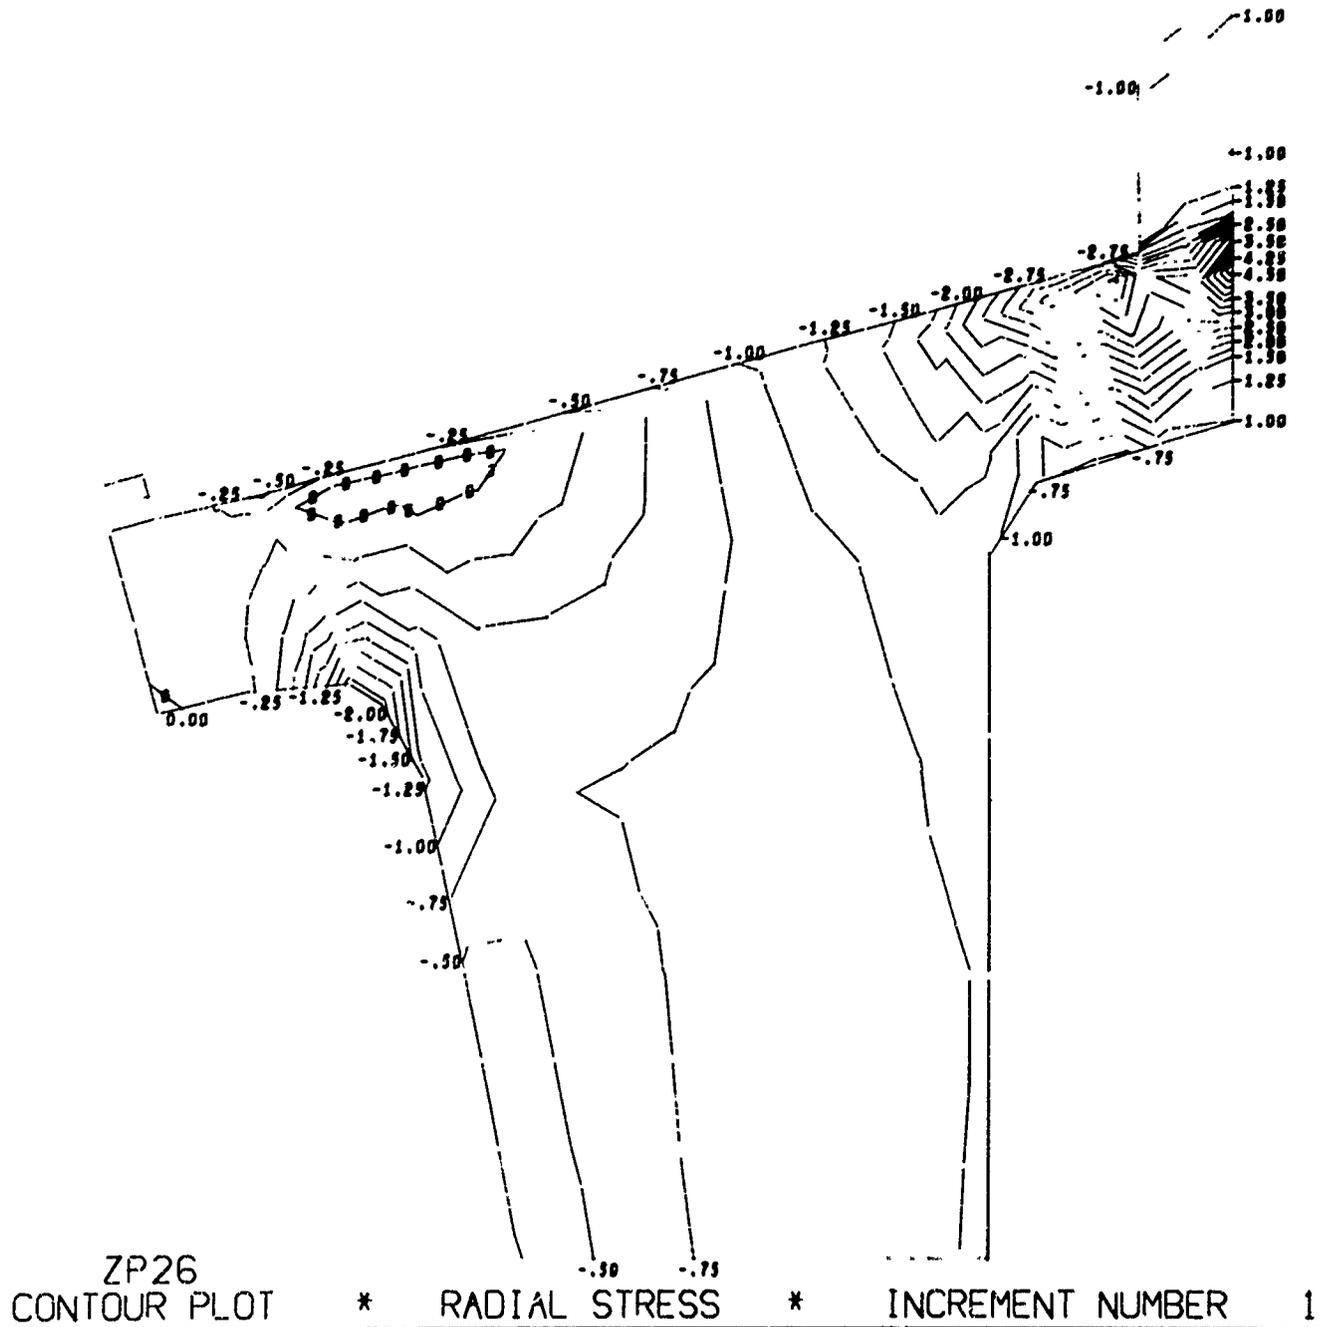
Figure B.5. Magnitude and distribution of stresses in window-flange assembly Configuration A utilizing a steel flange, fiber-reinforced-epoxy gasket, and glass ceramic window (problem 102). (sheet 5 of 7)

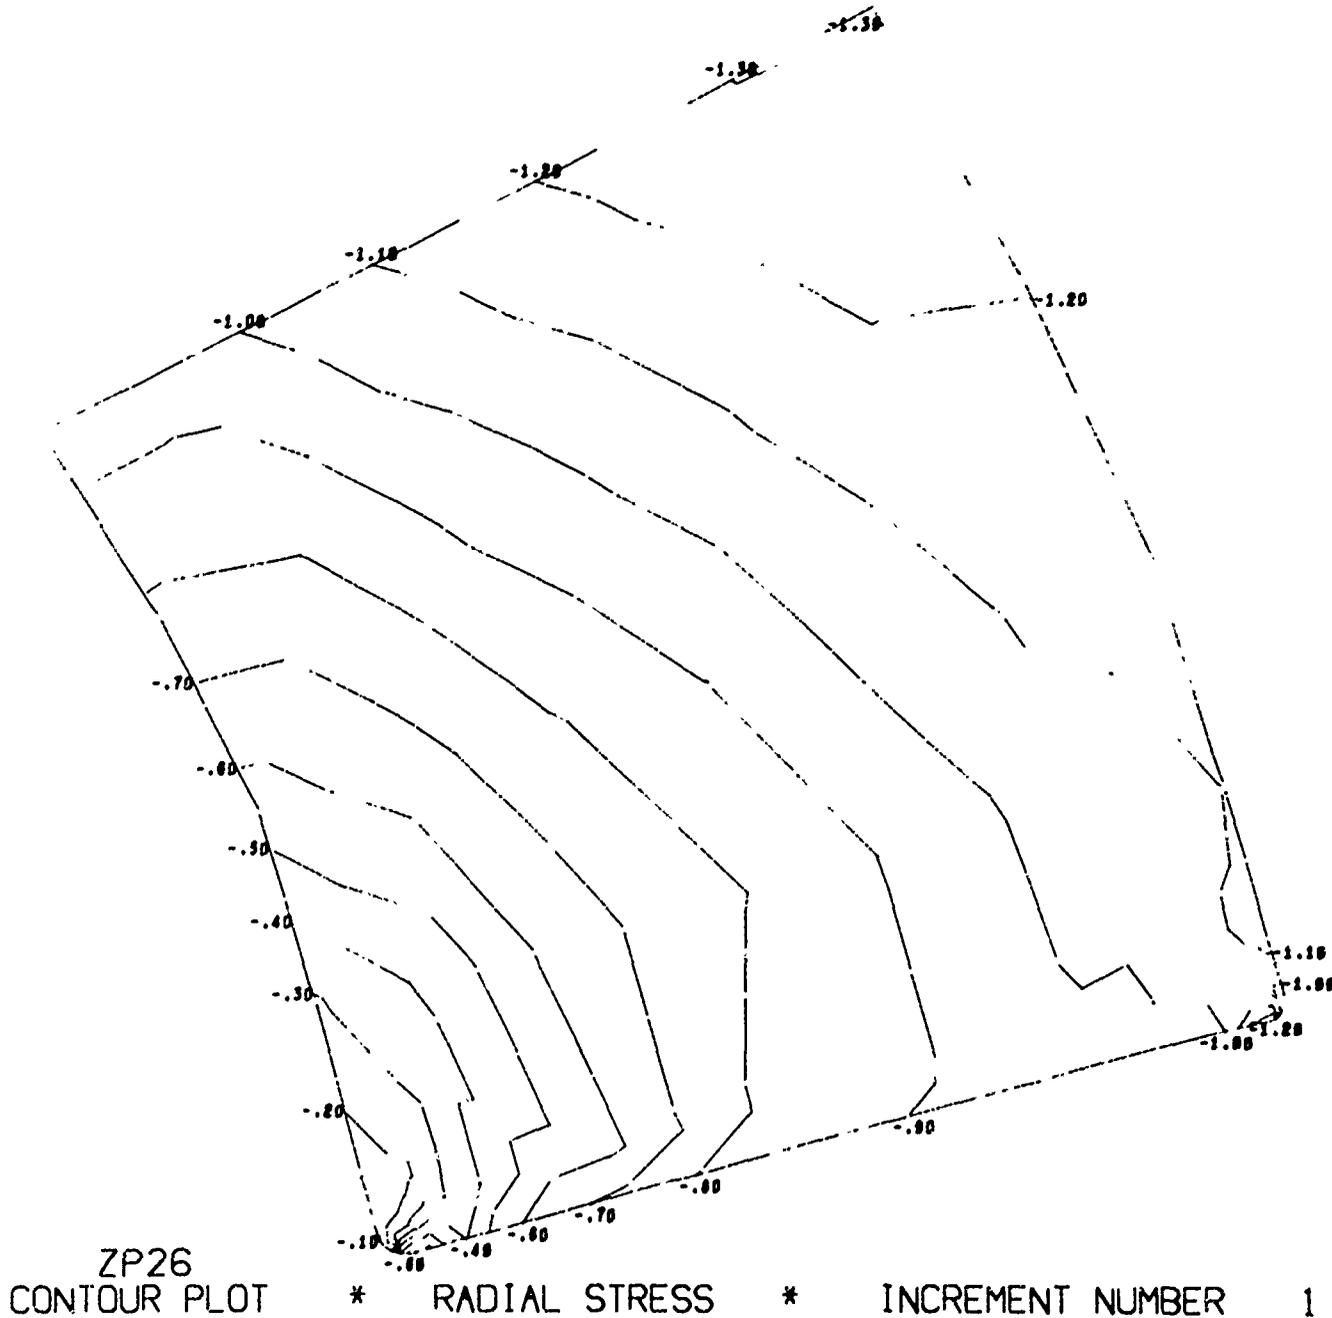
Figure B.5. Magnitude and distribution of stresses in window-flange assembly Configuration A utilizing a steel flange, fiber-reinforced-epoxy gasket, and glass ceramic window (problem 102). (sheet 6 of 7)

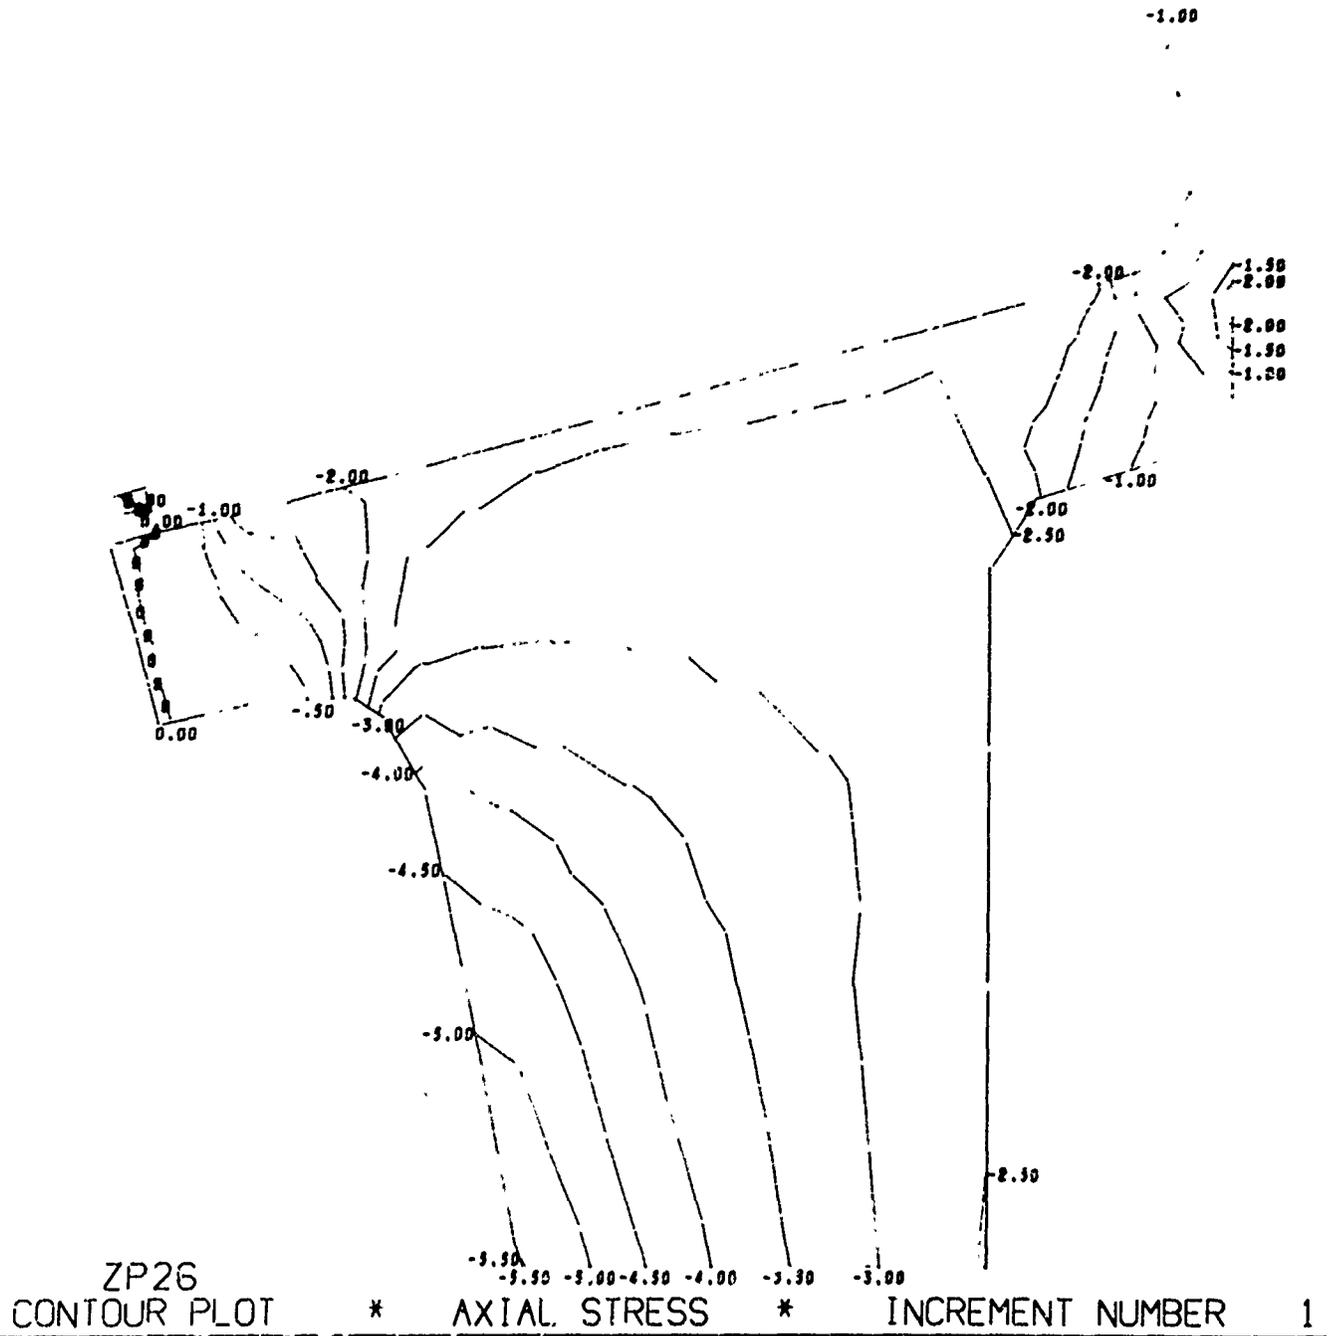
Figure B.5. Magnitude and distribution of stresses in window-flange assembly Configuration A utilizing a steel flange, fiber-reinforced-epoxy gasket, and glass ceramic window (problem 102).(sheet 7 of 7)

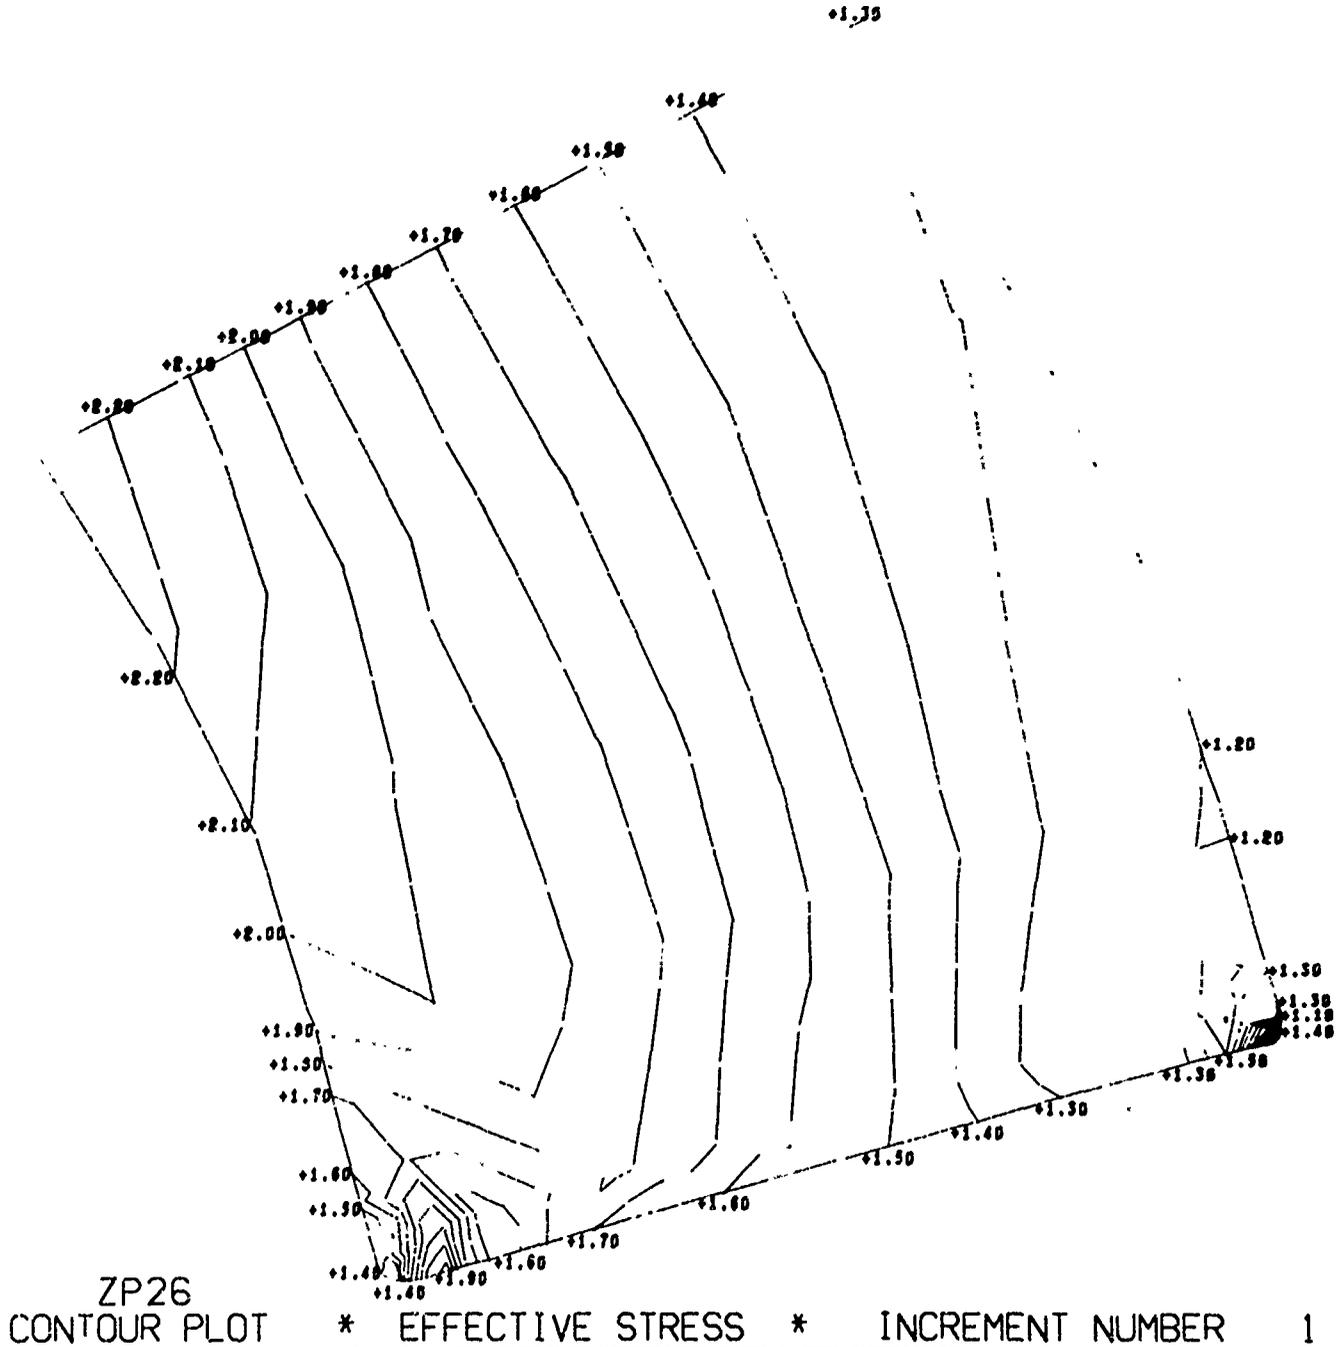
Figure B.6. Magnitude and distribution of stresses in window-flange assembly Configuration A utilizing a titanium flange, fiber-reinforced-epoxy laminate gasket and glass ceramic window (problem 106). (sheet 2 of 8)

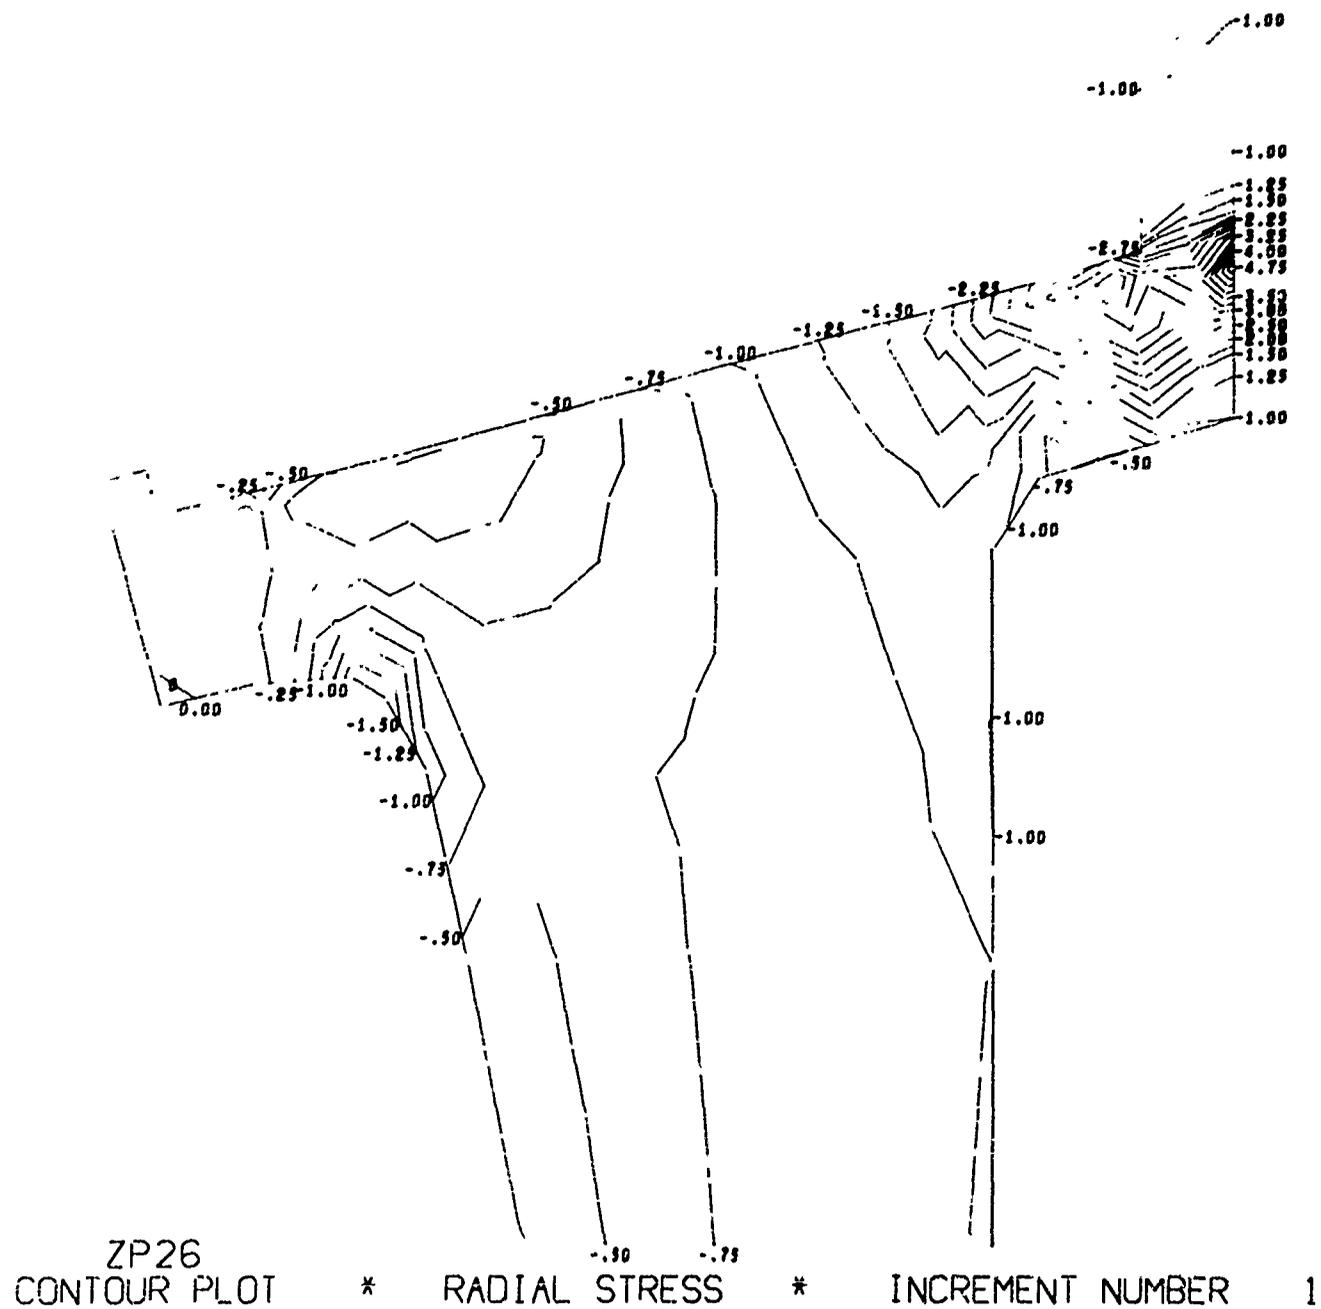
Figure B.6. Magnitude and distribution of stresses in window-flange assembly Configuration A utilizing a titanium flange, fiber-reinforced-epoxy laminate gasket and glass ceramic window (problem 106). (sheet 5 of 8)

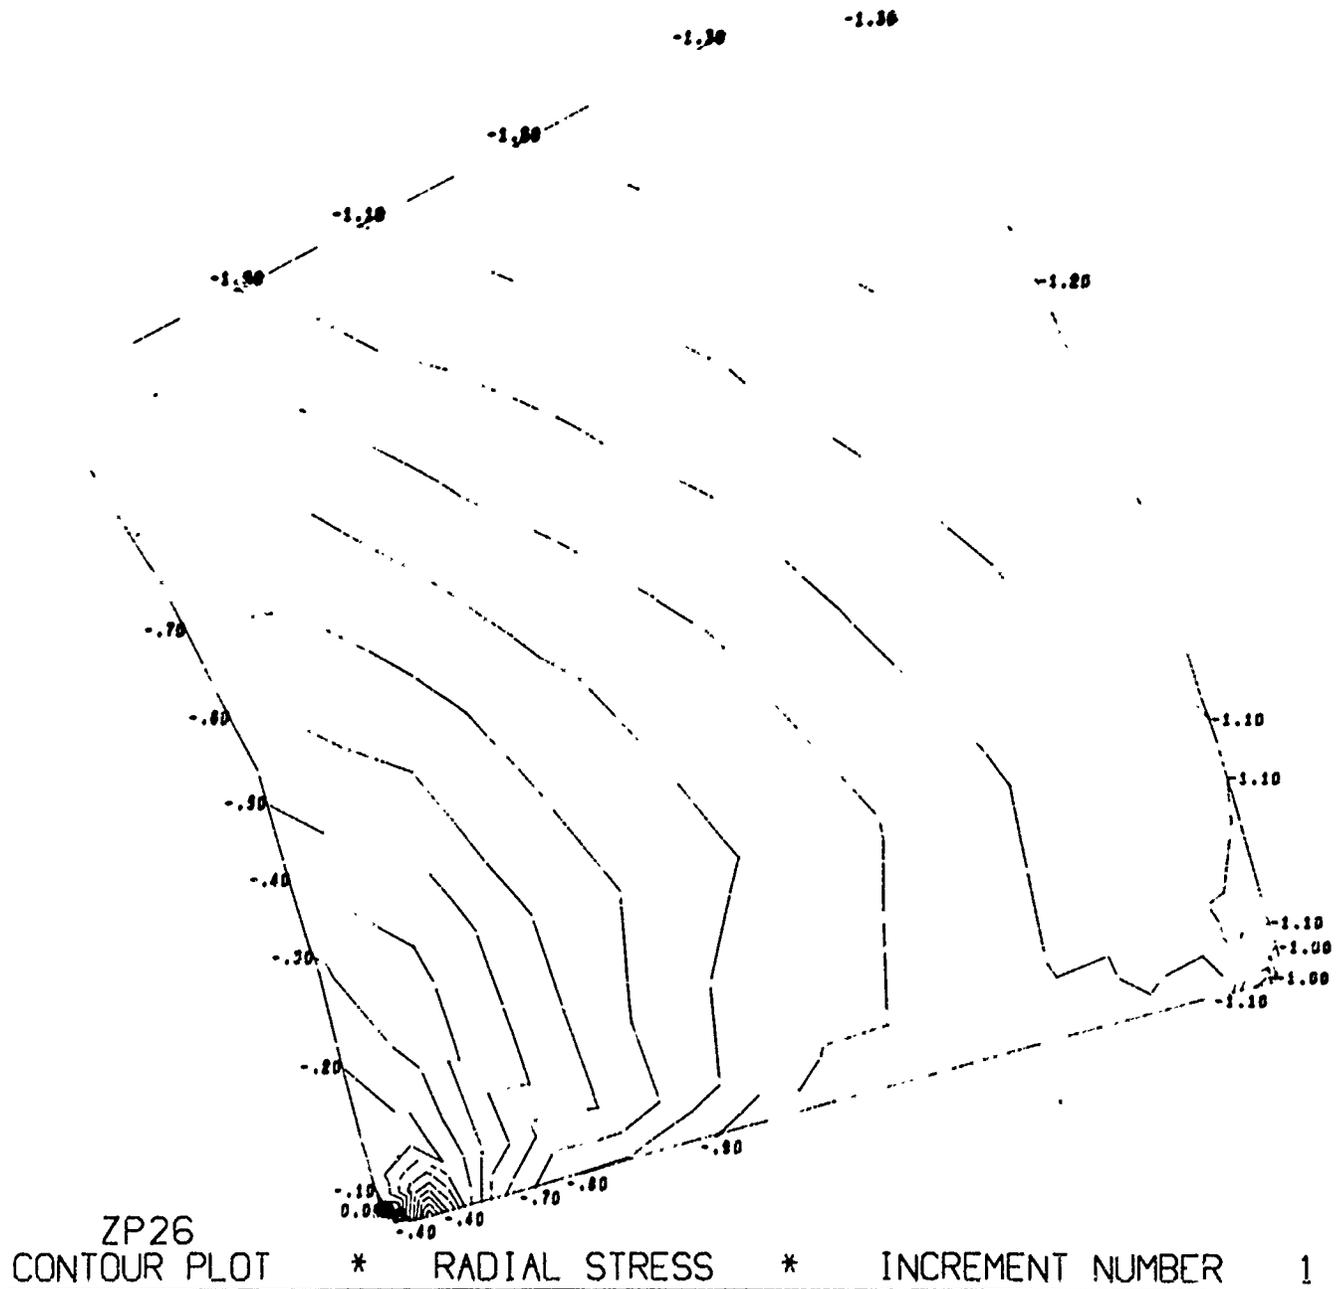
Figure B.6. Magnitude and distribution of stresses in window-flange assembly Configuration A utilizing a titanium flange, fiber-reinforced-epoxy laminate gasket and glass ceramic window (problem 106). (sheet 6 of 8)

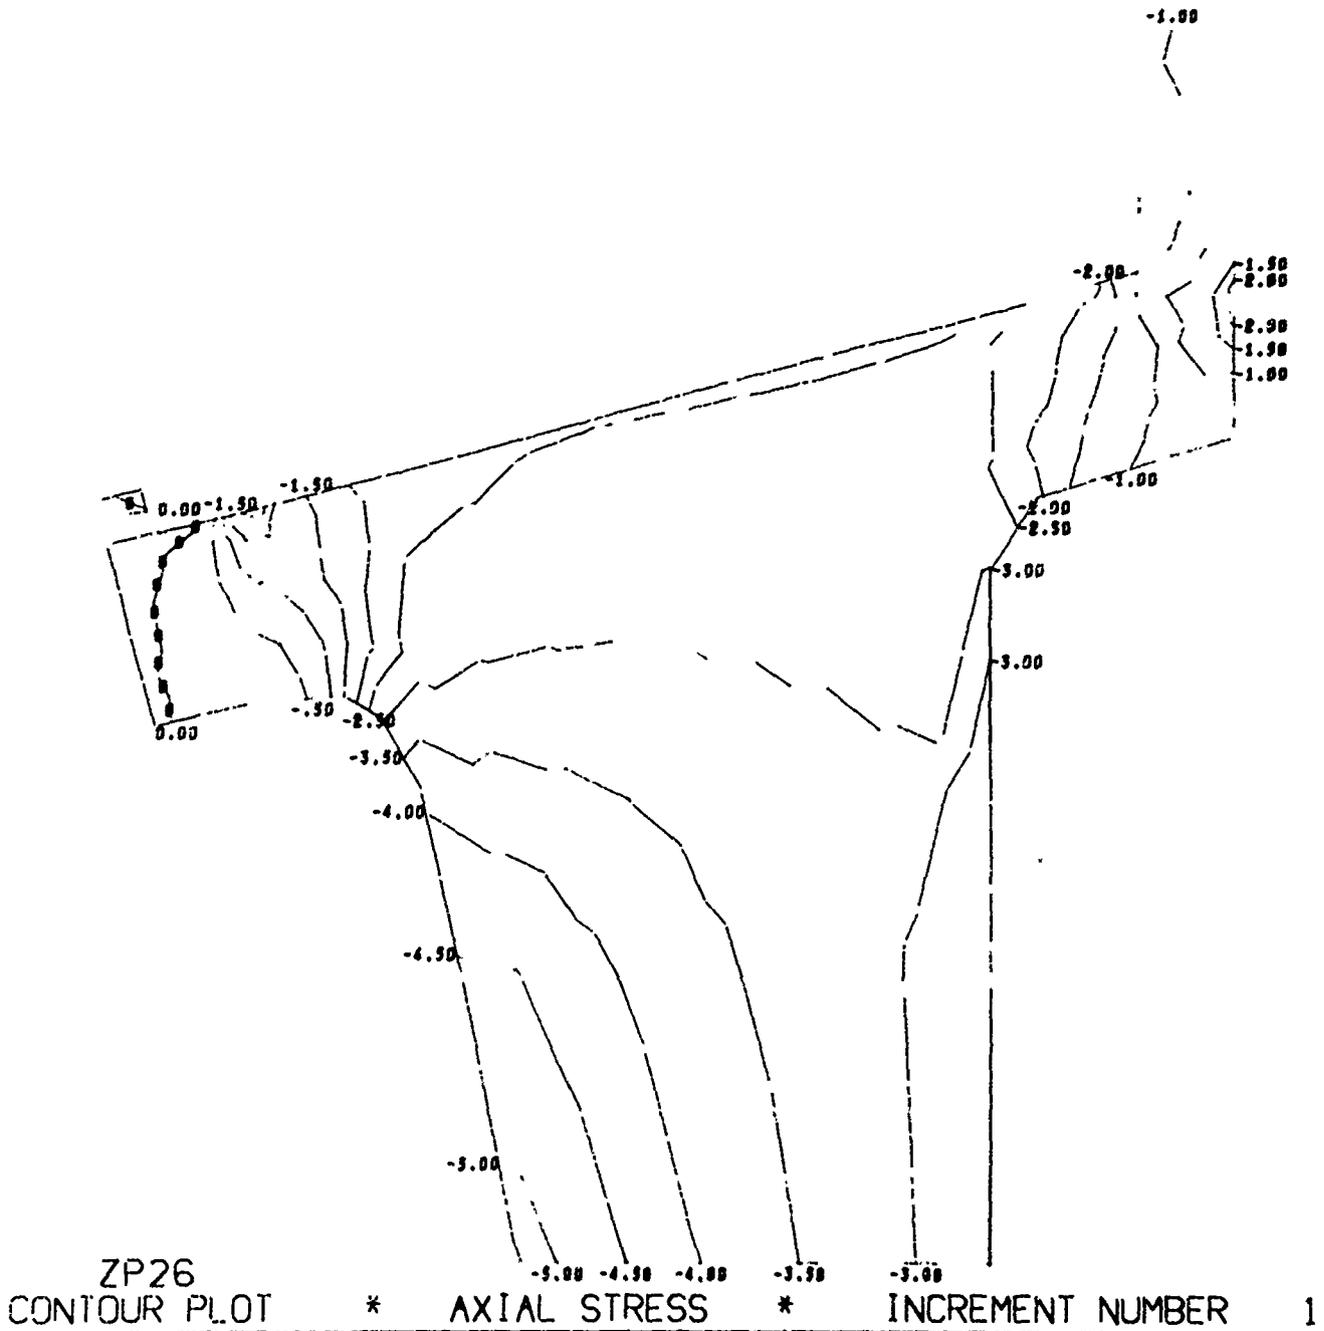
Figure B.6. Magnitude and distribution of stresses in window-flange assembly Configuration A utilizing a titanium flange, fiber-reinforced-epoxy laminate gasket and glass ceramic window (problem 106). (sheet 7 of 8)

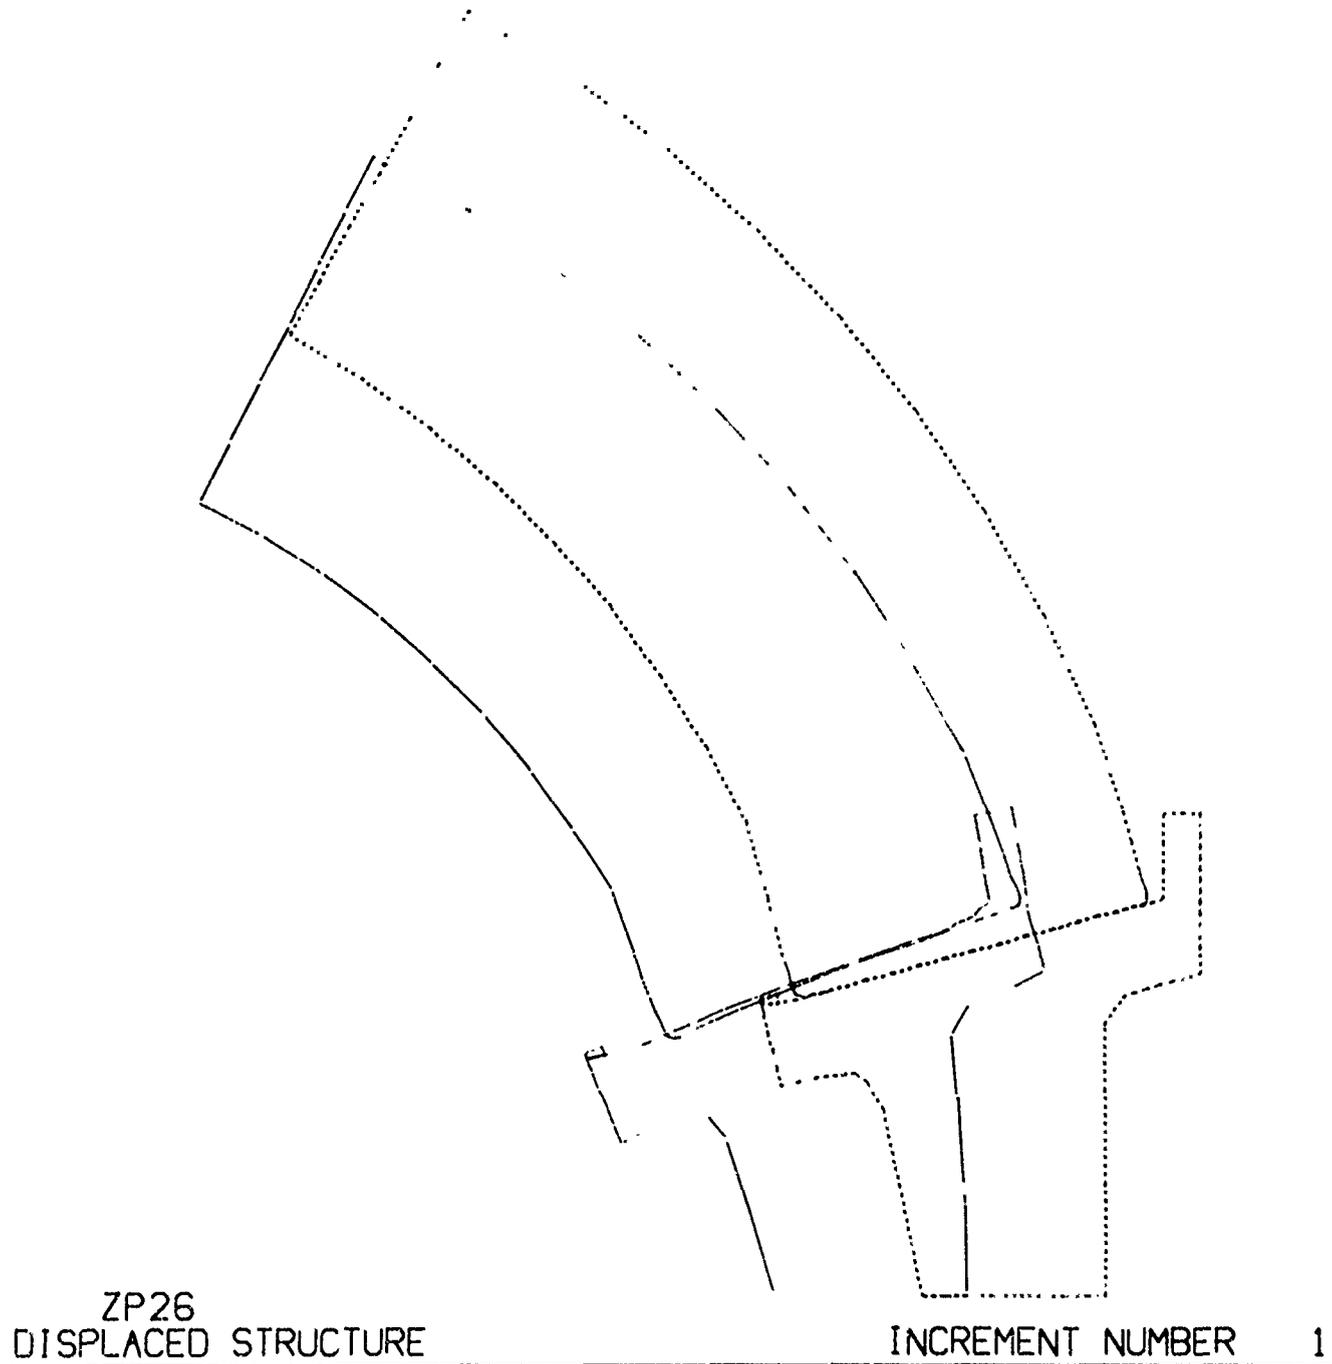
Figure B.7. Radial displacements of window and flange in Configuration A under external hydrostatic loading: problem 102, glass ceramic on steel.

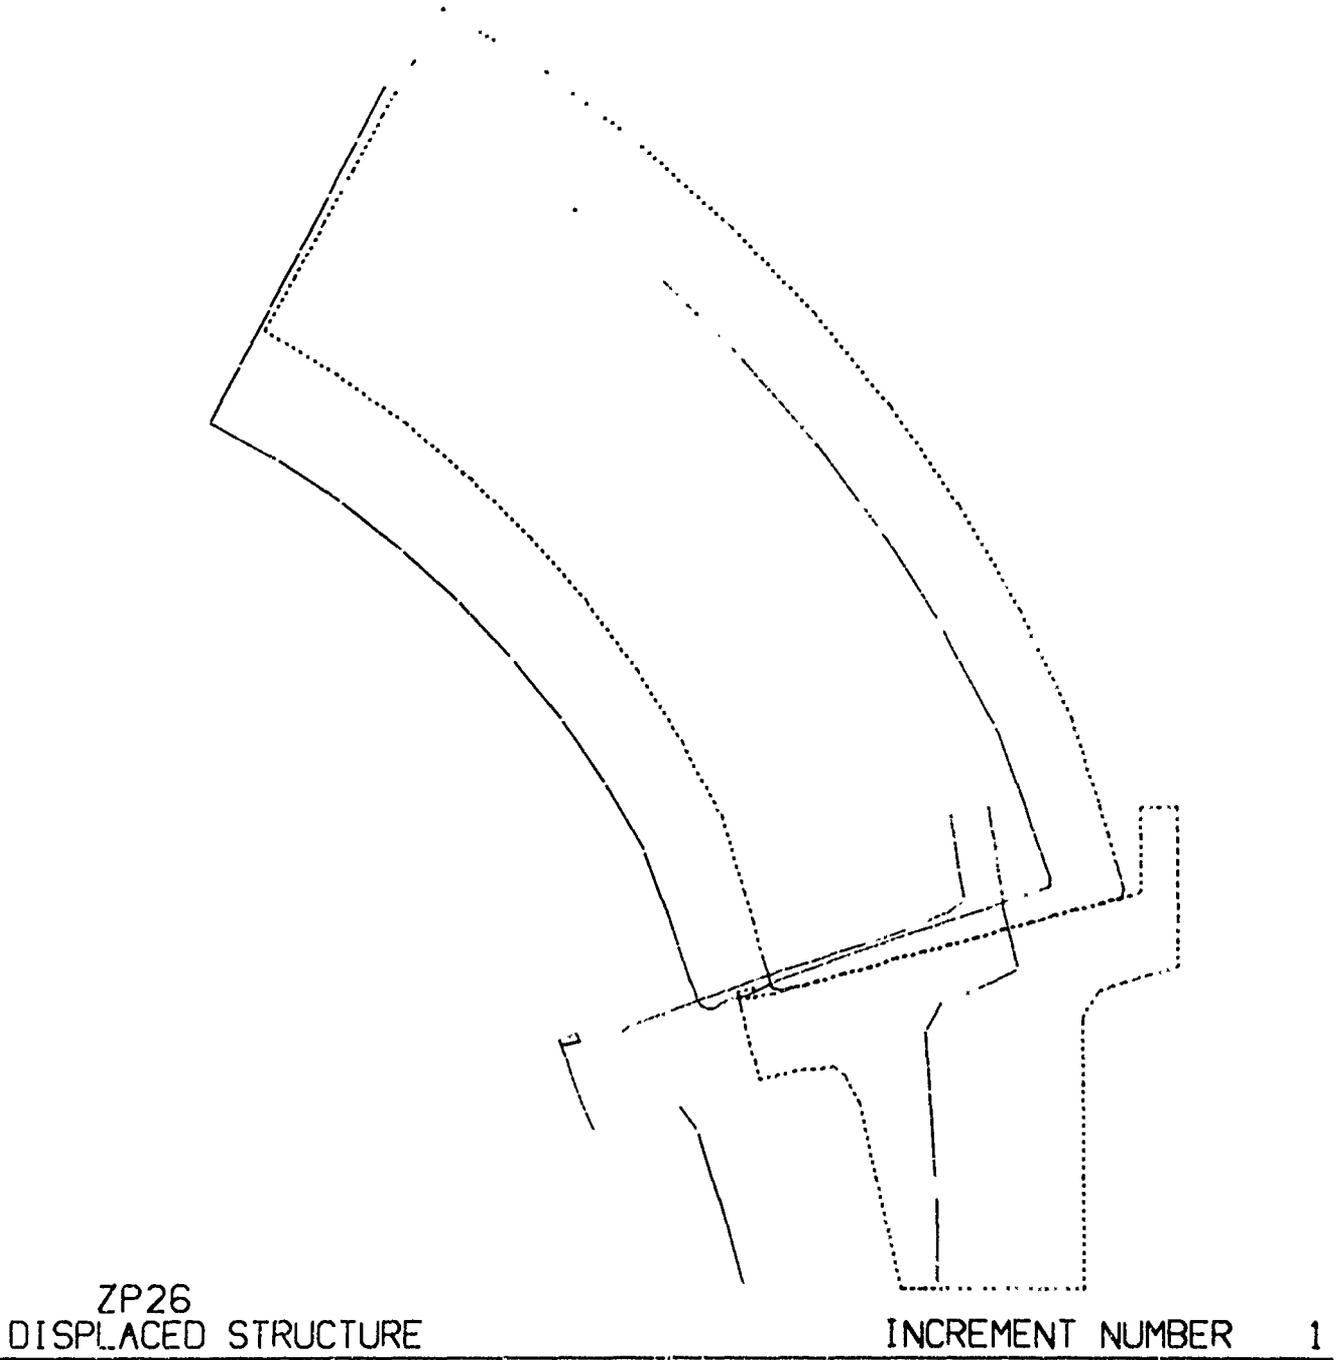
Figure B.7. Radial displacements of window and flange in Configuration A under external hydrostatic loading: problem 106, glass ceramic on titanium.
