GLASS OR CERAMIC SPHERICAL-SHELL
WINDOW ASSEMBLY FOR 20,000-PSI
OPERATIONAL PRESSURE

Jerry D. Stachiw

Naval Undersea Center
San Diego, California

May 1974

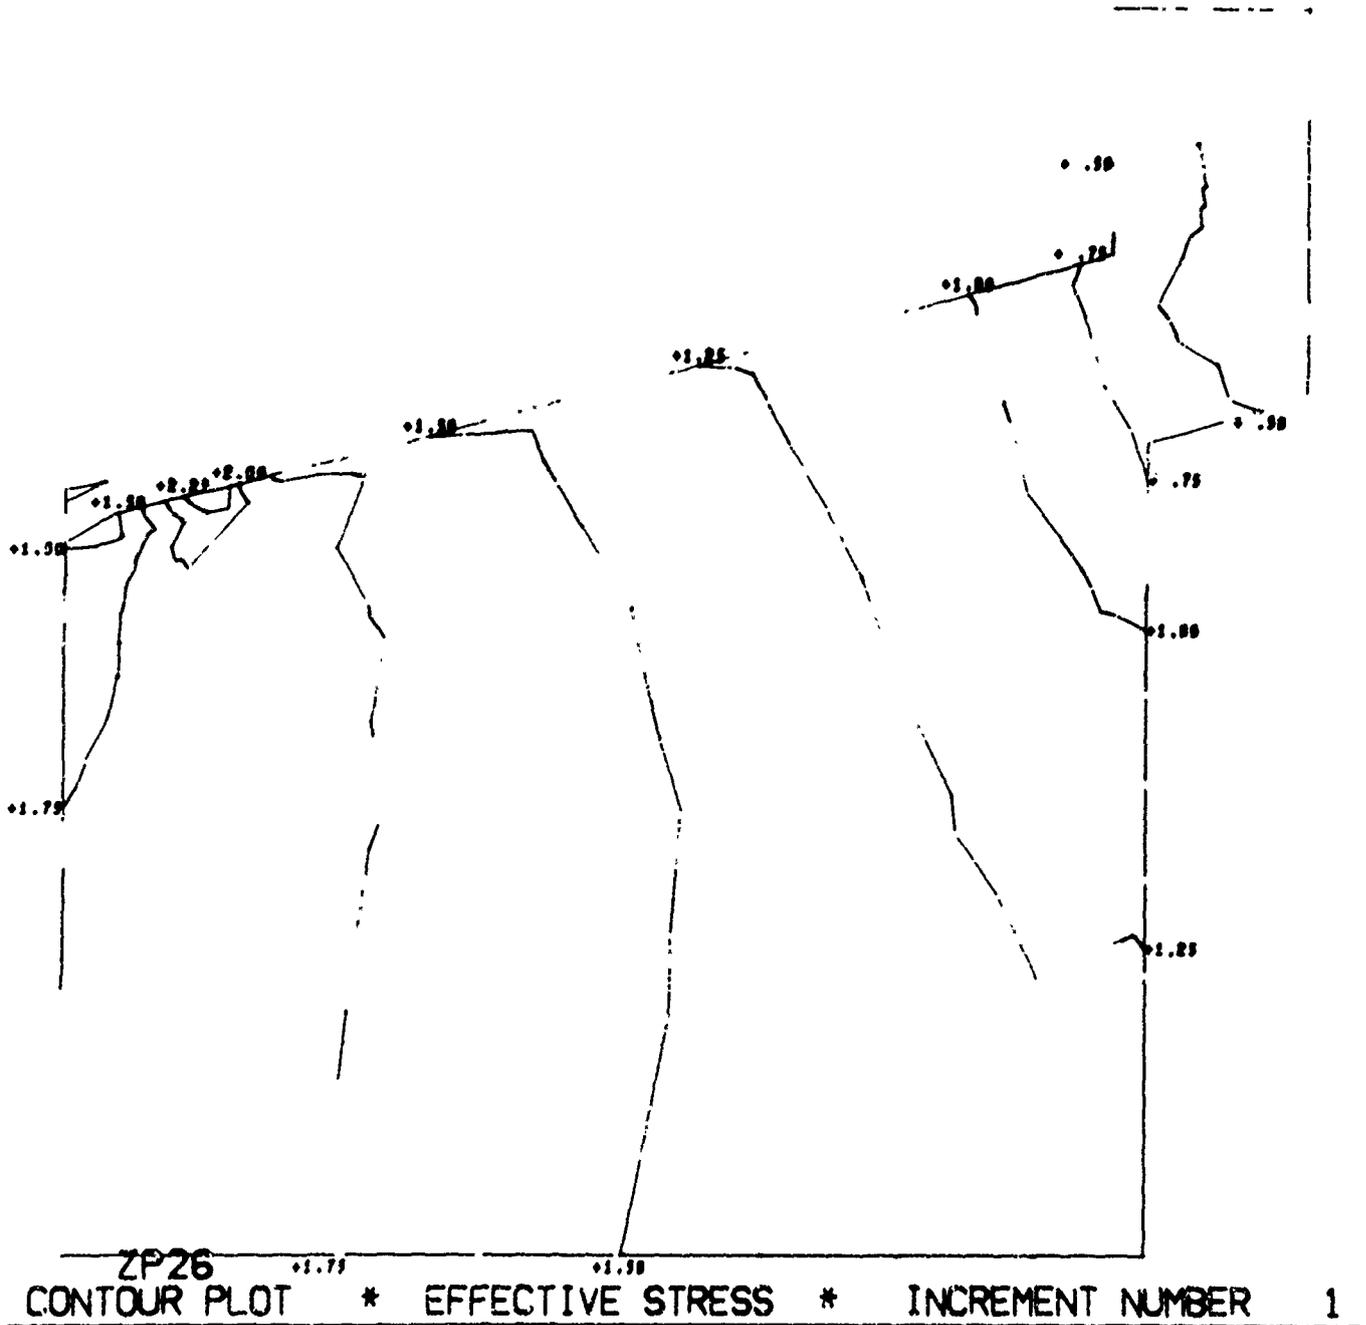
Figure B.8. Magnitude and distribution of stresses in window-flange assembly Configuration B, utilizing a glass-reinforced-plastic flange and glass ceramic window (problem 204). (sheet 1 of 8)

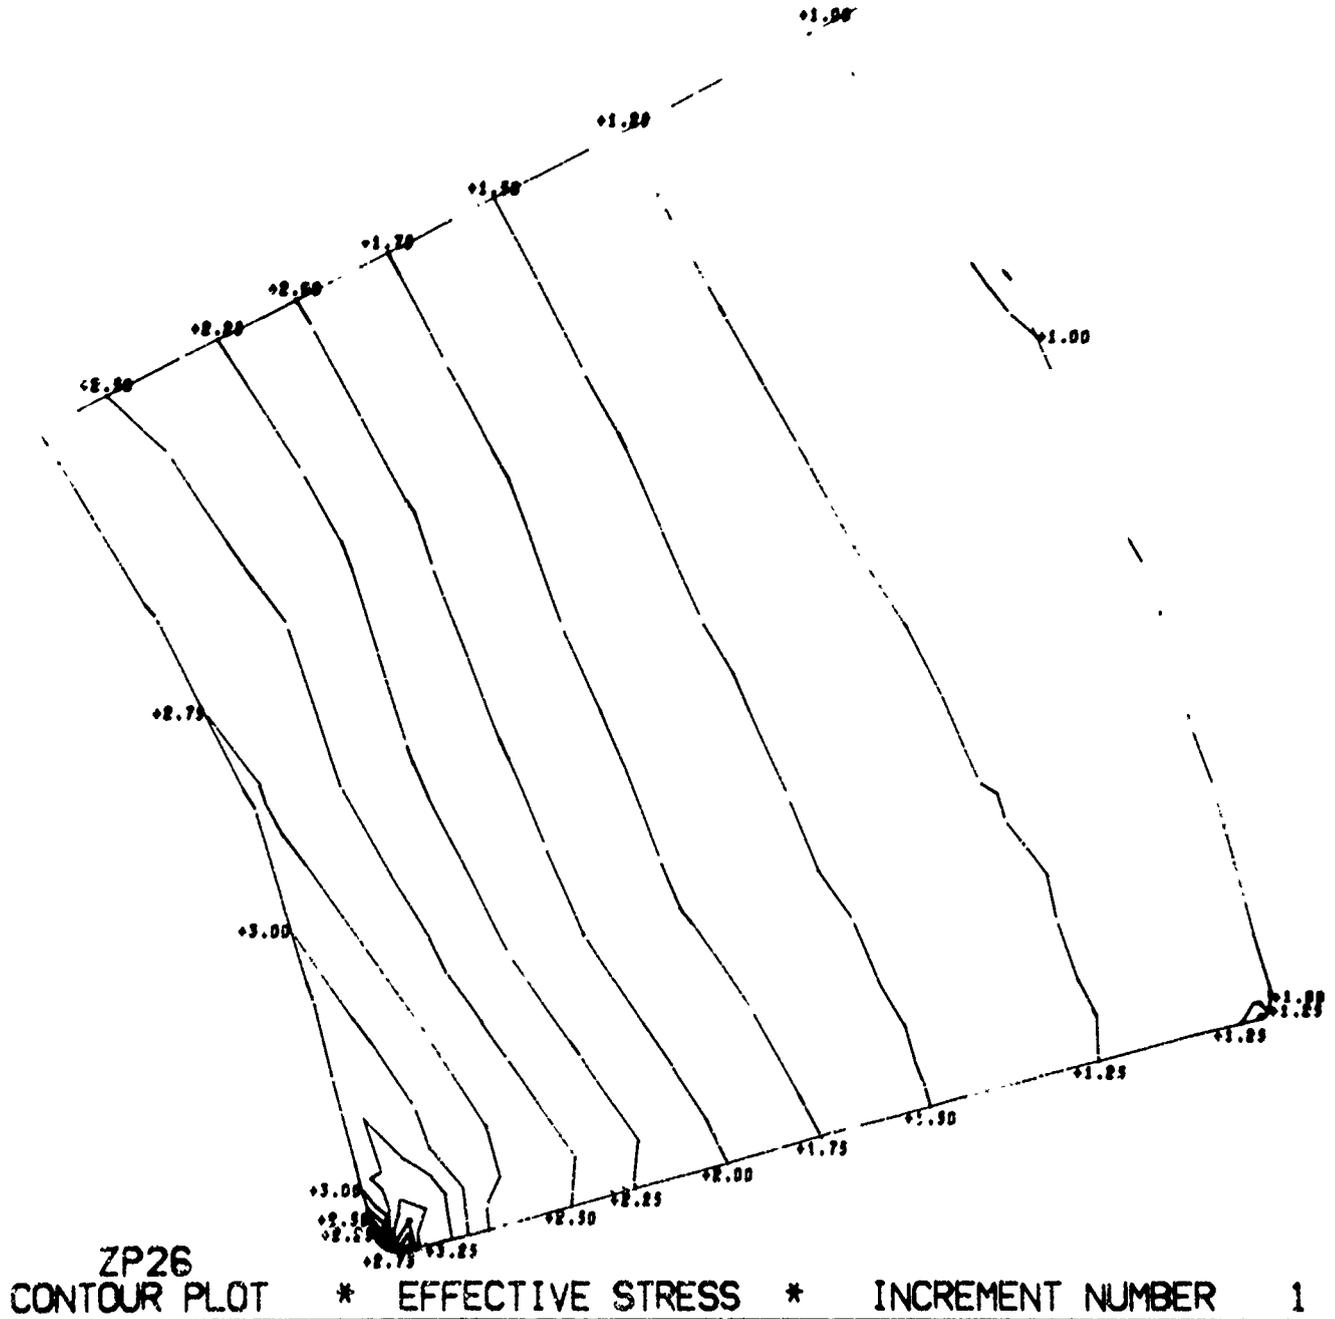
Figure B.8. Magnitude and distribution of stresses in window-flange assembly Configuration E, utilizing a glass-reinforced-plastic flange and glass ceramic window (problem 204). (sheet 2 of 8)

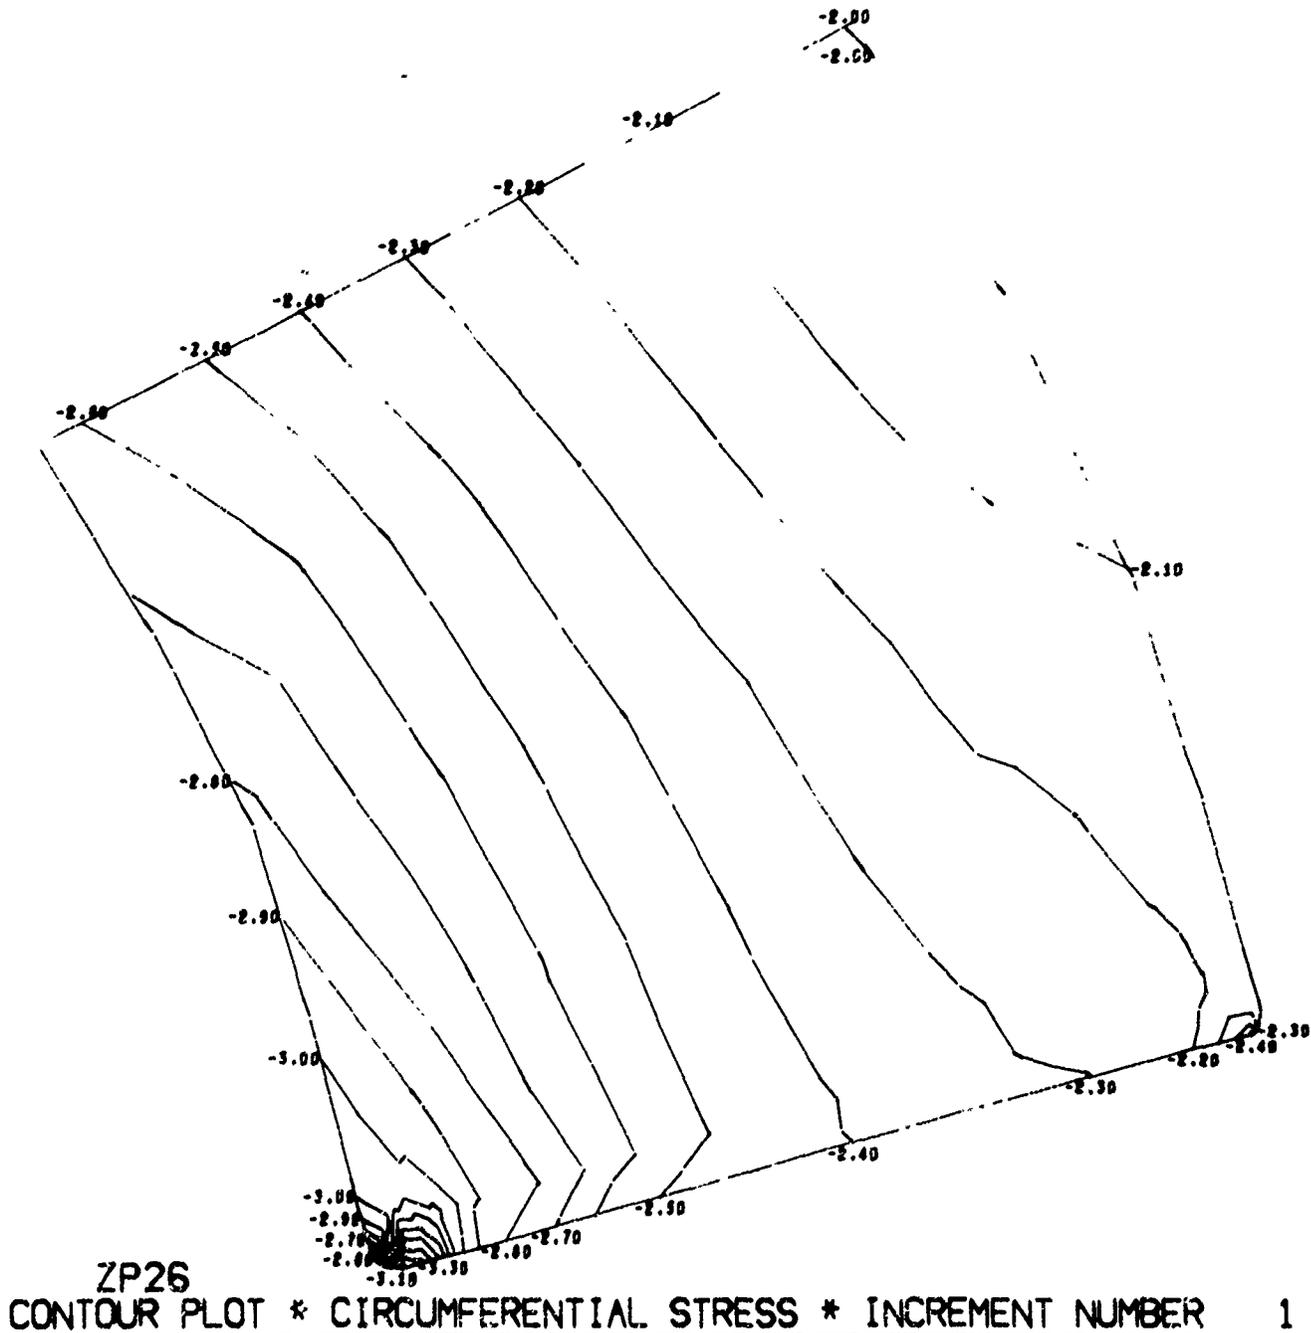
Figure B.8. Magnitude and distribution of stresses in window-flange assembly Configuration B, utilizing a glass-reinforced-plastic flange and glass ceramic window (problem 204). (sheet 4 of 8)

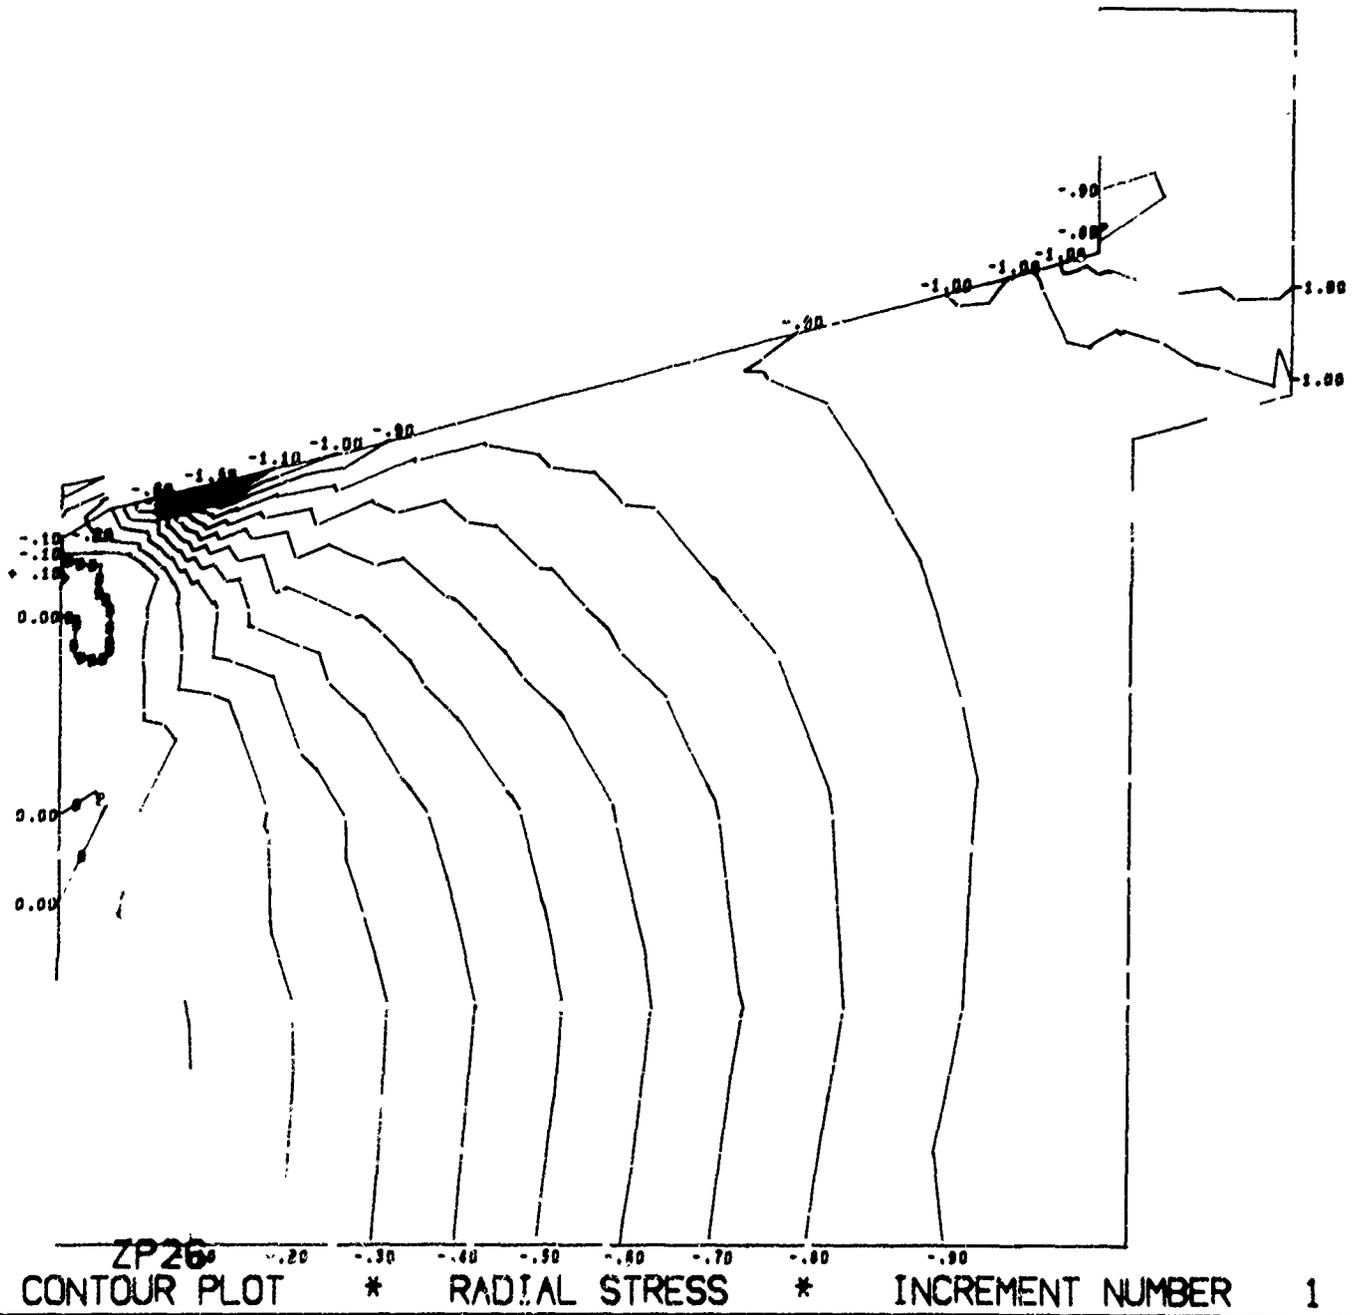
Figure B.8. Magnitude and distribution of stresses in window-flange assembly Configuration B, utilizing a glass-reinforced-plastic flange and glass ceramic window (problem 204). (sheet 5 of 8)

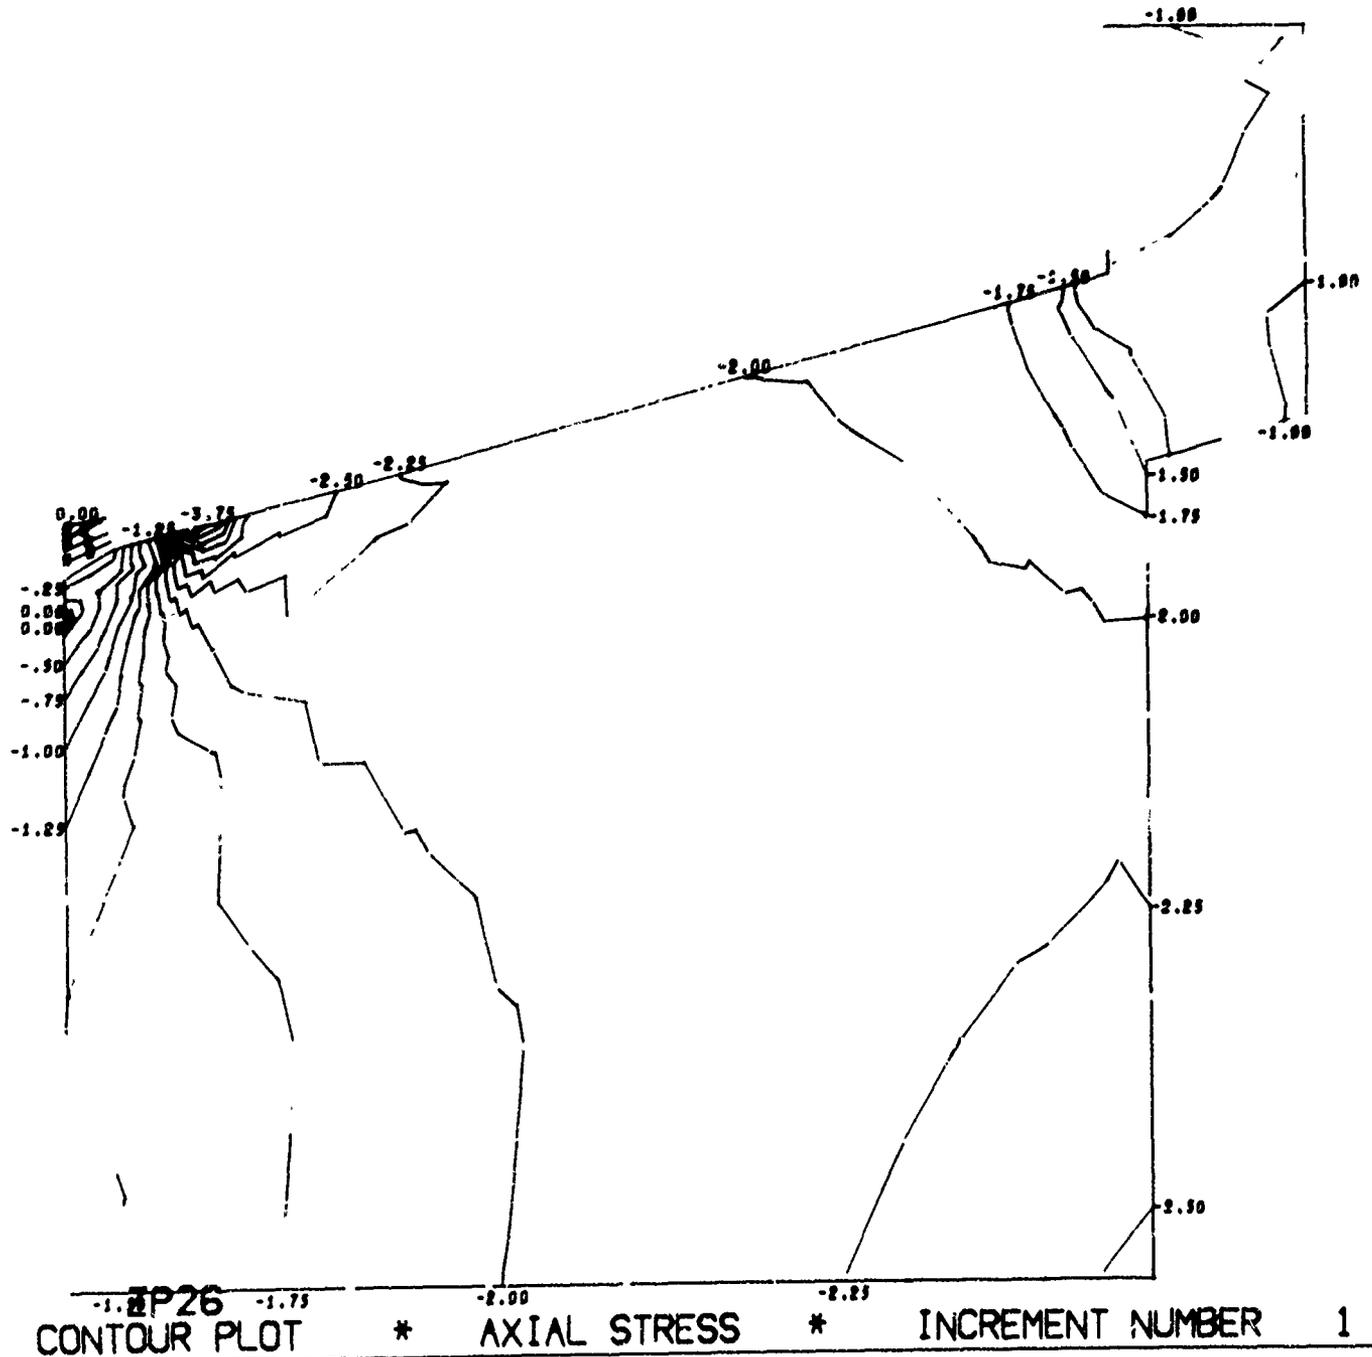
Figure B.8. Magnitude and distribution of stresses in window-flange assembly Configuration B, utilizing a glass-reinforced-plastic flange and glass ceramic window (problem 204). (sheet 7 of 8)

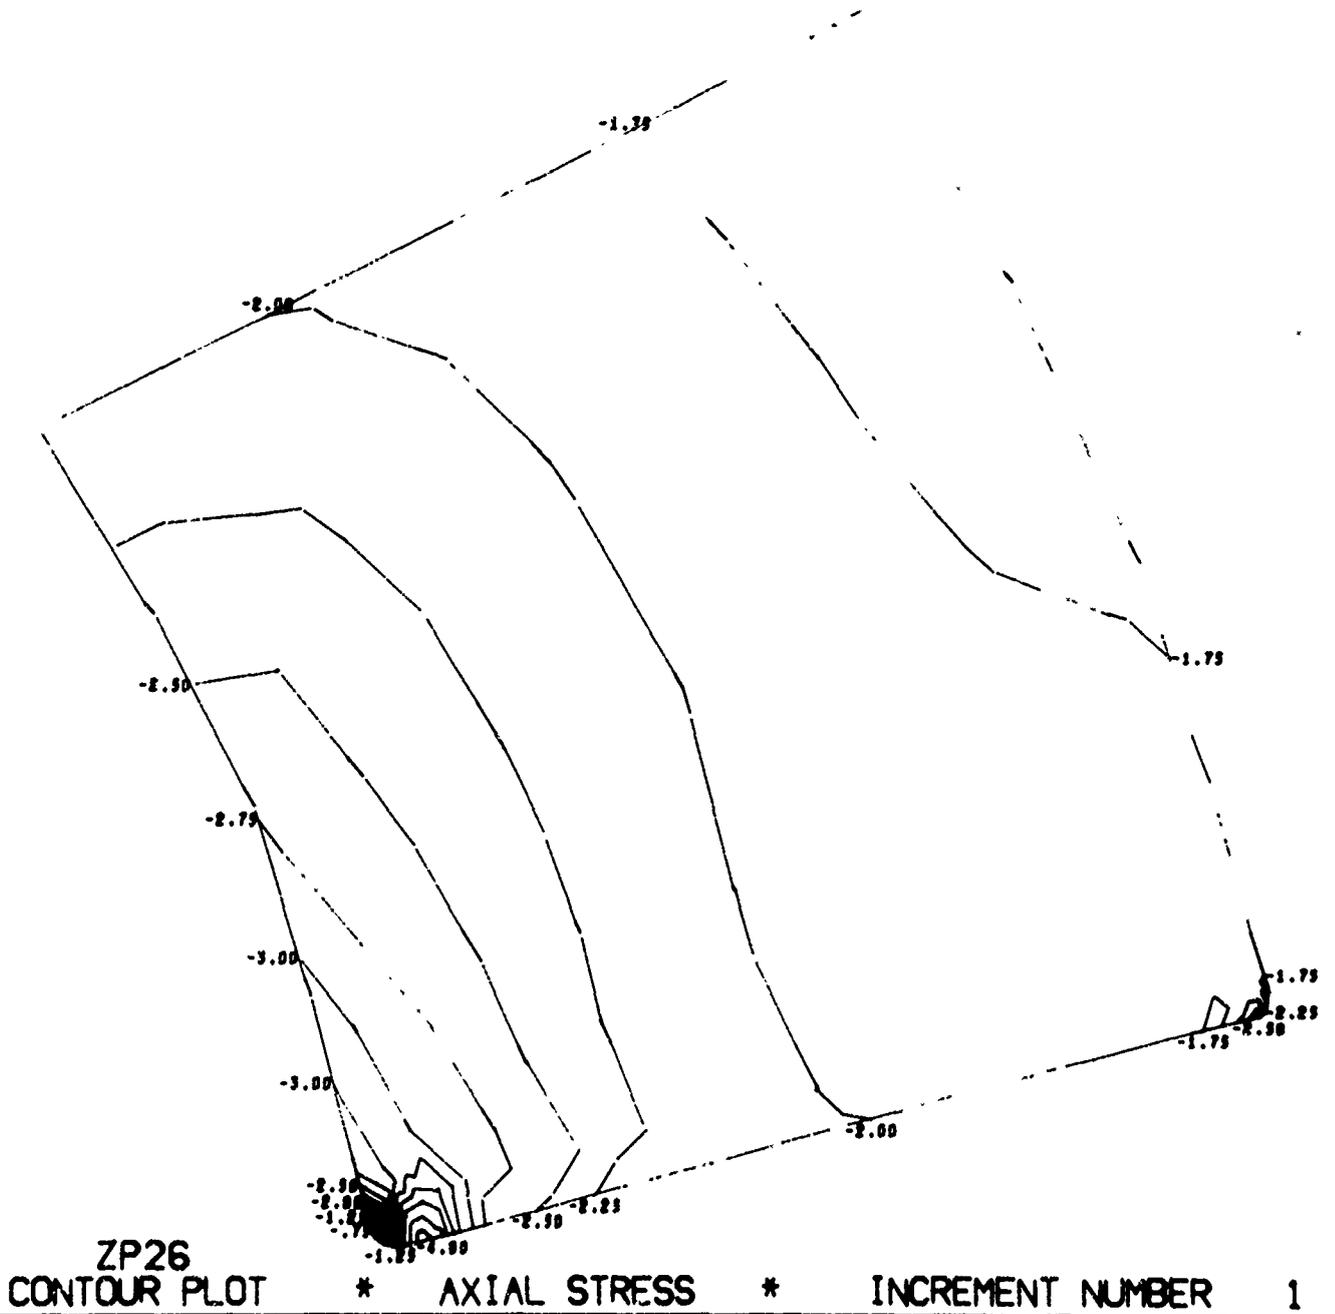
Figure B.8. Magnitude and distribution of stresses in window-flange assembly Configuration B, utilizing a glass-reinforced-plastic flange and glass ceramic window (problem 204). (sheet 8 of 8)

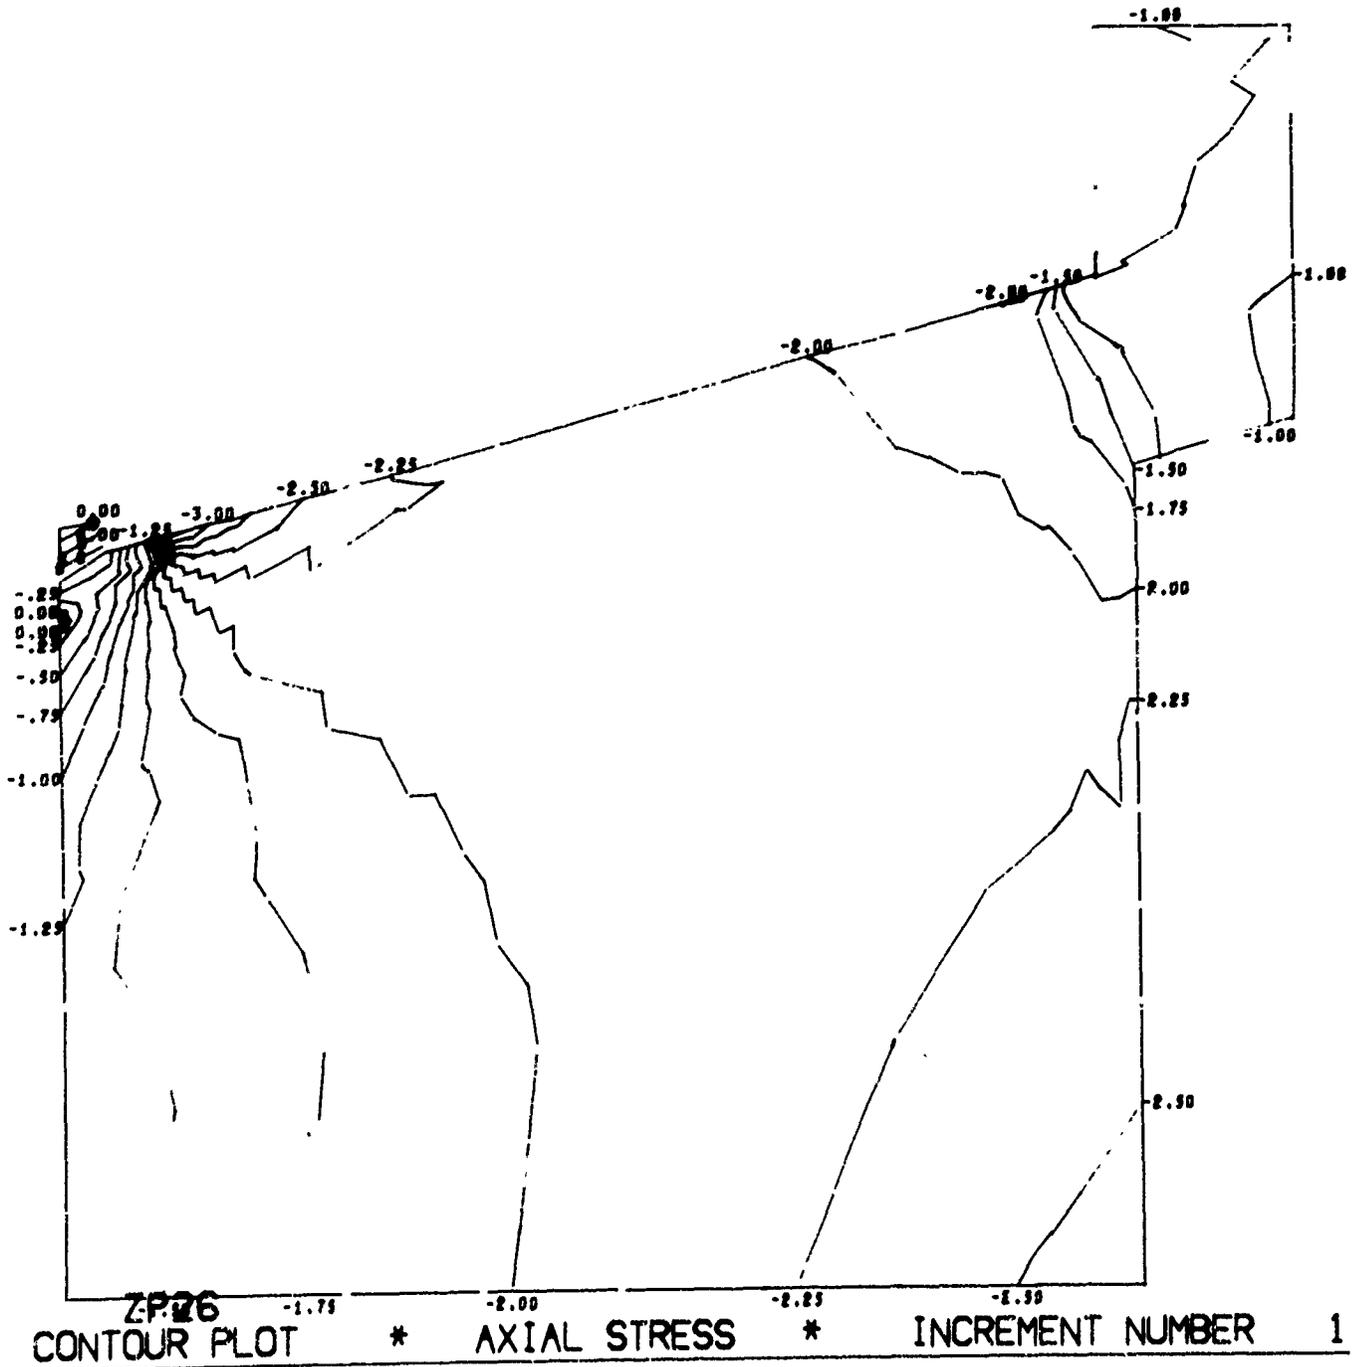
Figure B.9. Magnitude and distribution of stress in window-flange assembly Configuration B utilizing an aluminum flange, fiber-reinforced-epoxy gasket, and glass ceramic window (problem 203). (sheet 2 of 8)

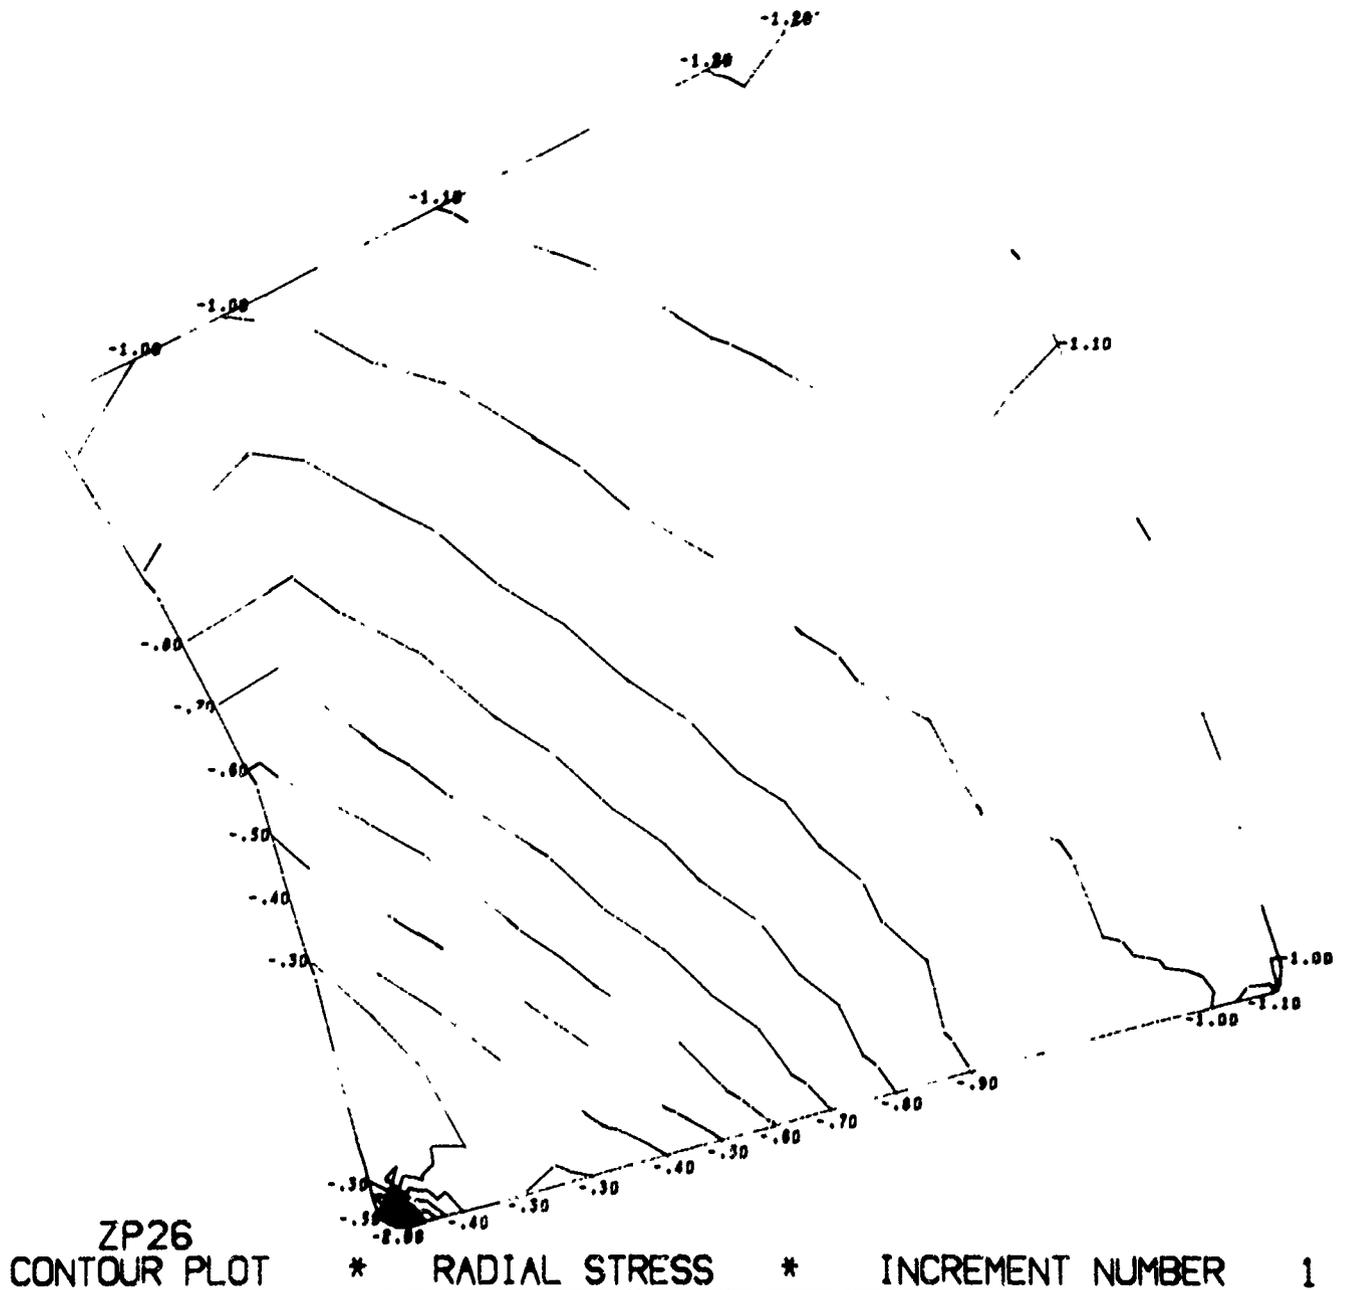
Figure B.9. Magnitude and distribution of stress in window-flange assembly Configuration B utilizing an aluminum flange, fiber-reinforced-epoxy gasket, and glass ceramic window (problem 203). (sheet 3 of 8)

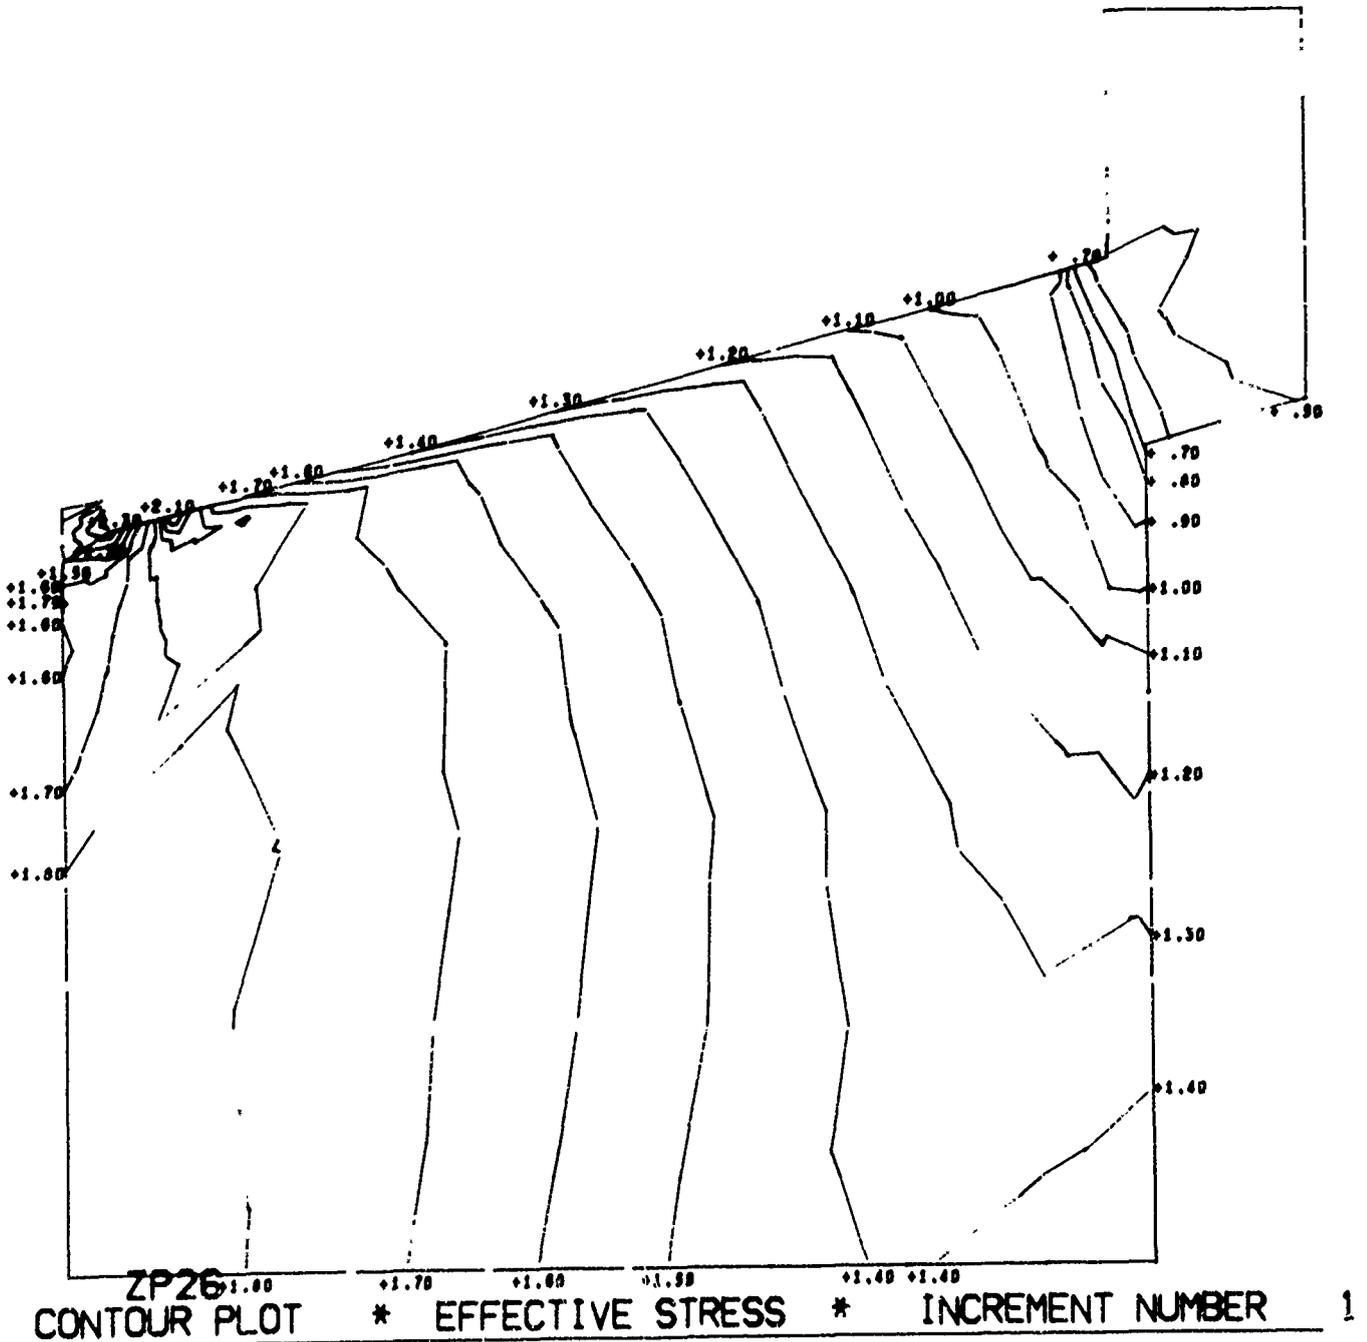
Figure B.9. Magnitude and distribution of stress in window-flange assembly Configuration B utilizing an aluminum flange, fiber-reinforced-epoxy gasket, and glass ceramic window (problem 203). (sheet 8 of 8)

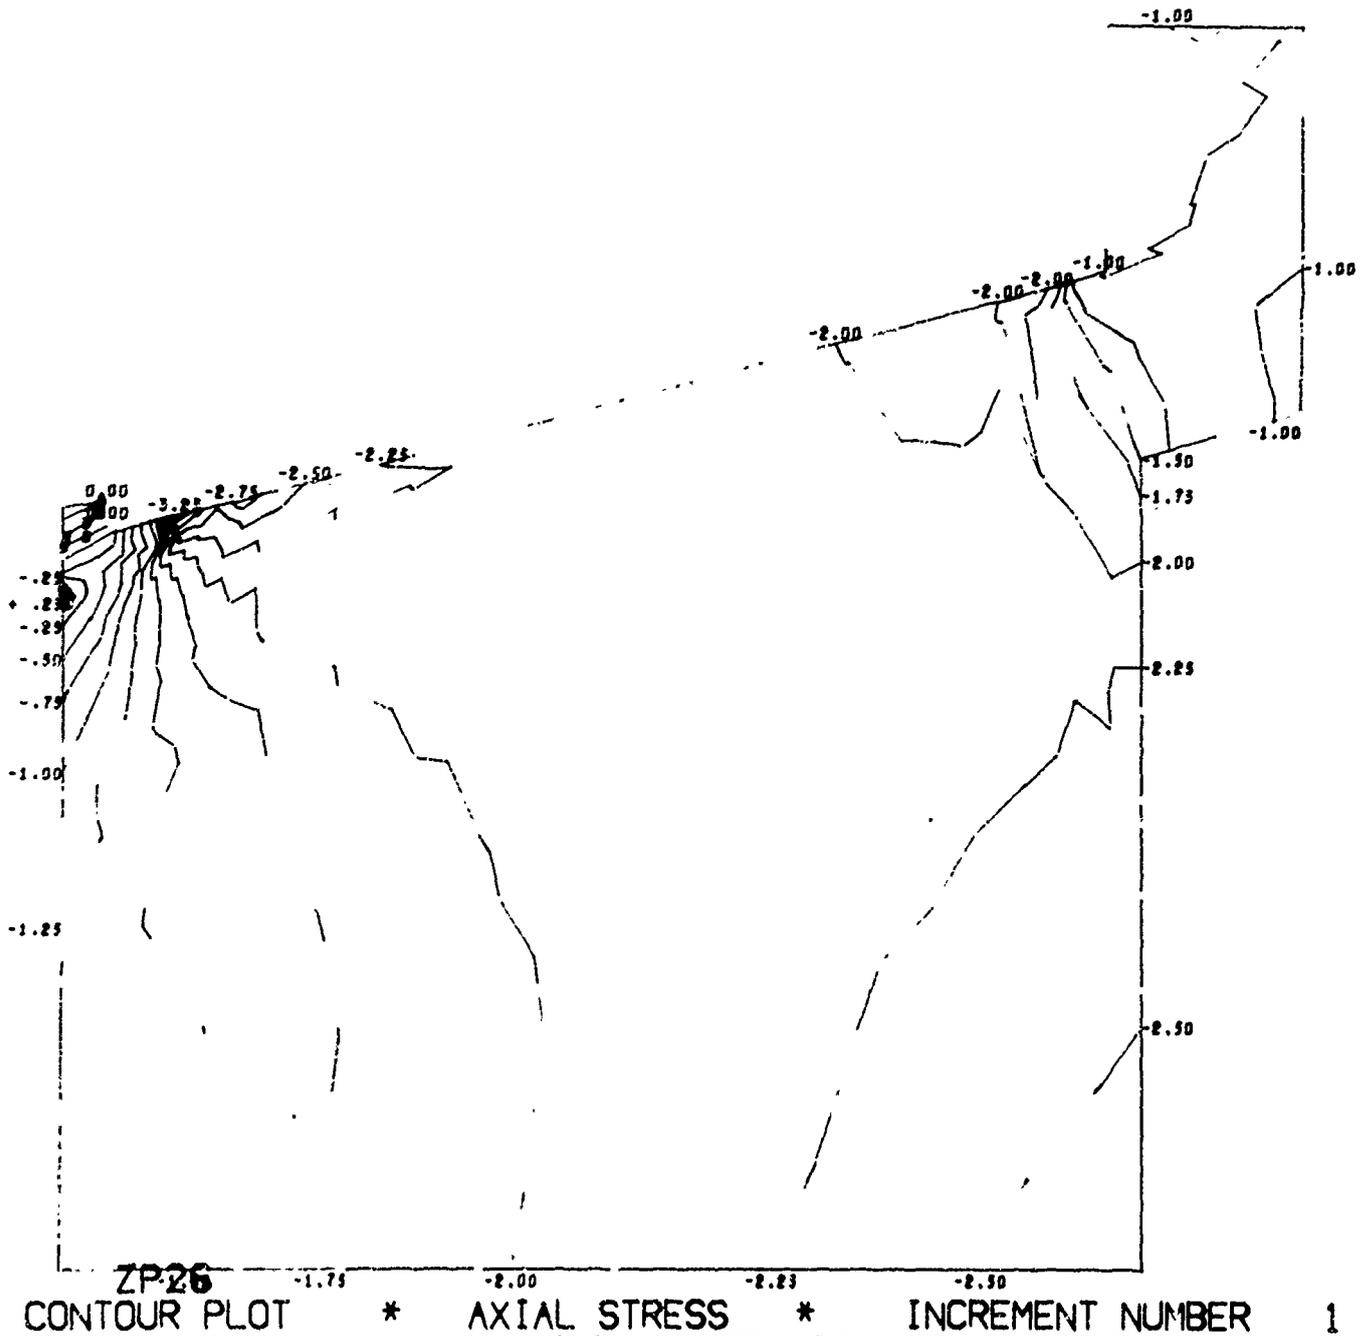
Figure B.10. Magnitude and distribution of stress in window-flange assembly Configuration B utilizing a titanium flange, fiber-reinforced-epoxy gasket, and glass ceramic window (problem 202). (sheet 2 of 8)

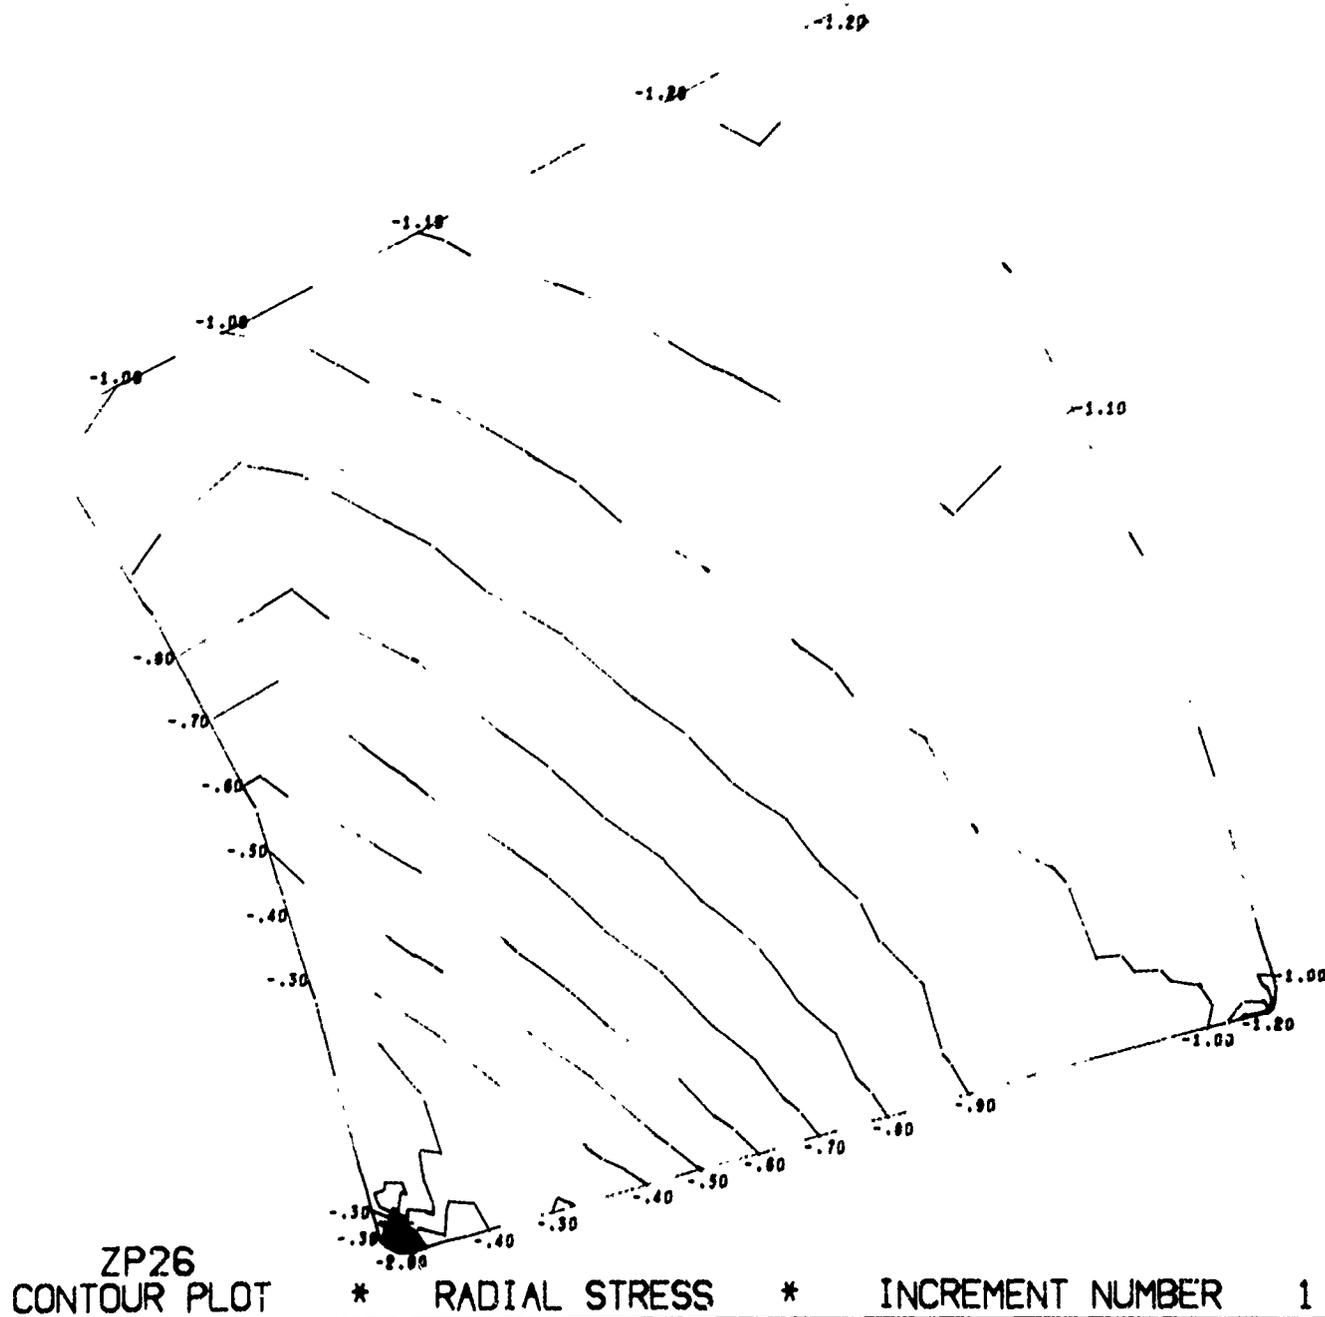
Figure B.10. Magnitude and distribution of stress in window-flange assembly Configuration B utilizing a titanium flange, fiber-reinforced-epoxy gasket, and glass ceramic window (problem 202). (sheet 3 of 8)

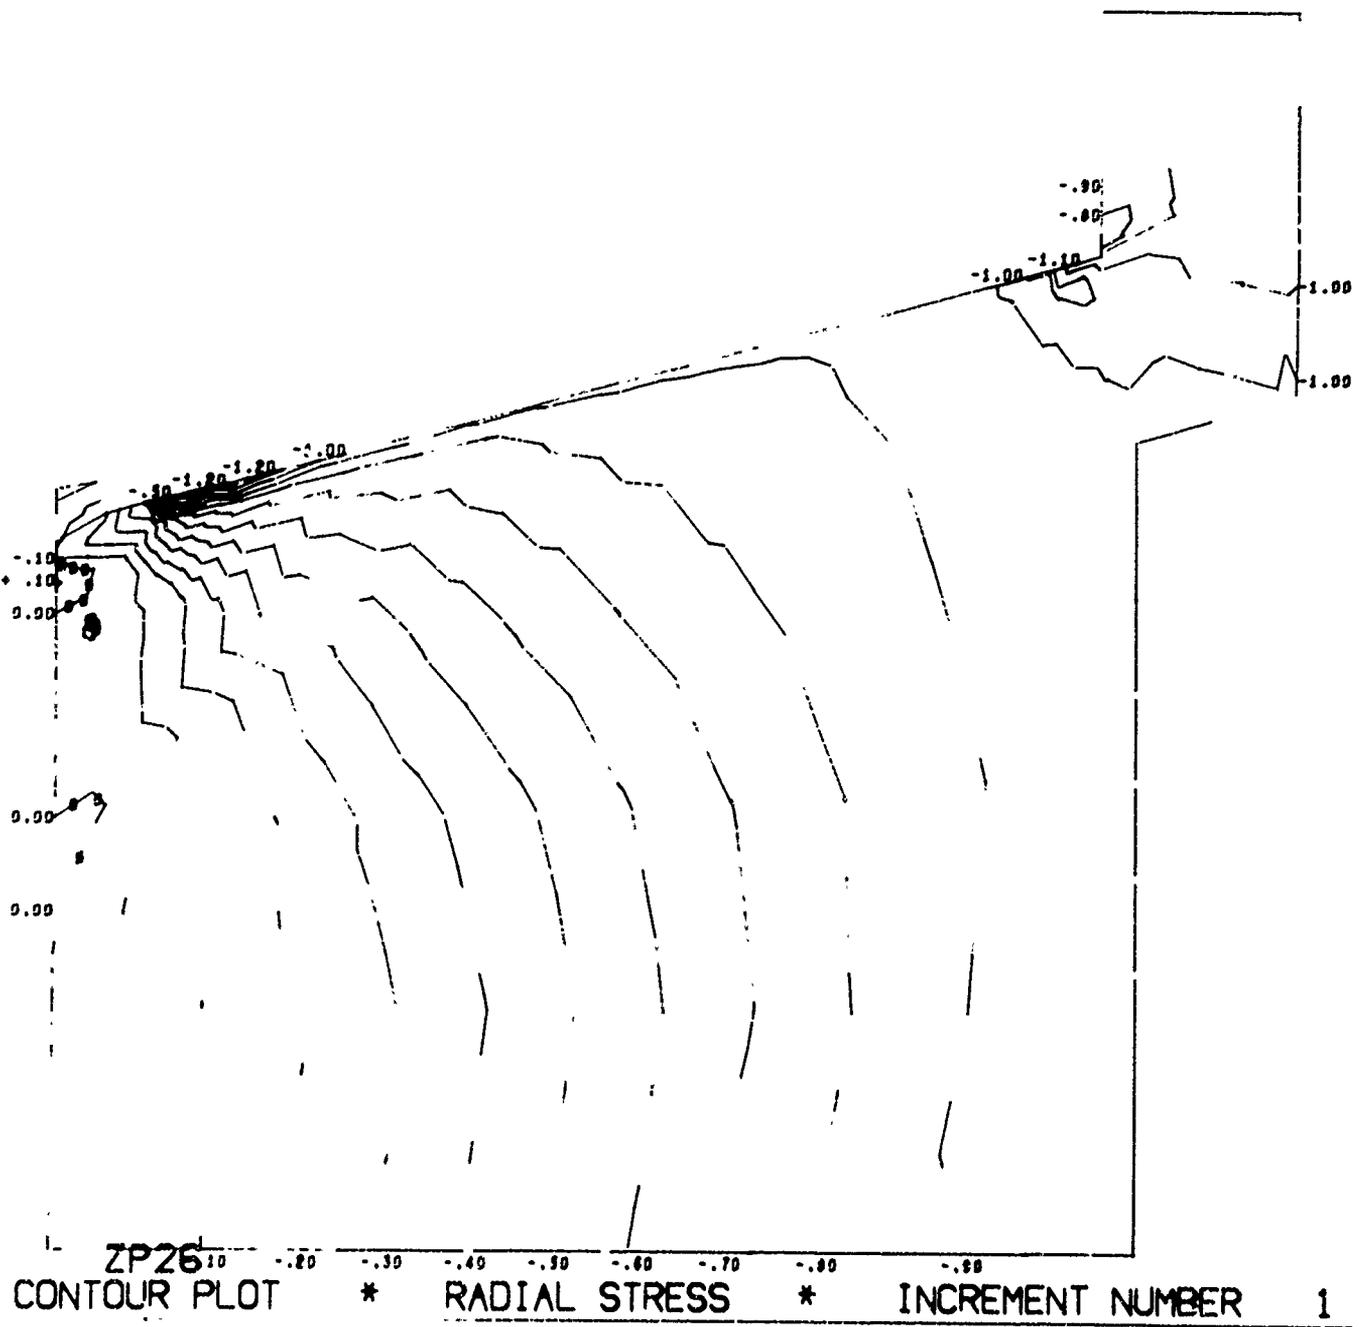
Figure B.10. Magnitude and distribution of stress in window-flange assembly Configuration B utilizing a titanium flange, fiber-reinforced-epoxy gasket, and glass ceramic window (problem 202). (sheet 4 of 8)
