GLASS OR CERAMIC SPHERICAL-SHELL
WINDOW ASSEMBLY FOR 20,000-PSI
OPERATIONAL PRESSURE

Jerry D. Stachiw

Naval Undersea Center
San Diego, California

May 1974

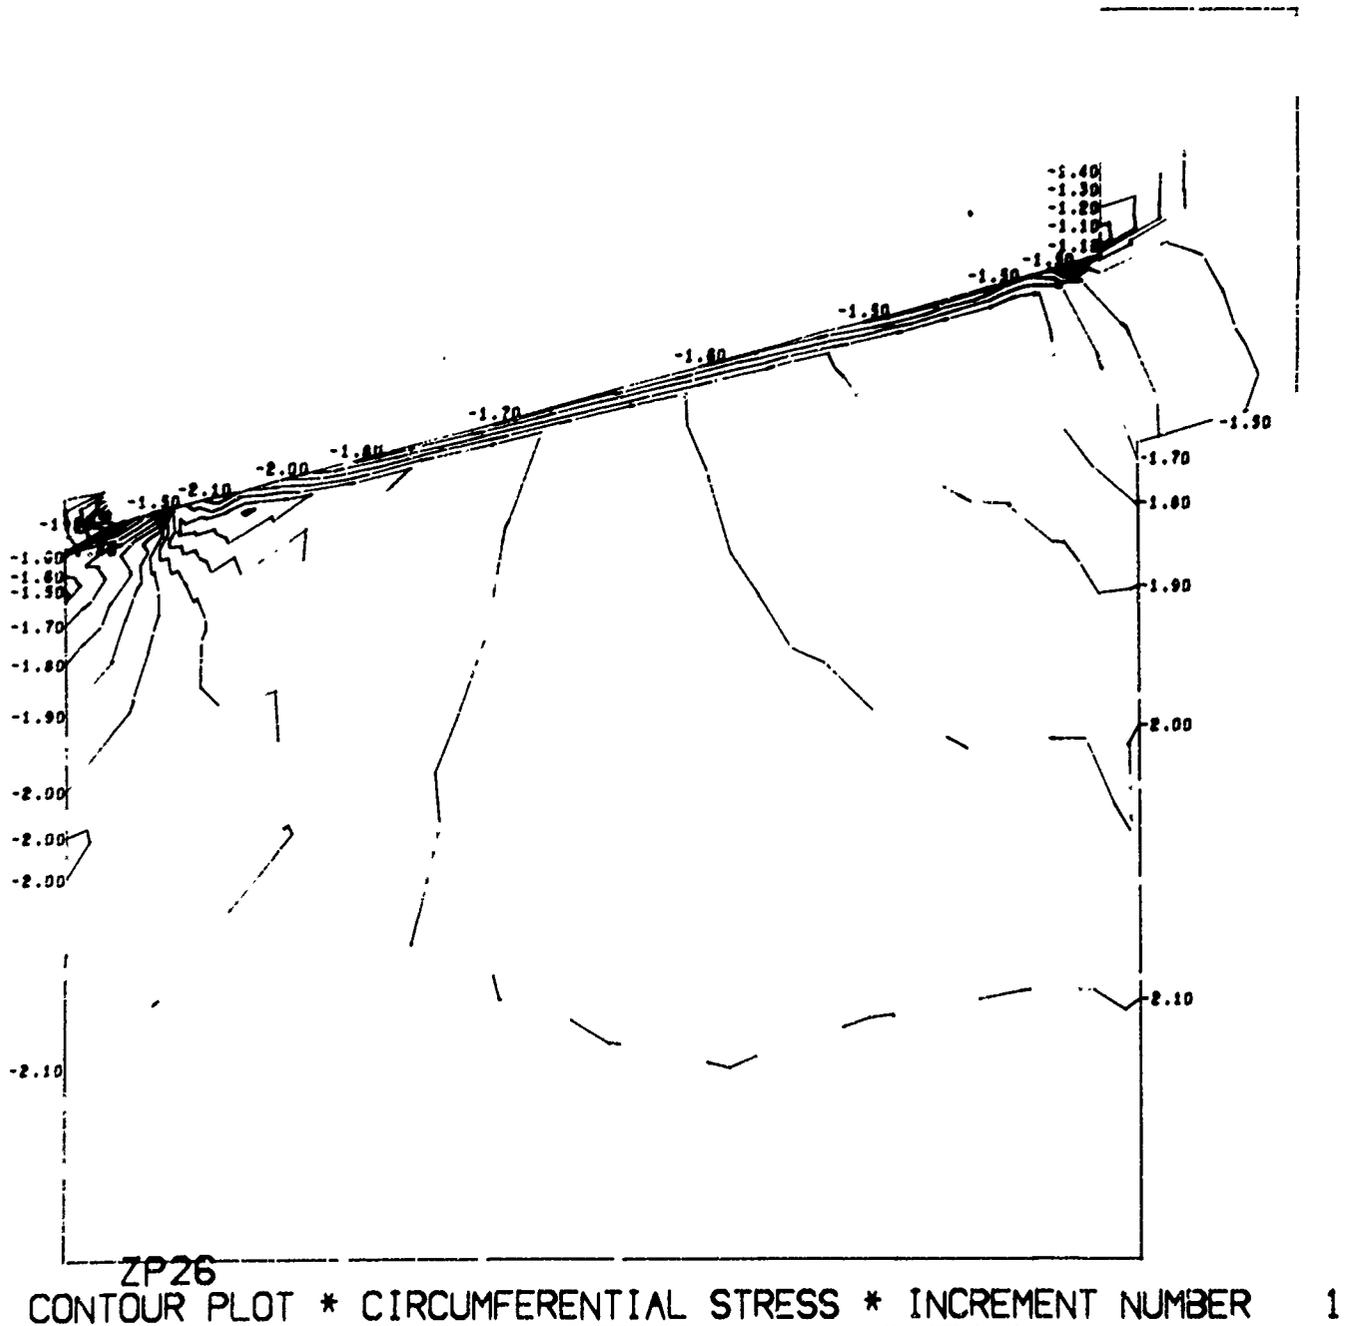
Figure B.10. Magnitude and distribution of stress in window-flange assembly Configuration B utilizing a titanium flange, fiber-reinforced-epoxy gasket, and glass ceramic window (problem 202). (sheet 6 of 8)

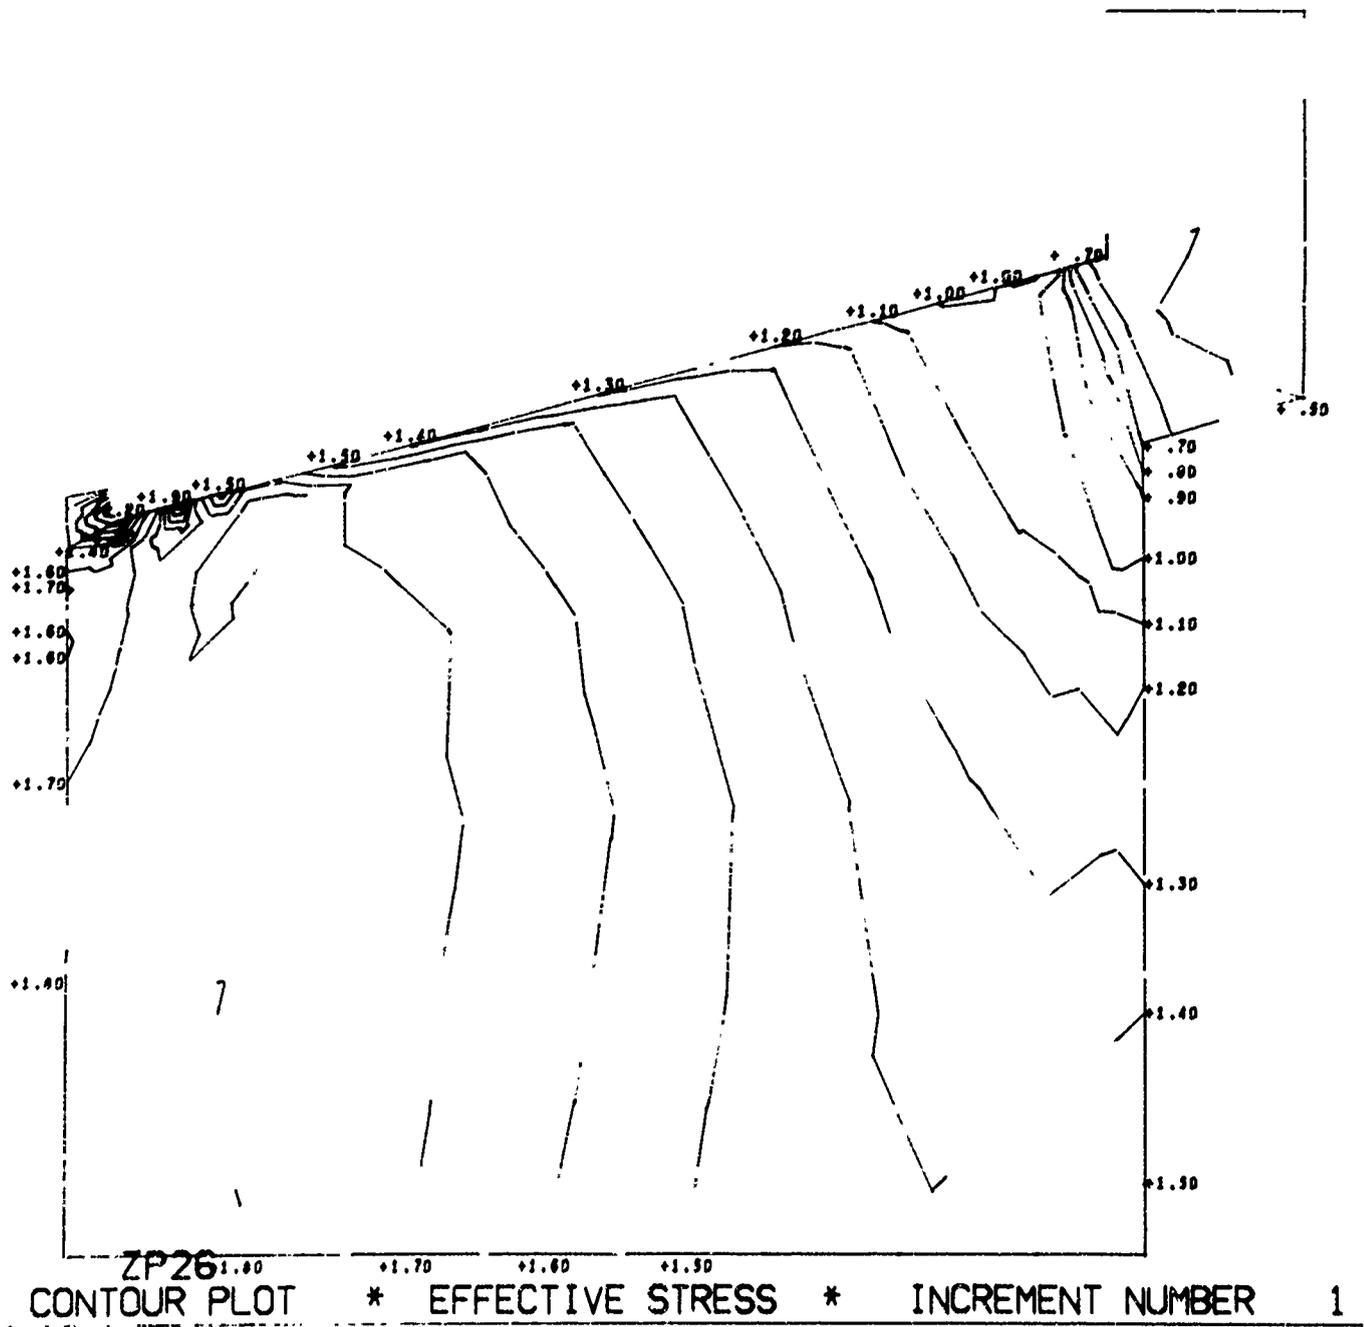
Figure B.10. Magnitude and distribution of stress in window-flange assembly Configuration B utilizing a titanium flange, fiber-reinforced-epoxy gasket, and glass ceramic window (problem 202). (sheet 8 of 8)

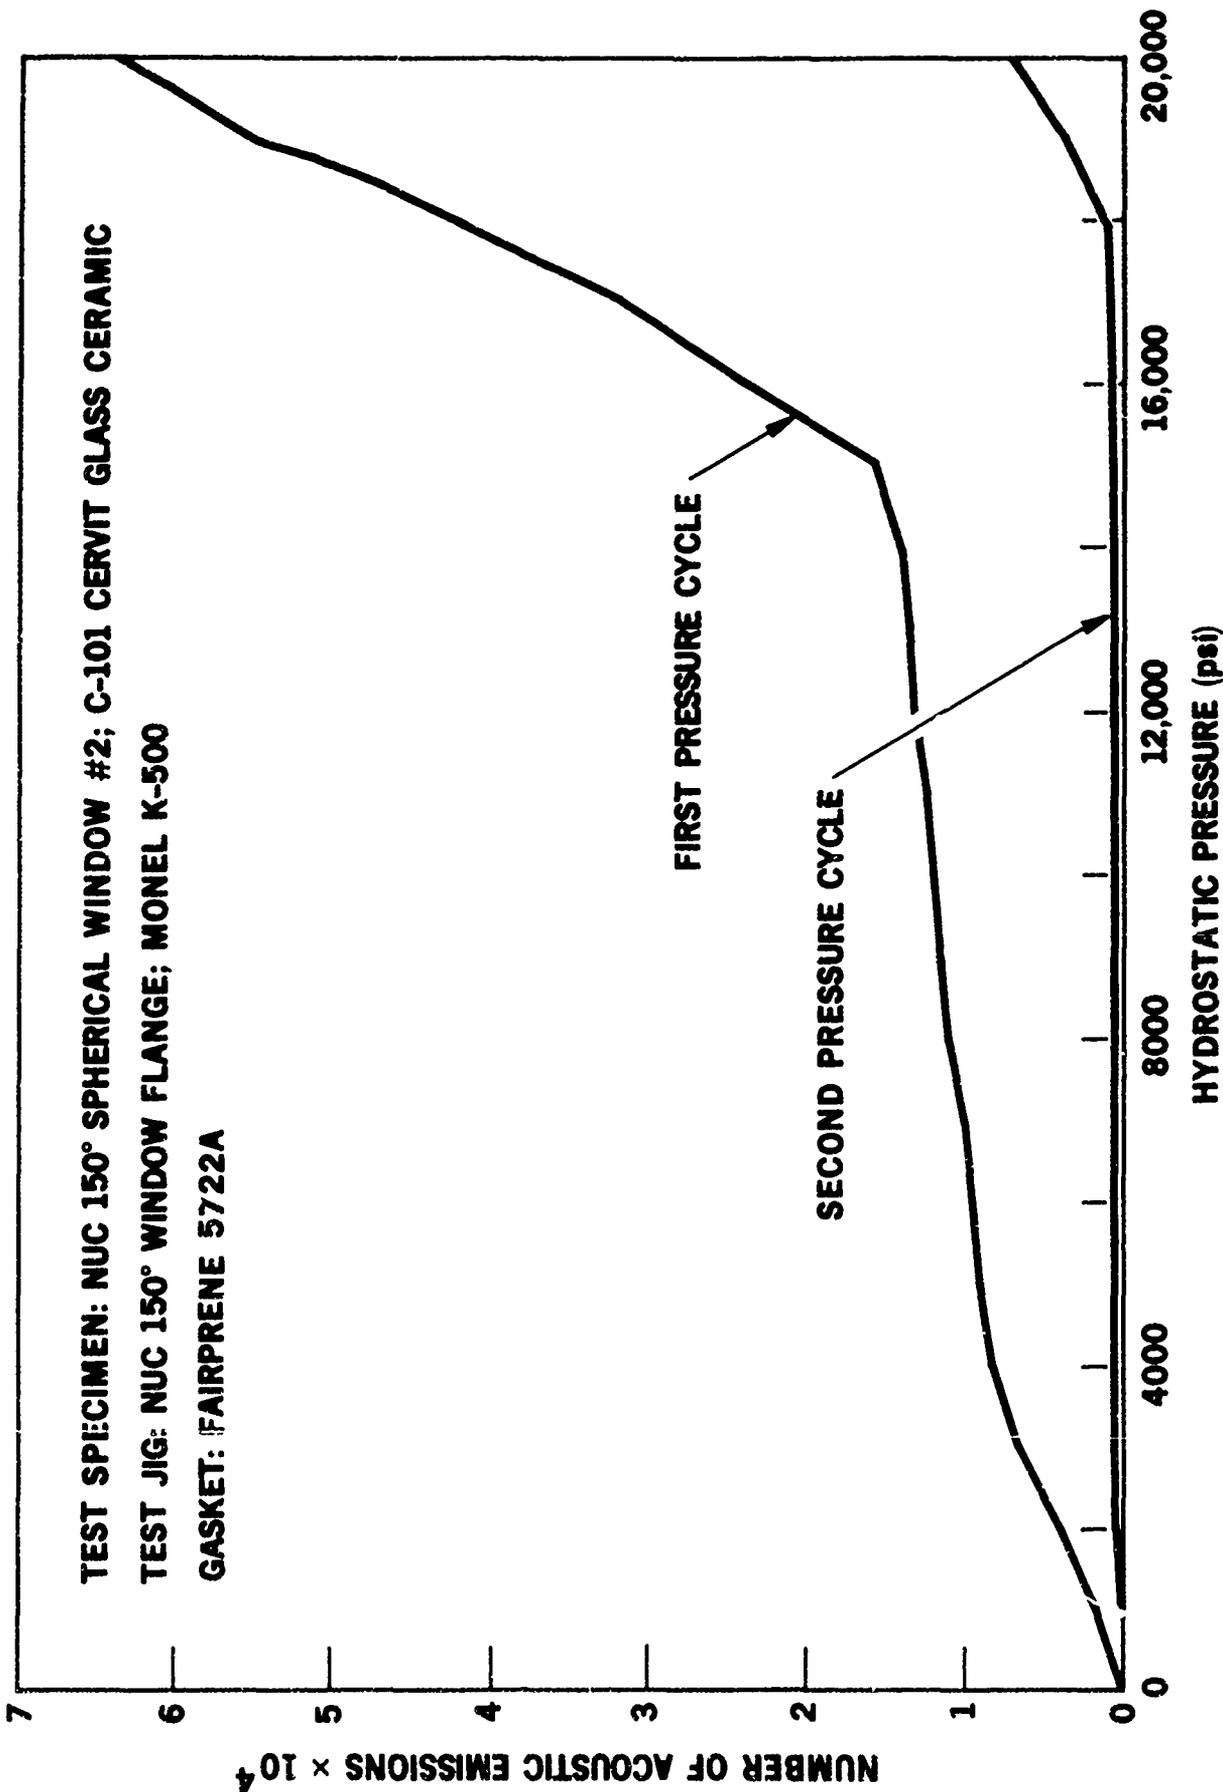
Figure D.1. Cumulative number of acoustic emissions generated by a C-101 glass ceramic, spherical window in NUC 150-degree conical flange seat when subjected to succeeding pressurizations from 0 to 20,000 psi.

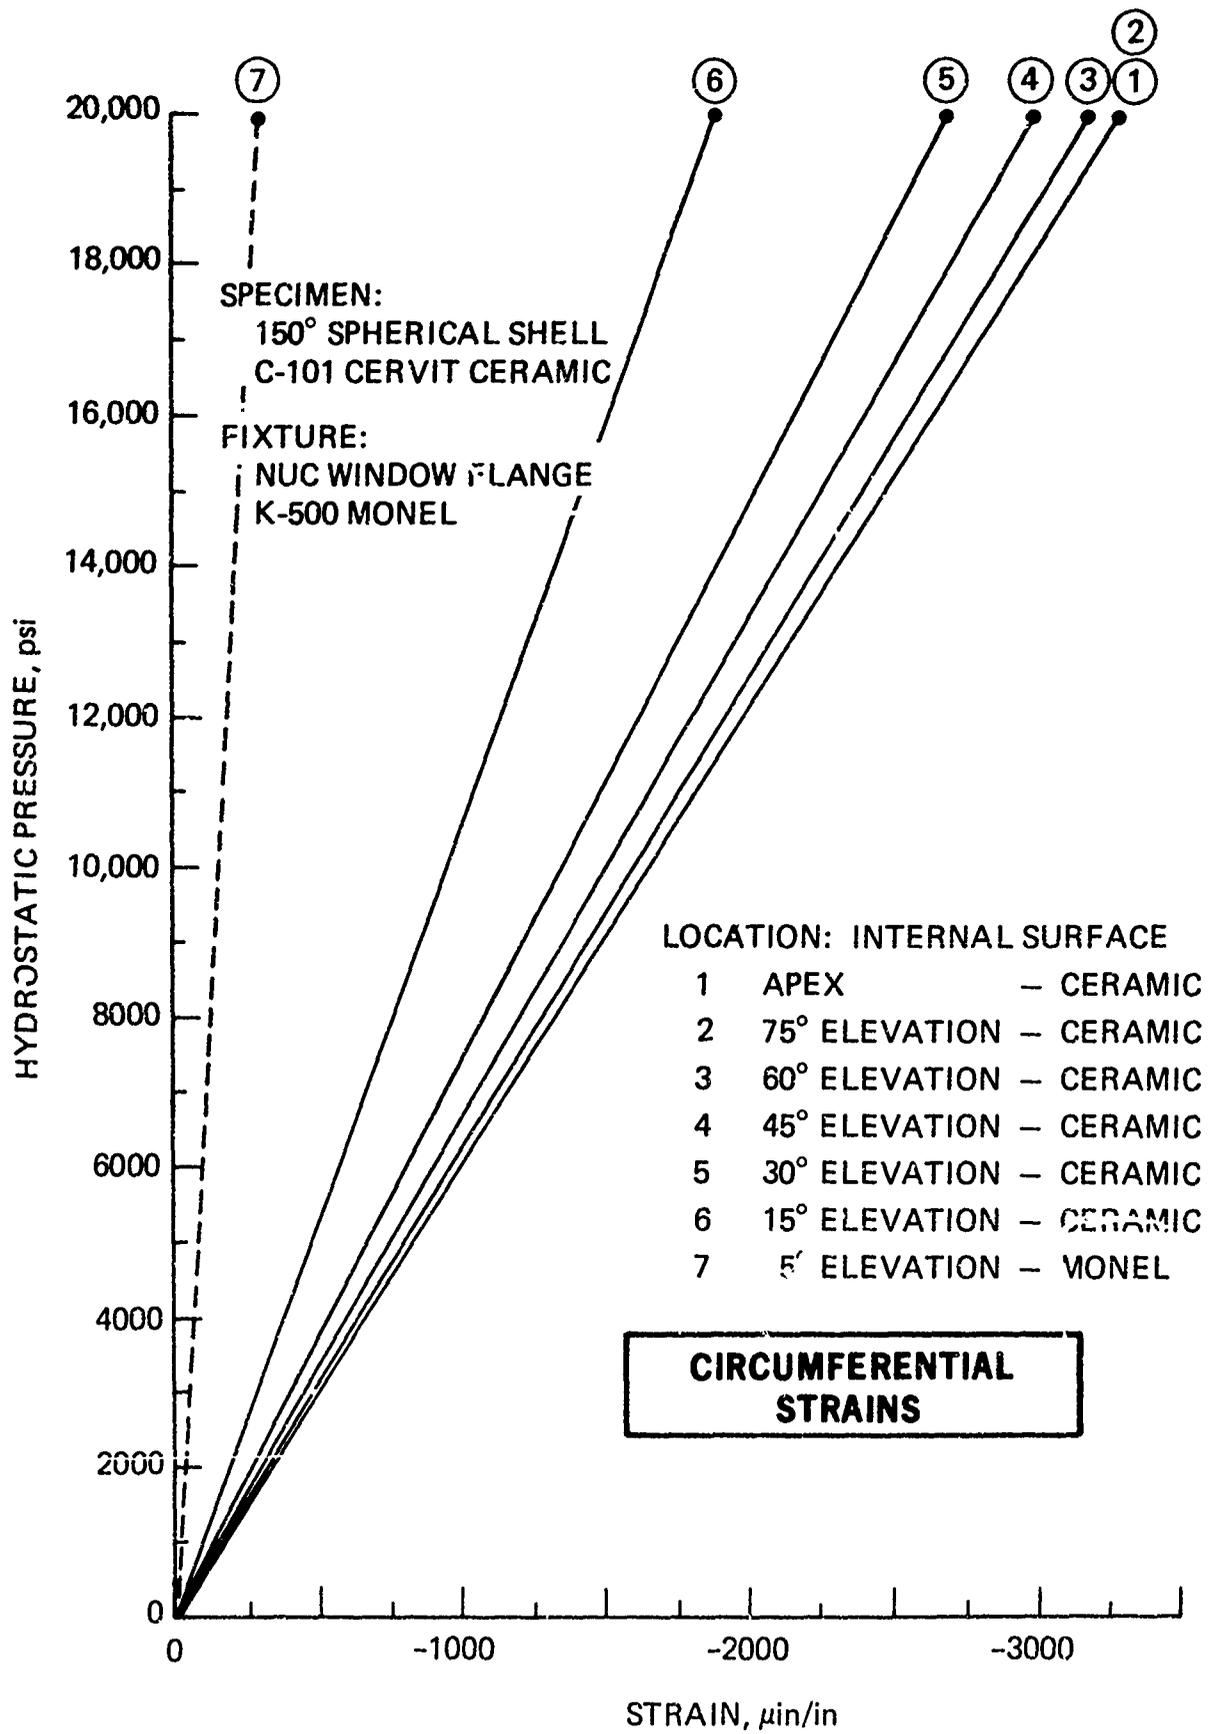
Figure E.1. Comparison of circumferential strains in Cer-Vit C-101 window and Monel K-500 flange.

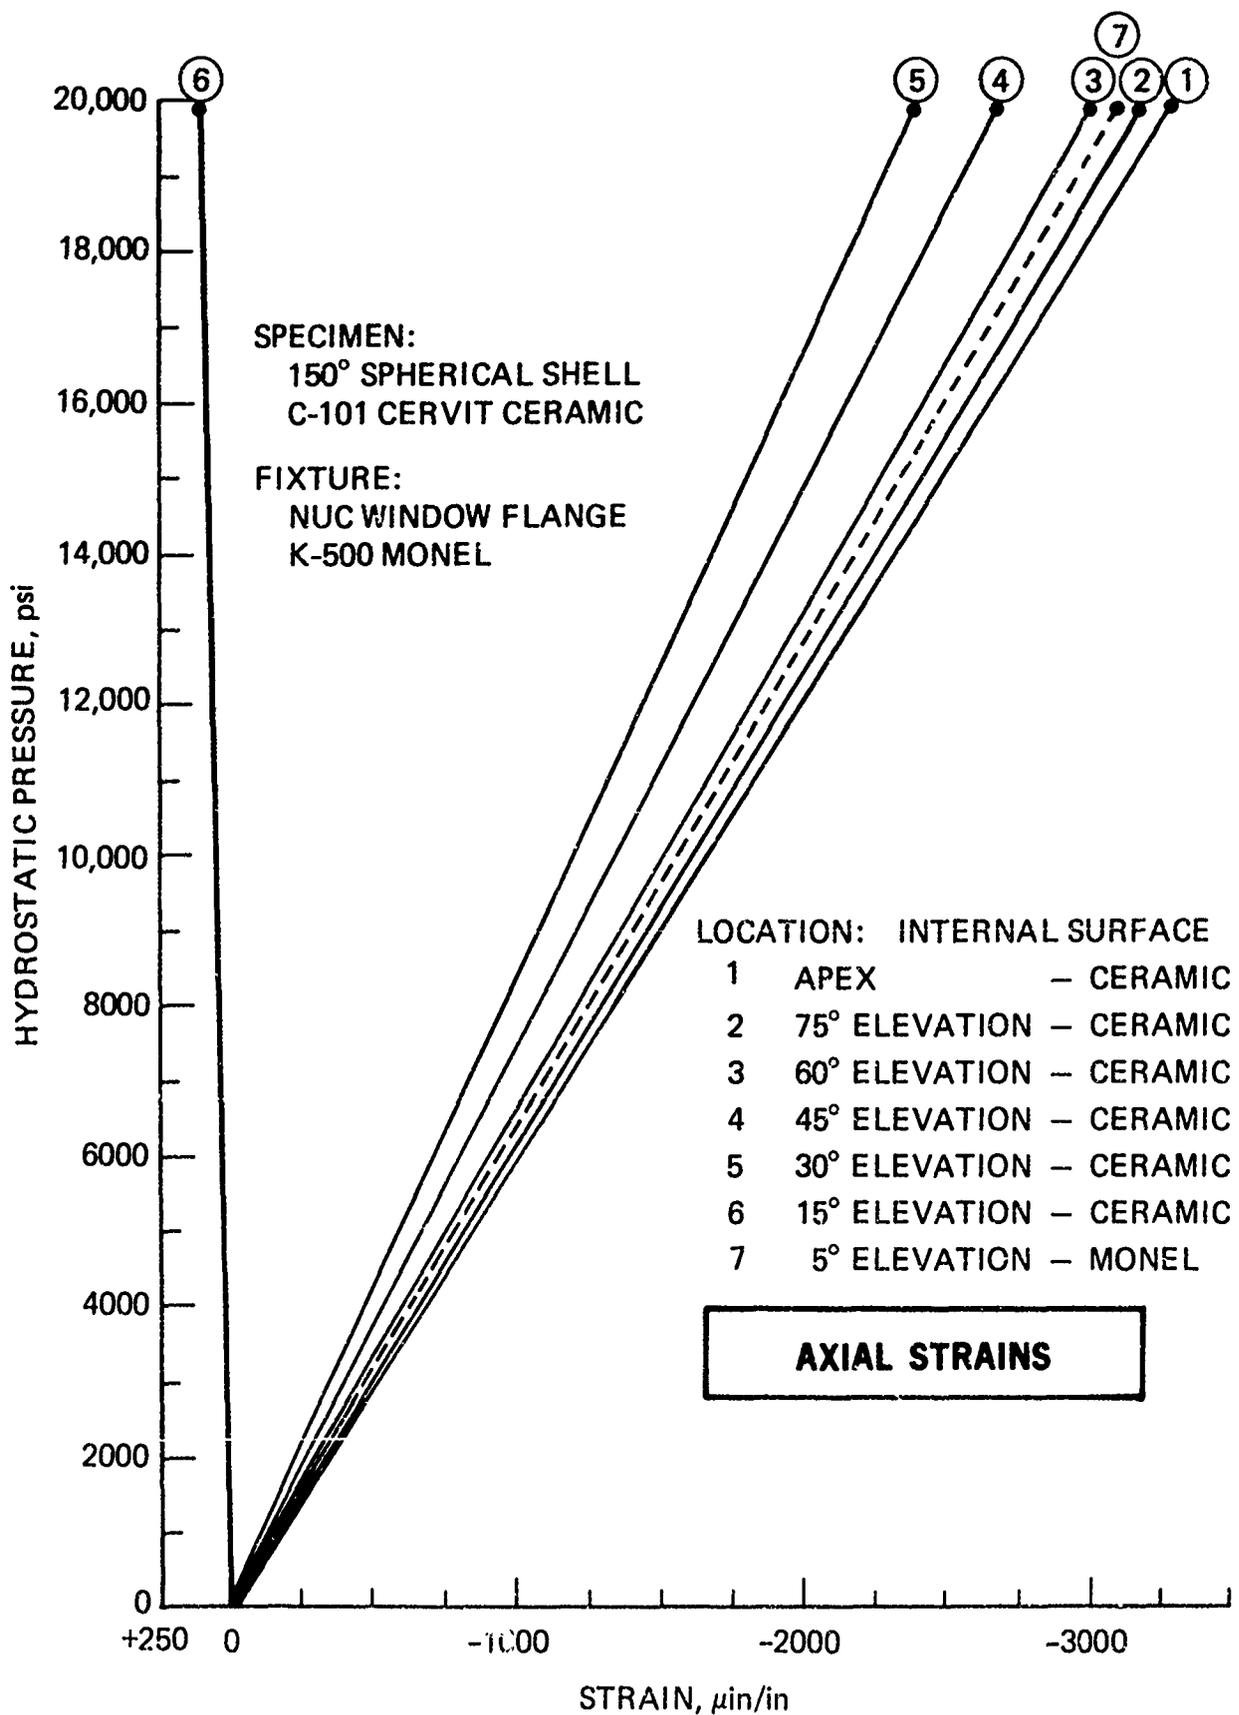
Figure E.2. Comparison of axial strains in Cer-Vit C-101 window and Monel K-500 flange.

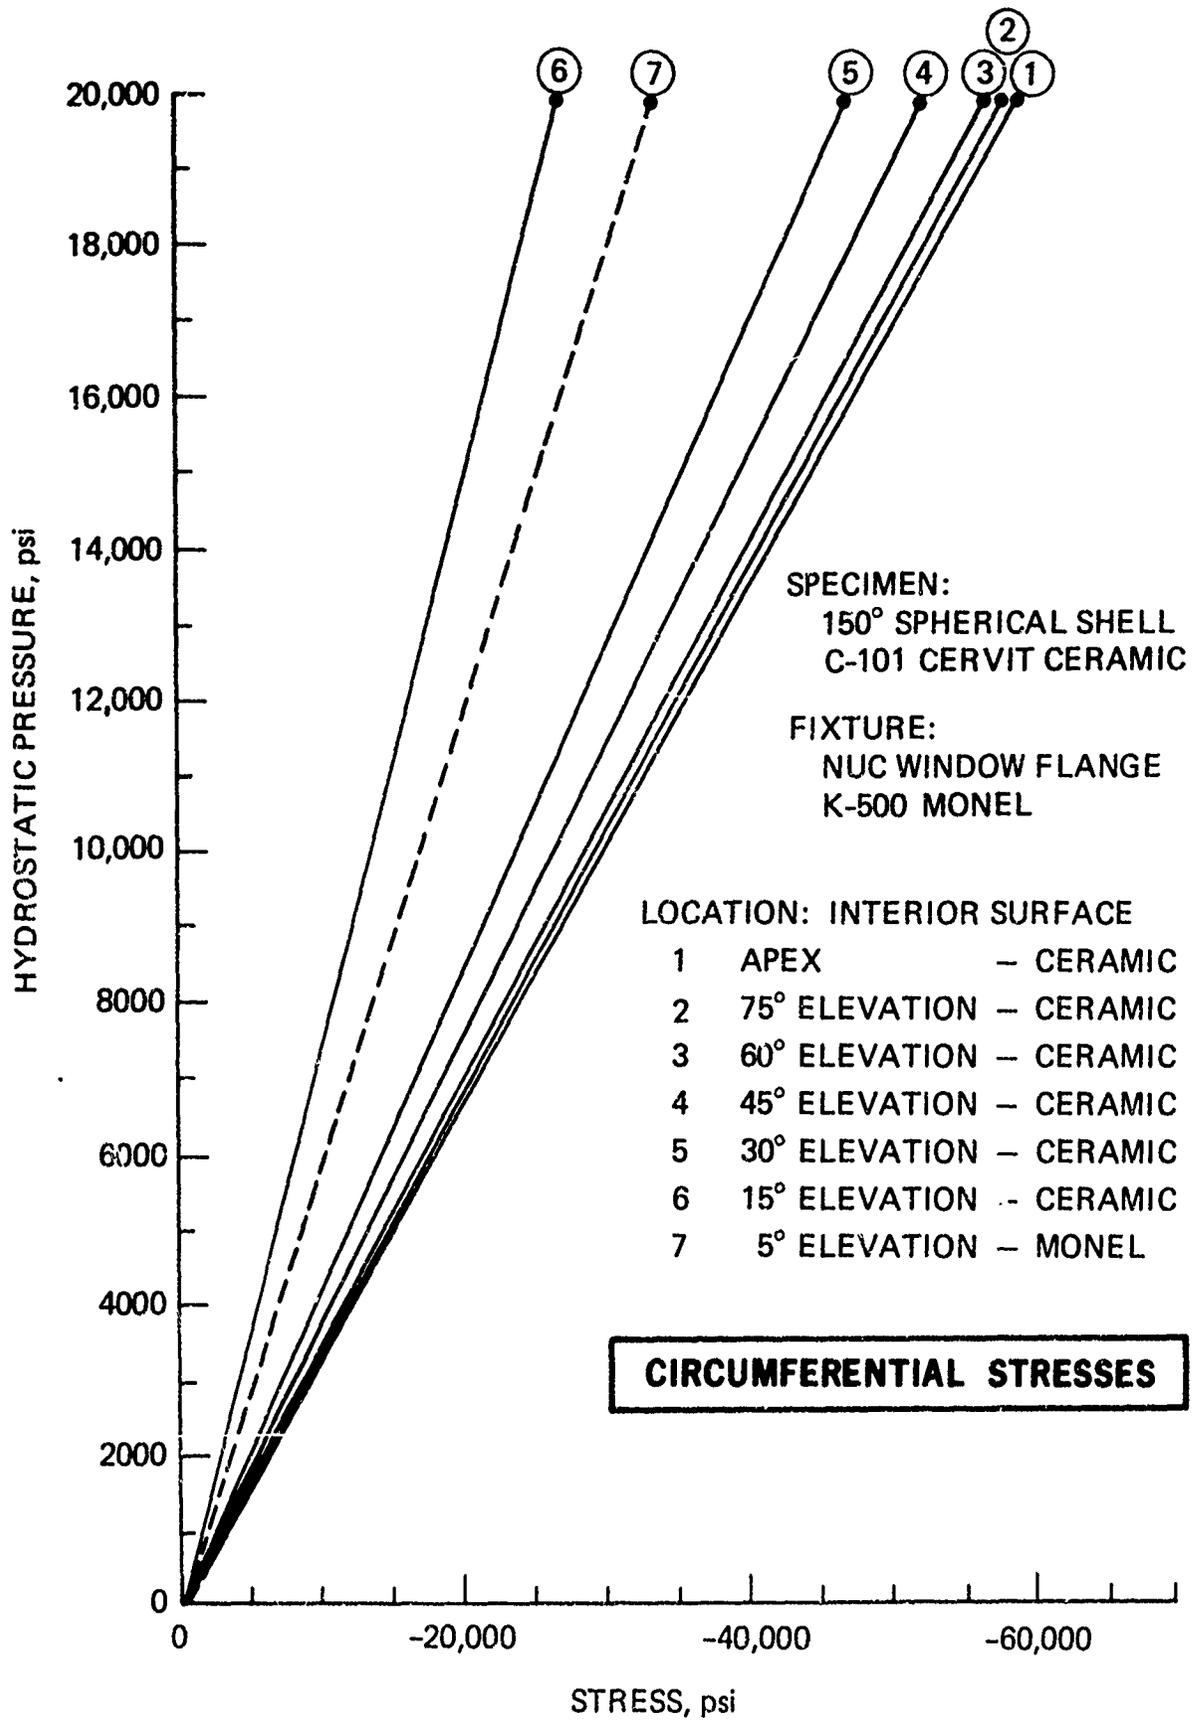
Figure E.3. Experimentally generated stresses in Cer-Vit C-101 window and Monel K-500 flange.

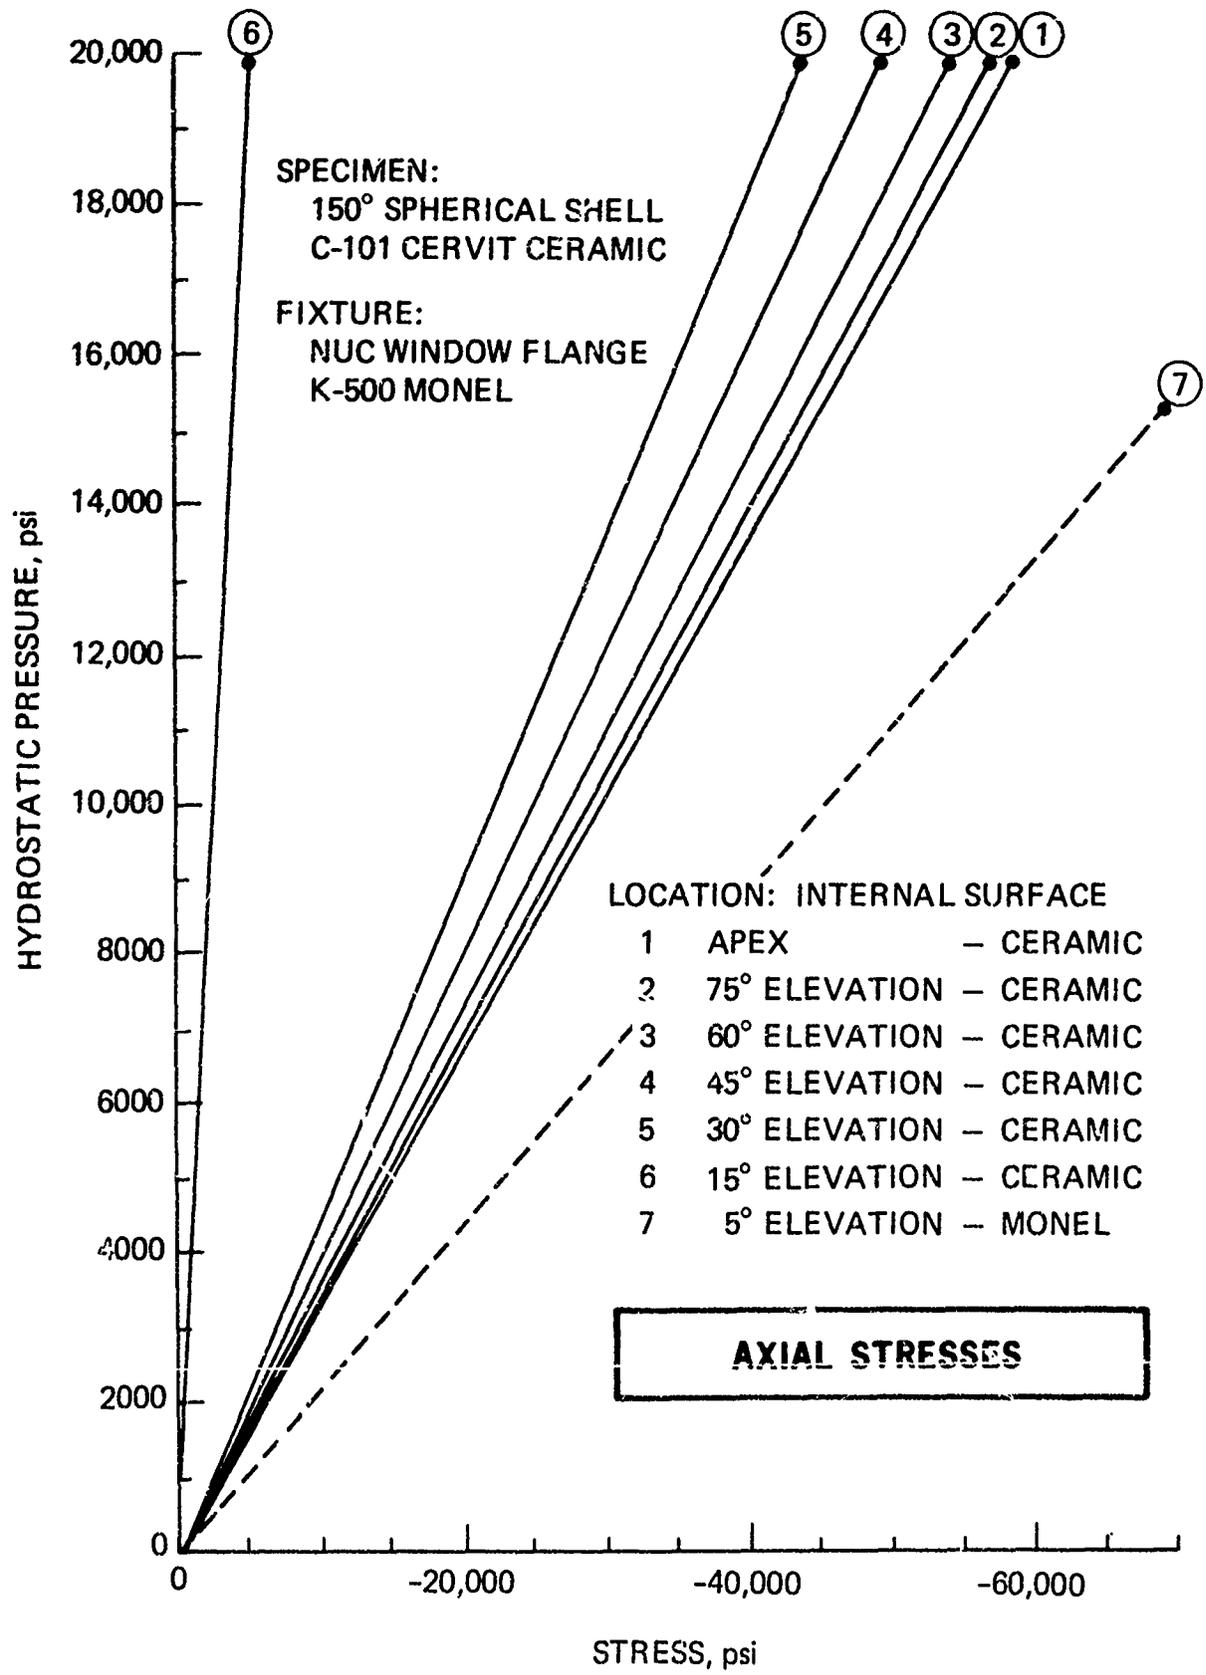
Figure E.4. Experimentally generated axial stresses in Cer-Vit C-101 window and Monel K-500 flange.

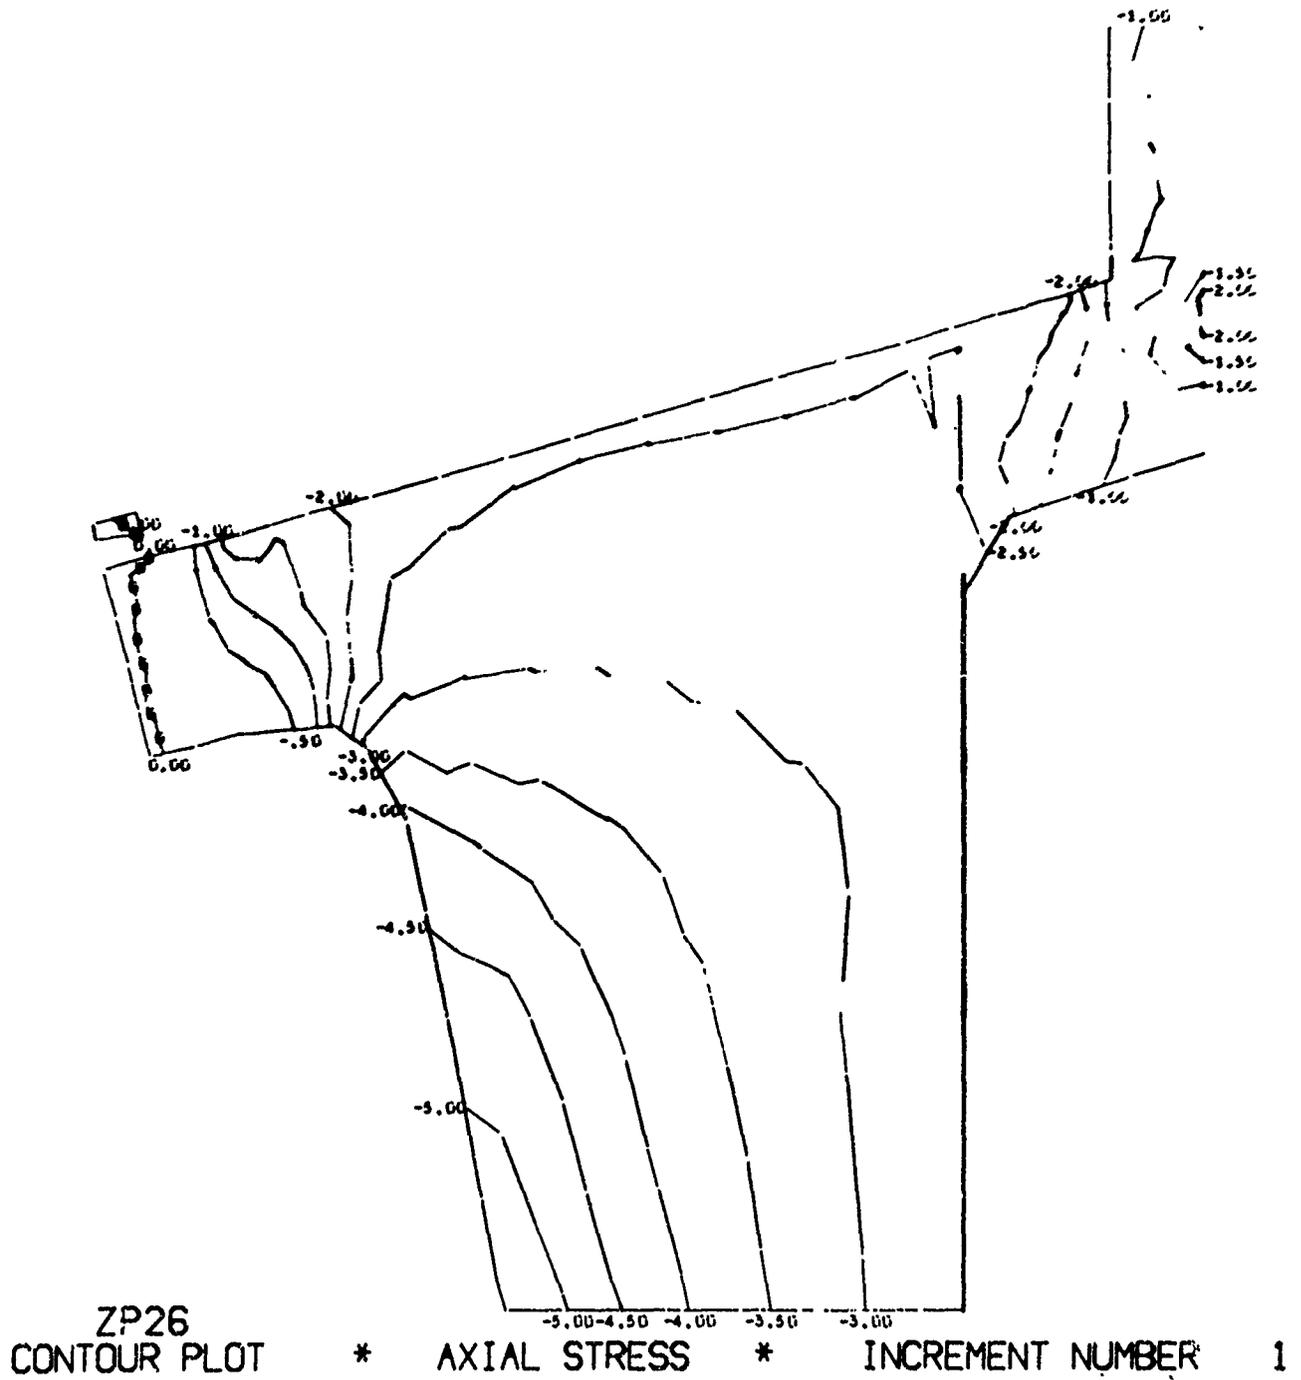
Figure E.6. Calculated axial stresses in Cer-Vit C-101 window and Monel K-500 flange. (sheet 1 of 2)

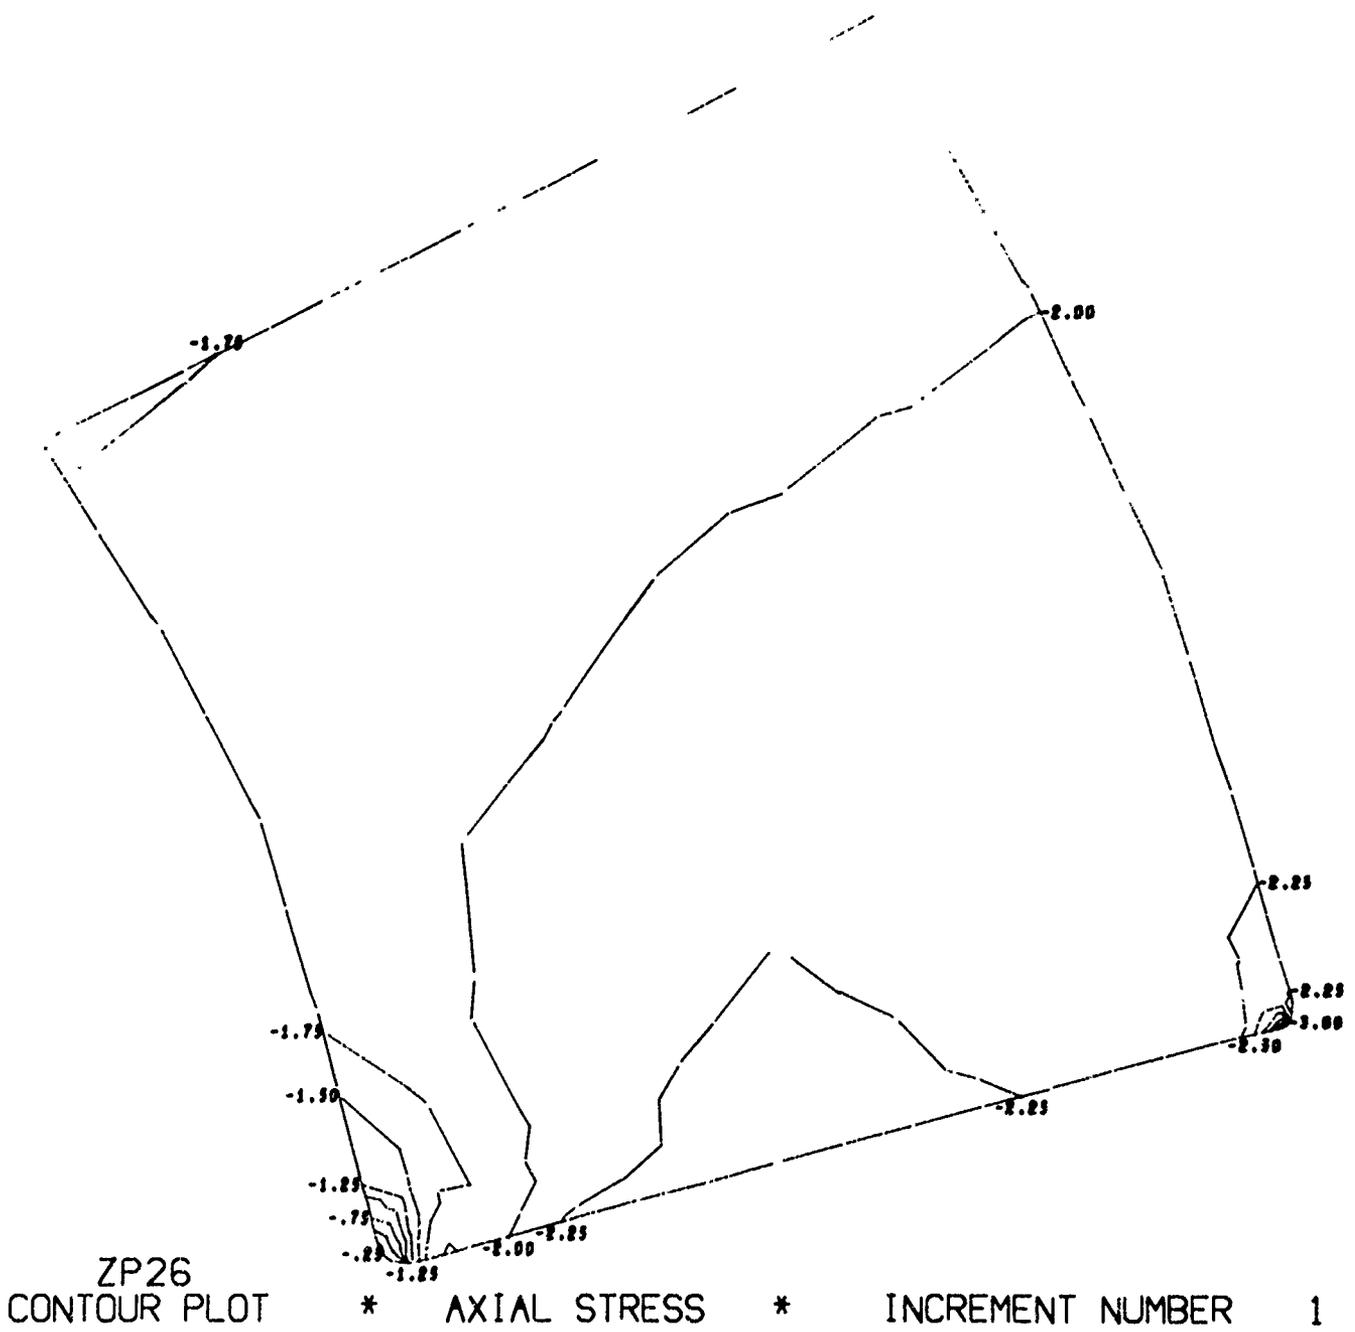
Figure E.6. Calculated axial stresses in Cer-Vit C-101 window and Monel K-500 flange. (sheet 2 of 2)

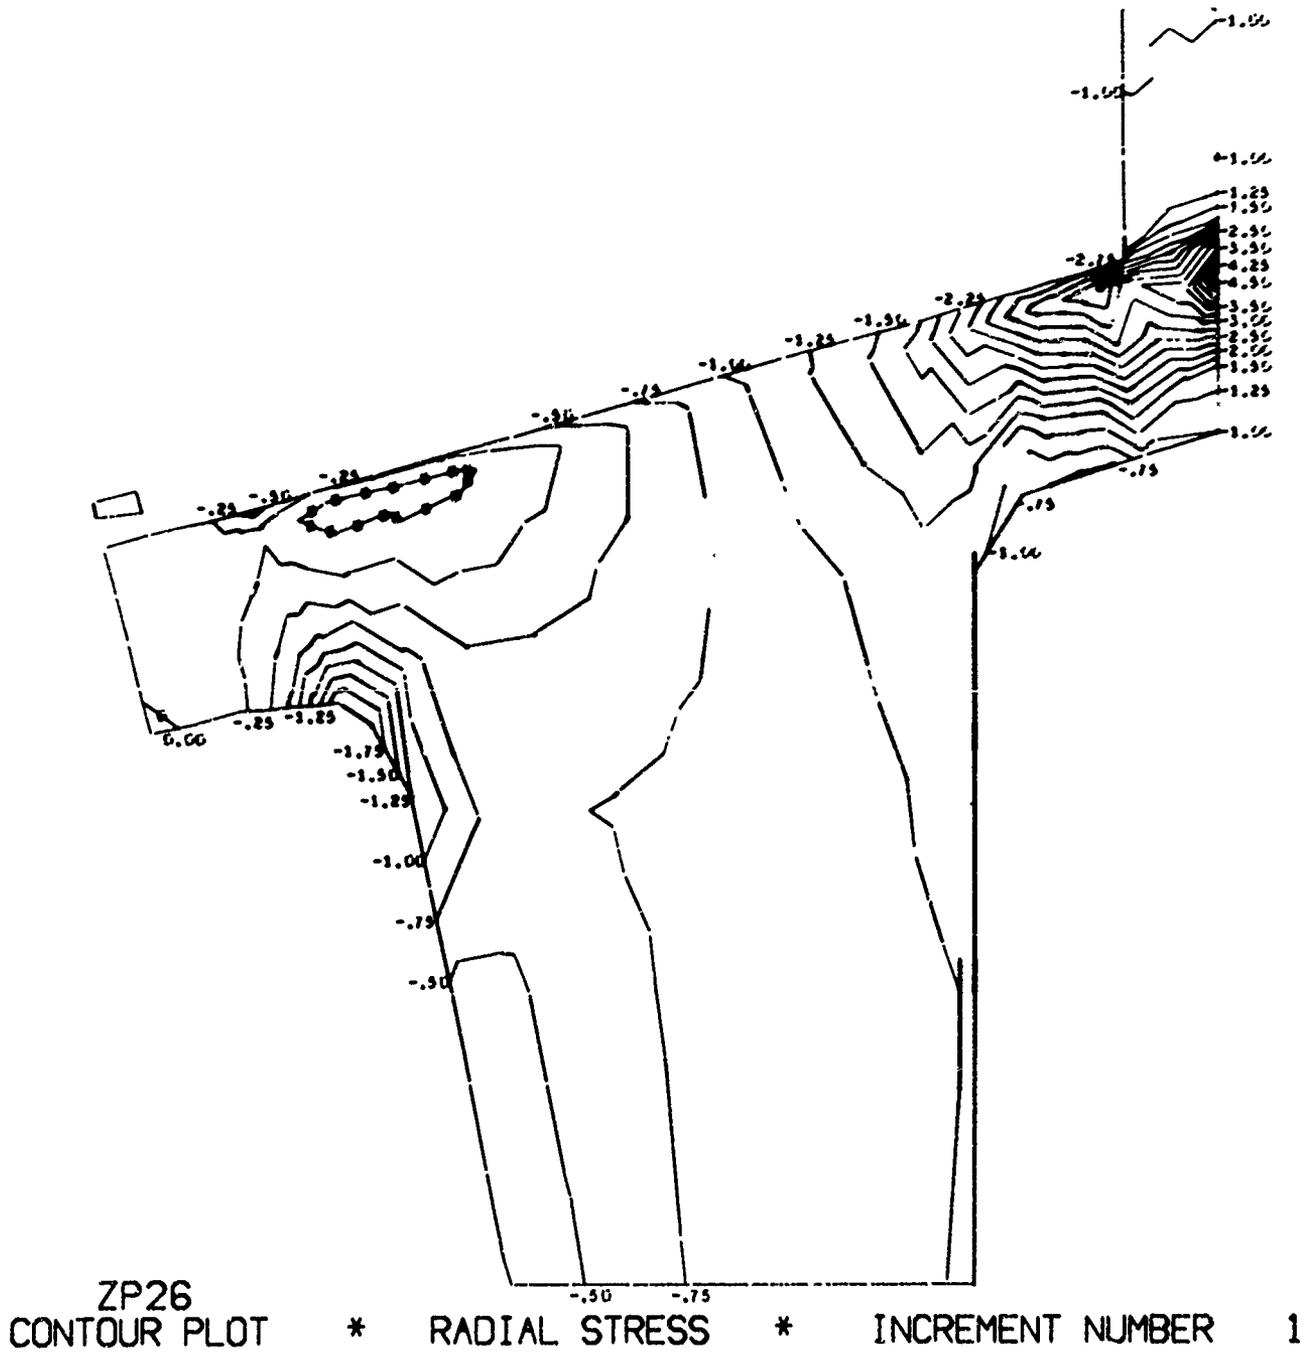
Figure E.7. Calculated radial stresses in Cer-Vit C-101 window and Monel K-500 flange. (sheet 1 of 2)

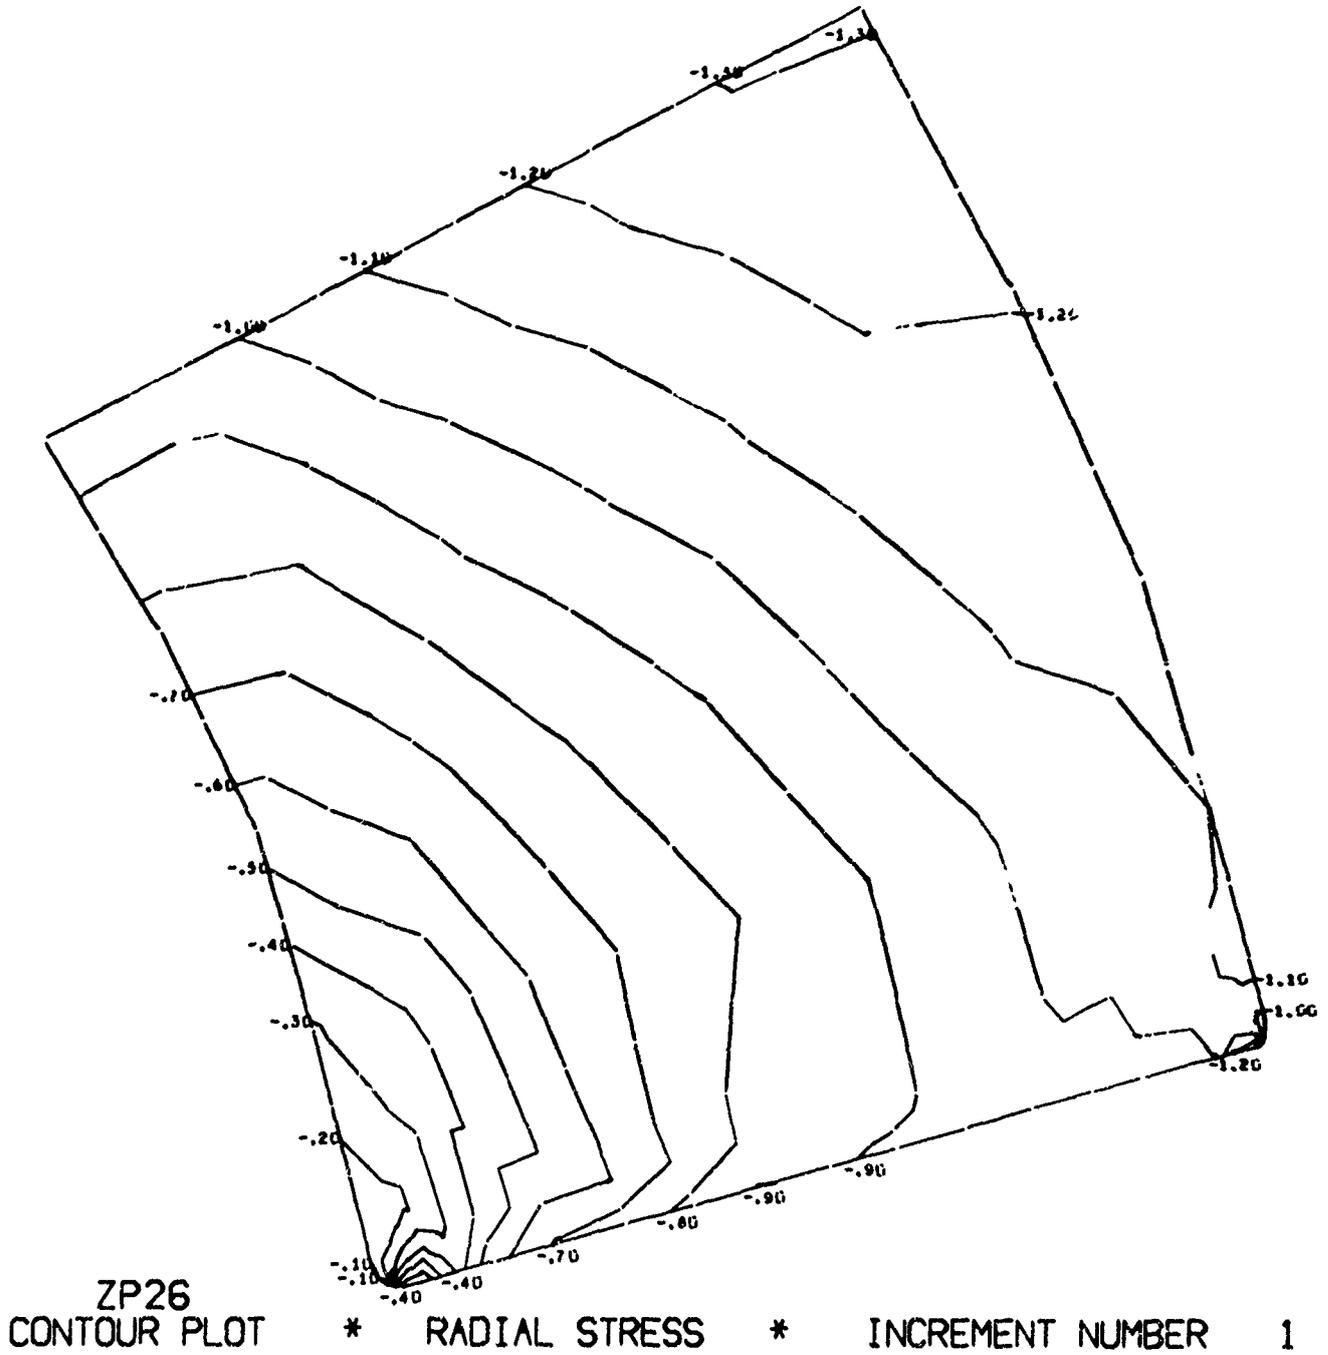
Figure E.7. Calculated radial stresses in Cer-Vit C-101 window and Monel K-500 flange. (sheet 2 of 2)
