GLASS OR CERAMIC SPHERICAL-SHELL
WINDOW ASSEMBLY FOR 20,000-PSI
OPERATIONAL PRESSURE

Jerry D. Stachiw

Naval Undersea Center
San Diego, California

May 1974

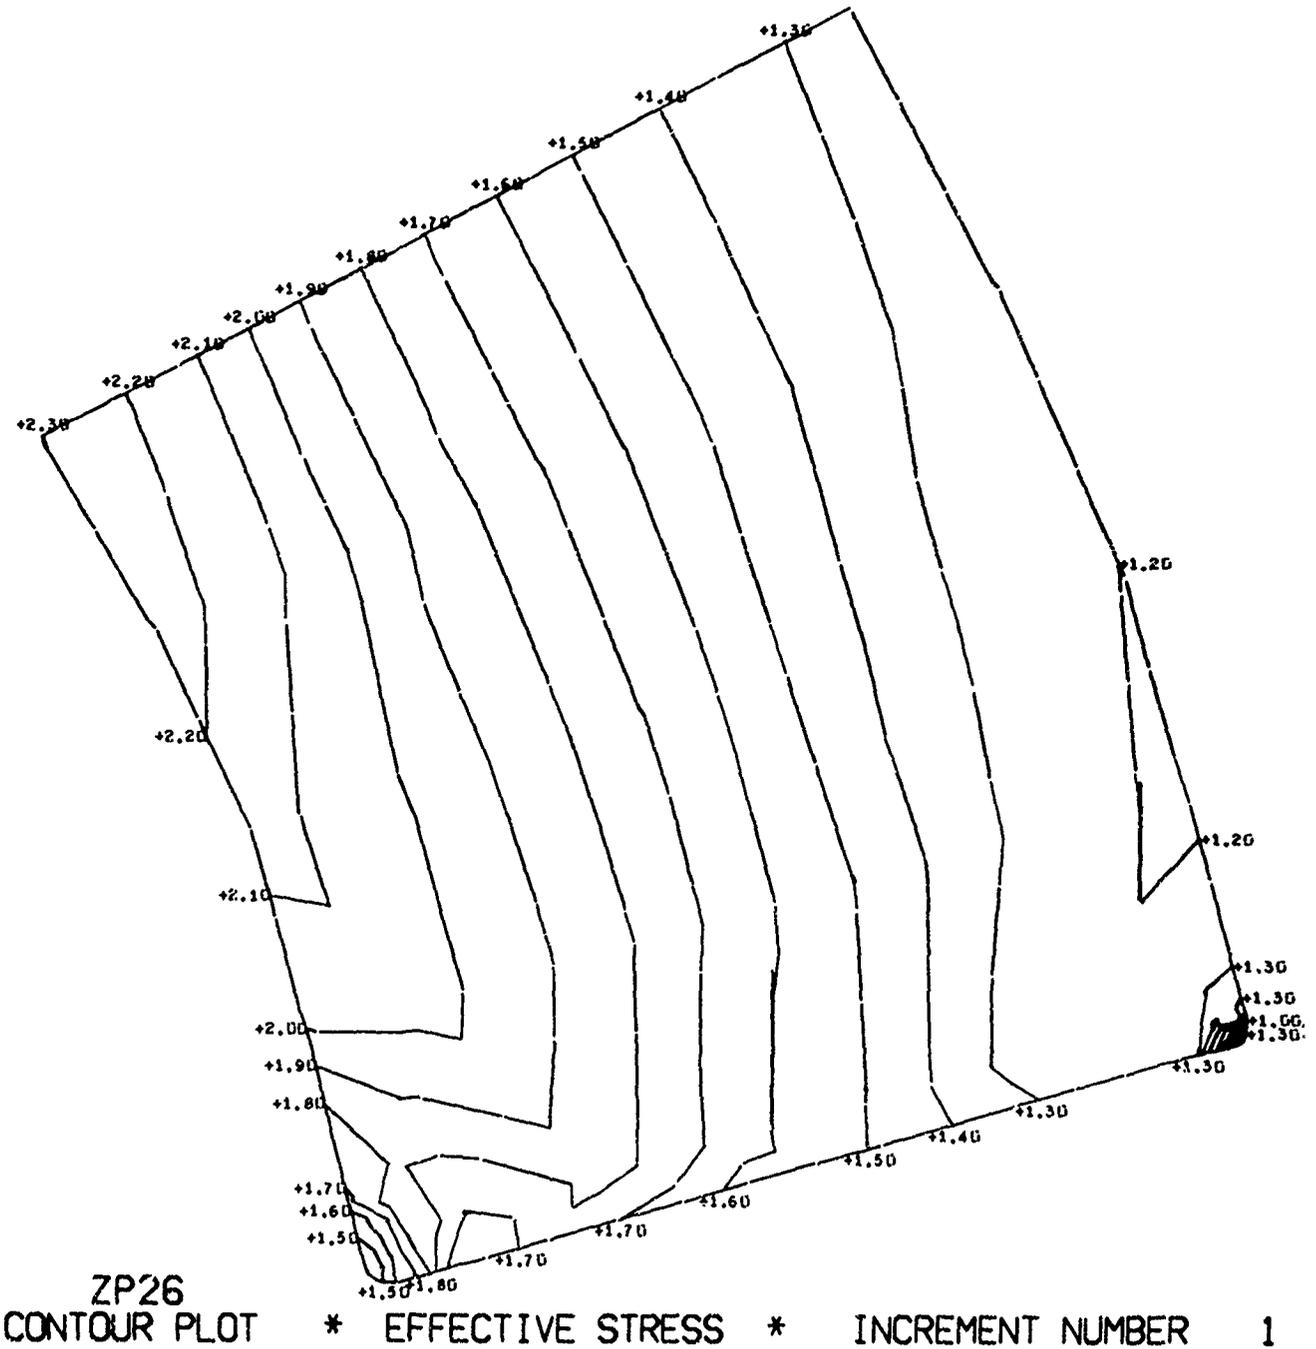
Figure E.8. Calculated effective stresses in Cer-Vit C-101 window and Monel K-500 flange. (sheet 2 of 2)
