RAPID PREPARATION OF QUICK-CURE RESIN TEST SITES IN SOUTHEAST ASIA

Part I Southeast Asia Test Program

TECHNICAL REPORT AFAPL-TR-66-148, PART I

28 FEBRUARY 1967

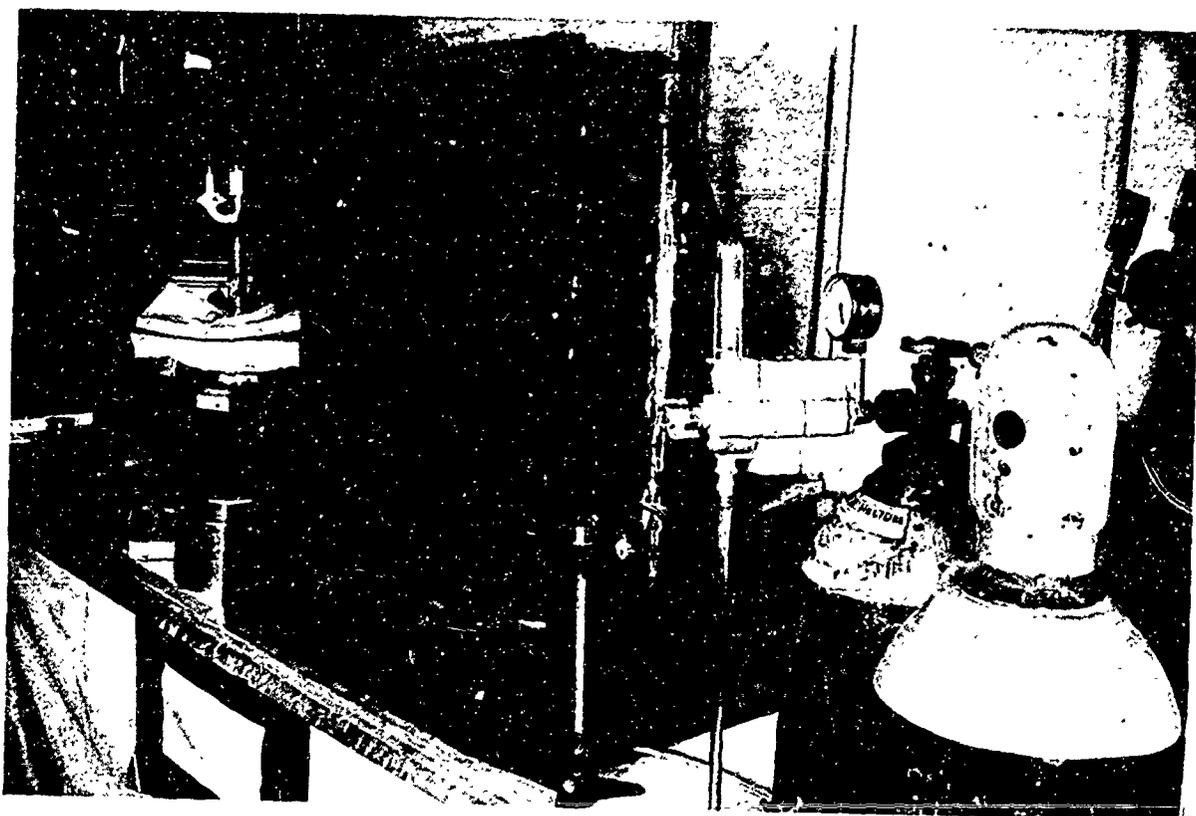
Figure 7. Views of the Toxicity Test Setup

A 24-inch square box was fabricated from Hetron 24505 Resin, with inlet and outlet tubes bonded at the extreme opposite corners of the box. The inlet was fitted with a flowmeter and regulator, and the outlet hose was attached to a liquid nitrogen cold trap. The system was protected from moisture by a drying tube connected to the cold trap outlet. Figure 7, page 19, presents views of this test setup. After completion of set up, the box was allowed to stand 18 hours - then purged using 600 liters of helium (107 grams) over a 6-hour period. This cycle was repeated on a 24-hour basis over a period of fourteen days. No samples were taken on Saturdays or Sundays. At the end of each purging period the cold trap was removed, the sample was weighed, and the residue subjected to infrared analysis. See Table VII, page 20, for toxicity test data. Figure 8, page 21, presents a plot of residue vs helium eluent. An infrared spectrum was made using a Perkin-Elmer Model 21 Infrared Spectrophotometer on the combination of all the samples, since the individual samples had similar spectra.

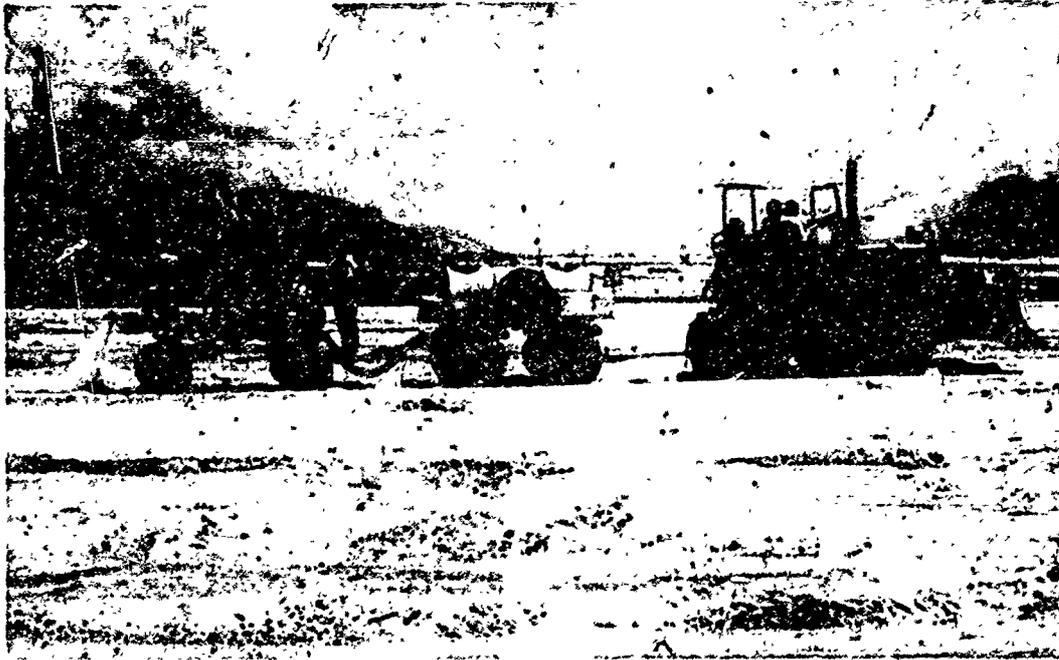
Figure 22. Views of Latex Base Soil Stabilization Material Application and Results

MATERIAL APPLICATION

BROKEN SOIL STABILIZATION MATERIAL CRUST

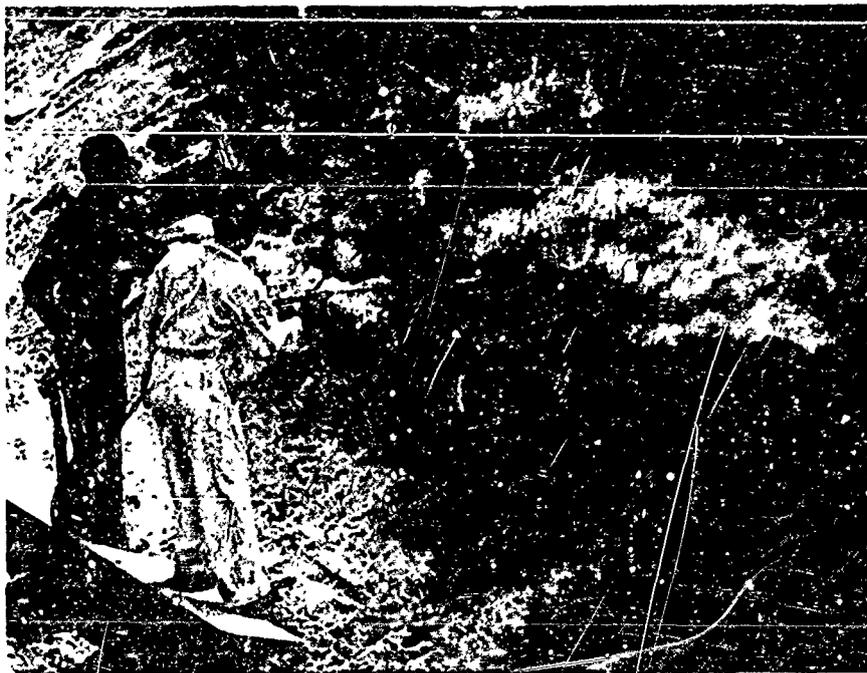
Figure 23. Views of Sand Ammunition Revetment Site Construction
(Sheet 1)

Three types of coverage were used - resin only, resin with woven glass, and resin with spray glass. The resin-only area was not satisfactory due to cracks that resulted from sand shifting and was subsequently recovered with woven glass and resin. Both the resin with spray glass and resin with woven glass performed well.

WOVEN ROVING AND RESIN COVERAGE

GUN ROVING AND RESIN COVERAGE

COMPLETED GUN ROVING AND RESIN AREA

CRACK DUE TO SAND SHIFTING IN RESIN-ONLY AREA

Figure 23, page 54, shows views of the ammunition revetment site construction. Table XII, page 56, presents material coverage data for this site. Three types of coverage were used for this site (resin only, resin with spray glass, and resin with woven glass). Resin with spray glass and resin with woven glass were very satisfactory. The resin only area was not considered satisfactory due to cracks that developed from the sand shifting, and was subsequently recovered with resin and woven glass. Also, some areas along the bottom of the revetment required reinforcement with woven glass, spray glass, and resin due to vehicles running up on them. The revetment reinforcement material coverage data is presented in Table XIII, page 57. Figure 24, page 59, shows a view inside the ammunition revetment along one side after completion of the lower edge reinforcement.

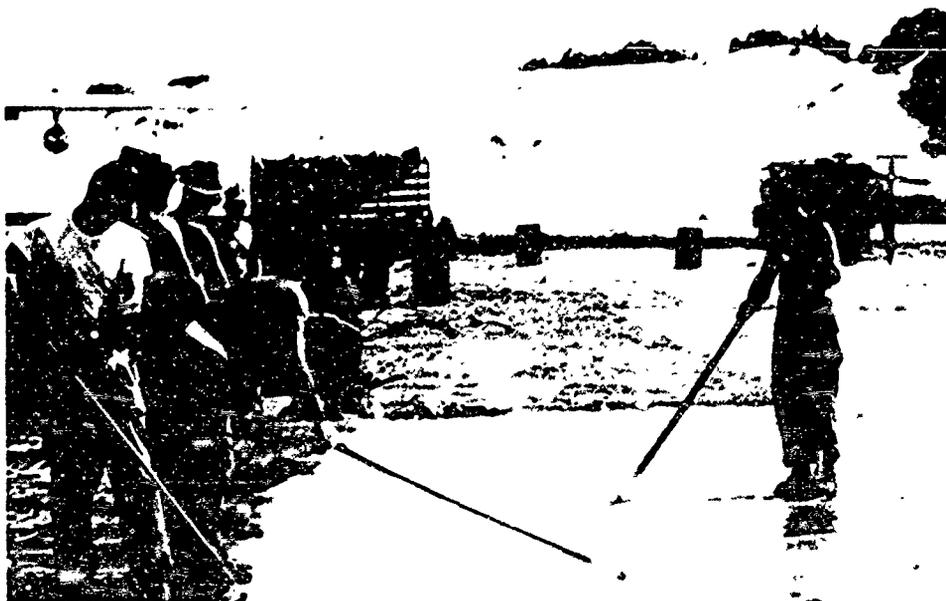
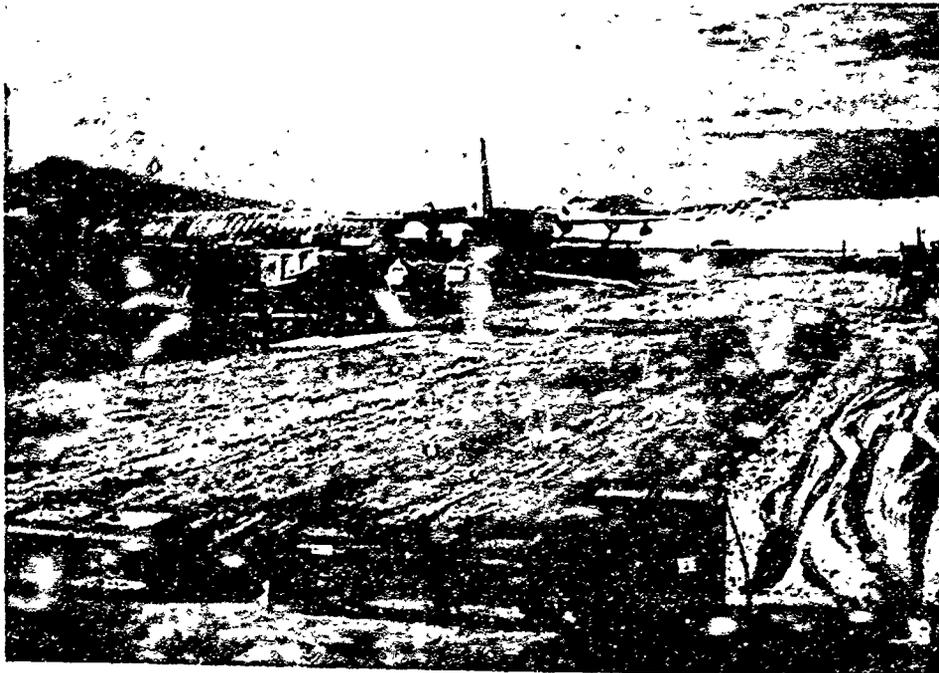
Figure 25. Views of Cargo Storage Site Construction
(Sheet 1)

START OF CONSTRUCTION

UNDER CONSTRUCTION

PARTIALLY CONSTRUCTED

TYPICAL OVERLAP ONTO PSP

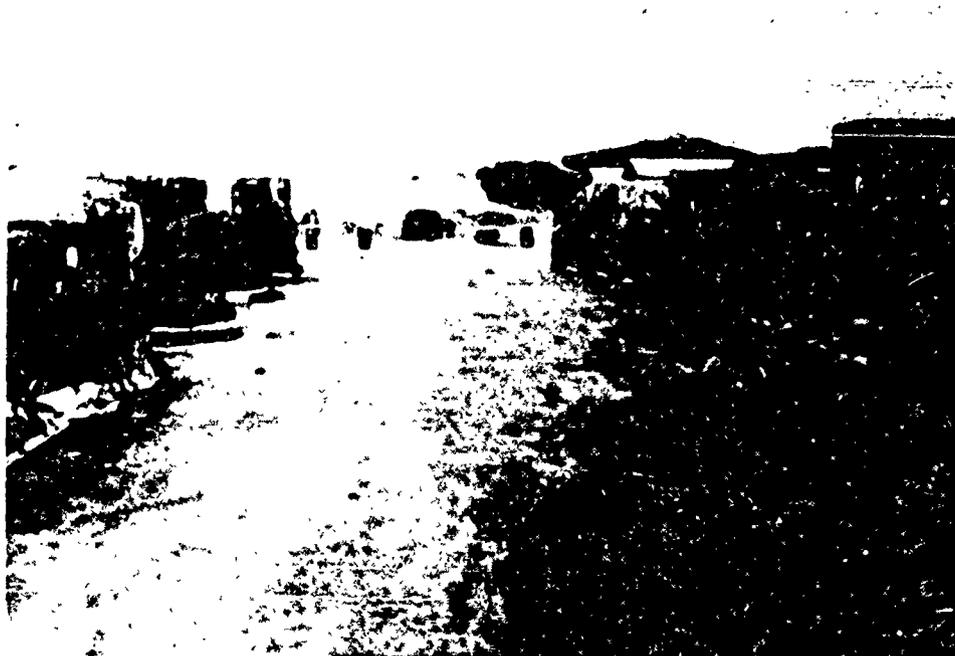
Figure 26. Views of Cargo Storage Site Testing
(Sheet 1)

27,270 POUND FORKLIFT

25,723 POUND FORKLIFT

FUEL TRUCK ON PAD NO. 2

STORAGE OF CARGO

Other testing was accomplished, however, using loaded fork lifts, a large loaded fuel truck, and cargo pallets placed on two boards (static loading). Views of initial testing of the Cargo Storage Site are presented in Figure 26, page 64. Table XV, page 66, presents test conditions and results of this testing. Before departure from SEA (after two weeks of heavy use), this site was examined and found to be in excellent condition.

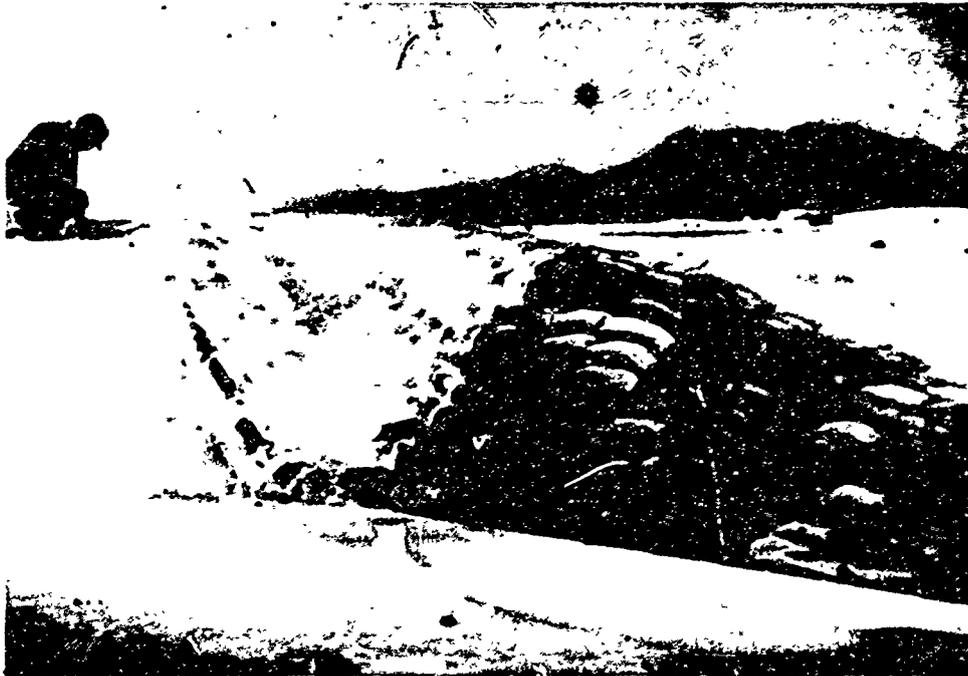
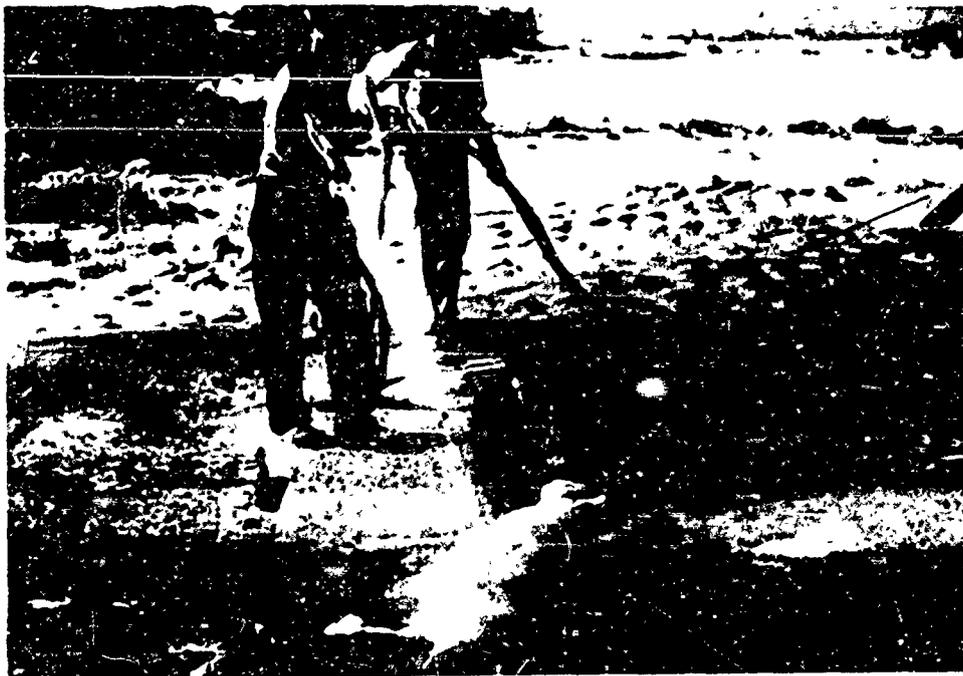
Figure 29. Views of Engine Runup Station Sites
(Sheet 1)

AREA NO.1 COVERAGE

SITE CONSTRUCTION

AREA NO.2 SAND EROSION

AREA NO.2 COVERAGE

Site construction was continued with the stabilization of two jet engine runup stands - to prevent soil erosion caused by the jet blast turbulence. This erosion was undermining the concrete support base and causing the concrete to crack. The application equipment was set up to spray with both systems. Preparations for spraying included removing a row of sand bags along the outer edge of the area to be covered. A ditch about six inches deep was dug with shovels to form an outer edge restraint. Spray glass and resin coverage was applied first, followed by a layer of woven glass and then additional spray glass and resin. A few inches of overlap onto the concrete were used to secure the inward edge. Overlapping into the trench secured the outer edge. At completion of spraying the dirt and sand bags that were previously removed along the trench were put back in place. Table XVI, page 69, presents coverage data for these sites. Figure 28, page 71, presents a sketch of engine runup area No. 1; engine runup area No. 2 is similar. Figure 29, page 72, presents views of these sites. Examination of these sites after jet blast operation, revealed that erosion was prevented in the coverage areas, and that these sites were entirely satisfactory.

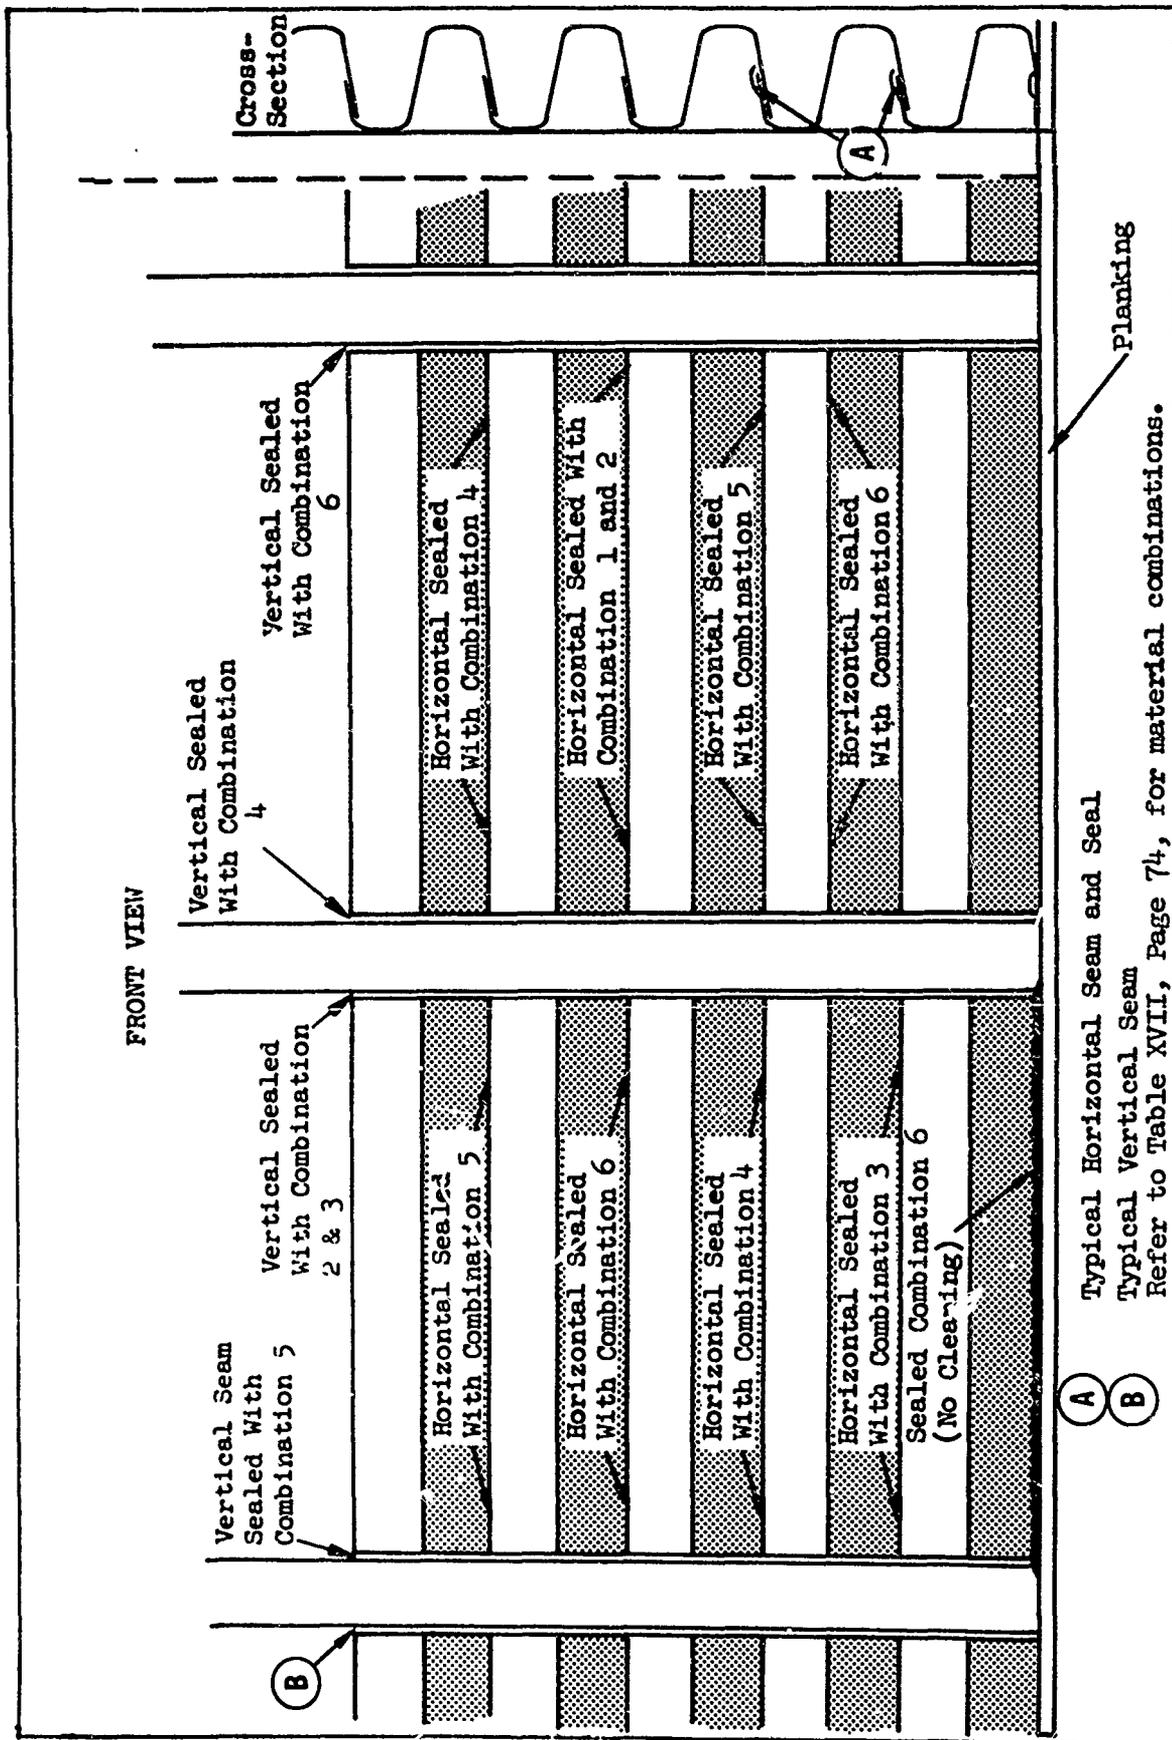
Figure 30. Metal Revetment Coverage Areas

(A) Typical Horizontal Seam and Seal
 (B) Typical Vertical Seam
 Refer to Table XVII, Page 74, for material combinations.

Another problem that was encountered was leakage of sand filled metal revetments during aircraft jet engine operation. A test section of metal revetment was selected for sealing with Rapid Site material. Six different material combinations were used to seal both horizontal and vertical seams. These material combinations are presented in Table XVII, page 74. Resin only was applied to a horizontal seam and was found to be too thin to effect a good seal. The resin only seam was resealed with the resin and Cab-O-Sil mixture. Each selected material combination was applied to selected horizontal and vertical seams, as shown in Figure 30, page 75. See Figure 31, page 76, for views of the metal revetment.

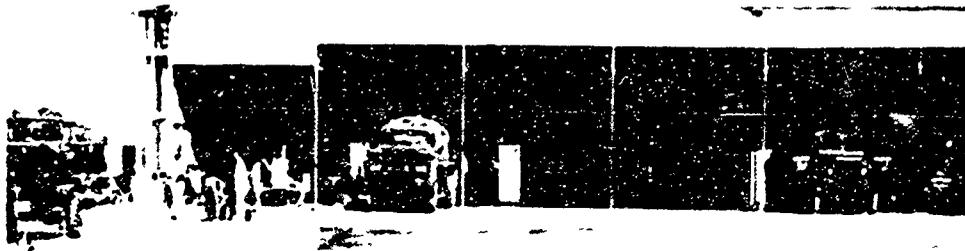
Figure 34. Views of Fire Station PSP Overspray Site

COMPLETED SITE

SITE JOINED TO ALUMINUM MAT RUNWAY

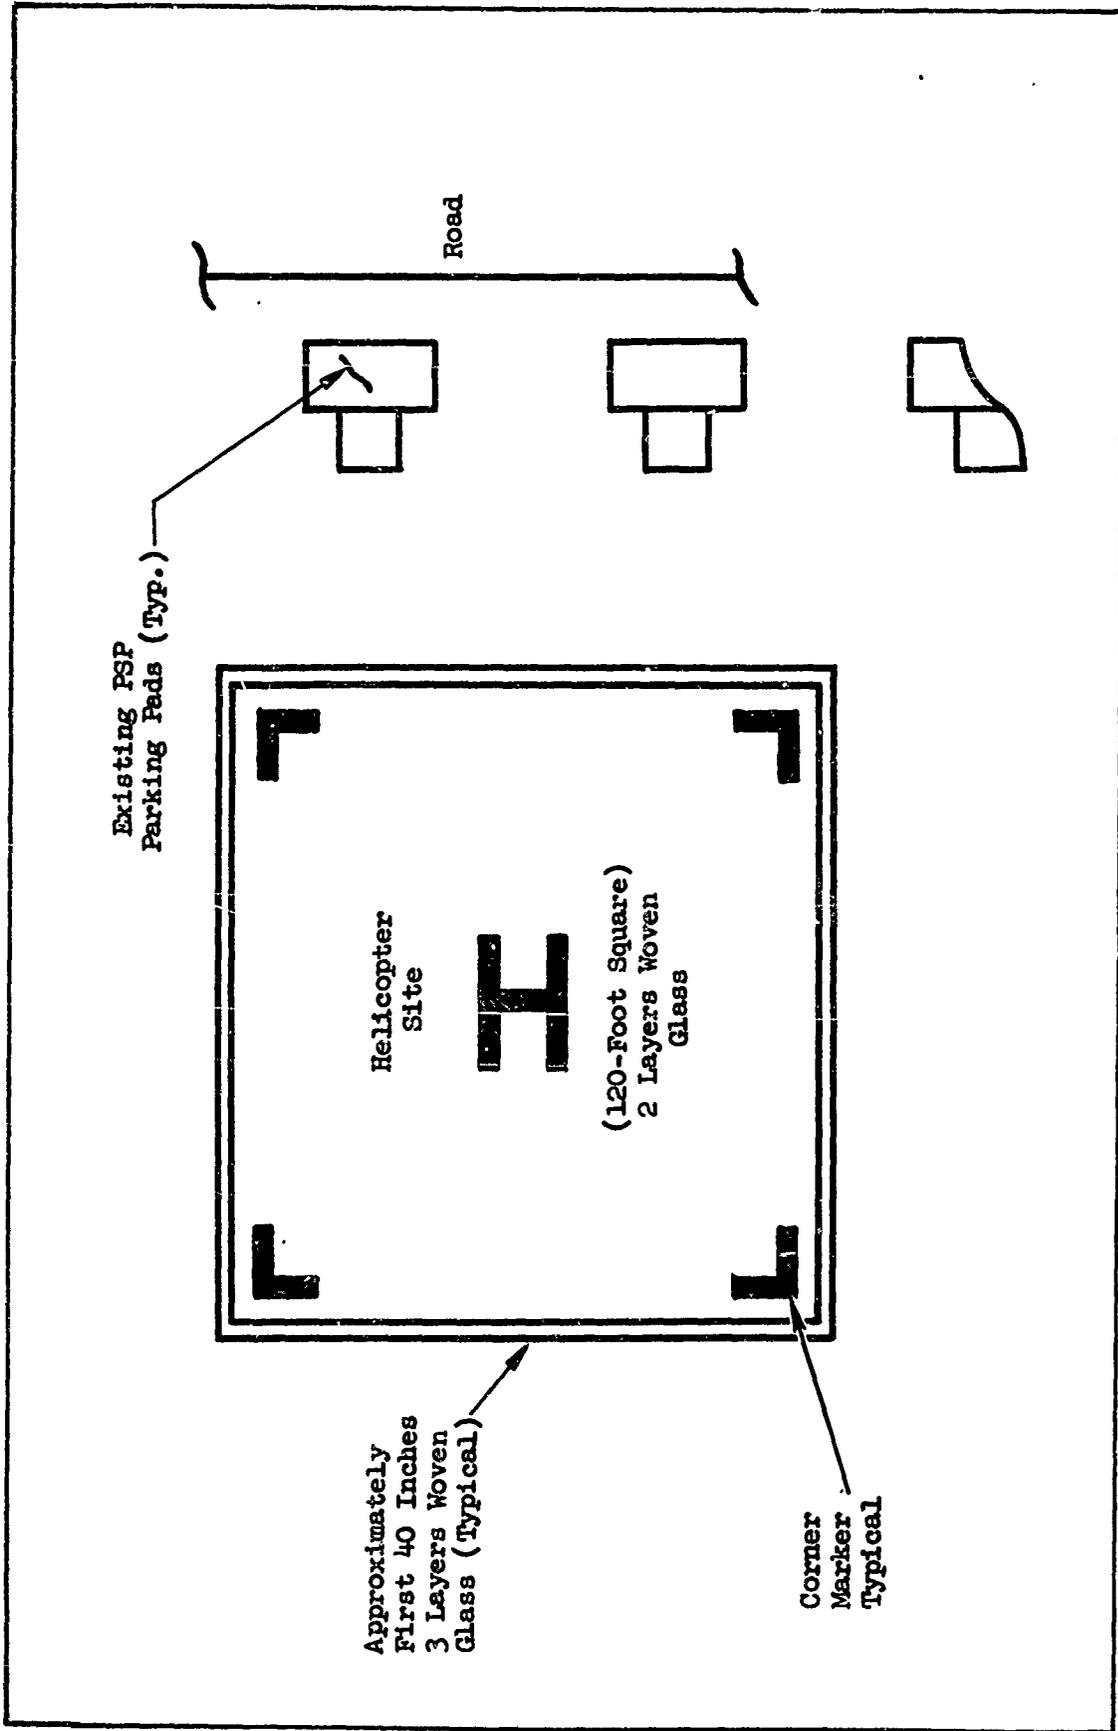
Figure 37 • Helicopter Site

Existing PSP
Parking Pads (Typ.)

Approximately
First 40 Inches
3 Layers Woven
Glass (Typical)

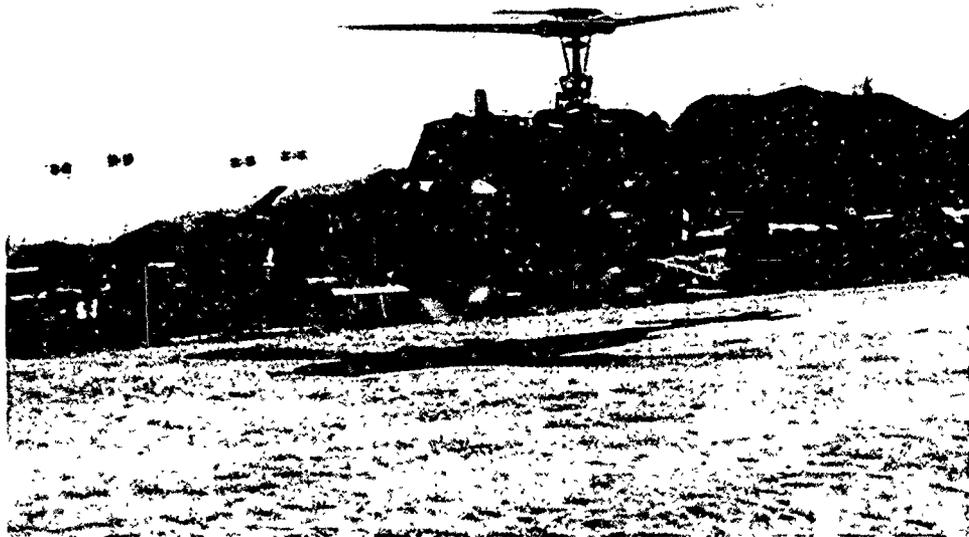
Figure 38. Views of Helicopter Site Construction (Sheet 2)

UH-1 LANDING
