# EVALUATION OF A HEAT-FLUX MEASUREMENT SYSTEM

TECHNICAL REPORT AFRPL-TR-69-238

NOVEMBER 1969

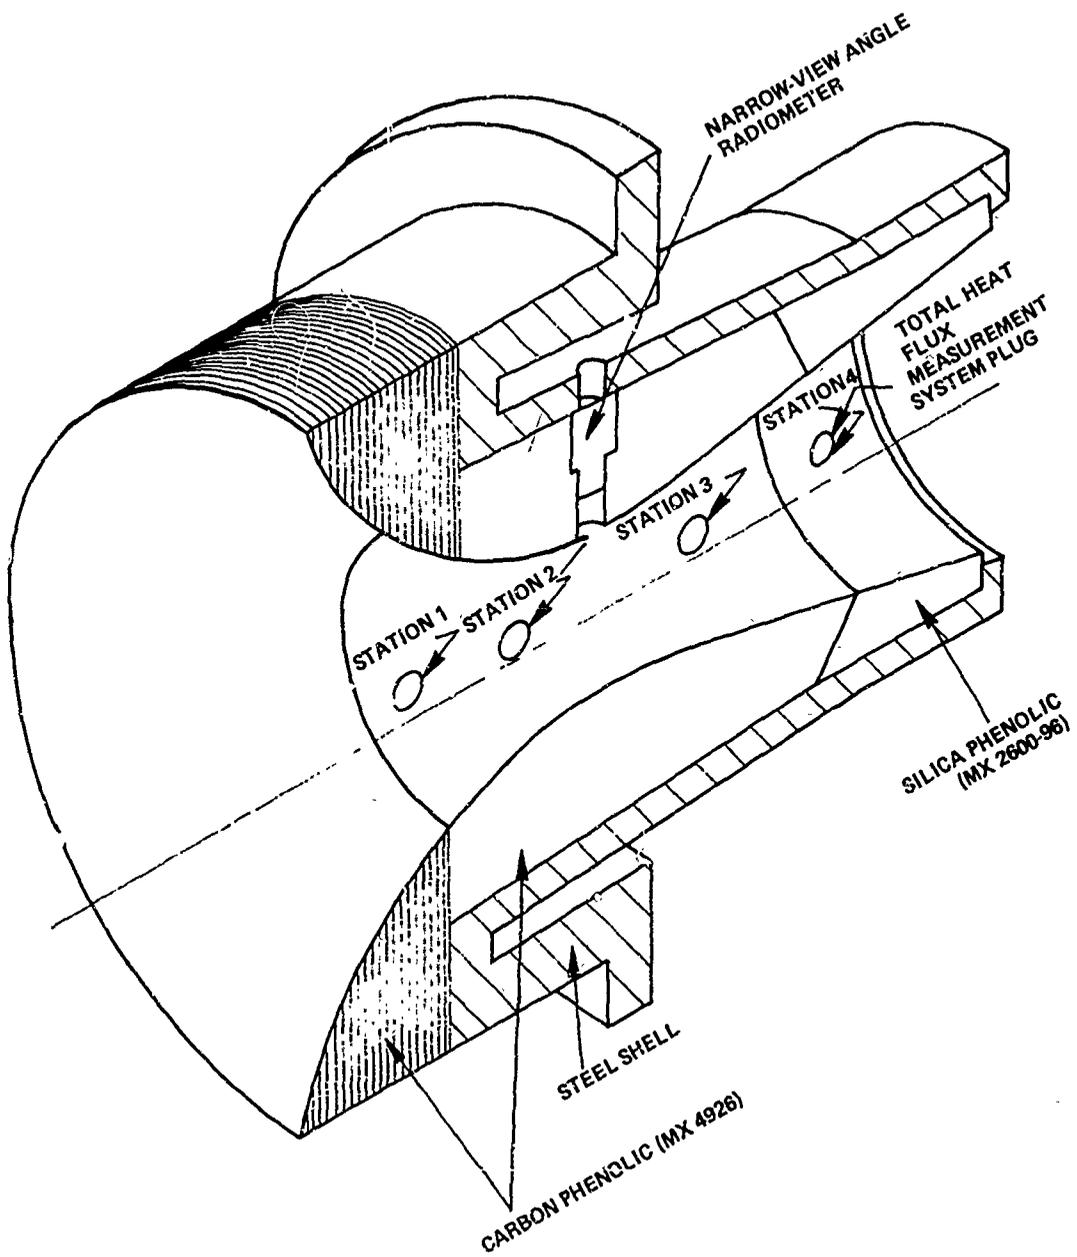
Figure 1. Char Motor Nozzle - Total and Radiative Heat-Flux Sensors

A cross section of the test nozzle and instrumentation is shown in Figure 1. More detailed views of the total flux plugs, radiometer, and radiometer installation are shown in Figures 2, 3, and 4, respectively. The Char motor performance was monitored by two 0 to 1500-psig-capacity strain-gage-type pressure transducers. All data was recorded on a digital system.

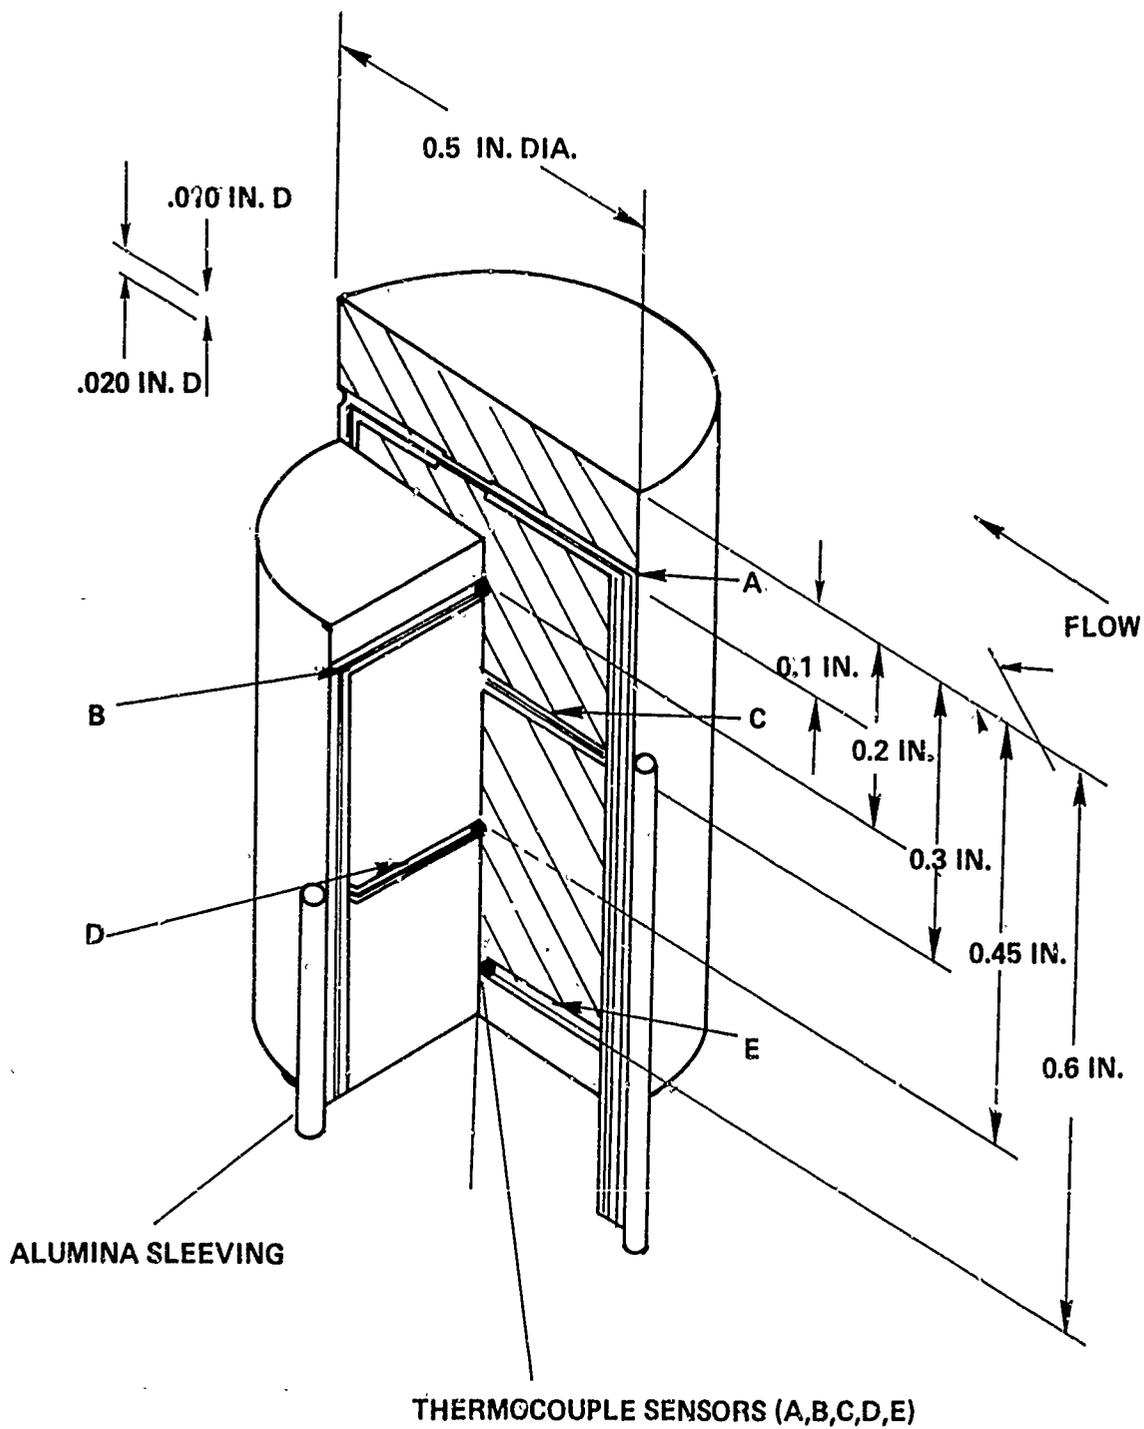
Figure 2. Total-Heat-Flux Measurement System Plug

The primary measurement devices for the total-heat-flux determination were five thermocouples located below the flame surface of the instrumented plug. Thermocouples A, B, C, and D (Figure 2) were tungsten 5% rhenium/tungsten 26% rhenium, while E was chromel/alumel. The thermocouple selection was based on the expected temperature gradients and surface recession.

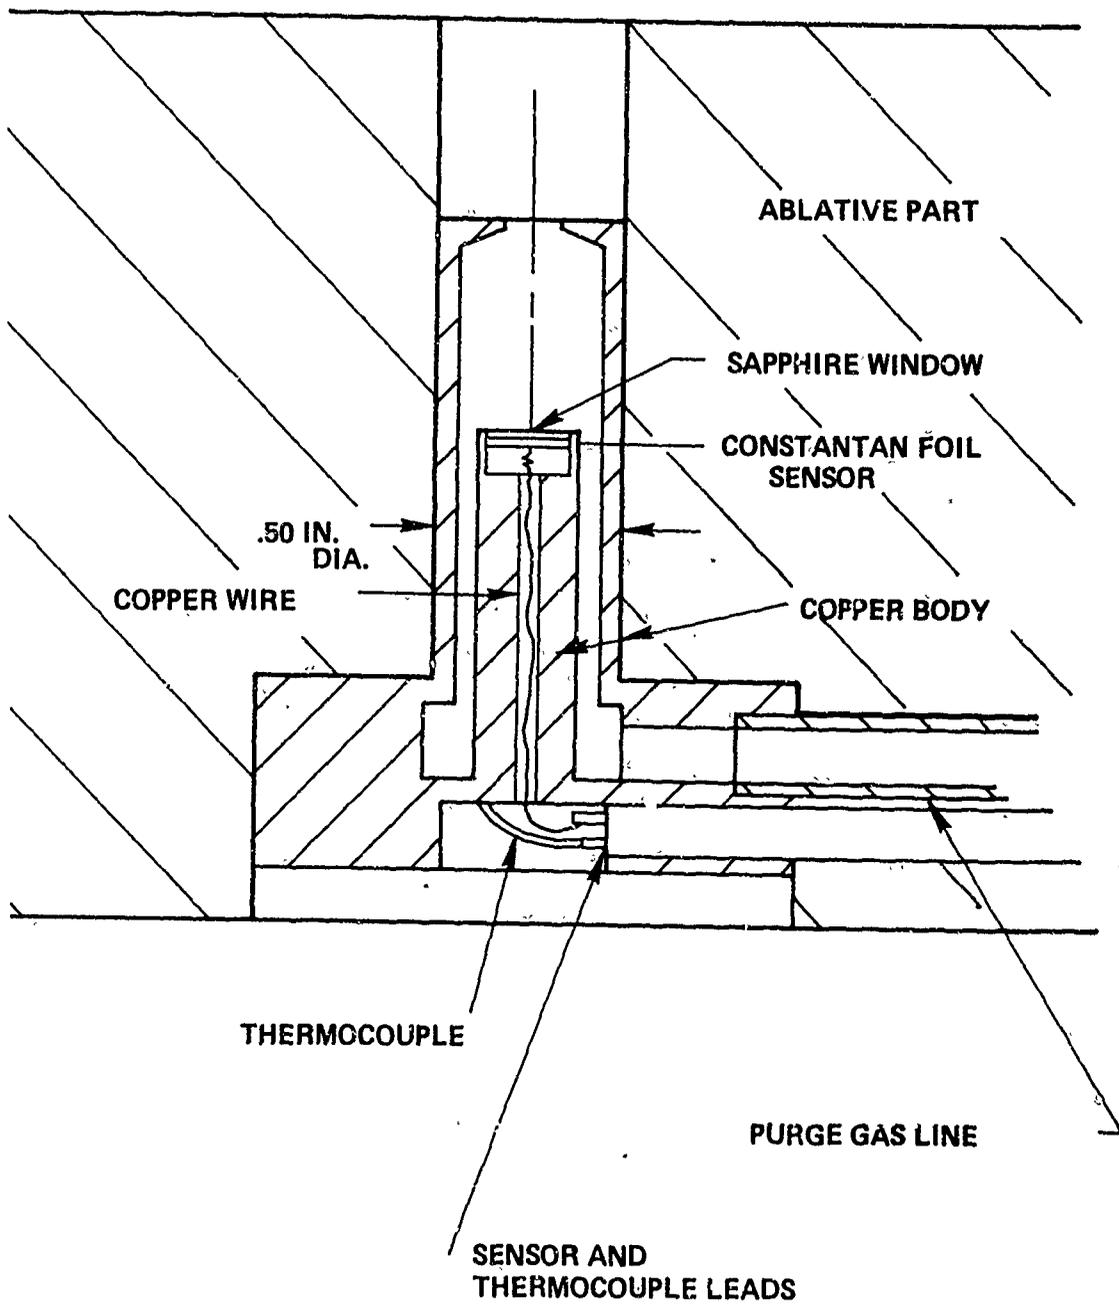
Figure 3. Schematic of Radiation-Heat-Flux Measurement System

The primary sensing instrument was a narrow-view angle radiometer which employed a Gardon-type flux gage. The temperature difference between the center of the constantan foil sensor and the copper heat-sink body resulted in a varying thermocouple output, an indicator of heat flux. A nitrogen purge gas was utilized to provide convective cooling of the sensor body and the lens. The lens was necessary to shield the foil disk

1. The unexpected high chamber pressure resulted in a decrease in the design purge gas flow and therefore a thermal failure of the radiometer view restrictor and sapphire window (Figure 3). The nitrogen purge gas flow is controlled by a sonic orifice so that the variations in local static pressure (or chamber pressure) do not influence the flow rate. This requires a supply pressure slightly more than twice that of the maximum local static pressure (to also account for the pressure drop downstream of the sonic orifice). The maximum local static pressure was 620 psia, which therefore indicated a nitrogen purge gas supply pressure slightly greater than 1240 psia was required. The actual supply pressure was 1250 psia, indicating the potential for a decrease in the purge gas flow.

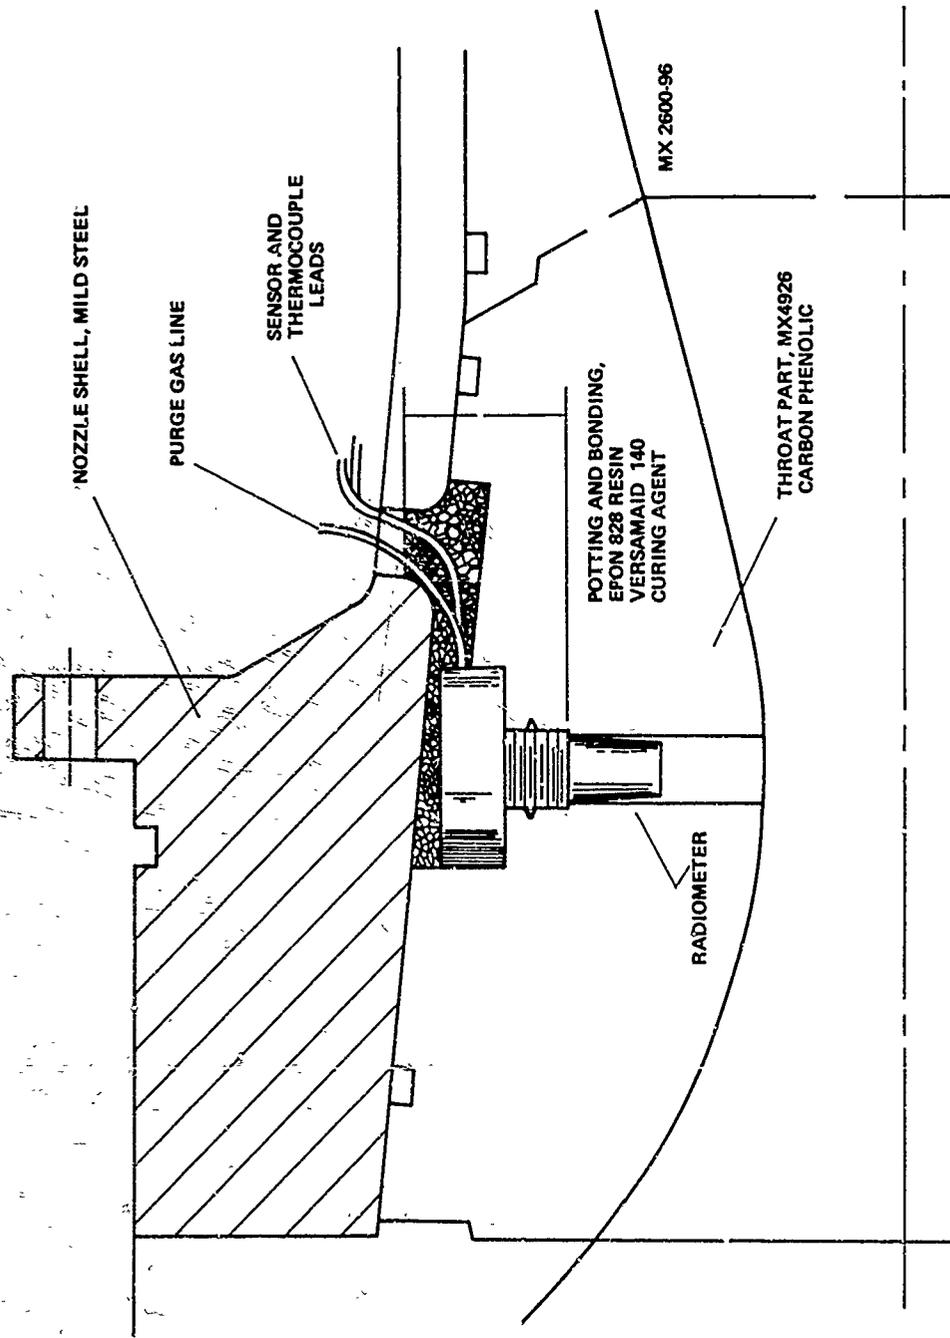
Figure 4. Radiation-Heat-Flux Measurement System Installation In Char Motor Nozzle

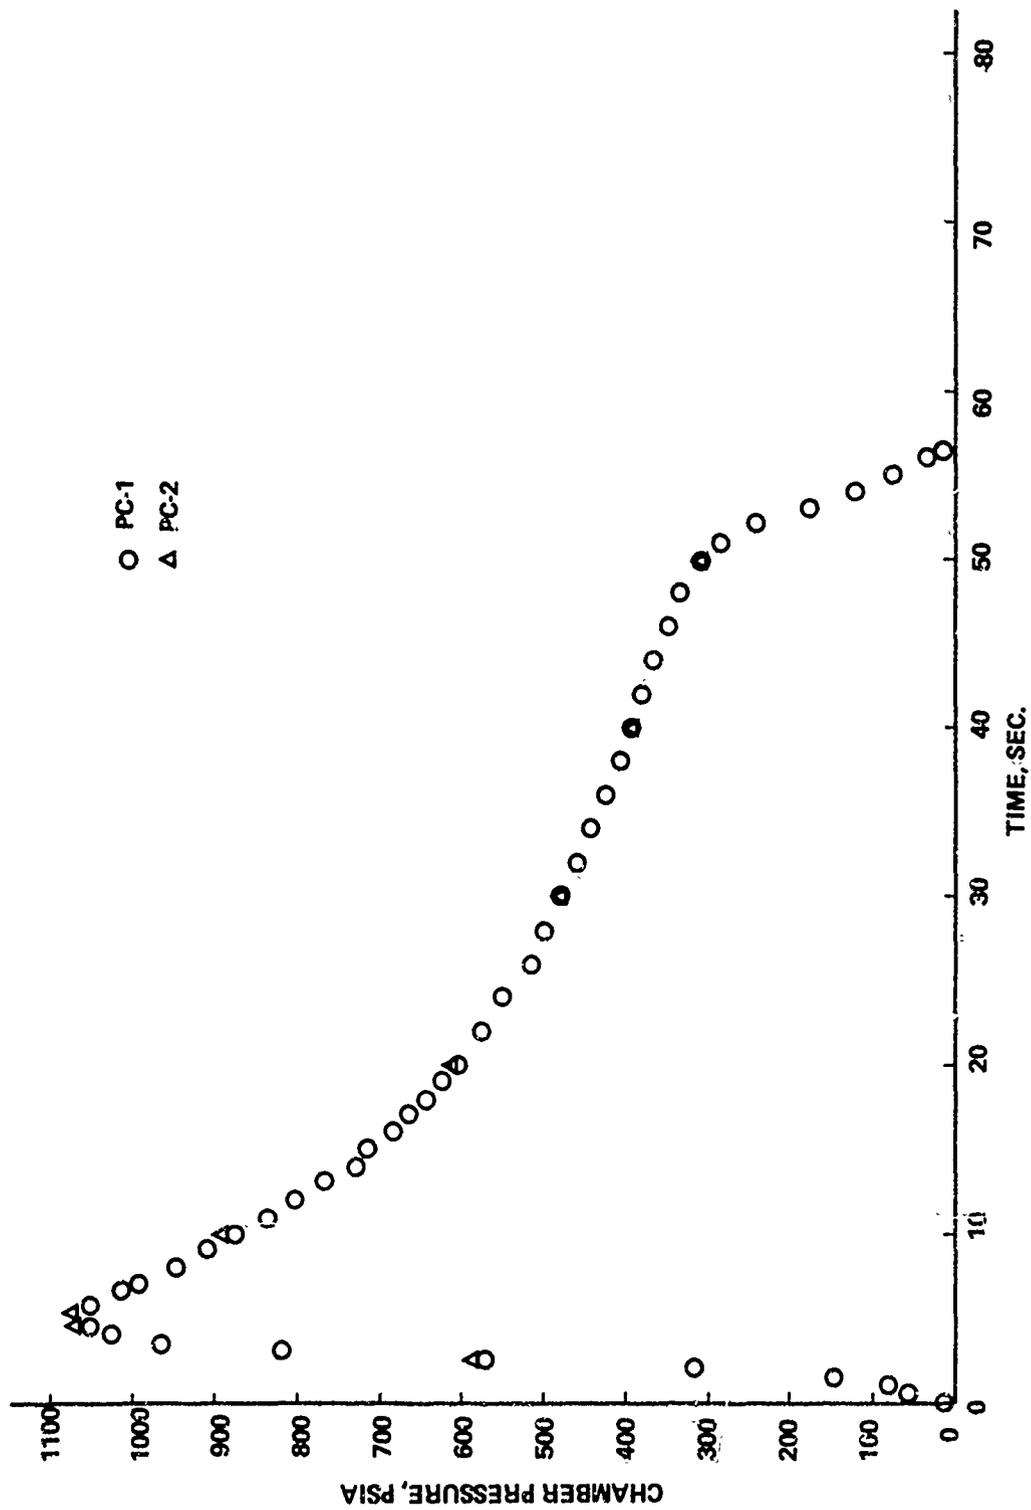
Figure 9. Chamber Pressure-versus-Time Trace

The motor was fired on 12 August 1969, and a sharply regressive chamber pressure-versus-time trace (Figure 9) was obtained. Maximum chamber pressure was 1061 psig and average pressure was 580 psig. The actual test conditions were somewhat more severe than those desired as is shown in the following table.

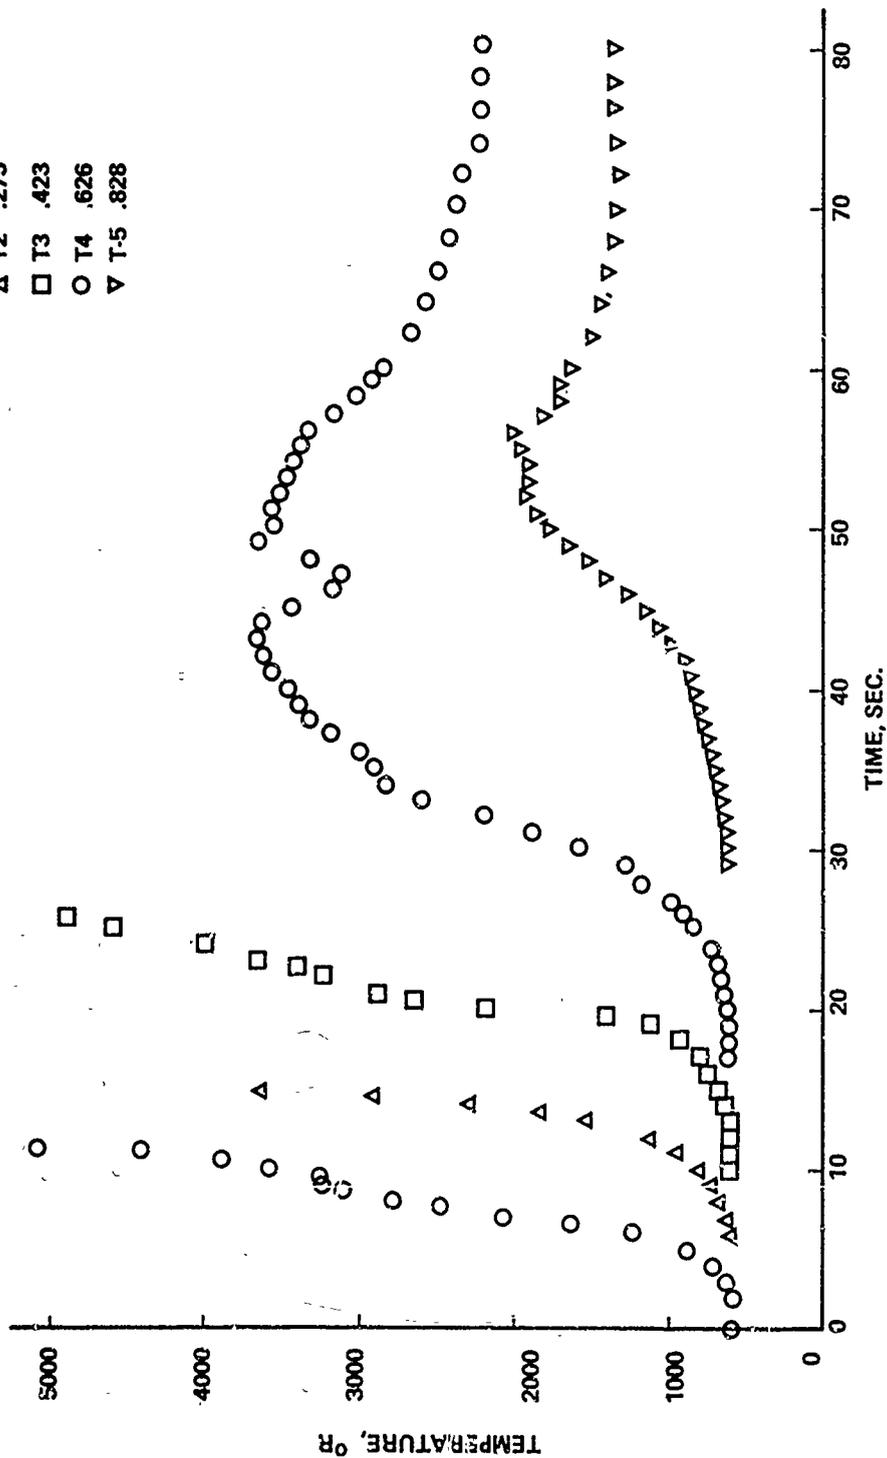
DEPTH BELOW  
ORIGINAL SURFACE, IN.

- T1 .151
- △ T2 .275
- T3 .423
- T4 .626
- ▽ T-5 .828

Figure 12. Measured Temperatures In Forward  
End of the MX4926, Station 1

<u>Heat-Flux System</u>	<u>Station</u>	<u>Location</u> <sup>2</sup>	<u>Quality of Data</u>	<u>Comments</u>
Total	1	$A/A_* = -2.0$	OK	Data in Figure 12
Total	2	$A/A_* = 1.0$	OK except	Erratic response of 3 thermocouples; valid results for complete firing expected however; data in Figure 13
Total	3	$A/A_* = 2.0$	OK	Data in Figure 14
Total	4	$A/A_* = 4.0$	OK	Data in Figure 15
Radiation	2	$A/A_* = 1.0$	OK to 3 sec	Apparent loss of nitrogen purge gas after 3 seconds; data in Figure 16

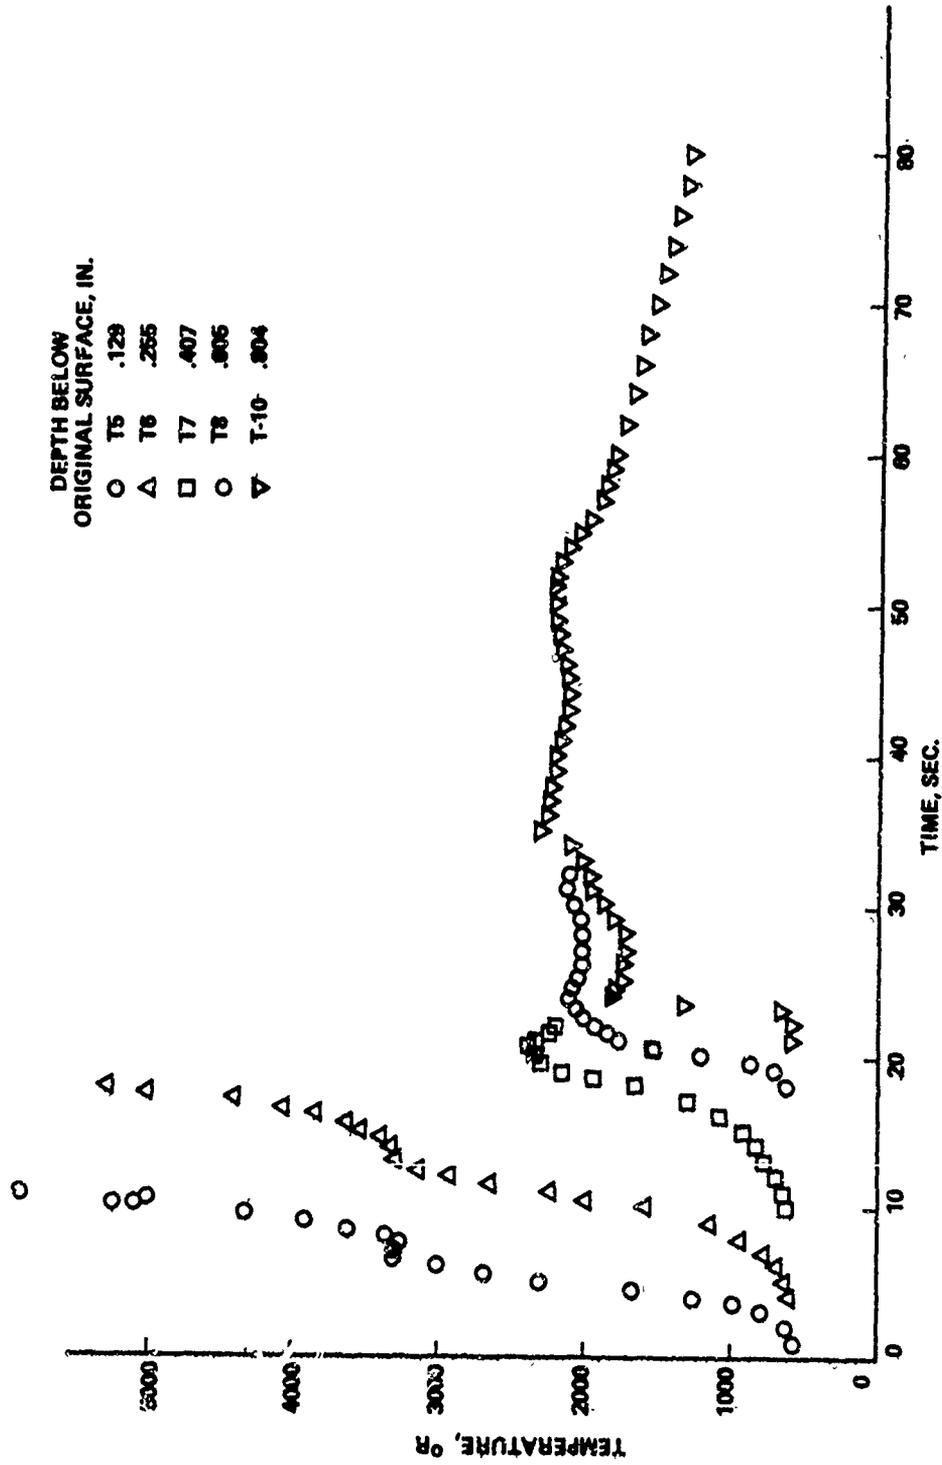
Figure 13. Measured Temperatures at the Throat of the MX4926, Station 2.

In the total-flux system at the throat, the three deepest thermocouples exhibited an erratic response. Sufficient data are available, however, to provide a valid definition of the flux at this location through the complete test firing. The reason for this erratic response has not been defined. None of the other plugs exhibited this type of behavior.

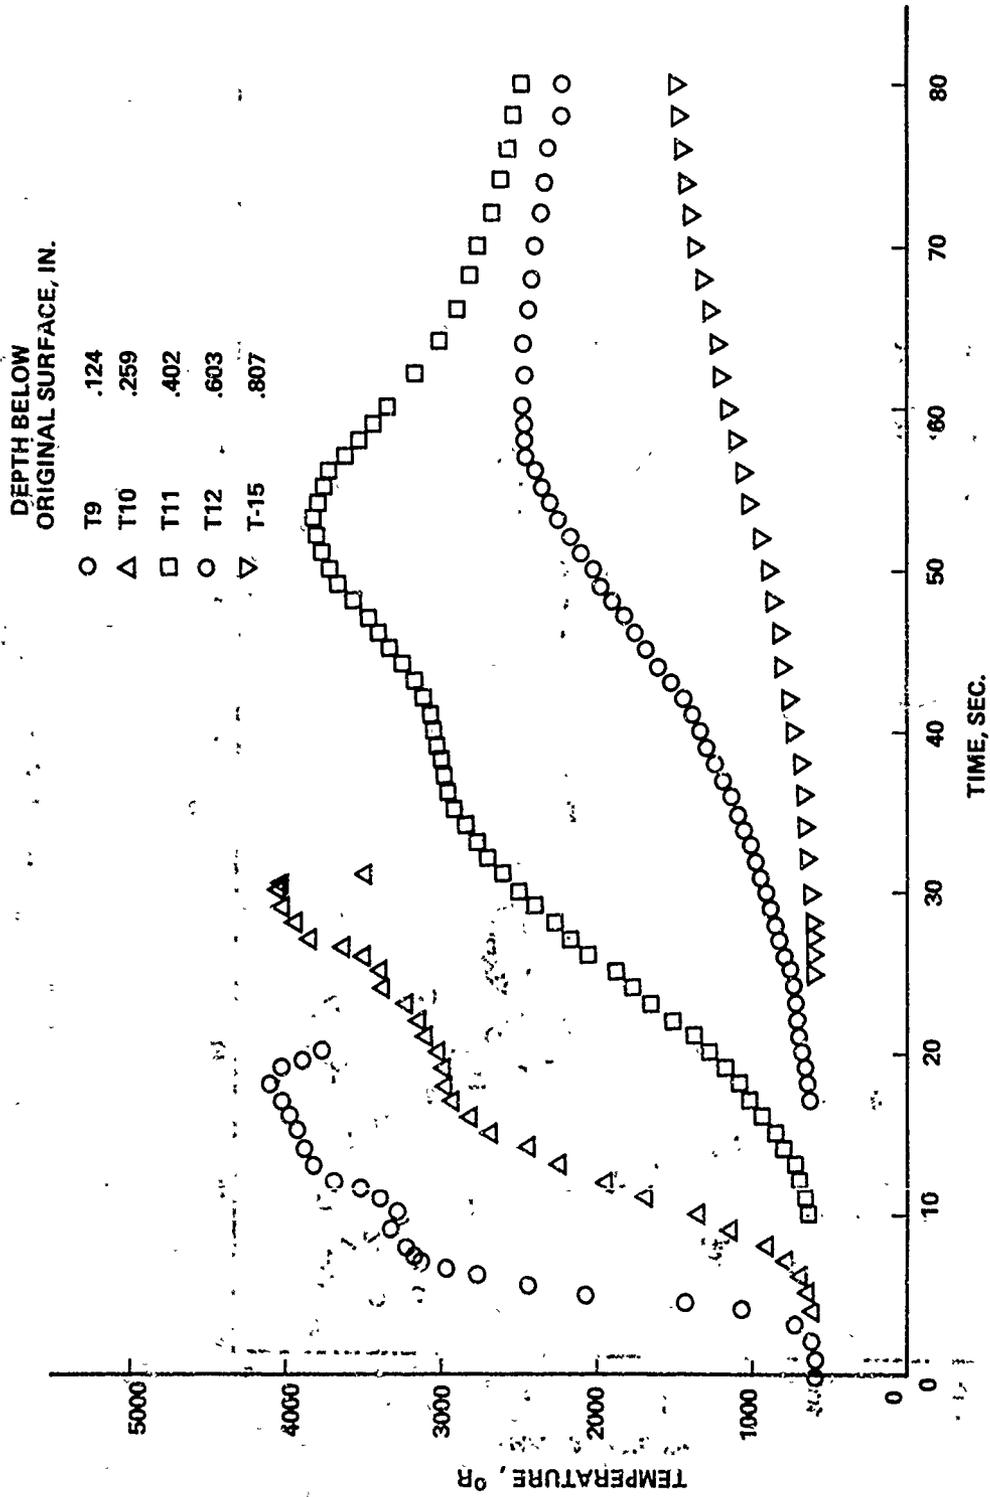
Figure 14. Measured Temperatures at the Downstream End of the MX4926, Station 3

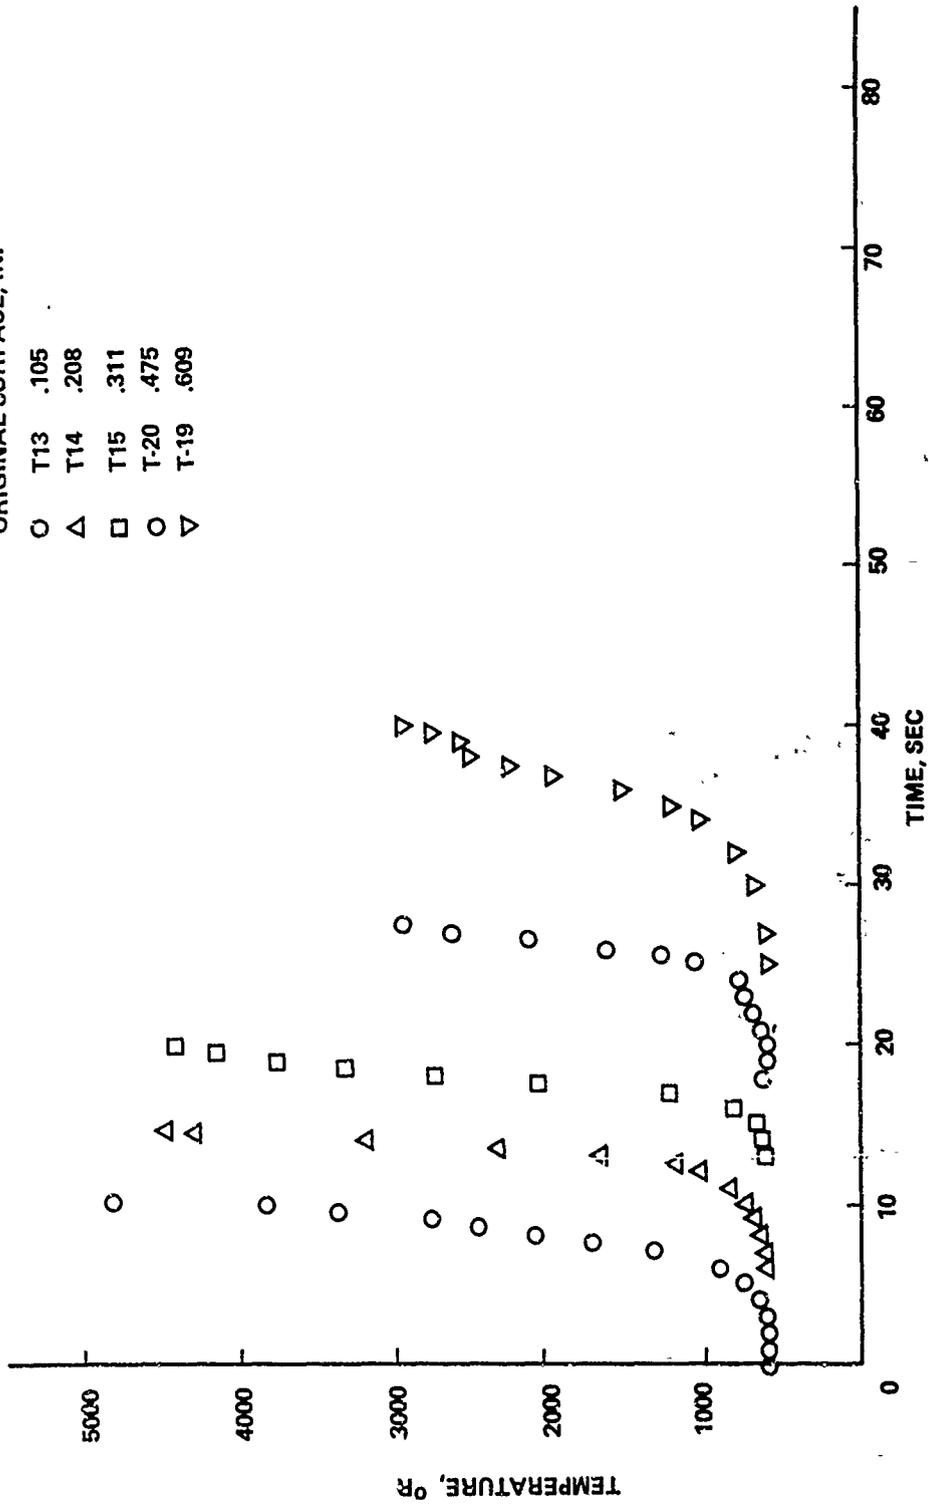
DEPTH BELOW ORIGINAL SURFACE, IN.

- T13 .105
- △ T14 .208
- T15 .311
- T-20 .475
- ▽ T-19 .609

Figure 15. Measured Temperatures in the Exit Cone, MX2600, Station 4

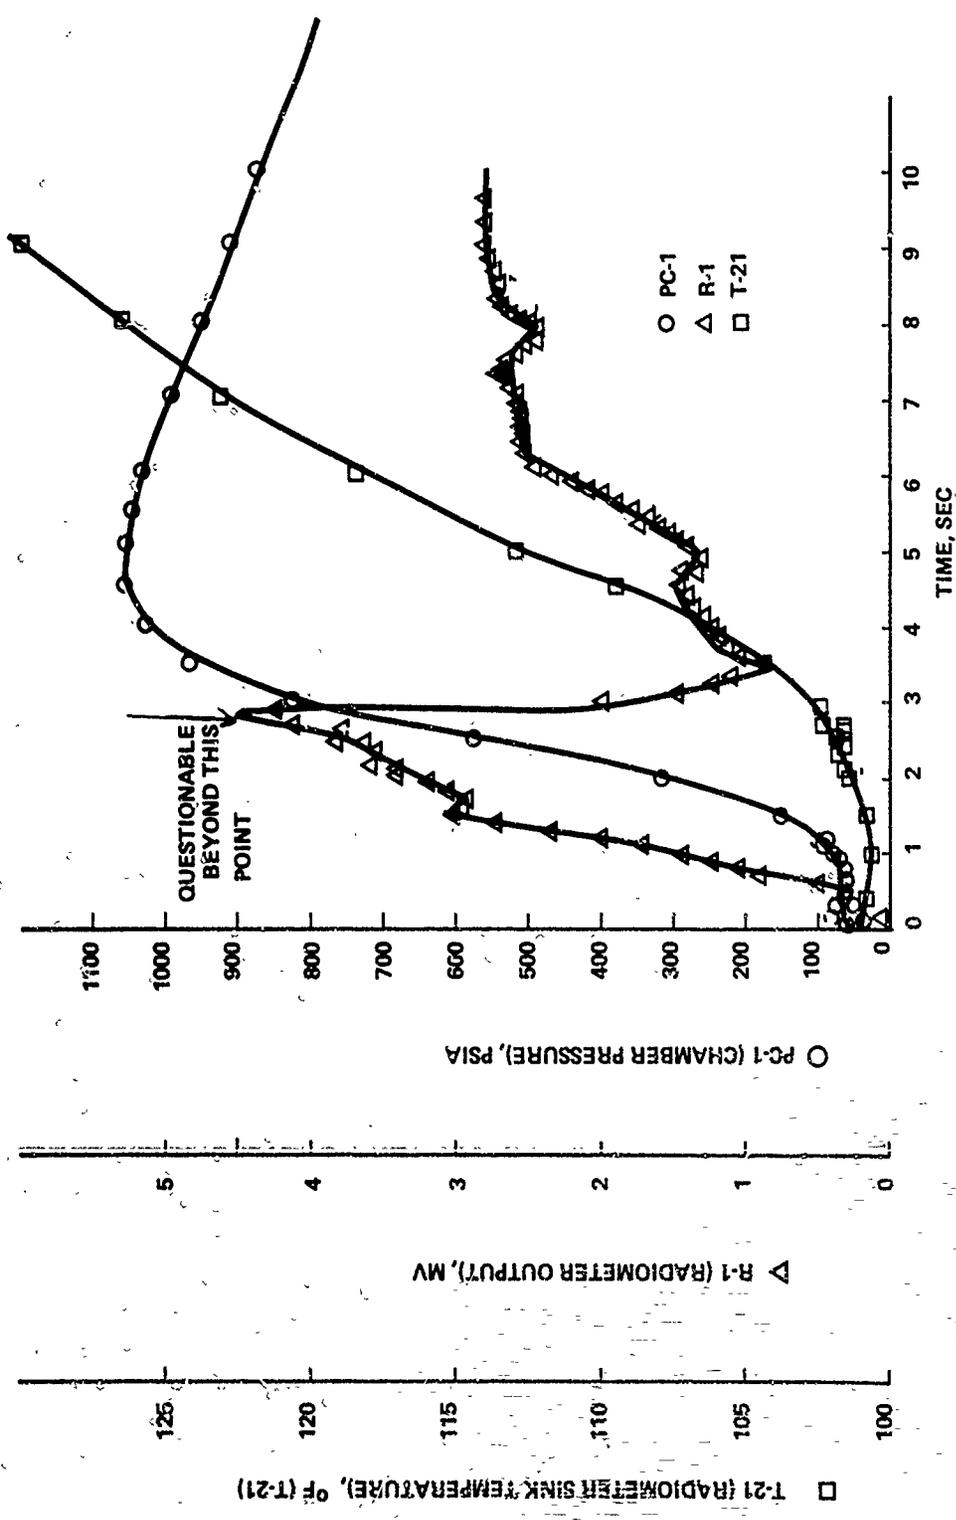
Figure 16. Radiometer Output and Associated Information, Station 2

In the radiative-flux system, a decrease in the required nitrogen purge gas flow apparently occurred at 3 seconds into the firing followed by a complete loss of this flow at 15 seconds. The failure at 15 seconds was due to the thermal decomposition of the supply hose caused by the high-radiation flux from the exhaust plume. The explanation for the event at 3 seconds is not so clear-cut, however. Several explanations are possible as outlined below:

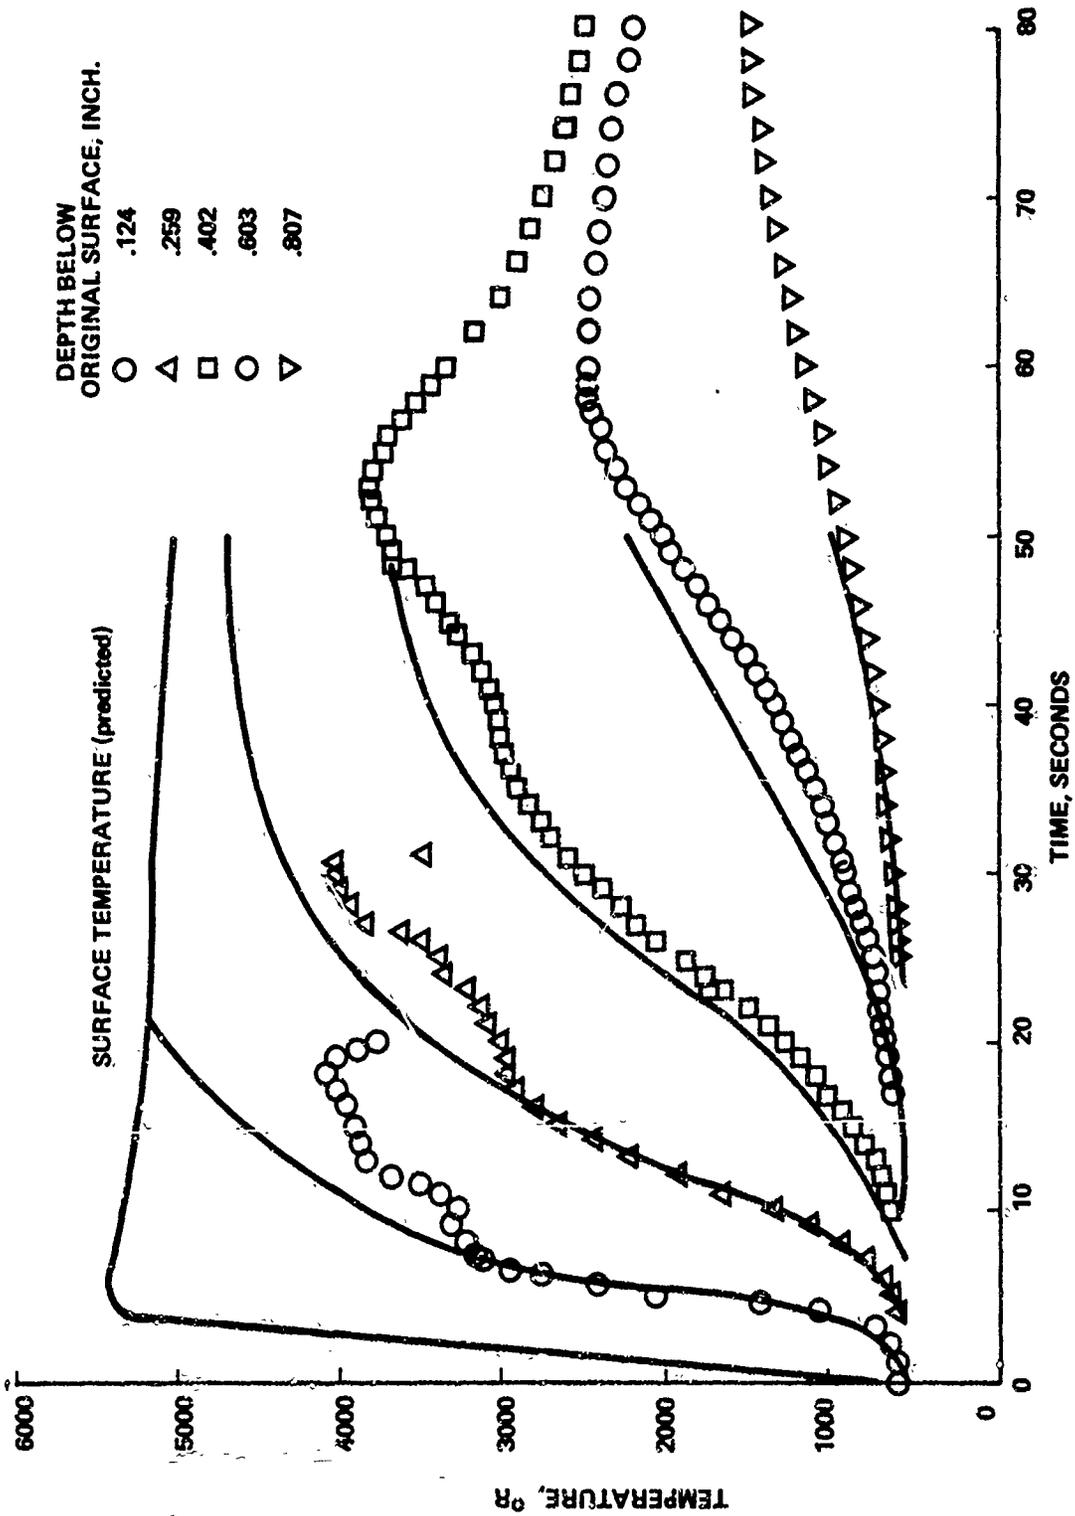
Figure 17. Measured and Predicted Temperatures for Station 3 in the MX 4926

A preliminary data analysis was conducted. Examples of the results currently available from the reduction of the total-heat-flux measurement system data are presented in Figures 17 and 18. Figure 17 shows the measured in-depth temperature histories for the plug at  $A/A_* = 2.0$  and the corresponding analytical fit of these results on which all subsequent data reduction is based. Note that the surface temperature and surface recession histories through the test (Figures 17 and 18, respectively) are also defined. The continuation of this data reduction process to define the total heat flux is now in progress for all measurement locations. Based on the excellent correlation of measured and predicted temperature data (e.g., Figure 17), the measured total heat fluxes are expected to approach within 20% of predictions.

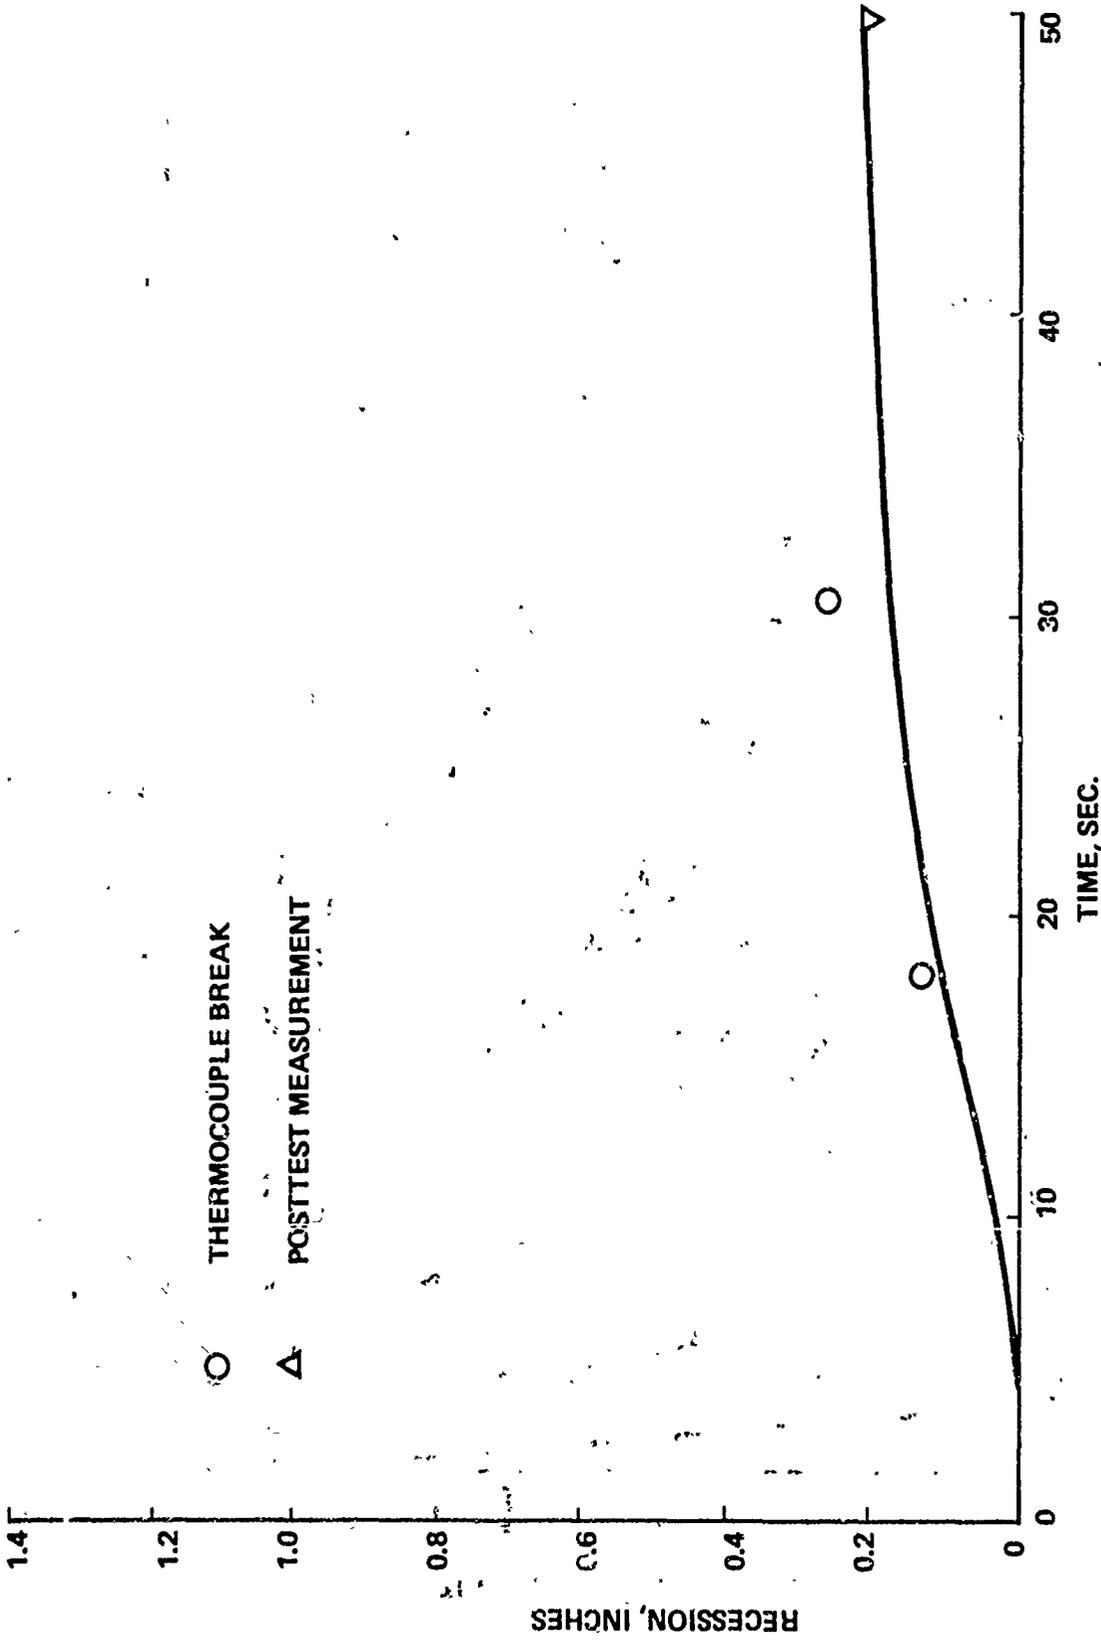
Figure 18. Surface Recession as a Function of Time  
For Station 3, MX4926

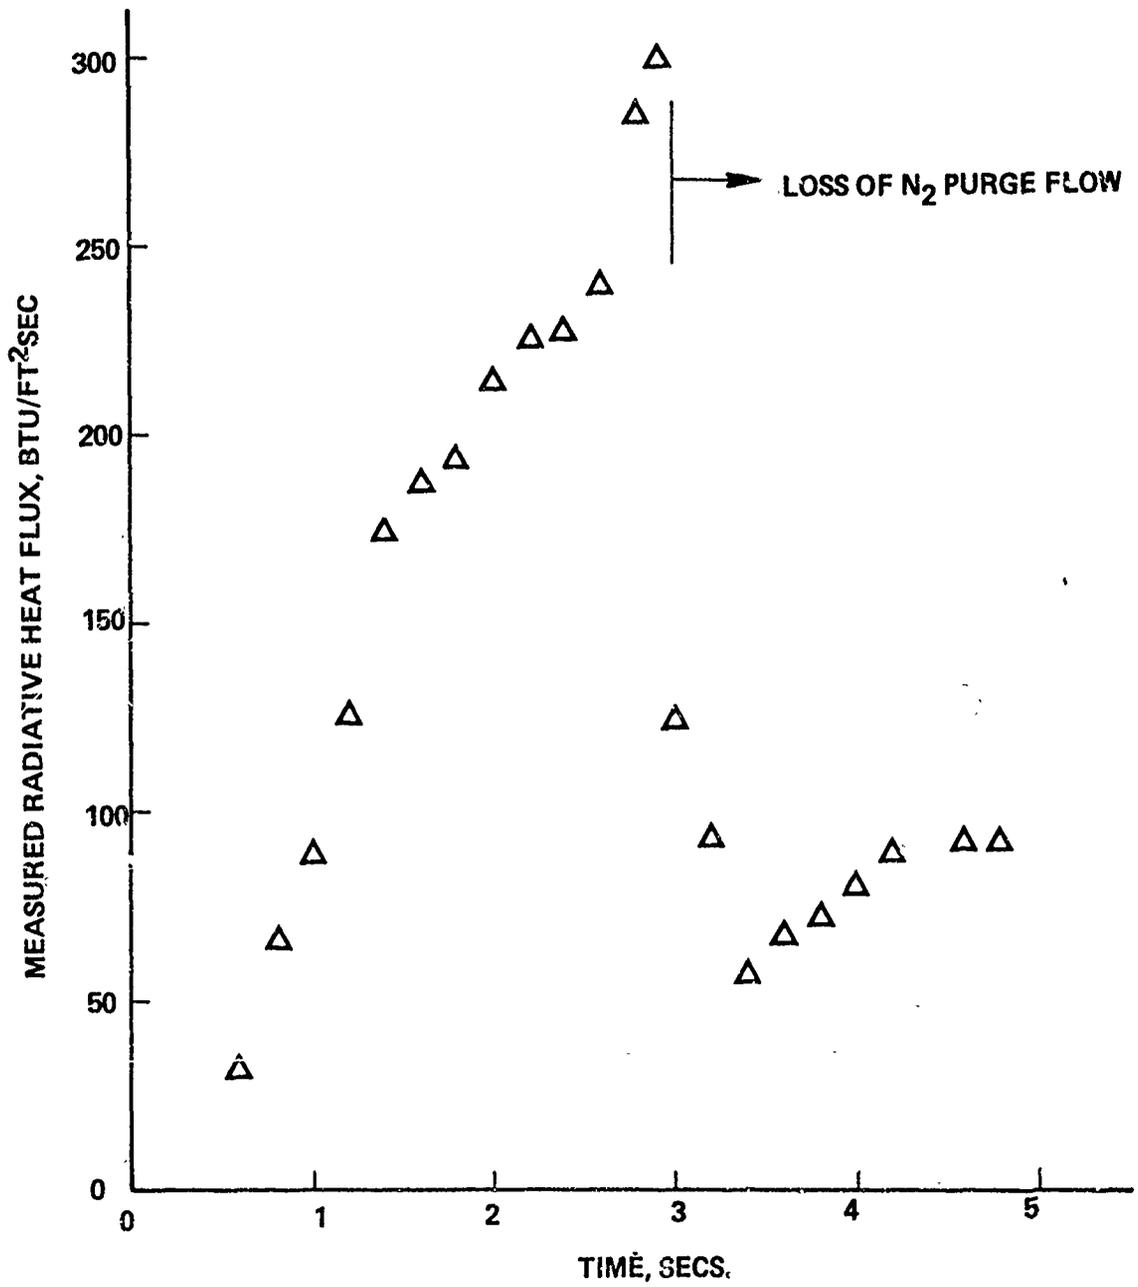
Figure 19. Measured Radiative Heat Flux at Throat Of Char Motor Nozzle

The measured radiation-heat-flux history is presented in Figure 19. This measured radiation flux during the first 3 seconds is somewhat lower than was anticipated based on empirical calculation techniques, but is within the possible flux range. The empirical techniques for calculating radiative heat flux are heavily dependent on gas emissivity. In metalized propellants, the gas is composed of two phases: solid particles and gaseous combustion products. The uncertainty in the technique is due primarily to the impossibility of analytically assessing the contribution of the particle cloud. The quantitative comparison and interpretation of the results is affected by uncertainties in the conditions of the motor starting transient.

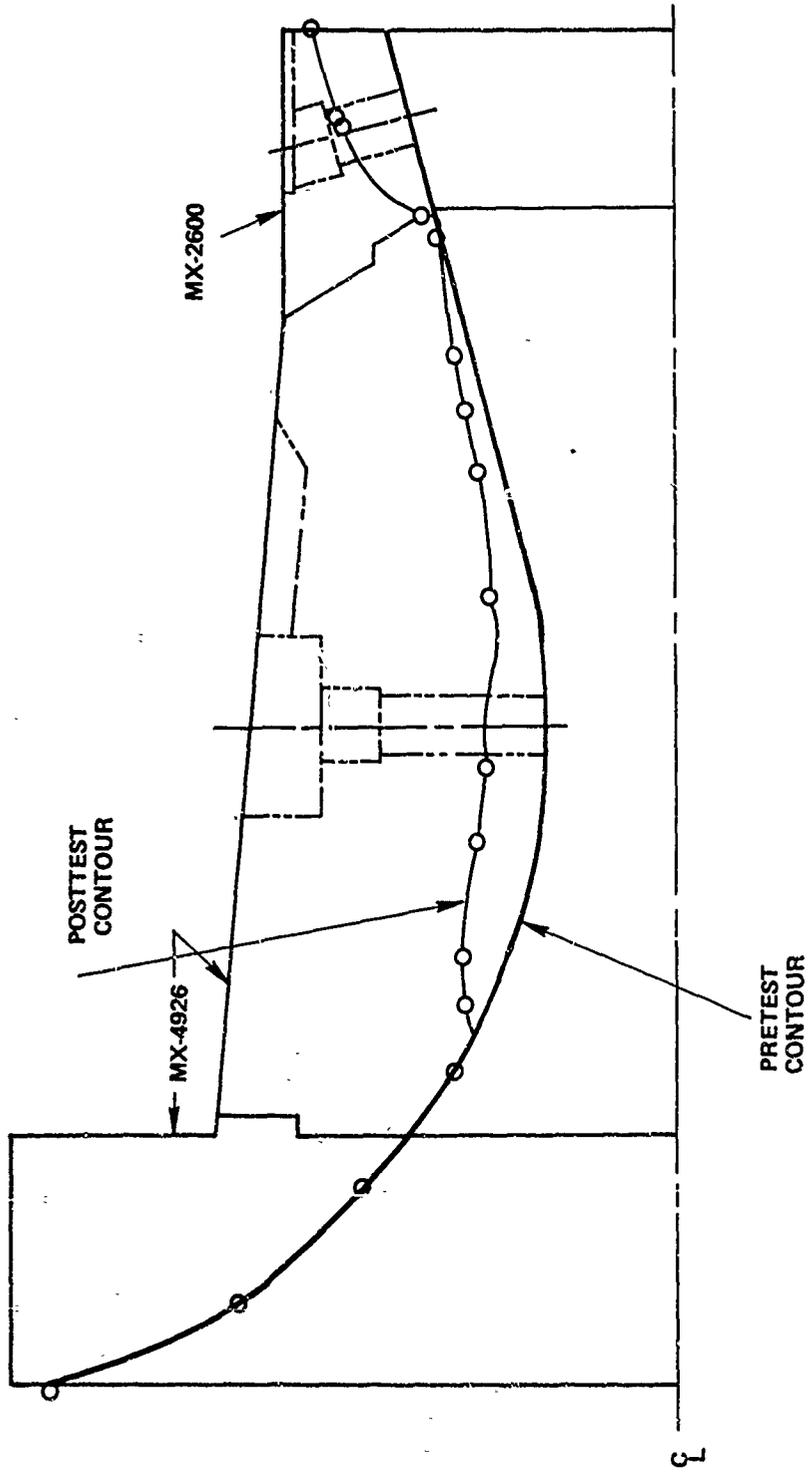
Figure 20. Pretest and Posttest Contour

The general performance of the test nozzle is shown in the erosion profile, Figure 20.
