Technical Note N-1222

IN-PLACE MAINTENANCE PAINTING OF
STEEL PILING

C. V. Brouillette and R. W. Drisko

NAVAL CIVIL ENGINEERING LABORATORY
Port Hueneme, California 93043

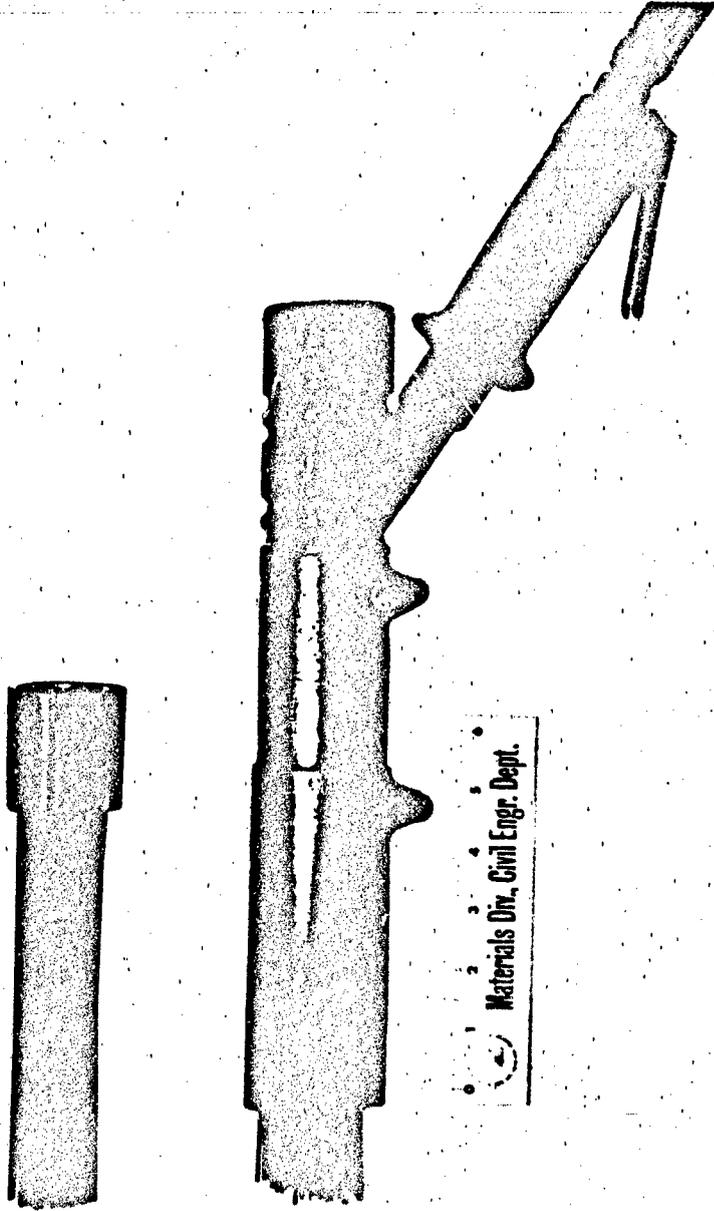
Figure 2. Von Arx Model 3B needle gun for removing rust and scale.

A laboratory test was conducted to determine the relative bonding strengths of viscous polyamide-cured epoxy compounds (splash-zone compounds) to steel surfaces cleaned underwater by a pneumatic needle gun, as compared to such materials bonded to steel surfaces cleaned by more conventional methods. Steel panels pre-rusted in seawater were cleaned by sandblasting, wirebrushing, or using a Von Arx Model 3B needle gun (Figure 2), made by Von Arx Limited of Sissoch, Switzerland, but available through local suppliers. Both 2mm and 3mm width needles were used in the gun so that comparisons of their effectiveness could be made. The former were found to be much easier and faster to use.

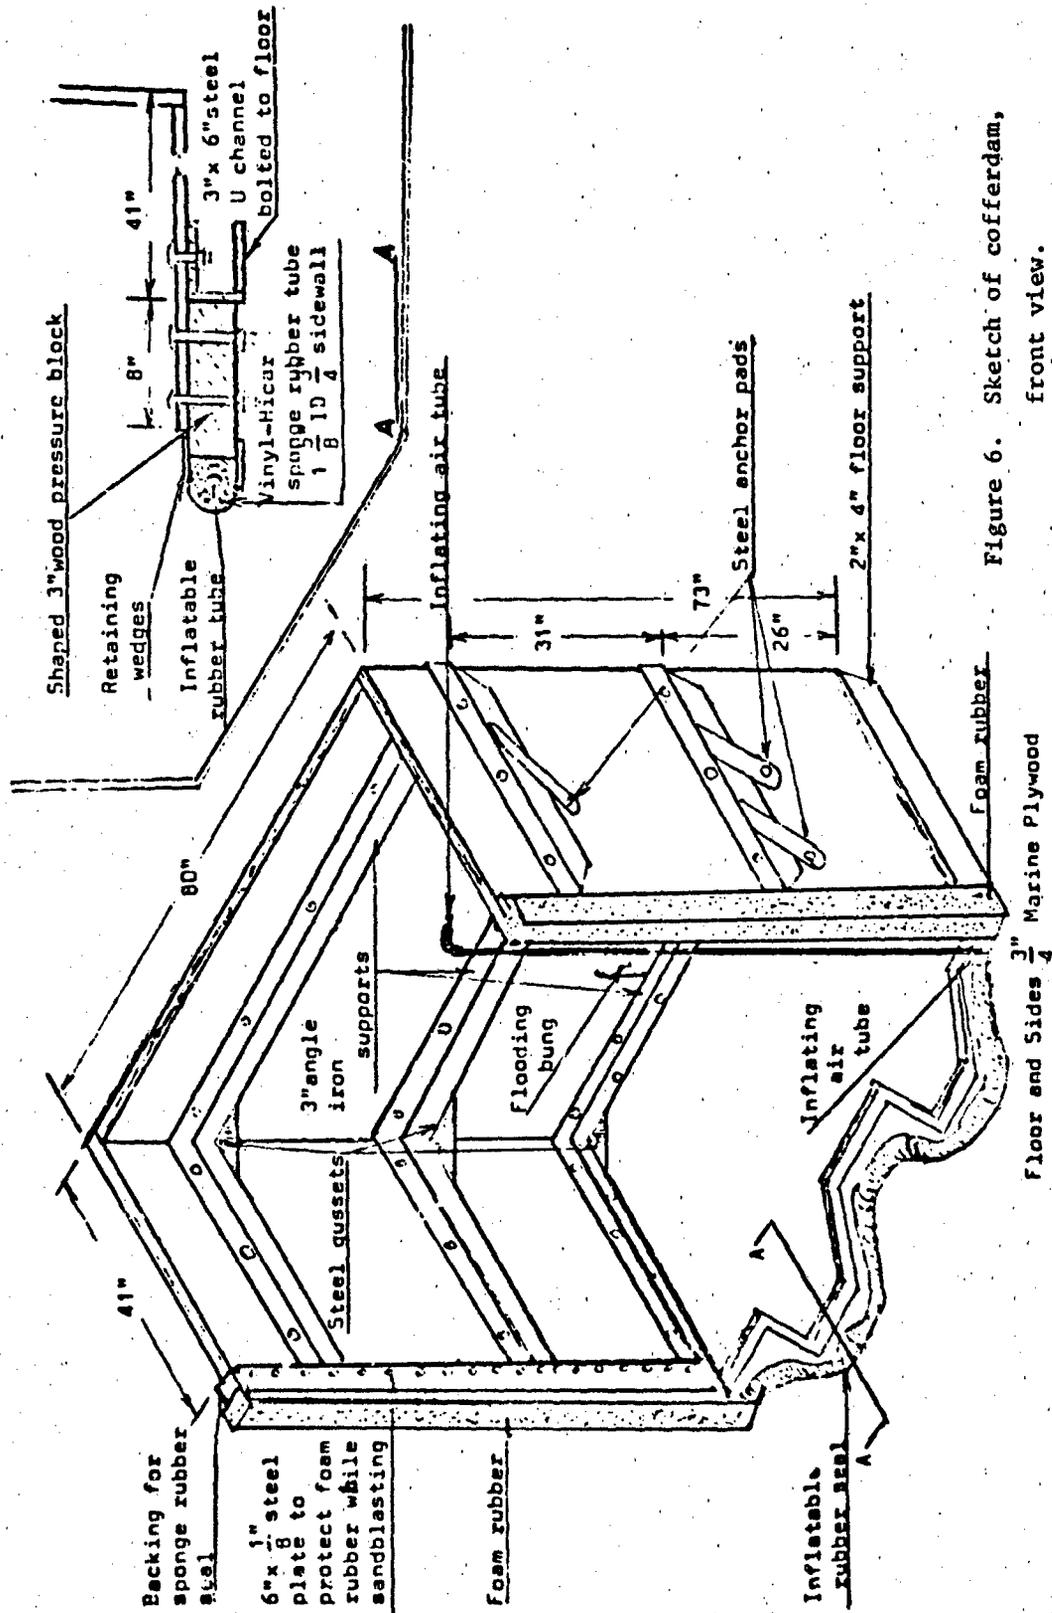
Figure 6. Sketch of cofferdam, front view.

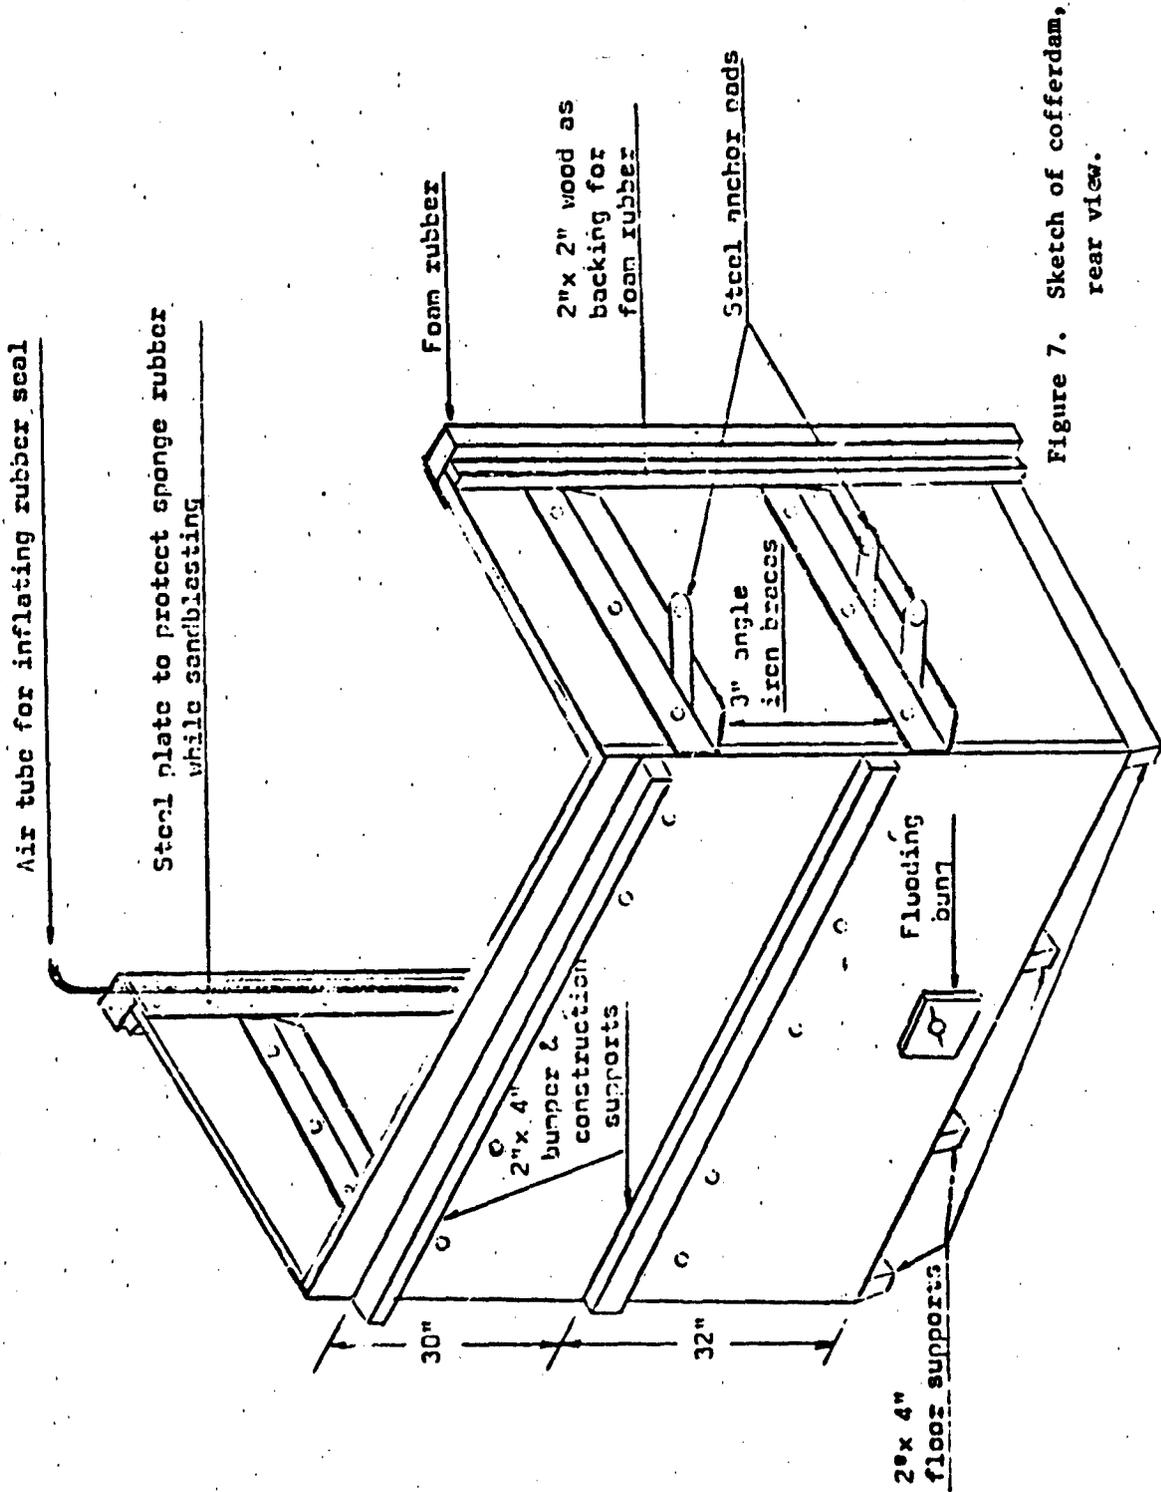
Figure 7. Sketch of cofferdam, rear view.
