TECHNICAL REPORT C-75-2

A CONCEPT FOR RAPID REPAIR OF BOMB-DAMAGED RUNWAYS USING REGULATED-SET CEMENT

George C. Hoff

U. S. Army Engineer Waterways Experiment Station
P. O. Box 631, Vicksburg, Miss. 39180

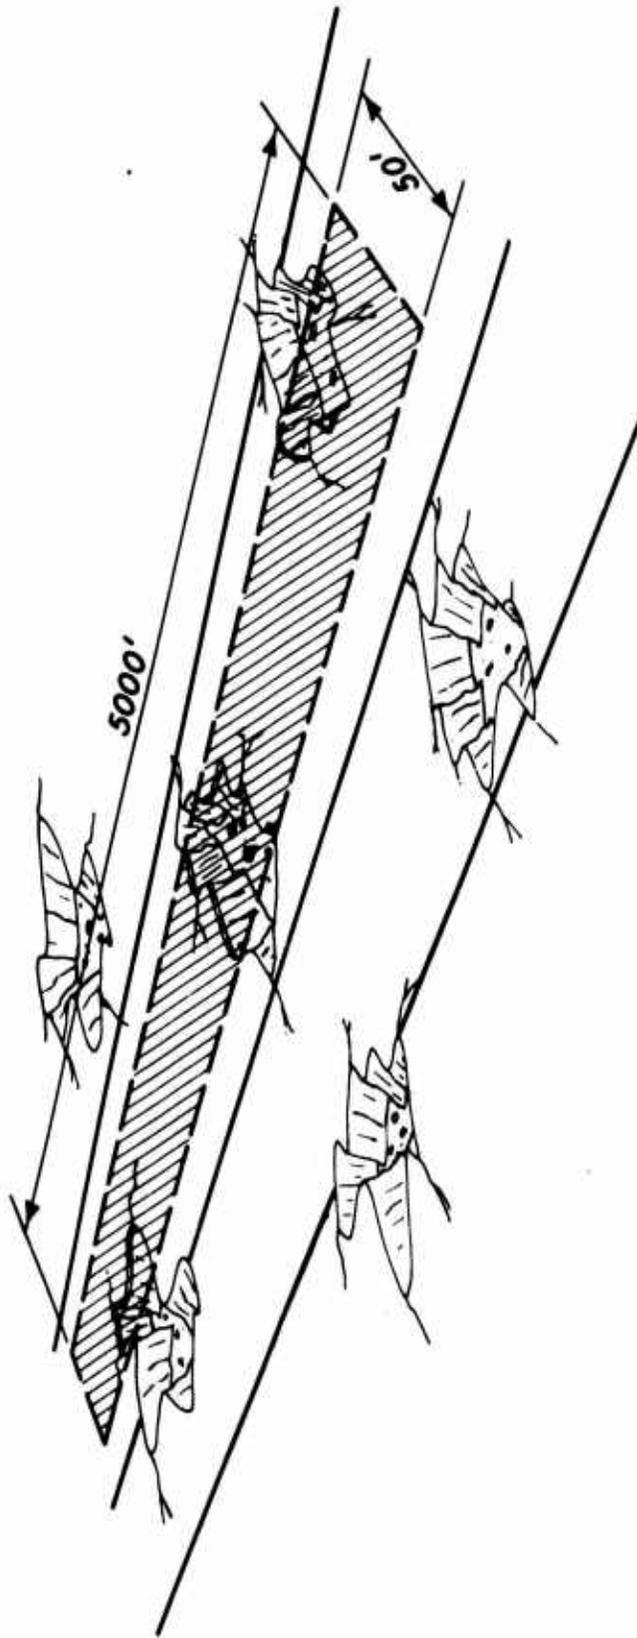
Figure 1.1 Required operational area on a bomb-damaged runway.

Immediately after an attack on the runway, a damage assessment team determines which craters are to be repaired to obtain the desired runway surface (Figure 1.1). Each repair team then separates into three groups--one group each for runway cleanup and crater filling, landing mat retrieval and assembly, and select-fill retrieval and transport. Two large front-end loaders (FEL's) are used on each crater to clear debris from undamaged runway around the craters (Figure 1.10). A grader and sweeper are used to clear an adjacent area for assembly of the landing mat (Figure 1.11). The two FEL's and a bulldozer push debris in the crater lip area into the crater (Fig. 1.12). As filling progresses, the bulldozer compacts debris in the bottom of the crater while simultaneously loosening and pushing up damaged pavement around the crater (Figure 1.13); these pieces of pavement are either pushed off the runway or back into the crater. Landing mat necessary to cover the crater is simultaneously assembled adjacent to the crater (Figure 1.14). The select fill is removed from stockpiles (Figure 1.15) and moved by dump truck to the crater where it is spread by a dozer and leveled and compacted by the grader. A final compaction is applied by a tractor-towed vibratory roller. The assembled landing mat is then pulled over the fill area and anchored; when this is completed for all three craters, the runway should be operational.

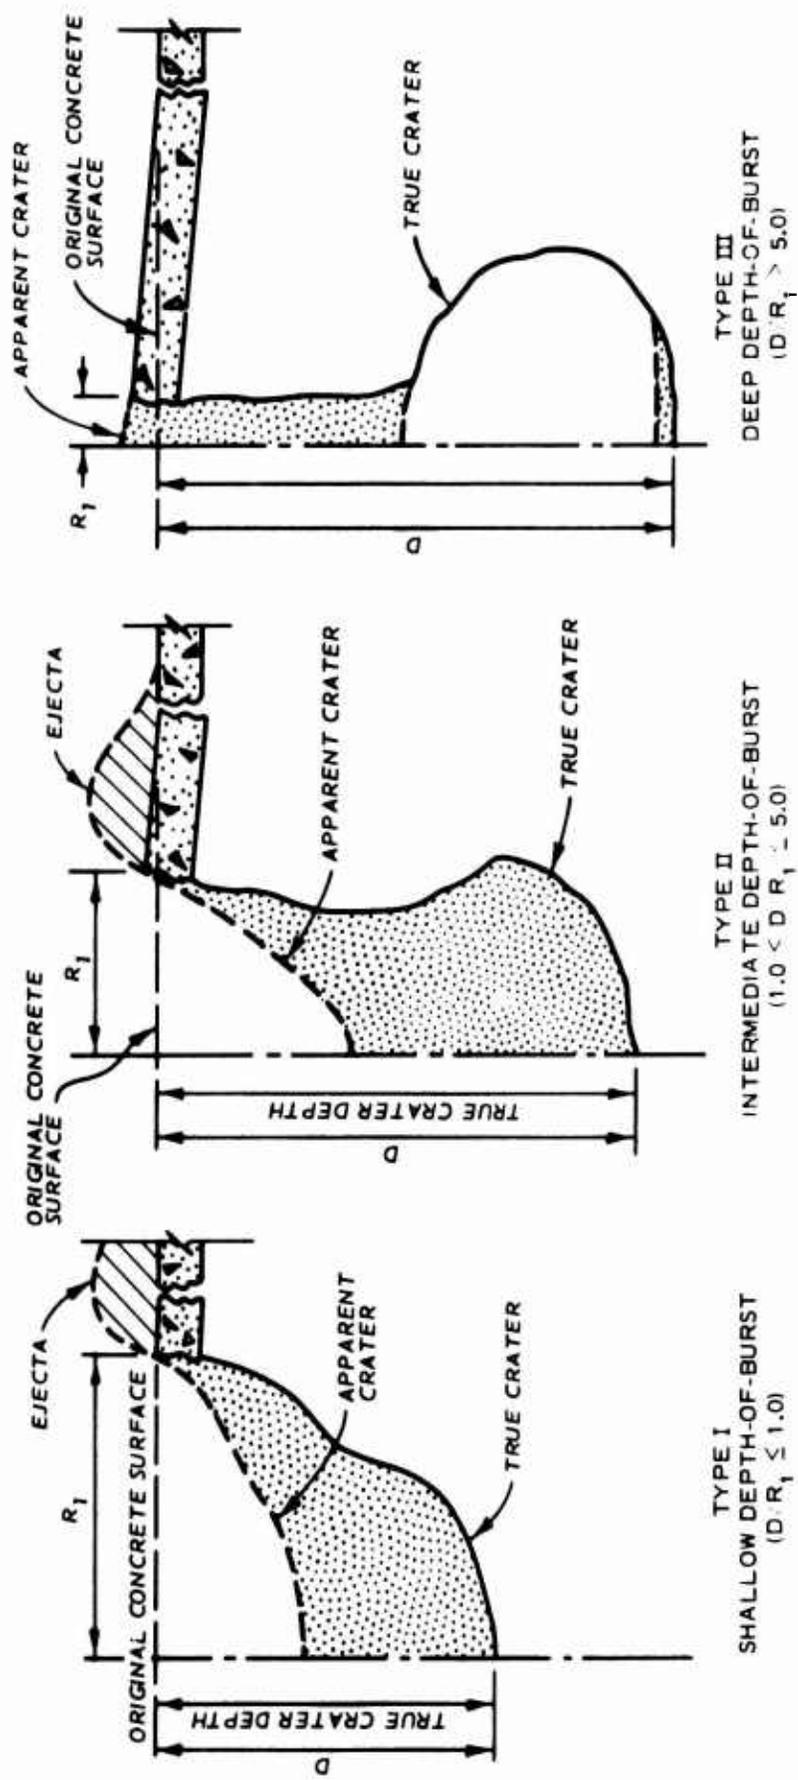
Figure 1.2 U. S. Air Force pavement crater classifications (Reference 2).

on pavement thickness, pavement subgrade, the size and type of munition, and its depth of penetration into the pavement and underlying subgrade (Reference 2). The U. S. Air Force has described craters as Types I, II, and III, as shown in Figure 1.2, based on depth of burst. A Type I crater (shallow depth of burst) is generally hemispherically shaped with widely spread debris but with no appreciable heaving or cracking in adjacent pavement. A Type II crater (intermediate depth of burst) is generally conical with widely spread debris; the adjacent pavement is cracked and heaved. Both Types I and II craters are partially filled with debris fallback that provides an apparent crater surface. The Type III crater (deep depth of burst) has a large cavity in the subgrade and from the pavement surface does not appear to be cratered at all. There is very little debris, but the adjacent pavement is cracked and heaved in large wedge-shaped sections. For repair purposes, the Type III crater can be transformed into a Type I or II shape using additional smaller detonations. The U. S. Army Corps of Engineers has refined the pavement crater description with classifications that range from Types 1-7 (Reference 3), as shown in Figure 1.3; a description of these craters is contained in Table 1.1.

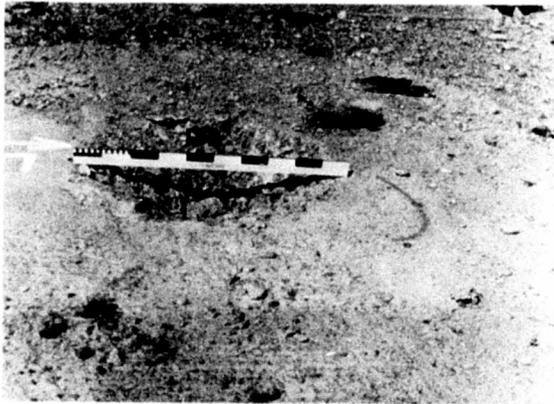
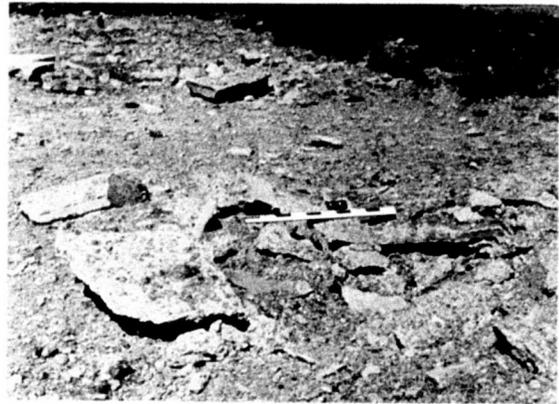
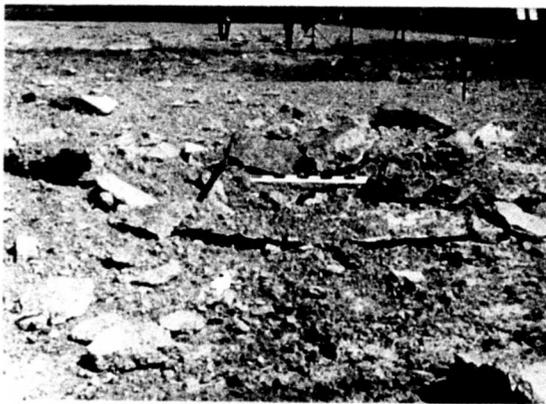
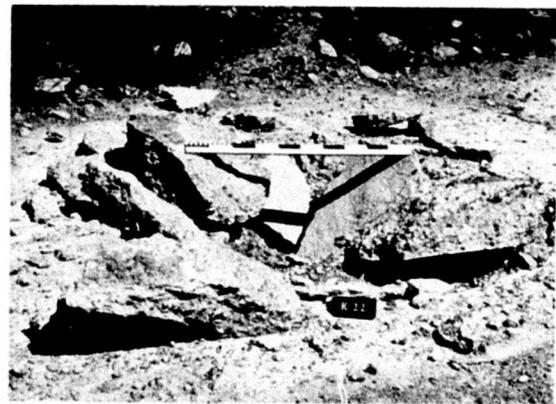
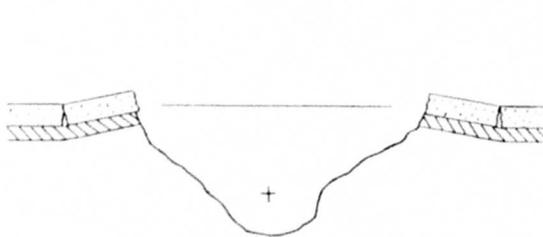
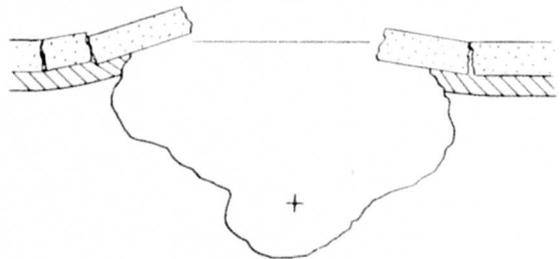
TYPE 1 - SLAB OR SPALL CRATER

TYPE 2 - BLOW-OUT CRATER

TYPE 3 - STANDARD CRATER

TYPE 4 - HEAVE CRATER

Figure 1.3 U. S. Army Corps of Engineers pavement crater classifications (Reference 3). True crater profiles are shown in and below pavements and subgrades (shaded areas). Depths of burst are indicated by small crosses (sheet 1 of 2).

The same type of approach can be used to repair spall or blow-out craters (Types 1 and 2, Figure 1.3); however, only the capping material would be used to repair spall craters, while the blow-out crater would require the sanded cellular concrete in the lower portion of the crater with the capping material on the surface; no debris would be used in a blow-out crater repair. Before the approach described above can be used for repair, heave craters and camouflet craters with heave mound

(Types 4 and 6, Figure 1.3) must be reshaped by mechanical means or explosives to resemble the Type 3 standard crater. In the camouflet and camouflet with spall craters (Types 7 and 5, Figure 1.3), no debris would be used, only the sanded cellular concrete in the lower portions of the crater with the capping material on the surface.

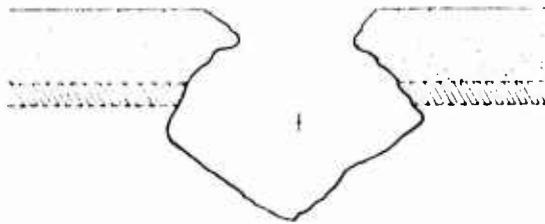
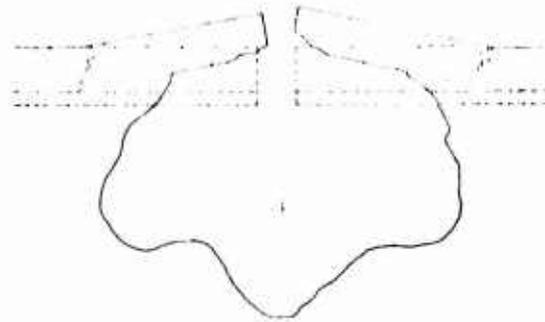
Figure 1.3 (Sheet 2 of 2).

TYPE 5 - CAMOUFLET WITH
SPALL CRATER

TYPE 6 - CAMOUFLET WITH
HEAVE MOUND

TYPE 7 - CAMOUFLET

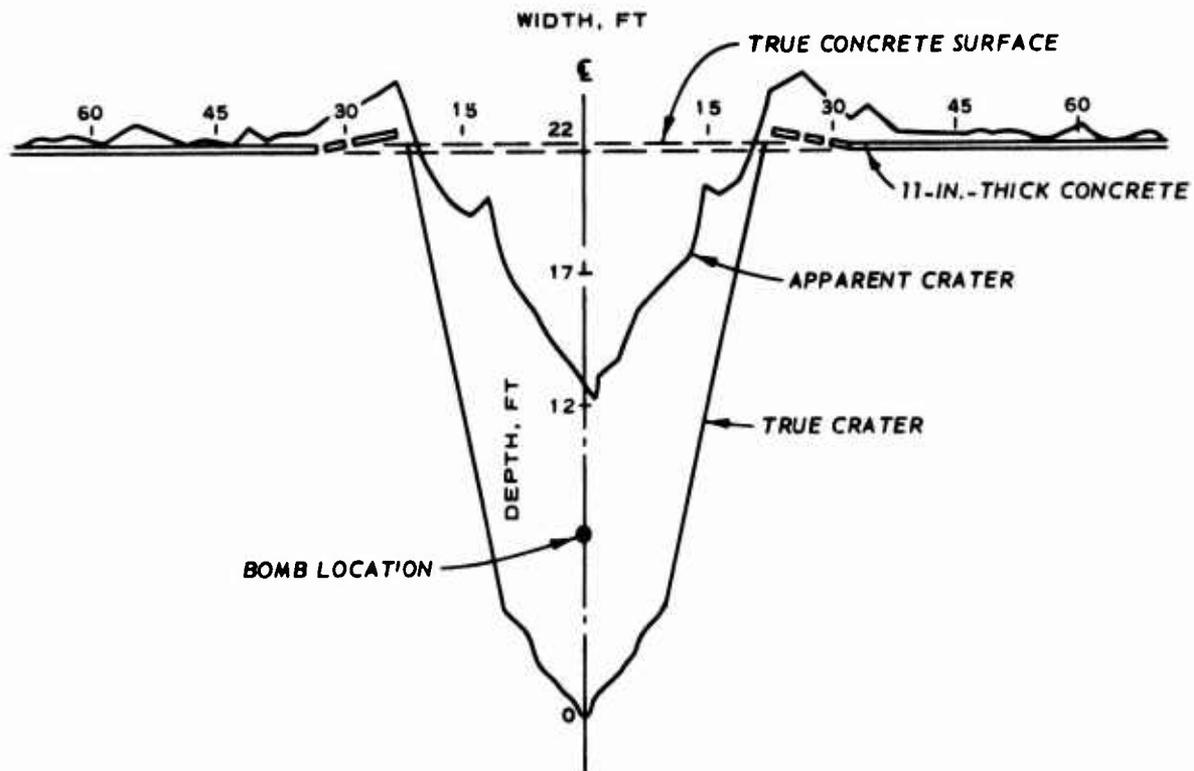
Figure 1.4 Cross section of 750-pound bomb crater, Hays, Kansas (Reference 4).

2.2.1 Crater Repair Volumes. Using the damage area shown in Figure 1.4 as a model of the standard crater for repair, a simplified crater approximating the Type 3 crater (Figure 1.3) in shape was developed as shown in Figure 2.2. It is assumed that, to obtain a satisfactory pavement surface after repair, all damaged pavement would have to be removed along with a small amount of base course (approximately 2 feet total in depth) to a point 35 feet from the center of the crater, thereby necessitating the replacement of a 70-foot-diameter section of pavement surface. In actual practice, the amount of damaged pavement to be removed is determined by using a straightedge to identify pavement rises that exceed an 11/16-inch rise in each 4 feet of horizontal distance; this pavement must be removed (Reference 6).

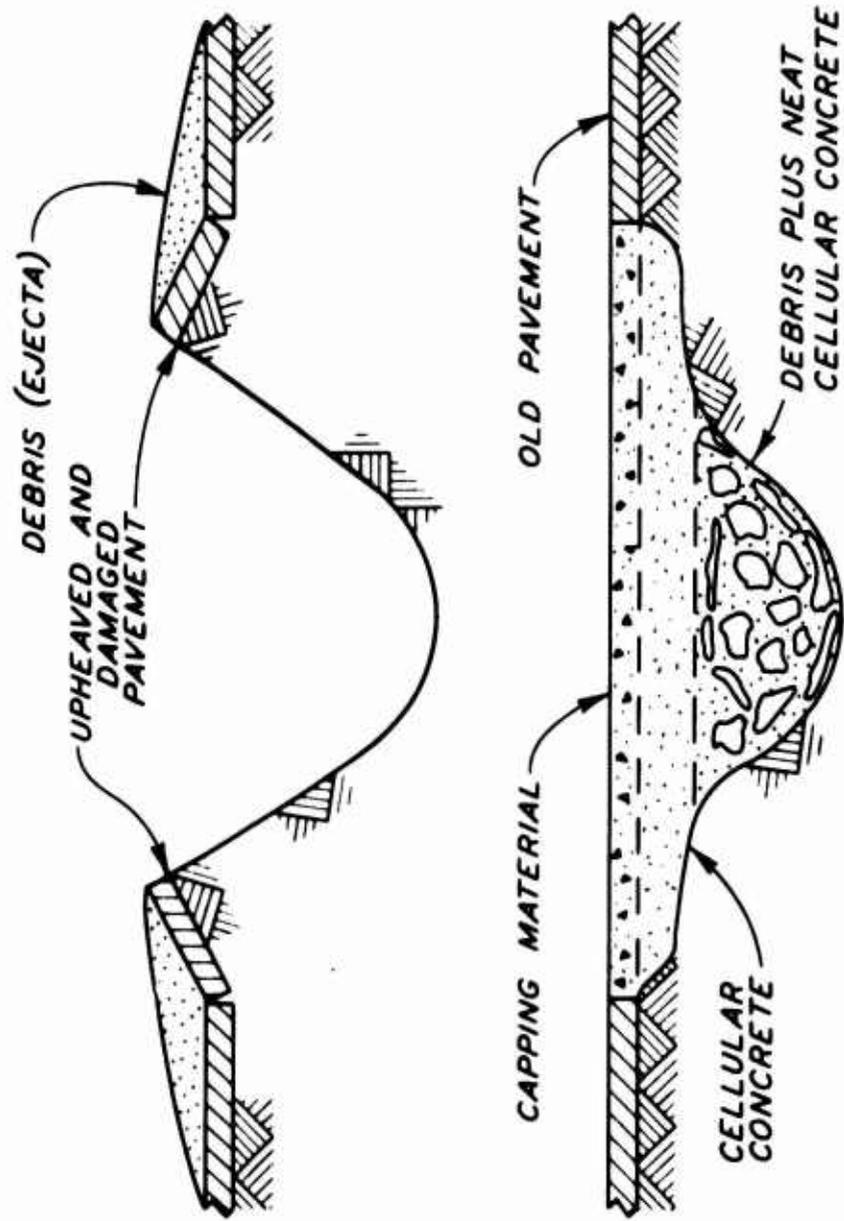
Figure 2.1 regulated-set cement repair scheme for bomb-damaged pavements.

The regulated-set cement repair scheme for craters in bomb-damaged runways is shown in Figure 2.1. The lower portion of the crater is filled with a combination of debris and neat (no aggregate) cellular concrete. This concrete, often referred to as foamed concrete, is made with regulated-set cement, water, and a preformed foam. It has a very high air content and low density and will flow readily around the debris dumped or pushed into the crater concurrently with cellular concrete during the filling of the crater. The crater is filled in this manner until it reaches a point approximately 3 feet from the desired top surface of the runway. At that point, no more debris is placed in the crater. The foam content, which is mostly air, of the concrete is reduced, and sand is added to the cellular concrete as aggregate. Bank-run sand and gravel could also be used providing the aggregate size was not so large that it could not be pumped with the type of pumps described in Section 4.6.5. These procedures increase the density and bearing strength of the cellular concrete. The filling operation continues using this cellular concrete containing aggregate to a point approximately 11-12 inches below the desired pavement surface. All preformed foam (or air) is then left out of the concrete, with the resulting cement, sand, and water composite providing the capping material which will function as the structural wearing surface. The capping material is placed to the desired level, screeded off, and finished, if desired.

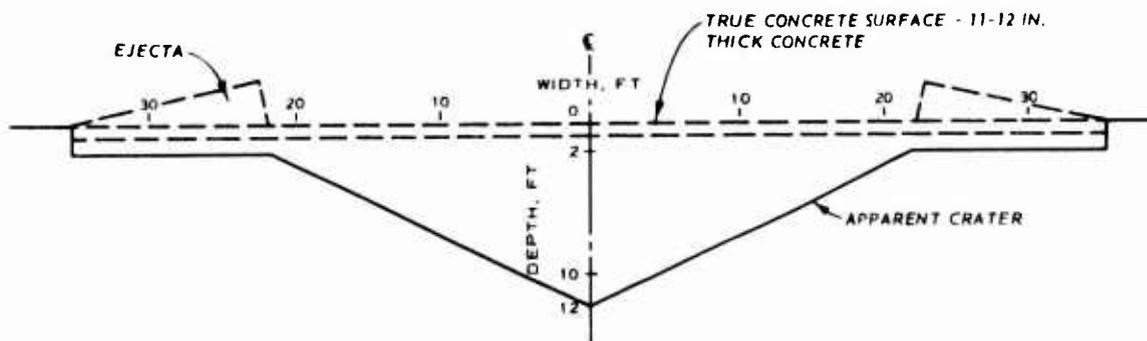
Figure 2.2 Simplified crater for repair.

The maximum depth from the pavement surface to the surface of the apparent crater is assumed to be 12 feet. A triangular cross section for the apparent crater profile was used to obtain the volume of the subgrade portion of the crater. This volume plus the volume for the damaged pavement removal totals a repair volume of approximately 473 yd^3 of which 131 yd^3 would be the replacement of

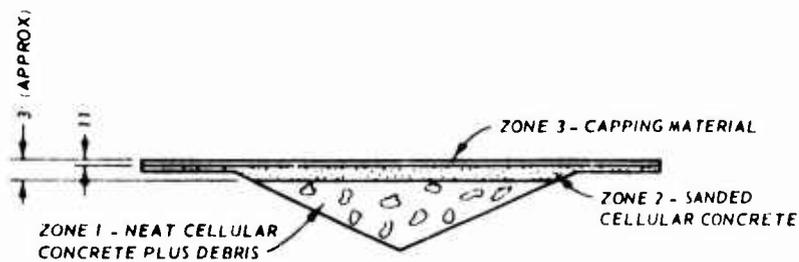
ZONE 1 - BACKFILL	137 CU YD
ZONE 2 - SUBBASE	205 CU YD
ZONE 3 - STRUCTURAL CAP	131 CU YD
TOTAL	473 CU YD

Figure 2.3 Crater repair scheme plus volumes involved.

an 11-inch-thick pavement surface. For repair purposes, the simplified crater is delineated into three zones as shown in Figure 2.3. Zone 1, the lower portion of the crater, will be filled by both debris and neat cellular concrete. Zone 2 will be repaired by sanded cellular concrete (no debris). Zone 3 is the capping material. Approximate volumes for Zones 1, 2, and 3 are 137, 205, and 131 yd³, respectively.

The exact amount of water required at the crater is difficult to determine and will depend on the mixture proportioning and the amount used for cleanup and washing. To get an indication of how much will be required, however, assume that the wearing or surface cap will have a water/cement ratio of 0.55 (by weight) and a cement content of 800 lb/yd³. This mixture then requires 440 pounds of water or 52.80 gal/yd³ of concrete. From Figure 2.3, the Zone 3 repair would then use:

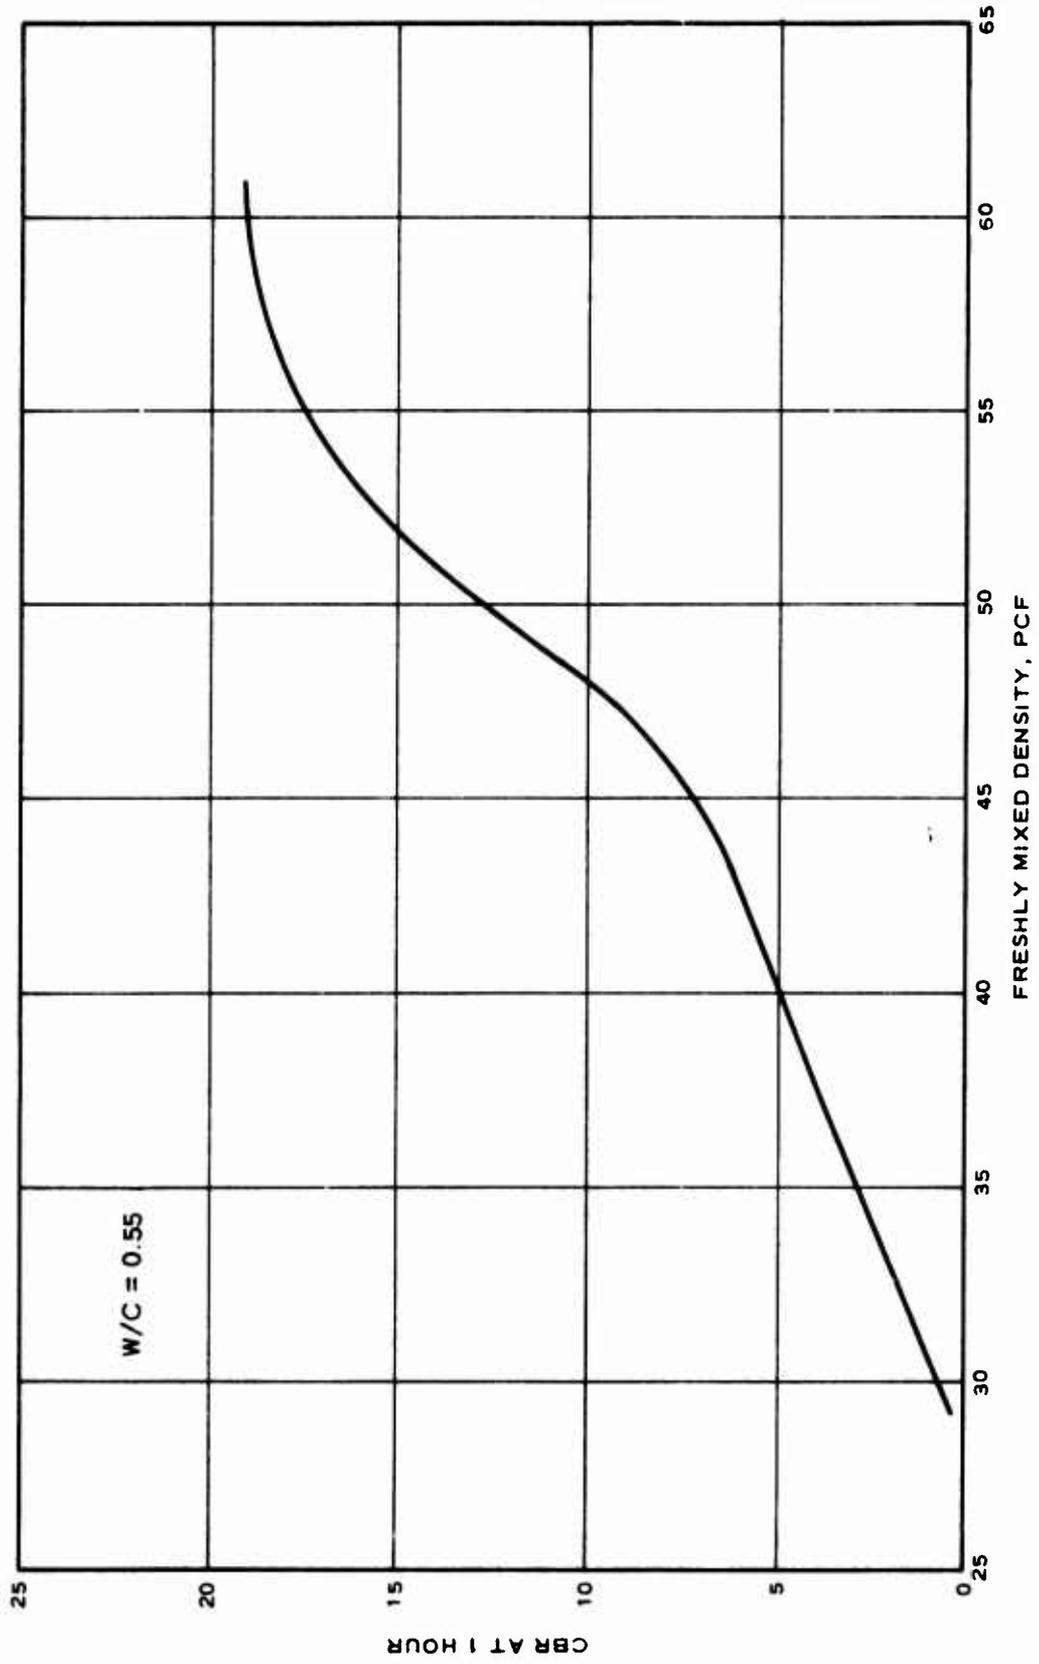
Figure 2.4 One-hour CBR value versus density for a neat cellular concrete.

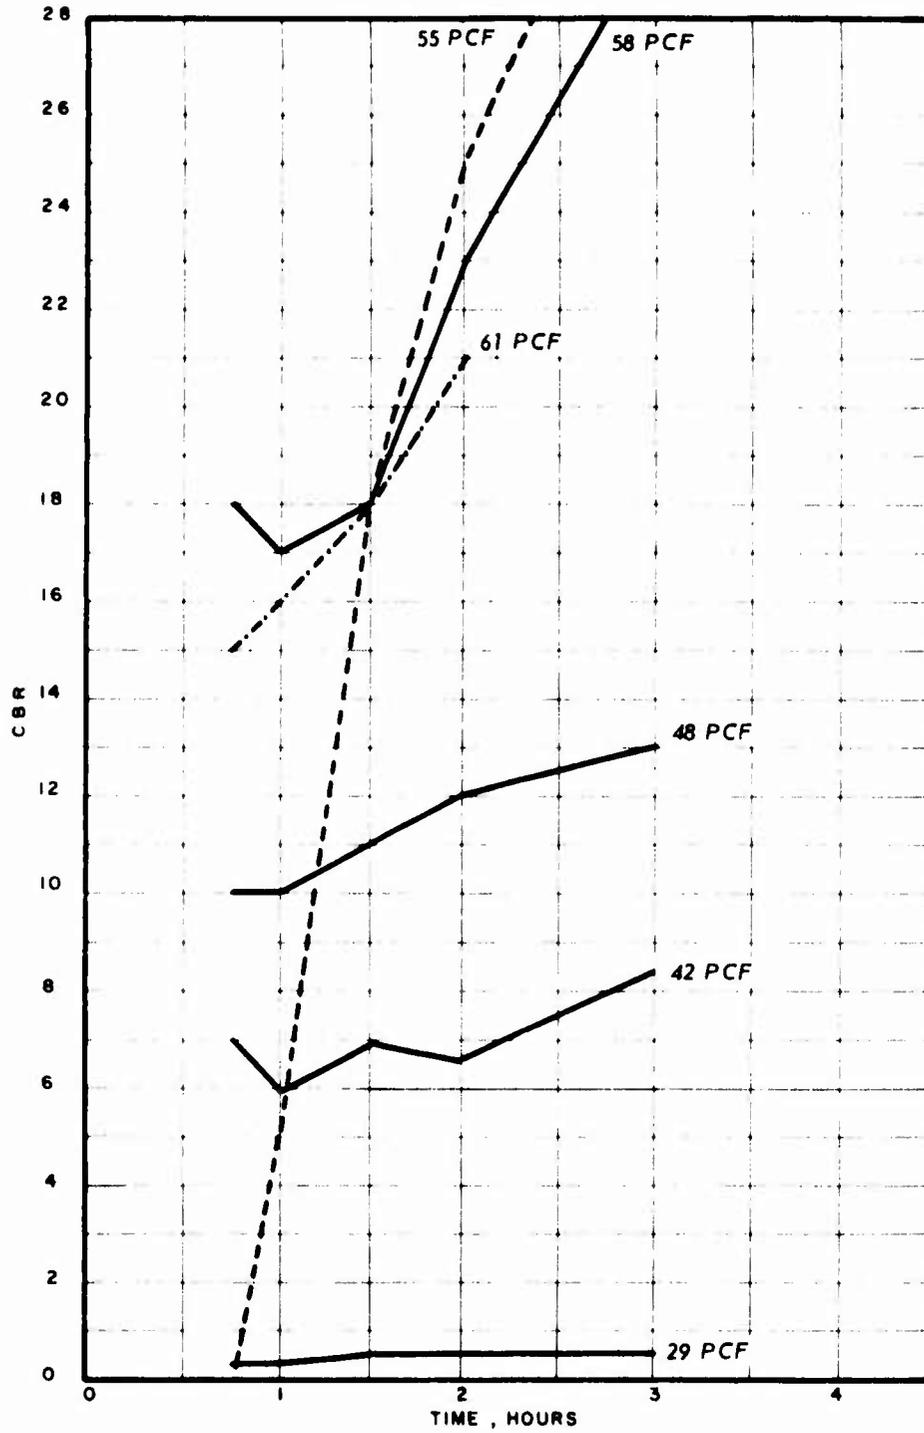
Figure 2.5 CBR value versus elapsed time for neat cellular concretes of various densities.

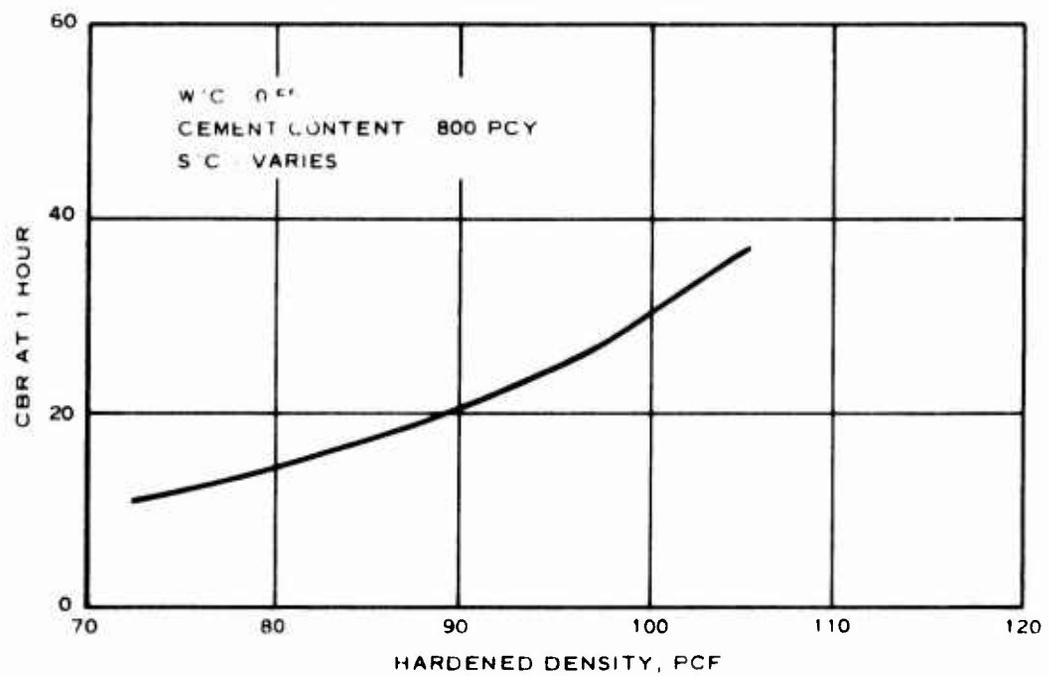
Figure 2.6 CBR at one hour versus density for sanded cellular concrete.

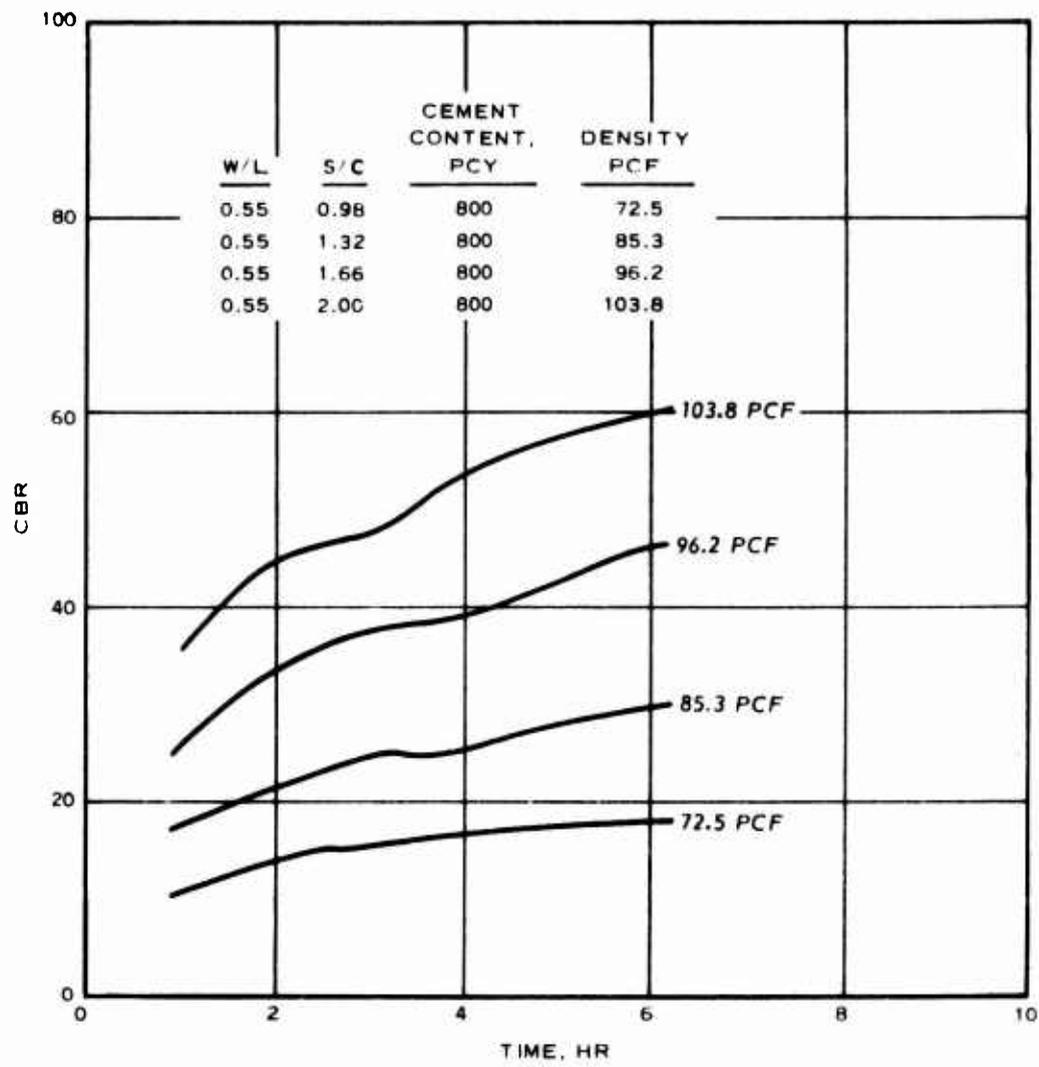
Figure 2.7 CBR versus time for sanded cellular concrete.

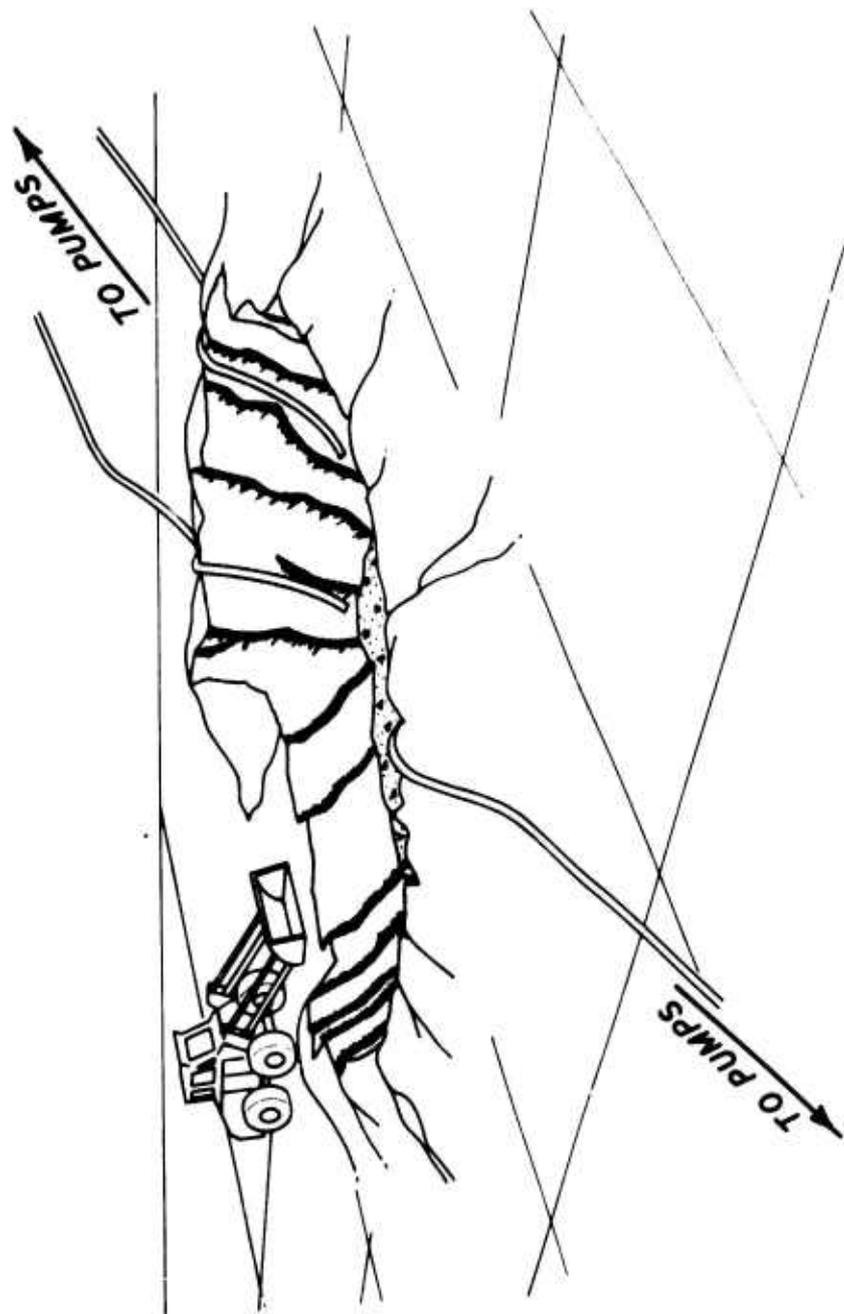
Figure 2.8 Concurrent filling of crater with debris and neat cellular concrete.

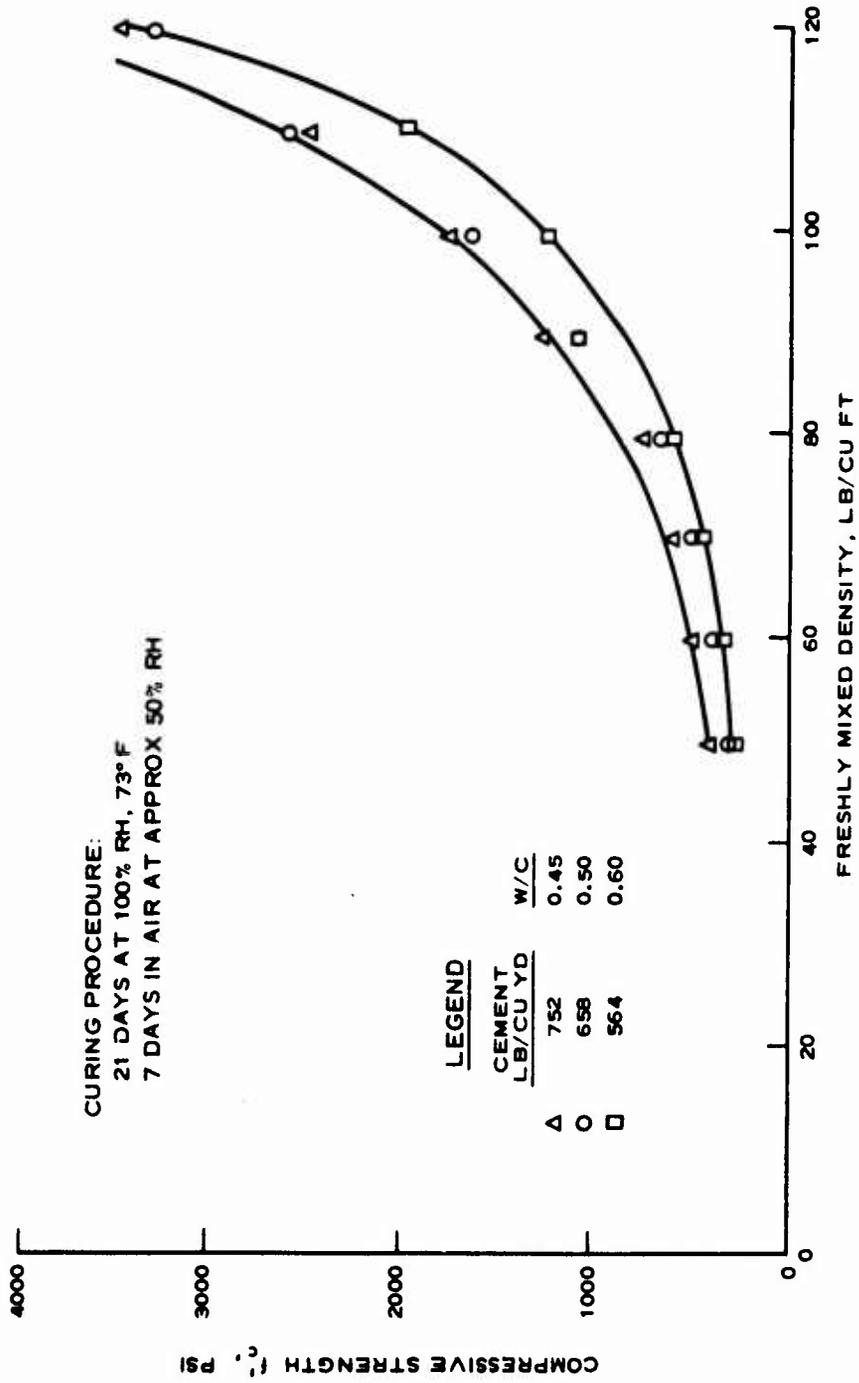
Figure 3.2 Strength versus density for sand cellular concretes (Reference 13).

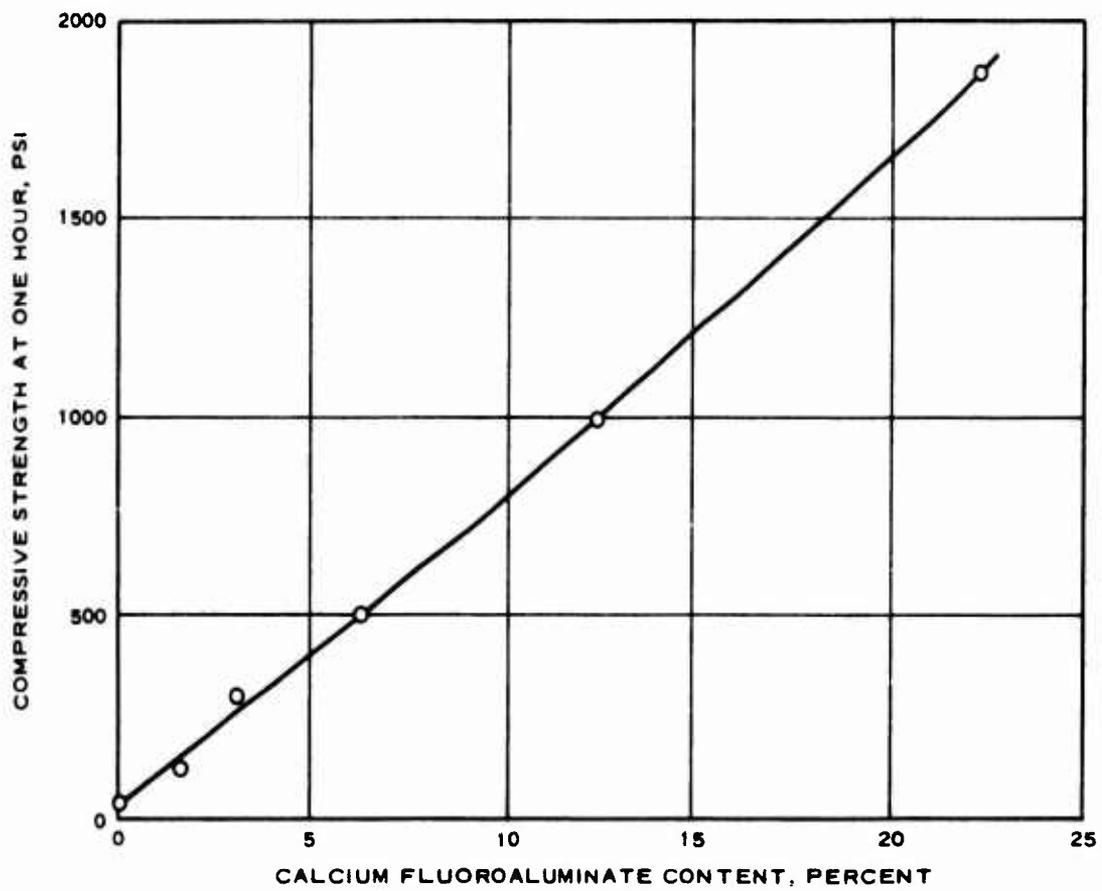
Figure 3.3 Influence of calcium fluoroaluminate content on 1-hour strength (Reference 17).

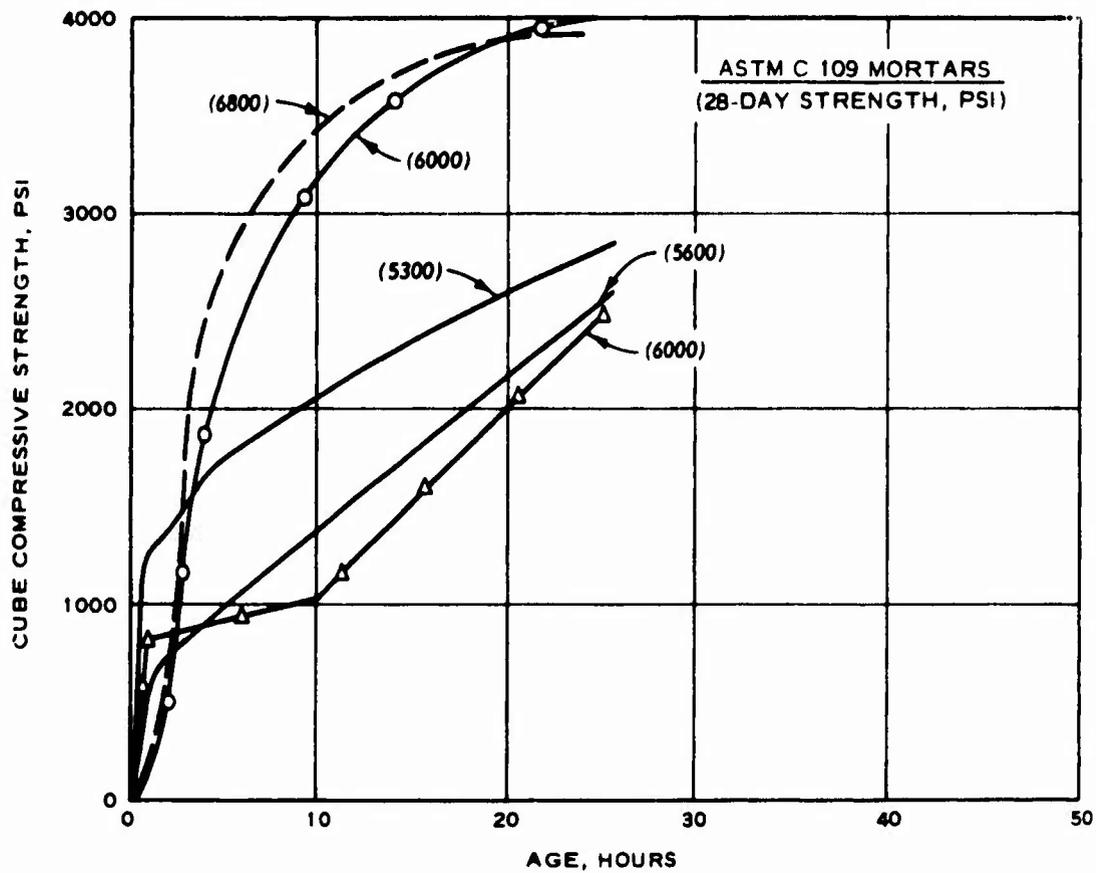
Figure 3.4 Compressive strength versus age for regulated-set cement mortars.

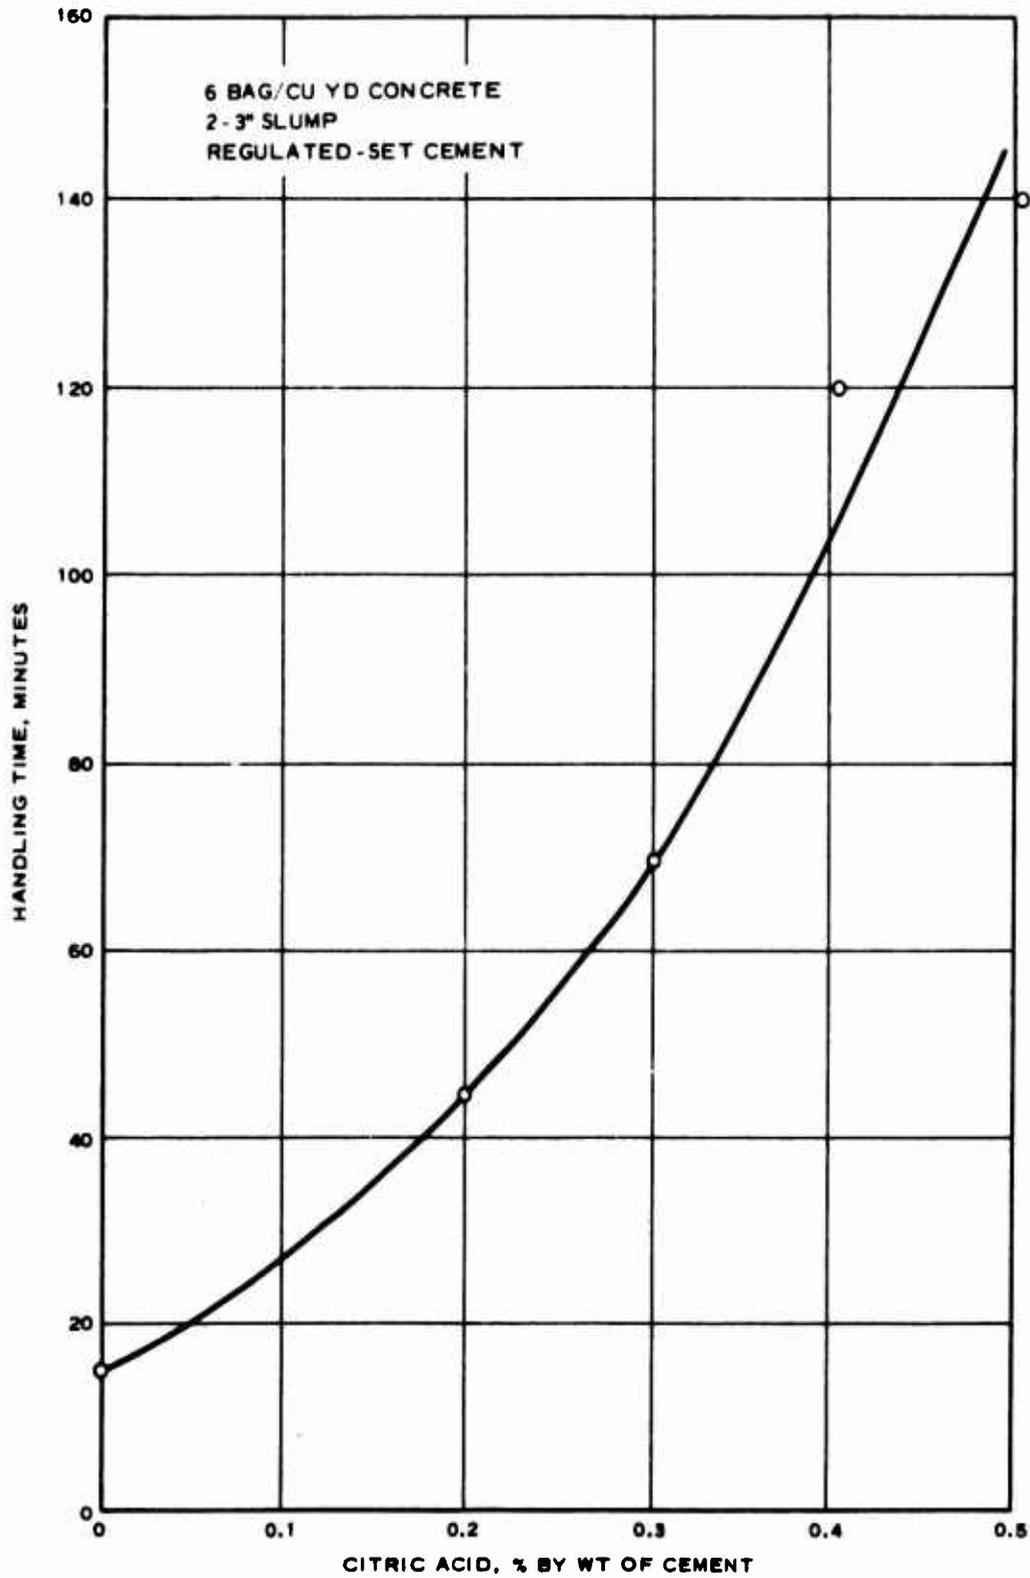
Figure 3.8 Effect of citric acid on handling time of concrete (Reference 17).

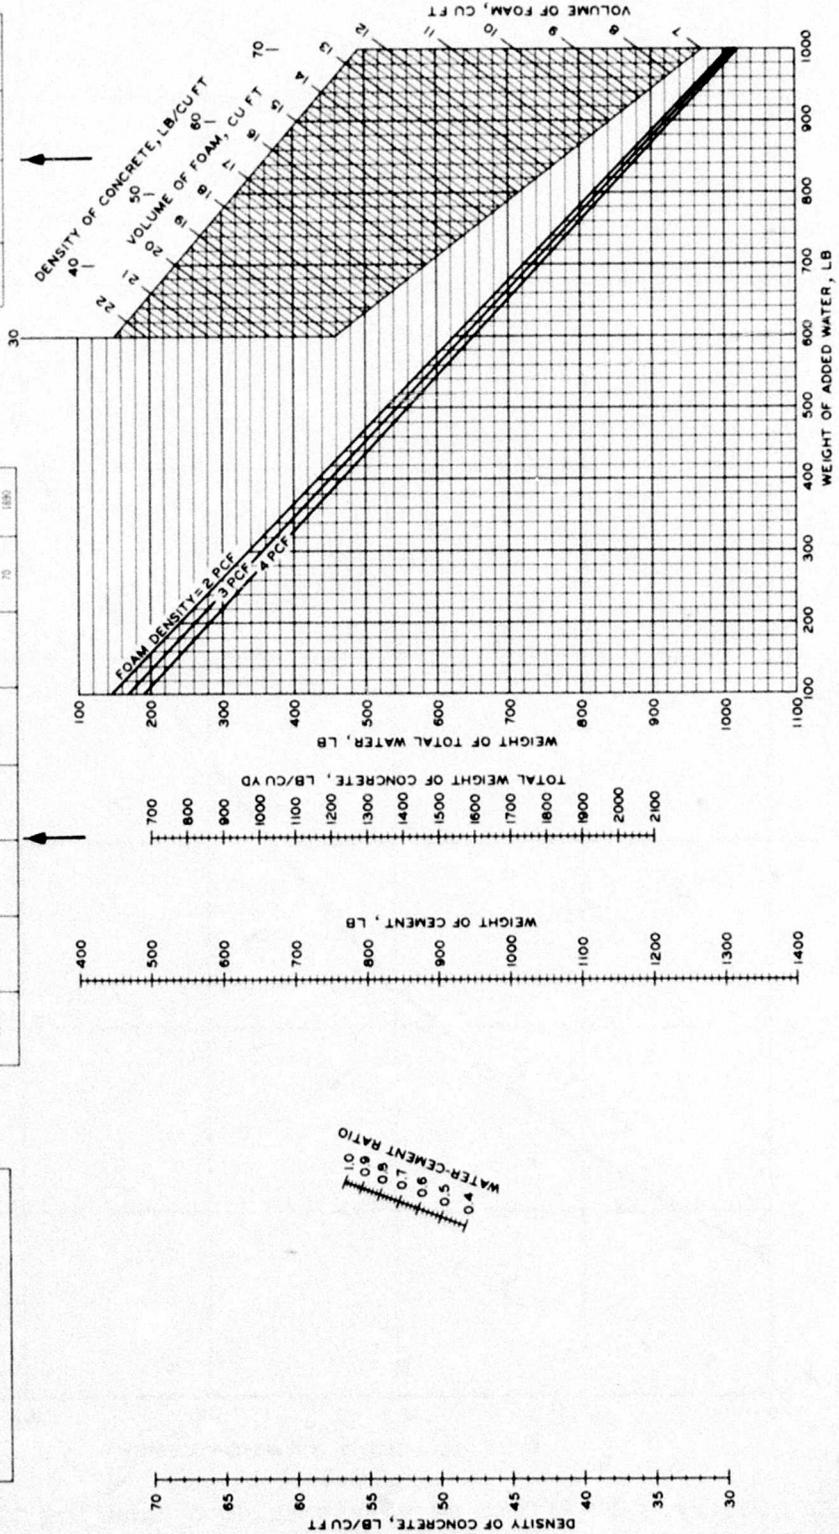
Figure 3.9 Nomograph for proportioning neat cellular concrete.

3.8.2 Nomographs. The crater will be actually repaired in a stress situation in which the time for calculations such as those shown in Section 3.8.1 will be minimal, if any time is available at all. In these circumstances, the individual in charge of the repair should know in advance which densities of concrete are needed in the various parts of the crater, which water-cement ratio should be used, the density of the preformed foam, and the discharge rate of the foam generators. With this information, and a nomograph (Figure 3.9), the quantities of materials needed can be determined in a few seconds.

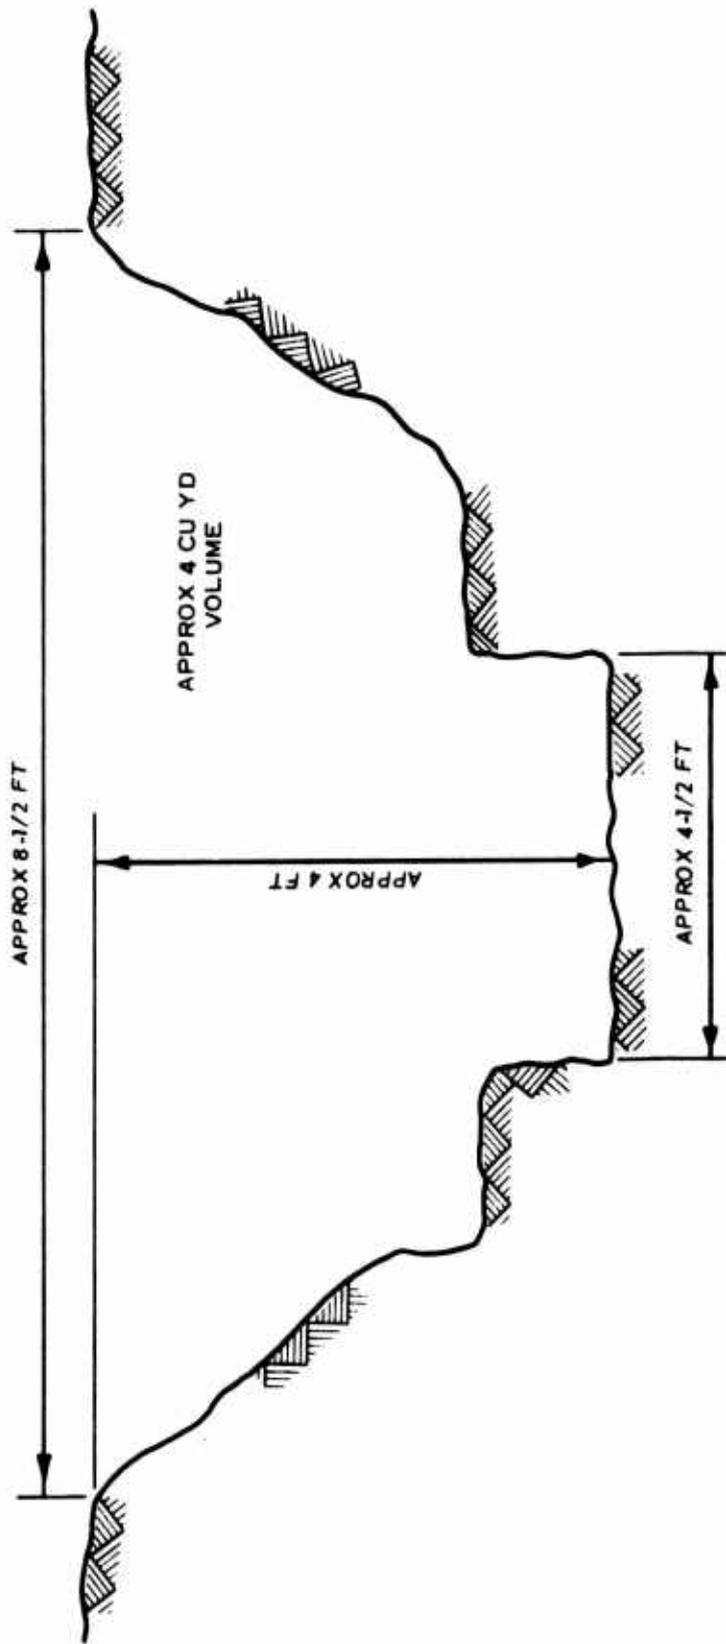
Figure 5.1 Cross section of small simulated crater.
