TECHNICAL REPORT C-75-2

A CONCEPT FOR RAPID REPAIR OF BOMB-DAMAGED RUNWAYS USING REGULATED-SET CEMENT

George C. Hoff

U. S. Army Engineer Waterways Experiment Station
P. O. Box 631, Vicksburg, Miss. 39180

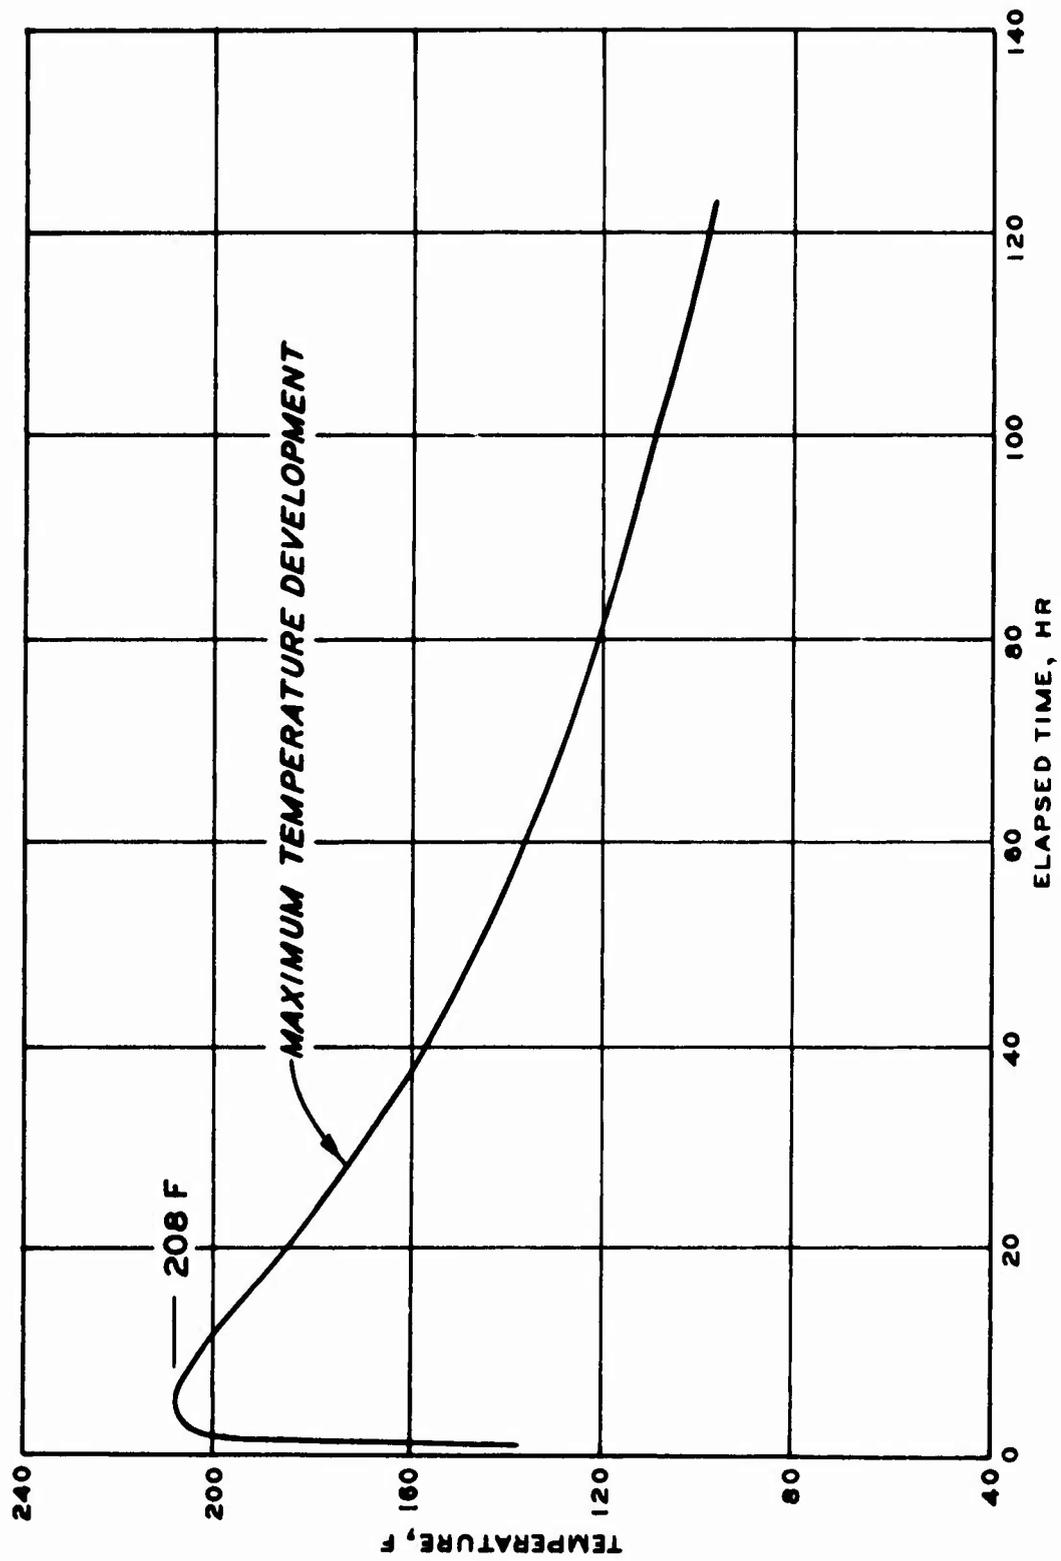
Figure 5.9 Maximum temperature development versus time after placing relation for simulated crater repair.

As mentioned in Sections 5.1.1 and 5.1.2, the heat development in large sections of regulated-set cement concrete is substantial. The temperature of the air in the loaded pipes was 220°F. Extremely warm temperatures were noted for the PVC module tests conducted at WES (Section 5.1.2), but softening of the pipes was not observed because it was not looked for in the test. The PVC pipes at WES appeared hard but were never loaded. The maximum temperature developed in the Tyndall crater was approximately 30°F greater than in the WES crater. This is probably due to the larger volume of cement used and the fact that the temperature of the mixture at placement at Tyndall was 18°F greater than at WES.

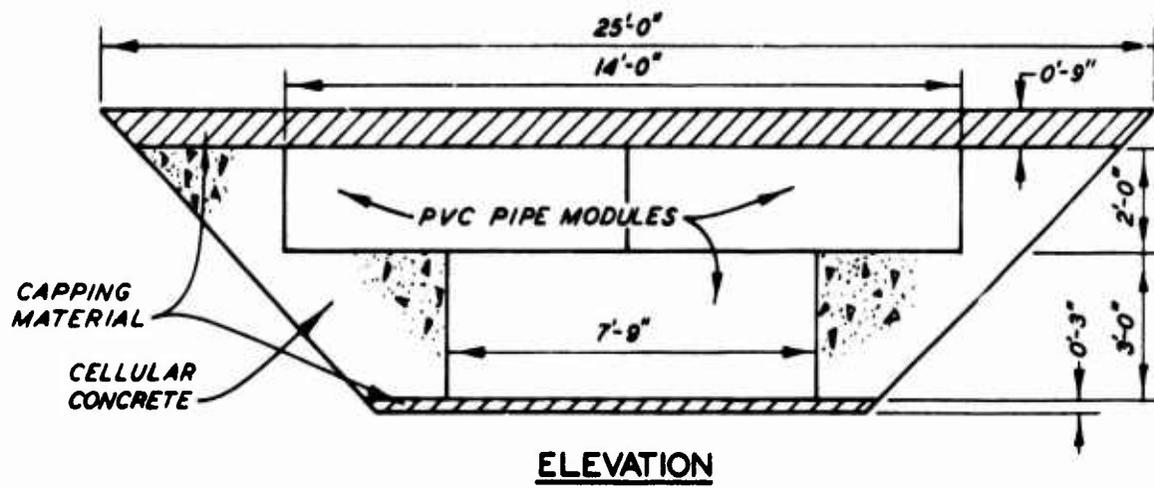
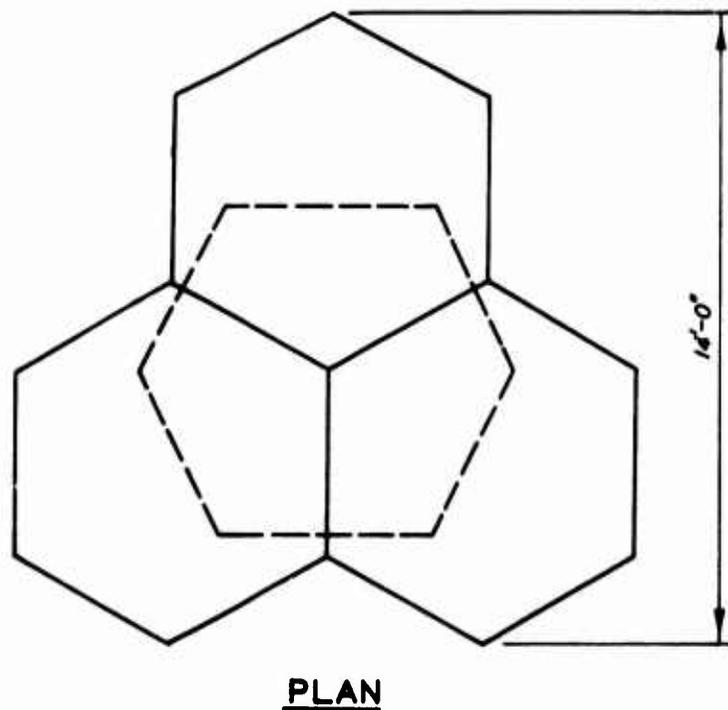
Figure 5.10 PVC pipe module repair scheme.

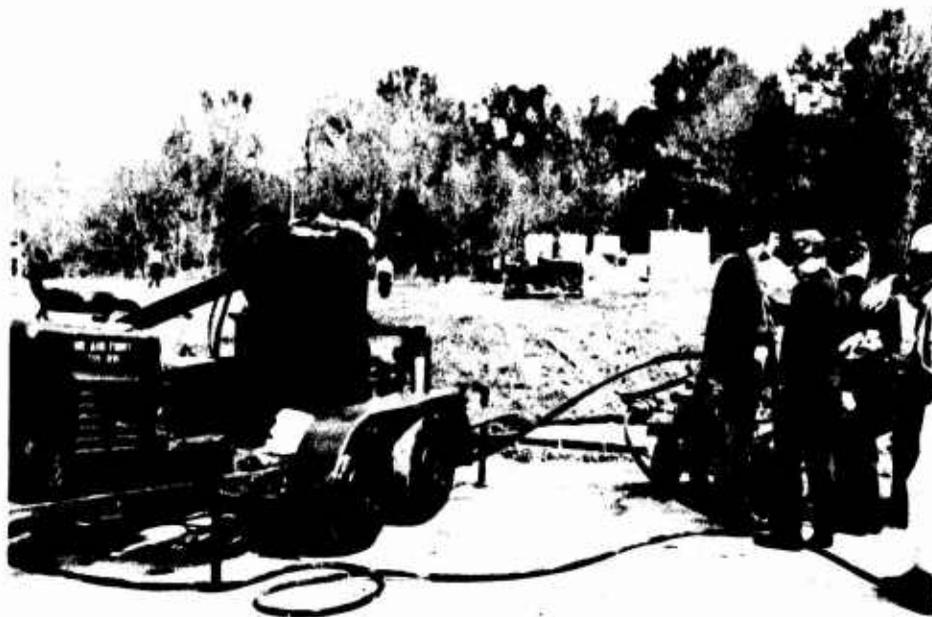
Figure 5.11 Batching and pumping unit - WES one-sixth-size crater trials.

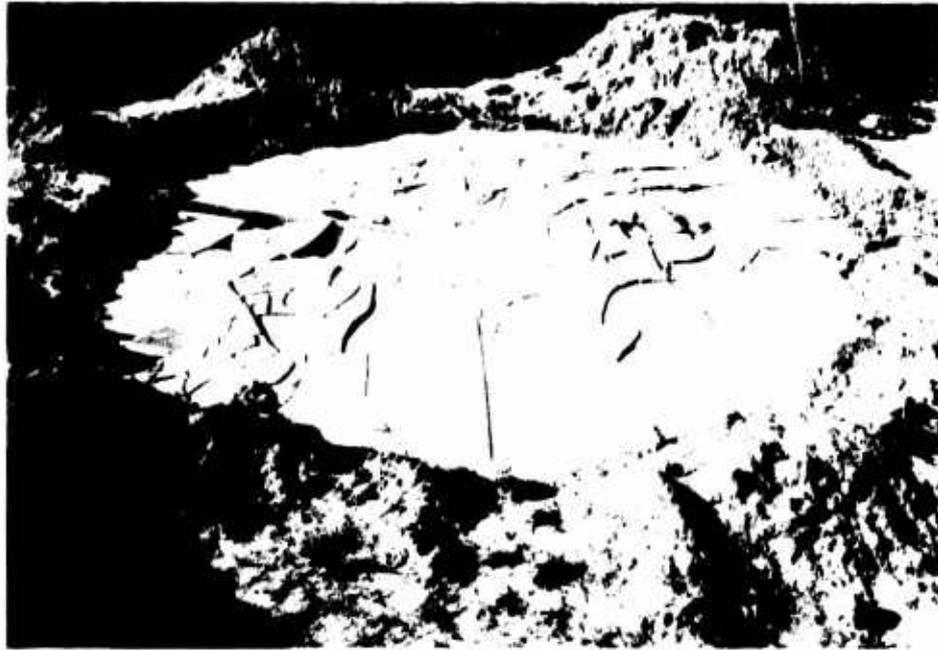
Figure 5.29 Severe drying shrinkage cracking.

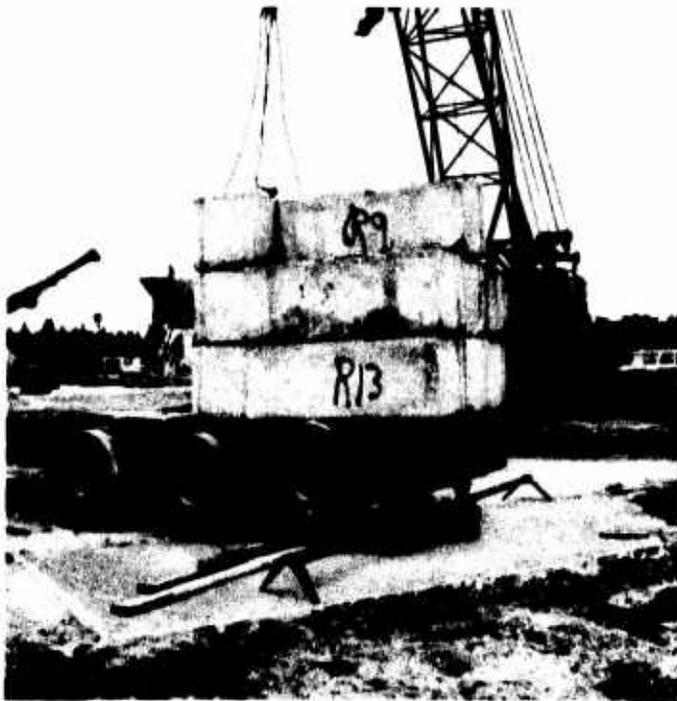
Figure 5.50 Loading of repaired crater by cart loaded with 50,000 pounds of blocks.

crater. This cart exerted a 30,000-pound load to the pavement through an F-4E tire inflated to 265 psi. The tire of the load cart penetrated the cap until stopped by the axle. The failure was a classical punching shear type. Examination of the hole after the cart was removed revealed that the PVC pipes had softened considerably due to the heat developed by the hydration of the cement and were offering no support to the cap. In effect, the cap was acting as an unreinforced slab spanning an empty hole except for some edge support provided by the cellular concrete. This lack of subgrade support from the PVC modules also explains the failures during the load plate test. Strain gages on the PVC pipes indicated that the pipes had compressed under the load and had retained the deflected shapes upon removal of the load.

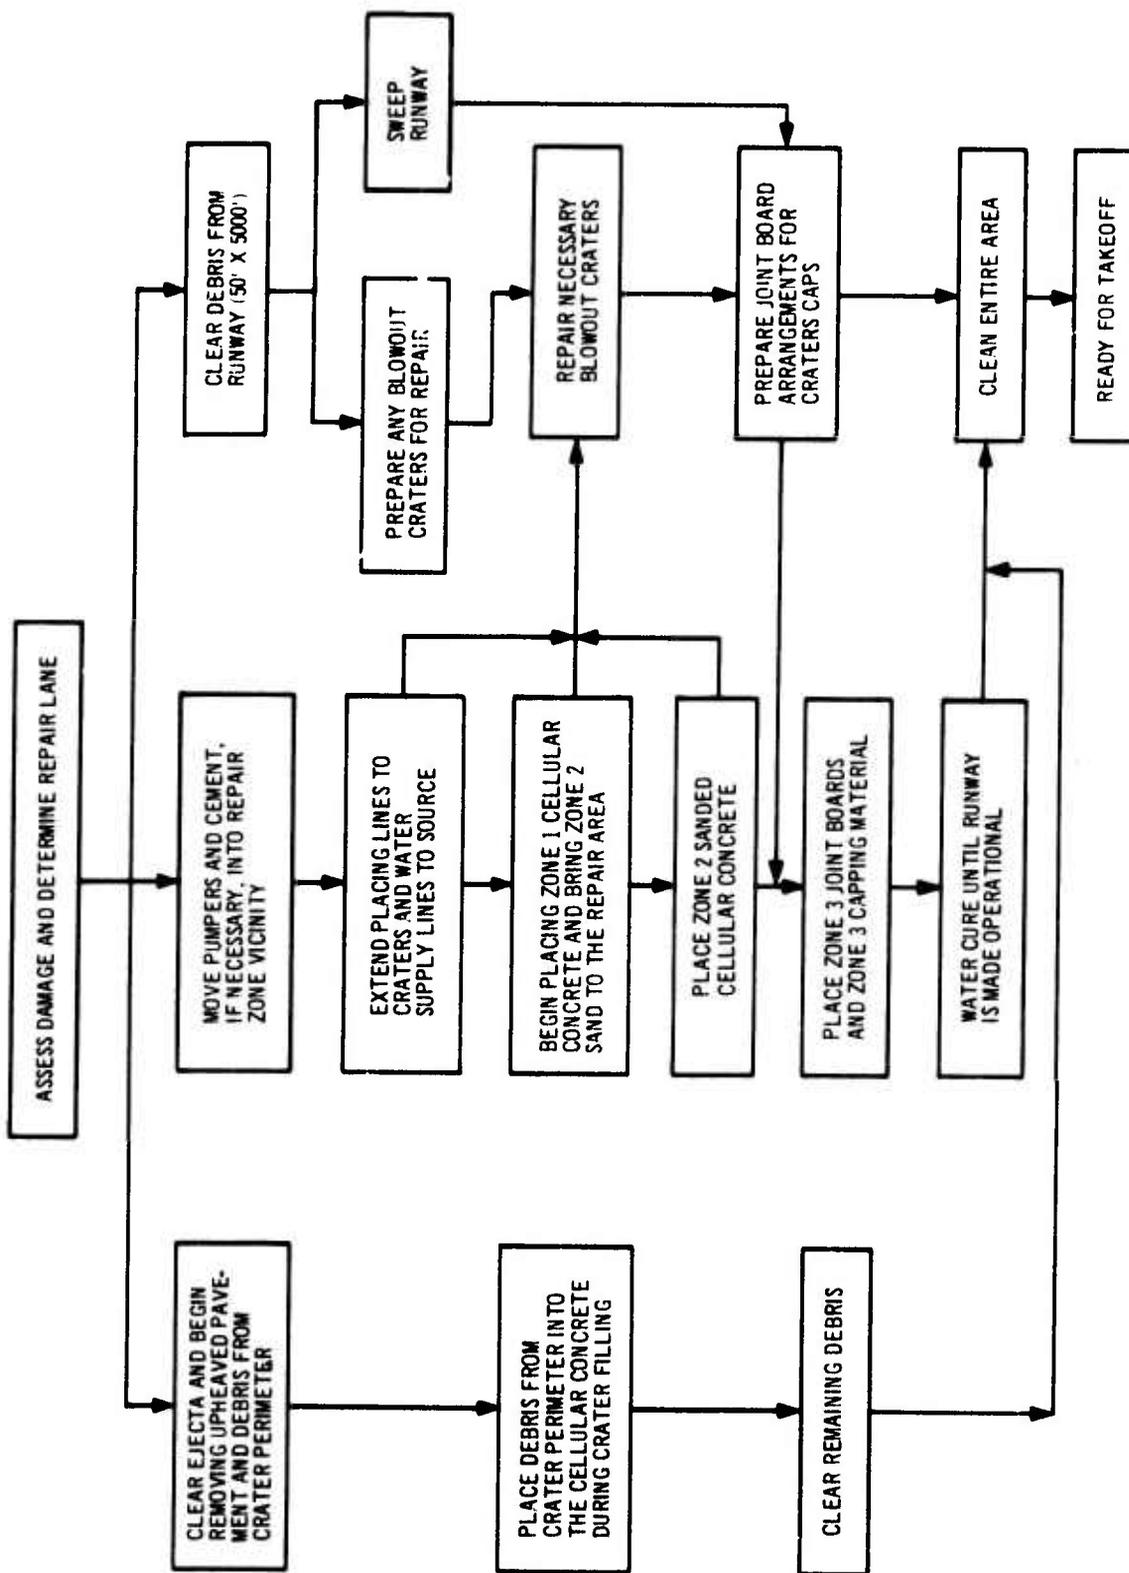
Figure 6.1 Regulated-set cement system repair flow diagram
