EFFECTS OF ELECTROLESS NICKEL PROCESS VARIABLES ON QUALITY REQUIREMENTS

FINAL REPORT

Fielding Ogburn
and
Christian E. Johnson

JUNE 1976

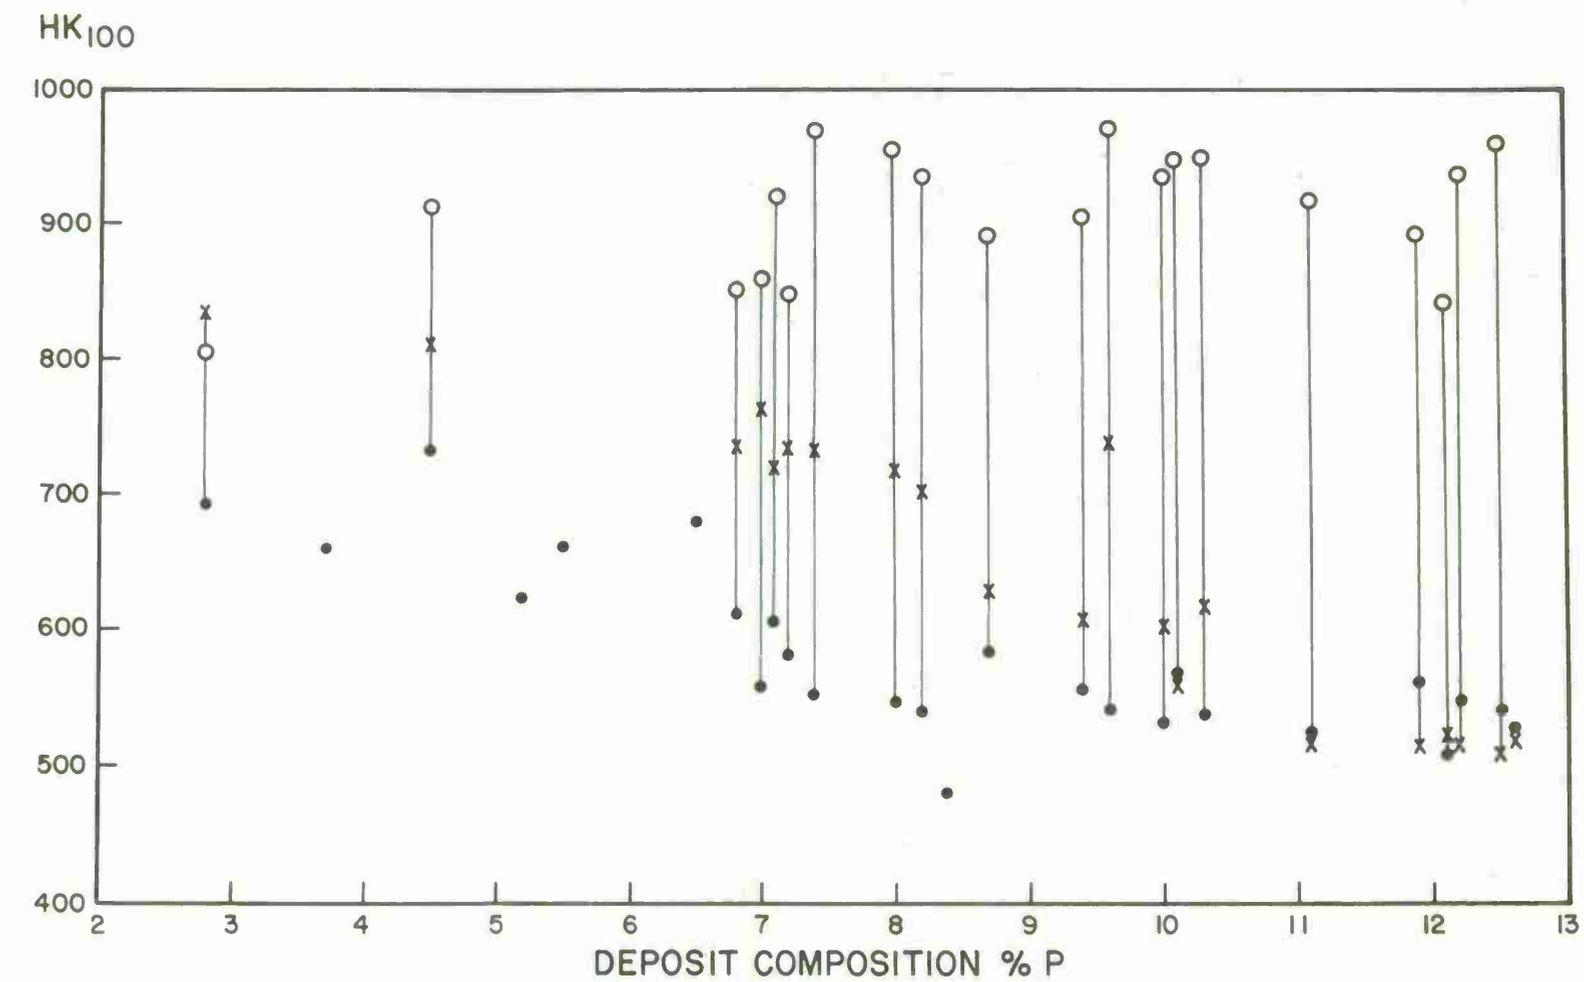
FIGURE 1

as-plated

x after 8 hours at 200°C

HARDNESS OF Ni-P ALLOY

The hardness data for the Ni-P alloys are summarized in Tables 2 to 7 and Figures 1-6. These data include hardnesses as-plated and after heat treatments of 1/2 hour to 9 days at temperatures of 100°C to 800°C. Also these data are for deposits from all the baths mentioned earlier and most of these had been operated at more than one composition and under several different operating conditions. Thus these data represent a variety of electroless Ni-P deposits.

The data of Table 2 and Figure 1 raise the question of what would the data look like after different heat treatment times. Was the hardening process complete? Consequently, data on hardness changes with heat treatment with time were obtained. Starting with storage at room temperature, 19-23°C, for two years, a decrease in hardness was observed for one low phosphorus specimen and no significant change for two others.

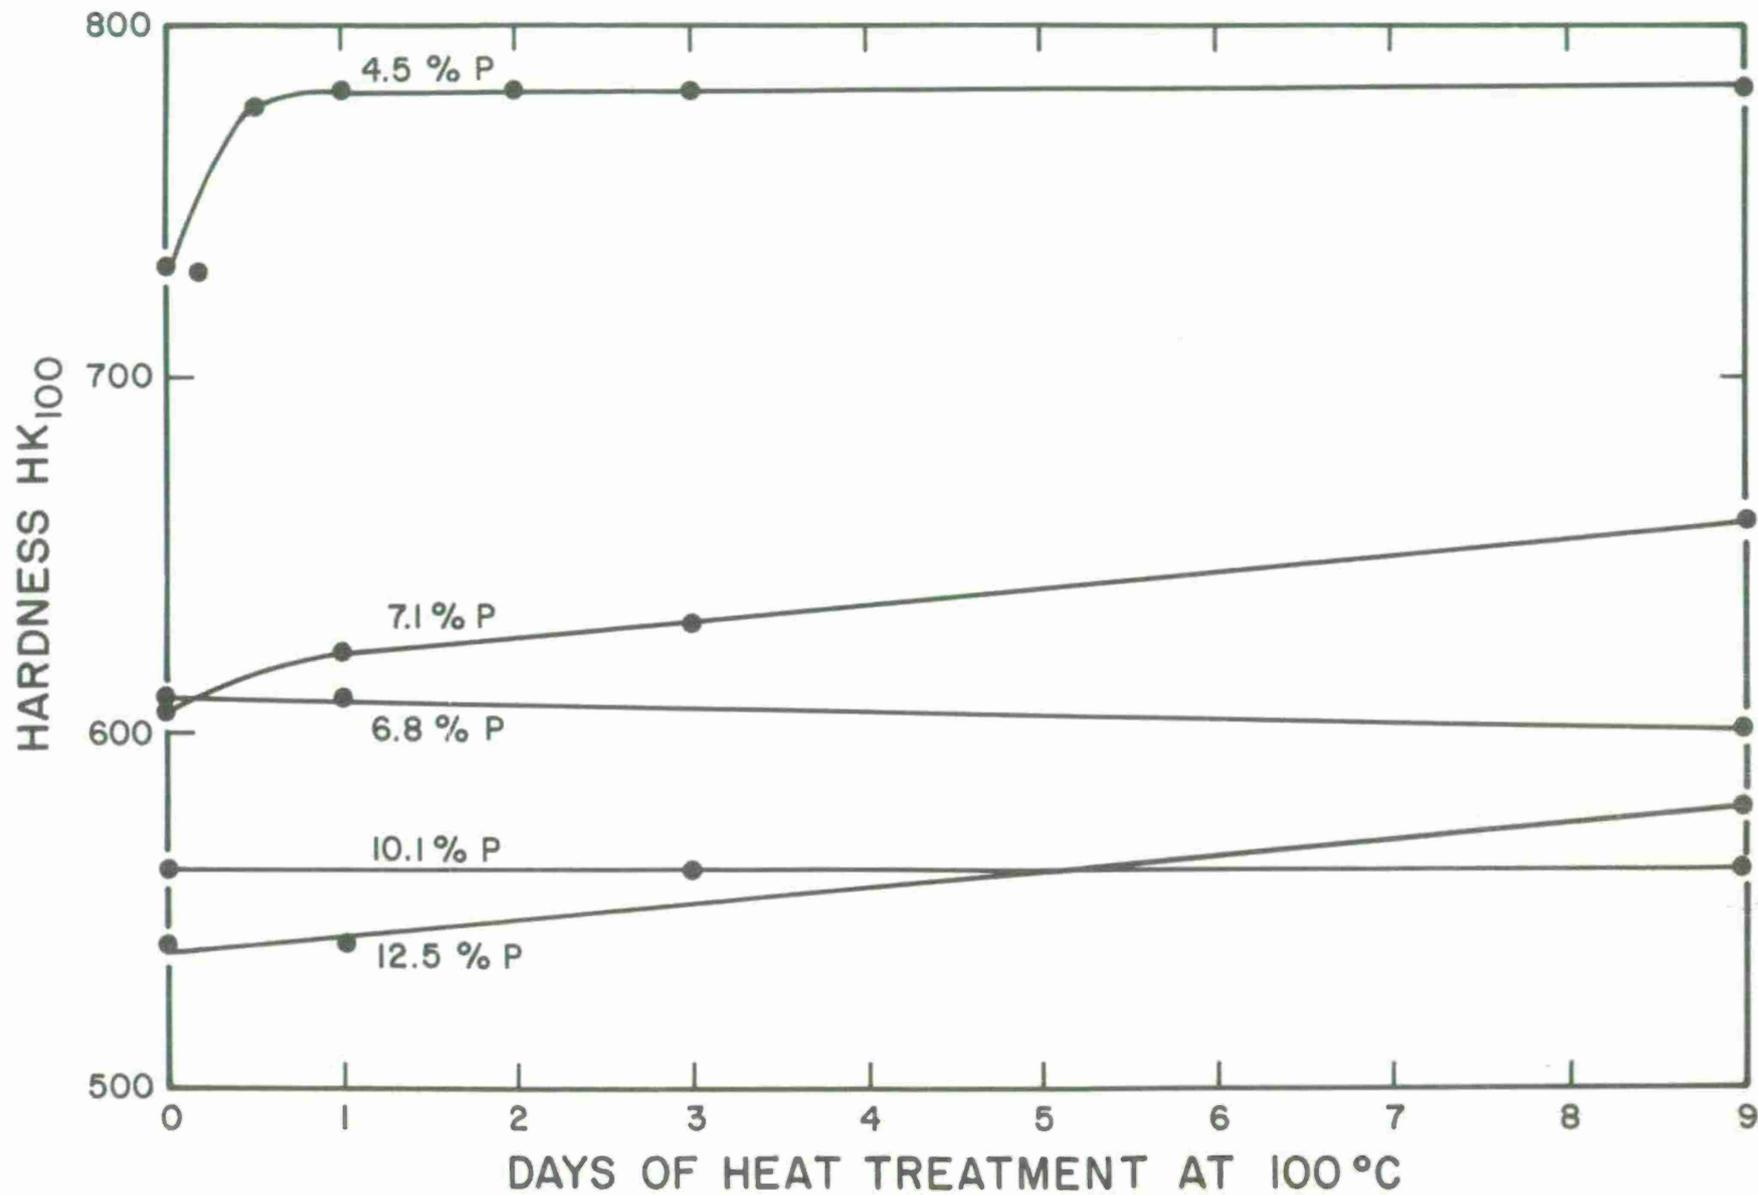
FIGURE 2

EFFECT OF DURATION OF HEAT TREATMENT AT $100^{\circ}C$ ON HARDNESS

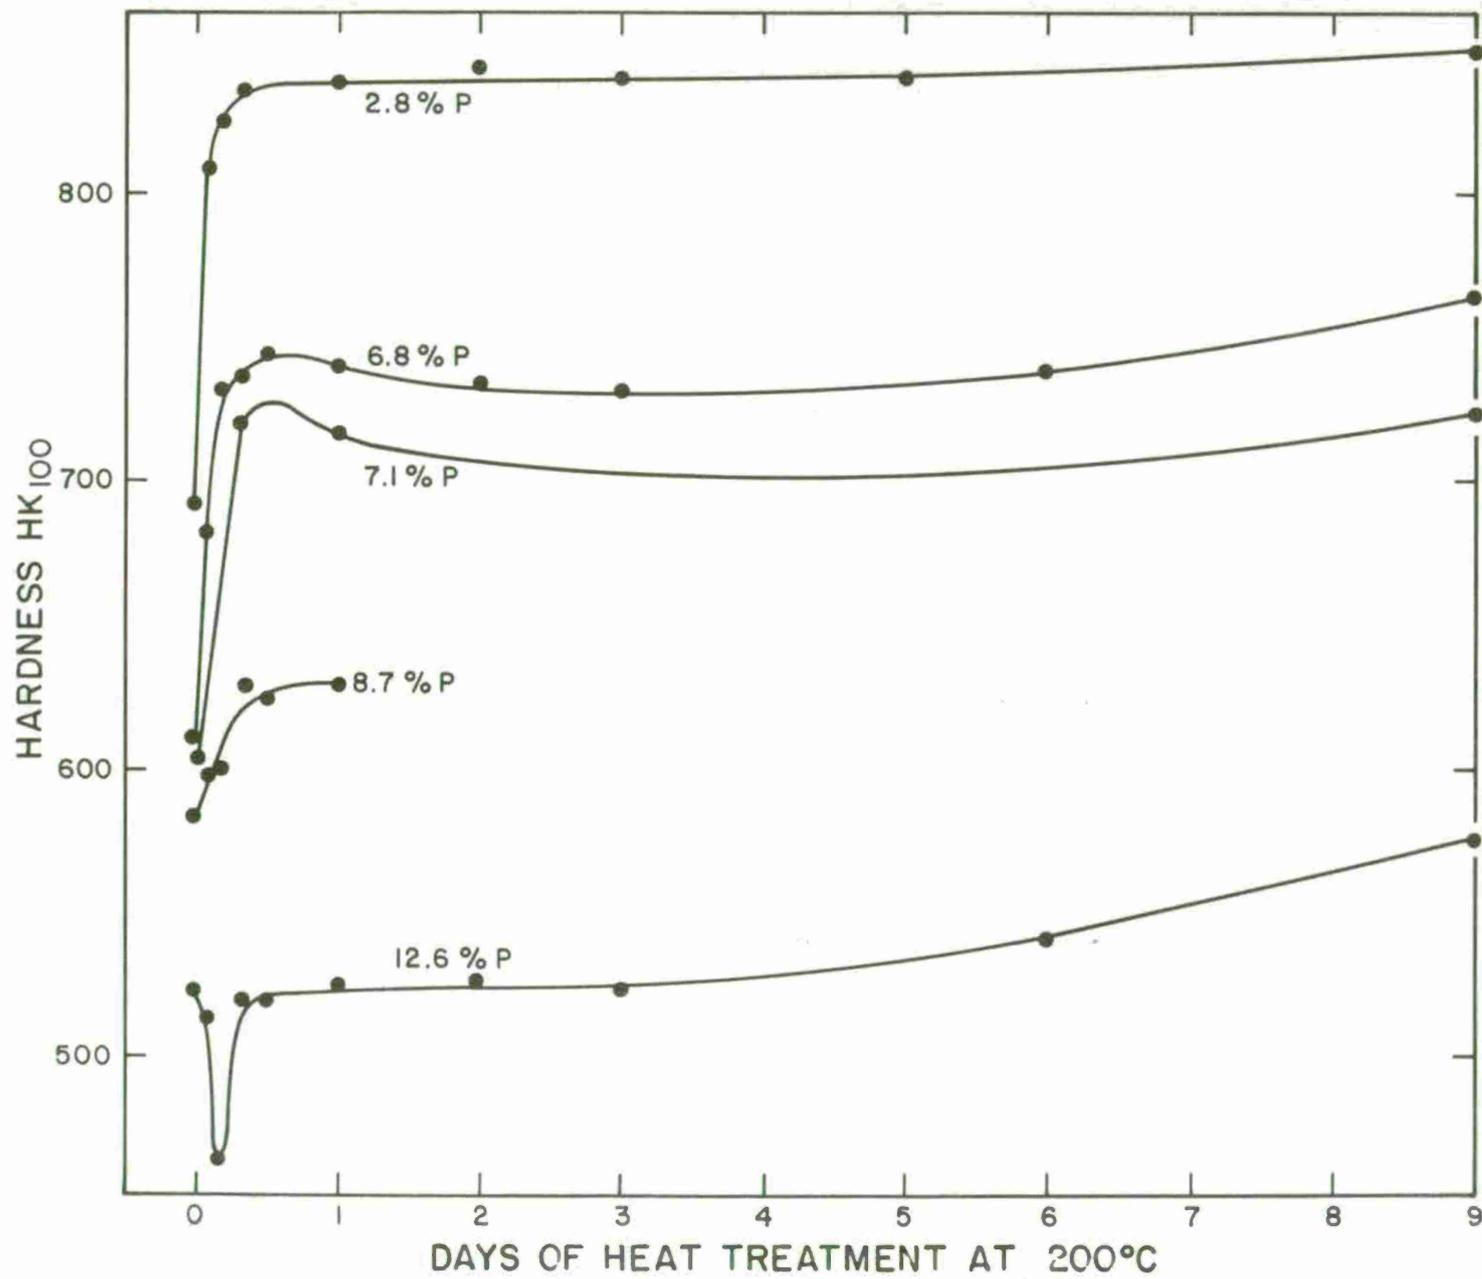
FIGURE 3

DAYS OF HEAT TREATMENT AT 200°C
EFFECT OF DURATION OF HEAT TREATMENT AT 200°C ON HARDNESS

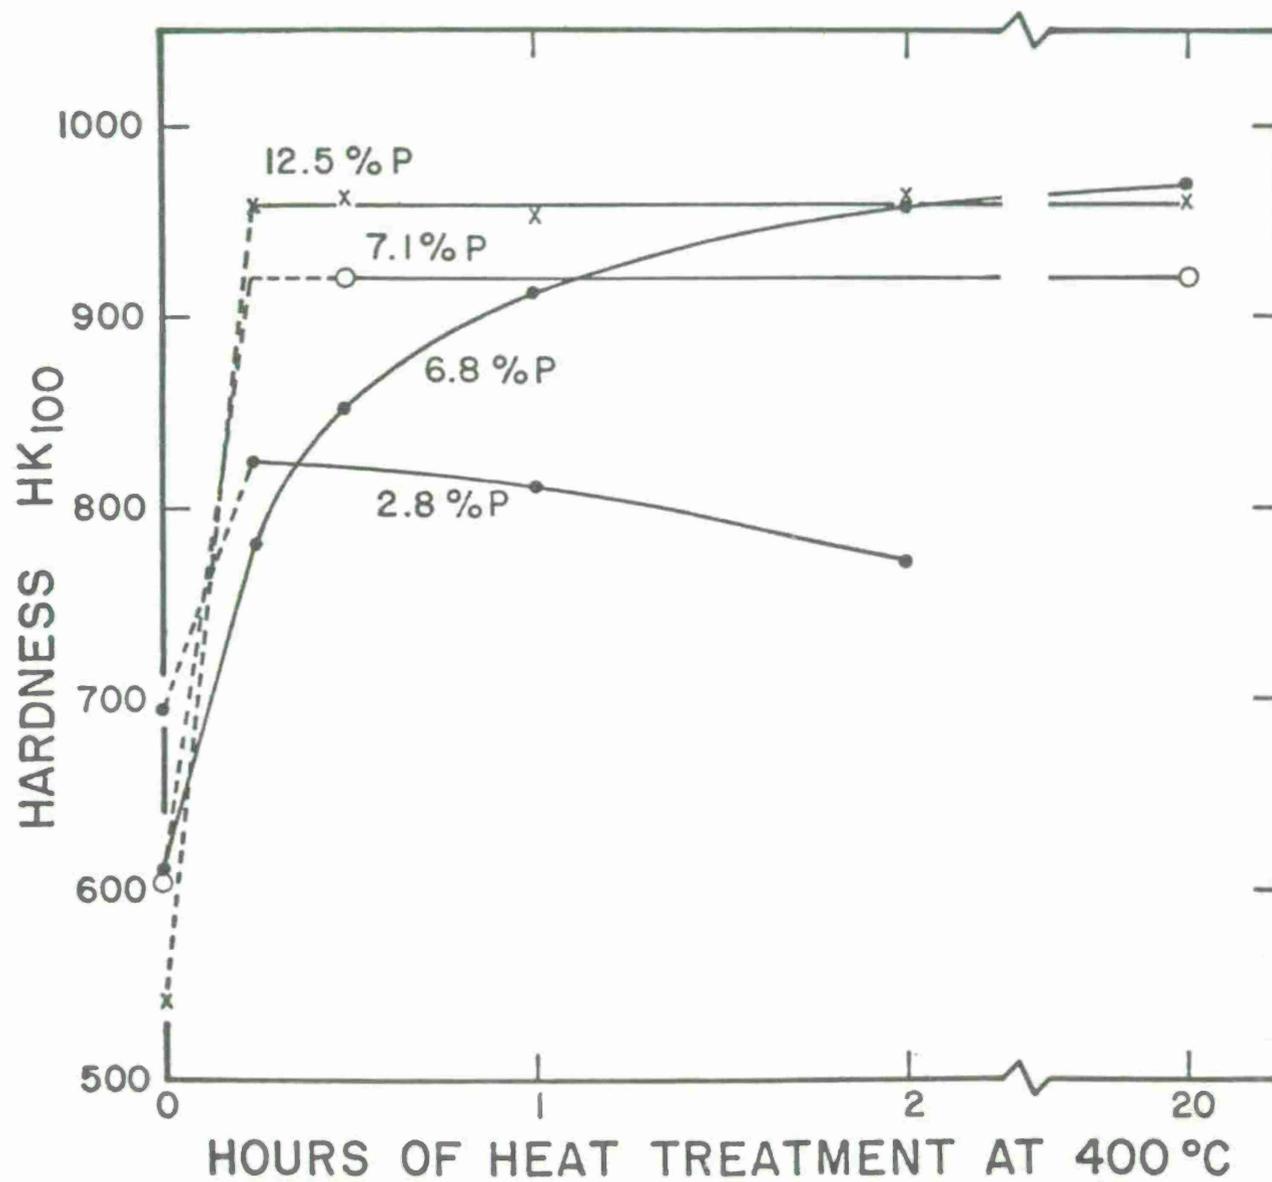
FIGURE 4

EFFECT OF DURATION OF HEAT TREATMENT AT 400°C ON HARDNESS

Data for hardness vs. time at 400°C are given in Table 5 and some of them are used to construct Figure 4. In Figure 4, where the 0 and 1/4 hour points are connected by straight lines, the hardness rapidly increases and then abruptly levels off or slowly decreases. We do not know where the break occurs. Higgs⁹ observed that this break occurred within five minutes or perhaps even one minute. Two of the deposits with 4.5 and 6.8%P did not show that abrupt change, but continued to increase in hardness for at least two hours. Again it is apparent that the properties of electroless nickel do not depend solely on phosphorus content.

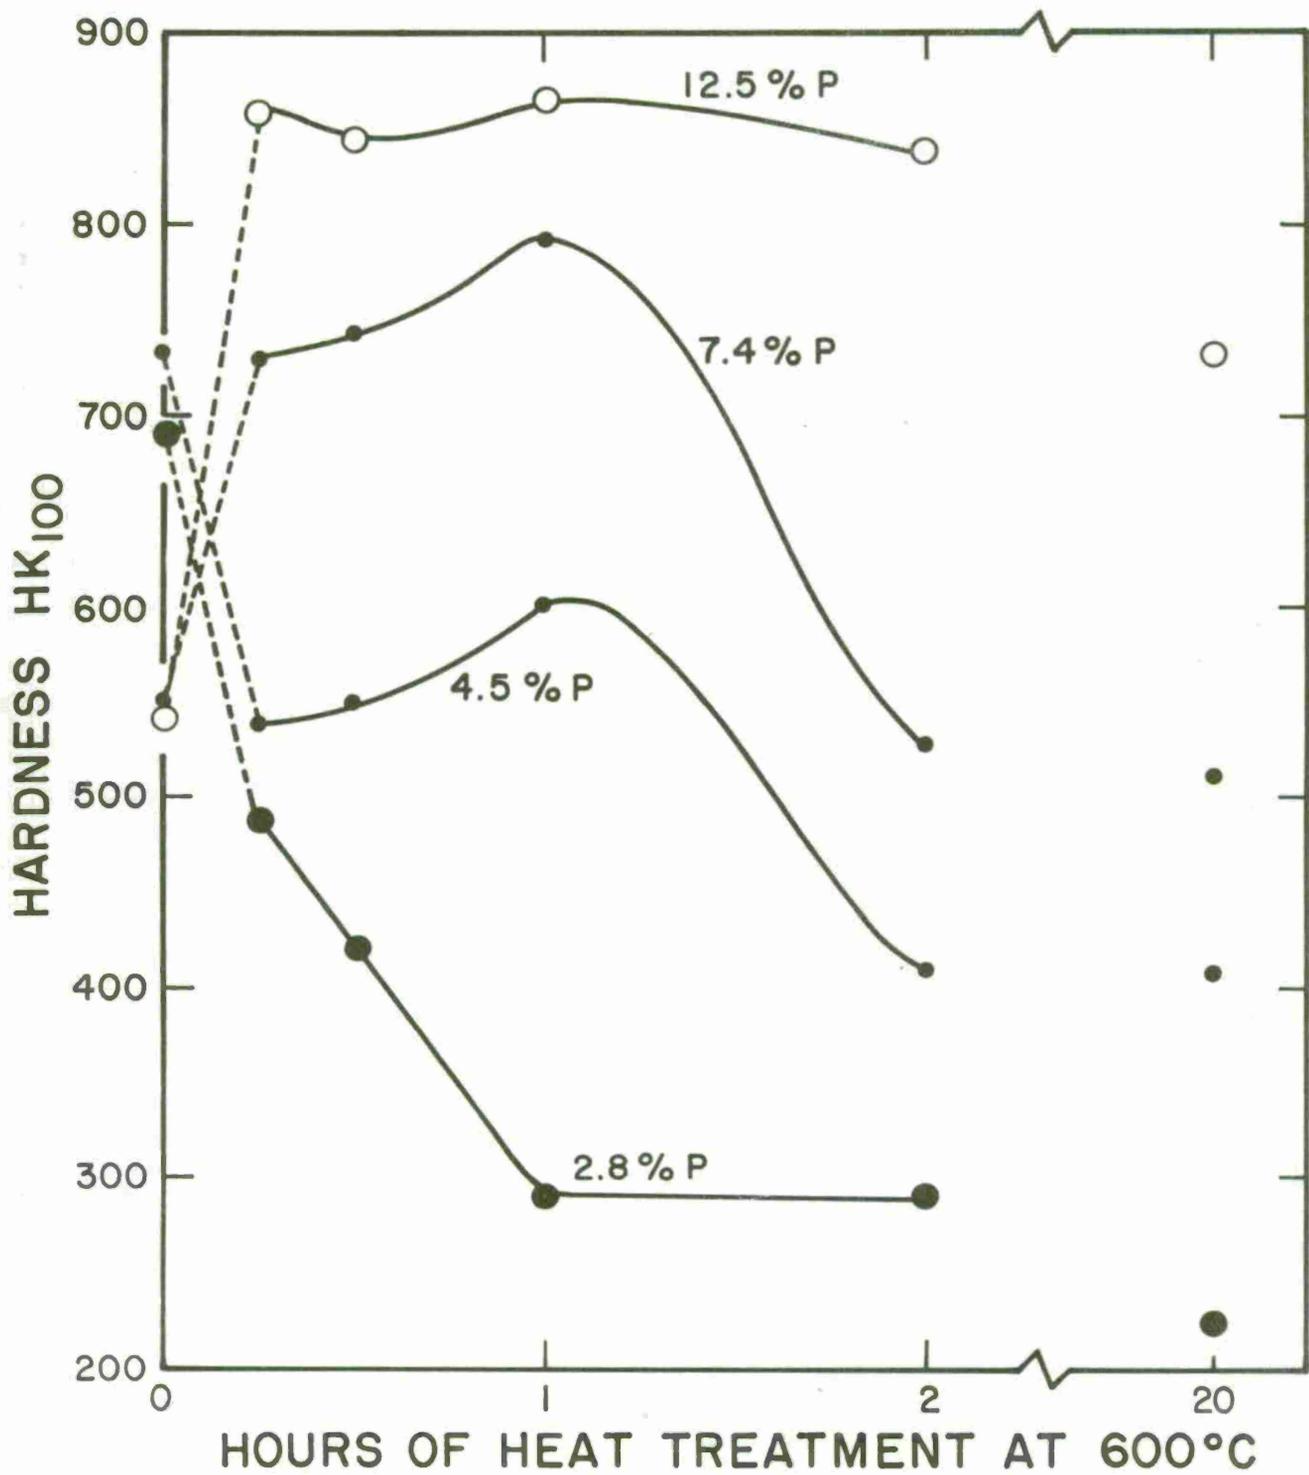
FIGURE 5 EFFECT OF DURATION OF HEAT TREATMENT AT 600°C ON HARDNESS

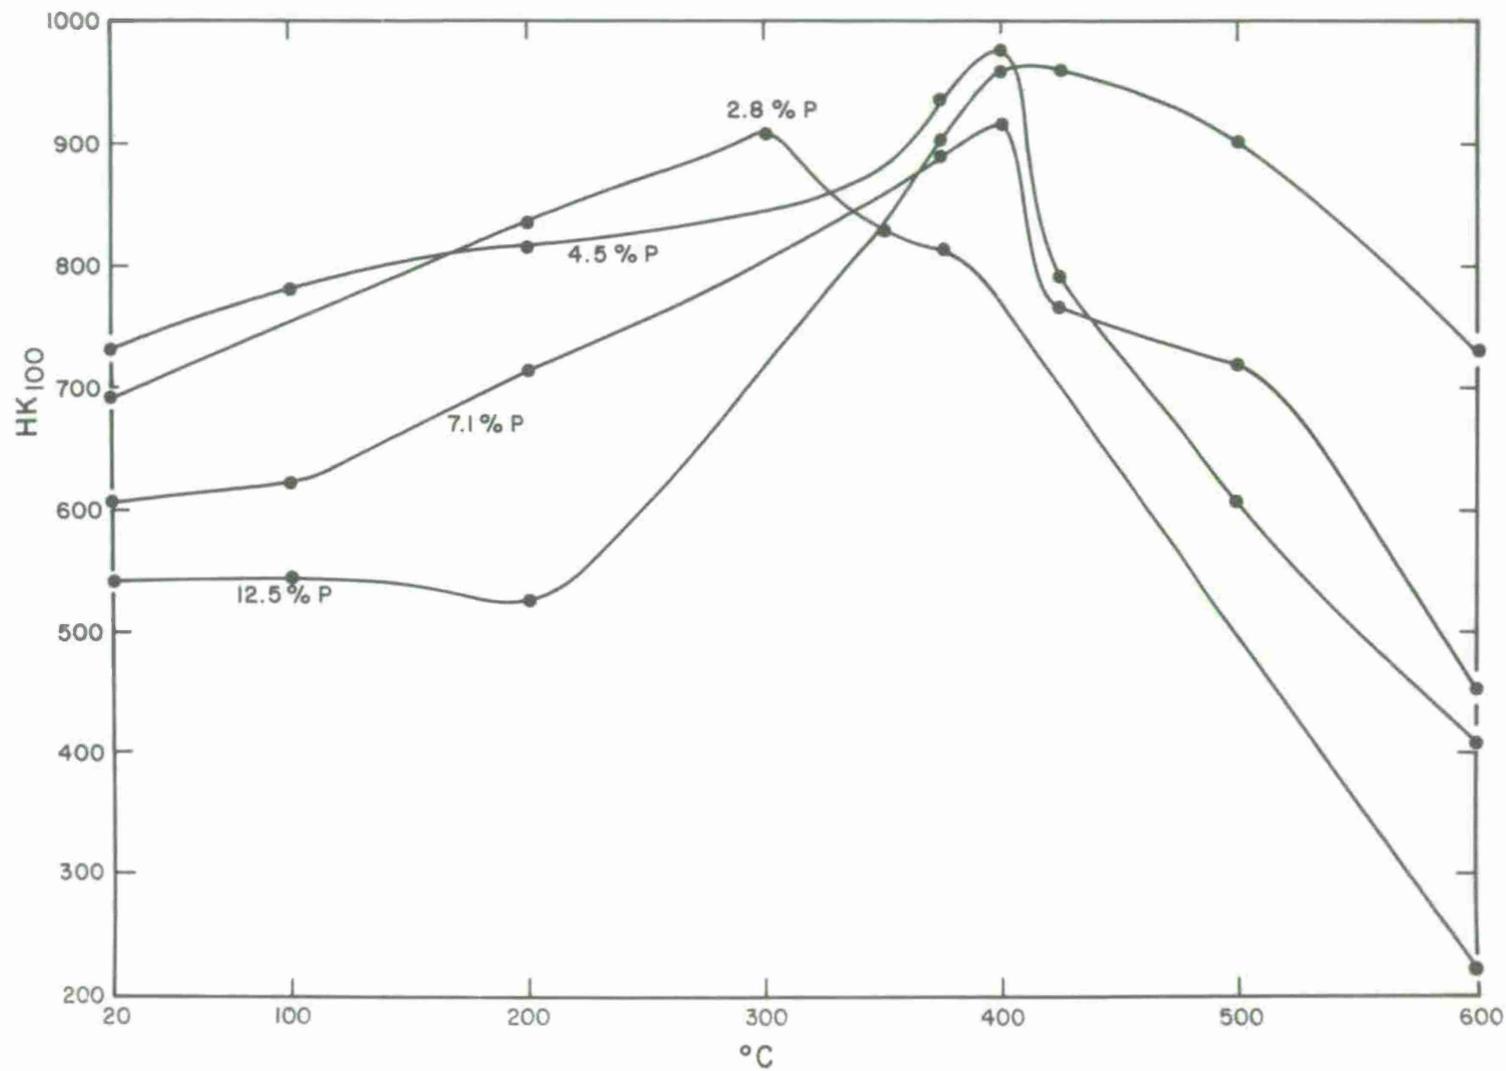
FIGURE 6

HARDNESS vs. TEMPERATURE OF HEAT TREATMENT
24 Hours at 100°C and 200°C
20 Hours at 300°C - 600°C

The curves of Figure 6 are reminiscent of, but substantially different from, those published by Gutzeit and Mapp,¹⁰ Baldwin and Such,¹⁰ and Higgs⁹ for one hour heat treatments of specimens with 8 to 9% phosphorus. The differences are attributable to the duration of heat treatment, phosphorus content, and, more importantly, the conditions of deposition. Of practical significance is the temperature of maximum hardness and how critical the temperature is. Gutzeit and Mapp¹⁰ and Higgs⁹ gives the temperature for maximum hardness at 400°C. Baldwin and Such¹⁰ found it to be nearer 350°C. Our data shows a maximum nearer 300°C for 2.8%P, but within $410 \pm 15^\circ\text{C}$ for deposits of the higher phosphorus contents. The sharp drop off of hardness with temperatures could change the hardness substantially. With one hour treatments, this hardness decrease seems to be less severe, but still could be significant. If the heat treatment temperature is to be designated in procurement specifications, the danger of going to too high a temperature should be considered. It would be advisable to determine the minimum temperature at which a sharp drop can occur.

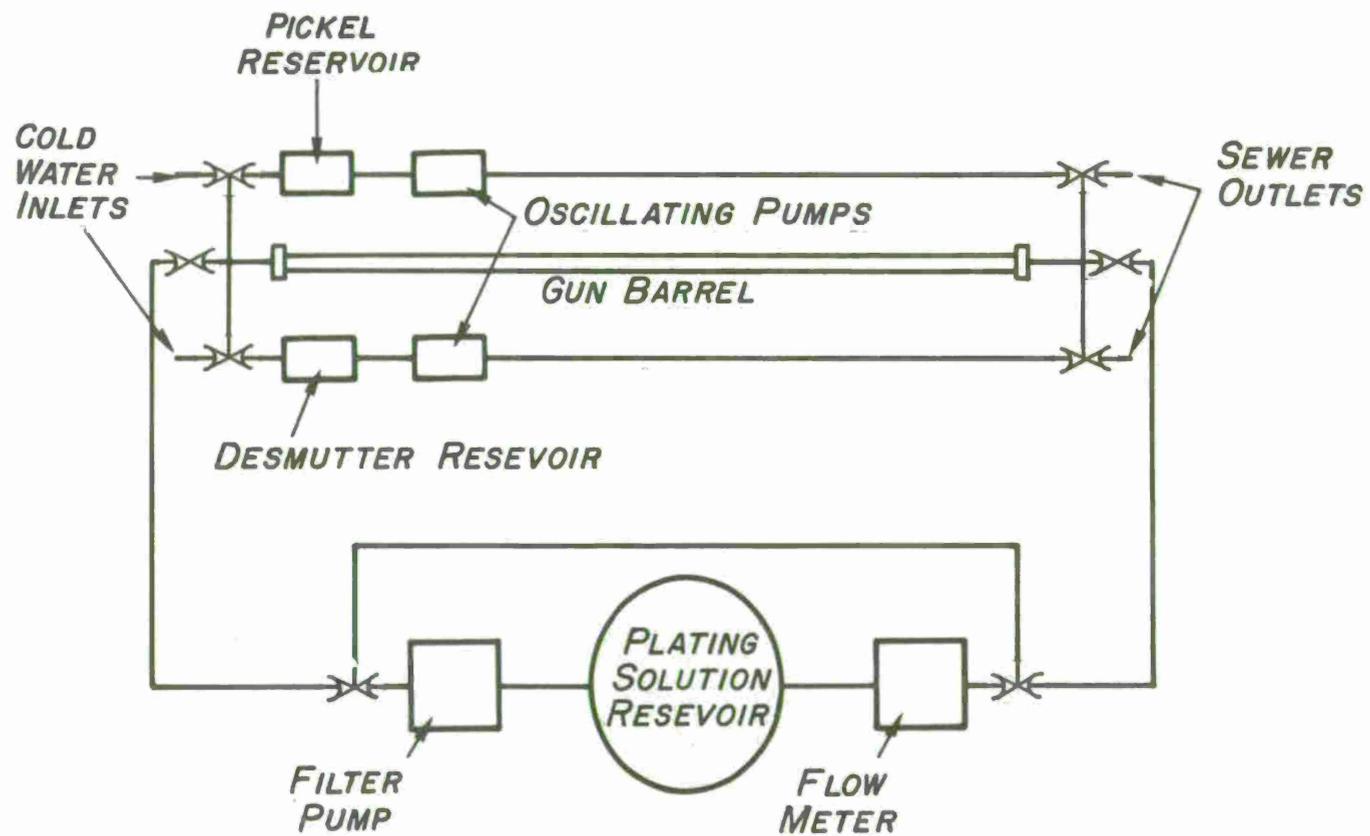
FIGURE 7

DIAGRAM OF EQUIPMENT FOR PLATING TUBE BORES

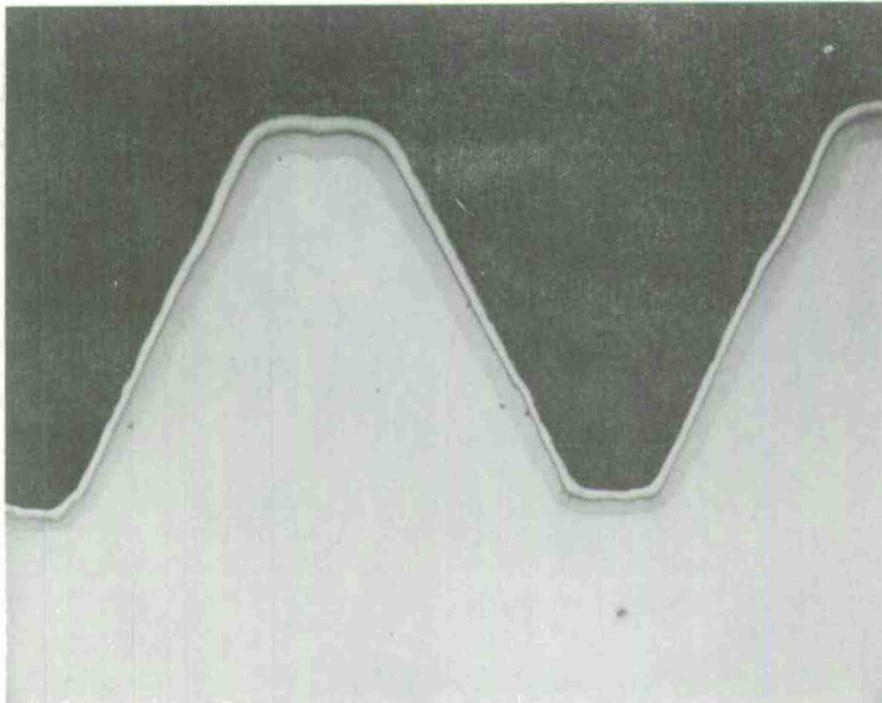
FIGURE 8 PHOTOMICROGRAPH OF CROSS SECTION OF BRASS BOLT PLATED WITH ELECTROLESS NICKEL IN BRENNER BATH WITHOUT AGITATION AT 0.6 MIL/HR. OVERPLATED WITH NICKEL. 90X PEAK TO VALLEY THICKNESS RATIO IS 2.

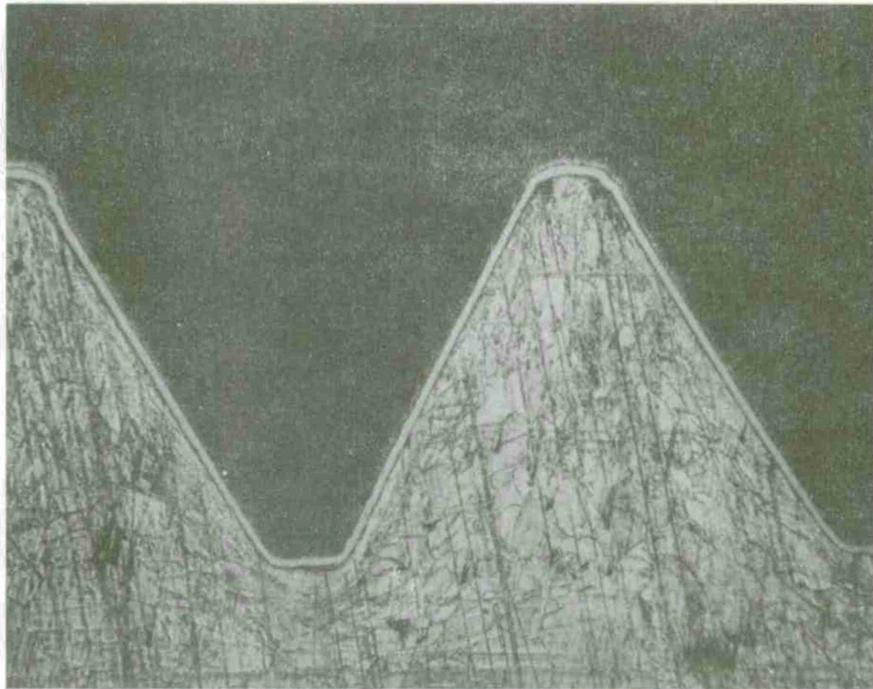
FIGURE 9 PHOTOMICROGRAPH OF CROSS SECTION OF BRASS BOLT PLATED WITH ELECTROLESS NICKEL IN BATH A WITHOUT AGITATION AT 0.2 MIL/HR. OVERPLATED WITH NICKEL. 90X PEAK TO VALLEY THICKNESS RATIO IS 1.2

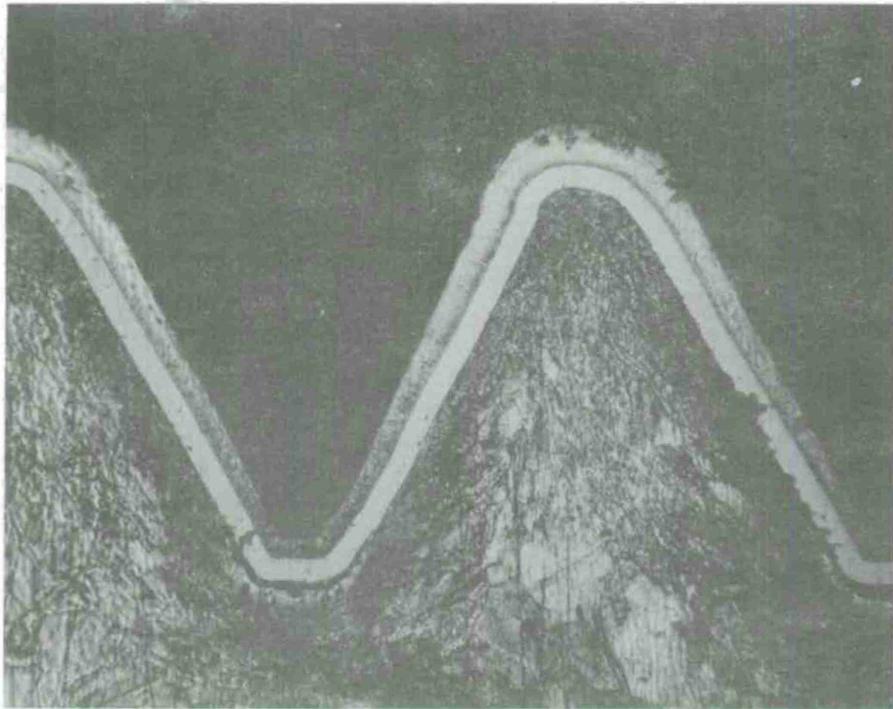
FIGURE 10 PHOTOMICROGRAPH OF CROSS SECTION OF BRASS BOLT PLATED WITH ELECTROLESS NICKEL IN BATH A WITH AGITATION AT 0.6 MIL/HR. OVERPLATED WITH NICKEL. 90X PEAK TO VALLEY THICKNESS RATIO IS 1.01

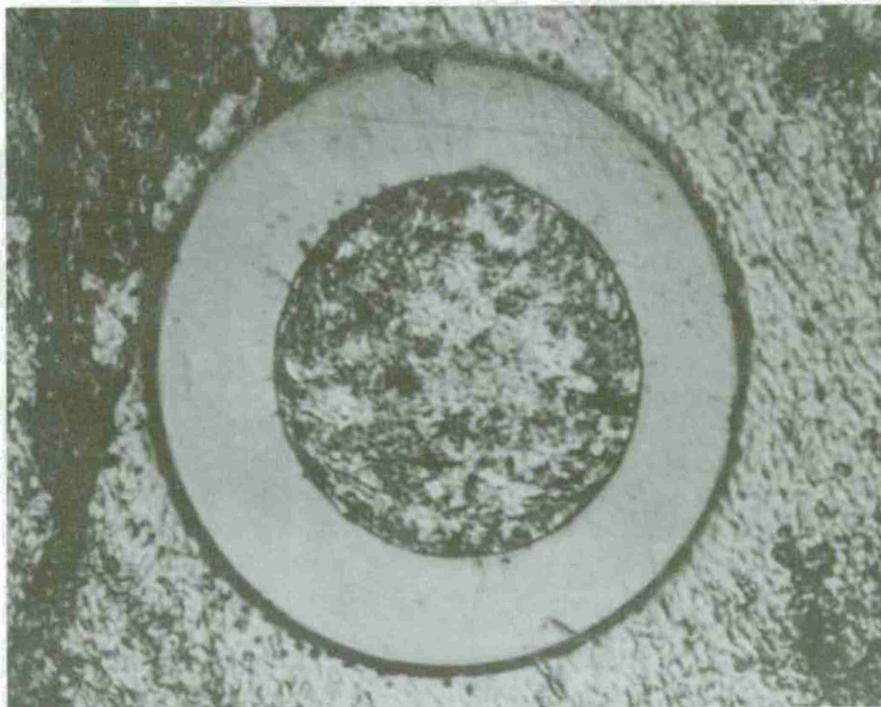
FIGURE 11 PHOTOMICROGRAPH OF CROSS SECTION OF 4 MIL COPPER WIRE PLATED
WITH ELECTROLESS NICKEL IN BATH A WITH AGITATION AT 0.6 MIL/HR.
OVERPLATED WITH NICKEL. 470X
MAXIMUM THICKNESS RATIO IS 1.25

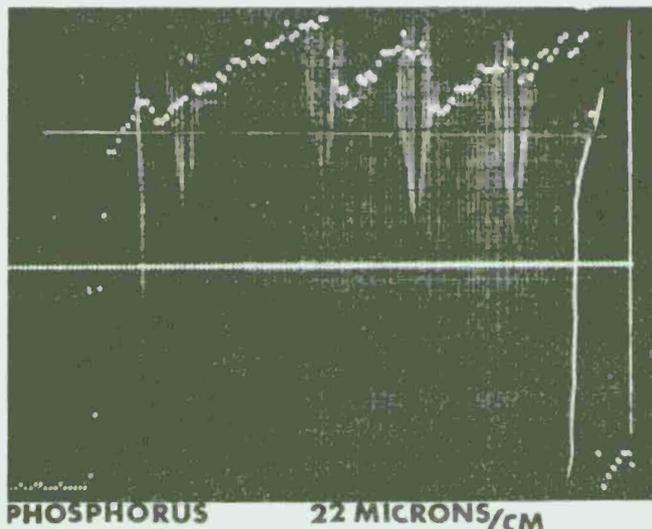
Fig. 2. Electron probe trace of phosphorus content across cross section of electroless nickel deposit. Zero per cent phosphorus is indicated by white dots in lower left corner. Maximum value is about 8 wt per cent phosphorus. Row of dots across center indicates position of each measurement.

Each of these values for phosphorus had, before rounding, a standard deviation of 0.7 per cent of the phosphorus concentration. Comparing these data with Fig. 1 shows again the inverse relation of phosphorus content with depth of etching.
