# NAVAL POSTGRADUATE SCHOOL Monterey, California

## THESIS

Type 1 Hot Corrosion Furnace Testing  
and Evaluation

October 1982

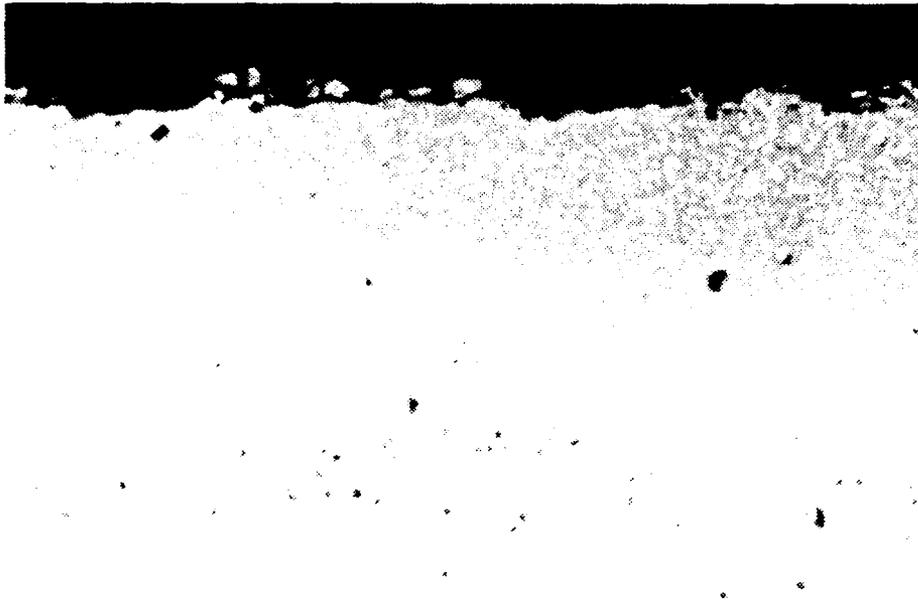
Figure 1. Typical Inward Aluminide Coating (650X).

The corrosion of the IN 738 aluminides tested varied from poor to excellent. The simple aluminides failed in under 500 hours of exposure. The corrosion rates obtained for both the inward and outward aluminides were as severe as in the uncoated IN 738, but are not truly indicative of the hot corrosion resistance of these aluminide coatings. Since the coatings were penetrated and consumed relatively early, the corrosion of the inner diffusion zone and substrate cannot be directly correlated with corrosion of an uncoated alloy. The inward aluminide coating had an original thickness of 4 mils and was penetrated after 300 hours of exposure. The higher aluminum content outward aluminide was originally 2

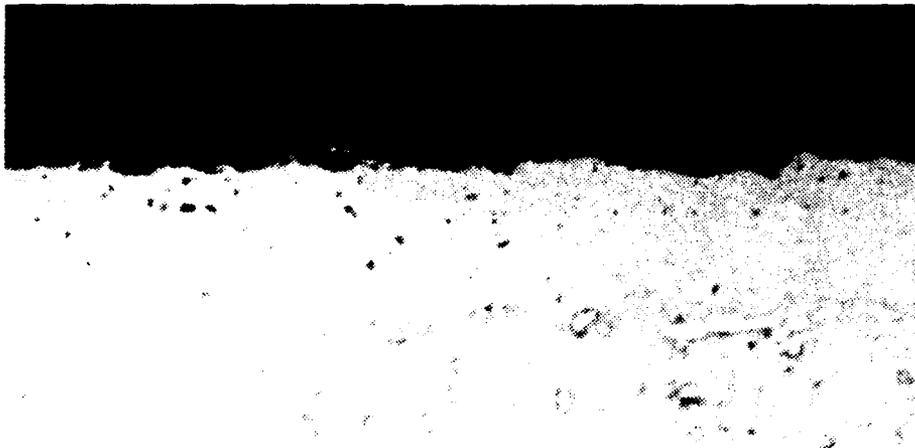
Figure 2. Typical Outward Aluminide Coating (650X).

mils thick and was not penetrated until after 350 hours of exposure. In view of this, the outward aluminide was more corrosion resistant than the inward aluminide coating under type 1 conditions.

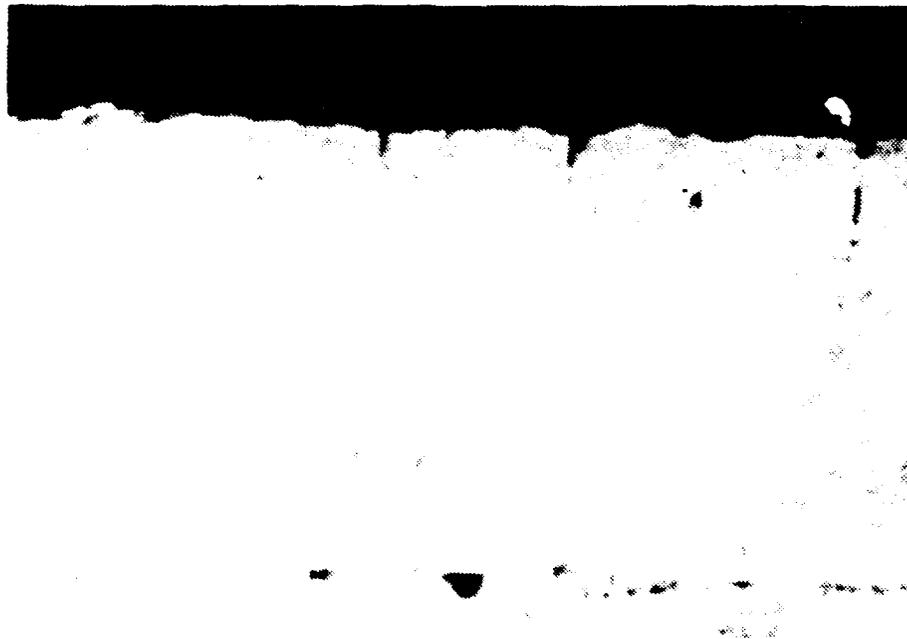
Figure 3. Typical CoCrAlY (BC 21) Overlay Coating, 650X, unetched.

For example, the cobalt base BC-21 coating used on the first and second stage blades of the LM 2500 engine has a high chromium content, 20-24%, to increase hot corrosion resistance. This high chromium necessitates a lower aluminum content, 10-12%, to maintain sufficient ductility and adequate thermal fatigue. In contrast, the cobalt base ATD-6 (Airco Temescal) coating is used on the first stage blades of the AV8A Harrier engine. This blade requires a very ductile coating to combat the thermal fatigue caused by the high temperature cyclic operation of the engine. Accordingly, its composition is 18% chromium and 8% aluminum. As a result, the hot corrosion and oxidation resistance is less than that of BC 21 but the environment is less corrosive and the required life time is much less than that of the LM 2500.

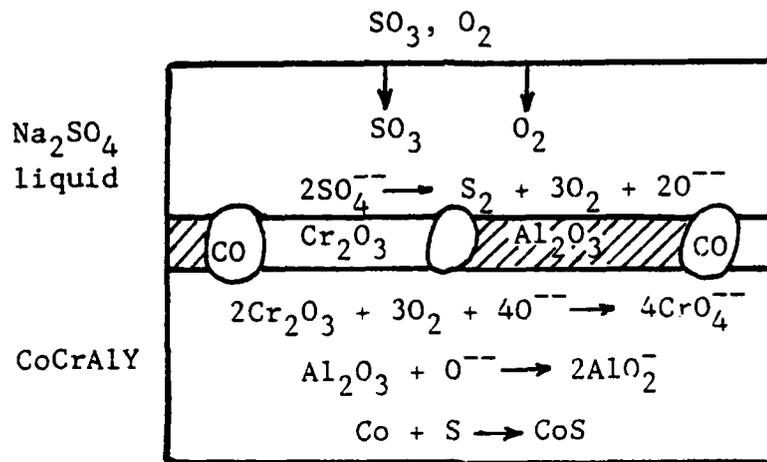
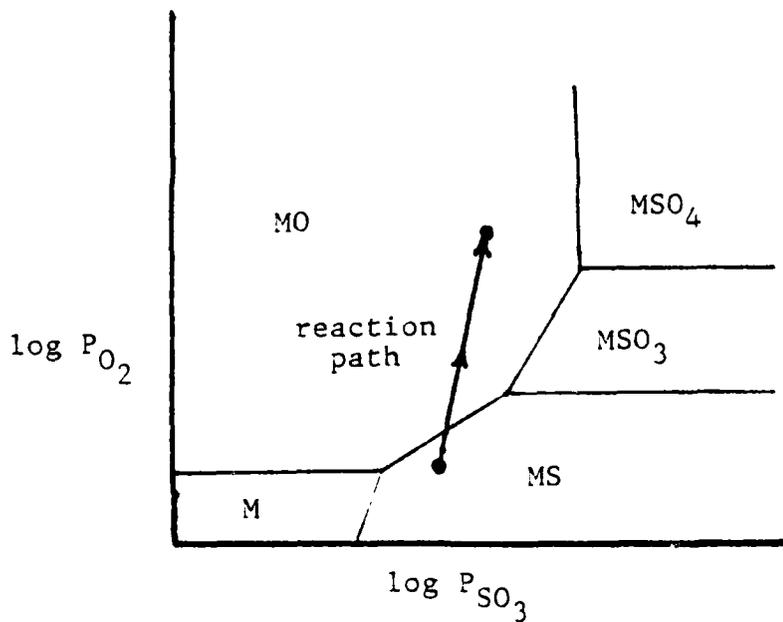
(a) Type 1 hot corrosion reactions

(b) Stability Diagram

Figure 4. Schematic diagram to illustrate type 1 hot corrosion

The type 1 hot corrosion degradation morphology is shown schematically in Figure 4. Due to the molten salt film and the partial pressure gradients of  $O_2$  and  $SO_3$ , the low partial pressure of  $O_2$  at the molten salt/protective oxide interface causes the following reactions to occur:

Gas composition encompasses two variables, partial pressures of  $O_2$  and  $SO_3$ , which are critical to both the type of attack and the rate of attack. As can be seen from the stability diagram of Figure 4, the partial pressure gradients across the molten salt layer determine the degradation mechanism. Although type 1 and type 2 hot corrosion are identified by temperature range, it is possible to have type 2 hot corrosion at higher temperatures if sufficient  $SO_3$  partial pressure is present. Efforts to accelerate type 1 hot corrosion by increasing  $SO_3$  partial pressure is limited by this fact. The  $SO_3$  partial pressure is also inversely related to temperature such that for a given  $SO_2$  input rate, the  $SO_3$  partial pressure can be increased by decreasing the temperature.

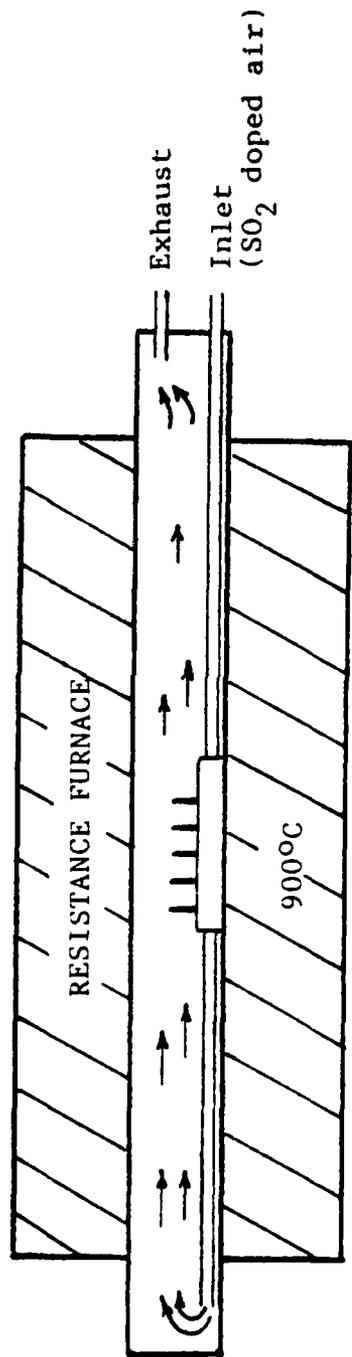
Specimens with Na<sub>2</sub>SO<sub>4</sub> salt coating

Figure 5. Cross Section of a Tube Furnace.

The necessity for understanding the basic mechanisms of hot corrosion led to development of laboratory furnace tests. These tests incorporate only the significant variables necessary to produce the phenomenon: temperature,  $\text{SO}_3$  partial pressure, salt amount, and composition. A furnace test which not only meets this requirement but also provides a simple means of assessing the hot corrosion resistance of materials, as does the burner rig, has been developed and is the major concern of this thesis. Furnace tests are significantly less expensive, often of shorter duration and allow precise control of the specific parameters. These factors make the furnace test more suited to university programs. The tube furnace design used at the Naval Postgraduate School is shown in Figure 5.

Compressed air is regulated and passed through moisture indicating "drierite" desiccant at a rate of 2000 ml/min. The air is mixed with  $\text{SO}_2$  at a flow rate of 20 ml/min to produce a mixture containing 1% by volume and gas velocity of 1 cm/sec over the test specimens. The air mixture enters the furnace through a stainless steel tube and flows the length of the furnace in the tube to preheat the gas mixture prior to flowing back over the specimens. The air is finally exhausted into a fume hood.

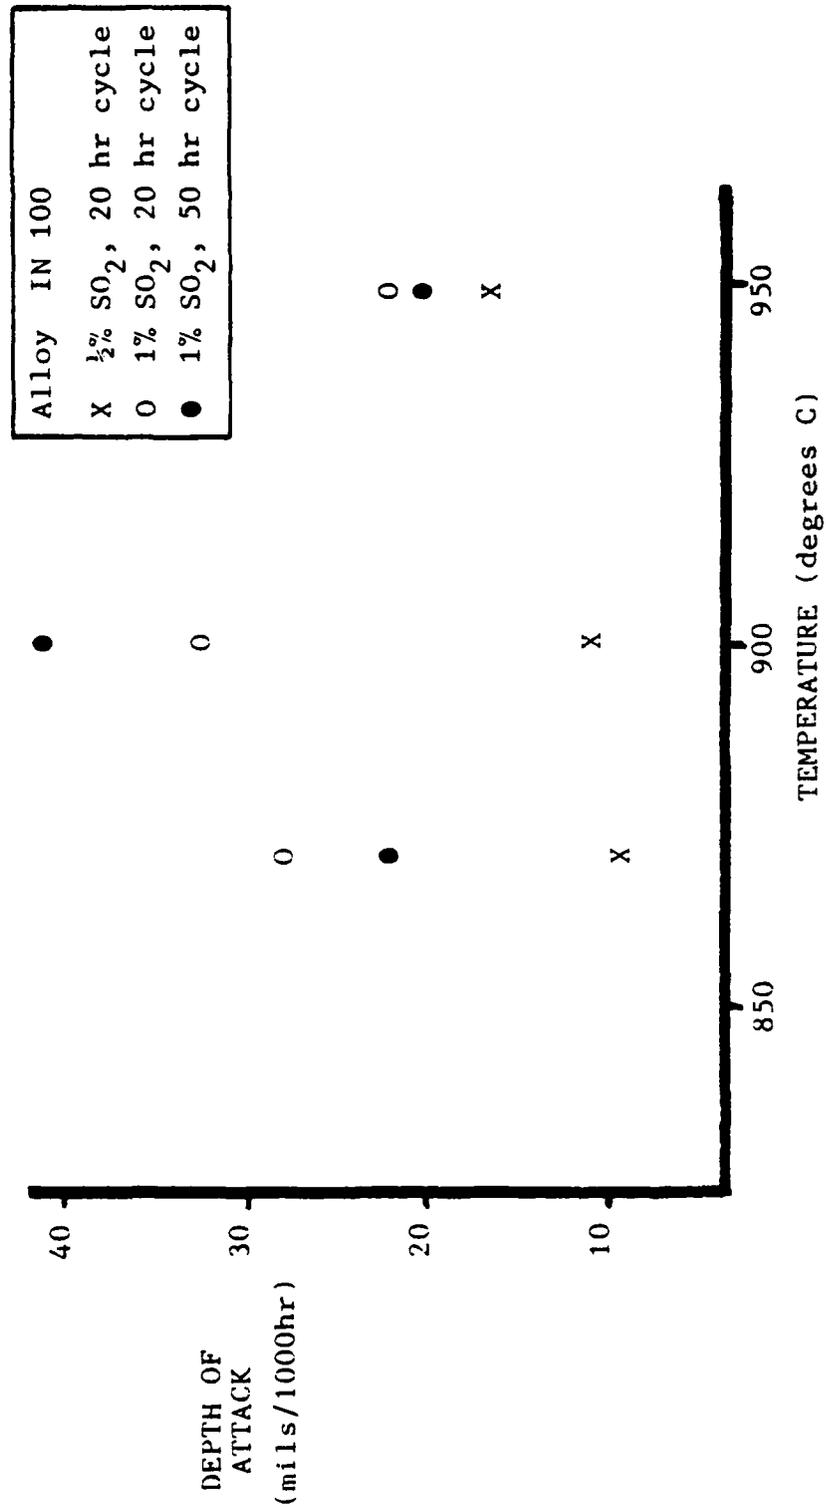
CORROSION RATES VS. CORROSION FACTORS

Figure 6. Corrosion Rates of Uncoated IN 100 with varying Furnace Test Parameters.

The primary variables in the tube furnace test are temperature, percent SO<sub>2</sub> gas, amount of NaSO<sub>4</sub> coating, cycle time and total exposure time. Using IN 100 as a standard, because of its poor corrosion resistance, several short term test runs were made varying these parameters to determine the values which would produce the most aggressive type 1 attack. From these results given in Figure 6, 900°C and 1% SO<sub>2</sub> were chosen as test values.

Figure 6 indicated an increase in corrosion rate with increased volume percent  $\text{SO}_2$ , as predicted. To assure type 1 hot corrosion morphology in the tests, 1%  $\text{SO}_2$  was the maximum value used even though the corrosion rate should be more aggressive above this value.

A maximum in corrosion rate vs. temperature is also seen in Figure 6. This maximum occurring at approximately  $900^\circ\text{C}$  is important in lending credence to the tests. The peak is associated with the most viscous, adherent form of the molten  $\text{Na}_2\text{SO}_4$  layer. At temperatures below  $900^\circ\text{C}$ , pure  $\text{Na}_2\text{SO}_4$  is solid ( $T_m=886^\circ\text{C}$ ) and at temperatures above  $900^\circ\text{C}$  the salt becomes less viscous and does not adhere to the surface [Ref. 18].

Figure 6 provides no direct correlation between corrosion rate and cycle time. It would be expected that increased corrosion would occur with shorter more numerous cycles. The IN 100 used for these tests produced a very thick, heavy scale and the oxides formed were not protective. With more corrosion resistant alloys, and particularly coatings, the effects of cycle time will vary with the tenacity of the oxide formed. A 50 hour cycle time was chosen for use in this study for further testing to maintain simplicity in the test.

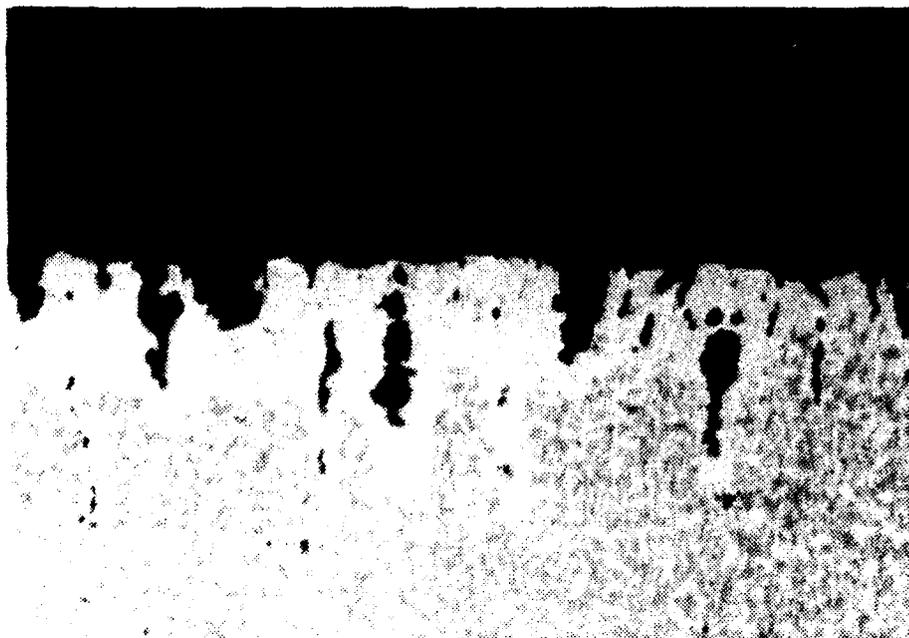
Figure 7. Type 1 Hot Corrosion in CoCrAlY (BC 21) Coating (500 Hours at 900° C), 650X, unetched.

Upon completion of the 500 hour furnace test of the alloys and alloy/coating systems listed in Table 1, the specimens were examined to verify type 1 hot corrosion as the mode of the attack and ranked by their relative corrosion resistance. Microscopic examination of a standard CoCrAlY specimen (IN 738 with BC 21 coating) revealed the occurrence of type 1 hot corrosion. A single phase aluminum-depleted layer beneath the oxide scale forms within the coating with type 1 hot corrosion of CoCrAlY. This single phase layer

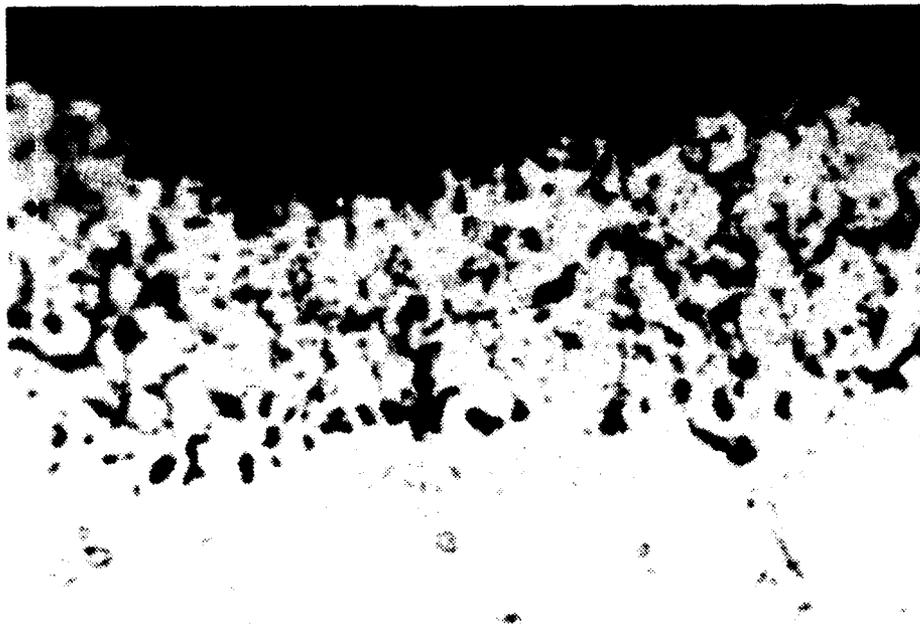
Figure 8. Type 1 Hot Corrosion in Uncoated IN 100 (500 Hours at 900°C), 650X, unetched.

To further verify the aluminum depletion zone indicative of type 1 hot corrosion, electron back-scatter images of the CoCrAlY specimen were taken under a scanning electron microscope. Figures 8 through 10 are examples of the corrosion morphology observed in other specimens tested. All specimens underwent what appeared to be type 1 hot corrosion degradation.
