Structures Technical Memorandum 361

AIRCRAFT FATIGUE - WITH PARTICULAR EMPHASIS ON
AUSTRALIAN OPERATIONS AND RESEARCH

J.Y. MANN

APRIL, 1983

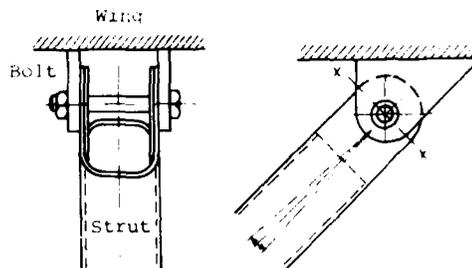
FIG. 3(b) DORNIER "MERKUR" WING/STRUT ATTACHMENT (Ref.)

of-balance oscillator should be mounted on the wing to reproduce slipstream induced vibrations. However, it was the tragic crash with the loss of six lives of a Dornier Merkur high-wing monoplane (Fig. 3(a)) of the German airline Lufthansa near Schleiz in Eastern Germany in September 1927^{28,29} which focussed attention on fatigue as being a potential problem in aircraft structures. This accident, which resulted from the failure of a wing to strut fitting (Fig. 3(b)), led to an extensive program of research at the Deutsche Versuchsanstalt fuer Luftfahrt (DVL) in Berlin²⁹ on the fatigue of full-scale wing spars made of wood, steel and duralumin²³. On 17 June 1929, the 'City of Ottawa'^{*}, a Handley-Page W.10 aircraft operated by Imperial Airways, was lost in the English Channel together with seven lives as the result of the fatigue failure of an engine connecting rod stud³⁰; and on 27 July 1934 a Swissair Curtiss Condor biplane crashed near Tuttelingen in Germany with the loss of eleven lives³¹ because of the failure of a wing strut. These accidents provided further evidence that the aircraft fatigue problem was not under control.

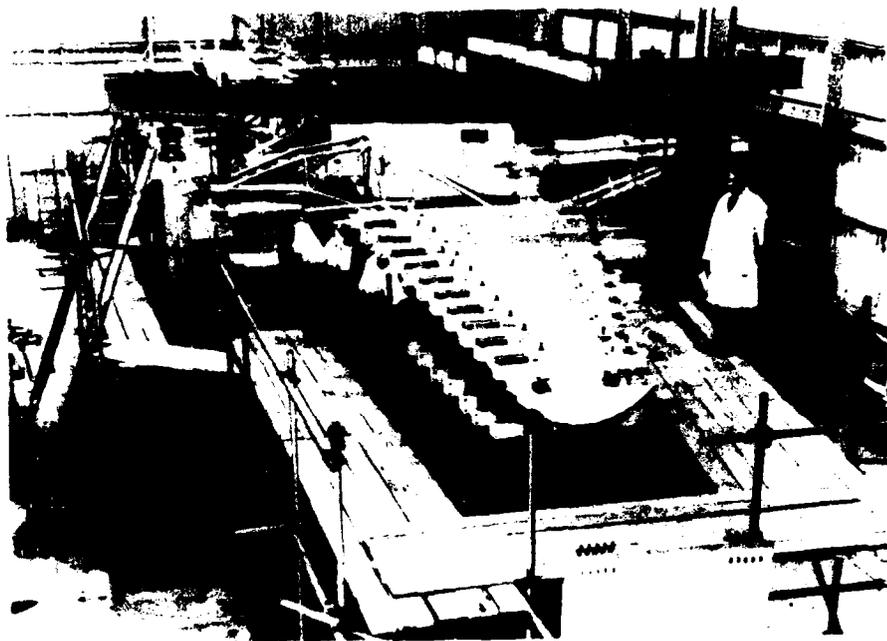
FIG. 4 "MOSQUITO" WING TEST RIG

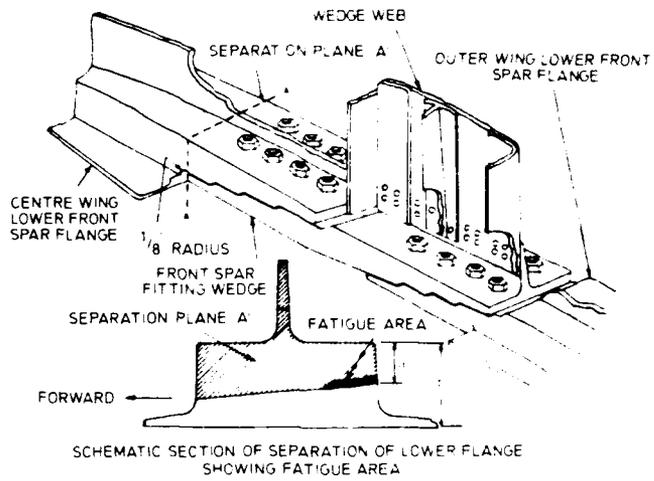
FIG. 7 MARTIN 2-0-2 WING ROOT FITTING FATIGUE FAILURE (Ref.)

On 29 August 1948 the crash of a Northwest Airlines Martin 2-0-2 near Winona, Minnesota after only 1321 flying hours with the loss of 37 lives was apparently the first major aircraft accident in the United States resulting from structural fatigue failure. This resulted from extensive fatigue cracking in the lower boom of the front spar of the port wing at a joint between the centre section and outer wing⁹⁷⁻⁹⁹ as shown in Fig. 7. Although it was reported that the aircraft which crashed was flying through a severe thunderstorm at the time, fatigue cracks were subsequently found at similar locations in the spars of three other 2-0-2's; and a disturbing feature of the accident was that the 2-0-2 wing had been subjected to a full-scale fatigue test (single-load-level at a high alternating load range) before it entered airline service⁹⁹.

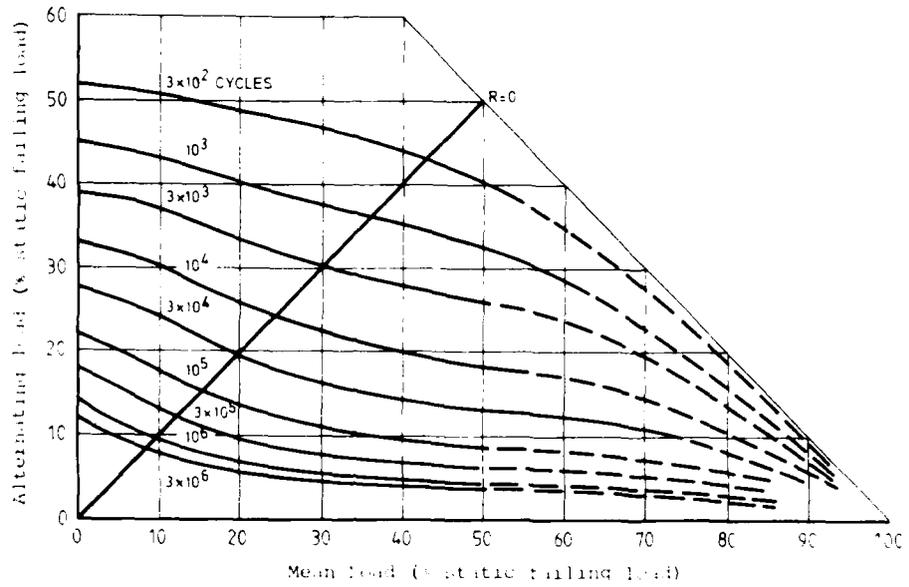
FIG. 9 ALTERNATING LOAD - MEAN LOAD DIAGRAM FOR MUSTANG WING FINAL FAILURE

behaviour of full-scale aluminium alloy aircraft structures, and provided the basis for the alternating stress-mean stress diagram shown in Fig. 9. When used in conjunction with an appropriate cumulative damage hypothesis, this enabled predictions to be made of the fatigue lives of aircraft structures under a range of flight loading conditions. The constant-amplitude Mustang tests also indicated that the logarithmic normal distribution provided a good approximation to the frequency distribution of fatigue lives for such structures, and that a figure of 0.20 was a conservative estimate of the standard deviation of log. life¹⁴⁶. The benefits of static preloading (which reduced the effective value of stress concentrations by plastic deformation) were again demonstrated by tests which showed that the value of preload which provided a maximum relative increase in fatigue life was 80% to 85% of the static UFL.

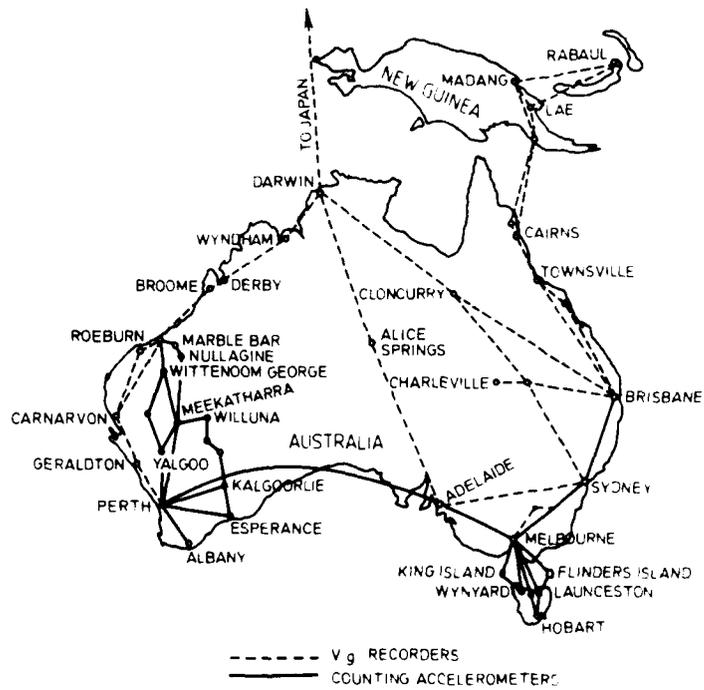
FIG. 10 FLIGHT LOADS MEASUREMENTS, AUSTRALIAN ROUTES-EARLY 1950's (Ref. 10)

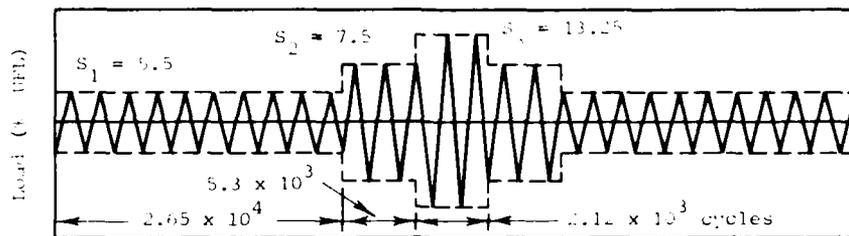
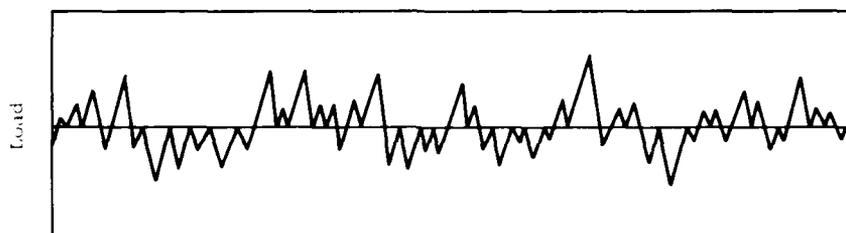
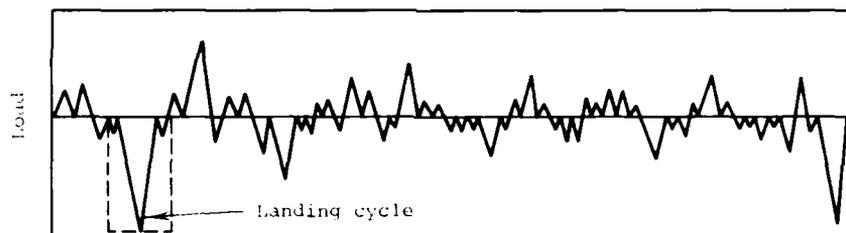
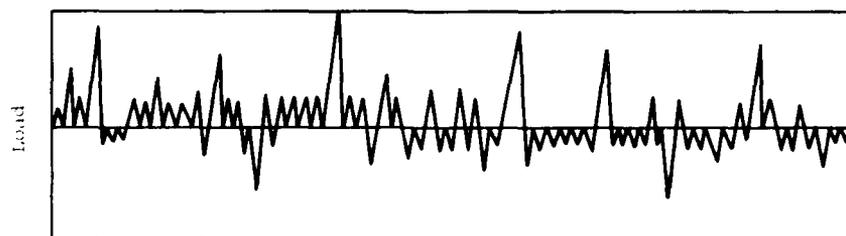
(a) Program block 3-load-level test (vibration rig)

(b) Typical random gust load sequence (hydraulic rig)

(c) Typical ground-air-ground cycle/gust load sequence (hydraulic rig)

(d) Typical manoeuvre load sequence (hydraulic rig)

FIG. 11 EXAMPLES OF VARIOUS MULTI-LOAD-LEVEL SEQUENCES USED DURING MUSTANG WING INVESTIGATIONS

The original objectives of the Mustang program were extended to include multi-load-level tests (program and random loading) under symmetric (gust) and asymmetric (manoeuvre) spectra, the effects of ground-air-ground cycles, comparisons of various life estimation methods and an investigation into the residual static strength of fatigue-cracked wings. Some of the loading sequences used (which include the three-load-level 'Airworthiness' test and a representation of the ARL 24-load-level random gust load sequence) are illustrated in Fig. 11. The results were summarised by Payne in Reference 146 and, among other things, showed that the simple three-load-level test and random gust sequence test were equivalent as regards fatigue lives for all types of failure observed in the structure. Further detailed information was published in References 155-160.

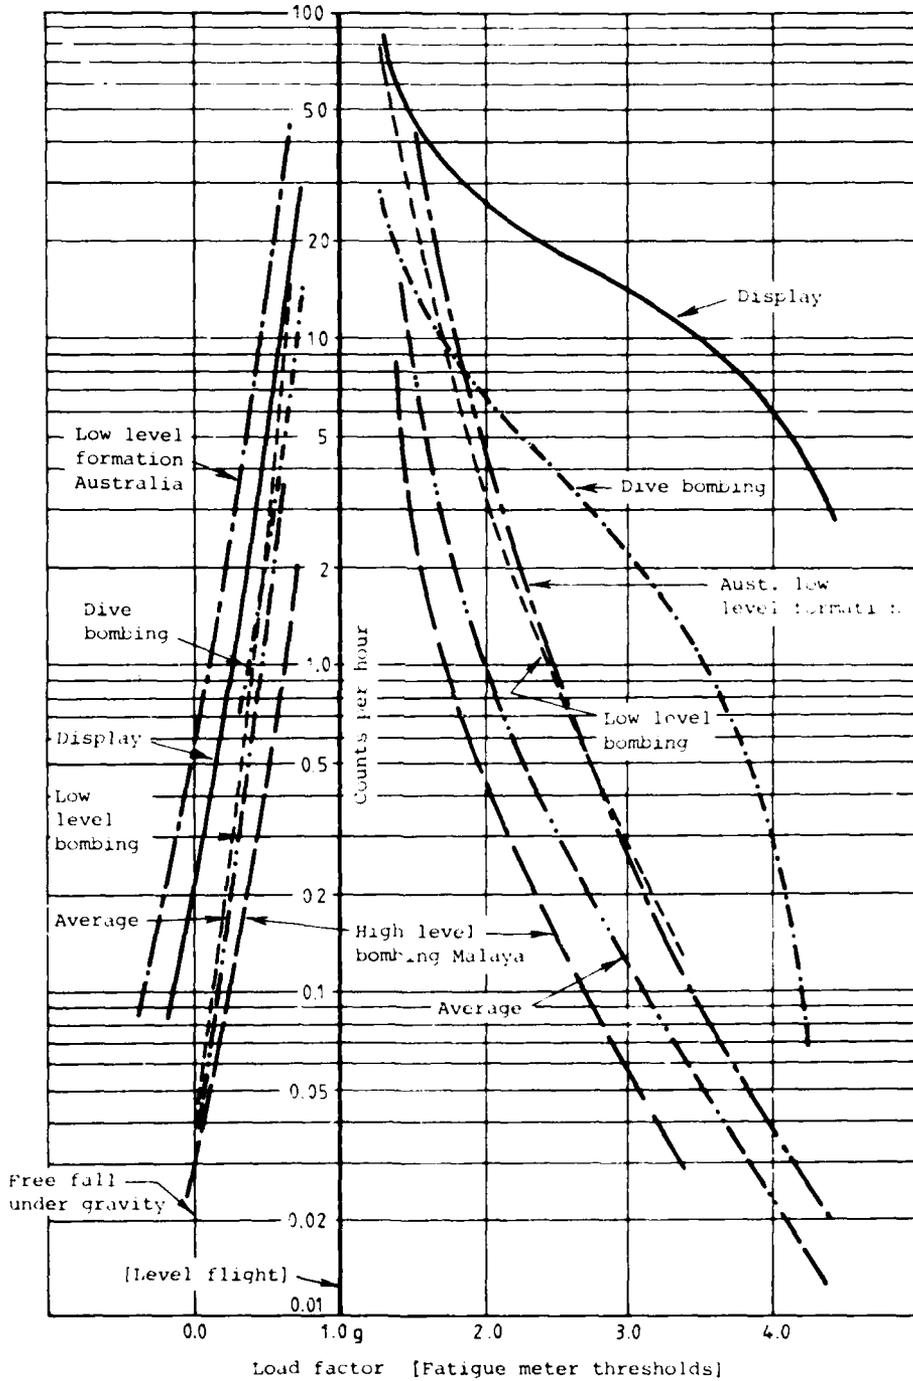
FIG. 12 LOAD-FREQUENCY CURVES FOR R.A.A.F. CANBERRA AIRCRAFT (Ref. 10)

One of the first aircraft on which a fatigue-life assessment was made was the Canberra, the flight loads measurements on which have already been referred to¹⁷⁰. Based on these measurements a simple arithmetical damage formula was derived for progressively calculating (from Fatigue Meter readings) the fatigue life consumed by the structure in various roles¹⁸⁰ and this allowed the aircraft to be safely operated by the RAAF into the 1980's. However, it was probably the promulgation (in the United Kingdom in late 1960) of the relatively short safe-life of 2000 hours for the Avro Lincoln bomber which accelerated

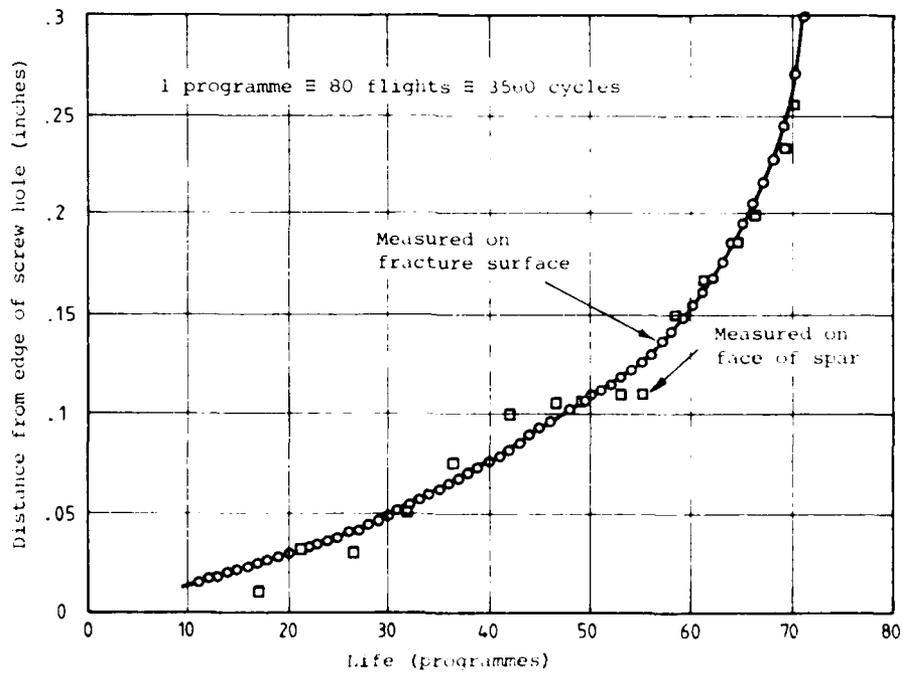
FIG. 13(b) CRACK LENGTH VERSUS LIFE, "VAMPIRE" SPAR (Ref. ...)

The variety of fatigue failures in both aluminium and steel structural components of the Vampire provided the opportunity for utilizing the fractographic analysis techniques developed by Ryder at RAE¹⁸⁵, to study the fractures of aluminium alloy specimens¹⁸² and to determine fatigue crack propagation rates in some fractured structural items¹⁸⁶⁻¹⁸⁸. A typical example is shown in Fig. 13(b).

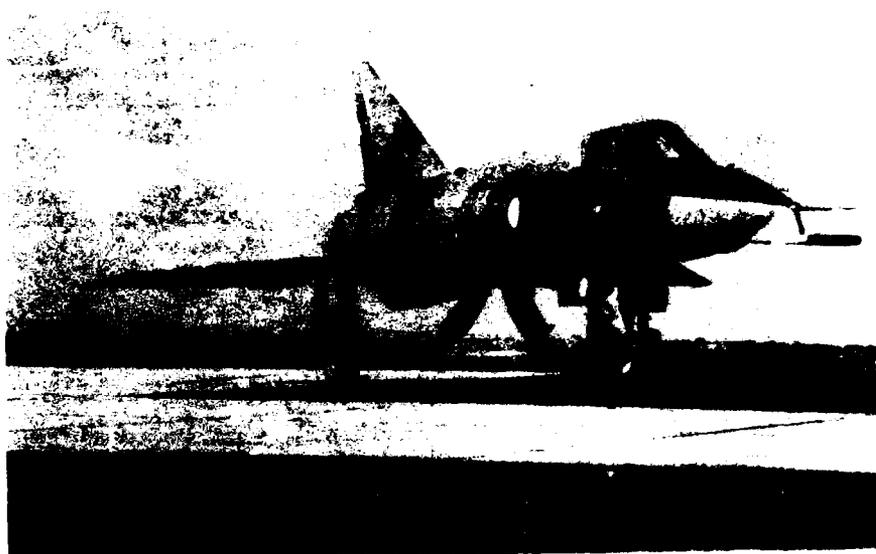
FIG. 14 RAAF MIRAGE AIRCRAFT A3-76 SHOWING ARL DESIGNED GUST PROBE

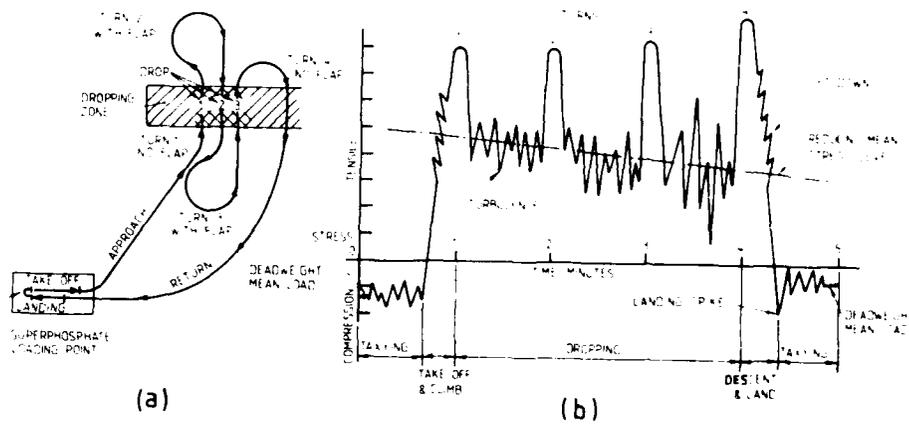
FIG. 15 (a) TYPICAL FLIGHT PATH FOR AERIAL AGRICULTURE OPERATIONS
 (b) STRESS-TIME PROFILE ON WING SPAR FLANGES FOR AIRCRAFT
 AT VARIOUS STAGES OF OPERATION (Ref. 10)

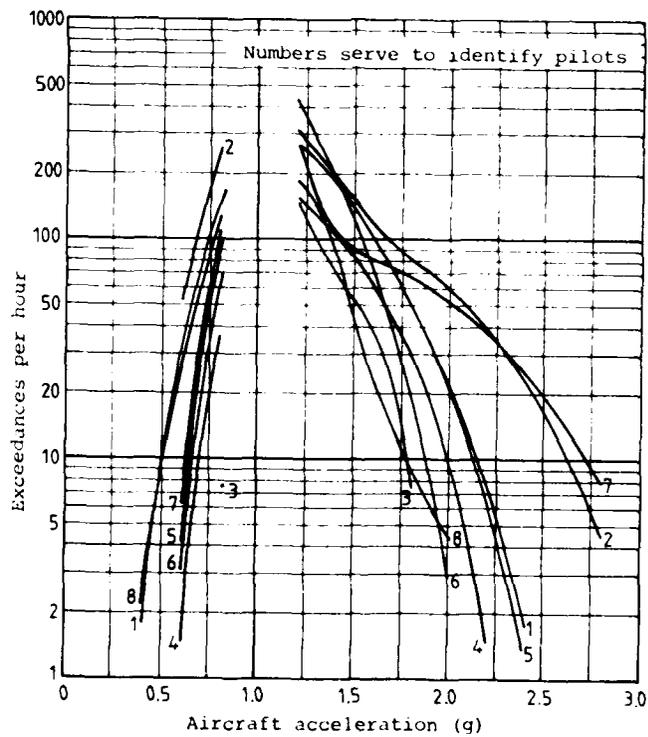
FIG. 16 VARIABILITY IN LOAD HISTORY CAUSED BY DIFFERENT PILOTS
 IN THE SAME AIRCRAFT (Ref. 10)

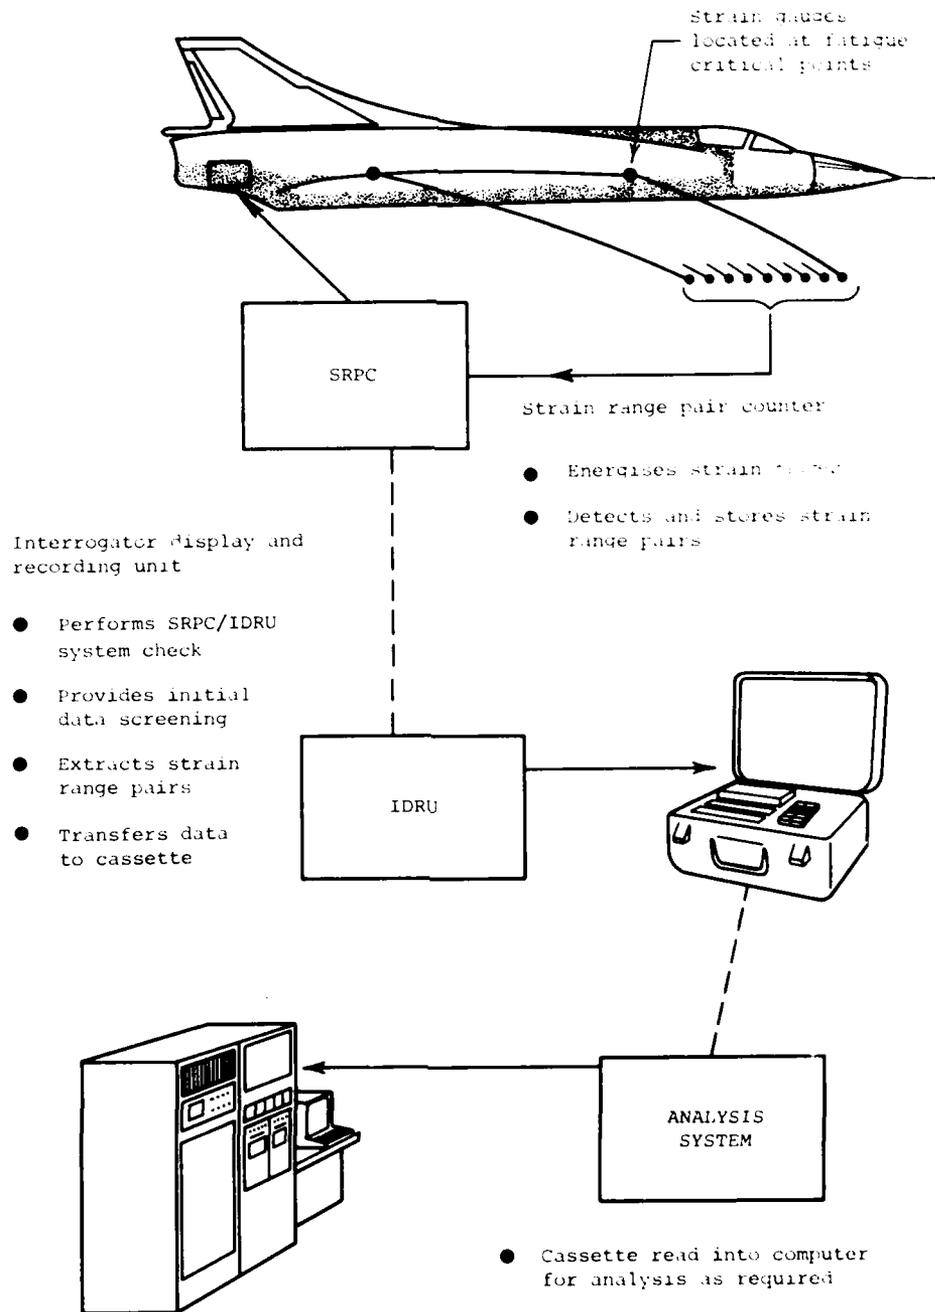
FIG. 17 THE AIRCRAFT FATIGUE DATA ANALYSIS SYSTEM (AFDAS)

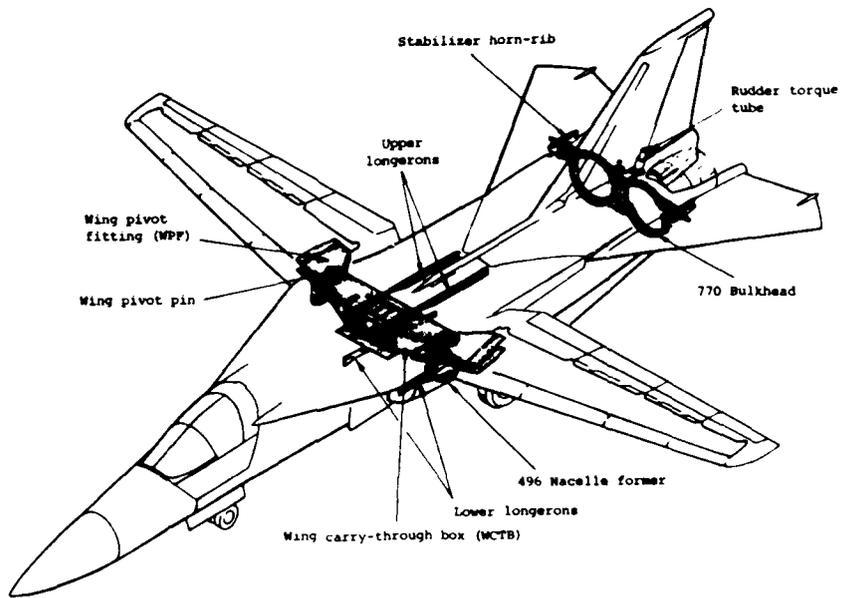
FIG. 19(a) D6AC STEEL STRUCTURAL MEMBERS IN F-111

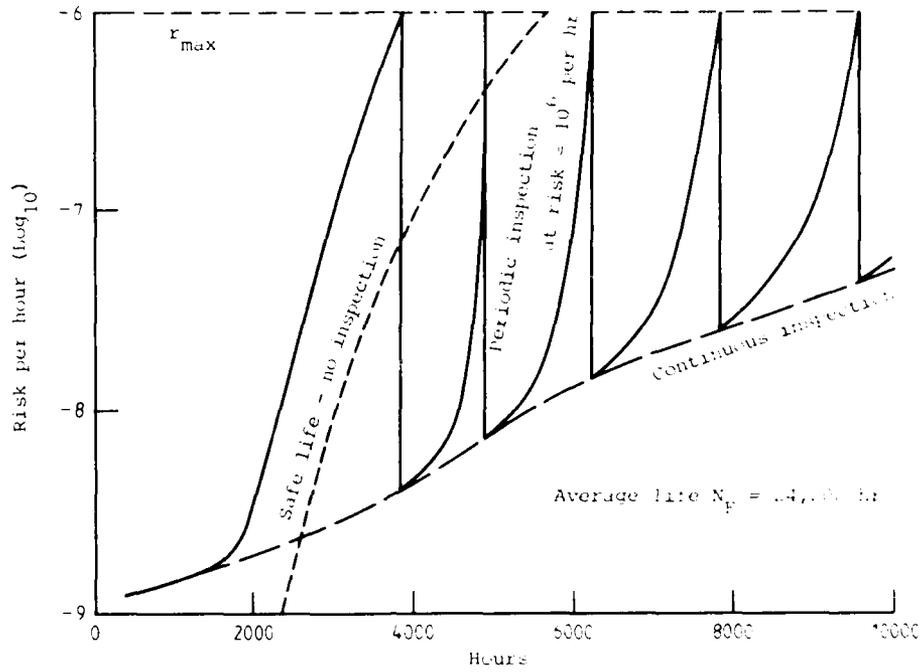
FIG. 18(a) RISK PER HOUR vs LIFE

ARL has taken an active part in the development of the reliability approach to structural fatigue²¹⁰⁻²²⁰. In this approach (which makes use of representative residual strength and fatigue crack propagation data) the increasing risk of failure in a structural component as a function of service life as the crack propagates can be calculated for any prescribed load spectrum, taking into account the variability in static strength during crack growth and the variability in crack propagation rates²¹⁷. It requires an appreciation of the impossibility of achieving absolute safety, and agreement regarding acceptable risk. The reliability approach provides a quantitative solution to both the fail-safe and safe-life philosophies and has been developed to provide a method for establishing inspection intervals on the basis of an acceptable risk of failure per hour. The optimum procedure (Fig. 18) would be continuous inspection so that cracks are always limited to the detectable size. However, as this is usually not feasible in practice inspections are carried out at prescribed

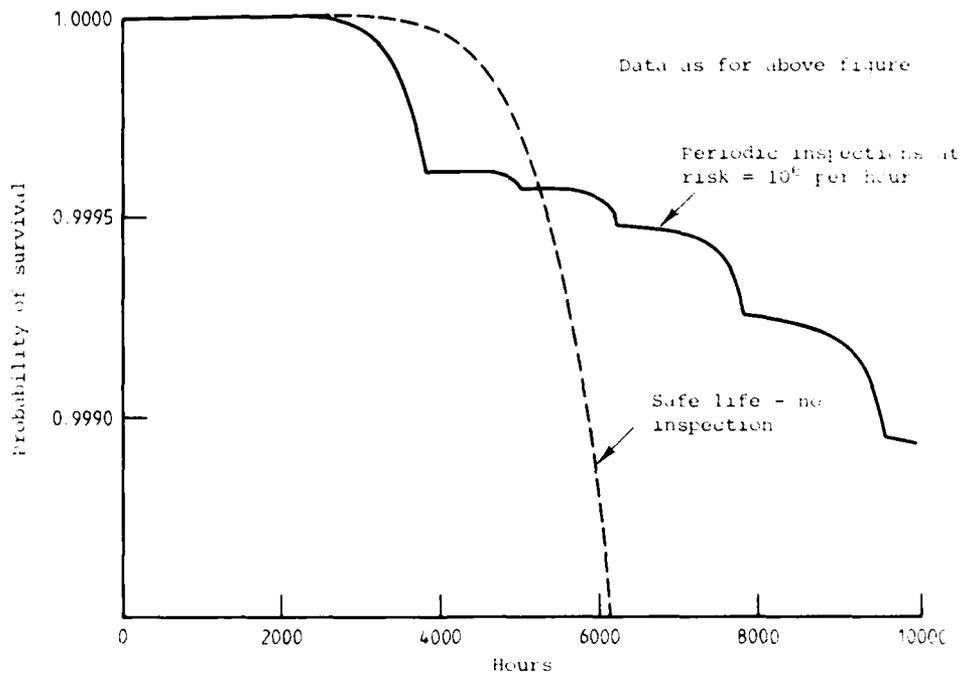
FIG. 18(b) PROBABILITY OF SURVIVAL vs LIFE (ref. 1)

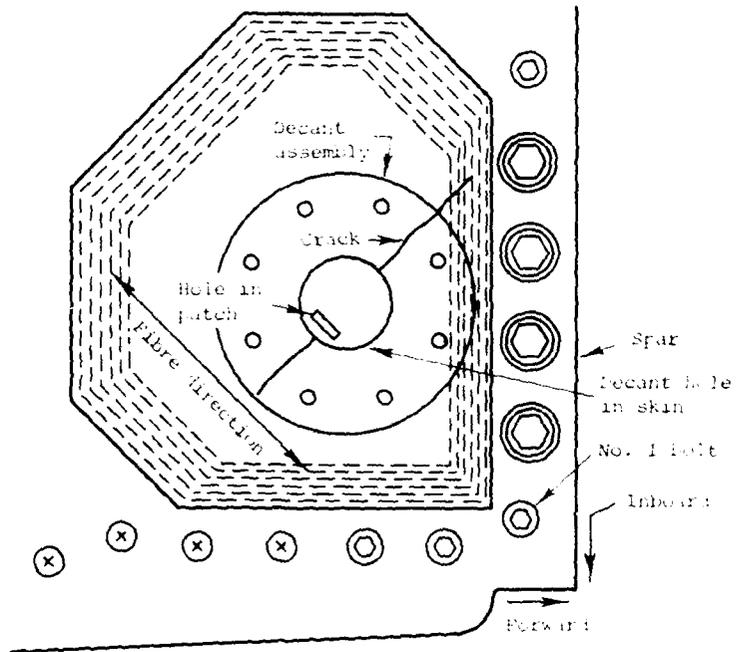
FIG. 20 BFRP PATCH FOR MIRAGE DECANT HOLE FATIGUE CRACKING

several wings. A suitable multi-layer BFRP patch (Fig. 20) was designed and incorporated as a routine field repair on the RAAF Mirage fleet²⁴⁵⁻²⁴⁷.

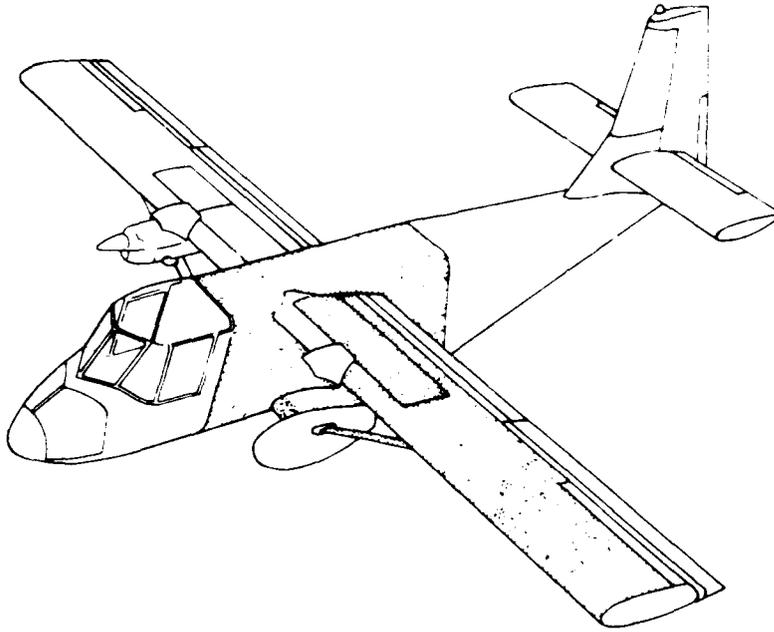
FIG. 21 GAF "NOMAD N22" (Shaded area shows extent of structural fatigue test article)

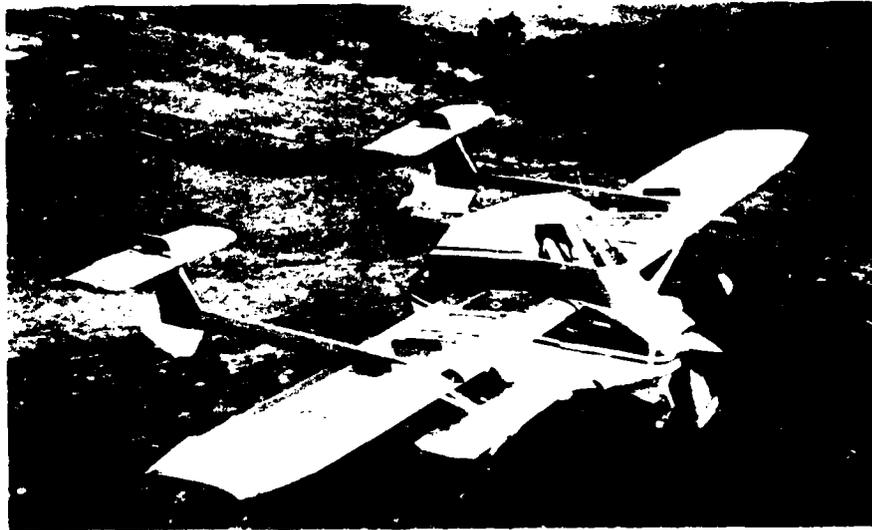
FIG. 22 TRANSAVIA "AIRTRUK" AGRICULTURAL AIRCRAFT

The Transavia PL-12 Airtruk (Fig. 22) is a single seat, piston engined agricultural aircraft of rather unusual configuration. It is a twin tailboom sesquiplane with a short, stubby fuselage. The cockpit is located above the engine, with the hopper behind. This arrangement allows for easy loading from the rear. Some 112 aircraft have been manufactured since production commenced in 1966 and of these 75% have been exported - to New Zealand, Thailand, Malaysia, Taiwan, South Africa, Denmark and Yugoslavia. Aircraft have also been delivered to the USA and to Spain for evaluation. The latest model has an agricultural maximum weight for take-off of 1925 kg and the maximum structural hopper load is 907 kg. Wing spars are of welded fabricated sheet steel construction, and safe lives (derived by conservative analysis) of 11650 and 8680 hours have been promulgated for the main and stub wings respectively. A fatigue test program has been proposed to verify these lives.

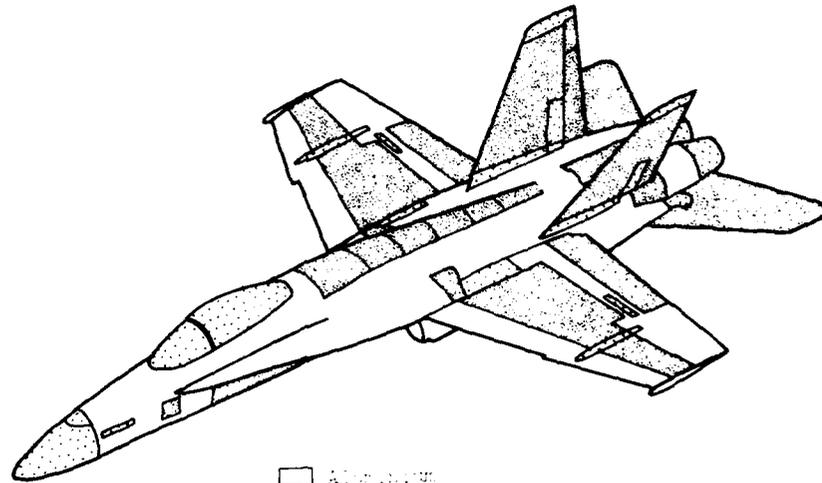
- Aluminum
- Inconel/Steel
- ▨ Titanium/Aluminum
- ▩ Graphite/Epoxy Composite

FIG. 23 F/A-18, INDICATING APPLICATIONS OF GRAPHITE/EPOXY COMPOSITES
