US Army Corps
of Engineers
Omaha District

Post-Flood Report Missouri River and Tributaries Spring Floods 1984

October 1984

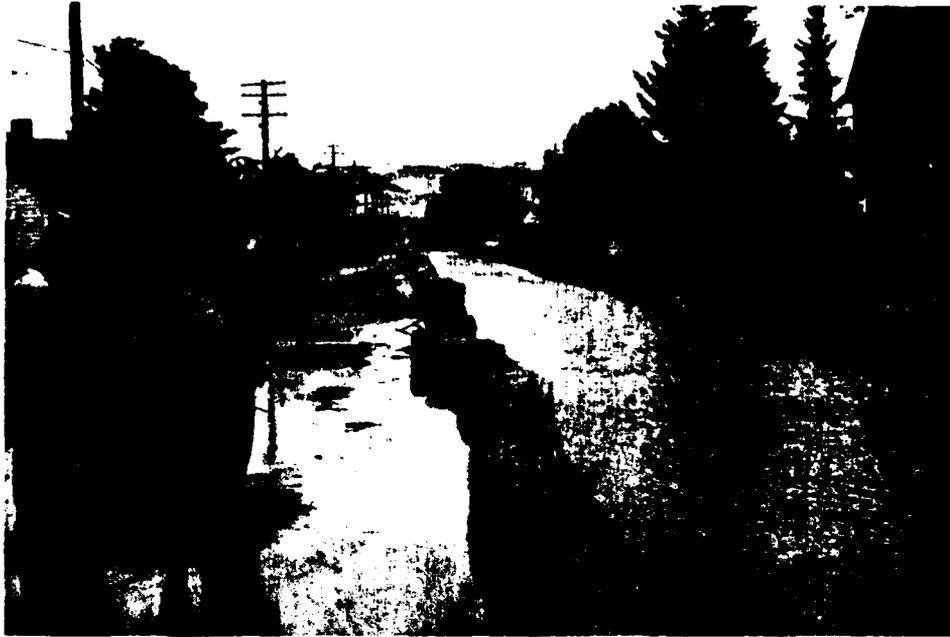
Figure 5. View of overflow from Blacktail Creek being routed down a city street in Dillon, Montana, 22 June 1984.

southwestern Montana. Although the Missouri River downstream from Canyon Ferry Dam stayed within its banks, the Beaverhead River downstream from Clark Canyon Dam went over its banks, causing minor overland flooding. Blacktail Creek, which runs through the town of Dillon before it joins with the Beaverhead River, went overbank as the result of the rainfall in June. Part of the Blacktail Creek flow was routed through a city street using hay bales and railroad ties, much the same way as floodwater was routed in the highly publicized event in Salt Lake City in 1983. Photos of the high water that occurred are shown as figures 1 through 8. A list of selected stream gaging sites within the Missouri River basin is presented as exhibit B. A few stations in the basin upstream from Canyon Ferry Dam are shown. Exhibit B also presents data on flood conditions and compares the stages and peak discharges of the flood of record with the 1984 flooding.

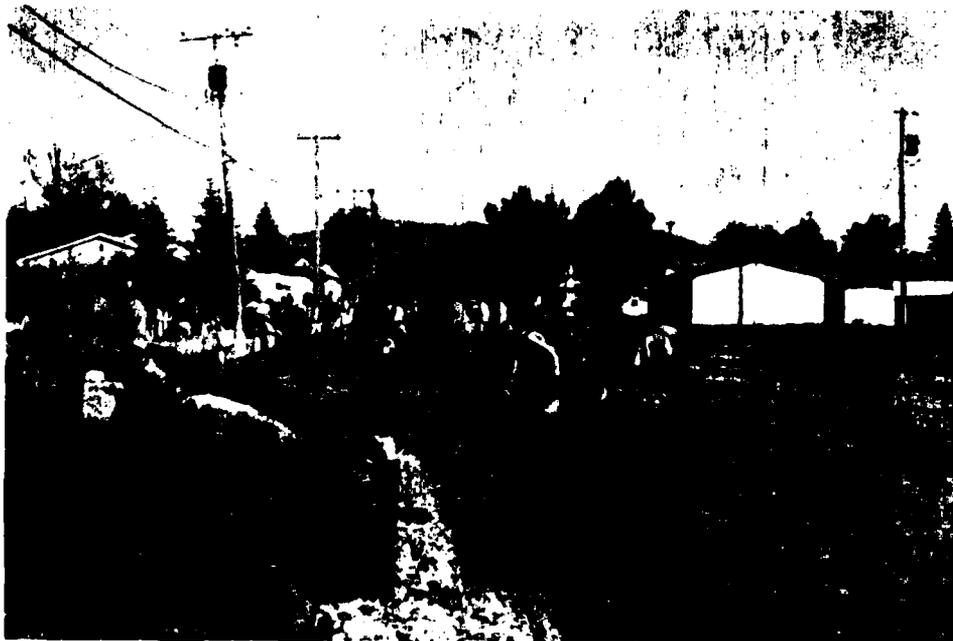
Figure 6. View of overflow from Blacktail Creek being routed down a city street in Dillon, Montana, 22 June 1984.

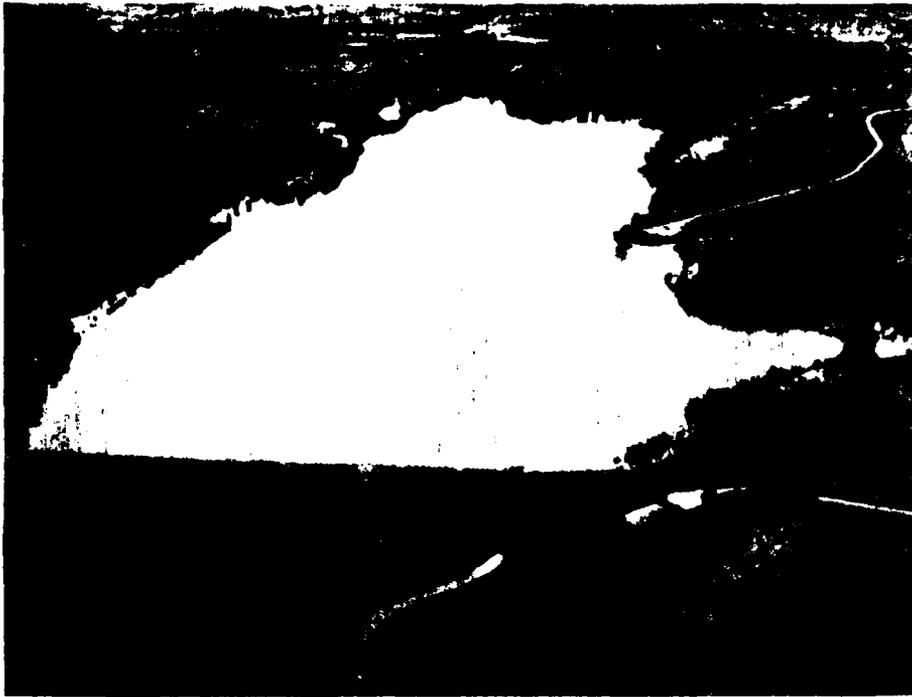
Figure 9. View of Salt Creek Dam No. 2 - Olive Creek, 13 June 1984. (Pool Elevation - 1342.63 feet m.s.l.)

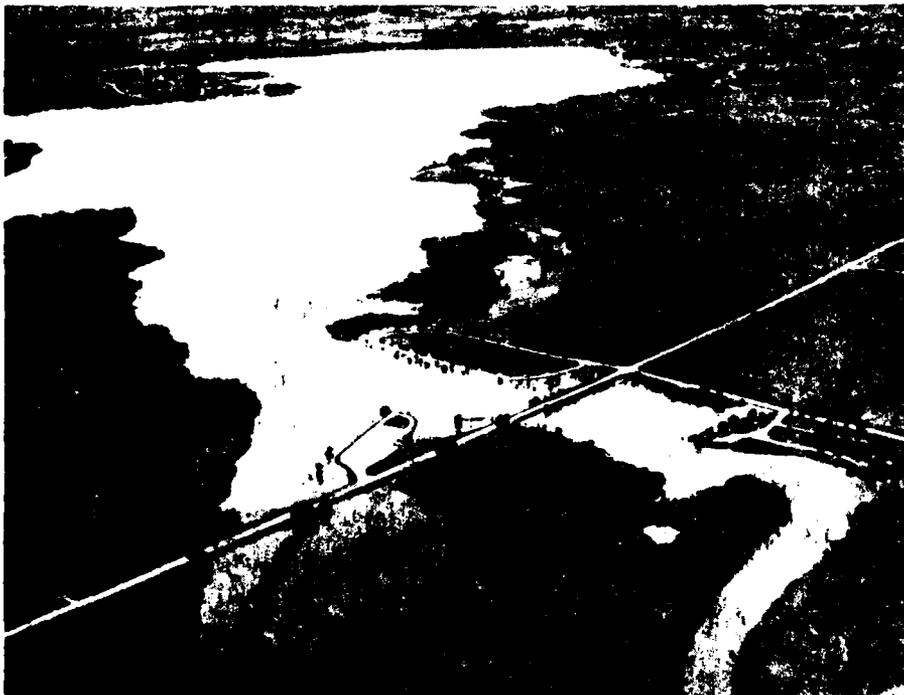
Figure 10. View of Salt Creek Dam No. 14 - Pawnee Lake, 13 June 1984. (Pool Elevation - 1246.8 feet m.s.l.)

Aerial photographs of the record pools are shown as figures 9, 10, and 11. The recreation areas and marina at Holmes Park Lake were extensively damaged by the high water. Other Salt Creek recreation areas that were closed because of high water included boat ramps and campgrounds at Wagon Train, Stagecoach, Bluestem, and Olive Creek Lakes. Minor flooding also occurred at other areas within the basin. A high-water profile for Salt Creek is shown on plate 55. Two fatalities were recorded in the city of Lincoln as a result of flooding on Stevens Creek, a right-bank tributary to Salt Creek.

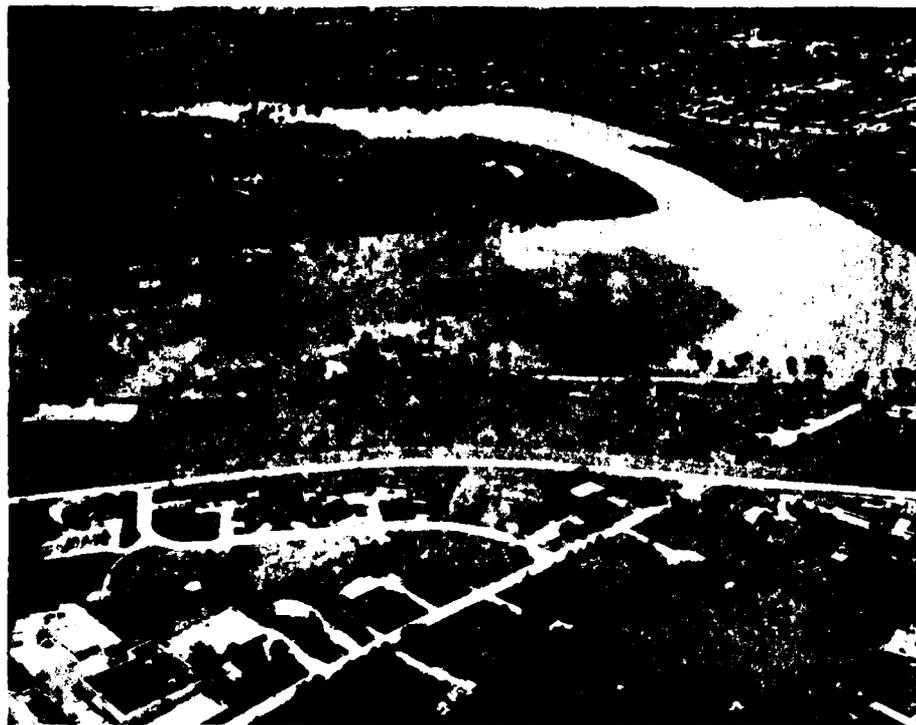
Figure 11. View of Salt Creek Dam No. 17 - Holmes Park Lake,
13 June 1984. (Pool Elevation - 1245.9 feet m.s.l.)

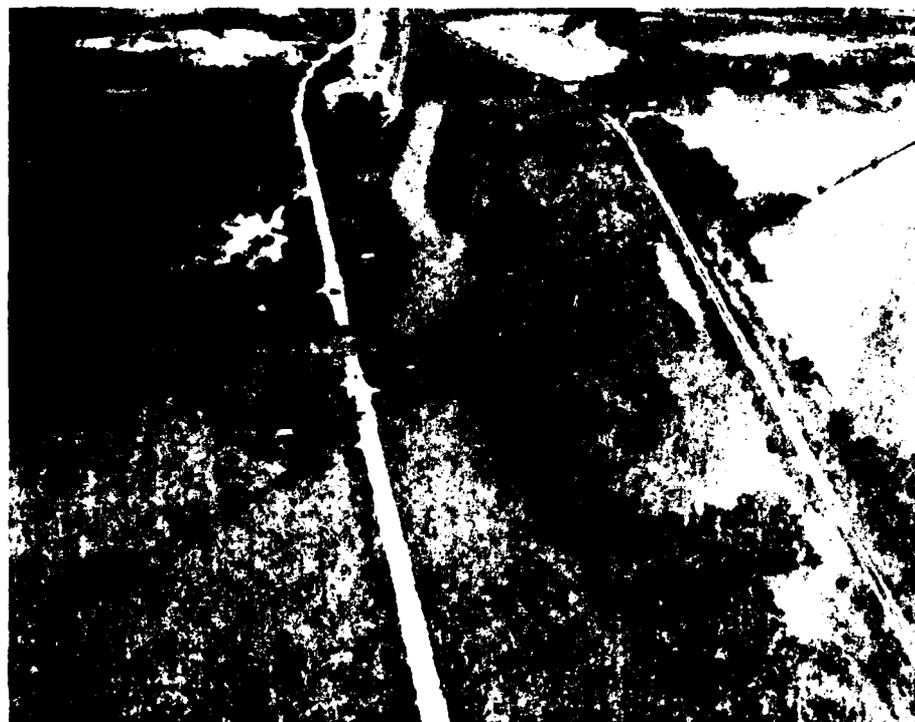
Figure 12. View of collapsed bridge on Highway 6 near Ashland,
Nebraska, caused by flooding from Salt Creek,
14 June 1984. (At Greenwood, Nebraska: Discharge -
15,000 c.f.s., Gage Height - 16.34 feet)

The combined Salt Creek reservoirs and associated levees and channel improvements were effective in reducing flood damages in Lincoln. The high water that occurred at Greenwood, shown on plate 56, and Ashland was induced by the extensive rainfall that occurred downstream from the Salt Creek project. The rainfall on 11-12 June left the city of Ashland surrounded by water with only one road access to the community. The National Guard camp near Ashland flooded and the State of Nebraska asked for assistance from the Corps to cope with channel bank erosion and flood problems at the camp. Photos of the flooding in the Ashland area are shown as figures 12 and 13.

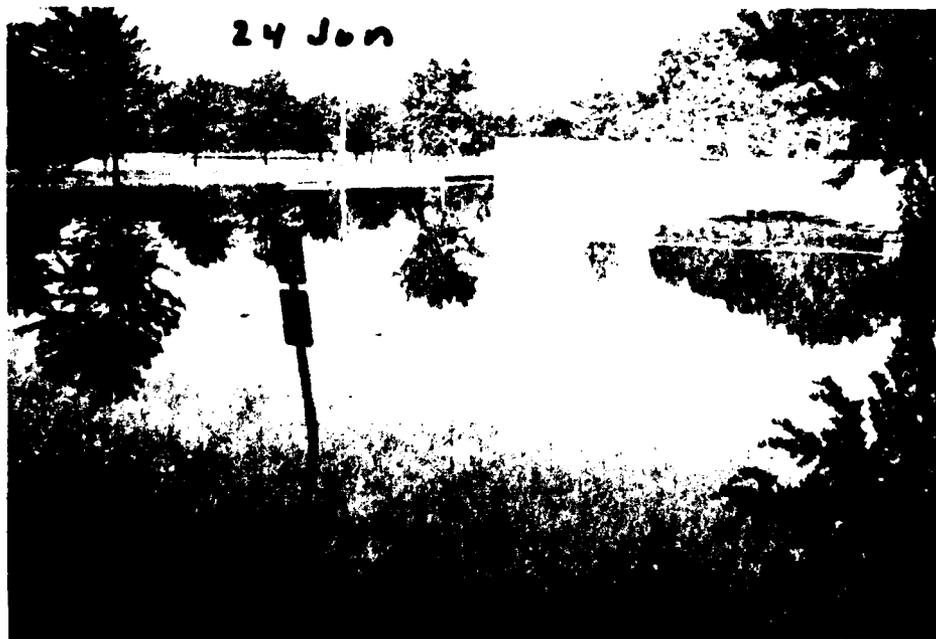
Figure 17. View of N. P. Dodge Park in Omaha, Nebraska,
24 June 1984. (Omaha Discharge - 107,000 c.f.s.,
Gage Height - 28.34 feet (8 inches below crest))

Although the rainfall that produced the flooding along the Missouri River and its tributaries fell downstream from the six main stem dams, additional flooding was prevented by the regulation of the dams. As shown on plate 120, Gavins Point Reservoir releases were decreased in early June to alleviate flooding problems downstream from the mouth of the Platte River. After the storm that hit the area upstream from the mouth of the Platte River, Gavins Point Reservoir releases were reduced to 10,000 c.f.s. (less than one-third of normal) in an effort to reduce the flooding from Sioux City to Omaha. The total system storage for the six main stem dams increased by nearly 4 million acre-feet in the month of June. Had the main stem dams not been in place, the estimated peak gage height at Sioux City would have been 7.2 feet higher than that experienced. Figures 14 through 20 show the high water on the Missouri River near Omaha.

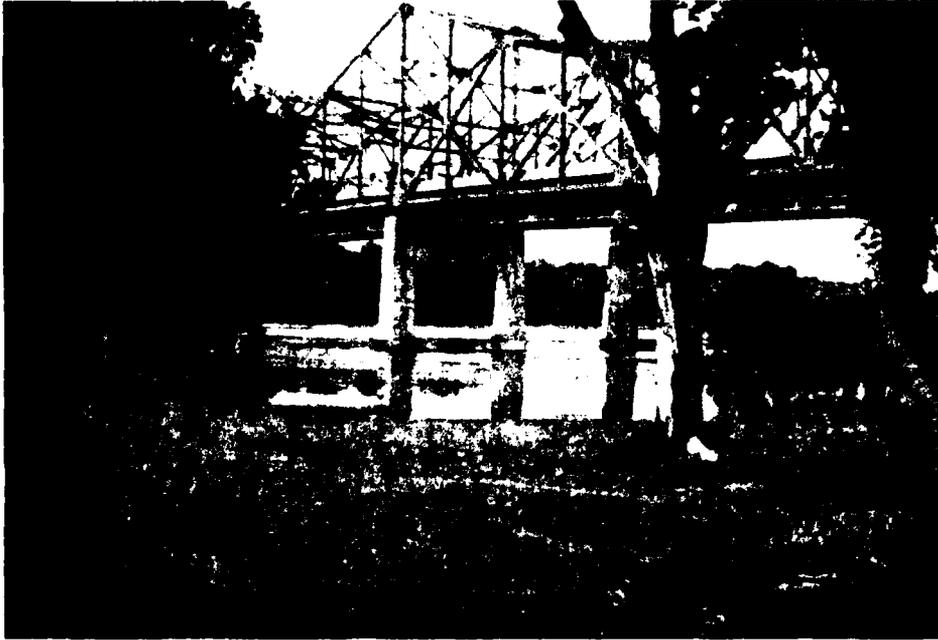
Figure 18. View of Interstate 680 - Mormon Bridge over the Missouri River in Omaha, Nebraska, 27 June 1984. (Omaha Crest: Discharge - 114,000 c.f.s., Gage Height - 29.03 feet)

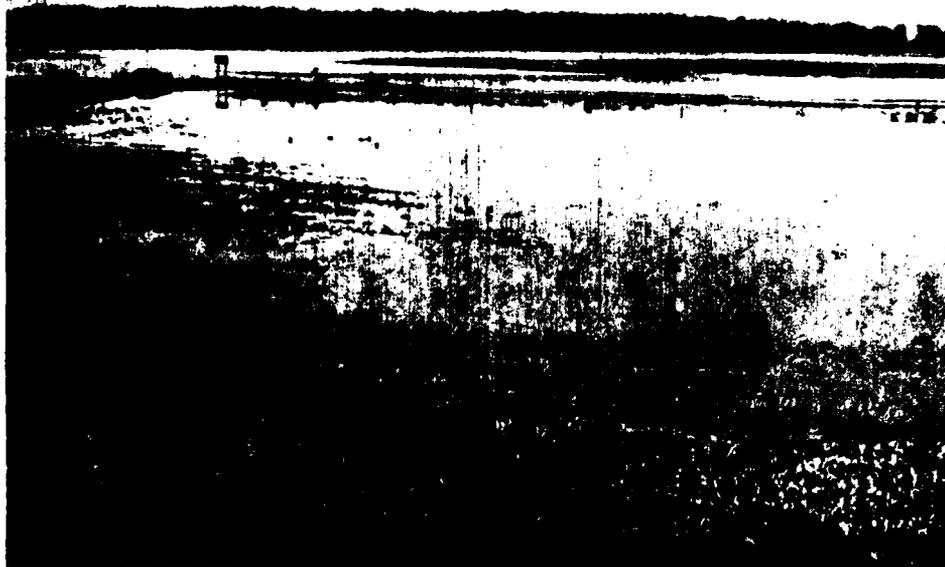
Figure 20. View of the east end of the Mormon Bridge, 27 June 1984.
