ENVIRONMENTAL AND WATER QUALITY OPERATIONAL STUDIES

TECHNICAL REPORT E-84-11

ENVIRONMENTAL FEATURES FOR STREAMBANK PROTECTION PROJECTS

Jim E. Henderson, F. Douglas Shields, Jr.
Environmental Laboratory

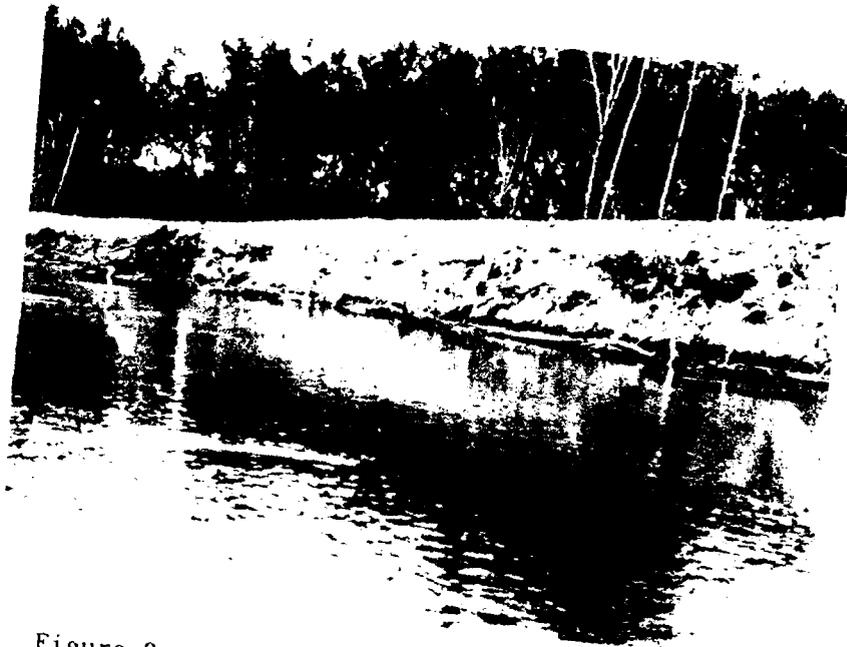
Figure 9. Notch placement of windrow revetment (from OCE 1981, Appendix E)

74. Construction may be either from land or water. Stone fill is placed in one of two ways, in an excavated notch at the top of the bank line (Figure 9) or in a trench excavated near the top of the bank, parallel to the bank line. Placement in a notch requires less bank clearing. The exposed surface of the stone is covered or backfilled with excavated material. Trench placement utilizes an excavation at least 2 ft deep. As further erosion takes place, the stone fill is "launched" down the bank and blankets the bank at a naturally established slope. Stone is then added on an as-needed basis until a stable equilibrium is

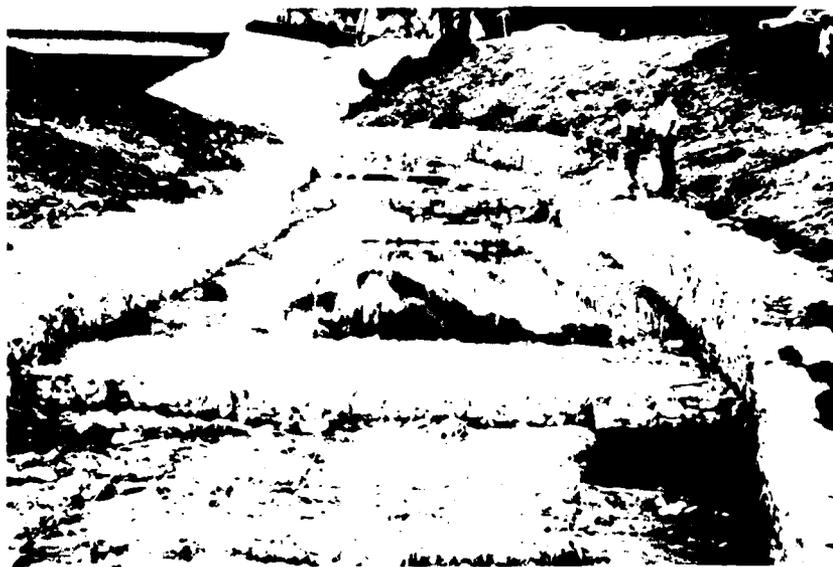
Figure 33. Gabions used for grade control
(from Linder 1976)

149. Gabion works may be used as toe protection only, or stacked to form grade control structures (Figure 33) (Maccaferri 1981). When gabions are used for toe protection, the upper bank may be graded and planted in grasses, or the upper bank may simply be backfilled behind the gabions. Gabions may be used in enlarged channels to define a low-flow channel as well as to provide toe protection (OCE 1981, Main Report). The USAED, Omaha, used gabions to realign a channel for urban development. This design incorporated gabion drop structures for grade control (OCE 1981, Appendix H).

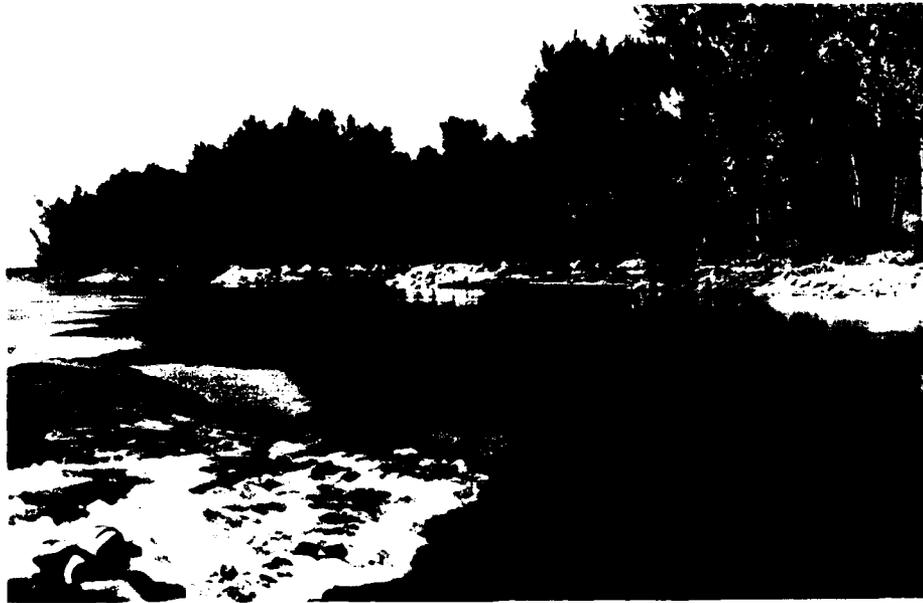
Figure 36. Hard point system (from OCE 1981, Appendix E)

165. The crown at the riverward end is constructed to the normal water surface elevation. The hard point crest slopes upward from the riverward end to 5 ft above the normal water surface elevation at the landward end. Crown width varies up to a 10-ft maximum and is inversely proportional to water depth. On the Missouri River, the lower toe zone below the normal water surface is constructed of 500-lb (maximum) stone or low-grade material, and the remaining upper portion and root are

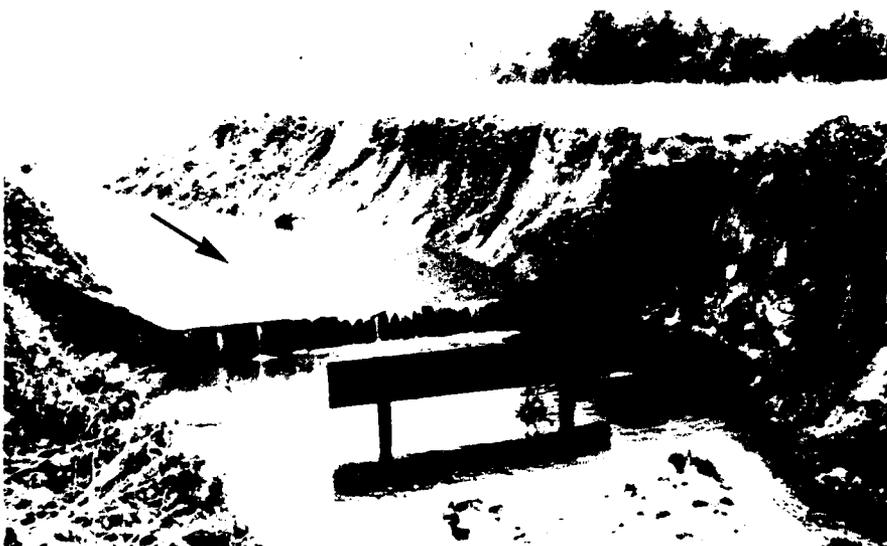
Figure 40. Drop structure consisting of a weir and baffle plate (from OCE 1981, Appendix F)

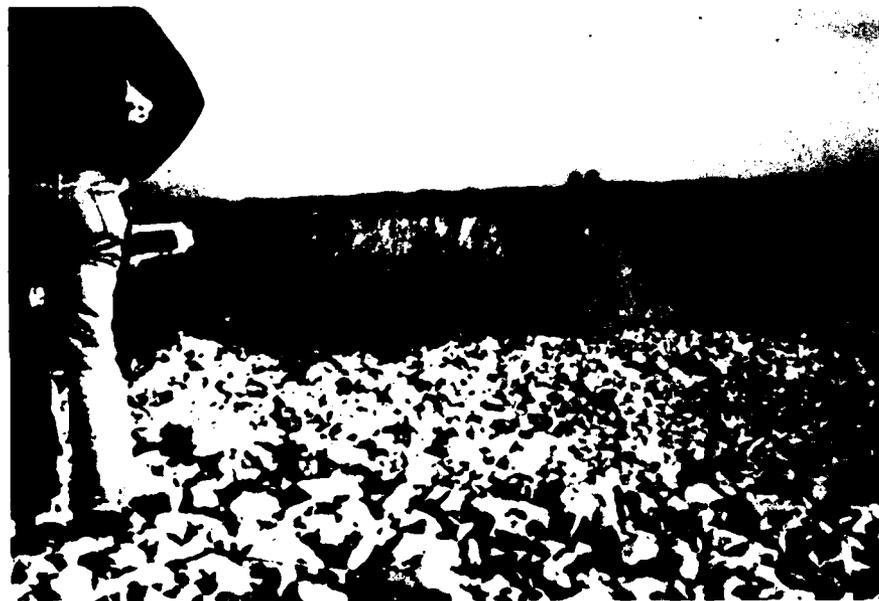
Figure 44. Vegetation on earth core dike

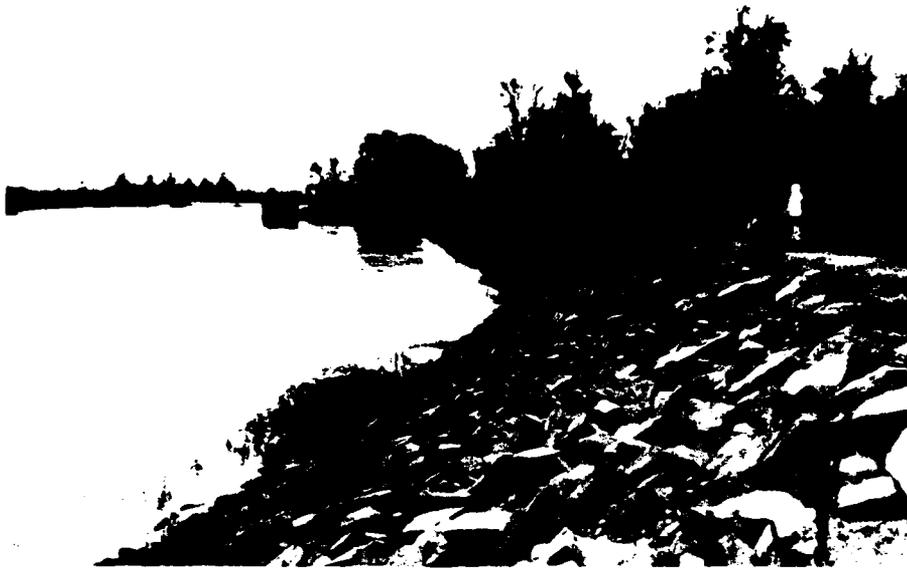
Figure A2. Stone revetment along the Willamette
