MECHANISMS OF CORROSION FATIGUE IN HIGH STRENGTH I/M AND P/M ALUMINUM ALLOYS

R. P. Wei  
Lehigh University

P. S. Pao  
McDonnell Douglas Research Laboratories

Final Technical Report

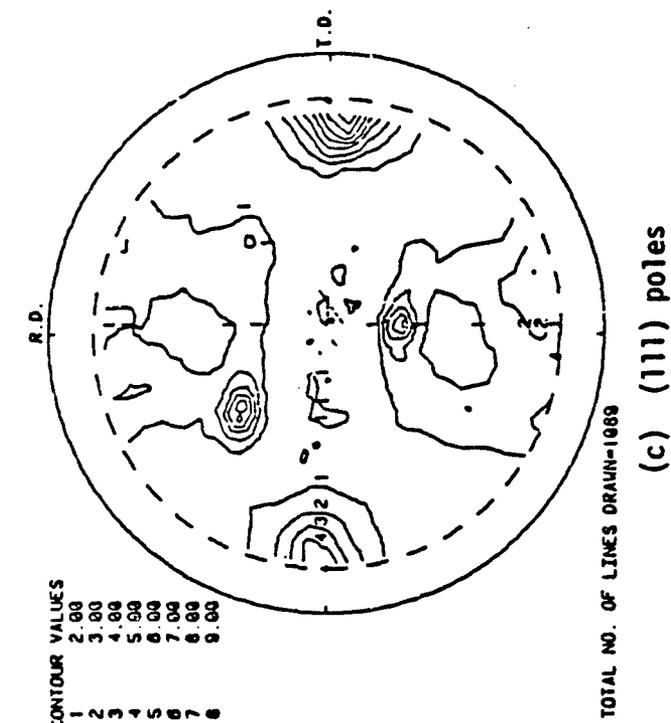
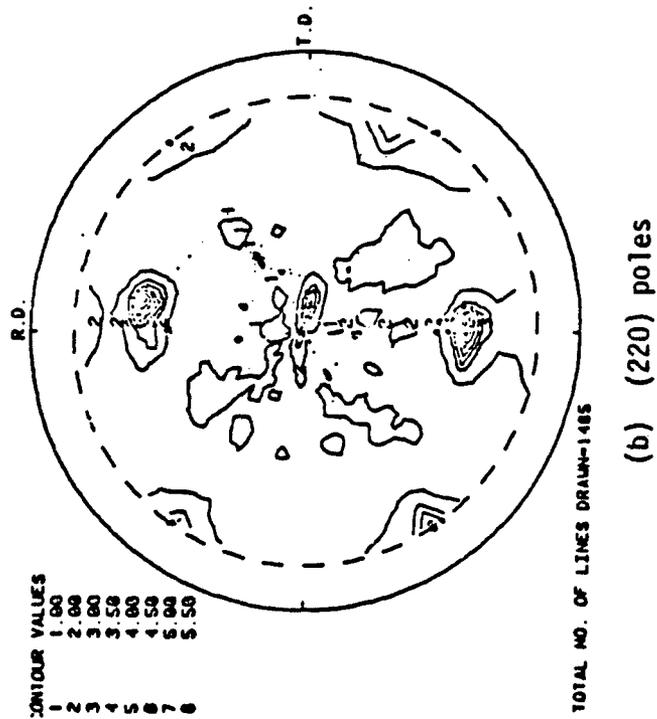
Fig. 1: Pole figures for the rolling plane of 7050-T7451 aluminum alloy plate taken at the plate surface: (a) (200); (b) (220), and (c) (111).

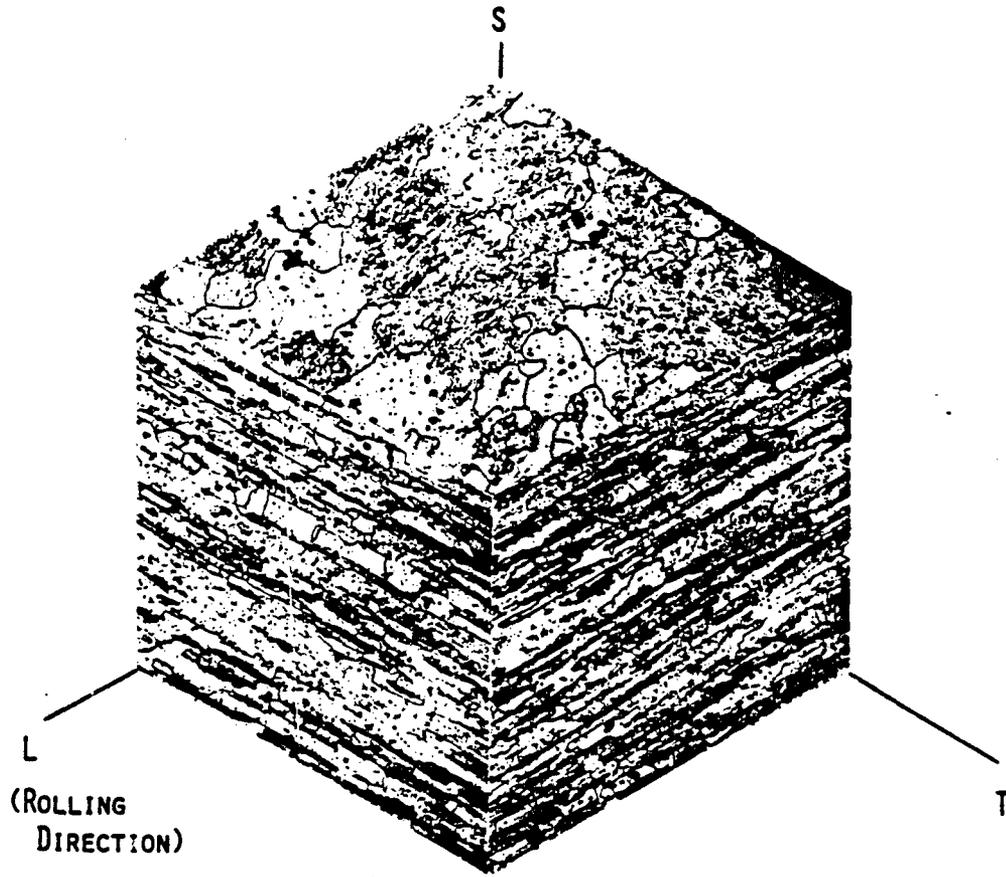
Fig. 3: Representative microstructure of 7050-T7451 aluminum alloy, 80X.

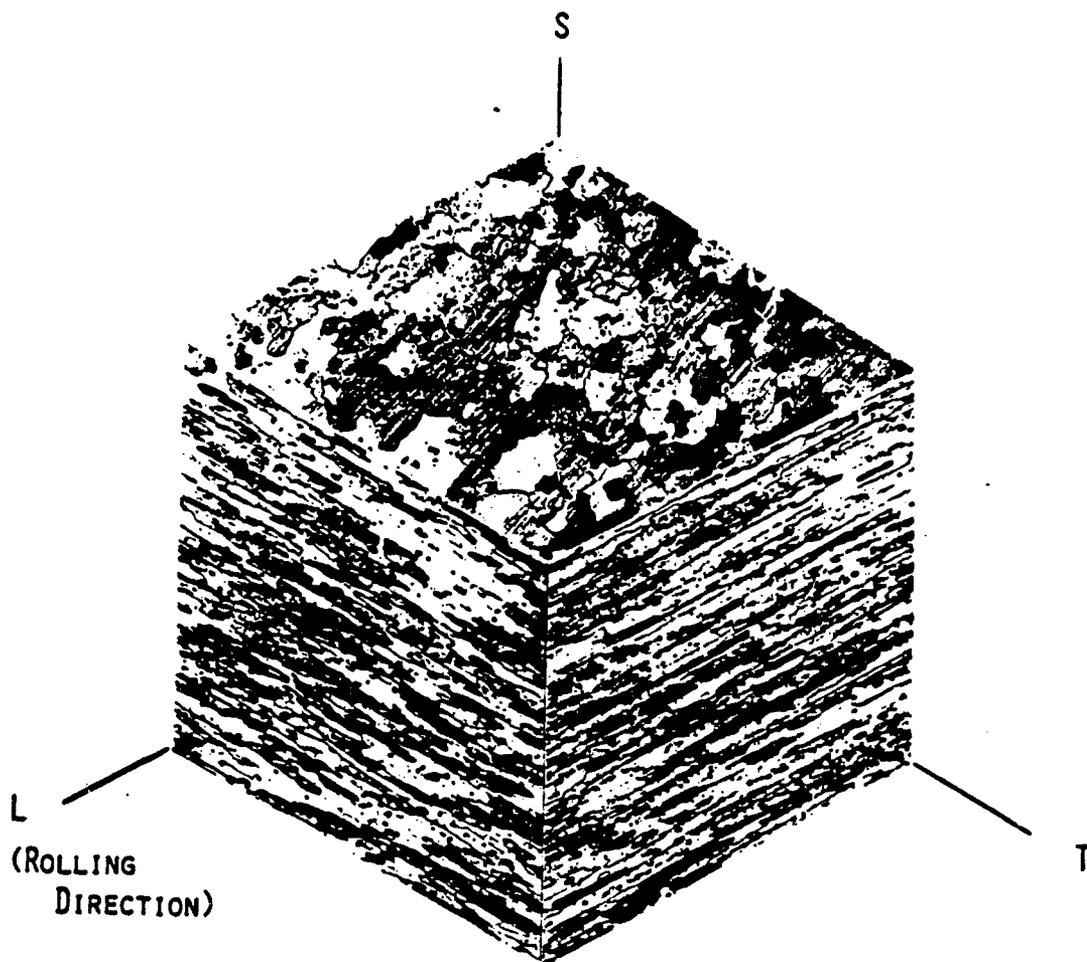
Fig. 6: Representative microstructure of 7075-T651 aluminum alloy, 80X.

A 12.7 mm thick plate of commercial 7075-T651 aluminum alloy was used. The nominal composition and mechanical properties of this alloy are given in Table 1 [4,5]. Representative optical and transmission electron micrographs of the alloy microstructure are shown in Figs. 6 and 7. The overall grain structure of this alloy is similar to that of the 7050-T7451 alloy. The anisotropic nature of the uncrystallized grains is evident in Fig. 1,

with "packets" of grains elongated along the rolling direction (L) of the plate. Transmission electron micrographs indicate the typical microstructure of 7075-T651 alloy contains a high density of  $\eta'$  precipitates and of dislocations. A number of large "constituent" particles (some as large as 1  $\mu\text{m}$ ) are also present.

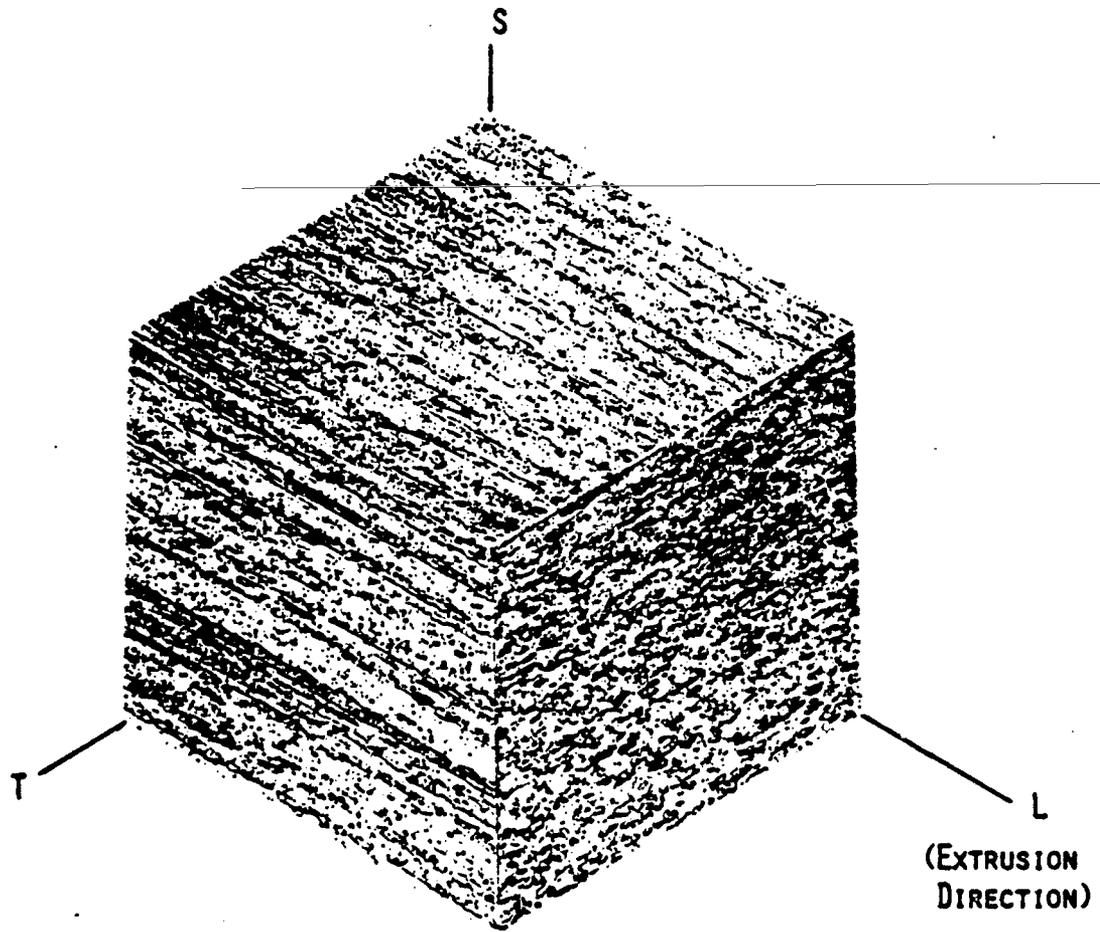
Fig. 10: Representative microstructure of P/M 7091-T7E70 aluminum alloy, 420X.

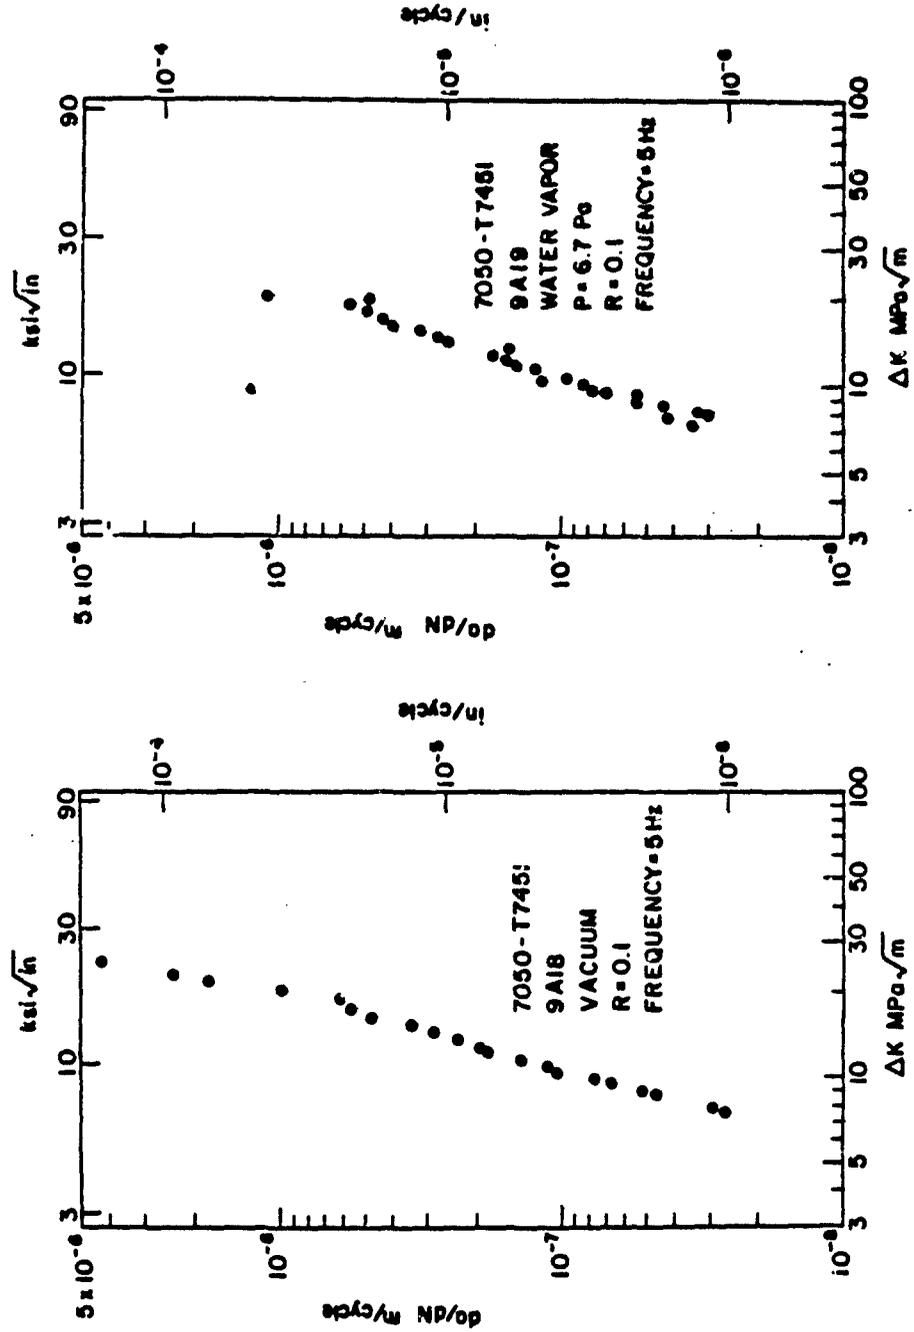
Fig. 13: Kinetics of fatigue crack growth for 7050-T7451 aluminum alloy at room temperature (R = 0.1 and f = 5 Hz) in vacuum ( $<10^{-6}$  Pa) and in water vapor at 6.7 Pa.

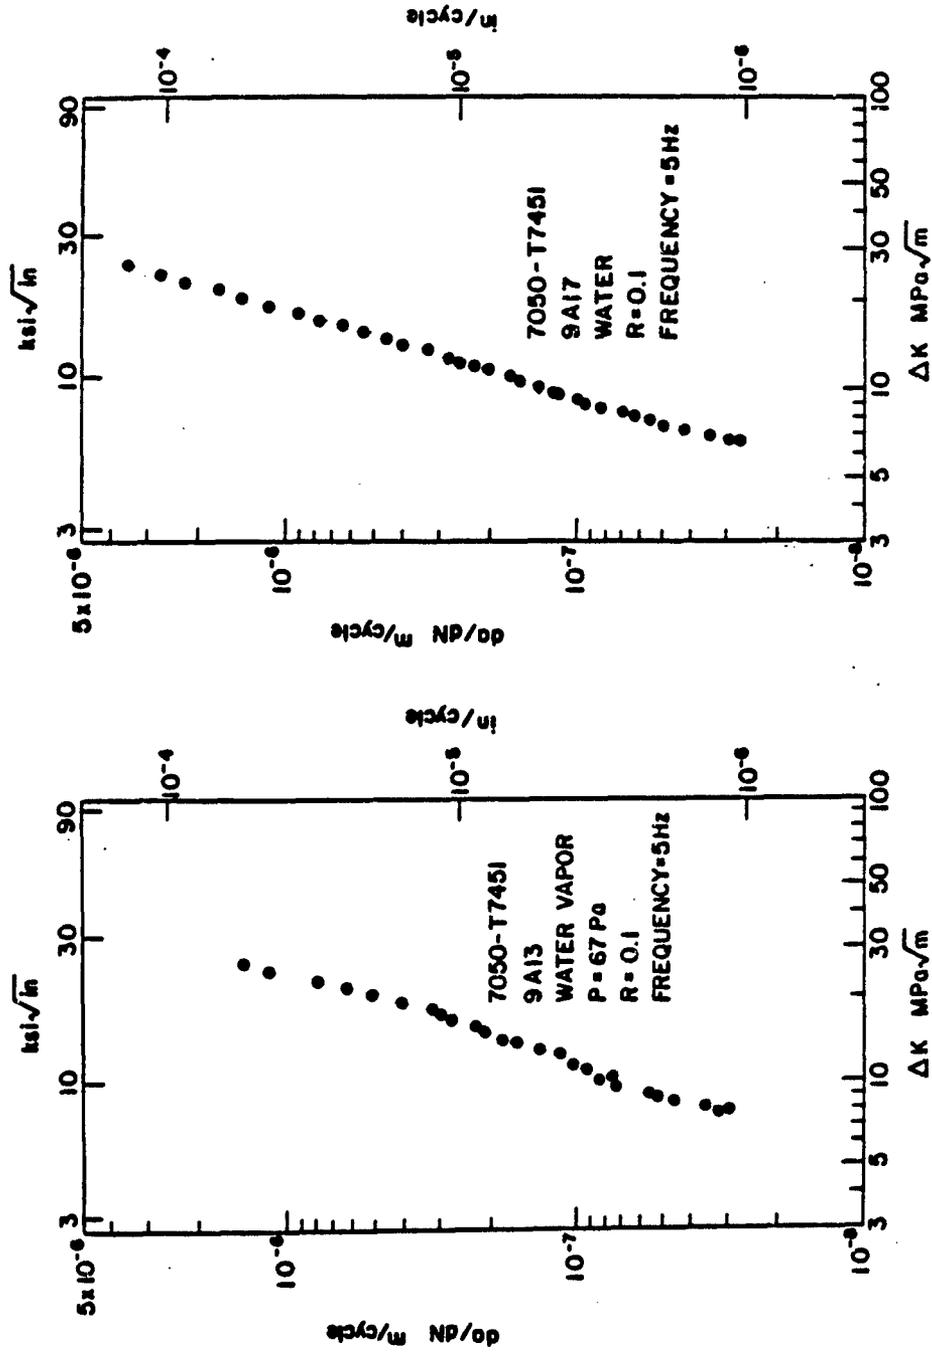
Fig. 14: Kinetics of fatigue crack growth for 7050-T7451 aluminum alloy at room temperature ( $R = 0.1$  and  $f = 5 Hz$ ) in water vapor at 67 Pa, and in distilled water.

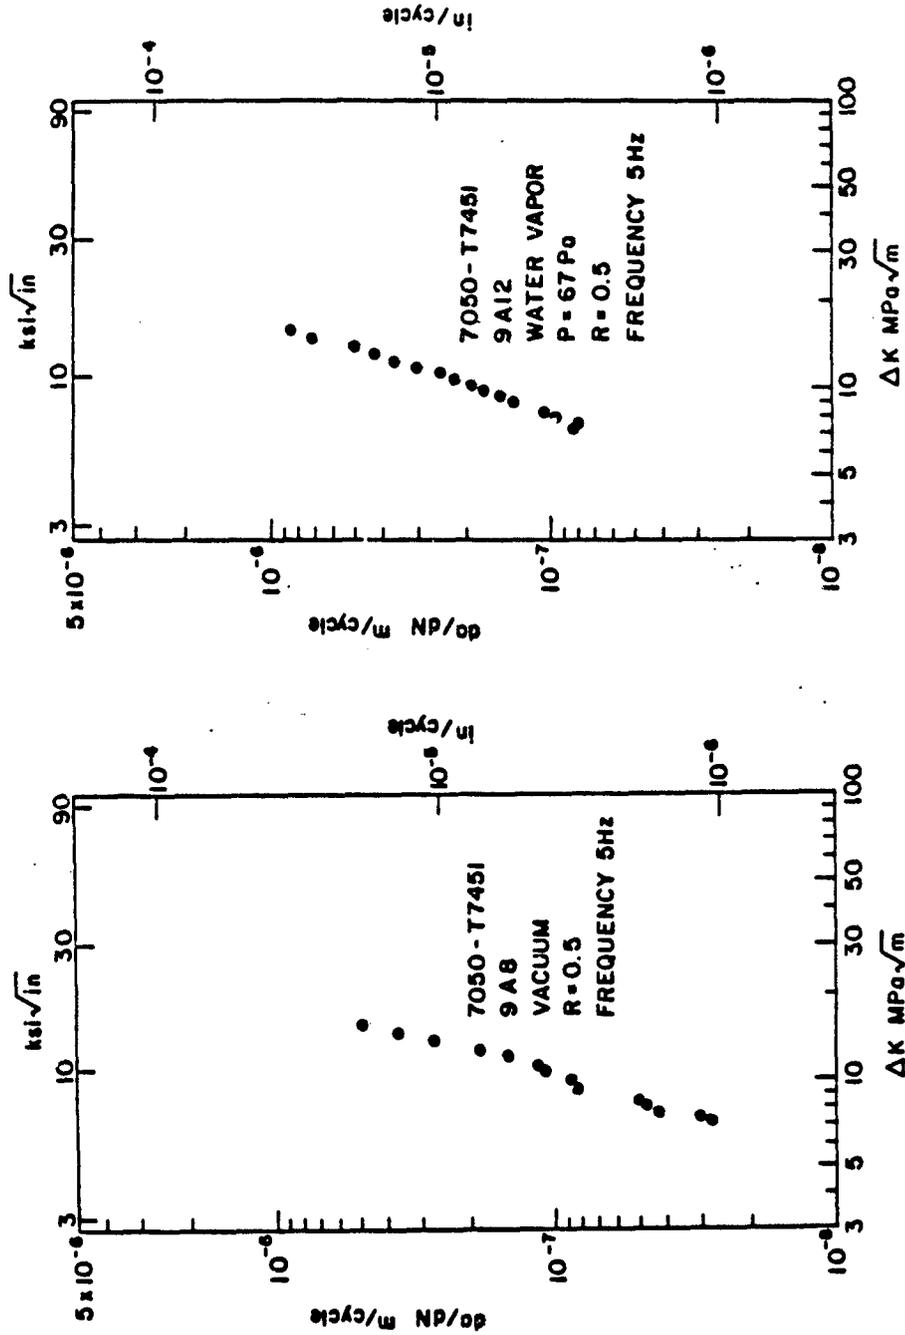
Fig. 15: Kinetics of fatigue crack growth for 7050-T7451 aluminum alloy at room temperature (R = 0.5 and f = 5 Hz) in vacuum ( $<10^{-6}$  Pa) and in water vapor at 67 Pa.

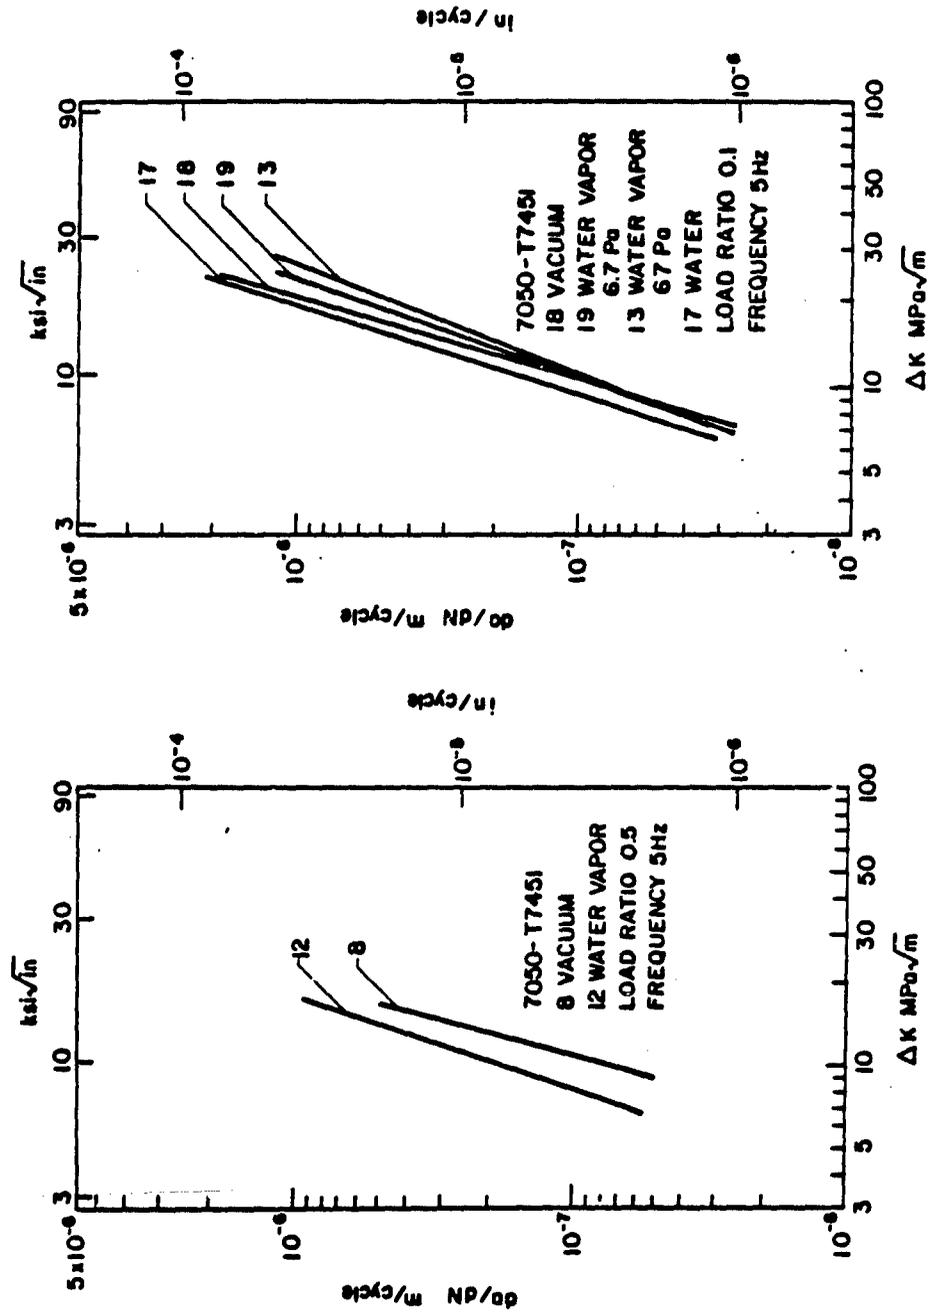
Fig. 16: Comparison of the kinetics of fatigue crack growth in 7050-T7451 aluminum alloy tested in vacuum, water vapor and water at  $R = 0.1$  and  $0.5$ . (Lines represent data shown in Figs. 13-15.)

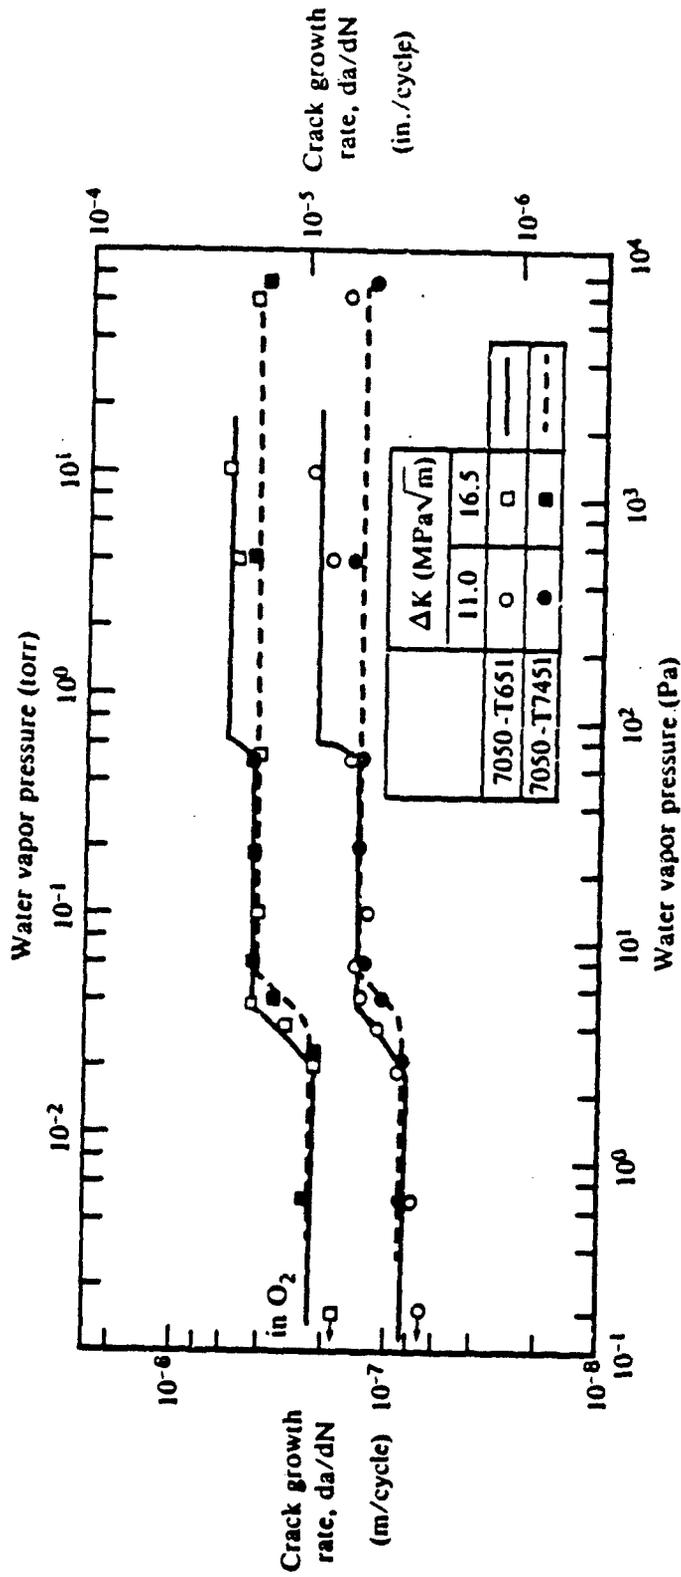
Fig. 17: The influence of water vapor pressure on the fatigue crack growth rate in I/M 7050 aluminum alloys at room temperature ( $R = 0.1$  and  $f = 5$  Hz).

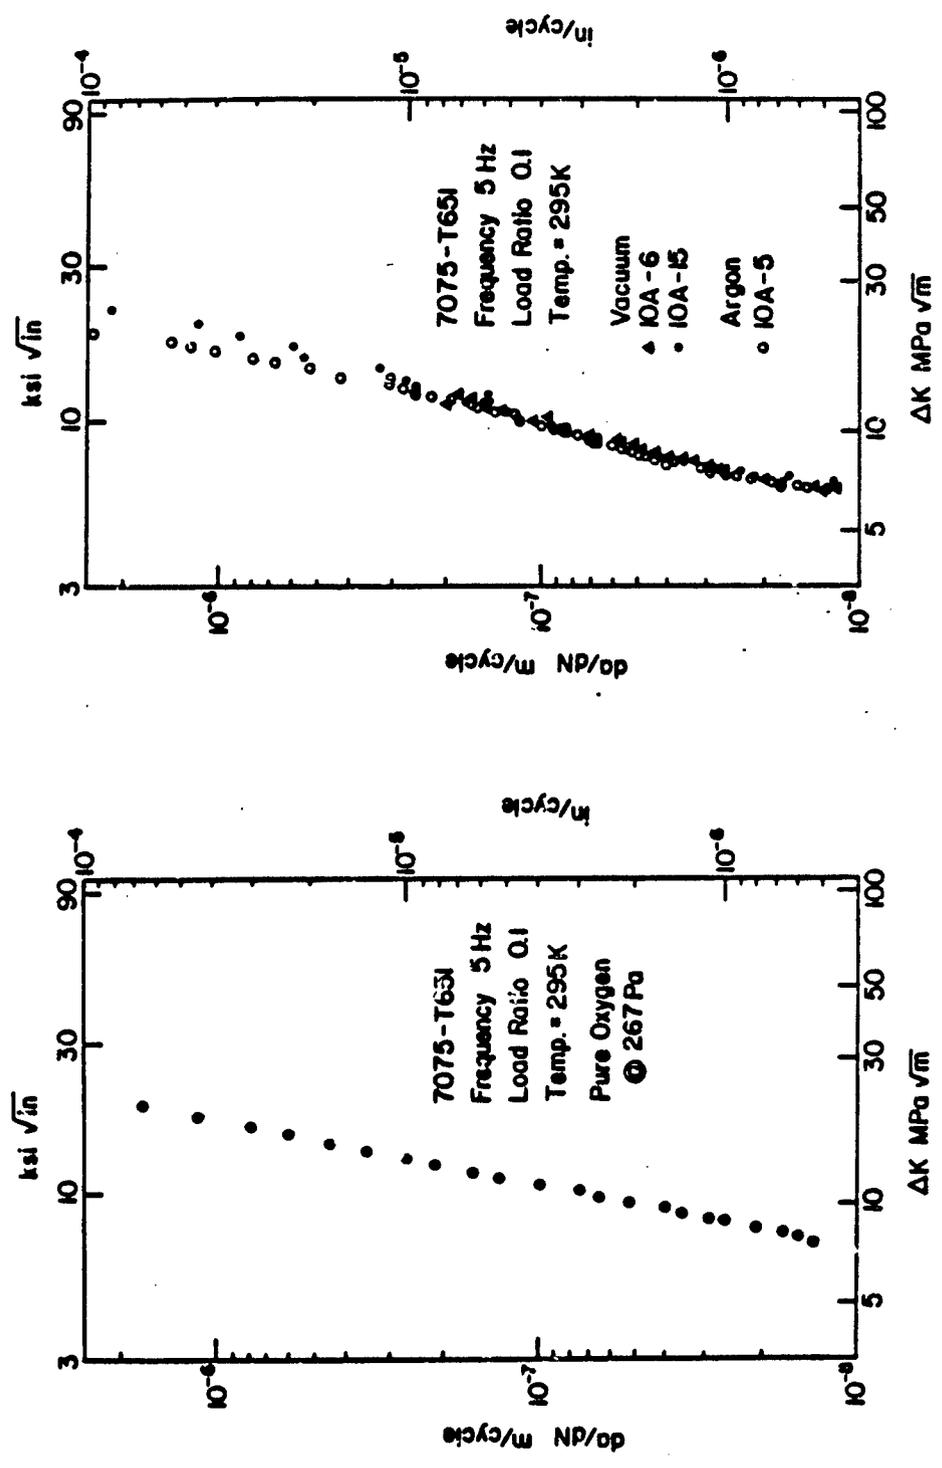
Fig. 18: Kinetics of fatigue crack growth for 7075-T651 aluminum alloy at 295K (R = 0.1 and f = 5 Hz) in pure oxygen at 267 Pa, and in vacuum ( $<10^{-6}$  Pa) and argon.

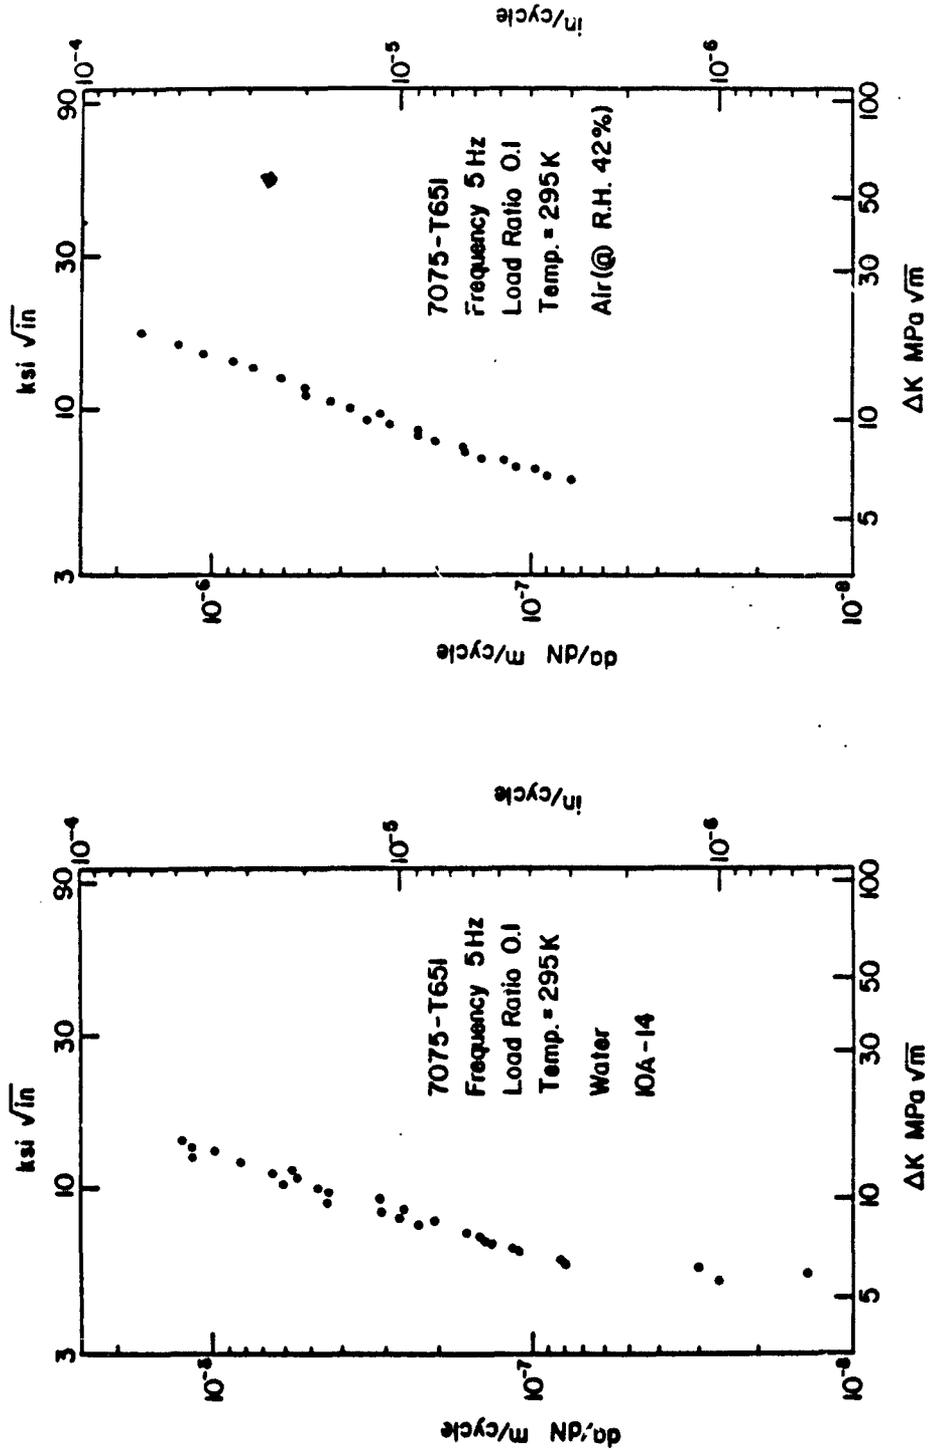
Fig. 19: Kinetics of fatigue crack growth for 7075-T651 aluminum alloy at 295K (R = 0.1 and f = 5 Hz) in water and in air at 42% relative humidity.

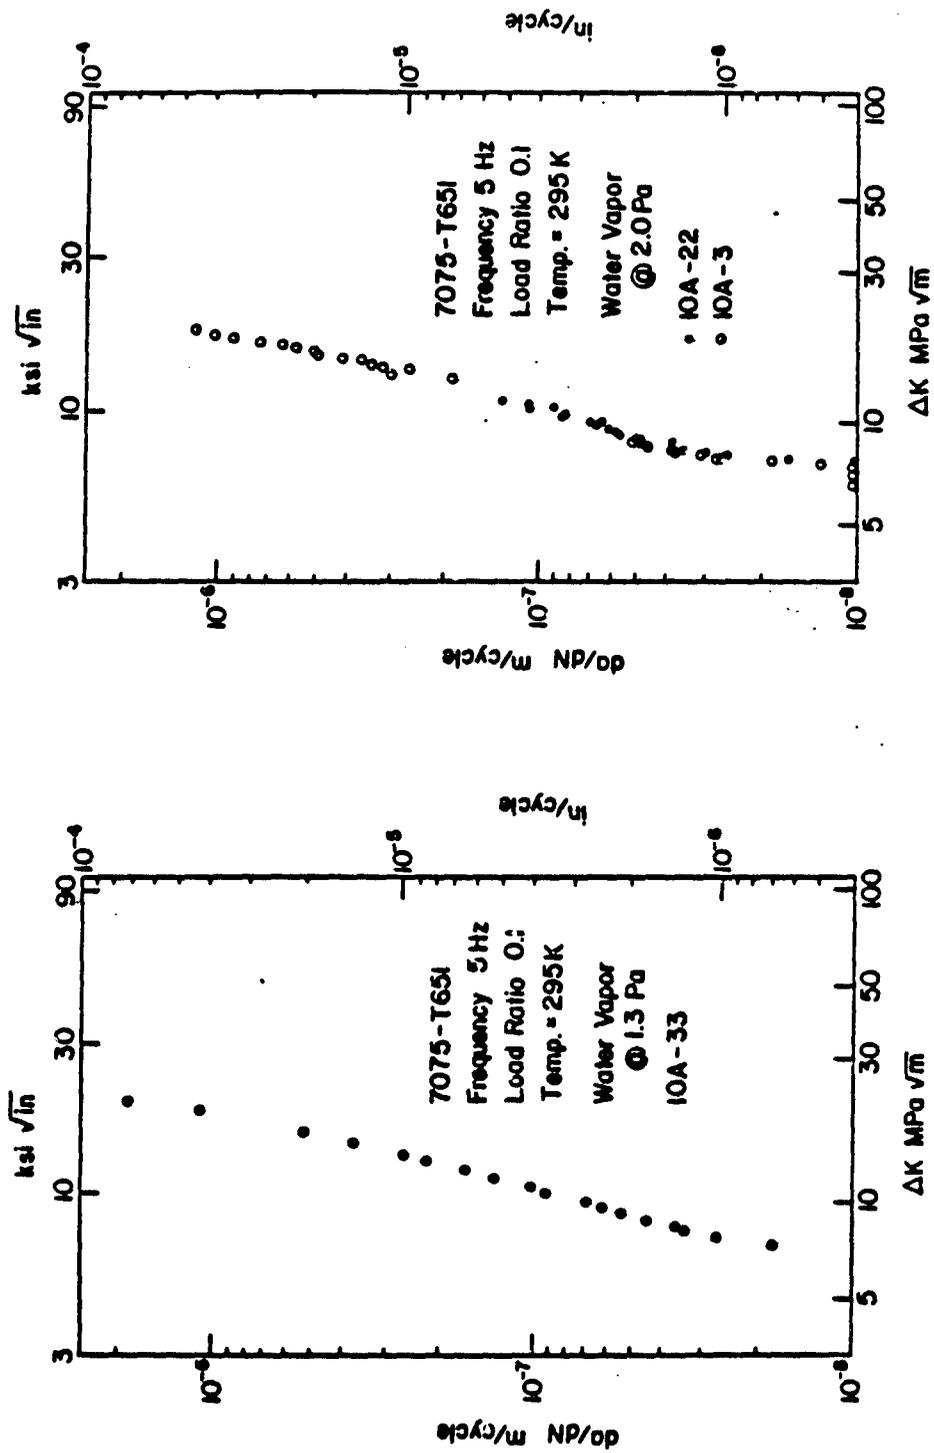
Fig. 20: Kinetics of fatigue crack growth for 7075-T651 aluminum alloy at 295K (R = 0.1 and f = 5 Hz) in water vapor at 1.3 Pa and 2.0 Pa.

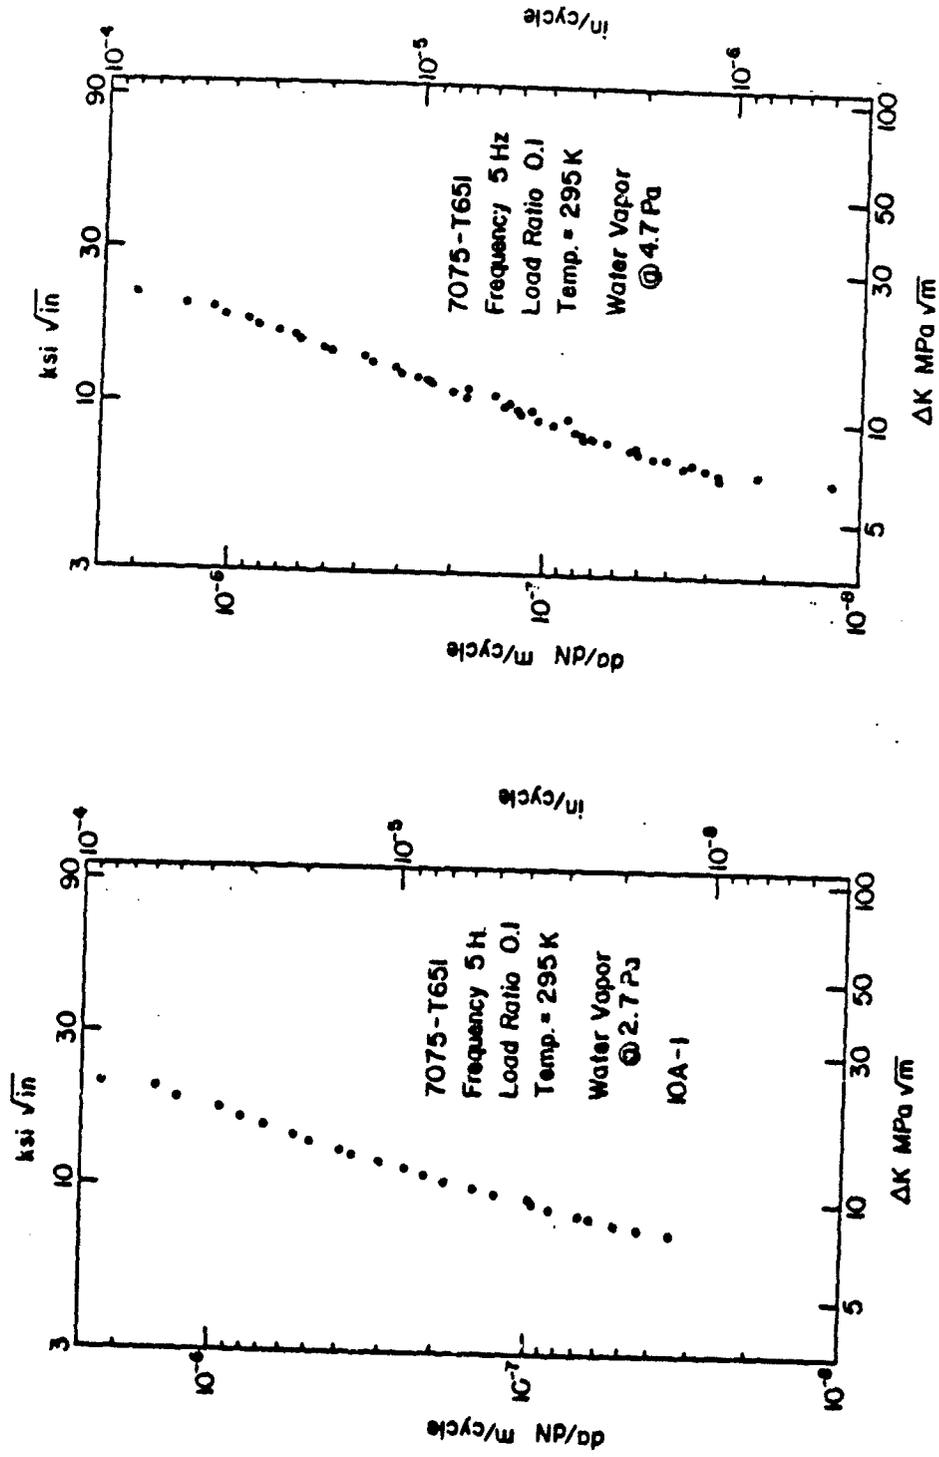
Fig. 21: Kinetics of fatigue crack growth for 7075-T651 aluminum alloy at 295K (R = 0.1 and f = 5 Hz) in water vapor at 2.7 Pa and 4.7 Pa.

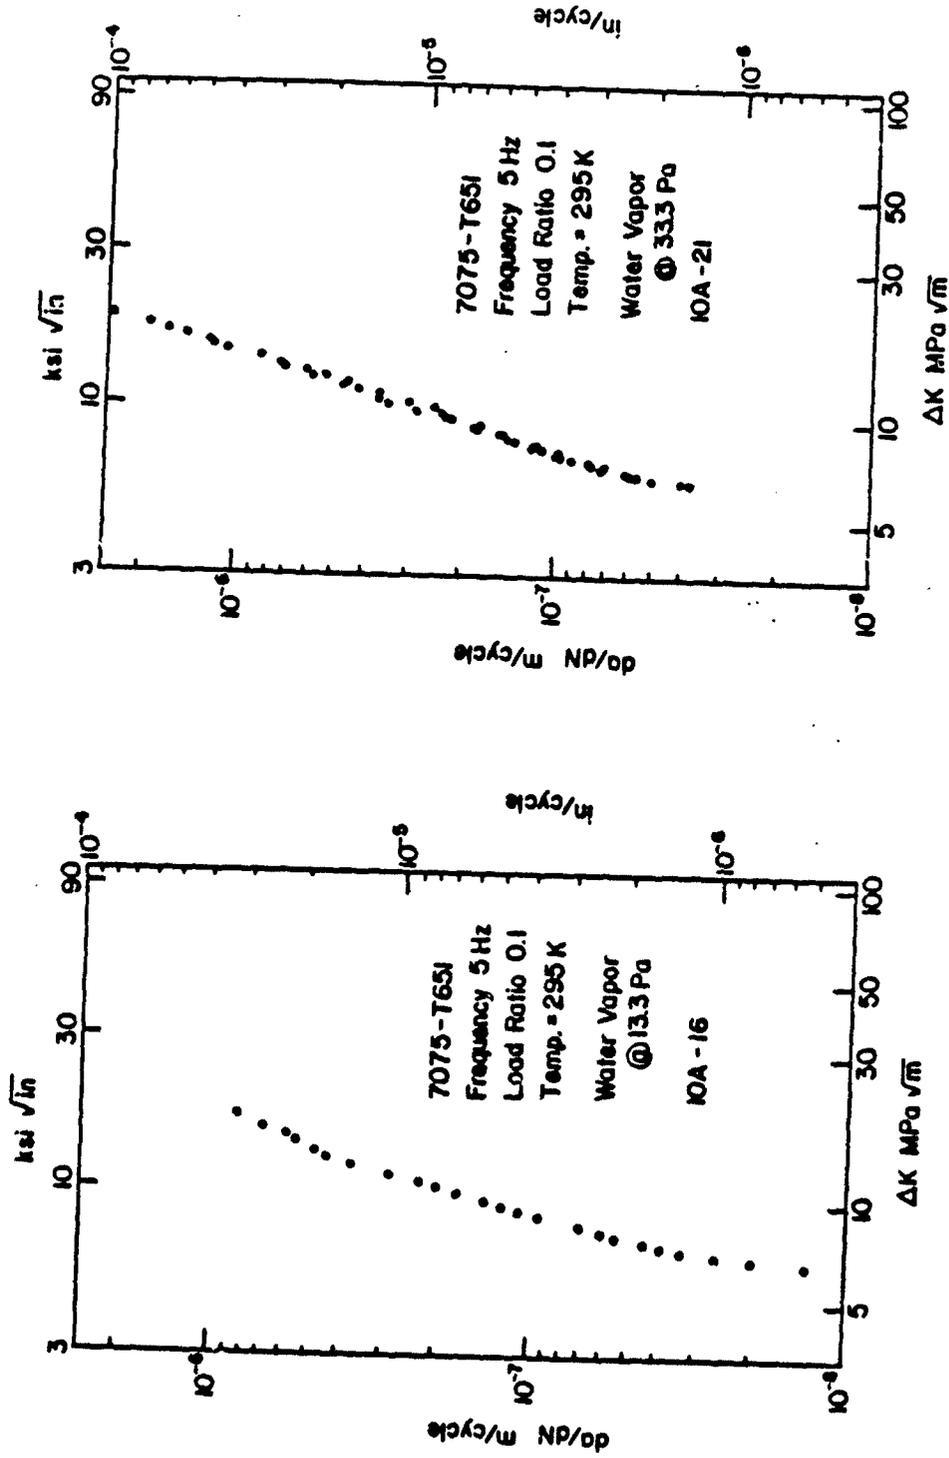
Fig. 22: Kinetics of fatigue crack growth for 7075-T651 aluminum alloy at 295K (R = 0.1 and f = 5 Hz) in water vapor at 13.3 Pa and 33.3 Pa.

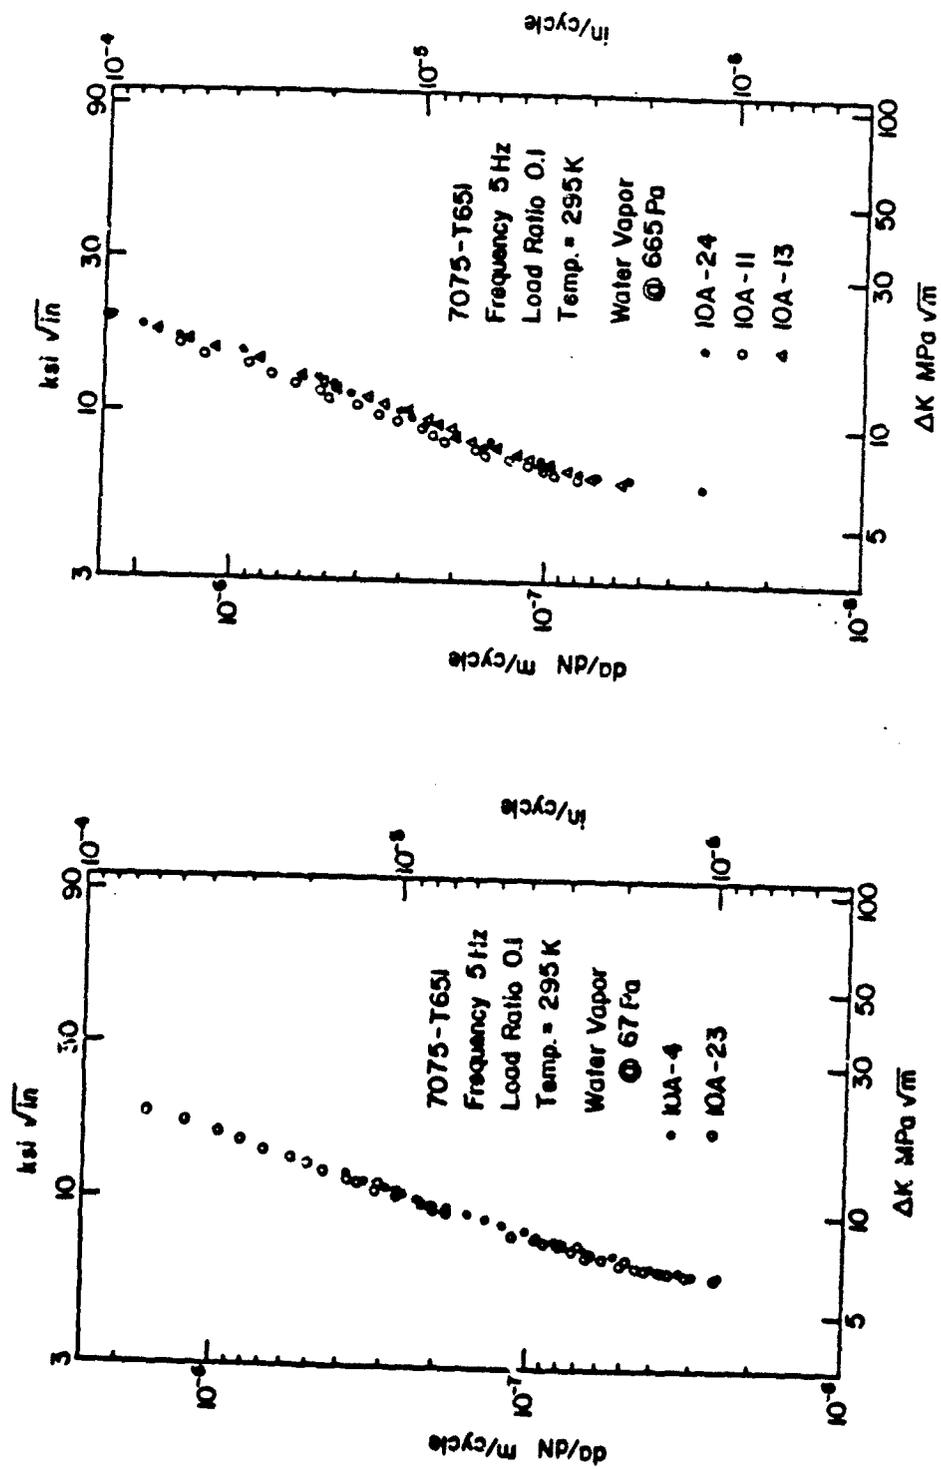
Fig. 23: Kinetics of fatigue crack growth for 7075-T651 aluminum alloy at 295K (R = 0.1 and f = 5 Hz) in water vapor at 67 Pa and 665 Pa.

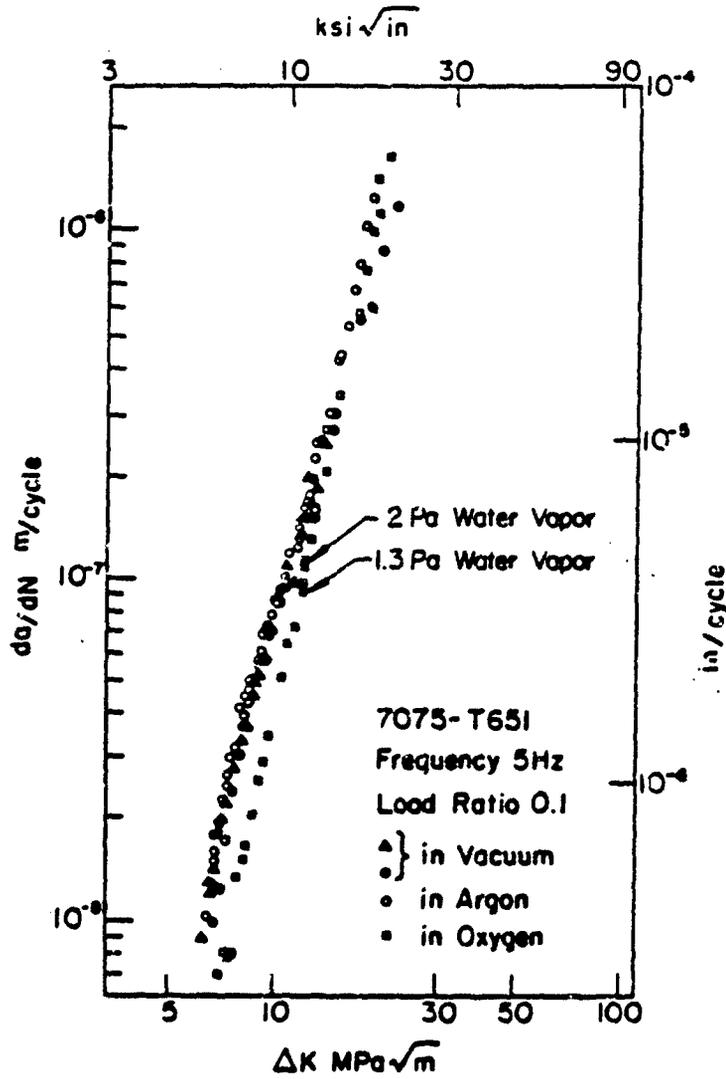
Fig. 24: Comparison of the kinetics of fatigue crack growth in I/M 7075-T651 in vacuum, pure argon and pure oxygen.

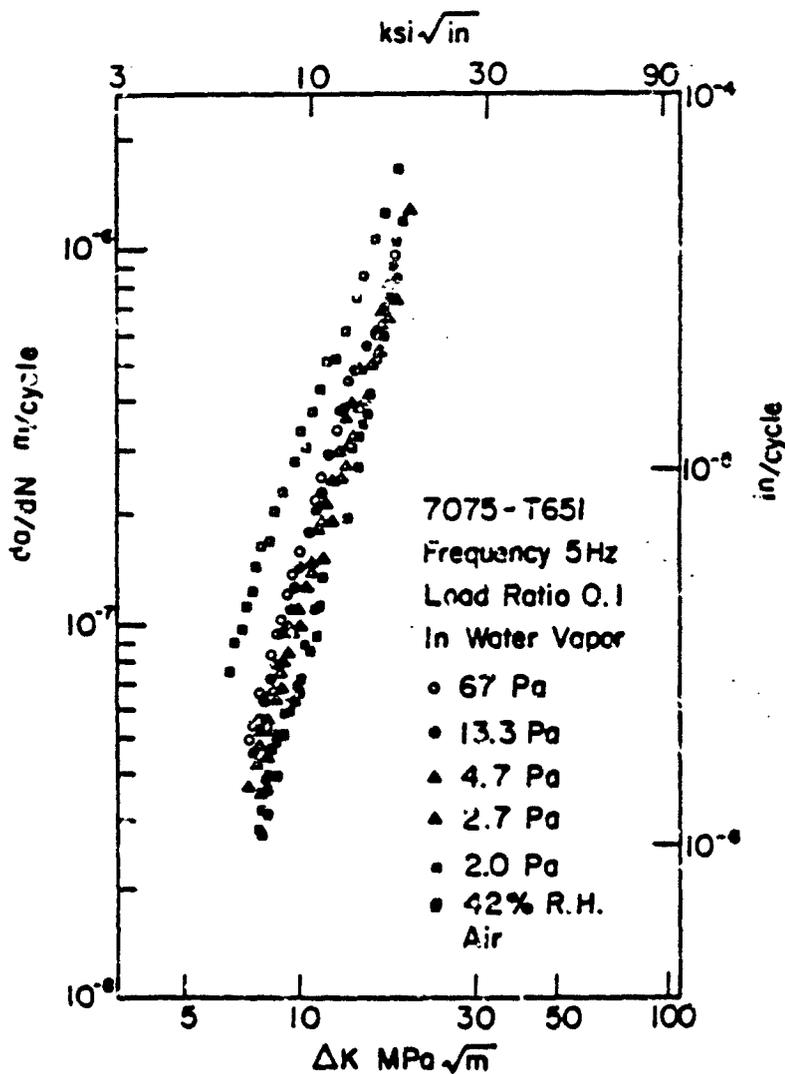
Fig. 25: Effect of water vapor pressure on fatigue crack growth kinetics for I/M 7075-T651 ( $f = 5 \text{ Hz}$ ,  $R = 0.1$ ).

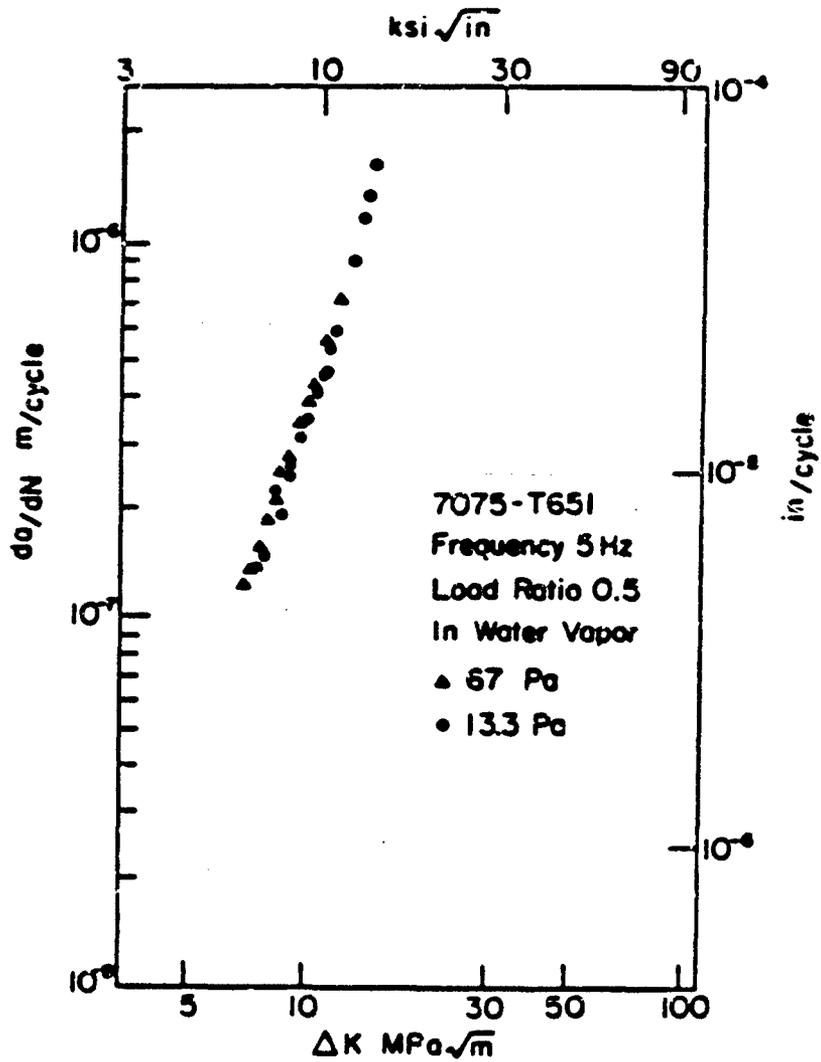
Fig. 26: Effect of water vapor pressure on fatigue crack growth kinetics for I/M 7075-T651 (R = 0.5 and f = 5 Hz).

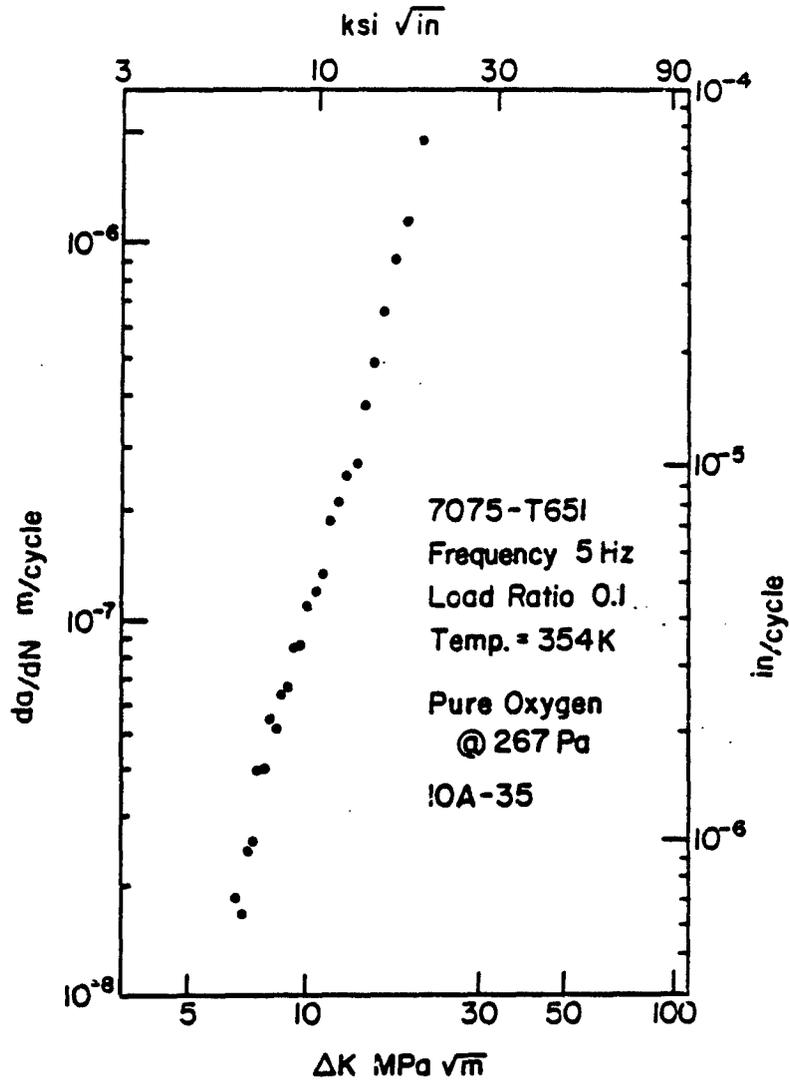
Fig. 28: Kinetics of fatigue crack growth for 7075-T651 aluminum alloy at 354K (R = 0.1 and f = 5 Hz) in pure oxygen at 267 Pa.
