MECHANISMS OF CORROSION FATIGUE IN HIGH STRENGTH I/M AND P/M ALUMINUM ALLOYS

R. P. Wei  
Lehigh University

P. S. Pao  
McDonnell Douglas Research Laboratories

Final Technical Report

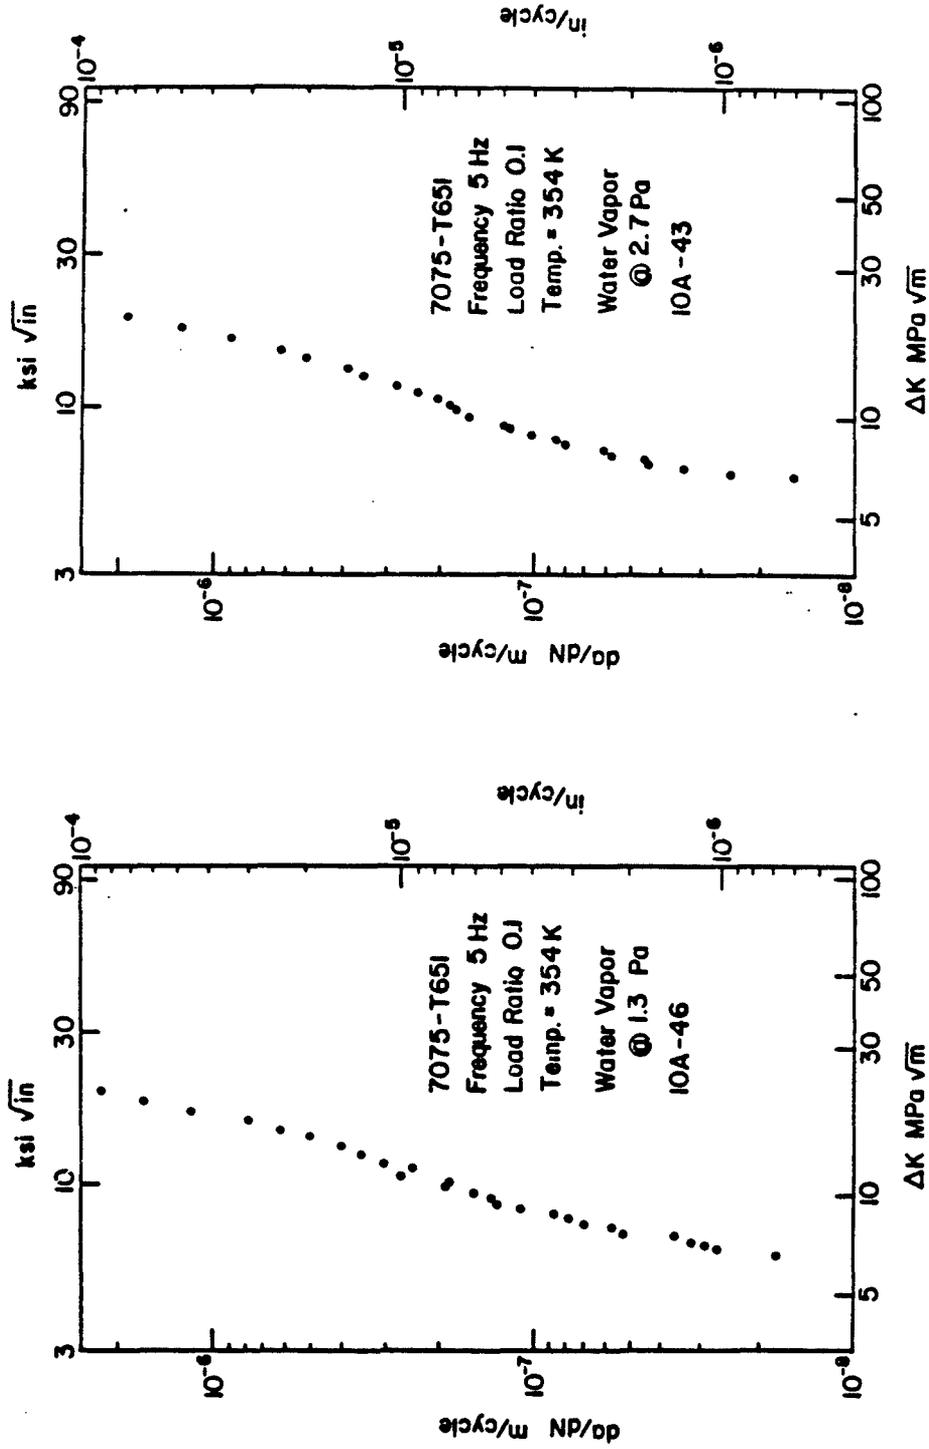
Fig. 29: Kinetics of fatigue crack growth for 7075-T651 aluminum alloy at 354K (R = 0.1 and f = 5 Hz) in water vapor at 1.3 Pa and 2.7 Pa.

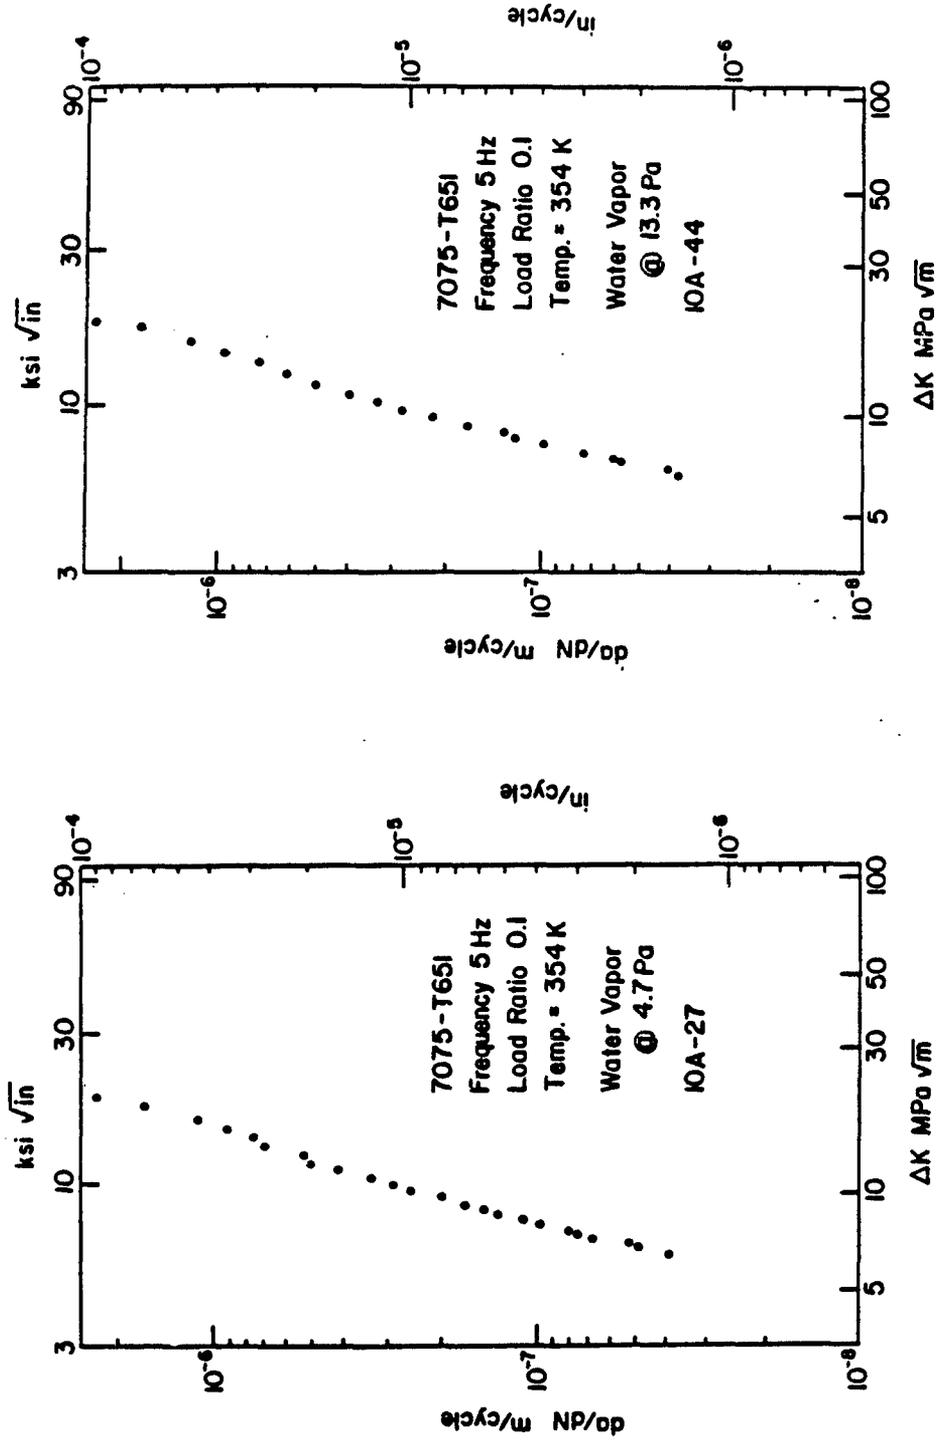
Fig. 30: Kinetics of fatigue crack growth for 7075-T651 aluminum alloy at 354K (R = 0.1 and f = 5 Hz) in water vapor at 4.7 Pa and 13.3 Pa.

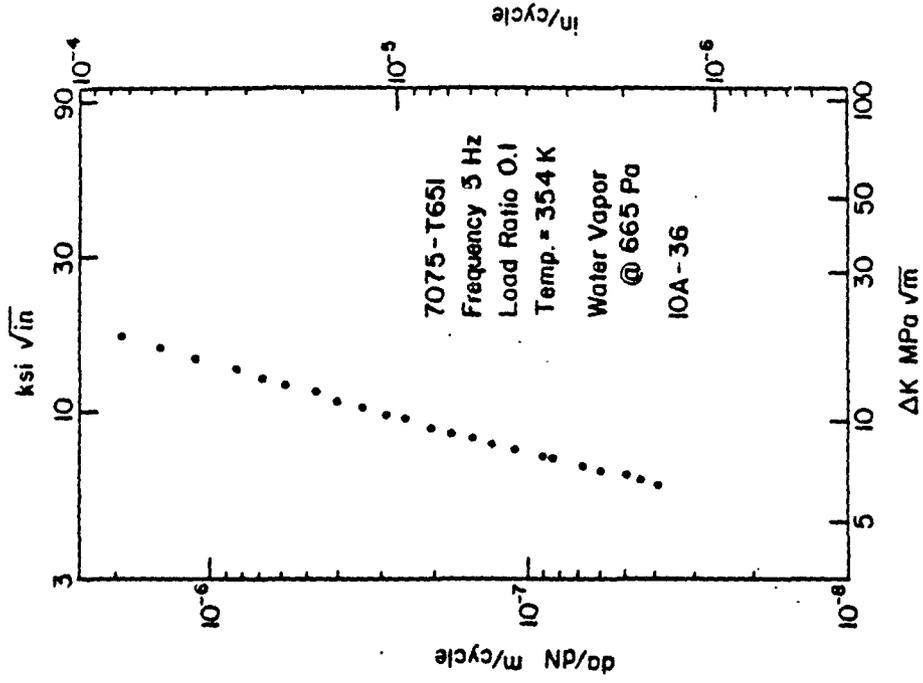
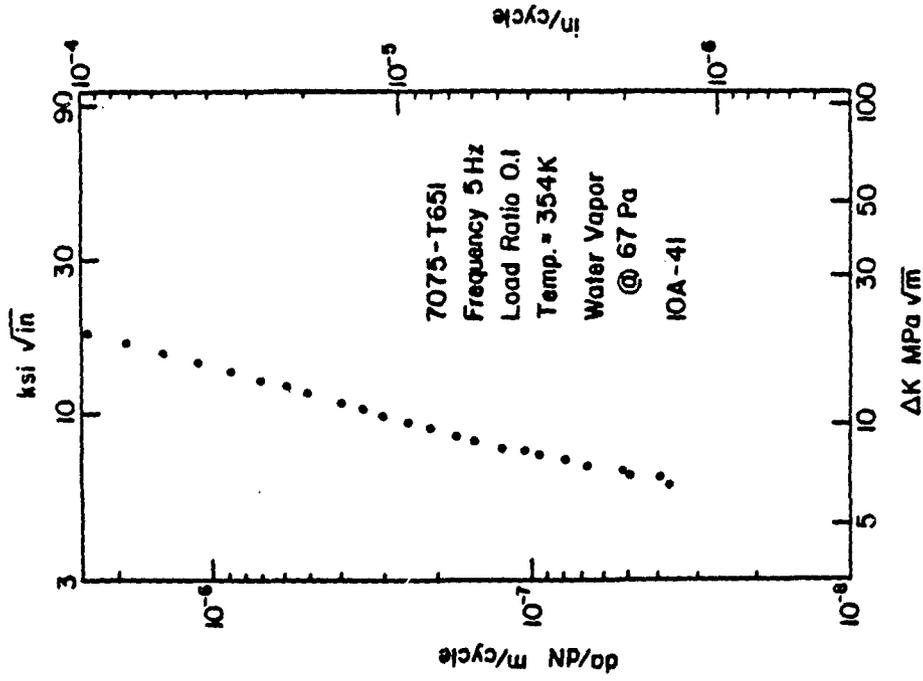
Fig. 31: Kinetics of fatigue crack growth for 7075-T651 aluminum alloy at 354K (R = 0.1 and f = 5 Hz) in water vapor at 67 Pa and 665 Pa.

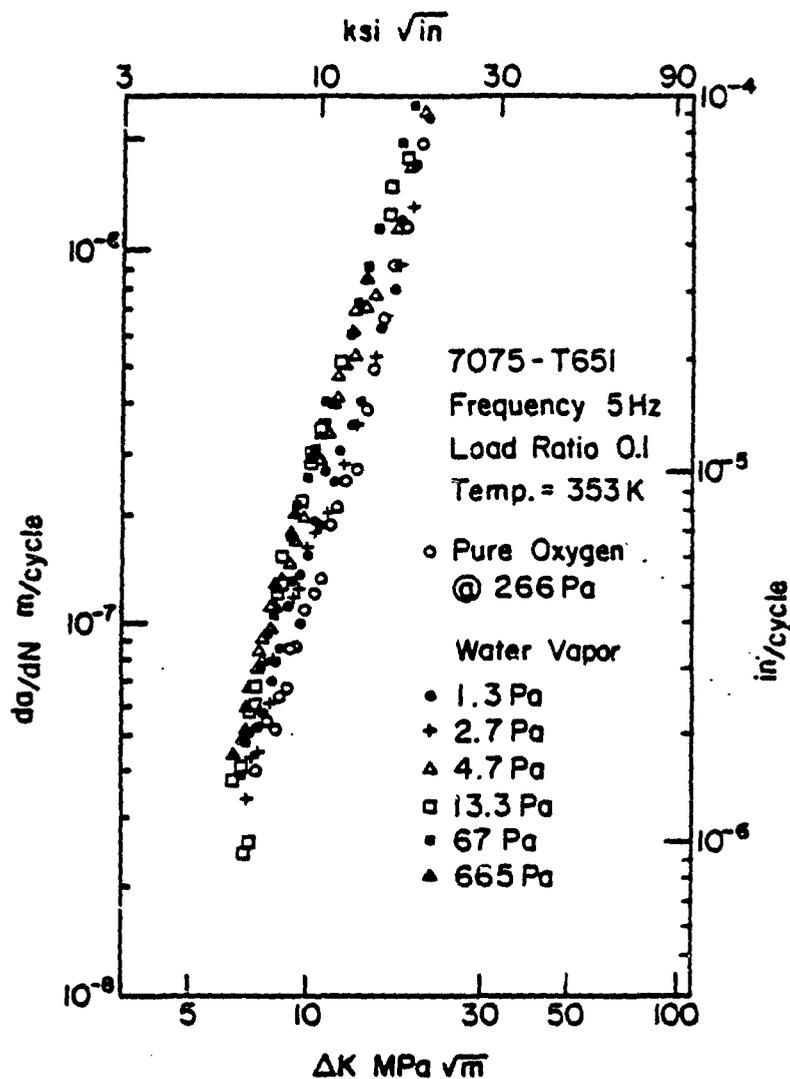
Fig. 32: Comparison of kinetics of fatigue crack growth in I/M 7075-T651 aluminum alloy at 354K in pure oxygen and in water vapor.

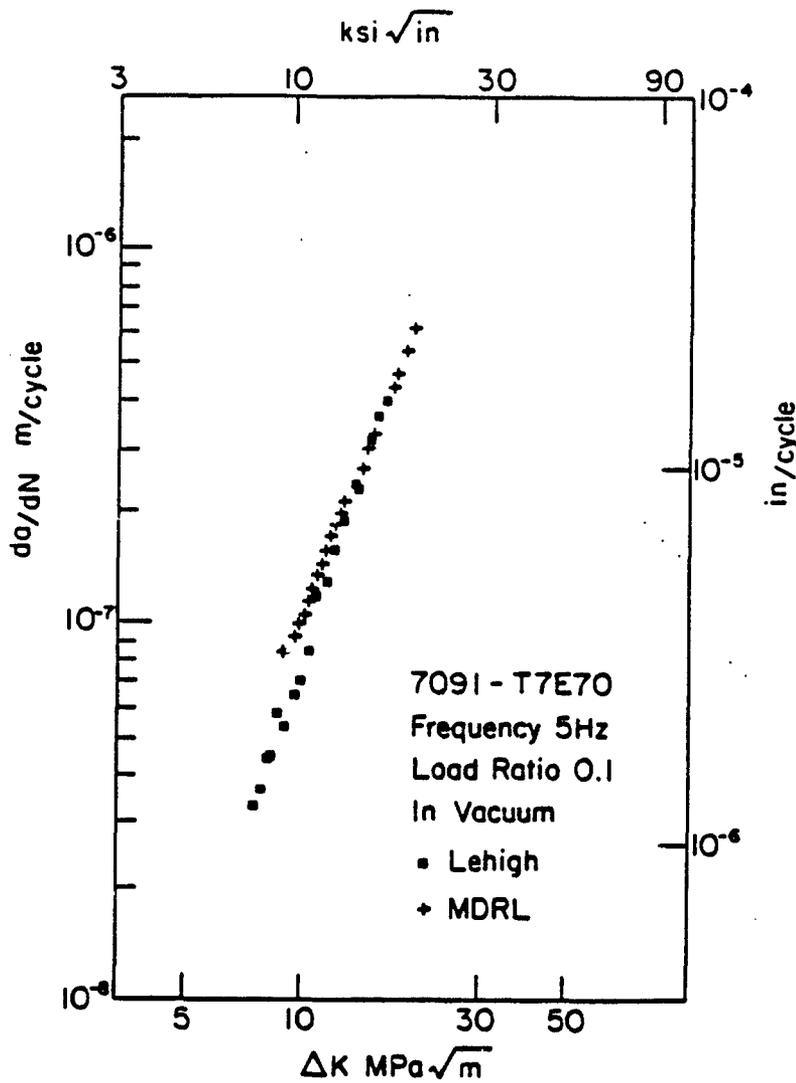
Fig. 33: Comparison of kinetics data of fatigue crack growth experiments in vacuum on P/M 7091-T7E70 aluminum alloy conducted at LU and MDRL.

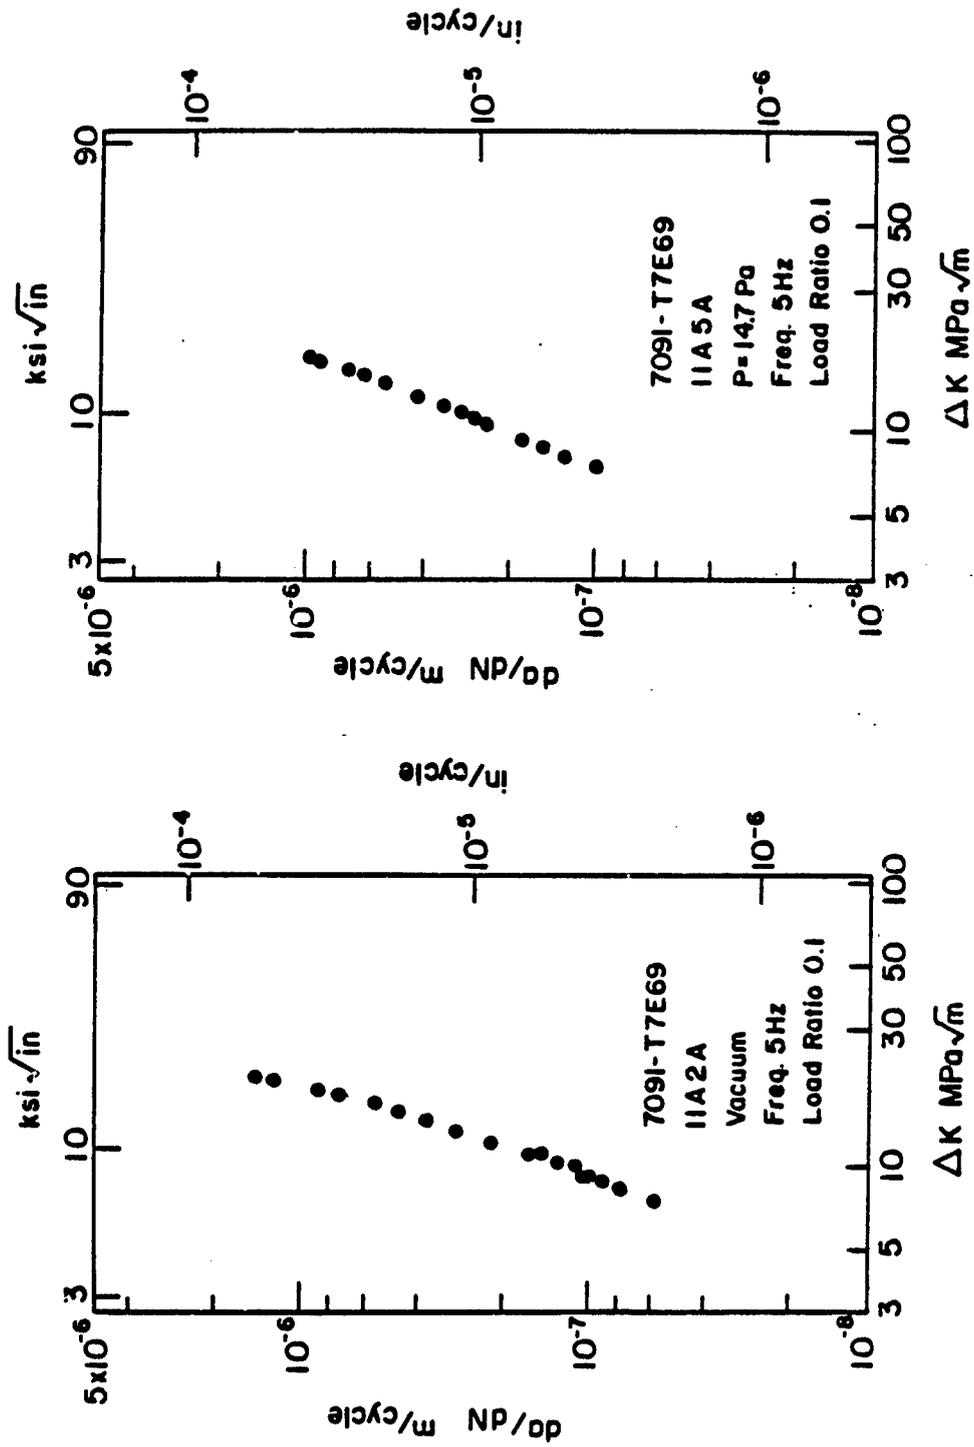
Fig. 34: Kinetics of fatigue crack growth for P/M 7091-T7E69 aluminum alloy (R = 0.1 and  $f = 5$  Hz) in vacuum ( $<10^{-6}$  Pa) and in water vapor at 14.7 Pa.

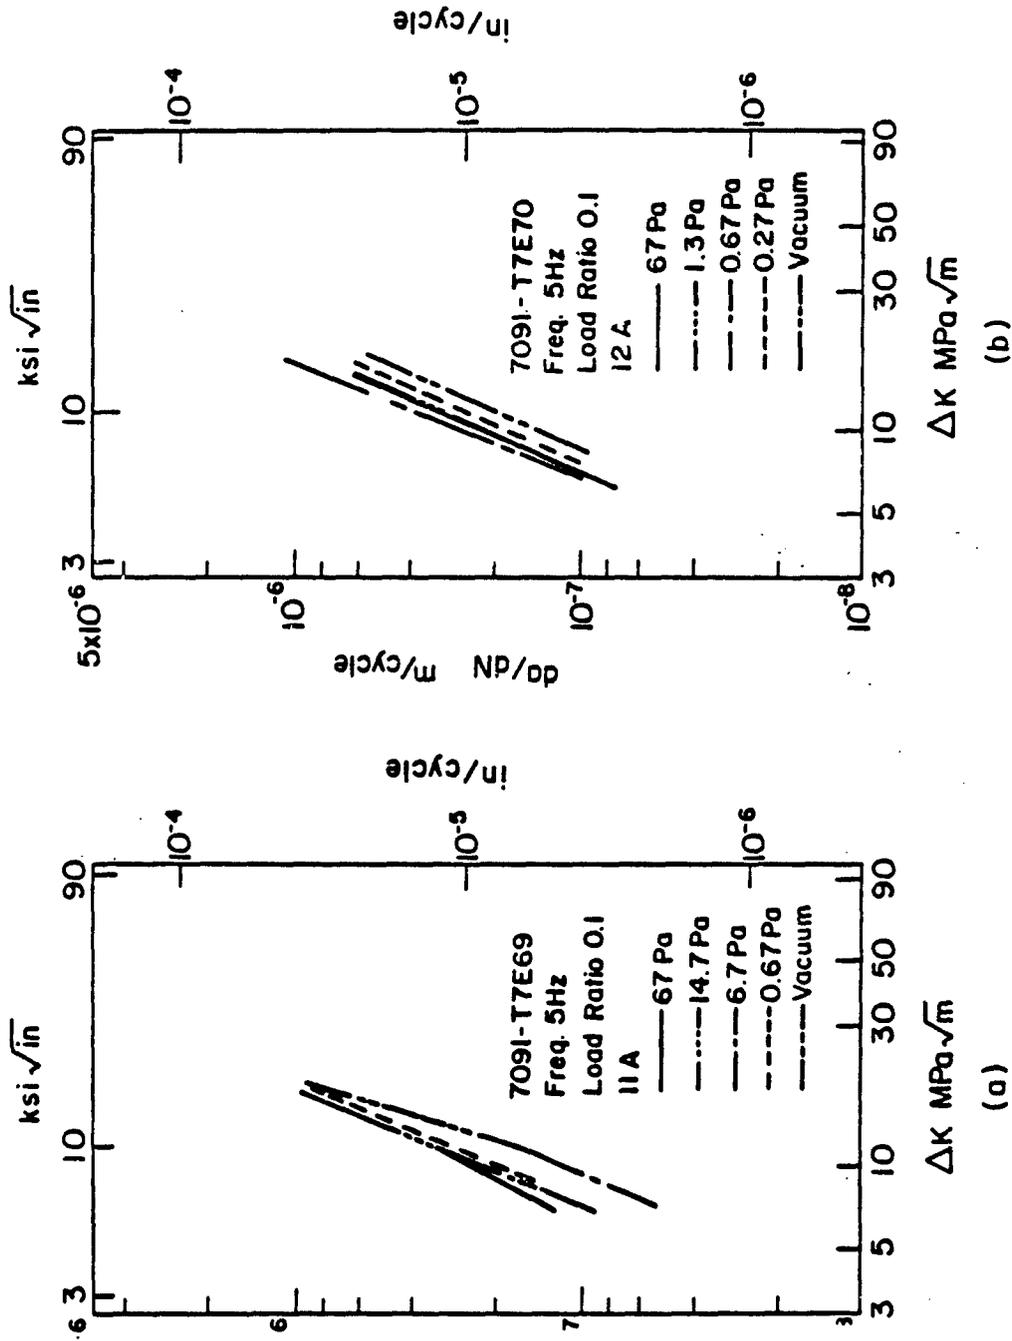
Fig. 35: Comparison of kinetics of fatigue crack growth in 7091-T7E69 and in 7091-T7E70 aluminum alloys tested in vacuum and water vapor environments: (a) 7091-T7E69, and (b) 7091-T7E70.

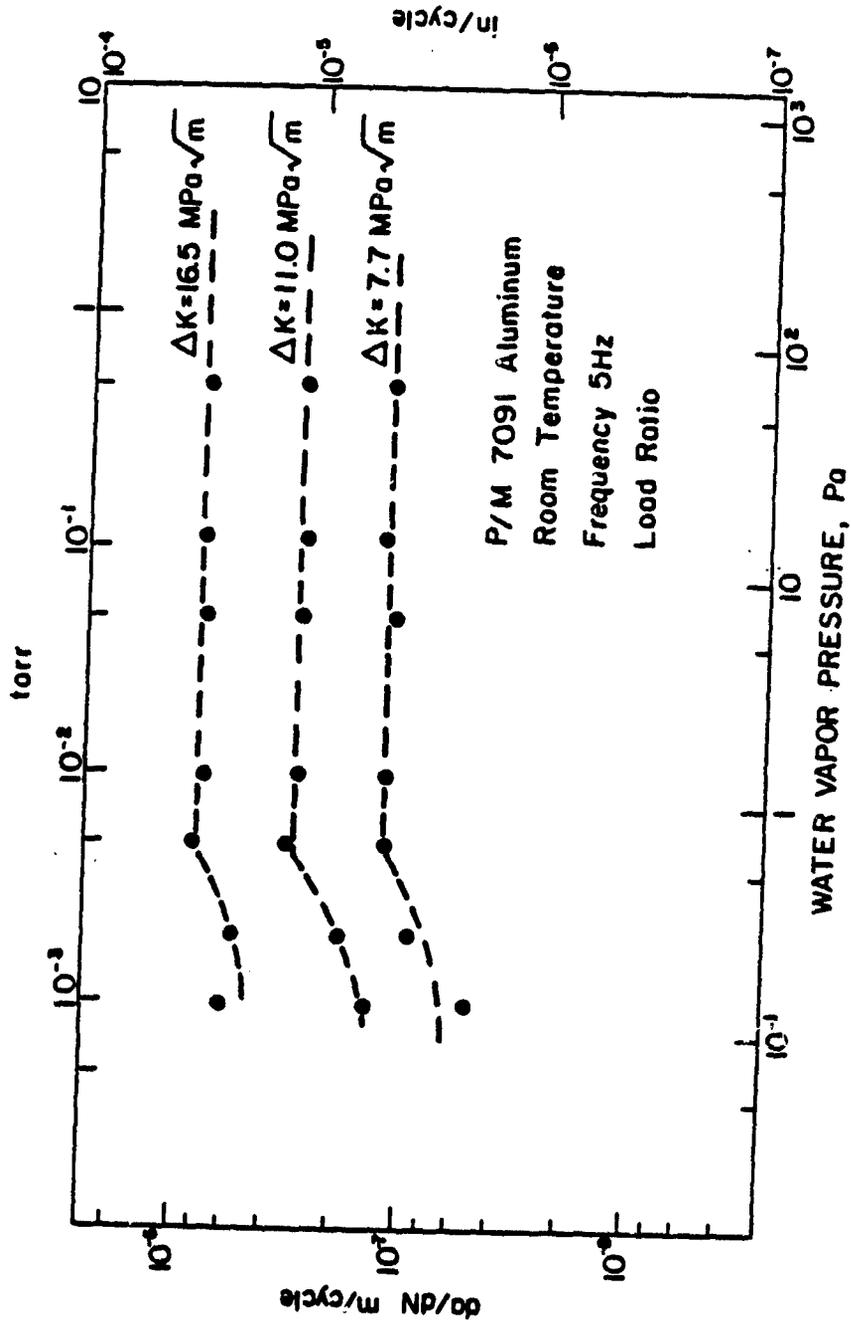
Fig. 36: Influence of water vapor pressure on the fatigue crack growth rate in P/M 7091 aluminum alloy.

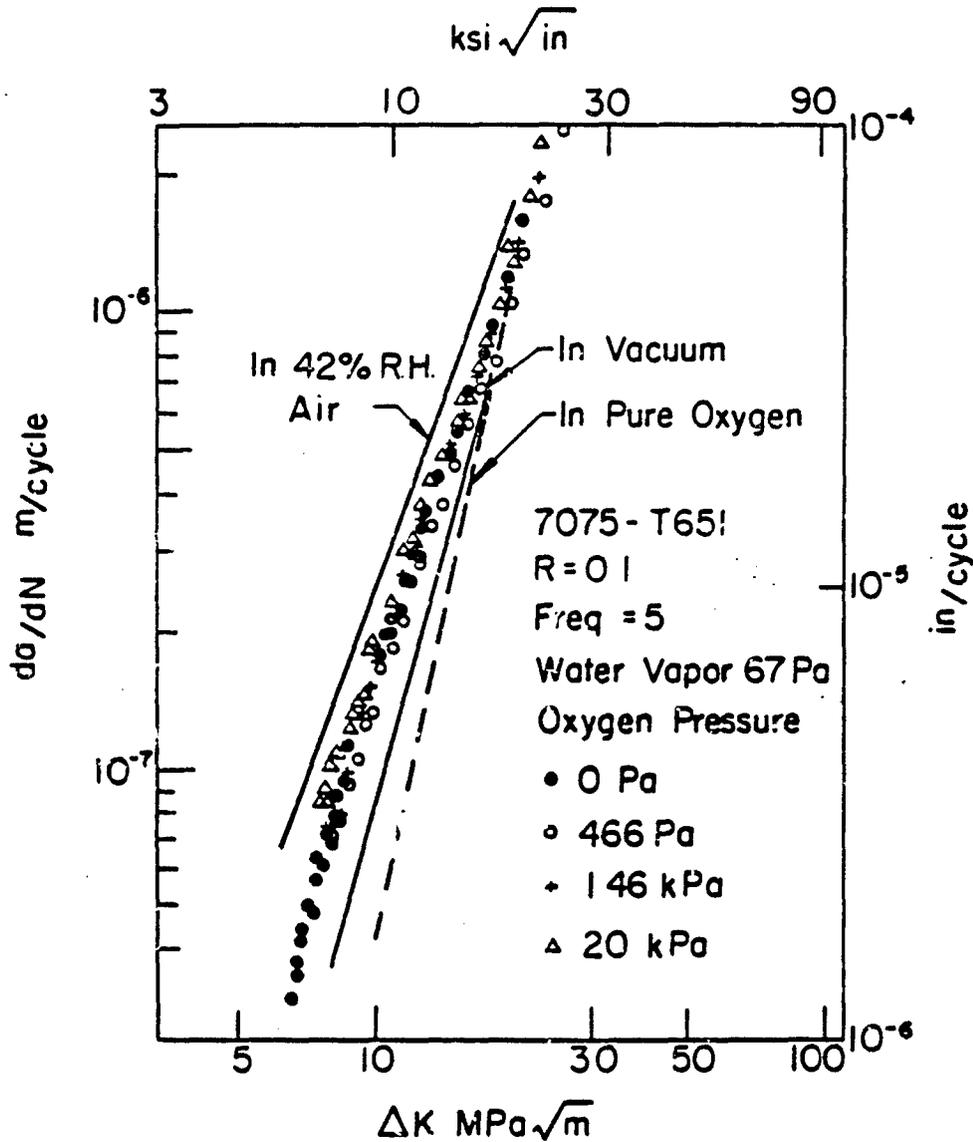
Fig. 37: Effect of oxygen pressure on fatigue crack growth kinetics in a binary gas mixture ( $P_{\text{H}_2\text{O}} = 67 \text{ Pa}$ ) for I/M 7075-T651 aluminum alloy.

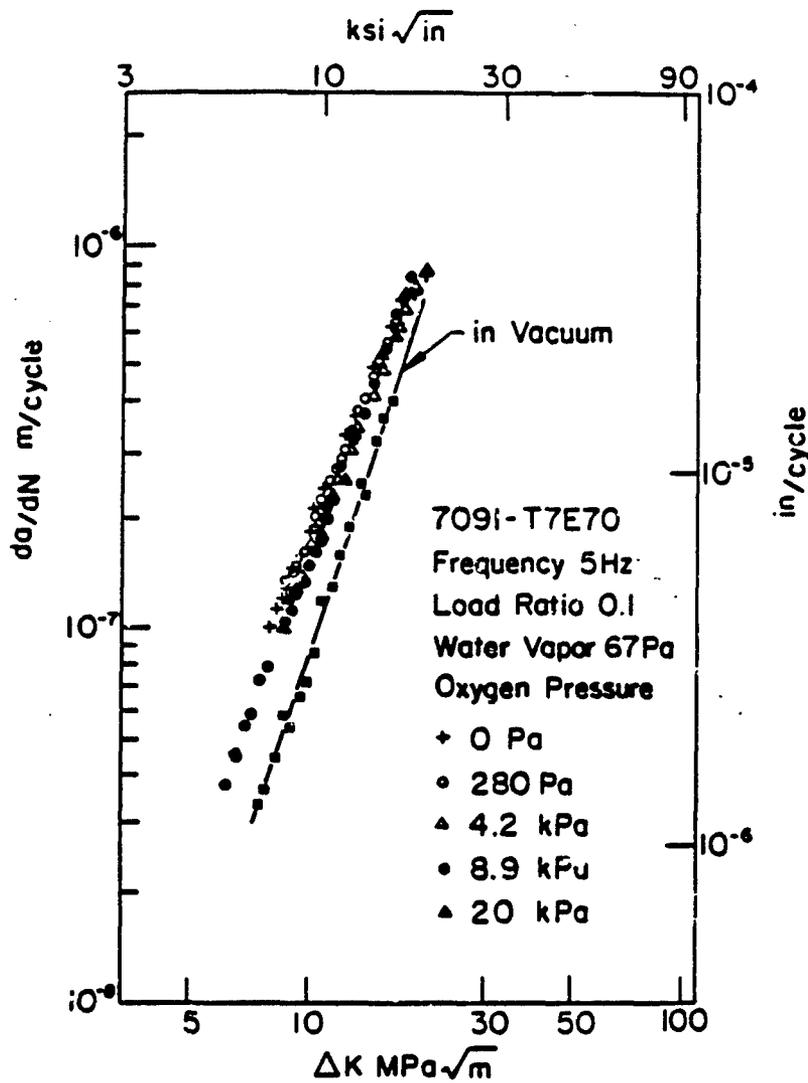
Fig. 38: Effect of oxygen pressure on fatigue crack growth in a binary gas mixture ( $P_{\text{H}_2\text{O}} = 67$  Pa) for P/M 7091-T7E70 aluminum alloy.

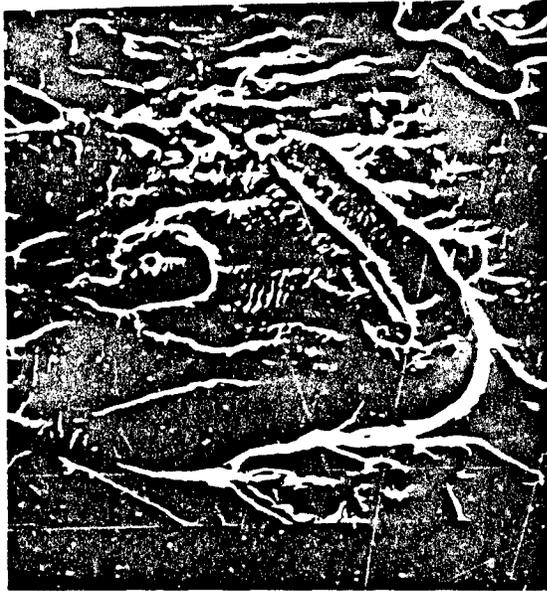
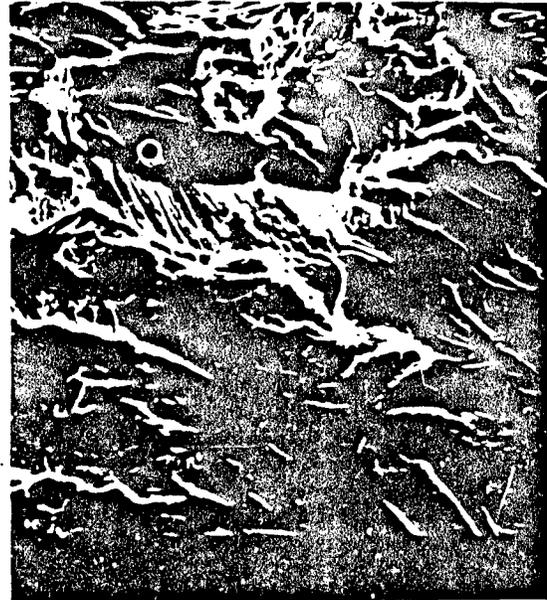
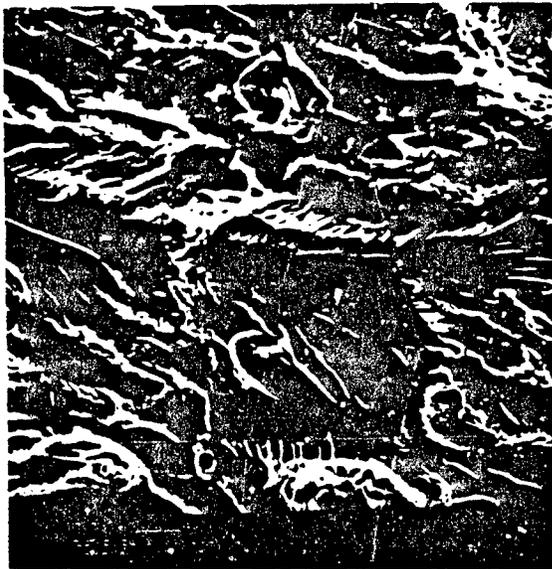
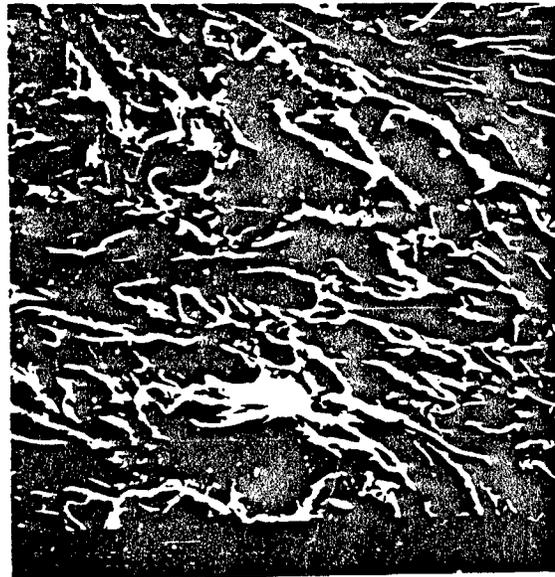
Fig. 39: Scanning electron microfractographs of 7050-T7451 aluminum alloy specimens tested in fatigue at room temperature at  $R = 0.1$  ( $\Delta K = 10 \text{ MPa}\sqrt{\text{m}}$ ): (a) in vacuum; (b) in water vapor at 6.7 Pa; (c) in water vapor at 67 Pa, and (d) distilled water.

Representative scanning electron (SEM) microfractographs from the fatigue crack growth specimens for  $R = 0.1$  and  $R = 0.5$ , corresponding to a  $\Delta K$  of  $10 \text{ MPa}\sqrt{\text{m}}$ , are shown in Figs. 39 and 40, respectively. These micrographs indicate the crack path to be transgranular, irrespective of the test environment.

The morphology of fracture surfaces for specimens tested in water vapor and distilled water are similar, but are different from that for specimens tested in vacuum. Fracture surfaces in vacuum (Figs. 39(a) and 40(a)) show evidence of ductile tearing and fatigue striations. Fracture surfaces of specimens tested in water vapor (Figs. 39(b,c) and 40(b)) and in water (Fig. 39(d)), on the other hand, are characterized by flat featureless regions, regions that contain "brittle" striations, and small areas of ductile tearing.

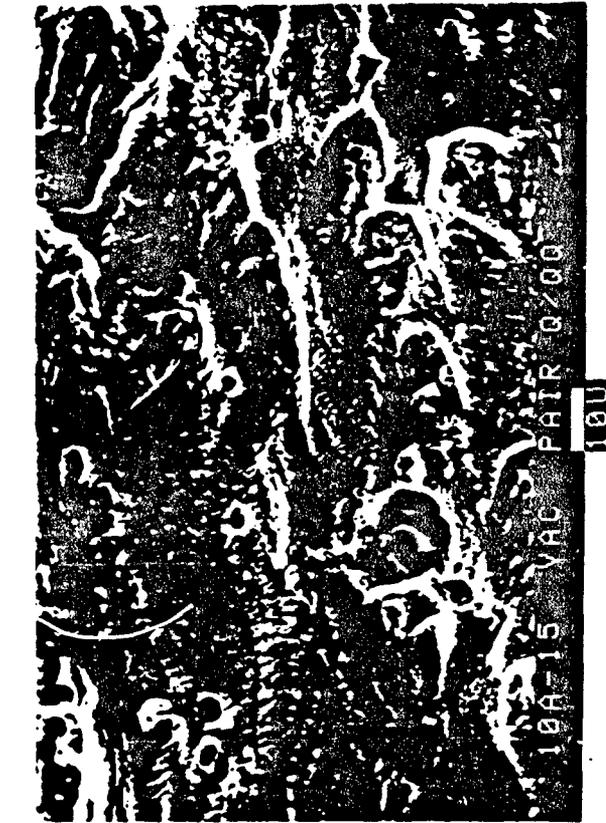
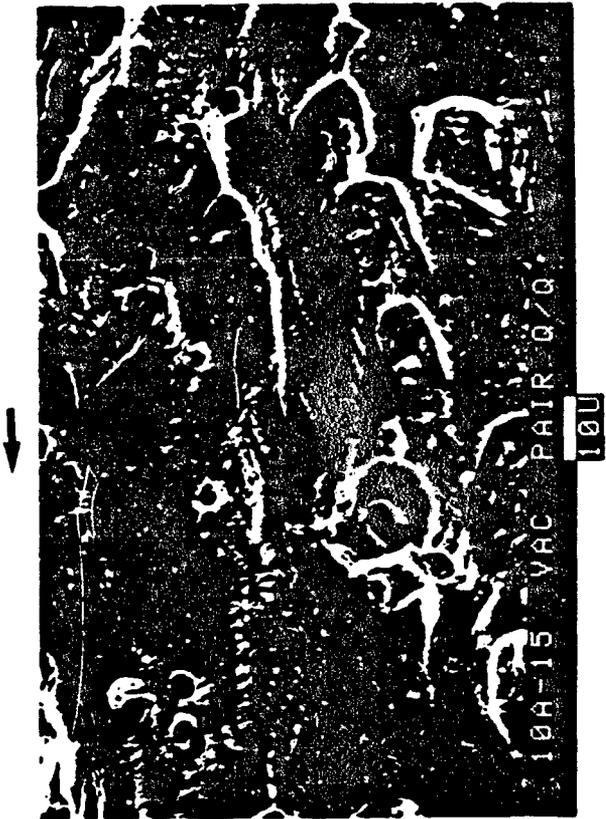
Fig. 43: Stereo pair of the fracture surface morphology for 7075-T651 tested in vacuum. The stereo pair of the mating half is shown in Fig. 44.

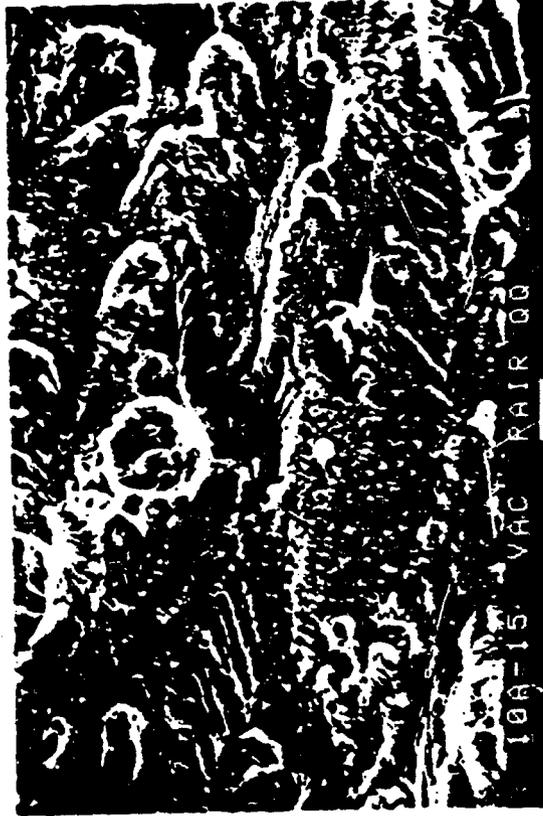
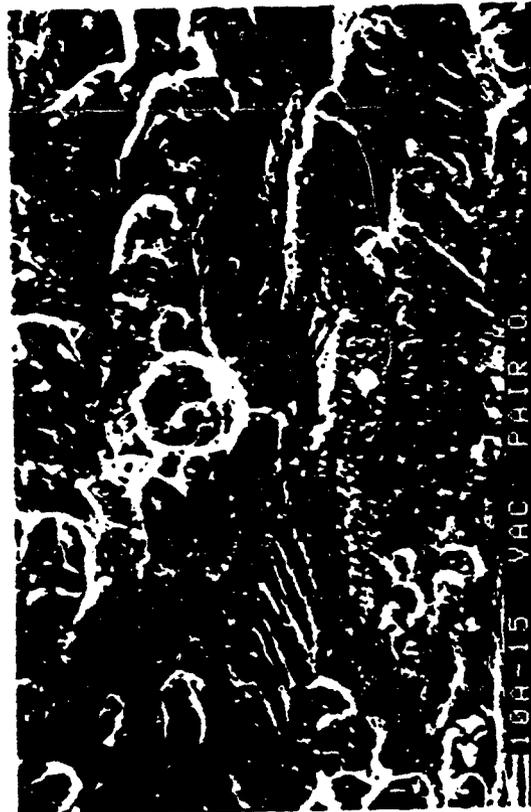
Fig. 44: Stereo pair of the fracture surface morphology for 7075-T651 tested in vacuum. The stereo pair of the mating half is shown in Fig. 43.

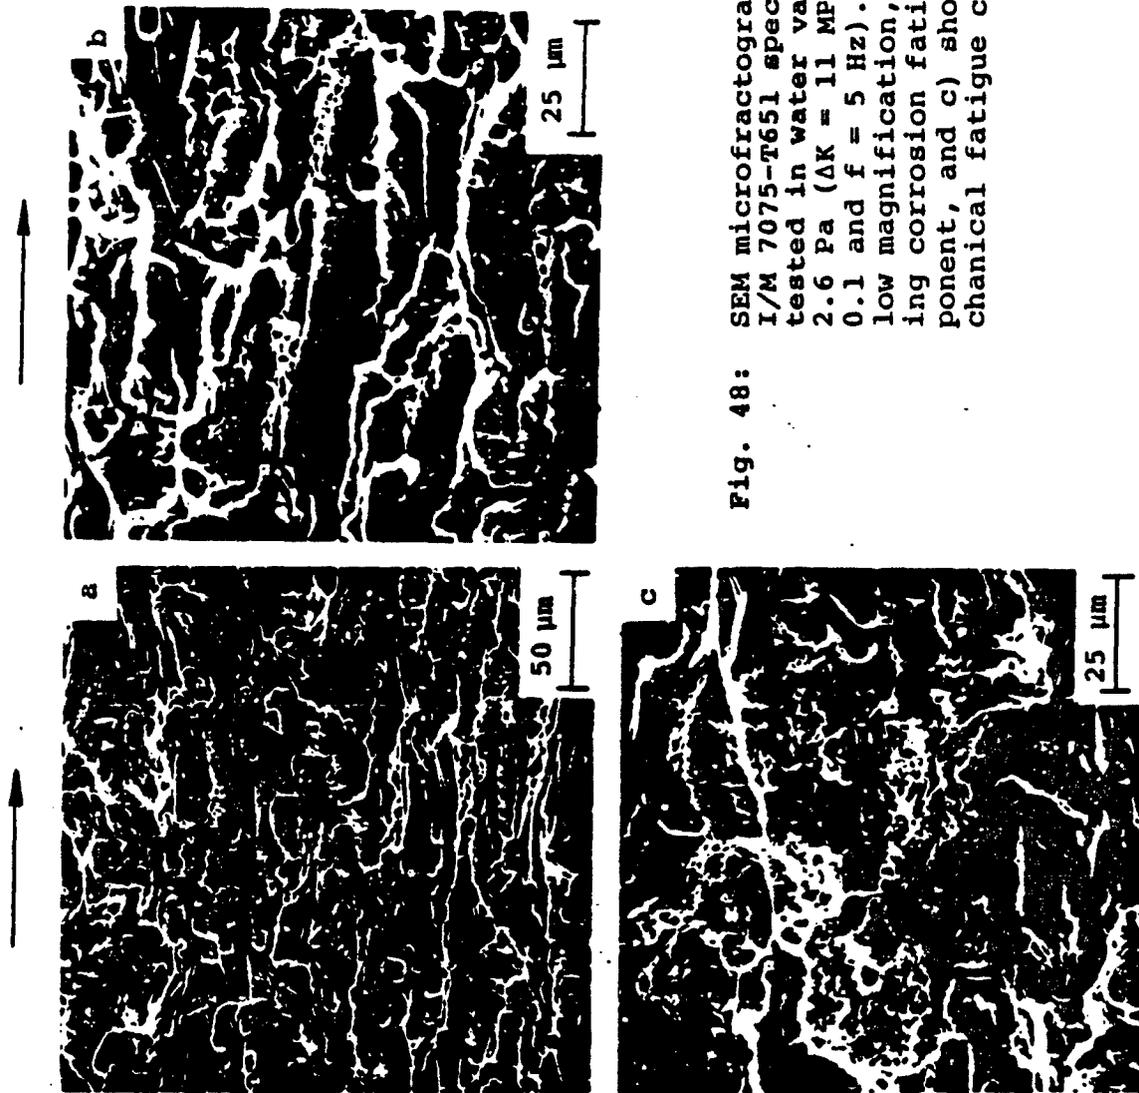
Fig. 48: SEM microfractographs of I/M 7075-T651 specimen tested in water vapor at 2.6 Pa ( $\Delta K = 11 \text{ MPa}\sqrt{\text{m}}$ ,  $R = 0.1$  and  $f = 5 \text{ Hz}$ ). a) at low magnification, b) showing corrosion fatigue component, and c) showing mechanical fatigue component.

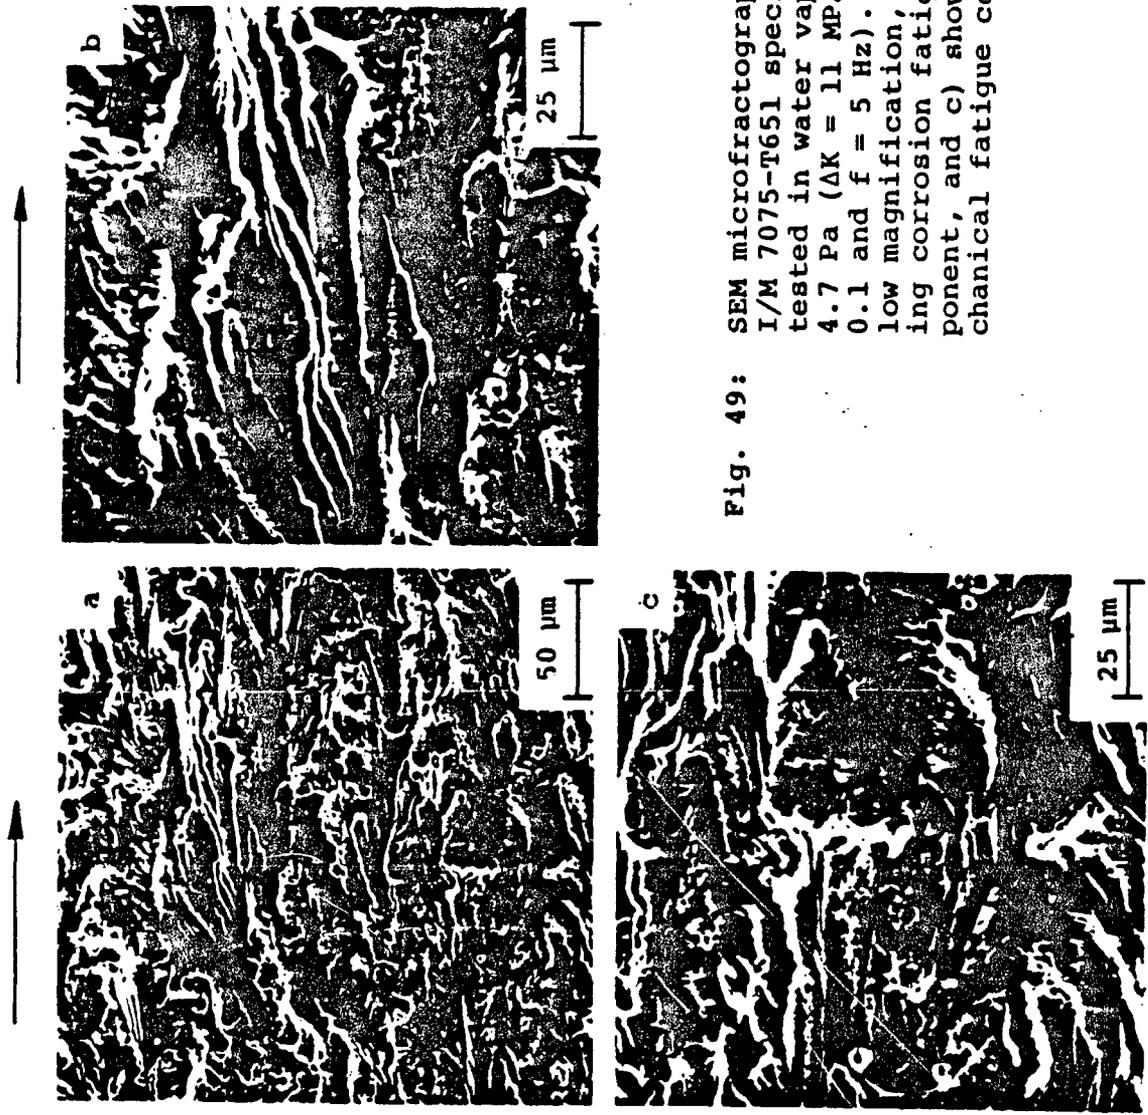
Fig. 49: SEM microfractographs of I/M 7075-T651 specimen tested in water vapor at 4.7 Pa ( $\Delta K = 11 \text{ MPa}\sqrt{\text{m}}$ ,  $R = 0.1$  and  $f = 5 \text{ Hz}$ ). a) at low magnification, b) showing corrosion fatigue component, and c) showing mechanical fatigue component.

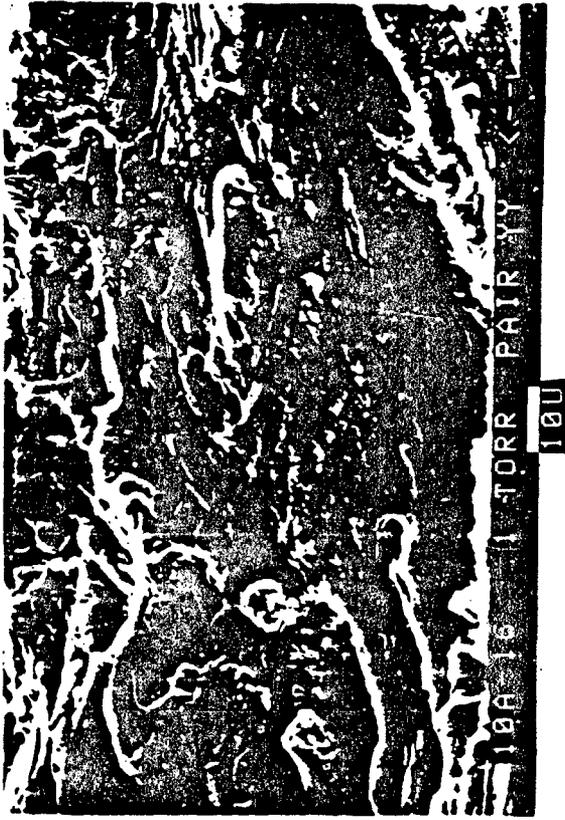
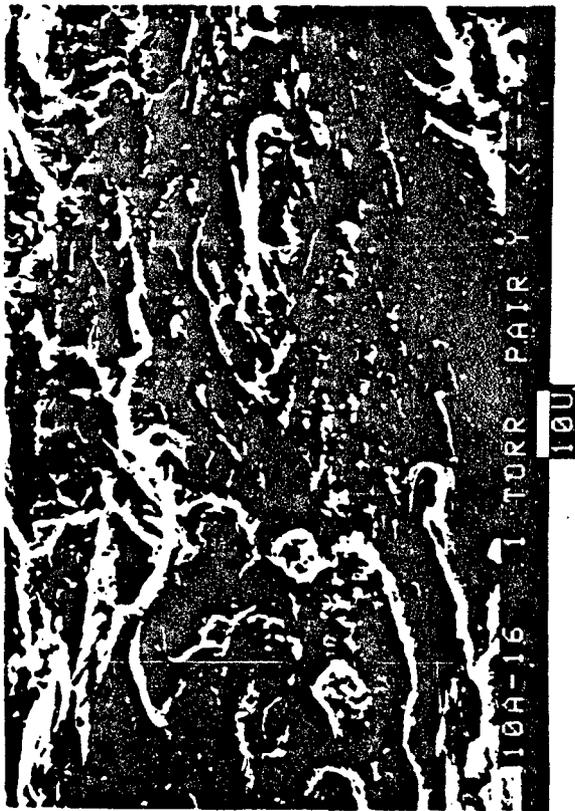
Fig. 51: Stereo pair of the fracture surface morphology for 7075-T651 tested at 133.3 Pa in water vapor. The stereo pair of the mating half is shown in Fig. 52.

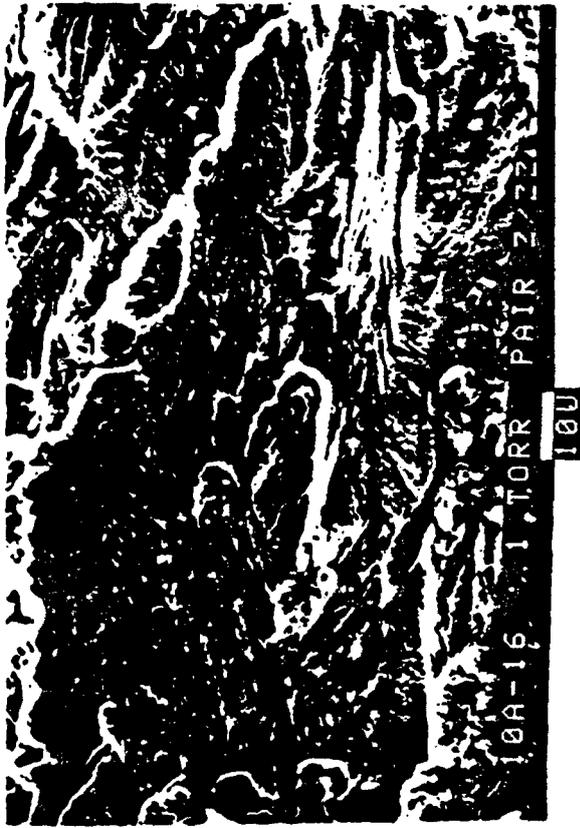
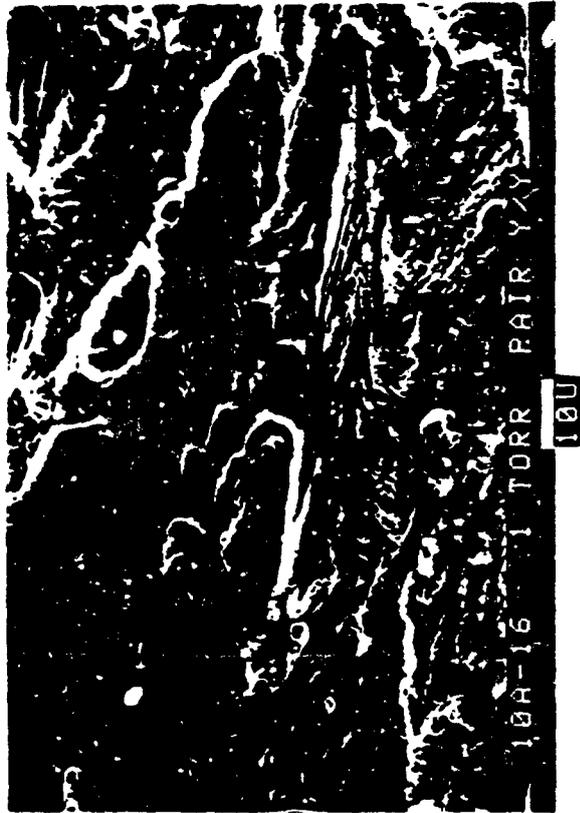
Fig. 52: Stereo pair of the fracture surface morphology for 7075-T651 tested at 133.3 Pa in water vapor. The stereo pair of the mating half is shown in Fig. 51.

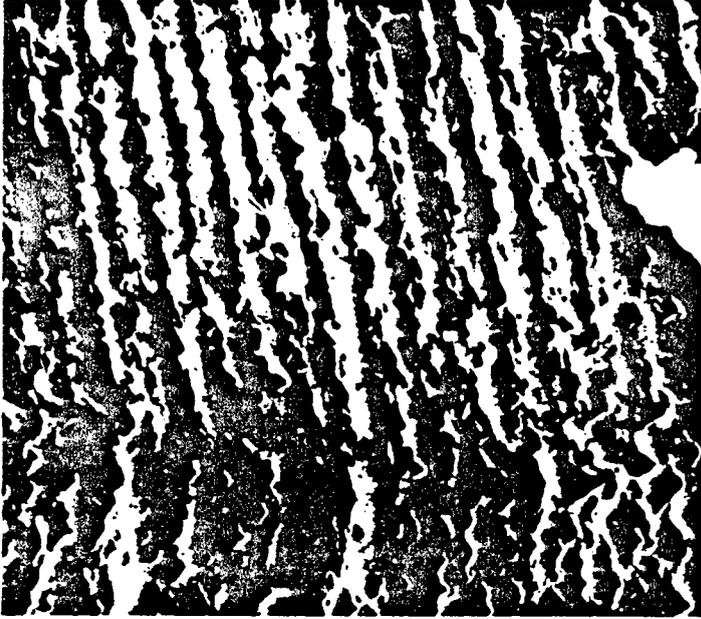
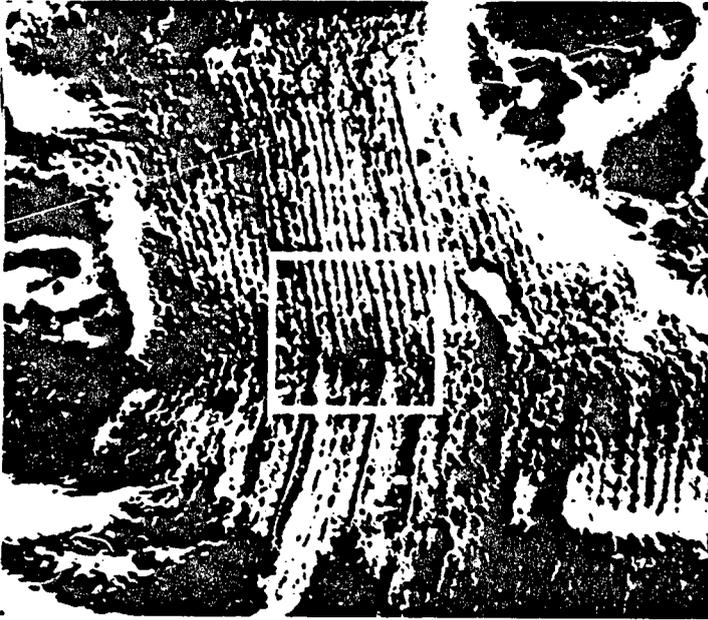
Fig. 55: Representative SEM microfractographs of etched surface of 7075-T651 aluminum alloy tested in air at room temperature showing alignment of striations along  $\langle 110 \rangle$  on  $\{100\}$  fracture planes; although their orientations changed slightly from one subgrain to another.

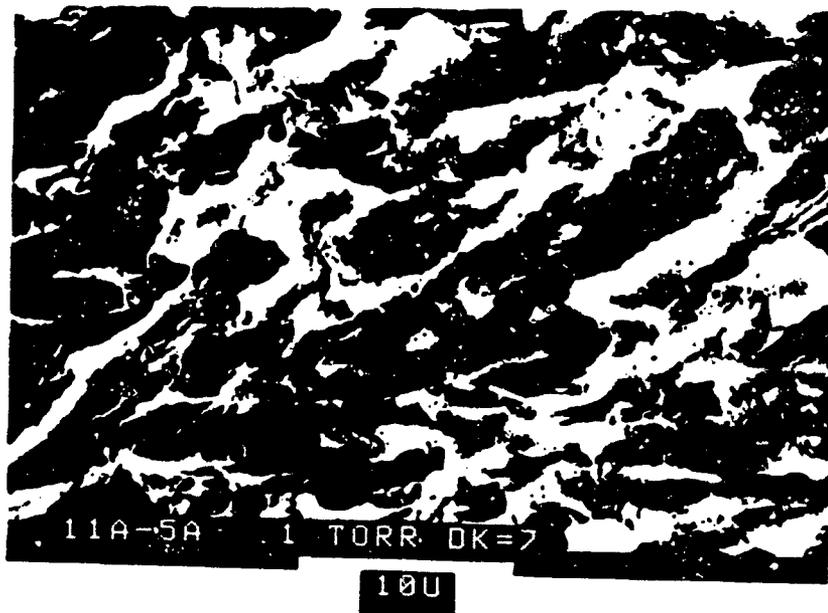
Fig. 56: SEM microfractographs of P/M 7091-T7E69 tested in (a) vacuum, and (b) 133.3 Pa in water vapor ( $R = 0.1$  and  $f = 5$  Hz).

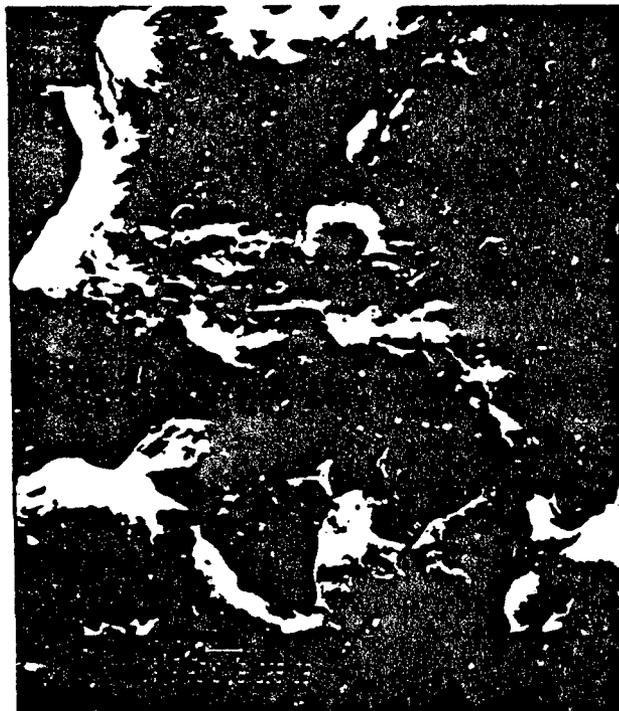
Fig. 57: SEM microfractographs of P/M 7091-T7E70 tested in pure oxygen ( $\Delta K = 11 \text{ MPa}\sqrt{\text{m}}$ ,  $R = 0.1$  and  $f = 5 \text{ Hz}$ ), a) 1500X and b) 5000X.

Representative SEM microfractographs from 7091-T7E69 alloy tested in vacuum and in 13.3 Pa water vapor, at  $\Delta K$  of 11 MPa $\sqrt{m}$ , are compared in Fig. 56. Representative SEM microfractographs from 7091-T7E70 alloy tested in pure oxygen at 267 Pa, also at  $\Delta K$  of 11 MPa $\sqrt{m}$ , are shown in Fig. 57. These microfractographs indicate that the fracture path in all three environments is primary transgranular and is typical of high strength aluminum alloys fractured in fatigue. No clearly discernible fatigue striations can be found for any of the test environments.

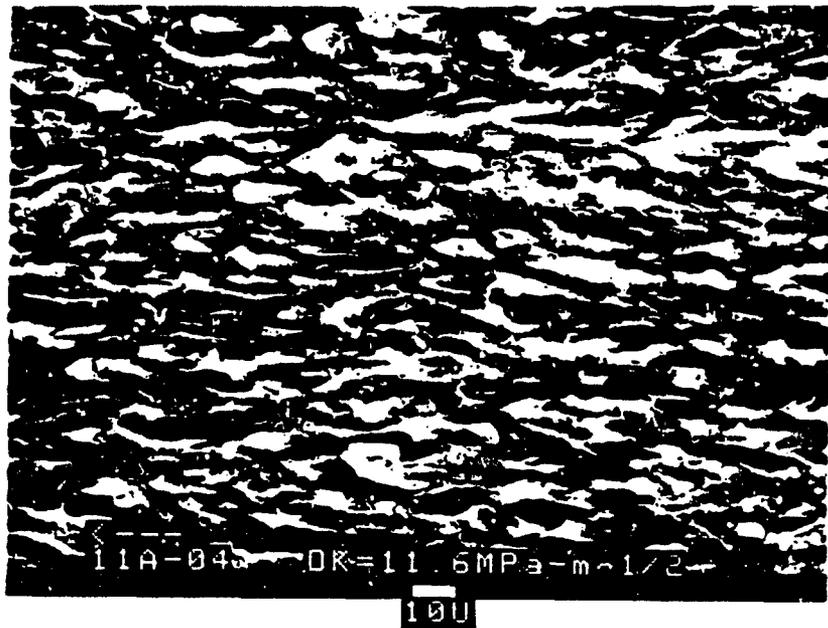
Fig. 58: Comparison of the fracture surface morphology of (a) P/M 7091-T7E69, and (b) I/M 7050-T7451. Both specimens were fatigue tested in water vapor environment ( $R = 0.1$  and  $f = 5$  Hz).
