MECHANISMS OF CORROSION FATIGUE IN HIGH STRENGTH I/M AND P/M ALUMINUM ALLOYS

R. P. Wei  
Lehigh University

P. S. Pao  
McDonnell Douglas Research Laboratories

Final Technical Report

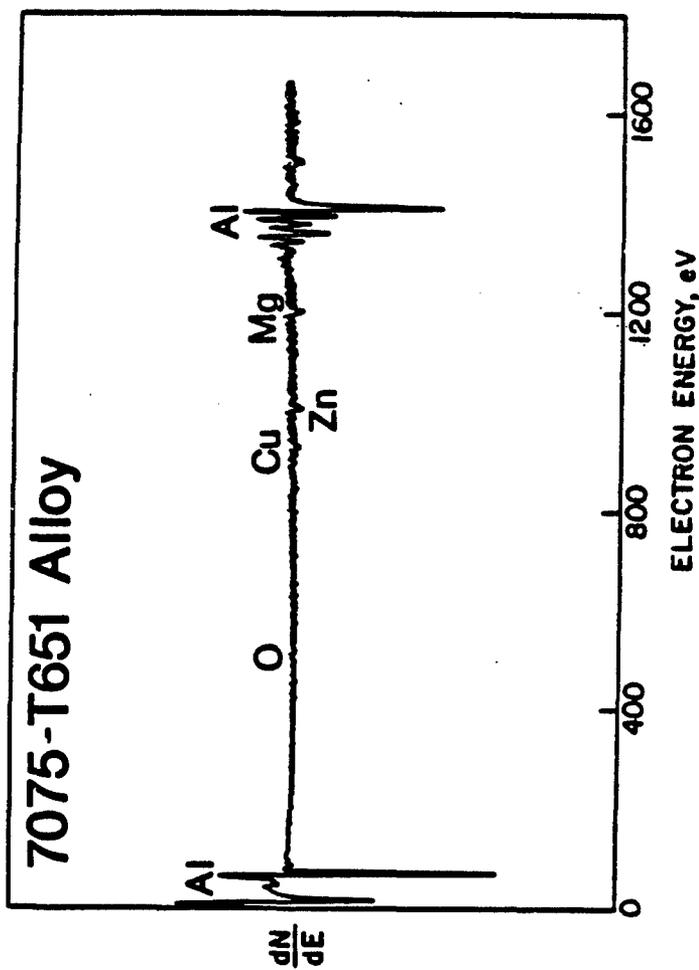
Fig. 60: Auger electron spectra of a "clean" surface of 7075-T651 aluminum alloy.

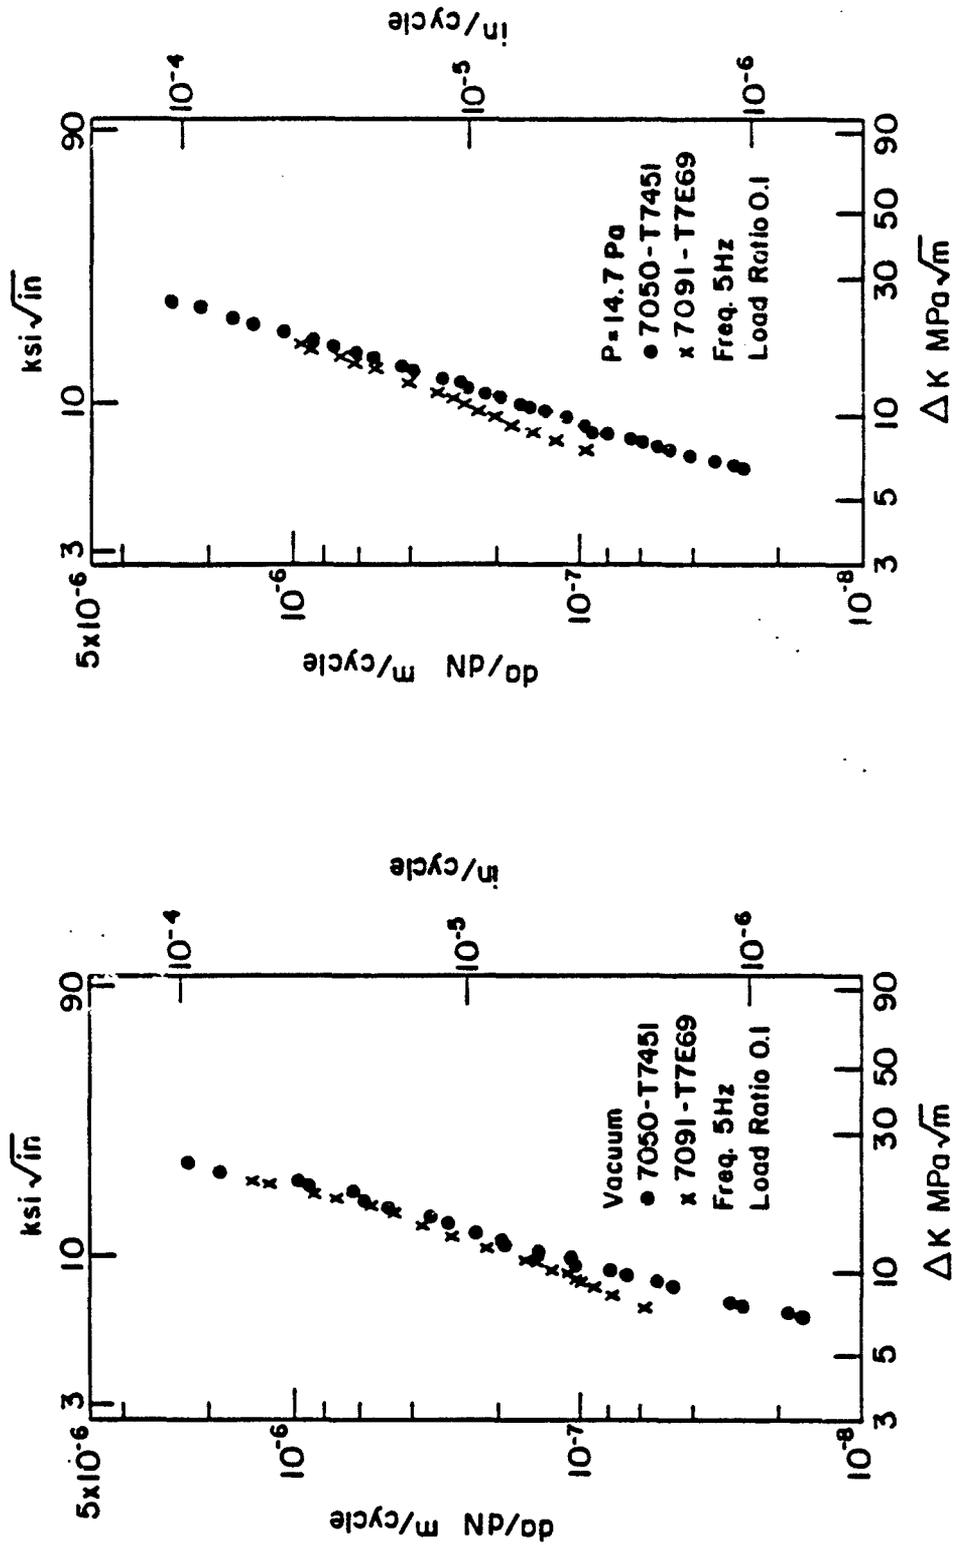
Fig. 67: Comparison of the kinetics of fatigue crack growth in I/M 7050-T7451 and in P/M 7091-T7E69 ( $R = 0.1$  and  $f = 5$  Hz) in vacuum ( $<10^{-6}$  Pa) and in water vapor at 14.7 Pa.

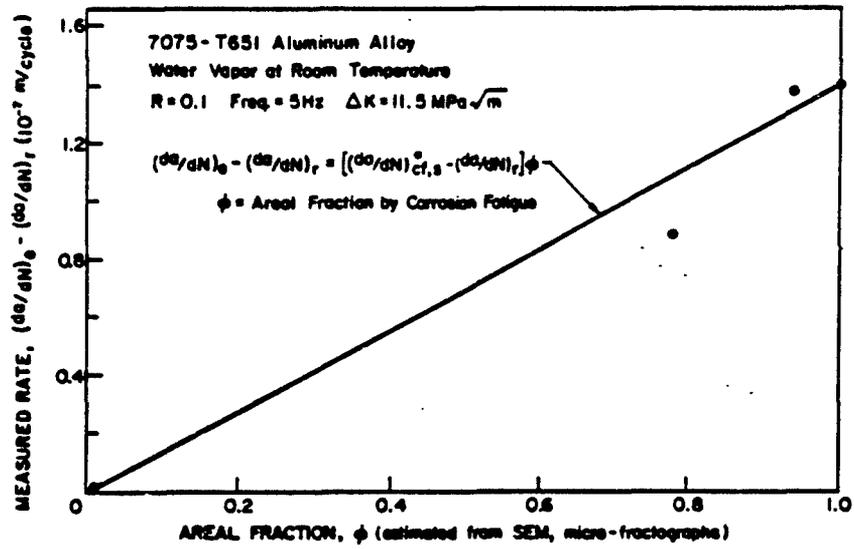
Fig. 68: Comparison between model predictions and fractographic observations on a 7075-T651 aluminum alloy tested in water vapor.

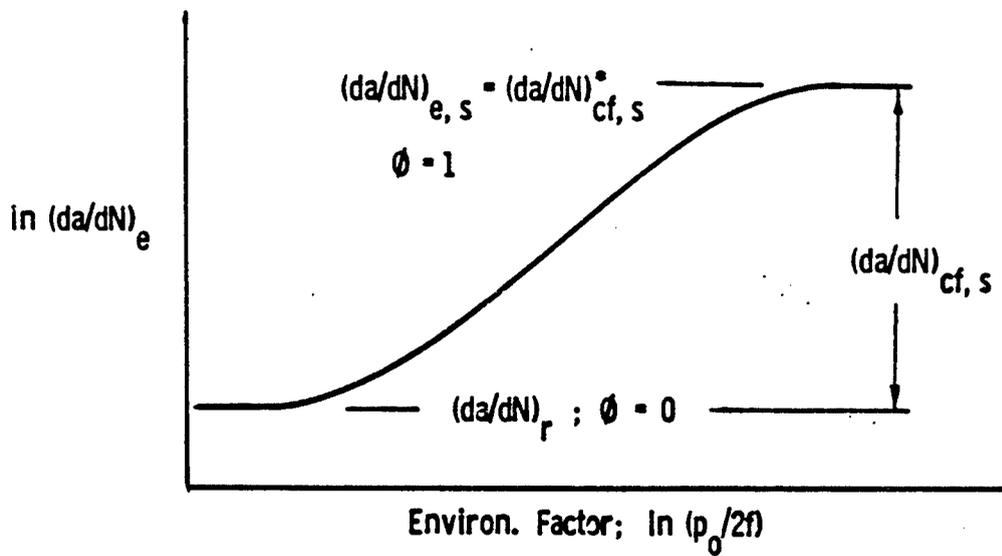
Fig. 69: Schematic illustration of environmentally assisted fatigue crack growth response and of the relationship between the various terms in the original and the modified models.

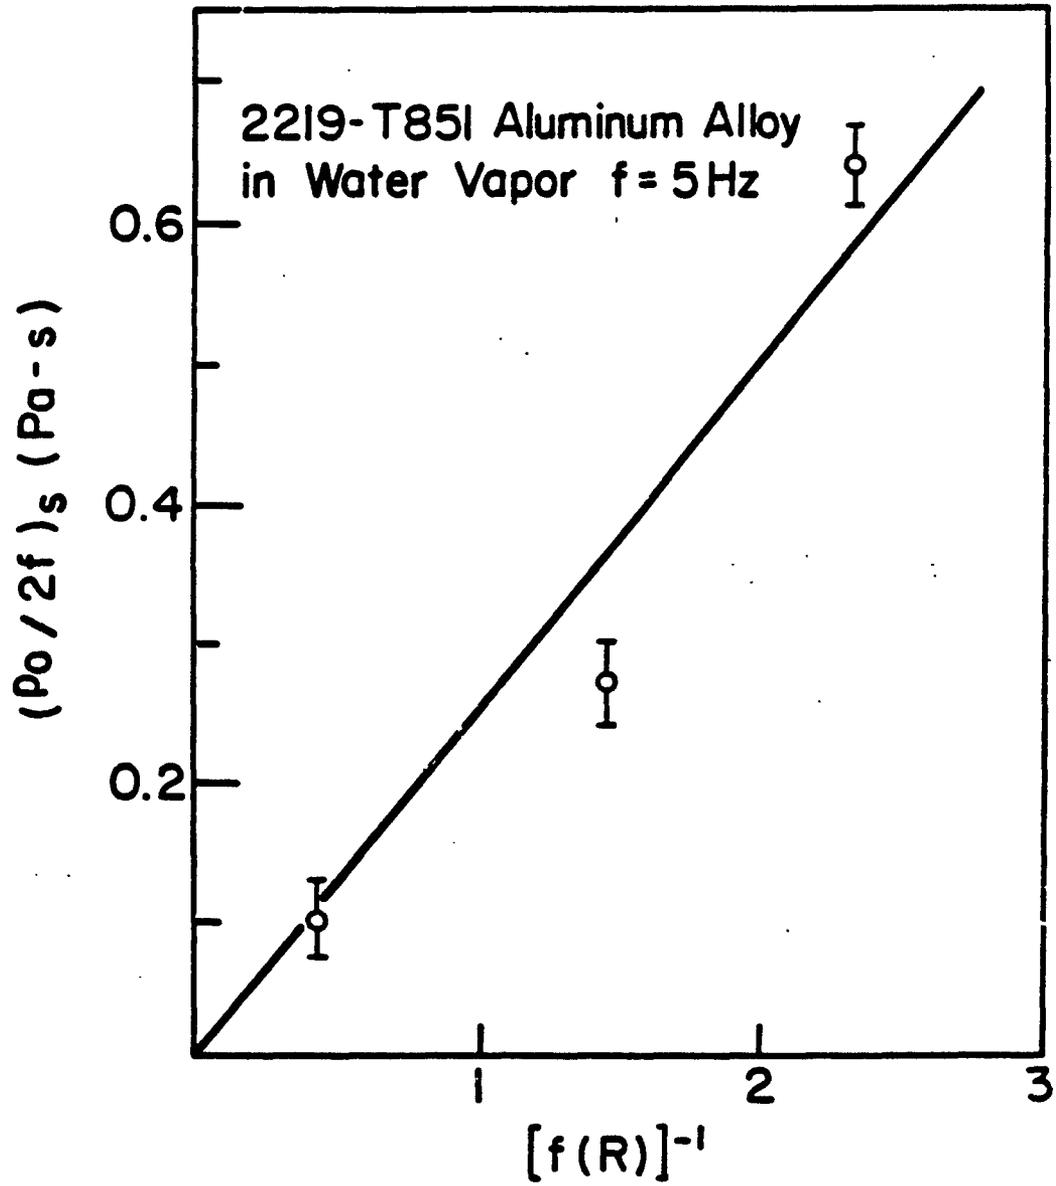
Fig. 70: Influence of load ratio on the saturation value of exposure in 2219-T851 aluminum alloy at room temperature. Solid line represents the best fit to the data.

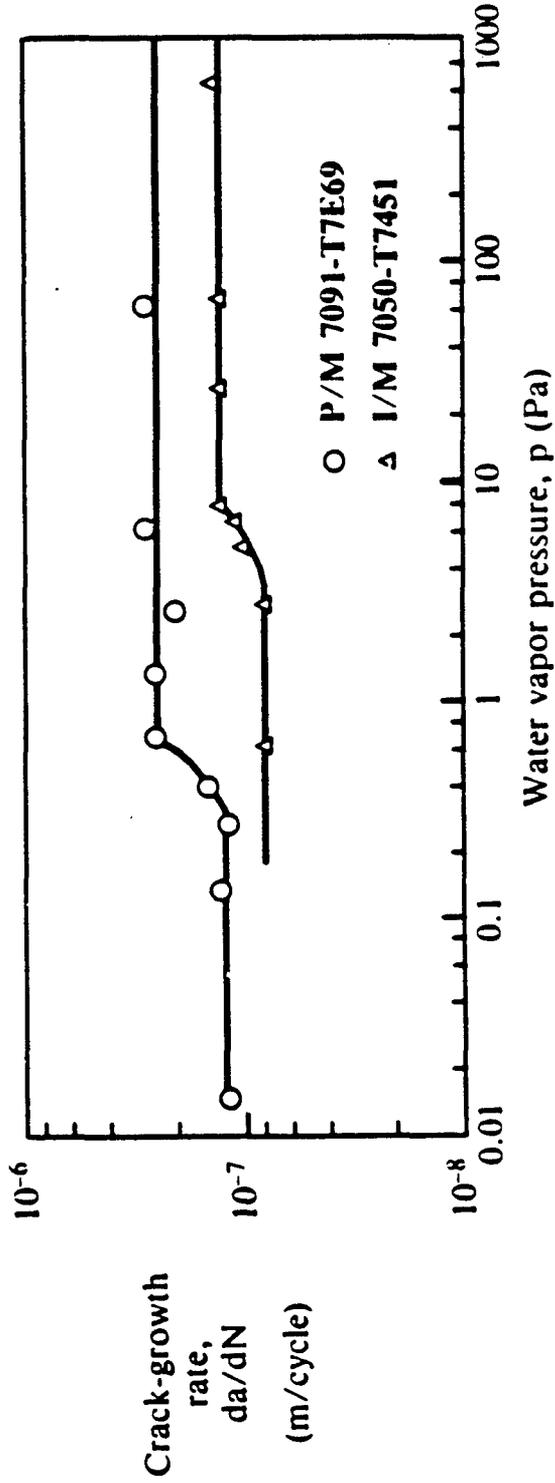
Fig. 71: Comparison of environmentally assisted fatigue crack growth response between P/M 7091-T7E69 and I/M 7050-T7451 aluminum alloys.

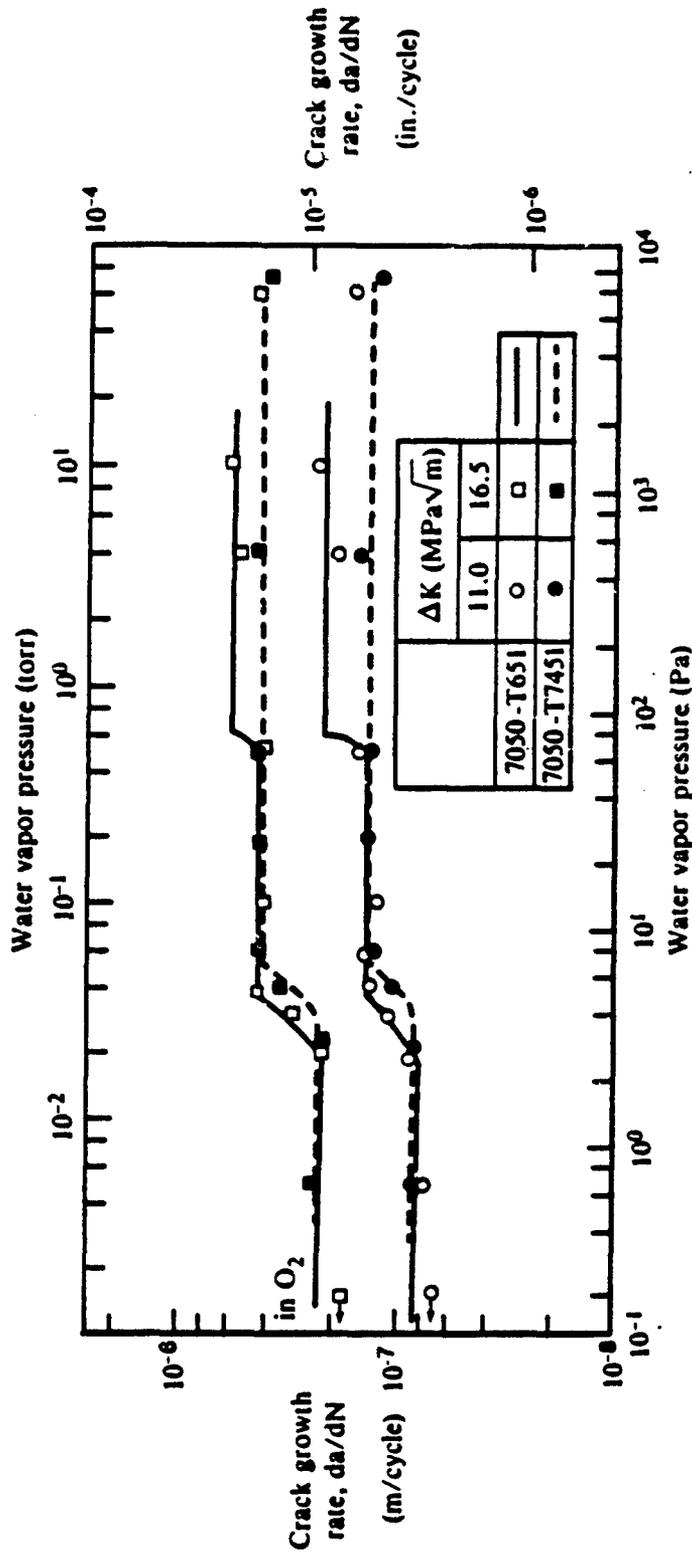
Fig. 72: Comparison of environmentally assisted fatigue crack growth response between 7075-T651 and 7050-T7451 aluminum alloys.

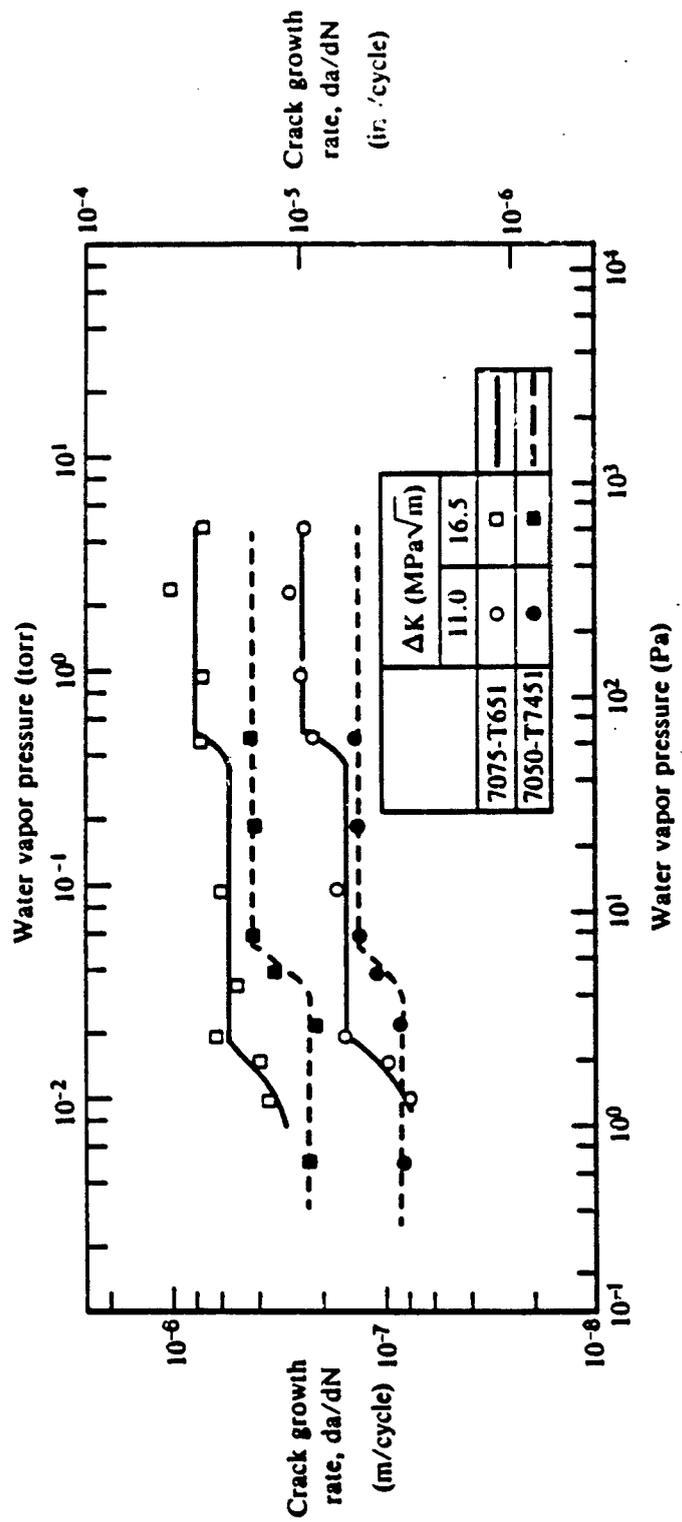
Fig. 73: Comparison of environmentally assisted fatigue crack growth response between 7050-T7451 and 7075-T651 aluminum alloys.

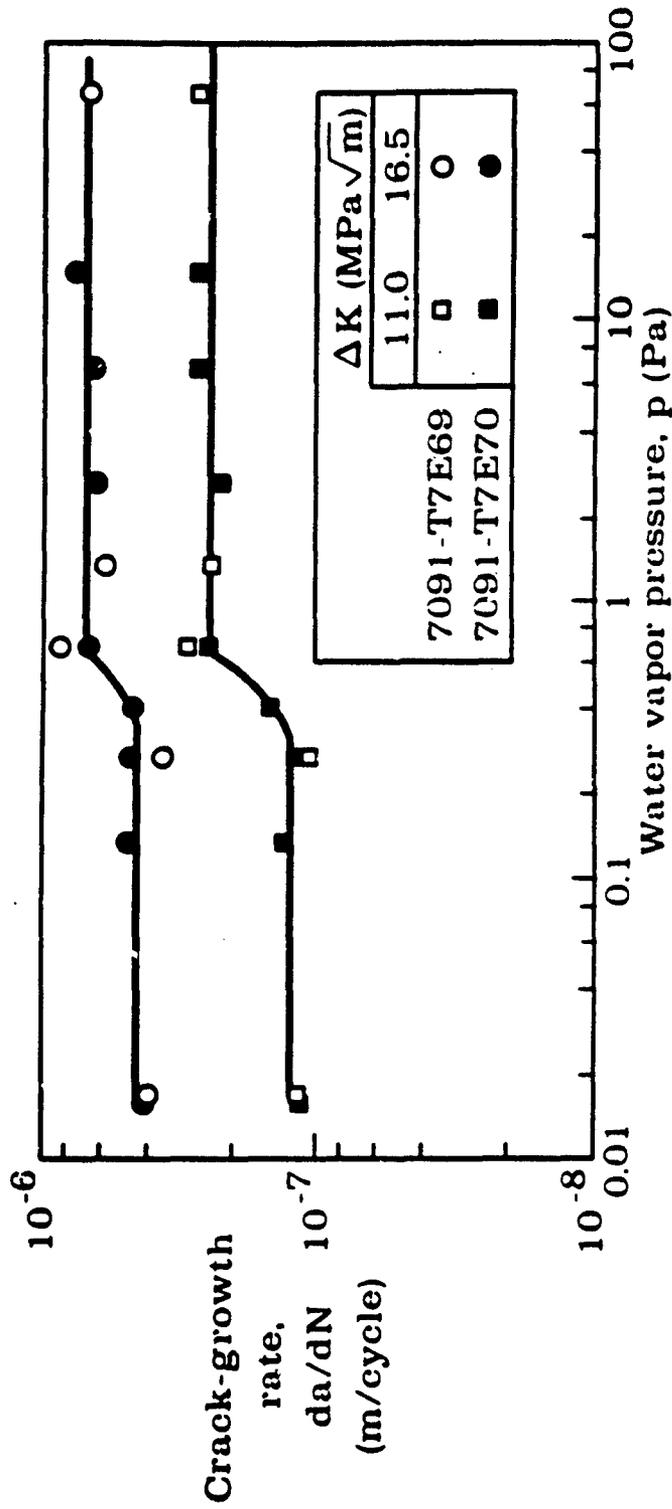
Fig. 74: Comparison of environmentally assisted fatigue crack growth response between 7091-T7E69 and 7091-T7E70 aluminum alloys.

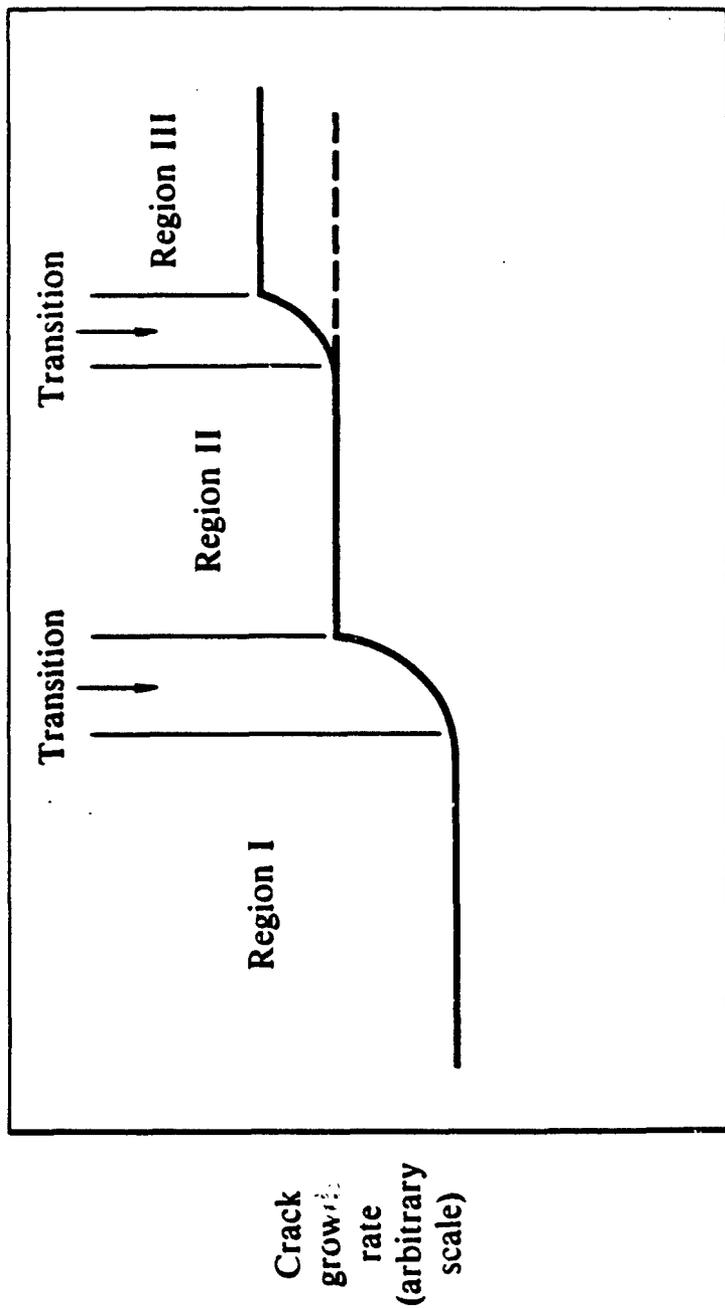
Fig. 75: Schematic diagram of fatigue crack growth response in high strength aluminum alloys.

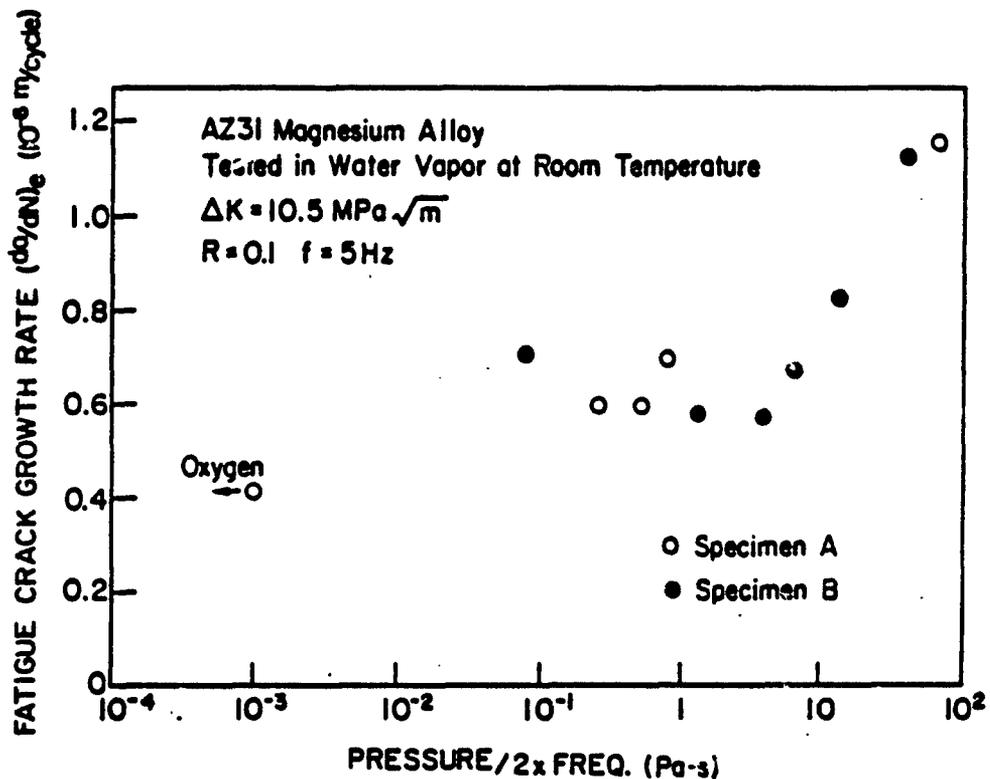
Fig. 76: The effect of water vapor pressure (or pressure/2xfrequency) on fatigue crack growth in AZ31 magnesium alloy at room temperature [26].

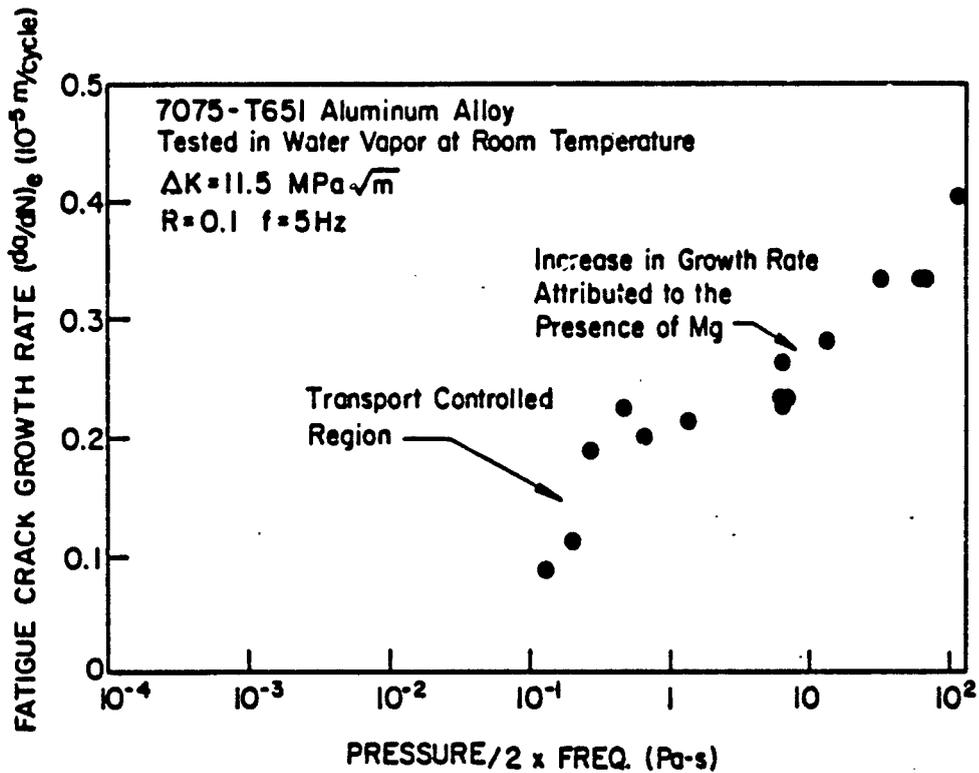
Fig. 77: The effect of water vapor pressure (or pressure/2xfrequency) on fatigue crack growth in 7075-T651 aluminum alloy at room temperature [26].
