TECHNICAL REPORT M-86/08

Corrosion Mitigation and Management System

# Demonstration of the Pipe Corrosion Management System (PIPER)

by  
A. Kumar  
W. Riggs  
M. Blyth

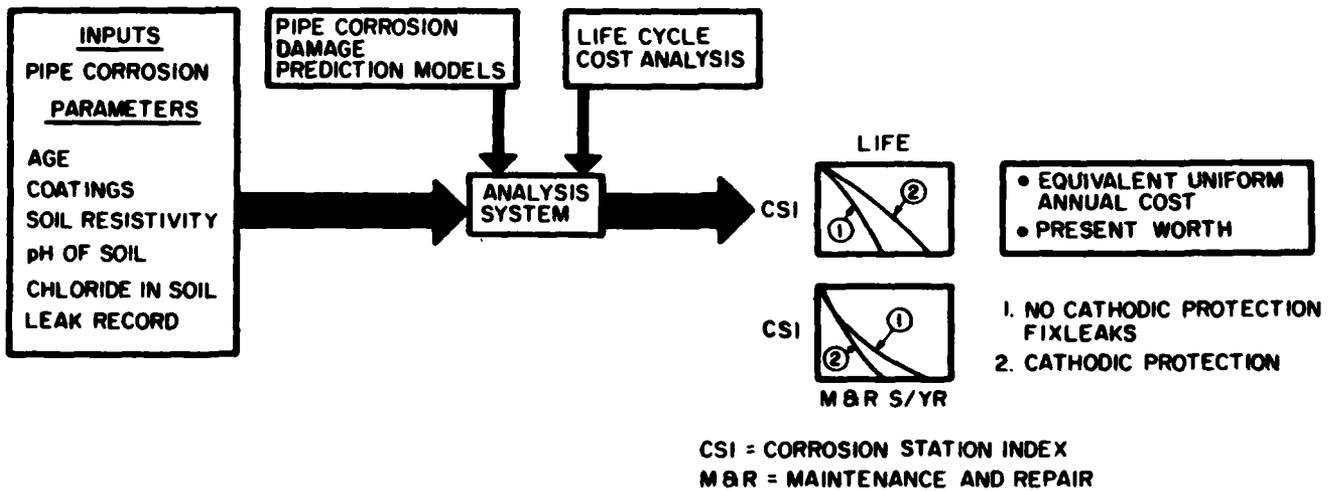
Figure 1. Pipe Corrosion Mitigation and Management System (PIPER).

The U.S. Army Construction Engineering Research Laboratory (USA-CERL) has completed preliminary work on concepts for a computerized Pipe Corrosion Management System (PIPER), designed for use by Army installations.<sup>1</sup> As Figure 1 shows, PIPER is a maintenance decision-making tool for assigning priorities to corrosion-related maintenance and repair of underground pipes. It provides fast data storage and retrieval, inventories an installation's pipe network, computes the corrosion status index (CSI), predicts present and future corrosion status based on soil properties, predicts leaks, and gives an economic analysis of maintenance options for budget planning. All output can be formatted into user-defined reports. PIPER is part of the Army's Corrosion Mitigation and Management System (CM<sup>2</sup>S).

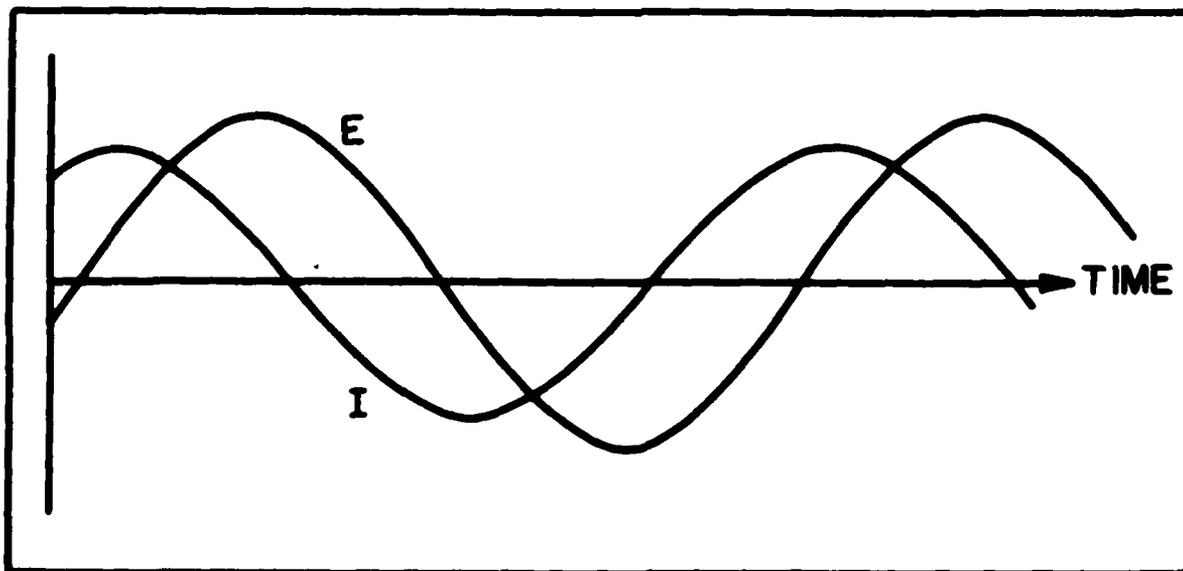
Figure 2. Electrical waveforms for a.c. impedance.

Figure 2 represents typical plots of a voltage sine wave (E) applied across a given circuit and the resultant a.c. waveform (I). Note that the two traces differ in amplitude as well as in phase (I leads E). The capacitor in the circuit (in this case, the pipeline corrosion product) is said to "impede" the current flow—thus the term "a.c. impedance." In general, parameters characterizing corrosion behavior can be determined by measuring the frequency dependence of the complex impedance, Z.<sup>3</sup> ("Frequency" is defined as the number of alternating cycles through which the voltage goes in 1 sec. By varying the applied frequency, different

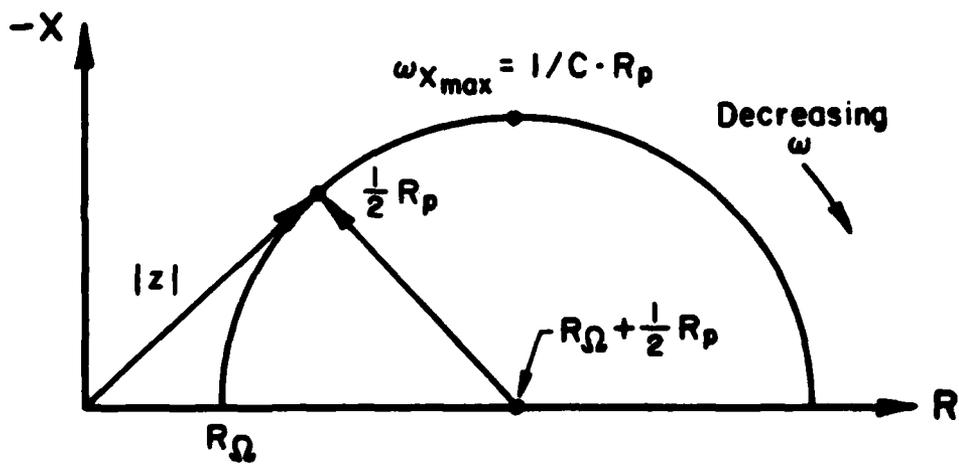
Figure 4. Cole-Cole plot.

R is then plotted on the horizontal axis and -X on the vertical axis. The circuit is tested at several frequencies, and the plot shown in Figure 4 is obtained. This "Cole-Cole" plot allows determination of the purely resistive circuit elements, the polarization resistance, and hence, the capacitance, C. Capacitance is an indicator of the amount of corrosion, with greater amounts of corrosion having larger C values.

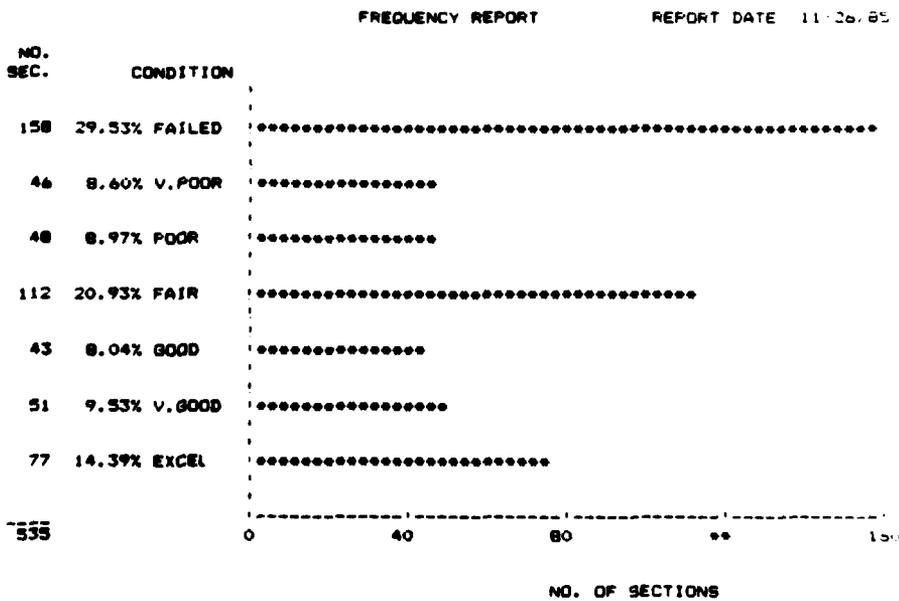
Figure 6. Fort Riley frequency report.

The frequency report is a histogram that summarizes the condition of an installation's pipes. Headquarters engineers can use this report to compare one installation with another. This report also is a decision-making tool that helps the engineer determine if a single section or many pipe sections should be repaired/replaced. For instance, if an installation's piping is in generally poor condition, it might be better to replace it rather than make repairs.

form of a specify report. Although the year of first leak data (if applicable) would have made the predicted CSI more accurate, this information was unavailable so the CSI was calculated without it. Figures 6 and 7 are the frequency and rank reports generated.

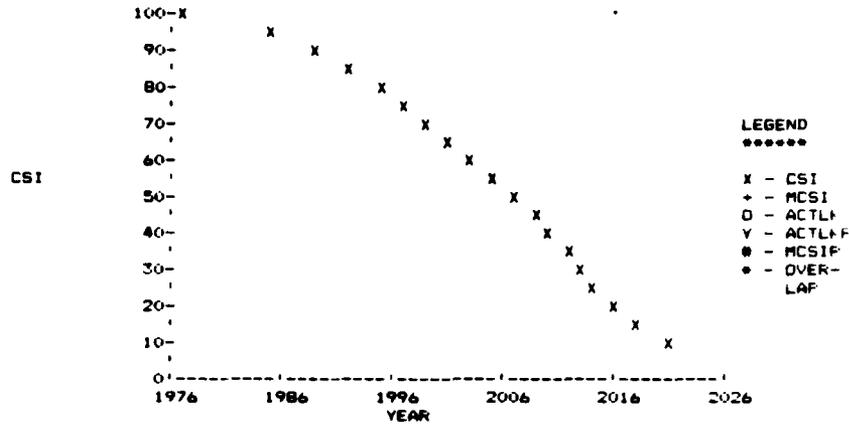
Figure 8. CSI prediction report, CP test station 9.

PIPE ID : CPSTA9 SECTION NUMBER: 1  
 SOIL RESISTIVITY : 1475.00 SOIL PH : 8.45  
 COATING MATERIAL : YES WALL THICKNESS: .3650  
 YEAR INSTALLED : 1977  
 PREDICTED FIRST LEAK: 2013  
 ACTUAL FIRST LEAK : DATA NOT AVAILABLE

Figures 8 through 25 show year to first leak, CSI-versus-year-graphs, and cumulative leak tables. The reason for variations in these reports is that the soils at NSD Guam vary markedly, from a 710-ohm-m resistivity and 7.7 pH at U-35 to a 6750-ohm-m resistivity and 8.9 pH at the causeway rectifier.

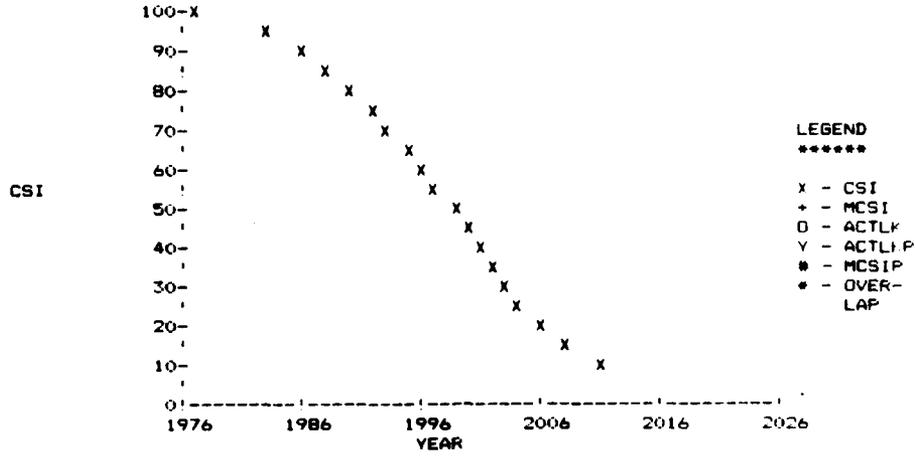
Figure 10. CSI prediction report, Nimitz Hill rectifier.

PIPE ID : NIMITZ SECTION NUMBER: 1  
 SOIL RESISTIVITY : 1010.00 SOIL PH : 6.81  
 COATING MATERIAL : YES WALL THICKNESS: .3650  
 YEAR INSTALLED : 1977  
 PREDICTED FIRST LEAK: 2003  
 ACTUAL FIRST LEAK : DATA NOT AVAILABLE

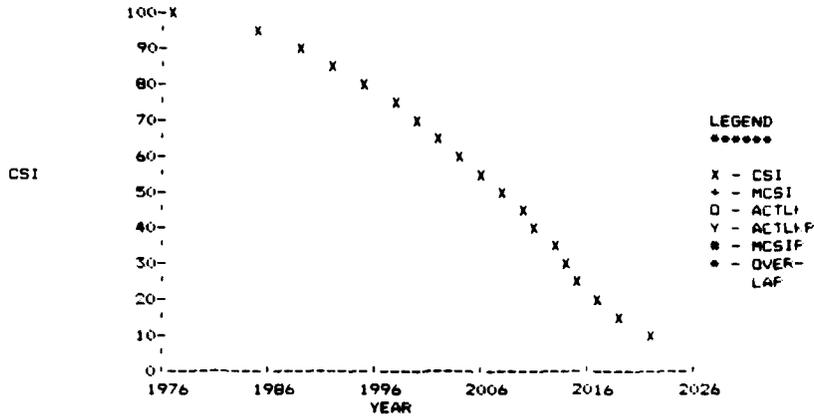
Figure 12. CSI prediction report, NAS pumphouse.

PIPE ID : NABPUMP SECTION NUMBER: 1  
 SOIL RESISTIVITY : 1510.00 SOIL PH : 8.61  
 COATING MATERIAL : YES WALL THICKNESS: .3650  
 YEAR INSTALLED : 1977  
 PREDICTED FIRST LEAK: 2014  
 ACTUAL FIRST LEAK : DATA NOT AVAILABLE

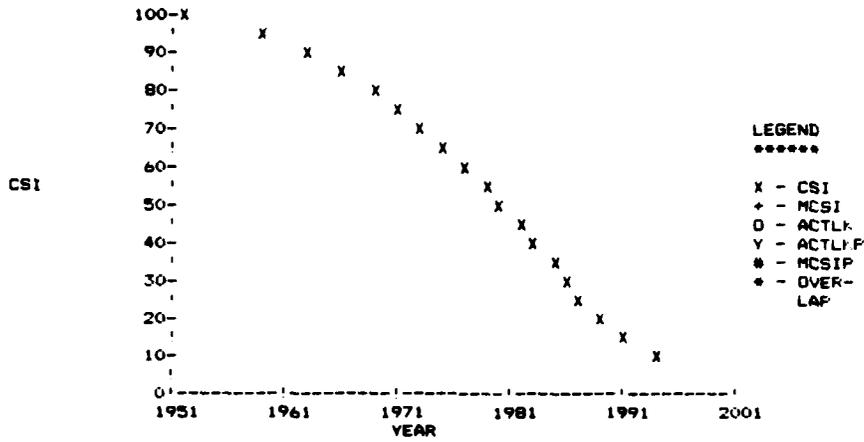
Figure 14. CSI prediction report, booster pumphouse.

PIPE ID : BOOSTER SECTION NUMBER: 1  
 SOIL RESISTIVITY : 1140.00 SOIL PH : 7.88  
 COATING MATERIAL : YES WALL THICKNESS: .3650  
 YEAR INSTALLED : 1952  
 PREDICTED FIRST LEAK: 1986  
 ACTUAL FIRST LEAK : DATA NOT AVAILABLE

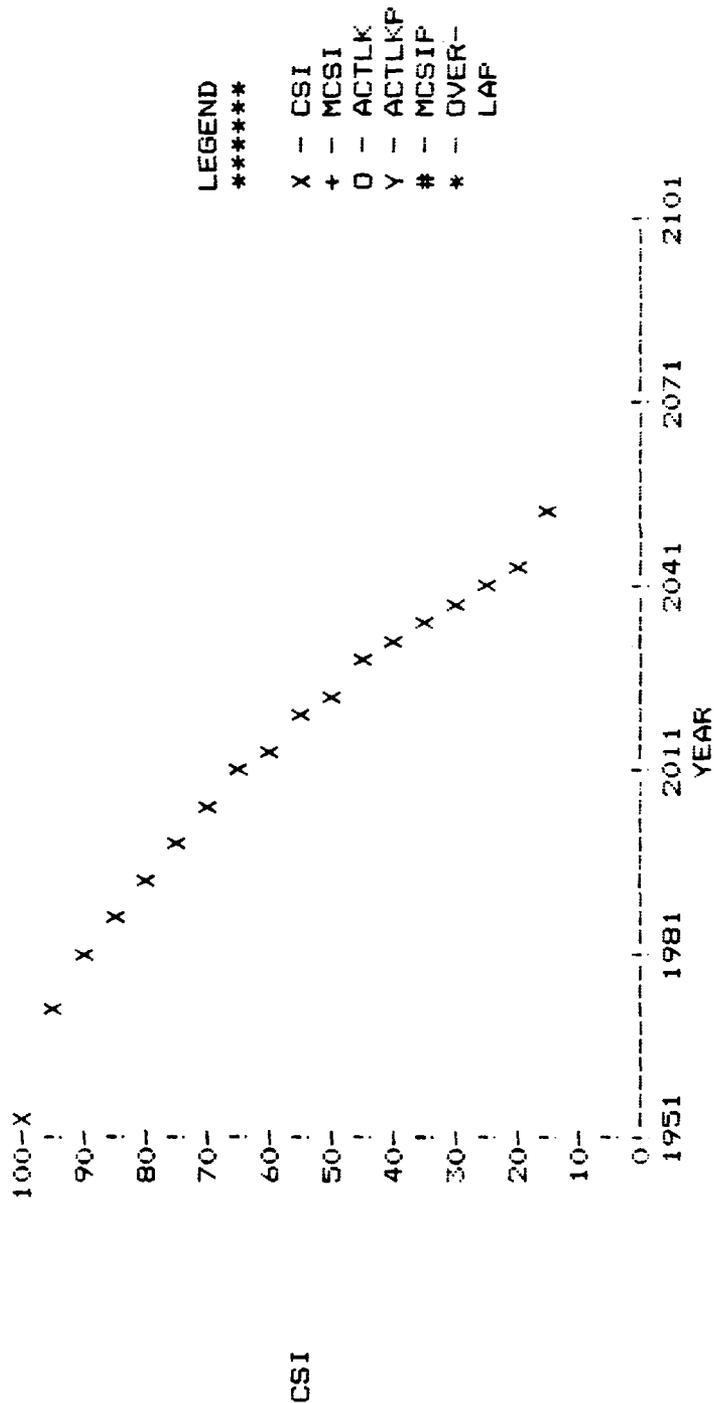
Figure 16. CSI prediction report, causeway rectifier.

PIPE ID : CAUSREC SECTION NUMBER: 1  
 SOIL RESISTIVITY : 6750.00 SOIL PH : 8.87  
 COATING MATERIAL : YES WALL THICKNESS: .3650  
 YEAR INSTALLED : 1952  
 PREDICTED FIRST LEAK: 2038  
 ACTUAL FIRST LEAK :

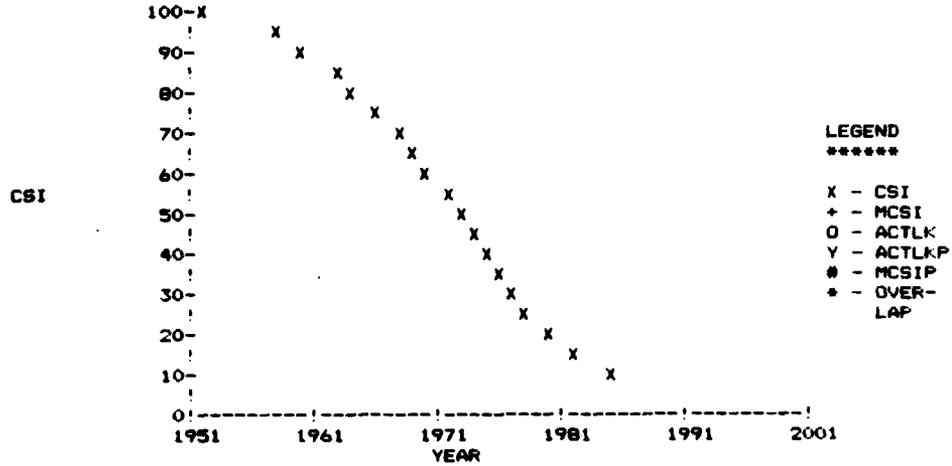
Figure 18. CSI prediction report, tank U-5.

PIPE ID : US SECTION NUMBER: 1  
 SOIL RESISTIVITY : 775.00 SOIL PH : 8.06  
 COATING MATERIAL : YES WALL THICKNESS: .3130  
 YEAR INSTALLED : 1952  
 PREDICTED FIRST LEAK: 1977  
 ACTUAL FIRST LEAK : DATA NOT AVAILABLE

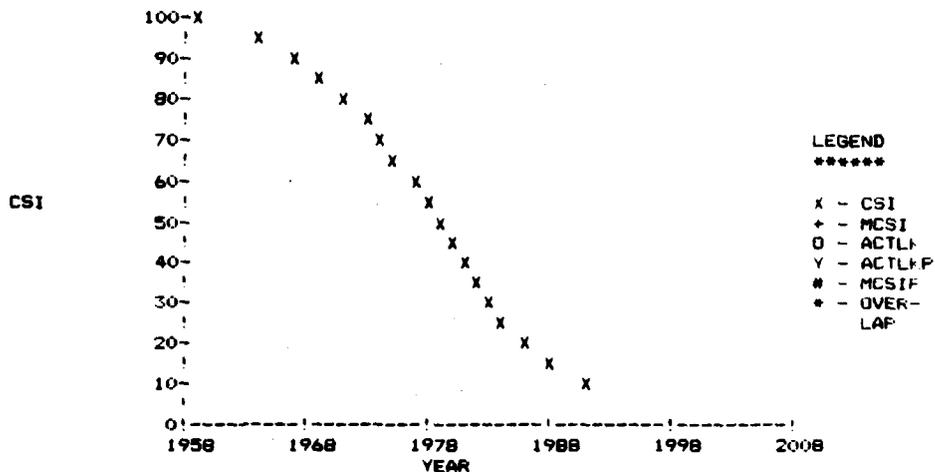
Figure 20. CSI prediction report, tank U-20.

PIPE ID : U20 SECTION NUMBER: 1  
 SOIL RESISTIVITY : 730.00 SOIL PH : 7.48  
 COATING MATERIAL : YES WALL THICKNESS: .3130  
 YEAR INSTALLED : 1959  
 PREDICTED FIRST LEAK: 1983  
 ACTUAL FIRST LEAK : DATA NOT AVAILABLE

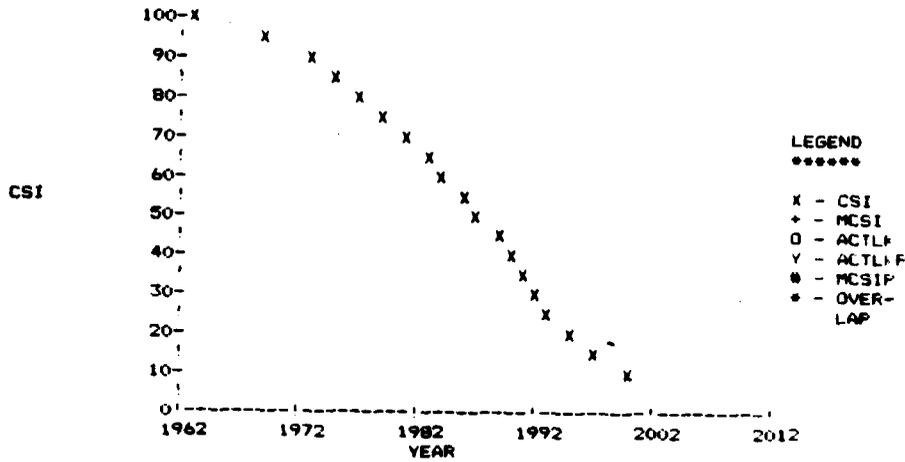
Figure 22. CSI prediction report, tank U-28.

PIPE ID : U28 SECTION NUMBER: 1  
 SOIL RESISTIVITY : 1110.00 SOIL PH : 8.70  
 COATING MATERIAL : YES WALL THICKNESS: .3130  
 YEAR INSTALLED : 1963  
 PREDICTED FIRST LEAK: 1992  
 ACTUAL FIRST LEAK : DATA NOT AVAILABLE

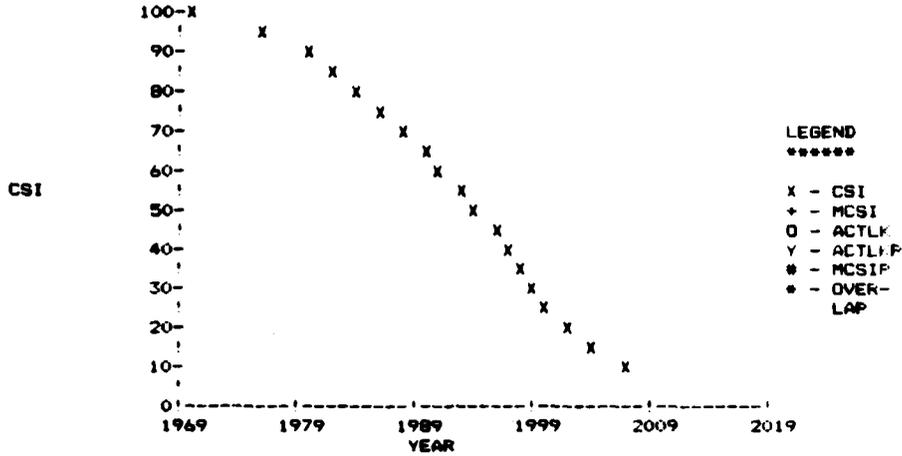
Figure 24. CSI prediction report, tank U-35.

PIPE ID : U35 SECTION NUMBER: 1  
 SOIL RESISTIVITY : 710.00 SOIL PH : 7.70  
 COATING MATERIAL : YES WALL THICKNESS: .3750  
 YEAR INSTALLED : 1970  
 PREDICTED FIRST LEAK: 1999  
 ACTUAL FIRST LEAK : DATA NOT AVAILABLE

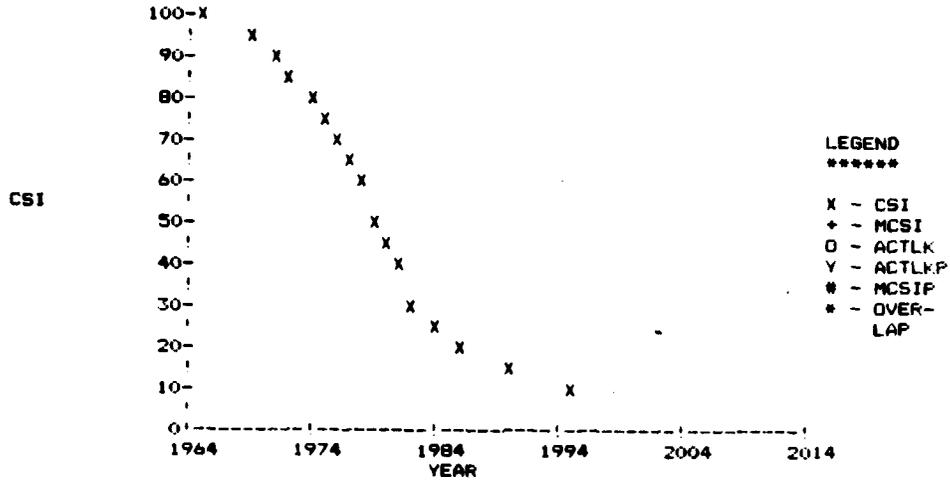
Figure 26. CSI prediction report, economic analysis example.

Figure 26 is the first half of the CSI prediction report. As indicated, the expected year of first leak is 1982. Figure 27 is the graph table that accompanies the CSI prediction report in Figure 26 and shows that, by 1995, 82 cumulative leaks are predicted. Two leaks are projected for year 20 (1984).

PIPE ID : FTCERL SECTION NUMBER: 1  
 SOIL RESISTIVITY : 5000.00 SOIL PH : 6.00  
 COATING MATERIAL : COALTAR WALL THICKNESS: .2500  
 YEAR INSTALLED : 1965  
 PREDICTED FIRST LEAK: 1982  
 ACTUAL FIRST LEAK : DATA NOT AVAILABLE
