FMC TECHNICAL REPORT 4381

**17-INCH SINGLE PIN ALUMINUM
TRACK DEVELOPMENT PROGRAM
FOR FUTURE U.S. MARINE CORPS
TRACKED VEHICLES**

Phase I Final Report
By
FMC Corporation
San Jose, CA 95108

20 NOVEMBER 1986

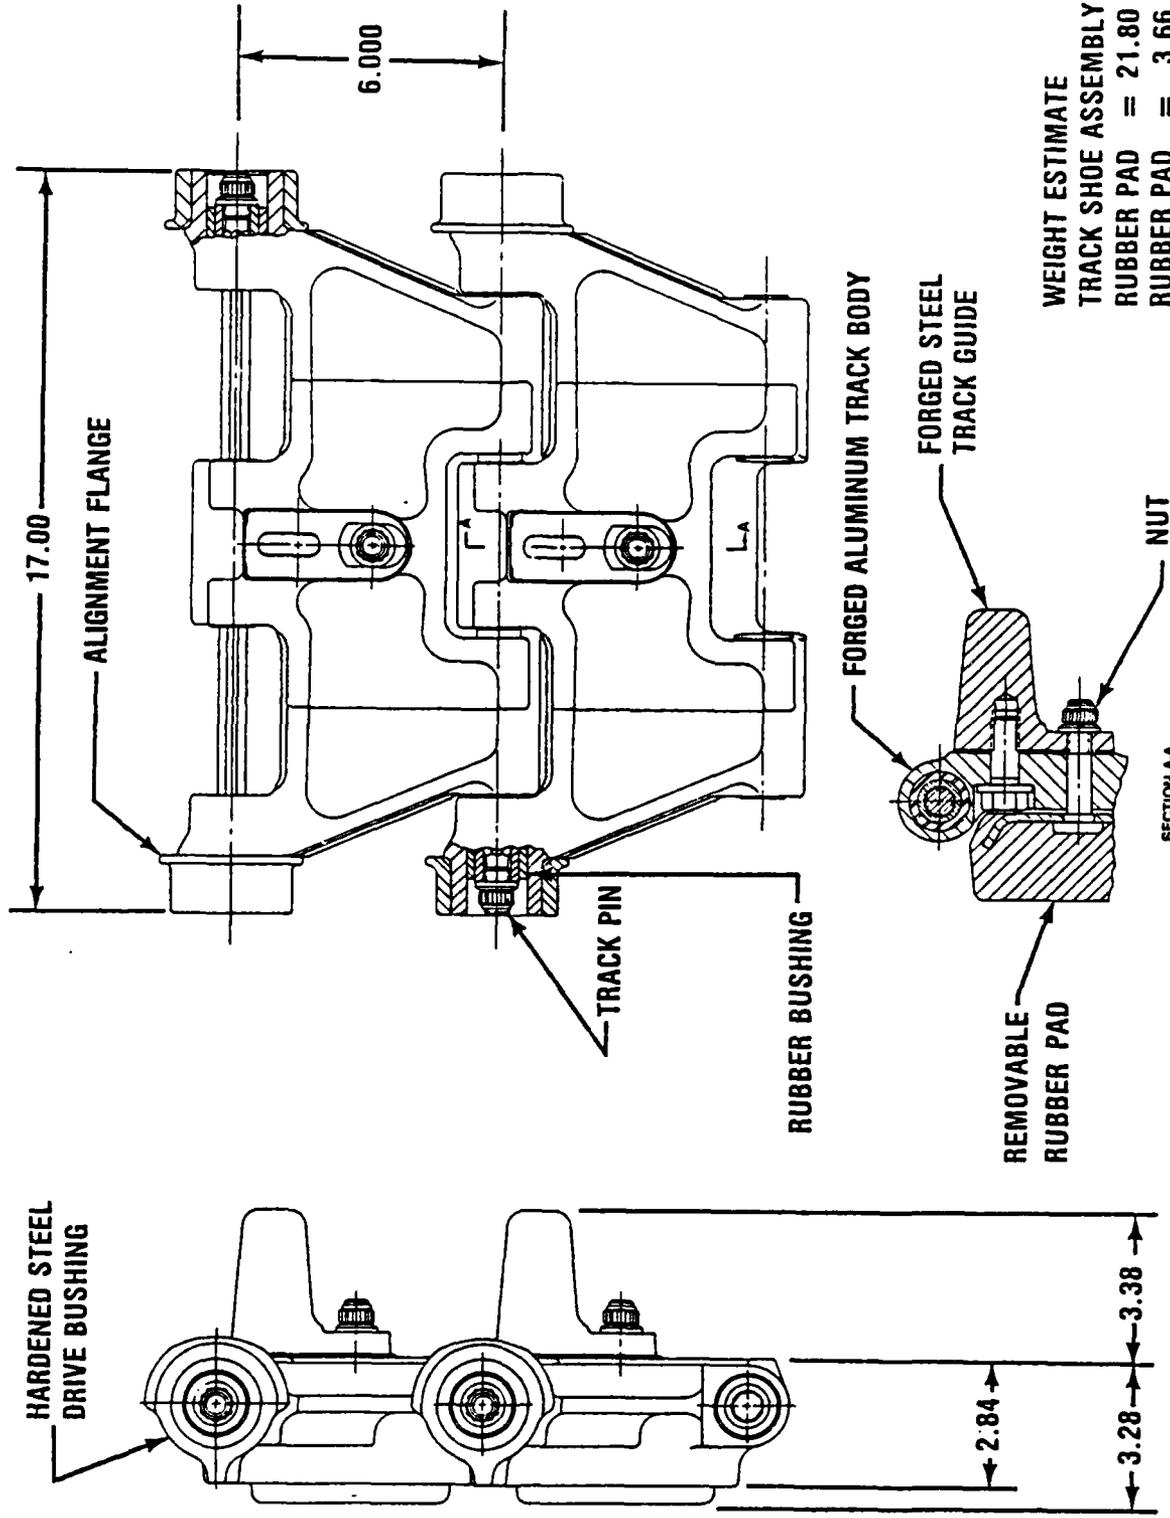
FIGURE 1

17-Inch Aluminum Track Shoes

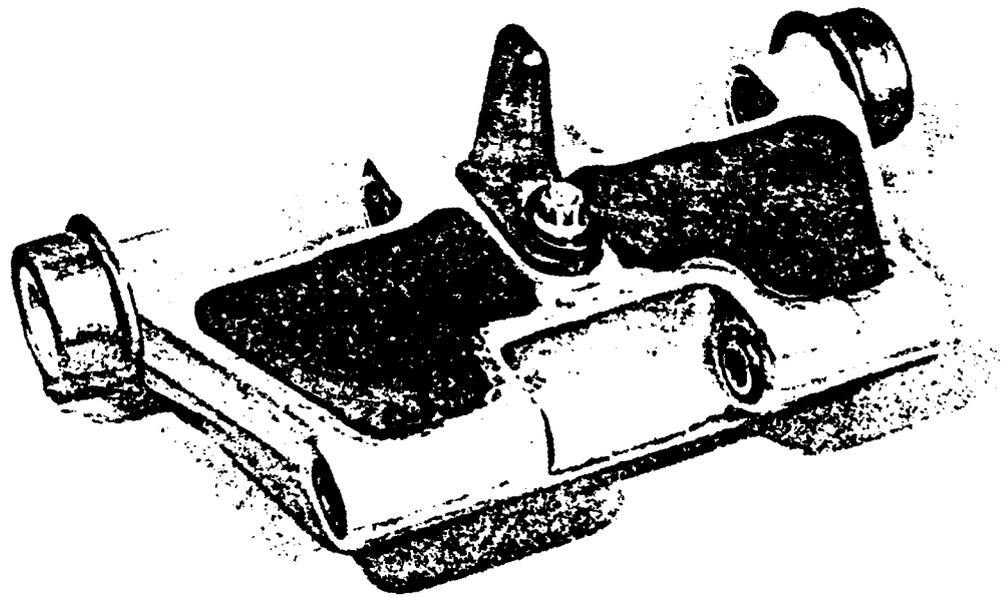
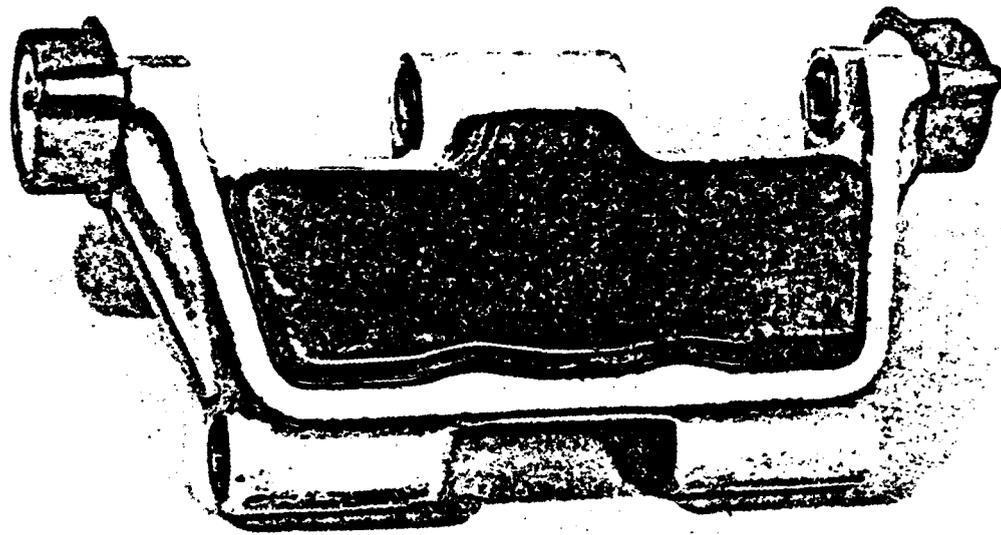
FIGURE 2

TOP AND BOTTOM VIEW OF TRACK SHOE
P/N 4219265

The guide is fastened to the shoe by a bolt and the track pad nut. Therefore, it can be replaced if it becomes worn or damaged. Grouser wear has been regarded as a limiting factor in the track life. The track addresses this limitation by incorporating a larger pad, larger grouser and hardened steel outboard grousers integral with the drive bushings. The actual track shoe is shown in Figure 2.

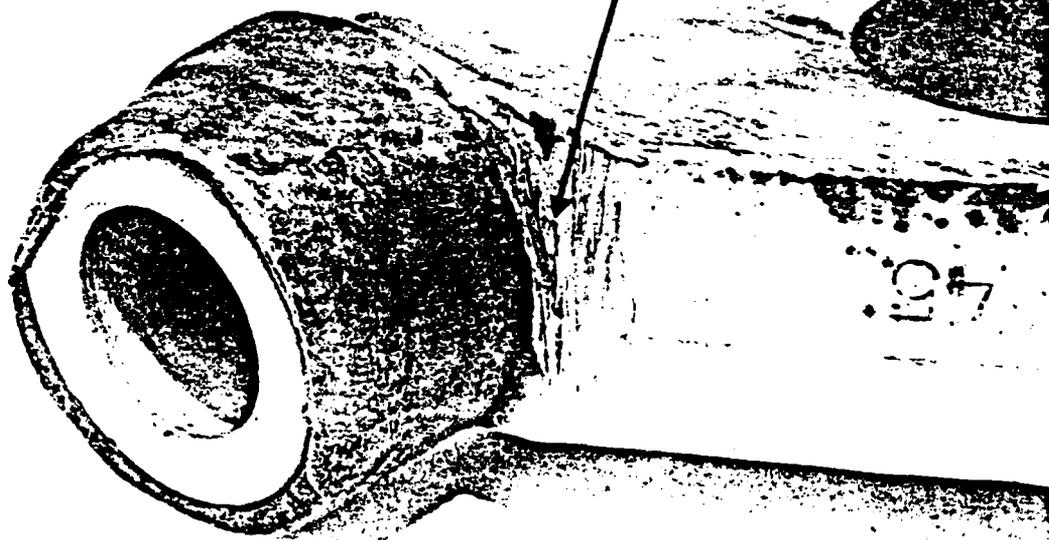
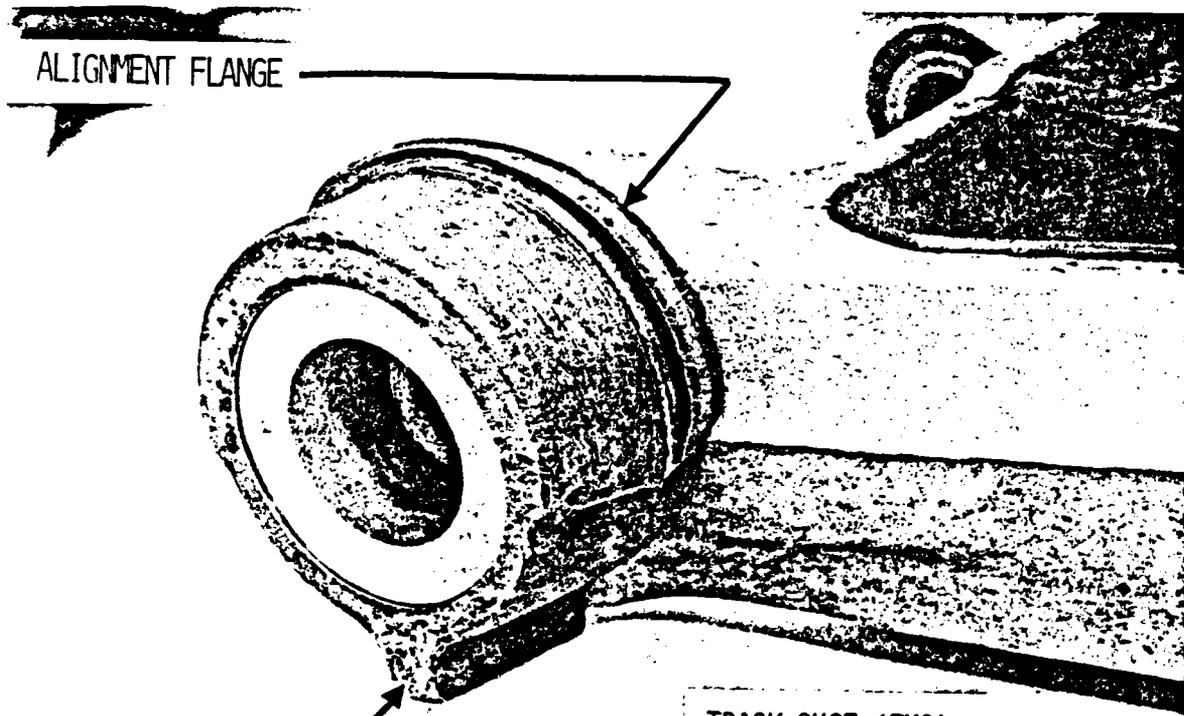
FIGURE 5

DAMAGE CAUSED BY SPROCKET

TRACK SHOE (ALCOA)
DWG. NO. D296015

ALIGNMENT FLANGE

GROUSER

TRACK SHOE (FMC)
DWG. NO. E4219265

CORRECTIVE MEASURES TAKEN IN
THE NEW DESIGN

In the new design, consideration was given to the wear that takes place between the sprocket teeth and the aluminum shoe body adjacent to the drive bushing. In the ALCOA-FMC developed shoe, this damage is caused by a progressive increase in clearance between the track guide and the sprocket carrier guide rings due to wear. A used 21 inch ALCOA track shoe and a new 17-inch track shoe are shown in Figure 5. To alleviate the wear that is observed on ALCOA-FMC shoe, an alignment flange was added to the drive bushing. This flange was designed to keep the sprocket teeth in line with the driving surface of the shoe. The drawing tree listing all track details is in Figure 6.

The steel drive bushings are equipped with an integral steel grouser for aggressiveness and to reduce the wear of the aluminum grouser, primarily when operating on pavement. The added alignment flange prevents the damage to the aluminum body caused by an increasing clearance between the track guide and the sprocket guide rings.

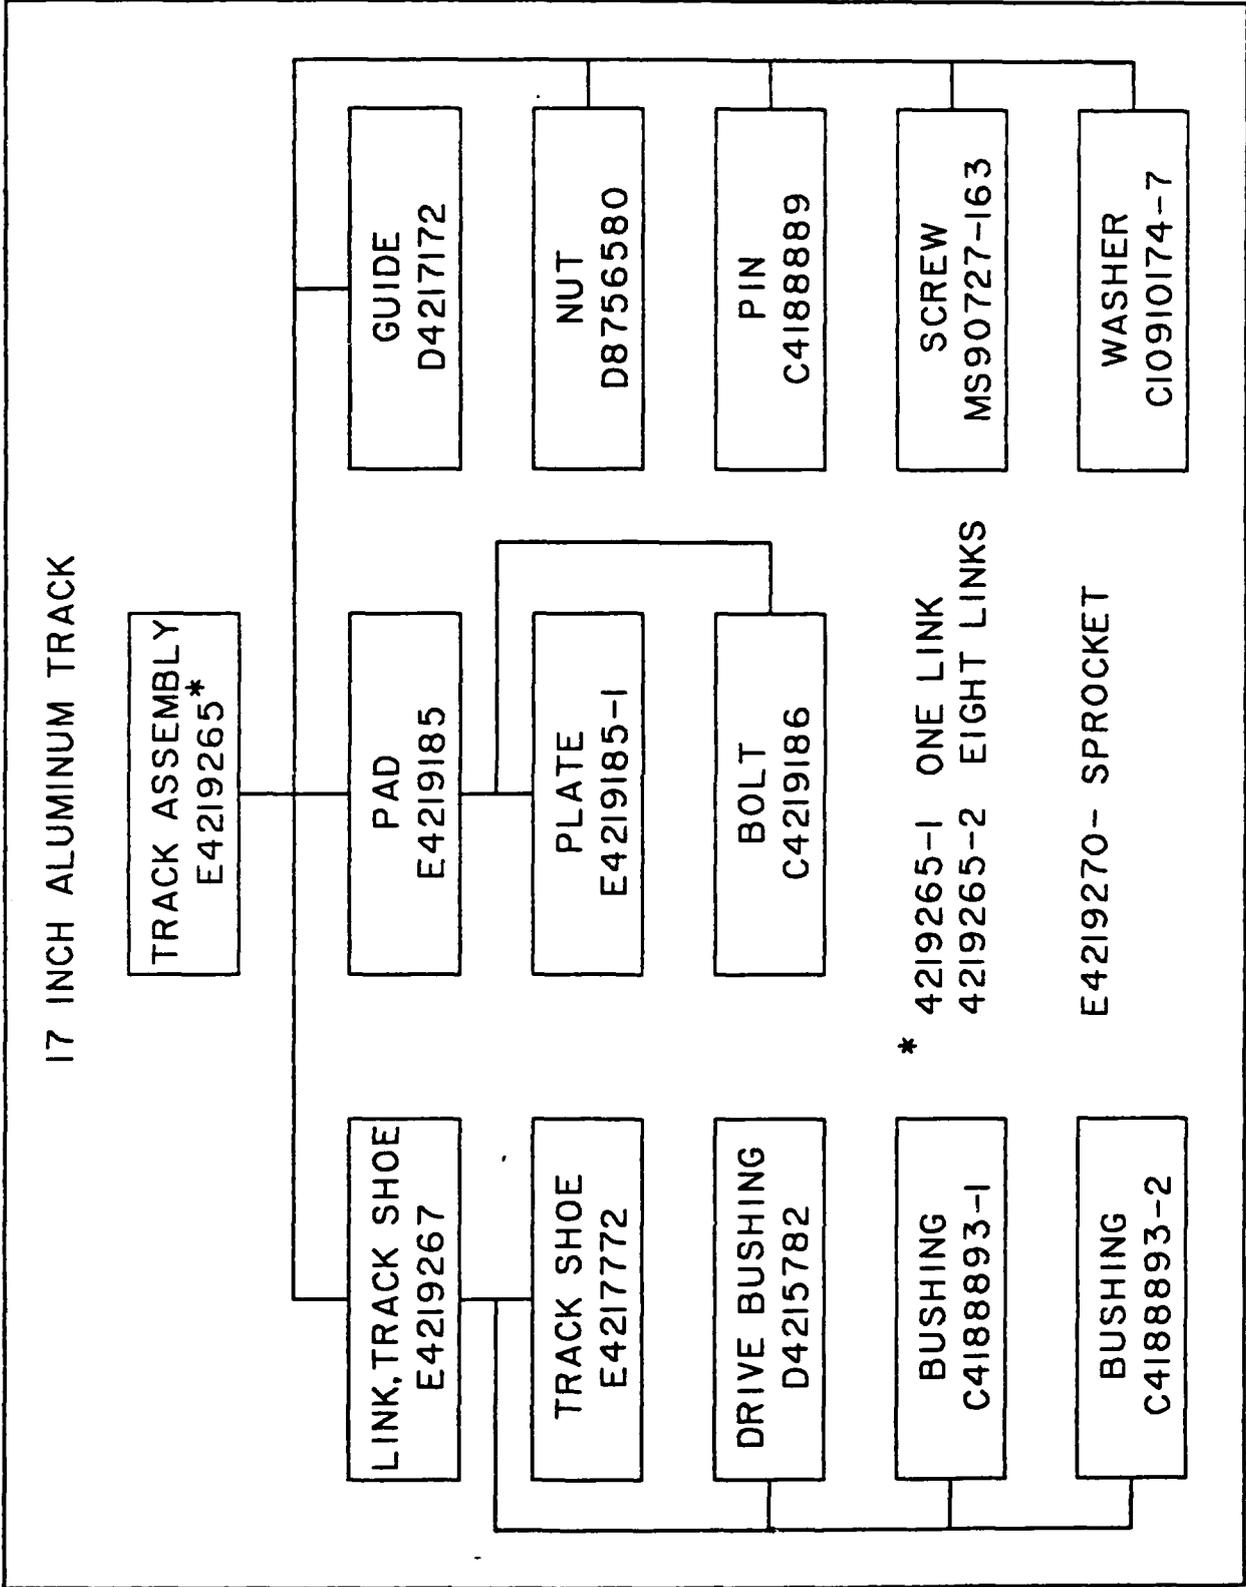
* 4219265-1 ONE LINK
4219265-2 EIGHT LINKS

E4219270- SPROCKET

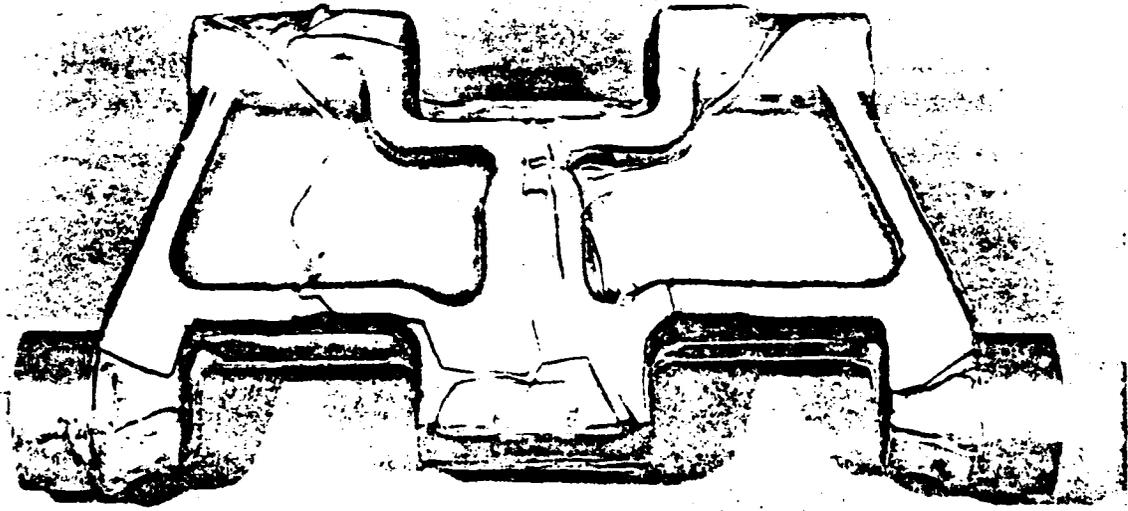
FIGURE 7

TOP VIEW OF TEST SHOE

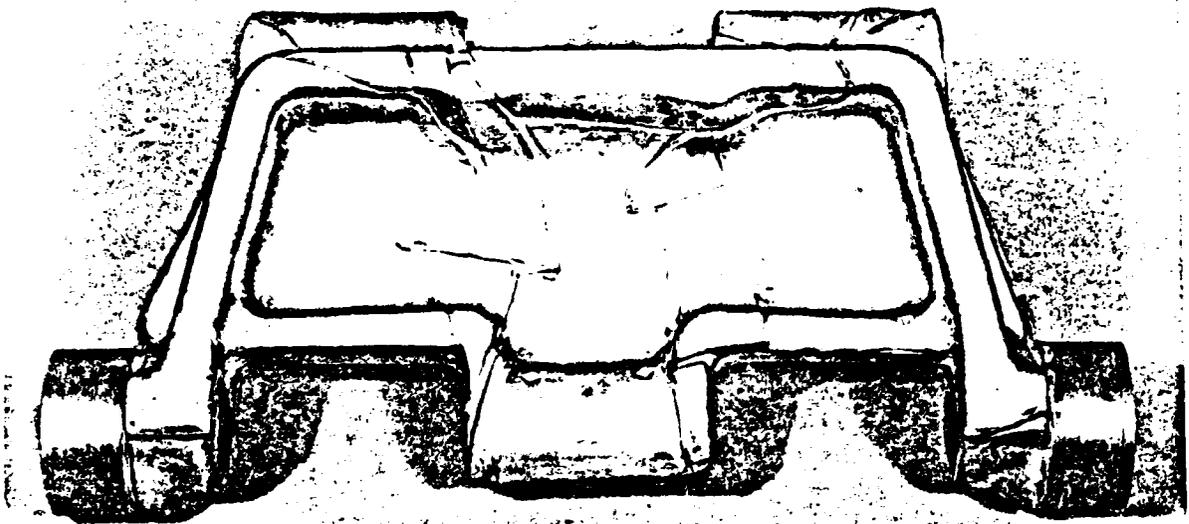
FIGURE 8

BOTTOM VIEW OF TEST SHOE

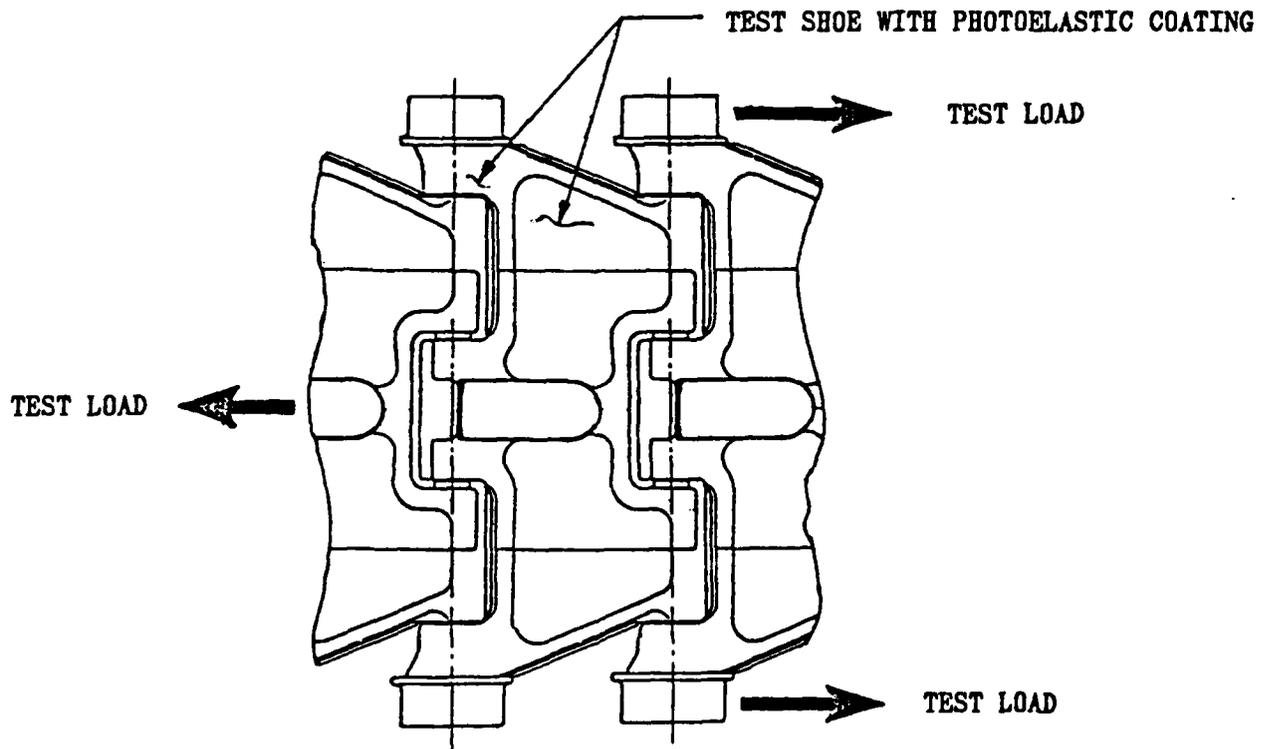
FIGURE 10

TEST LOAD CONDICTIONS

The photoelastic stress analysis was done at FMC's Steel Products Division. Figures 9 and 10 depict the loading conditions in the test. A sample of the data gathered during the test is located in the appendix in Figure A. The initial photoelastic test revealed areas where stress levels were quite high. Modifications were implemented to reduce this stress concentrations and the track shoe was tested again. The second test demonstrated that the modifications greatly reduced the stresses in the shoe. Figure 11 shows the track shoe before and after the modifications. A close-up of a modified section with added material is shown in Figure 12.

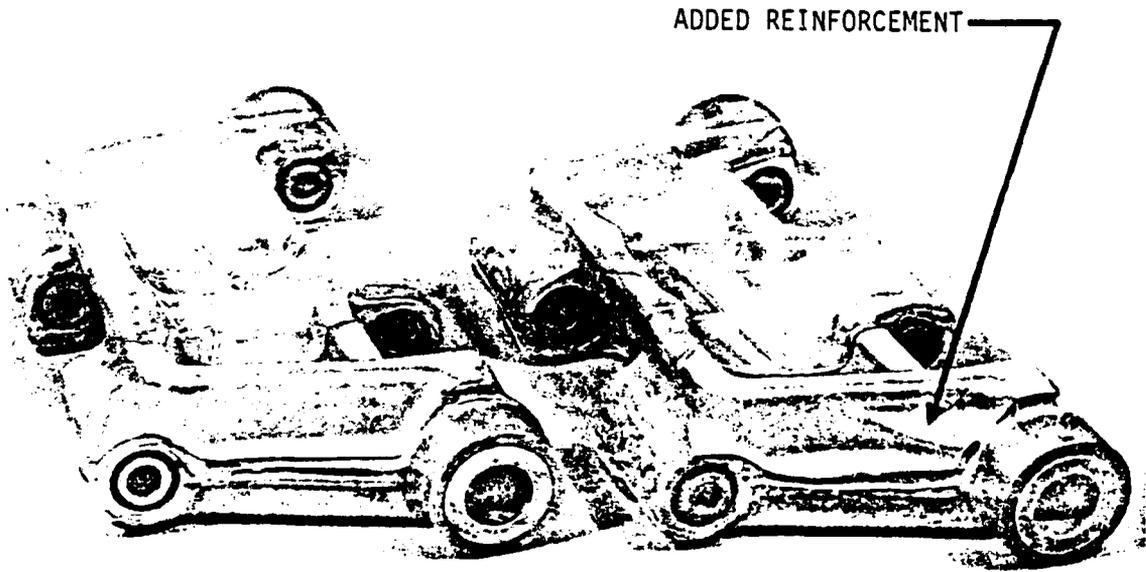
FIGURE 11

COMPARISON OF TRACK SHOE
BEFORE AND AFTER MODIFICATION

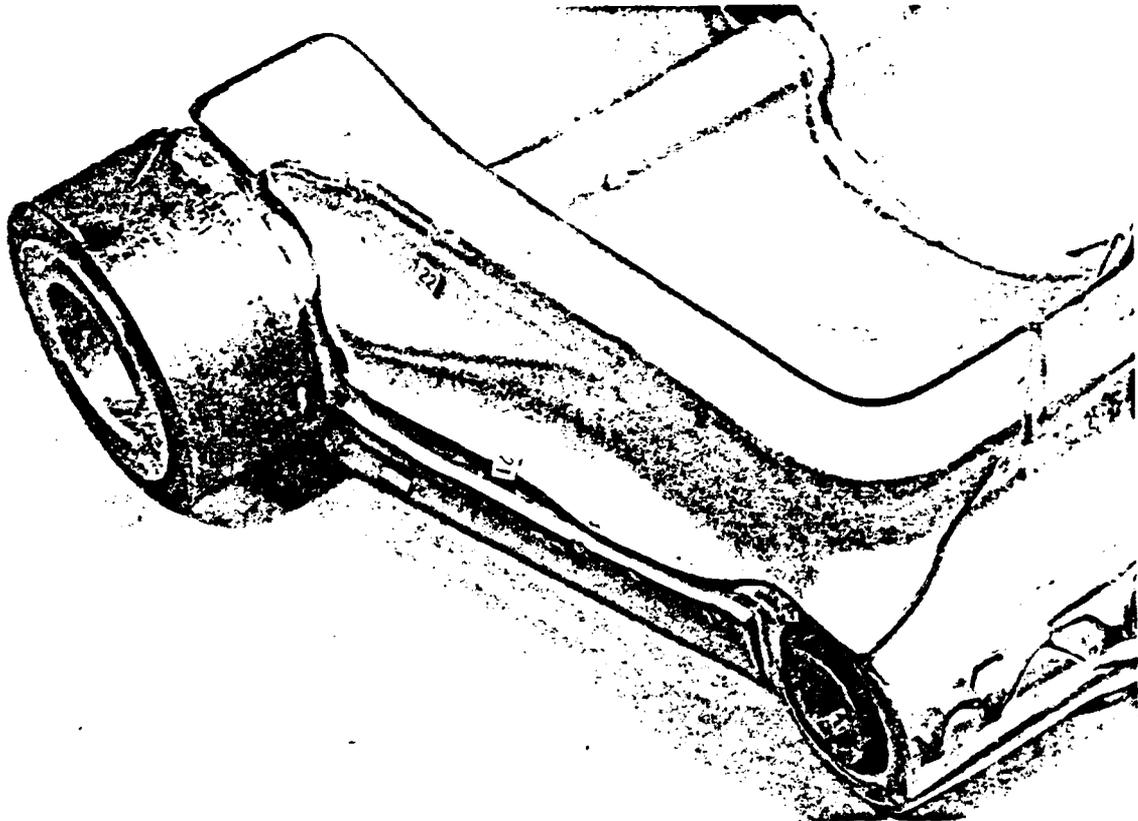
FIGURE 12

MODIFIED SECTION WITH
ADDED MATERIAL

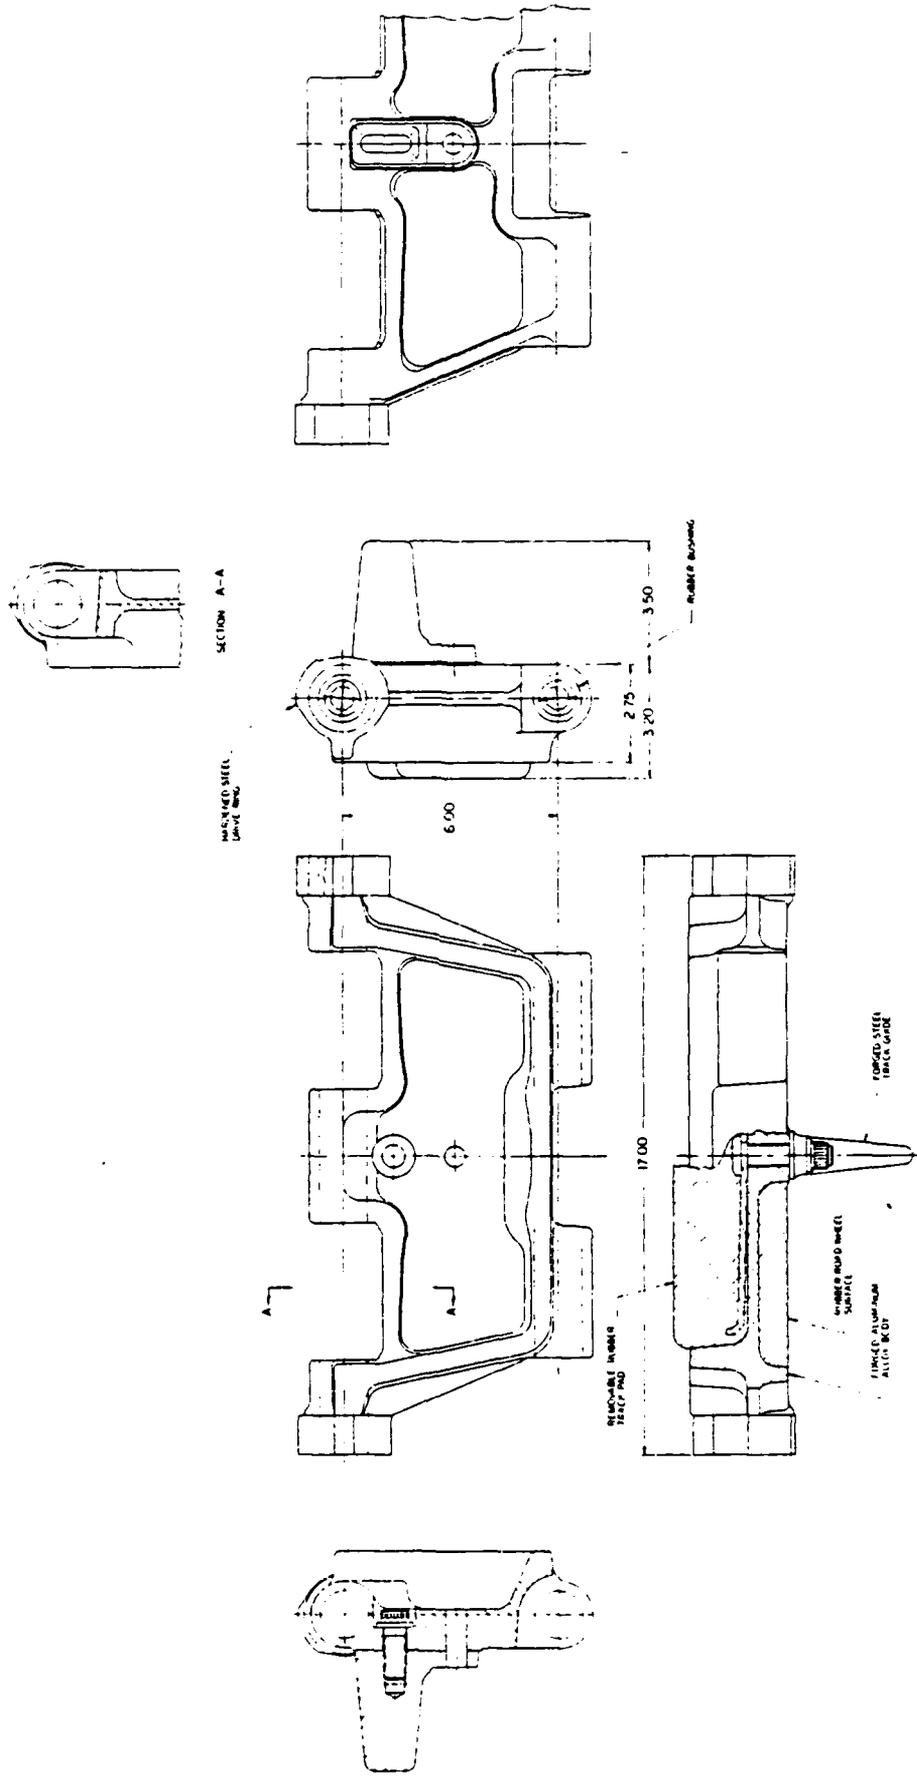
FIGURE A

17 INCH TRACK, SINGLE PIN, LIGHTWEIGHT
 DRAWING NO. 4211626

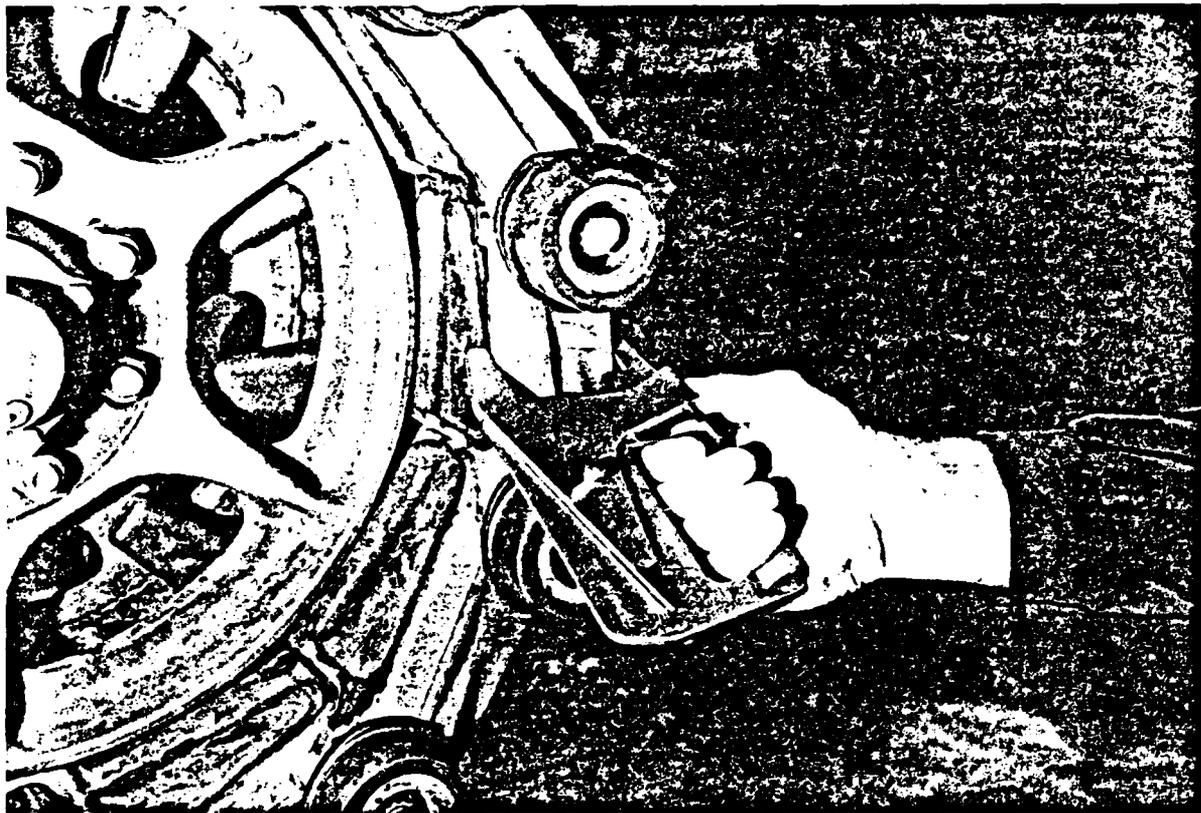
Measure the grouser height from the road wheel surface of the shoe to the top of the grouser. If the gage reading is more than 0.4 inches, the shoe must be replaced.

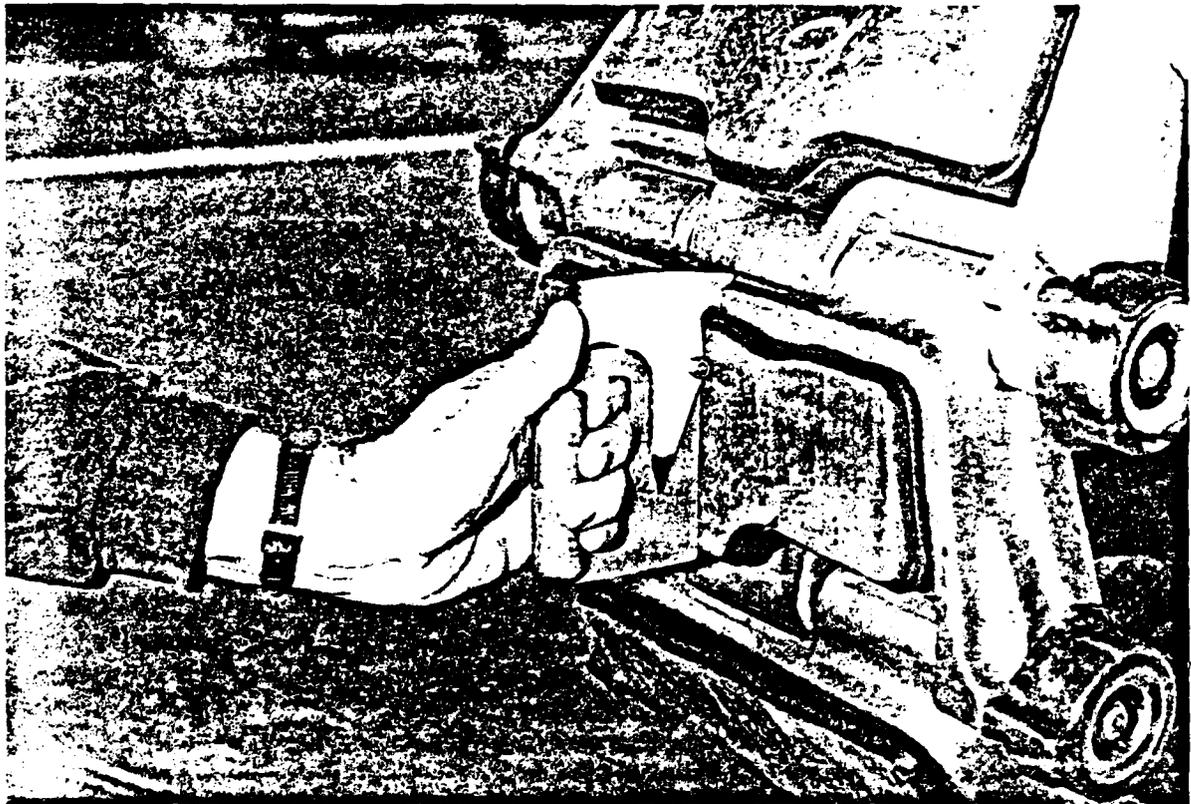
2. Track Pad Wear

Measure the height of the top of the track pad above the grouser. If the gage reading is less than 0.05 inches, the pad is too worn for the shoe and must be replaced.

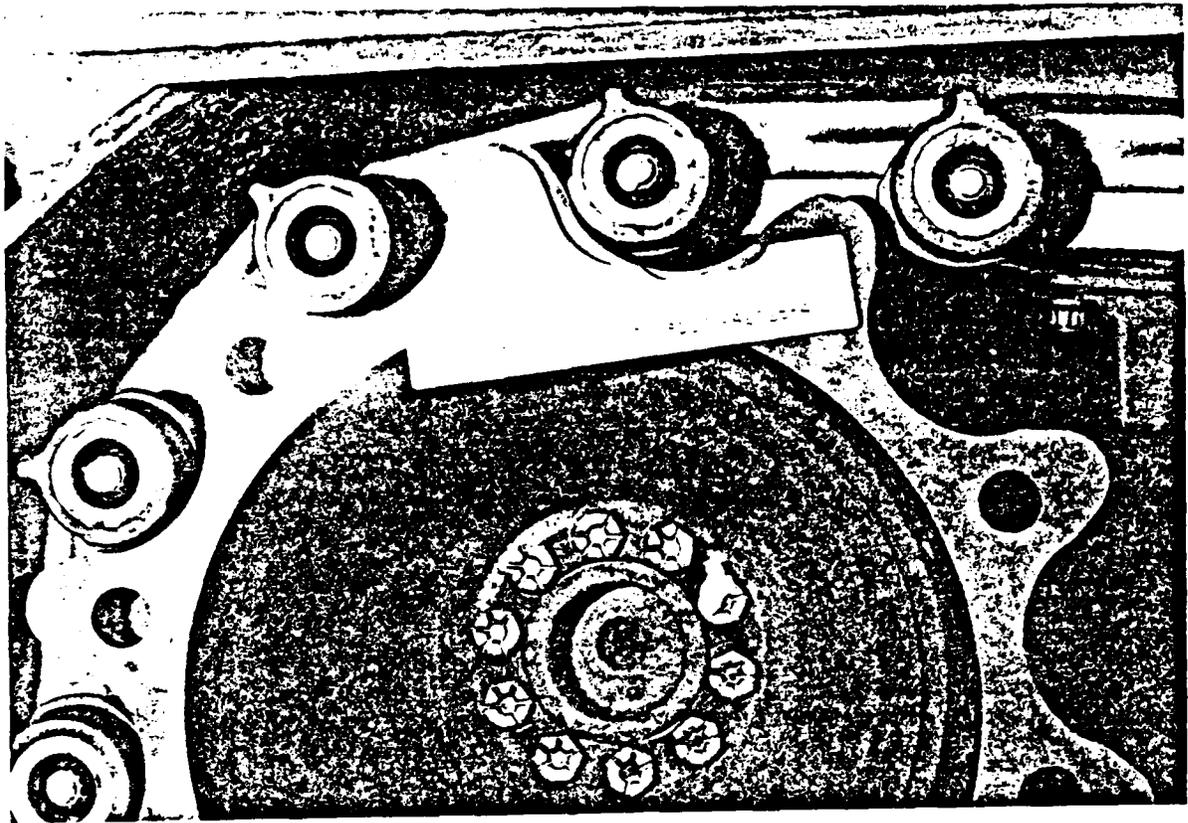
3. Sprocket Tooth Wear Place the gage in the positioning holes as shown and visually check the sprocket teeth. If a tooth is worn beyond the outline of the gage, the sprocket must be replaced.

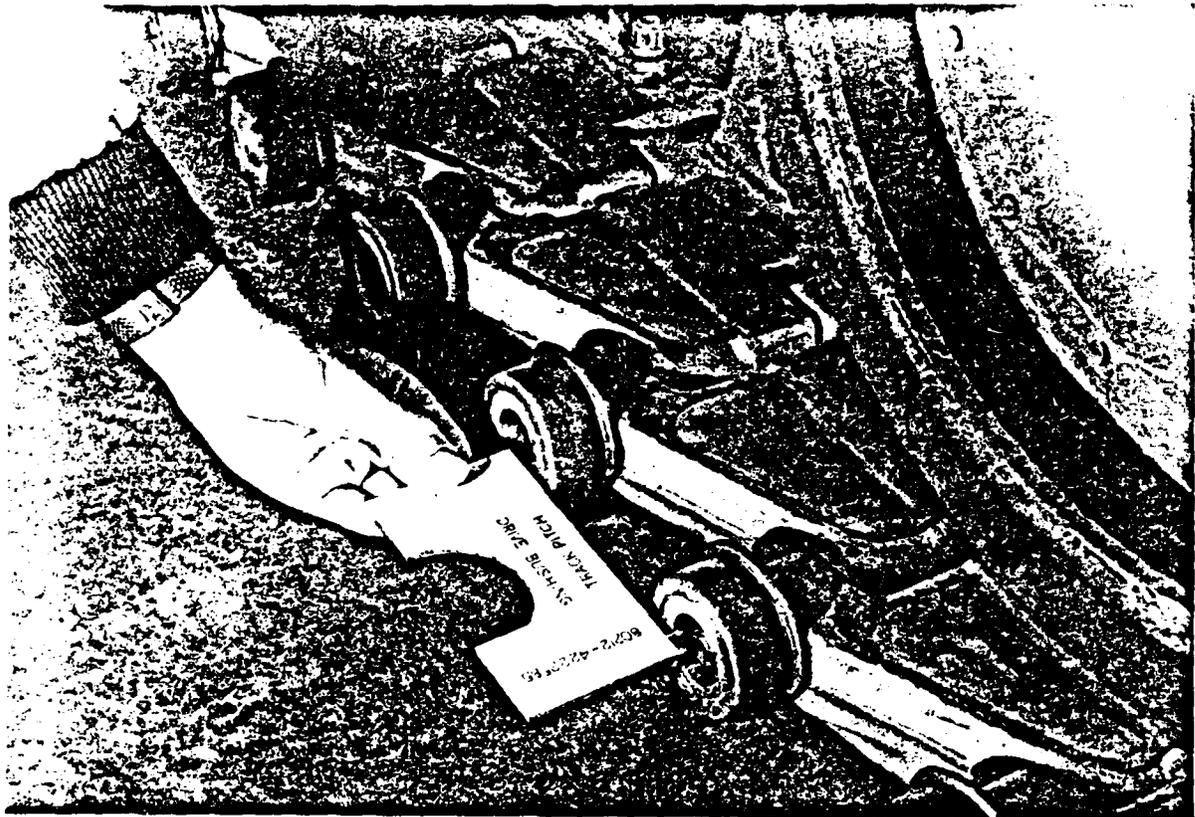
4. Track Pitch

Place the track pitch measurement pins in the boss inside bore. If the distance between bore diameters is too large for the pins the bushings have worn too much and the shoe must be replaced.

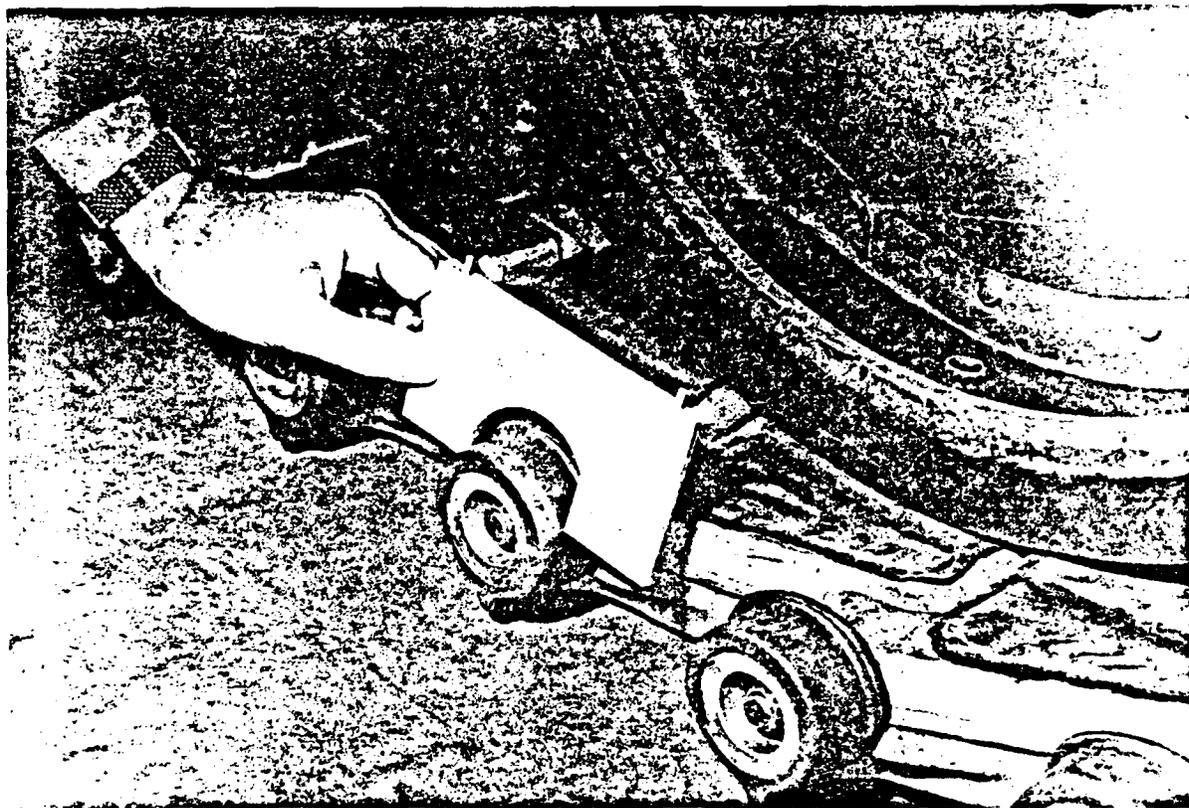
5. Drive Bushing Wear

Place the drive bushing gage over the drive bushing. If the bushing fits into the contoured wear pattern, the bushing is no longer good and the shoe must be replaced.

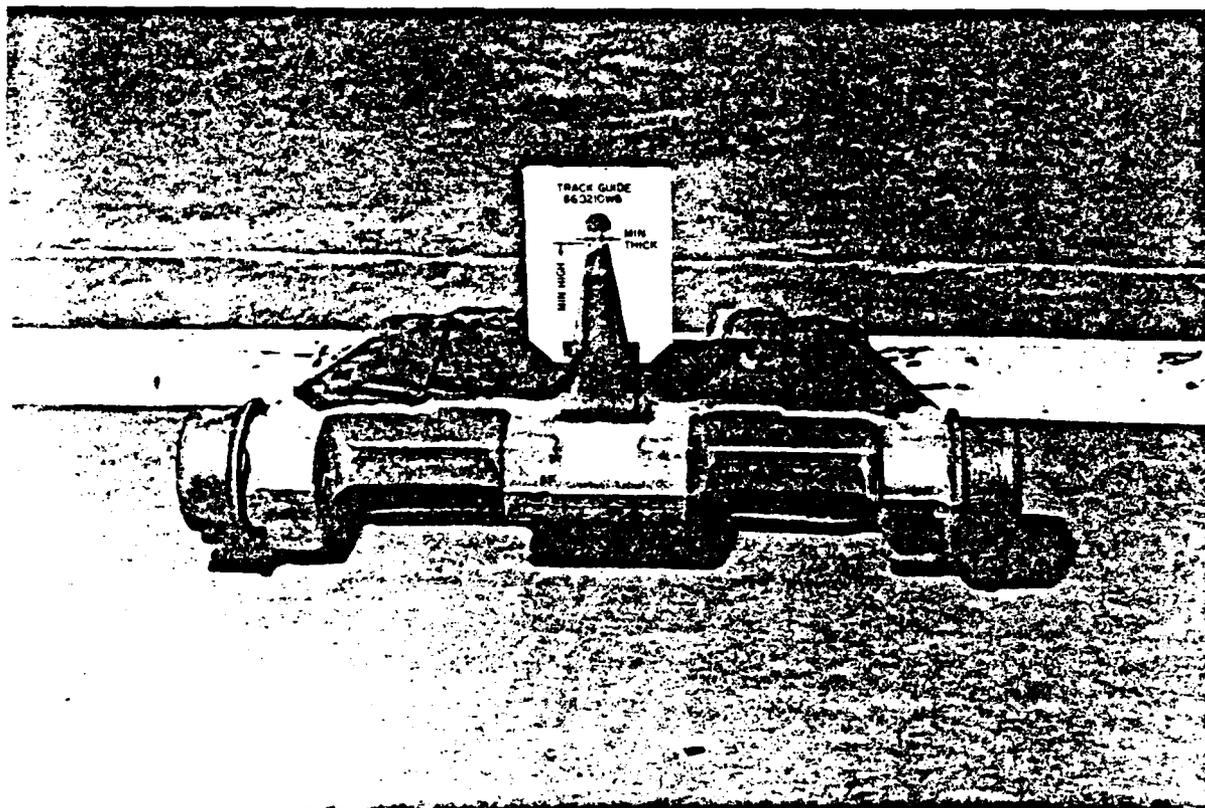
6. Track Guide Wear

Place the track guide wear gage over the track guide and visually check to make sure the minimum thickness and height are obtained. If the guide is below minimum, replace the track guide.

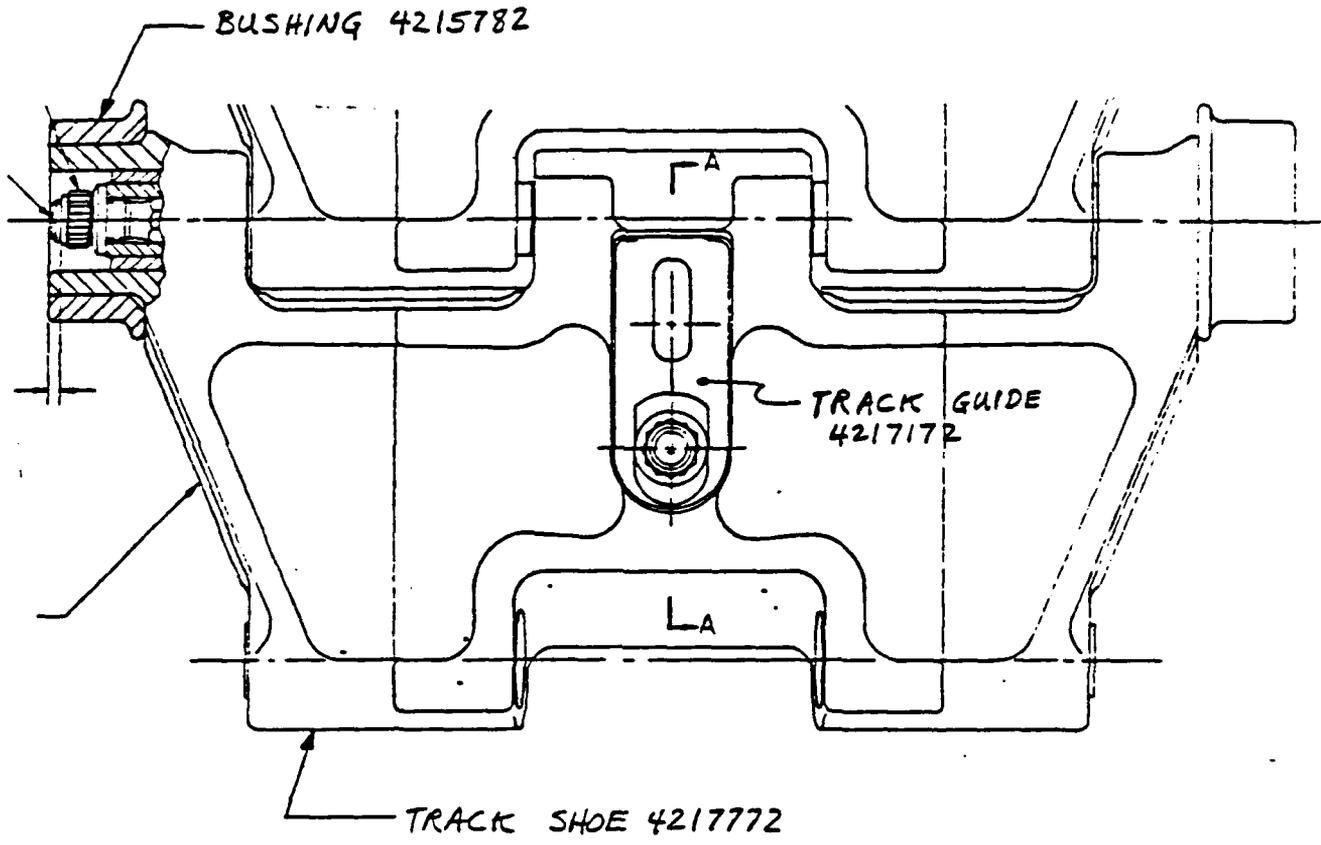
Task # 1:
 Determine bearing stresses (+FS's) on shoe 4217772
 just due to bolt preloads of guide 4217172:

TRACK ASSEMBLY 4219265: (reduced)

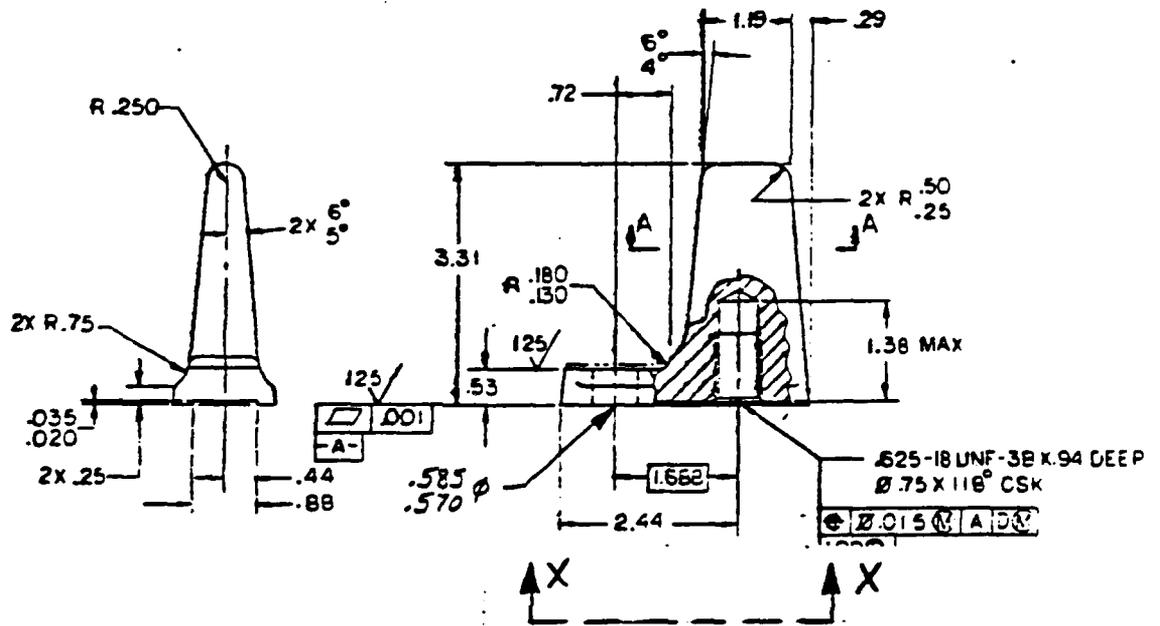
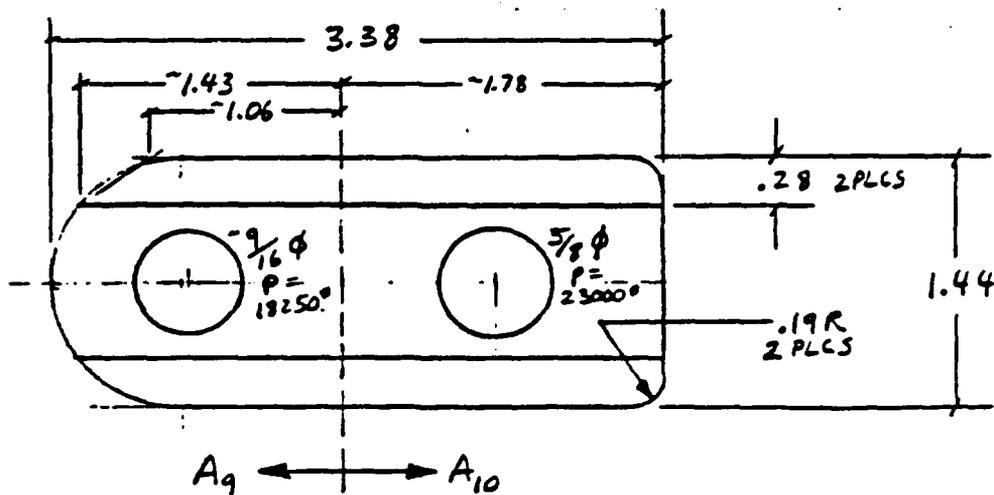
TRACK GUIDE 4217172 : (reduced)

View X-X: (full scale)

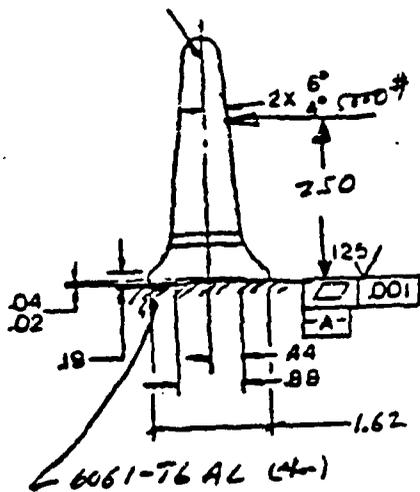
Find avg. σ 's ^{+FS'd} of guide on shoe due to preloads and specified 5000 # side load (as shown below).
 Also, find max σ 's due to bending and shear of guide runner leg (as shown below).

← Guide 4217172 showing side load of 5,000 lb at ht. of 2.50", as provided by O. Wong.

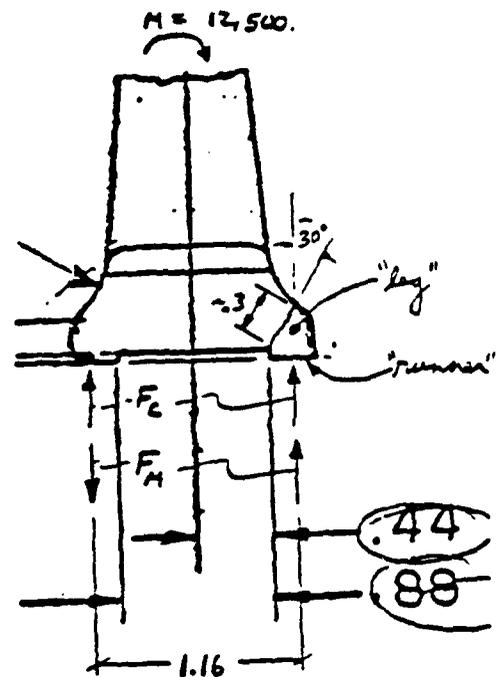
F_c = forces due to clamping of bolt preloads.

F_M = forces due to reaction of 12,500 lb-in Moment.

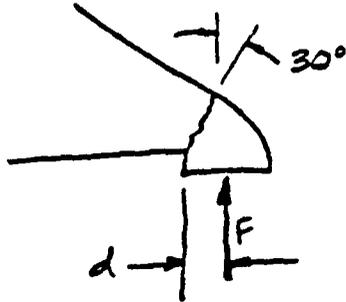
Estimate max stress section (sketch, p. 15).

Scaled thickness $\approx .2$, angle $\approx 30^\circ$, as shown.

$$\therefore \sigma_{max} = My/I + F \sin 30 / A \quad (\text{EQ. \#1A})$$

$$\text{and } \tau_{max} = 1.5 V/A = 1.5 F \cos 30 / A \quad (\text{EQ. \#1B})$$

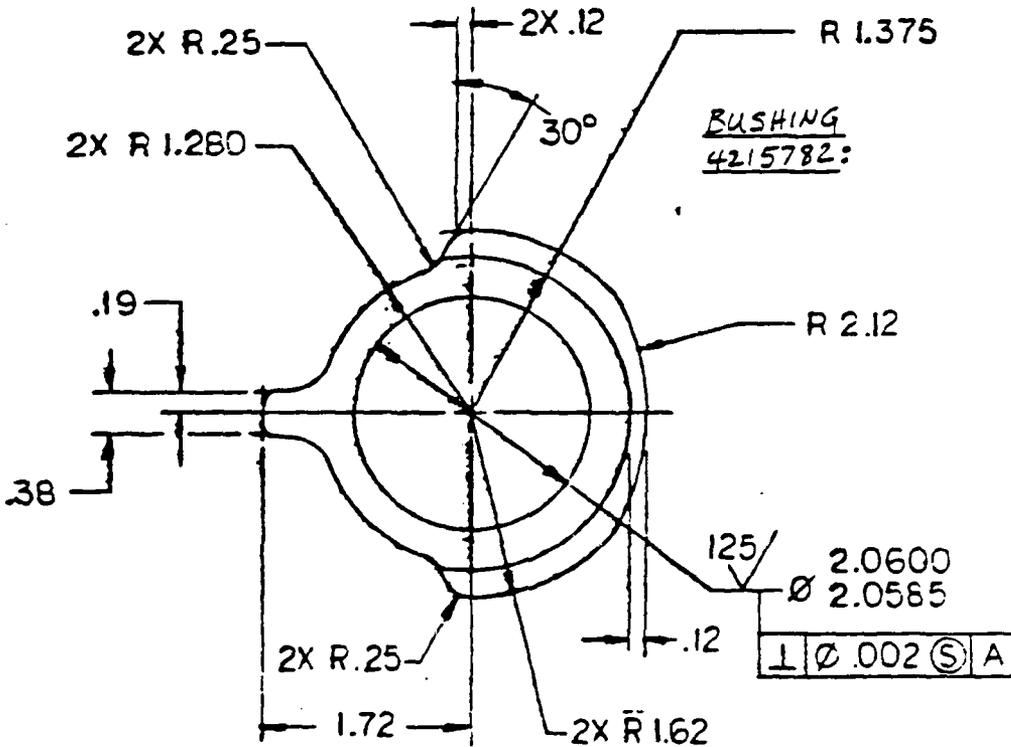
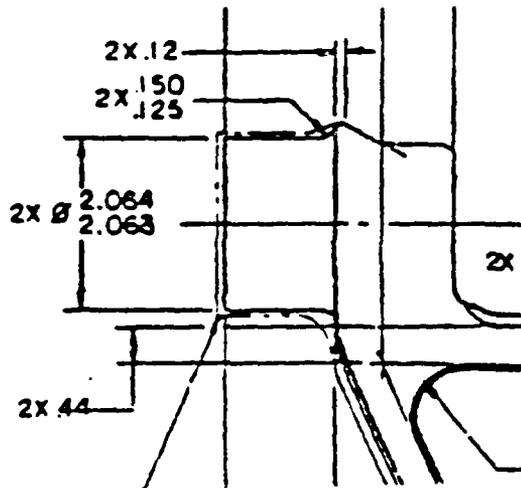
Find σ 's + FS's in al shoe boss and steel drive bushing 4215782 due to shrink fit only.

SHOE 4217772:

end boss dia

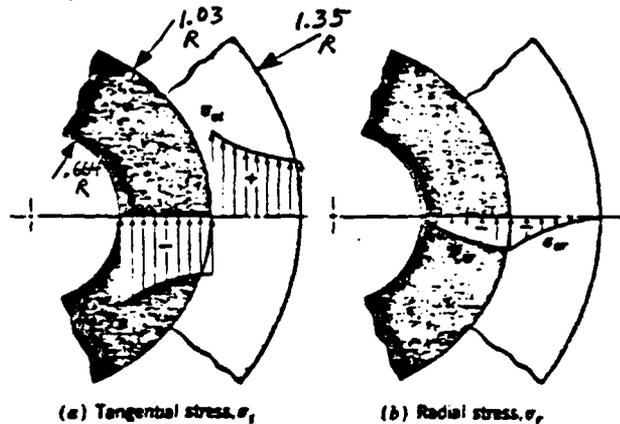
The distribution of σ 's will look like Fig 2-29 from Shigley:

FIGURE 2-29
 Distribution of radial and tangential stresses in shrink-fitted members
