FMC TECHNICAL REPORT 4381

**17-INCH SINGLE PIN ALUMINUM
TRACK DEVELOPMENT PROGRAM
FOR FUTURE U.S. MARINE CORPS
TRACKED VEHICLES**

Phase I Final Report
By
FMC Corporation
San Jose, CA 95108

20 NOVEMBER 1986

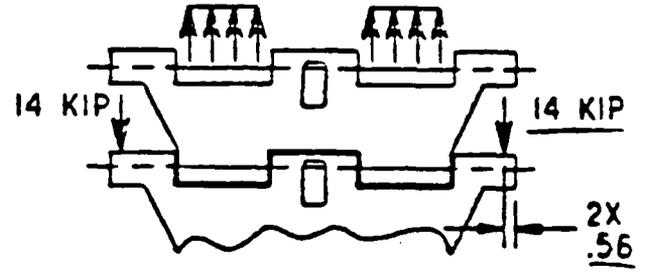
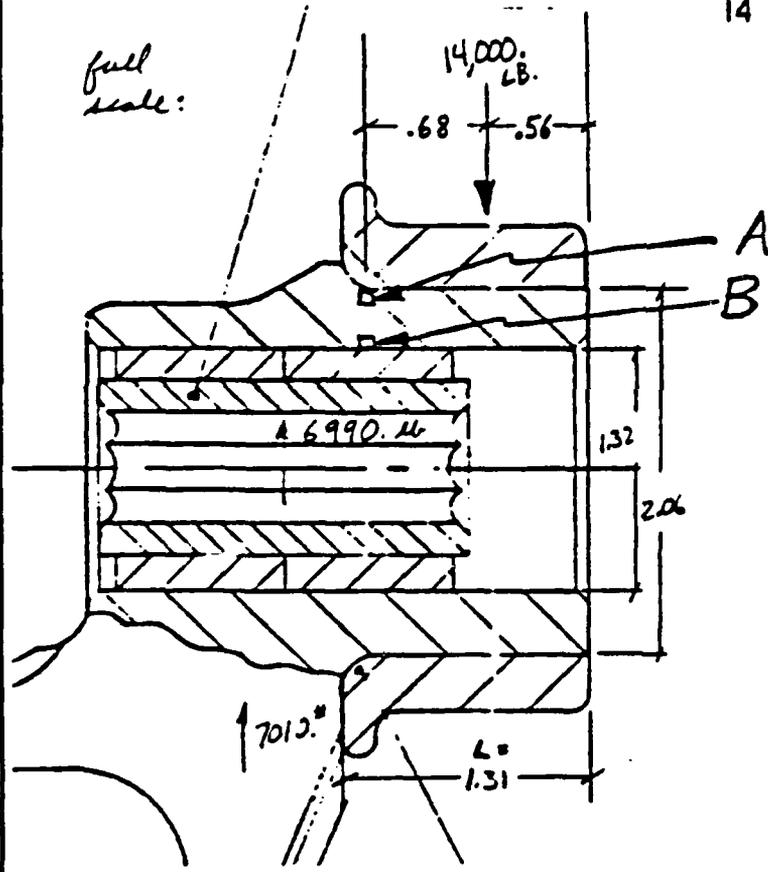
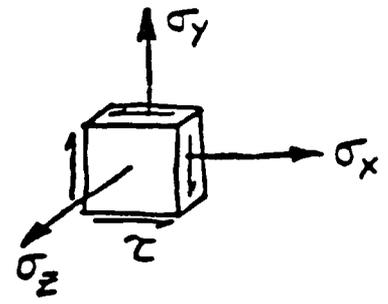
Find σ 's + FS's of all bolts under the drive bushing due to shrink fit and driving load "case 7".

→ CASE 7
 SPROCKET DRIVE

stresses on point A or B:

- σ_x = axial stress = bending σ due to 14 kip at .68"
- σ_y = radial σ , due to shrink and 14k bearing load
- σ_z = tangential σ , due to shrink fit
- τ = shear stress, due to 14 kip load

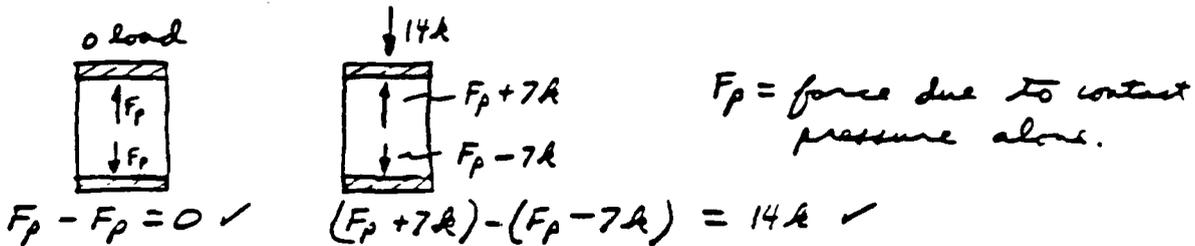
Task #4, cont'd: Cat A, cont'd
 If bushing were rigid, would it "gap" on side away from load?

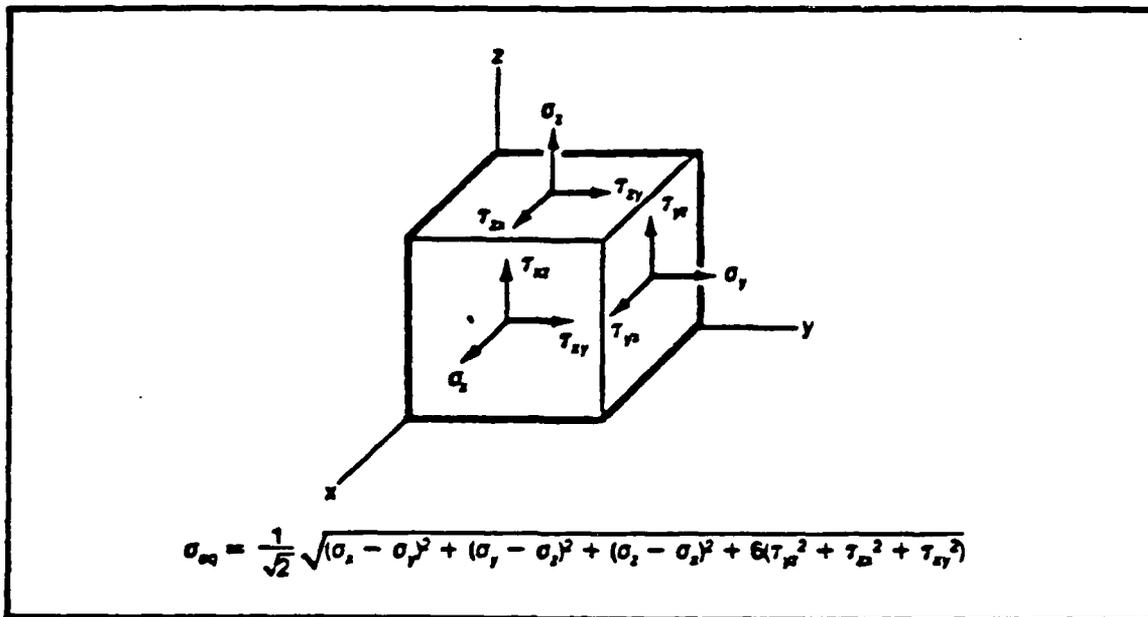
Task #4, cont'd: σ at A, cont'd:
 Use FMC Design Manual 3-D σ_{eq} formula:

Figure 10-2. Material Element Subjected to General Triaxial Normal and Shear Stresses

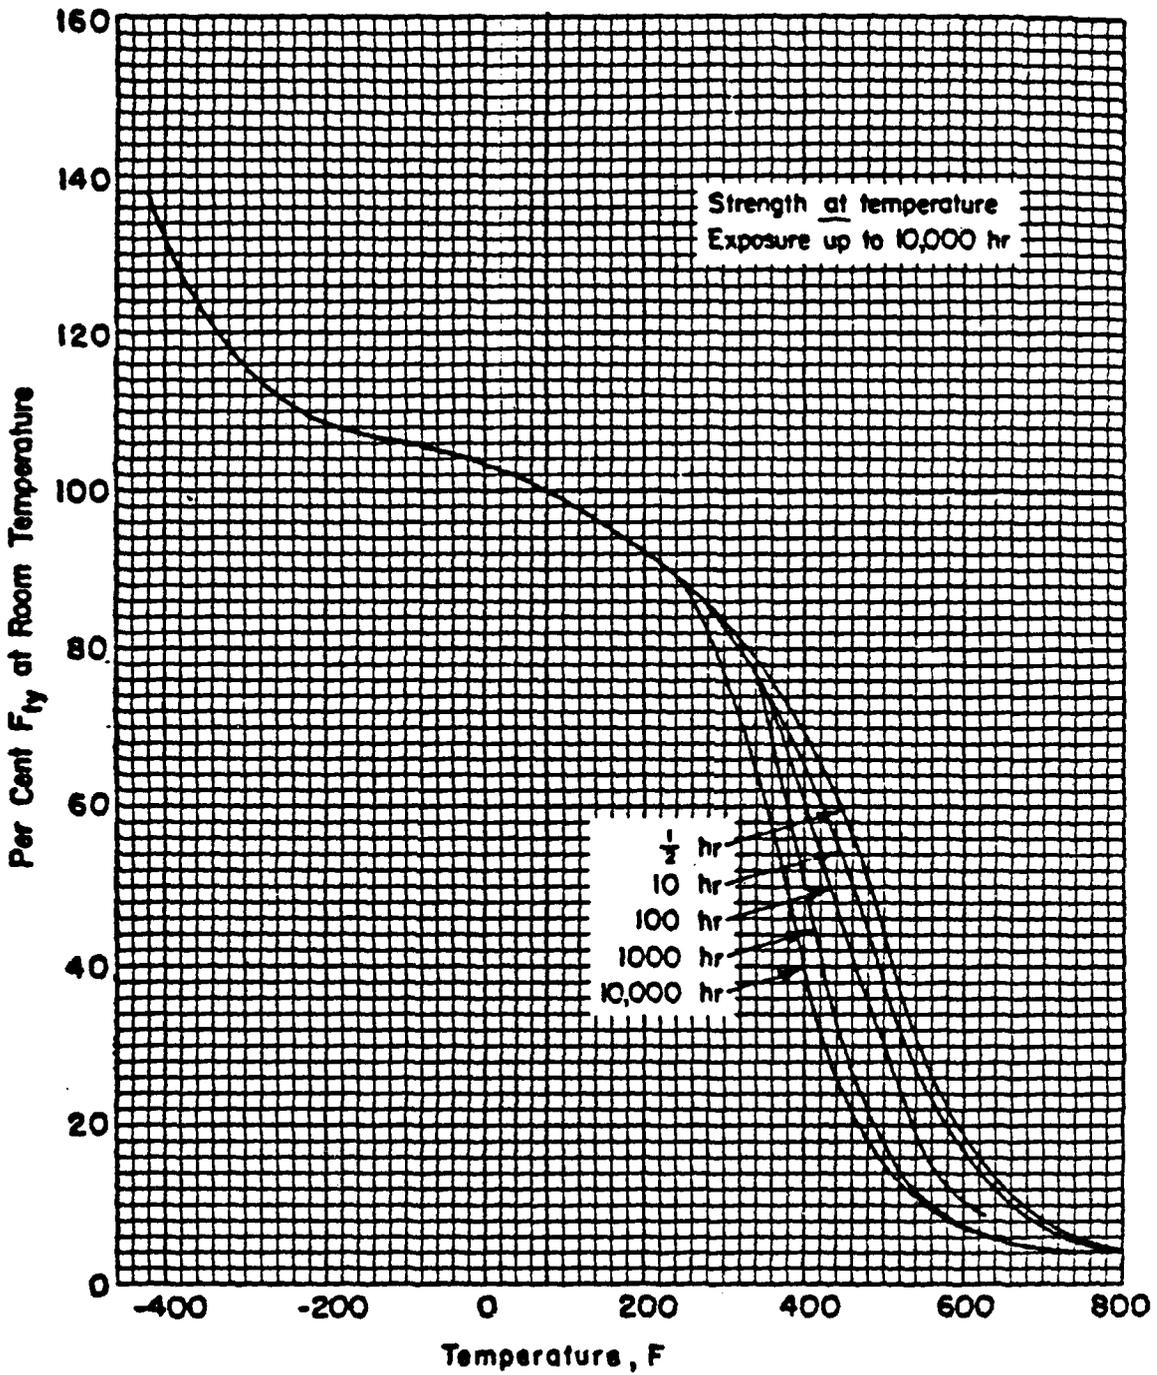
FIGURE 3.6.1.2.1(b). Effect of temperature on the tensile yield strength (F_{Ty}) of 6061-T6 aluminum alloy (all products).

This is the strength at the elevated temp.

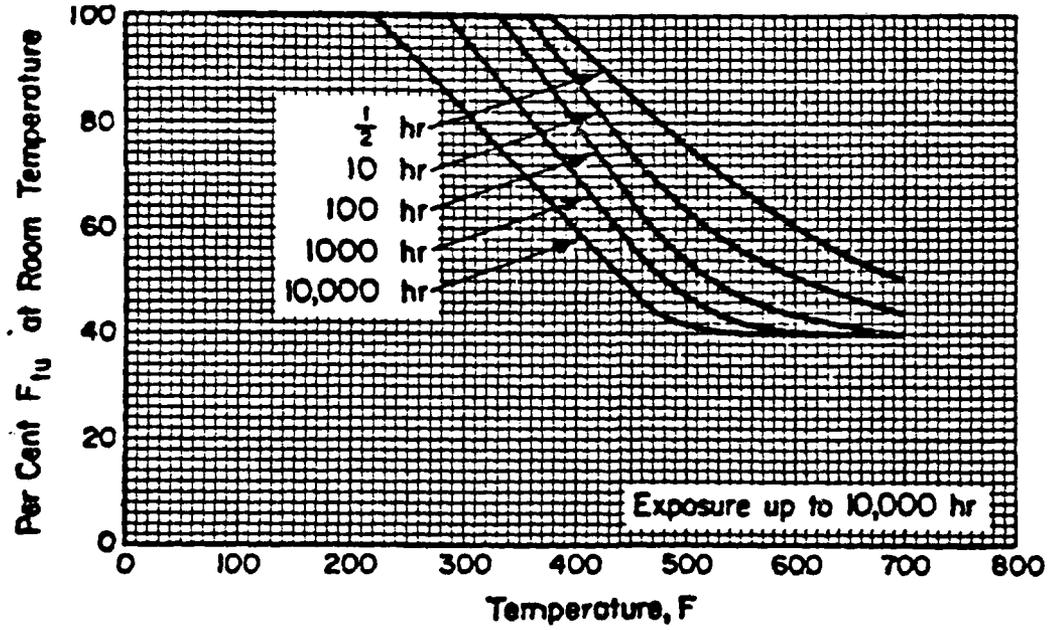
FIGURE 3.6.1.2.1(c). Effect of exposure at elevated temperatures on the room-temperature ultimate tensile strength (F_{tu}) of 6061-T6 aluminum alloy (all products).

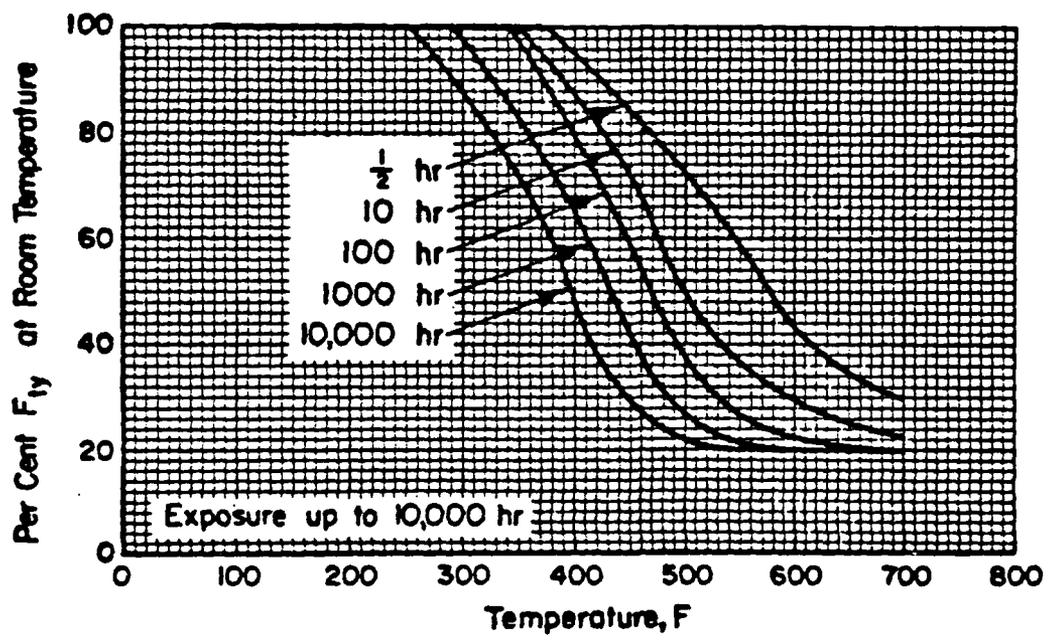
FIGURE 3.6.1.2.1(d). Effect of exposure at elevated temperatures on the room-temperature tensile yield strength (F_{ty}) of 6061-T6 aluminum alloy (all products).

These are the strengths after bringing back to room temp.

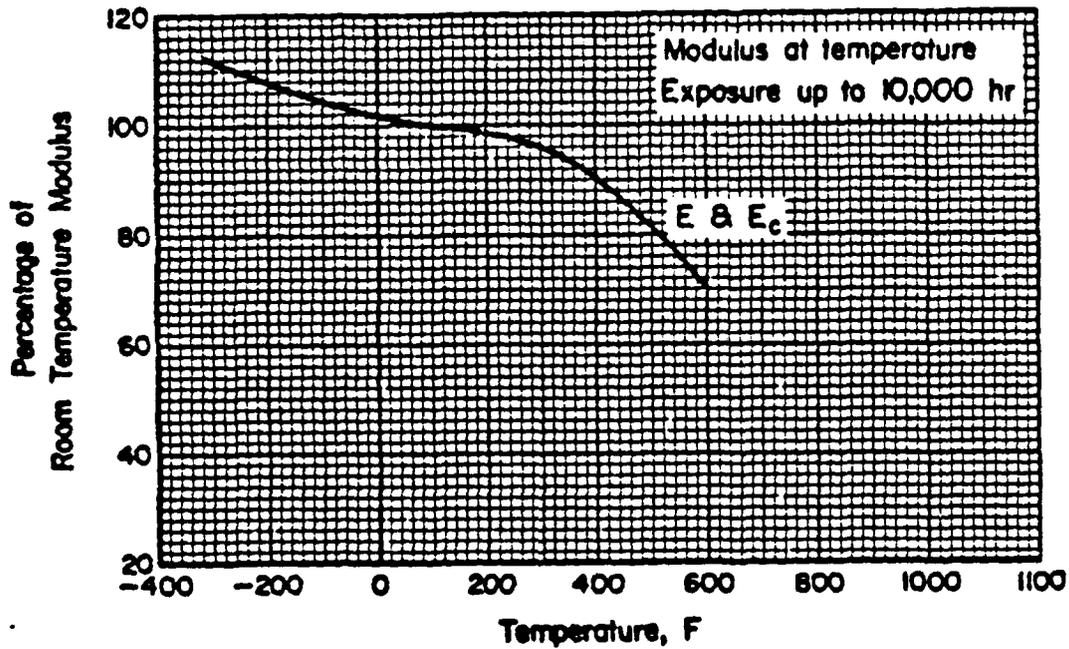
FIGURE 3.6.1.2.4. Effect of temperature on the tensile and compressive moduli (E and E_c) of 6061 aluminum alloy.

*probably independent of exposure time,
except the specimen tested must be at one uniform Temp.*

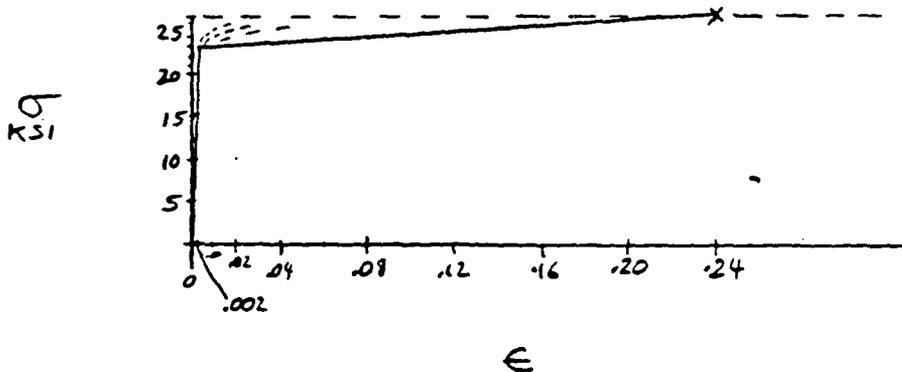
Check stress/strain curve at 350 F:
 Use the prop't from Alum. Stds & Data '76,
 from previous page, to draw σ/ϵ curve
 to scale:

Scale σ/ϵ curve: (6061-T6, at 350°F)

$$\epsilon \text{ at YP: } \sigma = E\epsilon \therefore \epsilon = \sigma/E = 23000/10M = 2.3E-3$$
