# FOUNDATION REPORT

# WYNOOCHEE DAM

US Army Corps  
of Engineers  
Seattle District

WYNOOCHEE DAM  
FOUNDATION REPORT

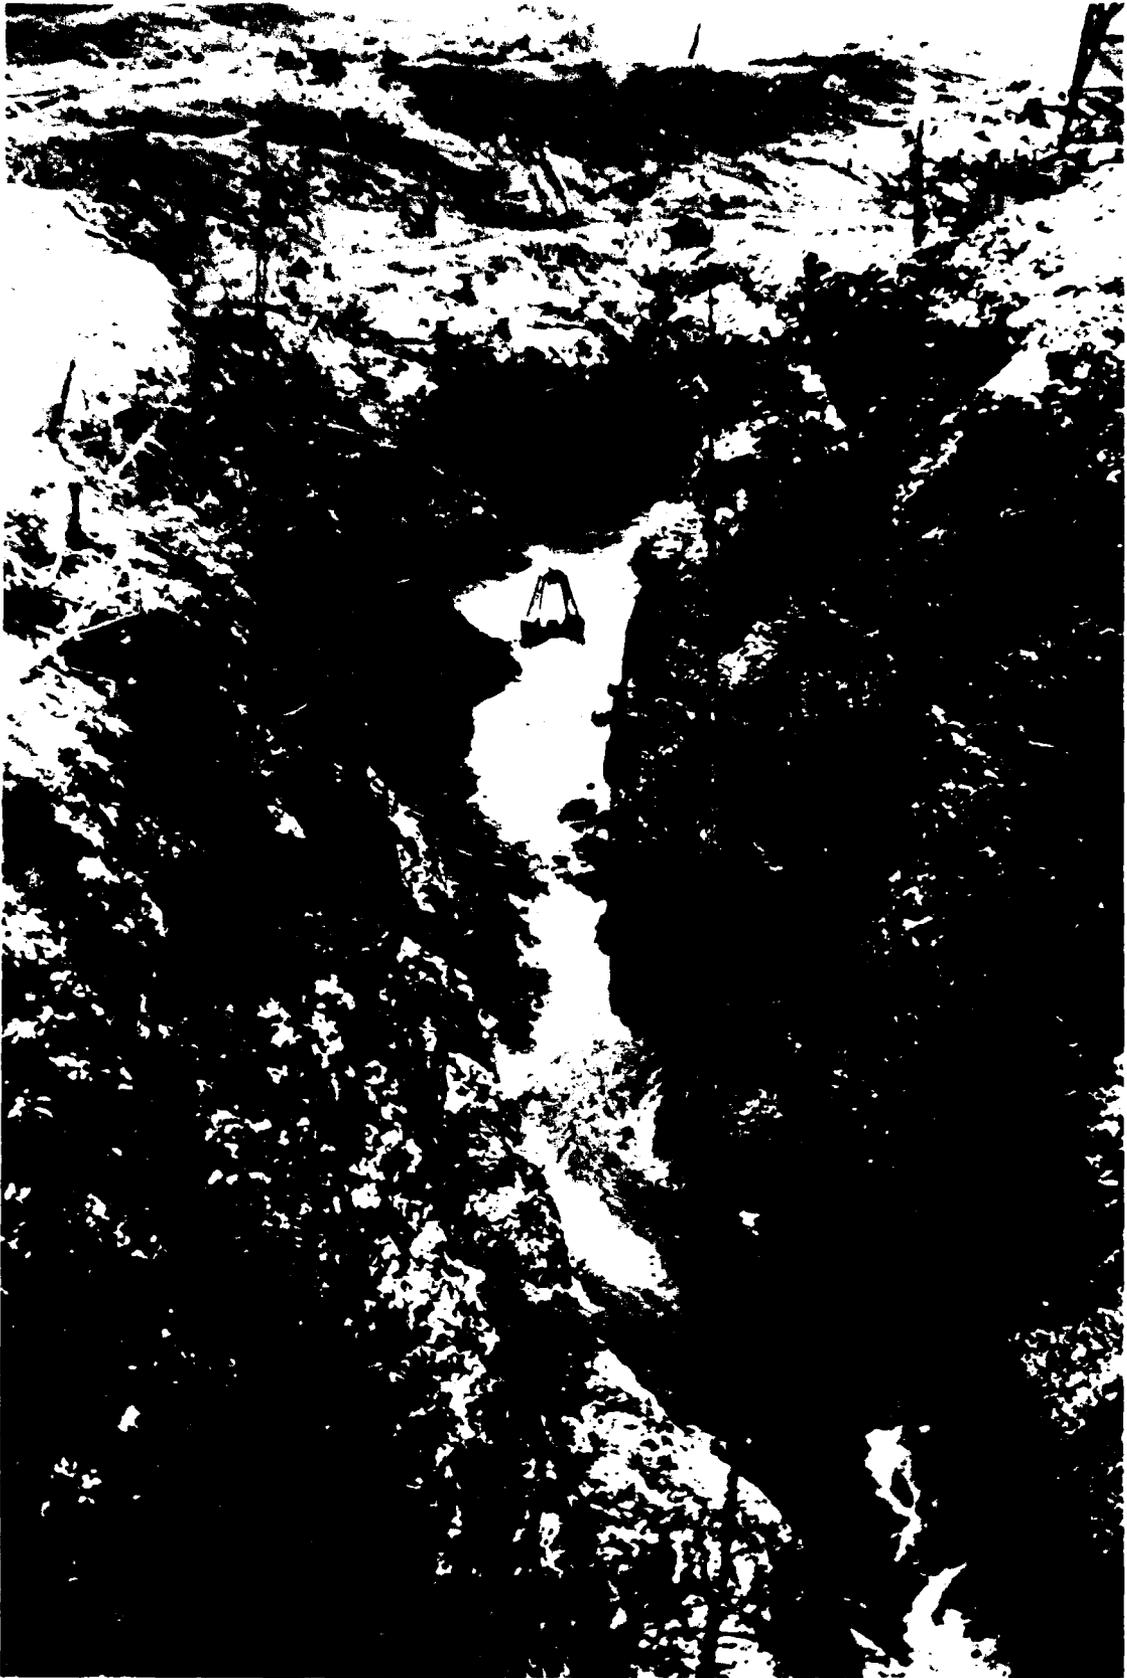
**FIGURE 3-3**

**PRECONSTRUCTION WYNOOCHEE CANYON — VIEW UPSTREAM SHOWING WYNOOCHEE RIVER CANYON BEFORE CONSTRUCTION OF WYNOOCHEE DAM (1969)**

3.03.2 All of the concrete dam is founded on bedrock (figure 3-3). Basalt forms the right abutment, diabase forms the left, and a contact zone between the two rock types occurs in the valley bottom beneath the dam (plate 8). Generally, basalt occurs downstream of a diagonal vertical plane extending from the downstream end of the spillway chute along a N20°W bearing through the heel of monolith 5. Diabase is exposed in the foundations of monoliths 5, 6, and 7 and in all left abutment monolith foundations. The contact zone rock occurs with irregular near vertical boundaries and crosses the foundation along a diagonal zone ranging from 1 to 20 feet wide. The zone enters the dam area at the downstream end of the spillway chute, enters the dam foundation at the toe of monolith 7, and passes out of the foundation in the heel of monolith 5.

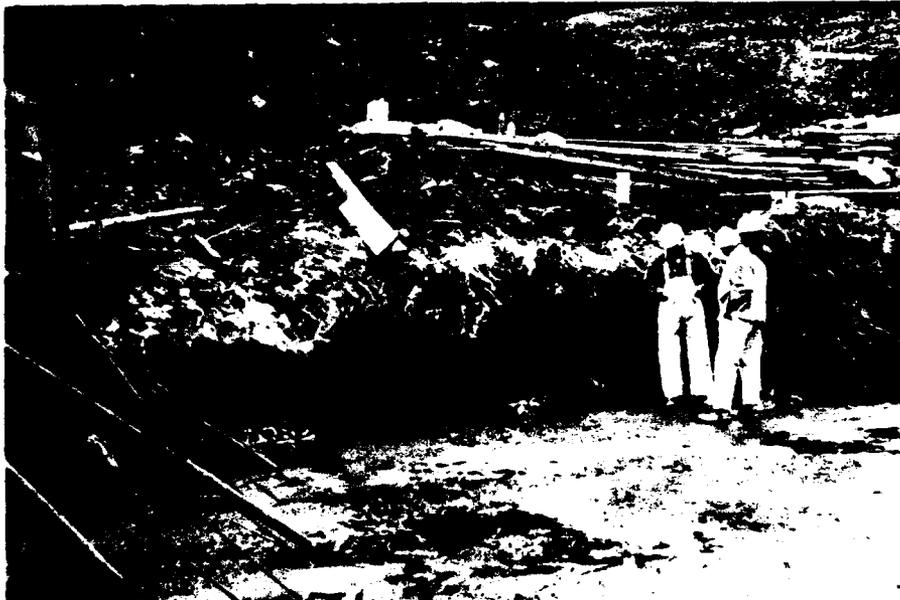
**Mono. 1 foundation, view right (west) showing backfill concrete to elevation 750 feet, 9 Nov. 1970.**

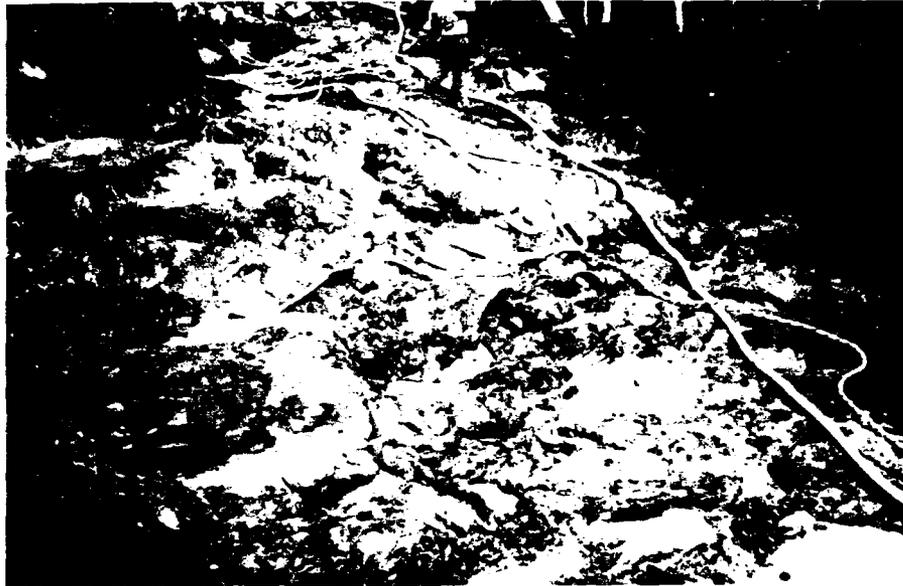
Monolith 10, view upstream (northeast) showing rock foundation, 30 Oct. 1970.

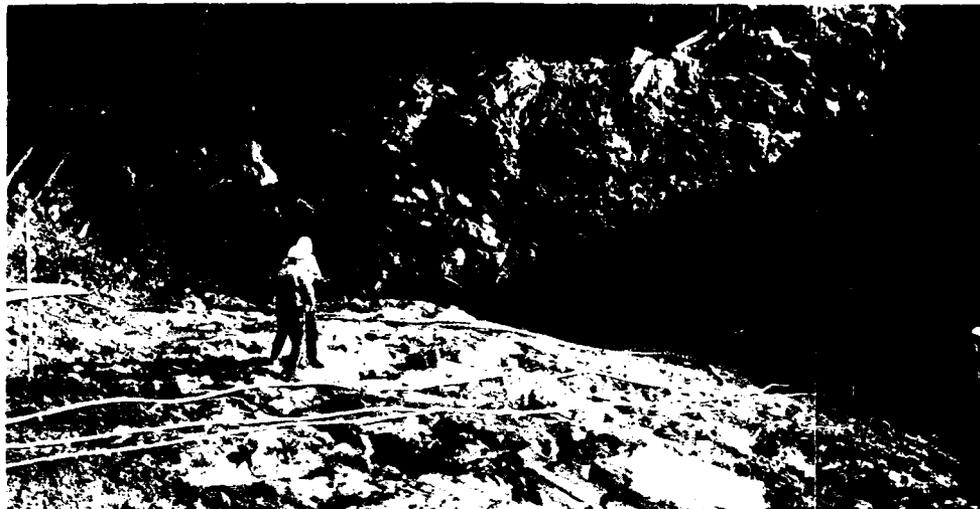
Monolith 11 bench cut slope foundation, view east, 14 Oct. 1970.

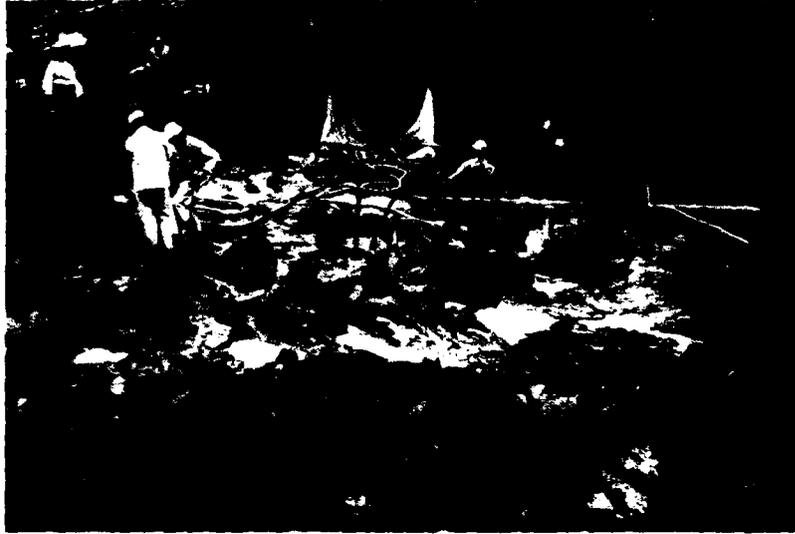
**Monolith 10, view east showing final foundation preparation with uplift pressure cells, two in center and two on right. Monolith 11 concrete in background, 6 Nov. 1970.**

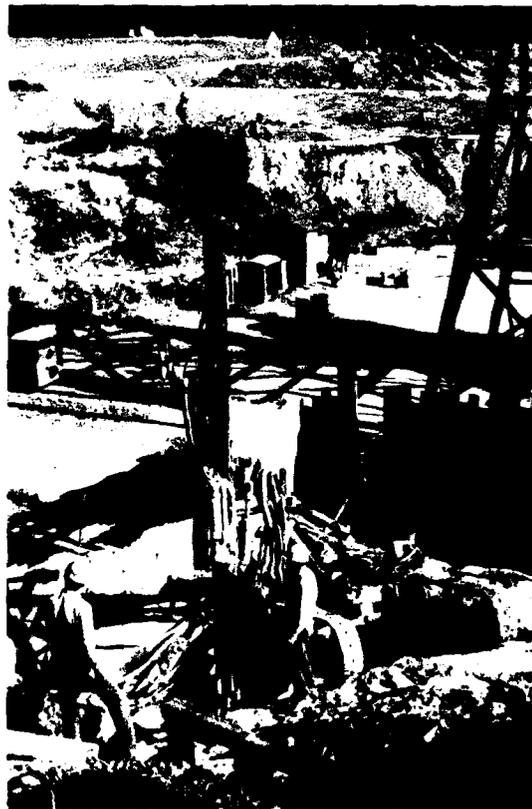
Monolith 12, view north showing Joy model 500 track drill boring "J" bar holes in foundation, 15 Sep. 1970.

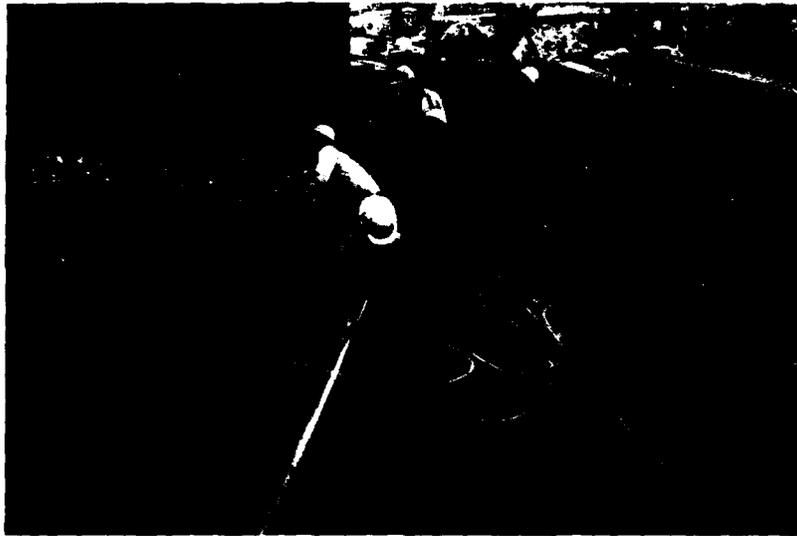
**Monolith 13, view north showing final foundation preparation. Note grouting gallery gutter forms at right, 12 Oct. 1970.**
