WRDC-TR-89-4138

# X-RAY COMPUTED TOMOGRAPHY OF CASTINGS

Boeing Aerospace & Electronics  
P.O. Box 3999  
Seattle, WA 98124 2499

Interim Report for Period April 1989 - September 1989

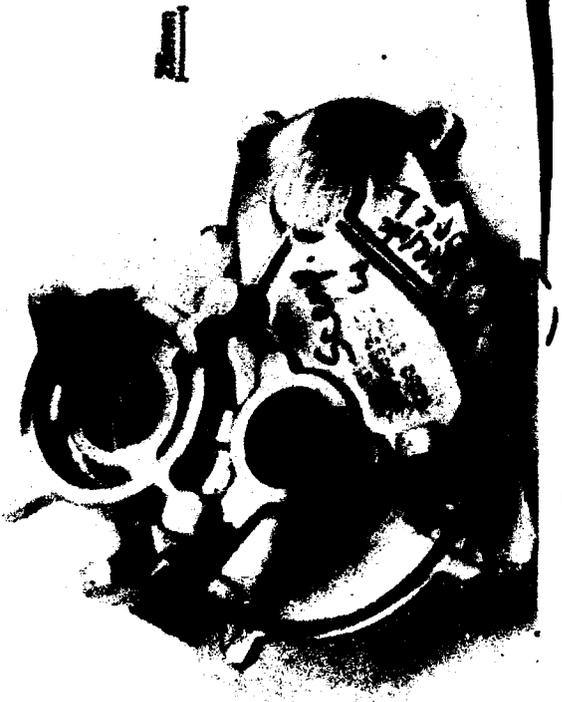
Figure 3.1-2 PID #119, filamentary shrinkage

A small coupon, PID #119, containing multiple string like or filamentary low density indication (LDI) areas caused by shrinkage during solidification of the casting was excised from an aluminum aircraft housing. Figures 3.1-2(a) and (b) are photographs of the full-sized and the excised part. Figure 3.1-2(c) shows two film RT views and Figure 3.1-2(d) shows a DR from System J. Figure 3.1-3(a) through (c) shows three CT slices of the coupon from System J taken at the slice planes indicated in the DR of Figure 3.1-2(d). The filamentary shrinkage area is seen in cross section as string-like low density groupings ranging from 0.25 to 2.0 mm (0.01 to 0.08 inches) in diameter. Figure 3.1-3(d) shows a CT image taken on system K at approximately location CT3. The contrast level setting used in the reproduced image is such that the defect area is observed as an enlarged hole. This system can readily detect the defect feature but does not resolve the detail.

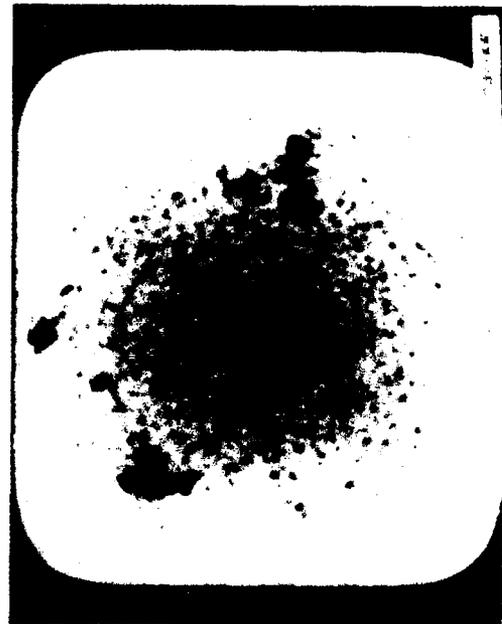
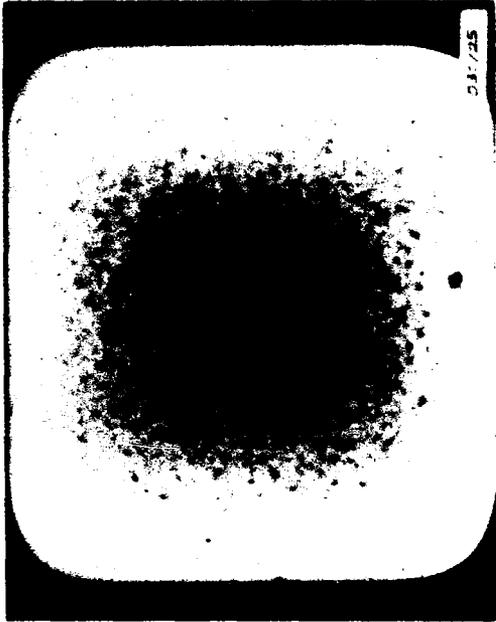
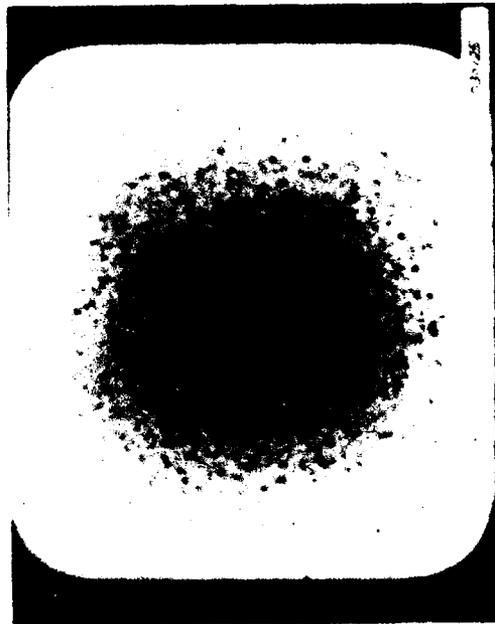
Figure 3.1-6 CT scans of PID #125, shrinkage holes

A series of four CT images obtained from system J are shown in Figure 3.1-6. The slices were taken near the top surface, in the middle and near the bottom surface of the coupon. The images show that the holes are not evenly distributed through the depth of the coupon. The middle contains multiple small holes visible down to 0.25 mm (0.01 inch) in size. The lighter shade of grey at the edges of the images is the beam hardening artifact common in CT. It is caused by

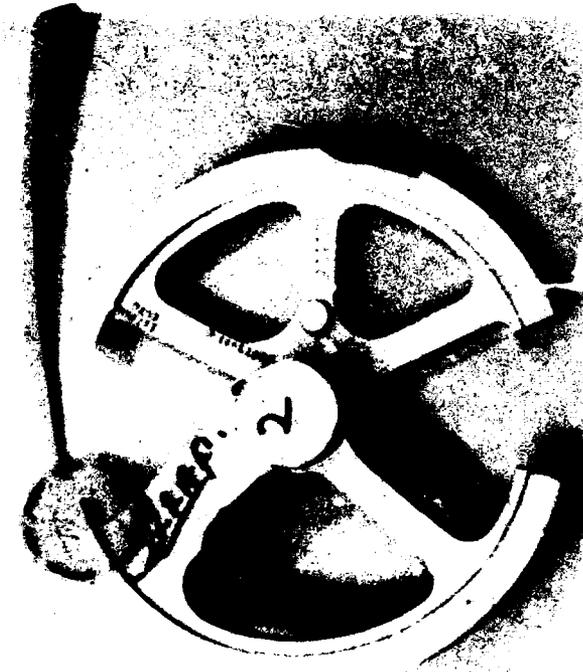
Figure 3.1-9 PID #120, 0.5 mm surface cracks

Surface cracks measuring 30 mm (1.2 inches) long and 0.5 mm (0.02 inch) wide were observed in an aluminum sand casting, pictured in Figure 3.1-9(a). A small (42 mm (1.65 inch) diameter x 7 mm (0.28 inch) thick) circular coupon containing the crack was excised from the larger casting for testing. The large shoulder near the crack was removed and the typically rough sand-cast surface was smoothed to eliminate confusing images of surface bumps appearing in the radiograph. The surface on the crack side was not faced off entirely smooth in order to preserve as much of the crack as possible. A slight cleft remained on the coupon as can be seen in the part photograph, Figure 3.1-9(b).

Figure 3.1-9(c) is a reproduction of the film radiograph of the coupon. Figure 3.1-9(d) is a 0.4 mm (0.016 inch) thick CT slice, taken on System B at 225 kV, very near the surface of the coupon. The image shows the near surface holes in the casting. Figure 3.1-9(e) is a CT slice across the part which images the depth of the crack.

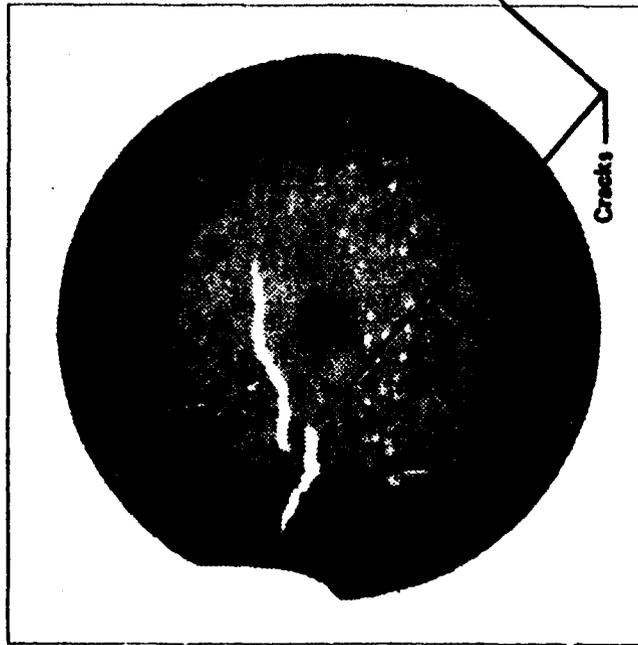
Figure 3.2-3 CT scans of PID #120 alone and inserted in Inlet duct casting

Figure 3.2-3 shows the comparison of images of the crack coupon (PID #120) scanned alone and scanned inserted in the inlet duct casting, on System B at 225 kV. The crack is less distinct but readily detected when it is inserted in the larger casting structure. The signal-to-noise ratios are 19 and 2.5 for the coupon alone and inserted in the inlet duct, respectively. Again, the slice planes are not necessarily at the same level in the part.

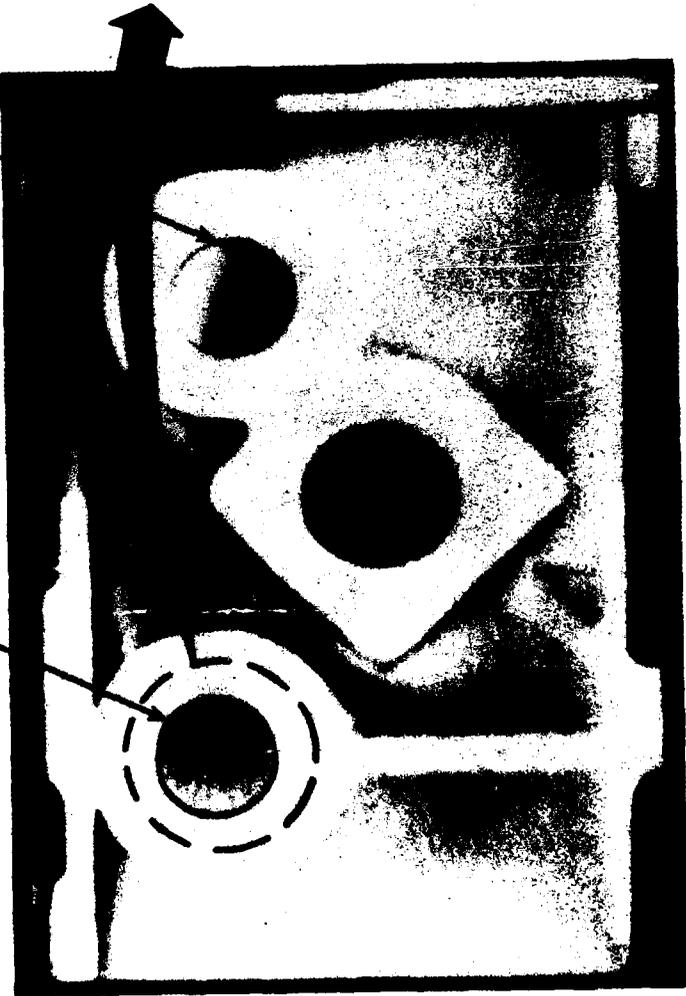
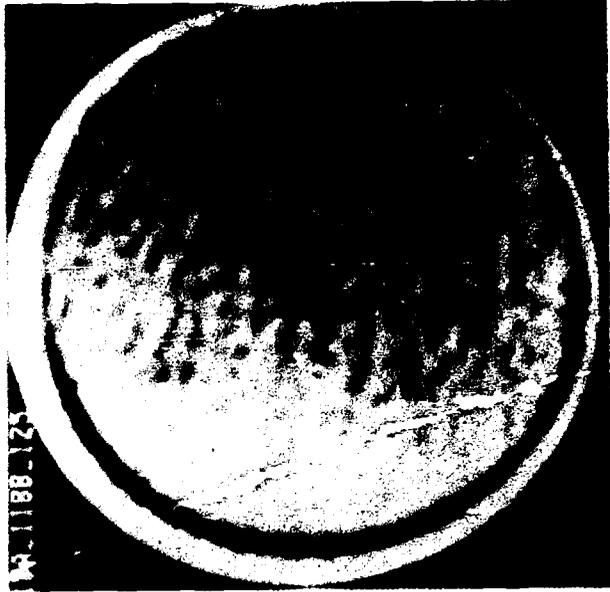
Figure 3.2-4 PID #118A and #120 Inserted in handle-box casting

The handle-box casting is larger than the inlet duct, and was CT inspected on System I which has a 2 MV source and a large field of view. Figures 3.2-4(a) and (b) are scans of test coupons PID #120 and PID #118A, respectively. Figure 3.2-4(c) shows the CT slice of the handle box with both of the test coupons inserted. The cracks and porosities in the test coupons were detectable when scanned in the full-scale casting. Figure 3.2-4(d) shows an enlargement of the PID #118A coupon region. There is an obvious reduction in the definition of the defect indications in this image of PID #118A as when compared to Figure 3.2-4(b). Note that (d) is reversed from (b), also the slice planes may not be exactly the same. In Figure 3.2-4(b) holes of approximately 6 x 3 mm (0.24 x 0.12 inch), 2 x 3 mm (0.079 x 0.12 inch), and 1 mm (0.039 inch) across are labelled 1, 2, and 3, respectively, and are easily detected. In Figure 3.2-4(d) holes 1 and 2 are easily detected and even 3 is detectable.

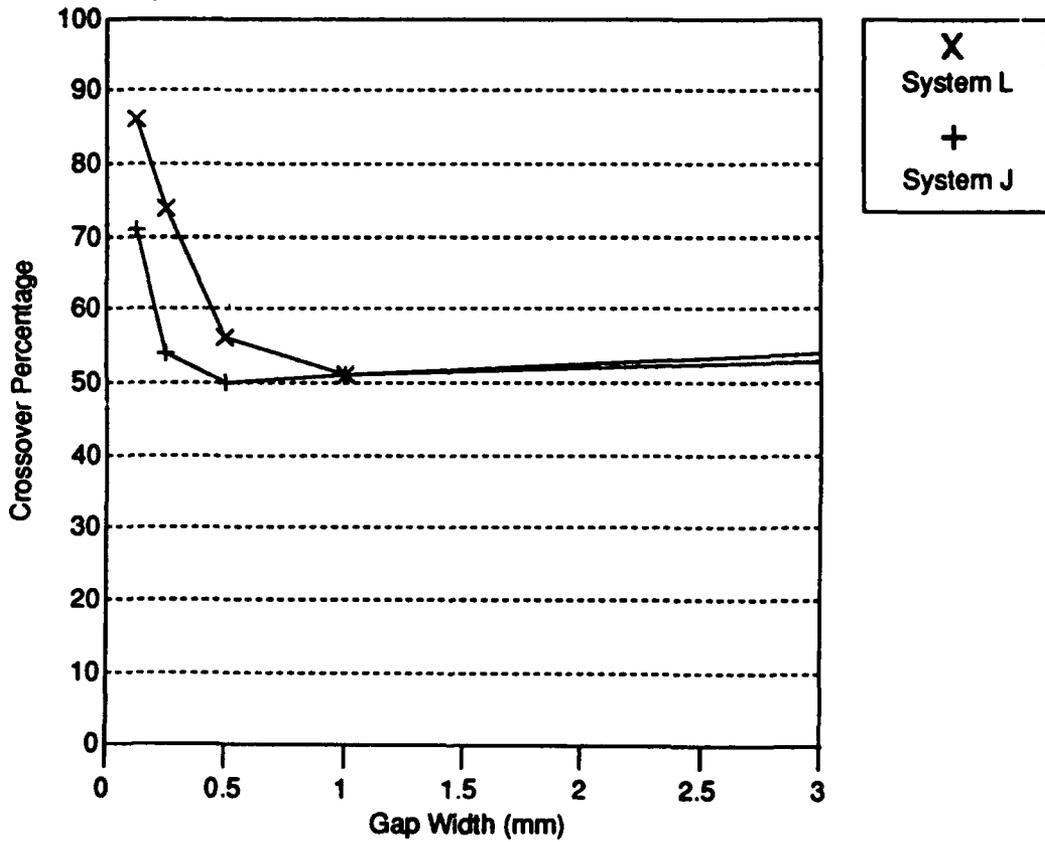
Figure 3.3-4 Crossover percentage vs gap width

Figure 3.3-4 shows a plot of the CT level setting (labelled crossover percentage to represent the CT value as a percent of the full modulation between air and metal) which would give the correct measurement of the gap for Systems L and J as a function of gap width. In the case of System L the crossover percentage increases more rapidly than for System J as the gap width decreases. This data confirms that the modulation is decreasing more rapidly in System L (a 1 lp/mm system) which has inherently less resolution than System J (a 2 to 4 lp/mm system) as discussed in CT system performance data of Figure 2.2-1.

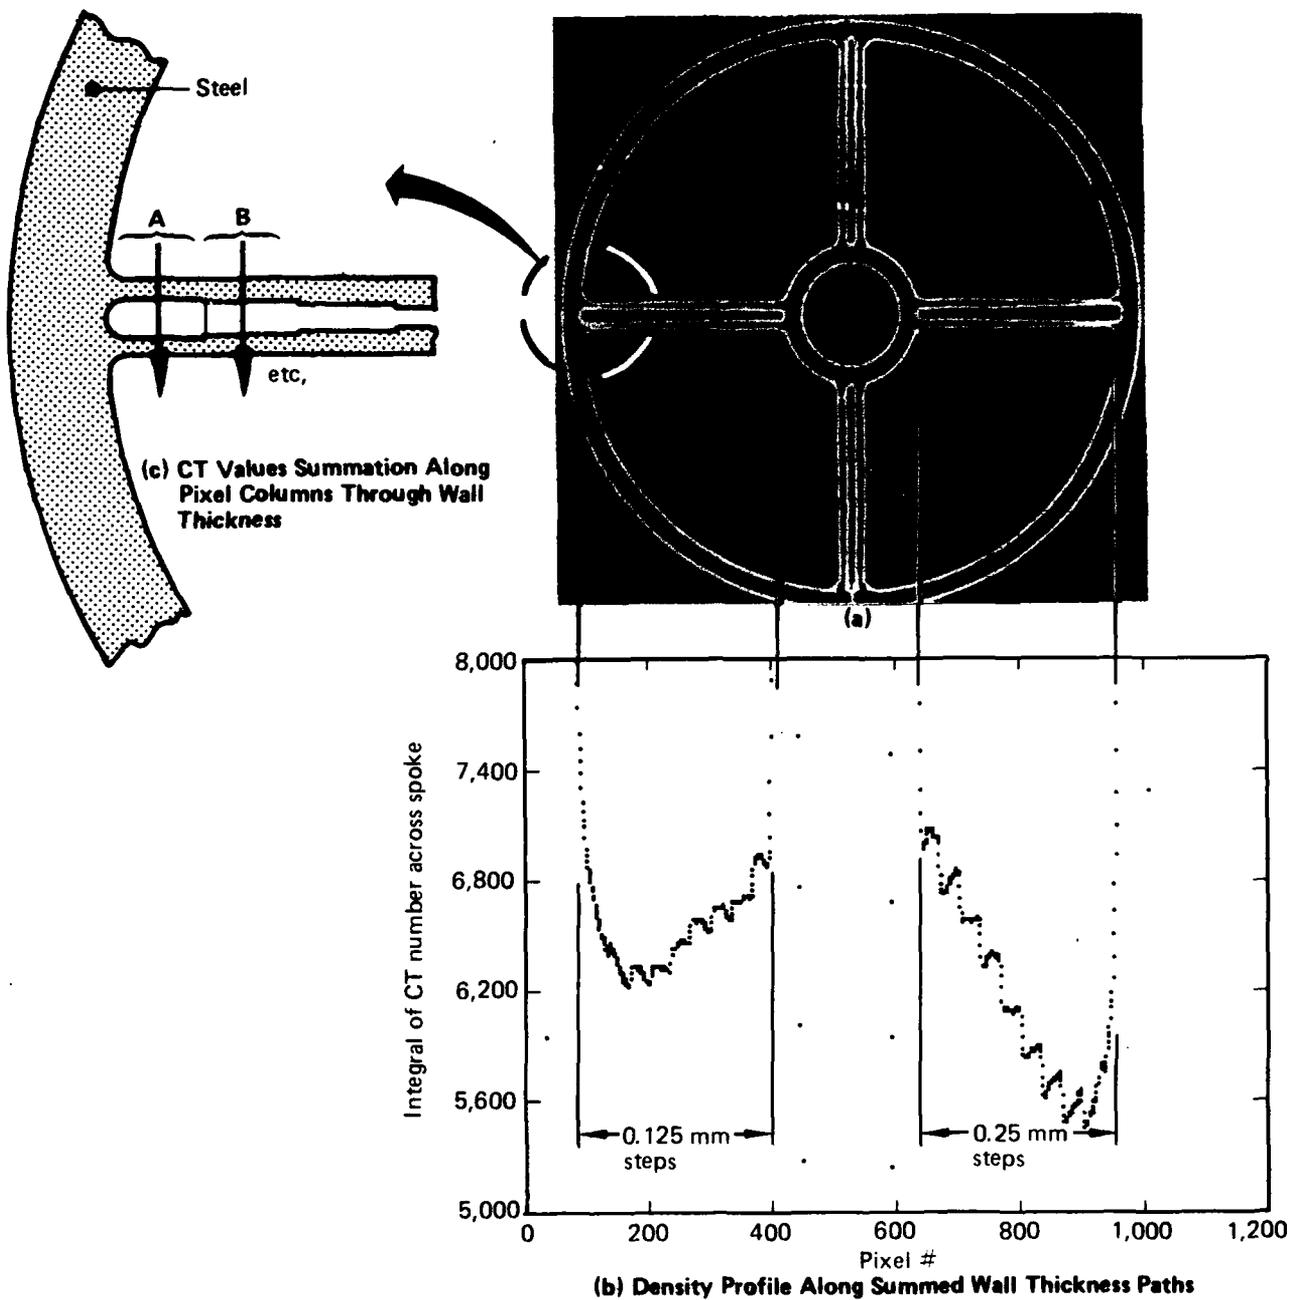
Figure 3.3-5 Steel dimensional phantom results

The large (380 mm (15 inch) diameter) stainless steel dimension phantom was scanned on a CT system with a 2 MV source capable of penetrating the thickness of steel in this part. Figure 3.3-5(a) is an image from System I. According to the CT performance data listed in Figure 2.2-2, the capability of System I for resolution is at best a few percent at 1 lp/mm; however, the 0.25 mm (0.01 inch) steps can be observed visually on the CT image. The plot in Figure 3.3-5(b), showing the steps, was obtained by summing CT numbers for data traces across the spokes for each image pixel column along the spokes. Figure 3.3-5(c) shows how the data was taken across the spoke. The summation of CT numbers across location B would be larger than across location A because more steel is present. In the plot of Figure 3.3-5(b), the summation is performed at each pixel column in the image. This is a very interesting approach to analyzing data for dimensional accuracy, and it clearly indicates the steps. By calibrating on a standard, this approach could be used to establish acceptance criteria for cast parts dimensional measurements. The accuracy appears to be in the range of 0.125 mm (0.005 inch).

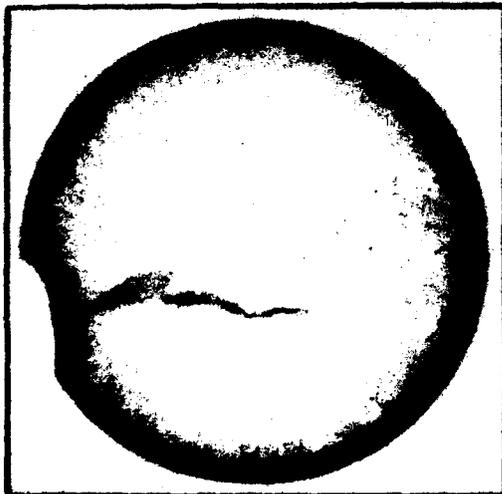
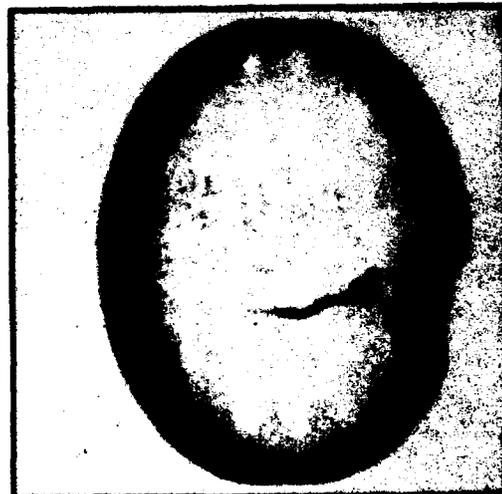
Figure 3.4-3 Two selected 3D views of PID #120 (crack)

Figure 3.4-1 is a 3D image of PID #119. The data was obtained from 200 slices taken at 410 kV with 0.125 mm (0.005 inch) slice thickness on System J. Figure 3.4-2 is a 3D image of the casting holes, PID #118A. The data was taken at 350 kV with 1.5 mm (0.06 inch) slice thickness and 1 mm (0.04 inch) slice indexing on System L. Figure 3.4-3 is a 3D image of the crack, PID #120. The data was obtained from 60 slices taken at 410 kV with 0.125 mm (0.005 inch) slice thickness on System J. Figure 3.4-4 shows a steel pipe coupler, PID #502, that was scanned on System I with 22 slices and 3 mm (0.12 inch) slice spacing. The aspect ratio of this part is slightly distorted in the display.

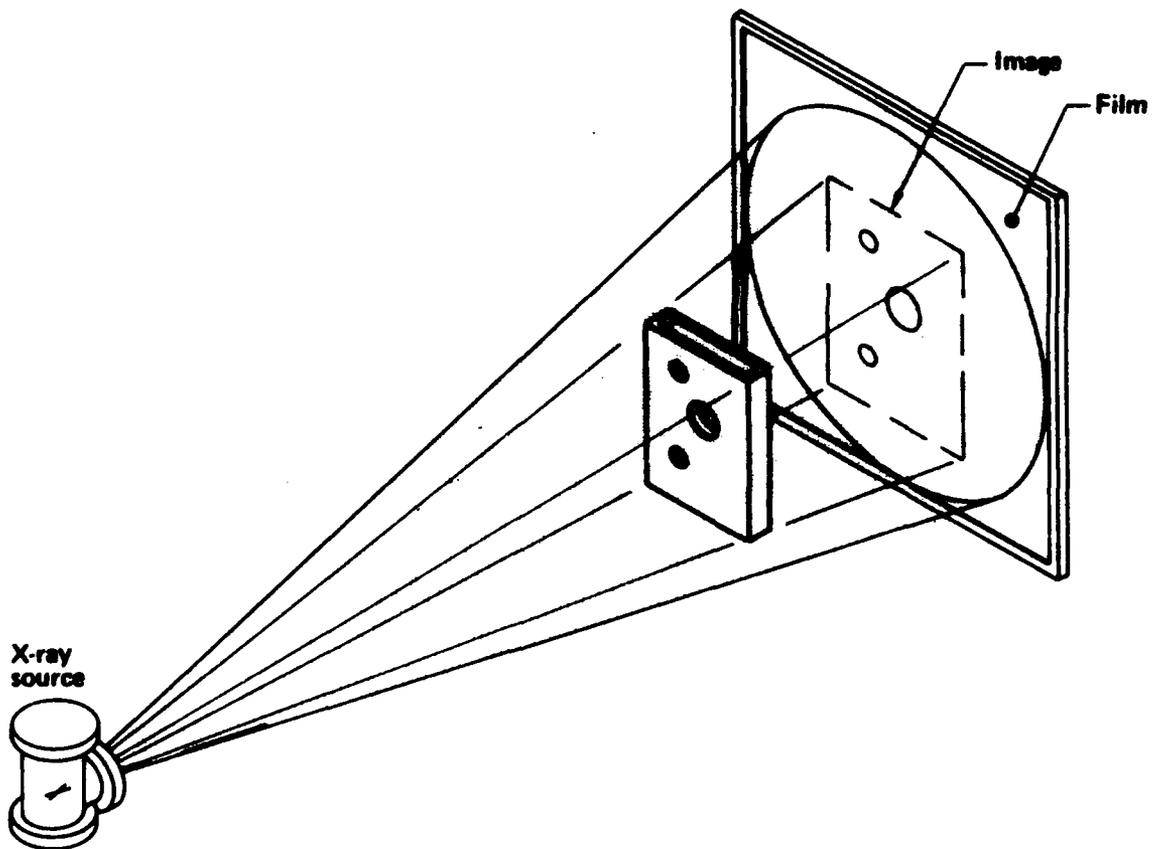
Figure A1-1 Film radiography

Conventional film radiography, as illustrated in Figure A1-1, uses a two-dimensional radiographic film to record the attenuation of the X-ray radiation passing through a three-dimensional object. This results in a shadowgraph containing the superposition of all of the object features in the image and often requires a skilled radiographer to interpret.

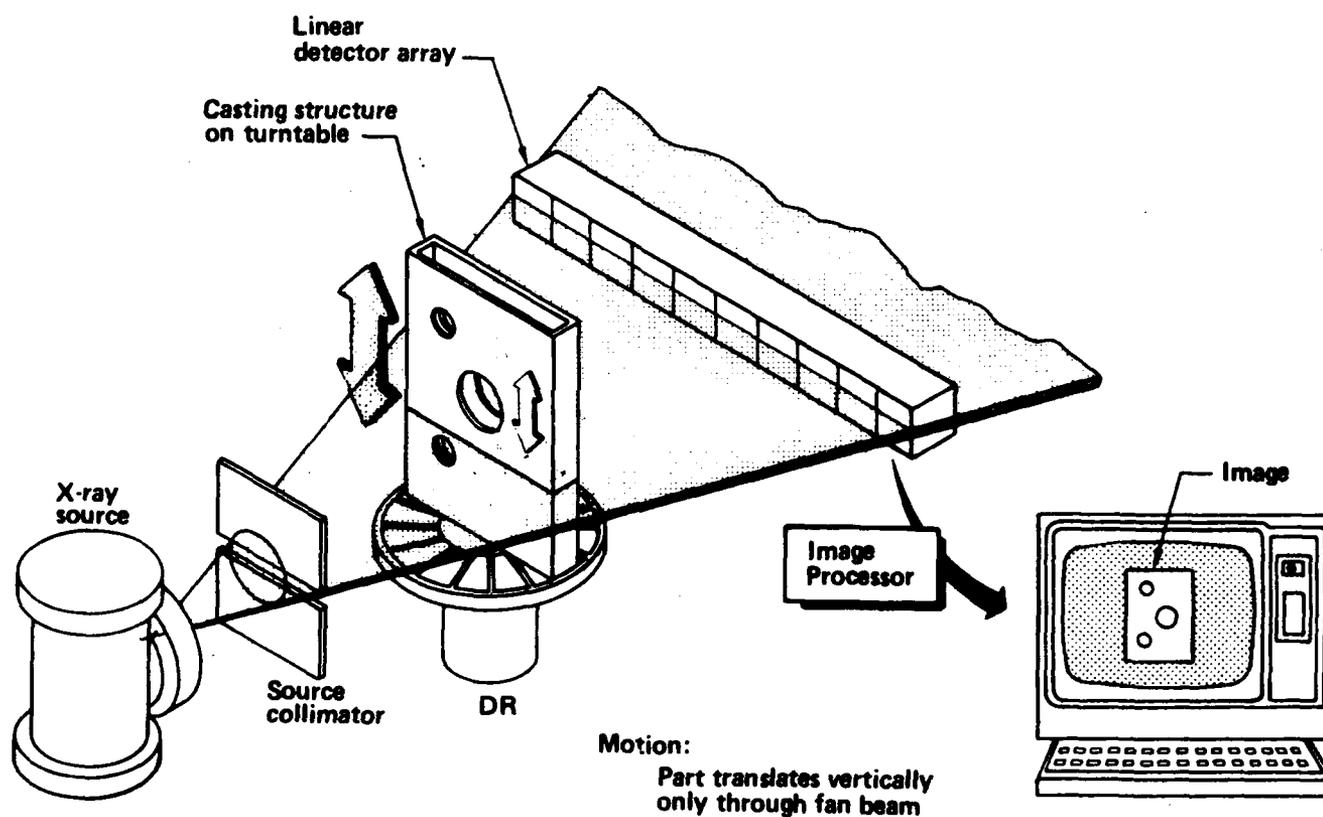
Figure A2-1 Digital radiography

Digital radiography (DR) is similar to conventional film radiography. The DR is performed on a system where the film is replaced by a linear array of detectors and the X-ray beam is collimated into a fan beam as shown in Figure A2-1. The object is moved perpendicular to the detector array and the attenuated radiation is digitally sampled by the detectors. The data is 'stacked' up in a computer memory and displayed as an image.

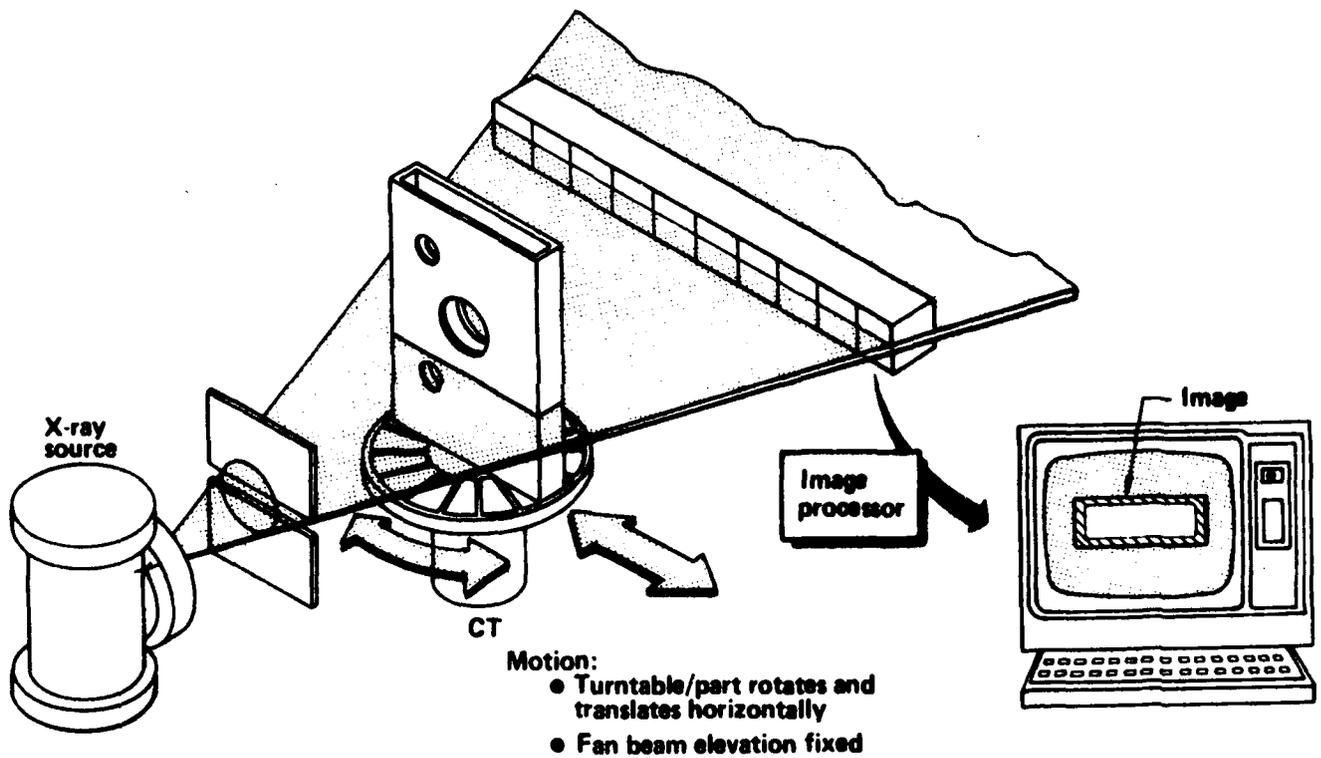
Figure A3-1 Computed tomography

Computed tomography (CT) produces cross-sectional images of thin planes of an object. To generate a CT image, X-ray transmission is measured by an array of detectors as shown in Figure A3-1. Data is taken by translating and rotating the object so that many viewing angles about the object are used. A computer mathematically reconstructs the cross-sectional image from the multiple-view data collected. A primary benefit of CT is that features are not superimposed in the image thus making it easier to interpret.

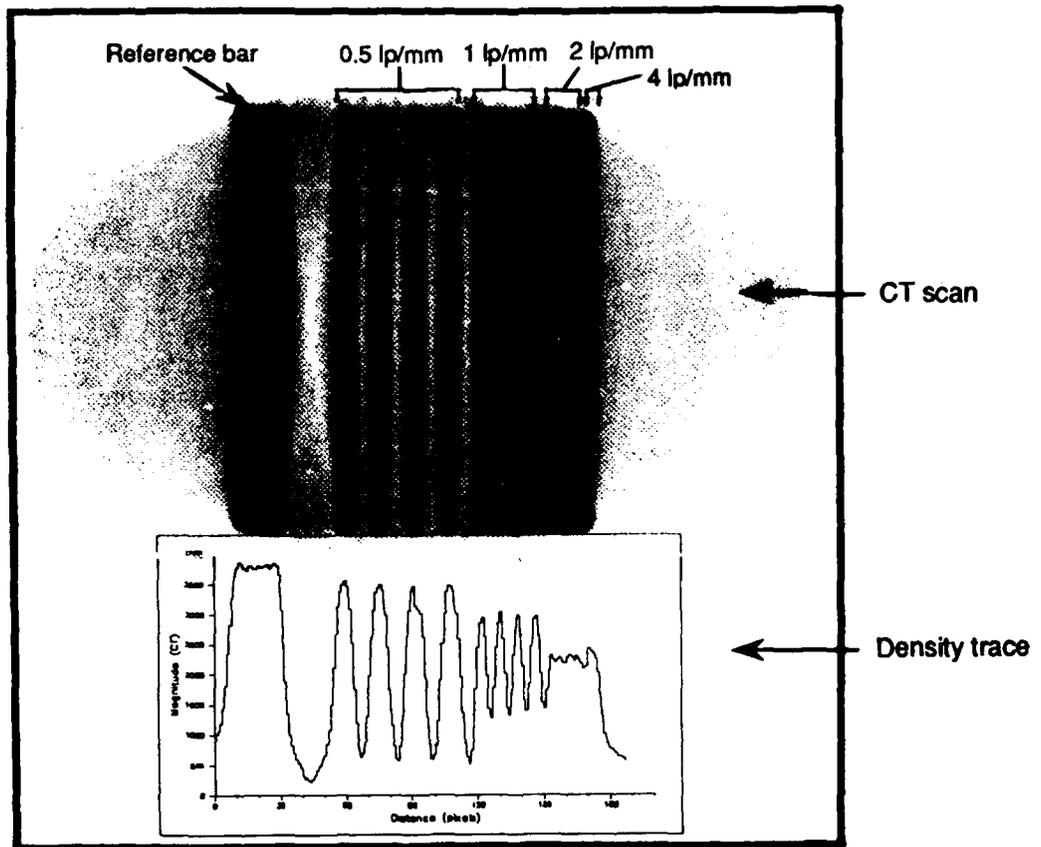
Figure C1-2 CT slice taken on the resolution phantom

Figure C1-2 shows a CT image of the steel resolution phantom obtained from a high-resolution CT machine. The CT image density contour line across the gauge indicates modulation for the respective line pair measurements at approximately 82 percent at 1/2 lp/mm, 46 percent at 1 lp/mm, 4 percent at 2 lp/mm, and 0 percent at 4 lp/mm.

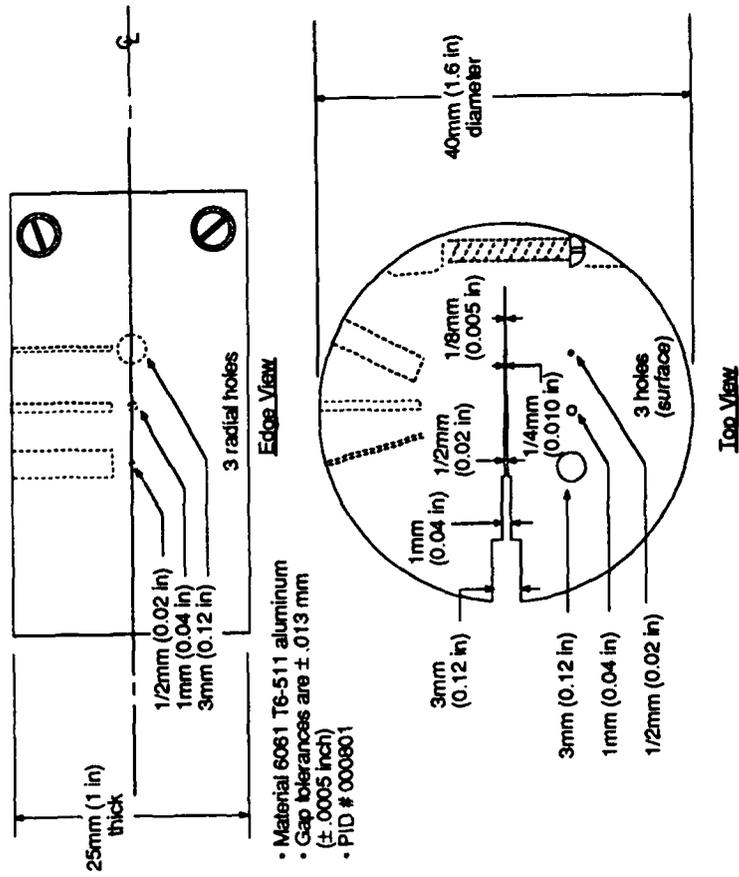
Figure C4-1 Aluminum dimensional phantom

Figure C4-1 is a drawing of a small (40 mm (1.6 inch) diameter x 25 mm (1 inch) thick) aluminum dimension phantom. The phantom contains machined surfaces, bolted together to form gaps of 3, 1, 0.5, 0.25, 0.15 mm (0.12, 0.04, 0.02, 0.01, 0.006 inch) and both axial and side drilled holes of 3, 1 and 0.5 mm (0.12, 0.04, 0.02 inch) diameter. Figure C4-2 is a photograph of the phantom (PID #000801).

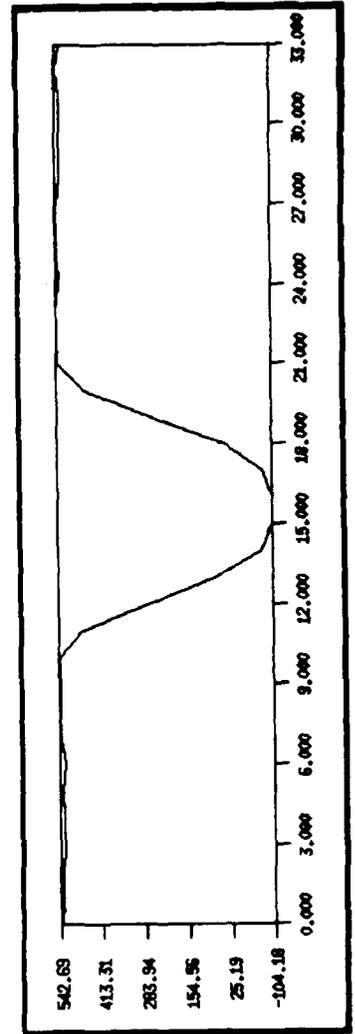
Figure C4-3 Line measurement of aluminum phantom

Dimensional measurement accuracy of a CT system will be a function of the resolution and contrast. Figure C4-3 shows a line trace taken across the 1 mm (0.04 inch) gap of the phantom from a CT system with approximately 10 percent modulation at 1 lp/mm and a signal-to-noise ratio of 70.

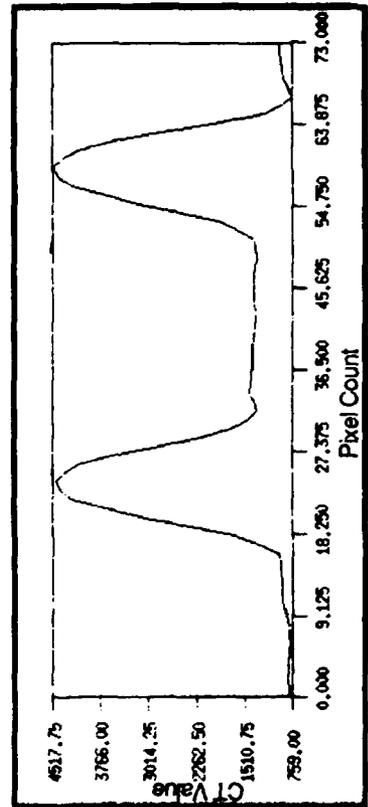
Figure C5-1 Steel dimensional phantom

Figure C5-1 is a drawing of a dimensional phantom that represents wall thinning in high alloy turbine engine parts. The material is steel. The 380 mm (15 inch) diameter phantom has spokes, two of which have thickness steps. One steps in units of 0.25 mm (0.01 inch) and the other in units of 0.125 mm (0.005 inch). Figure C5-2 is a photograph of the phantom (PID #000701). Figure C5-3 shows a line trace from a CT scan of the phantom to measure wall thickness.

- Material is 304 stainless steel (CFES)
- Gap tolerances are  $\pm .0005$  ( $\pm .013$  mm)
- PID # 000701
