TECHNICAL REPORT 9201

ENVIRONMENTAL TESTING OF THE XISCAN 1000, PORTABLE  
FLUOROSCOPIC AND RADIOGRAPHIC IMAGING SYSTEM

14 February 1992

U S ARMY BIOMEDICAL RESEARCH & DEVELOPMENT LABORATORY

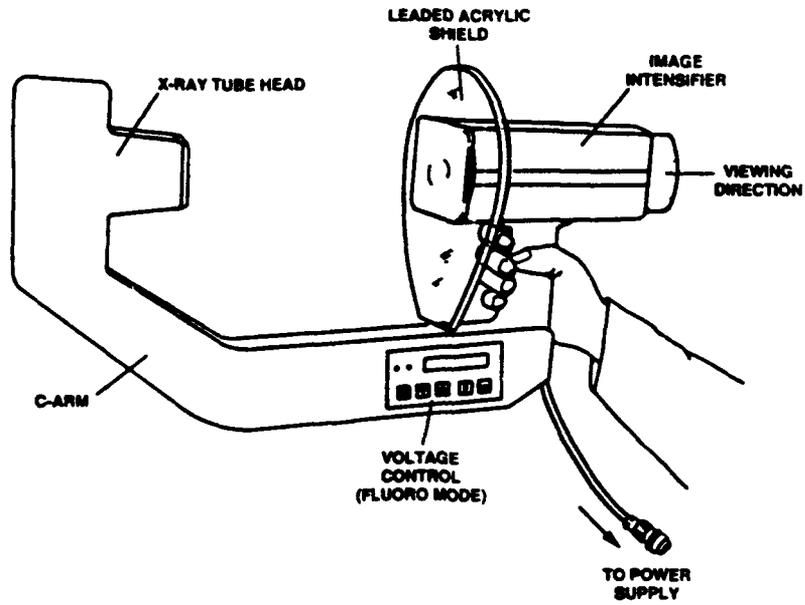
FIGURE 1: XI SCAN 1000 SYSTEM CONFIGURED FOR FLUOROSCOPY

The Xi Scan 1000, Portable Fluoroscopic and Radiographic Imaging System, (Xi Tech, Inc., Windsor Locks, CT), is a hand-held unit designed primarily for podiatric, pediatric, sports medicine, and veterinary practitioners. The complete system consists of a C-arm assembly, X-ray cassette tray, image intensifier with beam limiting device, video monitor, thermal printer, digital image storage device, mobile stand, and rechargeable battery power supply. It can be purchased in several configuration packages that include various subsets of the complete system. This study utilized the "System 3" package which includes the C-arm, cassette tray, image intensifier, and rechargeable battery power supply which weigh 30 pounds in the commercial carrying case. The system's modular design allows configuration as a 2.6 inch field of view fluoroscope (see Figure 1) or a standard X-ray machine (see Figure 2) with 8 by 10 inch film capacity. In either mode, the system is capable of imaging the extremities only. The system can operate continuously from line power (110 VAC) or from a NiCad battery pack which supports two hours of continuous fluoroscopy or up to 100 radiographic exposures.

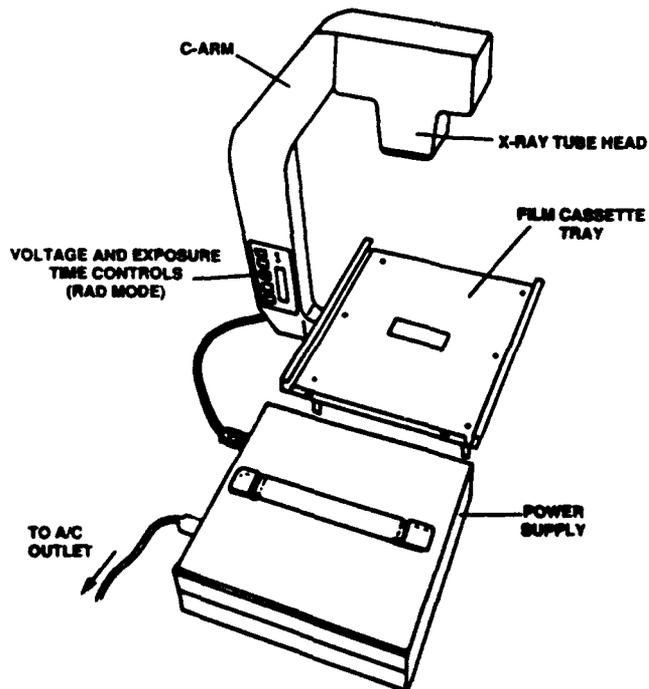
FIGURE 2: XI SCAN 1000 SYSTEM CONFIGURED FOR RADIOGRAPHY

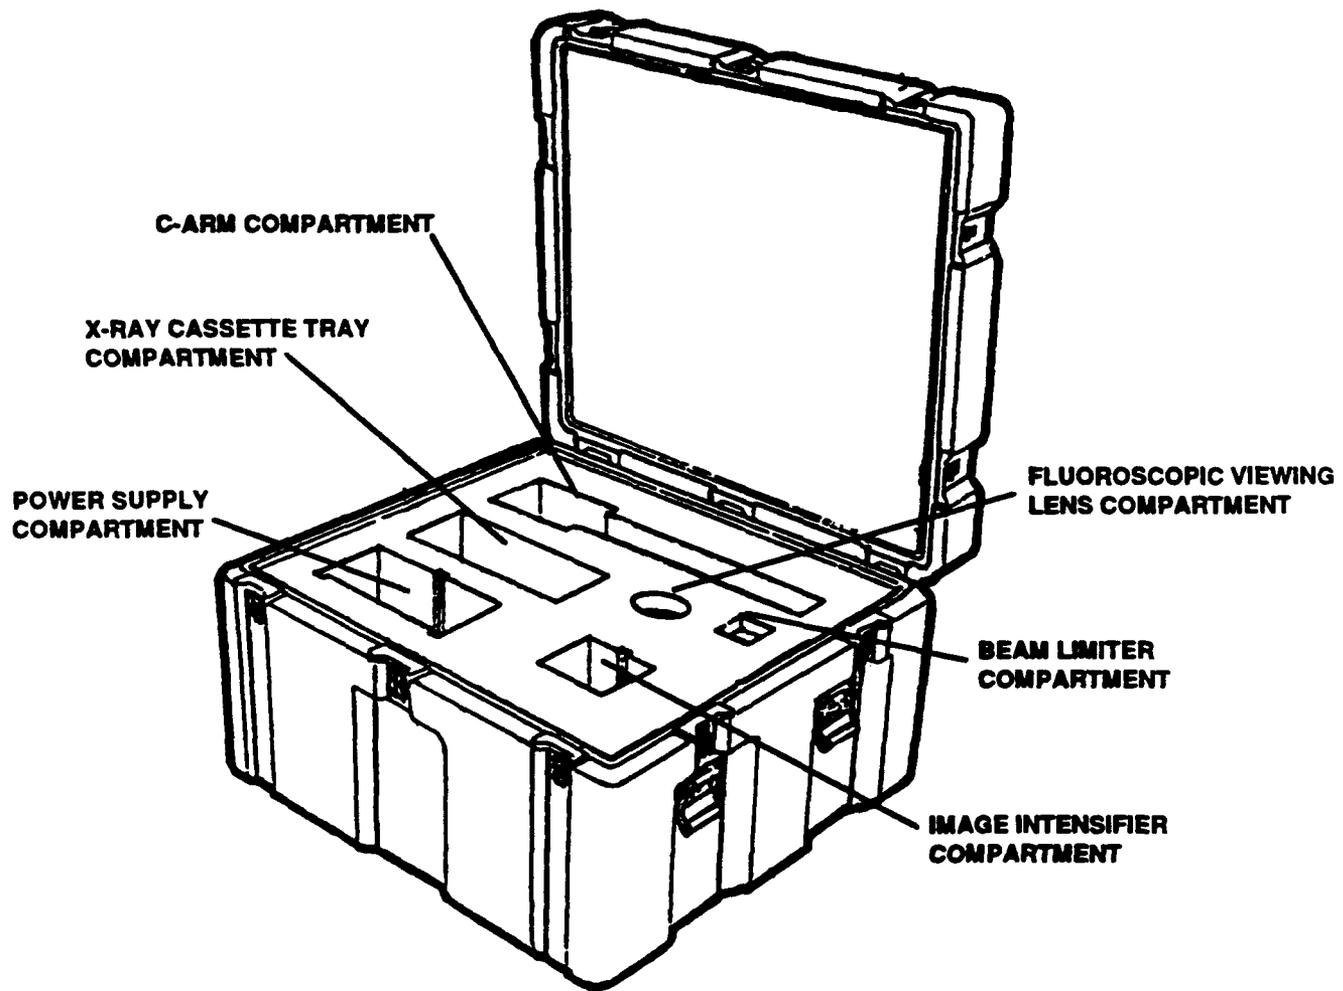
**FIGURE 3: ROTOMOLDED POLYETHYLENE SHIPPING CONTAINER  
(HARDIGG INDUSTRIES, INC., SOUTH DEERFIELD, MA.) FOR THE XI SCAN  
1000 X-RAY SYSTEM**

To optimize protection against environmental insult, a shipping container meeting the Deployable Medical Systems (DEPMEDS) packaging standard (MIL-D-42048) was procured for the basic Xi Scan 1000 (see Figure 3). The rotationally molded polyethylene container (Hardigg Industries, Inc., South Deerfield, MA) was 27 inches long by 26 inches wide by 14.8 inches high, weighed 30 pounds, and contained custom fabricated polyurethane foam cushioning.
