Branchbox Breakwater Design at Pickleweed Trail, Martinez, CA, Section 227 Demonstration Project

by Stephen T. Maynard, Michael F. Winkler, and David E. Demko

PURPOSE: The objective of this Coastal and Hydraulics Engineering Technical Note (CHETN) is to provide a preliminary design of the branchbox breakwater for the Martinez project site in the National Shoreline Erosion Control Development and Demonstration Program (Section 227) using existing design guidance and lessons learned from previous branchbox breakwater projects. The branchbox breakwater system proposed herein derives stability from both the breakwater and wetland plants between the breakwater and the shoreline. Selection of the type of wetland plants to use behind breakwaters is a critical part of bioengineering bank protection. While this technical note provides some information on plants used at specific projects, the focus of this report is on the design of the breakwater part of the system.

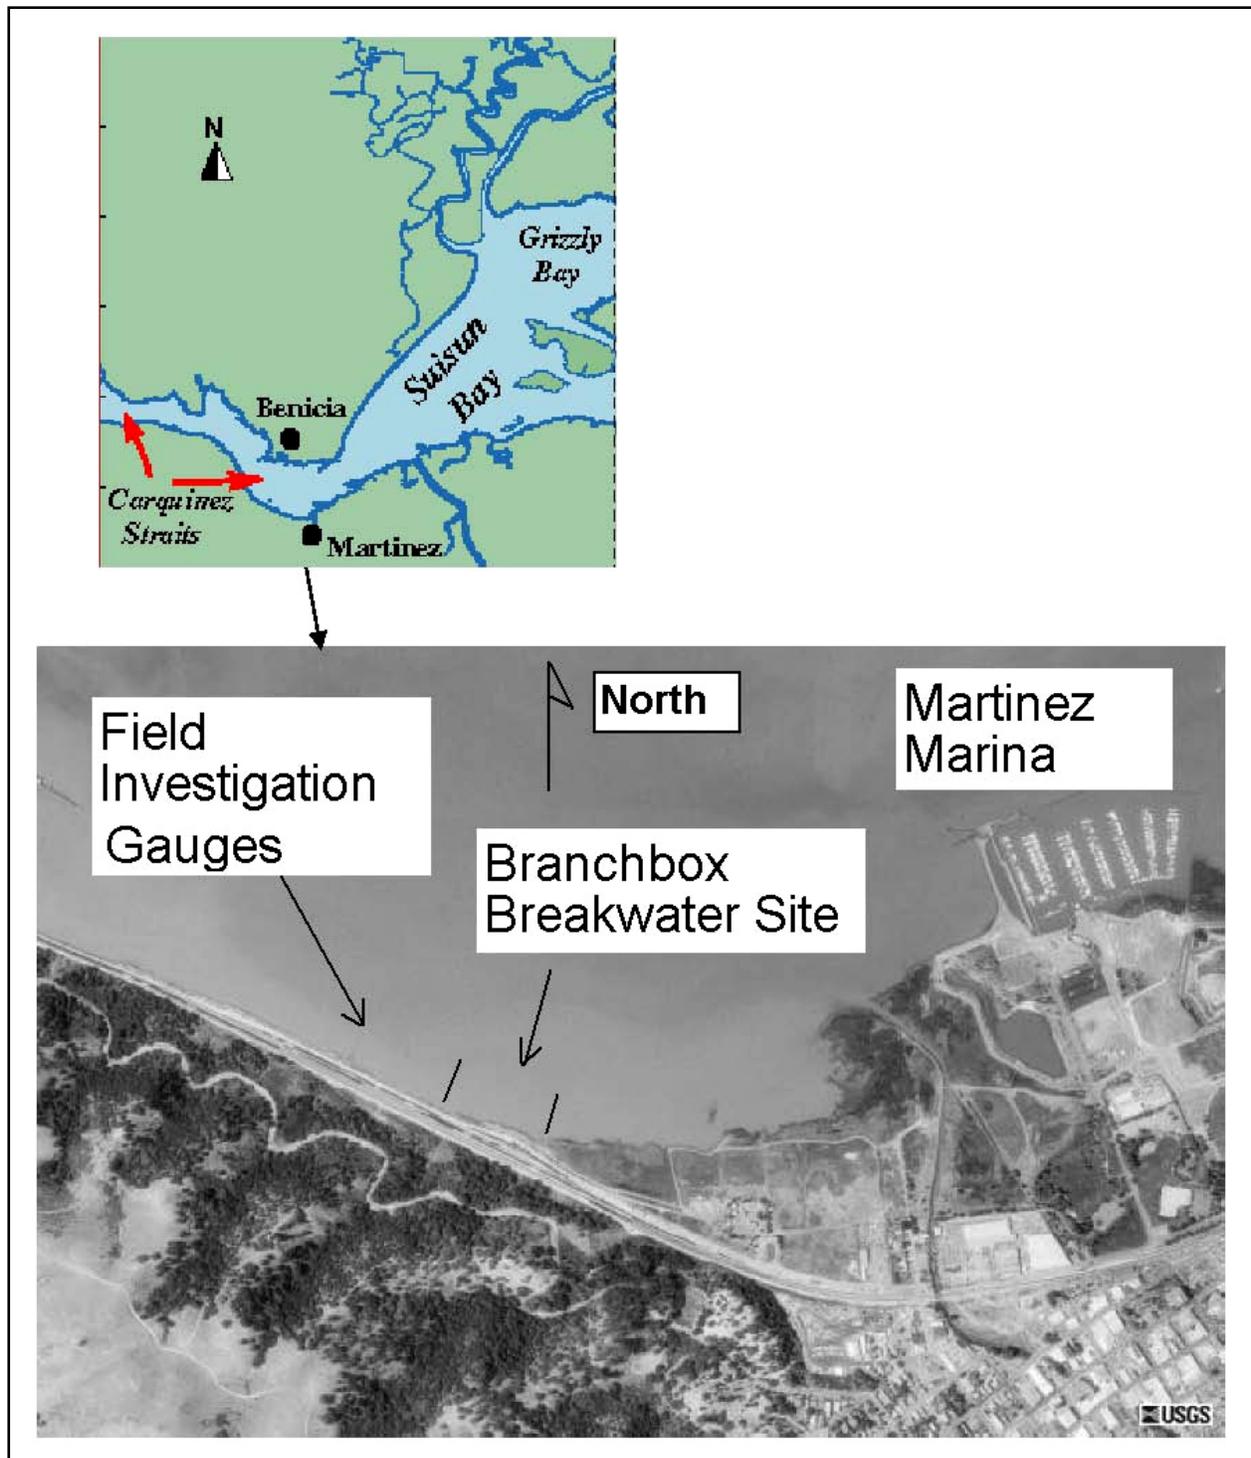
Figure 1. Section 227 project site at Martinez, CA

BACKGROUND: The city of Martinez is located in northern California's Contra Costa County, between San Pablo Bay and Suisun Bay. Pickleweed Trail is located within the Martinez Regional Shoreline Park in Martinez (Figure 1). The project area extends approximately 1,000 m along the southern shore of Carquinez Strait, adjacent to the Union Pacific Railroad right-of-way. Sandwiched between the strait and the main line of the railroad, this recreational hiking trail is maintained by the East Bay Regional Park District. The site, which is within the U.S. Army Engineer District, San Francisco, includes a coastal wetland habitat for a variety of species.

PROPOSED DESIGNS FOR MARTINEZ: Figure 1 shows the location of the proposed branchbox breakwater at Martinez. This location corresponds to the 183-m-long reach shown in Figure 3 where the shoreline is not protected with riprap and Pickleweed Trail is close to the eroding shoreline. Based on Tables 1 and 4, a branchbox or slab bundle breakwater at Martinez will need to be placed at an elevation of at least mean high water (mhw) or too much energy will pass over the breakwater at high tides. At Martinez, the elevation 0.0 m mllw bottom contour is the breakpoint between the extremely flat bottom slope channelward of this elevation and the 1V:5H to 1V:10H foreshore slope adjacent to the eroding bank. Elevation 0.0 m mllw is generally 6-12 m from the eroding shoreline. The key to stopping long-term shoreline erosion is preventing scour of the foreshore slope. While protection only of the vertical scarp at Martinez will have short-term success at halting shoreline recession, such a protection may be undermined and fail when the foreshore slope is scoured. The proposed breakwater should be placed at the elevation 0.0-m mllw bottom contour to prevent scour of the foreshore slope. To ensure a minimum level of marsh reclamation, the proposed breakwater should be placed at either the 0.0-m mllw bottom contour or 9 m from the vertical bank, whichever is greater. A single structure at the 0.0-m mllw contour and extending up to mhw would have to be 1.343 m high. That height is greater than a typical slab bundle breakwater. It is not recommended that larger than typical slab bundles be built because of the large forces involved in wave environments and the difficulty of handling large slab bundles. A solution more likely to withstand the wind wave climate at Martinez is to build one typical 0.9-m-high slab bundle breakwater at the 0.0-m mllw contour (or the 9-m distance) and a second 0.9-m-high breakwater up the foreshore slope at about the 0.6-m mllw contour. The top of the second row would be between mhw and mhhw. This would reduce wave forces on each breakwater, be high enough to significantly reduce wave energy at high tides, and also provide two different types of aquatic environment behind the breakwaters. For branchbox breakwaters, the same two-row technique would be constructed. In addition, a single row branchbox breakwater is proposed with top elevation equal to somewhere between 0.9 m and 1.4 m mllw to determine the effects of top elevation. The flume tests will help determine the height of the single row scheme. The two rows of posts in the branchbox breakwater are tentatively proposed to be 0.6 m apart. The ERDC flume should help define the required spacing between rows. Post spacing along each row should be about 0.9 m based on previous applications. Figure 13 shows a proposed cross section of the branchbox or slab roll concept at the Martinez site. Contours at 0.0 and 0.6 m mllw and the location of the near-vertical bank are shown in Figure 14. Note that the 0.6-m mllw contour is located at the near-vertical bank over some of the reach. In these cases, the slab bundle or branchbox will be placed close to the bank with only enough room for construction. The breakwater will be constructed in a shingled fashion to provide openings along the length of the structure as well as tiebacks perpendicular to the bank every 15-18 m to reduce velocity behind the structure. Figure 15 shows a layout of the proposed protection schemes. A portion of the reach east of the three protection schemes will be left unprotected to provide a comparison to the protected reach.

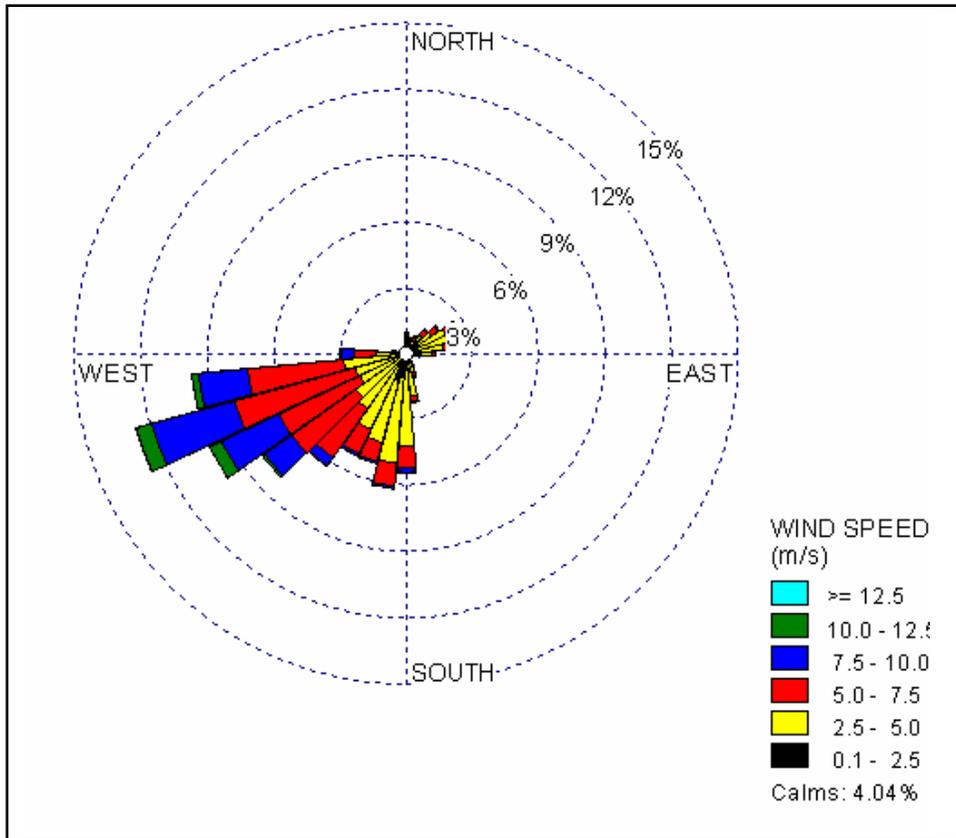
Figure 2. Wind rose for Port Chicago based on hourly winds from 1994-2001

The NOAA site for Port Chicago has hourly winds available from 1994-2001 and provided 63,671 records that were used to develop the wind rose shown in Figure 2. Each leg of the wind rose represents a 10-deg window. Average hourly wind speed at Port Chicago is 4.76 m/sec. The Air Force Combat Climatology Center in North Carolina has hourly wind data for Buchanan Field Airport from 1973-2005. Data from 1984-2003 were used and provided 124,838 records used in the analysis. Average hourly wind speed at Buchanan Field was 3.9 m/sec. Table 2 provides the fetch distance and percentage of winds versus wind direction for Port Chicago and Buchanan Field based on the hourly wind observations. The more extensive data at Buchanan Field show a greater portion of winds from the North and Northwest directions that are important to wave generation at Martinez. Percentage of winds from the longest fetch to the Northeast is slightly less at Buchanan Field.

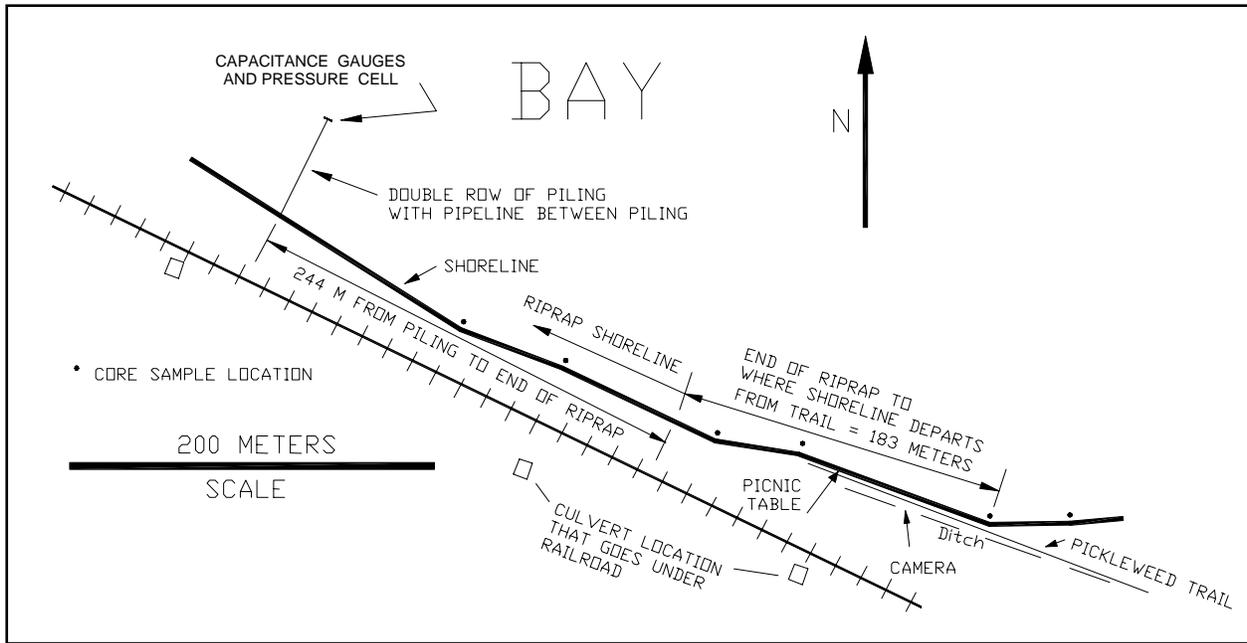
Figure 3. Layout of instrumentation and sediment borings during field study

During the field investigation, waves from ships and wind were measured with four capacitance rods (CR) and one pressure cell. The CRs were 3 m in length and were mounted to existing piling located at the site and were 58 m from the shoreline. The measurement location is at the west end of the proposed demonstration project. The pressure gauge was mounted in a tripod with the sensor about 40 cm above the bed. The pressure gauge and the capacitance rods sampled at 5 Hz, read data for 57 min/hr and stored data for 3 min/hr. A video camera was mounted at the site to monitor ship traffic and determine ship speed. A layout of the field instruments is shown in Figure 3.

Sediment Borings. During the field study, six sediment borings were taken about 10 m channelward of the Pickleweed Trail shoreline at the locations shown in Figure 3. These borings were taken with 0.91-m-long acrylic tubes, 3.8 cm inside diameter, 0.48-cm wall thickness, and having a square edge where pushed into the sediment. The tubes were pushed in by hand and length of sample ranged from 48 to 64 cm. Medium to coarse sands and gravel were found in the top 5 cm of four of the samples. Wet bulk-density tests were conducted on each sample using the lower 5 cm and the middle 5 cm of the sample. Wet bulk density ranged from 1.46 to 1.60 g/cu cm. No consistent variation of wet bulk density with depth or along the site was found.

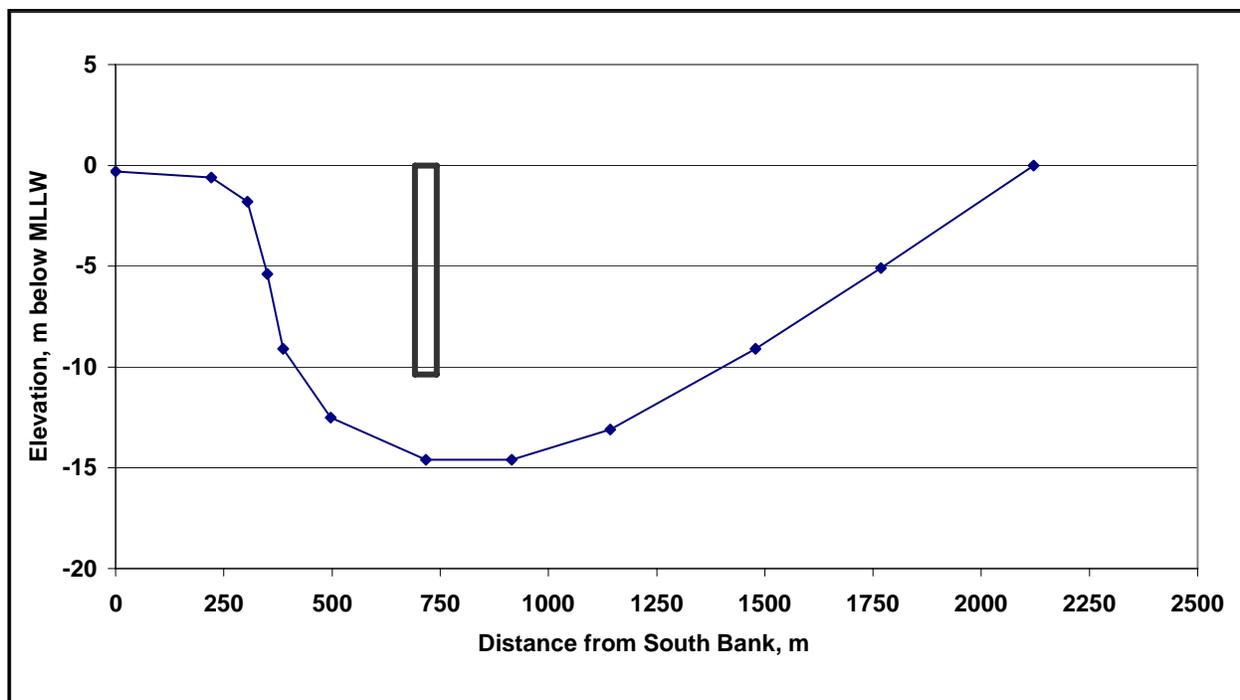
Figure 4. Channel cross section at Pickleweed Trail with 51-m beam by 10.4-m draft ship

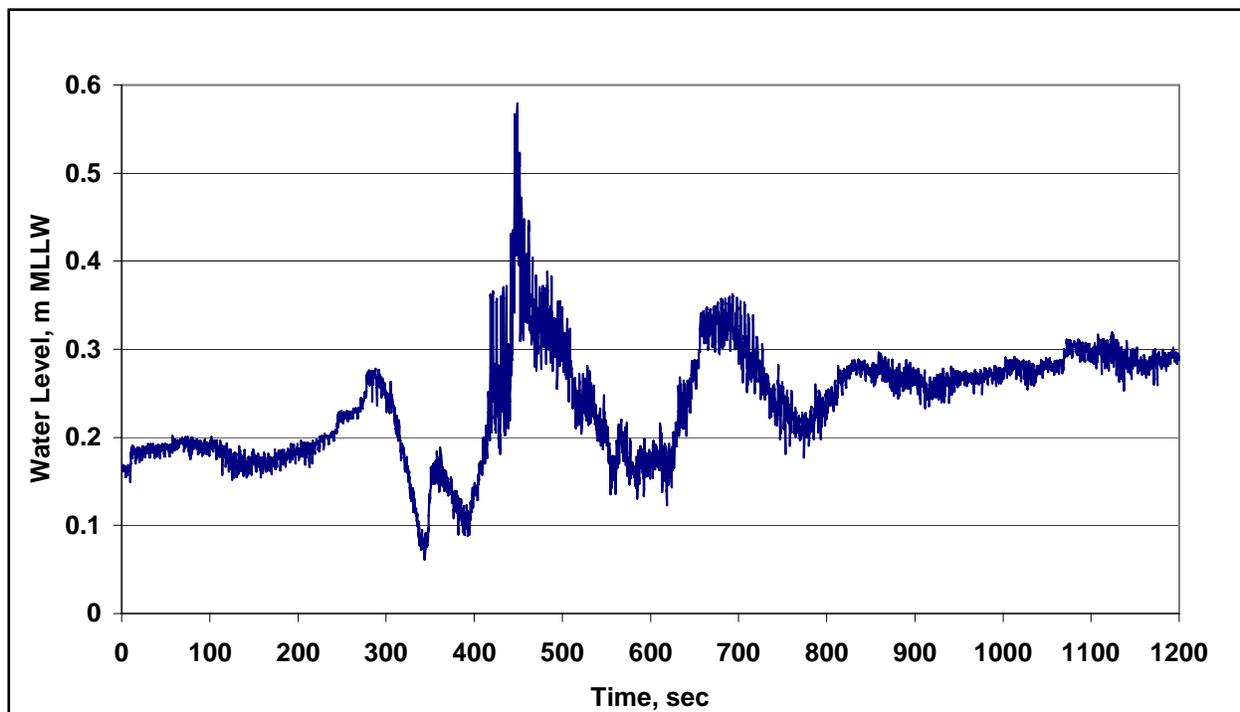
Figure 5. Time-history of water level from capacitance gauge during passage of deep-draft ship General Villa, time zero = 0748 on 26 August 2004

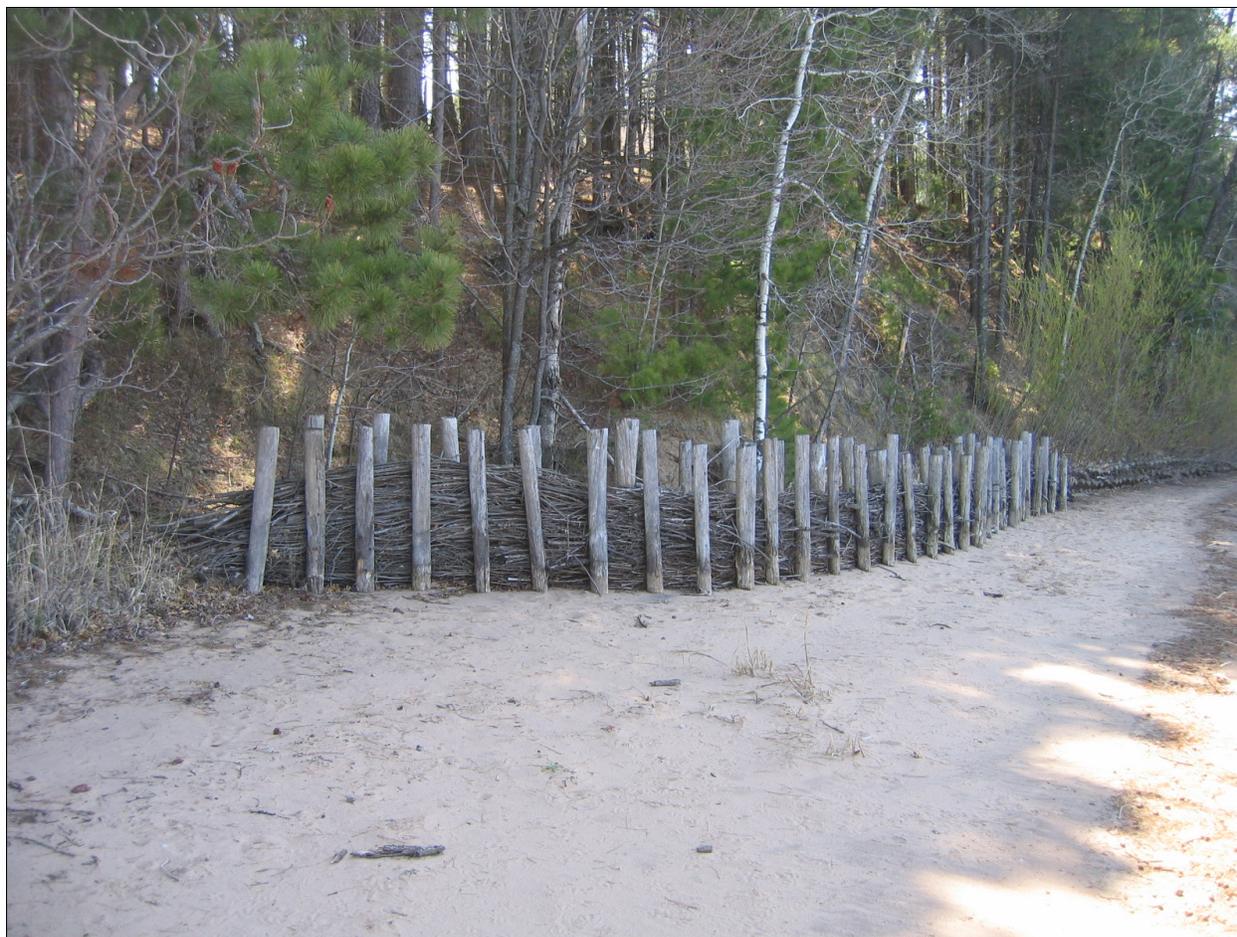
Figure 6. Branchbox breakwater at Rice Reservoir, front view

The overall performance of the branchbox breakwater is affected by several factors. The first factor is that the Wisconsin Department of Natural Resources (WDNR) restricted the placement of the structure in the permit to a distance of 4.5 m outward from the bank line. WDNR has since revised this and now allows a branchbox breakwater to be placed up to 9.0 m from an existing bank line. Though approximately 0.03 m of sediment has been deposited since 1999, Rice Reservoir contains very little suspended sediment, and it was expected that minimal accretion would occur landward of the breakwater. Vegetation was placed in front and behind the breakwater after construction. The vegetation in front of the breakwater was destroyed by wave action within the first year. Because the area behind the breakwater is shaded by shoreline vegetation, some of the vegetation landward of the breakwater was lost. Plant survival and possibly sediment accretion would have improved if the breakwater had been allowed to move further from the bank line. Smaller poles might be possible, but the effects of the ice heave were not known at the time of installation. Overall the branchbox breakwater has lasted over 10 years and has stabilized the bank line. Of all the shoreline stabilization methods tested by WVIC, the branchbox breakwater has proven to be the least expensive. Figures 6 and 7 show the branchbox breakwater in April 2005.

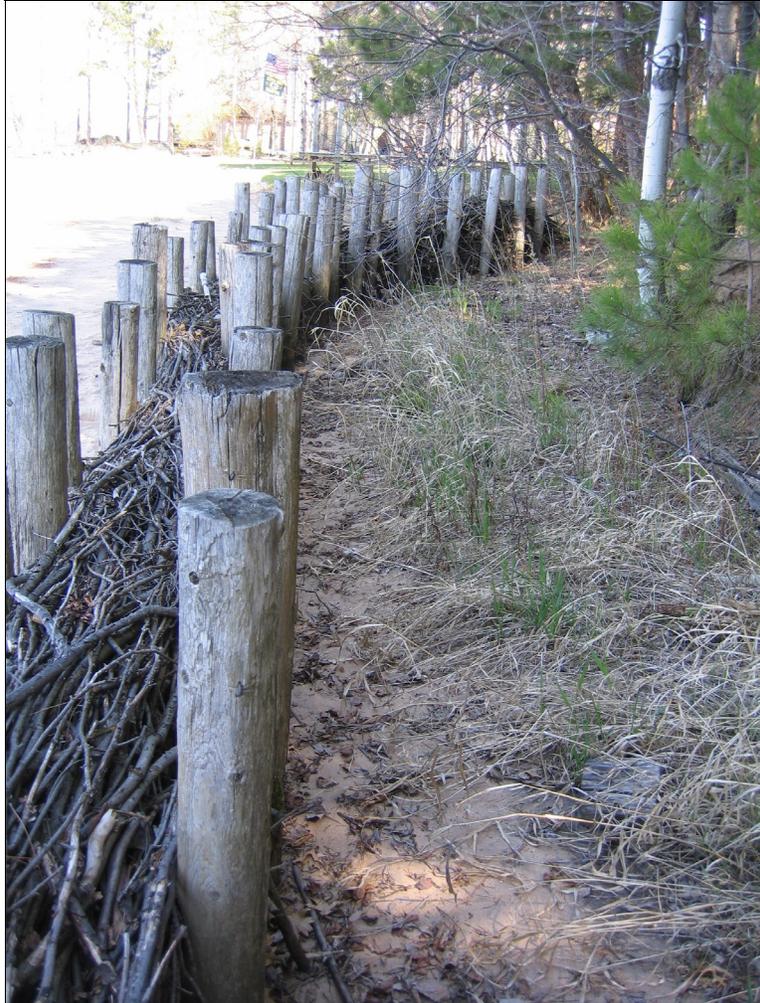
Figure 7. Branchbox breakwater at Rice Reservoir, behind breakwater

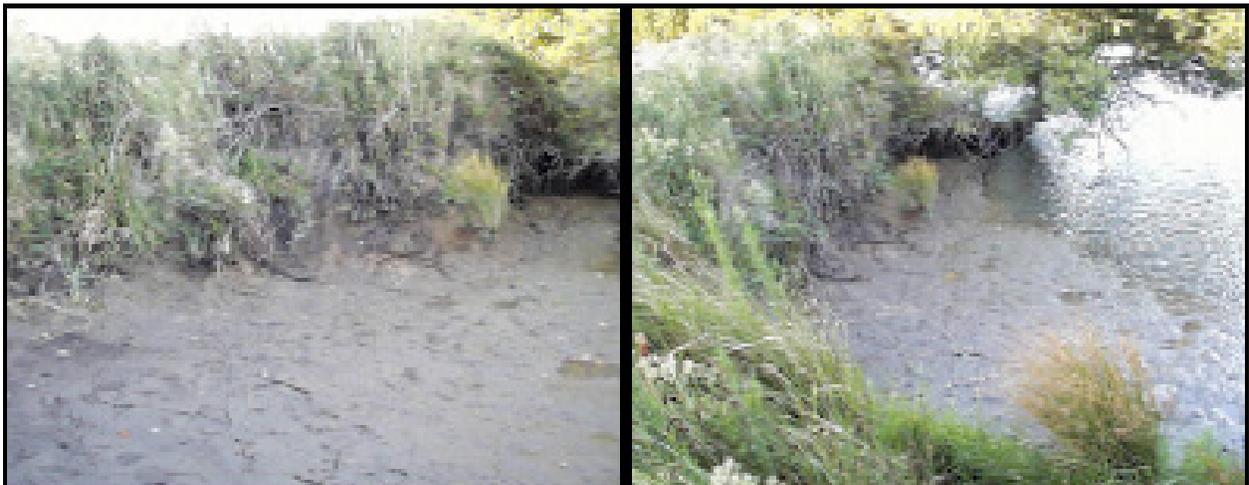
Figure 8. Scalloped bankline along Georgiana Slough

Georgiana Slough. The Sacramento-San Joaquin Delta is located in north central California, northeast of San Francisco Bay. Lying in the confluence of the Sacramento and San Joaquin rivers, it is the largest inland delta and the largest estuary on the west coast of North America (Hart and Hunter 2004). Georgiana Slough is located in the northern part of the Sacramento San Joaquin Delta. The slough is about 20 km long, varies from 50 to 100 m wide with an average bed slope of 0.01 percent (Hart and Hunter 2004). Currently, approximately 30 percent of the flow from the Sacramento River is being diverted into Georgina Slough. The shorelines of the slough are also subject to waves from local recreation boat traffic. Wind waves are minor because of limited fetch. The shoreline of the slough is experiencing erosion that can first be detected by the development of semicircular scallops along the shoreline. Figure 8 is a picture of one of the bank scallops.

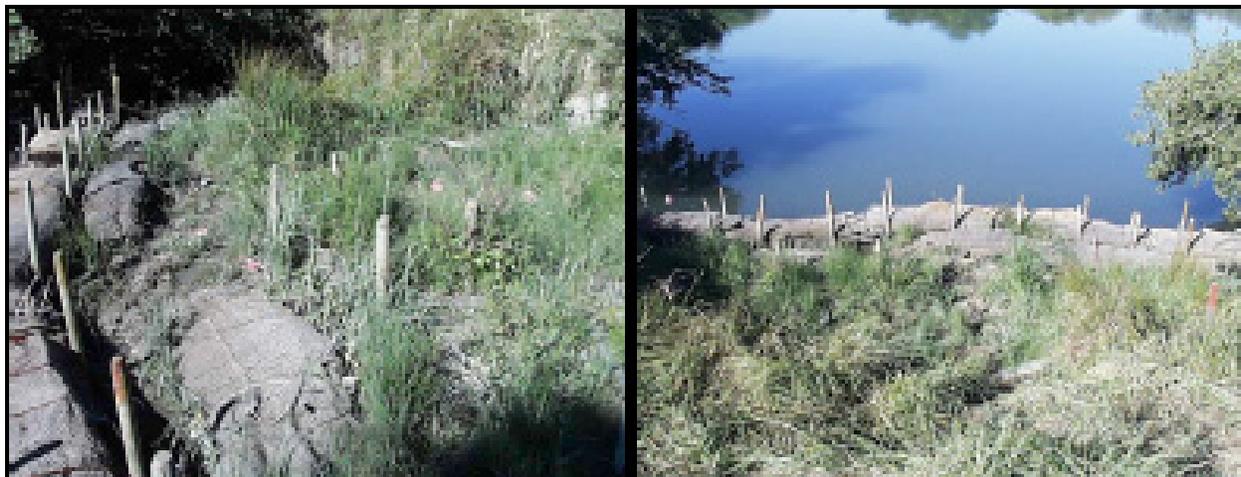
Figure 9. Branchbox breakwater at bank scallop on Georgiana Slough (1 year later from Figure 8)

At Georgiana Slough, additional materials were placed landward of the branchbox breakwater to further reduce wave and current effects at the shoreline. These additional materials included rooted material in blast buckets, brush bundles, and fiber rolls in a scallop repair. Hart Restoration also states that a branchbox breakwater is a system where the branchbox breakwater works in conjunction with the aquatic plants. (Personal Communication, 2005, Cathy Wendt, WVIC, Wausau, WI.) The breakwater is the first line of defense and the vegetation acts as a second line of defense to further reduce wave energy and promote sediment deposition. Figure 9 is the same site in Figure 8 site 1 year later after brush bundles and aquatic vegetation had been placed landward of the branchbox breakwater.

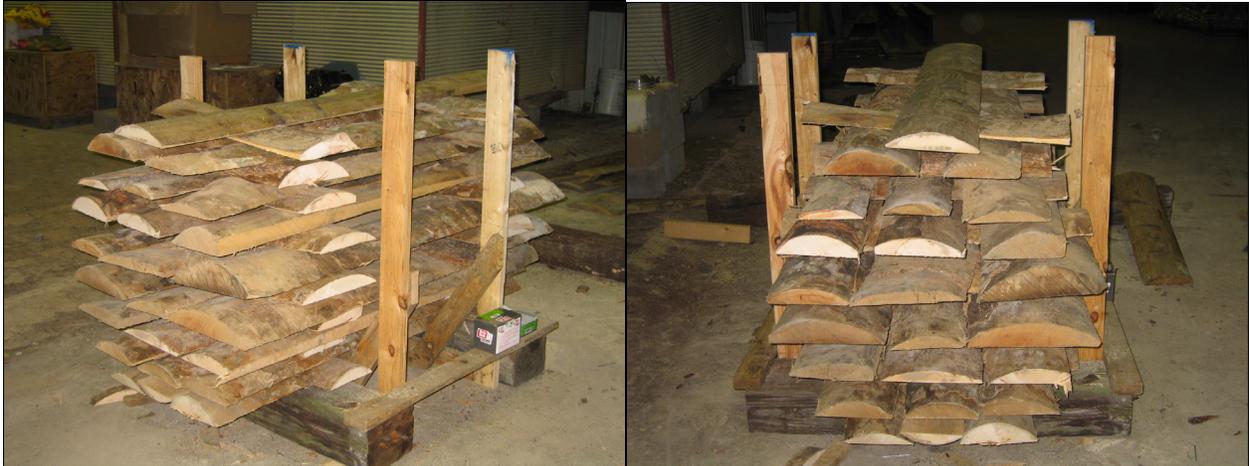
Figure 10. Slab bundle in jig used for building bundle

The slabs varying in width from 20 to 30 cm based on the diameter of the log from which they were cut, were loaded and trucked to a construction site from the lumber mill. They varied in thickness from 2 to 10 cm and were approximately 2.5 m long. A jig was constructed to form the bundles. The bundles were constructed by placing a layer of slabs parallel to the long axis of the bundle and then a layer of slabs perpendicular to the bundle axis. The perpendicular layer made the bundle porous as opposed to an almost solid bundle of wood. The slabs were nailed together with galvanized nails, and this process was repeated until the slab was approximately 0.9 m in height. The jig formed the slab into an elliptical shape with the bundle widest at a height of 0.45 m. Completed slab bundles are shown in Figure 10.

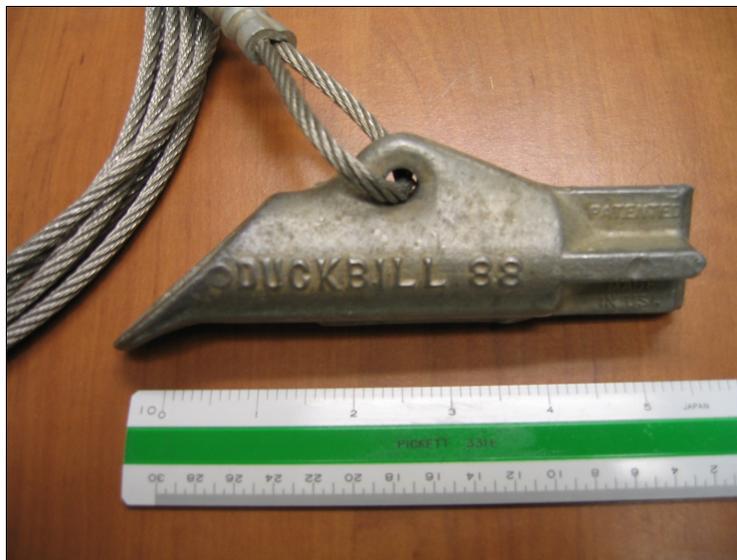
Figure 11. Duckbill anchor used to secure bundles

After the bundles were finished, but still in the jig, they were then bound together with stainless steel strapping. After strapping, they were transported and placed along a predetermined alignment to form a breakwater. The bundles were placed with the top of the bundle just below the normal pool elevation at St. Albans and Quincy. At this vertical position, the bundles were constantly in the water. The bundles were then anchored to the ground using Duckbill No. 88 anchors and 5-mm-diam stainless steel cable (Figure 11). The anchors were driven to about 1.8 m or refusal.

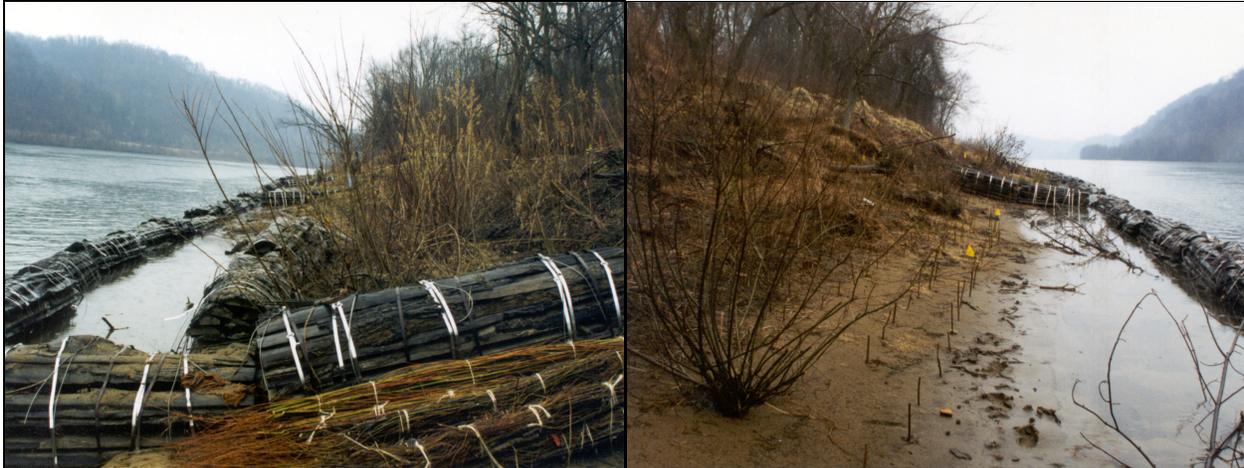
Figure 12. Slab bundles at Bat Grape Island. Notice second bundle placed landward of riverward bundle in left photograph and plantings in right photograph

The spaces in the bundle allowed for waves to pass through as wave energy was dissipated. As with the branchboxes, the slab bundles were a first line of defense. Local plants were selected and planted landward of the slab bundles to absorb the remaining wave energy and allow deposition of suspended sediments. Figure 12 shows slab bundles at Bat Grape Island with plantings shoreward of the bundles.

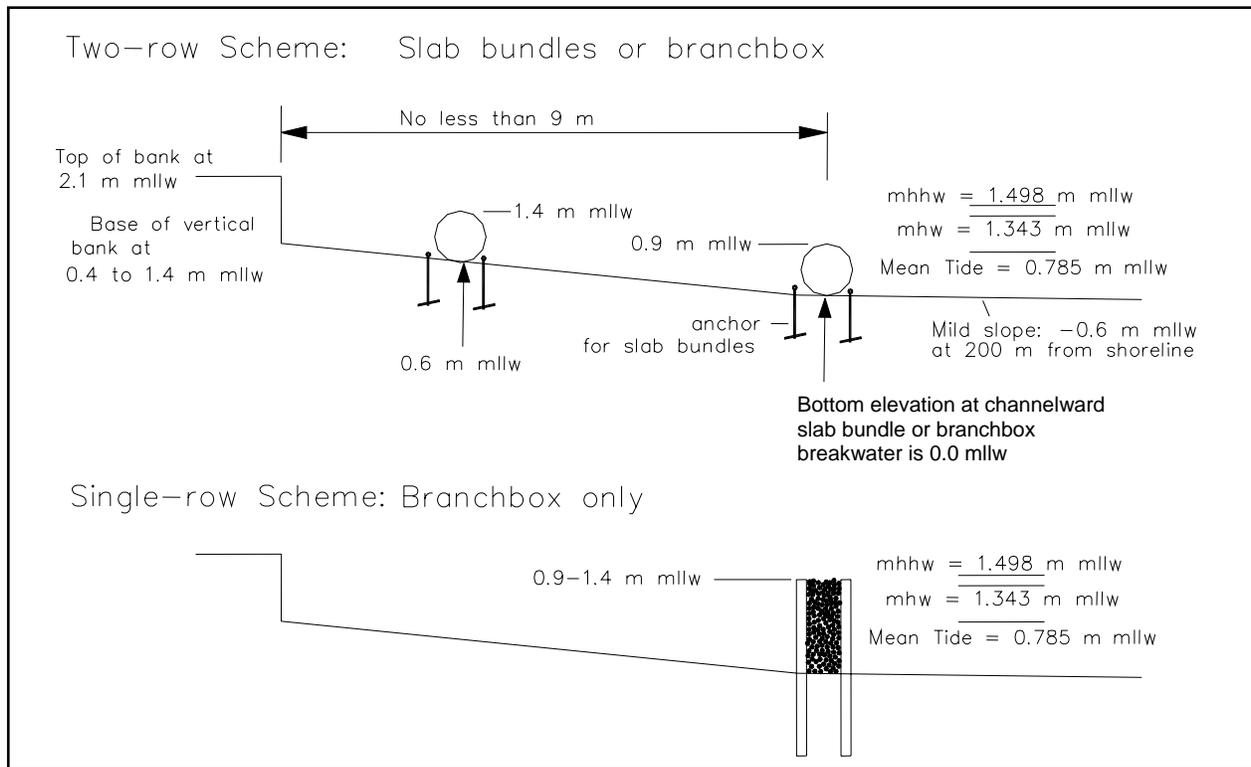
Figure 13. Cross sections of proposed branchbox or slab bundle breakwaters at Martinez

Because of the large tidal variation, the top of the breakwater should be at or above mhw to achieve significant energy dissipation at high tides. For slab bundles, a two-row protection scheme is proposed to address wave effects because a single-row of slab bundles cannot be built and handled that is large enough to protect from high tides. The first row will be placed with top elevation at slightly greater than the mean tide level. The second row, located on the foreshore slope between the first row and the vertical bank, will be placed with top elevation between mhw and mean higher high water (mhhw). Branchbox breakwaters will also be built in the two-row protection scheme and using a single row built to a top elevation of somewhere between the tops of the first and second rows in the two-row scheme.

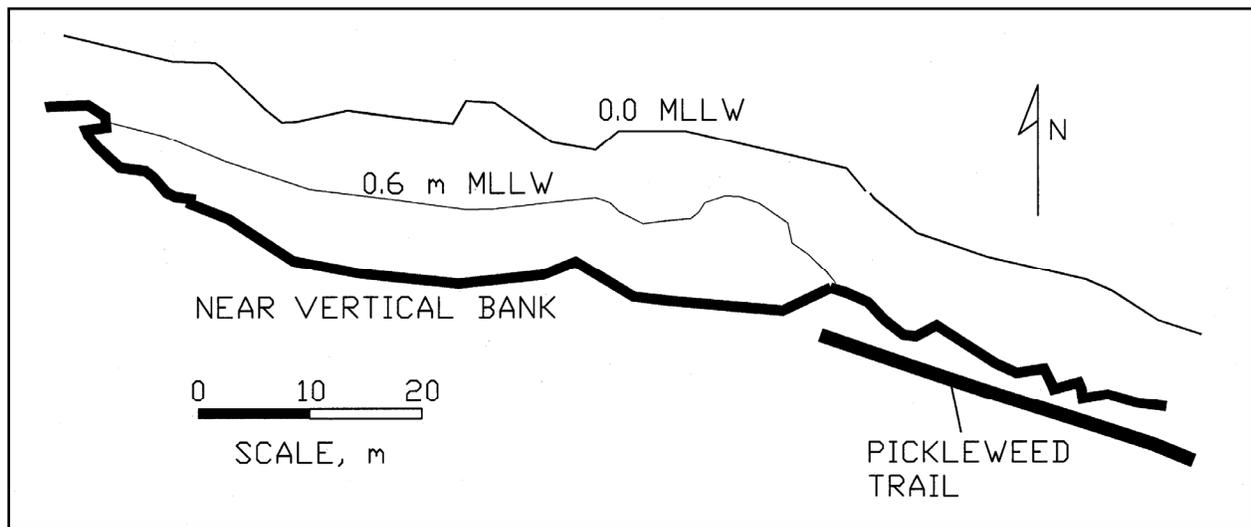
Figure 14. Location and alignment of mllw contour and 0.6-m mllw contour at Martinez

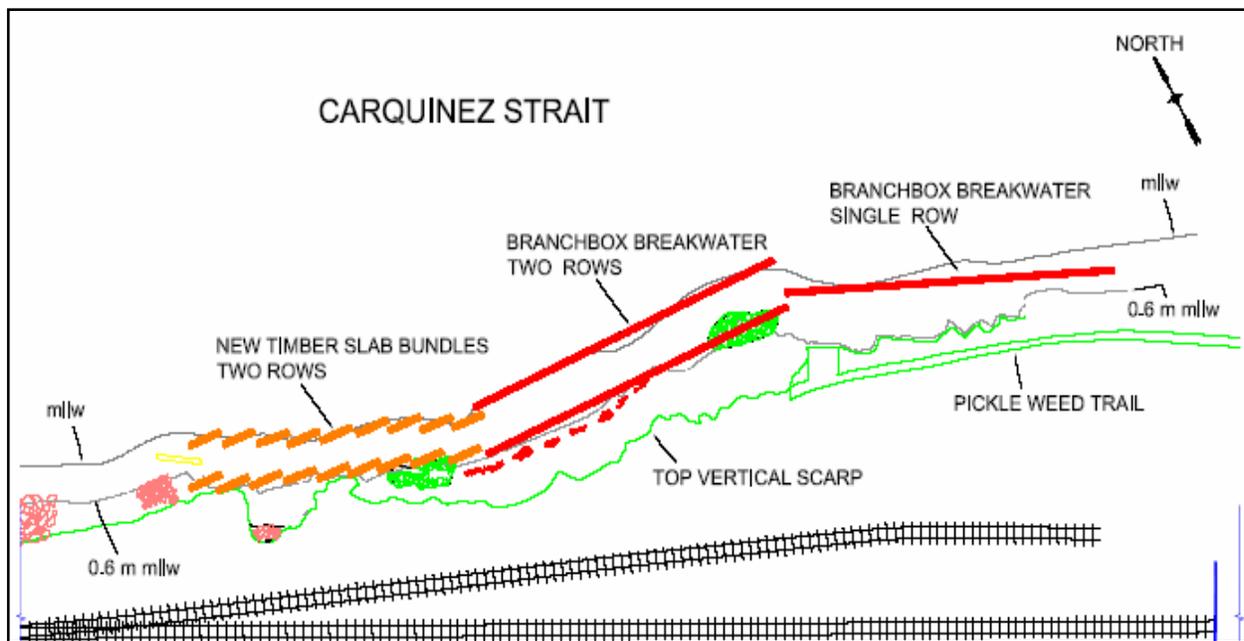
Figure 15. Layout of proposed protection at Martinez
